NATIONAL TRANSPORTATION SAFETY BOARD

MATERIALS LABORATORY FACTUAL REPORT

Report No. 08-108

Place : St. Louis, Missouri
Date : September 28, 2007
Vehicle : MD-80
NTSB No. : DCA07MA310
Investigator : Lorenda Ward

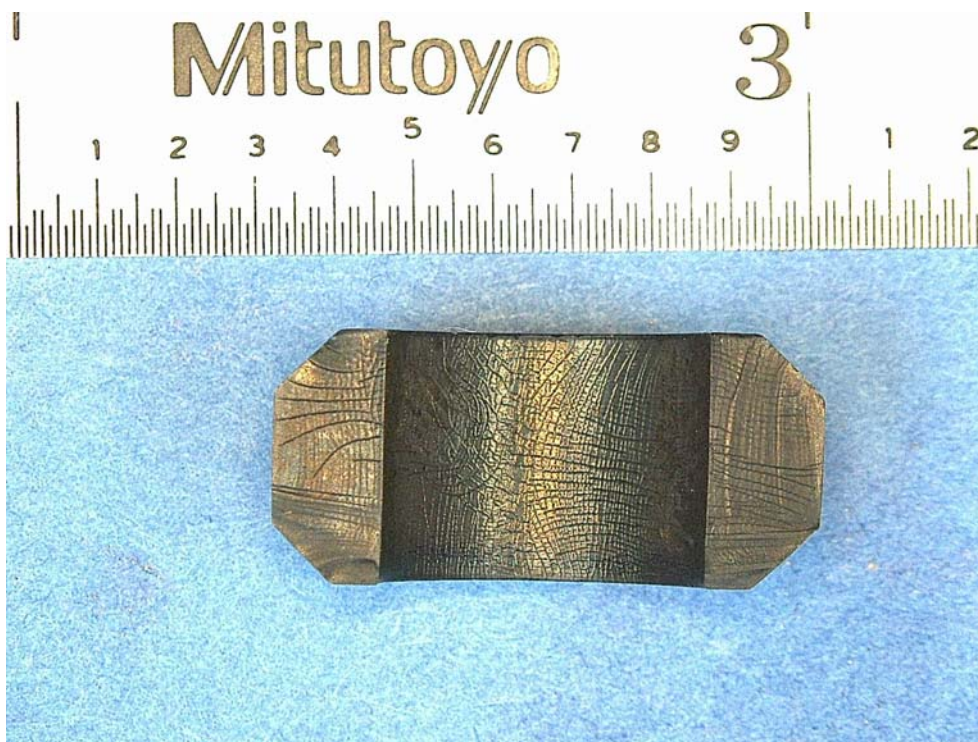
After the initial three minute exposure the packing was still flexible but slightly harder than what it was before the test. Additionally, the surface of the packing developed check marks and fine lines as depicted in figure 3. Measurement of the sample's weight indicated that it had lost 4.37 percent of its mass.

Figure 3: Elastomeric packing (half) after 3 minute exposure to 600 degree F oven

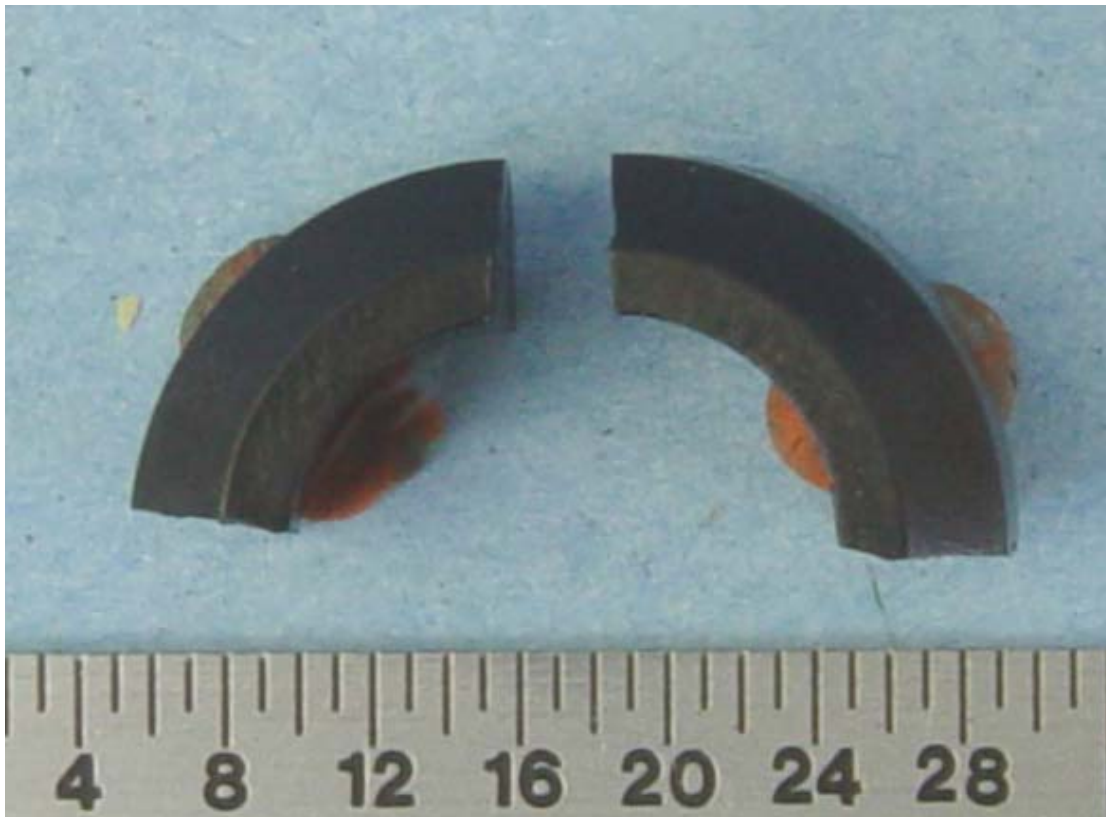
The sample was reinserted into the oven for an additional 6 minutes at 600 degrees Fahrenheit and then removed for inspection. The sample had become hard and brittle and the check marks had become more pronounced. Gently squeezing the sample caused it to

fracture in the middle (figure 4). Measurement of the sample weight indicated that it had lost 5.76 percent of its original weight.

Figure 4: Fractured elastomeric packing after squeezing. The packing had been exposed for a total of 9 minutes to the 600 degree F environment.

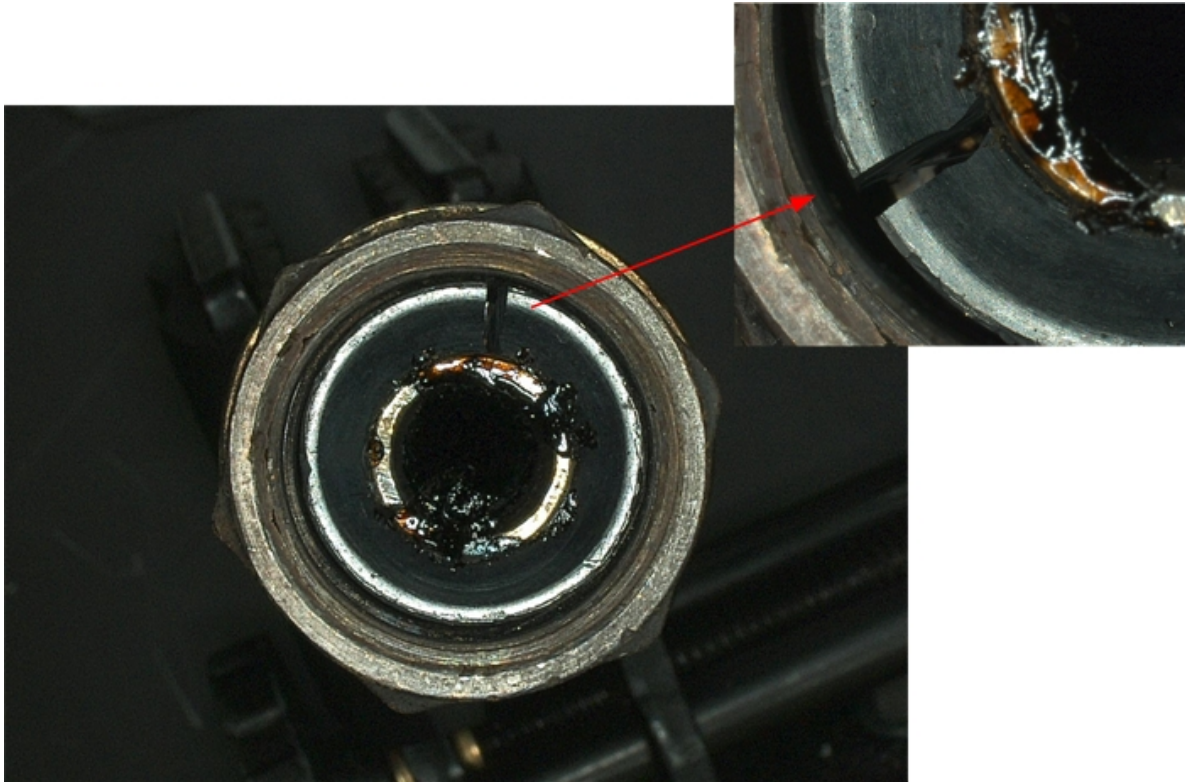
The next oven test consisted of assembling the primary fuel manifold fitting with a packing and packing retainer by following the assembly procedure outlined in the maintenance manual and then exposing it to a 600 degree Fahrenheit environment in the laboratory oven for two hours. The assembly of the fitting consisted of lubricating the packing and retainer with petrolatum, assembling the fitting and then tightening to a torque of 35 inch-pounds. The assembled fuel fitting was then secured with safety wire. The fitting was pressurized with air and found to be airtight. After the fitting was exposed in the oven for two hours it was removed and found to no longer be airtight. The fitting assembly felt like there was some play at the union and upon disassembly it was found that the packing retainer had melted and the packing was fractured (Figure 5).

Figure 5: Fractured packing in fuel fitting assembly after 2 hour oven test at 600 degrees Fahrenheit

After removing the fractured packing from the fitting it was found to be hard and brittle resembling the condition of the packing in the first oven test after the 9-minute cumulative exposure.

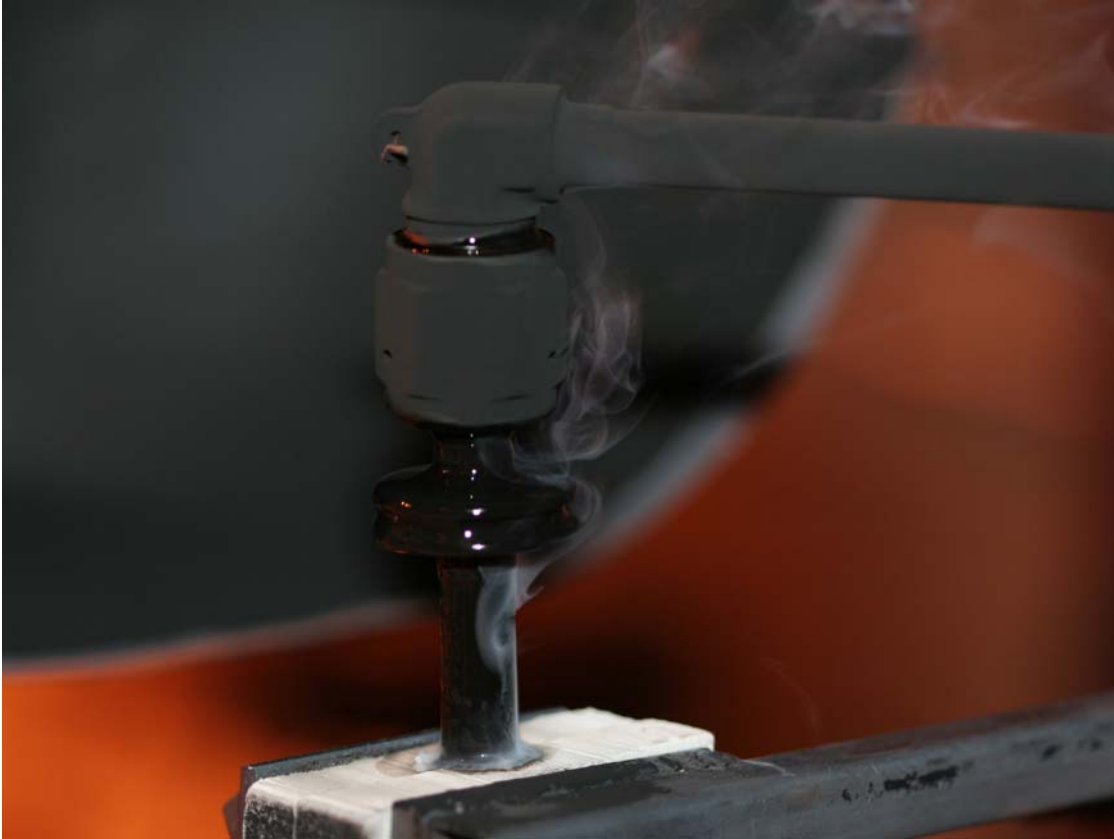
The first test employed a used packing and packing retainer that had been previously in service for 11,115 hours. At the conclusion of the five-minute period the fitting showed evidence of a leak, which then became more pronounced when the fuel recirculation was transitioned to static pressure at 300 psi (figure 8). The leak occurred at the end of the test and did not cause a fire. Disassembly of the fitting revealed that the packing had become friable along its outer perimeter, exhibiting a tendency to crumble when handled (figure 9). The packing had not hardened throughout as in the oven tests and remained somewhat pliable. The packing retainer was partially melted and had separated at one section of its circumference (figure 10).

Figure 8: Fuel fitting leaking under 300 psi static pressure at the end of the test.

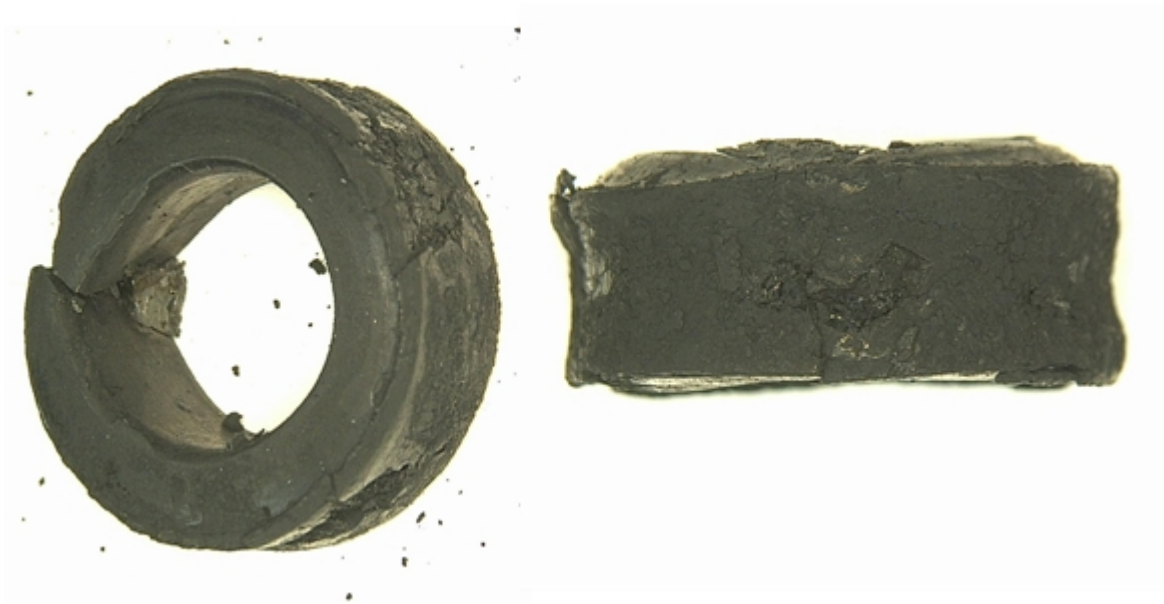
Figure 9: Two views of the packing removed from the fuel fitting after the first oil burner test

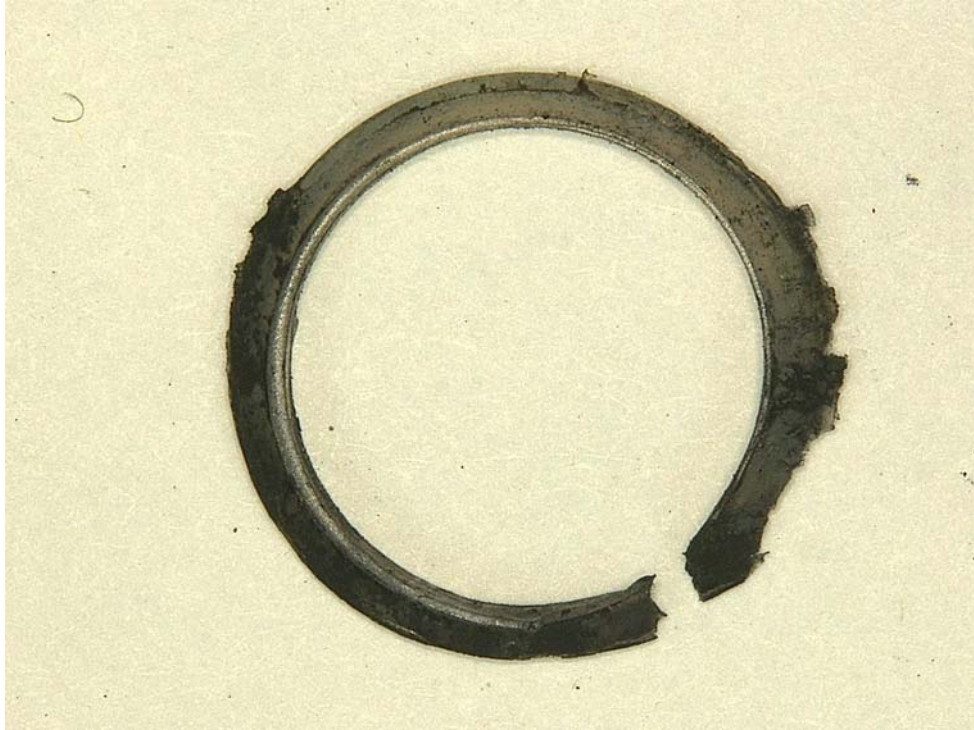
Figure 10: Nylon packing retainer after the first oil burner test

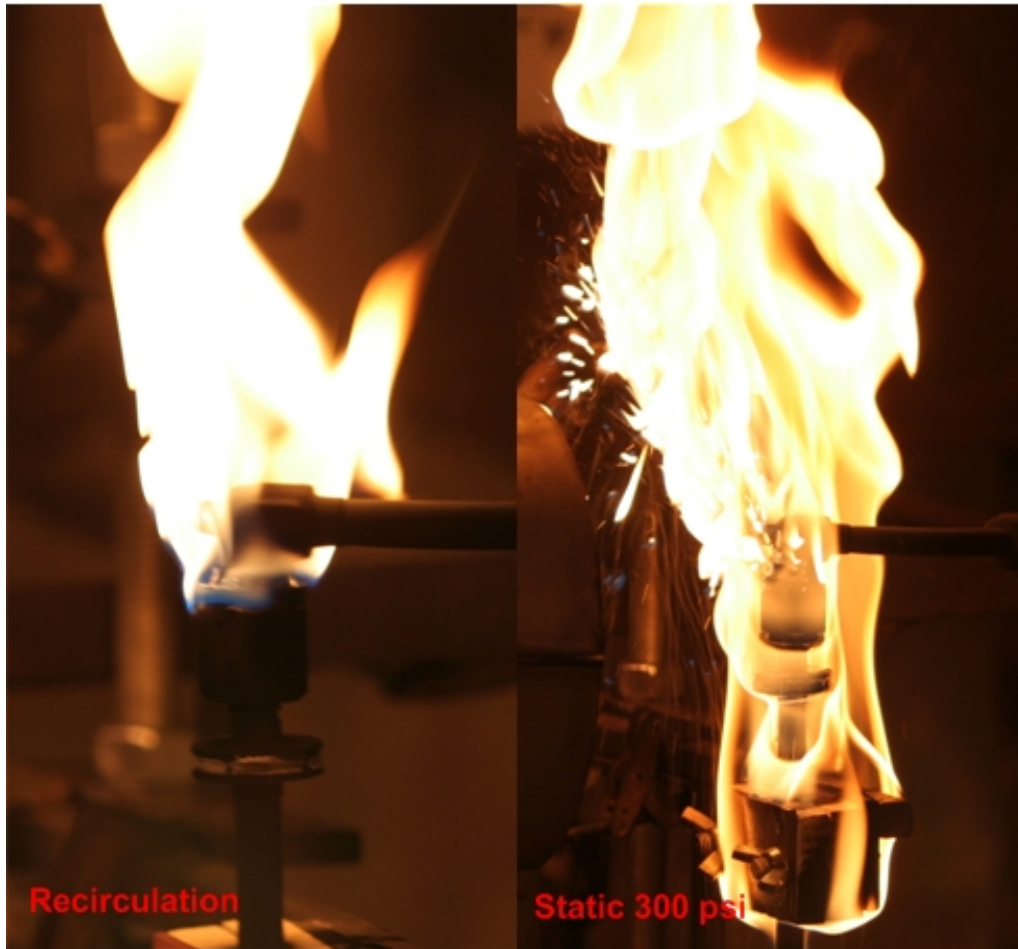
The second test was done using a new packing and new packing retainer. The procedure was the same as described above. At the conclusion of the 5-minute period when the burner was shut off the fuel fitting was on fire, indicating that it had begun to leak before the test was over. When the fuel recirculation was stopped and the static pressure was imposed, the fire became significantly larger and flaming droplets of fuel were observed (figure 11). After disassembly of the fuel fitting, the packing exhibited the same characteristics as were observed in the first oil burner test, although slightly less severe (figure 12). The packing retainer had discolored and exhibited minor indications of melting but had not separated as in the first oil burner test (figure 13).

Figure 11: Fuel fitting at the conclusion of the second oil burner test, 0.3 GPM recirculation at 20 psi and static pressure at 300 psi shown

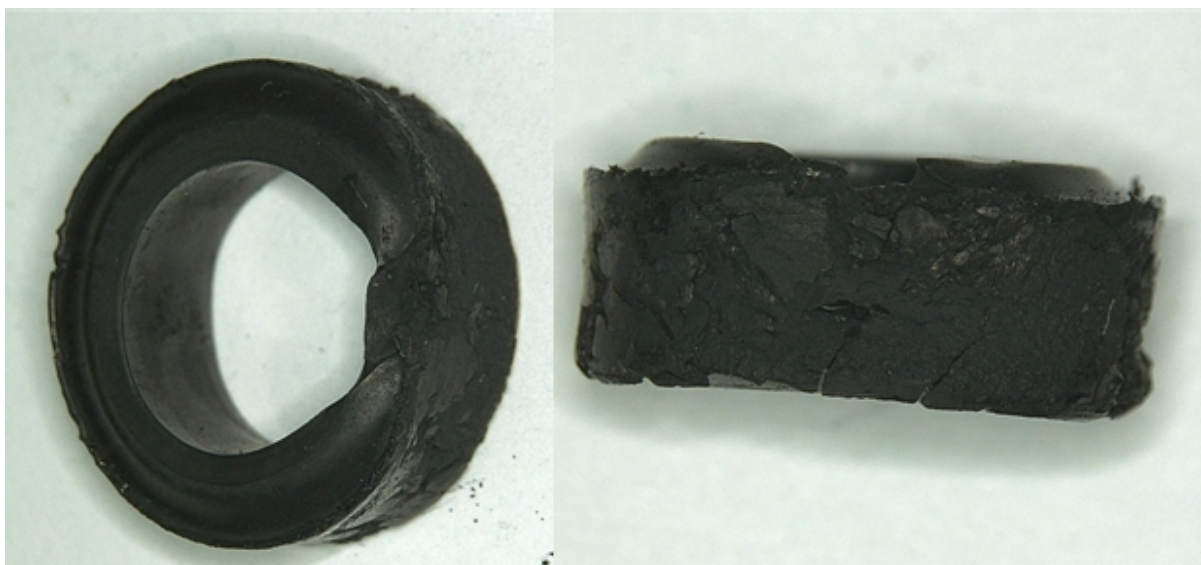
Figure 12: Two views of the packing removed from the fuel fitting after the second oil burner test

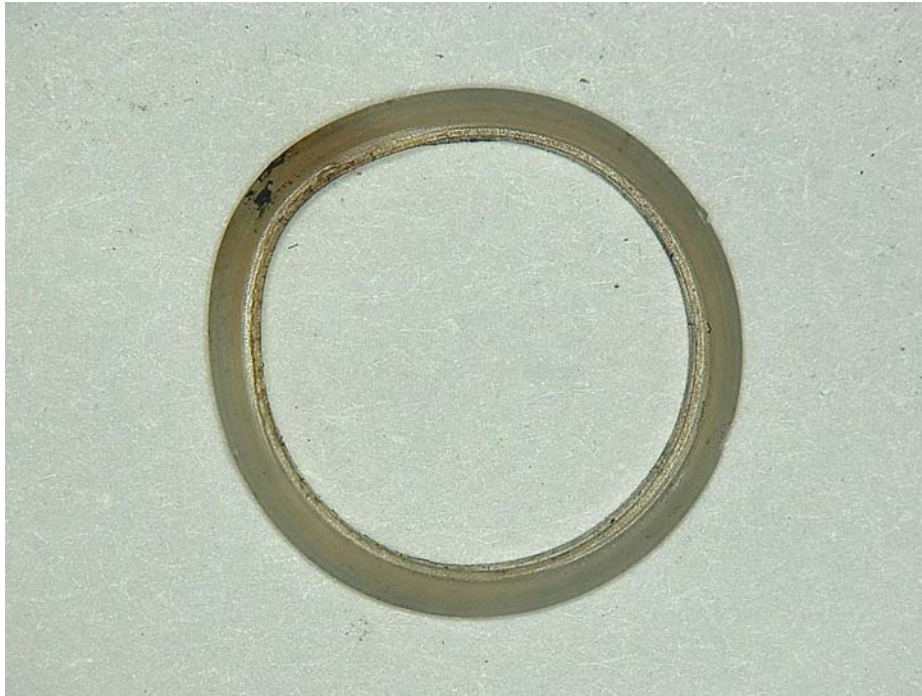
Figure 13: Nylon packing retainer after the second oil burner test

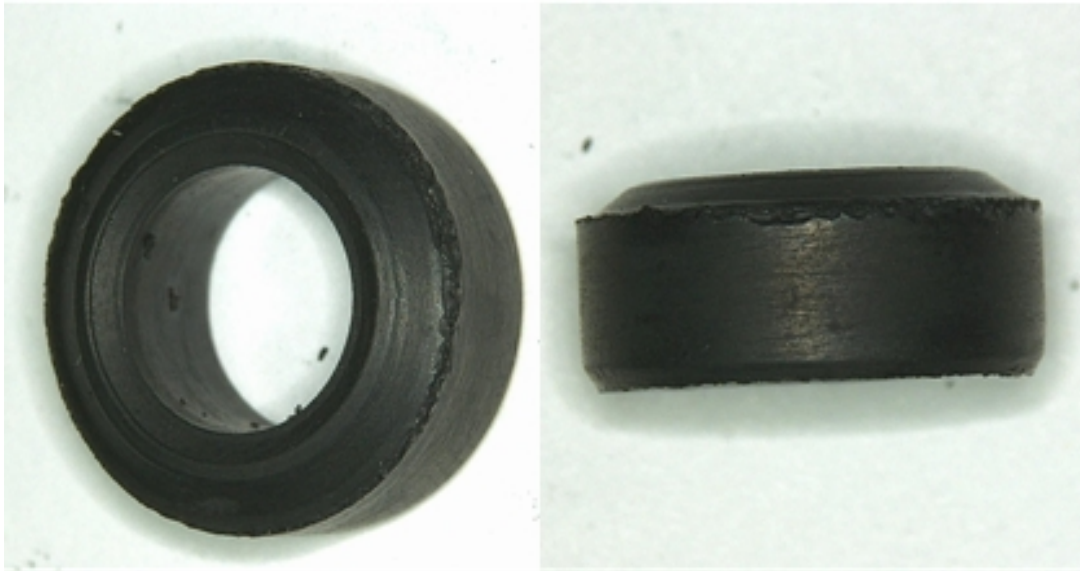
front of the heater and the static pressure was re-applied. The fuel fitting still did not leak. Disassembly of the fuel fitting revealed that the packing had not become friable and susceptible to crumbling when handled. The packing was still flexible and only exhibited what could be described as a ragged edge along its outer circumference (figure 15). The outer circumference also exhibited some minor striations. The packing retainer did not have any signs of melting or other damage (figure 16).

Figure 15: Two views of the packing removed from the fuel fitting after the first combustion heater test

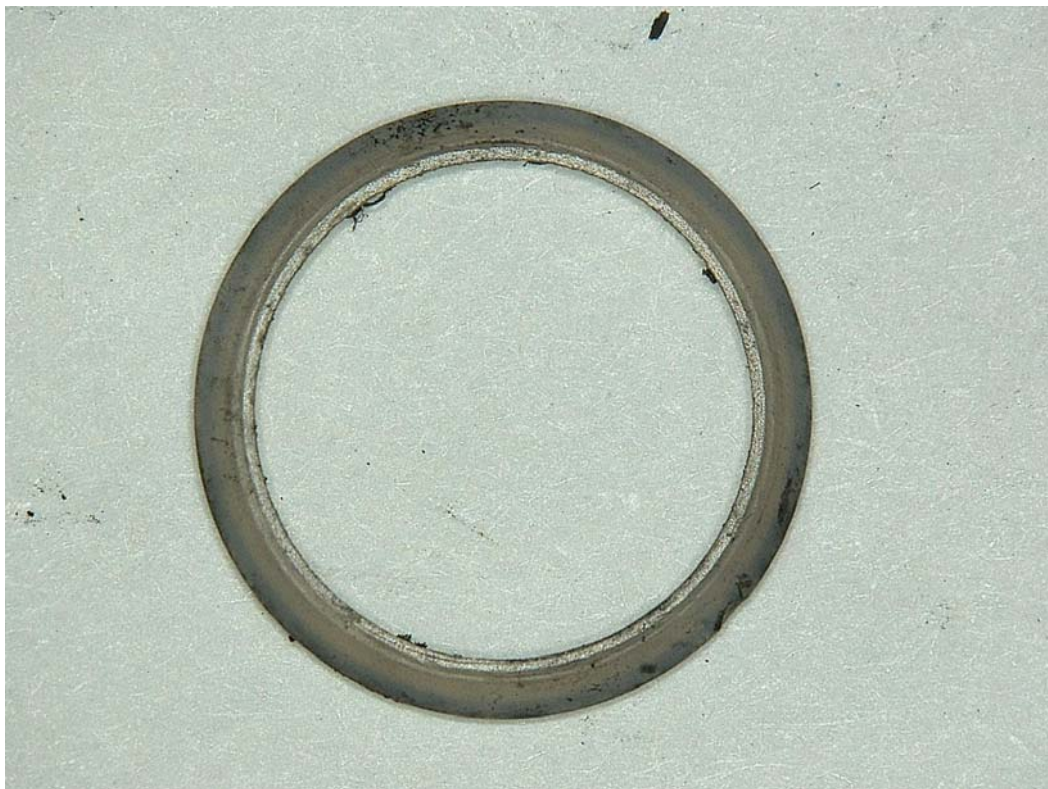
Figure 16: Nylon packing retainer after the first combustion heater test

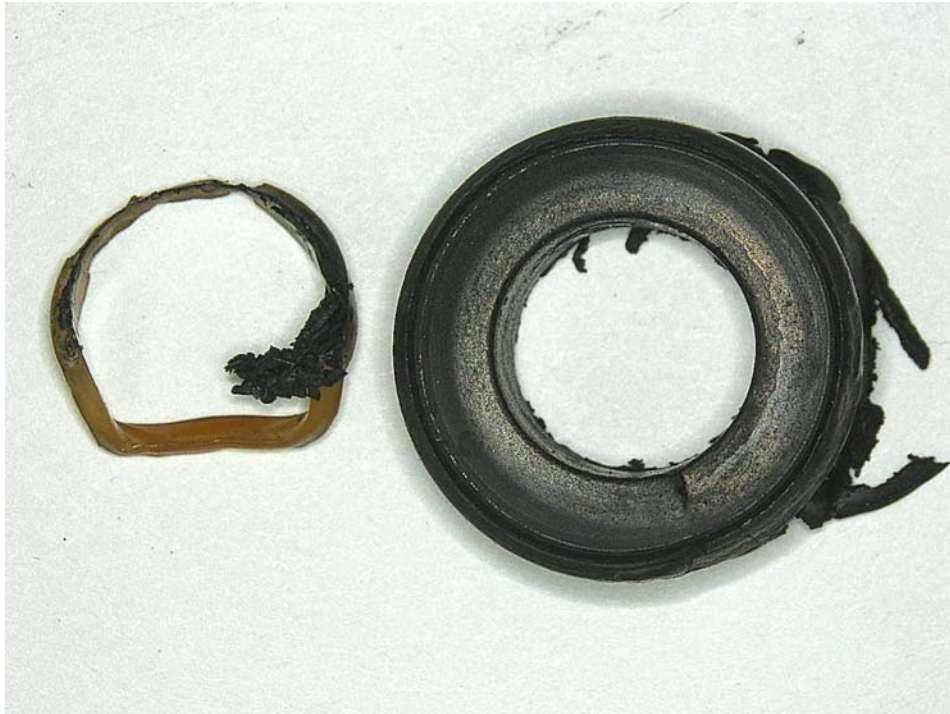
temperature was measured. For the duration of this test the fuel fitting was maintained at the 300-psi static pressure and fuel recirculation was not done. The fuel fitting was exposed to the heater for ten minutes after which it was removed and checked for leaks. The fuel fitting was found to not have any leaks at the end of the test. After disassembly the packing resembled the condition of the packing after the first combustion heater test but the ragged edge was significantly more pronounced especially on one side of the packing. There was a slightly ragged edge on the inner circumference of the packing also. The packing retainer was severely melted and deformed and had taken on a brown color. Both the packing and packing retainer can be seen in figure 17.

Figure 17: Packing and packing retainer after disassembly of the fitting at the conclusion of the second combustion heater test

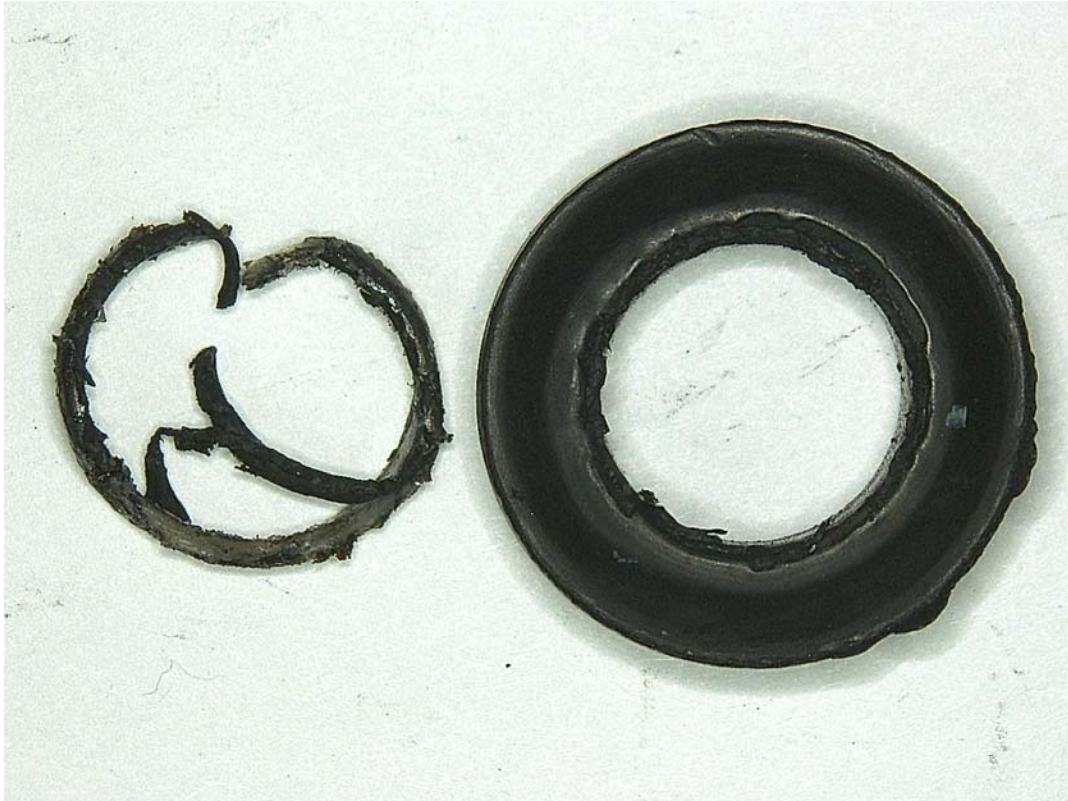
The third combustion heater test was done using a new packing and new packing retainer. The fuel fitting was pressure tested for leaks by subjecting it to the 300-psi static pressure; it did not leak. After the heater had warmed up for two minutes the fuel fitting was placed in front of the heater at the predetermined location where the 600 degree Fahrenheit temperature was measured. In this test the fitting was tightened to a torque of 15 inch-pounds, which was half of the manufacturer's specification. For the duration of this test the fuel fitting was maintained at the 300-psi static pressure and fuel recirculation was not done. The fuel fitting was exposed to the heater for ten minutes after which it was removed and checked for leaks. The fuel fitting was found to not have any leaks at the end of the test. After disassembly of the fitting the packing was found to have a ragged inner and outer circumference, and it was still flexible. The inner circumference was more ragged than in the previous combustion heater test. The packing retainer was found to be severely

melted and had become deformed but it had not turned brown. Instead it had portions that had become charred and were brittle, taking on a black appearance. Both the packing and packing retainer can be seen in figure 18.

Figure 18: Packing and packing retainer after disassembly of the fitting at the conclusion of the third combustion heater test
