NATIONAL TRANSPORTATION SAFETY BOARD

FIRE INVESTIGATION FACTUAL REPORT

Report No. 09-003

Place : San Francisco, California
Date : 6/28/2008
Vehicle : Boeing 767-200 Freighter
NTSB No. : DCA08MA076
Investigator : Lorenda Ward

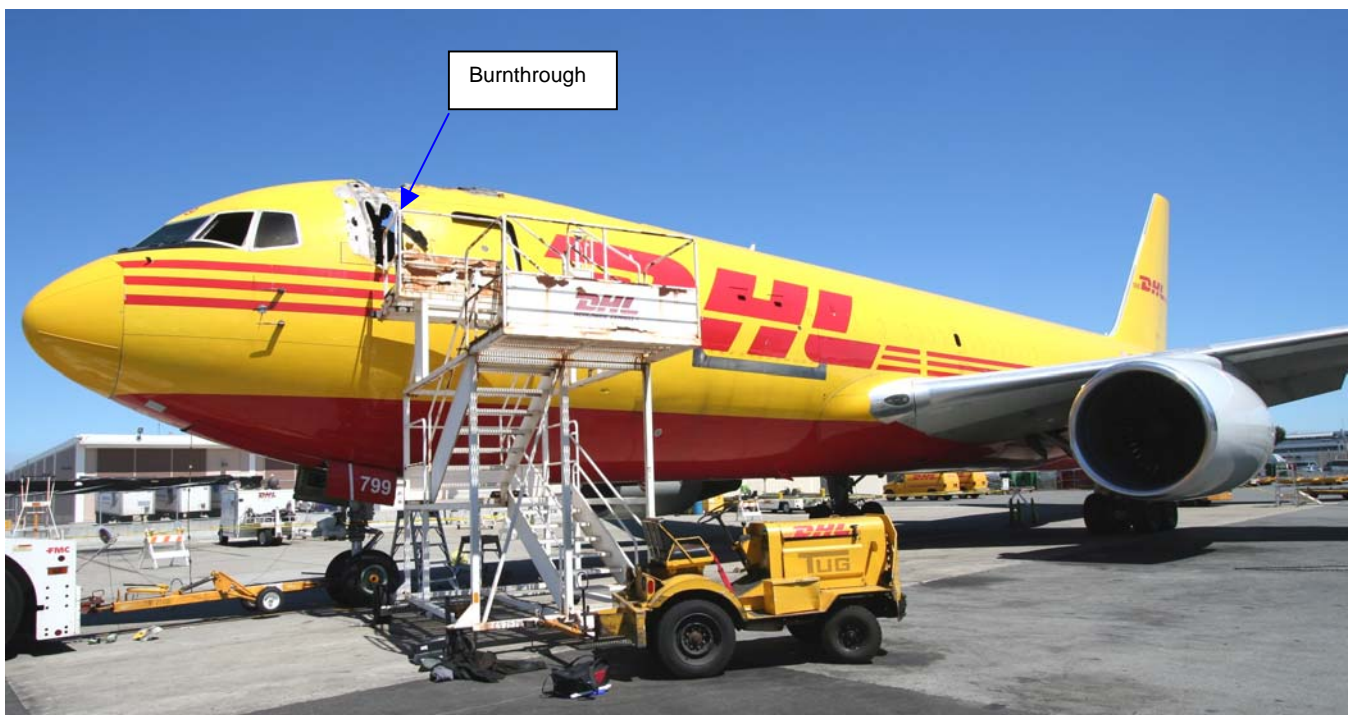
The exterior of the aircraft when viewed from ground level (figure 1) exhibited fire damage in an area between the left flight deck window and the L1 door. This damage was blistered paint and melted fuselage skin which created an opening into the aircraft. When using a lift truck and viewing the aircraft from above, large areas of crown burn-through were observed (Figure 2). The burn-through areas were centered over the lavatory and the supernumerary compartment of the aircraft. No other areas of the aircraft exterior exhibited any signs of fire damage.

Figure 1: Exterior view of the accident aircraft showing burn-through damage at lavatory location.

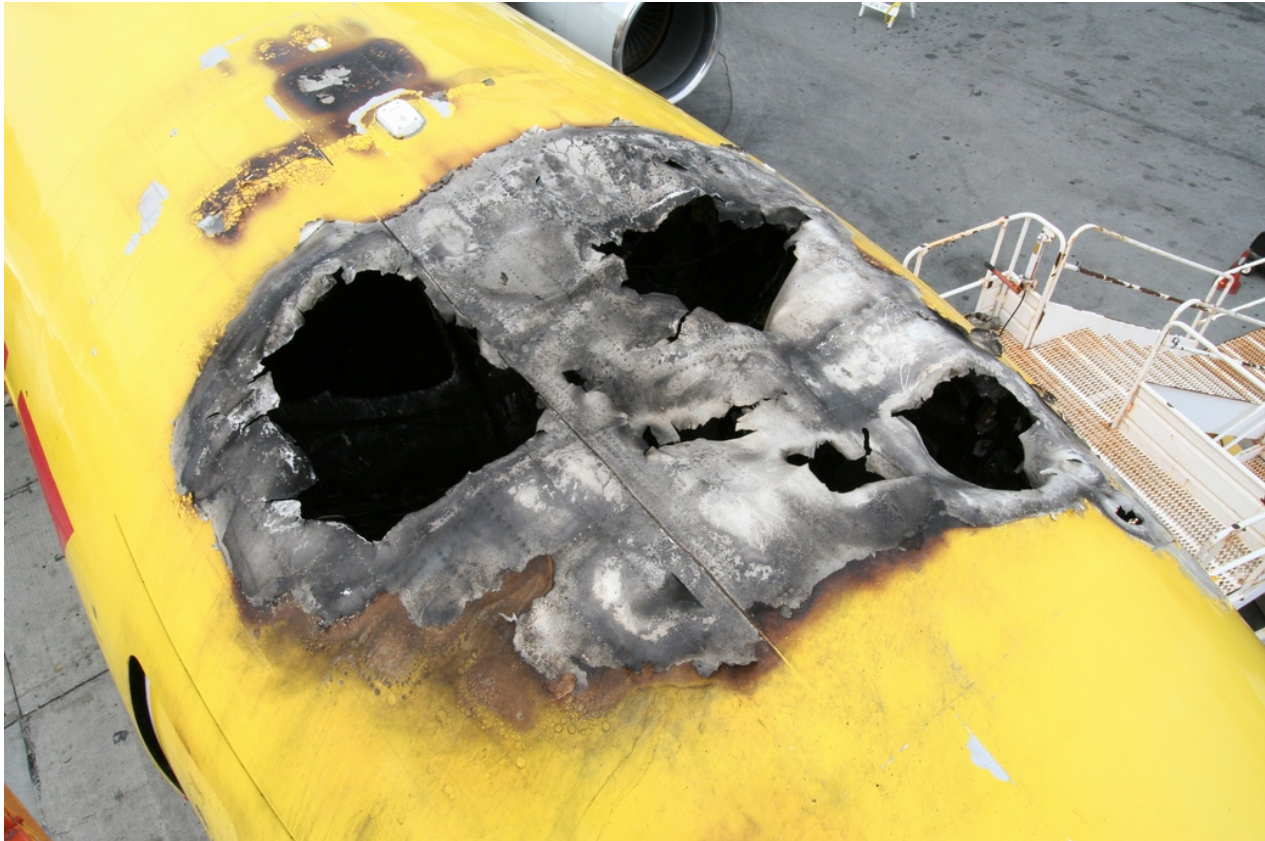
Figure 2: Burn-through on crown of accident aircraft centered over the supernumerary compartment

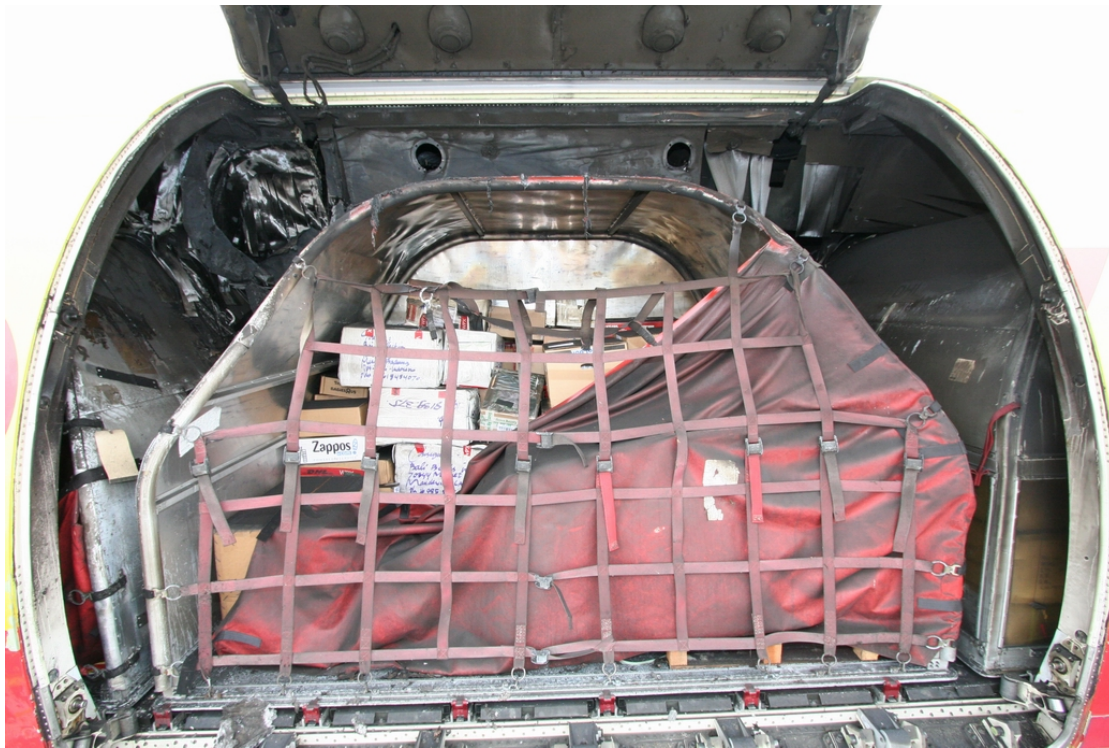
The main deck cargo door was opened to inspect the interior of the cargo compartment. The cargo position at the location of the door is cargo position A2L as seen in the diagram of figure 3. The container at this position (figure 4) had soot adhering to its surfaces, with a heavier concentration along the top half of the container. The contents of this container had a light coating of soot on them but no other type of fire damage.

Figure 4: Container A2L in position at cargo door location

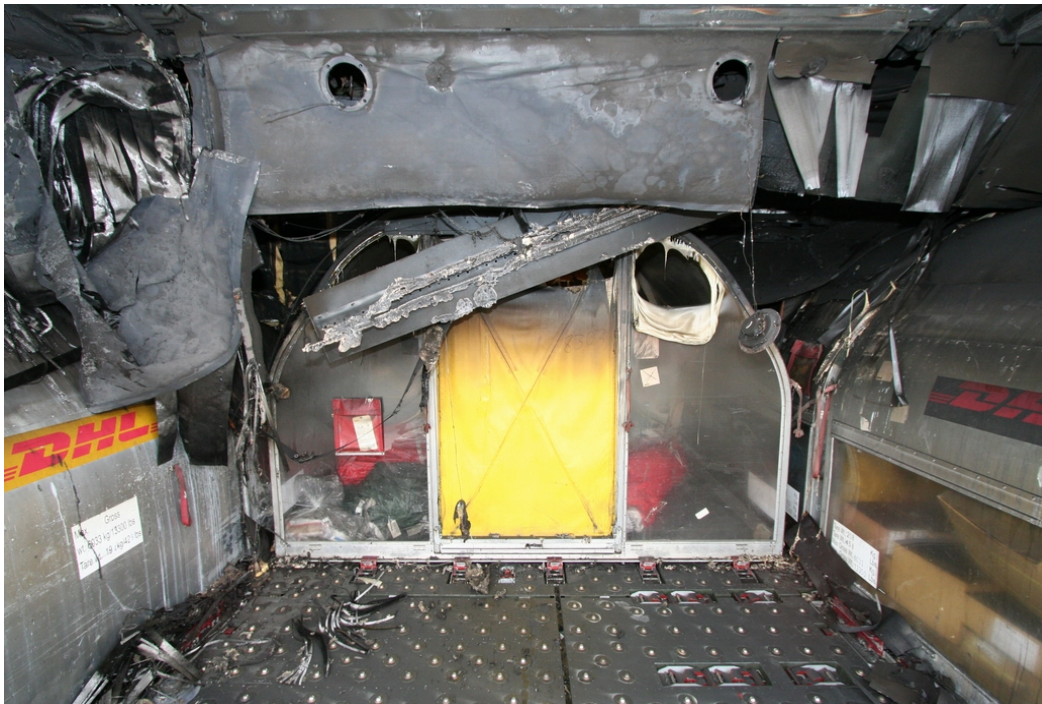
Container A2L was removed to inspect container A2R. This container can be seen in figure 5 below. This container exhibited external thermal damage, more heavily concentrated along the top half, but no fire damage to the packages inside, except for a light soot coating. The top two feet of this container exhibited areas of melted clear Lexan window material and the top of the rollup door was charred. This container was removed from the aircraft to examine containers A1L and A1R. The cargo liner above the number two cargo loading position was heavily fire-damaged and mostly missing or hanging vertically. From the number two cargo position, the aft-facing portions of the cargo containers in position one could be examined. The backs of these containers can be seen in figure 6. These containers had sustained thermal damage and soot accumulation to their upper portions. Viewing these containers from the forward facing side, by entering the cargo compartment from the supernumerary compartment, revealed that the front and top portions of these containers had sustained thermal damage resulting in burn-through and melting of the forward facing container walls (figure 7). Both containers were melted from a height of 55 inches above the floor in the center of the cargo compartment extending outboard and up to the top of the container on the outboard edges. The A1R container was loaded with rugs, which did not appear to have been involved in the fire (figure 8). The rolled up rugs had some external damage to their packaging in the form of

Figure 5: Container A2R in position inside the main deck cargo compartment

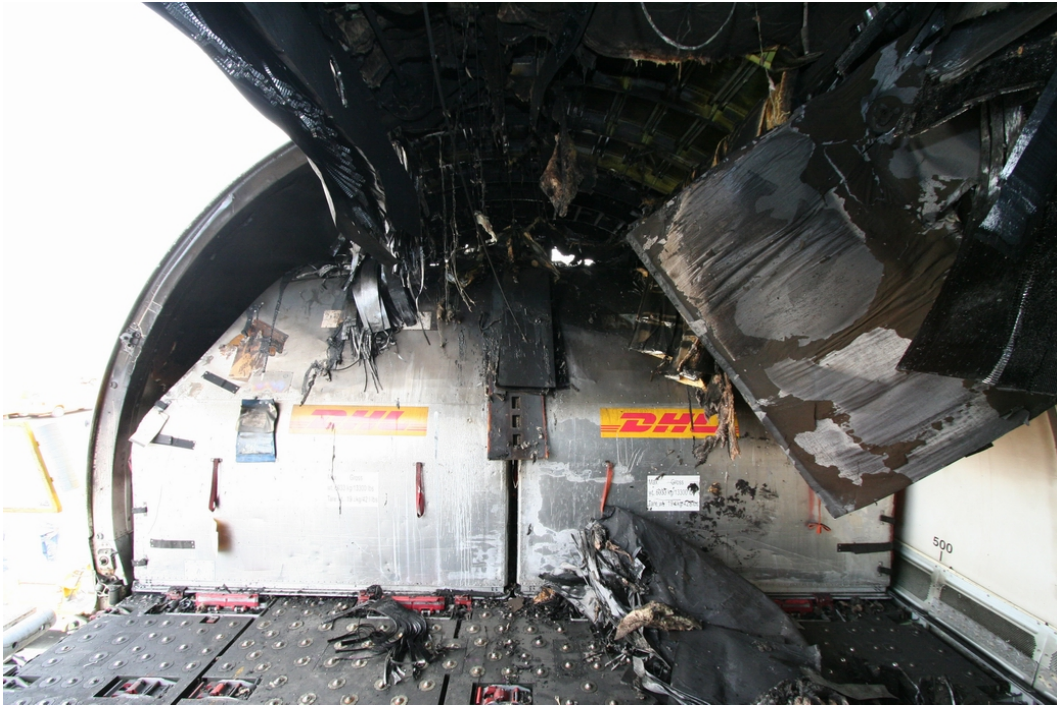
Figure 6: Aft facing portions of containers A1L and A1R

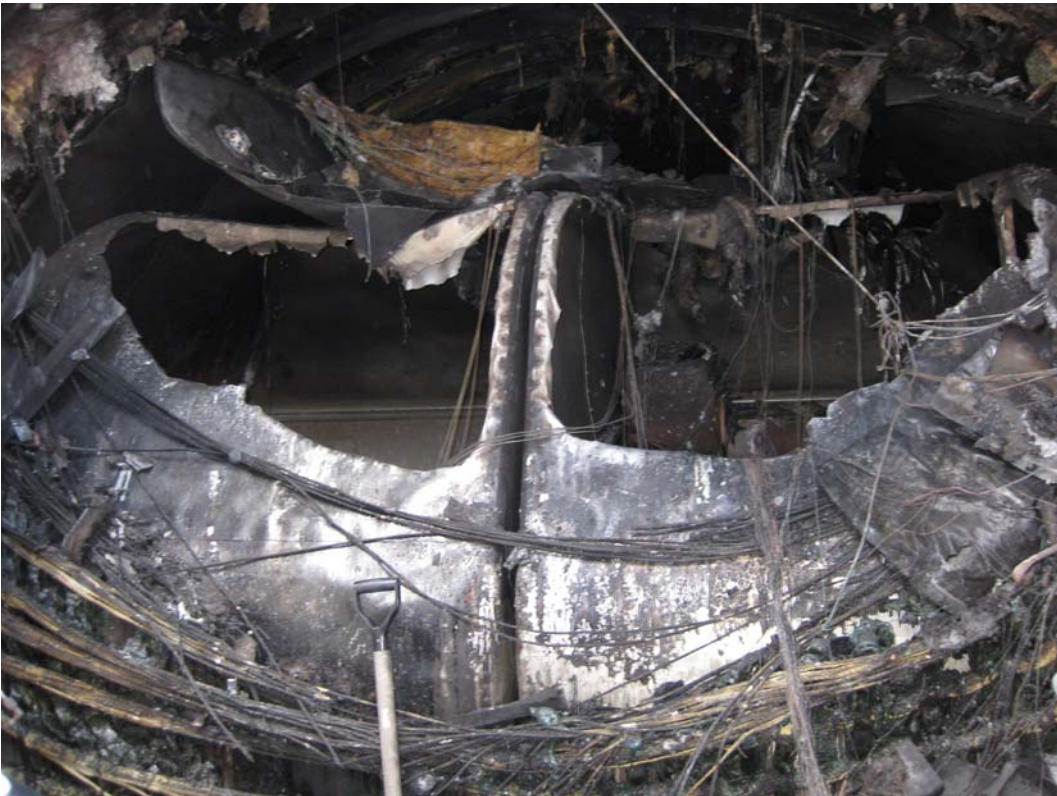
Figure 7: Forward facing portions of containers A1L and A1R

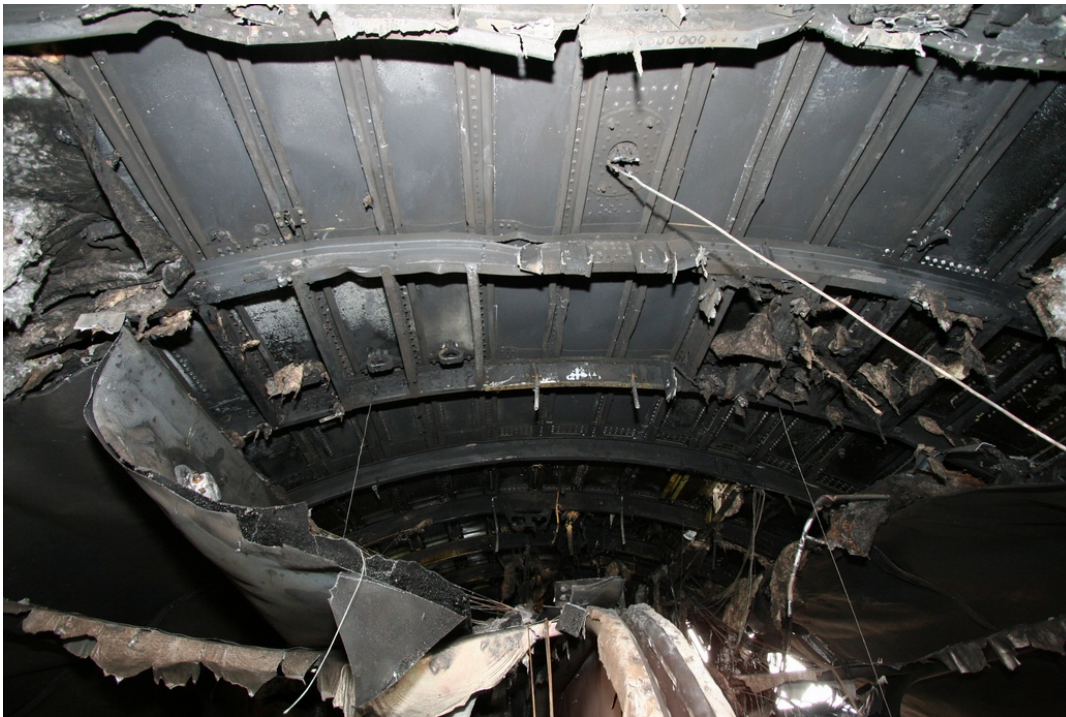
Above the number one cargo position and extending aft, the cargo liner along the ceiling was mostly missing (figure 9). Portions of charred cargo liner material were hanging vertically from the ceiling in various locations.

Figure 9: Ceiling cargo liner missing above cargo positions 1 and 2

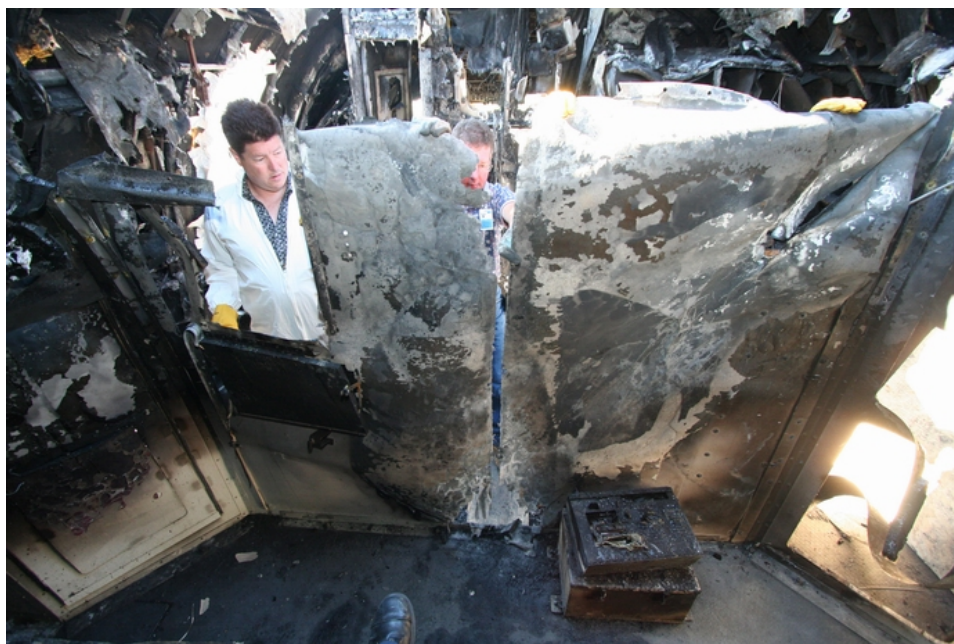
the fallen center section was raised back into the upright position (figure 11), it extended to a height of 77 inches above the cabin floor. The forward facing fiberglass face of the center section of the wall was charred from floor to ceiling and detached and/or missing in most places. The honeycomb inner section of the center section of the wall was either missing or charred in most locations. An 18 inch wide by 18 inch high section on the lower edge of the middle of the lateral wall was burned away. The left and right lateral wall sections were not connected. An aluminum strip normally connects the two sections but was melted away on the accident airplane. There is normally an upper section of the center wall that extends up and aft to connect to the ceiling of the cargo compartment near the top of the 9G cargo net. Some sections of this material were observed partially attached to parts of the center wall and partially attached to some sections of cargo liner ceiling material that had also collapsed from its normal position.

Figure 11: Aft facing side of smoke barrier wall. The wall is being held up in place after the loose fire debris had been removed from the area.

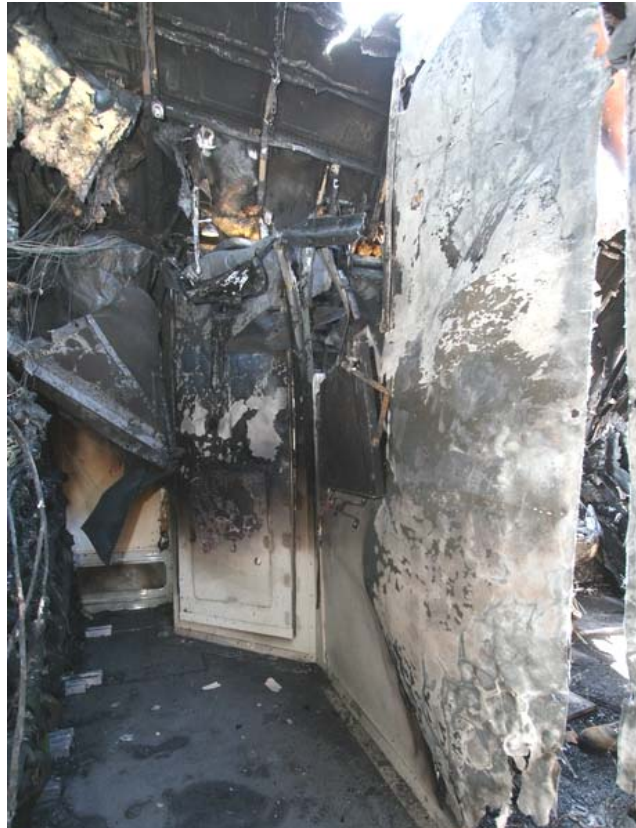
Figure 12: Left side of smoke barrier wall

Both the left side of the angled outboard section (figure 12), which contained the cargo compartment entry door, and the right side of the angled section (figure 13), which contained an upper and lower blowout panel, were still standing. The forward facing fiberglass face of these wall sections was charred from top to bottom. The aft facing fiberglass face was charred in the upper section and sooted but unburned in the lower section. The right, aft angled, portion of the smoke barrier wall in this area had undamaged cargo liner from the floor up to approximately 35 inches on the front and 50 inches on the rear. The cargo liner was charred above the undamaged portion and further up it was detached from the structure and hanging down exposing the insulation material behind. The insulation's face sheet was burned off and the fiberglass batting was blackened. The fire damage to this wall sloped upward from the front to the rear. The same fire damage was observed on the left side aft angled portion of the smoke barrier wall with approximately the same proportions of unburned, charred and detached cargo liner. The door located on the left portion of the wall connecting the main deck cargo area to the supernumerary area was undamaged at the base and showed progressively more charring going towards the top. The blow out panels on the right side portion of the smoke barrier wall retained the decorative face sheet on the aft face and were charred on the forward face. The blow out panels were found detached from the smoke barrier wall. Overall, the smoke barrier wall was more heavily damaged in the center with the damage extending up and outwards. The galley mat in this area between the smoke barrier wall and 9G net was intact and retained its non-slip texture. In the middle of the floor in this area there was some debris adhering to the galley mat at the base of the smoke barrier wall near the aircraft's centerline. No sign of blast damage or an overpressure event was observed in this area.

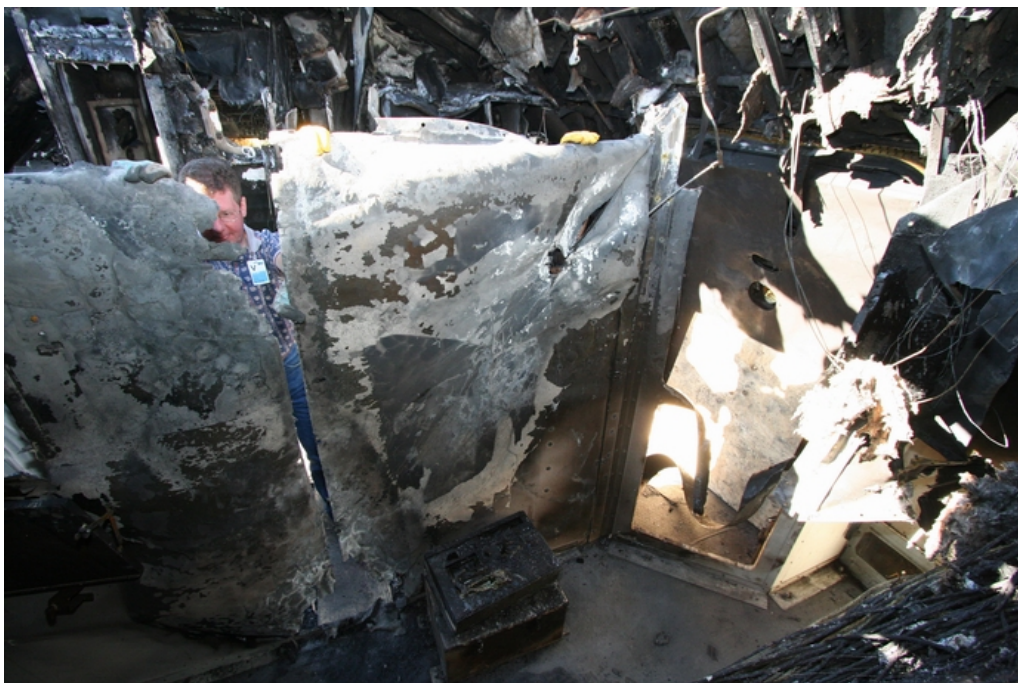
Figure 13: Center and right side of smoke barrier wall

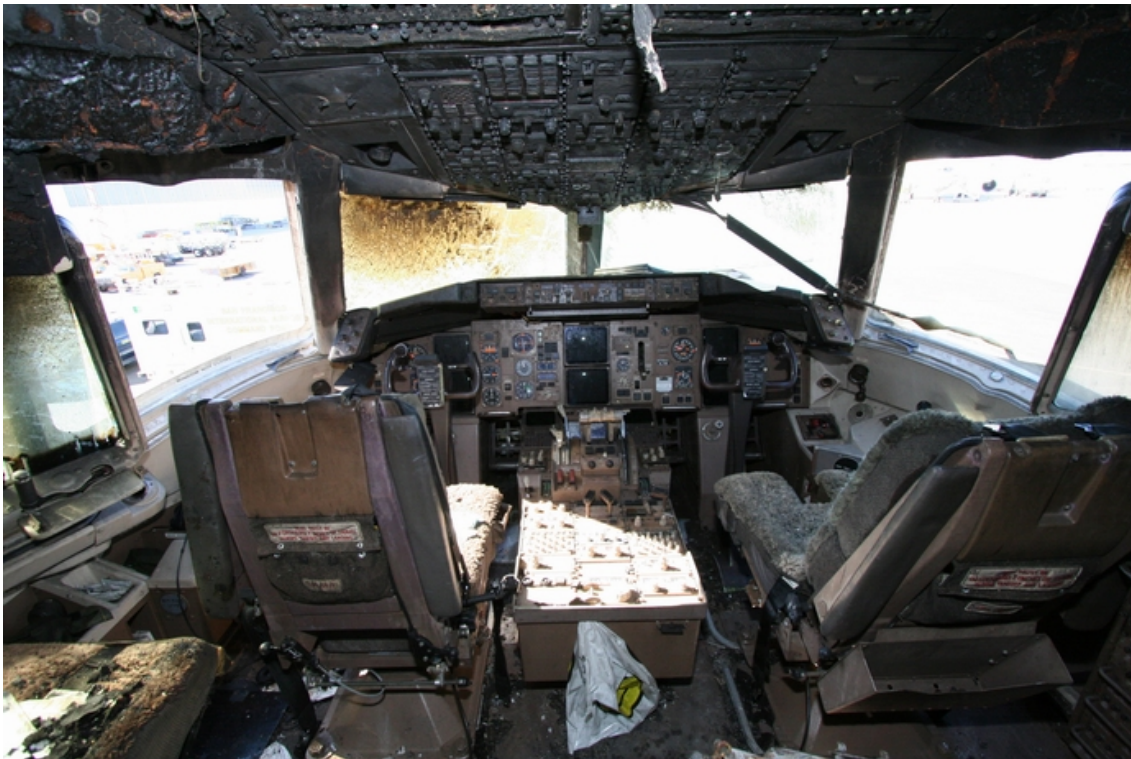
In the flight deck, the captain's and first officer's escape windows were found in the open position (figure 14). The ceiling area of this compartment was covered with soot, as were almost all of the other surfaces inside the flight deck (figures 15, 16). Heavy thermal damage was more notable in the aft portion of the flight deck ceiling. The flight deck ceiling housed the circuit breaker panels (figure 17). The aft most sections of the panels had been exposed to high temperature and some of the breakers had fallen down onto the floor and onto the two seats behind the captain's and first officer's seats. The bulkhead separating the flight deck from the supernumerary area of the aircraft was damaged by fire. The fire damage was in the form of charring and discoloration of the panels. This damage was concentrated along the upper portions of this bulkhead and did not extend all the way down to the floor. The thermal damage extended approximately 3 feet downwards from the ceiling. The remaining distance, from the thermal damaged area down to the floor, was covered with a light soot coating but was otherwise intact. On the left side³ of this bulkhead wall, outboard of the door, was a small area of burn-through approximately one foot in diameter. There was also a small area of burn-through in the bulkhead wall to the right of the flight deck door up towards the ceiling. The fire damage indicated that the fire entered the flight deck from the aft of the aircraft and worked its way from the flight deck ceiling forward and downwards. No sign of blast damage or an overpressure event was observed in this area.

Figure 14: Flight deck of accident aircraft

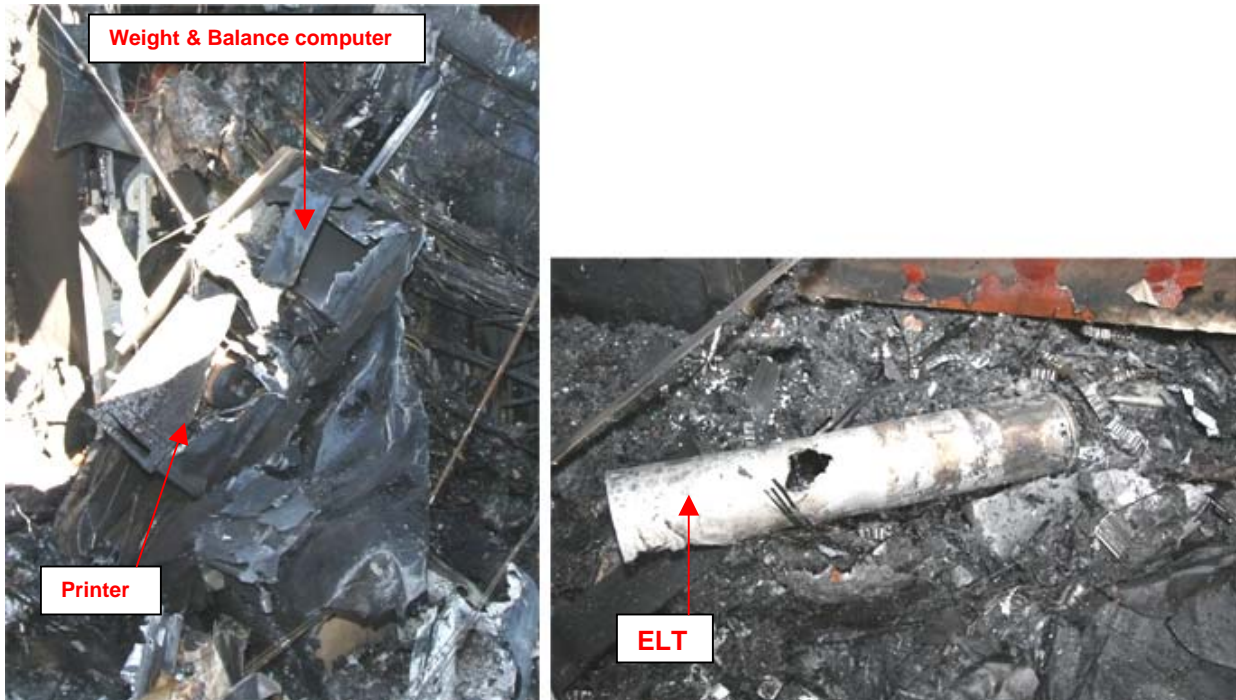
Figure 21: Remains of Weight & Balance computer, Printer and ELT

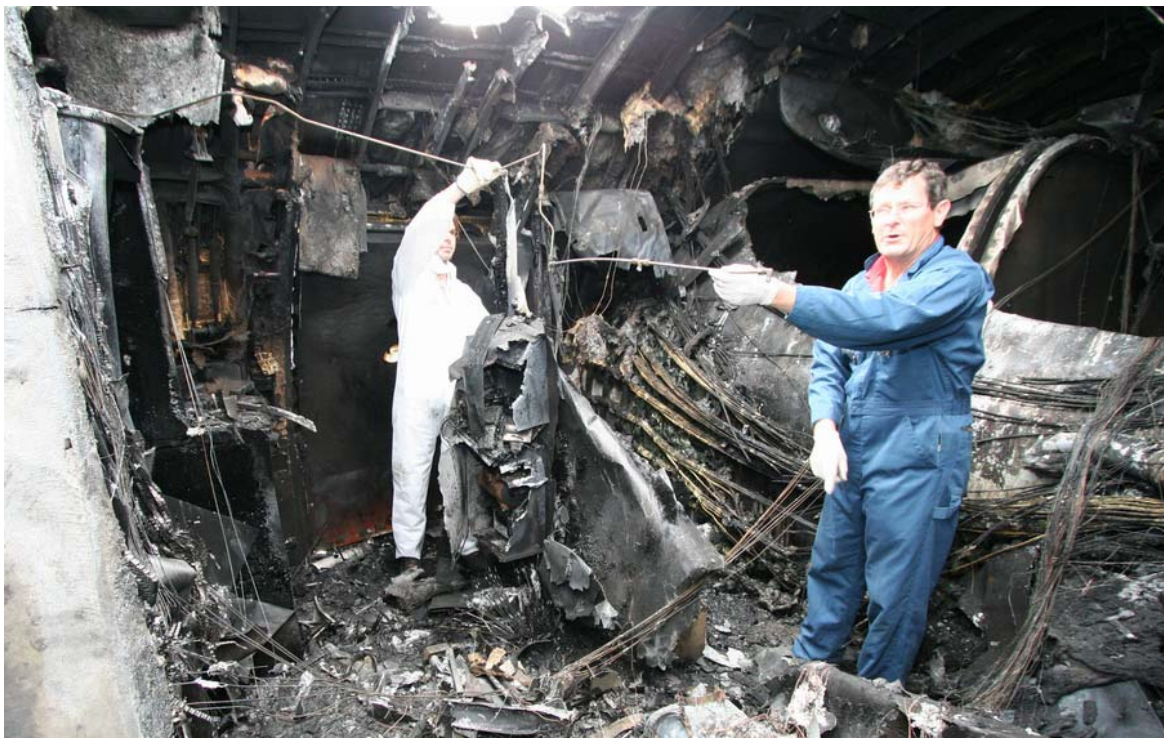
The main portion of the oxygen system that was found intact was the stainless steel tubing that extended from behind the bulkhead in the galley area and was routed above the ceiling and then downwards terminating at three separate threaded fittings. This stainless steel tubing was hanging down, from ceiling height near the galley area, to about floor level in the area where the three-person seat would have been. The tubing was intact with no visible damage except for some surface oxidation (figure 27).

Figure 27: Stainless steel oxygen supply line in supernumerary compartment, held in position by investigators

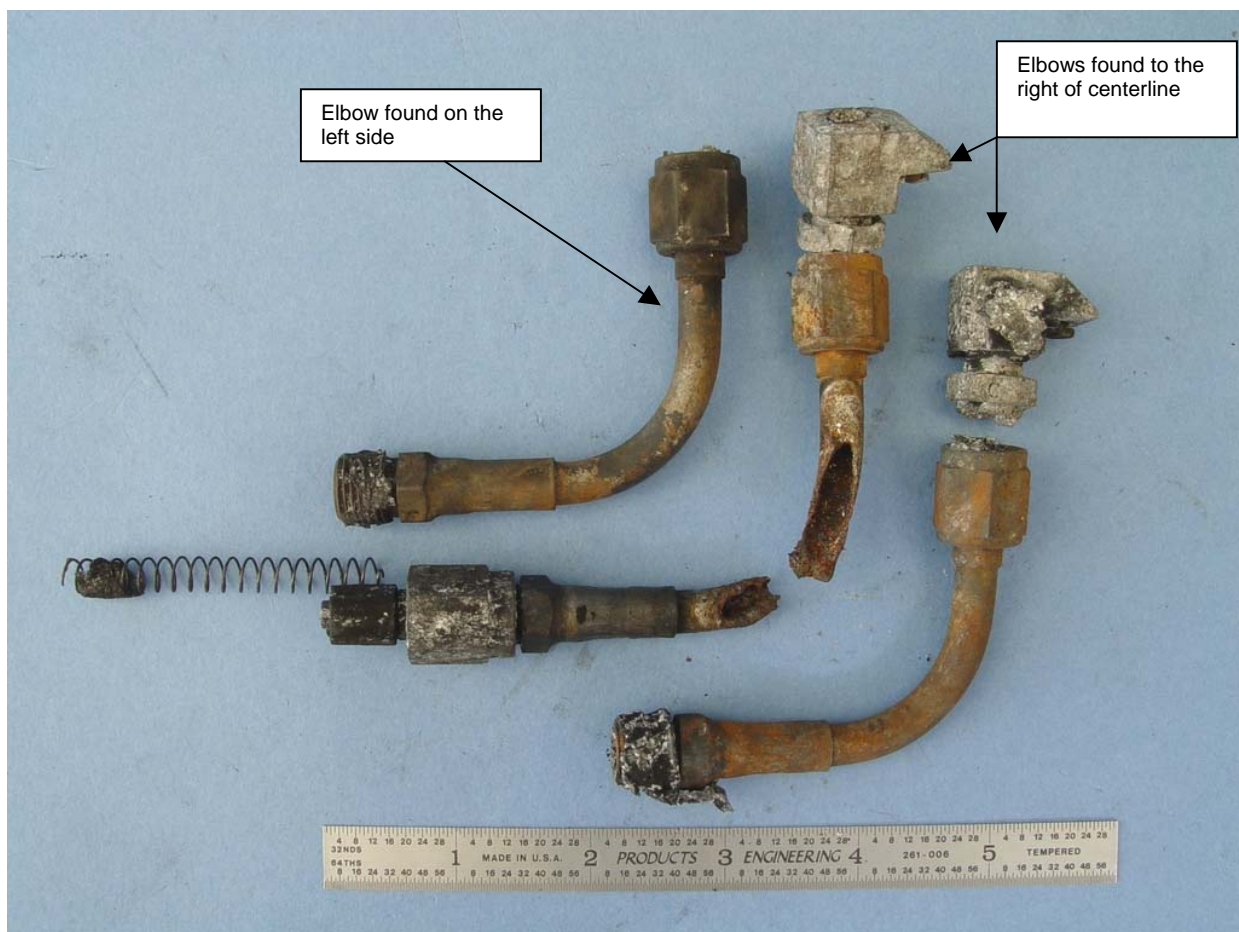
In addition to the stainless steel supply line, three stainless steel 90° elbows (figure 28) were recovered. One was found towards the left side of the aircraft near the base of the smoke barrier wall and the other two were found slightly to the right of the aircraft's centerline at the base of the smoke barrier wall, outboard of the three-passenger seat. The one found on the left consisted only of the stainless steel portion of the elbow with minimal remnants of the aluminum fittings that would have been attached to it. Of the two elbows found towards the right, one was found in two separate portions, with each of these portions exhibiting melting. The aluminum fittings from the flexible oxygen line and the stowage box were still attached to the two portions of the 90° elbow. The portion which would have been connected to the flexible oxygen line had a small, approximately three inch, portion of helically wound wire attached to the fitting on the end. The second of the two 90° elbows found to the right of the centerline had a small portion an aluminum fitting remaining. That fitting would have attached it to the mask stowage box. These three elbows were retained for laboratory examination.

Figure 28: Stainless steel 90° elbows recovered from the supernumerary compartment
