NATIONAL TRANSPORTATION SAFETY BOARD

MATERIALS LABORATORY FACTUAL ADDENDUM REPORT

Report No. 08-134AD

Place : Columbia, SC
Date : 9/18/2008
Vehicle : Learjet Model 60, N999LJ
NTSB No. : DCA08MA098
Investigator : Bob Swaim

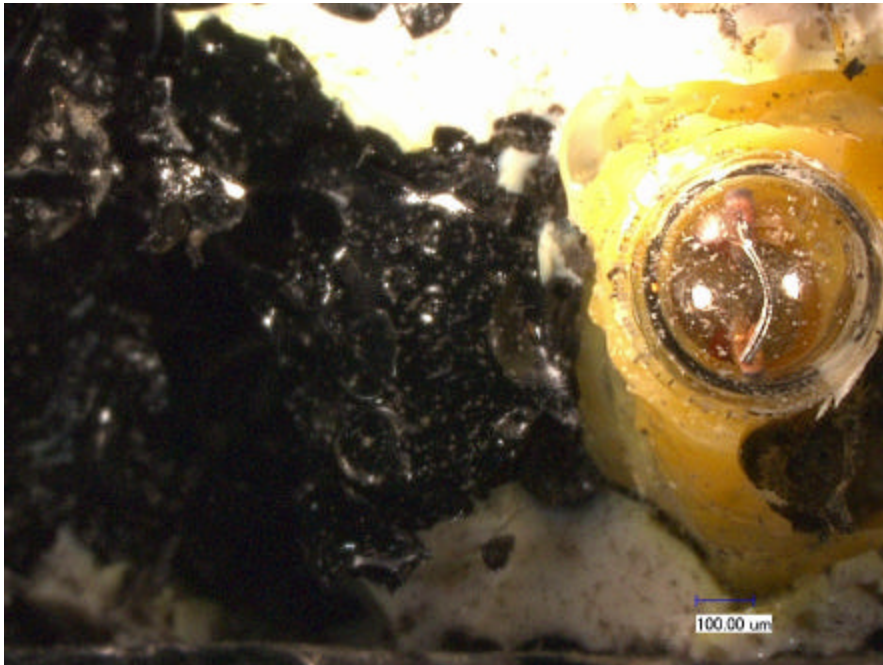
Six annunciator lights were examined in depth: 1) left TR unlock, 2) left TR arm, 3) left TR deploy, 4) right TR arm, 5) right TR deploy and 6) right TR unlock. The left TR unlock light was missing one bulb. However, the remaining bulb was intact and displayed no hot stretching relaxation of the coils. The left TR arm light had both filaments intact and did not display hot stretching relaxation of the coils. The left TR deploy light had damage to one of the bulb's glass covers, but both filaments were intact and did not display hot stretching relaxation of the coils. The right TR arm light had damage to one of the bulb's glass covers, but both filaments were intact and did not display hot stretching relaxation of the coils. The right TR deploy light had damage to one of the bulb's glass covers, but both filaments were intact and did not

Figure 1: Left TR unlock light bulb (left bulb missing)

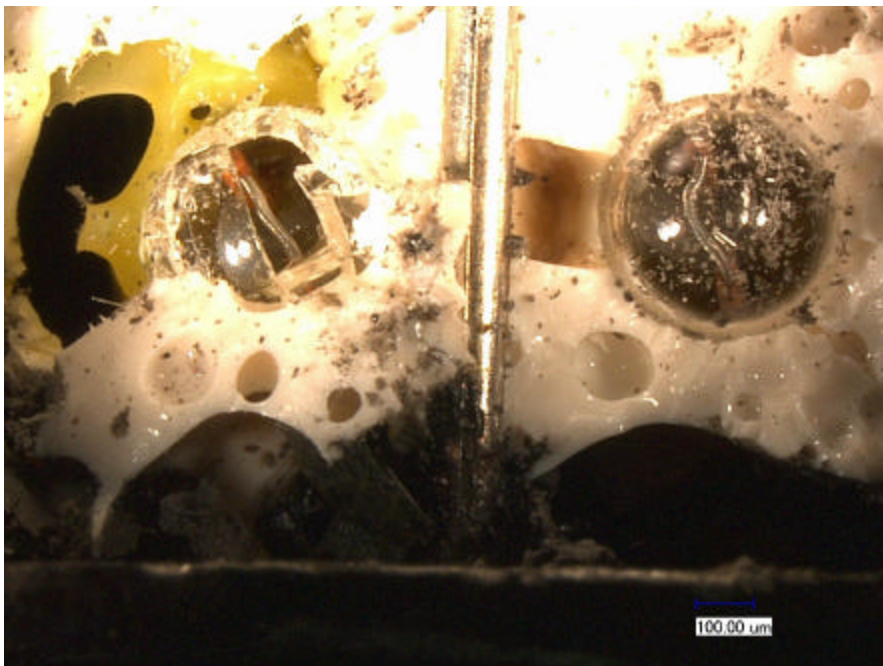
Figure 2. Left TR arm light bulbs

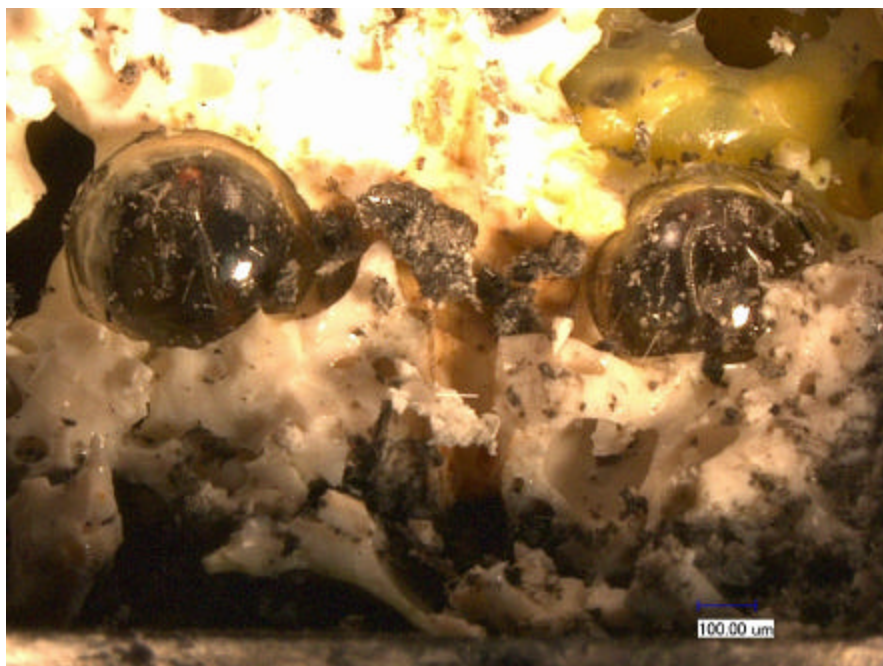
Figure 3: Left TR deolv light bulbs

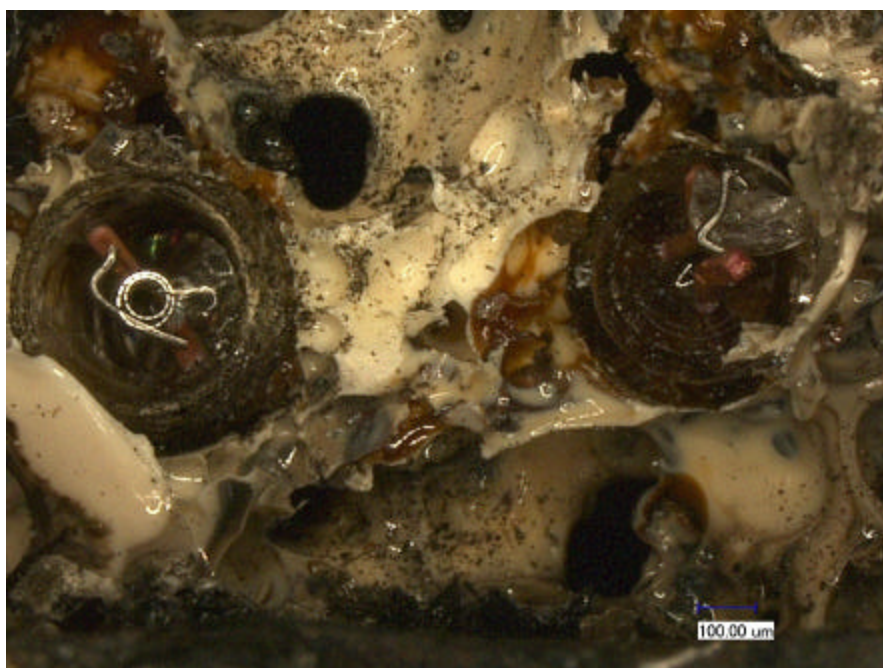
Figure 4. Right TR arm light bulbs

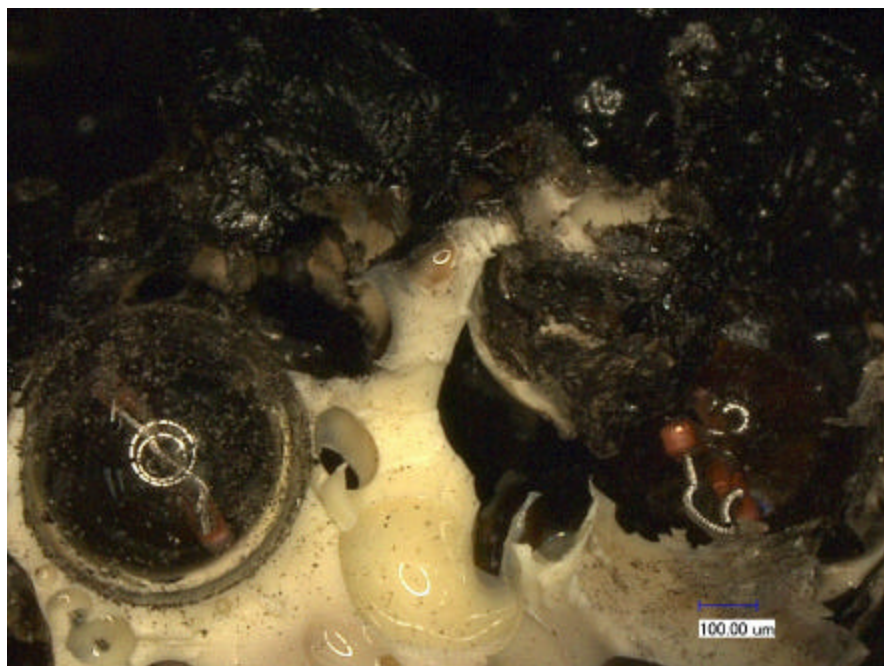
display hot stretching relaxation of the coils. The right TR unlock bulbs had both filaments intact and did not display hot stretching relaxation of the coils.

Figure 5: Right TR deployment light bulbs

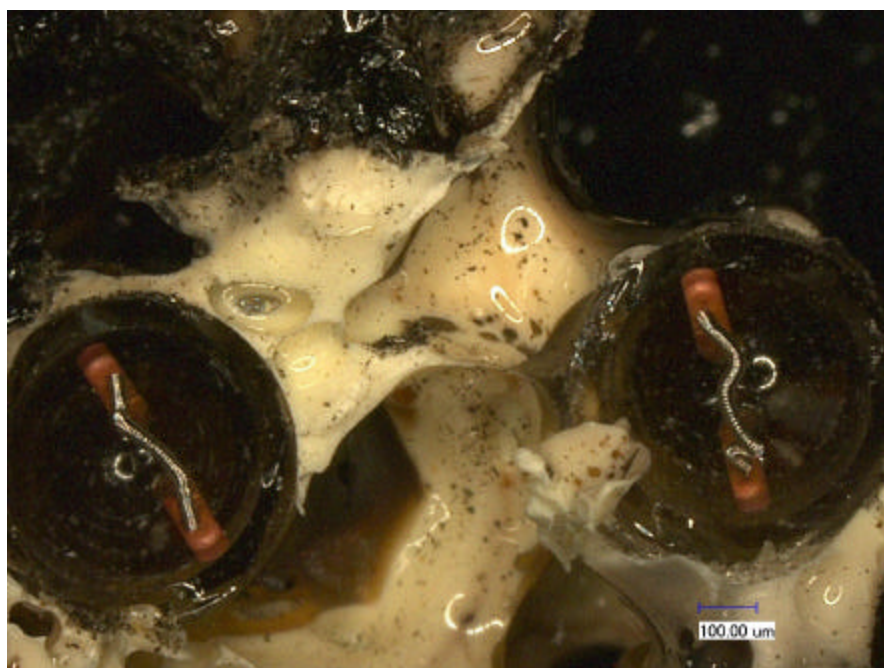
Figure 6. Right TR unlock light bulbs
