# NATIONAL TRANSPORTATION SAFETY BOARD

MATERIALS LABORATORY FACTUAL REPORT

Report No. 08-134

Place : Columbia, SC  
Date : 9/18/2008  
Vehicle : Learjet Model 60, N999LJ  
NTSB No. : DCA08MA098  
Investigator : Bob Swaim

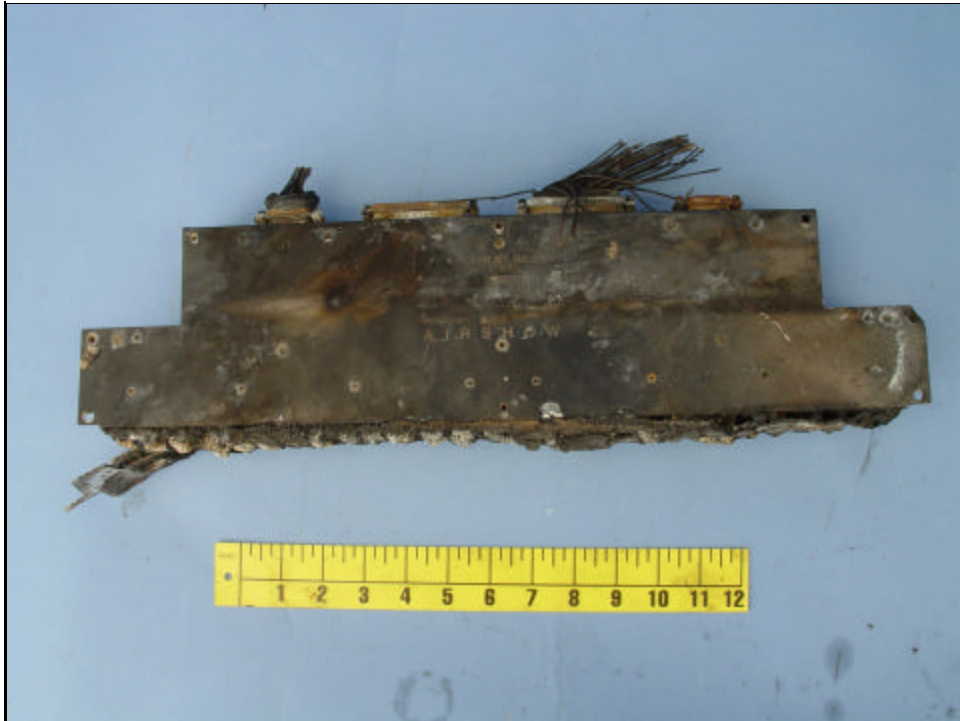
The cockpit annunciator panel was submitted to determine if there was any filament stretching in any of the annunciator panel lights. The panel was heavily fire damaged, as shown in Figure 1. The faceplate melted into the indicator fixtures. Once the plastic was removed from each indicator fixture, the bulbs were examined. Each indicator contained two bulbs. There were several damaged bulbs but, in every instance, the damage was limited to only one bulb of the pair in those fixtures. The damage most likely resulted from the removal of the melted plastic from fixtures. The filaments for the intact bulb of the pair were examined to determine the status of the indicator. None of the filaments examined had hot stretching relaxation of the coils (damage that, if present, would be an indication of impact loading while the filament was on). However, the "on" (or energized) filaments would not stretch if there was not significant impact loading.

Figure 1 Annunciator panel.

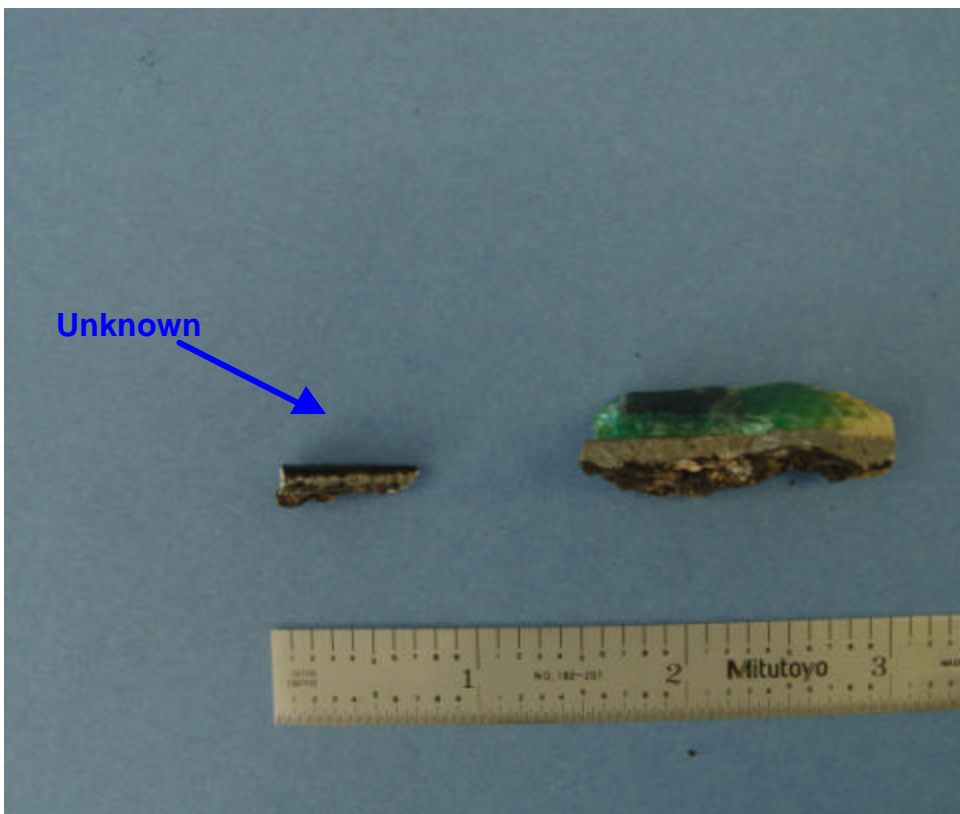
Fractured pieces of an unknown material were submitted for comparison to pieces of runway reflector found at the scene. An example of both materials is shown in Figure 2. The runway reflector consisted of four layers (although not all the pieces still contained all four layers): 1) a reflective upper layer, 2) a tan layer consistent in appearance to plastic, 3) a gray, flexible layer consistent in appearance with adhesive and 4) a black, aggregate-like layer consistent in appearance with asphalt. The unknown samples contained two layers. The lower layer was a black, aggregate-like layer consistent in appearance with asphalt similar to the bottom layer of the known reflector material. The top layer, which was shiny and black, was not consistent with any material found on the known reflector fragments.

Figure 2 Fragments of unknown material and a runway reflector.
