NATIONAL TRANSPORTATION SAFETY BOARD

MATERIALS LABORATORY FACTUAL REPORT

Report No. 00-071

Place : Nantucket, Massachusetts
Date : October 31, 1999
Vehicle : Boeing 767-366ER
NTSB No. : DCA0M-A006
Investigator : Scott Warren, AS-40

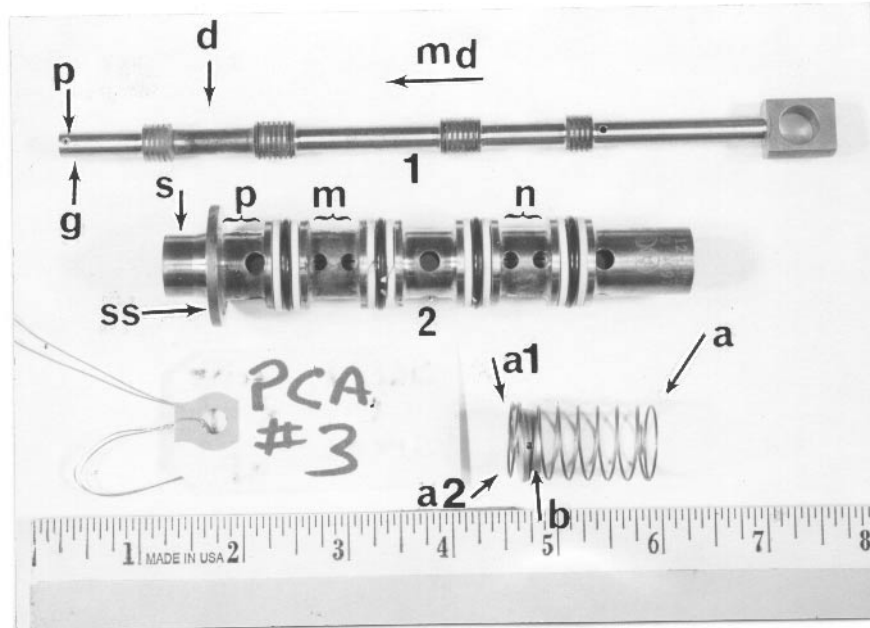
The bias spring from PCA #3 is denoted by arrow “a” in figure 1. The spring had about 8 1/2 coils with ground flat ends. In the as received condition², two coils on one side (see arrow “a1”) and one coil on the diametrically opposite side (see arrow “a2”) were positioned over the head portion of the spring guide. The spring guide is indicated by arrow “b” in figure 1. The guide was carefully removed from between the coils for close up examinations and measurements (see next section).

The servo slide is labeled “1” in figure 1. A portion of the slide denoted by arrow “d” in this figure was darkly discolored and exhibited evidence of corrosion damage. Some corrosion damage was also noted in the increased diameter portions of the slide containing lands and groves.

The servo sleeve is labeled "2" in figure 1. The external surface of the sleeve exhibited evidence of corrosion. The corrosion damage was most apparent on the outside diameter recesses containing metering ports (see brackets "m" and "n" in this figure) and on the land that contained return ports at the "spring" end of the sleeve (see bracket "p").

Figure 1. An overall view of the servo slide (1), servo sleeve (2), bias spring (arrow "a"), and spring guide (arrow "b") from PCA #3.

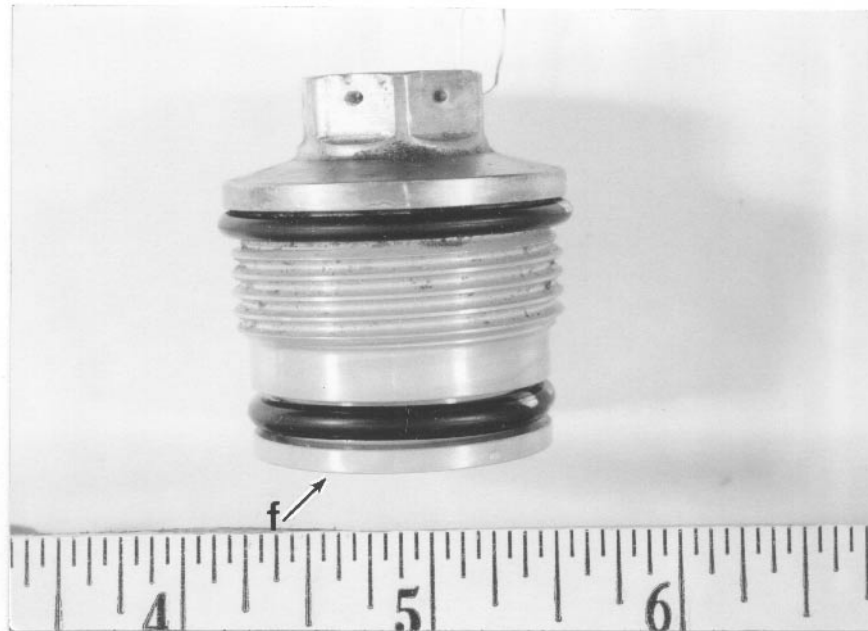
In the servo valve assembly, the cap (see figure 2) is positioned at the end of the servo sleeve shown by arrow "s" in figure 1. This end of the sleeve will be further referred as the "spring" end. The flat surface of the cap, denoted by arrow "f" in figure 2, butts up against the seating surface on the servo sleeve, which is indicated by arrow "ss" in figure 1. The internal diameter of the cap measured 0.872 inches and was within the range of 0.865 inches to 0.885 inches specified by the corresponding engineering drawing.

Figure 2. As received view of the servo cap. Arrow "f" indicates the face that in the servo valve assembly butts up against the seating surface on the servo valve (see arrow "ss" in figure 1).

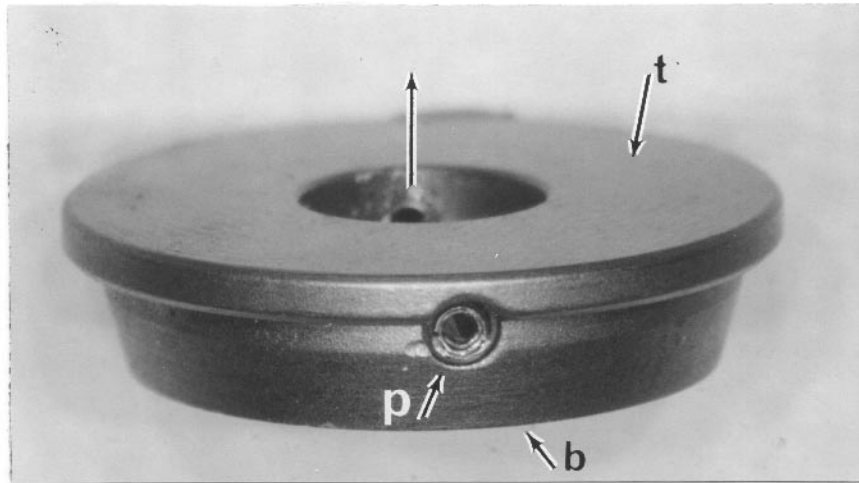
A close up view of the spring guide is shown in figure 3. For reference purpose, the face denoted by arrow “t” in this figure will be further referred as the “top” face on the guide and the face denoted by arrow “b” will be referred as the “bottom” face. The spring guide is positioned at the end of the servo slide indicated by arrow “g” in figure 1 and is attached to the slide with a single rolled pin (see arrows “p” in figures 1 and 3). Axial measurements of the location of this pin on the slide showed that, when assembled, the tip of the slide is flush with the “top” face on the guide.

The pin for the guide sheared at the interface between the exterior surface of the slide and the bore of the guide creating three separated pieces. Two pieces of the pin were still contained within the corresponding holes in the guide, the third piece extended through the interior of the servo slide.

Figure 3. A close up view of the spring guide. The unlabeled arrow indicates the direction of deformation on the fracture surfaces of the separated pin. (5X).

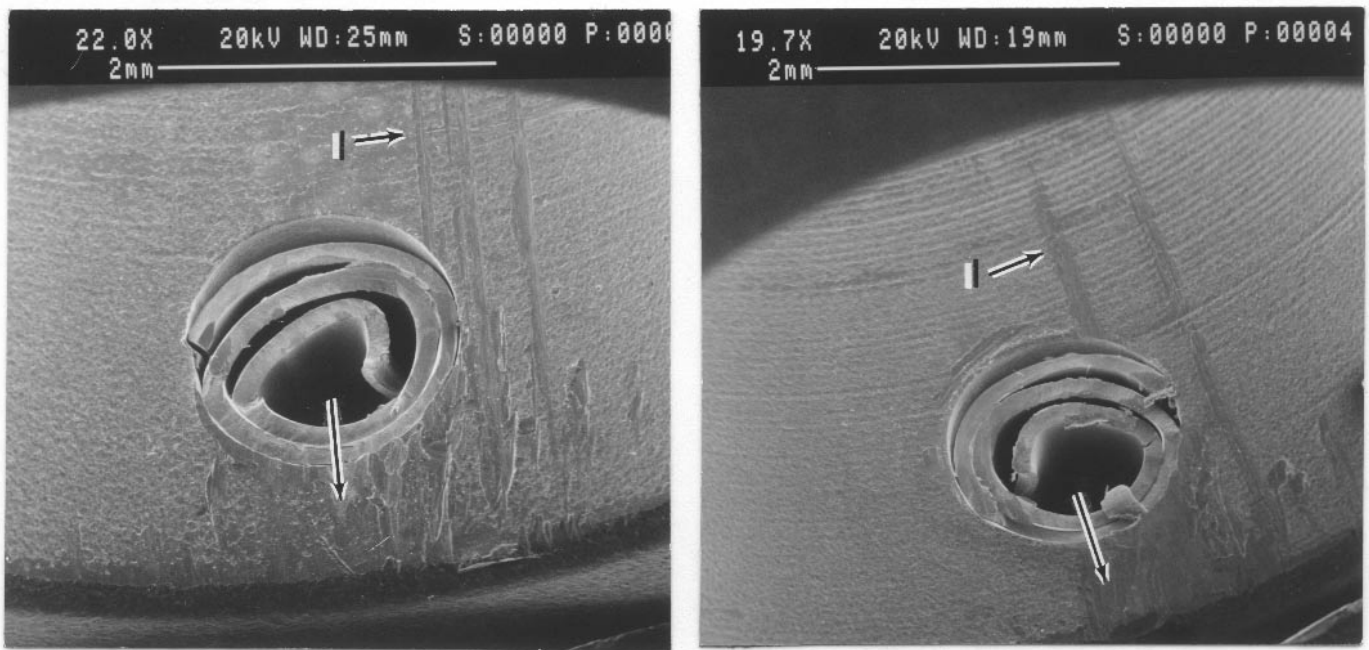
The pin fracture faces located on the bore of the guide were examined with a scanning electron microscope (SEM). SEM views of both fractures are shown in the two photographs of figure 4. The examination disclosed that at both fracture locations the layers of the rolled pin were deformed towards the “top” face on the guide as shown by unlabeled arrows in figures 3 and 4. The direction of deformation in combination with the appearance of scrape marks on the guide bore in the area between the pin holes and the top face were consistent with the servo slide moving through the hole in the guide in the direction indicated by arrow “md” in figure 1. The SEM examination of the two fracture faces at higher magnifications revealed that both were subjected to considerable mechanical damage after the separation. Undamaged portions of the fractures contained elongated dimples (see figures 5 and 6), typical of fractures created by direct shear overstress.

Figure 4. SEM views of the pin fracture faces on the bore of the spring guide. The unlabeled arrow on each fracture face shows the direction of deformation. Arrows "l" denote scrape marks on the bore surface of the guide. Magnification 22X -- left photograph and 19.7X -- right photograph.

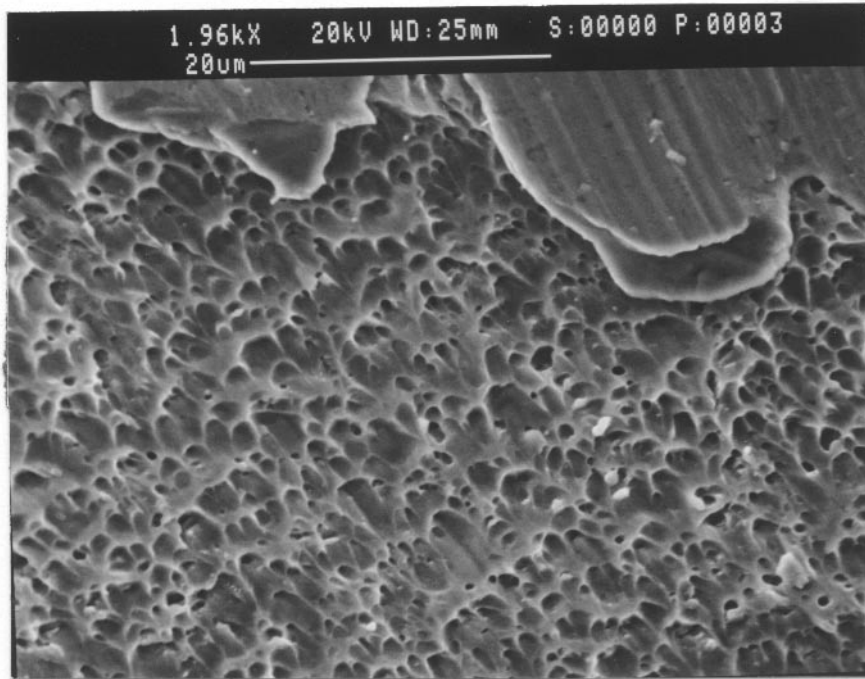
Figure 5. SEM view of typical microscopic features on the fracture face shown on the left photograph of figure 4. (1,960X).

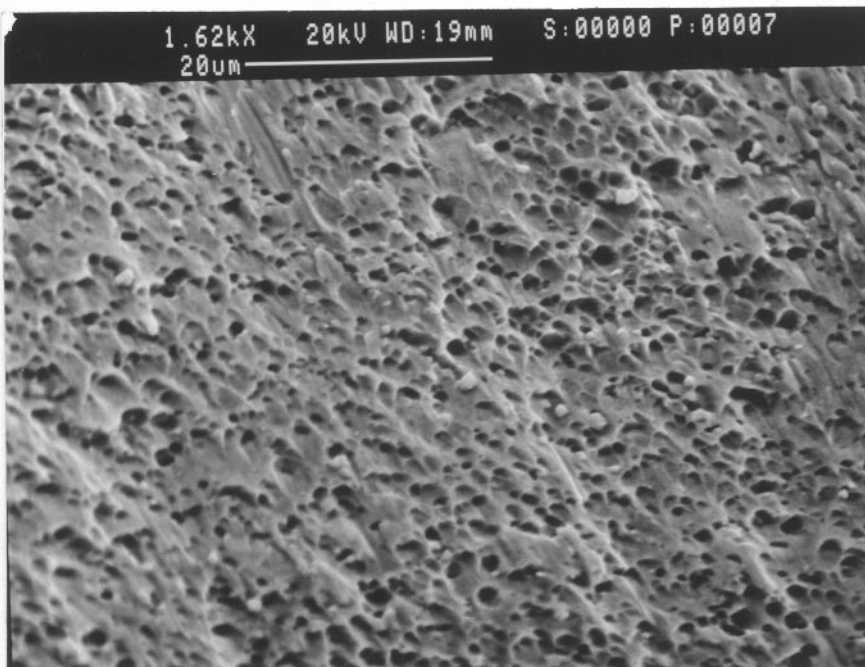
Figure 6. SEM view of typical microscopic features on the fracture face shown on the right photograph of figure 4. (1,620X).

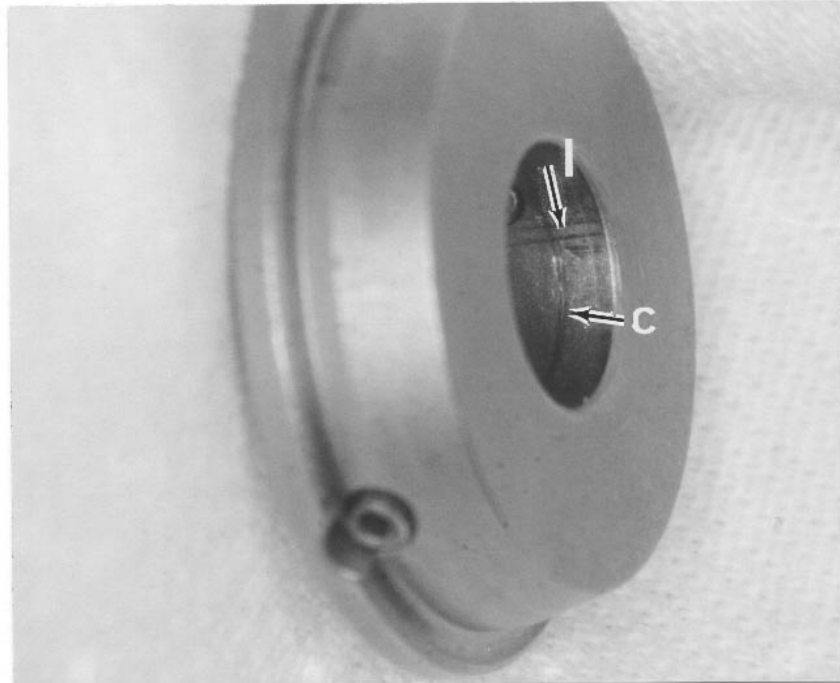
Figure 7 depicts the bore surface in the spring guide, as viewed from the “bottom” face at an acute angle. Detailed binocular microscope examination revealed that some of the longitudinal scraping marks on the guide bore extended through an area located between the pin holes and the “bottom” face on the guide, see arrows “l” in figures 4 and 7. The examination of the guide bore also revealed the presence of a circumferential score mark that extended through an arc of about 120 degrees. This mark is shown by arrow “c” in figure 7.

Figure 7. The bore surface of the spring guide as viewed at an angle from the “bottom” face. Arrow “l” shows the longitudinal scraping marks that extend up to the bottom face on the guide. Arrow “c” indicates the circumferential mark. (5X).

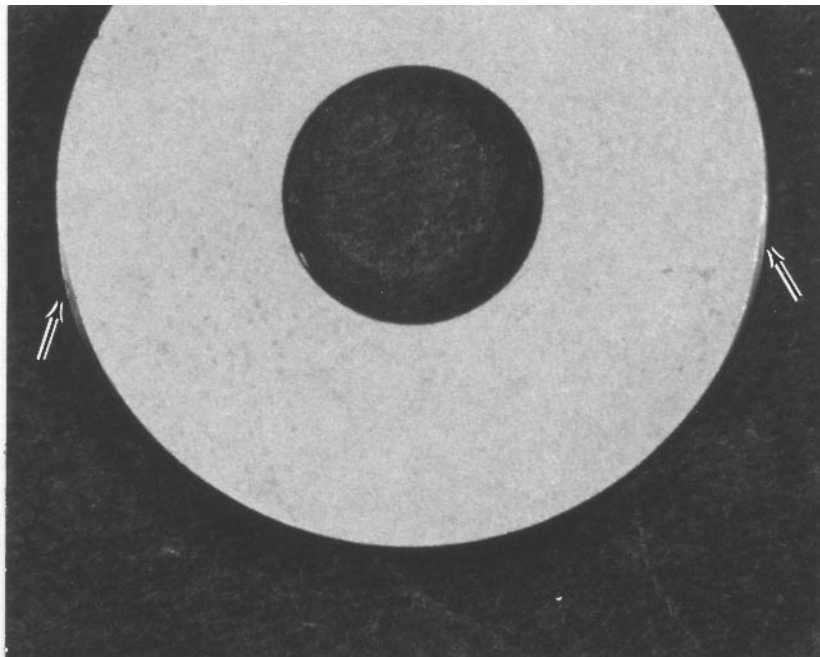
The “top” face on the guide contained two narrow indentations. The indentations, denoted by unlabeled arrowheads in figure 8, were located at the periphery of this face and had an appearance consistent with contact by the bias spring.

Figure 8. Indentations at the periphery of the top face on the spring guide (see arrowheads). (5X).

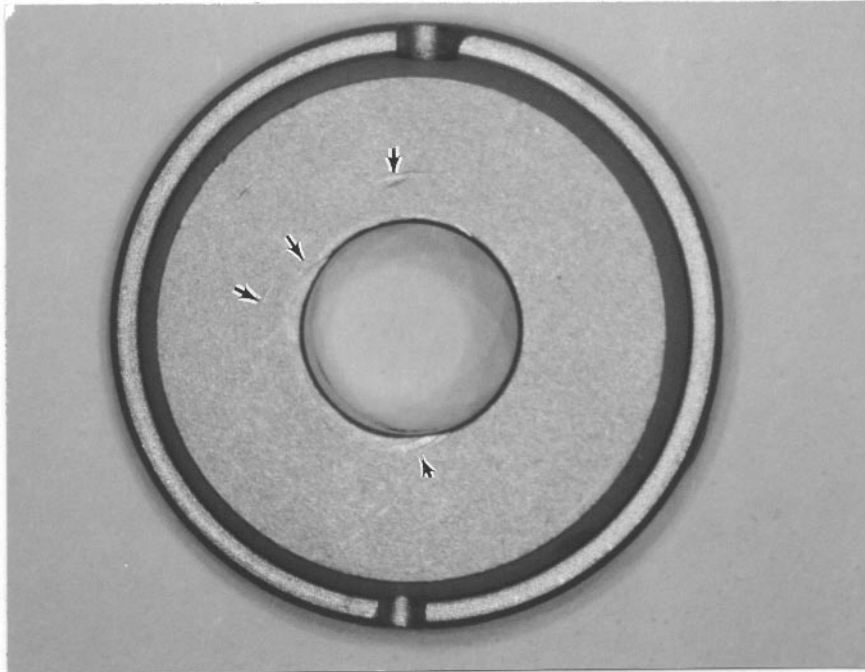
Figure 9 illustrates a view of the “bottom” face on the spring guide. This face contained a series of curved impact marks (see arrowheads) as if from repeated contact with the end of the servo slide⁴. Most of these marks were located around the internal hole in the guide (see figure 10) and two marks (denoted by arrows “a” in this figure)

Figure 9. A view of the "bottom" face on the spring guide. Unlabeled arrowheads show the locations of curved impact marks. (5X).

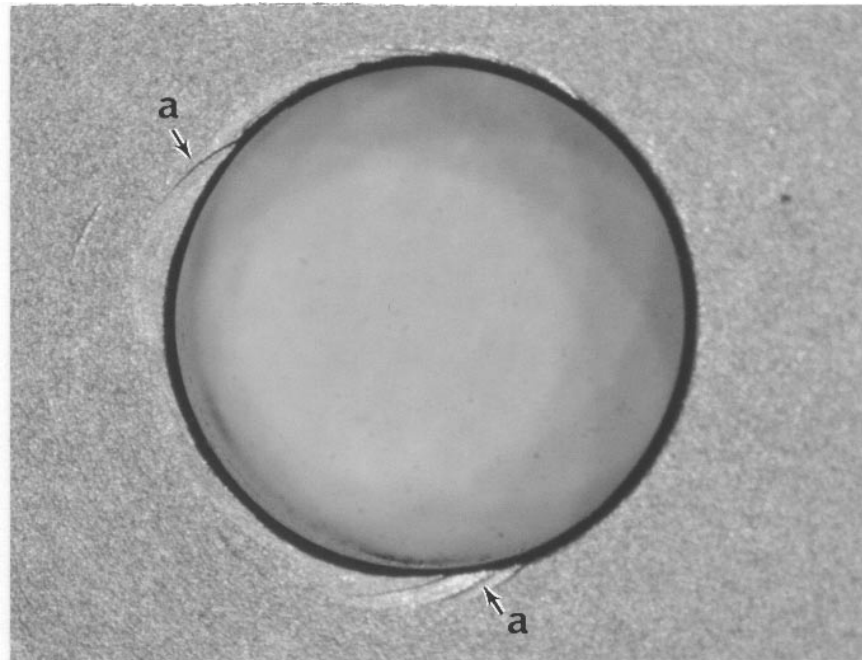
corresponded to the full diameter of the slide, as if the slide impacted the guide surface on a plane slightly offset from the guide centerline.

Figure 10. Close up view of the central portion of the "bottom" face on the guide. The marks indicated by arrows "a" correspond to the full diameter of the servo slide. (5X).

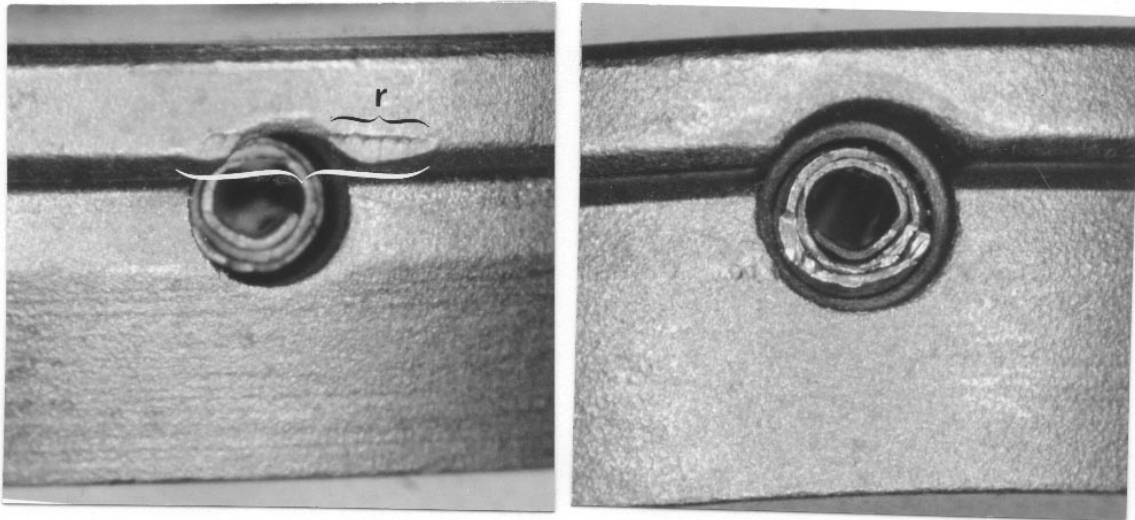
The two photographs in figure 11 show the sides of the spring guide adjacent to the ends of the rolled pin. The pin is reportedly intended to be inserted initially through the guide hole shown on the right in figure 11. (This hole tapers slightly to facilitate insertion of the pin, and it has a larger diameter than the opposite hole.) The insertion hole will be referred to as the larger diameter hole, and the opposite hole will be referred to as the smaller diameter hole. The examination revealed that the side of the guide in the vicinity of the smaller diameter hole contained a region of rubbing damage, see unlabeled white bracket in the left photograph of figure 11. The area of the rubbing damage was approximately 0.1 inch wide in the circumferential direction, 0.012 inch long (max.) in the axial direction and was located near the "top" edge of the hole. SEM examinations at higher magnifications revealed that the rub mark contained fine score lines that were oriented in the axial direction of the guide. An SEM view of the portion of the rub mark denoted by bracket "r" in the left photograph of figure 11 is depicted in figure 12 (see arrow "r"). The presence of a deformation lip (see arrow "l" in figure 12) indicated that the score lines extended toward the "top" face on the guide.

Figure 11. Close up views of the sides of the spring guide in the areas adjacent to the ends of the rolled pin. Unlabeled white bracket on the left photograph denotes the rub mark. Bracket "r" indicates the portion of the rub mark shown in figure 12. (15X).

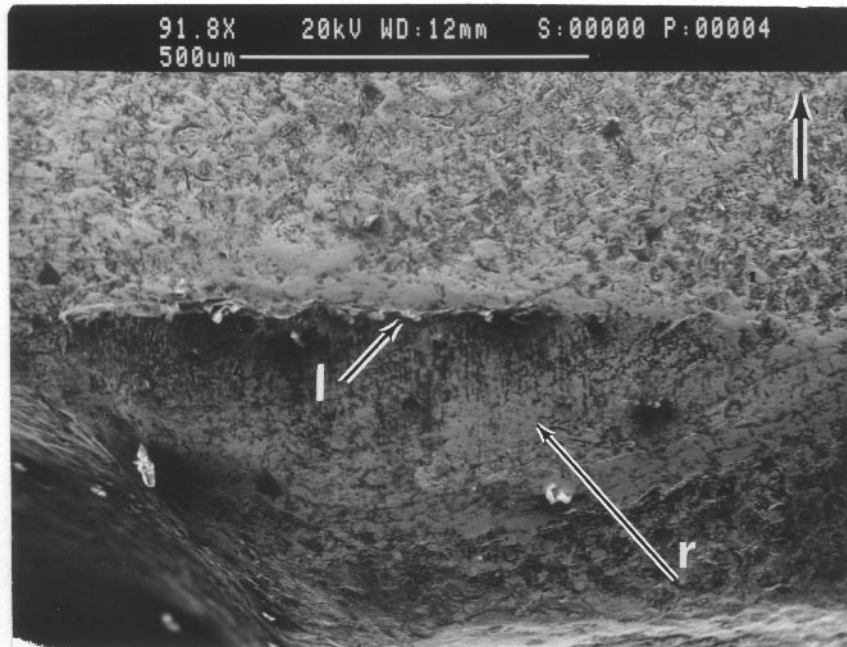
Figure 12. SEM view of the portion of the rub mark denoted by bracket "r" in figure 11. The unlabeled arrow in the right top corner of the photograph points in the direction of the "top" face on the spring guide. (91.8X).

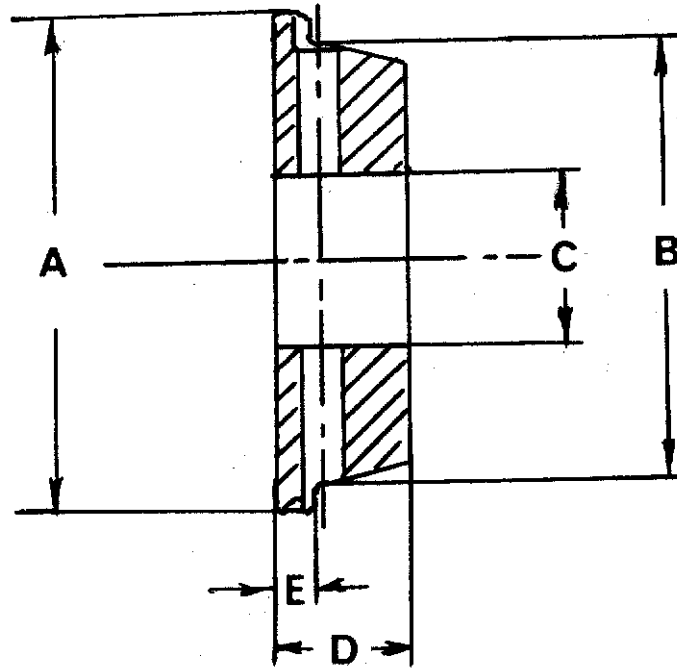
Figure 13. The dimensions measured on the guide.

Various dimensions of the guide were measured as shown in figure 13. Table 1 compares these measurements with the specified dimensions. All measured dimensions were within the dimensions specified by the engineering drawing for the guide.

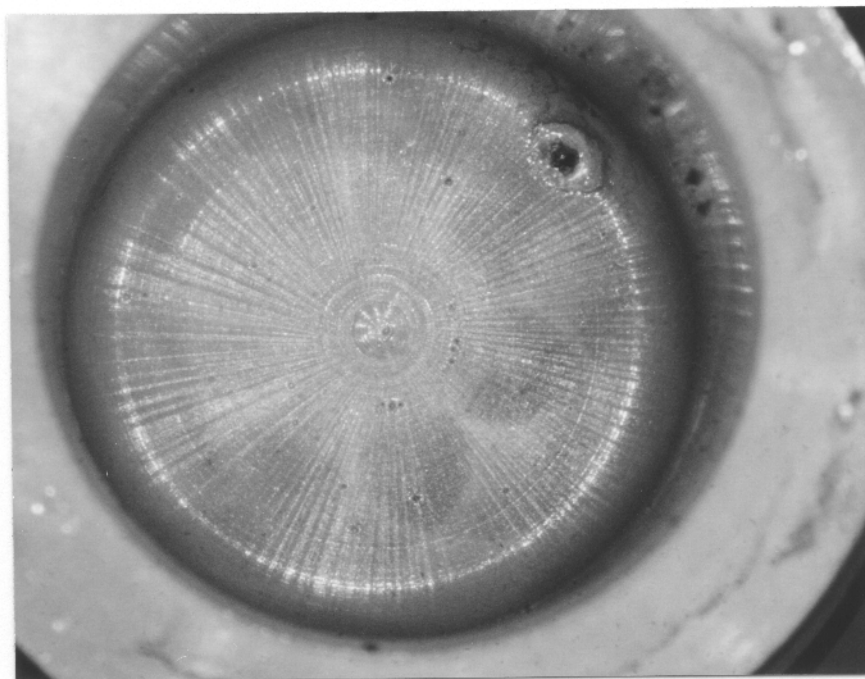
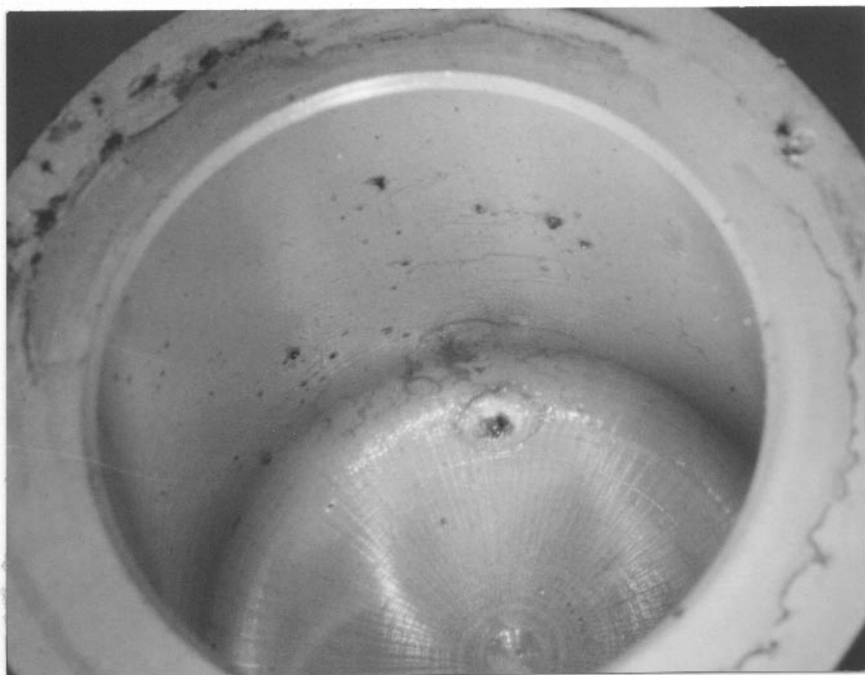
Examination with the aid of a low power binocular microscope revealed that the interior surface of the cap contained a number of foreign particles, see figure 14. The particles were collected using a double-sided adhesive carbon tape for EDS analysis of chemical composition. After most of the particles had been removed, the interior of the cap was cleaned with a cotton ball saturated in ethyl alcohol.

EDS analysis indicated that there were 3 basic groups of particles on the internal surface of the cap. Views of these particles, together with the corresponding EDS spectra, are present in the appendix. The particles in the first group measured approximately 0.008 inch (200 microns) in the longest direction⁵, had an appearance of a metal shaving or a chip, and had aluminum as a major element. The chemical composition of this group of particles was consistent with the chemical composition of the servo valve cap.

The particles in the second group ranged in size between 0.006 inch and 0.009 inch (150 microns and 230 microns) and contained silicon and oxygen as major peaks. The third “group” consisted of only one particle. This particle measured 0.012 inch by 0.010 inch (300 microns by 250 microns) and had iron as a major alloying element. The chemical composition of this particle was consistent with the chemical composition of the spring guide material.

Figure 14. The interior of the servo cap showing foreign particles on the bottom surface (top photograph) and on the side surface (bottom photograph). (3.75X).

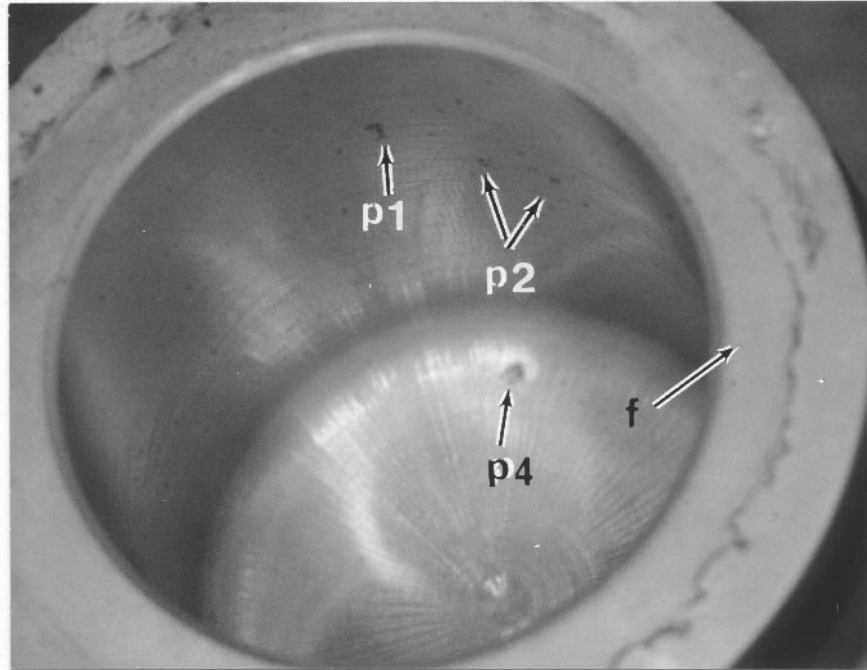
Examination of the internal surface of the cap after cleaning revealed several corrosion pits at the locations of former particles. Most of the corrosion pits were clustered on one side of the cap and are indicated by arrows "p1", "p2", "p3", and "p4", in figure 15. The corrosion pit indicated by arrow "p1" in this figure was located at a distance of about 0.31 inches from the seating face of the cap (denoted by arrow "f" in

figure 15), the corrosion pits arrowed “p2” and “p3” were both located at a distance of about 0.45 inch from this face, and the largest corrosion pit (arrowed “p4”) was located in the radius between the bottom and the side surfaces of the cap.

Figure 15. Appearance of the interior of the servo cap after the cleaning. Arrows "p1", "p2", and "p3" indicate corrosion pits on the interior surface of the cap. (3.75X).

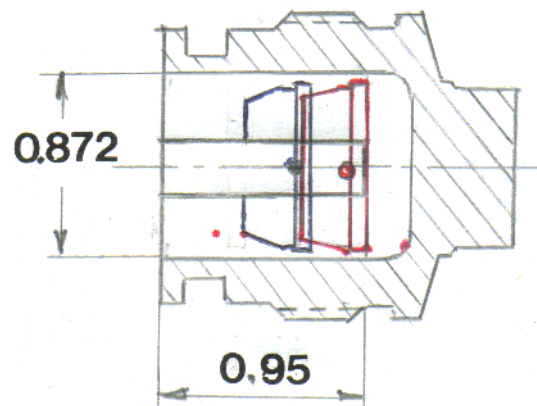
The neutral position of the servo valve was reported as a position in which both metering holes in the servo sleeve are covered with the lands on the servo slide. Placing of the servo sleeve and slide next to each other indicated that in the neutral position of the valve, the top surface of the spring guide is located approximately 0.95 inches away from the flat face on the cap (indicated by arrow “f” in figure 2). The position of the spring guide inside the servo cap in the neutral position of the servo valve is illustrated in the sketch shown in figure 16. Also shown in this sketch are the longitudinal positions of major corrosion pits on the interior surface of the cap and a position of the spring guide when the “bottom” face on the guide is butted up against the end face on the servo sleeve. Optical microscopic examination of the internal surface of the servo cap disclosed no apparent damage other than the previously mentioned corrosion pits.

Figure 16. A sketch illustrating the position of the spring guide inside the servo cap in the neutral position of the servo valve (red outline) and in the condition when the bottom face on the guide is butted up against the end face on the servo sleeve (blue outline). The red dots indicate the longitudinal positions of the corrosion pits.

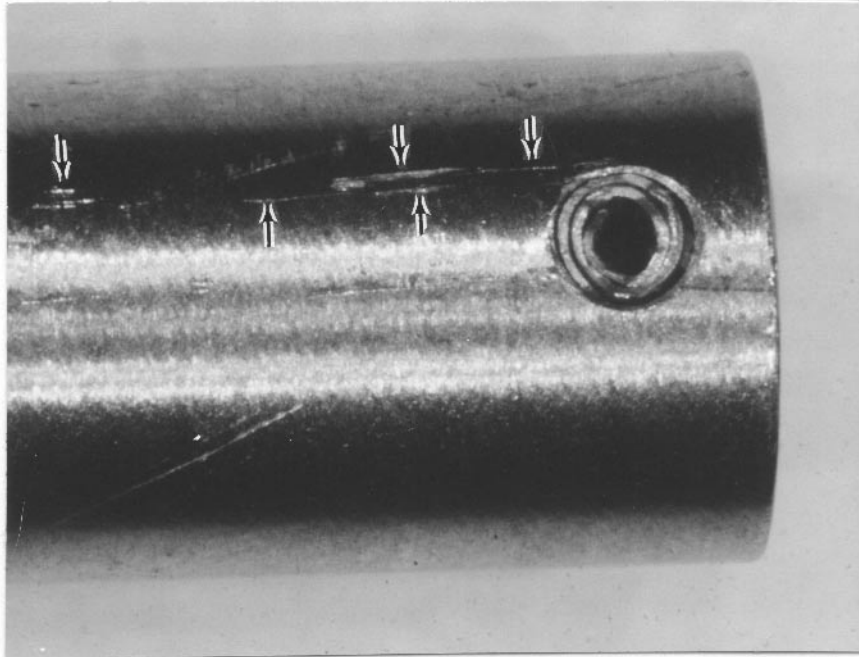
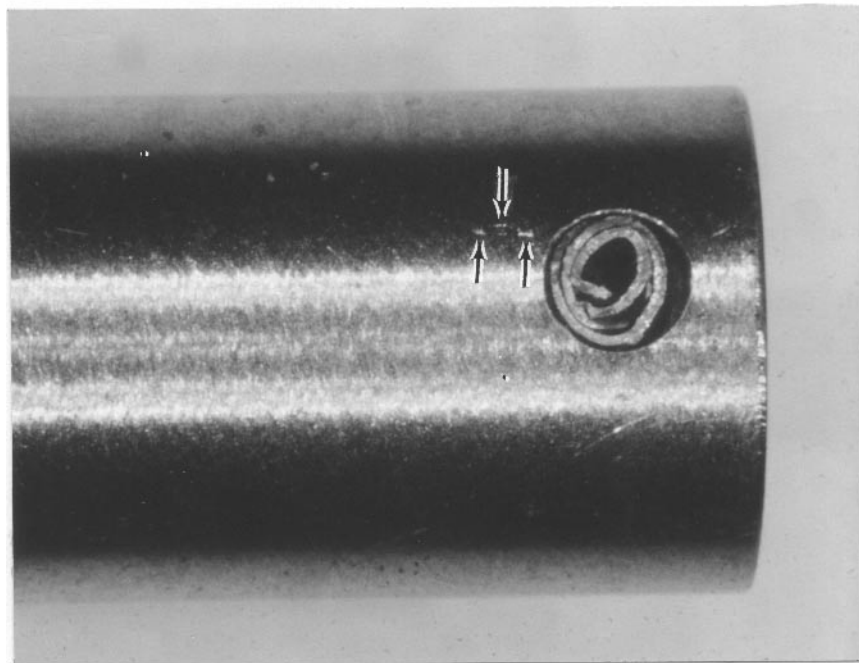
Two photographs in figure 17 depict close up views of the servo slide in the areas of the fractured rolled pin. Magnified examinations revealed several discontinuous score marks on the surface of the slide (see unlabeled arrows in each photograph).

Measurements showed that the two longest score marks extended to a distance of approximately 0.357 inches and 0.342 inches, each, from the end face of the slide. The termini of four intermittent marks observed on the surface of the slide were located at the distances of approximately 0.203 inches, 0.213 inches, 0.254 inches, and 0.258 inches from the end face of the slide. The center of the hole for the rolled pin in the slide is positioned at a distance of 0.077 inch from the end, suggesting that the slide moved a maximum of about 0.28 inch (0.357 inch minus 0.077 inch) relative to the spring guide.

Figure 17. Close up views of the end of the servo slide denoted by arrow "g" in figure 1 showing areas of the slide surrounding the fracture faces on the pin. Unlabeled arrows indicate the score marks. (10X).

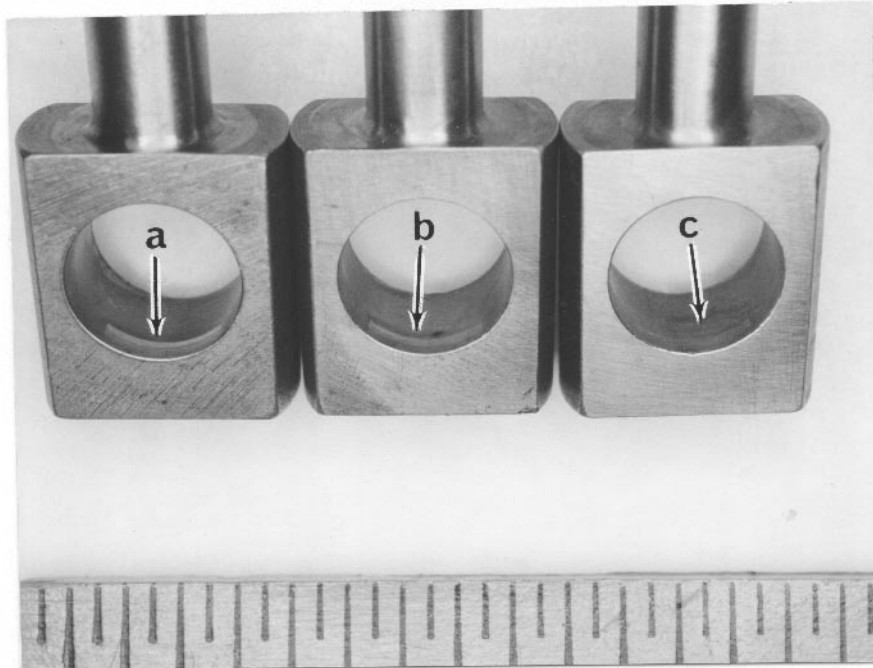
Figure 18 illustrates an oblique view of the input end of the slide from PCA #3 (on the left), and, for comparison, the similar areas on the slides from MH #1, and PCA # 4. The input end in the slide from MH # 3 was broken off and was not submitted to the materials laboratory. A magnified examination of the slide from PCA #3 revealed a wear mark in the bore of the input hole at the location indicated by arrow "a" in figure 18. The input hole in the slides from MH #1 contained a wear mark that was slightly less pronounced than the mark found on the slide from PCA #3. The input hole in the slide from PCA #4 was in a similar location but was much less noticeable.

Figure 18. Oblique view of the input ends in the slides from PCA #3 (left), MH #1, (center), and PCA #4 (right) showing wear marks by arrows “a”, “b”, and “c”.

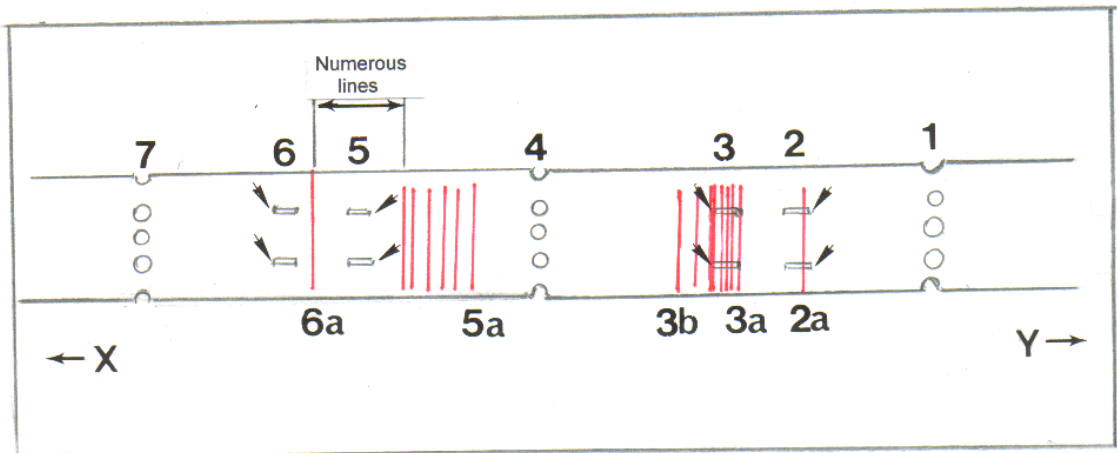
A development view of the internal surface of the sleeve is shown in figure 19. Arrows "X" and "Y" in this figure denote the "spring" and input ends on the sleeve, respectively. Red lines indicate positions of some of the corrosion stain bands. For reference purpose, all ports, including metering ports, return ports, and pressure ports in figure 19 are labeled "1" through "7", starting from the input end on the sleeve. The metering edges on the metering ports are indicated by the unlabeled arrowheads in this figure.

Measurements performed during boroscope examination showed that the metering ports labeled "2" in figure 19 were intersected by only one corrosion band (see position "2a"). The maximum extent of this band was 0.032 inch from the metering edge

towards the input end on the sleeve. The holes labeled “3” and the surrounding portions of the sleeve were intersected by numerous bands. The maximum extent of the bands from the metering edge of the port were 0.105 inches towards the “spring” end of the sleeve and 0.130 inches toward the input end (see positions “3a” and “3b” in figure 19). Portions of the sleeve in the areas of metering ports labeled “5” and “6” also contained numerous corrosion bands. The maximum extent of these bands from the metering edges of ports 5 and 6 towards the input end of the sleeve measured about 0.410 inches and 0.155 inches, respectively (see positions “5a” and “6a”).

Figure 19. A development view of the internal surface of the servo sleeve from PCA #3. The ports for reference purpose are labeled “1” through “7” starting from the input end. Red lines illustrate positions of some of the corrosion stain bands. The metering edges in the metering holes are shown by unlabeled arrowheads. Not to scale.

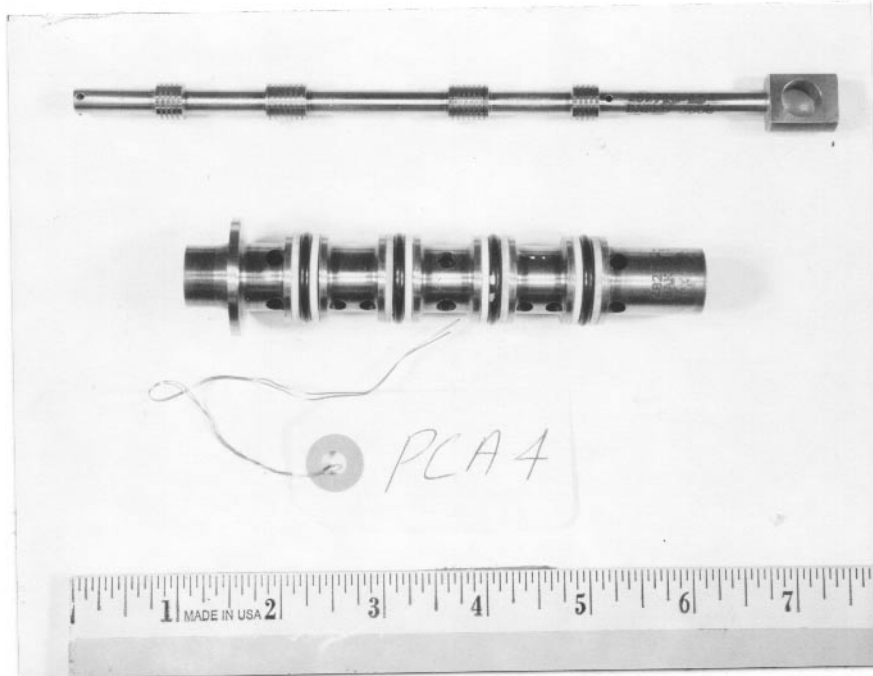
The servo slide and sleeve from PCA #4 are shown as received in figure 20. Visual magnified examination of both components revealed no apparent evidence of corrosion damage either on the slide or the spool. A boroscope examination of the internal surface of the sleeve revealed no impact damage to the metering edges of the metering ports.

Figure 20. As received view of the servo slide and sleeve from PCA #4.

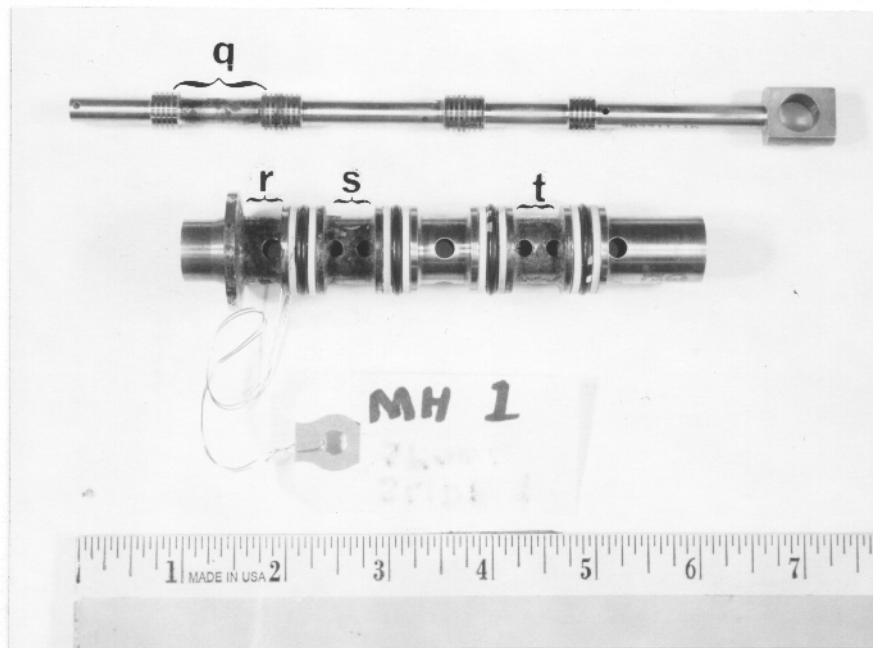
Figures 21 and 22 depict as received views of the components labeled “MH #1” and “MH #3”, respectively. Visual examination of the servo slide from MH #1 revealed corrosion damage on the land denoted by bracket “q” in figure 21. Extensive corrosion damage was also evident at the external surface of the sleeve, in recesses containing metering ports (see brackets “r” and “s”) as well as in the recess containing return ports at the “spring” end of the sleeve (see bracket “t”).

Figure 21. As received view of the servo slide and sleeve from the unit labeled MH #1. Brackets "q", "r", "s", and "t" denote areas of the corrosion damage.

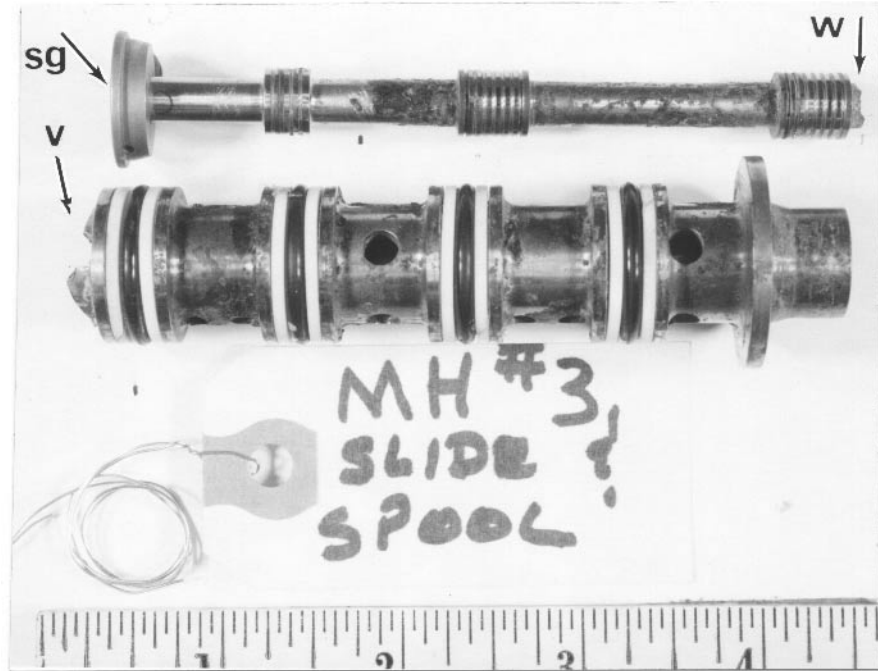
The servo sleeve from MH #3 separated through the return ports located at the input end of the unit. The fracture face on the sleeve is indicated by arrow “v” in figure 22. The servo slide separated adjacent to the increased diameter portion, in the area denoted by arrow “w” in this figure. When the slide and the spool were placed next to each other in the position corresponding to the neutral position of the servo valve, the fracture face on the sleeve was displaced approximately 0.4 inches towards the input end relative to the fracture face on the slide.

The spring guide was still attached to the servo slide from unit “MH #3”, see arrow “sg” in figure 22. The rolled pin positioning this guide at the end of the slide was intact.

The exterior surfaces of both the slide and the sleeve from “MH #3” contained extensive corrosion damage. A boroscope examination of the internal surface of the servo sleeves from both units showed no evidence of impact markings or foreign particles at the metering edges of metering ports.

Figure 22. As received view of the slide and sleeve from the unit labeled MH #3. Arrow "v" indicates the fracture face on the sleeve and arrow "w" indicates the fracture face on the slide. Note that the longitudinal orientation of the servo sleeve in this view is reversed relative to the orientation of the slide.

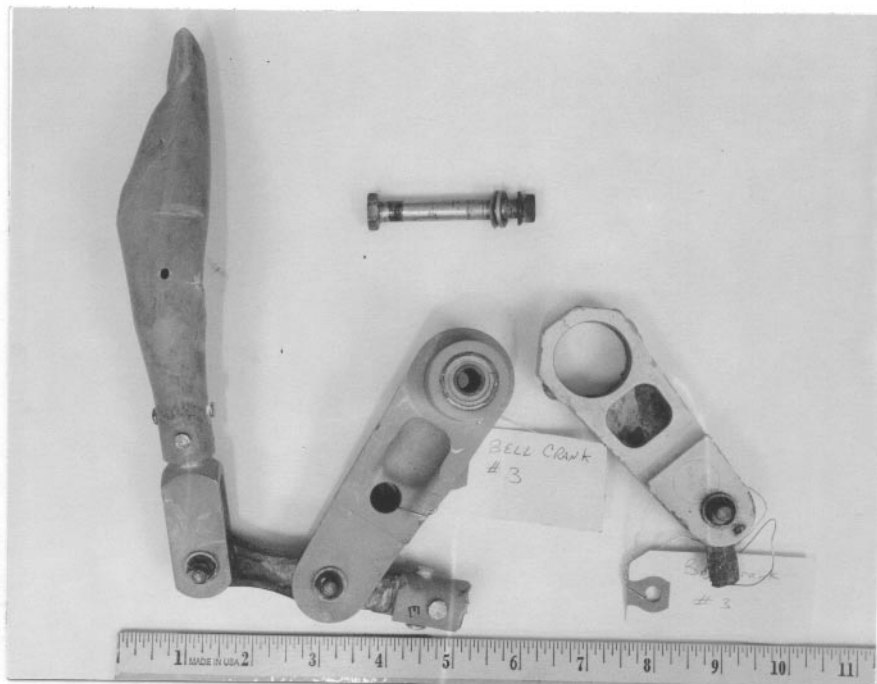
Figure 25. An overall view of bellcrank labeled # 3.

The rivets in the bellcrank arms from units No. 3 and No. 4 separated flush with the recess surface in the shaft portion of the outboard arm. Examination with the aid of a low power binocular microscope and then at higher magnifications with the scanning electron microscope revealed that all fracture faces on the rivets from these units were grossly smeared and contained elongated dimples, typical of ductile shear overstress. The direction of the shear in all rivets from these two units was as if the bellcrank arms were moving to a lower relative angle.

The outboard portion of the push-pull rod between the No. 3 and No. 4 bellcranks was broken off and remained attached to the No. 3 bellcrank (see figure 25). The inboard portion of the push-pull rod that was extending inboard of the No. 5 bellcrank was also broken off. This piece of the push-pull rod was not submitted for examination. The fractures in both push-pull rods had characteristic features of overstress.

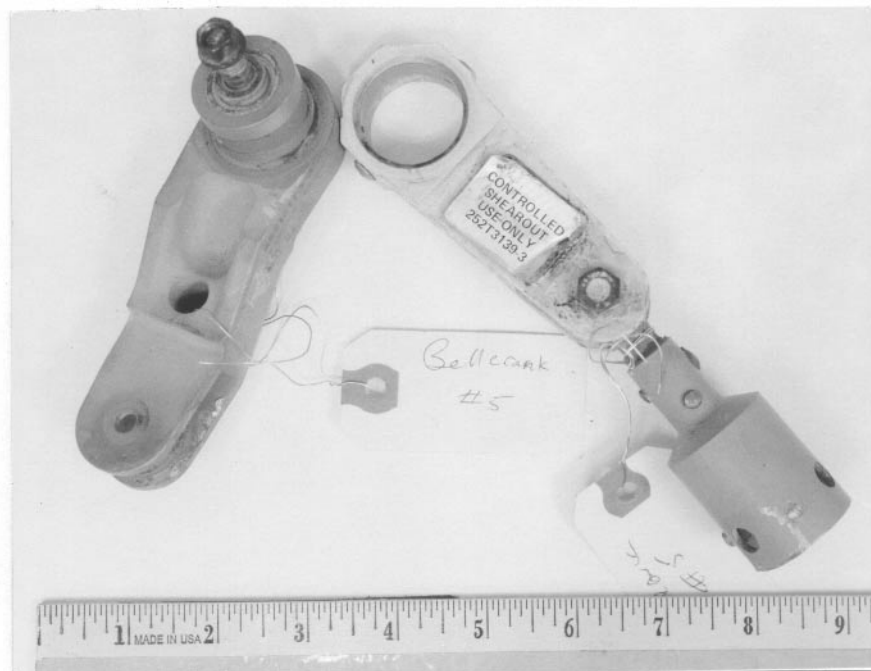
Figure 27. An overall view of bellcrank labeled # 5.

Examination of the bellcrank arms in bellcrank #5 (figure 27) showed that one of the two rivets sheared flush with the recess surface in the outboard arm, similar to the rivets from units No. 3 and No. 4. However, the origin of the shear fracture in the second rivet was in line with the bearing surface on the outboard arm. A side view of this arm is shown in figure 28. Unlabeled arrowheads in this view denote the two bearing surfaces on the bell crank, bracket "r" indicates the recessed area, and arrow "rv" indicates the sheared rivet. The fracture in this rivet propagated on a slightly slant plane and terminated flush with the bottom of the recess. An SEM view of the fracture face on this rivet is shown in figure 29 with arrow "o" indicating the origin of fracture. The SEM examination also revealed the presence of a circumferential crack in the rivet. This crack propagated flush with the surface of the recess in the bellcrank arm, see arrow "c" in figure 29. What appeared to be an origin of this crack was obscured by the smeared over final portion of the fracture face on the rivet. The SEM examination of the fracture face on the rivet at higher magnifications disclosed elongated dimples, consistent with a

direct shear overstress. Both rivets in the bellcrank No. 5 were sheared as if the bellcrank arms were moving to a higher relative angle.

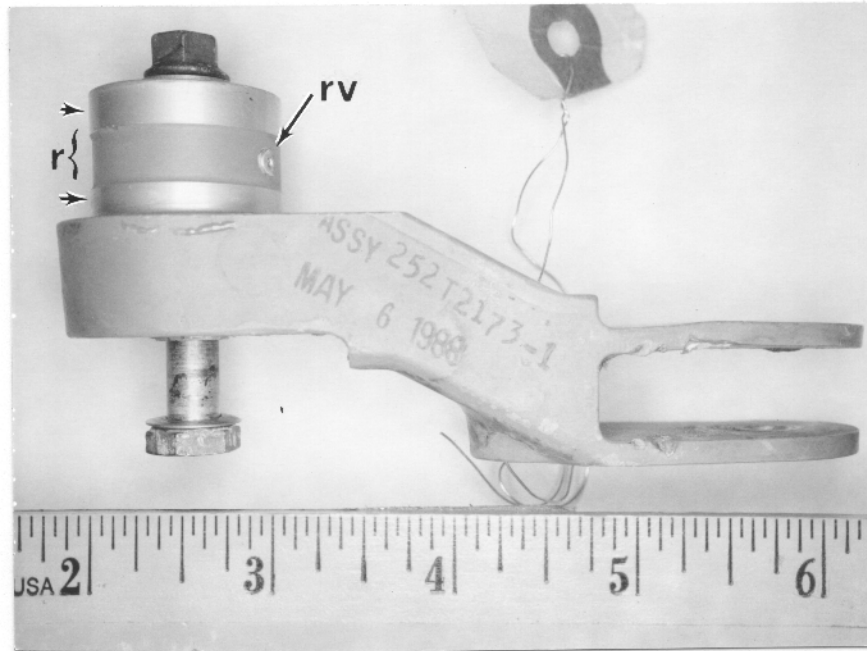
Figure 28. The side view of the outboard arm from bellcrank #5 showing the two bearing surfaces by unlabeled arrowheads, the recessed area by bracket "r", and the sheared rivet by arrow "rv".

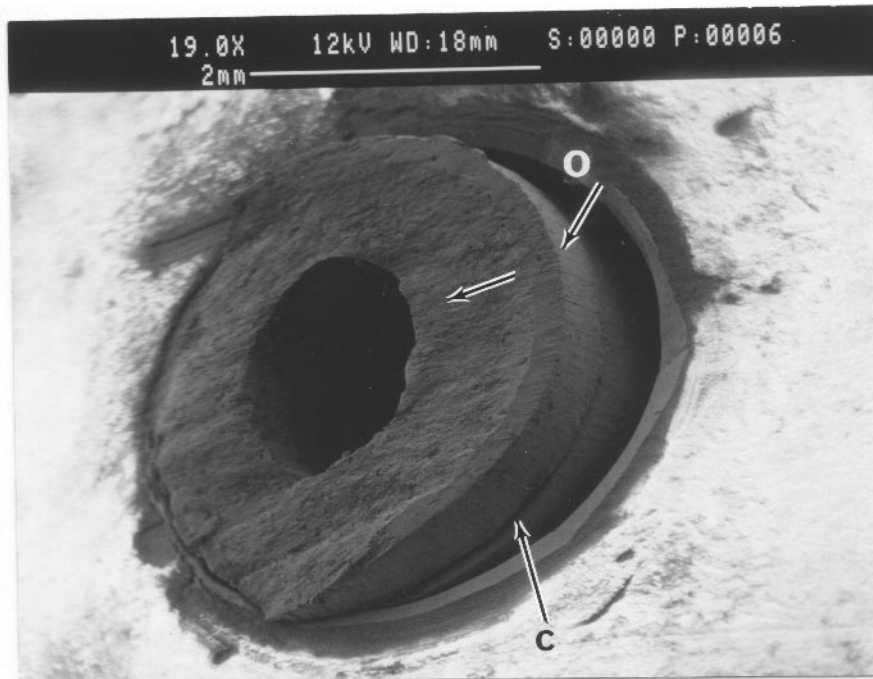
Figure 29. SEM view of the fracture surface on the rivet indicated by arrow "rv" in figure 26. Arrow "o" indicates the origin of fracture, the unlabeled arrow indicates the direction of the fracture, and arrow "c" indicates the circumferential crack. (19X).

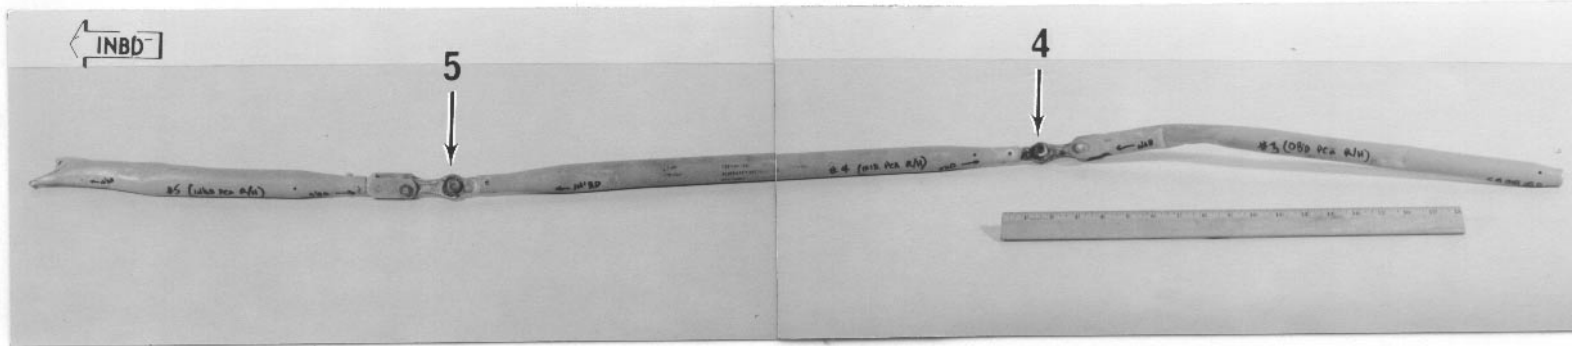
An overall view of the push-pull rods for the Nos. 3, 4, and 5 bellcranks is shown in figure 30. The positions of bellcranks No. 4 and No. 5 are shown by the corresponding arrows. All three rods were found to be deformed by bending. The most severe deformation was noted on the push-pull rod between bellcranks No. 3 and No. 4. The push-pull rod between bellcranks No. 4 and No. 5 was subjected to the least amount of deformation.

Figure 30. An overall view of the push-pull rods for the Nos. 3, 4, and 5 bellcranks. Arrows "5" and "4" indicate positions of bellcranks No. 5 and No. 4.
