# NATIONAL TRANSPORTATION SAFETY BOARD

MATERIALS LABORATORY FACTUAL REPORT

Report No. 00-084

Place : Nantucket Island, Massachusetts  
Date : October 31, 1999  
Vehicle : Boeing 767-366-ER, SUGAP  
NTSB No. : DCA00-M-A006  
Investigator : Gregory Phillips

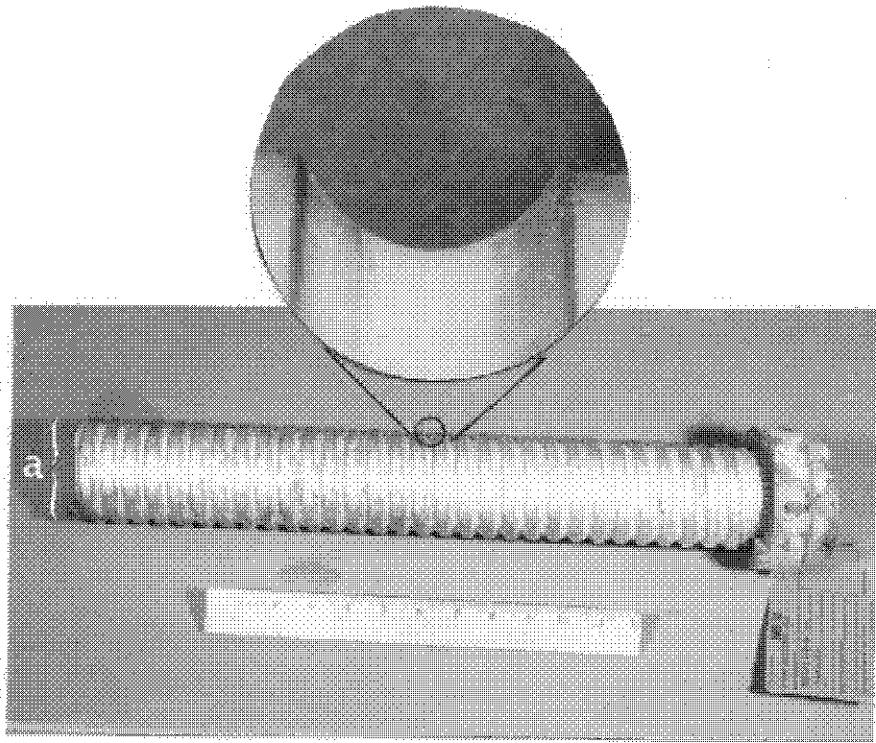
The lower portion of the horizontal stabilizer jackscrew received for examination is illustrated in figure 1. The portion was approximately 21.5 inches long and had been separated at the location indicated by bracket "a". The screw portion illustrated is a ball screw and not a conventionally threaded screw. The helix of the ball screw is a circular groove (insert in figure 1) that matches with balls constrained within the interacting nut. The balls in the nut (not submitted for examination) are located in a helical pattern that matches the helix of the screw.

Figure 1. The lower portion of the jackscrew received for examination.

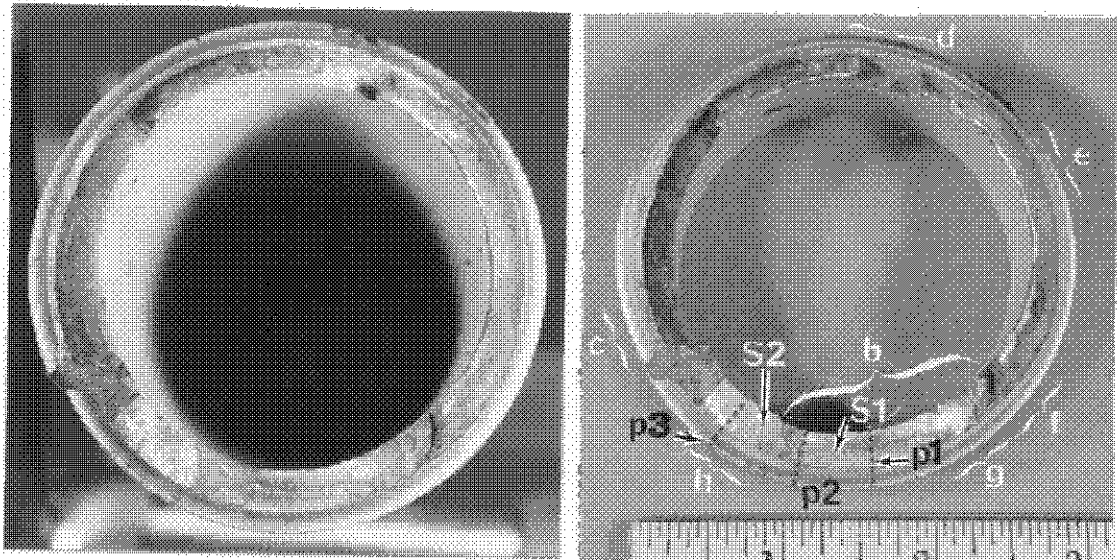
Figure 2 illustrates the fracture face indicated by bracket "a" in figure 1. The left view is the "as received" condition and the right view is after the fracture face had been saw cut from the remainder of the jackscrew and cleaned. Most of the fracture was on a slant plane, typical of overstress. However, the area indicated by bracket "b" in figure 2 contained a flat fracture region and was examined in more detail. Brackets "c", "d", "e", "f", "g" and "h" in figure 2 indicate areas on the outside diameter that are illustrated in figures 10 and 11. The red dashed lines identified as "p1", "p2" and "p3" represent cuts made to produce examination specimens "S1" and "S2".

Figure 2. The jackscrew fracture face as received (left view) and after cleaning (right view).

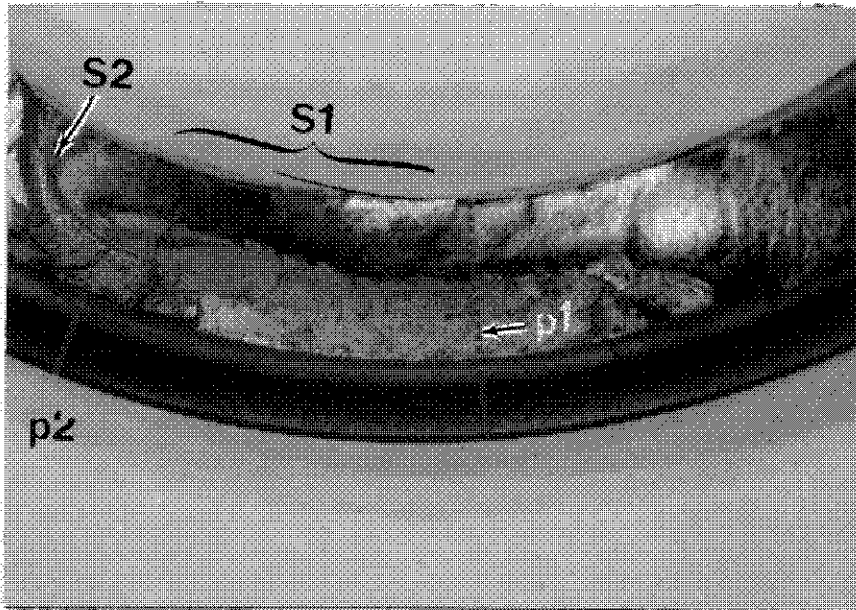
The area indicated by bracket "b" in figure 2 is illustrated in figure 3. Specimens "S1" and "S2" and cutting lines "p1" and "p2" are indicated as in figure 2.

Figure 3. The area indicated by bracket "b" in figure 2. (3.7X)

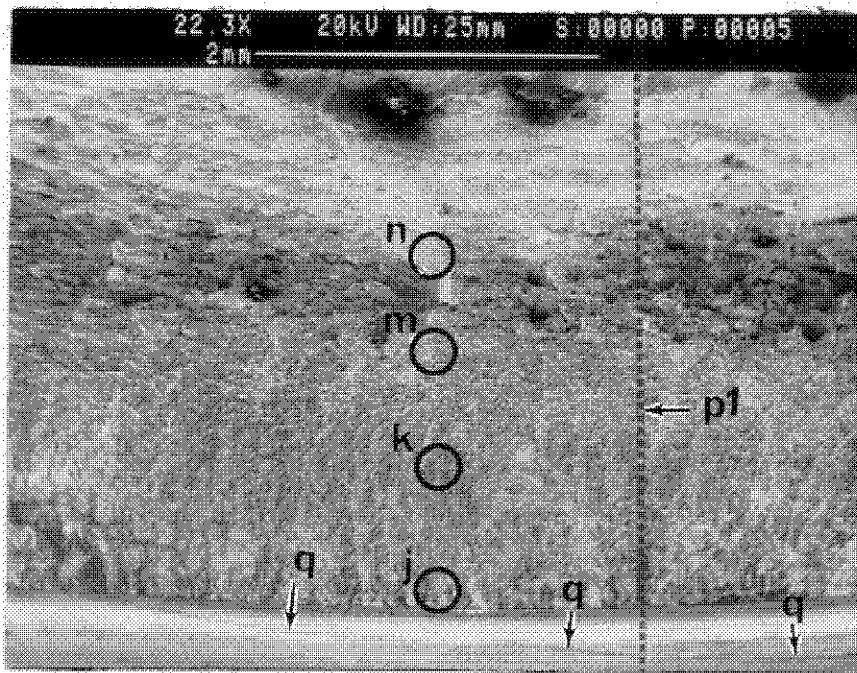
The fracture face was placed in a scanning electron microscope (SEM) for examination. Figure 4 is a view adjacent to the indicated cutting line "p1". Features observed at the locations indicated by circle "j", "k", "m" and "n" are illustrated in figures 5 and 6. A circumferential crack, adjacent to the separation, is indicated by arrow "q".

Ductile dimples, indicative of overstress separation, were found throughout the thickness of the fracture (from the inside diameter surface to the outside diameter surface) in the area shown in figure 4. Figure 5 illustrates the dimples observed within circle "j" of figure 4, and figure 6 illustrates the dimples observed within circle "n". The features within circle "k" and "m" were almost identical.

Figure 4. SEM photograph of the area of the fracture face adjacent to the cutting line "p1". (22.3X)

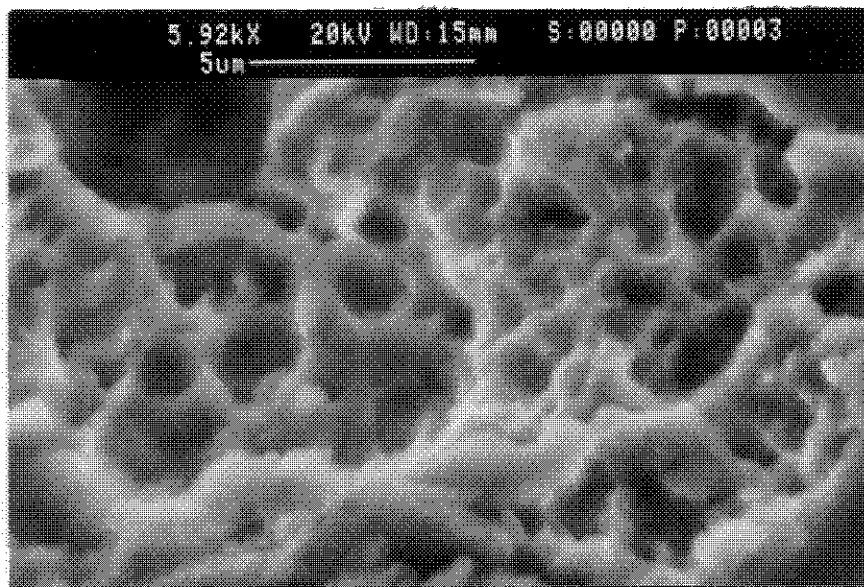
Figure 5. SEM photograph of the surface features observed within circle "j" of figure 4. (5,920X)

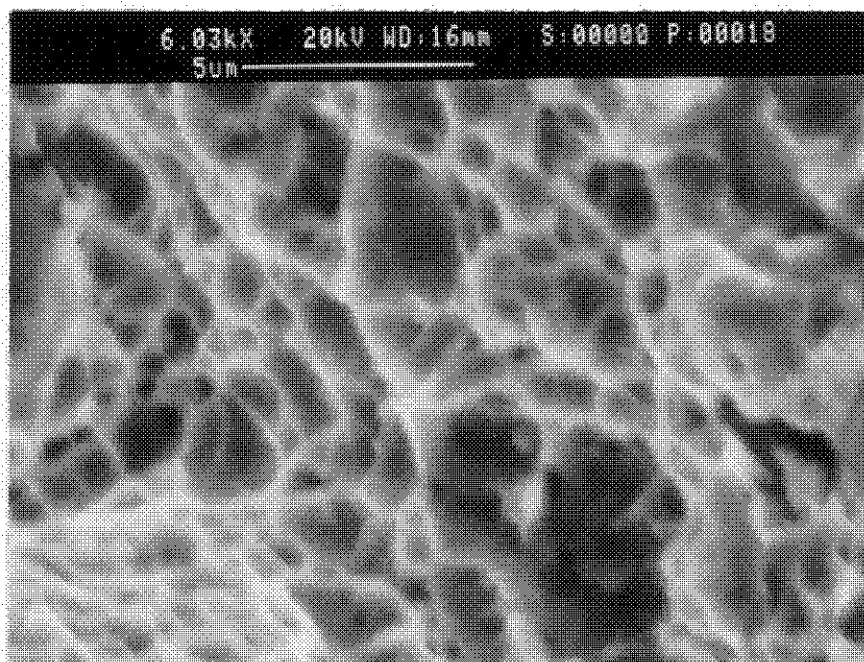
Figure 6. The surface features observed within circle "n" of figure 4. (6,030X)

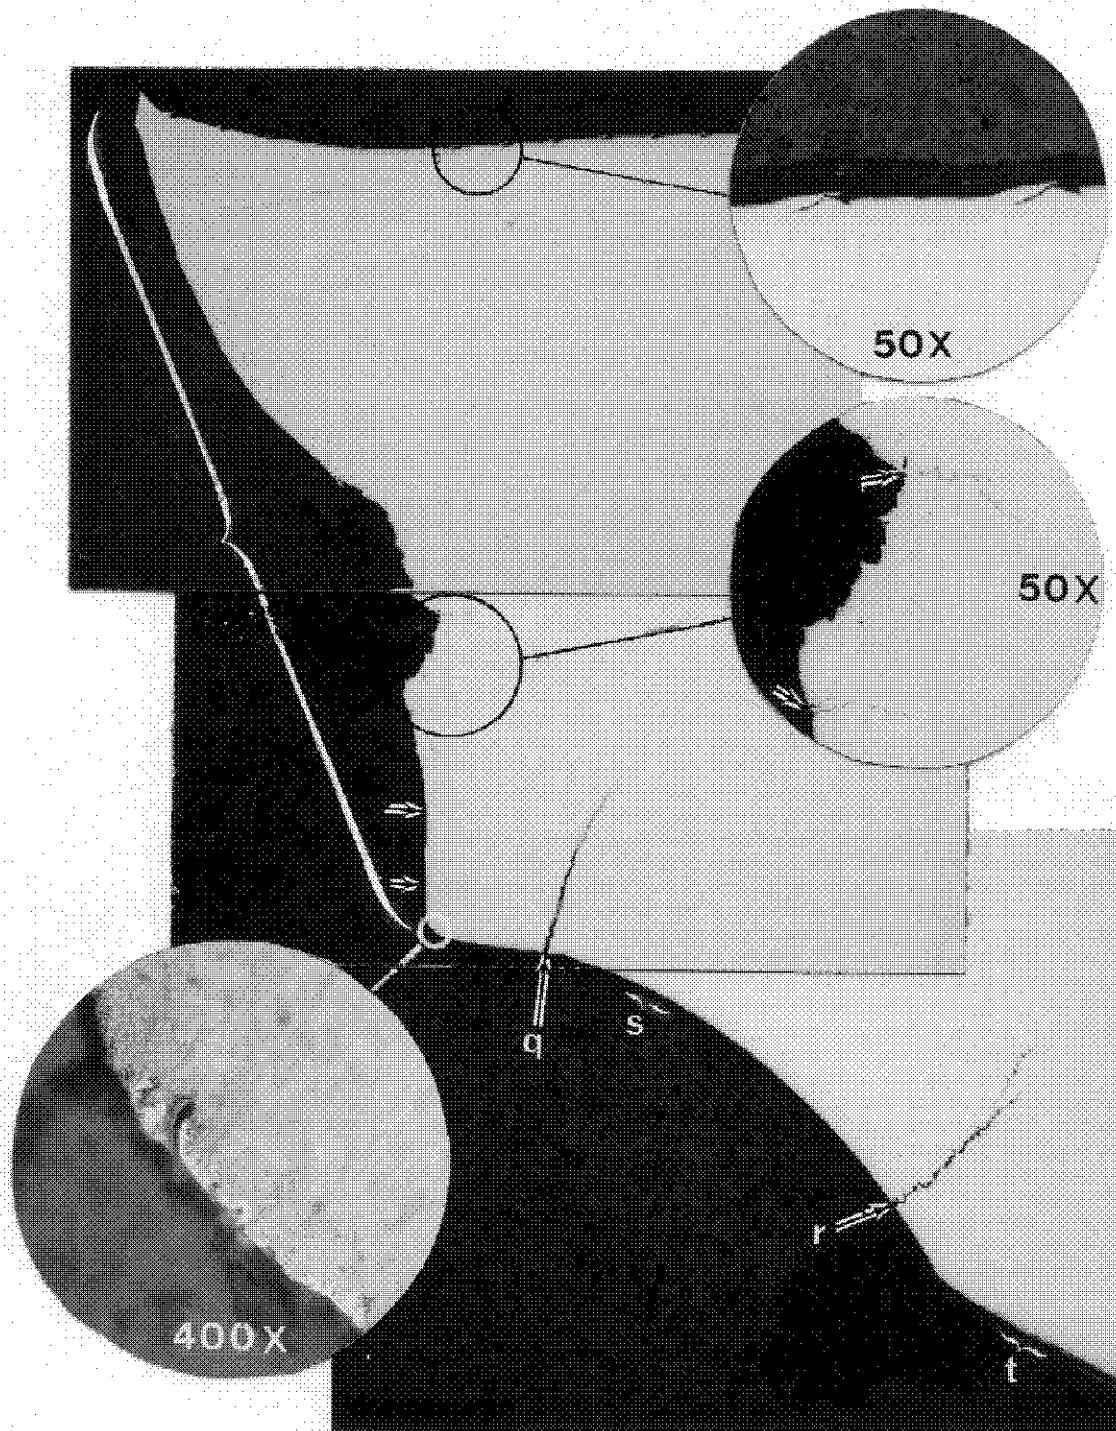
Specimen "S1" was saw cut from the remainder of the fracture piece, mounted, and polished for metallurgical examination. The section adjacent to the fracture face and along cutting line "p1" is illustrated in figure 7. The unmarked bracket indicates the fracture face. The circumferential crack indicated by arrow "q" in figure 4 is similarly indicated. A second significant crack located in the ball groove is indicated by arrow "r". The unmarked arrows on the composite illustration and on the middle insert indicate lesser cracks. The upper insert illustrates regularly space lapped features observed on the inside diameter of the jackscrew. The regular spacing and similarity of these features are consistent with tool marks from an inside diameter machining operation with a general finish requirement. The lower insert illustrates the initial separation edge after the surface had been etched with 2% Nital to reveal the plated surface.

Figure 7. Sectional view of the fracture face and the adjacent ball groove along cutting line "p1". (20X)

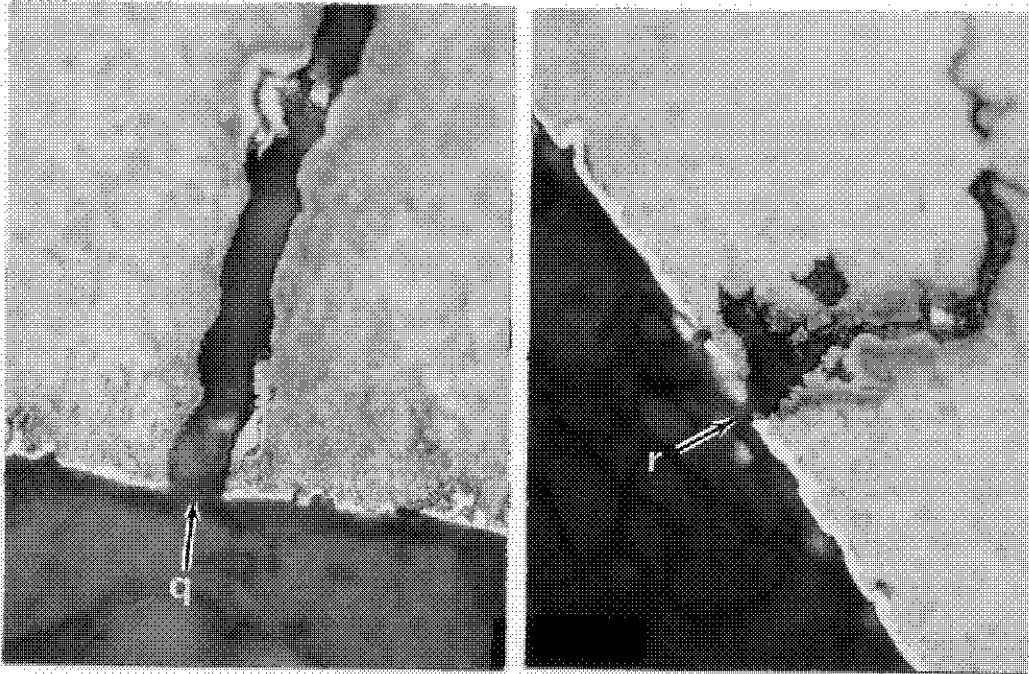
Figure 8 illustrates the cracks indicated as "q" and "r" in figure 7. The etching revealed that the plating was on the surface and did not penetrate into the crack. Measurements of the plating thickness revealed that it was in the 3.6 to 4.1 micron range (0.00014 to 0.00016 inches). Energy dispersive spectrometer (EDS) analysis revealed that the plating was chromium with a trace of nickel at the interface with the base material.

Figure 8. Closer view of the intersection of cracks “q” (left view) and “r” (right view) with the surface of the jackscrew. (Nital etchant, 400X)

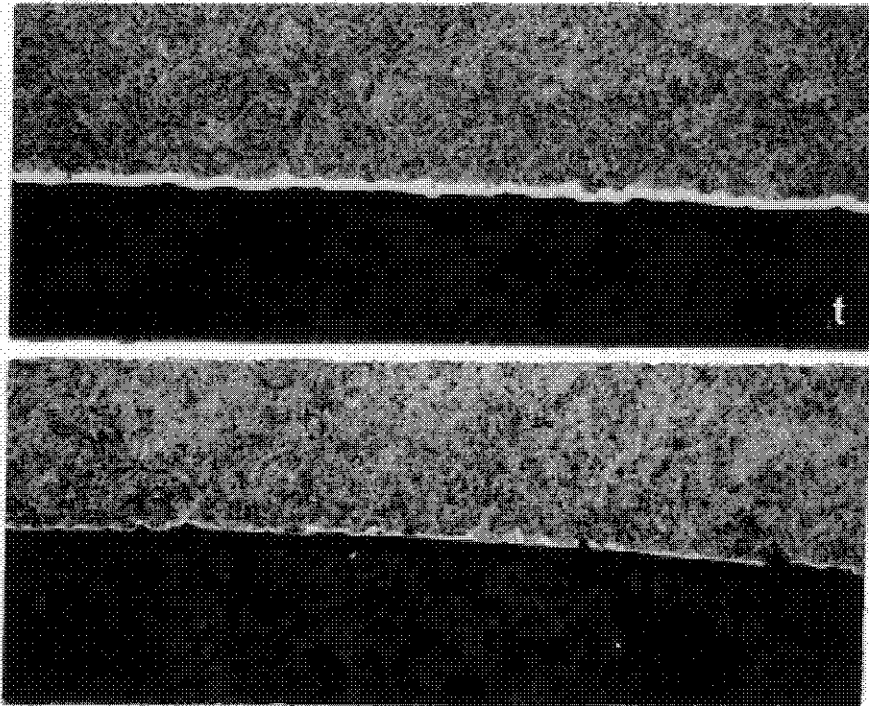
The upper view in figure 9 illustrates the flat surface between the two ball grooves indicated by bracket "t" in figure 7. The plating thickness was measured at this location and found to be in the 9.1 to 9.9 micron range (0.00036 to 0.00039 inches). The lower view in figure 9 illustrates the surface in the ball groove adjacent to the one illustrated in figure 7. The corresponding location in the groove adjacent to the fracture is indicated by bracket "s" in figure 7. The plating thickness at the location shown in the lower view in figure 9 was measured and found to be in the same 3.6 to 4.1 micron range as the ball groove illustrated in figures 7 and 8.

Figure 9. Views showing the plating thickness at bracket “t” (top view) in figure 7 and in the ball groove (lower view) adjacent to the one illustrated in figure 7. (Nital etchant, 200X)

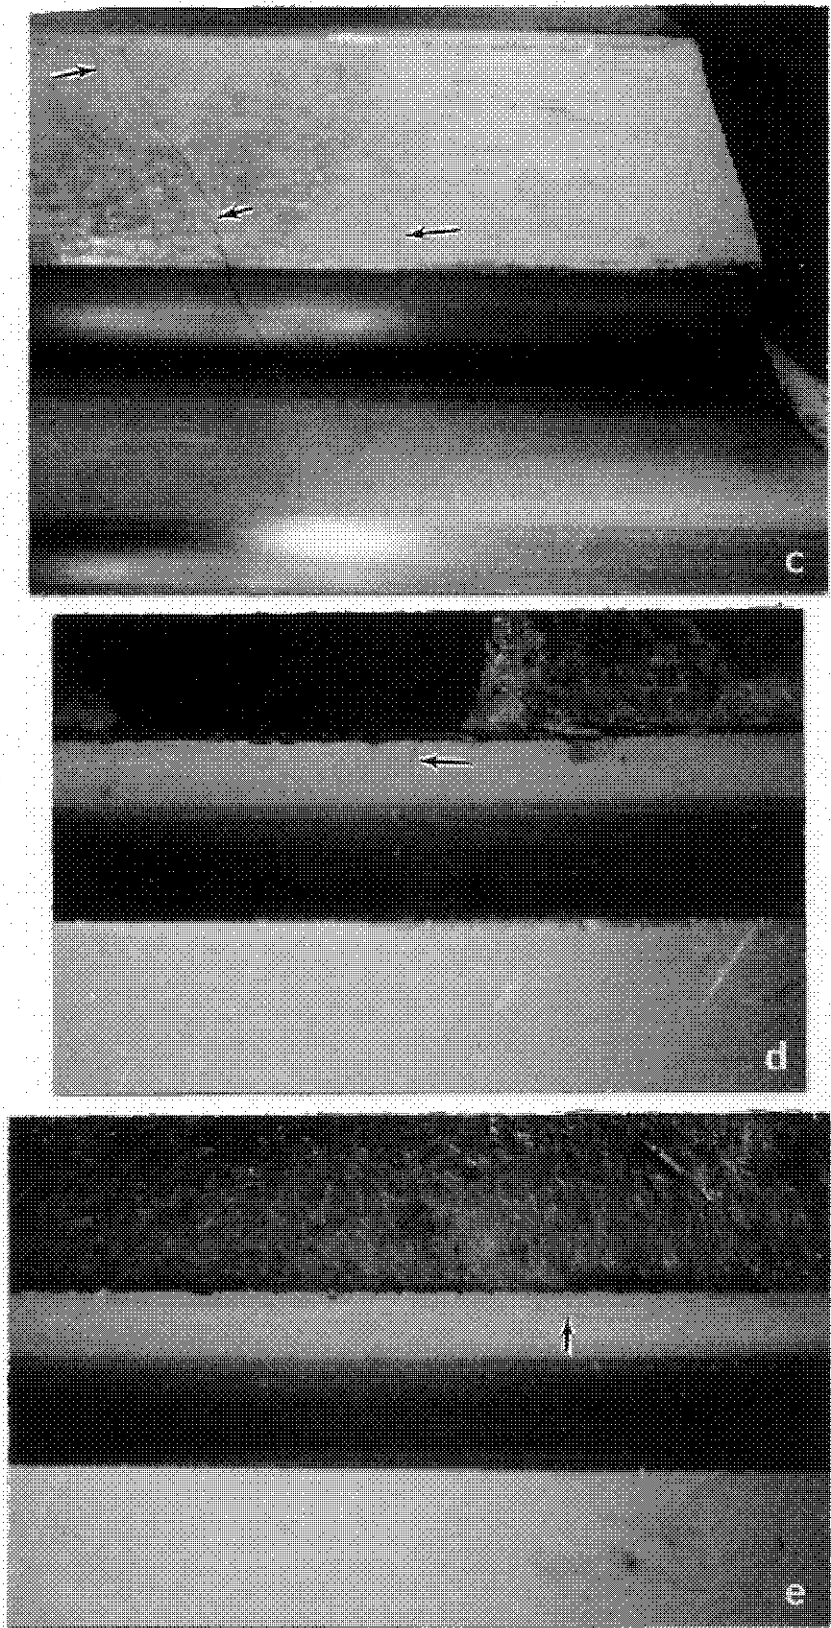
Cracks were found on the outside surface of the jackscrew at the locations indicated by brackets "c", "d" and "e" in figure 2. Figure 10 illustrates these cracks. The unmarked arrows at location "c" indicate where three longitudinal cracks crossed the flat of the screw. The center crack progressed into the ball groove. The unmarked arrow at location "d" indicates a longitudinal crack, much shorter than those observed at location "c", that

initiated at the fracture face. The unmarked arrow at location “e” indicates a circumferential crack similar to the one indicated by arrow “q” in figure 4.

Figure 10. Cracks observed at locations "c", "d" and "e" in figure 2. (10X)

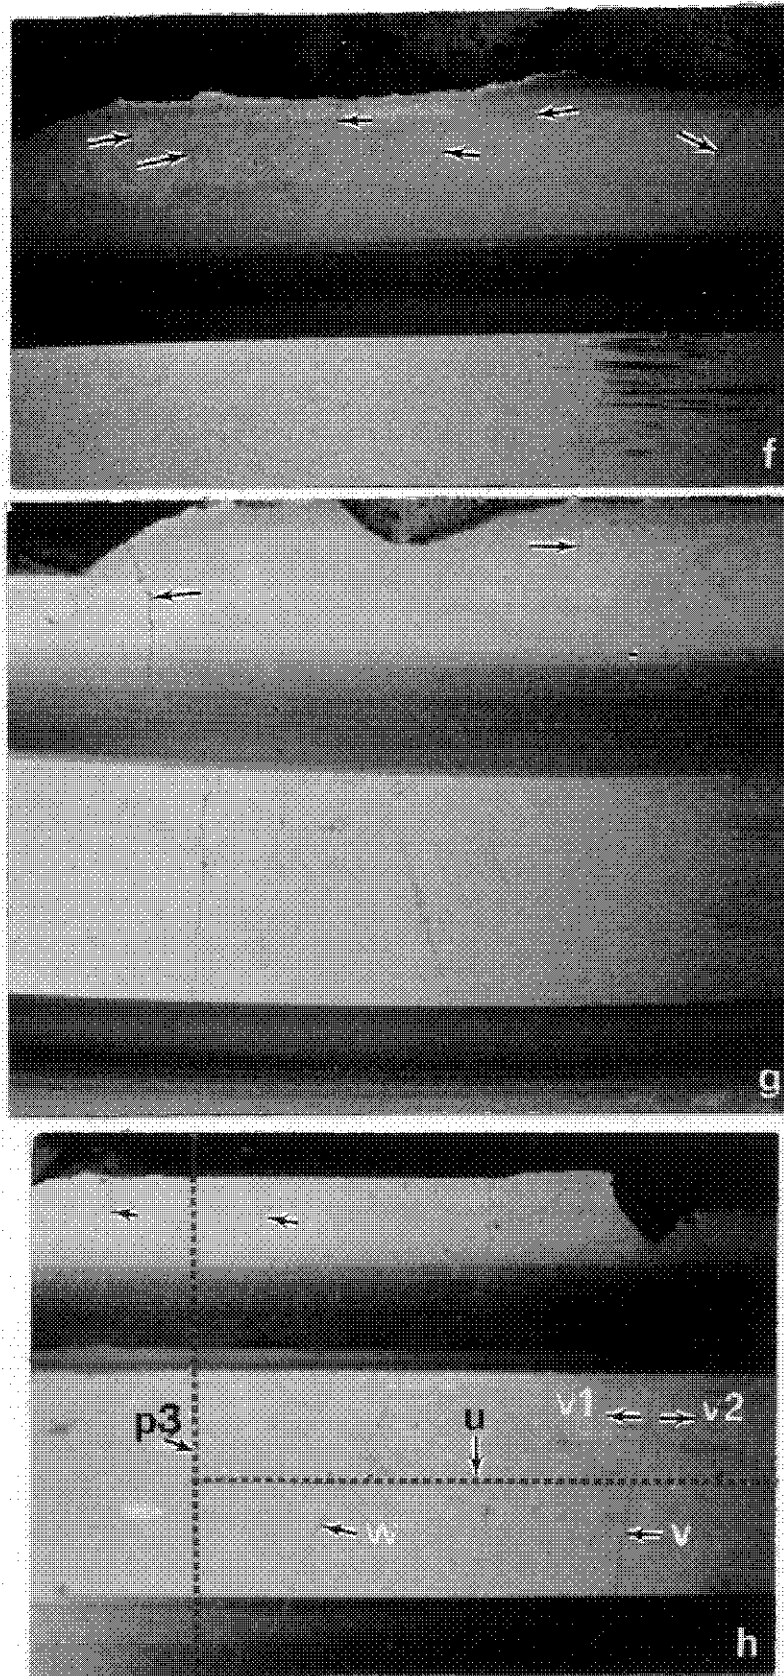
Cracks were also found on the outside surface of the jackscrew at the locations indicated by brackets “f”, “g” and “h” in figure 2. Figure 11 illustrates these cracks. The unmarked arrows at location “f” indicate six small longitudinal cracks, within the ball groove, that initiated at the fracture face. The two unmarked arrows at location “g” indicate the cracks initiating at the fracture face. The left arrow indicates a crack that initiated at the fracture face, propagated across the groove, along the flat of the screw and into the adjacent groove.

Multiple cracks were found at the “h” location, as shown in the lowest photograph in figure 11. The two unmarked arrows at location “h” indicate small cracks initiating from the fracture face. The cracks arrowed “v” and “w” start at the fracture face and propagate across the ball groove. Arrow “p3” in the lowest photograph in figure 11 indicates the red dashed cutting line as indicated in figure 2. Also, arrow “u” indicates a red dashed cutting line that crossed cracks “w” and “v” and divided specimen “S2” into two pieces. The lower piece (further from the fracture) was metallurgically prepared for examination. The upper piece was then separated in the directions indicated by arrows “v1” and “v2” (see figure 11) in order to examine the face of crack “v”.

Figure 11. Cracks observed at locations "f", "g" and "h" in figure 2. (10X)

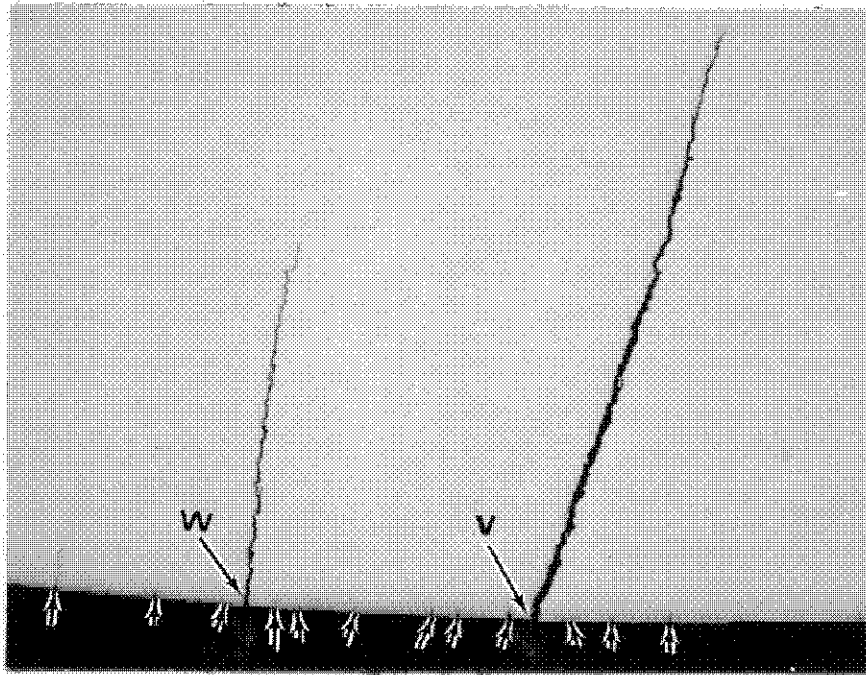
A view of the polished surface along cutting line “u” (see figure 11) is illustrated in figure 12. The cracks indicated by arrows “v” and “w” are similarly identified. The unmarked arrows indicate very shallow surface cracks. Hardness testing was performed on this prepared specimen utilizing an Antonik micro hardness tester, model MHT2 (Knoop indenter at 500g). The results indicated that the hardness was within a range of 55 – 60 HRC (Hardness, Rockwell, C scale) from the chrome plating to a depth of approximately 0.04 inches. From the depth of 0.04 inches to 0.10 inches the hardness was in the range of 45 – 52 HRC and from a depth of 0.10 inches to 0.35 inches the hardness was in the range of 42 – 45 HRC. Direct hardness measurement utilizing an Antonik hardness tester, model ADR8 (“C” indenter at 150Kg), indicated that the hardness was 43.2 HRC at a depth of 0.09 inches, 40 HRC at a depth of 0.18 inches and 40.8 HRC at a depth of 0.27 inches.

Figure 12. Sectional view on cutting line "u" in figure 11 location "h" with cracks "v" and "w" indicated. (As-polished, 20X)

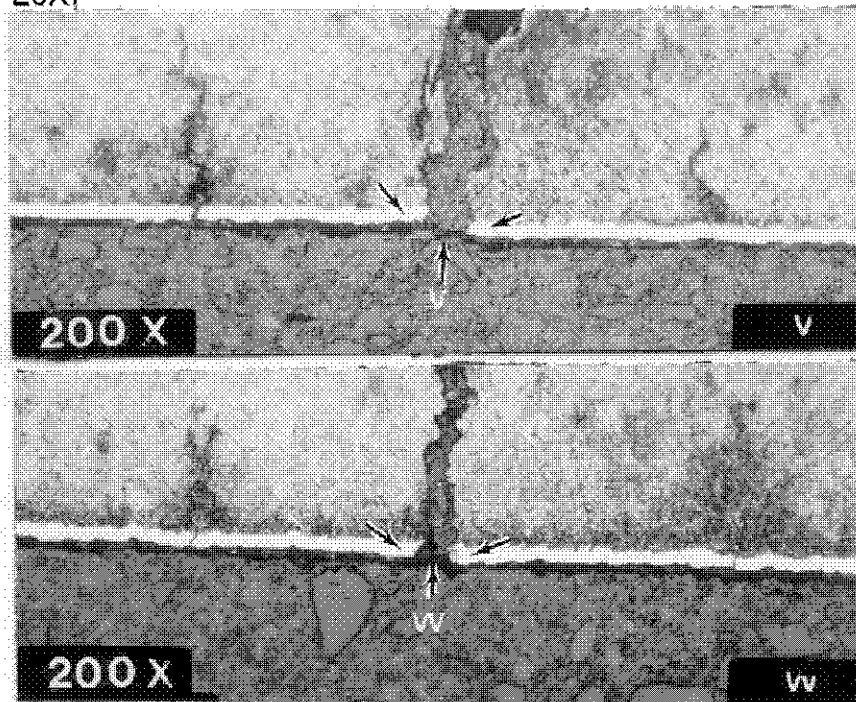
Figure 13 illustrates higher magnification views of the intersection of cracks “v” and “w” with the exterior surface of the jackscrew. The unmarked arrows indicate the cleanly separated chromium plating. Several of the smaller surface cracks on both sides of cracks “v” and “w” (indicated by the unmarked arrows in figure 12) are visible in figure 13. Chromium plating thickness on the section shown in figure 13 was in the same range as the upper view of figure 9.

Figure 13. Closer views of the intersection of cracks "v" and "w" with the exterior surface of the jackscrew. (Nital etchant, 200X)

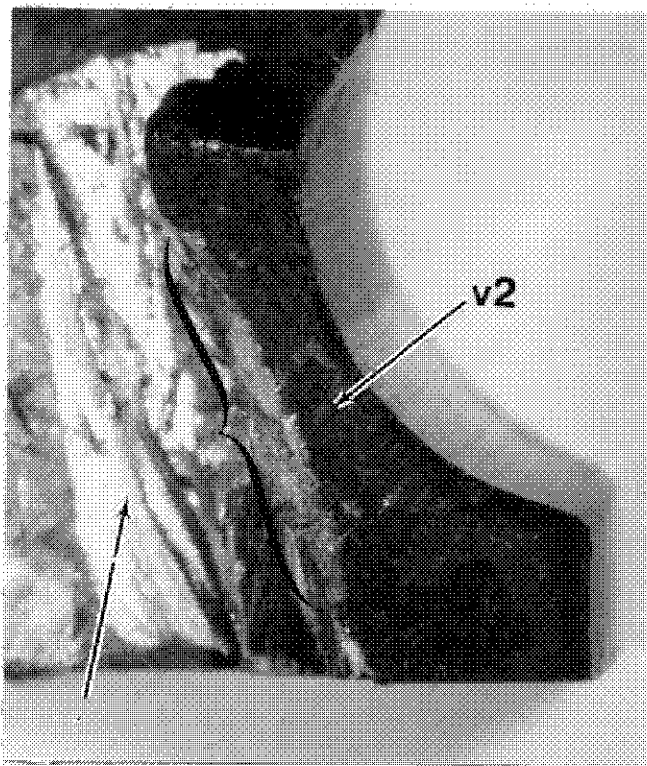
The face of crack “v” separated at arrows “v1” and “v2” in figure 11, location “h”, is illustrated in figure 14. The crack face shown in this figure was the face on the portion of the jackscrew under the arrow “v2” in the lowest photograph in figure 11. The unmarked arrow in figure 14 indicates the material that was mechanically removed to assist in opening crack “v” and the material in the bracket is the fracture area created in the

laboratory. The surface of crack "v" (indicated by arrow "v2" in figure 14) contained relatively uniform dark rust-colored deposits. Examination of the crack face revealed features that were consistent with an overstress separation.

Figure 14. Fracture face "v2" of crack "v" in figure 11, location "h". (6.5X)
