NATIONAL TRANSPORTATION SAFETY BOARD

MATERIALS LABORATORY STUDY

Report No. 98-116

A study was initiated to examine Boeing 737 rudder power control unit (PCU) servo valves that were involved in accidents and compare them to representative exemplar valves removed from service that were not involved in accidents. The primary reason for doing this study was to document the differences and/or similarities between non-accident and accident valves. Exemplar valves were obtained from Parker Hannifin that had known service histories. In addition a valve used in testing, referred to as the "minimum tolerance valve", was obtained and added for comparison.

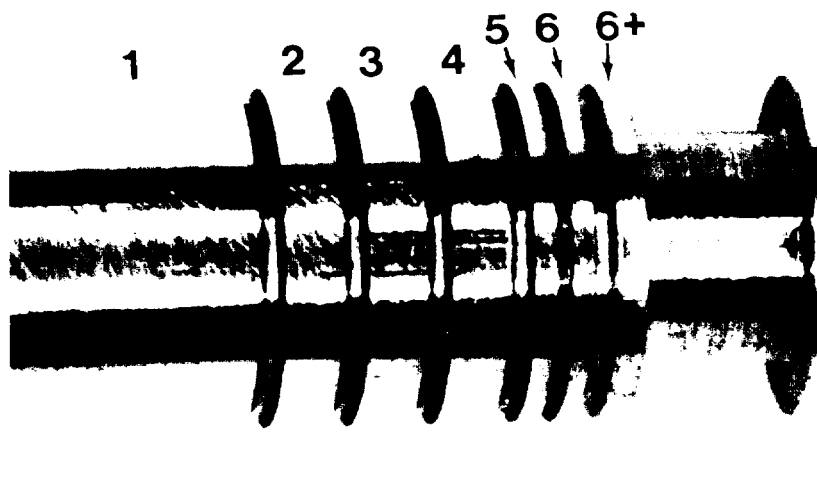
Figures 1 through 4 show selected areas of the primary outside diameter lands that contained a relatively large concentration of burnishing marks (shown as thin dark marks aligned longitudinally). Other areas also contained burnishing marks but were not as concentrated as those shown in these figures.

Figure 1. Primary for exemplar 2108X showing a location of concentrated burnishing marks. Lands 1 through 6+ reference angular position about 130 degrees X7.5

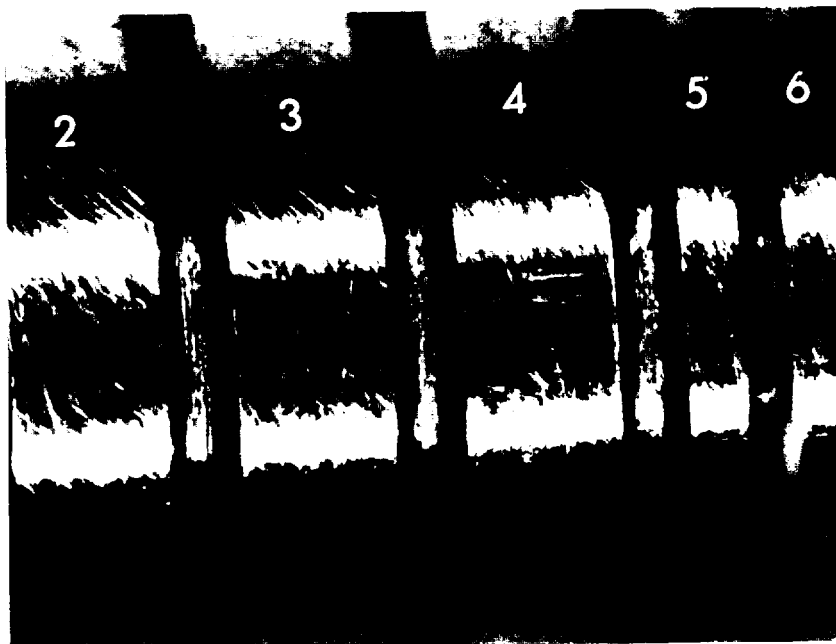
Figure 2. Higher magnification view of figure 1 in area of burnishing marks X20

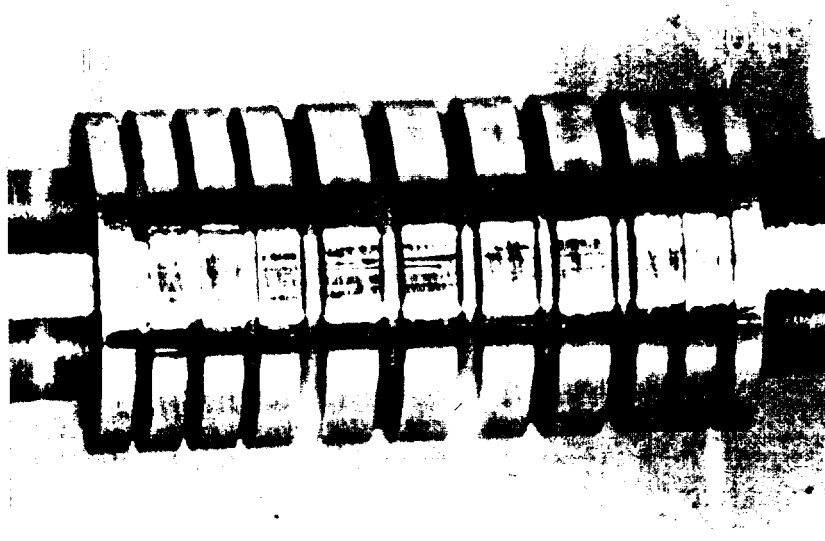
Figure 3 Another area showing a high concentration of burnishing marks. Exemplar 2108X primary, lands 12 to 20+ at 30 degrees X7.5

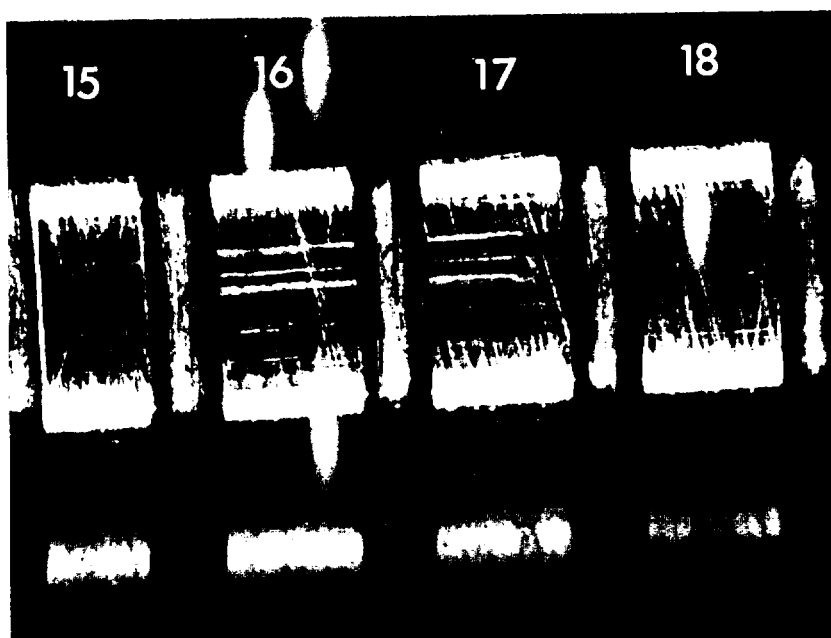
Figure 4 Higher magnification view of burnish mark area shown in figure 3 X20

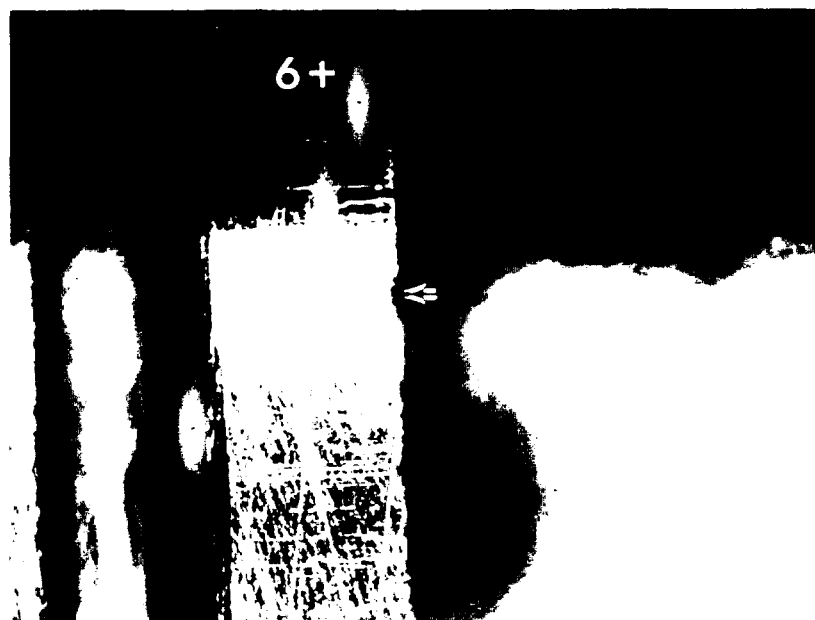
Areas of small chip outs of the land /metering cavity corner were noted at some of the metering edges. Two chip out areas (30 and 300 degree reference positions) are displayed in figures 5 and 6 on the metering edge associated with land 6+. Three other chip out areas (50, 160, and 235 degrees) are shown in figure 7 for land 11++.

Figure 6 Another small area of chip out (arrowed) of metering edge
Exemplar primary 2108X land 6+ at 30 degree
reference X50

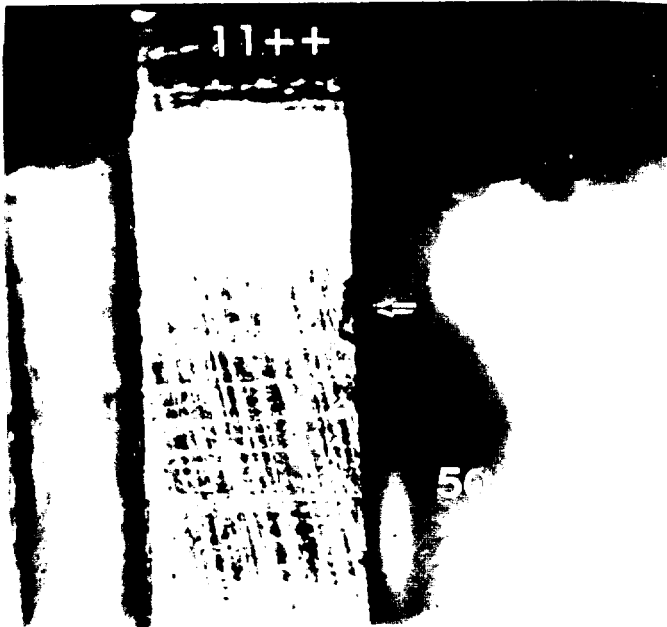
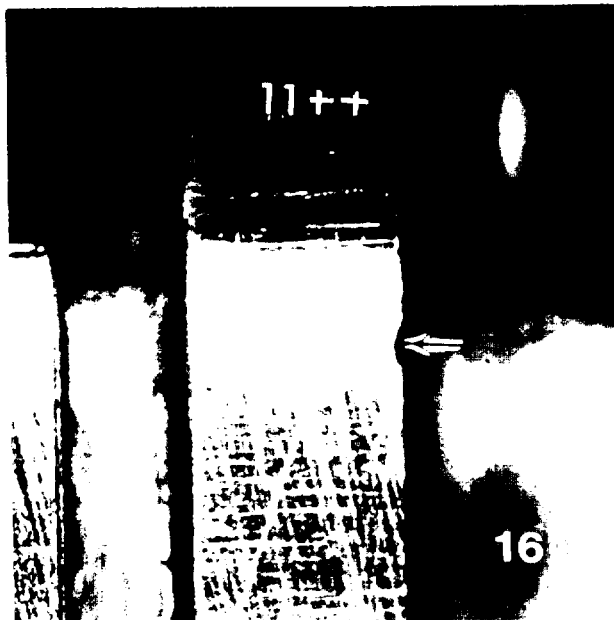
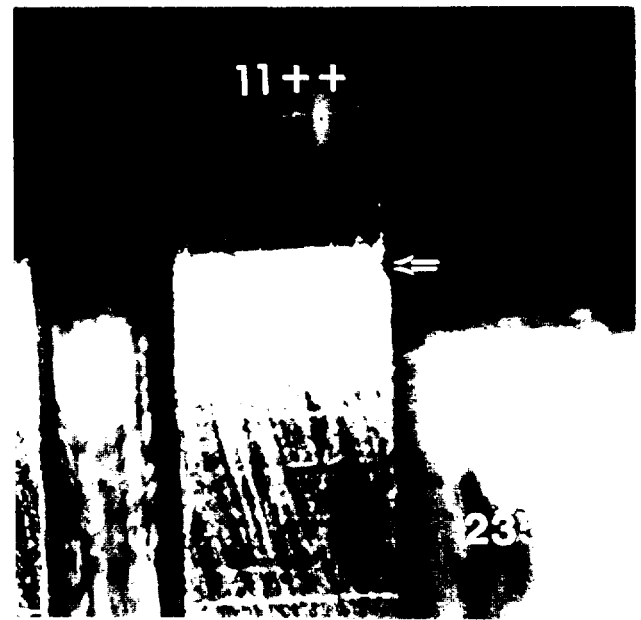
Figure 7 Three areas of small chip outs (arrowed) at metering edge 11++ Approximate angular positions shown to right of metering edge All photos X50

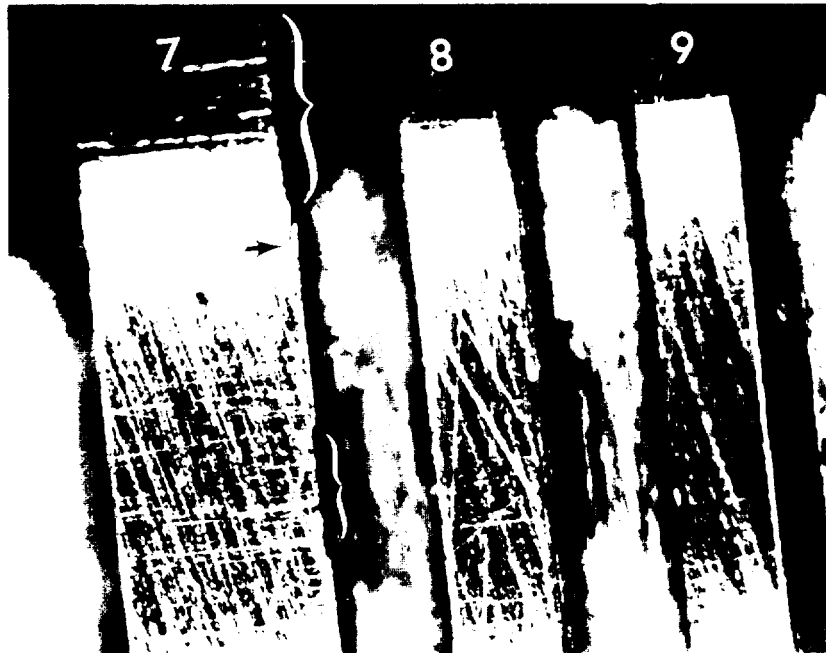
In addition, significant chip out areas of the corner between the land and groove were noted that were associated with the first balance groove from the metering edge. One area was on land 7 as shown in figures 8 and 9. Other areas are shown in figures 10 through 13 for land 13, and figures 14 through 16 for the groove side of land 21. The chipped out portions were approximately 0.001 inch along the longitudinal land surface with a maximum of about 0.003 inch within the groove below the land. However, these chip out areas were of varying sizes circumferentially, some of which extended circumferentially over 0.04 inch (see figure 10 as an example). In the longer circumferentially chipped areas the chipping appeared to follow circumferential lines on the land as shown by the unmarked arrows in figures 10 and 11.

When first examined, the chip out area shown in figure 8 displayed a crack in the area of the arrow. It was noted that this same area had changed with more chipping (extension of crack) after the primary was rotational hand wiped with a Kimwipe (laboratory tissue) in attempts to remove what appeared to be contamination on the surface. Figure 9 displays the same area after this wiping (arrow in this figure indicates the identical area shown by the arrow in figure 8). The area of bracket "1" in figure 9 indicates the amount of the corner edge that was removed by this wiping.

Figure 8. Chip out areas (bracketed) of the corner between the land and balance groove. Arrow denotes a small crack. Exemplar S/N 2108X, land 7 at 200 degrees. X50

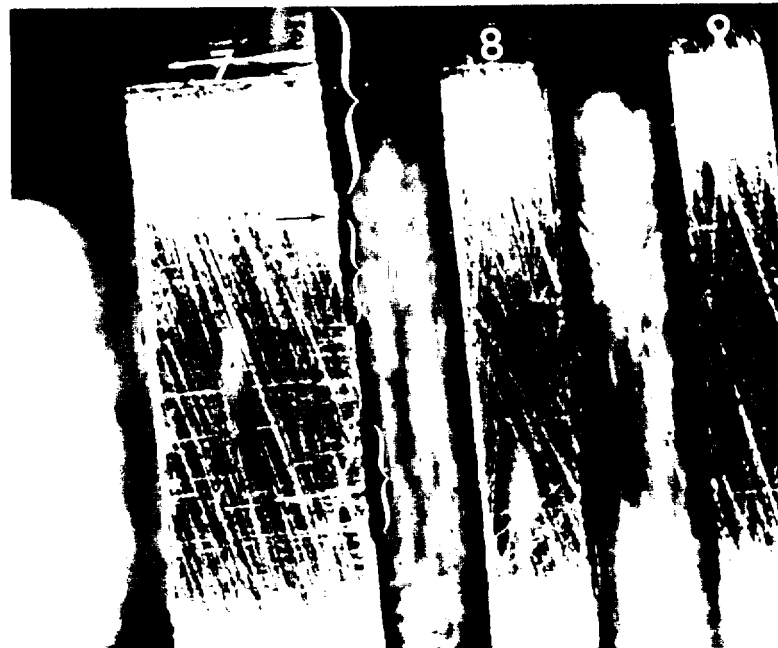
Figure 9. Same as above except photograph taken after the primary was rotational wiped with a Kimwipe tissue. Arrow locates same area as that shown by the arrow in figure 8 above. Note small area of additional chip out produced in the area of bracket "1". X50

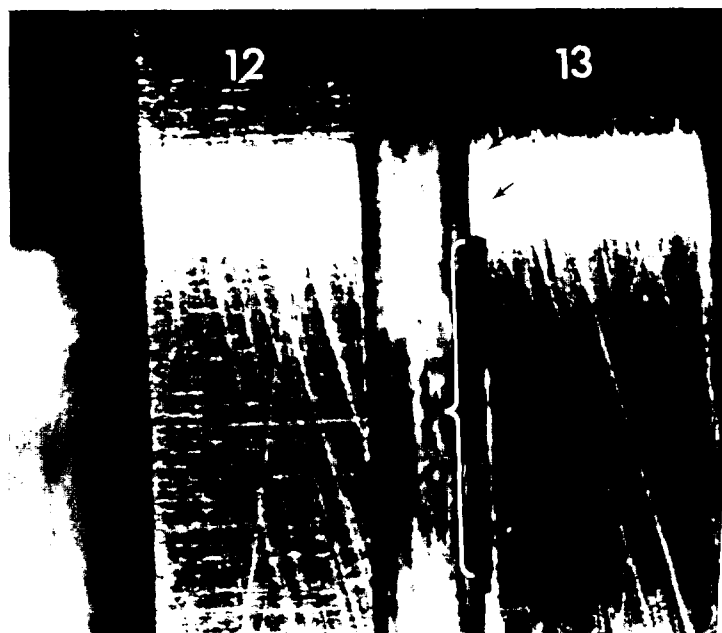
Figure 10 Larger chip out area (bracket area) of the land / balance groove corner found on exemplar 2108X at about 45 degrees for land 13 Note circumferential mark located by arrowheads X50

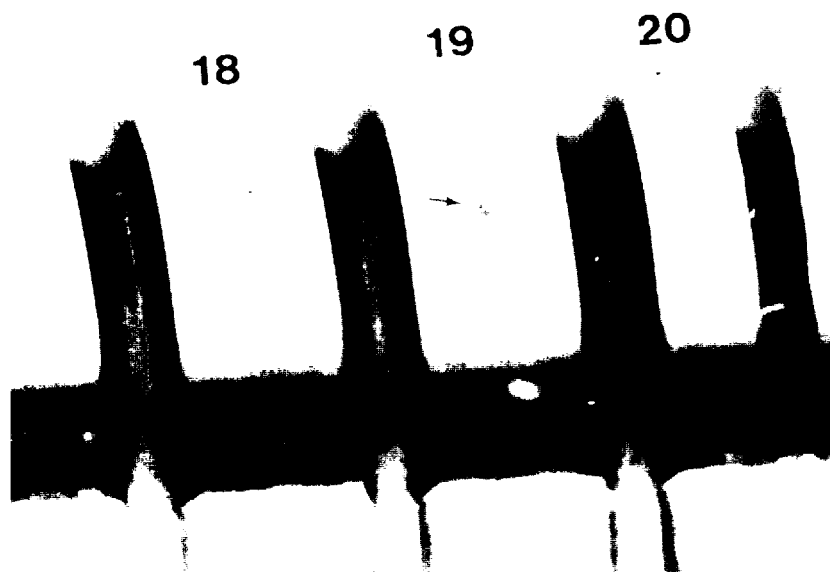
Other superficial markings were also noted and are only mentioned for thoroughness. A few areas contained blemishes or splotches on the land surface as shown by the arrow in figure 17. These appeared to be a thin deposit on the surface. Figure 18 shows an area containing what appeared to be a scrape somewhat like a burnished area. The brackets in figure 19 locate two longitudinally roughened areas which were in contrast with the remaining polished surface. Small circular dark regions exhibiting a comet tail were also noted on the land surfaces in some areas (typical examples are shown in figure 20).

Figure 17. Splotching (probably deposit) found on land 19. Photograph taken after alcohol wiping with a Kimwipe to try to remove the deposit. About X20
