Materials Laboratory Flap Actuators Factual Report

MATERIALS LABORATORY FACTUAL REPORT

Report No. 09-050

Place : Lubbock, Texas
Date : January 27, 2009
Vehicle : ATR 42, N902FX
NTSB No. : CEN09MA142
Investigator : Kristi Dunks, ASI-WPR

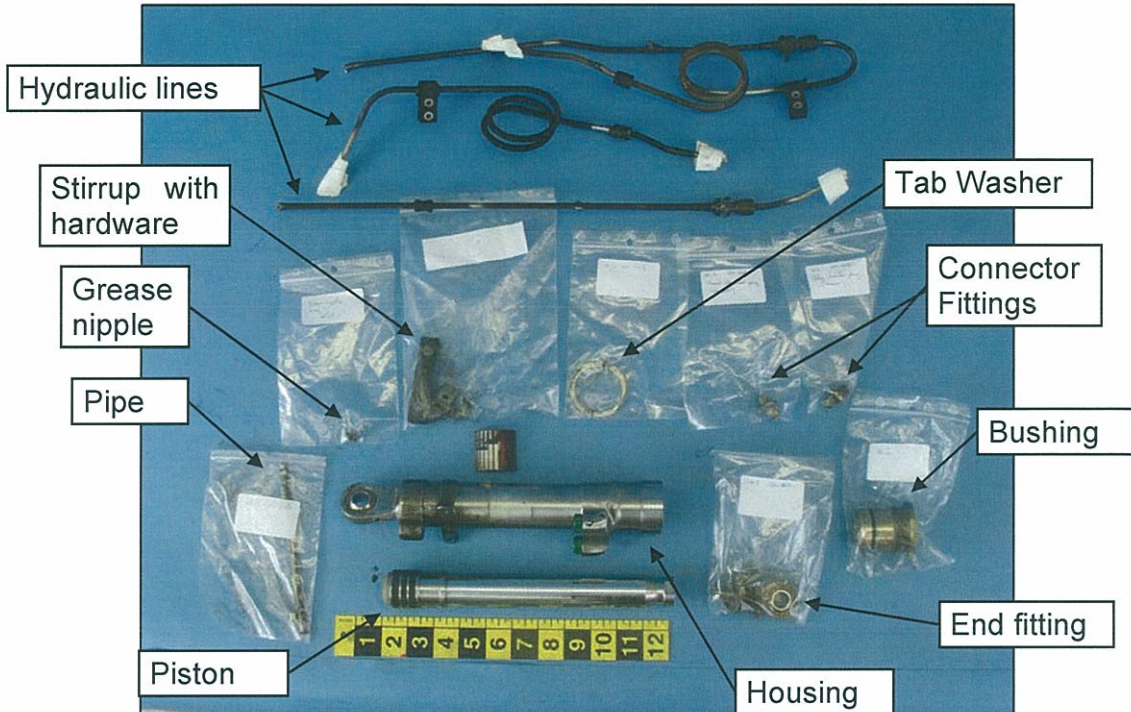
The left outboard actuator components are shown in figure 1. The left outboard actuator had the least amount of soot deposits and heat damage. The exterior surfaces of the hydraulic lines were blackened, and a black liquid dripped from the cut end of one line. The interior of the connector fittings were free of obstructions. The exterior of the pipe was blackened, and interior of the pipe was partially obstructed with black deposits near the notched end of the pipe.

Figure 1. Overall view of the left outboard flap actuator and hydraulic lines.

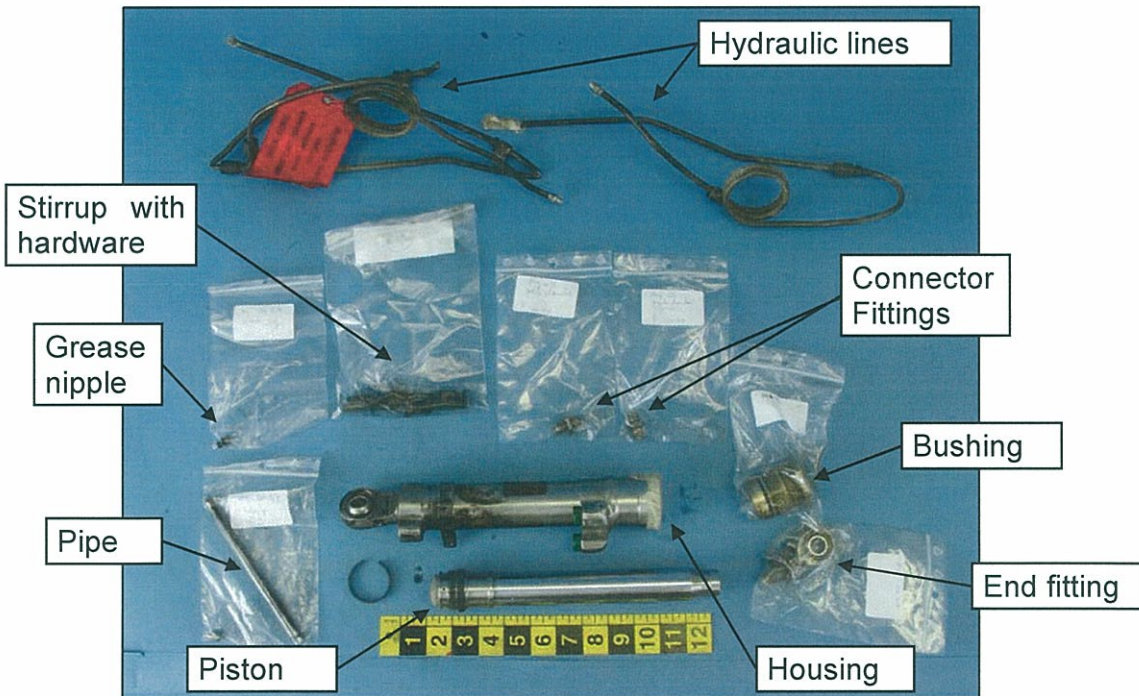
The left inboard actuator components are shown in figure 2. The left inboard actuator housing and hydraulic lines had similar levels of soot deposits as was observed on

the left outboard actuator, but the piston also showed soot deposits. The exterior surfaces of the hydraulic lines were blackened, and a green liquid dripped from the fractured end of one line. The interior of the connector fittings were clear of deposits. The exterior of the pipe was blackened, and interior of the pipe was free of deposits.

Figure 2. Overall view of the left inboard flap actuator and hydraulic lines.

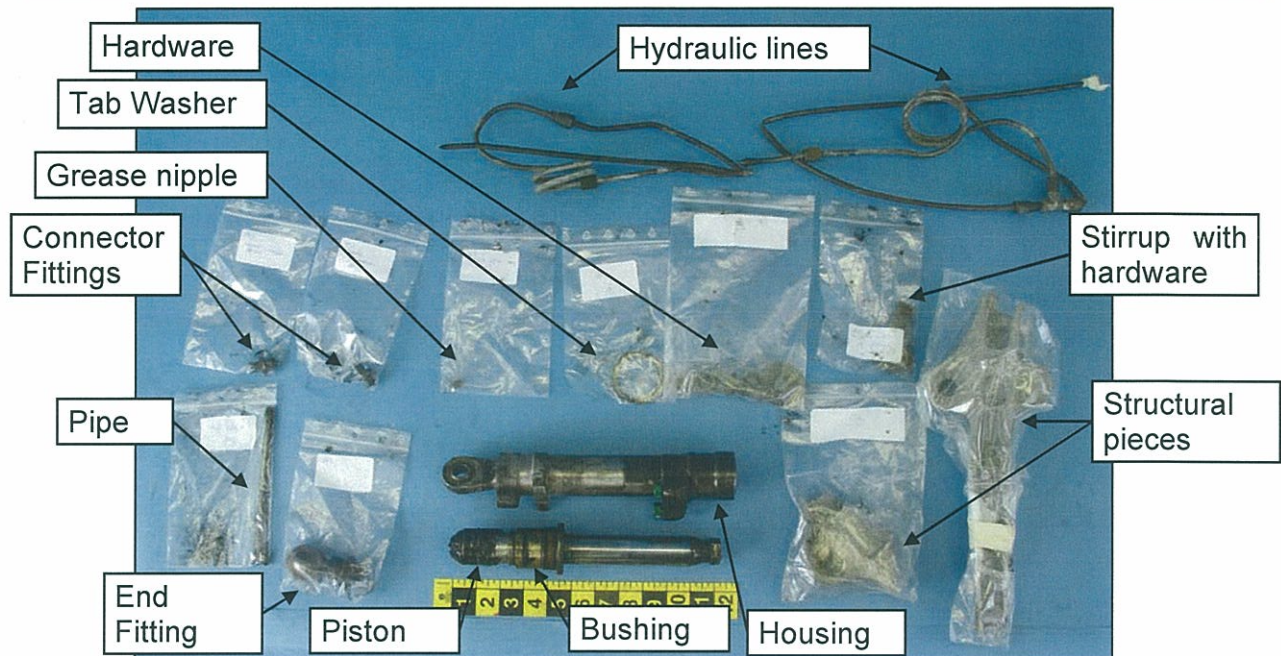
The right inboard actuator components are shown in figure 3. The right inboard actuator and hydraulic lines were darkened with soot deposits and heat tinting along their entire lengths. Green and black fluid was observed on the exterior surfaces of the hydraulic lines. Black deposits were observed on the interior of the connector fittings. The exterior of the pipe was blackened, and interior of the pipe was mostly obstructed with black deposits.

The structural pieces shown in figure 3 consisted of pieces of structure from the aft side of the actuator (smaller piece) and the forward side of the actuator (larger piece). Fractures on the aft structure piece had a speckled appearance with secondary cracking consistent with overstress fracture at high temperature. The forward structural piece also showed fractures with a speckled appearance and secondary cracks. Flowed metal and lamellar (woody) fracture features were also observed, all features consistent with overstress fracture at high temperature.

Figure 3. Overall view of the right inboard flap actuator and hydraulic lines.

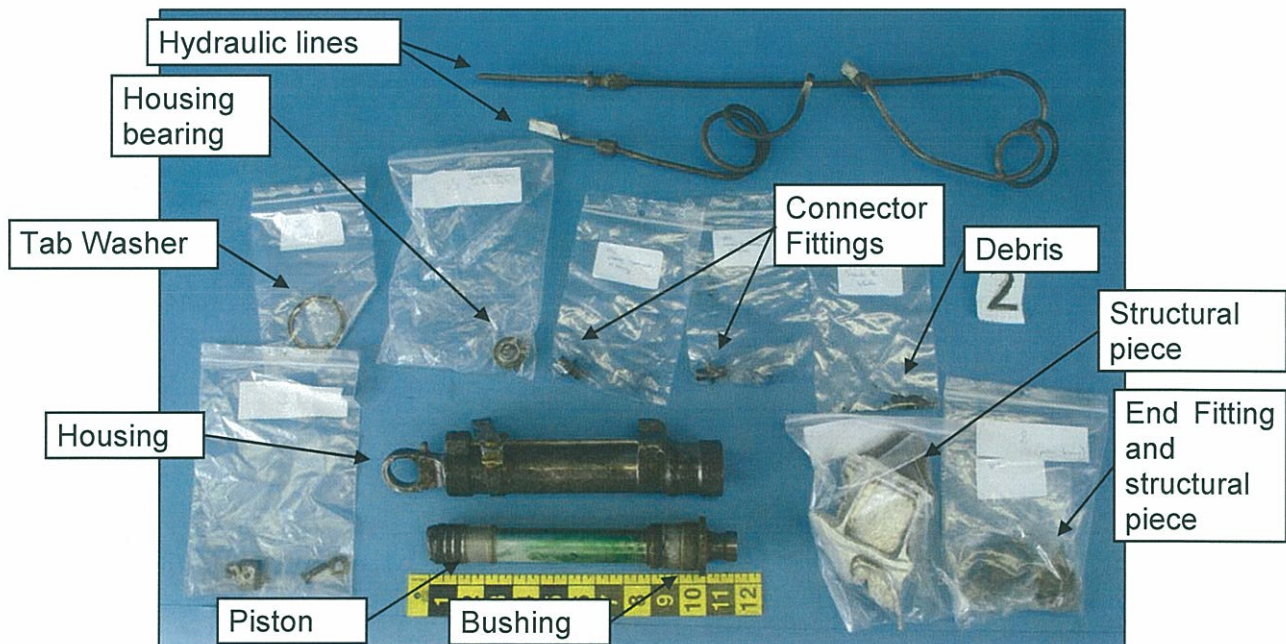
The right outboard actuator components are shown in figure 4. The right outboard actuator and hydraulic lines were darkened with soot deposits and heat tinting along their entire lengths. Green fluid was observed dripping from the end of the shorter of the two lengths of hydraulic lines. Black deposits were observed on the interior of the connector fittings partly obstructing one fitting and completely obstructing the other fitting. The pipe was attached to the housing, and the exterior of the pipe was blackened.

The structural pieces shown in figure 4 consisted of pieces of structure from the aft side of the actuator (smaller piece) and the forward side of the actuator (larger piece). Fractures on both structural pieces showed areas of lamellar (woody) fracture features and features with a speckled appearance and secondary cracks, features consistent with overstress fracture at high temperature.

Figure 4. Overall view of the right outboard flap actuator and hydraulic lines.

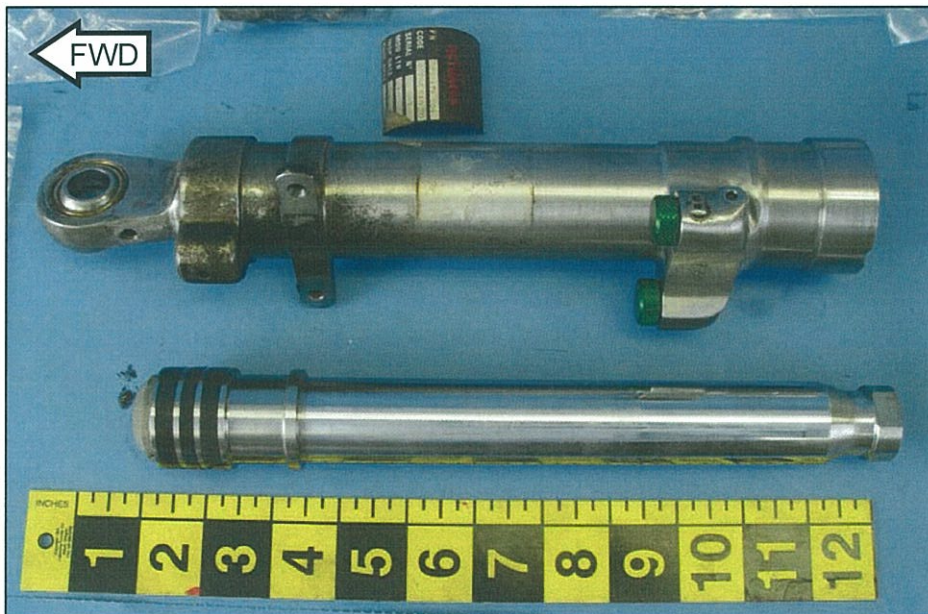
A close view of the actuator housing is shown in figure 6. The forward end of the actuator housing exterior surface was blackened and tinted darker than the rest of the housing, and the data plate had separated from the housing. The interior of the housing was clear of deposits or discoloration.

A close view of the piston is shown in figure 6. A polished circumferential mark approximately 0.05 inch wide was observed on the shaft approximately 1.47 inches from the aft end. The circumferential mark was up to 0.15 inch wide within a 70 degree arc with the aft edge of the mark located approximately 0.1 inch closer to the aft end. Slight longitudinal scratch marks were observed extending between 1.14 inches and 4.25 inches from the aft end of the piston. Some faint longitudinal marks extended up to 6.67 inches from the aft end of the piston. On the forward edge of the forward land, flat deformation of the corner was observed. A close view of this corner flat is shown in figure 7. In the land adjacent to the forward land, 10 longitudinal scratch marks were observed. A close view of five of these scratch marks is shown in figure 7.

Figure 6. Close view of the left outboard flap actuator housing and piston.

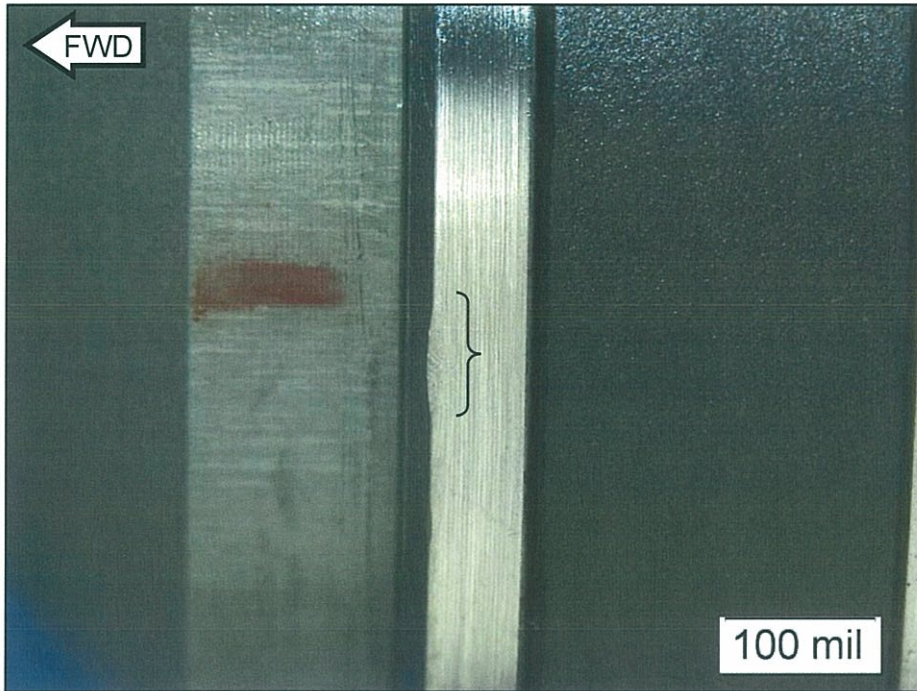
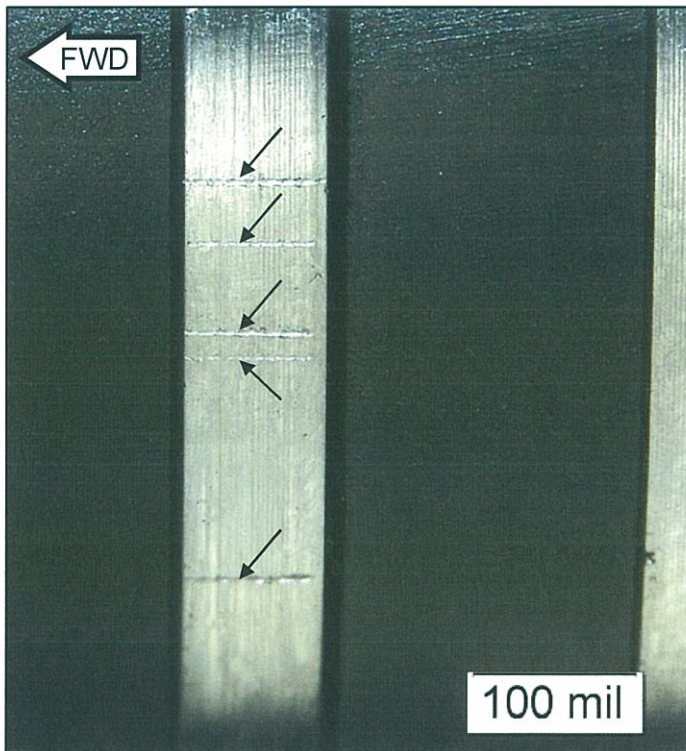
Figure 7. Close view of the forward land (above) and the forward middle land (left) on the left outboard actuator piston. An unlabeled bracket in the upper photo indicates a flat spot observed at the forward edge of the forward land, and unlabeled arrows in the left photo indicate longitudinal scratch marks on the land.

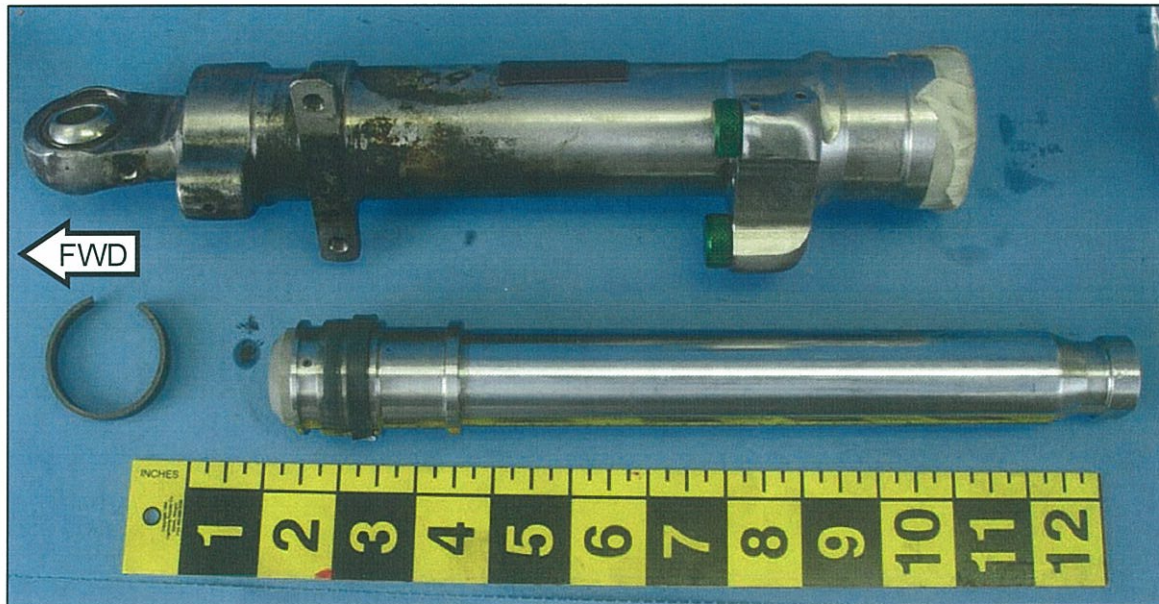
A close view of the actuator housing is shown in figure 8. The forward end of the actuator housing exterior surface was blackened and tinted darker than the rest of the housing. A view of the interior of the housing is shown in figure 9. A thin gray deposit was observed on the surface at the forward end of the housing interior. The interior was rinsed with alcohol into a dish to collect the deposit, but the deposit disintegrated into many small pieces and was not recovered for analysis.

A close view of the piston is shown in figure 8. Black soot deposits were observed on the aft end of the piston within up to 4.5 inches from the aft end. A polished circumferential mark approximately 0.02 inch wide was observed on the shaft approximately 1.47 inches from the aft end. Slight longitudinal scratch marks were observed extending from 1.16 inches from the aft end to 4.30 inches from the aft end. Some faint longitudinal scratches ended at 3.85 inches from the aft end, and others appeared to extend up to 7.06 inches from the aft end. A slight discoloration and roughness was observed between 6.4 and 6.5 inches from the aft end. Faint longitudinal scratches were observed continuously extending over the area of discoloration and roughness consistent with the scratches occurring after the discoloration and roughness. A 0.06-inch long circumferential mark was observed at a location 2.05 inches from the aft end. A close view of the circumferential mark is shown in figure 10.

Figure 8. Close view of the left inboard flap actuator piston and housing.

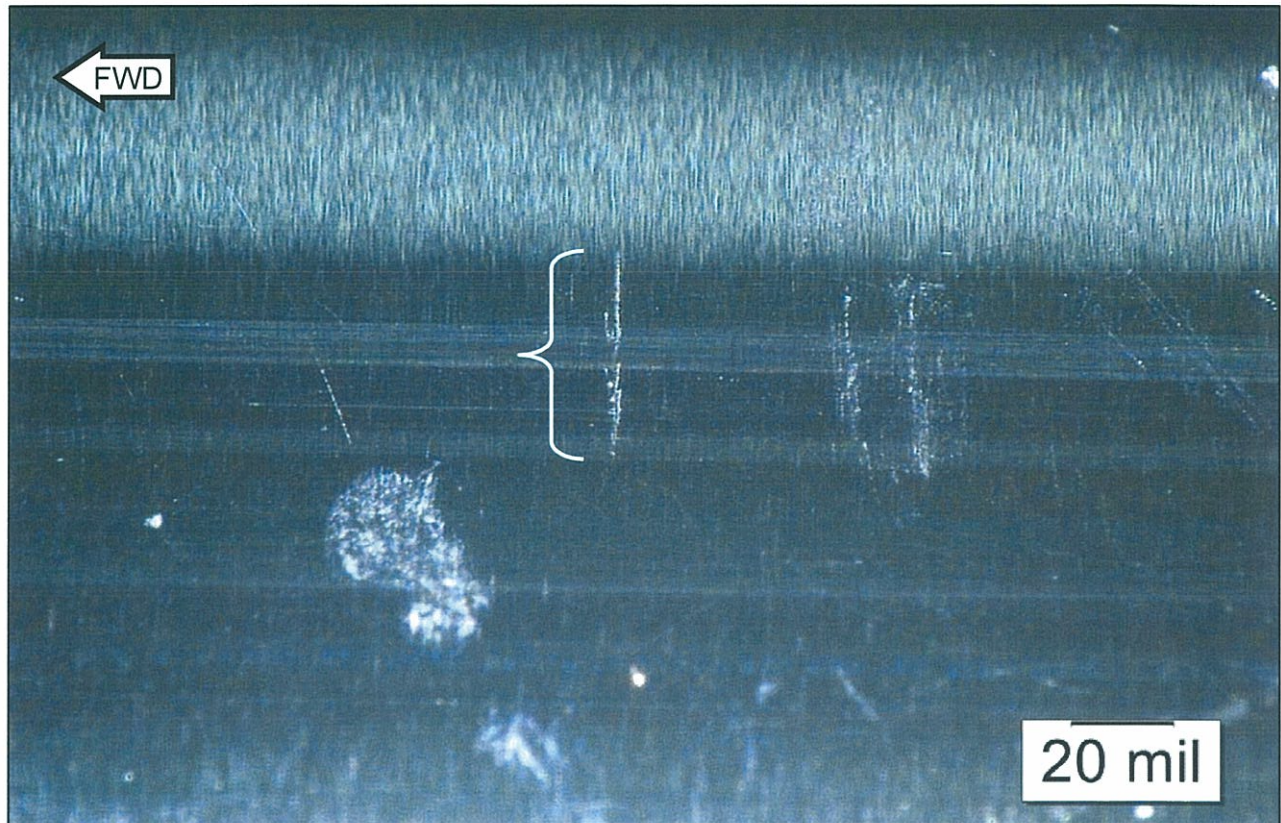
Figure 10. View of the right inboard flap actuator piston shaft surface near the aft end of the piston. An unlabeled bracket indicates a circumferential mark observed on the surface.

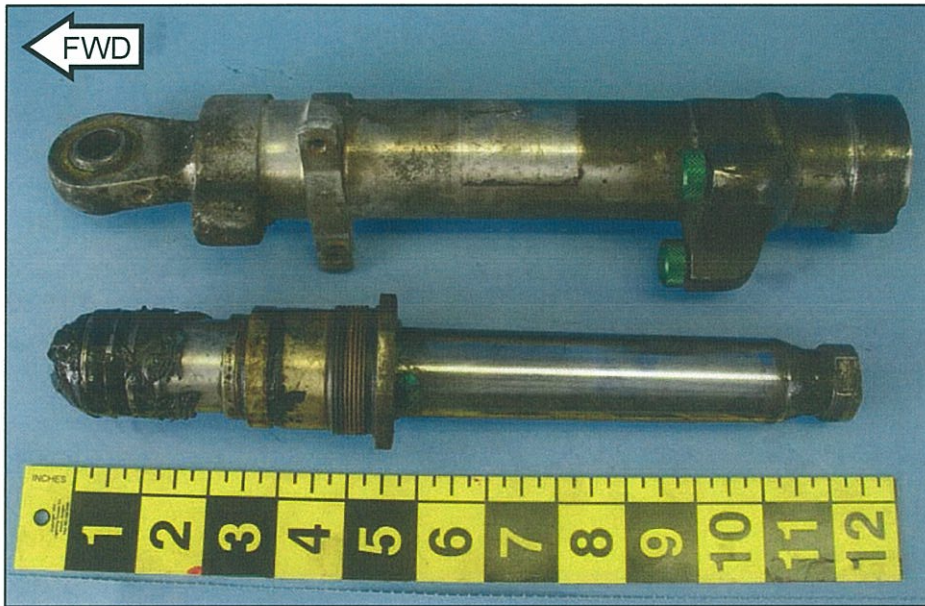
A close view of the actuator housing is shown in figure 11. The aft end of the actuator housing exterior surface was blackened and tinted darker than the rest of the housing. The interior surfaces were mostly covered with black deposits. Some green fluid was also observed on the interior surface of the housing.

A close view of the piston and bushing is shown in figure 11. The bushing was frozen on the piston against the stop flange on the piston. Black soot deposits were observed on the aft end of the piston within up to 1.1 inches from the aft end. The remainder of the piston surface was heat tinted. A dark-tinted circumferential mark approximately 0.06 inch wide was observed on the shaft approximately 1.48 inches from the aft end. Slight longitudinal scratch marks were observed extending from 1.18 inches from the aft end to 4.24 inches from the aft end. Some faint longitudinal scratches ended at 3.90 inches from the aft end. A cluster of longitudinal scratches approximately 0.10 to 0.20 inch long was observed on the shaft between 2.90 and 3.11 inches from the aft end of the piston. A close view of the aft end of the piston is shown in figure 12, and a closer view of the cluster of longitudinal scratches is shown in figure 13. Faint circumferential scratches appeared to coincide with the ends of the cluster of longitudinal scratches. The aft surface of the bushing was located 6.5 inches from the aft end of the piston. The forward corner of the forward land on the piston had a flat deformation similar to the corner flat observed on the forward land of the left outboard flap actuator piston.

Figure 11. Close view of the right inboard flap actuator piston and housing with the bushing remaining in place on the piston.

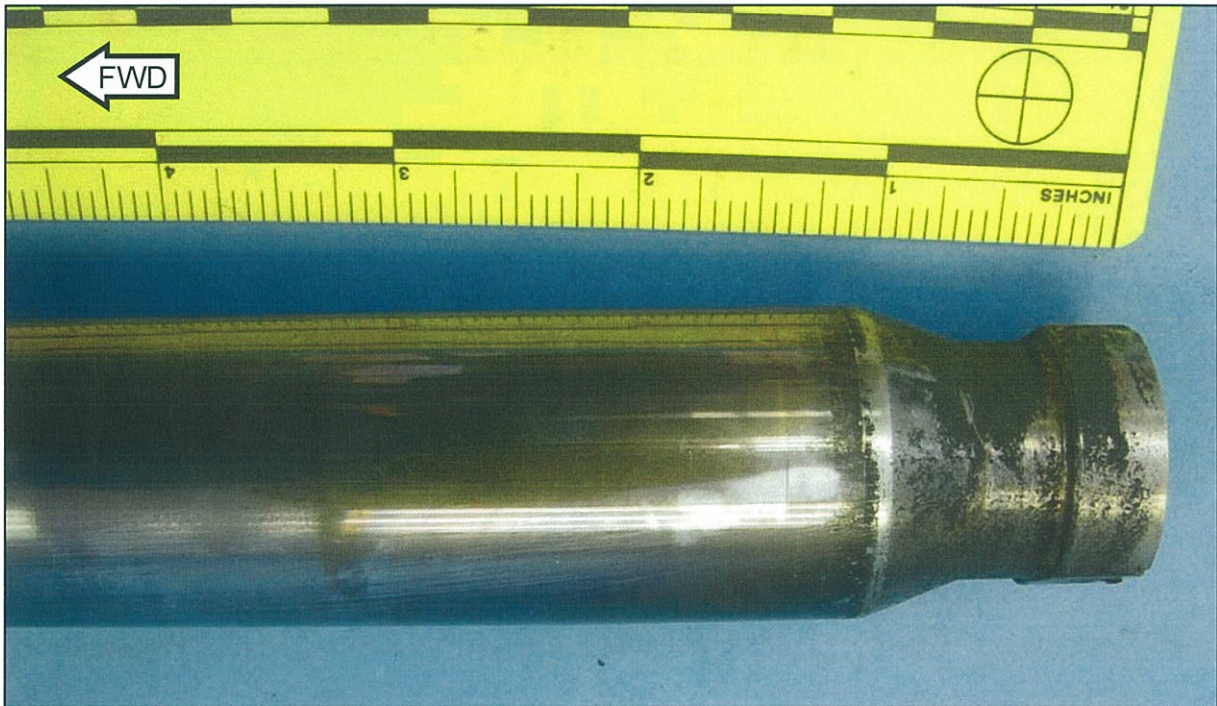
Figure 12. Close view of the aft end of the right inboard flap actuator piston.

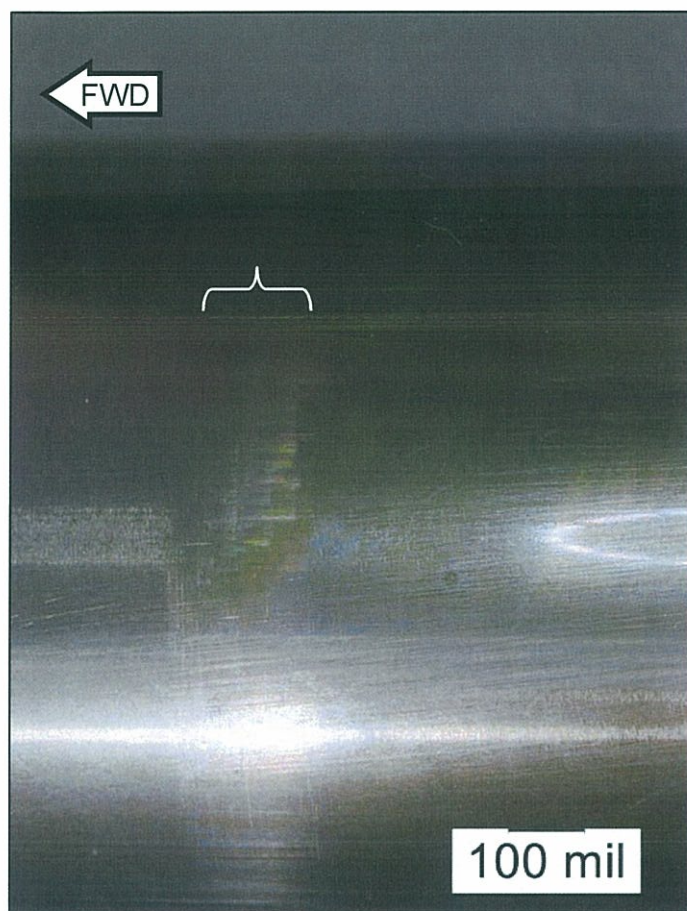
Figure 13. Close view of the right inboard flap actuator at a location approximately 3.1 inches from the aft end of the piston. An unlabeled bracket indicates a cluster of faint short longitudinal scratch marks and circumferential marks.

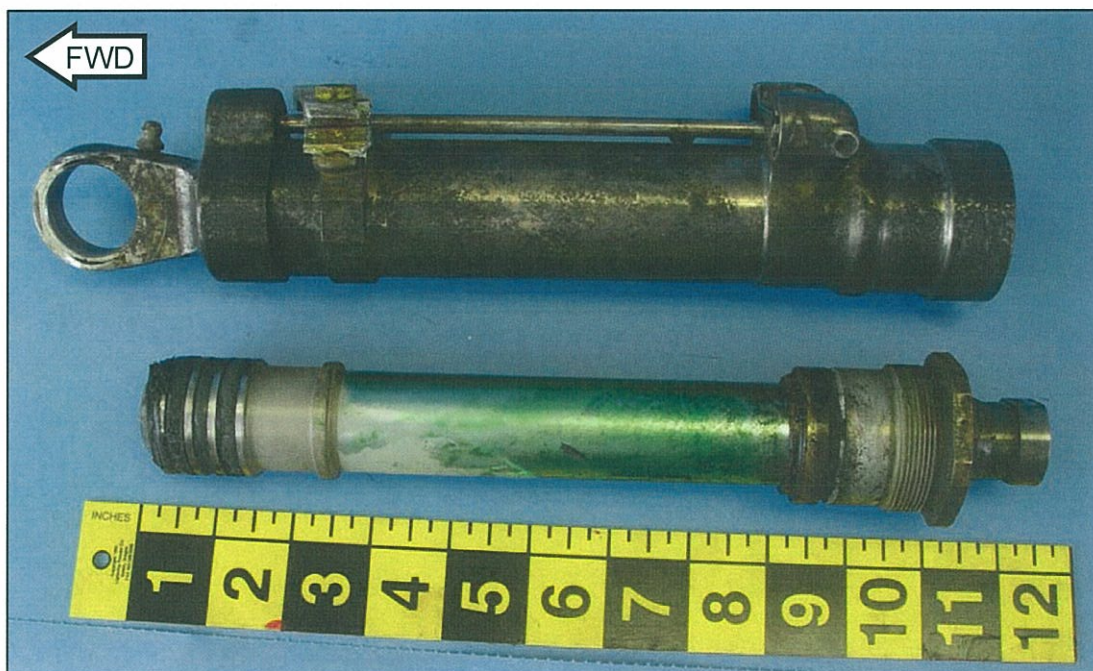
A close view of the actuator housing is shown in figure 14. The actuator housing exterior surface was blackened and tinted brown relatively uniformly along its entire length. The interior surfaces were mostly covered with black, orange, and green deposits. Some green fluid was also observed on the interior surface of the housing. Views of deposits on the housing interior surfaces are shown in figures 15 and 16.

A close view of the piston and bushing is shown in figure 14. The bushing was frozen on the piston near the aft end of the piston. The distance between the forward end of the bushing and the stop flange on the piston was measured at 4 locations around the circumference of the piston, and at each location the distance measured was 5.412 inches. The length of the bushing measured 2.089 inches, and the aft end of the bushing was located 1.091 inches from the aft end of the piston. Black soot deposits were observed on the end of the piston aft of the bushing.

Figure 14. Close view of the right outboard flap actuator piston and housing.

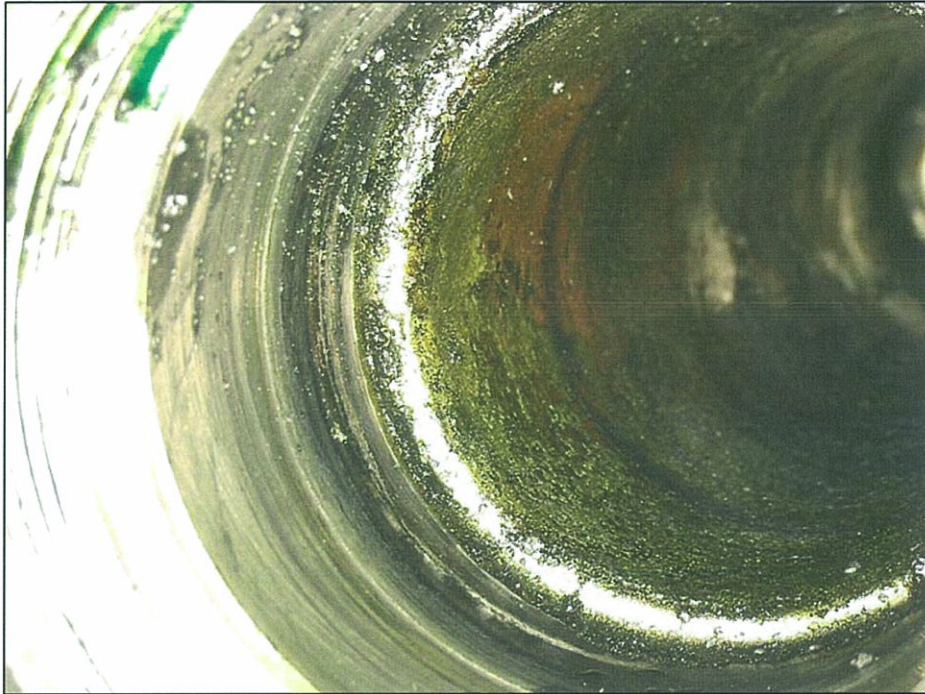
Figure 15. View of the interior of the right outboard flap actuator housing.

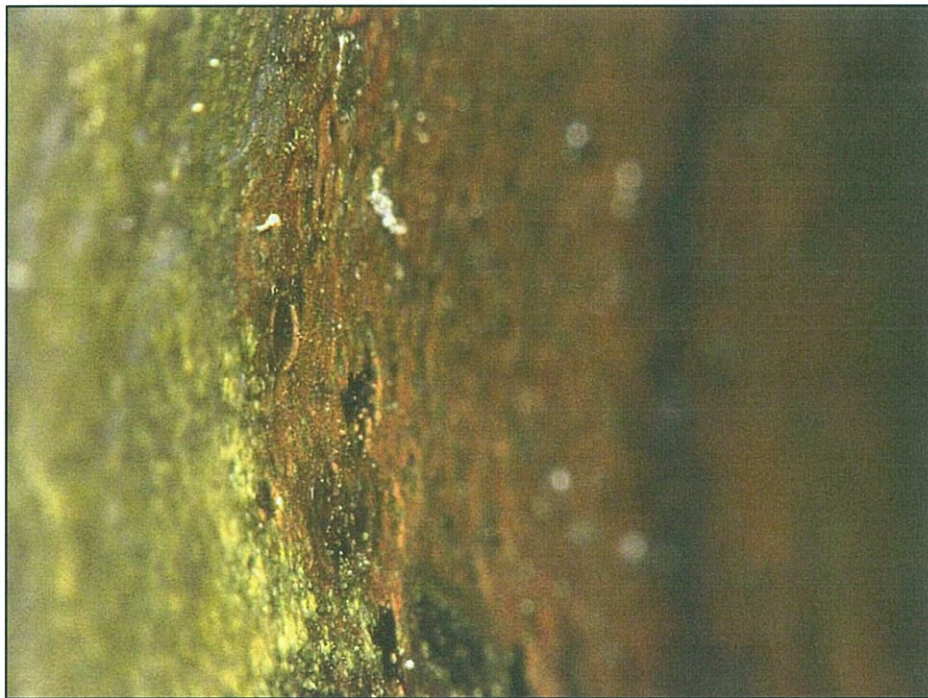
Figure 16. Closer view of deposits on the right outboard flap actuator housing interior.

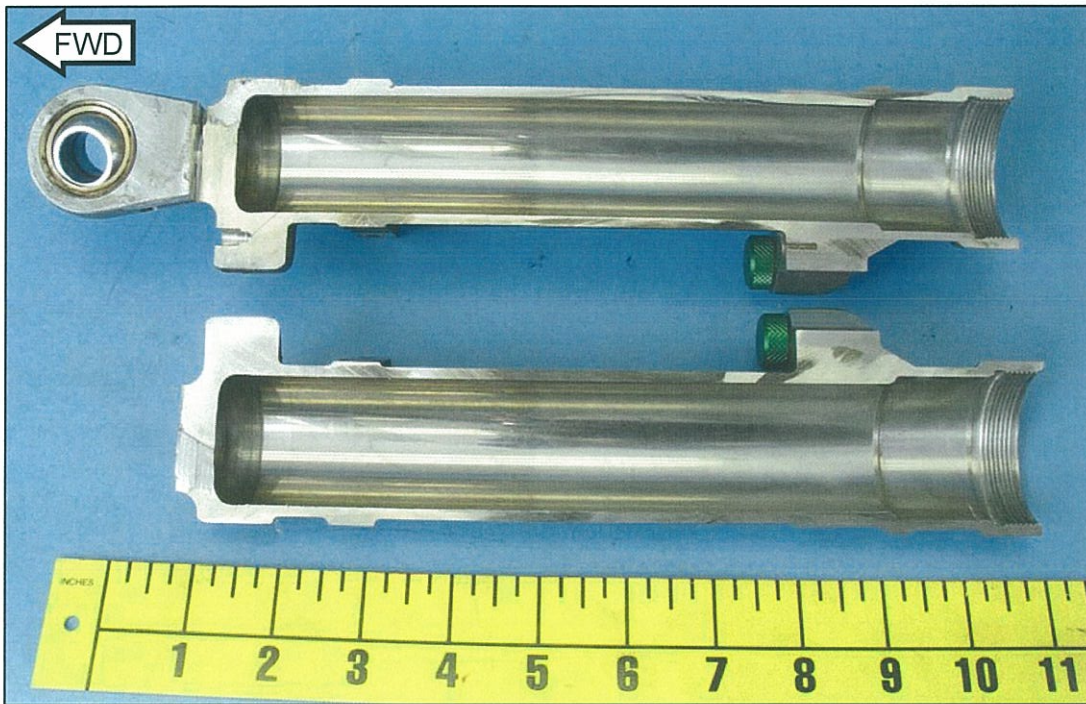
The interior surface of the left outboard flap actuator housing is shown in figure 20. The surface was reflective with manufacturing marks at 45 degree angles and no deposits along its entire length. The forward end up to 3.6 inches from the forward end of the actuator interior was more polished than the remainder of the surface with faint longitudinal scratches consistent with wear from piston displacement under normal actuation. A circumferential line was observed at a location 0.75 inch from the forward end of the interior, consistent with contact with the forward end of the piston middle seal in the retracted position.

Figure 20. View of the left outboard flap actuator housing interior surface after sectioning.

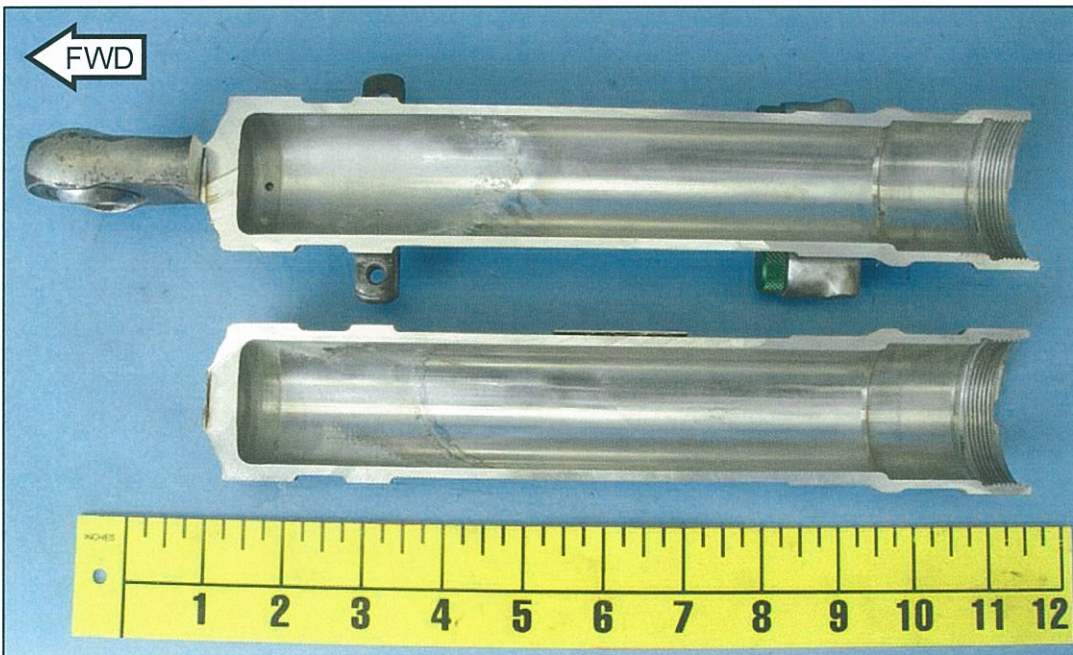
An overall view of the left inboard flap actuator housing interior is shown in figure 21. A gray film was observed over much of the upper surface and parts of the lower surface at the forward end of the housing interior. Somewhat thicker greenish gray deposits were generally observed at the edges of the gray film. Faint longitudinal scratches were observed ending approximately 3.6 inches from the forward end of the housing interior.

The surfaces within the normal working area of the piston appeared less polished or worn than that of the left outboard housing interior. Faint circumferential scratches were observed on the lower half of the actuator housing interior at a location 1.33 inches from the interior forward end.

Figure 21. View of the left inboard flap actuator housing interior surface after sectioning.

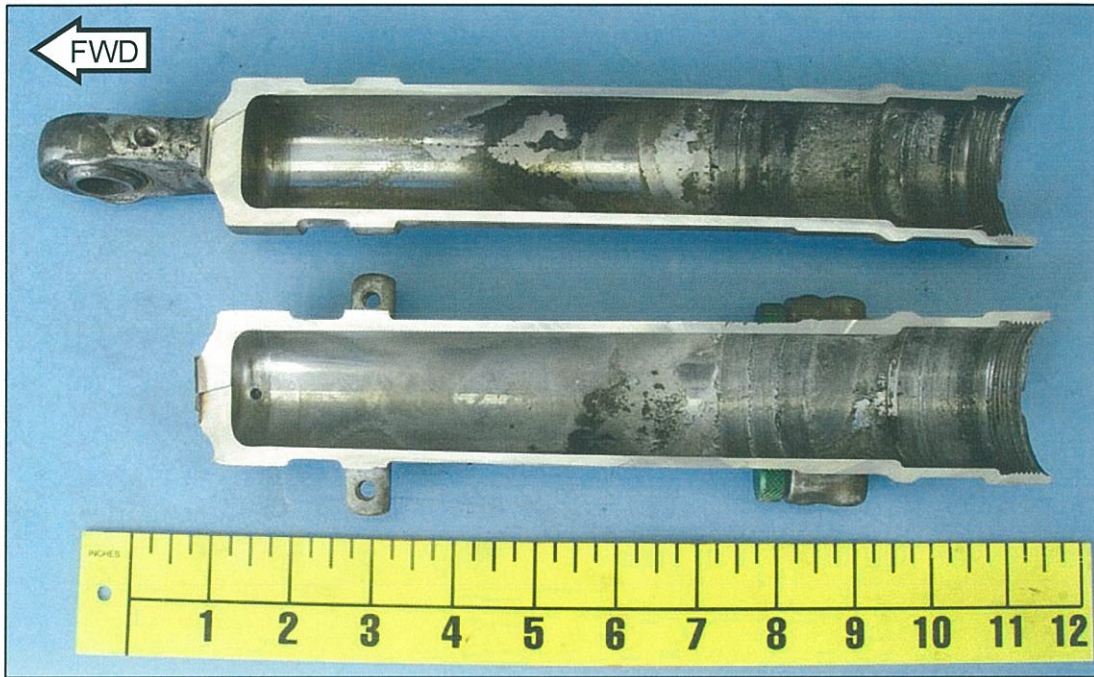
An overall view of the right inboard flap actuator housing interior is shown in figure 22. The interior was mostly covered with brown, gray, and black deposits. Faint longitudinal scratches were observed near the forward end of the actuator, but the ends were obscured by deposits.

Figure 22. View of the right inboard flap actuator housing interior surface after sectioning.

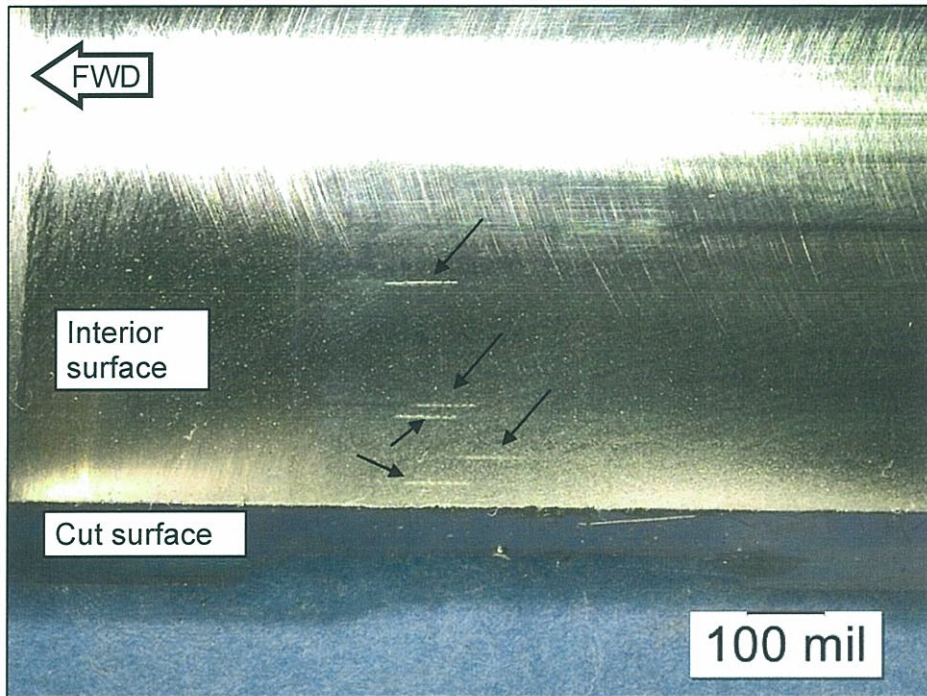
Approximately 10 longitudinal scratch marks, each approximately 0.1 inch long, were observed on the lower portion of the left outboard flap actuator housing interior spread across both halves of the sectioned housing. A view of five of the scratch marks are shown in figure 24. The scratch marks were similar in appearance to those observed on the left outboard flap actuator piston land as shown in figure 7. The longitudinal scratch marks were located between 0.85 and 1.35 inches from the forward end of the housing interior. A nearly circumferential scratch mark, shown in figure 25, was also observed on the left outboard actuator housing interior. The nearly circumferential scratch was approximately 0.08 inches long located in the lower outboard quadrant of the housing interior and was 2.29 inches from the forward end of the housing interior.

Figure 24. Five of the longitudinal marks, indicated with unlabeled arrows, observed on the interior of the left outboard housing.

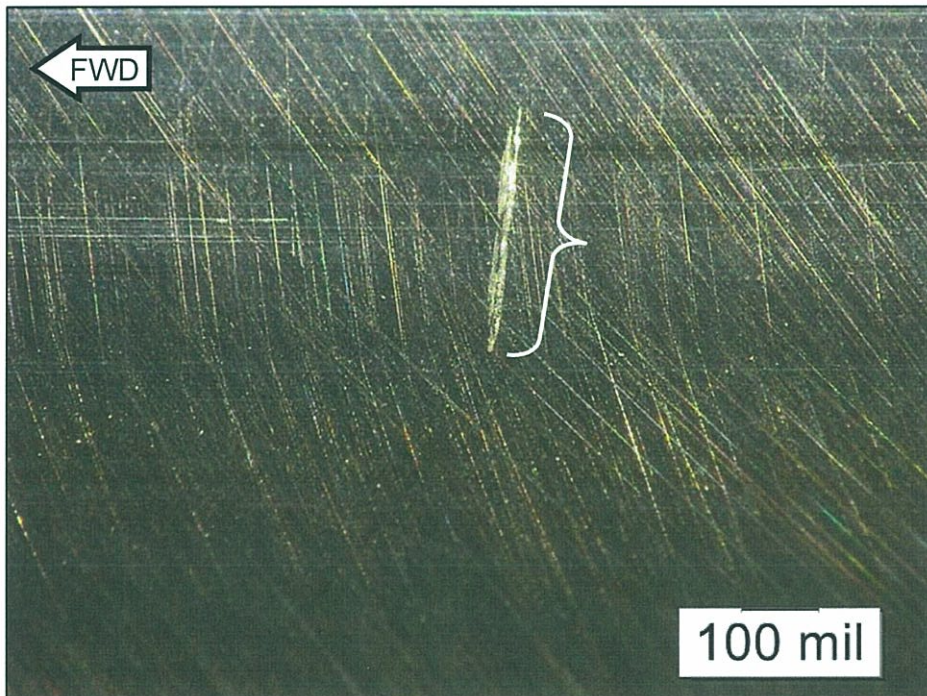
Figure 25. Nearly circumferential mark, indicated with an unlabeled bracket, observed on the interior of the left outboard housing.

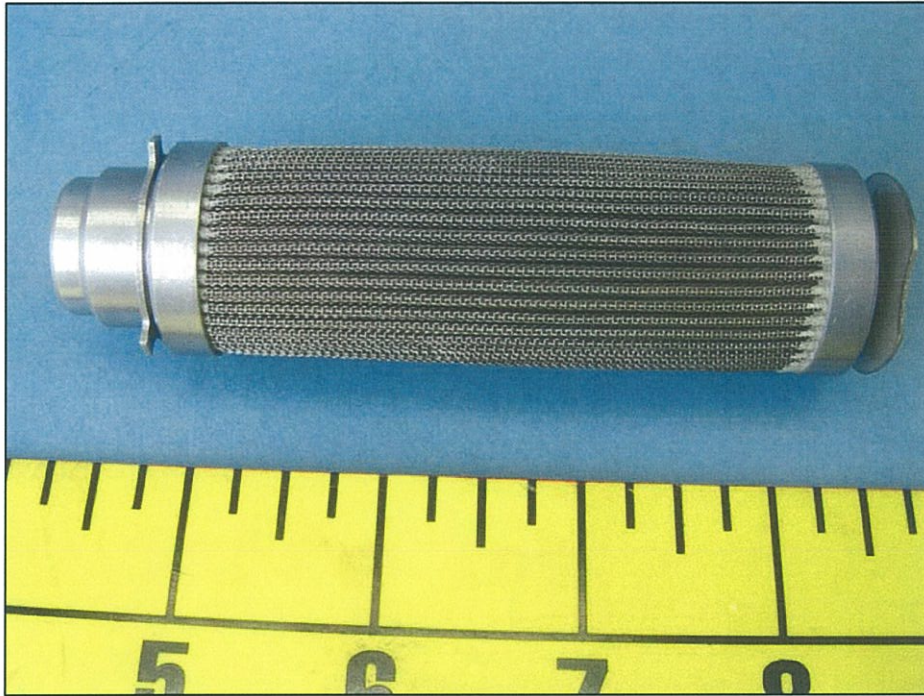
Overall views of the inboard and outboard filters for the blue hydraulic system are shown in figures 36 and 37. The exterior surfaces of the filters appeared mostly clear of debris and deposits. However, isolated green deposits were observed on the inboard filter, and isolated black deposits were observed on the black filter.

Figure 36. Overall view of the inboard filter from the blue hydraulic system.

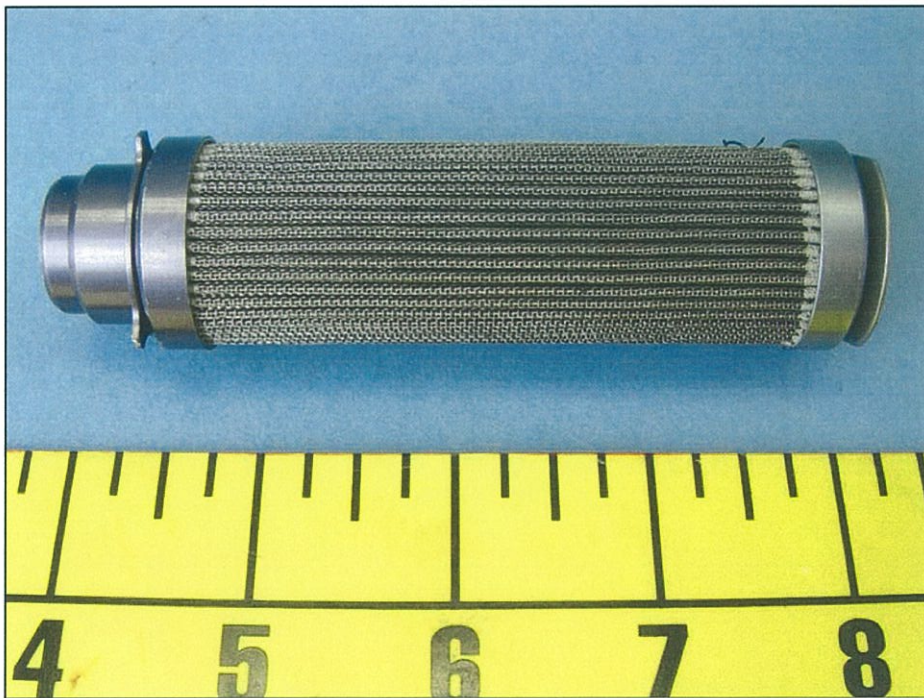
Figure 37. Overall view of the outboard filter from the blue hydraulic system.

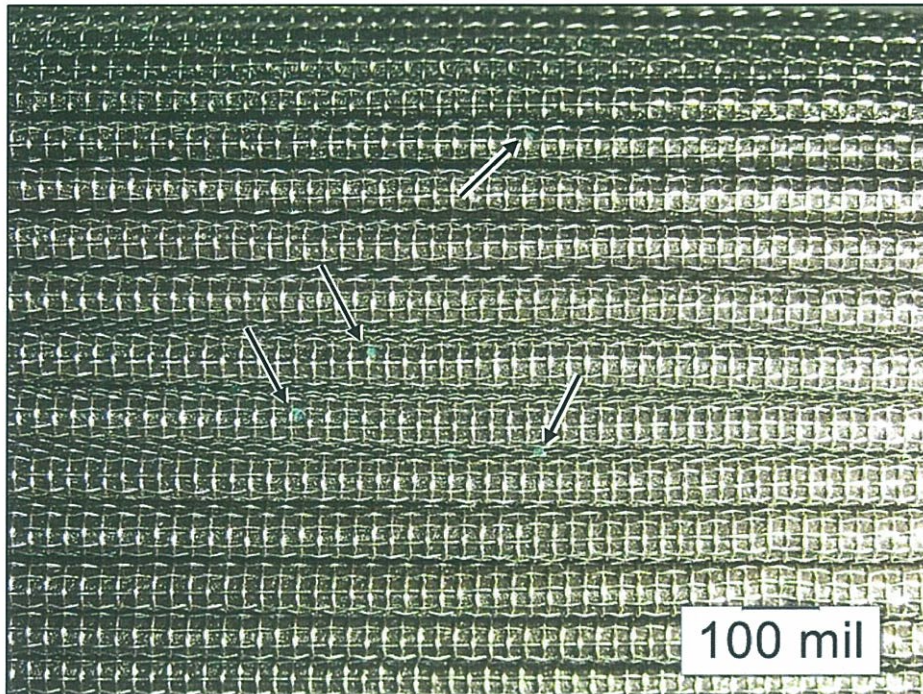
Figure 38. Close view of the inboard filter element from the blue hydraulic system. Arrows indicate green deposits in the filter.

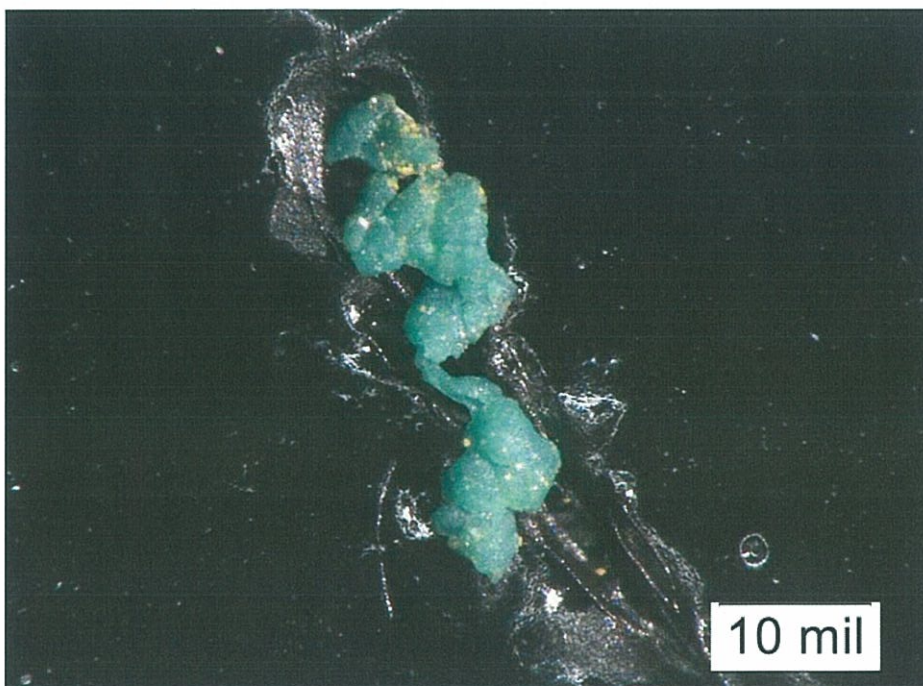
Figure 39. Close view of a green deposit removed from the inboard filter from the blue hydraulic system. The deposit is shown after cleaning in alcohol and placed on carbon tape for SEM examination.

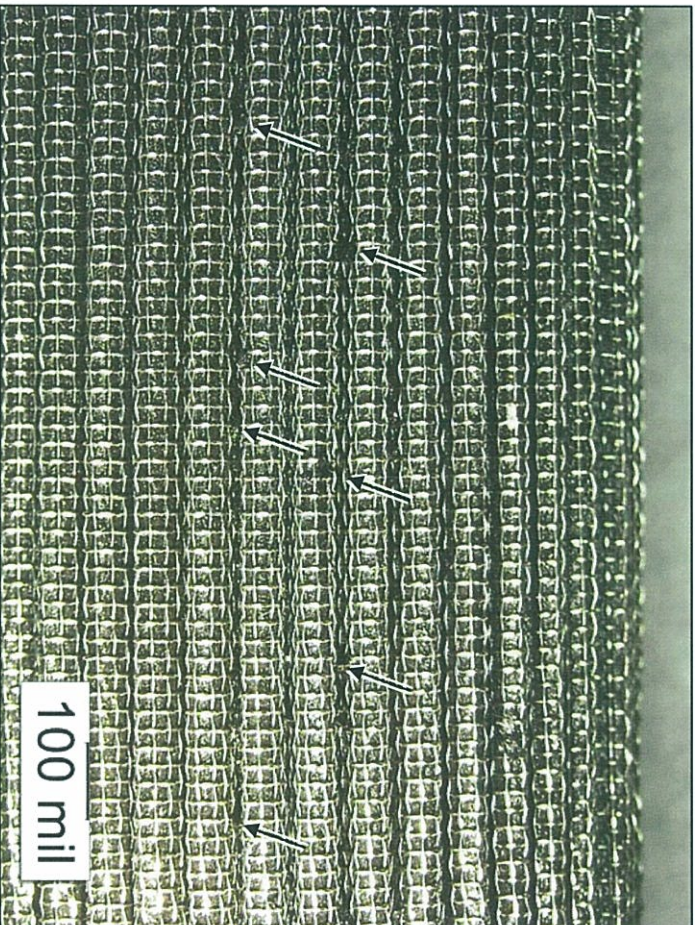
Figure 44. Close view of the outboard filter element from the blue hydraulic system. Arrows indicate black deposits in the filter.
