Docket No. SA-533

Materials Laboratory Aileron Control Rod Factual Report

MATERIALS LABORATORY FACTUAL REPORT

Place : Lubbock, Texas
Date : January 27, 2009
Vehicle : Aerospatiale Alenia ATR42-320
NTSB No. : CEN09MA142
Investigator : Kristi Dunks

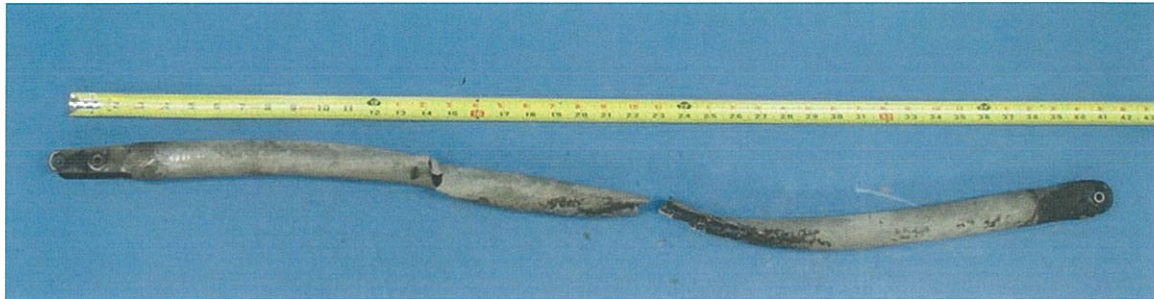
Two pieces of the left aileron control rod (figure 1,2).

Figure 1: Left aileron control rod

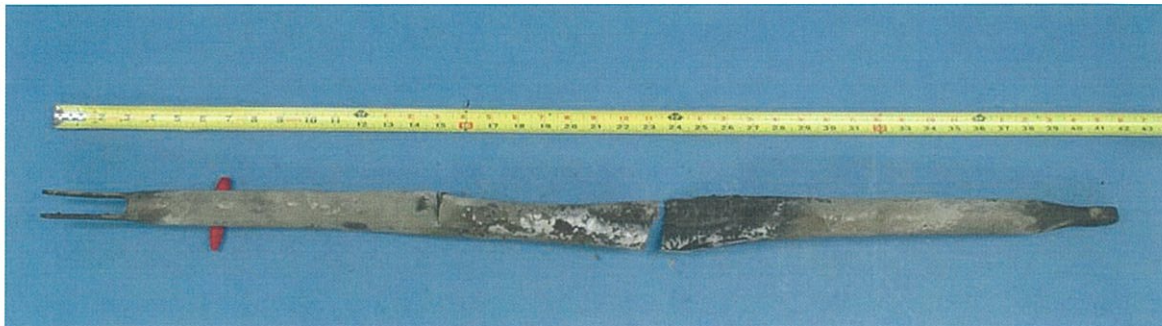
Figure 2: Left aileron control rod

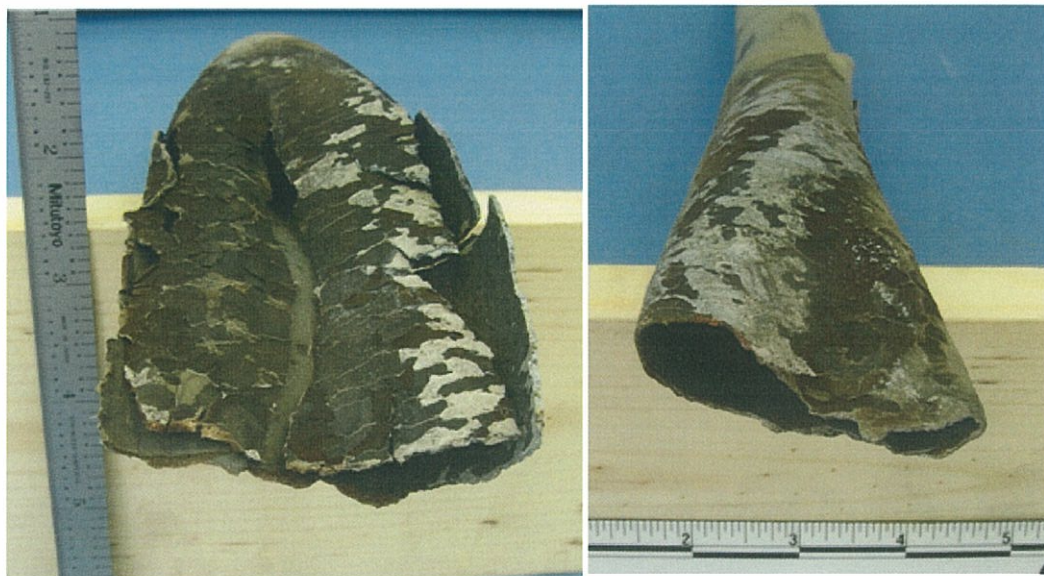
The examination of the two portions of the aileron control rod established that the control rod had been exposed to a high temperature environment. This high temperature exposure caused localized melting, causing the control rod to be severed into two portions. Both portions of the control rod had thermally damaged paint. Areas towards the ends of the control rod had cracks in the paint making a river line pattern¹. The paint at locations closer to the area of melting was flaking off. The area of melting where the tube was severed exhibited a black, flakey material consistent with charred paint adhering to the surface on both portions (figure 3). The melted ends of both portions of the control rod had flattened out, consistent with having softened and collapsed due to a high temperature exposure. No discernable fracture features were present on the severed ends of the two portions of the control rod.

Figure 3: Severed ends of the aileron control rod

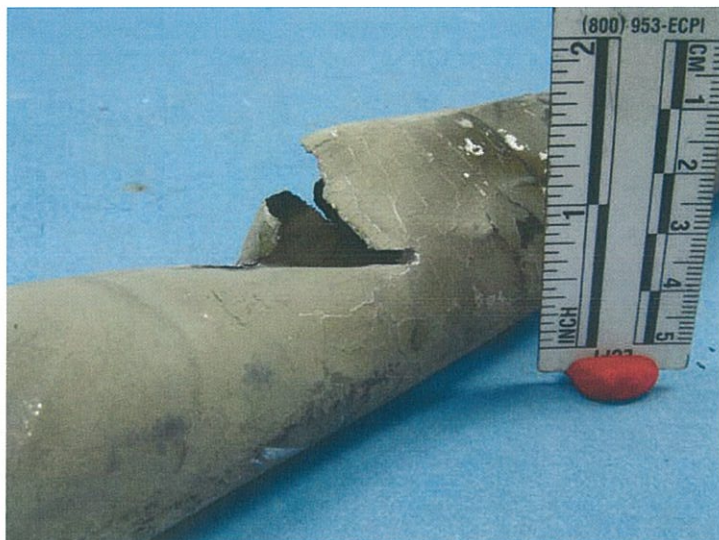
On the portion of the control rod with the yoke, a tear was present (figure 4). The tear appears to have happened after or during the exposure to high temperature based on the

discontinuity in the river line pattern of the thermally damaged paint. Additionally, the witness mark at the base of the tear was bright and shiny (figure 5), indicating that it did not precede the high temperature exposure.

Figure 4: Tear on the portion of the aileron control rod with the yoke

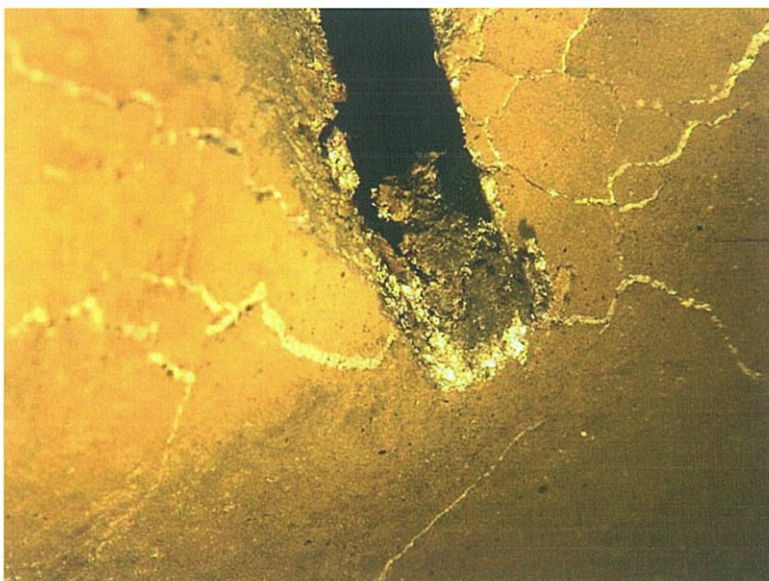
¹ A river line pattern is a pattern created by continuous lines with sharp bends and branch lines, resembling a river as viewed from a map. An example can be seen in figure 5.

Figure 5: Close up view of witness mark
