NATIONAL TRANSPORTATION SAFETY BOARD

MATERIALS LABORATORY FACTUAL REPORT

Report No. 17-067

Place : McKinleyville, California
Date : July 29, 2016
Vehicle : Piper PA31T
NTSB No. : WPR16FA153
Investigator : Brice Banning
IIC/AS-ANC

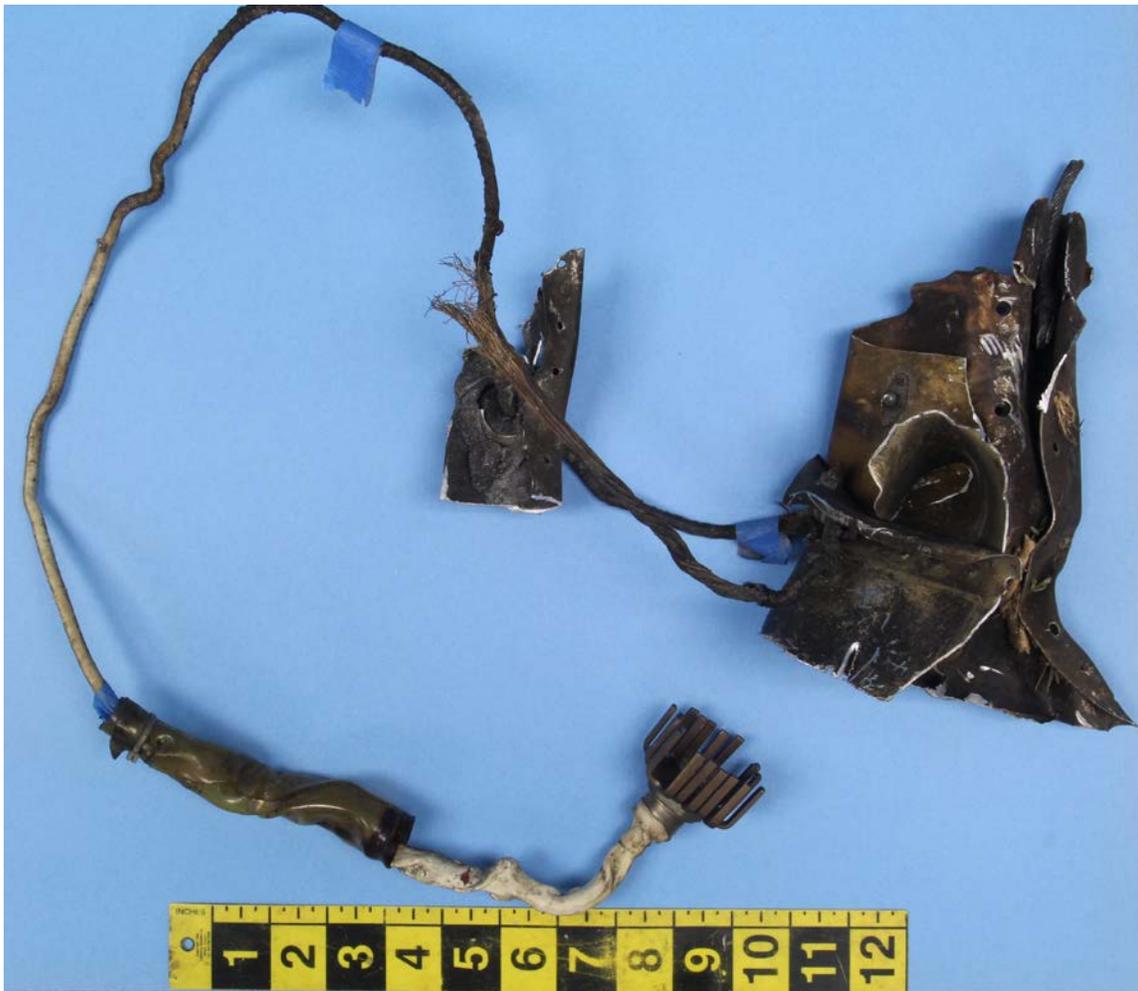
Wire Name	Recovered Length (inches)	Notes	Figure Number
L MAIN 2	35	A portion of the circuit breaker remained attached to the wire. In addition, the wire was trapped inside a section of structure. Approximately 11 inches of wire insulation were missing from the fractured end of the wire. The remaining insulation exhibited thermal discoloration and shrinking. Signs of heat damage reduced in severity moving away from the circuit breaker panel end. The fractured end was frayed, and the exposed conductor showed notching consistent with mechanical rubbing. The fractured end was examined using a scanning electron microscope (SEM). No obvious signs of arcing on exposed sections of conductor were found. Several areas of the cross diameter on several conductors were flattened and appeared to have missing material. The end was also examined using electron dispersive spectroscopy (EDS) to look for the presence of foreign materials present on the wire conductors. No foreign material was found.	1,2,3

Figure 1. Overall photograph of L MAIN 2.

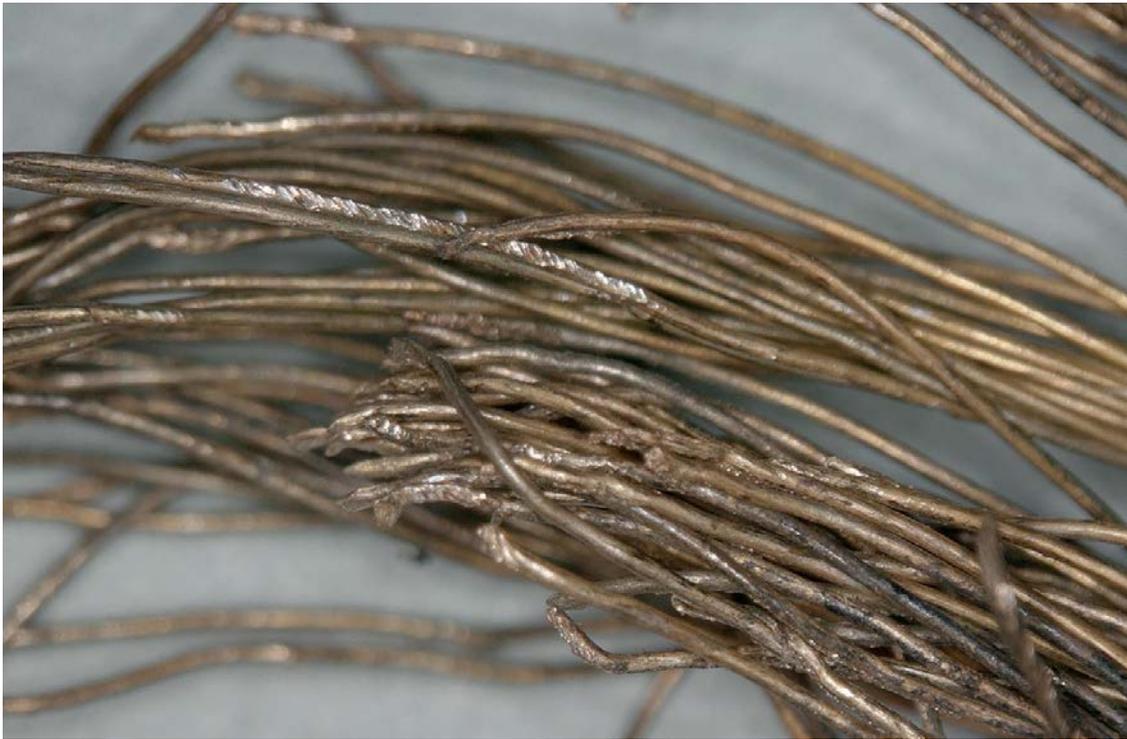
Figure 2. Closeup photograph of fractured end of L MAIN 2.

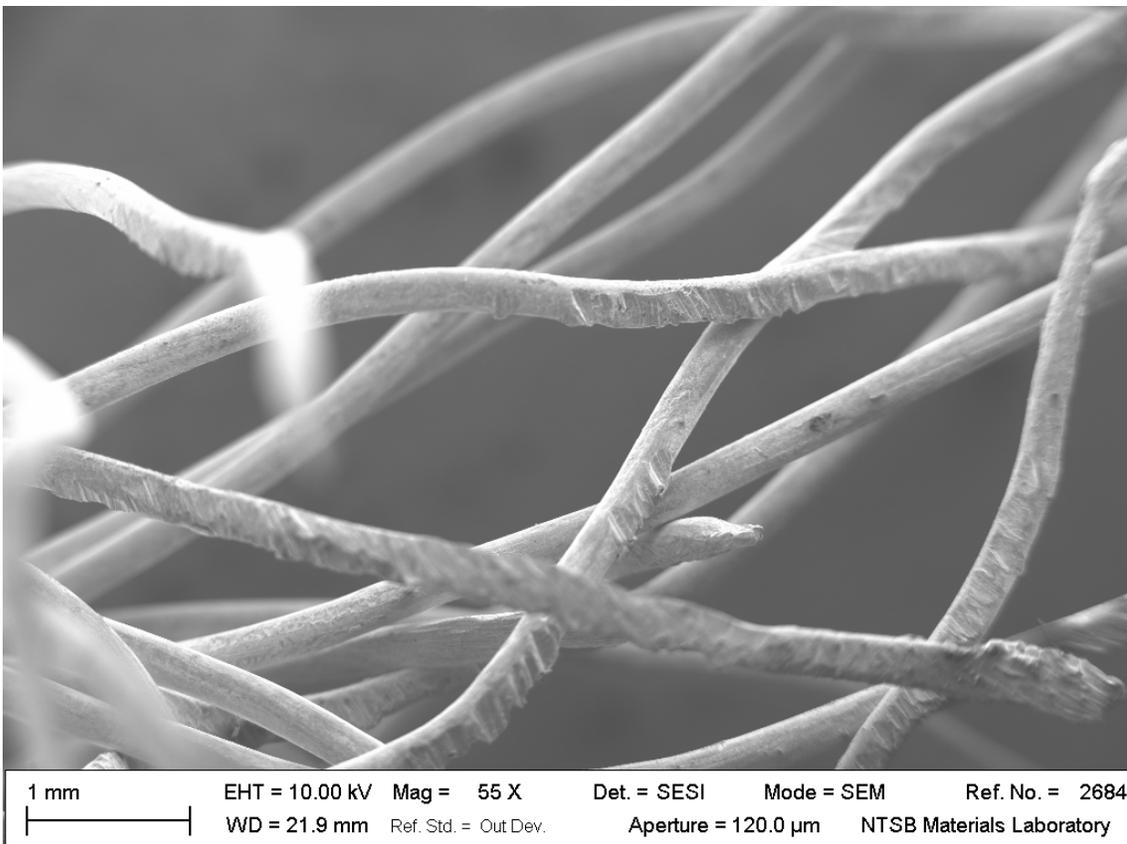
Figure 3. Micrograph of notching on conductor surface of L MAIN 2.

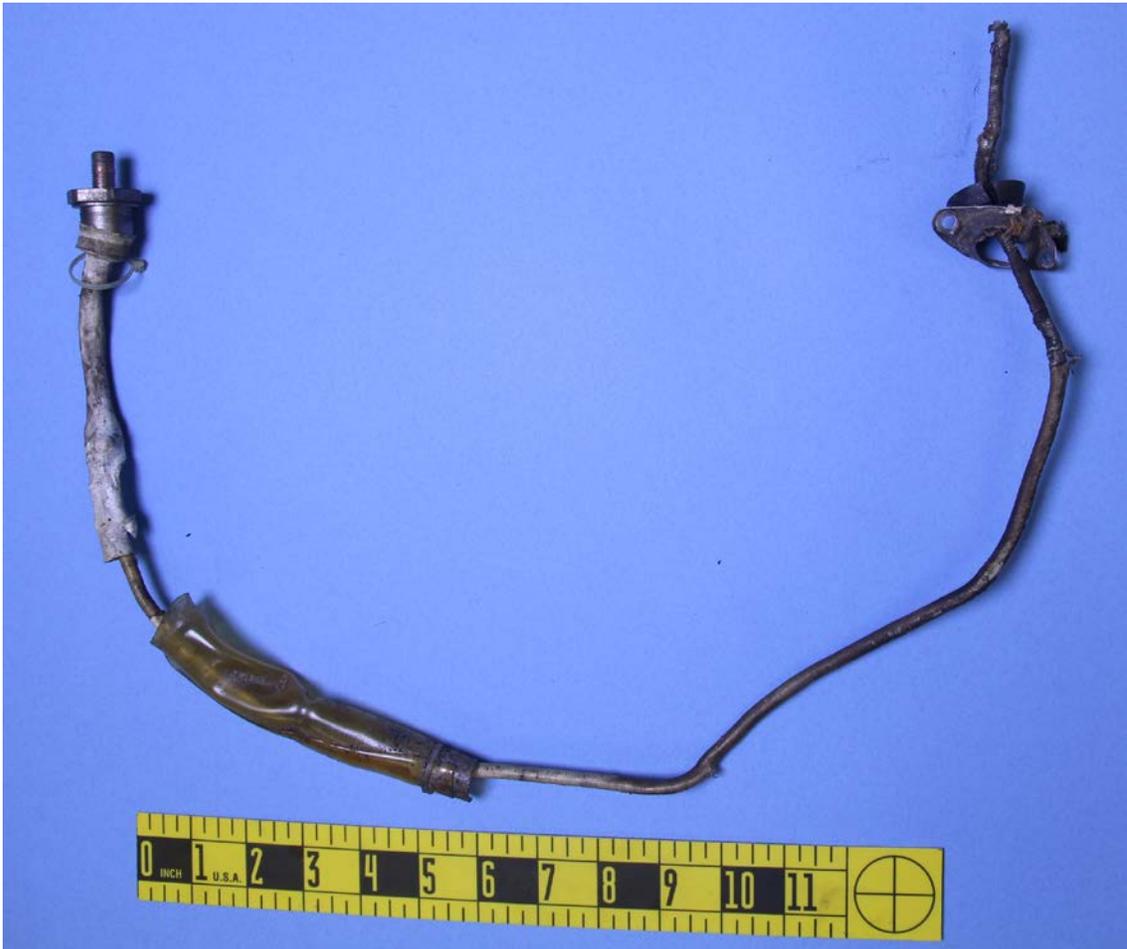
L MAIN 1	31	The wire insulation exhibited limited thermal discoloration. A section approximately 2.5 inches from the pressure seal had lost the outer insulation layer but the inner braided layer was still present. In addition, there were several small scattered areas of damaged outer insulation.	4
ICE L (Section 1)	26	This section was cut just below pressure seal for removal. Approximately 10.5 inches of insulation were missing from fractured end, followed by approximately 10 inches of thermal discolored insulation. No obvious signs of arcing on exposed conductors.	5
ICE L (Section 2)	~48	Approximately 20 inches of thermal insulation from the fractured end were discolored. The other end was disconnected directly from the circuit breaker panel. A small section of pressure bulk head seal was present.	6
STC Fuse to Bus Bar	13.5	The entire length was missing insulation. The fractured end showed signs of welding and beading. There were some signs of mid-conductor damage approximately 10 inches from fractured end. There were small areas of beading/welding also present in this area.	7

Figure 4. Overall photograph of L MAIN 1.

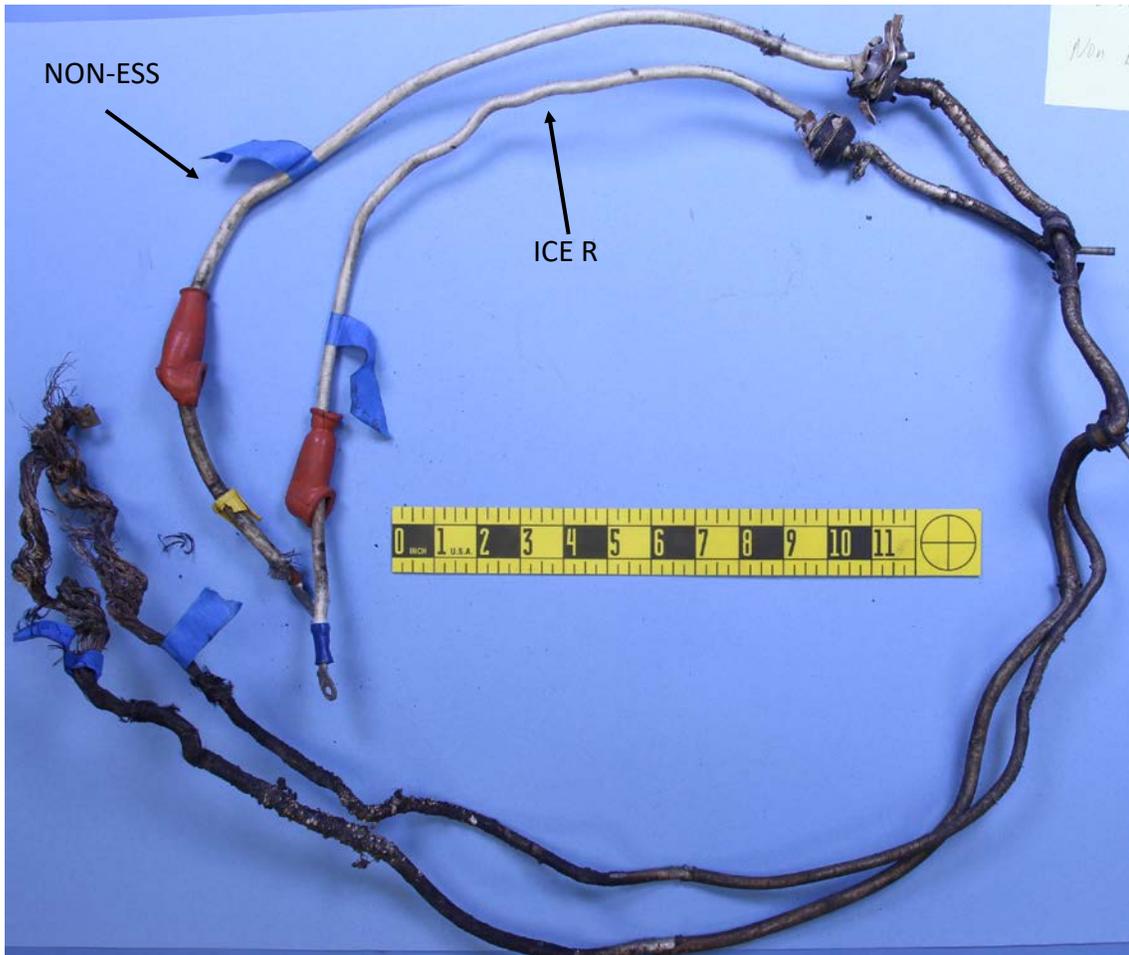
NON-ESS	74	This wire section was still attached (tied together) to the ICE R section. The section from the fractured end to pressure seal was 49.5 inches in length. The remaining section from pressure seal to the circuit breaker panel connector (Yellow) was 24.5 inches in length. There were approximately 8 inches of bare conductor at the fractured end. The remaining insulation was thermally damaged the entire length to the pressure seal. There was some scattered tearing and slippage of the insulation. No obvious thermal damage above the pressure seal to the connection. No obvious signs of arcing (beading or welding)	8
ICE R	97.5	This wire section was still attached to the NON-ESS section. The section from the fractured end to pressure seal was 47.5 inches in length and 20 inches from pressure seal to circuit breaker connector (Yellow). There were approximately 9 inches of bare conductor at the fractured end. The remaining insulation was thermally damaged the entire to the pressure seal. There was some scattered tearing and slippage of the insulation. No obvious thermal damage above the pressure seal to the connection. No obvious signs of arcing (beading or welding).	8

Figure 8. Overall photograph of NON-ESS and ICE R.

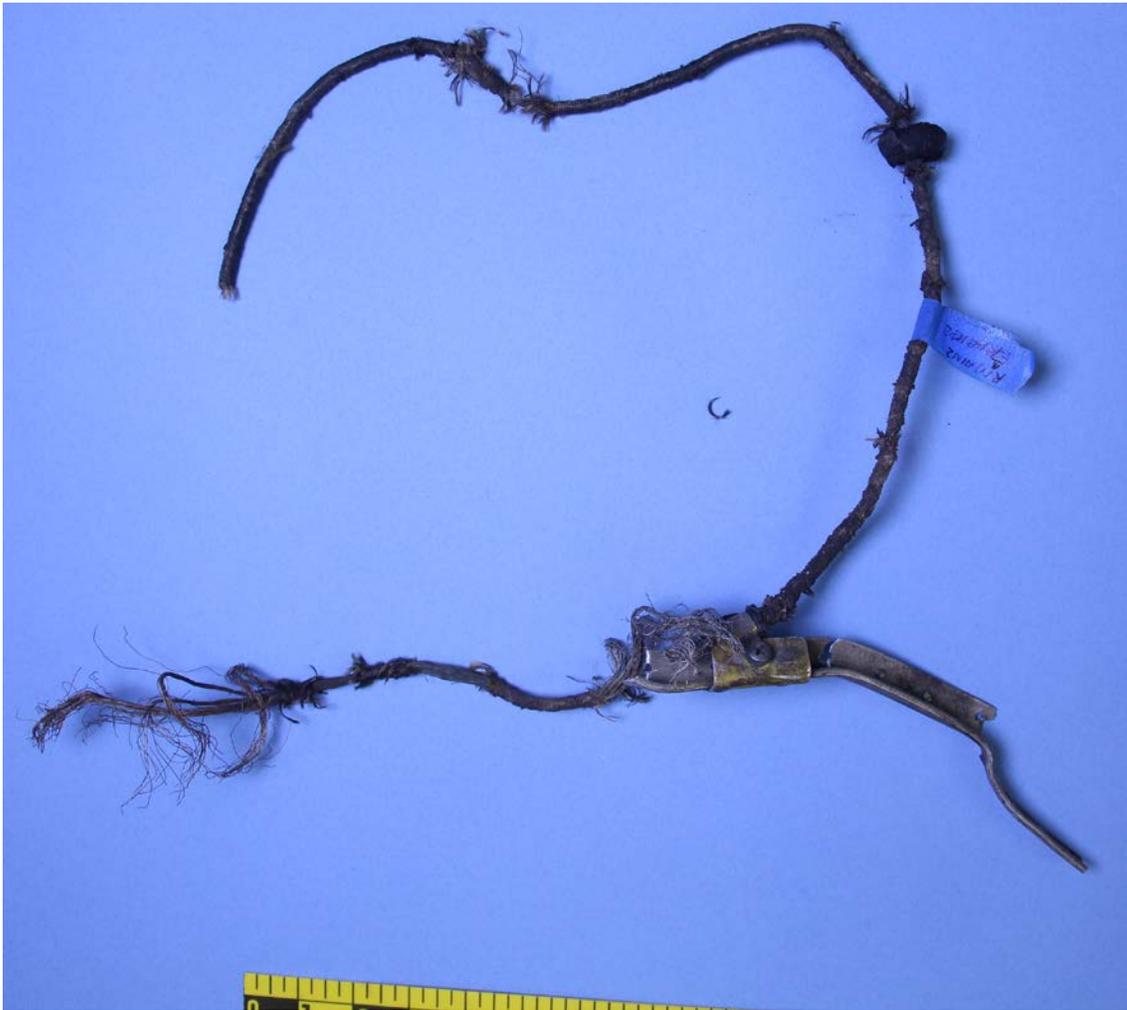
R MAIN2 (Section 1)	53	The section from the fractured end to the cut was 38 inches in length. The fractured end was frayed. The section from the cut to the pressure seal was 15 inches in length. There were approximately 5.5 inches of missing insulation at the fractured end. There were two areas of missing insulation located 1.5 and 3.5 inches from beginning edge of the insulation. There was approximately 1 inch of exposed conductor at pressure seal. The remaining insulation was numerous areas of thermal discoloration and sooting. There were also some small scattered areas of missing insulation. The pressure seal had thermal damage. There was some structure still attached with bare conductors leading up to the structure. No obvious signs of arcing (beading or welding) on the exposed conductors.	9

Figure 9. Overall photograph of R MAIN 2 (Section 1).

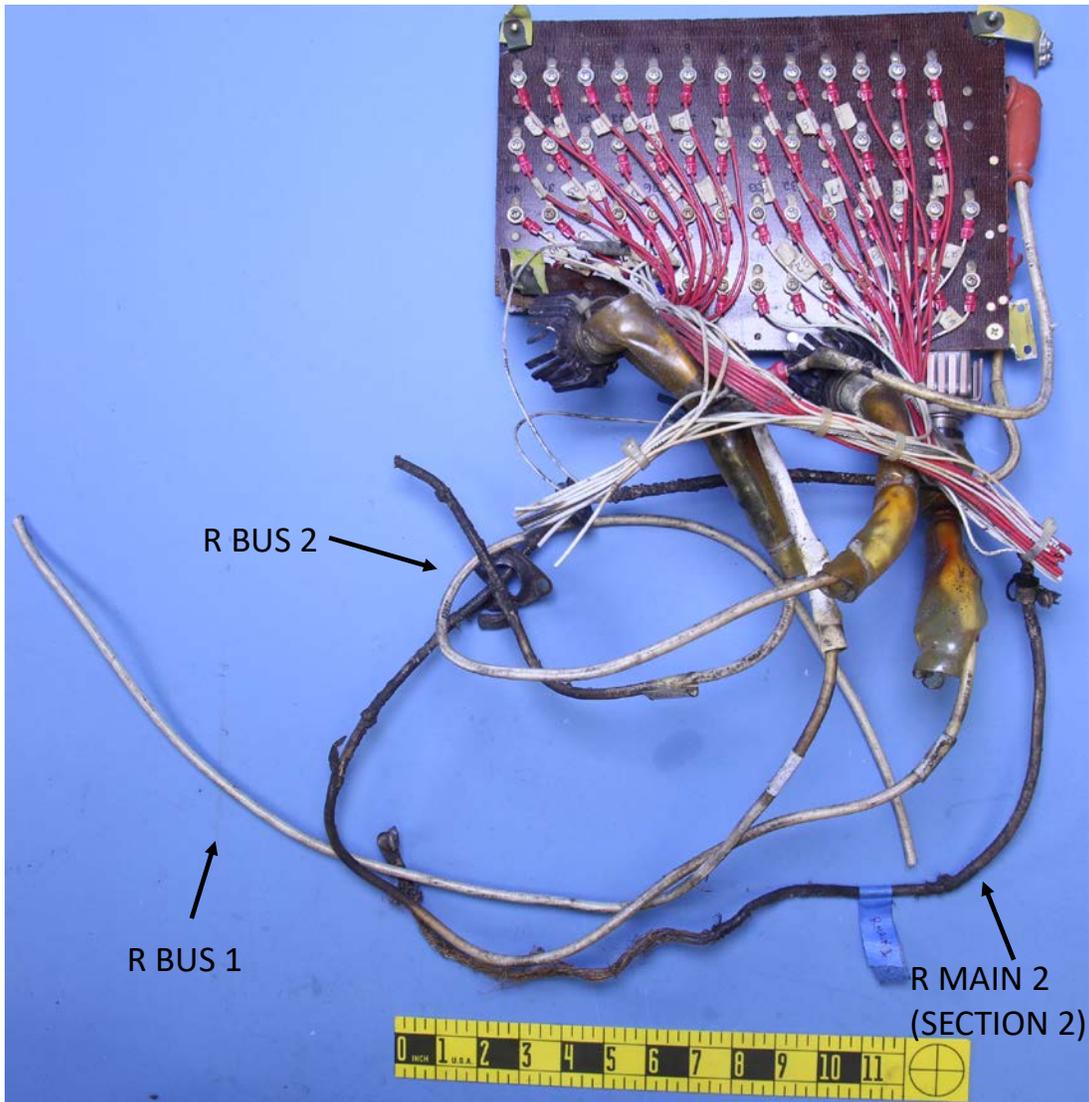
R MAIN2 (Section 2)	18	The section was still attached to the circuit breaker panel. The total recovered length ran from the cut end to the circuit breaker panel. The diode was still present. There were approximately 7 inches of exterior thermal damage to insulation, but the insulation was still intact.	10
RBUS 1	34	The section was still attached to the circuit breaker panel. The total recovered length ran from the cut end to the circuit breaker panel. No obvious signs of thermal damage.	10
RBUS 2	32	The section was still attached to the circuit breaker panel. The total recovered length ran from the cut end to the circuit breaker panel. No obvious signs of thermal damage.	10
R MAIN1	65	A portion of circuit breaker post was attached on the fractured end. The length from the fractured end to the pressure seal was 32.5 inches in length. The wire section from pressure seal to circuit breaker was 32.5 inches in length. There were approximately 9.5 inches of bare conductor on the fractured end. No obvious signs of arcing (beading or welding) on the exposed section. The remaining insulation exhibited thermal damage up to the pressure seal and continued to approximately 12.5 inches past the pressure seal. This section was x-rayed to look for conductor damage underneath the insulation. No anomalies were found in radiograph.	11

Figure 10. Overall photograph of circuit breaker panel with R BUS 1, R BUS 2, and R MAIN 2 (section 2) connected.

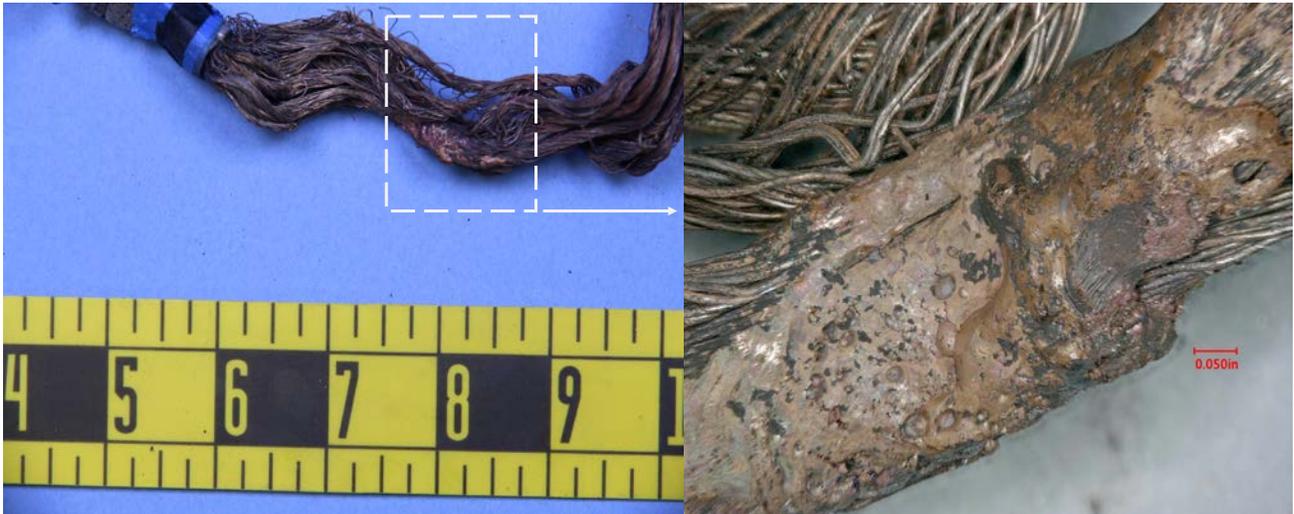
P3H	7	The wire section contains both terminal ends. The entire wire section was missing insulation. A large area of welded conductors/arcing was present approximately 2 inches and 4.5 inches from terminal ends.	12, 13, 14
P2B	6.5	The wire contained both terminal ends. The insulation was intact over the entire length with some scattered areas of thermal damage.	15
P3B to Battery	6	The insulation was missing over the entire length of the wire section. There were multiple small areas of welding conductors and some areas of mid-conductor beading.	15

Figure 13. Closeup photograph of welded area on P3H.

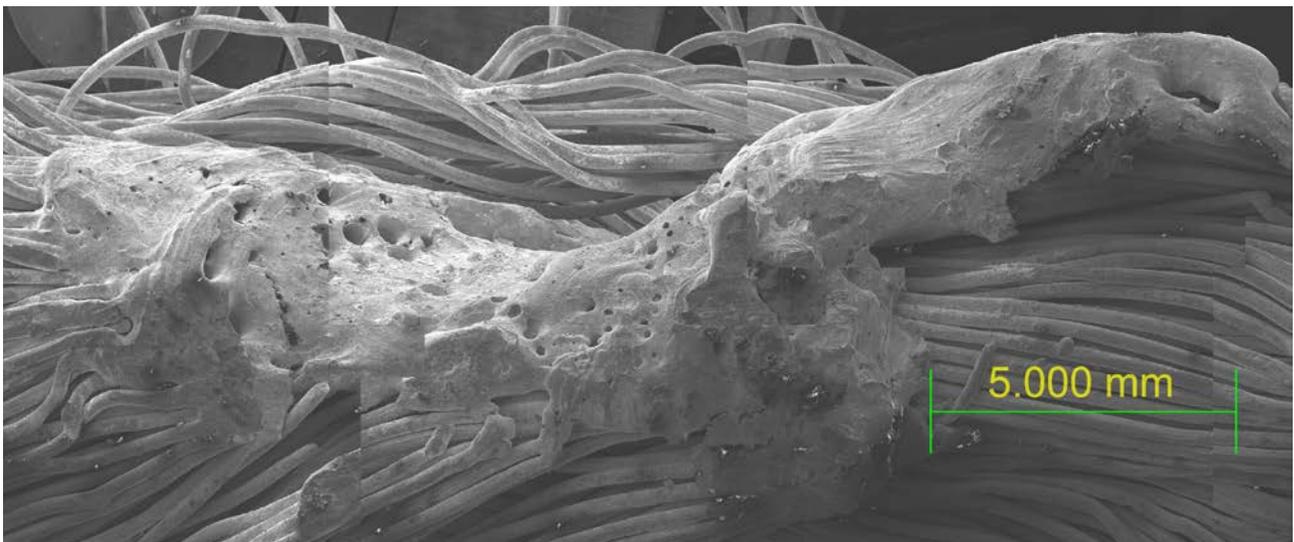
Figure 14. Micrograph of welded area on P3H.

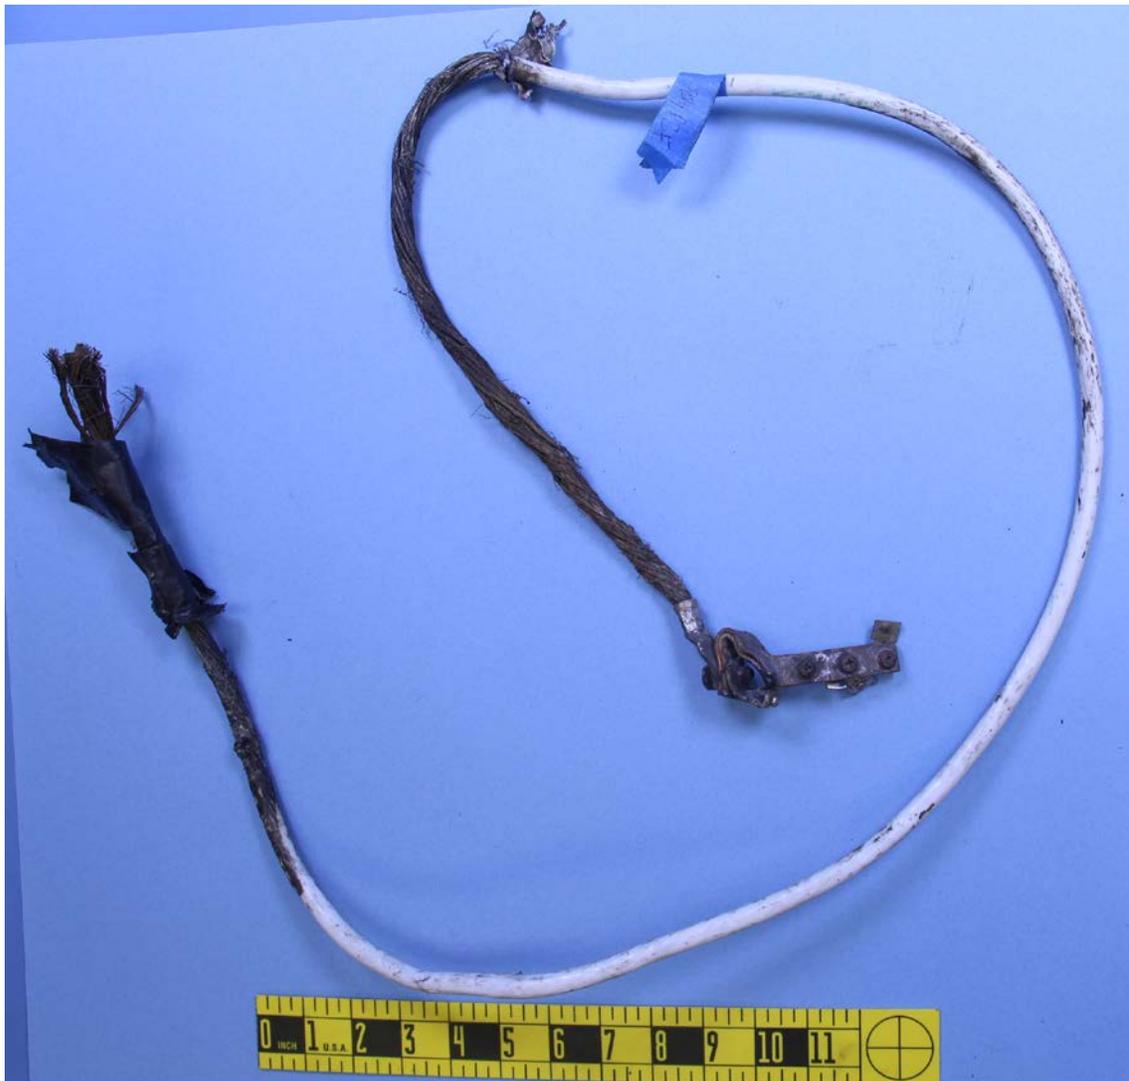
EMS PWR	61	There was a 23-inch section of bare conductor starting at the fractured end. Some nicks in the intact wire insulation as well as some slippage and areas of light sooting. There were a few random areas of small beading but no large area of welding or beading.	19
P2E	60	The bus bar was still attached to one end. with 13.5 inches of bare conductor on this end of the wire. There was approximately 6 inches of bare conductor on the fractured end. There was also scattered nicks and slippage and melting of insulation adjacent to the exposed conductor areas. There were no obvious signs of arcing (beading or welding). There was heavy sooting on the outer wire insulation in the area of the right wing (RW) disconnect.	20

Figure 20. Overall photograph of P2E.

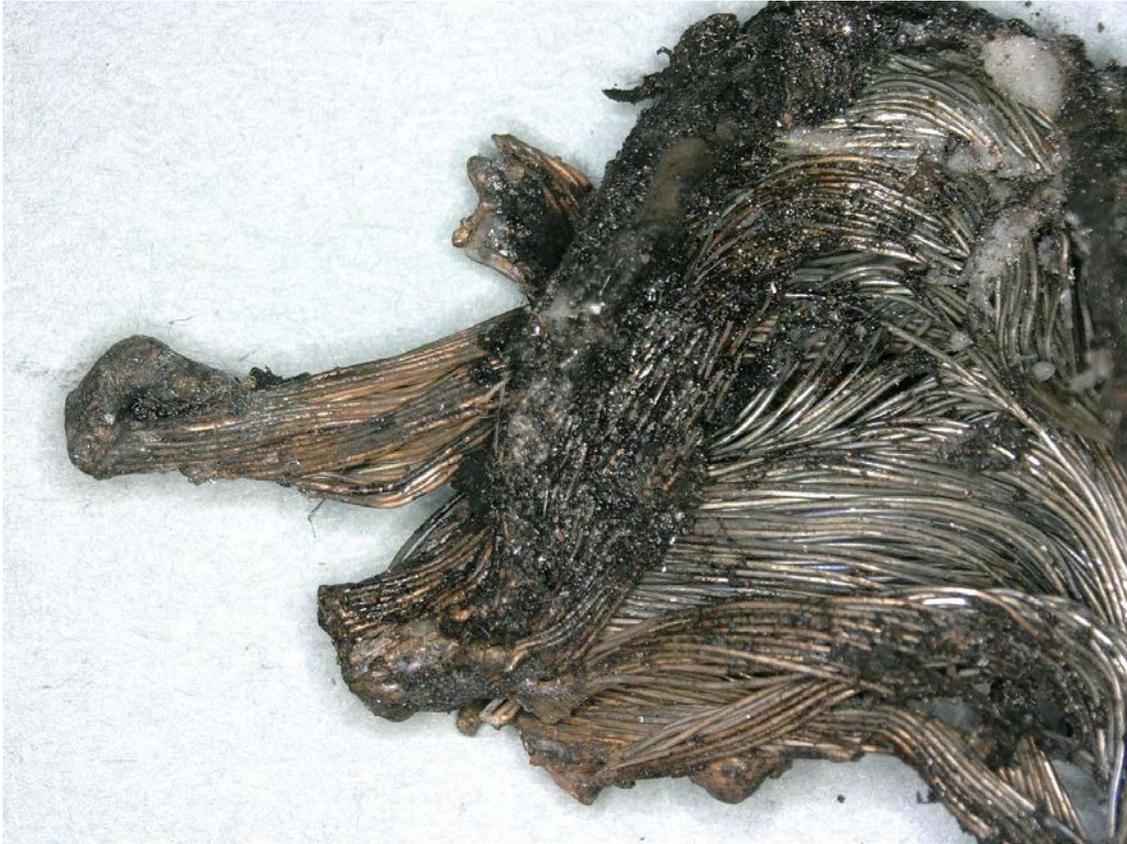
P1E	121	A section of the insulation from P1E and P1K had melted together. The shunt was present on one end. There was some beading and welding approximately 7 inches from fractured end. There were two areas along the length of the wire section with approximately 12 inches exposed conductors. There were several broken conductor strands in both exposed areas. The intact insulation adjacent to areas of bare conductor was melted.	23
Unidentified		There was approximately a 3-inch section of exposed conductor at the end of the section opposite the cut. There was slippage and melting of the insulation adjacent to this exposed area. There was some welding and beading at the very ends of the conductors on the bare end consistent with the conductor ends being pulled out of a connection.	24

Figure 24. Closeup photograph of welding and arcing damage on end of unidentified wire.

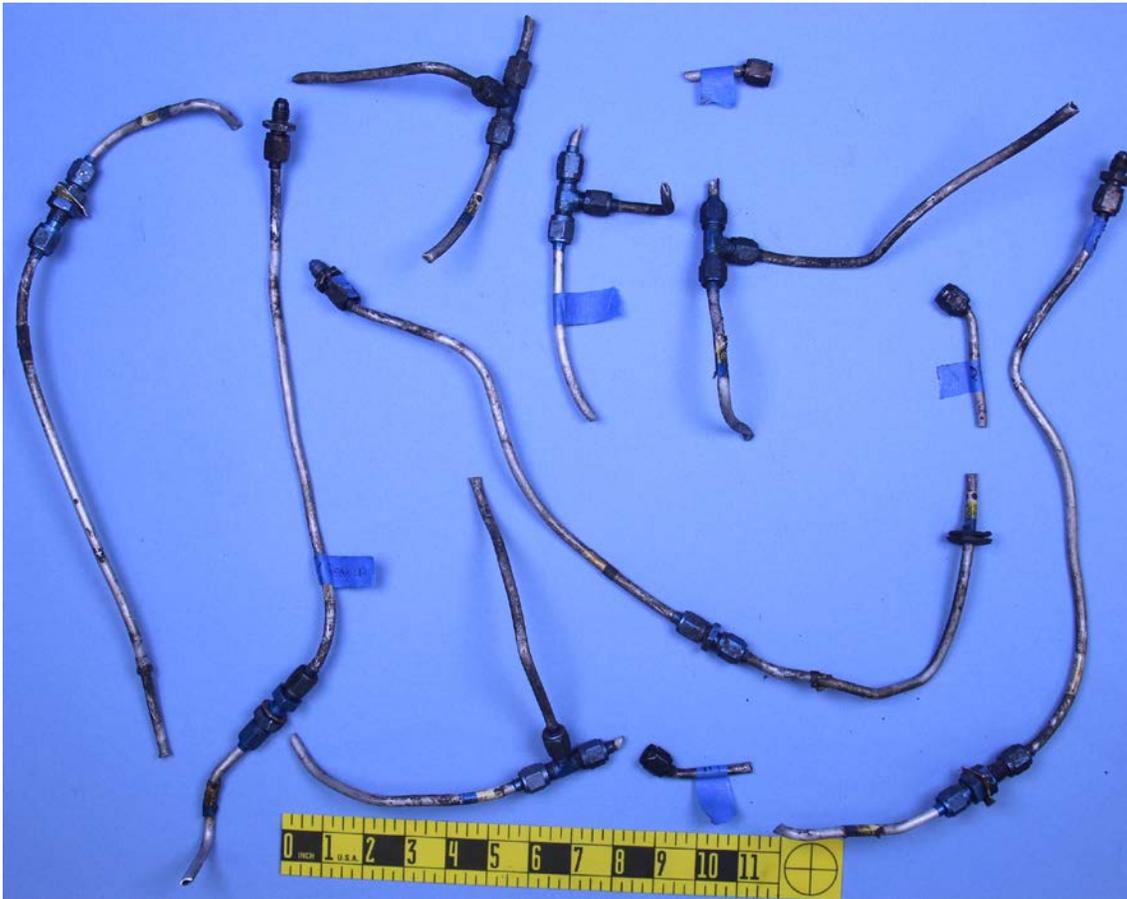
The remaining sections of the following hydraulic tubes were removed from the accident aircraft: 1) GEAR UP, 2) GEAR DOWN, 3) DOOR OPEN, and 4) DOOR CLOSED as shown in Figure 25. The hydraulic lines were constructed of 5050-0 aluminum tubing. All the

remaining lines displayed visible signs of heat exposure (material melting and changes in surface finish) and several inches of material were missing each of the lines.

The fractured ends on all the lines were examined. All the line ends exhibited patterns consistent with overstress fracture; some fractures exhibited features consistent with elevated temperature exposure as a contributing factor. On one of the fractured tubes, the GEAR UP line, intergranular fracture features were found as shown in Figure 26. A cross-section of fracture area showed severe grain separation along the grain boundaries, along with missing grains and intergranular voids. These features were consistent with incipient melting, where one of the solid phases (the interdendritic Zn/Mg-heavy phases) melt while the primary matrix (Al-rich) phase does not¹. This suggests that the temperature was above the solidus temperature for the alloy, but below the liquidus (complete melting) temperature². There were no indications of microstructural features consistent with stress corrosion cracking or embrittlement.

Figure 25. Overall photograph of hydraulic line as received in the laboratory.

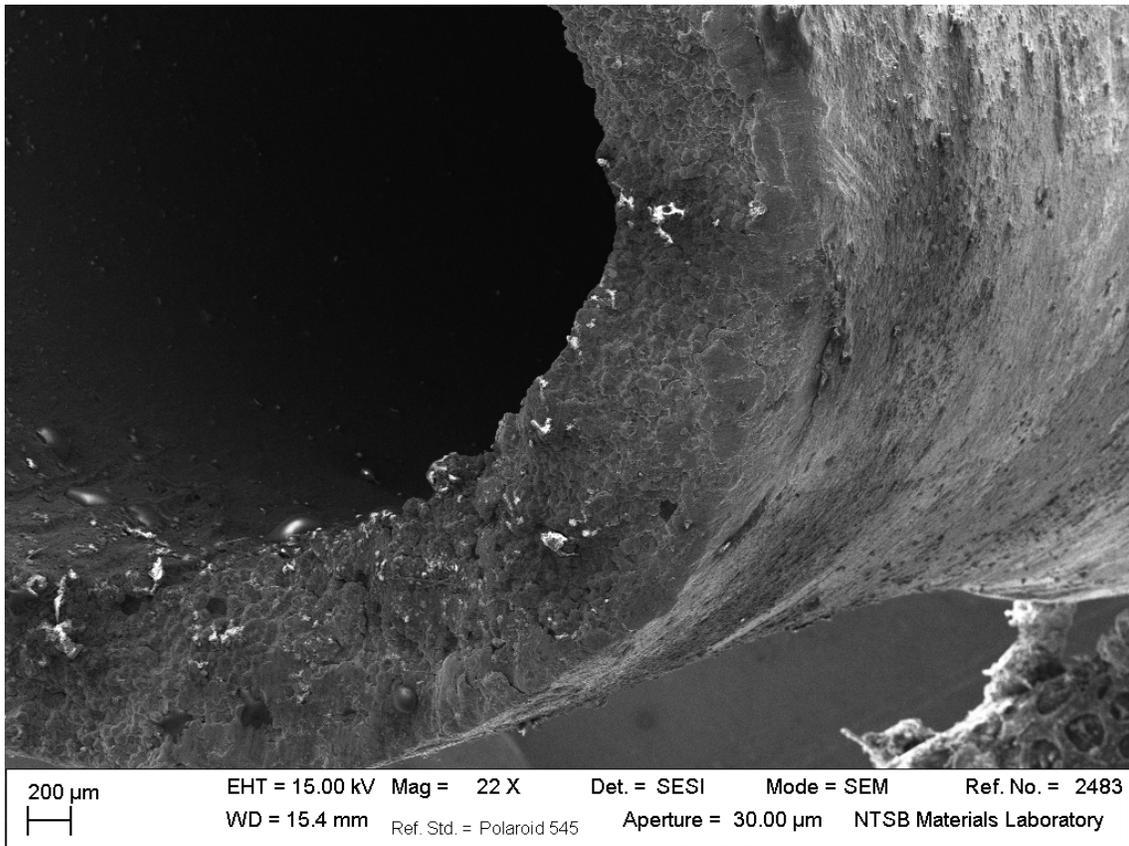
Figure 26. Micrograph of fracture surface of GEAR UP line showing intergranular features.

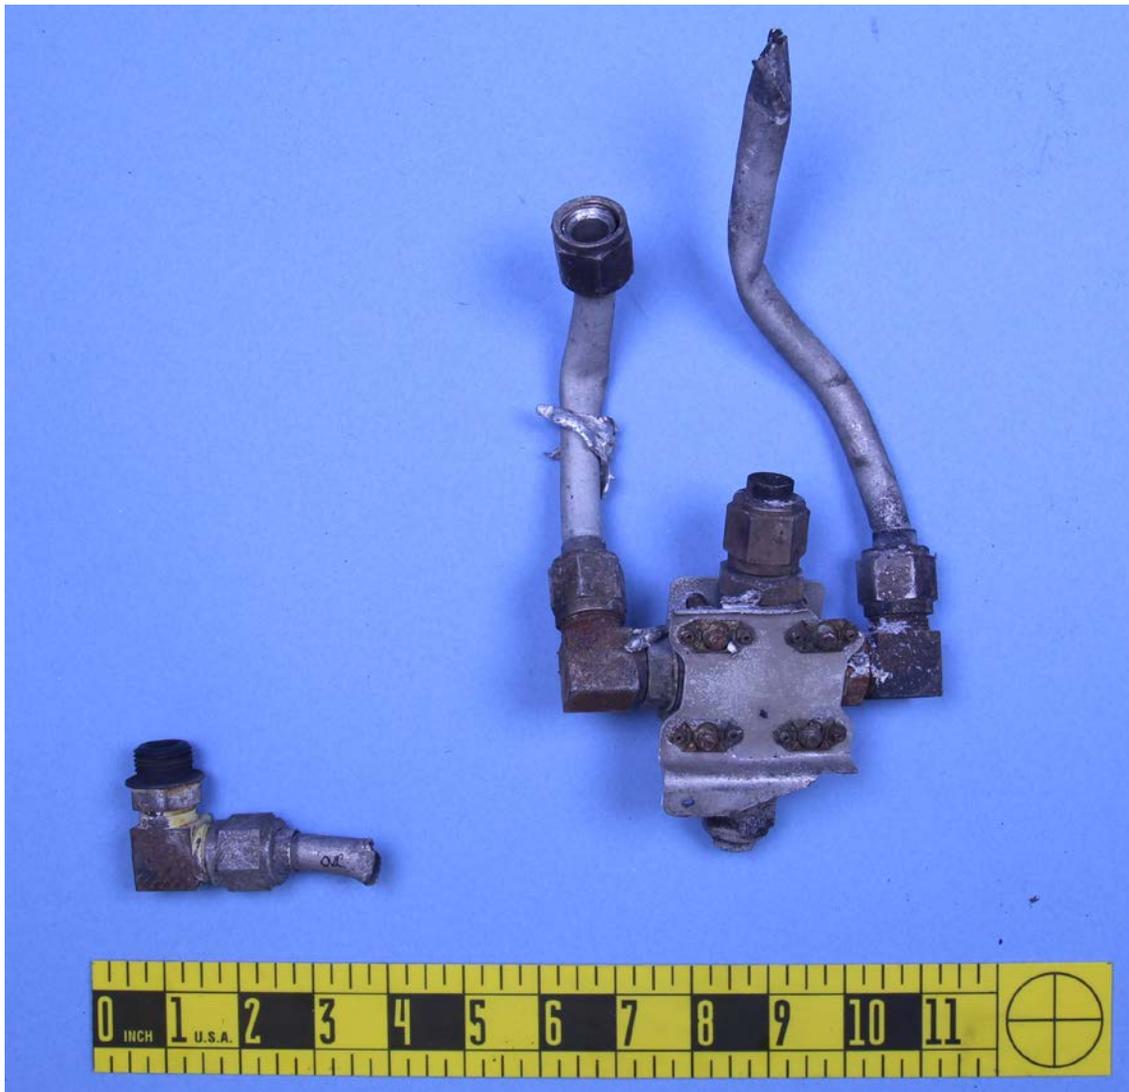
The cross-feed valve and several sections of associated fuel lines were submitted for examination. The components are shown in Figure 27. The left side line was intact to the fitting. A section of the right side was still present however the fitting was separated from the rest of the line. The fractured end of the right fitting shown fracture features consistent with overstress. The fracture end of the section still attached to the valve showed signs of melting and sagging consistent with thermal exposure.

Figure 27. Overall photograph of fuel system components as received in the laboratory.
