NATIONAL TRANSPORTATION SAFETY BOARD

MATERIALS LABORATORY FACTUAL REPORT

Report No. 14-055

Place: Casselton, ND
Date: December 30, 2013
Vehicle: BNSF Grain Freight Car, G-RYLRGT9-26A
NTSB No.: DCA14MR004
Investigator: Richard Hipskind, RPH-10

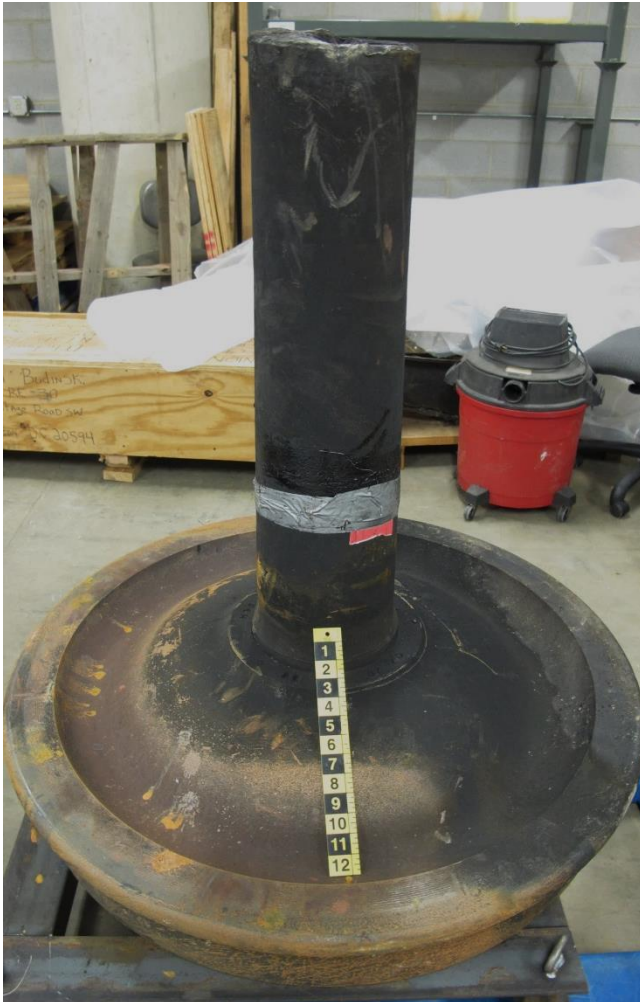
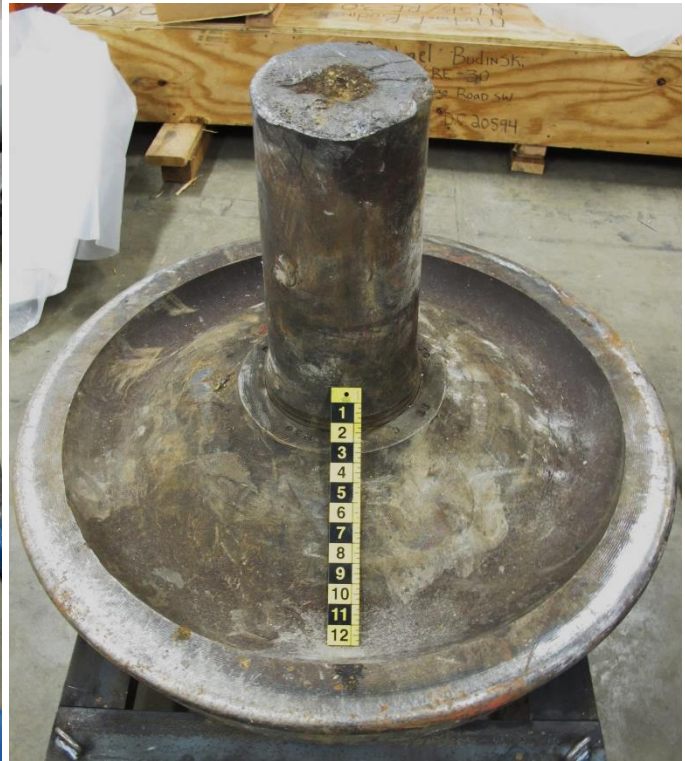
A broken axle and two wheels were recovered at the accident site and were shipped to the NTSB Materials Laboratory for further evaluation and analysis. Figure 1 illustrates both sides of the fractured axle, as received. The axle fractured such that one segment was shorter than the other longer segment. The axle had fractured at an

The fracture surface of the long axle segment, located approximately 32 inches from the wheelseat, exhibited soot deposits and bluish heat tinting, consistent with exposure to fire. The inboard wheel plate also exhibited indications of fire exposure. Some rusting was observed in sporadic areas on the long axle shaft. The fracture surface exhibited a small outward lip on one side of the fracture surface.

The short axle segment was absent these indications of fire exposure. However, much of the fracture surface had been smeared and scraped consistent with post fracture batter.

Figure 1 – The long and short segments of the fractured axle, as received.

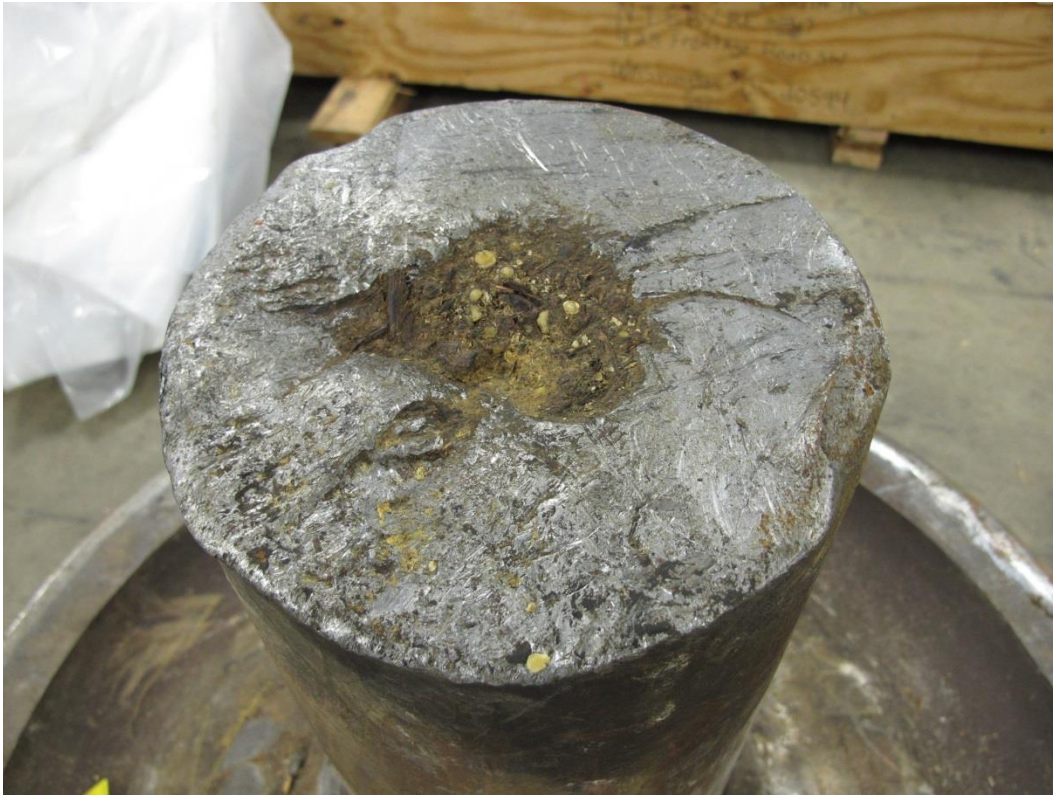
internal void located along the axle radial centerline, approximately 15 inches from the wheelseat of the short axle segment. The mating fracture surfaces are shown in Figure 2 and Figure 3. The exposed void halves in the fracture surfaces were filled with debris consistent with post-derailment ground impact. This debris was removed during the examination.

Figure 2 – The fracture surface of the short axle segment, as received.

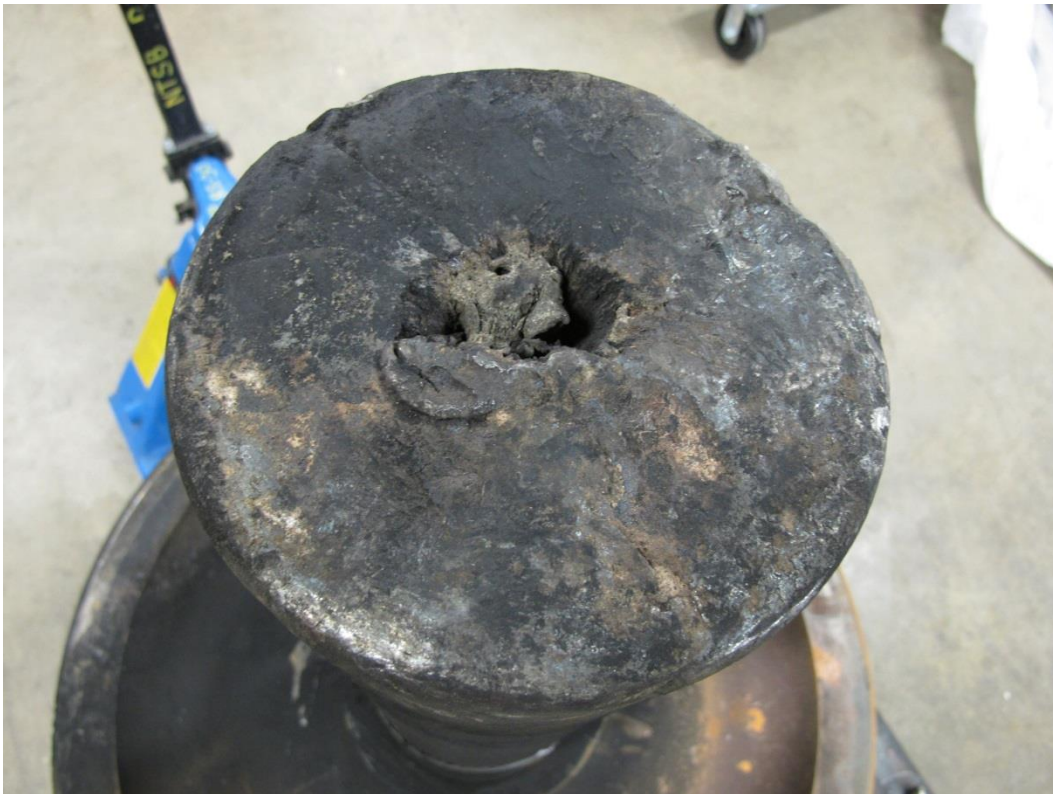
Figure 3 – The fracture surface of the long axle segment, as received.

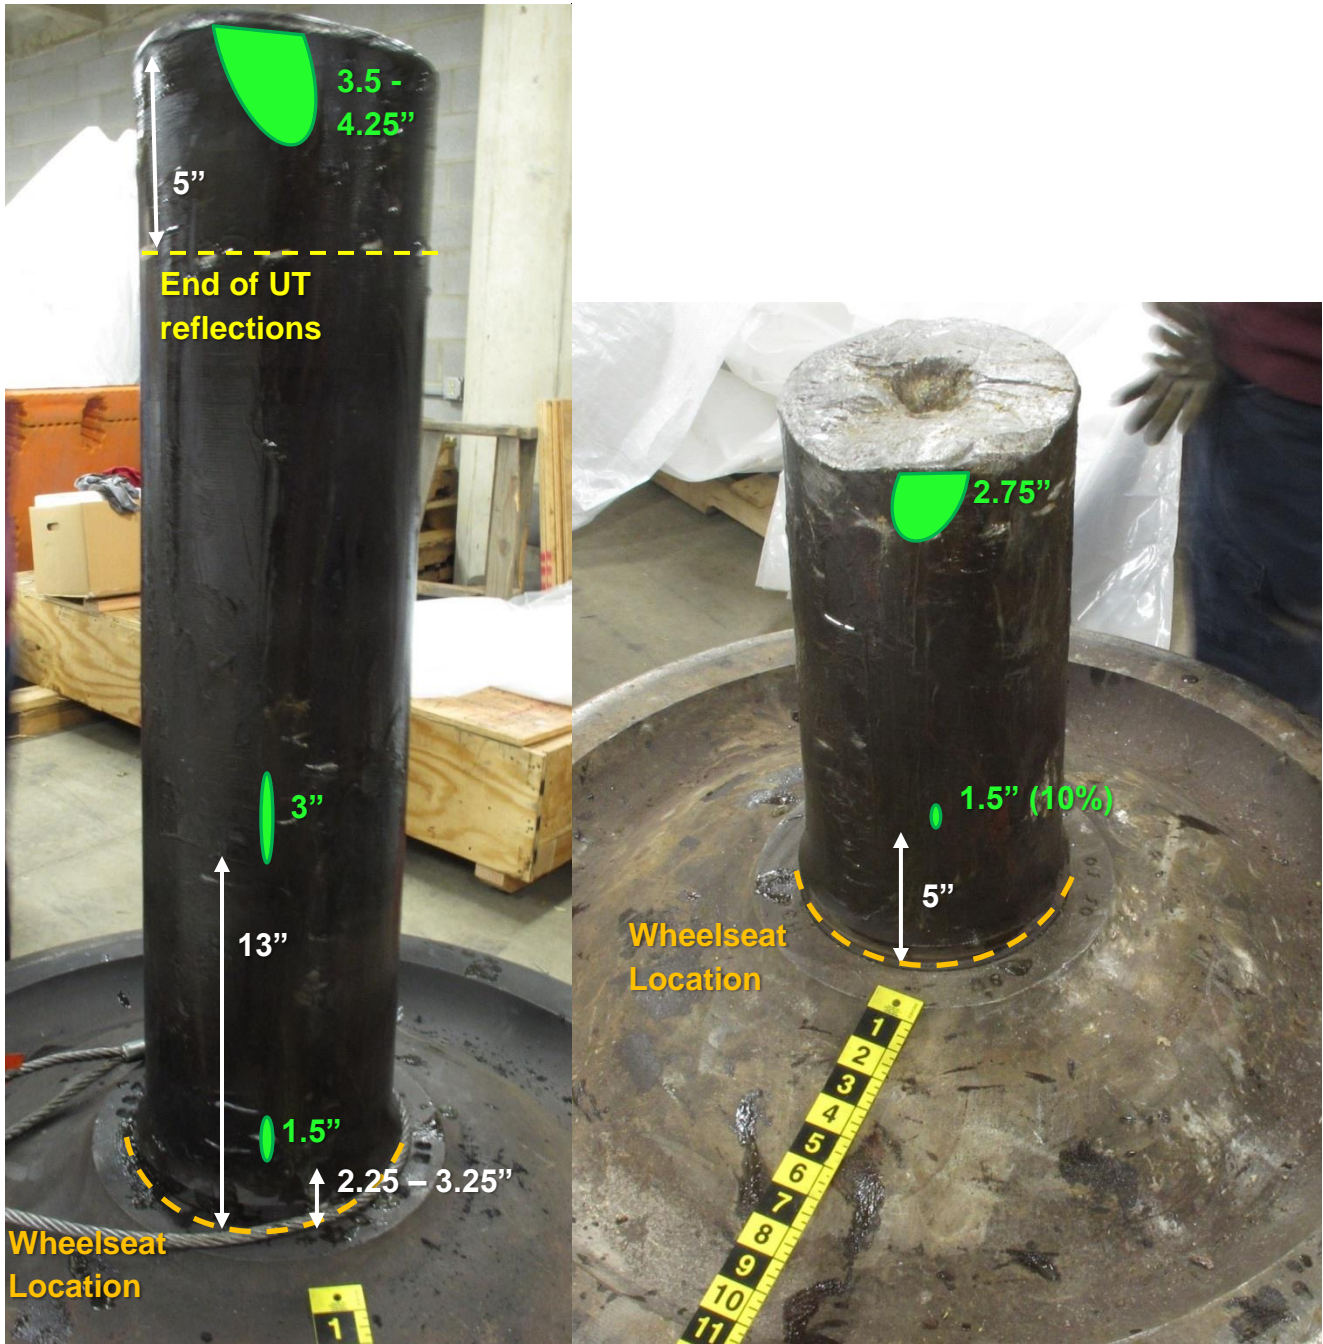
The summary of the results is depicted on the axles in Figure 4. The open centerline void at the fracture surfaces was characterized as asymmetrical in shape based on the UT reflectance data. The larger axle segment contained two indications outboard of the exposed centerline void at the fracture surface. The UT personnel stated that the middle indication was approximately 3 inches long, located approximately midway between the fracture surface and wheel seat. The shorter axle segment contained one indication besides the centerline void at the fracture surface. This indication was approximately 1.5 inches, but only displayed approximately 10% loss of reflectance off the back wall. These indications were examined further, as discussed in Section 4.3.

Figure 4 – The axle segments after UT NDT, with the green marks showing the relative locations and distances of the indications, based on the edge of the drop in UT transducer reflectance. The distances are relative to the wheel seat on the axle (dashed orange lines), or fracture surface.

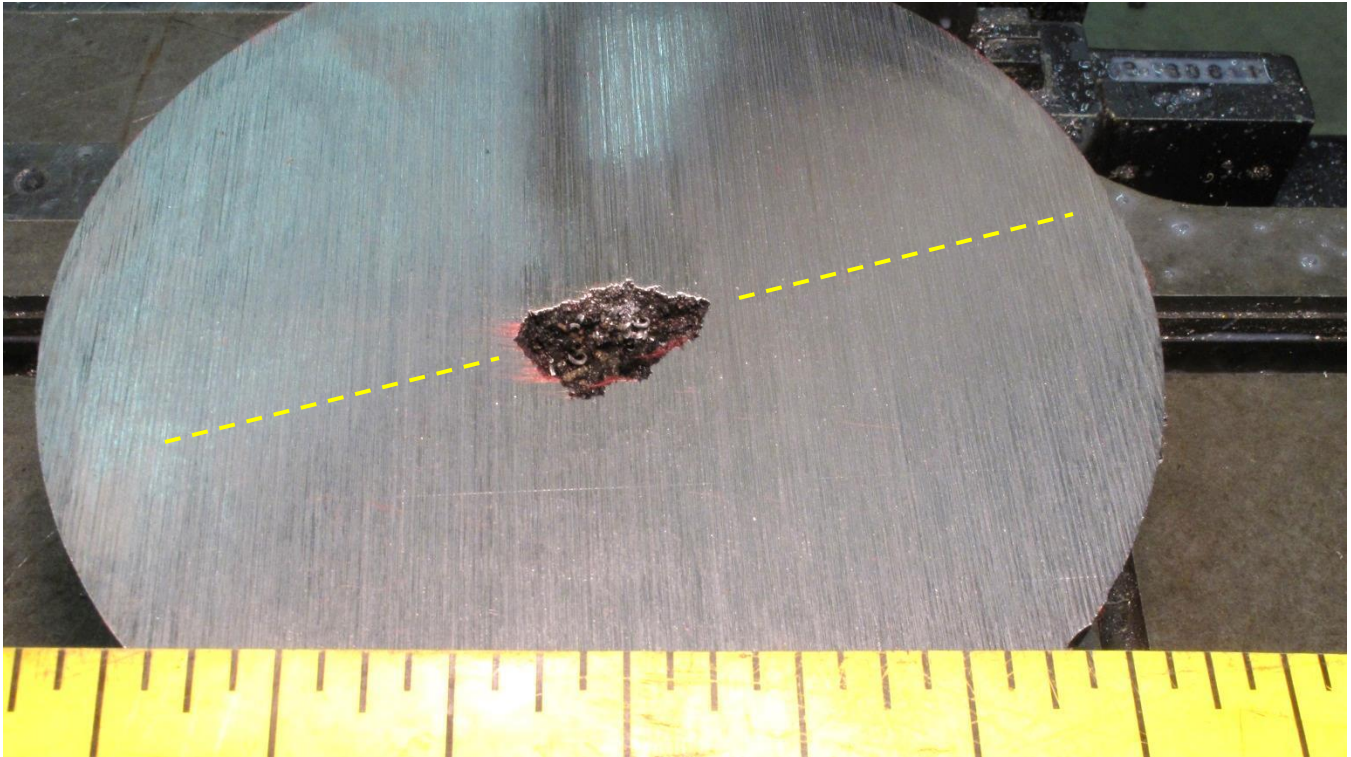
After the UT inspections, the longer axle segment was repositioned to allow for sectioning. The axle segment was sectioned below the UT indication for the edge of the transducer drop (yellow line in Figure 4). The fracture surface was then sectioned approximately 1 inch below the lowest surface point. The axle cross-section below the fracture surface is depicted in Figure 5. A portion of the void, approximately 1.25 inches by 0.75 inches, was visible. This axle portion was then cross-sectioned through the void, as depicted by the yellow line in Figure 5. Figure 6 shows the sectioned void from both mating halves of the axle fragment. The void at this cross-section was approximately 1 to 1.25 inches deep.

Figure 5 – The internal centerline void on the longer axle segment, after removal of the fracture surface (approximately 1 inch depth). The void measured 1.25" x 0.75". The dashed line represents the cross-section shown in Figure 6.

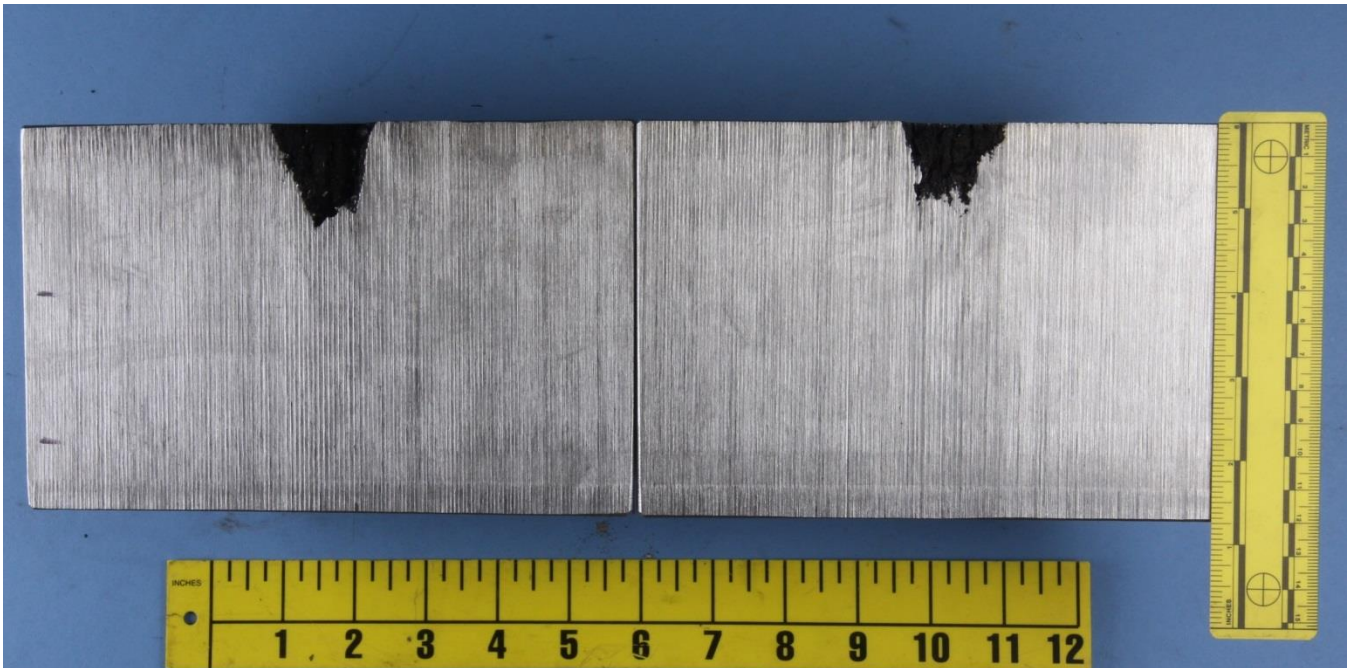
Figure 6 – The internal void from Figure 5 after sectioning down the middle.

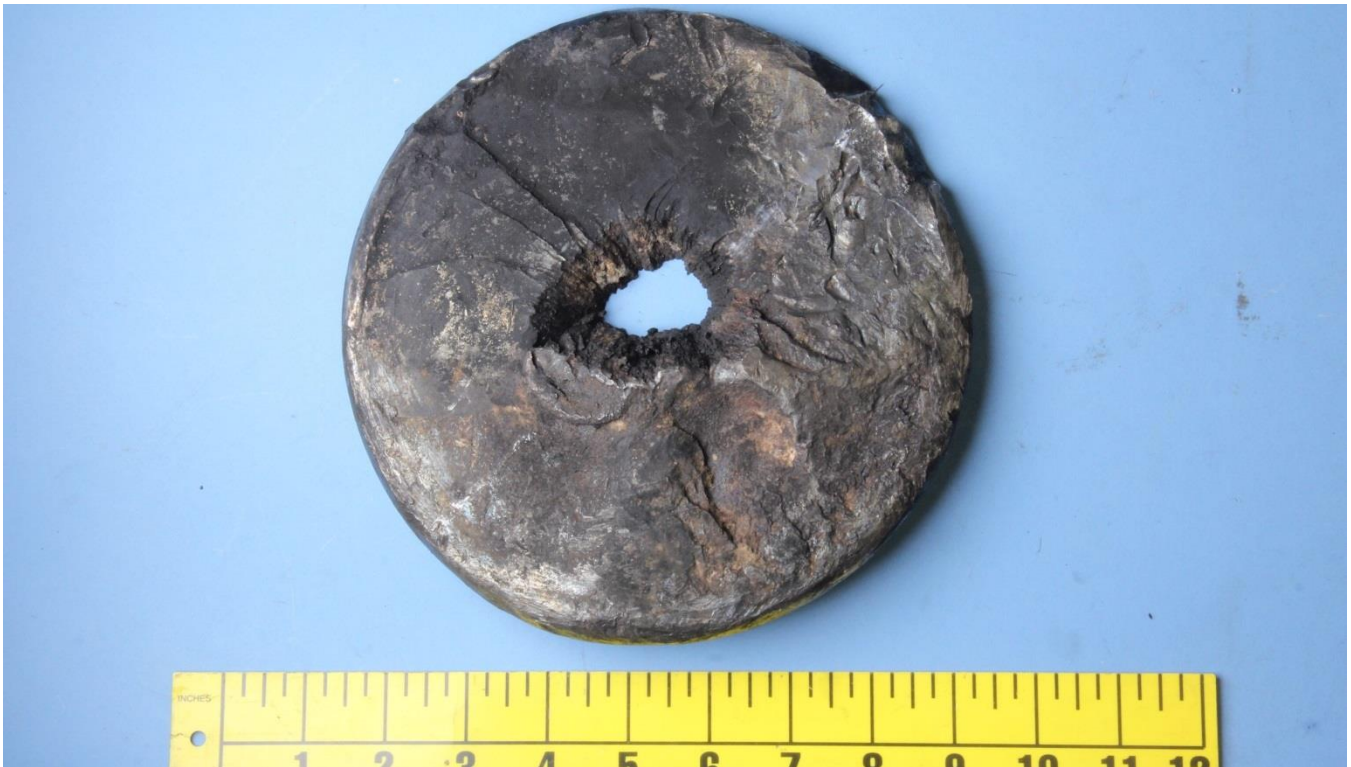
The fracture surface of the longer axle segment is shown after sectioning in Figure 7. The fracture surface was cleaned using mild abrasion with Sparkleen soap solution, followed by ultrasonic cleaning in acetone. As labeled in Figure 8, approximately half of the fracture surface exhibited features consistent with progressive cracking. The morphology of the progressive region was consistent with cracks that initiated at the internal void and grew outward towards the axle surface. The ratchet marks on the fracture surface were consistent with multiple crack initiation sites and coalescence during crack propagation.

Figure 7 – The longer axle segment fracture surface, after removal.

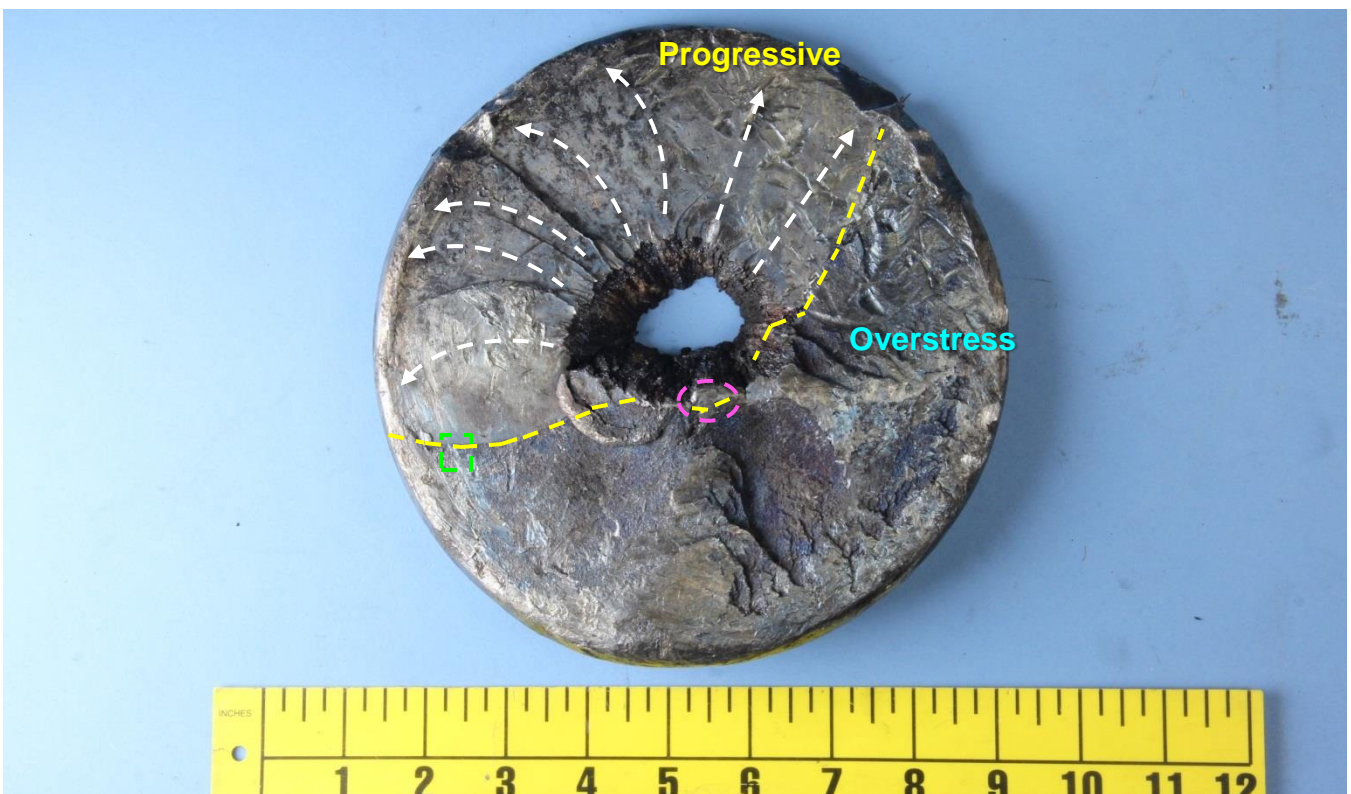
Figure 8 – The fracture surface from Figure 7, after cleaning, with the progressive and overstress areas labeled. The dashed line is the boundary between the progressive and overstress regions. The green dashed box is magnified in Figure 9, and the dashed oval is magnified in Figure 10.

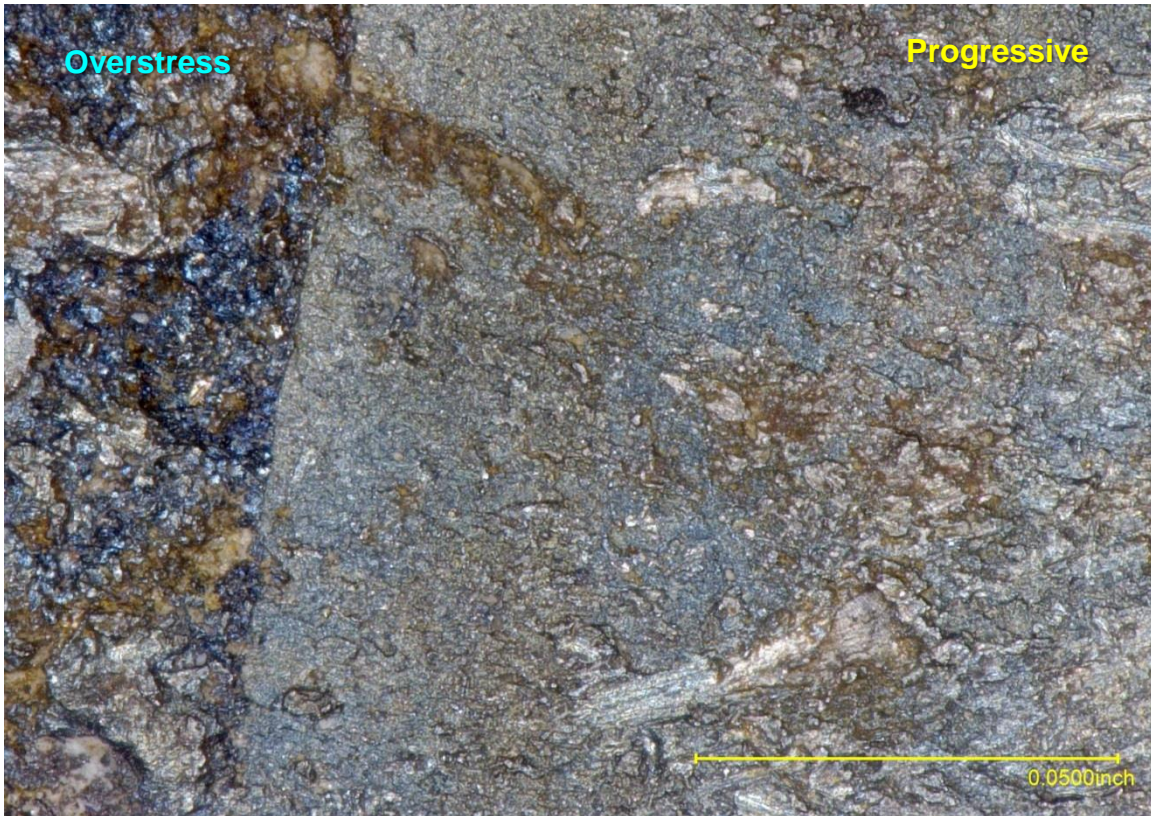
The remaining half of the fracture surface (from the long axle segment) exhibited an appearance consistent with overstress fracture. Figure 9 shows the edge of the progressive fracture, in contrast with the overstress regions. The progressive region appeared lighter in color and was generally flatter, oriented perpendicular to the axle length direction. Some faint crack arrest marks were visible in the progressive region. The overstress region exhibited rougher, tortuous surface texture. In addition, the heat tint coloring was more pronounced, with darker blues.

Figure 9 – Edge of the progressive crack on the axle fracture surface.

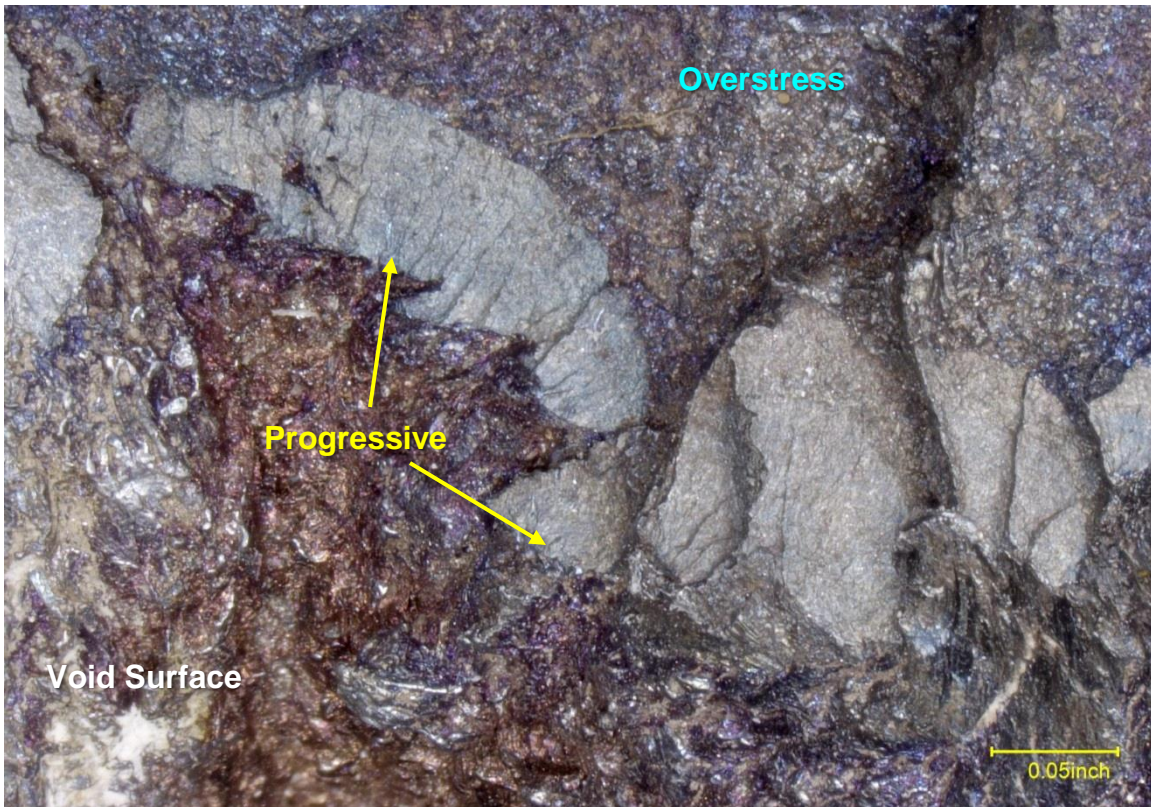
were relatively undamaged, such as depicted in Figure 10. This area, opposite the large progressive fracture region, contained small progressive cracks that had initiated at the centerline void. These small thumbnail-shaped cracks exhibited ratchet marks consistent with multiple crack initiation.

Figure 10 – Small fatigue cracks that had initiated and grew from the internal void in the axle.

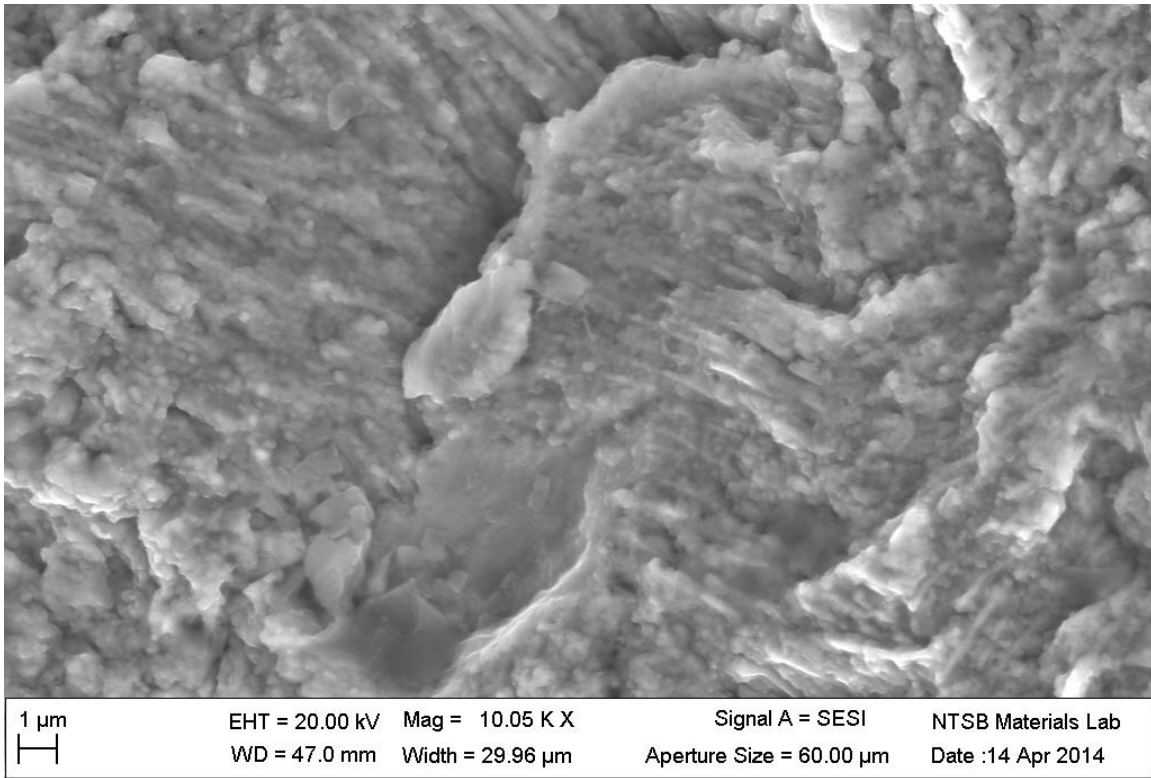
Examination in a scanning electron microscope (SEM) revealed fatigue striations present in the progressive fracture areas of the fracture surface (see Figure 12 and Figure 11). The striations emanated outward from the centerline void. No indications of features consistent with other fracture modes were found in the fatigue regions of the fracture surface.

Figure 11 – SE micrograph of oxidized fatigue striations on the long axle fracture surface.

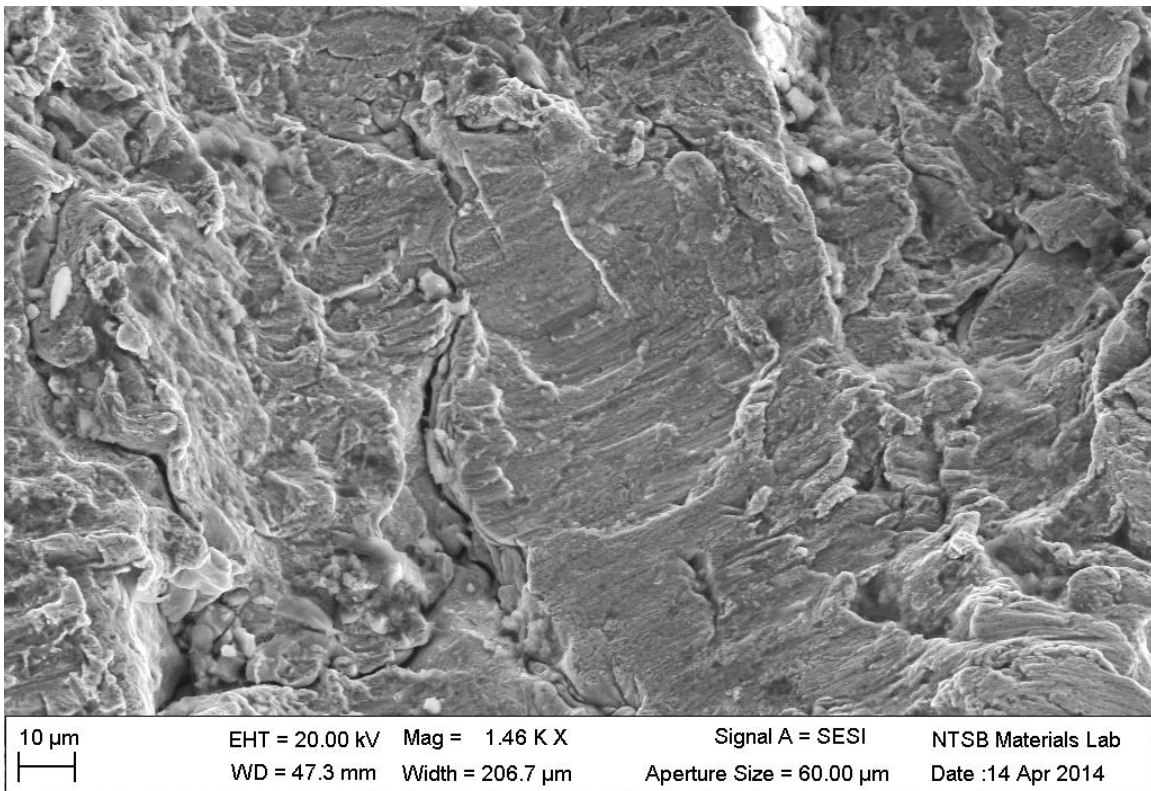
Figure 12 – Secondary electron (SE) micrograph of fatigue striations on the small progressive cracks adjacent to the void, depicted in Figure 10.

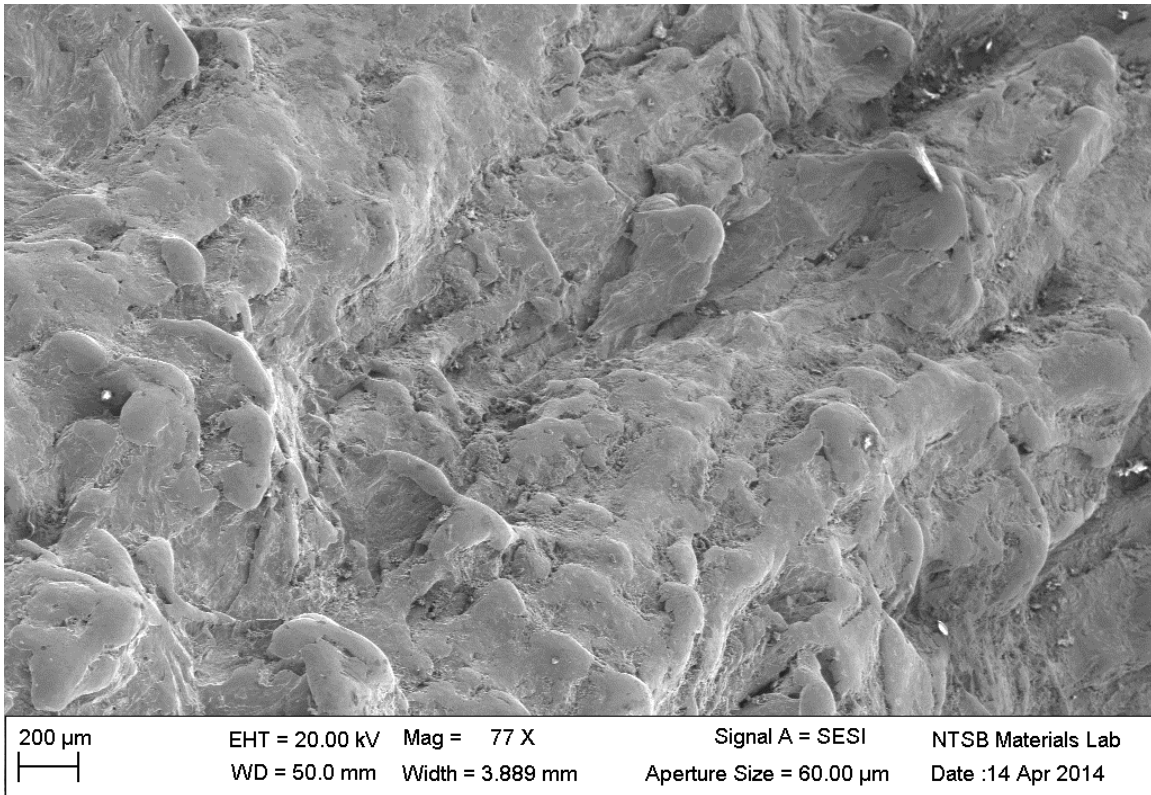
The surface of the centerline void was examined in a SEM, as illustrated in Figure 13 and Figure 14. The surfaces of the void consisted of deep valleys protruding into the axle material, with rounded, smoothed peaks. Much of the surface of the void exhibited electron-charging effects in the SEM, consistent with non-conductive material (typically non-metallic). Figure 14 shows a closer view of the void surface, exhibiting blocky non-metallic phases. Inspection of these phases using energy dispersive x-ray spectroscopy (EDS) revealed aluminum and silicon oxides. The other script-shaped surface features exhibited compositions consistent with the remainder of the void surface.

Figure 13 – SE micrograph of the internal void surface, showing rounded, rippled edges.

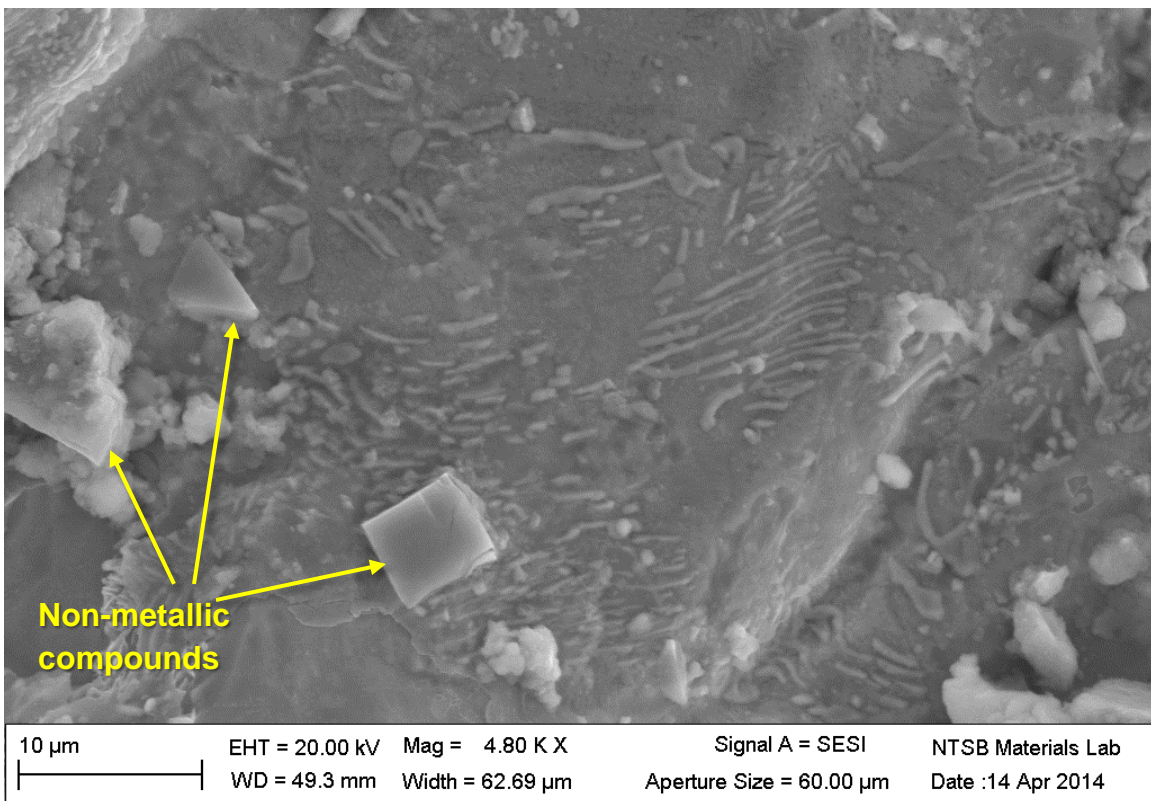
Figure 14 – SE micrograph of a closer view of the internal void surface.

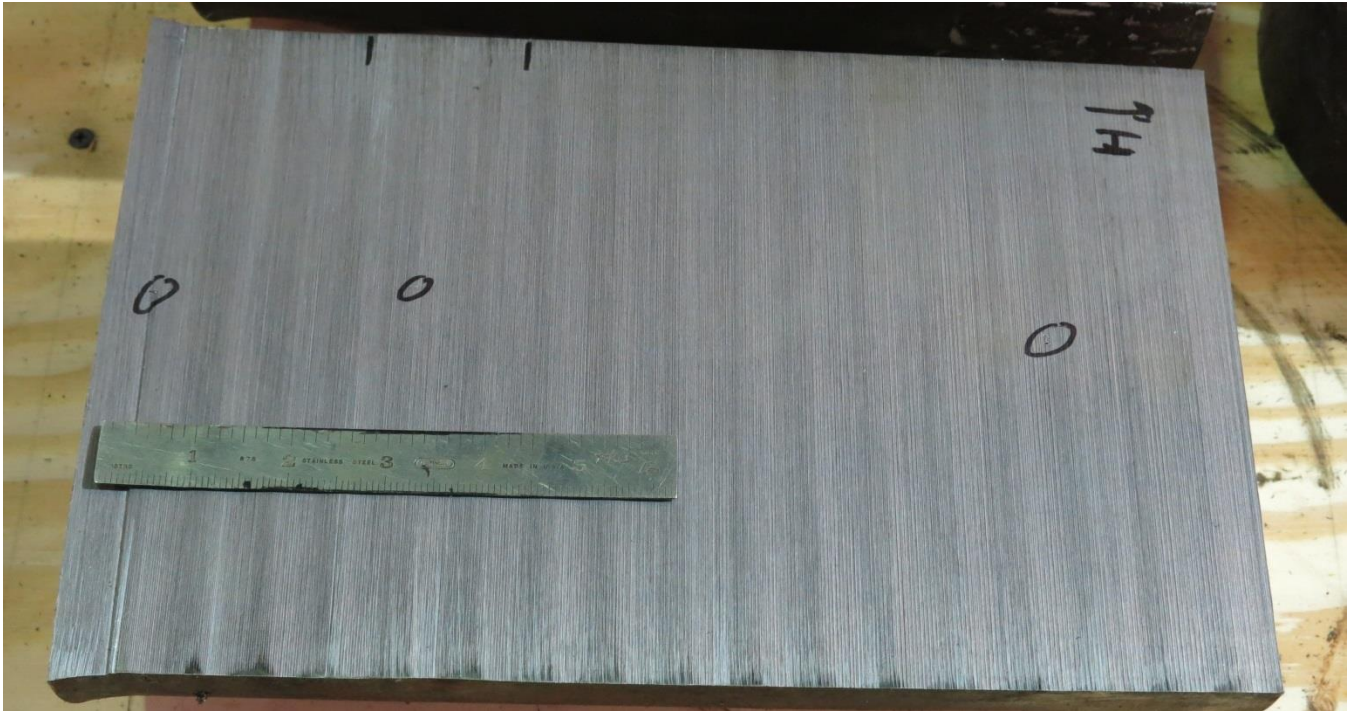
Figure 15 and Figure 16 show the voids observed after cross sectioning the axle fragments. The short axle fragment contained three voids, and the long axle fragment exhibited two voids—these voids were observable to the unaided eye. The second void from the wheel seat journal on the short axle segment (Figure 15) was consistent with the location of the observed indication from the ultrasonic inspection.

Figure 15 – Cross section of the short side axle fragment, showing three small voids along the centerline.

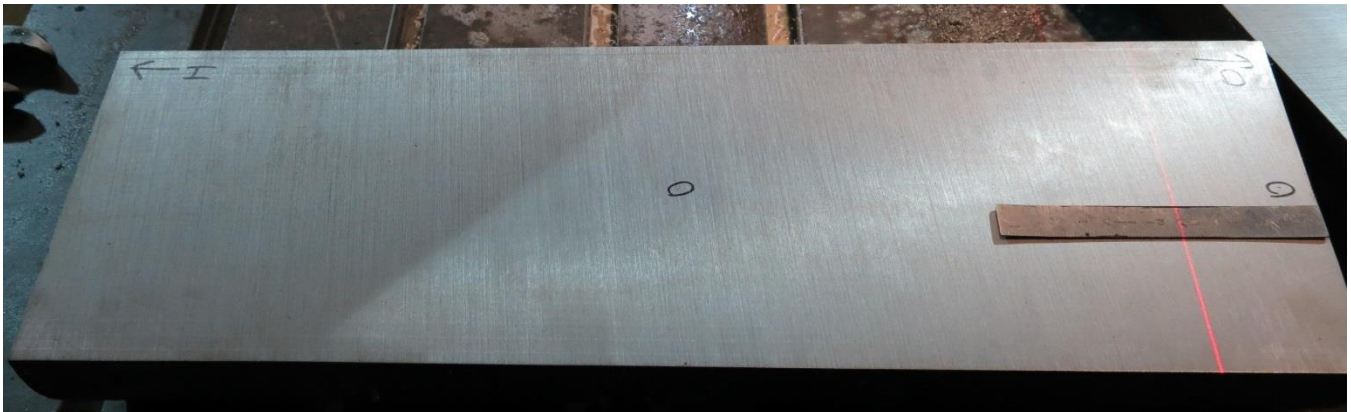
Figure 16 – Cross section of the long side axle fragment, showing two small voids along the centerline.

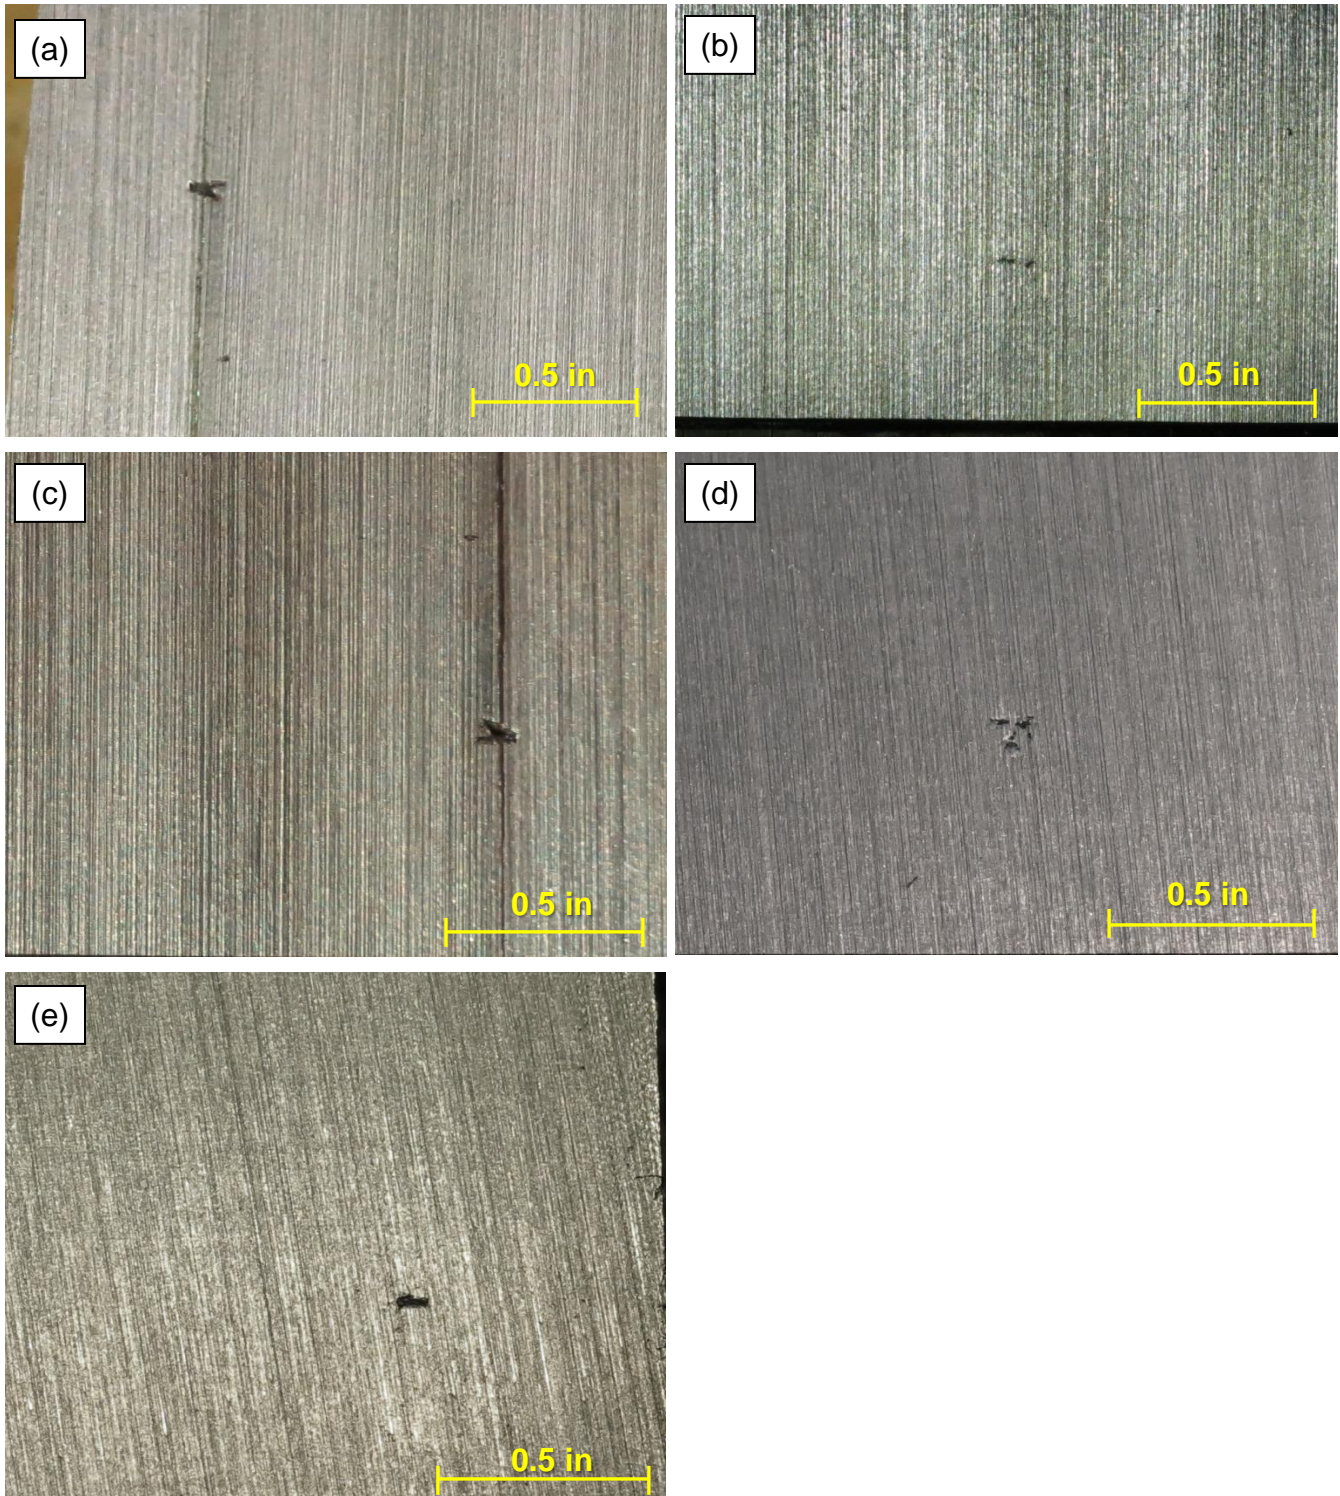
All of these voids are shown magnified in Figure 17, ordered from the near the outboard wheel seat journal on the short axle segment (left in Figure 15) to near the wheel seat journal outboard on the long axle segment. All of these voids were generally flattened, oriented along the forging (longitudinal) direction. All of the voids were considerably smaller in volume than the large centerline void at the fracture surface—the largest void was approximately 0.2 inches in the longest direction, located along the centerline location of the axle.

Figure 17 – The five cross-sectioned voids along the axle center lines observed in Figures Figure 15 and Figure 16.

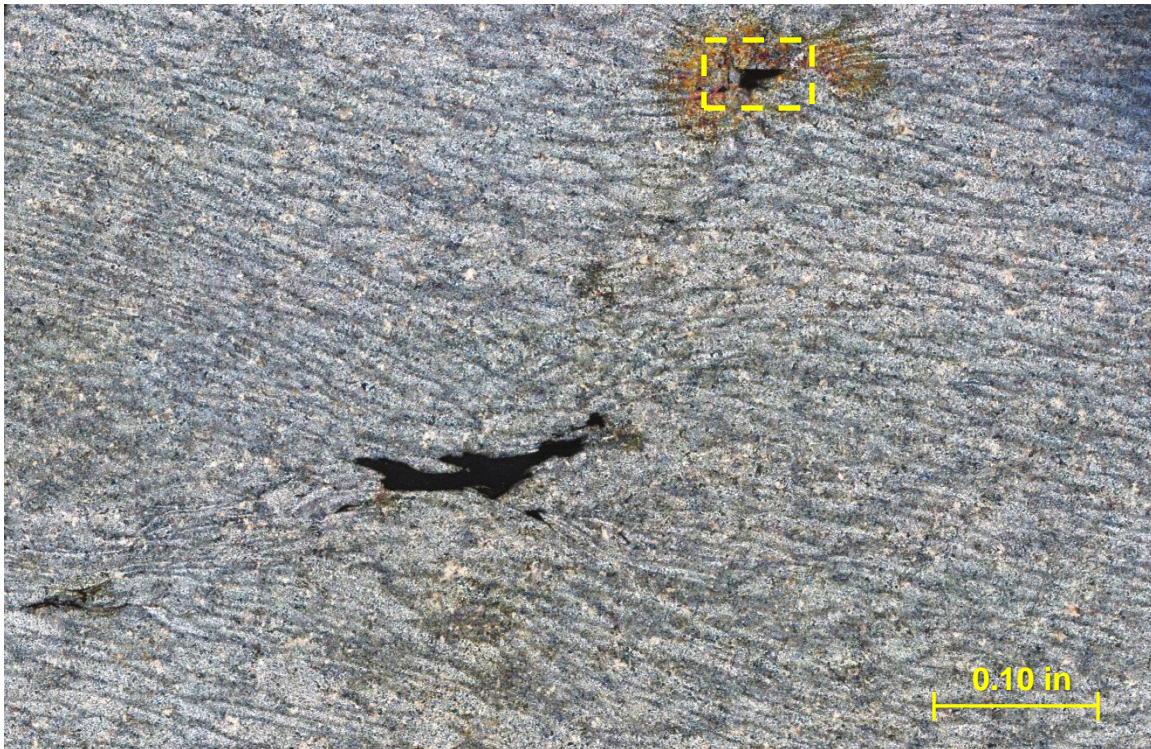
One of the voids (shown in Figure 17c), was sectioned, mounted, polished and etched using 2% Nital solution. This void is shown in Figure 18, with the etchant having revealed the grain flow about the expose voids. No overt changes to the microstructure were observed adjacent to the voids (see Figure 19). Figure 20 shows a closer view of

Figure 18 – Optical metallograph of a cross-section through a small void in the centerline of the axle (etched with 2% Nital). The boxed area is shown in Figure 19.

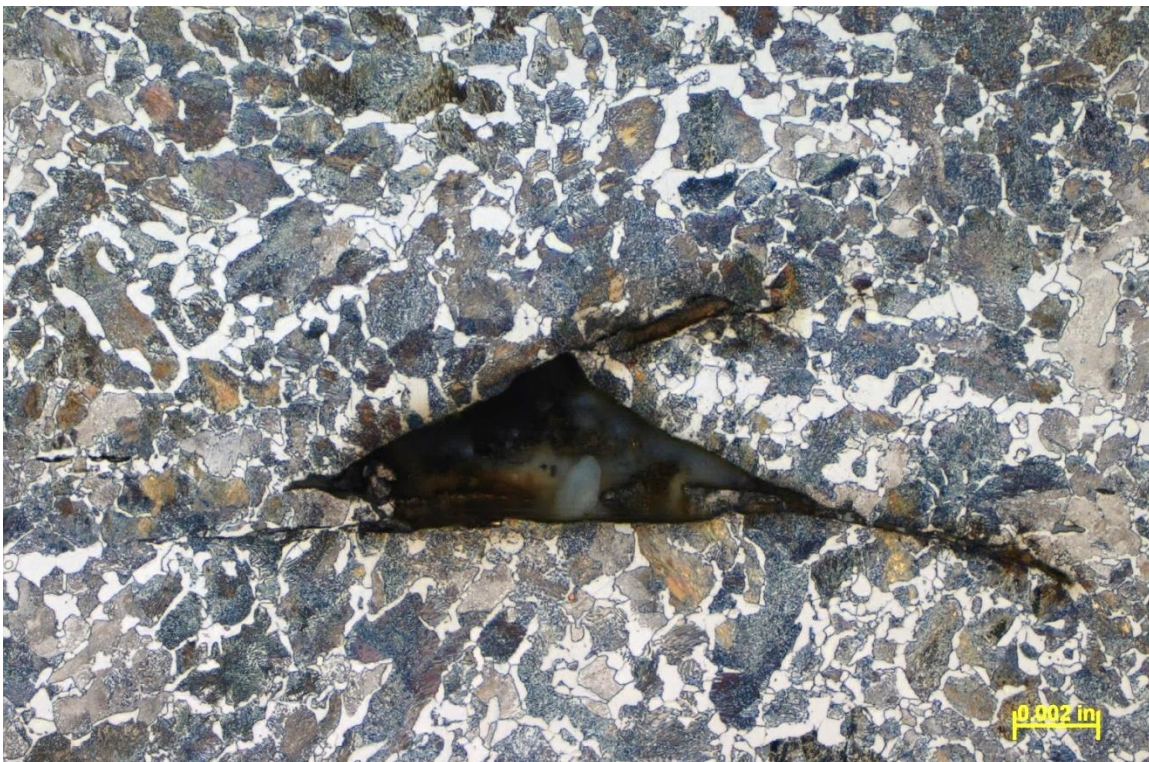
Figure 19 – Optical metallograph showing the microstructure of the axle, showing a small void, the boxed area in Figure 18 (etched with 2% Nital).

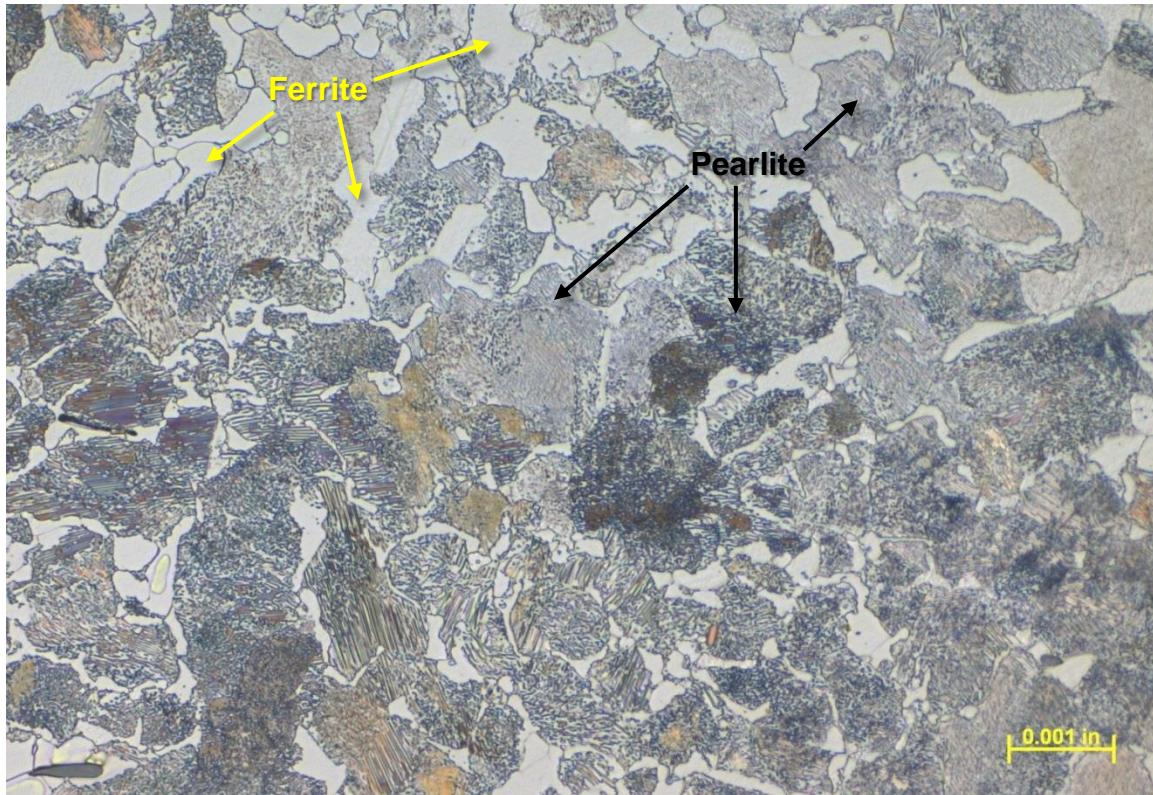
the axle microstructure. The microstructure consisted of a fine pearlite structure, with proeutectoid ferrite dispersed between the pearlite colonies. This microstructure morphology was consistent throughout all the areas inspected.

Figure 20 – Optical metallograph showing the microstructure of the axle, with colored pearlite between colorless ferrite (etched with 2% Nital).
