NATIONAL TRANSPORTATION SAFETY BOARD

MATERIALS LABORATORY FACTUAL REPORT

Report No. 14-055

Place: Casselton, ND
Date: December 30, 2013
Vehicle: BNSF Grain Freight Car, G-RYLRGT9-26A
NTSB No.: DCA14MR004
Investigator: Richard Hipskind, RPH-10

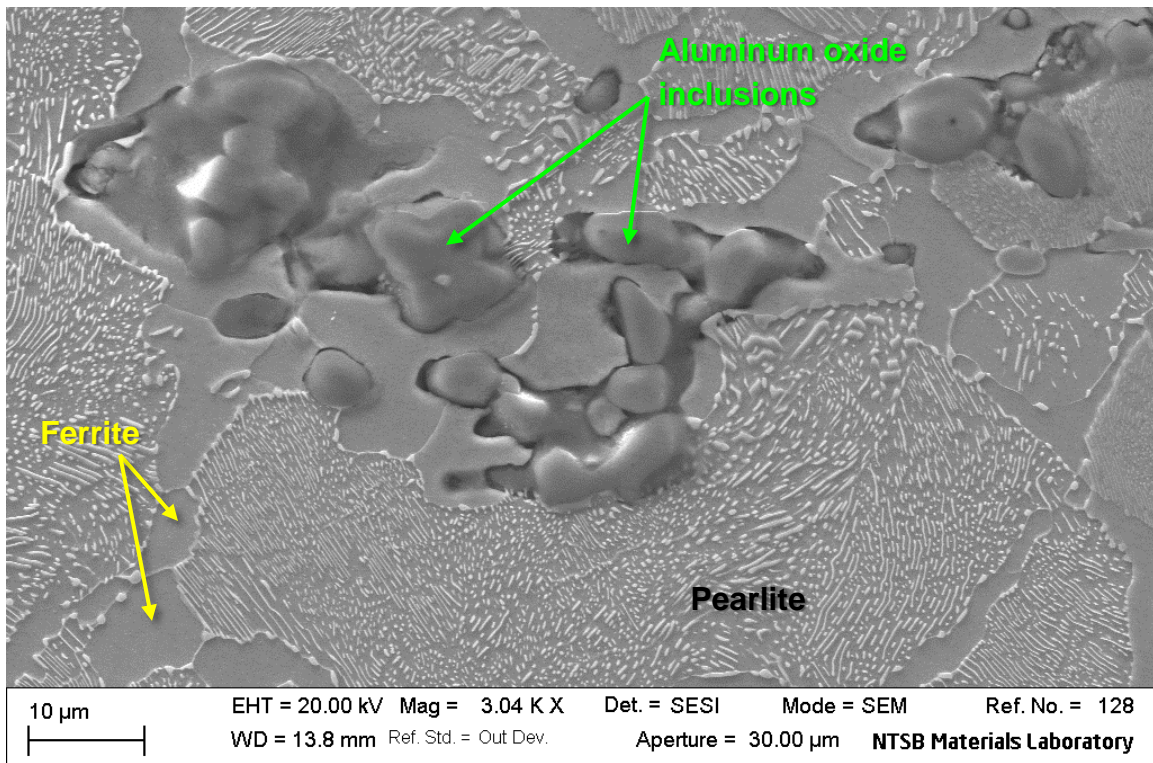
The cross-sectioned void was inspected using the SEM. Smaller areas of non-metallic material were observed along the periphery of the void surface. One such area is illustrated in Figure 21. This material was inspected using EDS, and its chemical composition was found to be consistent with aluminum oxide.

Figure 21 – SE micrograph of small inclusions near the void in Figure 19. These inclusions were consistent with aluminum oxide.

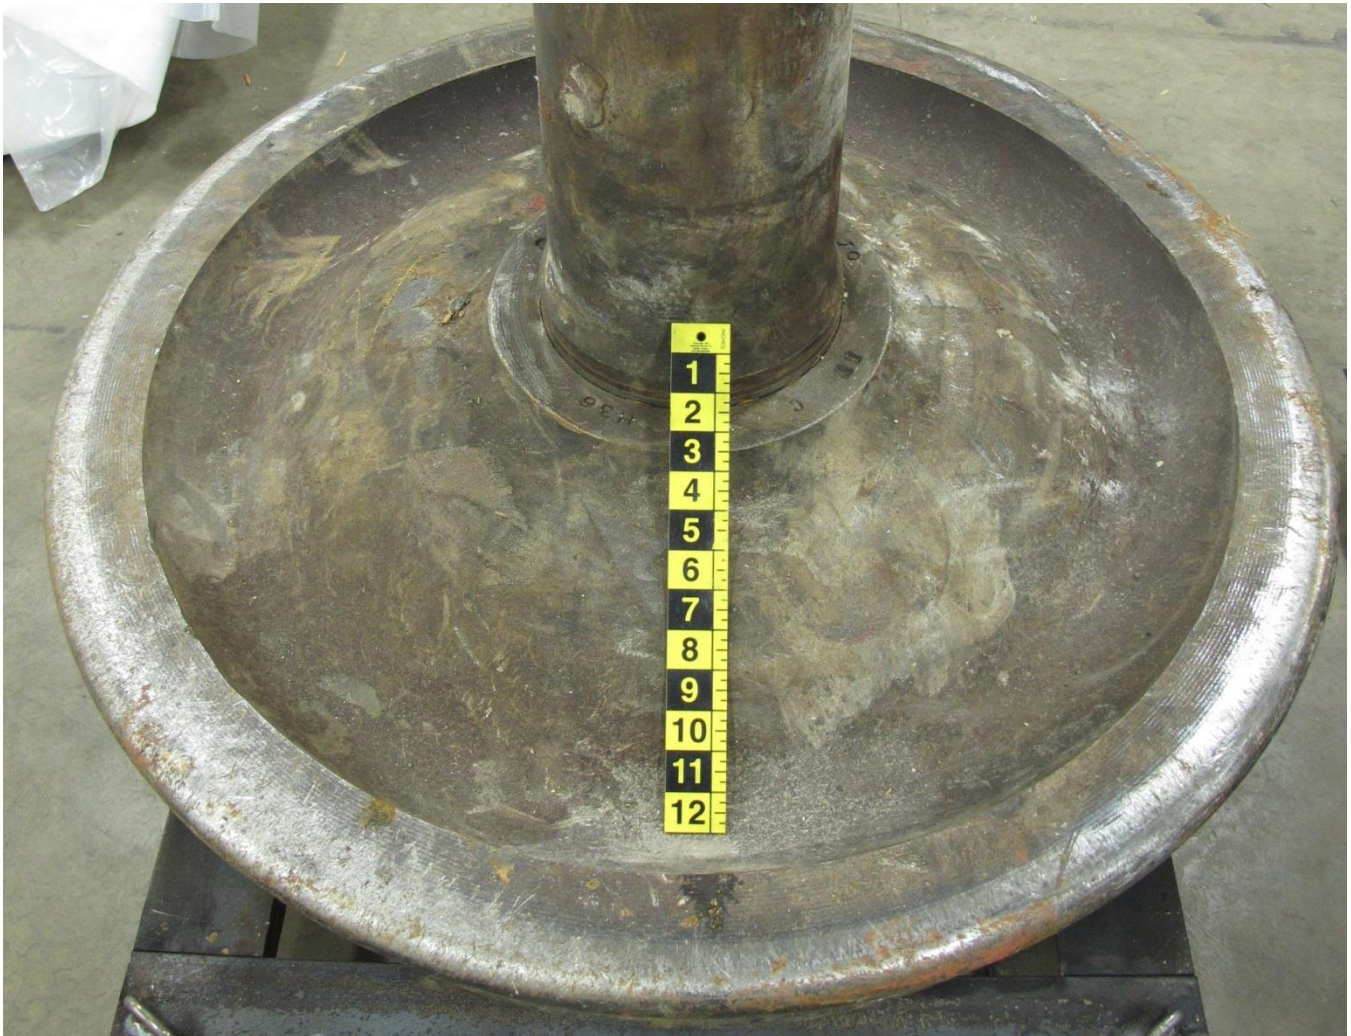
This wheel exhibited randomly oriented scratches, streaks, and gouges on the faces of both sides of the wheel. However, there were no indications of gross deformation or warping on the wheel. These witness marks were consistent with damage incurred during the derailment after the axle fractured. The rail contact surfaces of the wheel were intact, with no indications of wear, spalling, cracking, or denting. No indications of damage to the wheel flange were observed.

Figure 22 – The wheel on the short side of the axle, as received.

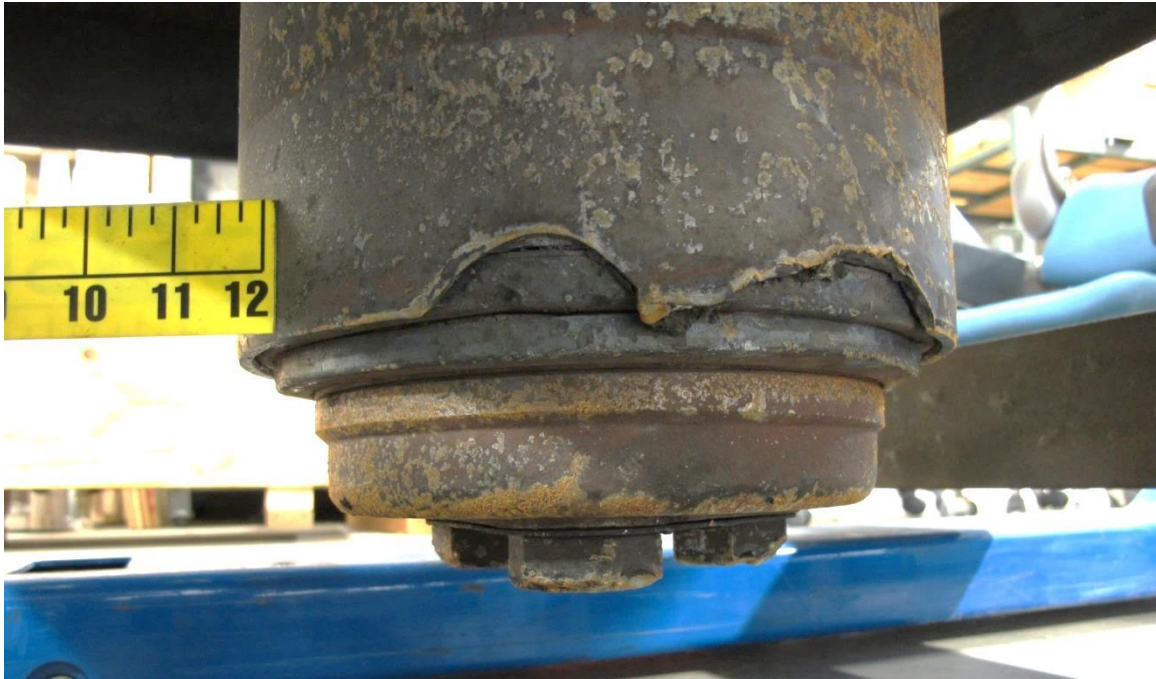
A portion of the axle bearing outboard of the wheel had fractured (see Figure 24). However, the shapes of the fracture, as well as features on the fracture surface, were consistent with overstress fracture consistent with damaged incurred during the derailment. Some fretting was observed around the axle journal seat adjacent the wheel

Figure 24 – Axle bearing from the short axle segment.

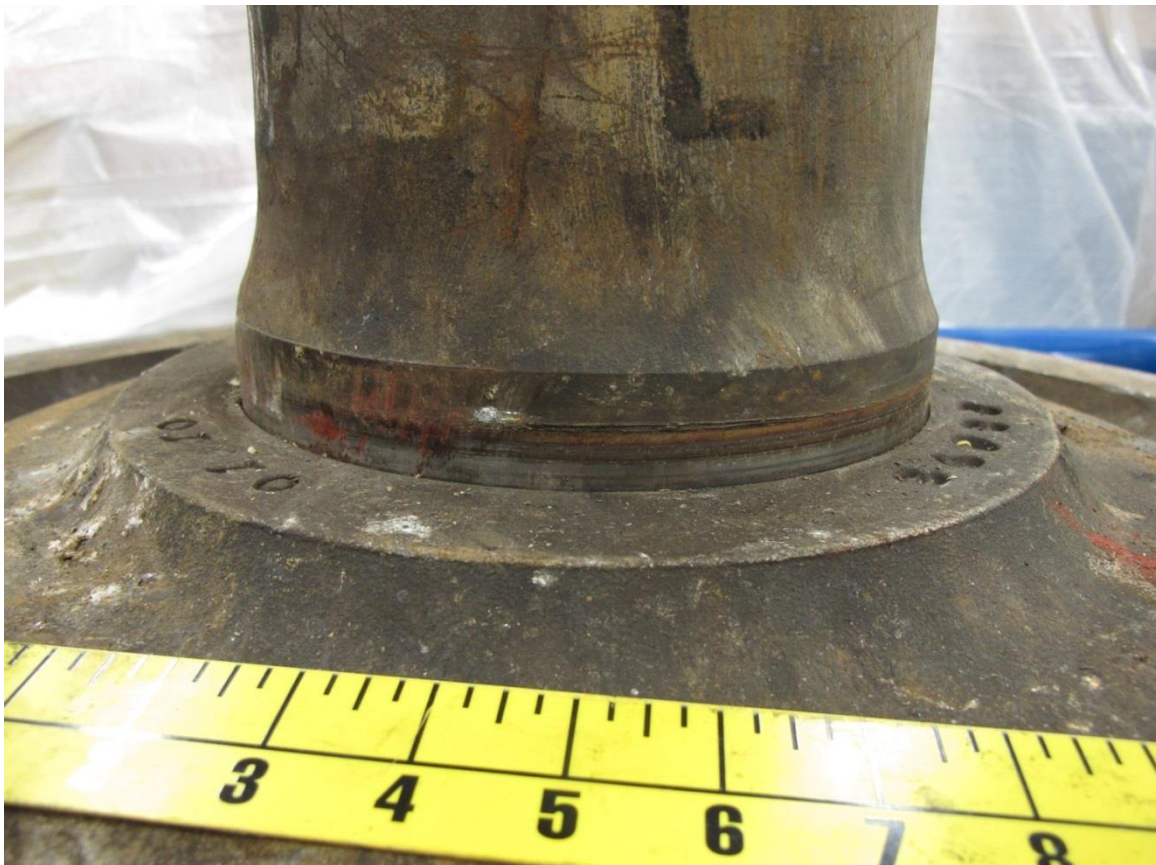
(see Figure 25). However, there was no indication that this wear was related to the axle fracture.

Figure 25 – Possible fretting around the wheel seat of the short axle segment.

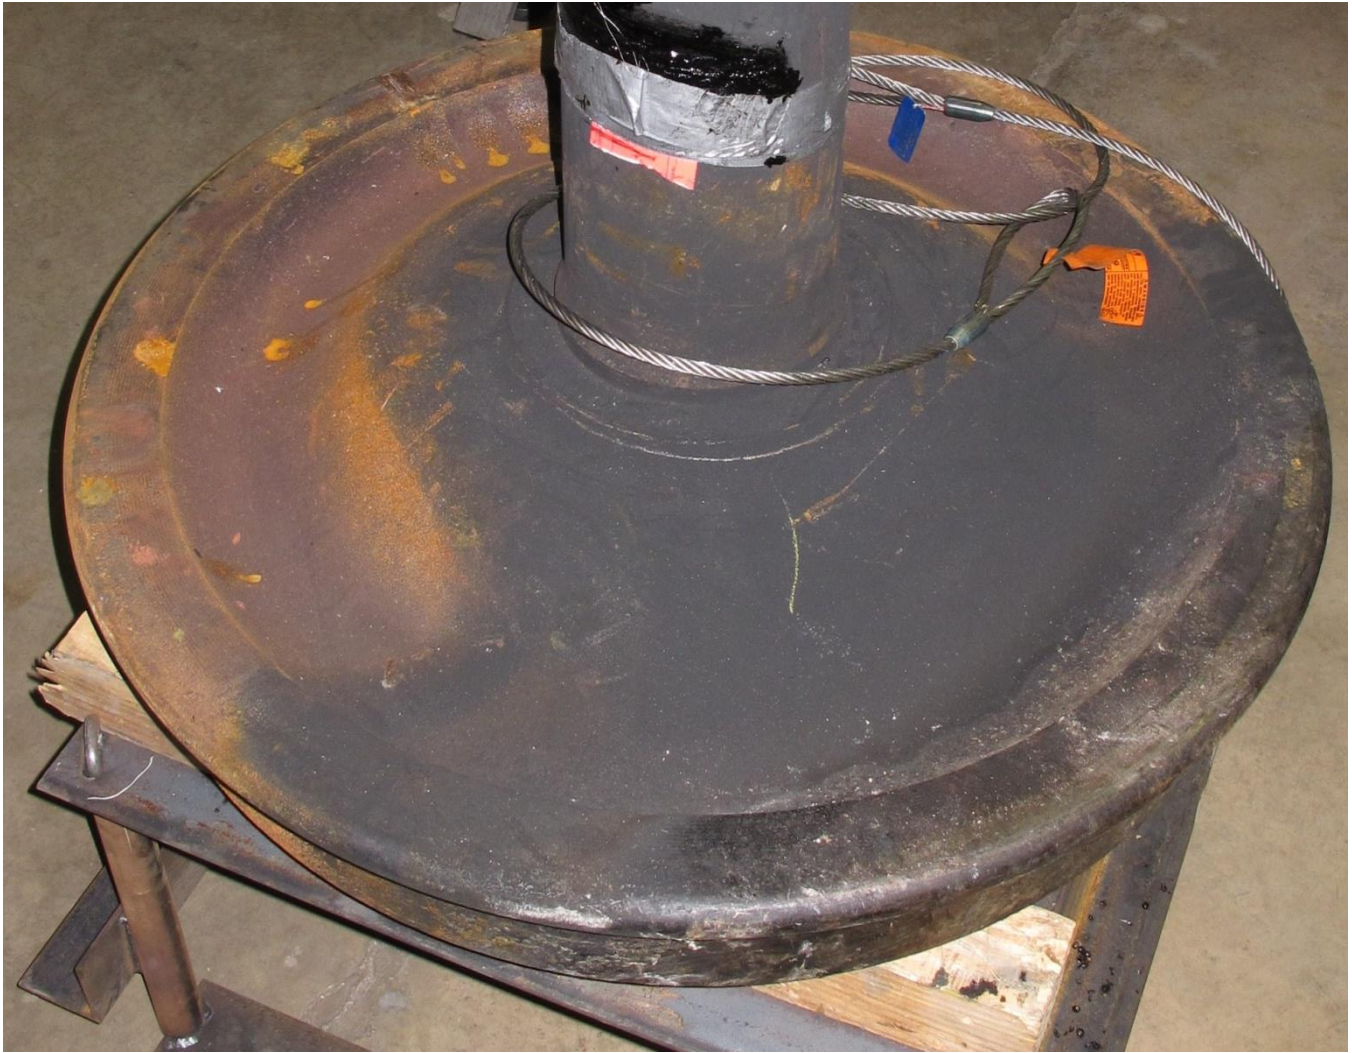
This wheel's surfaces exhibited darkening on one side, consistent with exposure to fire. No gross deformation was observed in these areas, indicative that the fire exposure was not long-term. The opposite side exhibited uniform surface rust. This rust was consistent with exposure to water after the derailment.

The flange and rail contact surfaces on one side of the wheel exhibited gouging and impact marks consistent with damage incurred after derailment. No indications of other damage on the wheels were observed. Some chatter marks were observed on the long axle segment adjacent to the inboard side of the wheel seat, but no indications of fretting were observed consistent with the short axle segment (see Figure 28).

Figure 26 – The wheel from the long axle segment, after cleaning.

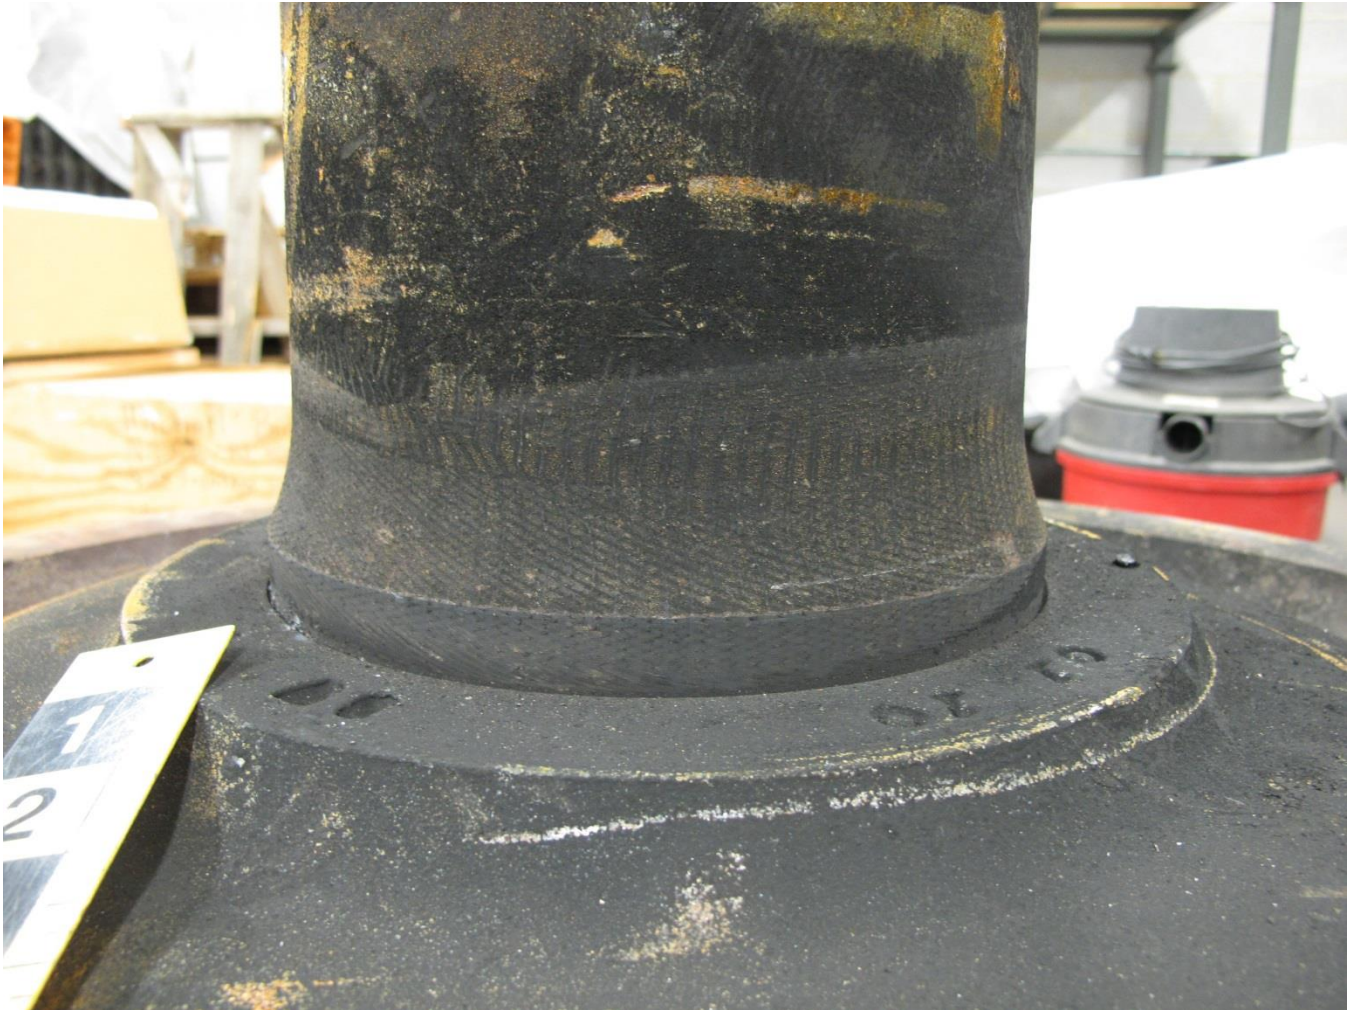
Figure 28 – Chatter marks on the body and in-board wheel seat of the long axle.
