# NATIONAL TRANSPORTATION SAFETY BOARD

MATERIALS LABORATORY FACTUAL REPORT

Report No. 05-104

Place : Los Angeles, California  
Date : September 21, 2005  
Vehicle : Airbus 320  
NTSB No. : LAX05IA312  
Investigator : Mike Hauf

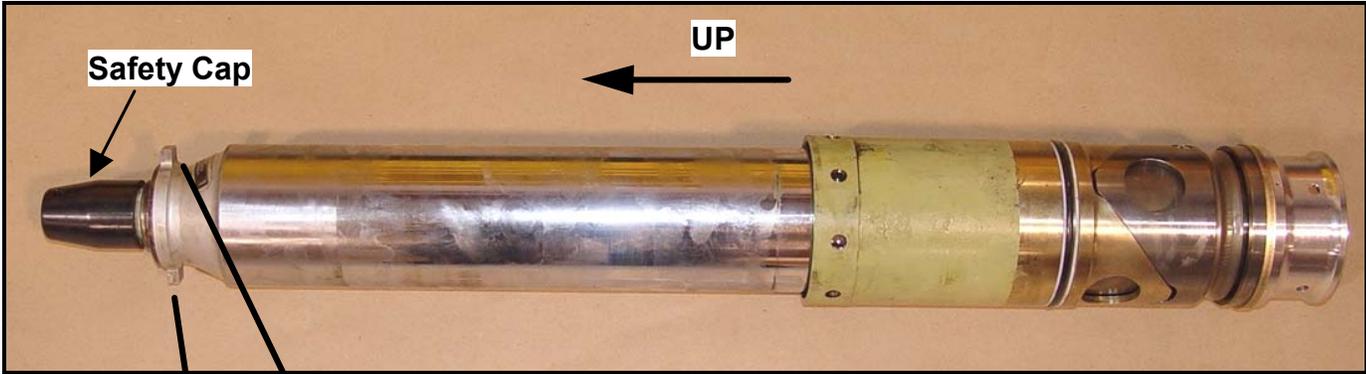
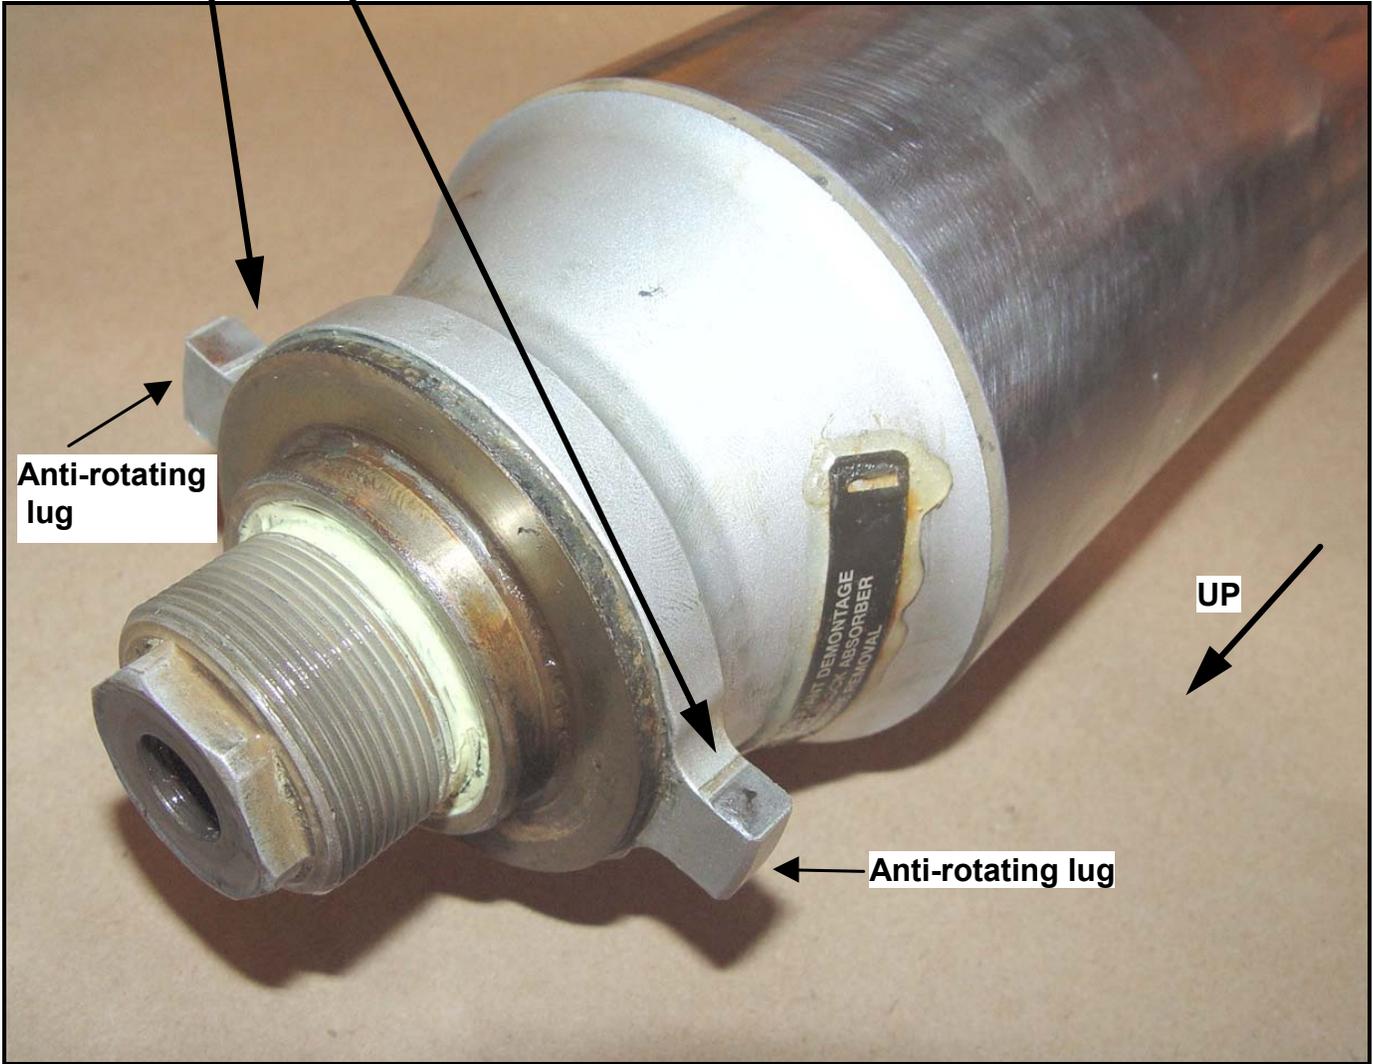
The nose landing gear assembly was disassembled at the Messier Services overhaul facility, Sterling, Virginia, on September 29 and 30, 2005, under the supervision of investigators from the National Transportation Safety Board and with participation of designated parties to the investigation. Figure 1 shows a photograph of the disassembled inner cylinder assembly. The upper end of this inner cylinder assembly contained two anti-rotating lugs, see figure 1. Inspection with a magnifying glass of the upper end of the inner cylinder assembly revealed that the anti-rotating lugs were intact and contained no evidence of a crack.

Figure 1. View of the disassembled inner cylinder assembly from the nose landing gear (top photograph) with safety cap that was attached after disassembly and close-up view of the upper end of the inner cylinder showing anti-rotating lugs (bottom photograph).

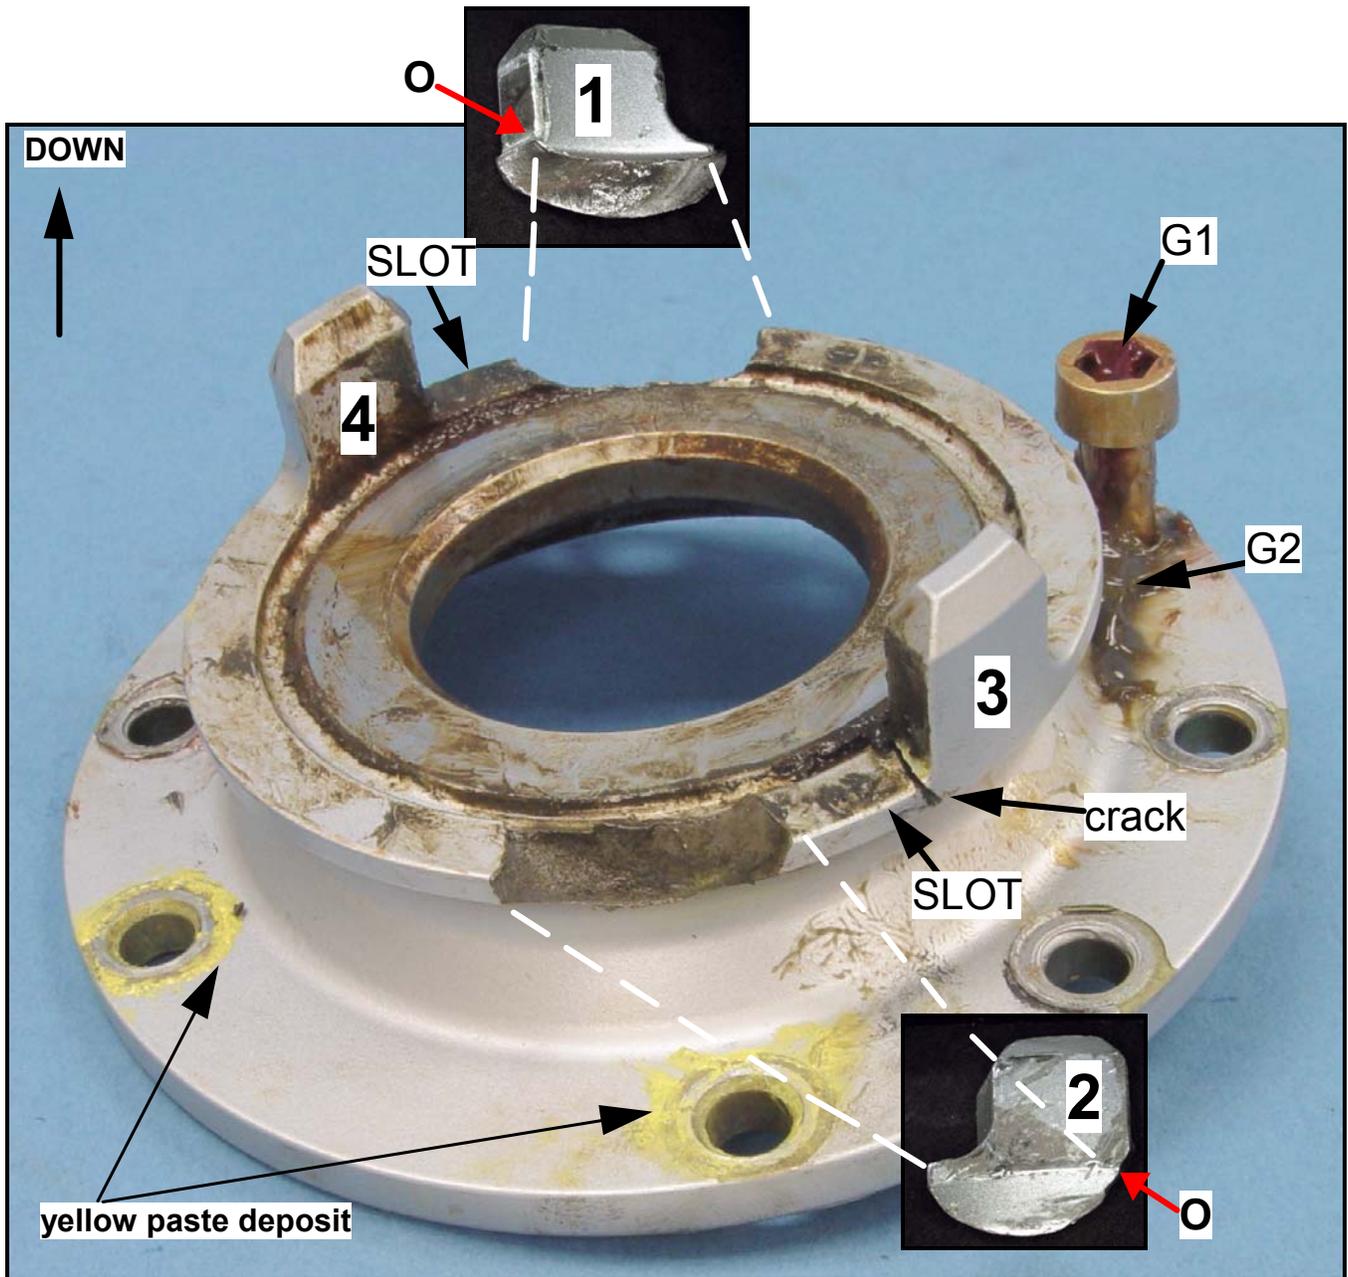
Figures 2A and 2B show photographs of the as-received upper support and fractured lugs. The edge of the outer support was impression stamped with Messier-Dowty part number "D59831 and characters "EM18604". The upper support was manufactured with four lugs, arbitrarily labeled "1" through "4", as shown in figure 2A. Anti-rotating lugs

from the inner cylinder (see figure 1) are inserted into corresponding slots between lugs 1 and 4, and between lugs 2 and 3 in figure 2A. Lug 1 contained a fracture at the base that extended slightly above the slot area. When measured on the outside diameter face along the fracture path (along the curved portion of the fracture), the fracture measured approximately 1.4 inch. When measured on the inside diameter face of lug 1 along the fracture path, the length of the fracture measured approximately 1.1 inch. The results of the measurements indicate that the length the fracture on the outer diameter surface was longer compared to the length of the fracture on the inner diameter surface. Lug 2 also fractured at the base. The size and contour of the fracture on lug 2 was similar to lug 1. Lug 3 contained a crack that intersected the fillet radius at the base portion of the lug, see figure 2A. The length of this crack along its fracture path on the outer diameter face measured approximately 1.2 inch. Lug 4 contained a crack that intersected the fillet radius at the base. This crack can be seen from the inner and outer diameter surface. Figure 4 shows a photograph of the crack when viewed from the outer diameter surface. This crack measured approximately 0.1 inch. The fracture at the base of lugs 1 and 2, and the cracks in lugs 3 and 4 intersected the fillet radius at the slot that corresponded to the anti-rotating lugs for the inner cylinder.

3. This attachment bolt could not be removed under hand forces. The lower surface of the upper support adjacent to two other through-holes was covered with a yellow paste deposit, as can be seen in figure 2A. EDS analysis of a sample from the yellow deposit removed from one of the two holes prior to cleaning produced a spectrum that was consistent with the spectrum from Mastinox.

Portions of the upper support were covered with grease. The head of attachment bolt contained red grease, indicated by arrow "G1" in figure 2A. Samples of grease were removed prior to any cleaning process. EDS analysis of a sample of the red grease produced a spectrum that contained a major elemental peak of silicon and minor peaks of aluminum, magnesium, carbon, oxygen, sodium, calcium, iron, phosphorus, and molybdenum. The shank portion of the attachment bolt and portions of the adjacent lower surface of the upper support contained dark gray grease; in the area indicate by arrow "G2" in figure 2A. A sample of this grease was removed and analyzed. The EDS spectrum from this grease contained the same elemental peaks as in the red grease, with additional peaks of copper and potassium. The upper support was coated with silver tinted paint. A sample of this silver tinted paint was removed from the upper support and cleaned in soap solution. EDS spectrum of silver paint contained a major elemental peak of aluminum and minor peaks of silicon, oxygen, and iron.

Figure 2A. View of the upper support and relative position of fractured lug pieces "1" and "2". Fatigue origins are indicated by arrow "O". When the nose landing gear is in the assembled condition, anti-rotating lugs from the inner cylinder are inserted into corresponding slots on the upper support (located between lugs "2" and "3" and between lugs "1" and "4"). Fractured lug pieces "1" and "2" are shown in this figure after they were immersed in a commercial degrease solution.

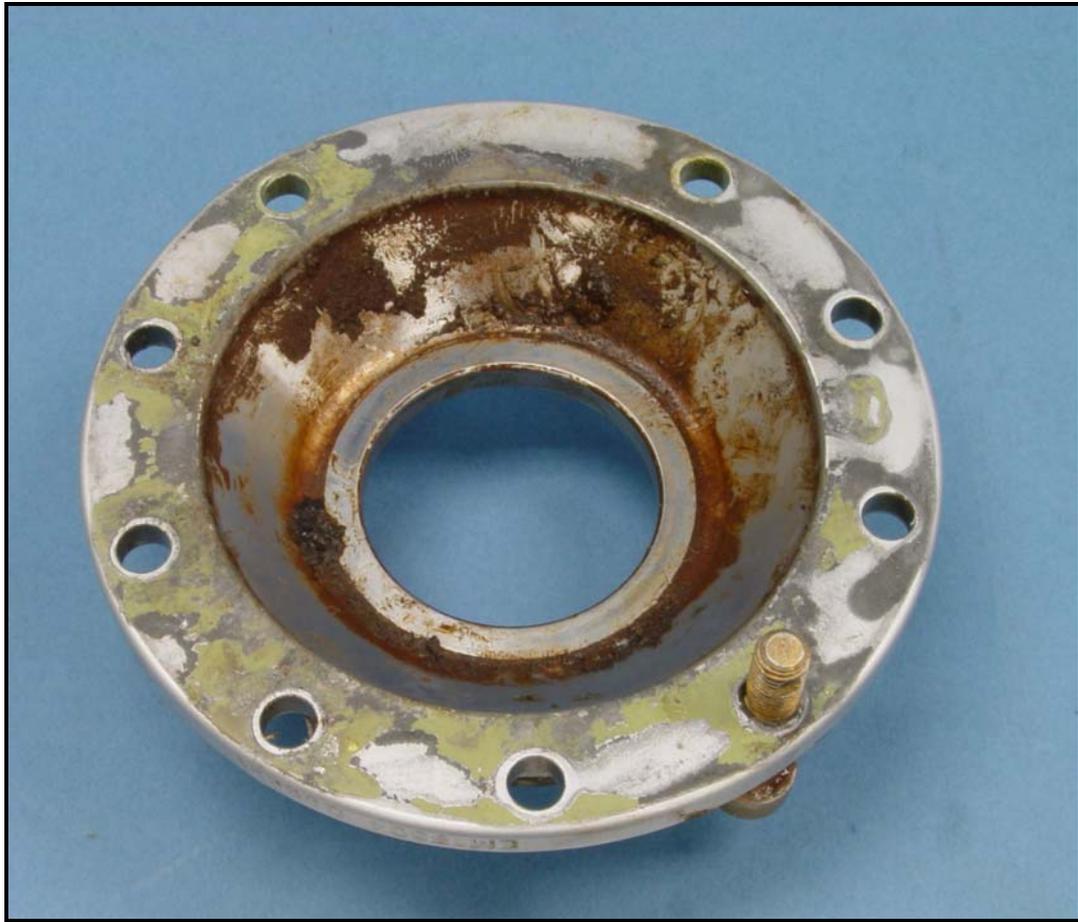
Figure 2B. View of the top side of the upper support.

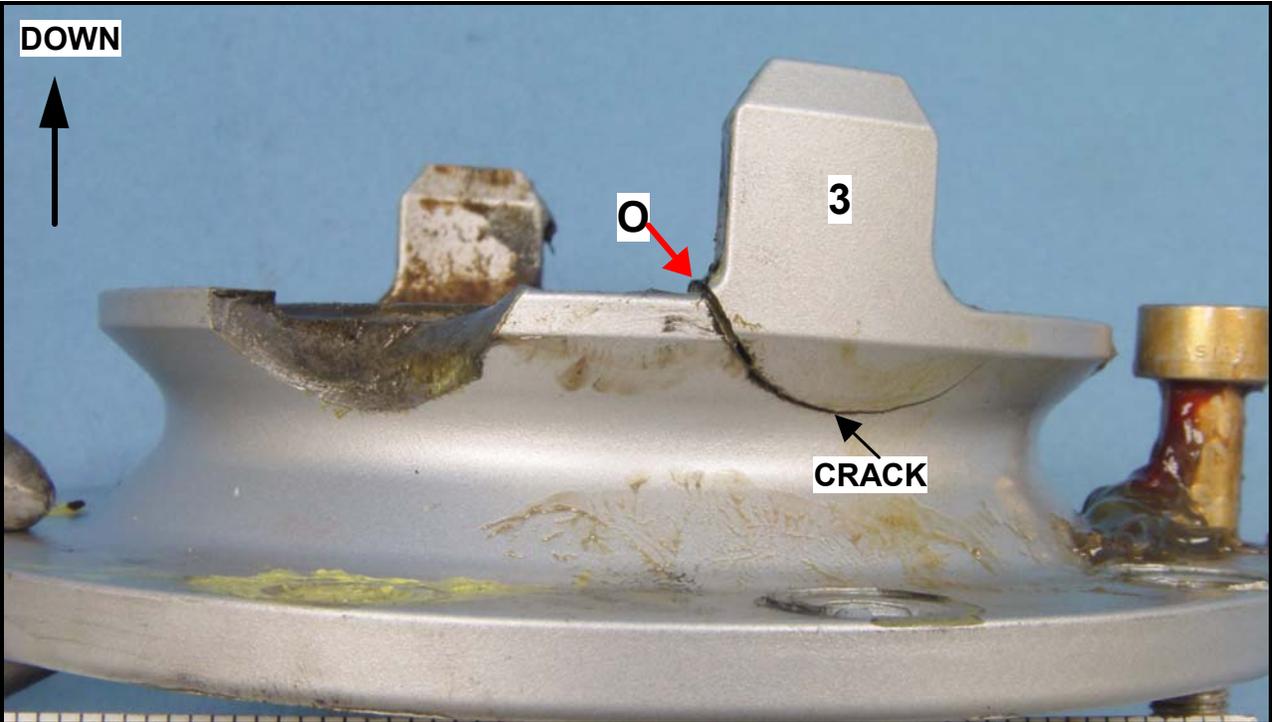
The contour of the crack at the base of lug 3 was similar to the contour of the fracture path on lugs 1 and 2. A saw cut was made through the remaining intact wall portion of lug 3 until it intersected the end of the crack. The exposed fracture face, see figure 13, contained crack arrests features typical of a fatigue crack that originated at the radius between the slot side of the lug and the lower surface of the upper support, near the inner diameter of the upper support, as indicated by arrow "O" in figure 11. Visual examination of the surface of the upper support in the vicinity of the origin area revealed the fatigue crack propagated through the exposed fracture face. A portion of the fracture face at the fatigue origin end was covered with Mastinox (verified by EDS analysis). The Mastinox region extended between the fatigue origin (arrow "O", figure 13) and the area indicated by a dashed line in figure 13. The length of the Mastinox region measured approximately 0.2 inch, when viewed from the outer diameter face of the lug.

Figure 3. Side view of the upper support showing lug "3" that contained a crack at the base. Arrow "O" indicates the location of the fatigue crack.

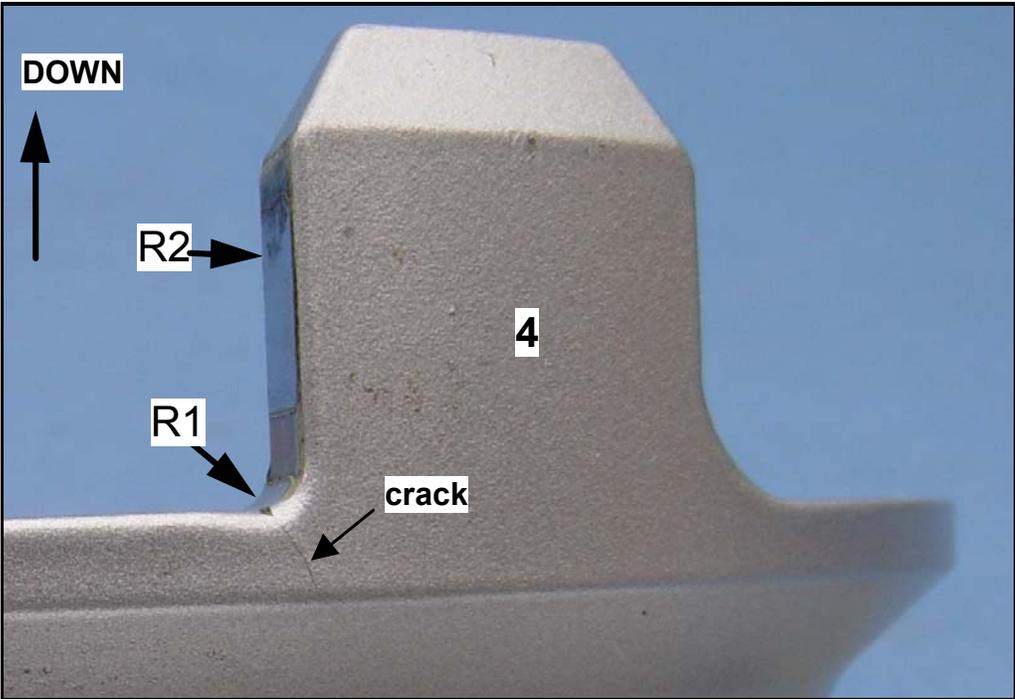
The crack at the base of lug 4 measured approximately 0.1 inch. The crack was not excised for examination.

Figure 4. View of lug "4" showing a crack that emanated from the radius at the base.

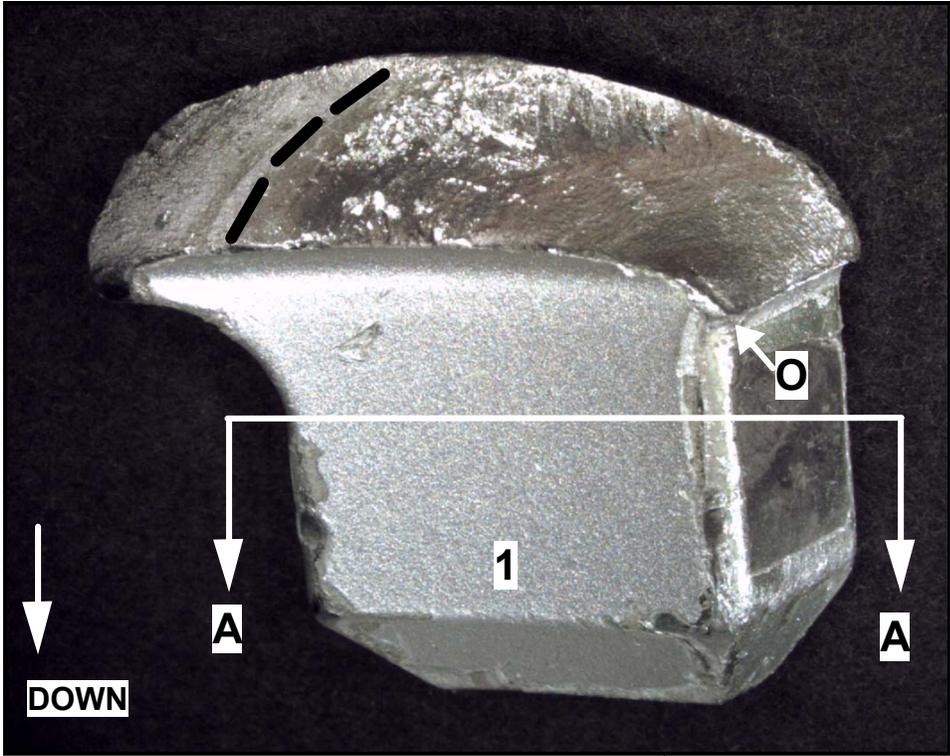
Figures 5 and 6 show close-up photographs of the fracture face from lug 1. Bench binocular microscope examination of lug 1 revealed the fracture face contained ratchet marks (radial lines), typical of a fatigue crack, that originated within the radius between the slot side of the lug and the lower surface of the upper support, near the inner diameter of the upper support, as indicated by arrow "O" in figures 2A, 5 and 6. The fatigue crack propagated through more than 95% of the fracture face. The fracture face was covered with a black-brown deposit that extended between the fatigue origin and the area indicated by a dashed line in figure 5. The black-brown region extended through approximately 75% of the fracture length, which calculates to about a 1-inch crack along the fracture path when viewed from the outer diameter face of the lug.<sup>1</sup> X-ray energy dispersive spectroscopy (EDS) analysis of the fracture face in the region that contained no evidence of a deposit produced a spectrum that contained a major elemental peak of iron and minor elemental peaks of carbon, chromium, manganese, molybdenum, nickel, and silicon, consistent with the specified Timken Latrobe Lescalloy 35NCD16 VAC-ARC High Strength Alloy Steel. An EDS spectrum of the black-brown region contained the same elemental peaks as in the base metal and a minor elemental peak of oxygen. The composition and appearance of the black-brown deposit are consistent with iron oxide.

A metallurgical section was made through the lug in the area and orientation indicated by section line "A-A" in figure 5. The section was metallurgically prepared and etched with 2% Nital reagent. Examination of the section revealed a microstructure of tempered martensite, typical of quenched and tempered steel. No anomalies were noted in the microstructure. Rockwell hardness testing of the section produced an average hardness of HRC 41. This converts<sup>2</sup> to an ultimate tensile strength of approximately 1,300 Mega-Pascal (MPa), which was within the specified range (between 1,230 MPa and 1,370 MPa). The corner radius between the slot and inner diameter face, indicated by "R2" in figure 4, measured between 1.43 and 1.5 mm, which was within the specified range (between 1.0 mm and 2.0 mm).

Figure 5. View looking at the inner diameter face of fractured lug "1". The fracture face contained a fatigue crack that emanated from the fillet radius at the base of the lug in the area indicated by arrow "O".

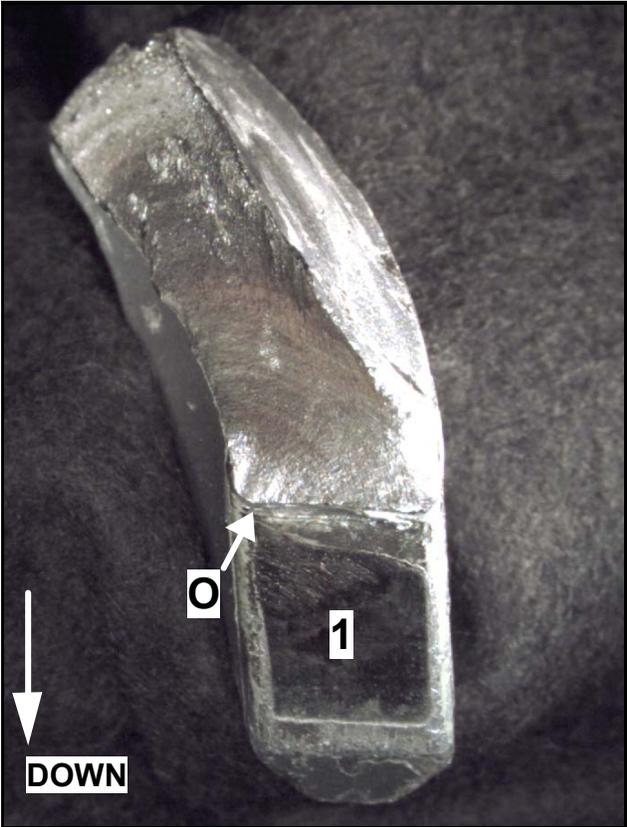
Figure 6. Another view of fractured lug "1" and the fatigue origin area indicated by arrow "O".

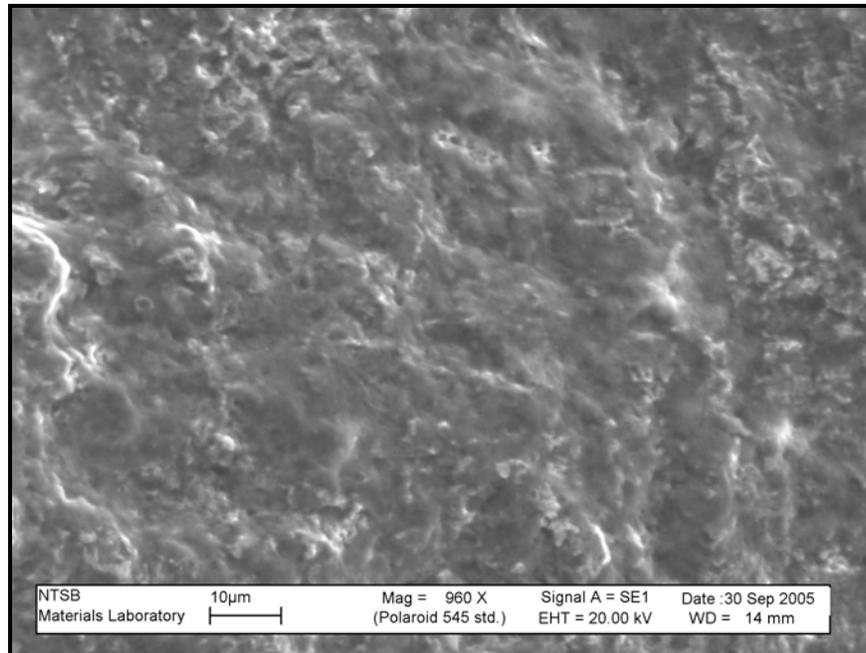
Visual and scanning electron microscope (SEM) examination of the lug revealed the surface of the radius at the fatigue origin area showed no evidence of mechanical damage, such as a gouge. The black-brown iron oxide region at the fatigue origin area covered the fine fracture features, see figure 7. The fracture face in the area slightly outside of the iron oxide region contained fatigue crack features (parallel fissures) that were mixed with regions of ductile dimple, see figure 8. The distance between the parallel fissures

Figure 7. SEM image of the black-brown oxide deposit on the fracture face of lug "1"

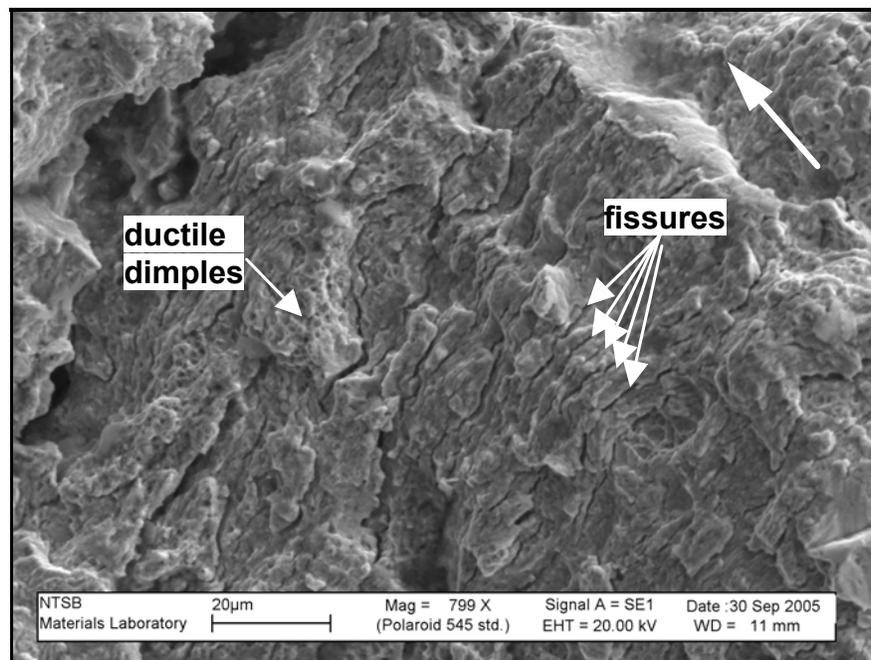
Figure 8. SEM image of the fracture face of lug "1" showing fracture features that were found outside and adjacent to the black-brown oxide region. This image shows fatigue crack features (parallel fissures) mixed with ductile dimple features. Arrow shows general direction of fatigue propagation.

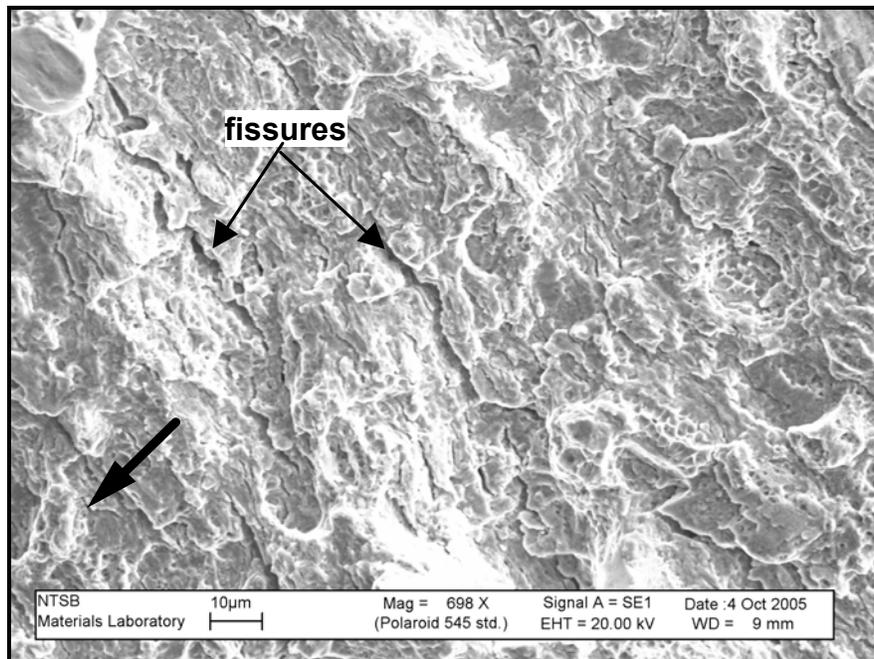
increased as the distance from the iron oxide region was increased. Figure 9 shows an SEM photograph near the end of the fracture. The last 5% of the fracture length showed for the most part ductile dimple features typical of overstress separation (picture not shown).

Figure 9. SEM image of the fracture face of lug "1" showing fracture features that were found near the terminus of the fracture. The fracture in this region contained mixed fatigue crack features (fissures) and ductile dimple features. Note that the distance between the fissures in this image was greater than those found in figure 8. Arrow shows general direction of fatigue propagation.

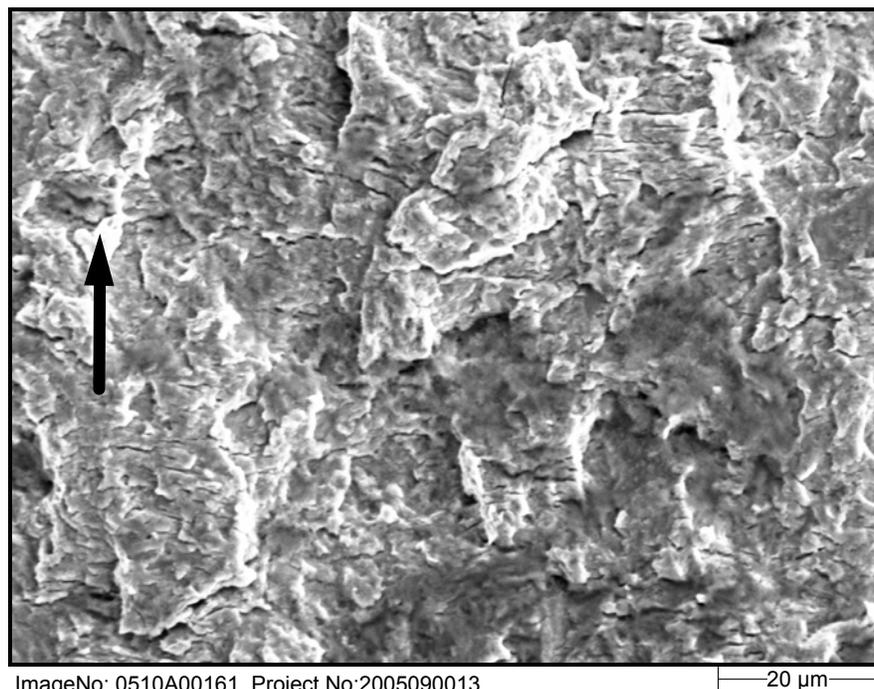
The fracture face was ultrasonically cleaned in acetone. This cleaning procedure did not remove the black-brown iron oxide region on the fracture surface. The lug was electrolytically cleaned with Endox 214, a solution that removes oxides from ferrous metals. This cleaning process removed iron oxide deposit in isolated areas of the fracture and exposed fatigue crack features. Figure 10 shows a photograph of fatigue crack features in an area where iron oxide was removed.

Figure 10. SEM image of the fracture face from lug "1" in the black-brown iron oxide region after electrolytically cleaning, showing exposed fatigue crack features. Arrow shows general direction of fatigue propagation.

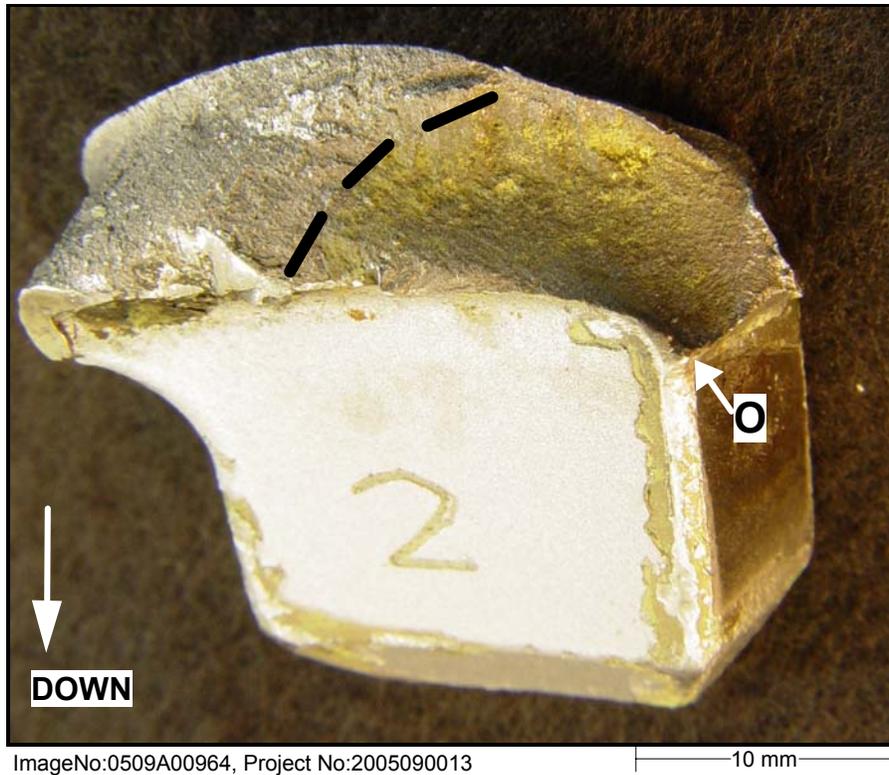
Figure 11 shows a close-up photograph of the fracture face from lug 2. The fracture face contained ratchet features (radial lines) typical of a fatigue crack that emanated from the radius between the slot side of the lug and the lower surface of the upper support, near the inner diameter of the upper support, as indicated by arrow "O" in figures 2A and 11. Visual and SEM examination of the fracture face revealed parallel fissure typical of fatigue crack features near the origin of the fracture. The fatigue crack propagated through more

Approximately 50% of the length of the fracture face at the fatigue origin end was covered with a yellow deposit. This calculates to about a 0.7-inch portion of the fatigue crack when viewed from the outer diameter face of the lug.<sup>3</sup> The yellow deposit region extended from the fatigue origin to the area indicated by a dashed line in figure 11. EDS analysis of the fracture face in the yellow deposit region produced a spectrum that contained the elemental peaks that were found in the base metal, in addition to a major elemental peak of silicon and minor peaks of barium, chromium, aluminum, magnesium, copper, carbon and oxygen. Mastinox is an anti-seizing compound that is applied to many parts of the airplane. This compound is yellow and typically is applied as a paste. A sample of Mastinox was received from Messier Services for analysis. EDS spectrum of the Mastinox compound contained a major elemental peak of silicon and minor peaks of barium, chromium, aluminum, magnesium, carbon and oxygen. The EDS spectrum of the yellow deposit on the fracture face contained elemental peaks that were consistent with the elemental peaks that were found on the EDS spectrum from a sample of Mastinox, see attachment 1 for comparison of the two EDS spectra.

Figure 11. View looking at the inner diameter face of fractured lug "2". The fracture face contained a fatigue features that emanated from area indicated by arrow "O".

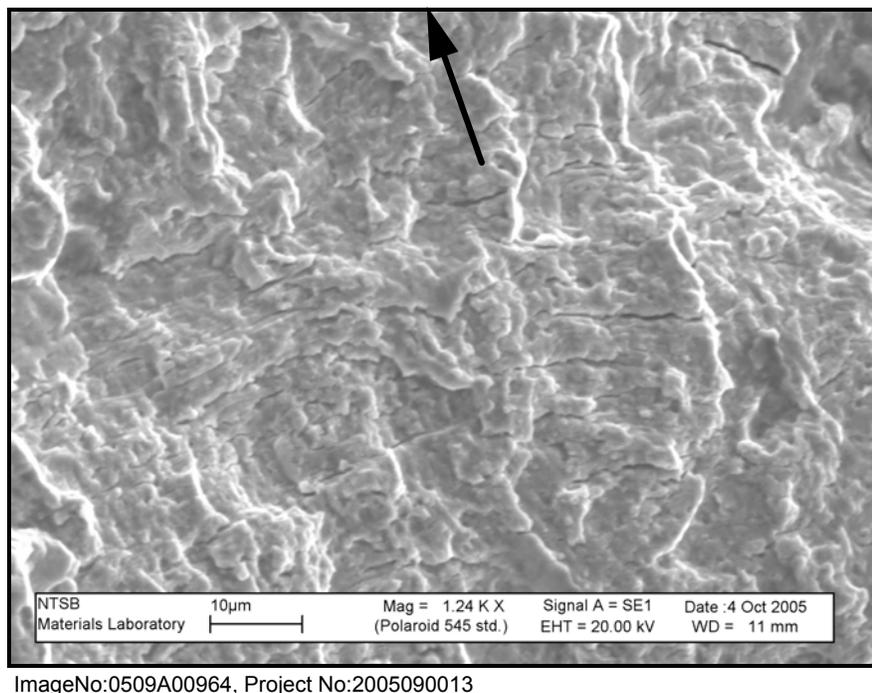
Figure 12. SEM image of the fracture face of lug "3" showing fatigue crack features that emanated from the fillet radius in the area indicated by arrow "O" in figure 11. Arrow shows general direction of fatigue propagation.

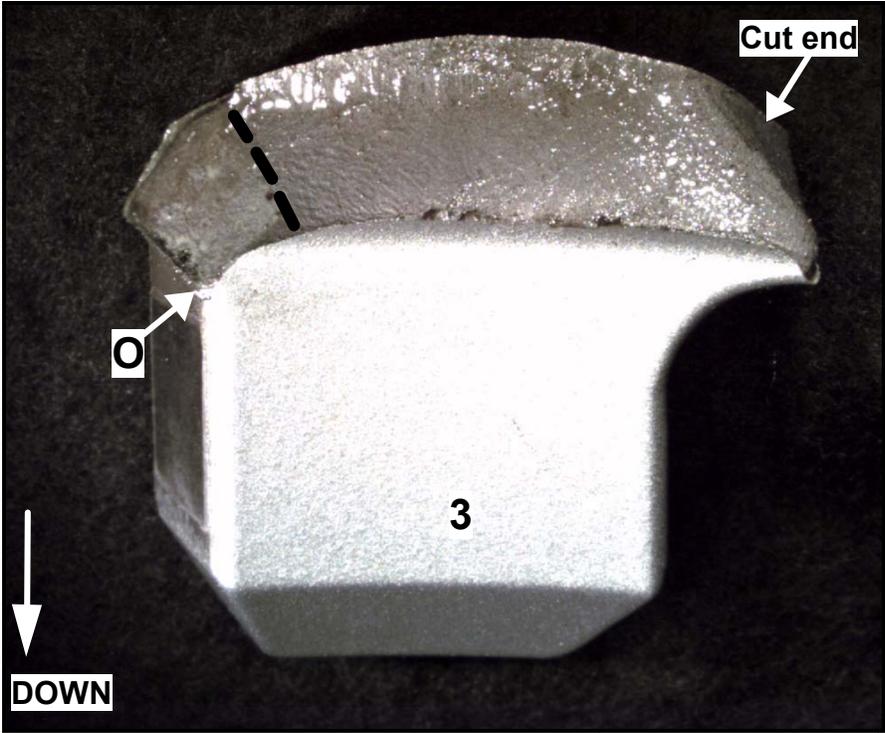
Figure 13. View looking at the inner diameter face of fractured lug "3". The fracture face contained a fatigue features that emanated from the area indicated by arrow "O".

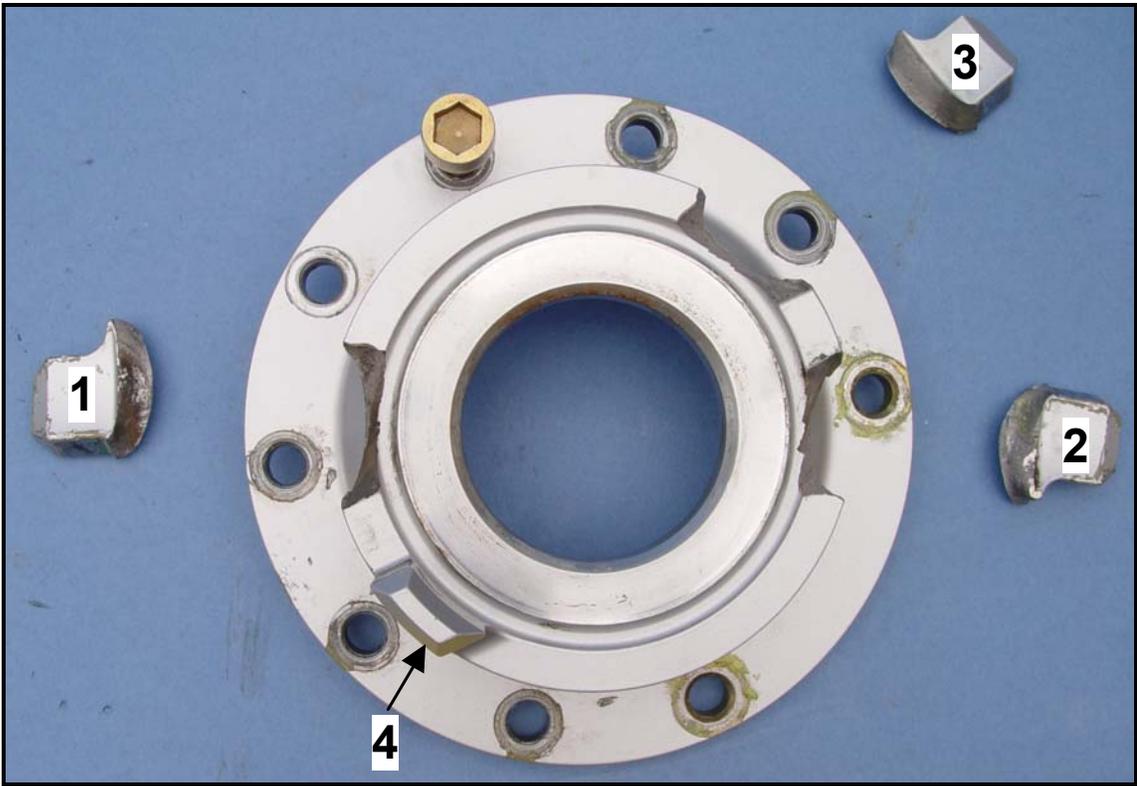
Figure 14 shows the lower face of the upper support after it was cleaned by immersion in a commercial degrease solution. The attachment bolt remained lodged in the upper support after cleaning. Examination of the bore of the exposed through-holes revealed no evidence of fretting damage. The diameter of the each exposed through-hole measured approximately 7.95 mm, as specified in the Messier-Dowty engineering drawing for the upper support. The upper support showed no evidence of other cracks.

Figure 14. View of the bottom face of the upper support after cleaning and lugs positioned next to their respective mating fractures.

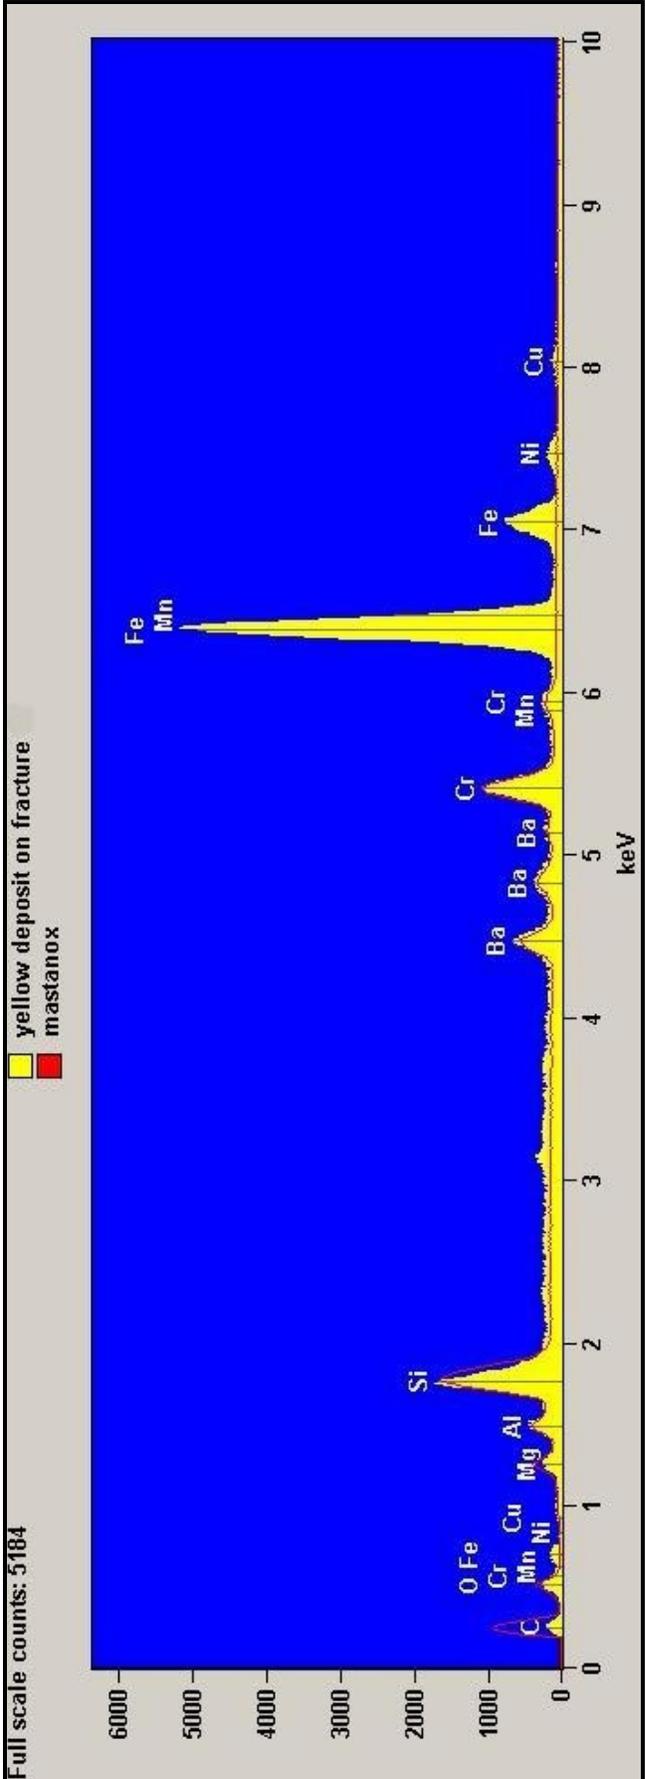
ATTACHMENT 1.

X-ray Energy Dispersive Spectroscopy Spectrum of yellow deposit that was found on the fracture face of lug "2" (shown as a solid yellow spectrum) and Mastinox (shown as an overlapping red line).
