# NATIONAL TRANSPORTATION SAFETY BOARD

MATERIALS LABORATORY FACTUAL REPORT

Report No. 05-136

Place : Los Angeles, California  
Date : September 21, 2005  
Vehicle : Airbus 320  
Operator : JetBlue  
NTSB No. : LAX05IA312  
Investigator : Mike Hauf, AS-40

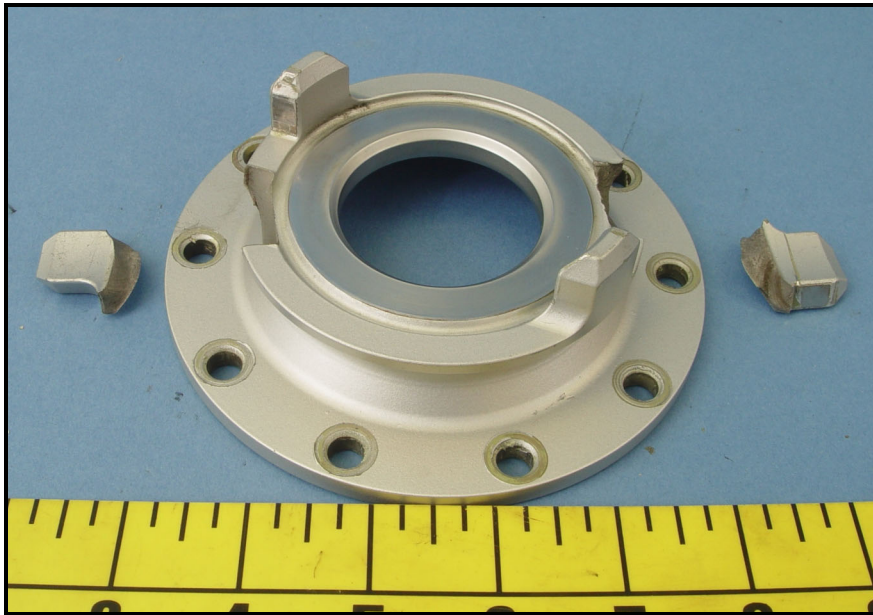
An overall view of the nose landing gear upper support is shown in figure 1. The lower side of the upper support has four lugs that form slots that engage lugs on the upper end of the nose landing gear inner cylinder assembly. As can be seen in this figure, two diametrically opposite lugs were fractured from the lower side of the upper support. Figure 2 shows close-up views of one face of the two lug fractures. Fracture features were typical of fatigue cracking, with initiation at the base of the lugs, near the corner between the slot side of the lug and the inner diameter of the upper support. Arrows "O" in figure 1 indicate the origin areas. Fatigue features were found through a large majority of the fracture surfaces. Adjacent to the fatigue origin areas, the fracture plane was smooth and did not contain shear lips, indicative of lower stress propagation. Further from the origin areas, the fracture became rougher, indicative of higher stress propagation.

Figure 1. Overall view of the upper support with the fractured lugs. View looking obliquely upward.

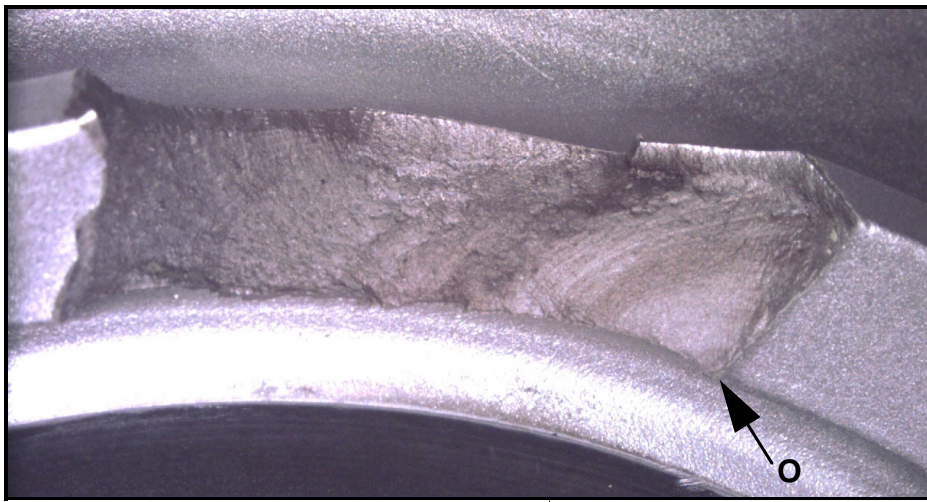
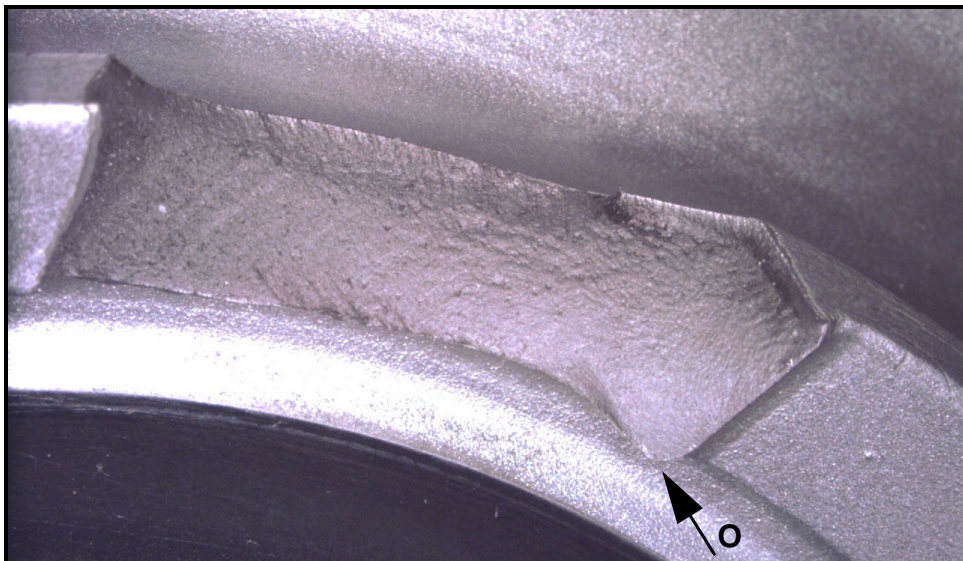
Detailed optical examination showed that the origin area for the fracture shown at the top in figure 2 was located on the upper side of the corner radius in an undamaged area and that the origin area for the fracture shown at the bottom in figure 2 was located lower on the lug in an area of contact wear from an anti-rotating lug of the inner cylinder assembly.

Figure 2. Closer views of the lug fractures on the main portion of the upper support. Arrows "O" indicate the approximate location of the fatigue origin areas. Views looking upward.
