# NATIONAL TRANSPORTATION SAFETY BOARD

MATERIALS LABORATORY FACTUAL REPORT

Report No. 06-020

Place : Mancos, Colorado  
Date : June 30, 2005  
Vehicle : Agusta A119, N403CF  
NTSB No. : DEN05FA103  
Investigator : Arnold Scott

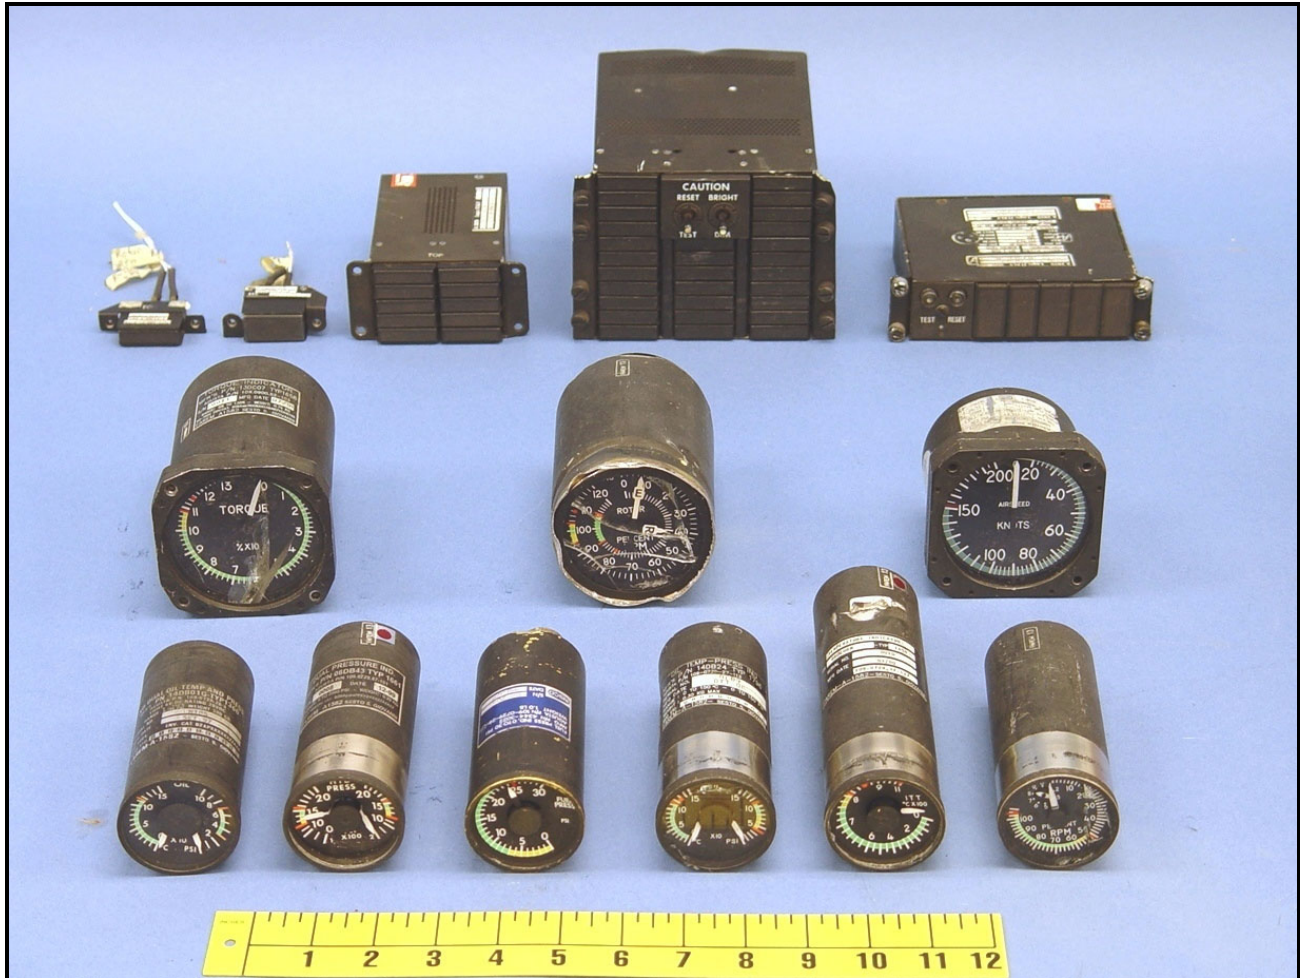
Figure 1. Instruments and annunciators submitted for examination.

Only the needles in the Engine/Rotor Tachometer appeared to be fixed in place; these needles indicated an engine rotation of 7 percent and a rotor rotation of 39 percent. The needles of the other instruments were found to move when the instruments themselves were moved. As received, the Fuel Pressure gauge indicated 24 psi and the left needle in the Dual Hydraulic Pressure gauge indicated 1350 psi. The positions of the other needles indicated approximately zero. The glass was missing from the Fuel Pressure gauge, the Temperature Indicator and the Dual Hydraulic Pressure gauge. The glass was cracked in the Engine/Rotor Tachometer, the Gas Producer Tachometer, the Torque Indicator, and the Transmission Oil Temperature/Pressure Indicator. The glass was intact in the Airspeed Indicator and the Engine Oil Temperature/Pressure Indicator. No impact marks were observed on any of the instruments to indicate the positions of the needles at the time of the accident.

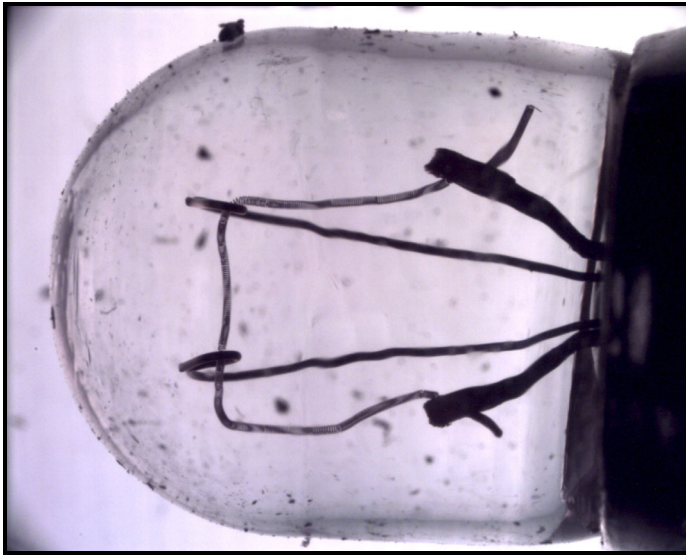
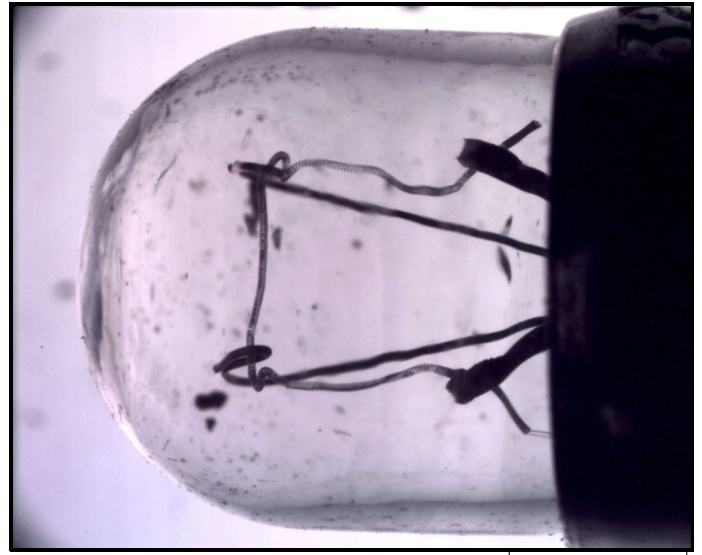
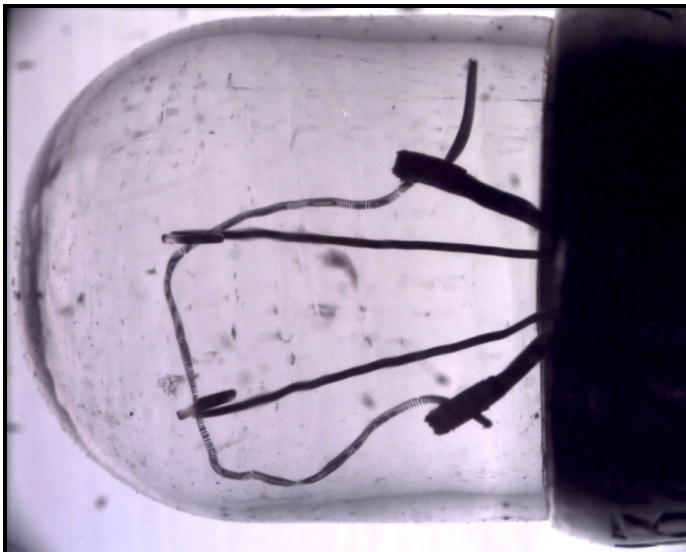
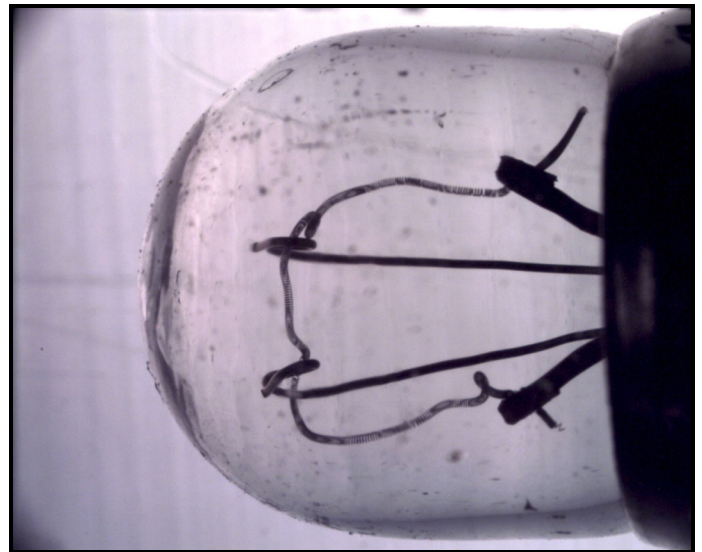
Annunciator	Filament Status	Filament Status
MASTER CAUTION	Top Left Bulb: Localized stretching.	Top Right Bulb: Aged. Localized stretching.
	Bottom Left Bulb: Localized stretching	Bottom Right Bulb: Aged. Localized stretching.
ROTOR RPM	Left Bulb: Aged. Not Stretched.	Right Bulb: Aged. Not Stretched.

Figure 5. Bulbs from the MASTER CAUTION annunciator. The filaments show some motion with respect to their support posts along with some slight localized stretching. The filaments in the bulbs on the right show curling deformation near the support posts associated with aging.

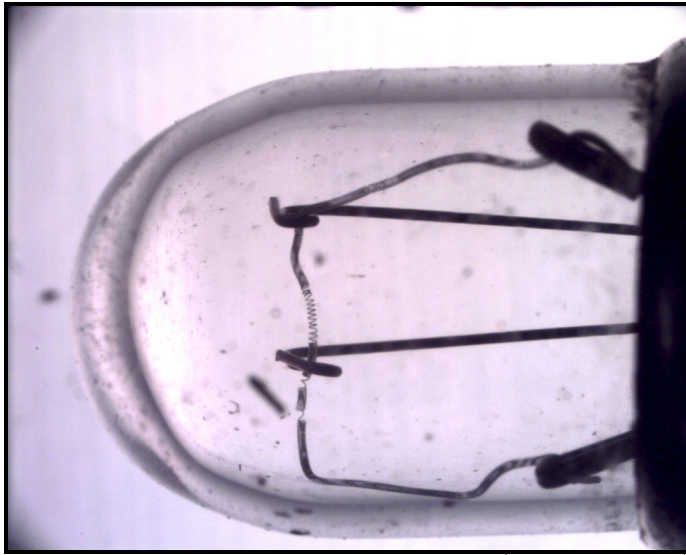
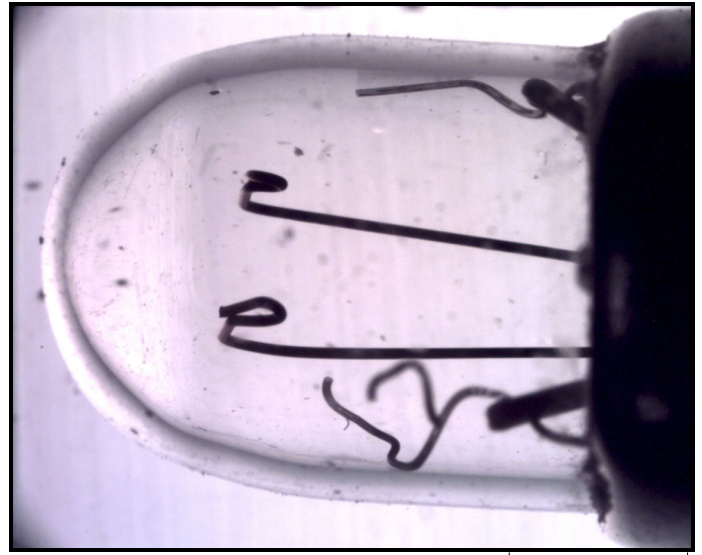
Figure 6. Bulbs from the OXY CLSD annunciator from the Advisory Panel. The filament in the bulb on the left shows some localized stretching. The filament in the bulb on the right is broken but not stretched.

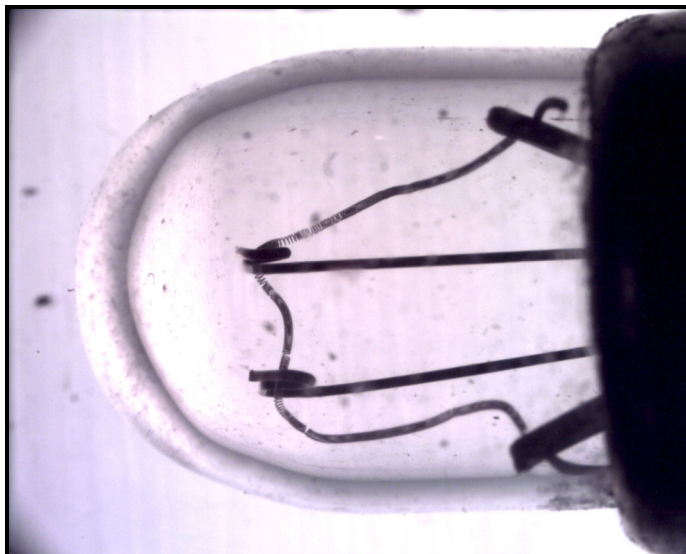
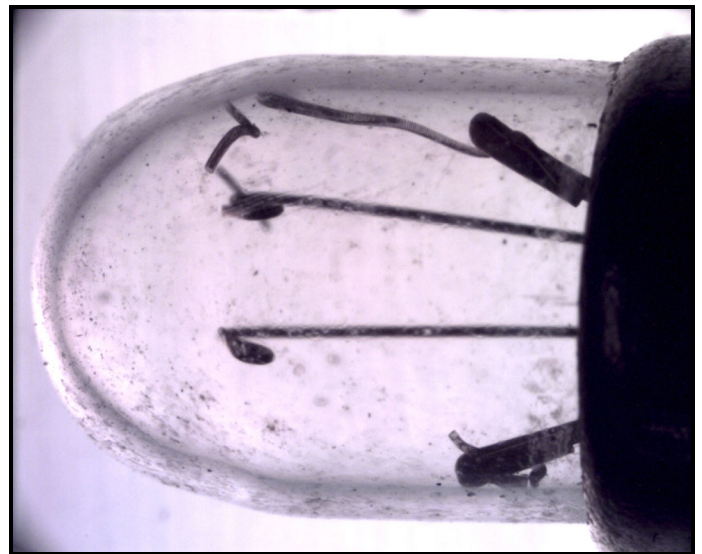
Figure 7. Bulbs from the EEC OPN annunciator from the Advisory Panel. The filament in the bulb on the left shows some localized stretching. The filament in the bulb on the right is broken but not stretched.

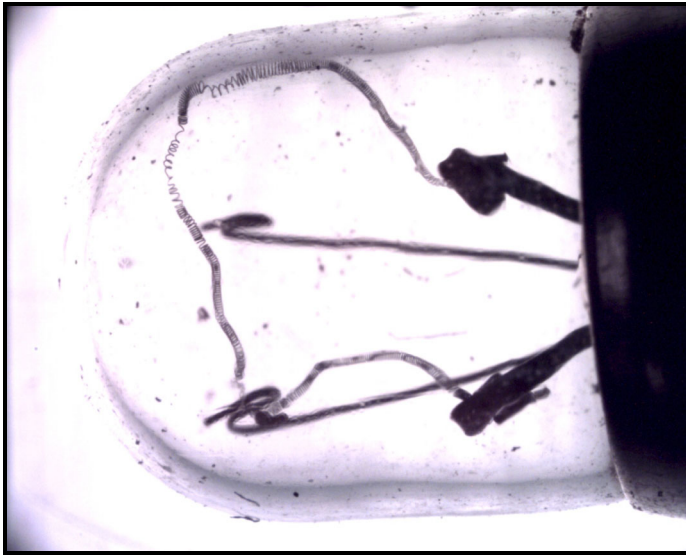
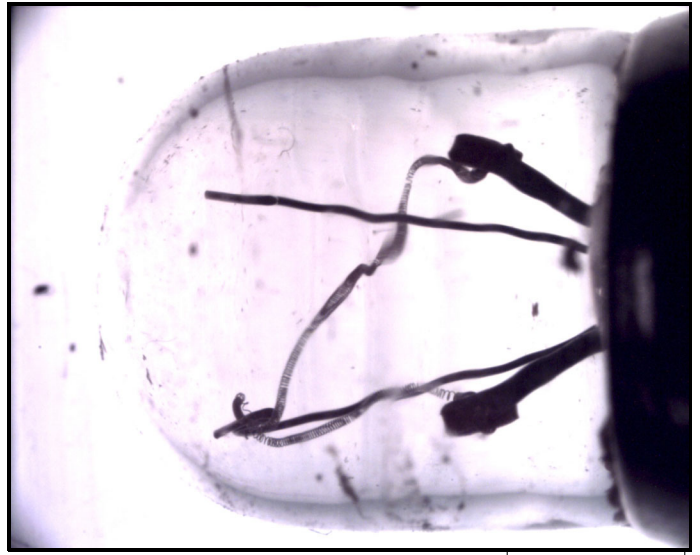
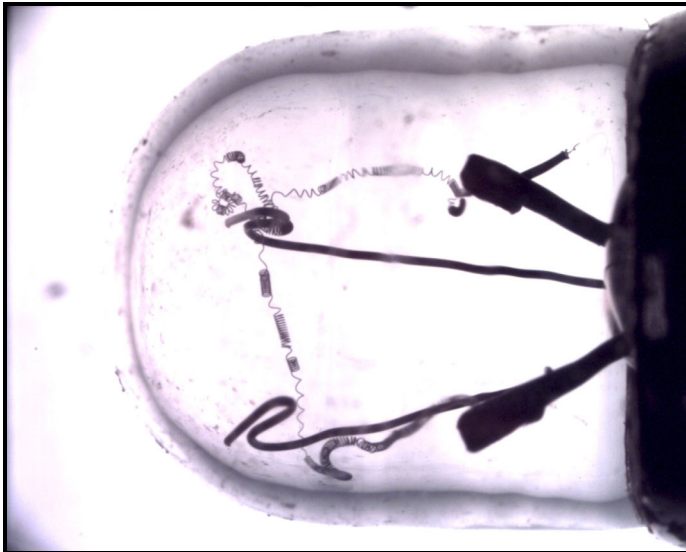
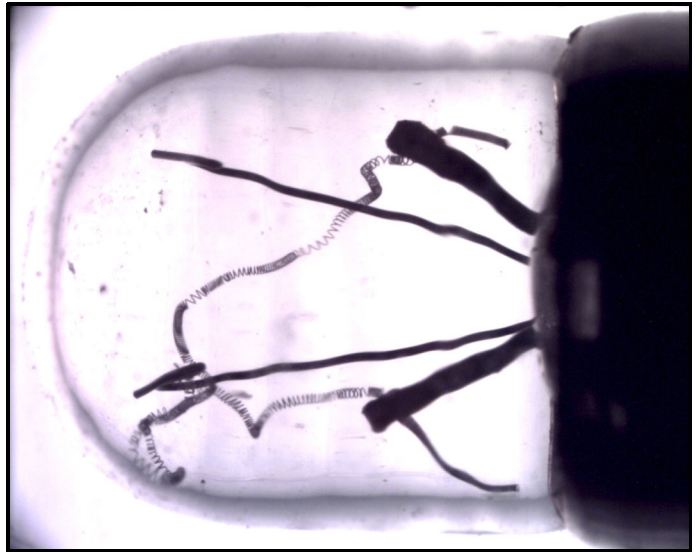
Table 4. Status of Warning Panel annunciators.		
Annunciator	Filament Status	Filament Status
XMSN OIL HOT	Top Left Bulb: Broken. Not stretched.	Top Right Bulb: Broken. Not stretched.
	Bottom Left Bulb: Not stretched.	Bottom Right Bulb: Not stretched.
XMSN OIL PRESS	Top Left Bulb: Stretched.	Top Right Bulb: Stretched.
	Bottom Left Bulb: Stretched.	Bottom Right Bulb: Stretched.
BAT HOT	Top Left Bulb: No bulb.	Top Right Bulb: No bulb.
	Bottom Left Bulb: No bulb.	Bottom Right Bulb: No bulb.
ENG OUT	Top Left Bulb: Aged. Localized stretching.	Top Right Bulb: Aged. Localized stretching.
	Bottom Left Bulb: Stretched.	Bottom Right Bulb: Aged. Localized stretching.
ENG FIRE	Top Left Bulb: Not stretched.	Top Right Bulb: Not stretched.
	Bottom Left Bulb: Not stretched.	Bottom Right Bulb: Not stretched.

Figure 8. Bulbs from the XMSN OIL PRESS annunciator from the Warning Panel. The filaments show substantial stretching associated with impact loading while the bulbs were illuminated.

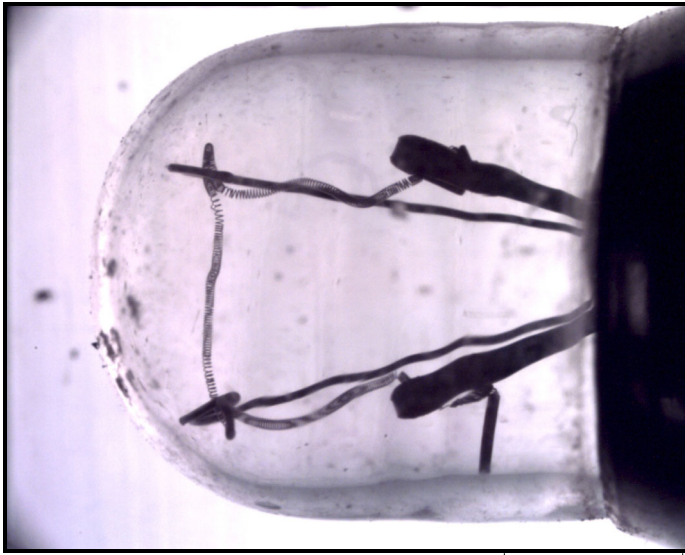
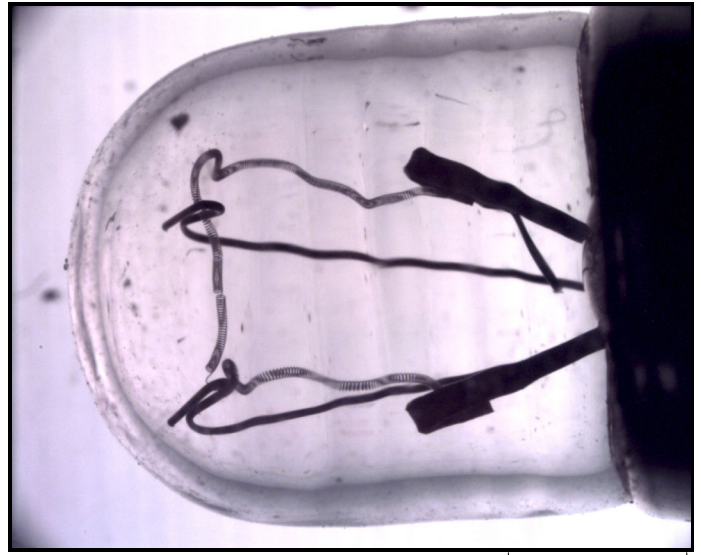
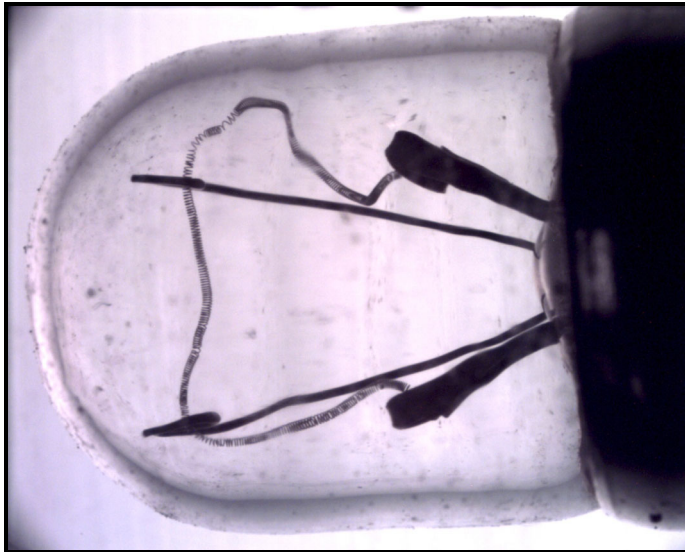
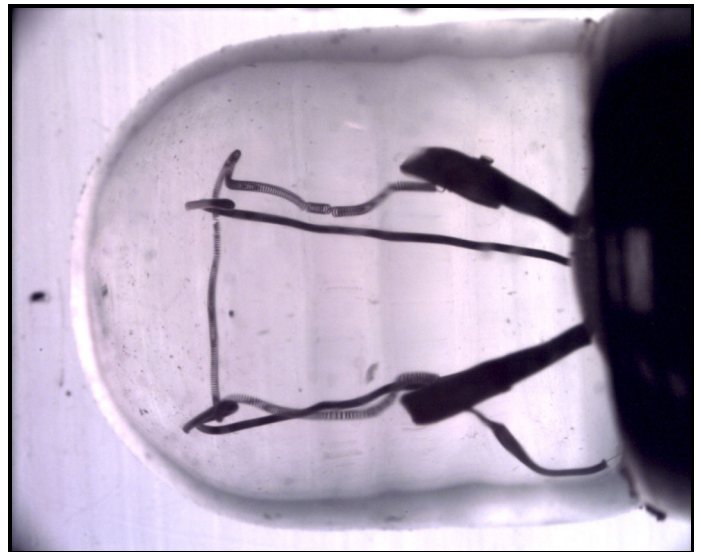
Figure 9. Bulbs from the ENG OUT annunciator from the Warning Panel. The filaments show slight localized stretching. The filaments in the top left bulb and in the bulbs on the right show curling deformation near the support posts associated with aging.
