NATIONAL TRANSPORTATION SAFETY BOARD

MATERIALS LABORATORY FACTUAL REPORT

Report No. 06-095

Place : New York, New York
Date : October 11, 2006
Vehicle : Cirrus SR-20
NTSB No. : DCA07MA003
Investigator : Carol Horgan, AS-40

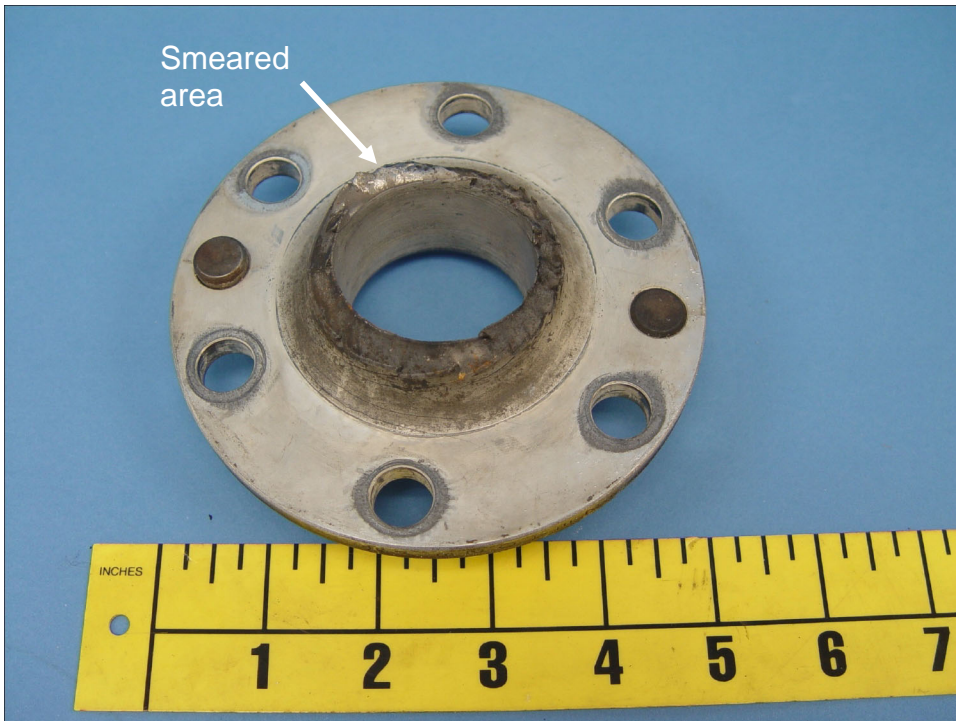
Image No.:0610A00953, Project No.: 2006100021

An overall view of the crankshaft propeller flange fracture is shown in figure 1. The crankshaft was fractured in the radius immediately aft of the flange. Fracture features were generally in a jagged slant plane with a matte gray appearance consistent with overstress fracture. Slant plane features were located around approximately 330 degrees. The remaining 30-degree portion of the fracture had shiny smeared appearance consistent with compression side of an overstress bending fracture. Spiral cracks were observed in the outer diameter hardened layer adjacent to the fracture as shown in figure 2 around approximately 180 degrees around the circumference approximately opposite from the smeared area. The cracks intersected jagged features of the fracture. The direction of the spiral was consistent with fracture under torsion loading, where the aft side of the fracture rotated clockwise relative to the forward side of the fracture.¹ On the inner diameter of the crankshaft adjacent to the fracture and slightly clockwise from the smeared area, parallel circumferential cracks were observed also consistent with bending. Further to the clockwise direction on the inner diameter, angled cracks were observed in the hardened layer that intersected jagged features on the fracture surface and turned circumferential near the crack tips. On the outer diameter near where the radius intersected the flange, nearly parallel circumferential cracks turning toward the radial direction near the crack tips were observed as identified in figure 2. These cracks were centered slightly clockwise from the position opposite the smeared area on the fracture surface.

Figure 1. Overall view of the aft side of the propeller flange.

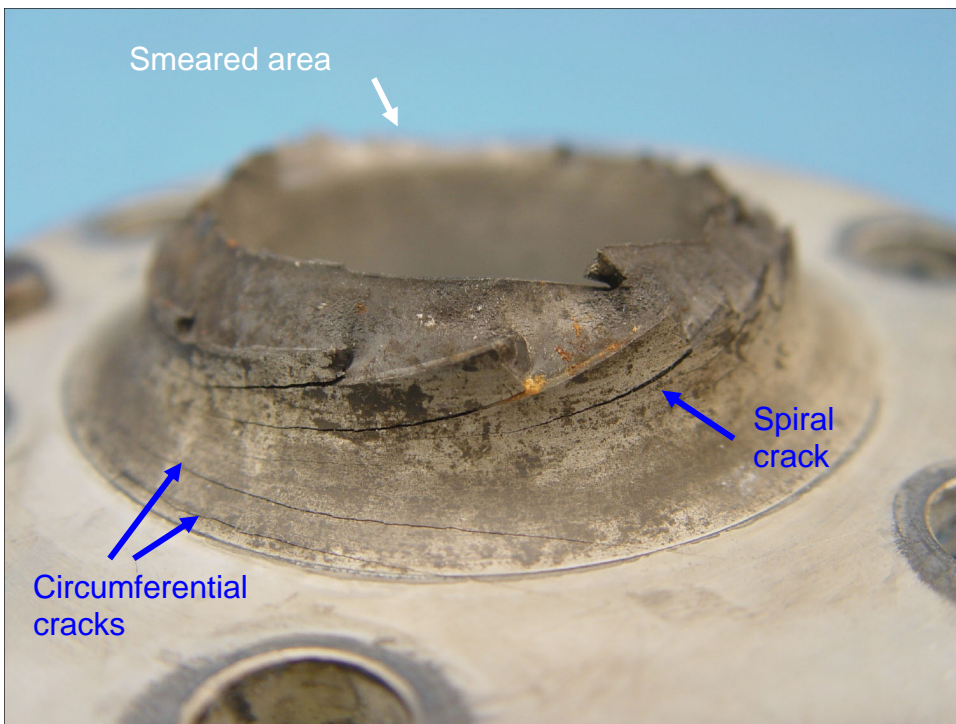
Image No.:0610A00955, Project No.: 2006100021

Figure 2. Close view of spiral cracks at the surface of the propeller flange.
