NATIONAL TRANSPORTATION SAFETY BOARD

MATERIALS LABORATORY FACTUAL REPORT

Report No. 08-121

Place : Weaverville, California
Date : August 5, 2008
Vehicle : Sikorsky S-61N, N612AZ
NTSB No. : LAX08PA259
Investigator : Mike Hauf (AS-40)

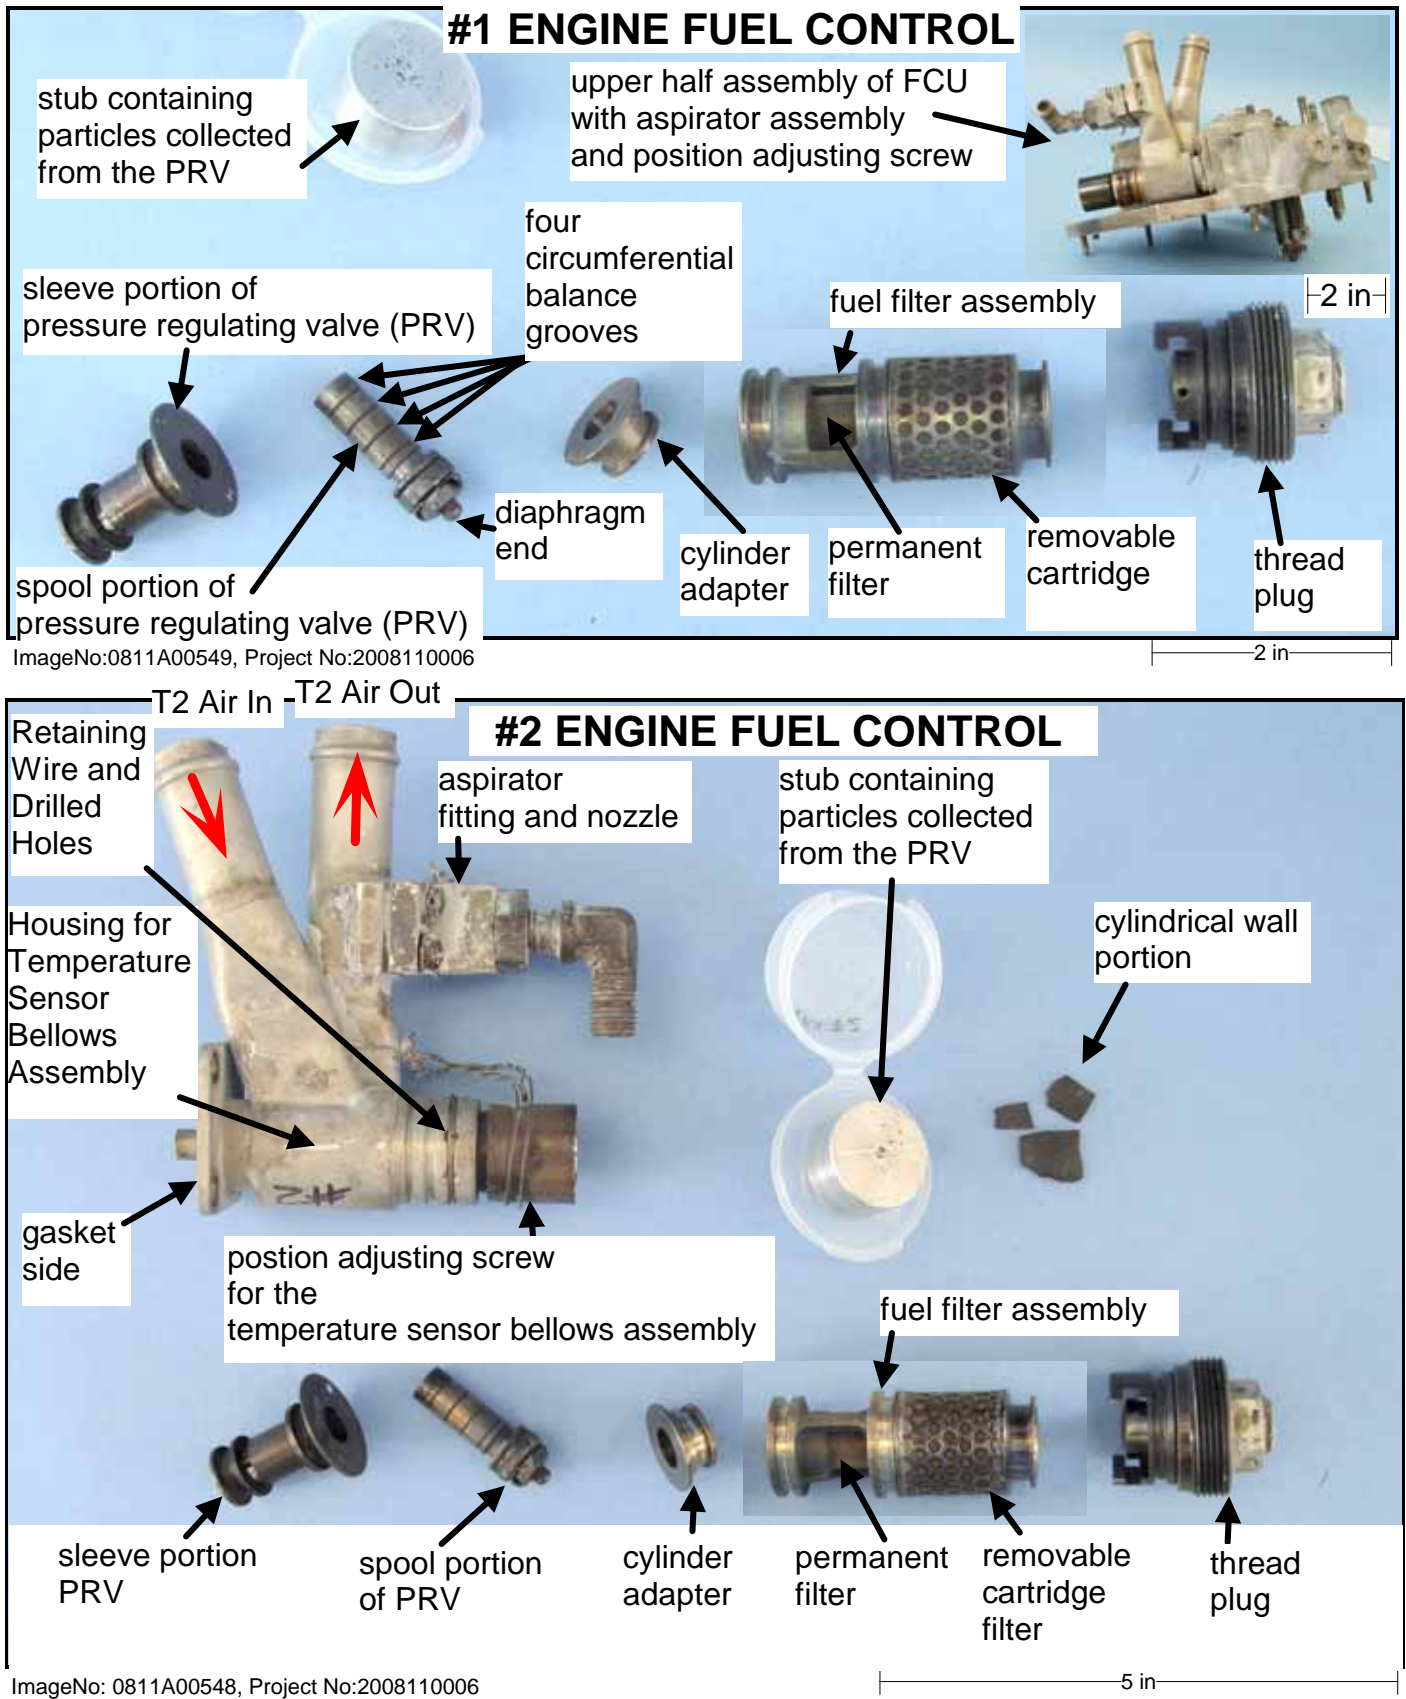
The cylinder adapter and thread plug from the number 1 engine, both shown in figure 1, contained no evidence of a crack.

Figure 1. As-received pieces from fuel control of the number 1 engine (upper photograph) and the number 2 engine (lower photograph).

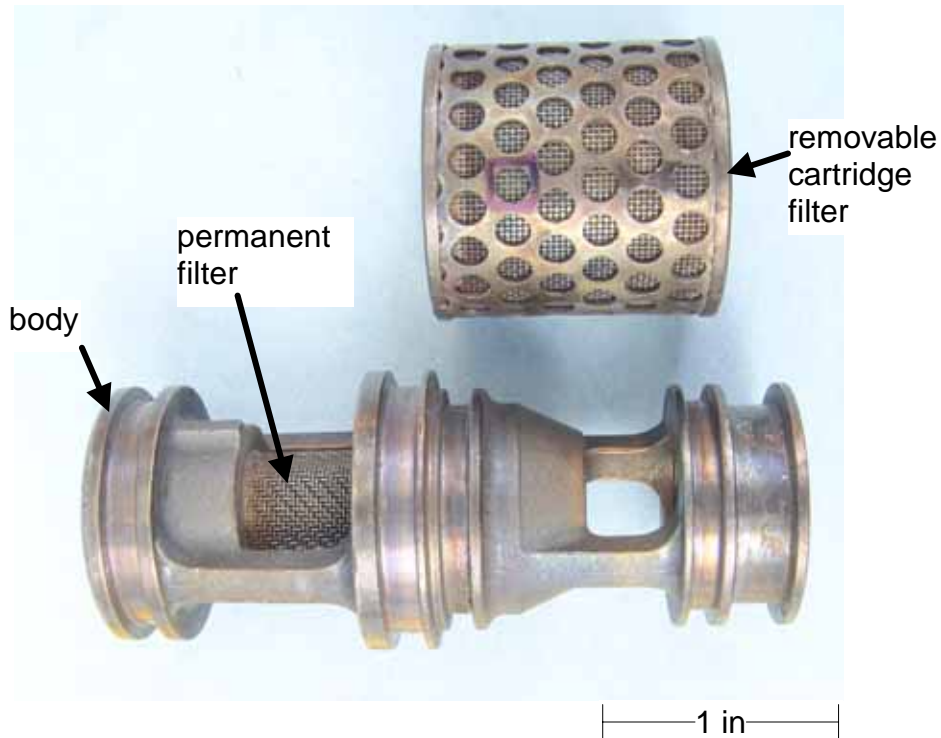
Figure 4 shows a photograph of the removable-cartridge and permanent filters from the number 1 engine. Fiber optic light was inserted inside each screen filter. When viewed from the outside, light was visible and passed through each screen filter.

Item	Estimated Plugging of Available Open Area ³
#1 Engine	Permanent Screen Filter	10%
	Removable Screen Filter	25%

According to the guidelines in the maintenance manual, the screen filters for the number 1 engine do not require a change in inspection/cleaning time interval.

Figure 4. Photograph of the fuel filter assembly from the number 1 engine after the cartridge filter assembly was disassembled from the body.

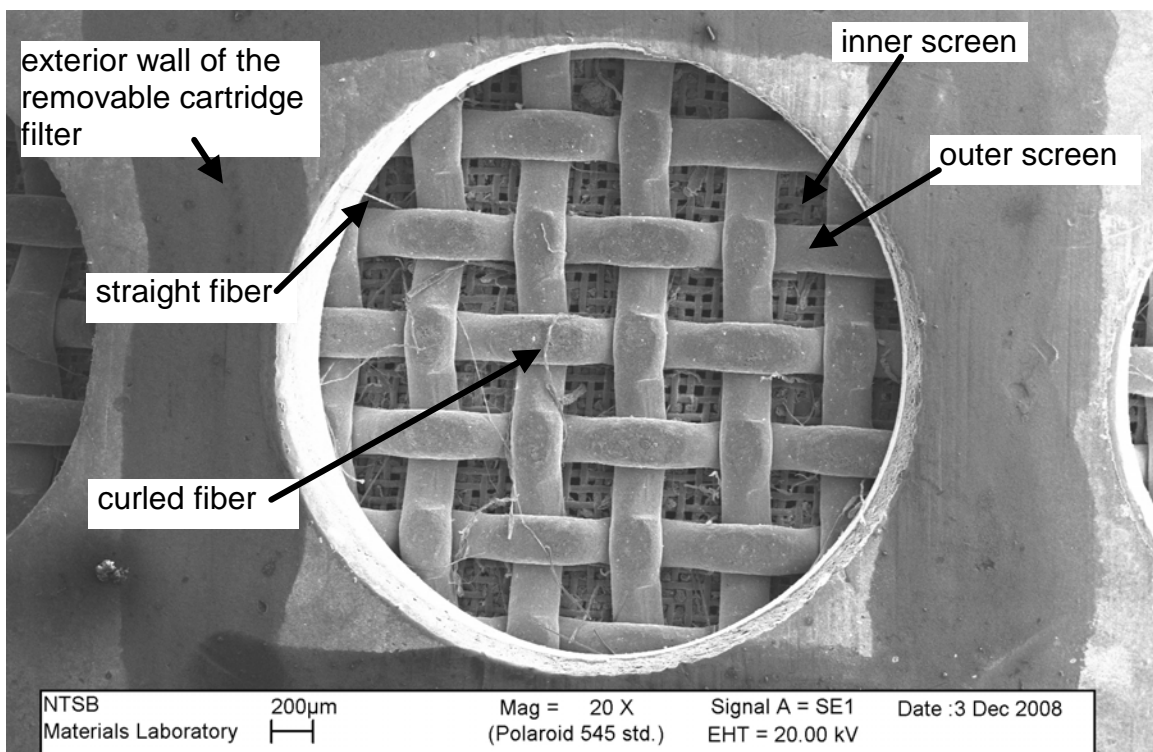
Bench binocular microscope examination of the exterior portion of the removable-cartridge filter revealed that the straight rod-like and curled fibers extended through the open cavities of the inner and outer wire screen, see figures 5 and 6. The inner wire screen also contained irregular block-like particles that were trapped within the cavities of the screen.

Figure 5. Scanning electron microscope (SEM) photograph of a portion of the external face of the removable cartridge filter for fuel control in the number 1 engine. This view shows one of the holes in the wall of the cartridge filter. The bore of the cartridge filter contained two layers of wire screen (referred as the inner and outer screens).

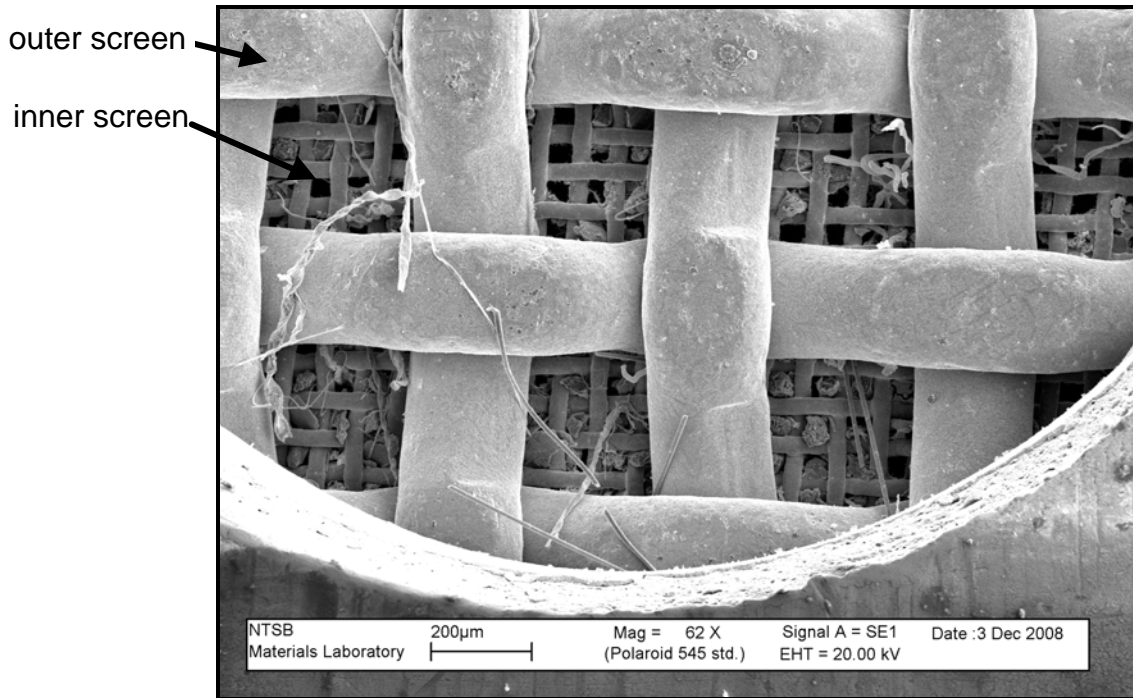
Figure 6. Higher magnification SEM photograph of a portion of the removable cartridge filter for fuel control in the number engine that was shown in figure 5. This view shows particles embedded in the inner and outer screens.

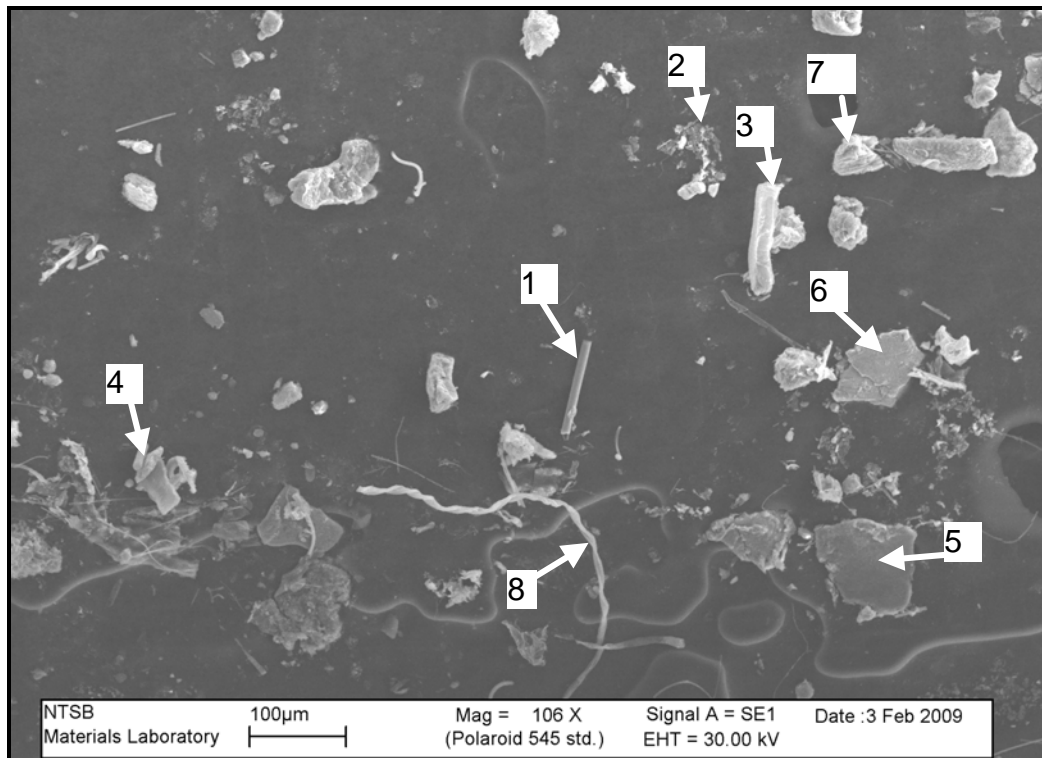
A piece of 0.3-inch wide carbon double-sided adhesive tape was inserted into the bore of the removable-cartridge filter assembly and pressed against the inner screen. The tape was then peeled from the filter. Tape was peeled in a single event (no repeated application) and from one isolated area of the inner screen. Particles from the inner screen were found adhering to the tape. The same procedure was following for each screen filter. A significant amount of particles remained on the inner screen of each filter in the corresponding area where particles were removed for analysis, as observed by fiber optic light examination. The amount of light that passed through the isolated area where the sample particles were removed appeared similar to the amount of light that passed through the same area before the particles were removed for analysis. SEM photograph of typical particles that were peeled from the inner filter is shown in figure 7. The adhesive surface of

the tape retained irregular block-like particles, straight and curled fibers that were consistent with the size and shape of the particles that were visible within the 0.1-inch holes of the removable-cartridge filter. The length and width of the irregular block-like particles measured as large as 120 micrometers (0.005 inch), when measured either lengthwise or widthwise. The size of a few irregular block-like particles was smaller than 20 micrometers (0.0008 inch), when measured either along the length, width, and thickness. When looking at various straight rod-like fibers, the following typical diameter sizes were encountered and were measured approximately: 5 micrometer, 10 micrometer, 20 micrometer and 40 micrometer. The length of the straight fibers measured as long as 400 micrometer (0.016 inch), whereas, the length of the curled fibers measured as long as 600 micrometers (0.024 inch). Appendix 1 shows the EDS spectra of eight particles labeled particles "1" through "8" in figure 7 that were randomly selected for analysis. The EDS spectrum of "straight rod-like (particle 1)" in Appendix 1 was consistent with a silicate glass fiber such as E-glass.

Figure 7. SEM photograph of typical particles that were removed with carbon adhesive tape from the inner screen portion of the removable-cartridge filter from fuel control in the number 1 engine. Background is carbon adhesive tape. EDS spectrum of the particles arrowed "1" through "8" is shown in Appendix 1.

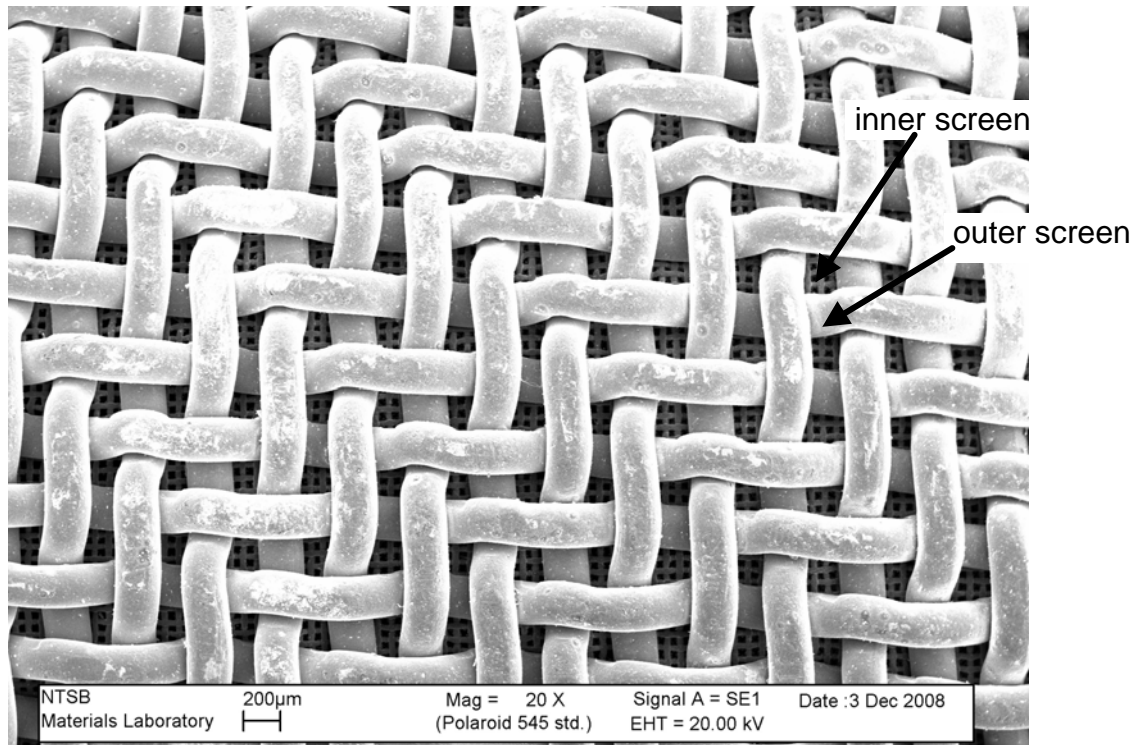
Figure 8 shows a photograph of a portion of the permanent filter when viewed from the exterior face. This permanent filter contained an inner and outer wire screen. The diameter of the wire and distance between the wires for the inner screen was smaller compared to those for the outer screen. For the outer screen, the open distance between parallel wires measured approximately 125 micrometers (0.005 inch). For the inner screen, the open distance between parallel wires measured approximately 45 micrometers (0.002 inch), within the range specified by the manufacturer. Carbon adhesive tape was placed in the bore of the permanent filter. The tape was peeled from the inner screen and particles were found adhering to the tape. SEM examination of the surface of the carbon adhesive tape revealed straight and curled fibers, and irregular block-like particles that were similar to those found in the inner screen of the removable-cartridge filter. The quantity of fibers and irregular block-like particles found on the inner screen was much less than that found on the inner screen of the removable-cartridge filter. The EDS spectra of various fibers and particles that were embedded within the openings of the inner screen from the permanent filter were similar to those from the inner screen of the removable-cartridge filter.

Figure 8. SEM photograph of a portion of permanent filter from fuel filter engine 1 showing the outer and inner wire screens.

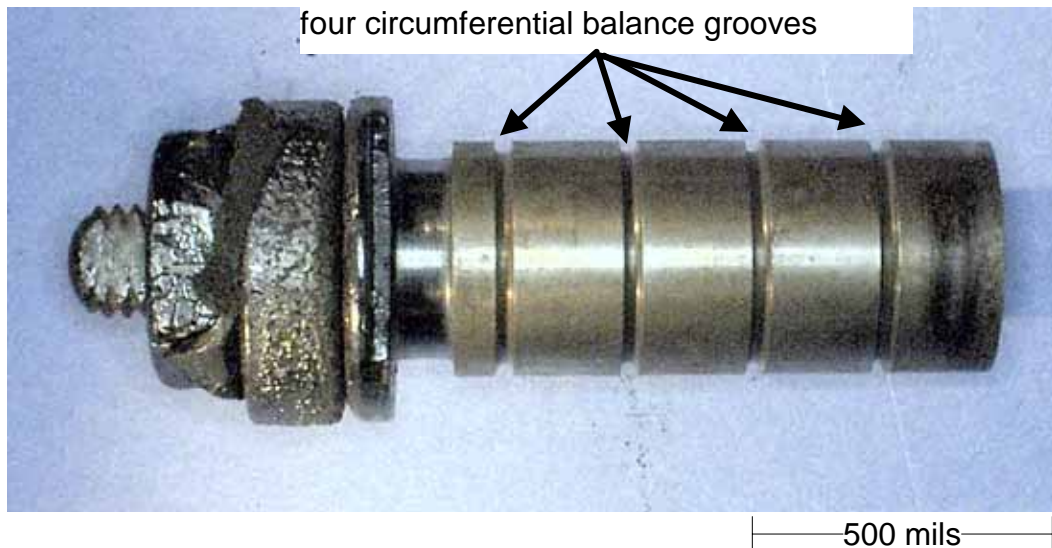
Figure 9 shows a photograph of the as-received spool portion of PRV from the number 1 engine. The spool portion contained four circumferential balance grooves. Figure 10 shows a higher magnification of two of the four circumferential balance grooves.

Figure 9. Photograph of the spool portion of PRV in the number 1 engine. The position of the circumferential balance grooves are indicated in the photograph.

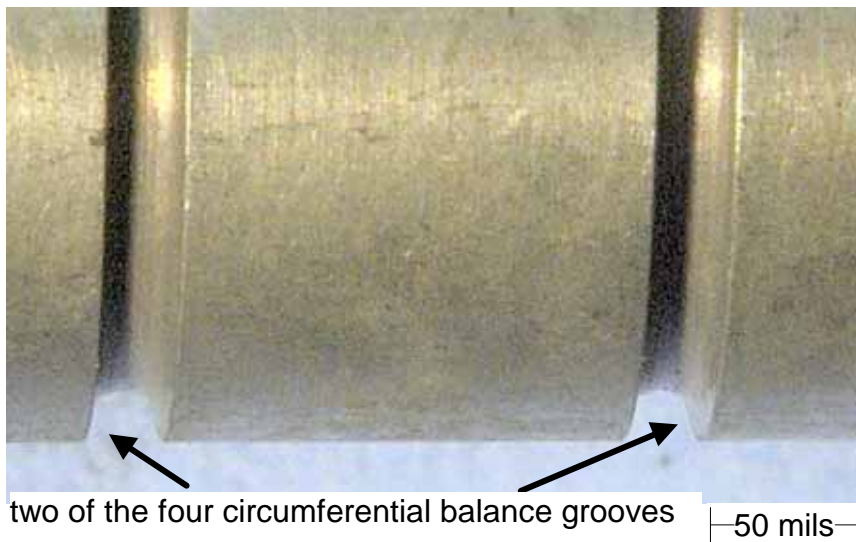
Figure 10. Close-up photograph of two of the four circumferential balance groove portions from the spool of PRV in the number 1 engine.

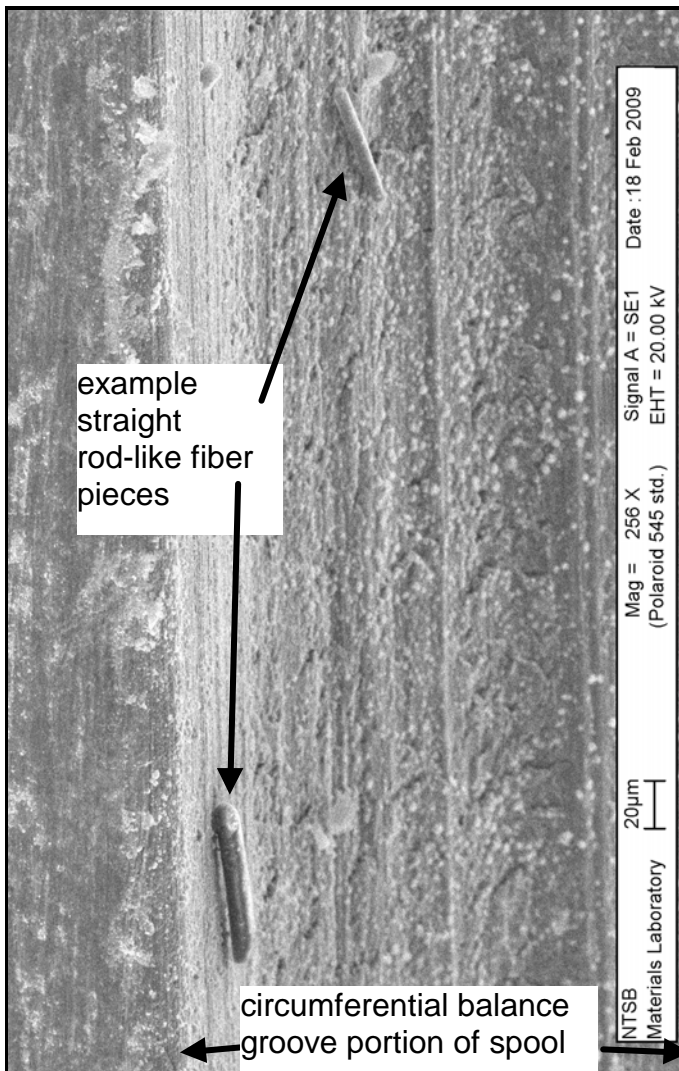
Visual examination of the spool's balance grooves with the unaided eye revealed no evidence of particle contamination. Bench binocular microscope and SEM examination of the spool portion from the PRV from the number 1 engine revealed each of the four circumferential balance grooves contained between two and three fragments of straight rod-like fibers. Figure 11 shows a photograph of two straight rod-like particles that were found in one of the four circumferential balance groove portions of the spool. The typical length of a straight rod-like fiber measured approximately 60 micrometers (0.0024 inch) and the typical diameter measured approximately 10 micrometers (0.0004 inch). EDS analysis of a straight fiber produced a spectrum that contained major elemental peaks of silicon, aluminum and calcium with minor elemental peaks of magnesium, carbon, and oxygen, consistent with a silicate glass fiber such as E-glass, and similar to the EDS spectrum of the fiber labeled "straight rod-like fiber (particle 1)" in Appendix 1 of the particle removed with tape from the removable cartridge filter of fuel control in the number 1 engine.

Figure 11. SEM photograph of a portion of a circumferential balance groove from the spool of PRV in the number 1 engine. This view shows two straight rod-like fibers located in the circumferential balance groove.

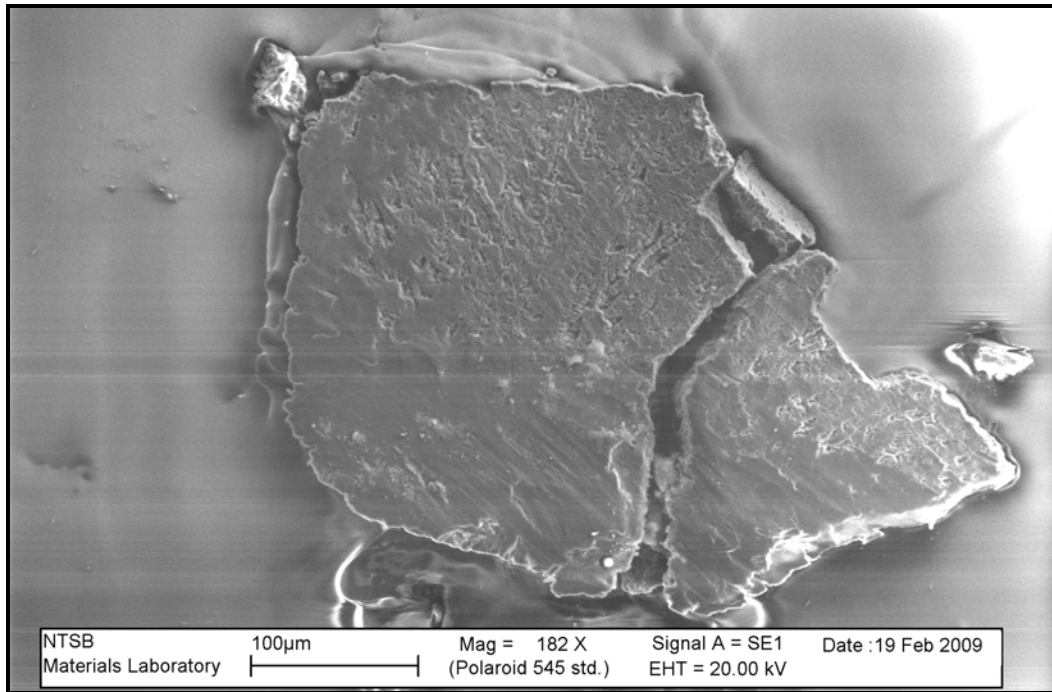
During the process of removing the spool from its sleeve assembly using an arbor press at Hamilton Sundstrand, particles fell off of the PRV assembly. These particles were collected and placed on a cylindrical aluminum "stub". (Reference Airworthiness Group Chairman's Factual Report). The as-received stub with the collected particles is shown in figure 1. SEM examination of the stub revealed particles of similar shape and size to those extracted from the inner screen of the removable-cartridge filter. The EDS spectrum of the particles on the stub were similar to the EDS spectrum of the particles from the inner screen of the cartridge filter, with the exception that EDS spectrum from a fragment in figure 12 showed a major elemental peak of fluorine and carbon. The EDS spectrum of the

fluorine-carbon particle is labeled particle 9 in Appendix 1. The fragment in figure 12 appears to be fractured into two major pieces. The total length and total width of the two fluorine-carbon fragments measured as large as 450 micrometers (0.018 inches) in either orientation of measure.

Figure 12. SEM photograph of one of the particles found on the stub for PRV engine 1. The particle fractured into two major pieces. The EDS spectrum from this particle contained elemental peaks of fluorine and carbon.

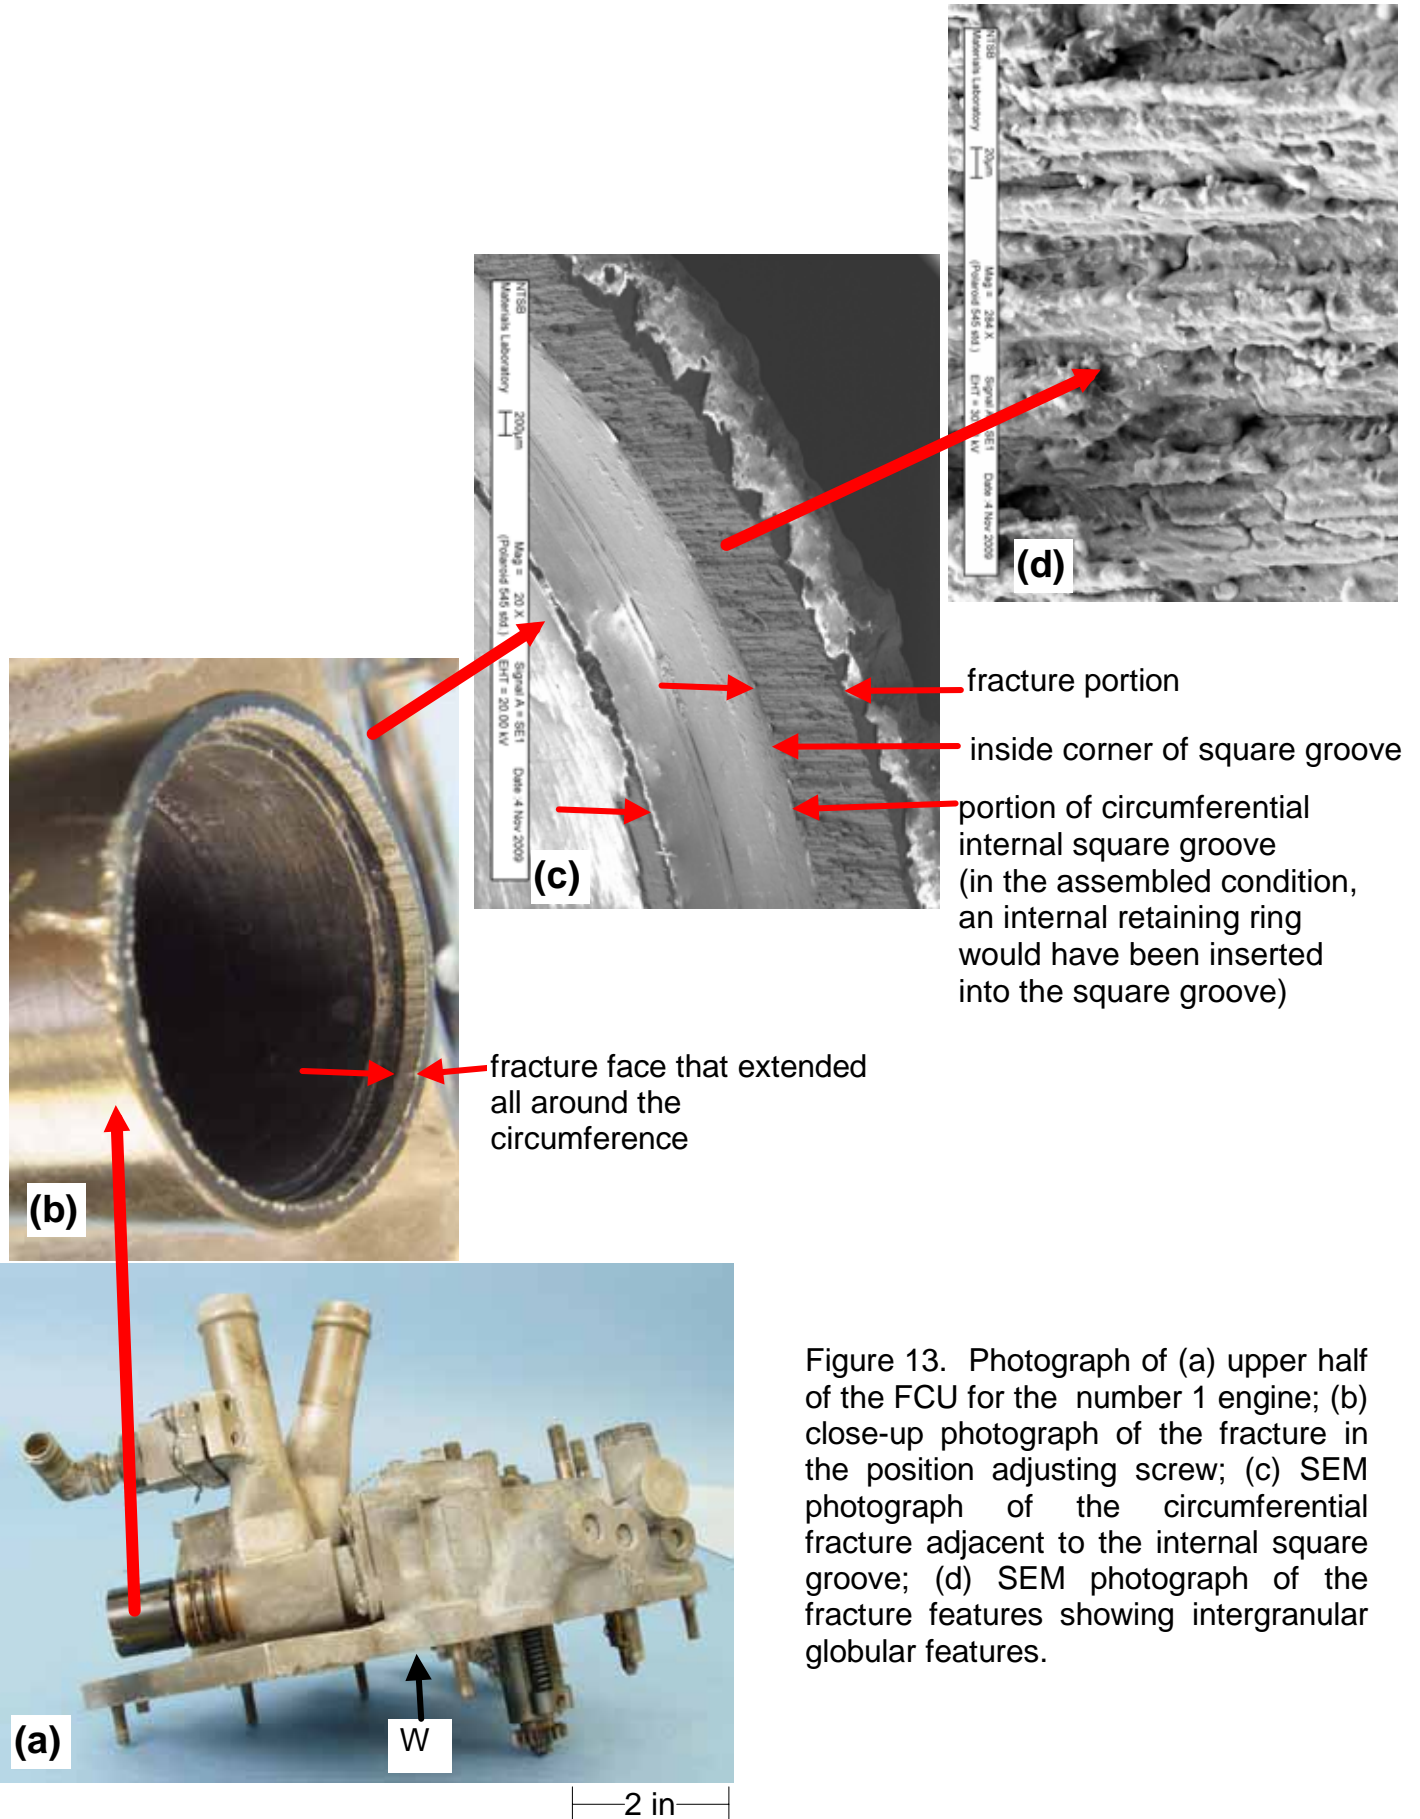
The number 1 engine upper half assembly of the FCU was submitted for examination (photograph is shown on the upper right corner in figure 1 and in figure 13). The aspirator assembly and position adjusting screw was attached to this assembly. The inner wall of this assembly in the general area indicated by arrow "W" in figure 13 was covered with dry black soot deposit. A sample of soot deposit was removed with carbon double sided adhesive tape. EDS analysis of the sample produced a spectrum that contained major elemental peaks of silicon, carbon, and oxygen.

Figure 13. Photograph of (a) upper half of the FCU for the number 1 engine; (b) close-up photograph of the fracture in the position adjusting screw; (c) SEM photograph of the circumferential fracture adjacent to the internal square groove; (d) SEM photograph of the fracture features showing intergranular globular features.

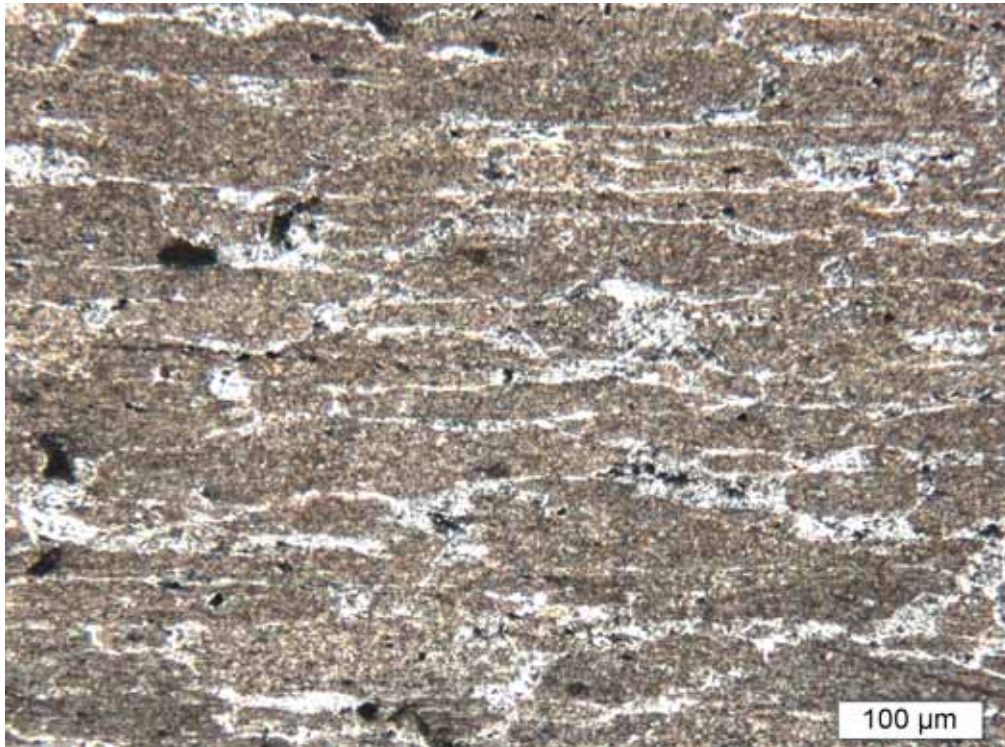
Examination of the aspirator assembly revealed that the temperature sensor bellows assembly, spring, spring retainer cap (an aluminum alloy), internal retainer ring, and external end cap (dust cover) were not submitted to the Safety Board Materials Laboratory. The wall of the position adjusting screw for the temperature sensor bellows assembly was specified as aluminum alloy 7075 and was to be heat-treated to the T6 condition. The position adjusting screw was attached to the housing portion of the aspirator assembly. Bench binocular microscope examination of the open end of the position adjusting screw revealed a fracture on the inner face that extended all around the position adjusting screw in the area between the inside corner of the inner circumferential square groove and the open end of the tube (see figure 13). SEM examination of the position adjusting screw revealed the circumferential fracture contained intergranular globular features and showed no evidence of fatigue cracking (see figure 13). Examination of the prepared and etched section revealed a microstructure that contained solid solution melting at the grain boundaries consistent with an overheated aluminum alloy (see figure 14).

Figure 14. Longitudinal-radial section of the wall portion of the position adjusting screw. The microstructure shows an overheated aluminum alloy. Etched with Keller's reagent.

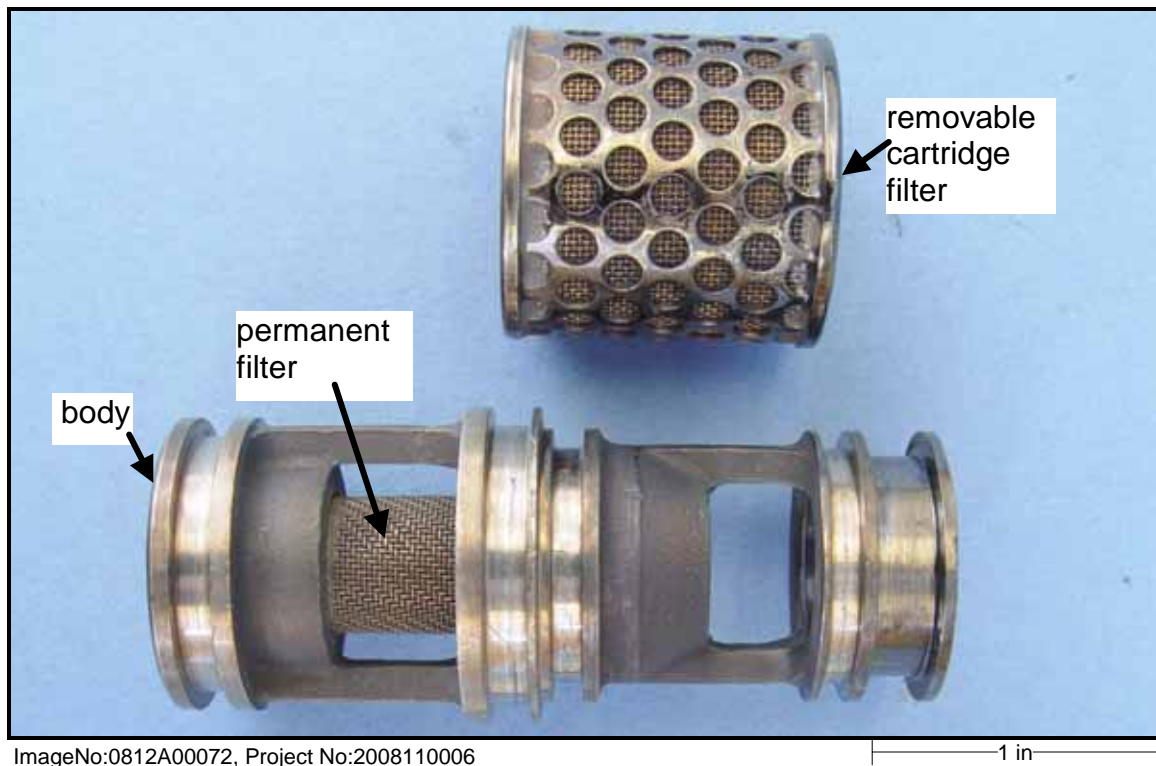
Figure 15 shows a photograph of the permanent and removable filters from the number 2 engine. When viewed from outside the screen filters (after the screen filters were disassembled from each other) with a 12.5X glass, the available open areas were estimated by the amount of light that passed the inner 40 micrometer screen. The table below indicates the estimated plugging of available open area on the inner screen portion of each screen filter (areas that did not permit passage of light).

Item	Estimated Plugging of Available Open Area
#2 Engine	Permanent Screen Filter	20%
	Removable Screen Filter	50%

According to the guidelines in the maintenance manual, the permanent and removable screen filters from the number 2 engine do not require a change in inspection/cleaning time interval.

Figure 15. Photograph of the fuel filter assembly from the number 2 engine after the cartridge filter assembly was disassembled from the body.

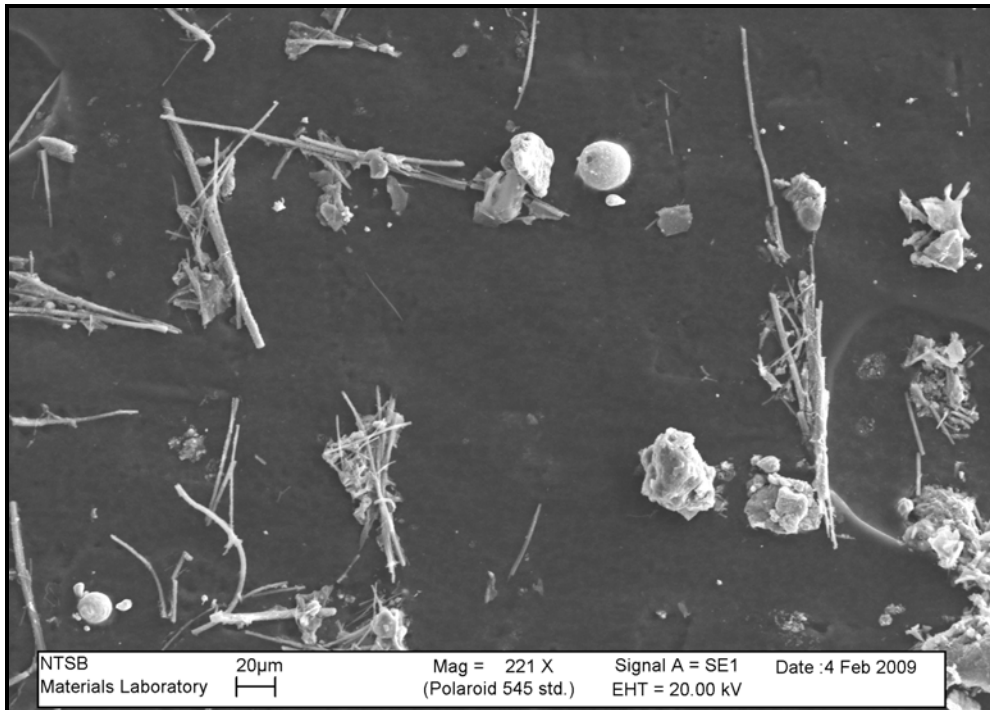
A piece of 0.3-inch wide carbon double-sided adhesive tape was inserted into the bore of the removable-cartridge filter assembly in the number 2 engine and pressed against the inner screen. The tape was then peeled from the inner screen. Particles from the inner screen were found adhering to the carbon tape (photograph not shown). Particles also were removed with carbon adhesive tape from the inner wire screen portion of the permanent filter of fuel control in the number 2 engine. Figure 16 shows an SEM photograph of typical particles that were extricated with carbon adhesive tape from the inner screen of the permanent filter. SEM examination of the carbon tapes revealed the inner screens for the removable cartridge and permanent filters contained irregular block-like particles, straight and curled fibers, that appeared similar to and more numerous than those found in the inner screen of the removable-cartridge filter and permanent filter from the number 1 engine.

Figure 16. SEM photograph of particles that were removed from the permanent filter of fuel control in the number 2 engine. Background is carbon adhesive tape.

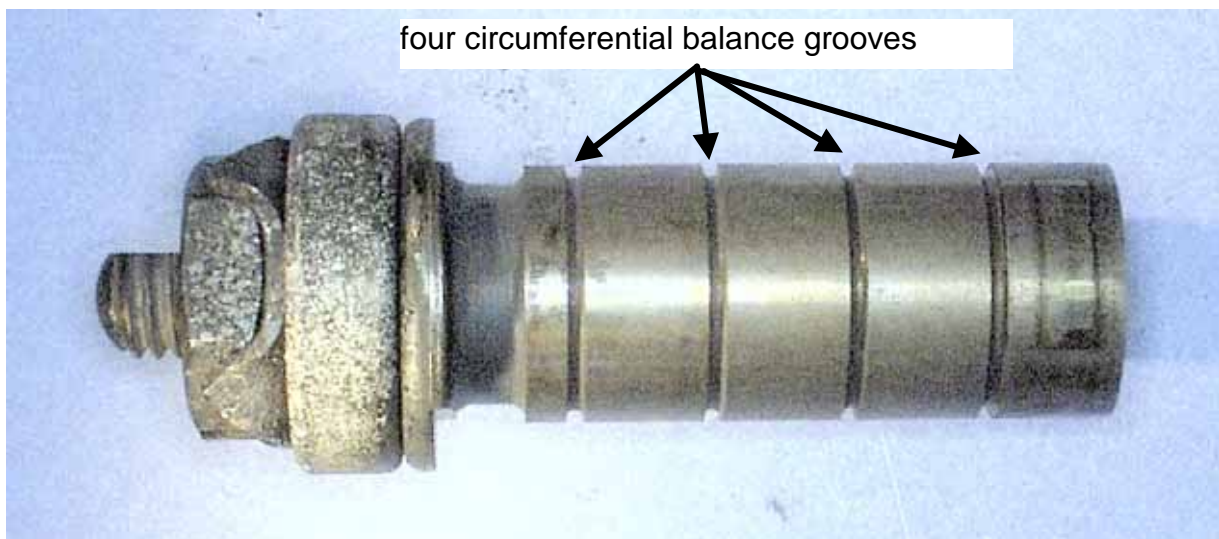
Figure 17 shows a photograph of the as-received spool portion of the PRV from the number 2 engine. Figure 18 shows a photograph of two of the four circumferential balance grooves from the spool portion. Visual examination of the spool's balance grooves with the naked eye revealed no evidence of particle contamination. SEM examination of the spool portion from the PRV of the number 2 engine revealed one area in one circumferential balance groove contained fragments of curled fibers. Figure 19 shows a photograph of the curled fiber particles. The typical thickness of the fibers measured 20 micrometers (0.0008 inch) maximum. EDS analysis of a curled fiber produced a spectrum that contained major elemental peaks of carbon and oxygen; similar to the EDS spectrum labeled "particle 8" in Appendix 1. No evidence of straight rod-like particles was found in the groove portions of the spool. Figures 19 and 20 show photographs of a portion of the longitudinal scoring marks that were found on the surface of the spool between the circumferential balance grooves. The score marks appeared more severe (e.g., wider and deeper) compared to those on the surface of the spool from PRV in the number 1 engine. The width of the more severe score marks measured between 8 and 20 micrometers. The depth of several score marks when viewed at the edge of a land measured between 4 and 11 micrometers.

Figure 17. Photograph of the spool portion of PRV in the number 2 engine. The position of the circumferential balance grooves are indicated in the photograph.

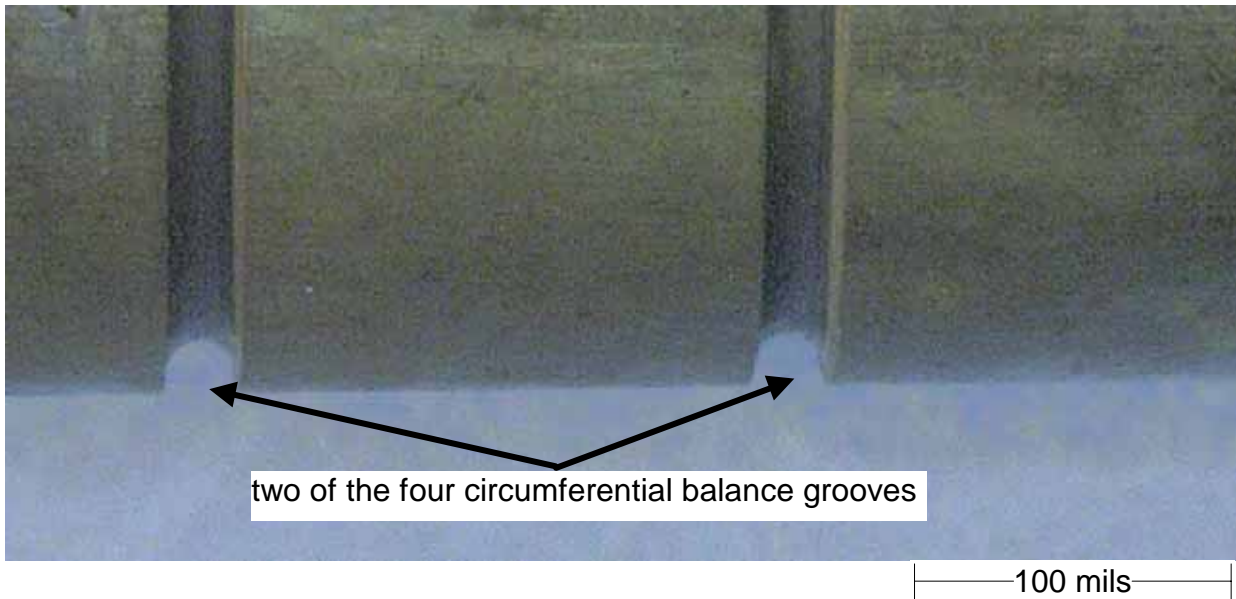
Figure 18. Close-up photograph of two of the four circumferential balance groove portions from the spool of PRV in the number 2 engine.

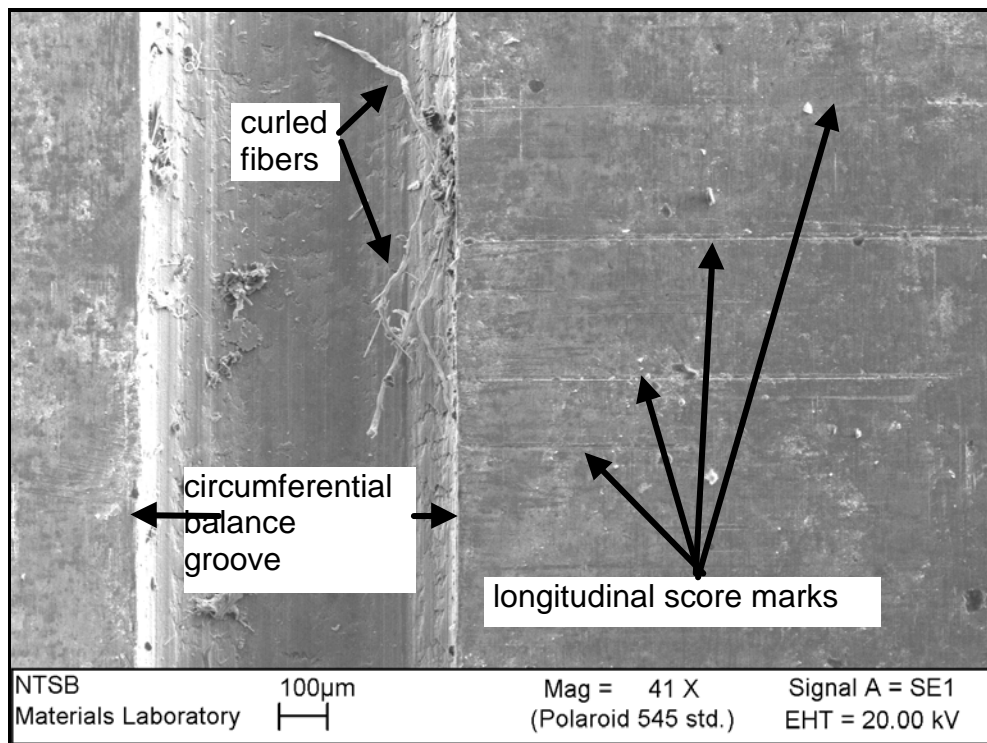
Figure 19. SEM photograph of a portion of the pool from the PRV in the number 2 engine showing one of the circumferential balance grooves. This view shows fibers within the groove in an area located adjacent to the spool surface. The surface also contained several longitudinal score marks that extend from the circumferential balance groove.

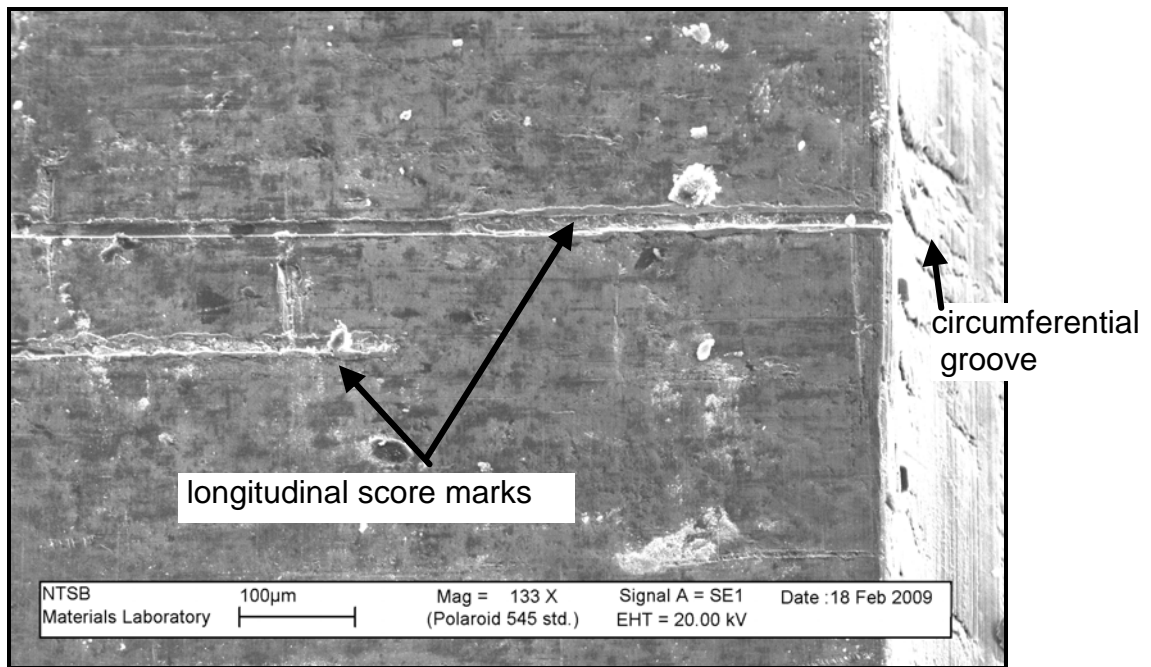
Figure 20. SEM photograph of a portion of the pool from the PRV in the number 2 engine showing one of the circumferential balance grooves. A longitudinal score mark extended from the circumferential balance groove.

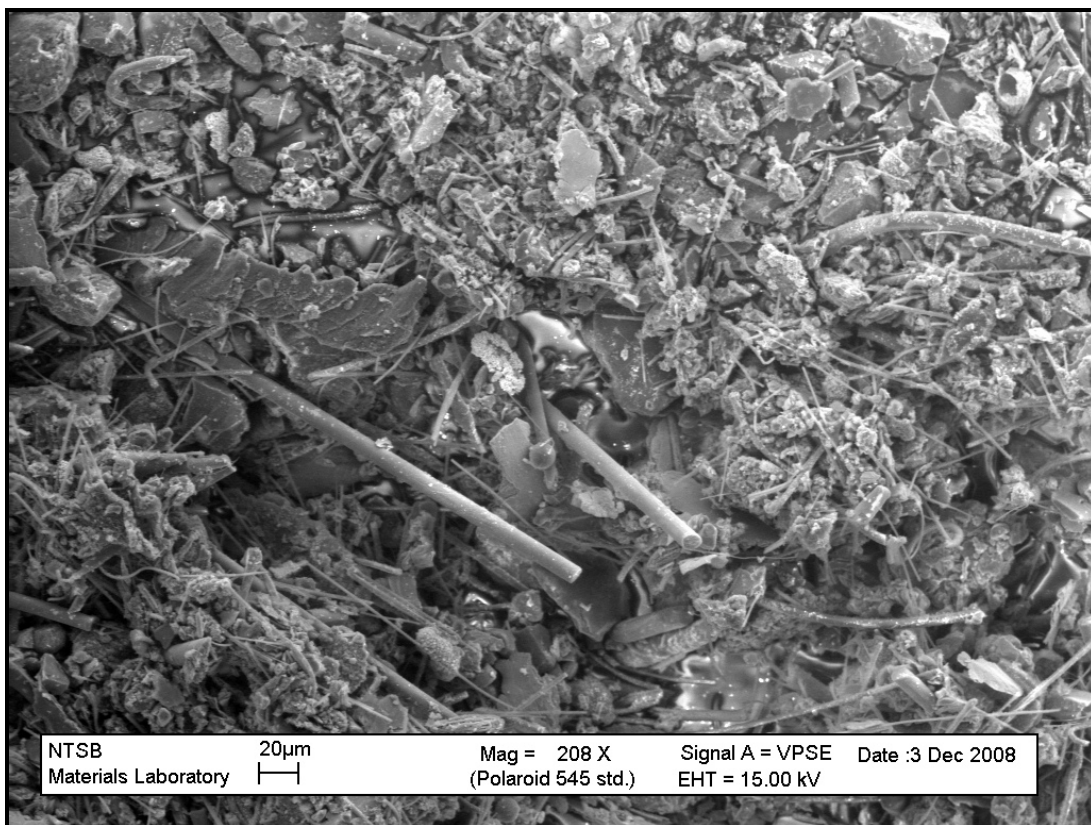
Figure 1 shows a photograph of the as-received cylindrical aluminum "stub". SEM examination of the stub revealed particles that appeared similar to and more numerous than those found in the stub from the number 1 engine, see figure 21. Additionally, the stub from the number 2 engine contained hair-like fibers that were attached to a flat-backing material, as shown in figure 22, that were not found in the stub from the number 1 engine. The hair-like fibers that extended from a flat-backing material were not present in the wire screens and stub of the number 1 engine. EDS analysis of the hair-like fibers, labeled particle 10 hair-like fibers in Appendix 1, produced a spectrum that contained a major elemental peak of silicon and minor elemental peaks of carbon, oxygen, sulfur, calcium, and zinc. EDS spectrum of the flat-backing material, labeled particle 10 flat-backing material portion in Appendix 1, showed a major peak of carbon and a minor peak of oxygen.

Figure 21. SEM photograph of particles found on the as-received stub that contained particled collected from PRV of the number 2 engine. The particles are embedded in adhesive bonded tape.
