NATIONAL TRANSPORTATION SAFETY BOARD

MATERIALS LABORATORY FACTUAL REPORT

Report No. 08-121

Place : Weaverville, California
Date : August 5, 2008
Vehicle : Sikorsky S-61N, N612AZ
NTSB No. : LAX08PA259
Investigator : Mike Hauf (AS-40)

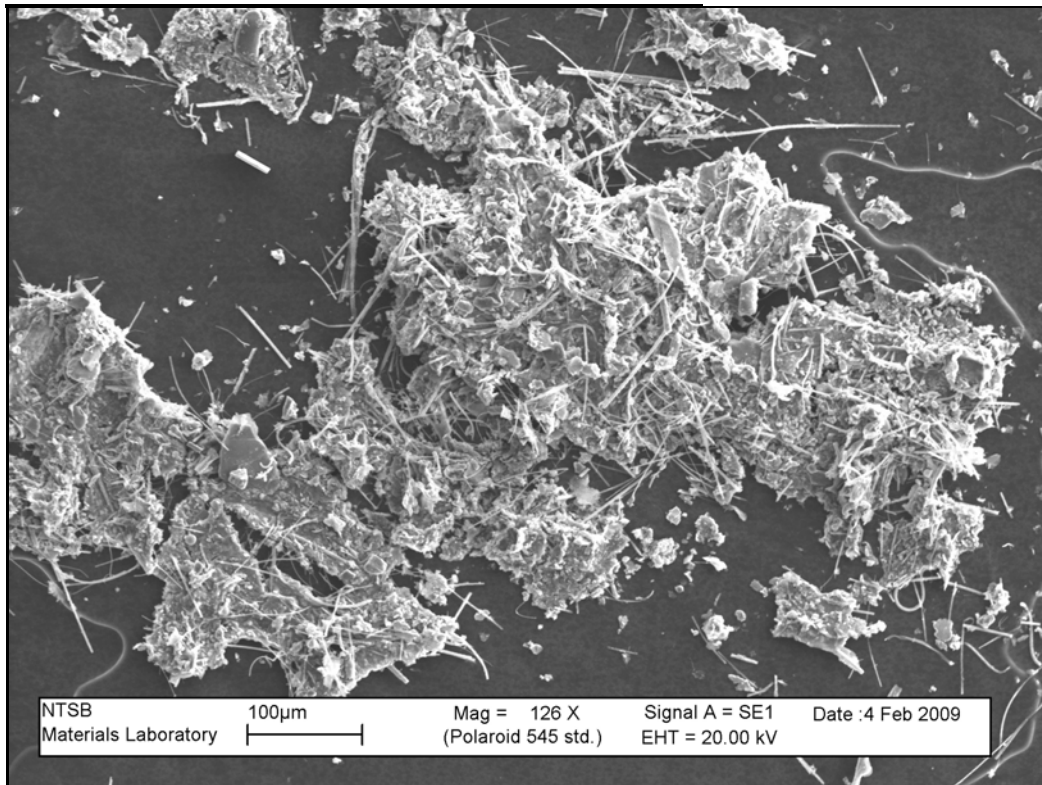
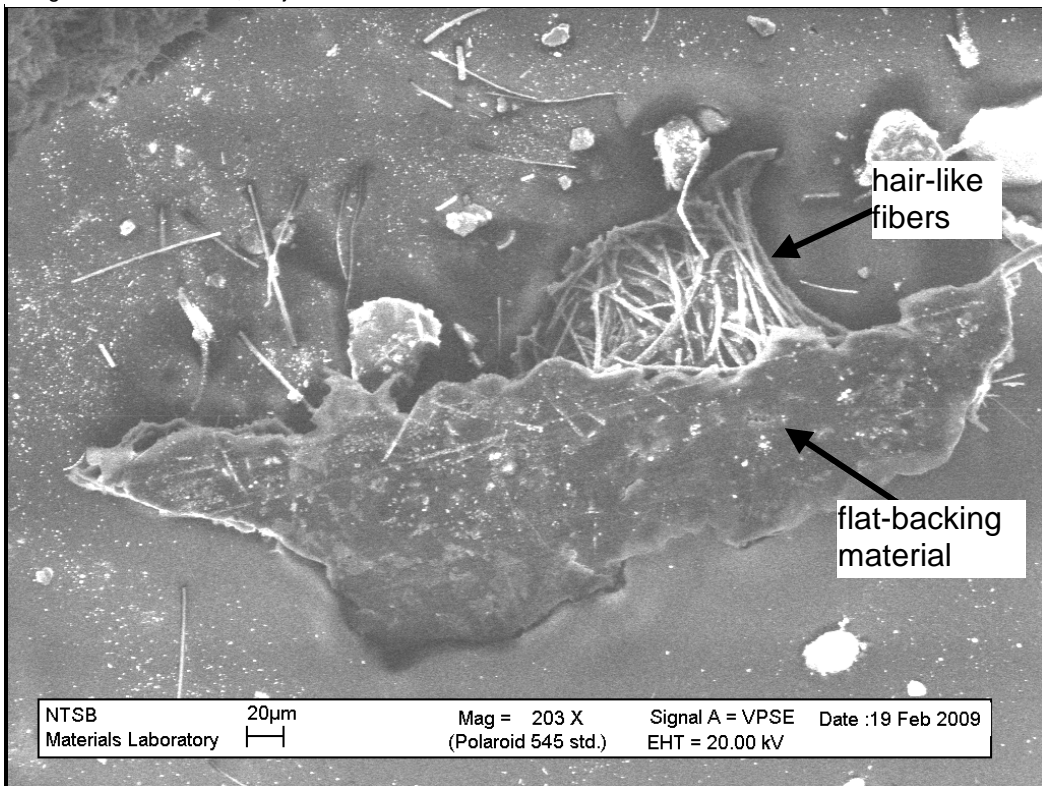
Figure 22. SEM photograph of particles on the stub from PRV of the number 2 engine (upper side of page) and a slightly higher magnification view one of the same particles after it was turned over to reveal the hidden back side. The majority of the particles appear to have a flat-backing material with hair-like fibers extending from the flat-backing material portion.

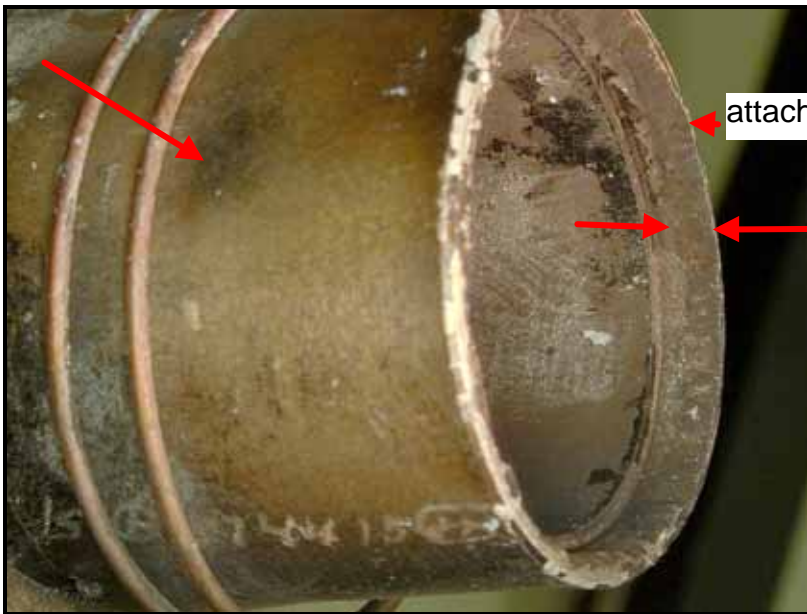
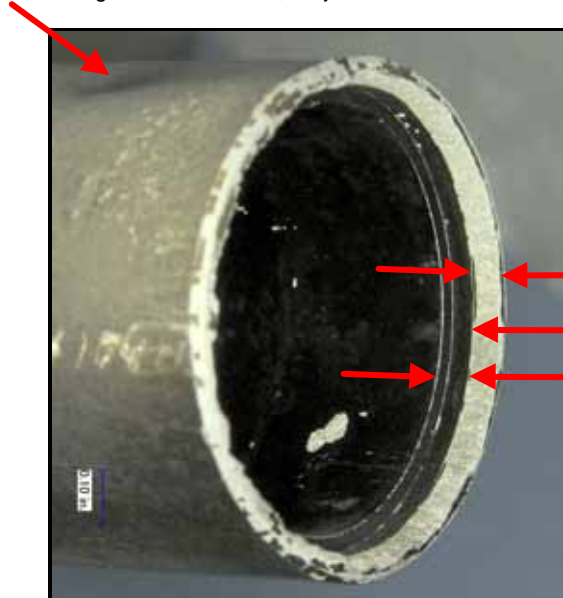
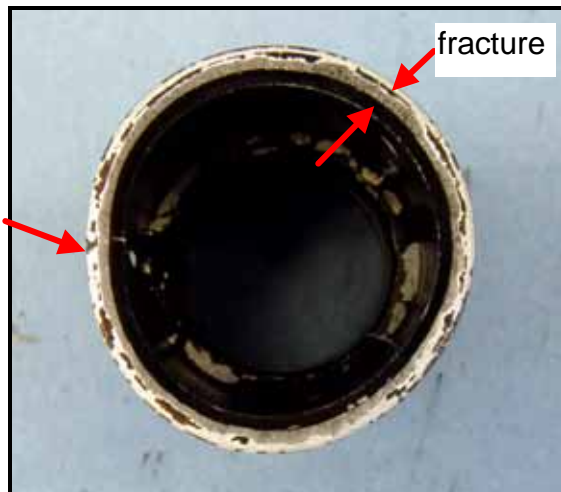
Examination of the aspirator assembly revealed that the temperature sensor bellows assembly, spring, spring retainer cap (an aluminum alloy), internal retainer ring, and external end cap (dust cover) were not submitted. As indicated earlier, the wall of the position adjusting screw for the temperature sensor bellows assembly was specified as aluminum alloy 7075 and was to be heat-treated to the T6 condition. The position adjusting screw was attached to the housing portion of the aspirator assembly. The exterior face of the round non-thread end portion of the position adjusting screw exhibited a dent in the area indicated by an unmarked arrow in figure 23. The dent was visible from the inner surface of the position adjusting screw. When looking into the open end of the position adjusting screw, the wall showed evidence of deformation (i.e., was not round). The inner and outer face of the position adjusting screw was covered with soot. Bench binocular microscope examination of the open end of the position adjusting screw revealed a fracture on the inner face that extended all around the position adjusting screw in the area between the inside corner of the inner circumferential square groove and the open end of the tube (see figure 24). The position adjusting screw was disassembled from the housing and ultrasonic cleaned with a commercial detergent. SEM examination of the position adjusting screw revealed micro-cracks on the inner and outer surfaces of the wall. The

Figure 23. View of the position adjusting screw for the temperature sensor bellows assembly in the number 2 engine, in the as-received condition (upper photograph); side view after disassembly and ultrasonic cleaned with detergent (center photograph); and view looking into the position adjusting screw (bottom photograph). Note the dent in the area indicated by an unmarked arrow. In the assembled condition, an internal retaining ring would have been inserted into the square groove.

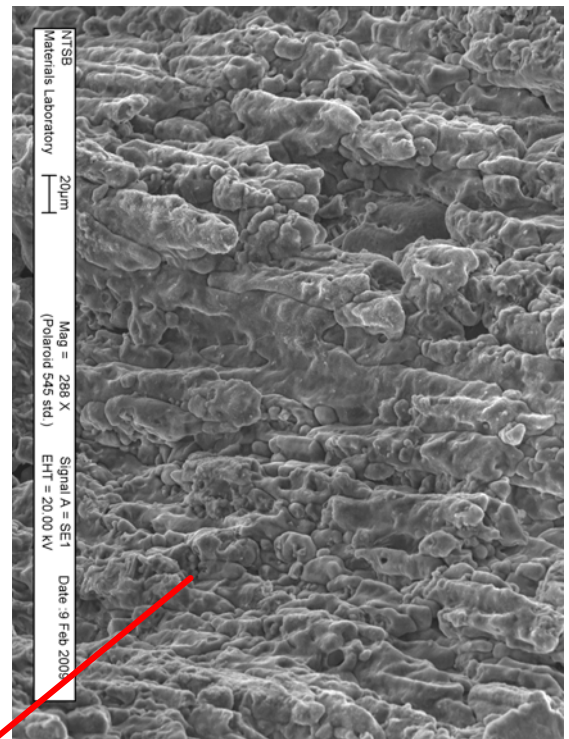
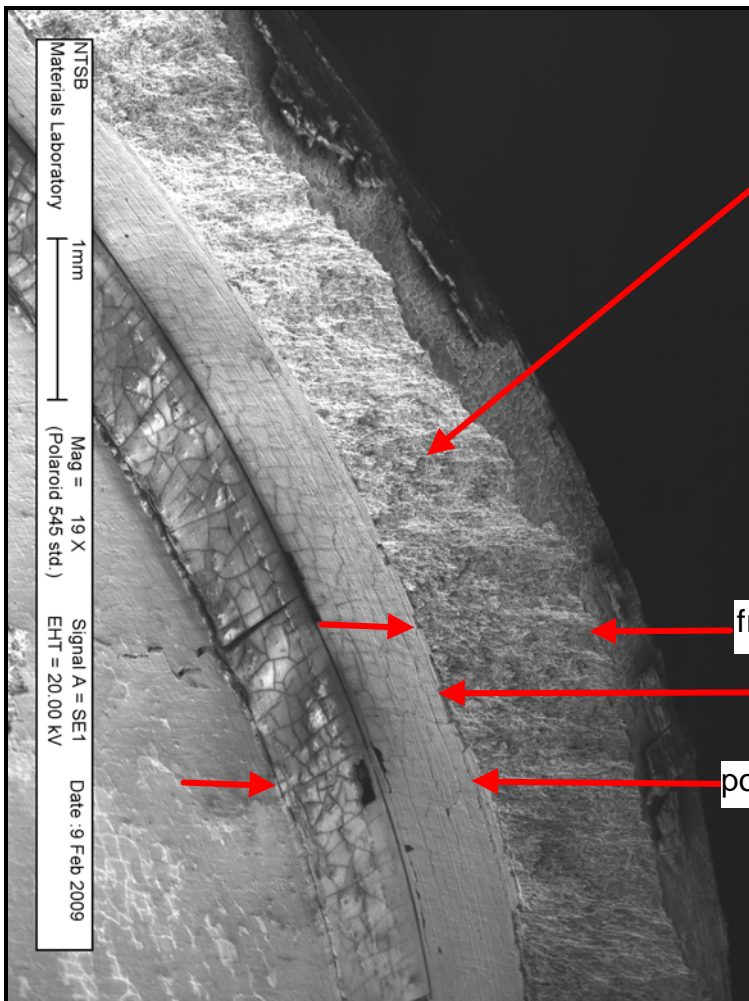
circumferential fracture contained intergranular globular features, showed no evidence of fatigue cracking (see figure 24), and appeared similar to the intergranular globular fracture features found in the fractured position adjusting screw for the number 1 FCU. A radial-longitudinal metallurgical cross-section was made through the wall of the position adjusting screw for the number 2 FCU. Examination of the prepared and etched section revealed a microstructure that contained solid solution melting at the grain boundaries consistent with an overheated aluminum alloy (see figure 25).

Figure 24. SEM photographs of a portion of the position adjusting screw for the temperature sensor bellows assembly (lower left corner of page) and a higher SEM photograph of the fracture face (upper right corner of page). In the assembled condition, an internal retaining ring would have been inserted into the square groove.

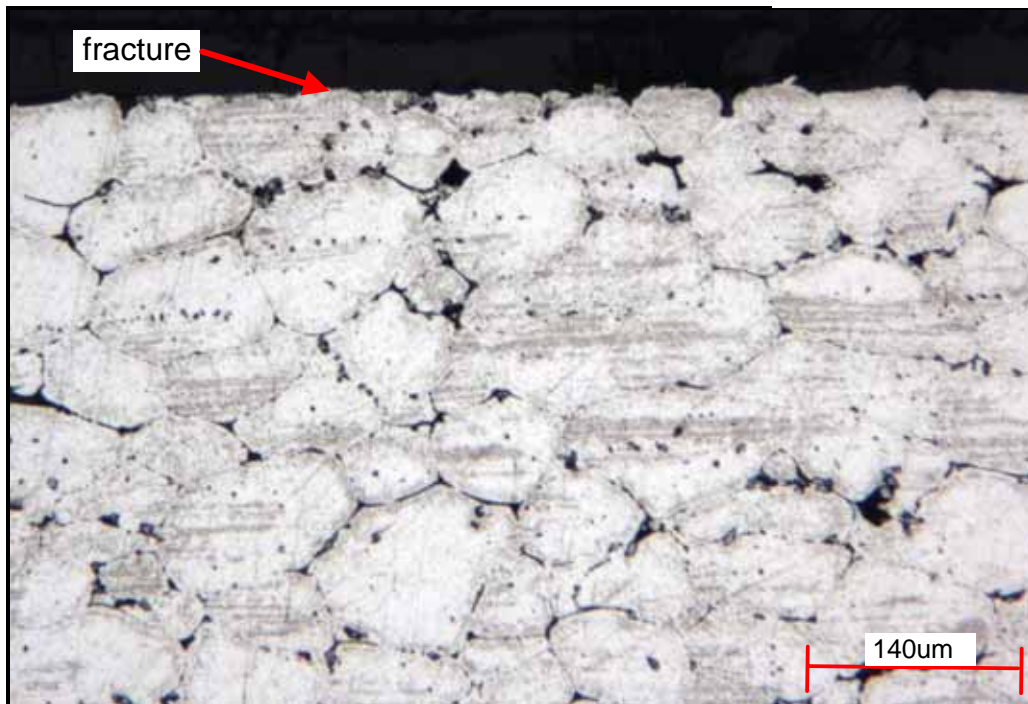
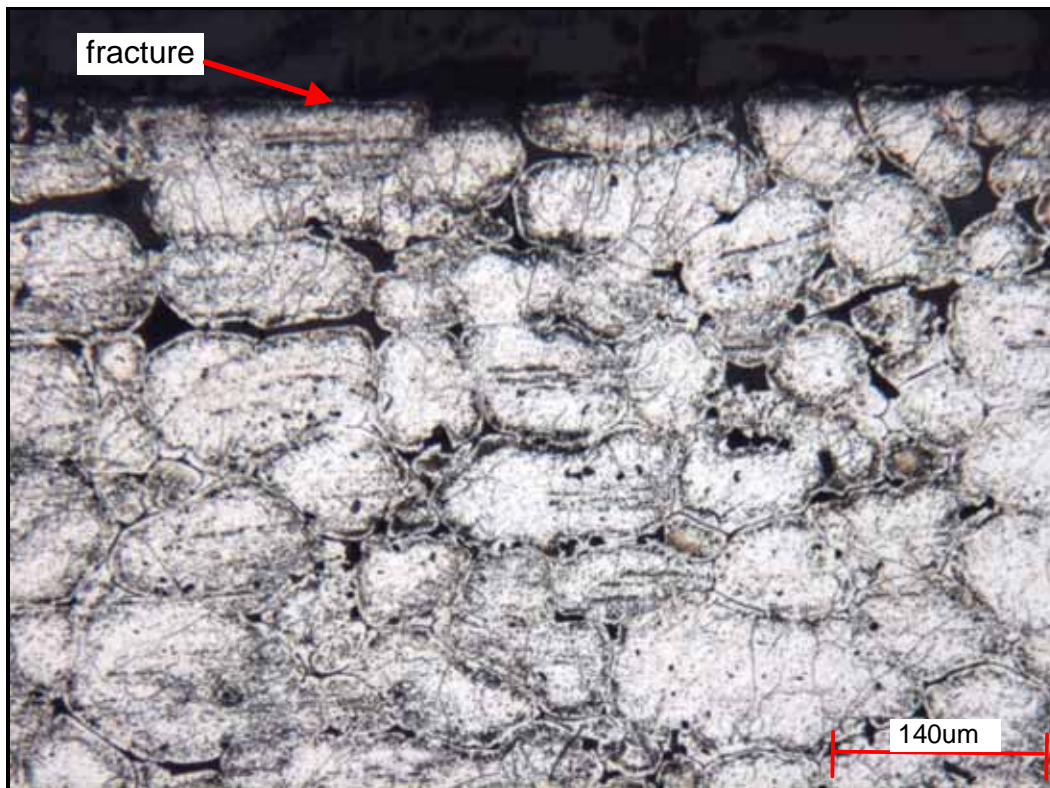
Figure 25. Longitudinal-radial section of the wall portion of the position adjusting screw from the temperature sensor bellows assembly. The microstructure shows an overheated aluminum alloy with solid solution melting at the grain boundaries. The two photographs were taken in an area that was located near each other and adjacent to the fracture face. The area shown on the bottom photograph was etched for a longer period of time compared to the area on the upper photograph. Etched with Keller's reagent.

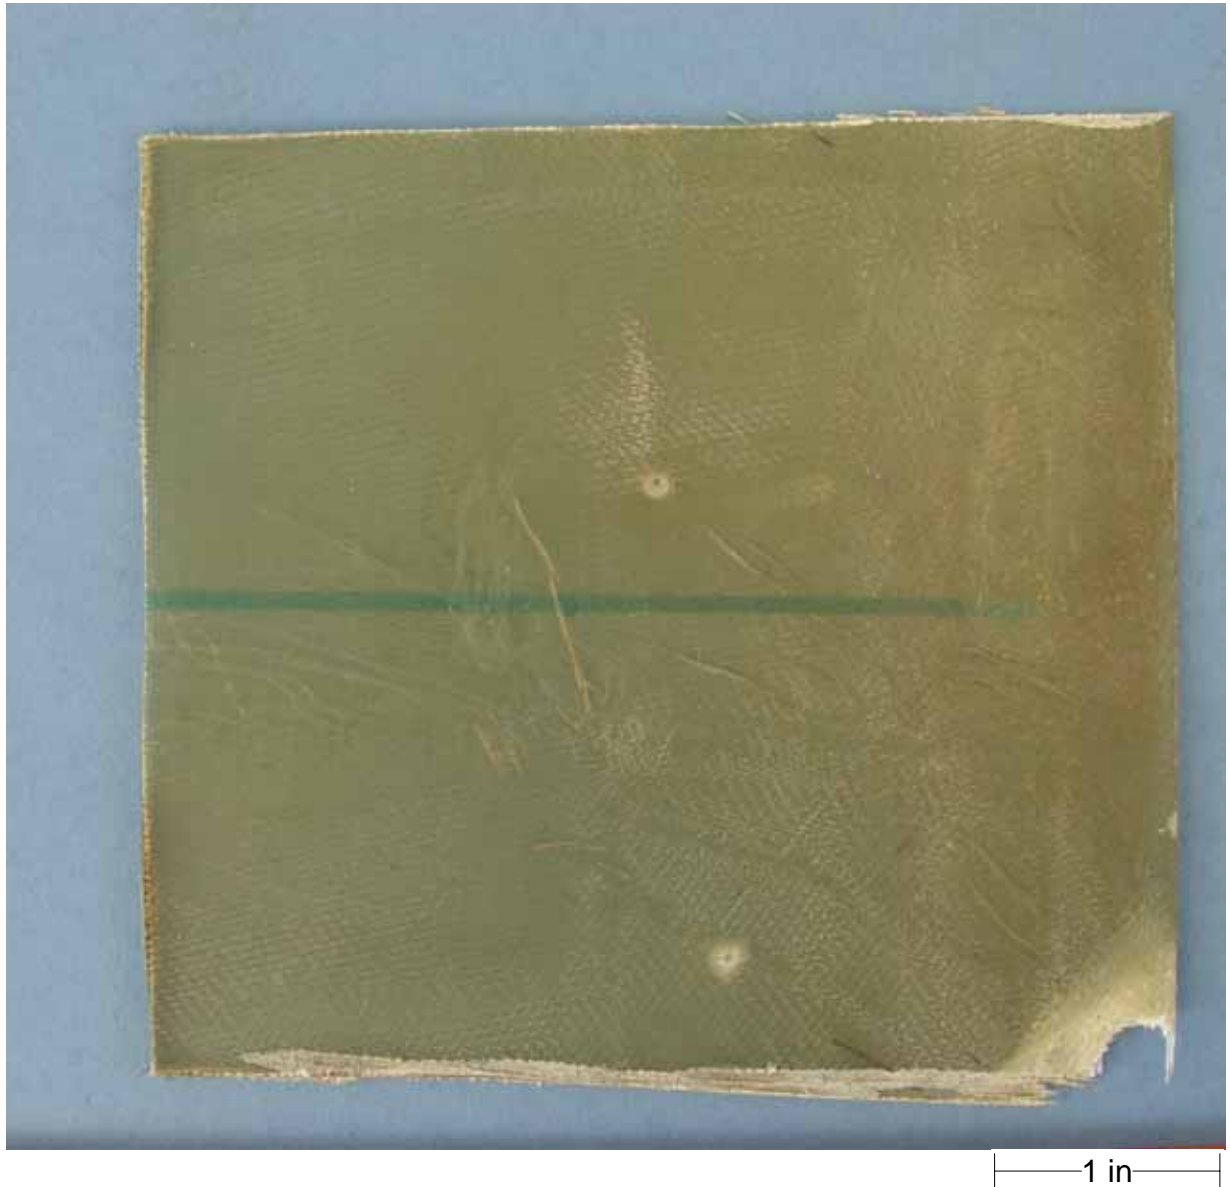
the submitted piece after a corner piece was removed for examination. SEM examination of the fractured corner piece revealed the wall contained a cross weave pattern of straight rod fibers, oriented 90 degrees to each other in a polymer matrix. For comparison purpose, Table 1 provides a description summary of particles that were found in the spool circumferential balance groove portions of the PRV for the number 1 and 2 engines and fiber sample found in the exemplar collector can. The diameter of the straight rod fibers from the collector tank measured between 8 and 10 micrometers, similar to the diameter of the fibers found in all four circumferential balance groove portions of the spool from PRV in the number 1 engine. EDS analysis of a straight rod fiber from the collector can produced a spectrum the contained major elemental peaks of silicon, aluminum and calcium with minor element of magnesium, oxygen, carbon, consistent with silicate glass fiber such as E-glass.

Figure 26. Photograph of the fiberglass wall portion from an exemplar collector can that was submitted by Carson Helicopter Services Incorporated. A piece from the lower right corner was fractured at the Safety Board Materials Laboratory for examination.
