NATIONAL TRANSPORTATION SAFETY BOARD

MATERIALS LABORATORY FACTUAL REPORT

Report No. 09-063

Place : Sanderson, FL
Date : 07/08/2009
Vehicle : Noles Van's RV7
NTSB No. : ERA09LA392
Investigator : Corky Smith

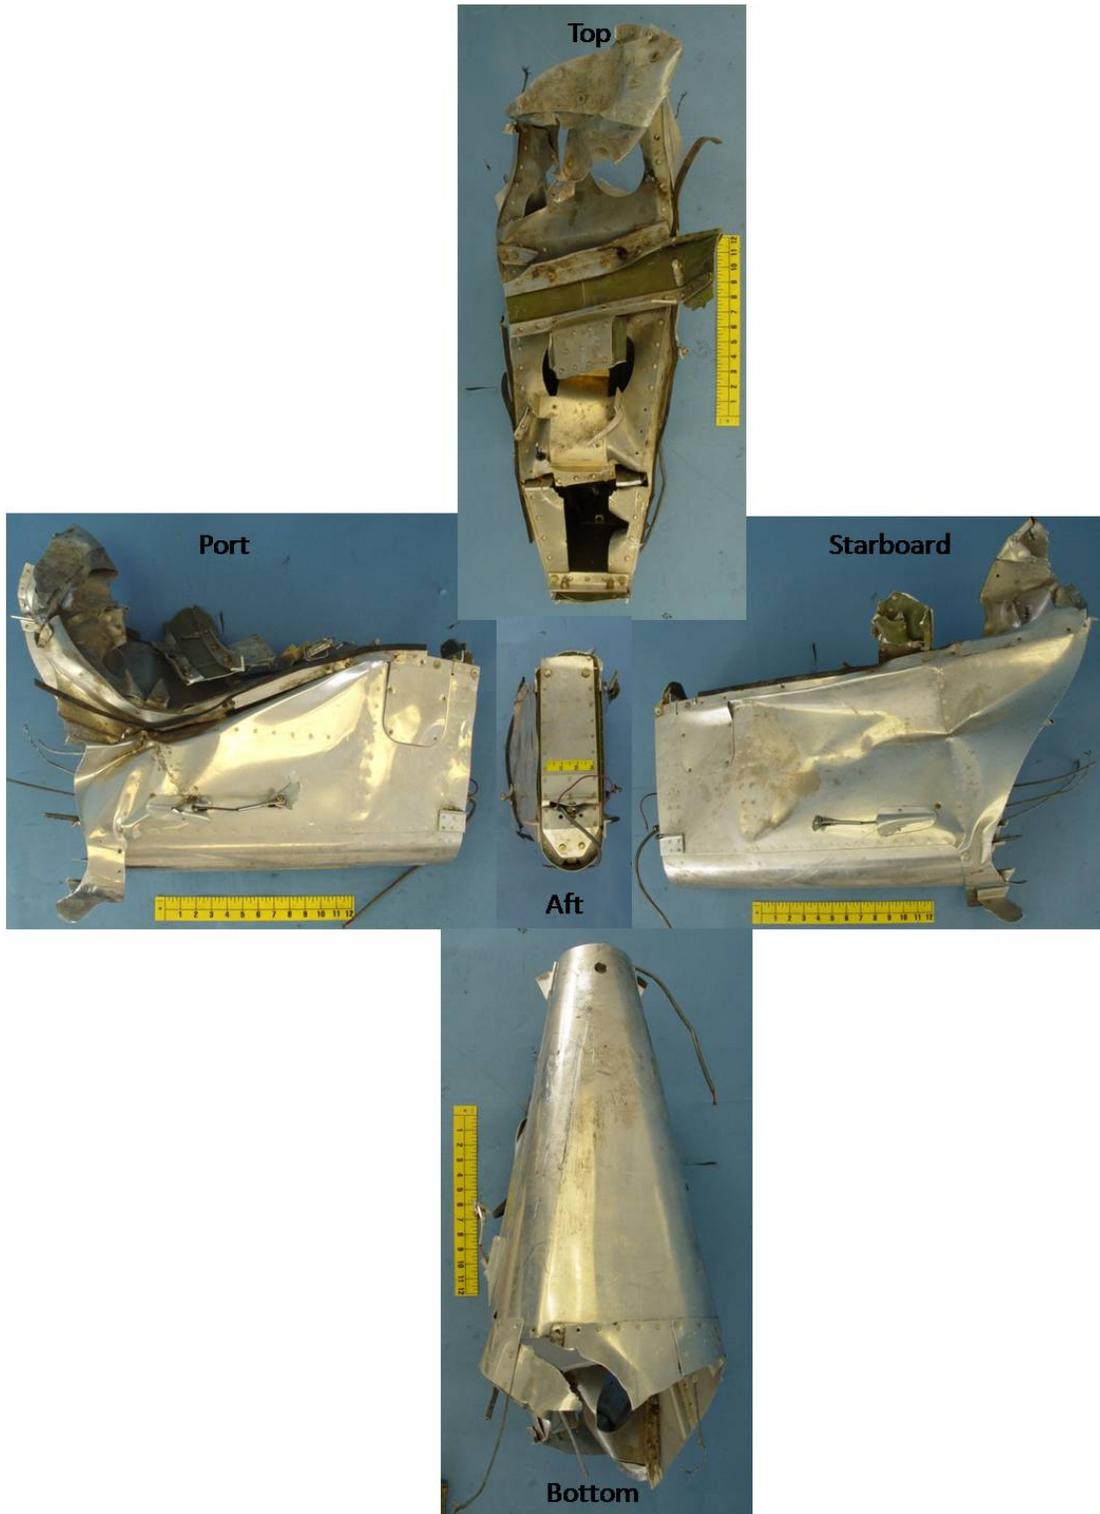
The piece tail section, as shown in Figure 1, was removed from the wreckage by a cutting saw. The horizontal stabilizers were also sawed from the piece of tail section. According to field investigators, the vertical stabilizer and rudder were not found at the wreckage site and have not been located. The purpose of this examination is to determine the mode of separation of the vertical stabilizer and rudder from the fuselage.

Figure 1 Projection montage of all sides of the piece of tail section.

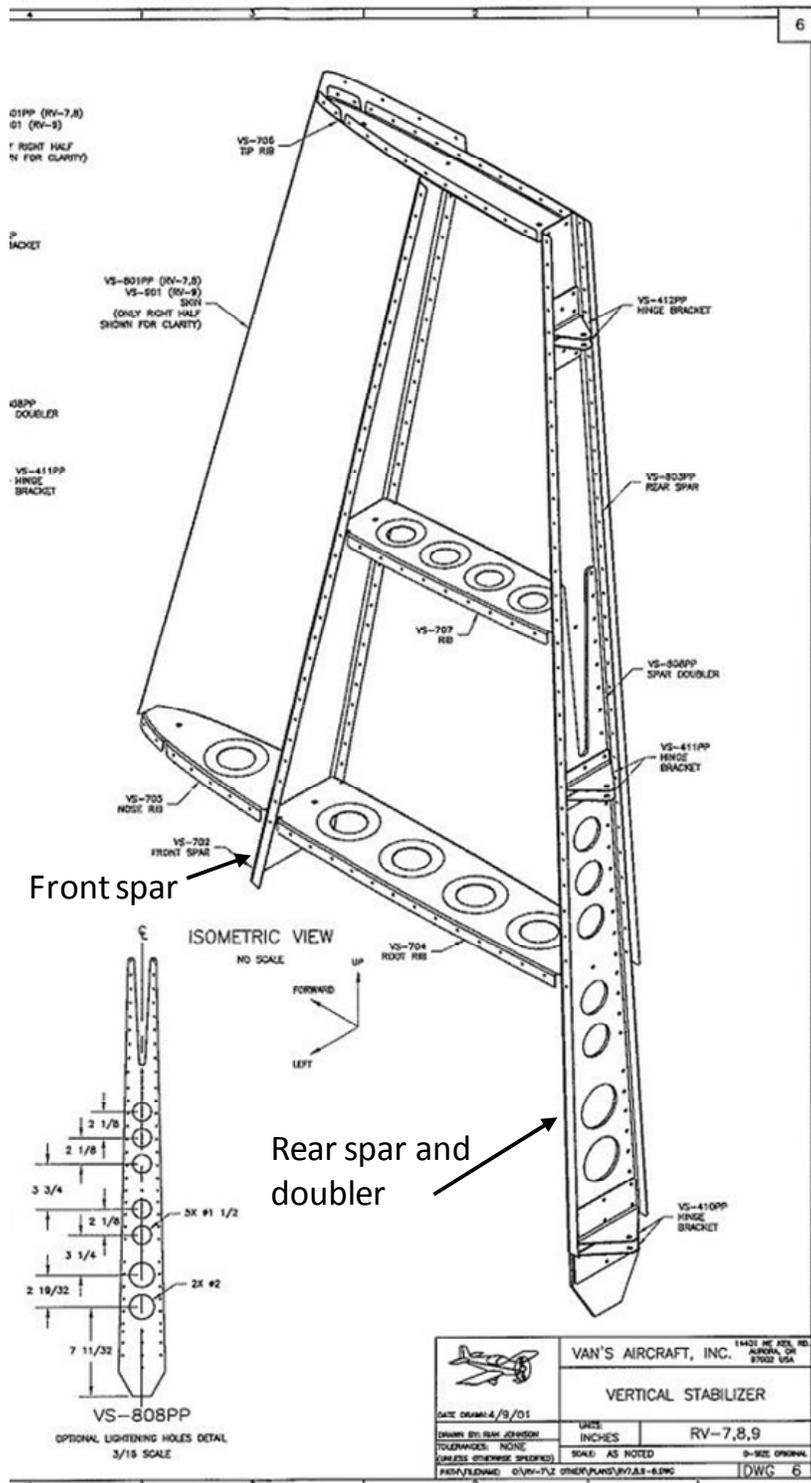
Figure 2 Portion of the assembly drawing for the vertical stabilizer showing the front and rear spars and the rear doubler.

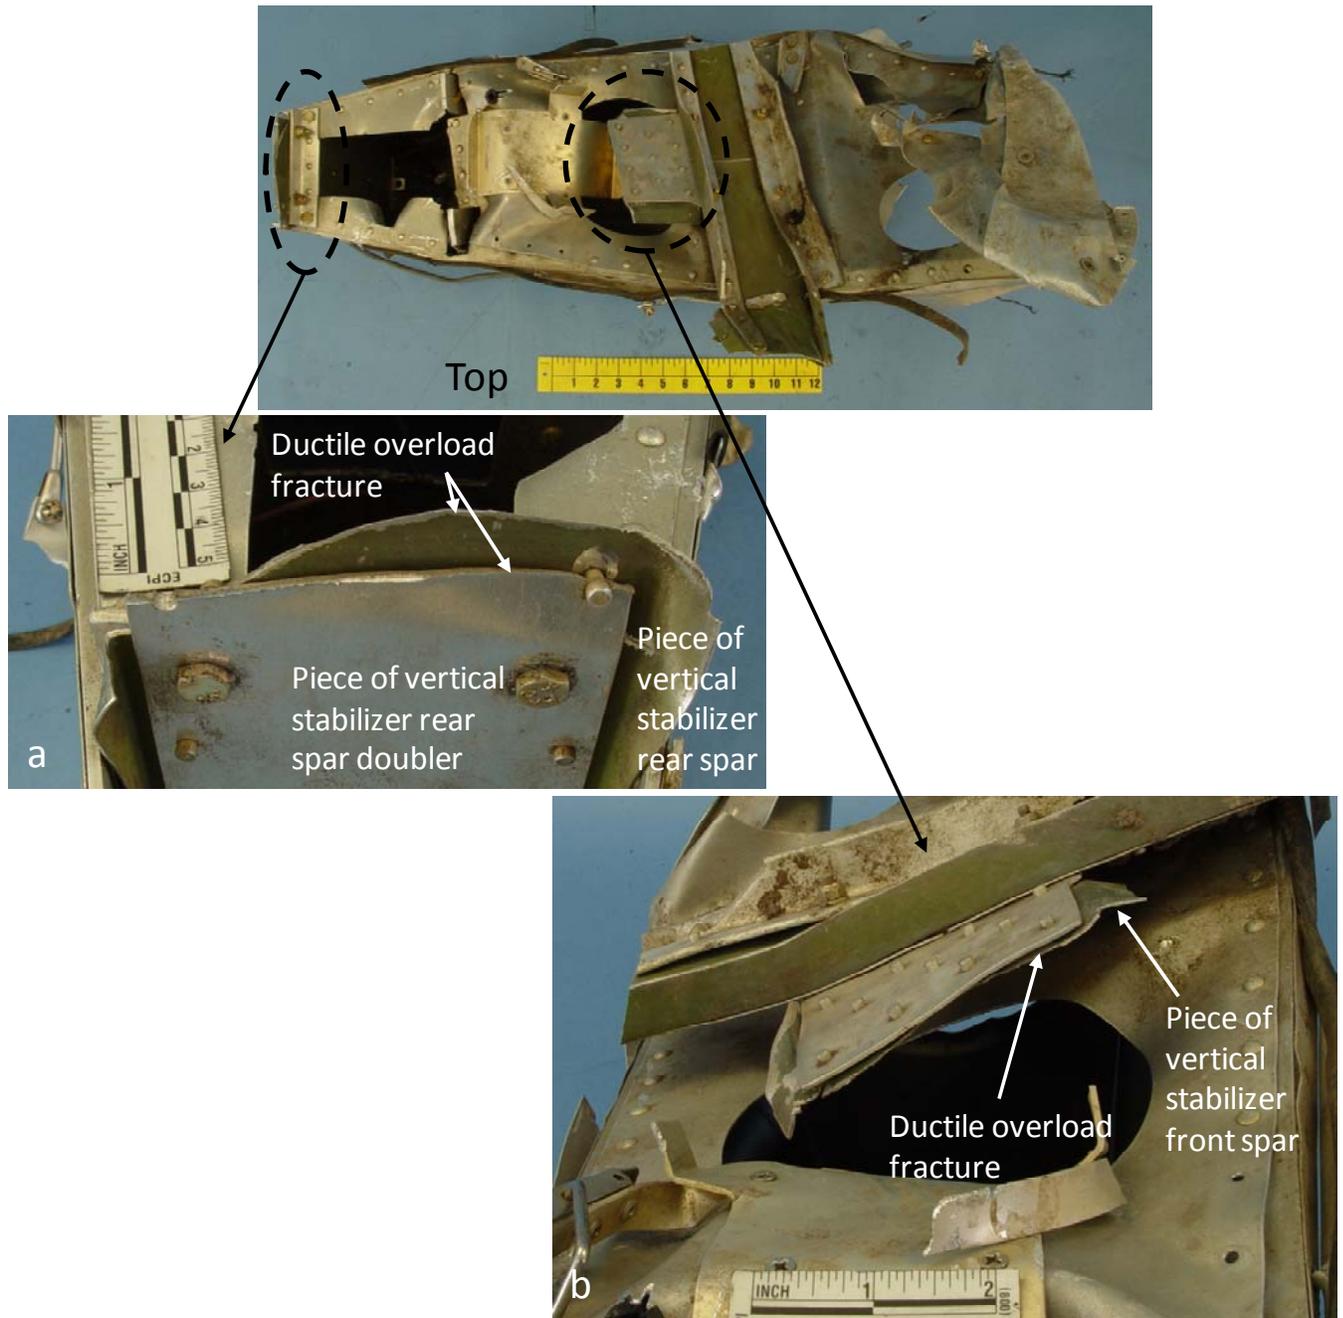
The vertical stabilizer is bolted to the tail of the fuselage at the forward spar and rear spar as depicted in Figure 2. Additionally, the rear spar is reinforced with a spar doubler which is riveted to the rear spar and bolted to the fuselage (also in Figure 2). As shown in Figure 3, the vertical stabilizer separated from the aircraft fuselage by fractures in the front spar and the rear spar/doubler assembly. The fracture surfaces on the front and rear spar pieces and the rear doubler piece exhibited slant-fracture features consistent with ductile overload. No evidence of preexisting damage such as fatigue or corrosion is noted.

Figure 3 a) macrograph showing the ductile overload fracture surfaces of the rear spar and rear spar doubler for the vertical stabilizer. b) macrograph showing the ductile overload fracture surface of the front spar for the vertical stabilizer.

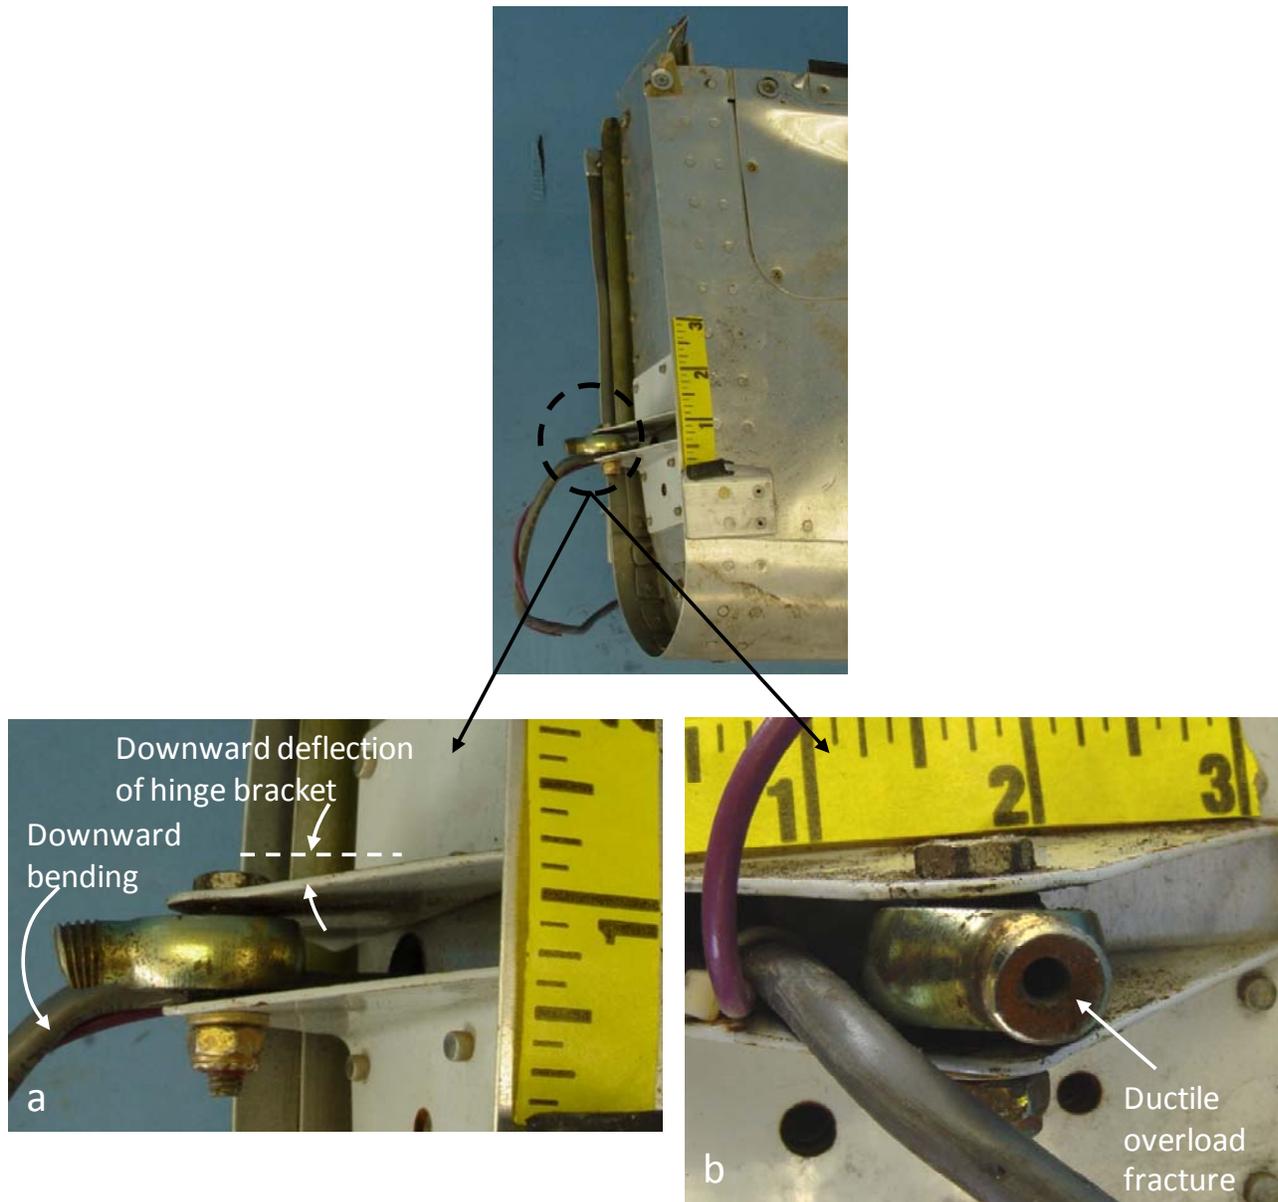
Figure 4 shows macrographs of the lower rudder hinge bracket and rod end assembly. As noted in Figure 4a, the rudder hinge brackets are bent downward and the threaded portion of the rod end is also bent downward. Figure 4b indicates that the threaded portion of the rod end fractured by ductile mechanical overload.

Figure 4 a) macrograph showing bent rudder hinge brackets and bent threads on a rod end. b) macrograph showing ductile overload fracture surface of the threaded section of the rod end.

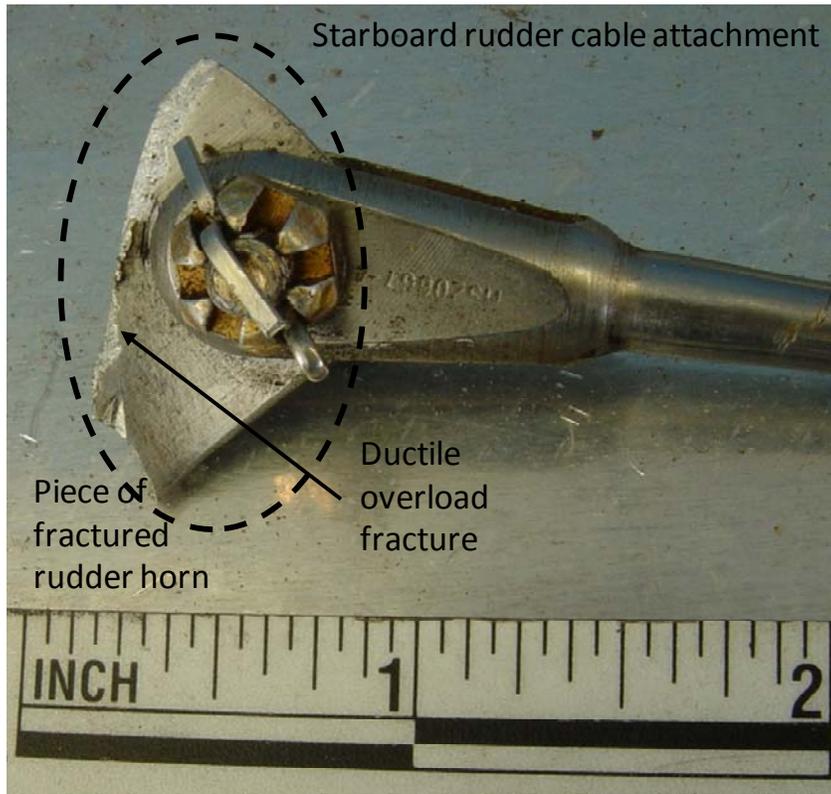
Figure 5 and 6 show macrographs of the starboard and port rudder cable clevises with pieces of rudder control horn bolted in place. In both instances, the rudder control horn fractured from the rudder cable clevises by ductile overload of the aluminum horn.

Figure 5 Macrograph showing a fractured piece of the starboard side rudder horn.

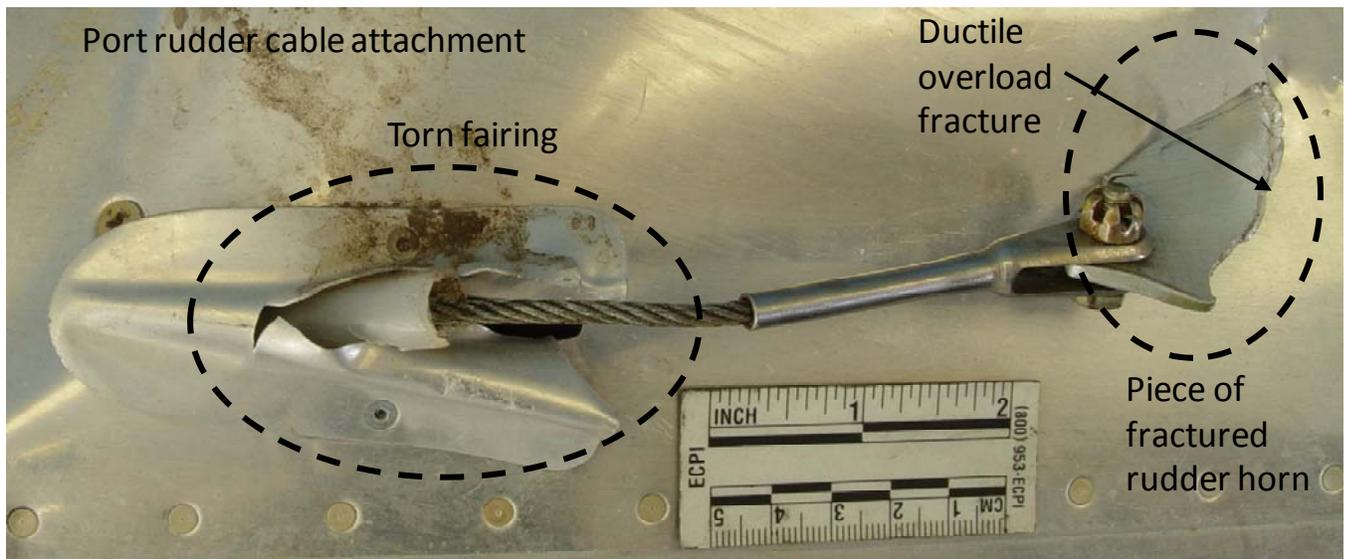
Figure 6 Macrograph showing a fractured piece of the port side rudder horn and torn fairing.
