# NATIONAL TRANSPORTATION SAFETY BOARD

MATERIALS LABORATORY FACTUAL REPORT

Report No. 09-094

Place : Goode Army Airfield, Afghanistan  
Date : August 19, 2009  
Vehicle : Sikorsky S-61  
NTSB No. : ENG09SA023  
Investigator : Mike Hauf (AS-40)

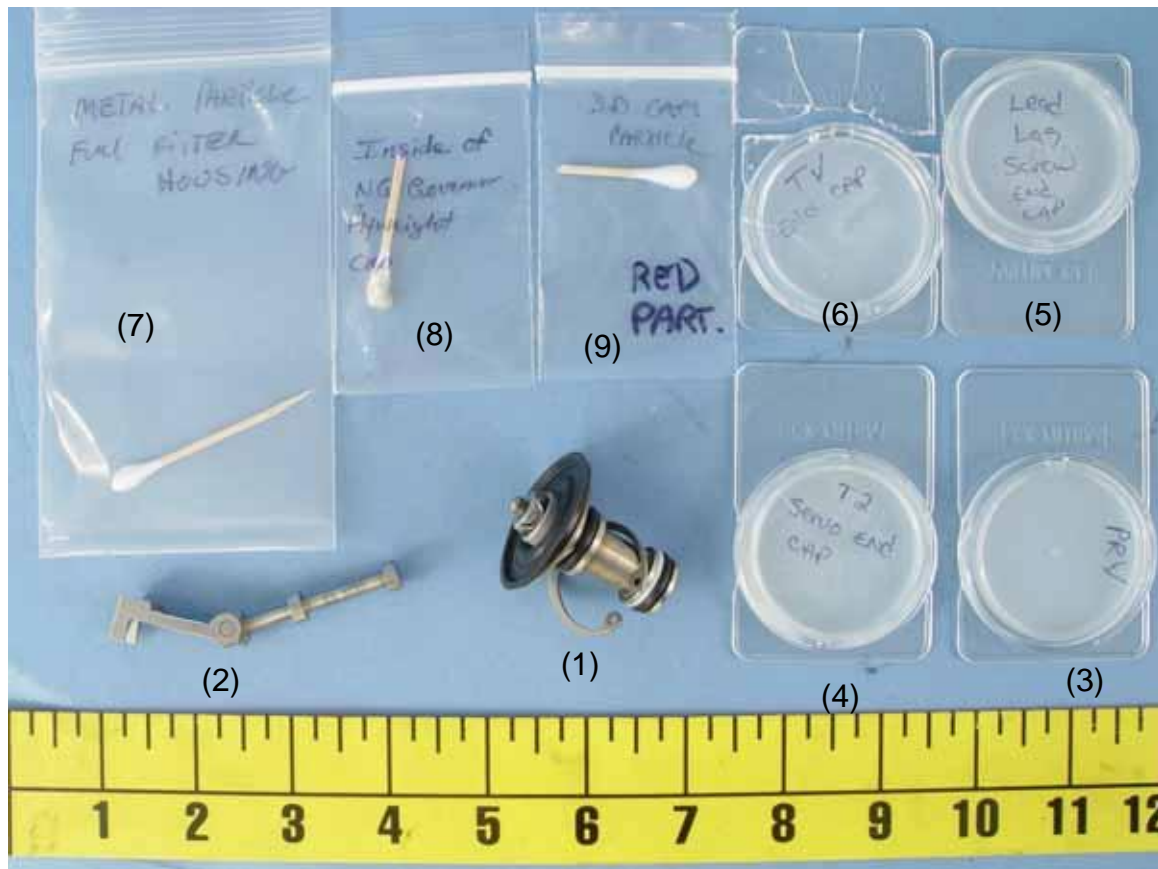
A photograph of the as-received spool and sleeve portion of the pressure relief valve (PRV); the rod portion of the pilot valve; contamination particles from various portions of the FCU is shown in figure 1. The spool was received inserted in the sleeve portion of the PRV.

Figure 1. Photograph of the as-received (1) spool and sleeve portion of the pressure relief valve with retaining ring; (2) rod portion of the pilot valve; (3) specimen container with cover labeled "PRV"; (4) specimen container with cover labeled "T2 servo end cap"; (5) specimen container with cover labeled "lead lag screw end cap"; (6) specimen container with cover labeled "TV (throttle valve) end cap"; (7) specimen bag with cotton swab labeled "metal particle fuel filter housing"; (8) specimen bag with cotton swab labeled "inside of NG Governor flyweight cap"; and (9) specimen bag with cotton swab labeled "3D CAM particle" that contained a red particle that was freely moving within the bag. The numbers on this page were randomly selected to facilitate identification of the submitted pieces and do not correspond to sample numbers used later in this report.

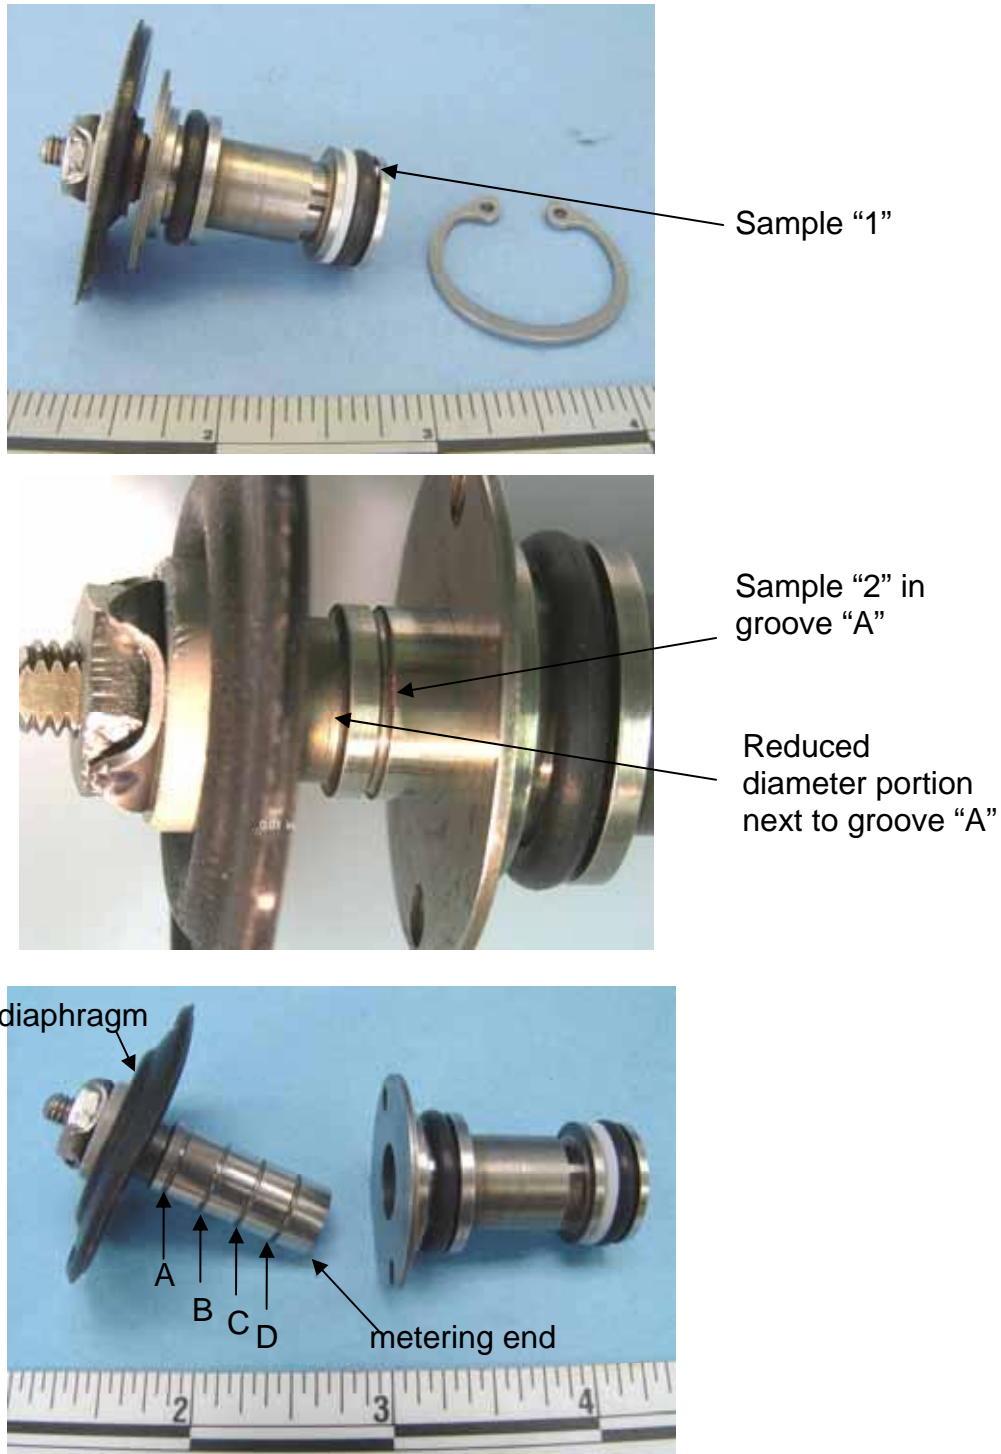
Bench binocular examination of the sleeve portion of the PRV before the spool was disassembled from the sleeve revealed the outer wall of the sleeve contained a particle, referred to as sample "1" in figure 2, which was embedded between the rubber O-ring and the housing near the bore at the metering end. Sample "1" was irregular and displayed a luster. This sample was removed with tweezers from the sleeve and placed on an aluminum stub that was covered with doubled-sided carbon adhesive tape. Scanning electron microscope (SEM) examination of sample "1" revealed a major portion of the fracture face contained smear (mechanical) damage. Figure 3 shows an SEM photograph of this sample. The areas of the fracture that contained no evidence of smear damage showed ductile dimple fracture features typical of overstress separation with no evidence of fatigue cracking. X-ray energy dispersive spectroscopy (EDS) analysis of sample "1" produced a spectrum that contained a major elemental peak of aluminum, and minor

A spool portion contains four circumferential balance grooves, referred to as grooves "A" through "D" in figure 2. Groove "A" was located next to the diaphragm portion and groove "D" was located next to the metering end. The spool portion was pulled out of the sleeve in increments to expose one groove at a time. Each time a new groove was exposed, the spool was rotated and the complete circumference was examined with bench binocular microscope for evidence of particles. During the examination at the Safety Board Materials Laboratory, the spool was completely pulled out of the sleeve with no resistance and with no evidence of binding. Particle(s) from the spool were pulled out of the groove with doubled-sided carbon adhesive tape and, in turn, this tape was placed on an aluminum stub. Particle(s) were examined by SEM, analyzed by EDS, and the approximate length, width, thickness, and elements in the particle(s) was determined.

Figure 2. Photographs of the as-received spool portion that was inserted into the sleeve portion (top of page); spool partially removed from the sleeve portion showing a red particle that was attached to balance groove "A" (center of page); spool portion disassembled from the sleeve portion showing grooves labeled A" through "D" (bottom of page).

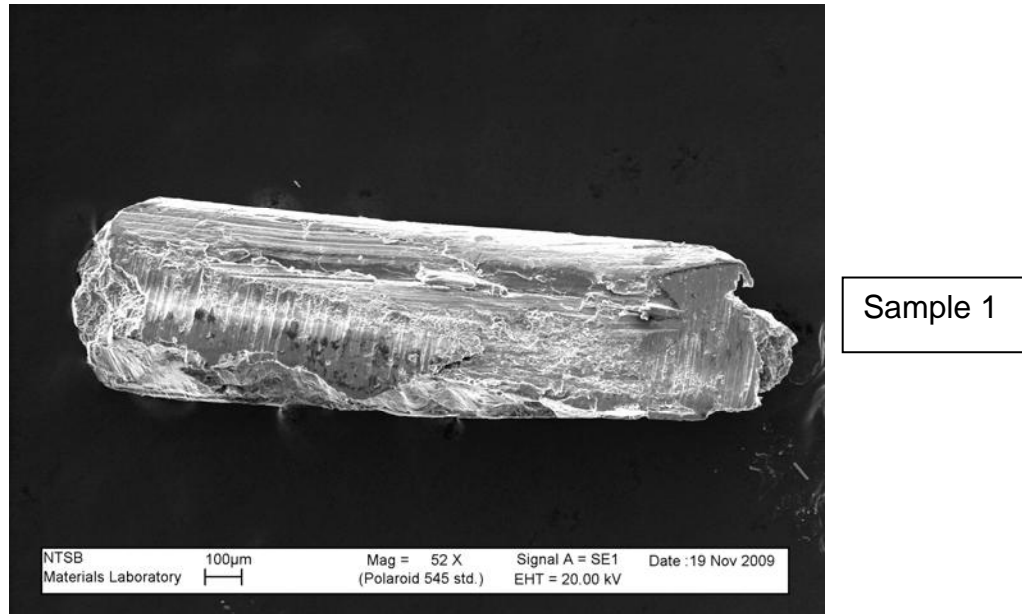
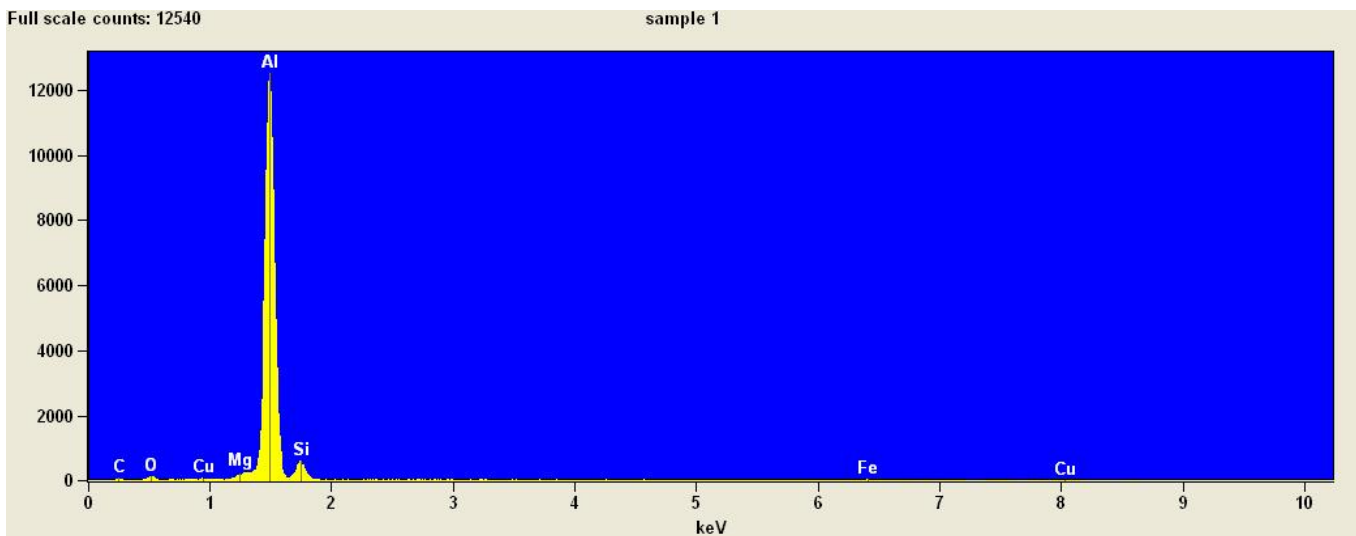
elemental peaks of silicon, magnesium, iron, copper, carbon, and oxygen, consistent with an aluminum alloy, as shown in figure 2. The grade of the aluminum alloy was not determined. Table 1 provides a summary of the description, major elemental peaks that were found in the EDS spectrum, and size for sample 1. Table 1 also shows example(s) of materials that contain such element(s) and measured particle sizes. Particle sizes were reported in micrometers and converted to inches (shown in parentheses). Table 2 shows the conversion units for most of the particles that were measured in order of increasing size.

Figure 3. Scanning electron microscope (SEM) photograph of the particle referred to as sample "1" that was found on the outside surface of the sleeve in the area between the metering end of the sleeve and the rubber o-ring seal.

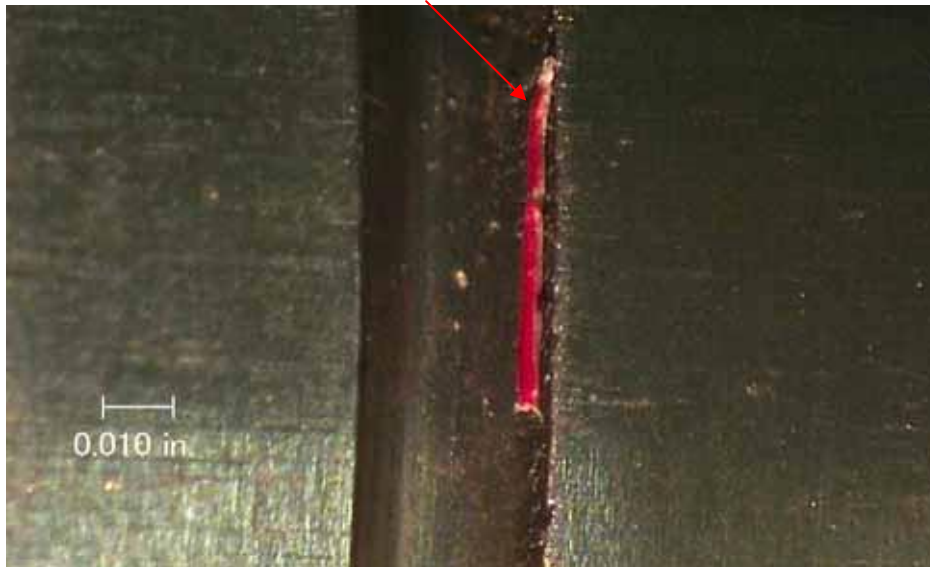
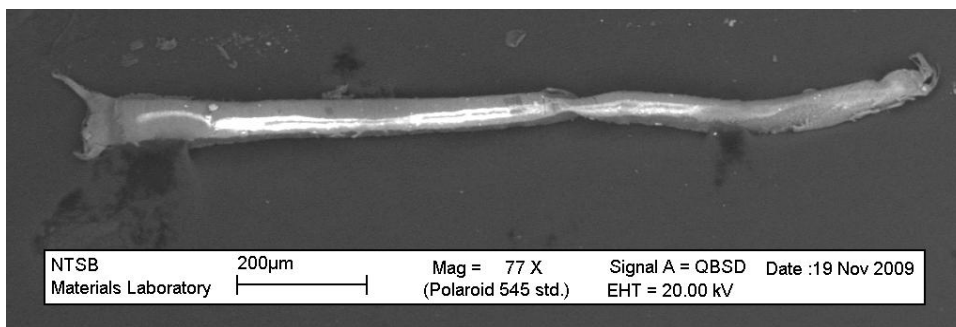
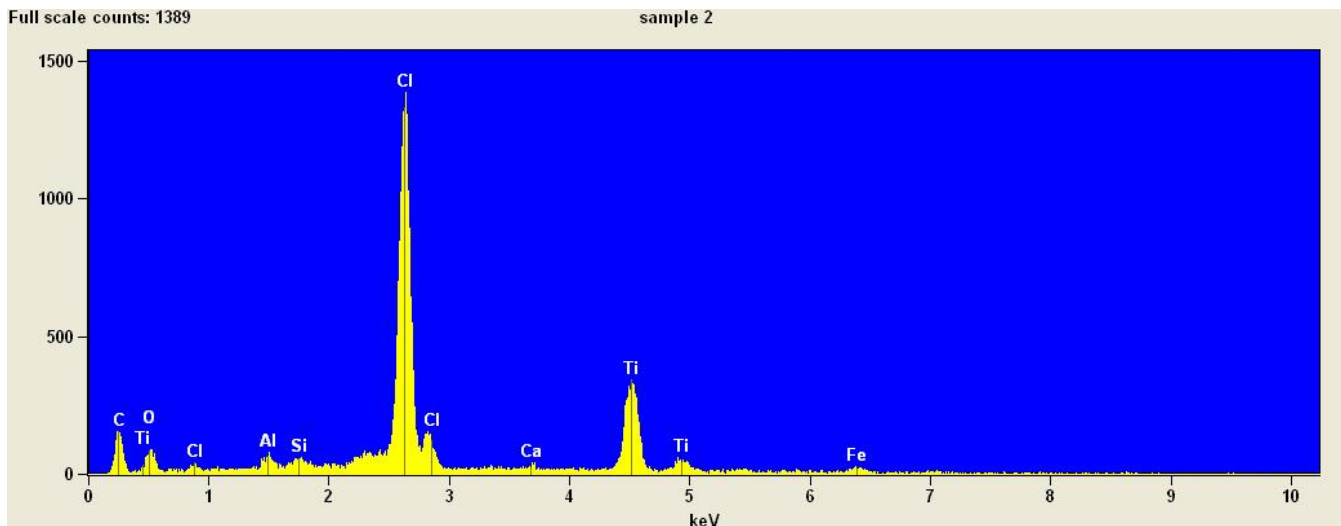
Sample 2 in groove "A"

Examination of the spool revealed groove "A" contained one narrow particle referred as sample "2" in figure 2 and at higher magnification in figure 4. This particle was red. When the particle was removed from groove "A", the back side of the particle was found to be white. EDS spectrum of this sample contained a major elemental peak of chlorine and minor elemental peaks of titanium, iron, calcium, aluminum, silicon, carbon, and oxygen, as shown in figure 4, consistent with a non-metallic material. Groove "B" contained dust-like particles in one isolated area of the groove, see figure 5. EDS analysis was performed on two typical particles, referred to as samples "3" and "3B". EDS spectrums of these two particles are consistent with a non-metallic material. Groove "C" contained one narrow particle that exhibited a luster, referred to as sample "4A" in figure 6. Initially, this sample was thought to have fallen out of the spool during extraction because the sample was not visible on the tape surface. However, SEM examination of the tape in electron backscatter mode (ability to detect materials with greater density than the tape) revealed sample "4A" was imbedded within the tape, and had fractured into two pieces. Two other particles were found in the tape, referred to as samples "4B" and "4C" in figure 6, which were not visible in the groove during bench binocular microscope examination. Figure 6 shows SEM photographs of samples "4B" and "4C". Figure 7 shows the EDS spectrum of samples "4A", "4B", and "4C". Samples "4A", "4B", and "4C" are consistent with nickel, cadmium, and stainless steel, respectively. Table 1 provides a summary description of particle(s) that were found in each groove and approximate sizes of each particle. Groove "D" contained one fiber referred to as sample 5 in figure 8. The EDS spectrum of this particle showed a major peak of carbon consistent with a non-metallic material, see figure 8.

Figure 4. Photograph of the spool portion of the PRV in the area of groove "A" showing a red particle referred to as "sample 2" that was found in this groove (top of page). SEM photograph of the same particle (center of page) and EDS spectrum of the same particle (bottom of page).

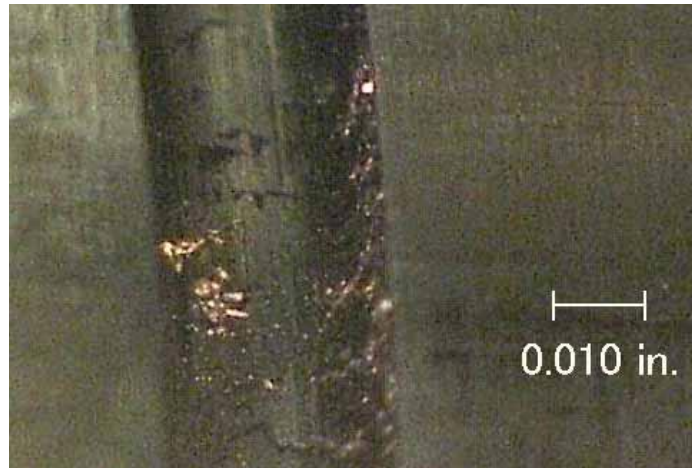
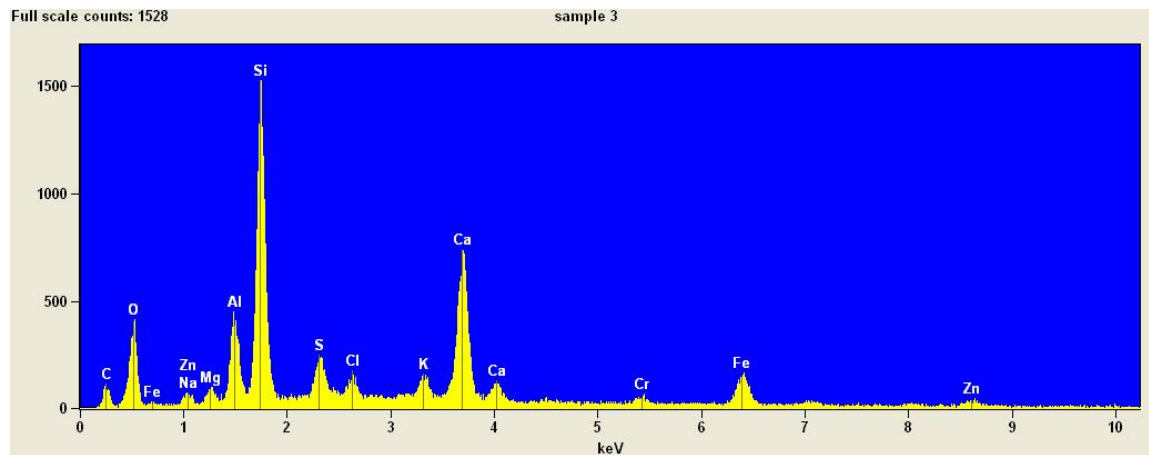
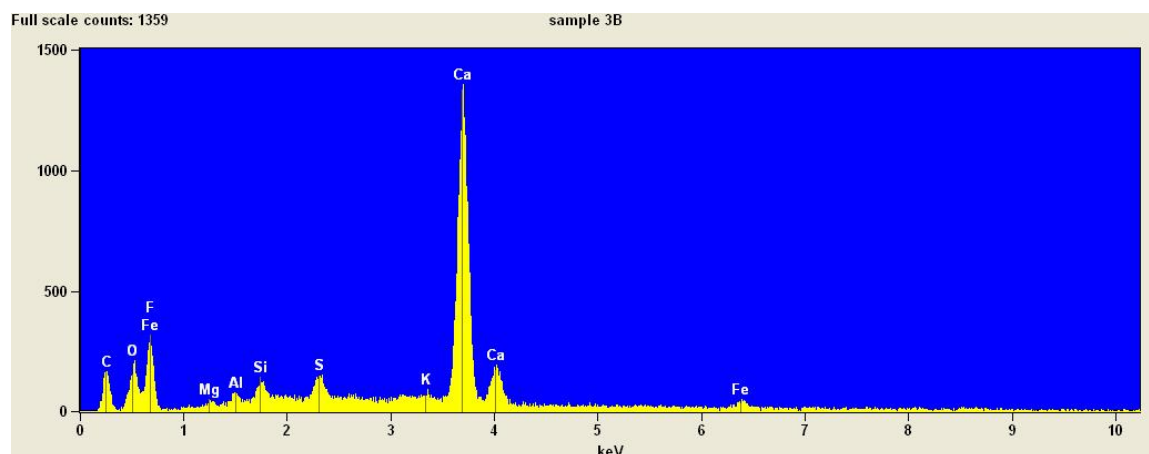
Dust particles in groove "B"

Figure 5. Photograph of the spool portion of the PRV in the area of groove "B" showing dust-like particles that were found in the groove (top of page). EDS spectrums from two typical dust-like particles referred to as sample "3" and "3B" are shown on the bottom of the page.

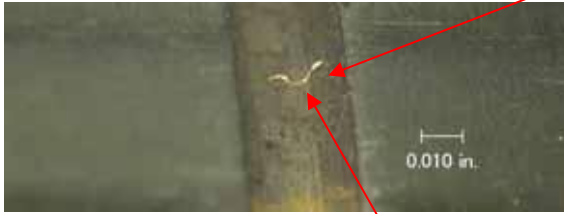
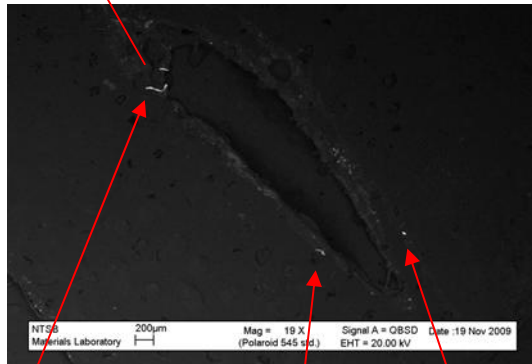
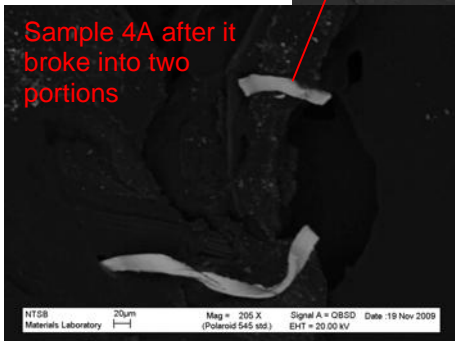
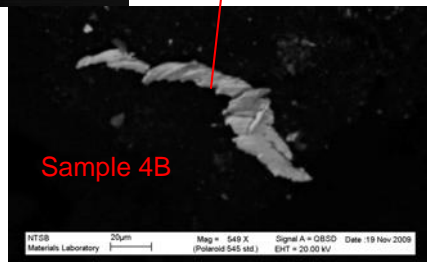
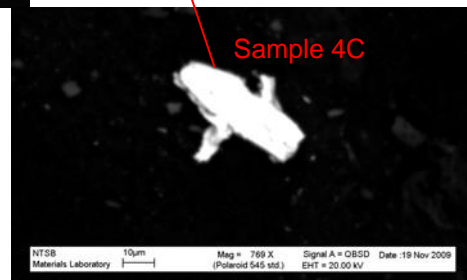
Sample "4A" in groove "C"

SEM photograph in backscatter mode showing particles (which appear white) embedded in the double sided adhesive tape (black background).

Figure 6. Photograph of narrow particle referred to as sample "4A" that was found in groove "C" of spool portion of the PRV (top of page). After removal with tape, sample "4A" fractured into two pieces. Follow-up examination of the tape with SEM in backscatter mode showed two additional particles (samples "4B" and "4C") were picked up on the tape that were not visible with binocular microscope.

Particles found in balance groove "C" portion of the spool	4A	Narrow, luster	Nickel	Nickel	380 (0.015)	20 (0.0008)	7 (0.0003)
	4B	Flat, irregular	Cadmium	Cadmium	132 (0.005)	20 (0.0008)	--
	4C	Flat, irregular	Iron, Chromium, Nickel	Stainless Steel	45 (0.002)	35 (0.0013)	--

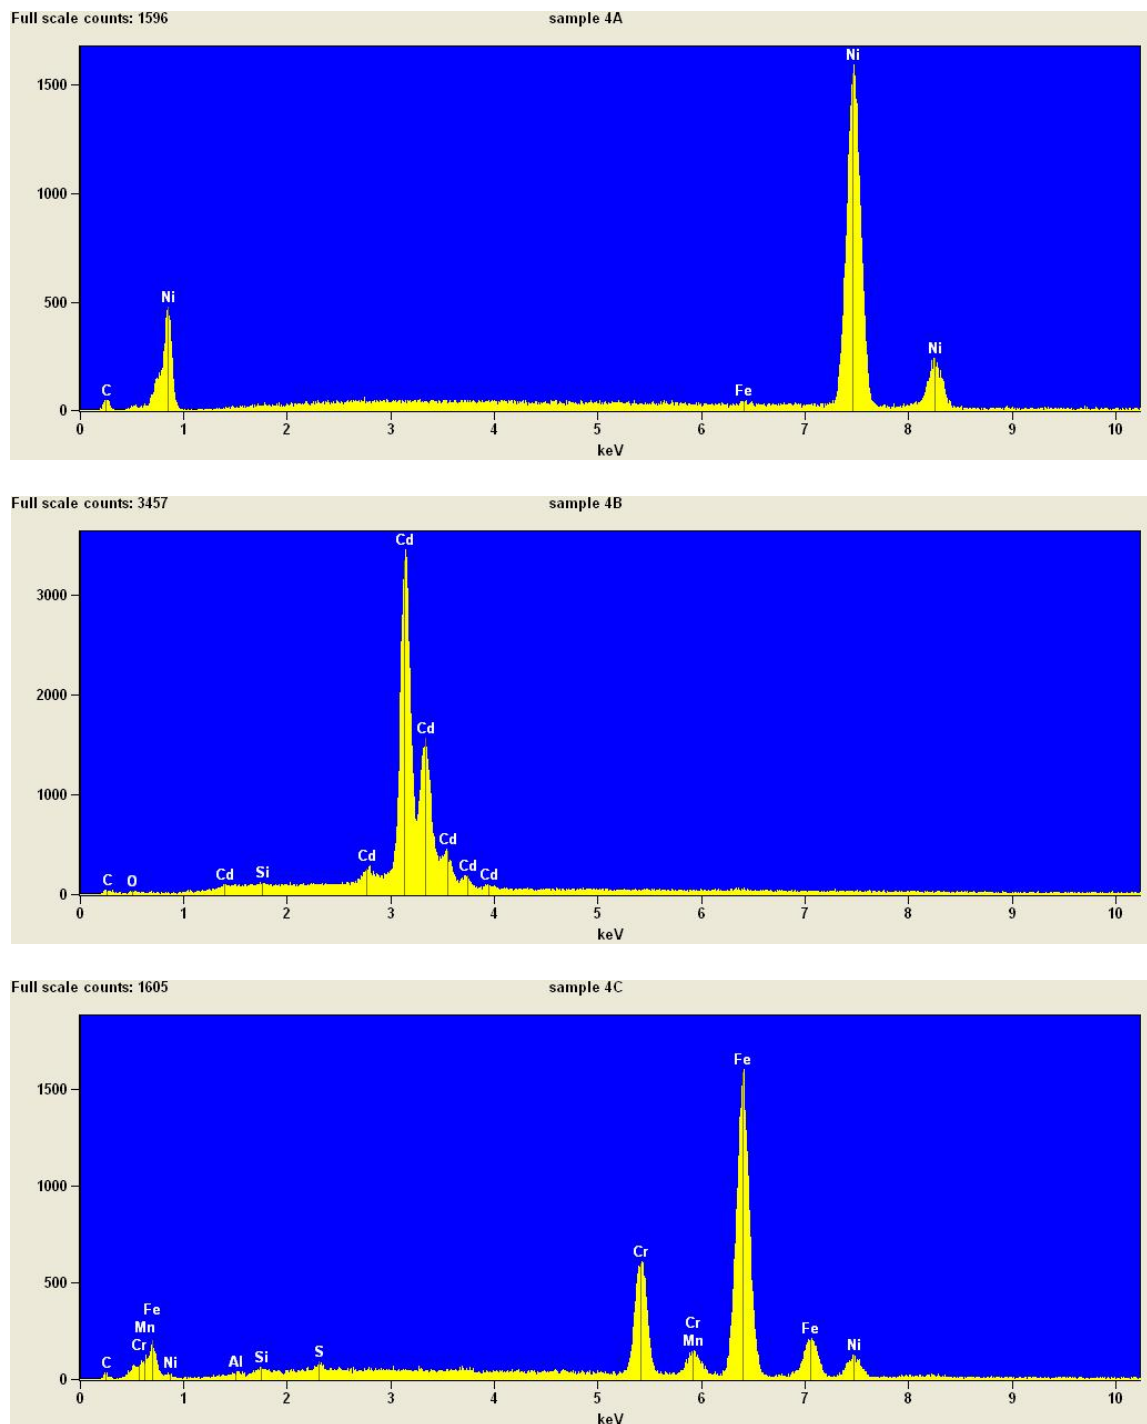
Figure 7. EDS spectrums of samples referred to as “4A”, “4B” and “4C”.

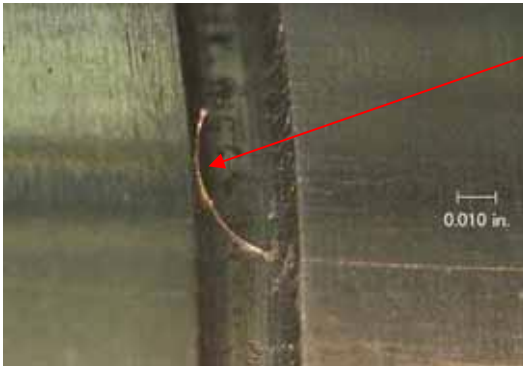
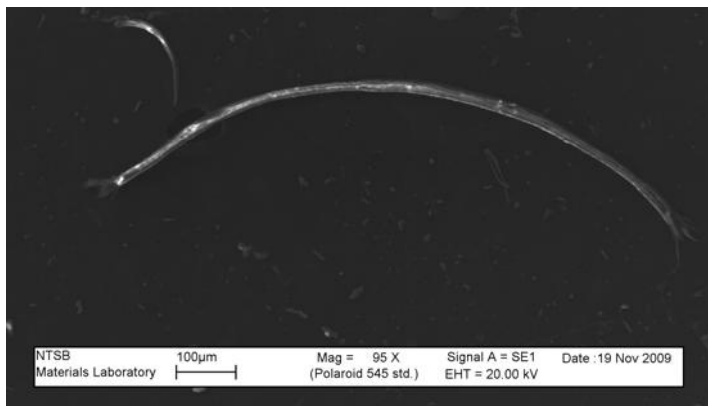
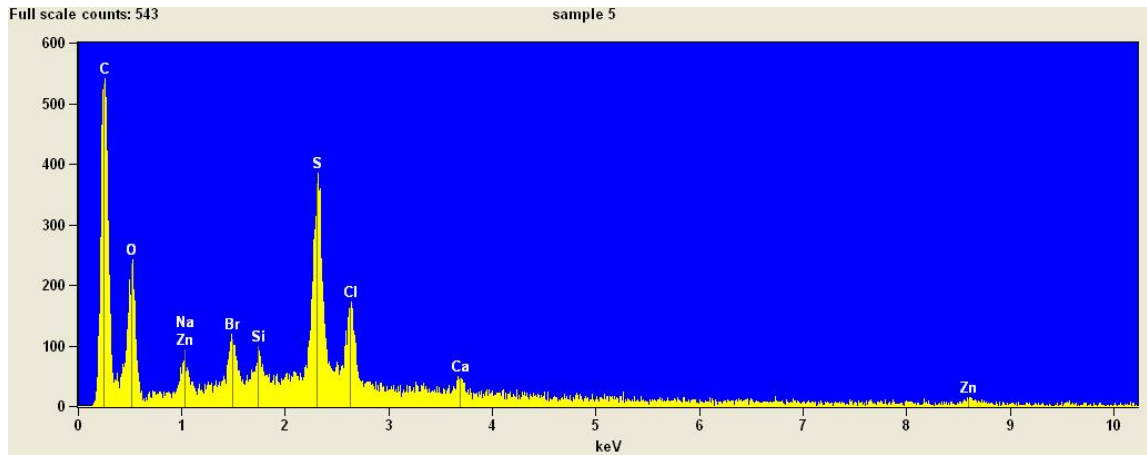
Sample 5 in groove "D"

Figure 8. Photograph of the spool portion of the PRV in the area of groove "D" showing a fiber referred to as sample 5 (top of page). SEM photograph of the same particle (center of page) and EDS spectrum of sample 5 (bottom of page).

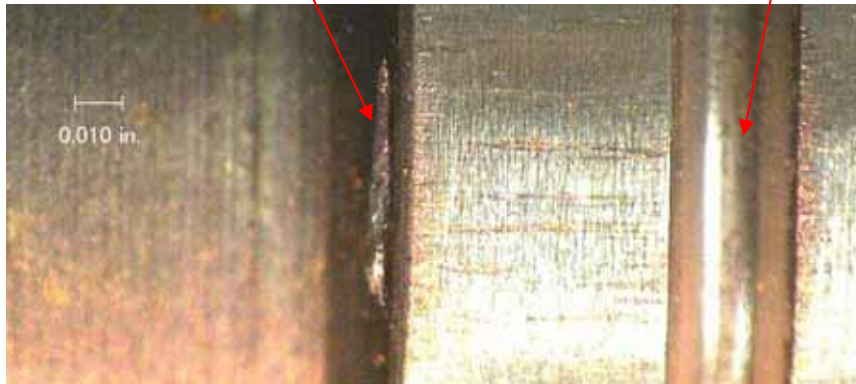
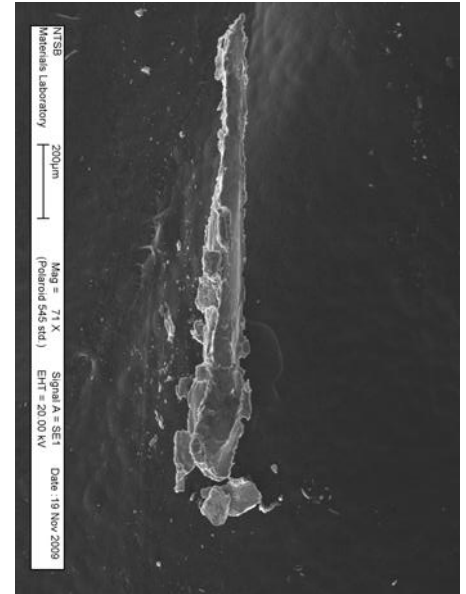
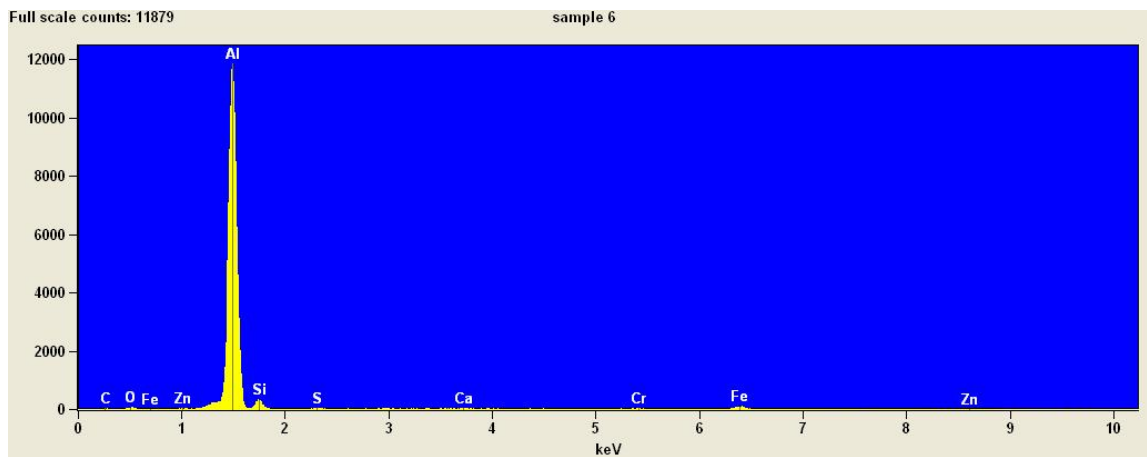
Sample "6" in the reduced diameter portion of spool

Areas outside of the grooves also were examined for evidence of particles. The reduced diameter portion of the spool in the area next to groove "A" contained one narrow particle referred to as sample 6 in figure 9. An EDS spectrum of this sample contained a major elemental peak of aluminum and minor peaks of silicon, zinc, iron, chromium, calcium, sulfur, oxygen, and carbon, consistent with an aluminum alloy. The grade of the aluminum alloy was not determined. The diaphragm is attached with a screw and nut to the spool. When looking into the bore of the spool from the metering end, the screw head was visible. Two particles were found embedded between the screw head and the bore of the spool, referred to as samples "7" and "8" in figure 10. EDS spectrums of samples "7" and "8" showed major elemental peaks of iron and chromium consistent with stainless steel. The EDS spectrum of sample "8" also contained minor elemental peaks of copper zinc, silver, tin, sulfur, aluminum, silicon, carbon and oxygen, consistent with materials typically found in bearing alloys. Table 1 provides a summary description of this sample and approximate size.

Figure 9. Photograph of a metal-like particle, referred to as sample "6", that was found on the reduced diameter portion of the spool in the area located between the diaphragm and groove "A" (upper left corner of page); SEM photograph of the same particle (upper right corner); and EDS spectrum of the particle (bottom of page).

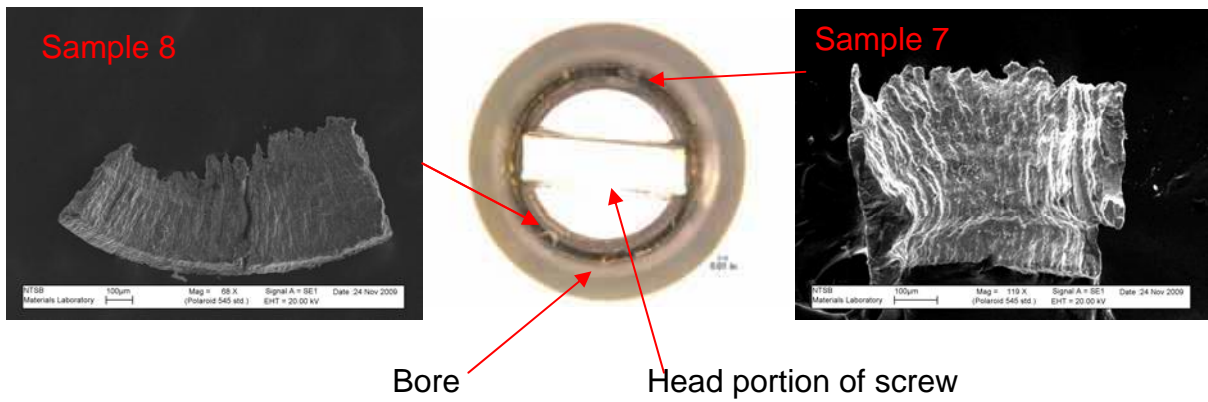
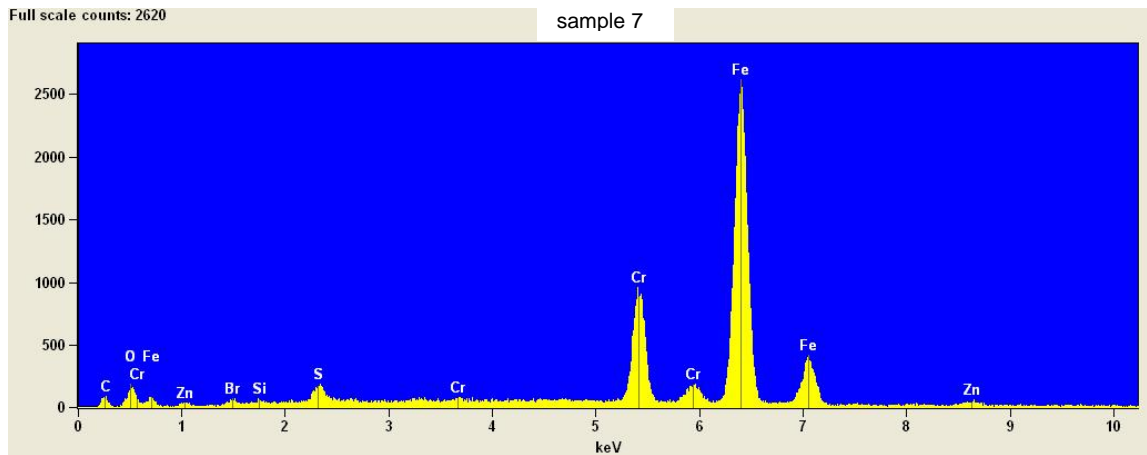
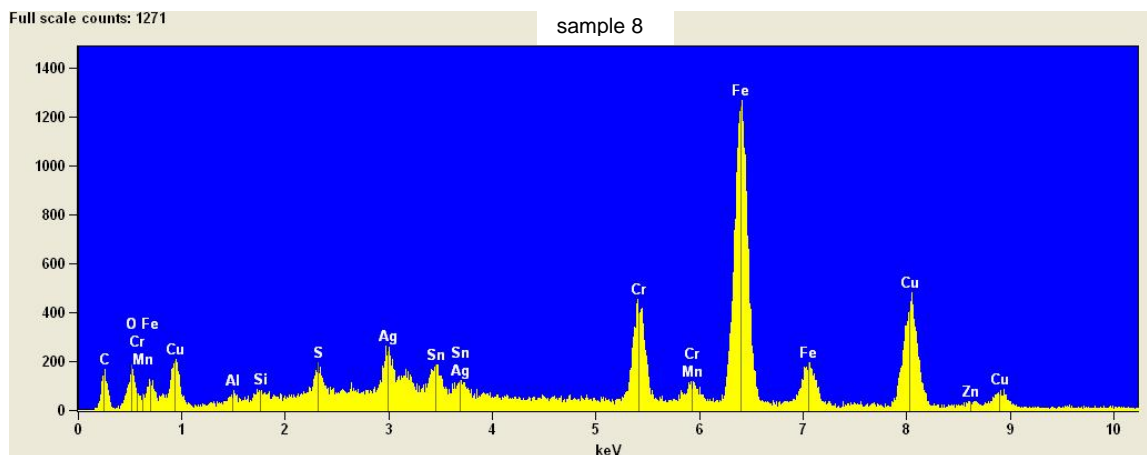
Figure 10. Photograph of the spool portion when looking into the bore and showing the head portion of the screw. Screw attaches the diaphragm to the spool. Particles referred to as sample 7 and 8 were found wedged between the head portion of the screw and the bore of the spool (top of page). EDS spectra of the two particles are shown at the bottom of the page.

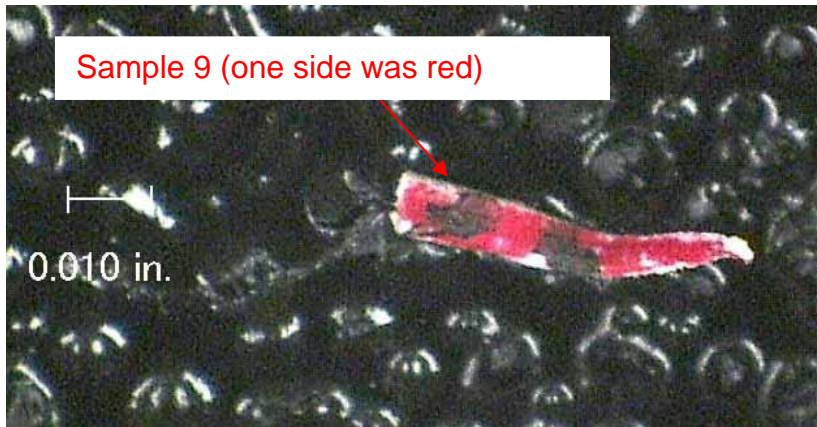
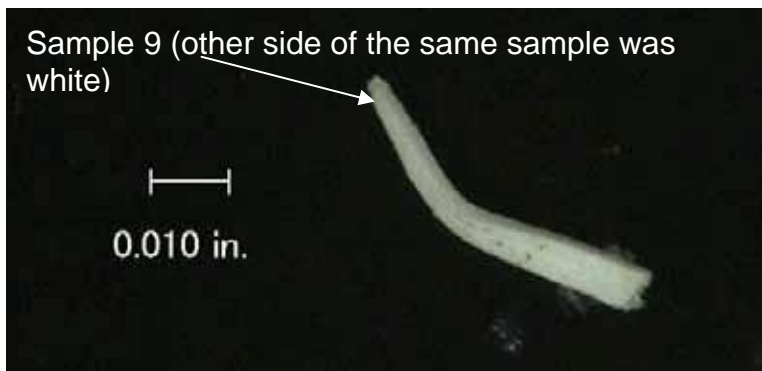
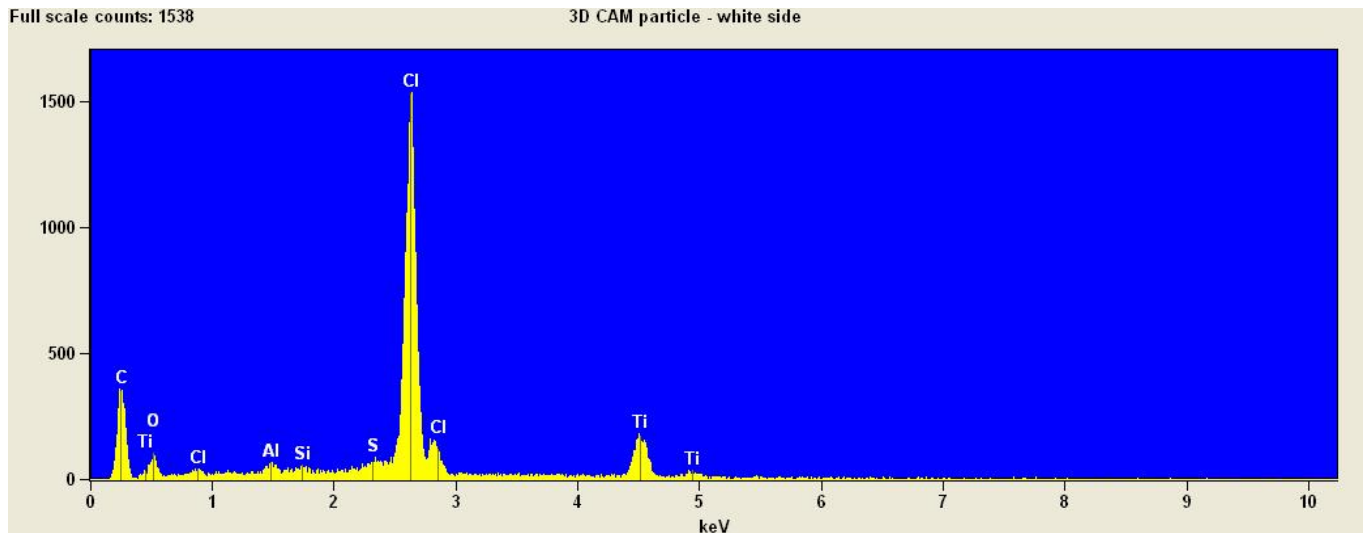
According to the Systems Group Chairman, contamination particles were found in various portions of the FCU during its examination at Columbia Helicopters, Inc. These particles were collected and placed in flexible plastic bags and rigid plastic containers, as show in figure 1. Plastic bag labeled "3D CAM particle" contained a cotton swab and a red particle at the bottom of the bag. For the purpose of this examination, the red particle was referred to as sample 9 in figure 11. Sample 9 was removed from the bag with tweezers and placed on an aluminum stub that was covered with doubled-sided carbon adhesive tape. When viewed with a bench binocular microscope, one side of sample 9 was red and the other side was white. Figure 11 shows a photograph of the red and white faces of sample 9 and EDS spectrum of this sample. EDS analysis of sample 9 produced a

spectrum that contained a major elemental peak of chlorine and minor peaks of titanium, sulfur, aluminum, silicon, oxygen and carbon, consistent with a non-metallic material. The approximate size of sample 9 is shown in table 1. The cotton swab showed no evidence of other particles.

Figure 11. Flat and narrow red particle removed from bag labeled “3D CAM particle”, referred to as sample 9. One side of the sample was red (top of page) and the other side of the same particle was white (center of page). EDS spectrum of the particle is shown at the bottom of the page.

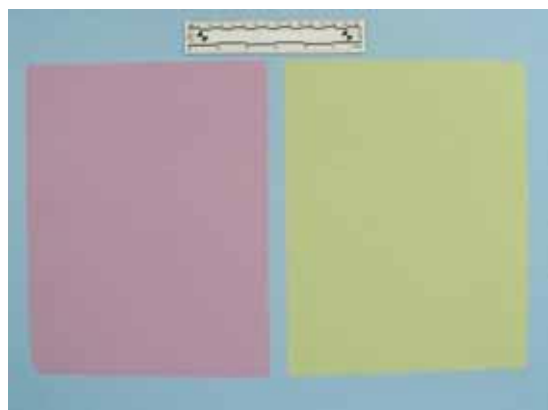
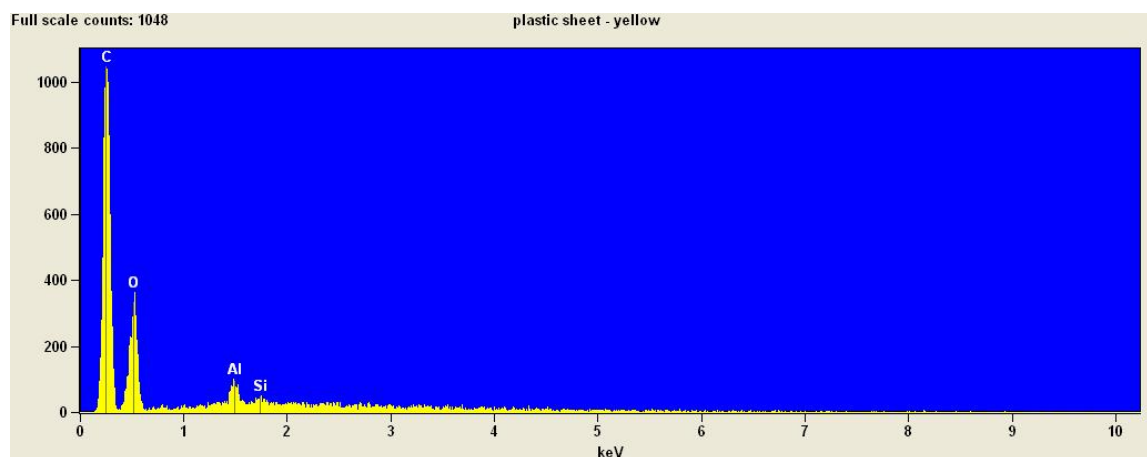
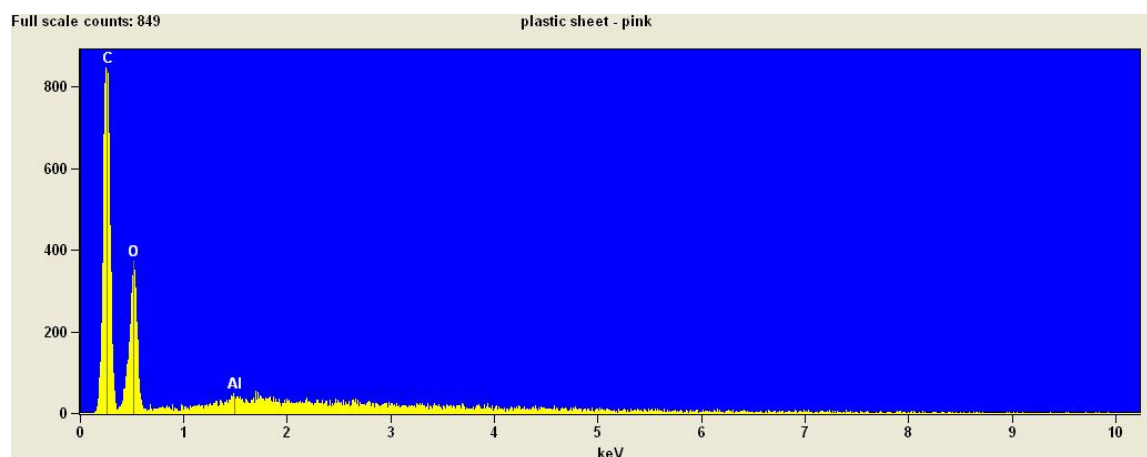
Two translucent plastic sheets were submitted by Columbia Helicopters Incorporated, as shown in figure 12. One sheet was pink throughout the thickness and the other sheet was yellow throughout the thickness, referred to as samples 16 and 17, respectively. Each sheet measured 8.5 inches by 11 inches. A representative from Columbia Helicopters Incorporated indicated the sheets are used as cleaning media for polishing and cleaning parts that are overhauled in their facility. The sheets are cut into smaller pieces when used as cleaning media. EDS analysis of a sample from each sheet produced a spectrum that contained major peaks of carbon and oxygen, as shown in figure 12.

Figure 12. Photograph of exemplar pink plastic sheet, sample 16, and yellow plastic sheet, sample 17, (top of page) shown against a blue background. EDS spectrums of the two sheets are shown at the bottom of the page.

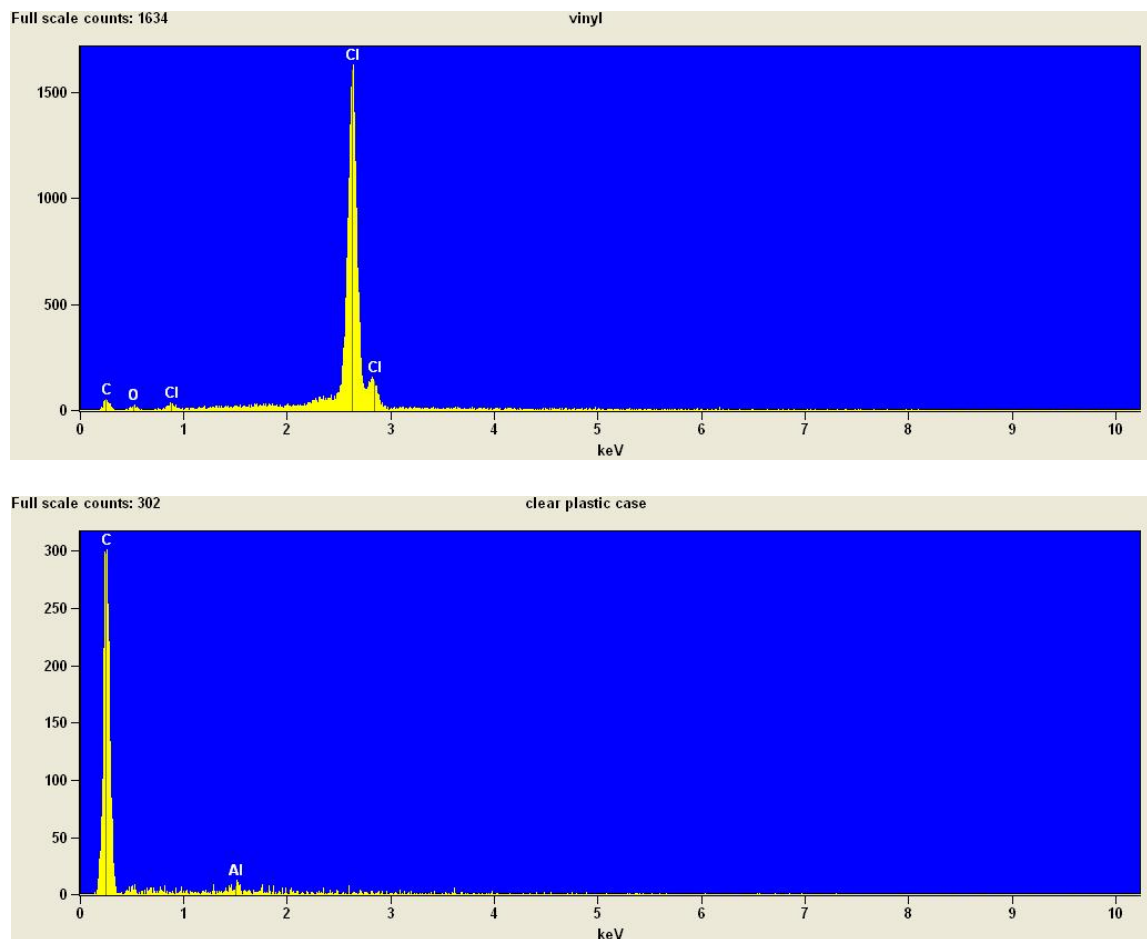
For purpose of comparison between particles, the Safety Board Materials Laboratory performed EDS analysis on a broken fragment of a clear plastic container that housed one of the submitted particles referred to as sample 18; and reference vinyl material, referred to as sample 19. EDS analysis of the clear plastic fragment from the container that housed one of the submitted particles produced a spectrum that contained a major peak of carbon and oxygen, whereas, the vinyl material produced a spectrum that contained a major peak of chlorine, as shown in figure 13.

Figure 13. EDS spectrum of a reference vinyl material (top of page) and broken fragment from the clear plastic container (bottom of page).

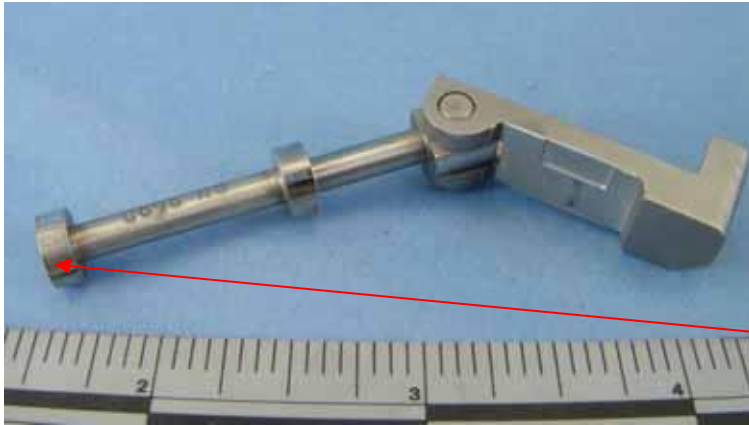
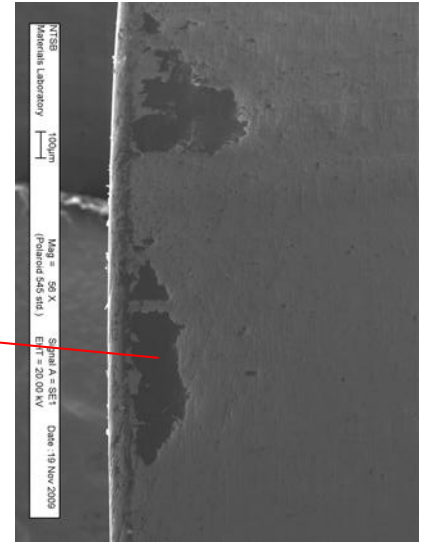
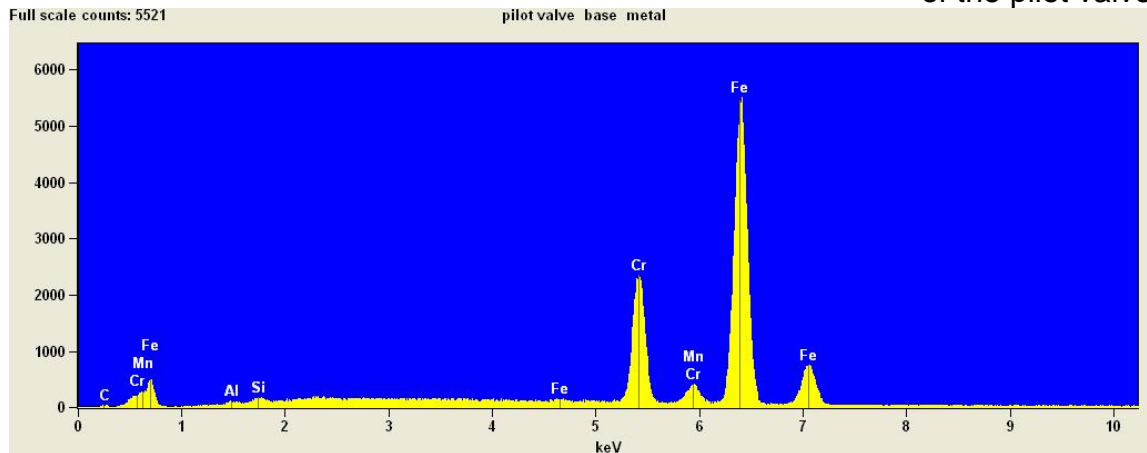
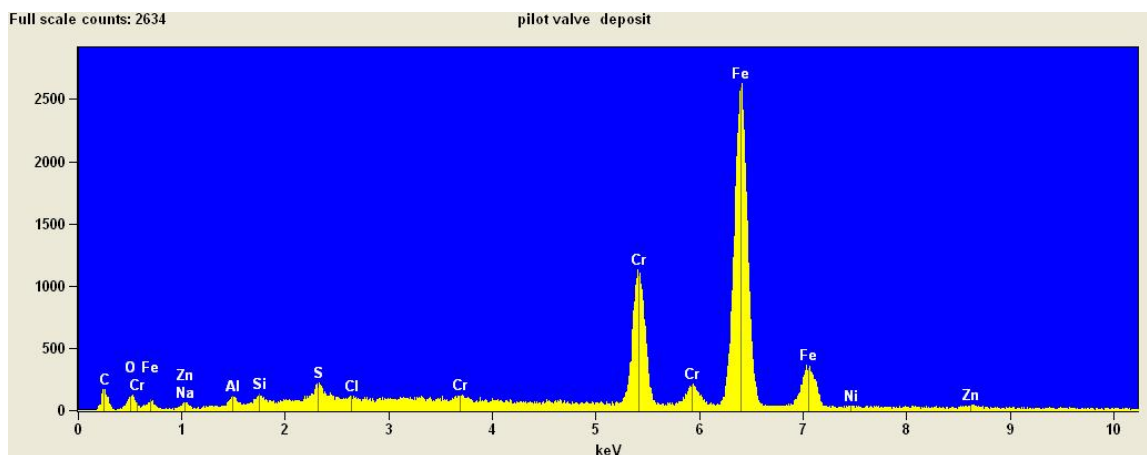
Pilot Valve

SEM examination of the pilot valve revealed the rod portions contained minor longitudinal score marks. The score marks measured as wide as 5 micrometer and the depth of the score marks was estimated to be as deep as the width (5 micrometer). EDS spectrum of the base metal produced a spectrum that contained major elemental peaks of iron, chromium, and nickel, consistent with stainless steel. The tip of a rod portion (left rod in figure 14) contained several deposits. The EDS spectrum of a deposit contained the same elemental peaks as the base metal as well as peaks of zinc, sulfur, and sodium. The EDS spectrum of the score marks (not shown) contained the same elemental peaks as the base metal for the pilot valve (score contained no transfer of foreign material).

Deposits at the rod portion of the pilot valve

Figure 14. Photograph of the pilot valve (upper left corner); SEM photograph of a rod portion of the pilot valve showing a deposit (upper right corner); EDS spectrum of the base metal (center of page); and EDS spectrum of the deposit found on the rod portion (bottom of page).
