NATIONAL TRANSPORTATION SAFETY BOARD

MATERIALS LABORATORY FACTUAL REPORT

Report No. 10-101

Place : Borrego Springs, California
Date : April 8, 2010
Vehicle : Snow Rocket F1 (N28VS)
NTSB No. : WPR10LA195
Investigator : Joshua Cawthra

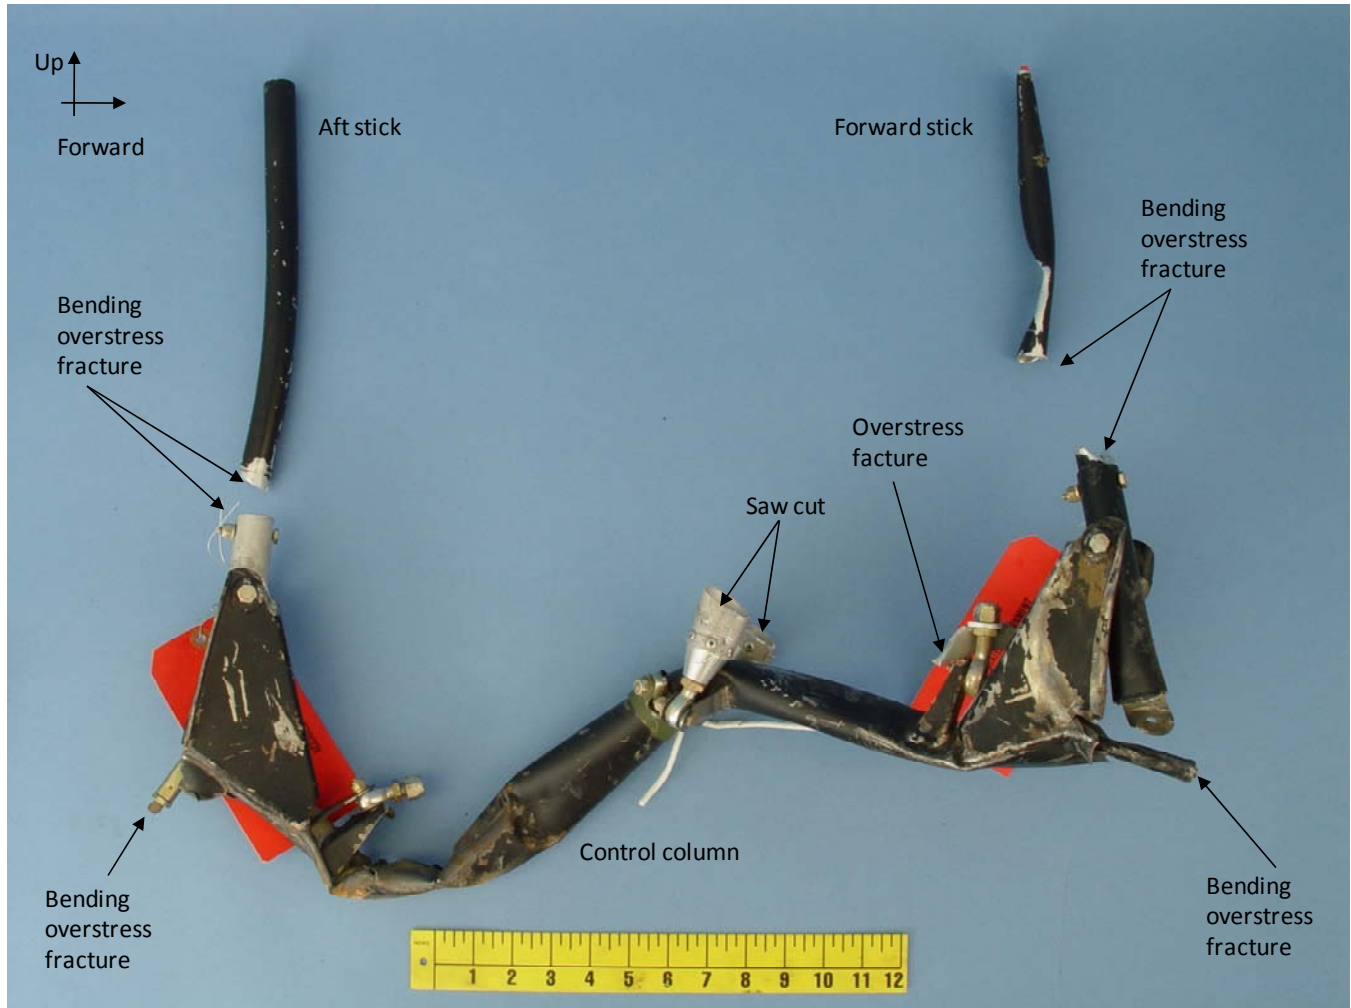
Figure 2 shows the partial control column assembly and the forward and aft control stick pieces. All fractures associated with these components were inspected using a 5X to 50X stereo zoom microscope. As indicated in Figure 2, each fracture occurred due to overstress. The forward control stick has a manually-drilled 0.22 inch diameter hole drilled in the forward side of the tube wall about 0.42 inch above the top of the stick socket. The overstress fracture initiated at the edges of this hole. The aft control stick has a 0.15 inch diameter hole drilled in the forward and aft sides of the tube wall (clearance holes to accommodate a mounting bolt) about 0.40 inch below the top of the stick socket. The overstress fracture in the aft stick initiated at the edges of the forward hole.

Figure 2 Partial control column assembly with the control stick pieces placed near their pre fracture locations. The mode of fracture for each broken piece is identified in the figure.

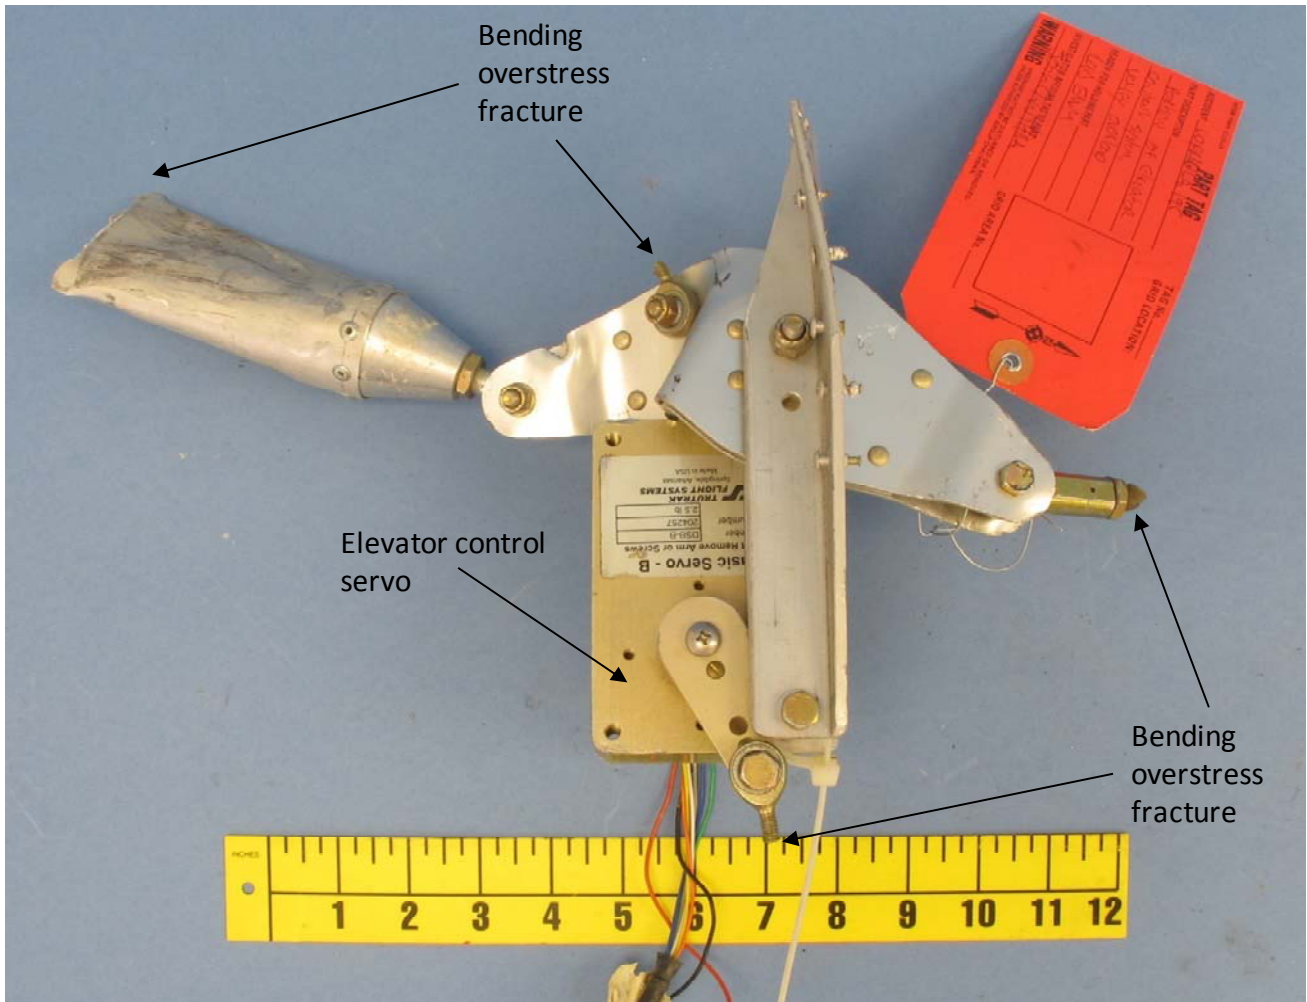
The linkage fractures associated with the elevator control servo assembly are shown in Figure 4. All fractures associated with the elevator control servo assembly were inspected using a 5X to 50X stereo zoom microscope. In all instances, the fractures are due to bending overstress.

Figure 3 Portion of elevator control servo assembly showing each linkage fracture.

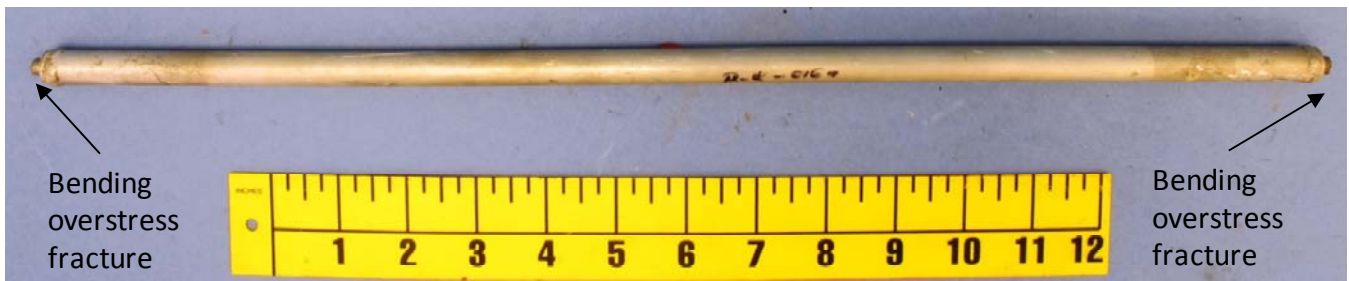
A control linkage that measured approximately 18 inches long and 0.5 inch in diameter had threaded ends as shown in Figure 4. Both threaded ends fractured due to bending overstress as indicated by inspection with a 5X to 50X stereo zoom microscope.\

Figure 4 Eighteen-inch long control rod piece showing bending overstress fractures in the threads at each end.

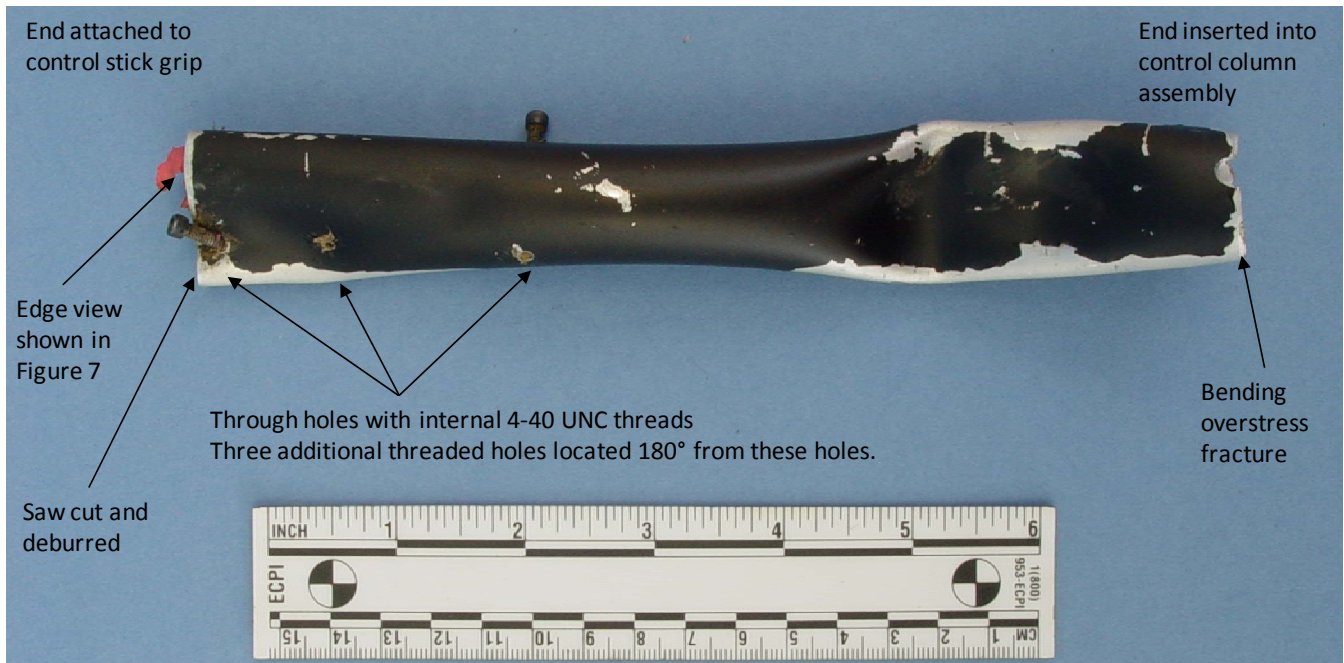
As indicated in Figure 5, the forward control stick fractured in overstress due to cantilever bending just above the control column fitting. Near the top of the forward control stick, six 4-40 NC threaded holes are located in the tube (see Figures 5 and 6). As indicated in Figure 6, the threads are stripped in holes labeled 1, 4, and 6. Hole 4 has a second untapped hole overlapping it. The top of the forward control stick is saw-cut and hand filed as indicated in Figures 5, 6 and 7.

Figure 5 Image of the forward control stick with significant features identified. The forward direction of the control stick is facing out of the page.

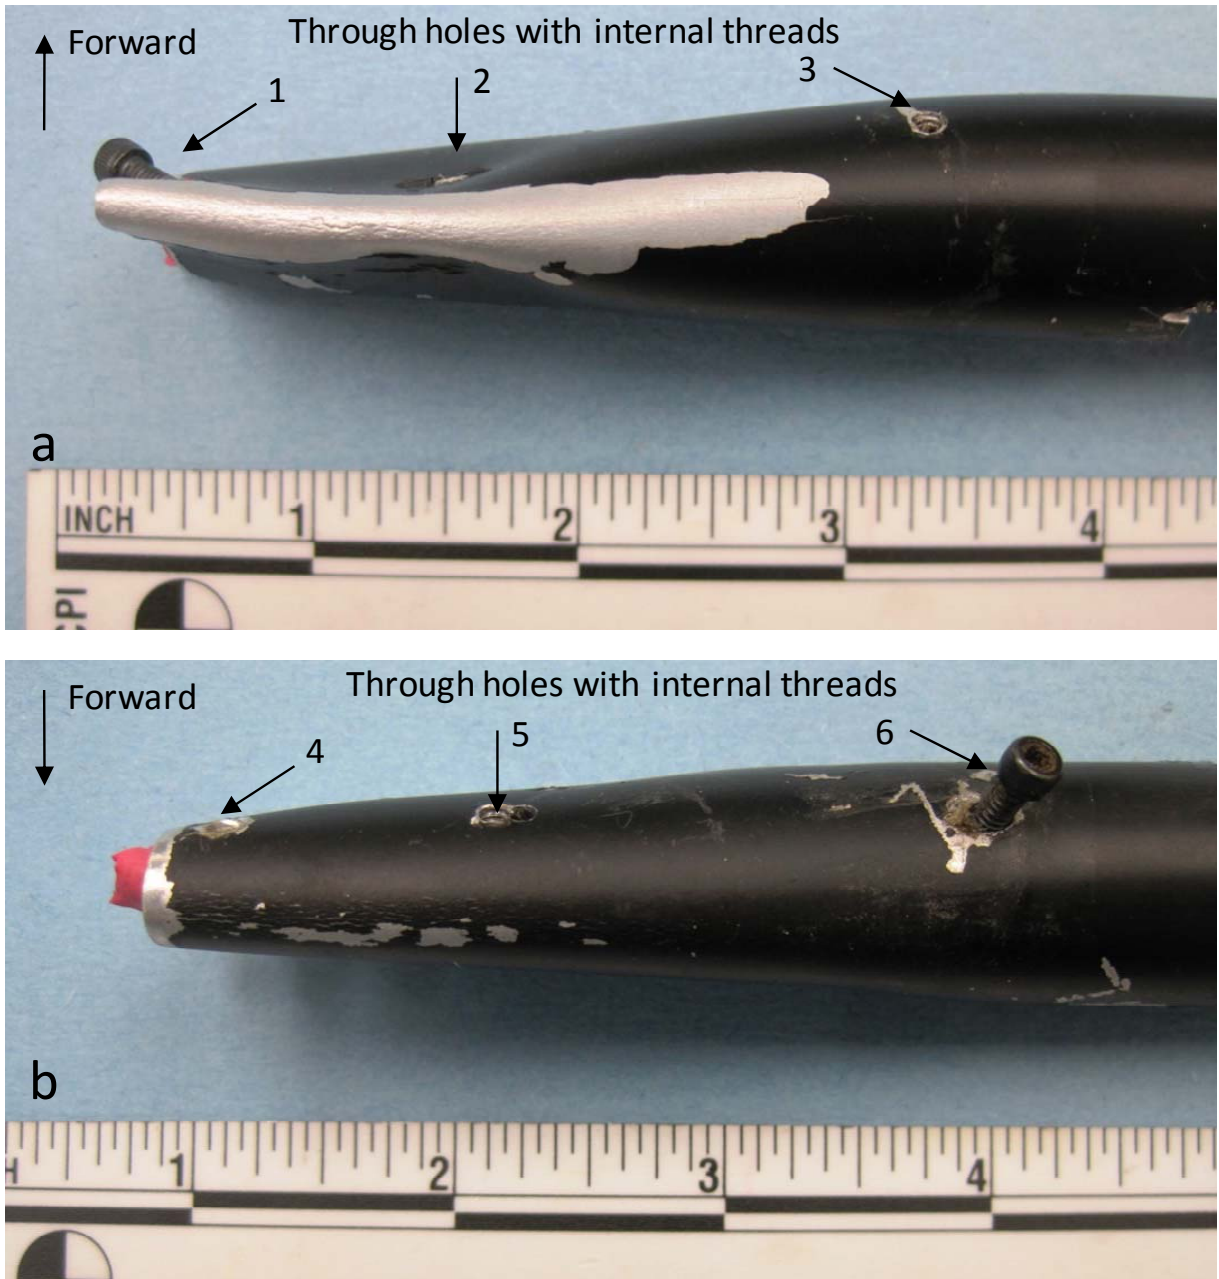
Figure 6 Upper end of the forward control stick showing the location of threaded holes.

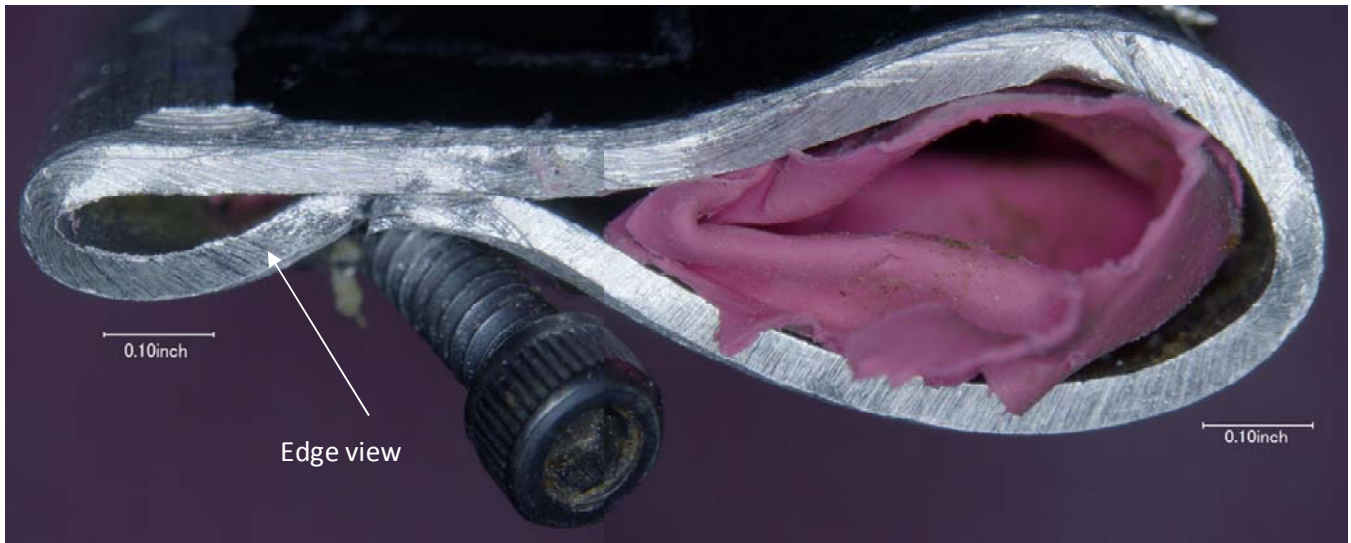
Figure 7 Edge view of the top of the forward control stick piece.
