NATIONAL TRANSPORTATION SAFETY BOARD

MATERIALS LABORATORY FACTUAL REPORT

Report No. 11-067

Place : Saltsburg, PA
Date : August 7, 2010
Vehicle : Beech 58
NTSB No. : ERA10FA404
Investigator : Timothy Monville

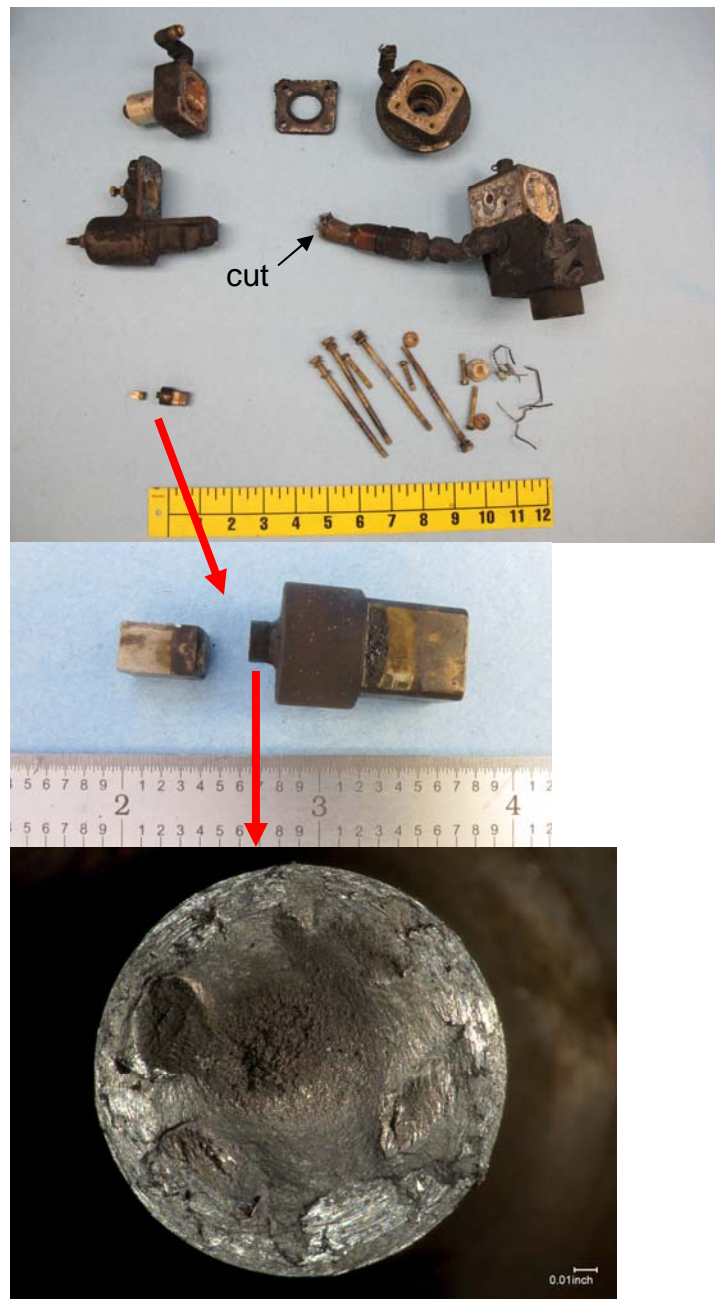
A photograph of the as-received pieces from the right engine-driven fuel pump is shown in figure 1. Detailed examination of the disassembled pump revealed the drive coupling fractured at the reduced diameter portion. Bench binocular microscope examination of the coupling revealed the fracture was flat and perpendicular relative to the length of the axis and the fracture faces exhibited a circular texture consistent with ductile overstress separation in torsion mode. No evidence of pre-existing fracture was found on the fracture faces or other areas of the pump.

Figure 1. Overall view of the as-received pieces of the right engine-driven pump pieces and fractured drive coupling (above); close-up photograph of the fracture coupling (center); and fracture face of the drive coupling (bottom).
