NATIONAL TRANSPORTATION SAFETY BOARD

MATERIALS LABORATORY FACTUAL REPORT

Report No. 11-094

Place : Clear Lake, ME
Date : 3/24/2011
Vehicle : Cessna A185F, N724MT
NTSB No. : ERA11GA207
Investigator : Dennis Diaz

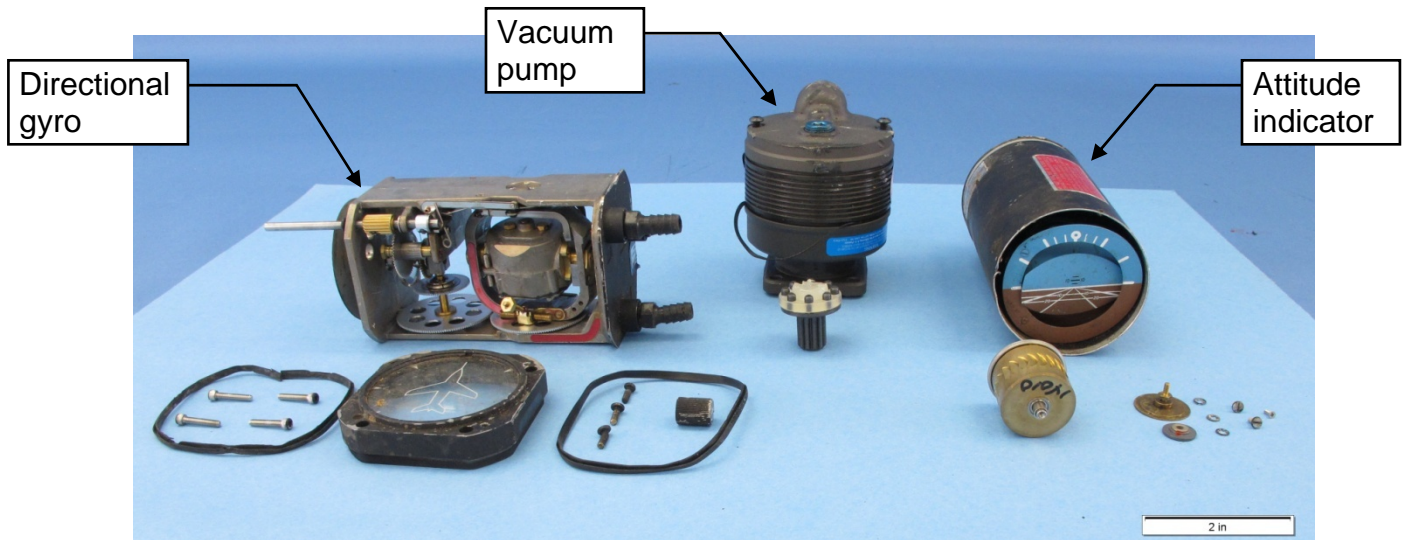
A Cessna A185F was substantially damaged when it impacted a frozen lake in Clear Lake, Maine. The purpose of this investigation is to evaluate the indicators from this aircraft for operational abnormalities. Overall views of the submitted indicators are shown in Figure 1.

Figure 1. Overall view of submitted parts.

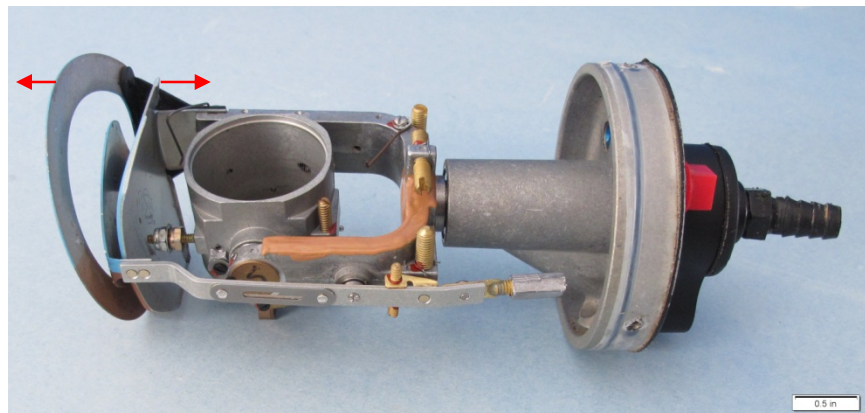
The attitude indicator was manufactured by Sigma Tek, Inc. in Augusta, KS (PN: 23-501-06-16, MN: 5000B-36, SN: T80903). As received, the attitude indicator had been previously disassembled and the rotor had been removed from the gyro housing. The display panel of the attitude indicator was misshaped, with the ring bent aft and the back plate bent forward toward the gyro case. The football was displaced with the loose end outside of the ring, and experienced limited movement. The attitude indicator without the case is shown in Figure 2 indicating these deformations. The roll yolk operated smoothly, with no resistance to rotation. However, the mechanism to connect gyro to football was missing so that gyro rotation initiated no football movement. The

Figure 2. Attitude indicator removed from case. The arrows show the directions of deformation on the display panel.

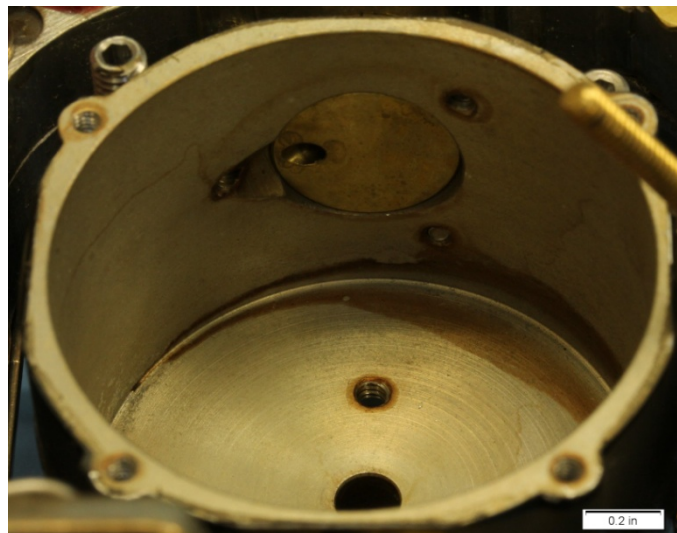
The directional gyro was manufactured by Kelly Manufacturing Company in Wichita, KS (MN: RCA11A-8, SN: 47C0057). As received, the directional gyro had been removed from the case. The screws were missing from the gyro housing (one out of the four was submitted with the parts) and there were tool marks on the housing. However, the housing was still sealed with the gyro inside. There were tool marks on the attachment hardware (blocked by the gimbal housing when assembled), indicating previous disassembly. There appeared to be no damage to the drive gears from the gyro yolk to the heading adjustment. The pitch bearings and the gyro case bearings were smooth with no indication of hesitation. The yolk movement initiated dial motion. The heading adjustment mechanism was operational. The bolts at the center of the rotor housing were loosened by hand. The rotor was removed from the gyro casing using a scalpel, screwdriver, and pliers. The rotor was stamped with "FEB 23 2007." The rotor rotated freely on its axis with no sign of hesitation. There were no aluminum shavings in the half-moons of the rotor. The rotor and housing did not show circumferential markings or slap marks, however the housing had stains on the interior, particularly around screw holes. These stains are shown in Figure 3.

Figure 3. Gyro housing of the directional gyro, showing stains.

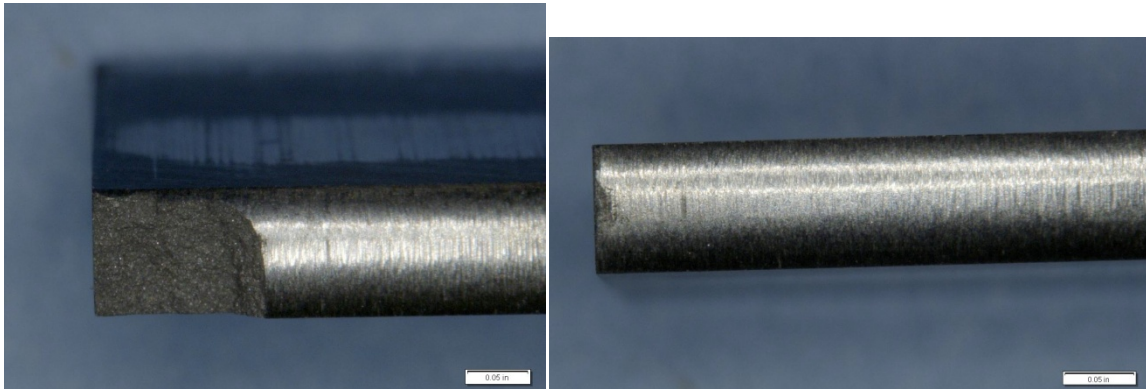
Disassembly was performed to reveal the interior of the pump. Assembly screws and the back flange were removed by hand. The seals and housing were removed to reveal the rotor and vanes. Vanes showed signs of previous removal, and were already numbered and were reinserted into the rotor slots incorrectly. The vein positions were corrected, and then the vanes were removed and inspected. Vanes 1, 2, 4, and 5 had smooth rubbing faces and no evidence of damage. Vanes 3 and 6 had small areas of damage on the rubbing face toward the forward end of the vanes. The damage to these vanes is shown in Figure 4. All vanes were free to move inside the rotor assembly. The rotor was removed and showed no damage besides rub marks on the forward and aft ends, consistent with operation. The housing was removed and showed five faint slap marks due to impact from the vanes. The shaft assembly, still attached to the mounting flange, had a uniform resistance to rotation, however rotated smoothly. The rubber sleeves were intact on the shaft assembly.

Figure 4. Damage on the rubbing face of vanes in the vacuum pump. Vein 3 is shown on the left and Vein 6 is shown on the right.

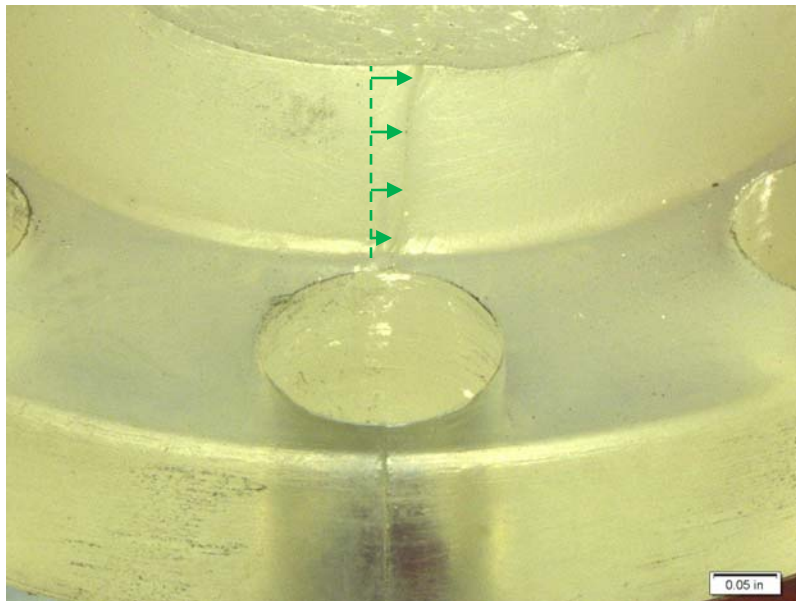
The fracture surface of the drive coupling flex center was examined. The flex center fractured near the center of the height of the part, in the region with the smallest cross-section diameter. Observation of the polymer revealed that this part was injection molded, and showed the presence of a parting line (due to the two halves of the mold

joining). This parting line exhibited permanent torsional deformation as indicated in Figure 5. The flex coupling was sputter coated with gold-palladium to aid in fracture examination. The fracture surface after sputter coating is shown in Figure 6. A portion of the fracture surface displayed a flat region with crack arrest features. This region starts at the circumference of the flex center near the parting line and continues into the center of the part. Along the circumference in this region are curved ratchet marks. The remainder of the fracture surface displayed elongated fibrils. The fibrils showed signs of a directional elongation, consistent with torsional loading.

Figure 5. Displacement of the parting line in the drive coupling flex center. The approximate original location is shown by the dotted line.

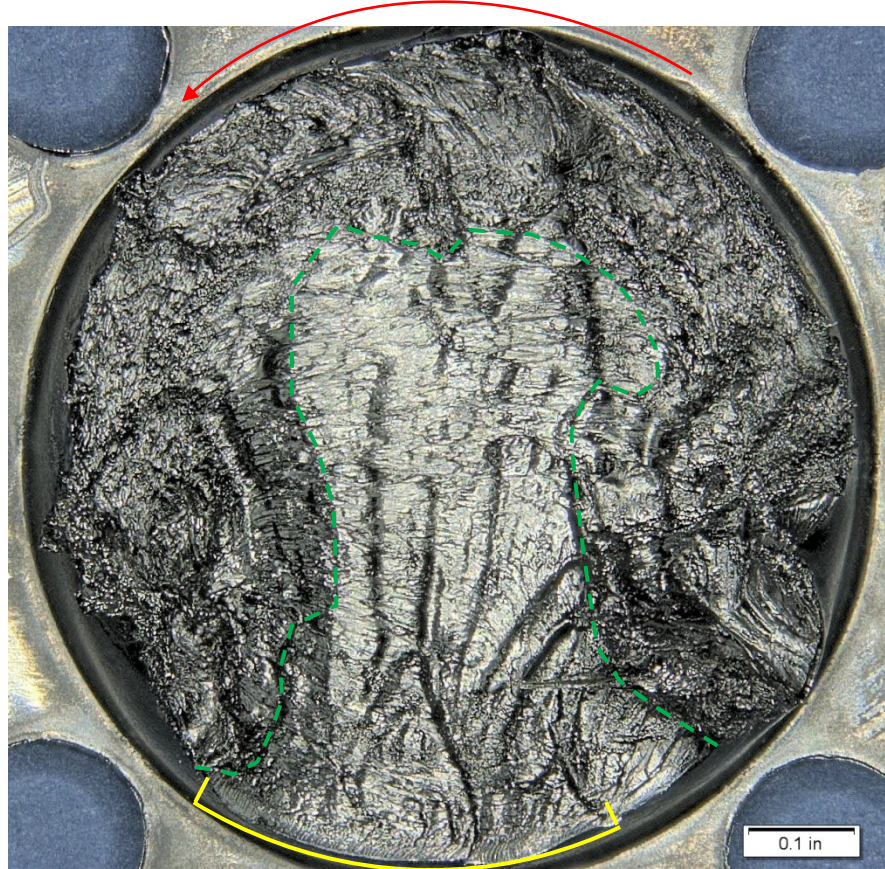
Figure 6. Fracture surface of the drive coupling flex center after sputter coating. The region of curved ratchet marks is shown by the yellow arc. The flat region is outlined by the dotted line. The red arrow shows the direction of the elongated fibrils.
