NATIONAL TRANSPORTATION SAFETY BOARD

MATERIALS LABORATORY FACTUAL REPORT

Report No. 11-123

Place : Dixie, GA
Date : 10/8/2011
Vehicle : Luscombe 8A, N41907
NTSB No. : ERA12FA017
Investigator : Jose Obregon

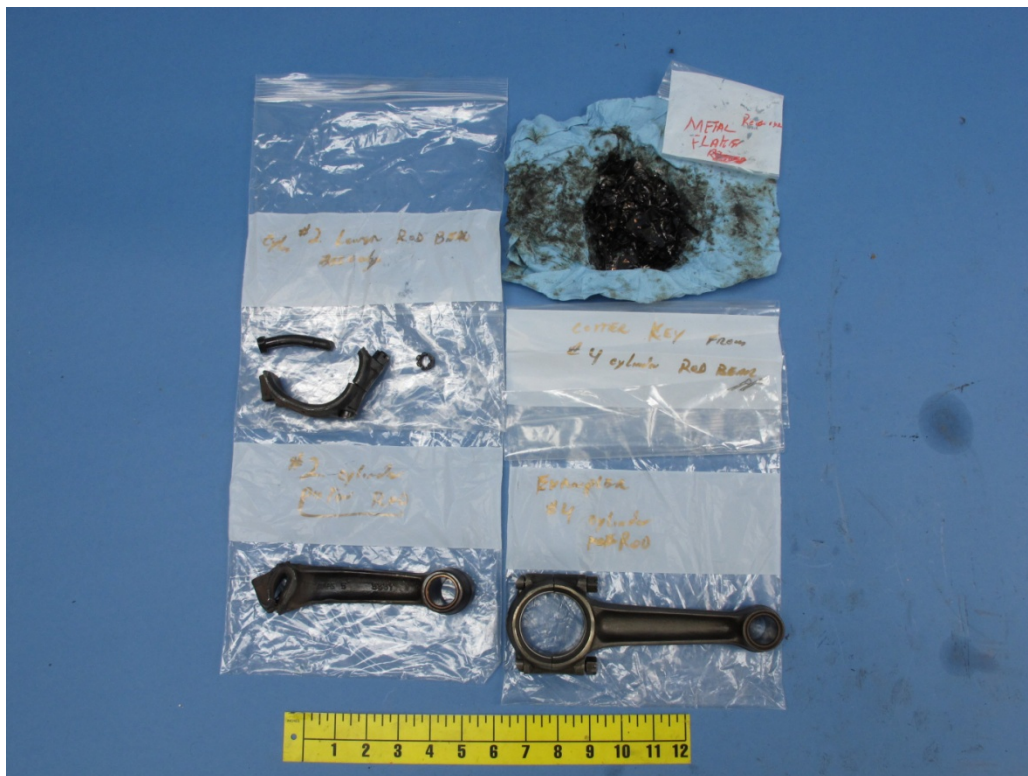
1 damaged connecting rod assembly (#2 cylinder), 1 exemplar connecting rod assembly (#4 cylinder from same engine), remnants of metal flakes and pieces from the damaged connecting rod bearing cap (figure 1)

Figure 1: Accident parts as received

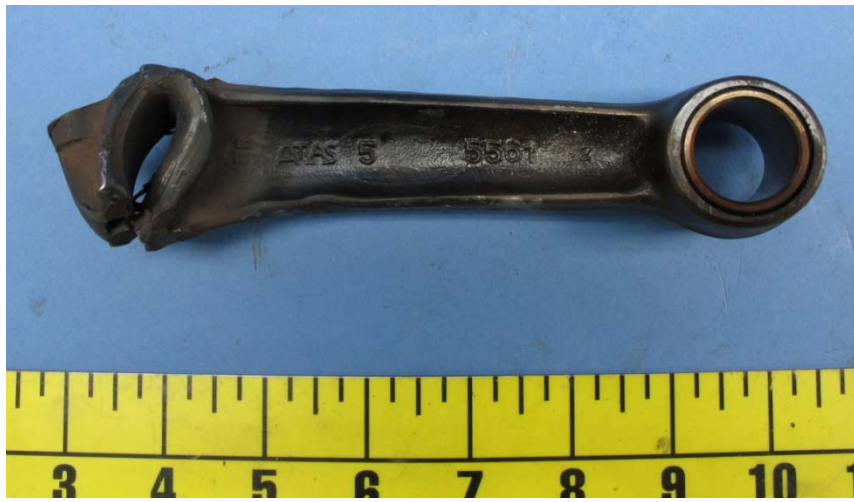
Figure 2: Damaged connecting rod assembly from the #2 cylinder

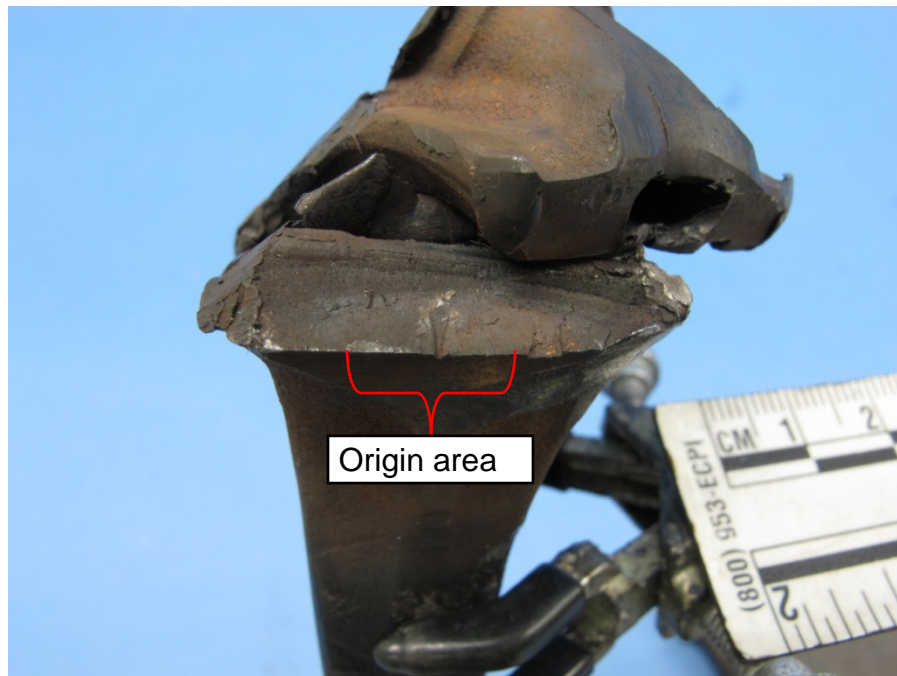
The damaged connecting rod assembly from the #2 cylinder was deformed and had sustained considerable damage to the end which would attach to the crankshaft (figure 2). Examination under the stereo microscope of the damaged end of the connecting rod assembly revealed a region with a flat fracture surface exhibiting crack arrest fronts consistent with a fatigue fracture (figure 3). The mating fracture surface was found attached to the #2 connecting rod's bearing cap which was recovered from inside the engine (figure 4). The mating fracture surface had a similar flat fracture region with crack arrest fronts (figure 5). The mating fracture surfaces associated with #2 cylinder connecting rod assembly are both consistent with a fatigue fracture. The fracture origin area was diffuse with no apparent defects.

Figure 3: Damaged end of #2 cylinder connecting rod assembly exhibiting a flat fracture region and crack arrest fronts.

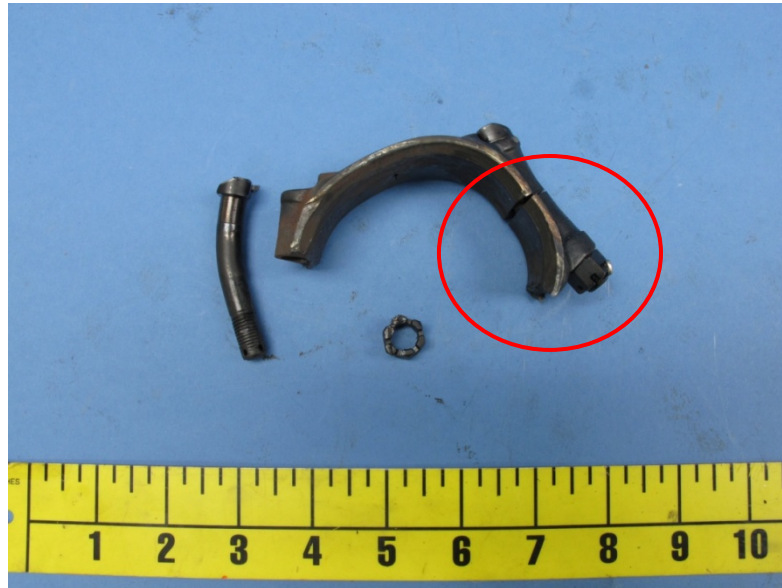
Figure 4: #2 piston rod bearing cap with portion of connecting rod attached (circled in the photo)

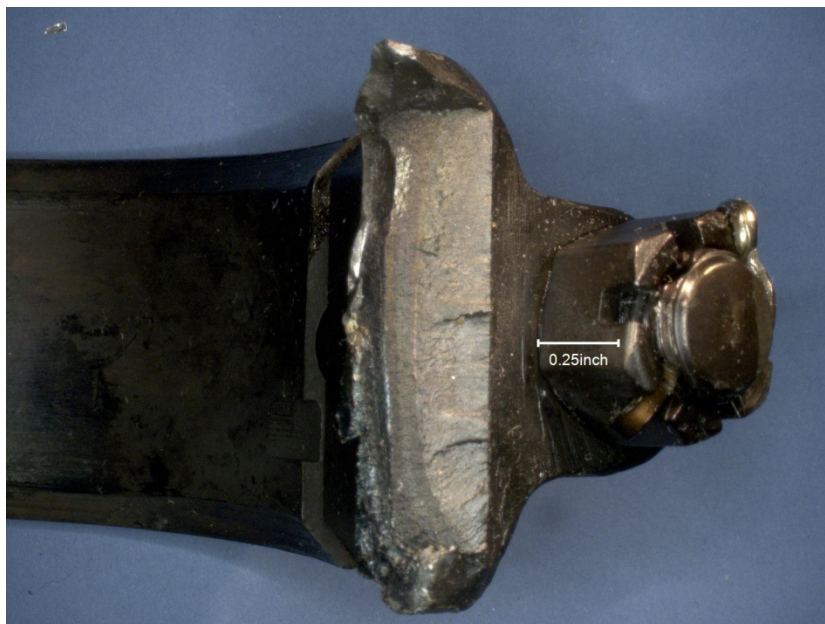
Figure 5: Mating fracture surface to the one shown in figure 3.
