NATIONAL TRANSPORTATION SAFETY BOARD

MATERIALS LABORATORY FACTUAL REPORT

Report No. 11-133

Place : Fitchburg, Massachusetts
Date : November 6, 2010
Vehicle : North American T-6
NTSB No. : ERA11LA050
Investigator : Ralph Hicks, AS-ERA

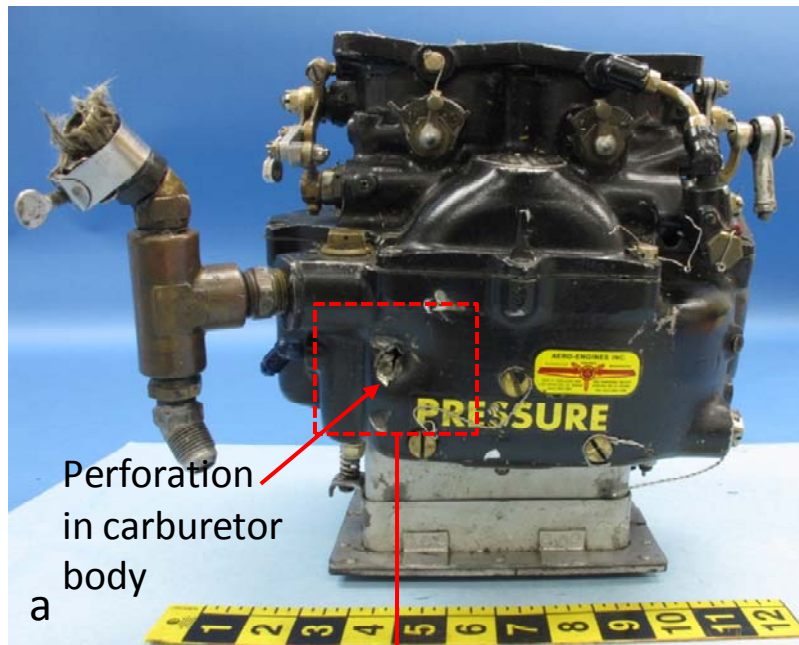
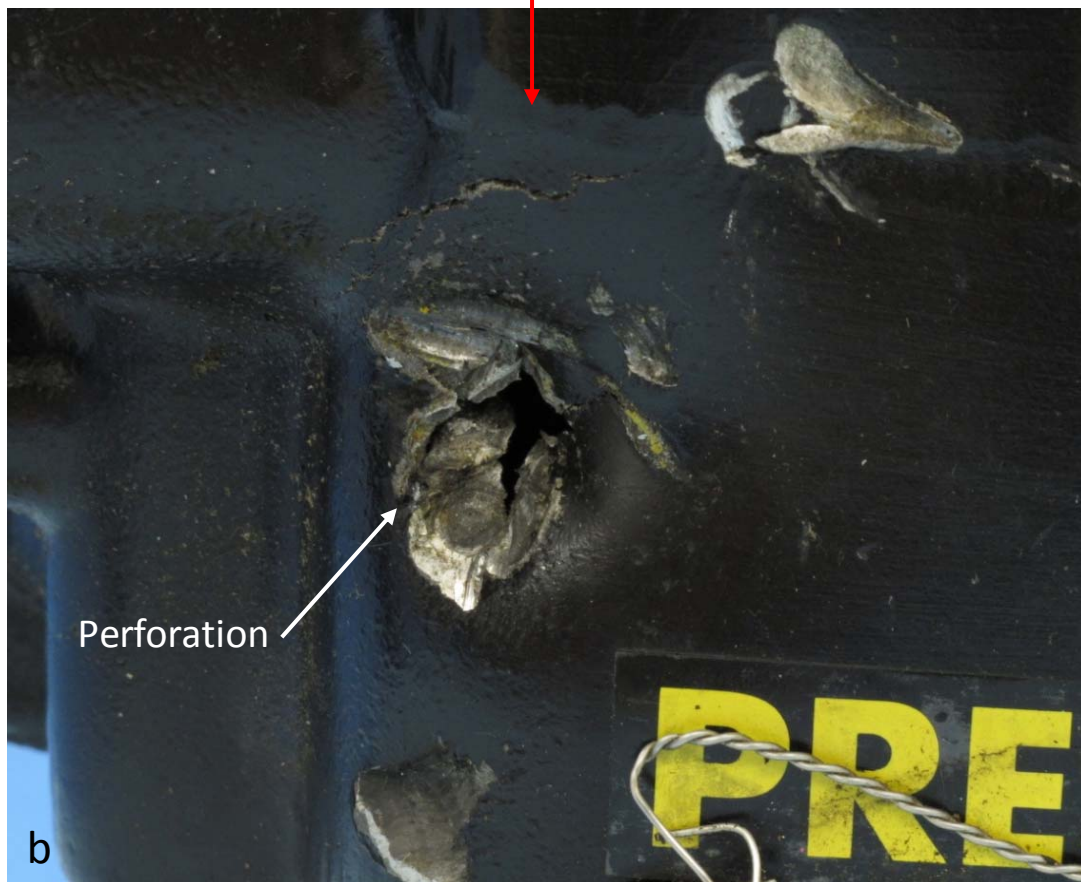
Various views of the as-received carburetor are shown in Figure 1. As indicated in Figure 2 the carburetor has the following identification markings: Bendix Stromberg Carburetor S/N 5774256, Model NA-Y9E1, Parts List 18639-7, manufactured by Bendix Products Aerospace Division, South Bend IN. The carburetor-to-engine mounting flanges are fractured in several locations, consistent with impact forces associated with the accident. The wall of the carburetor body is perforated through one of the float chambers as indicated in Figures 3 and 4. The perforation damage is consistent with an object perforating the wall from the exterior towards the interior. The float in the perforated chamber was not damaged or contacted by the perforating object or displaced metal. As indicated in Figure 4, one of the floats exhibited a fracture in the circumferential solder joint that affixes the two halves of the float.

Figure 3 Images showing the perforation through the wall of the carburetor body into a float chamber.

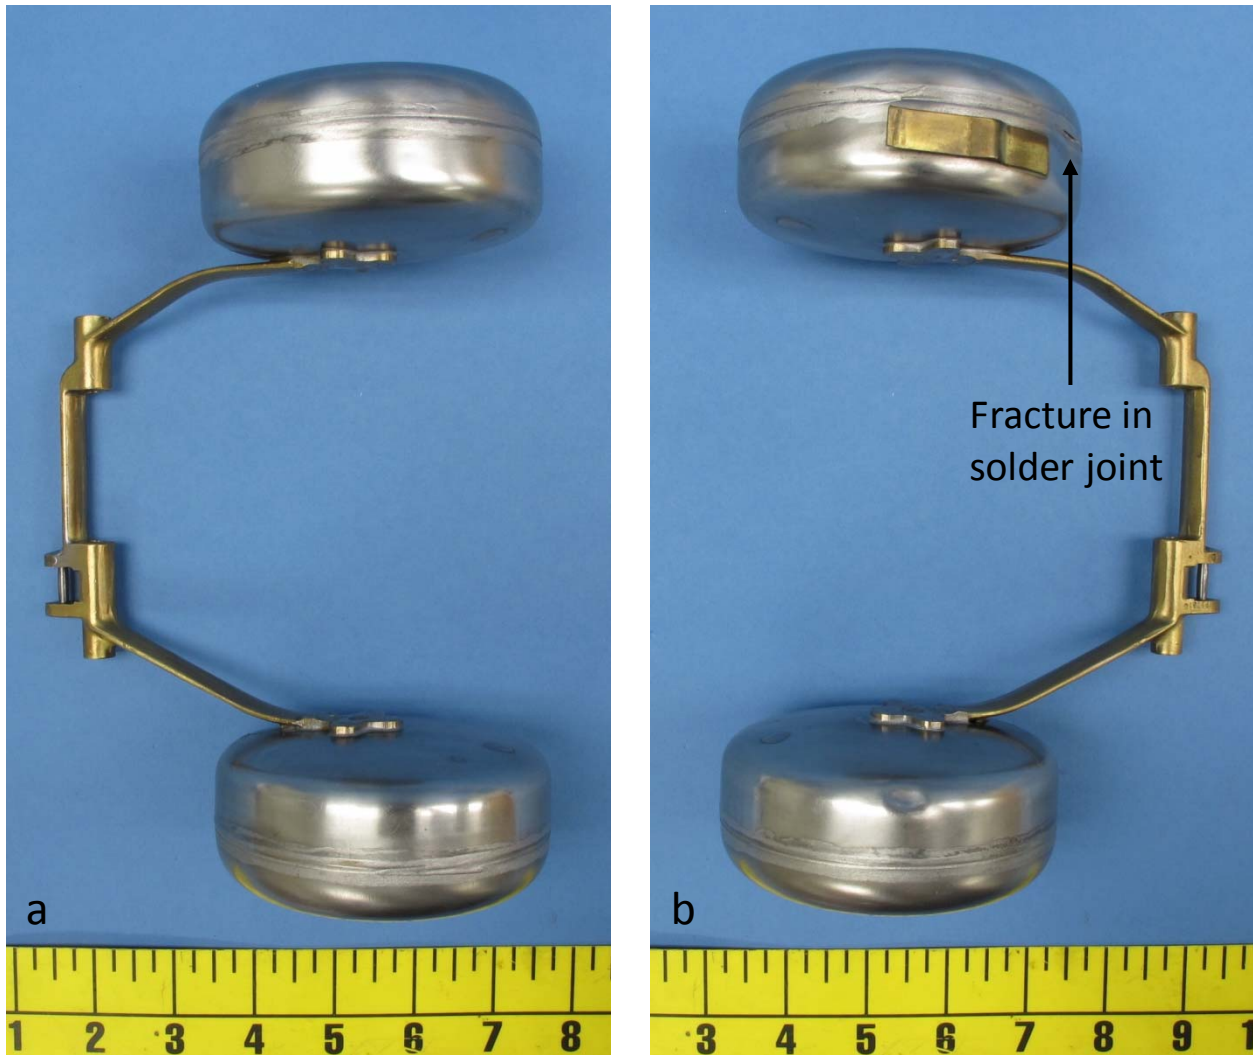
Figure 5 shows two views of the float assembly and the typical location of the circumferential solder joints on the floats. The surfaces of the float assembly were clean and the surfaces of the solder joints used to assemble the float components had a rippled surface texture consistent with mechanical cleaning (the surface of solder joints typically have a smooth, as-fused surface). The lower float in the images exhibited a few dents and the circumferential solder joint appeared free from cracks or injurious defects when examined under a 5X to 50X stereo zoom optical microscope. The upper float in the figure exhibits a fracture in the circumferential solder joint immediately adjacent to a dent in the surface of the float. Figures 6 and 7a are higher magnification images of the dent and the solder joint fracture.

Figure 5 Two views of the float assembly. The fracture in the solder joint of the upper float is identified in view (b).

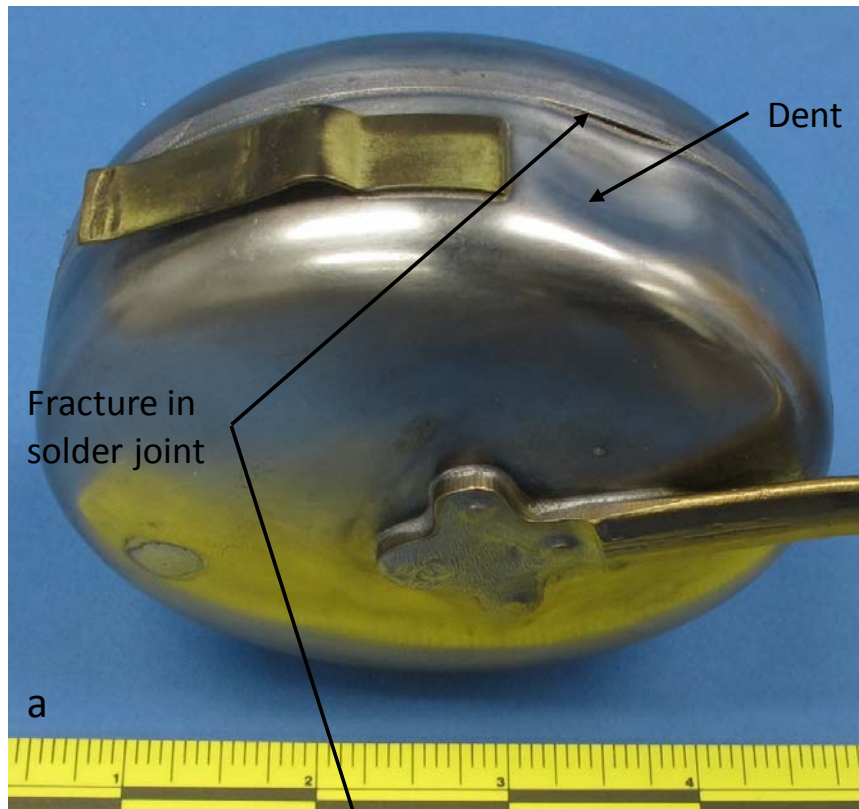
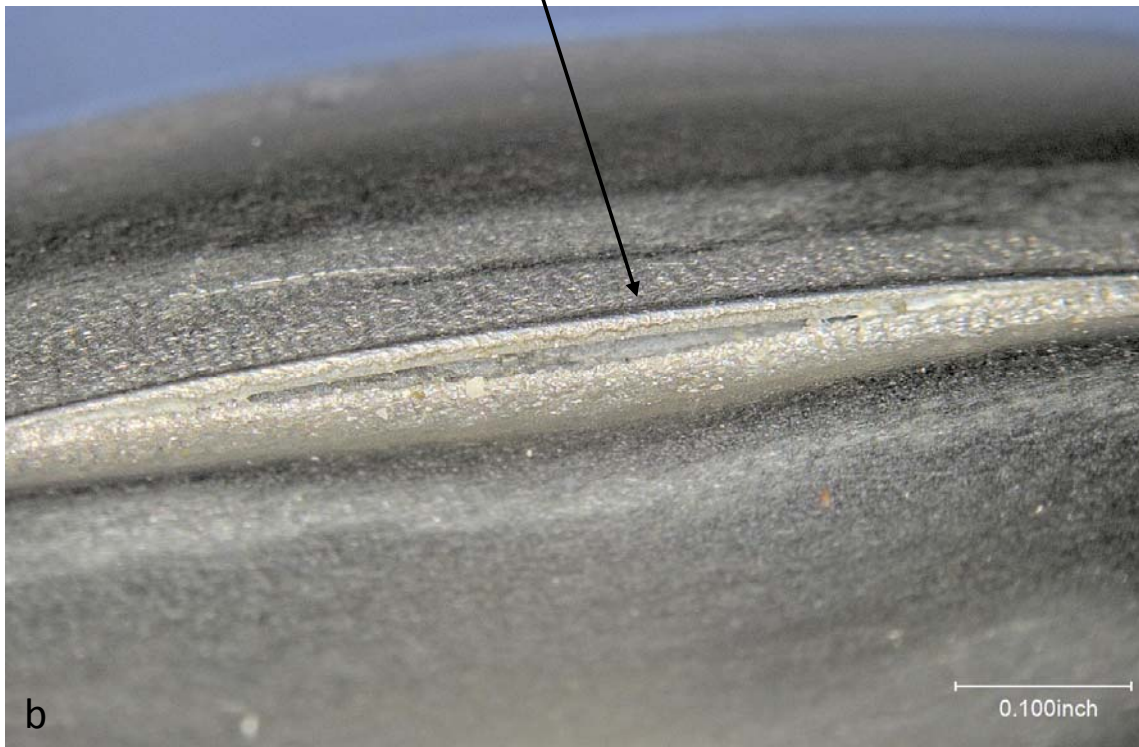
Figure 6 View (a) showing a dent on the surface of the float and a fracture in the solder joint. View (b) is a closer image of the solder joint fracture.

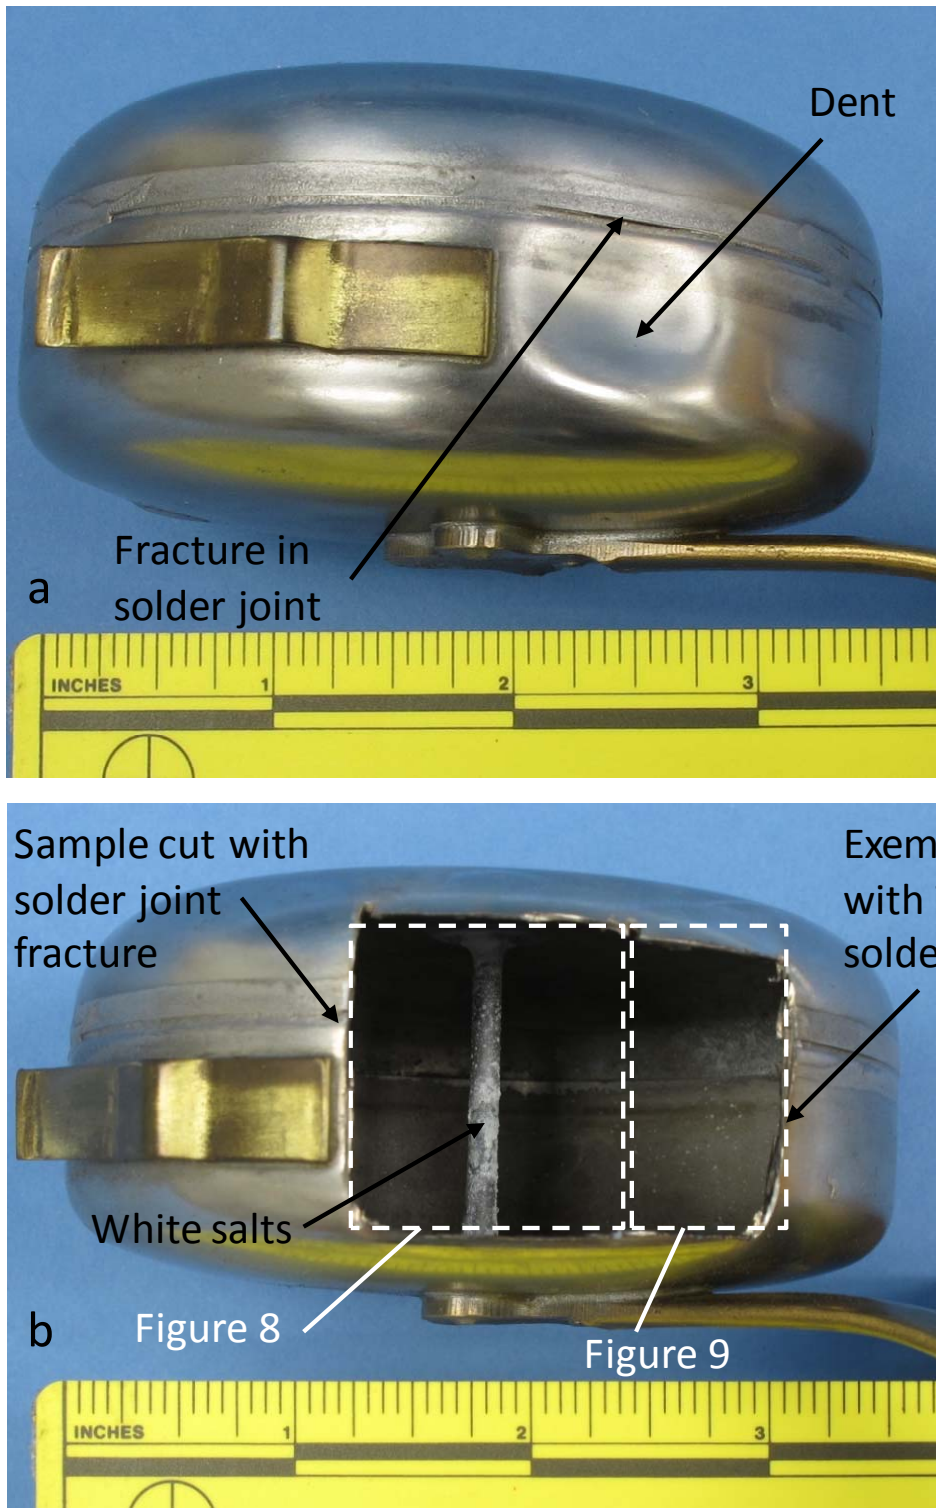
Two samples were cut from the float with the solder joint fracture as indicated in Figure 7b. One sample contained the dent and the fractured solder joint as shown in

Figure 7 Images of the float with the fractured solder joint before (View (a)) and after (View (b)) removal of samples for further examination.

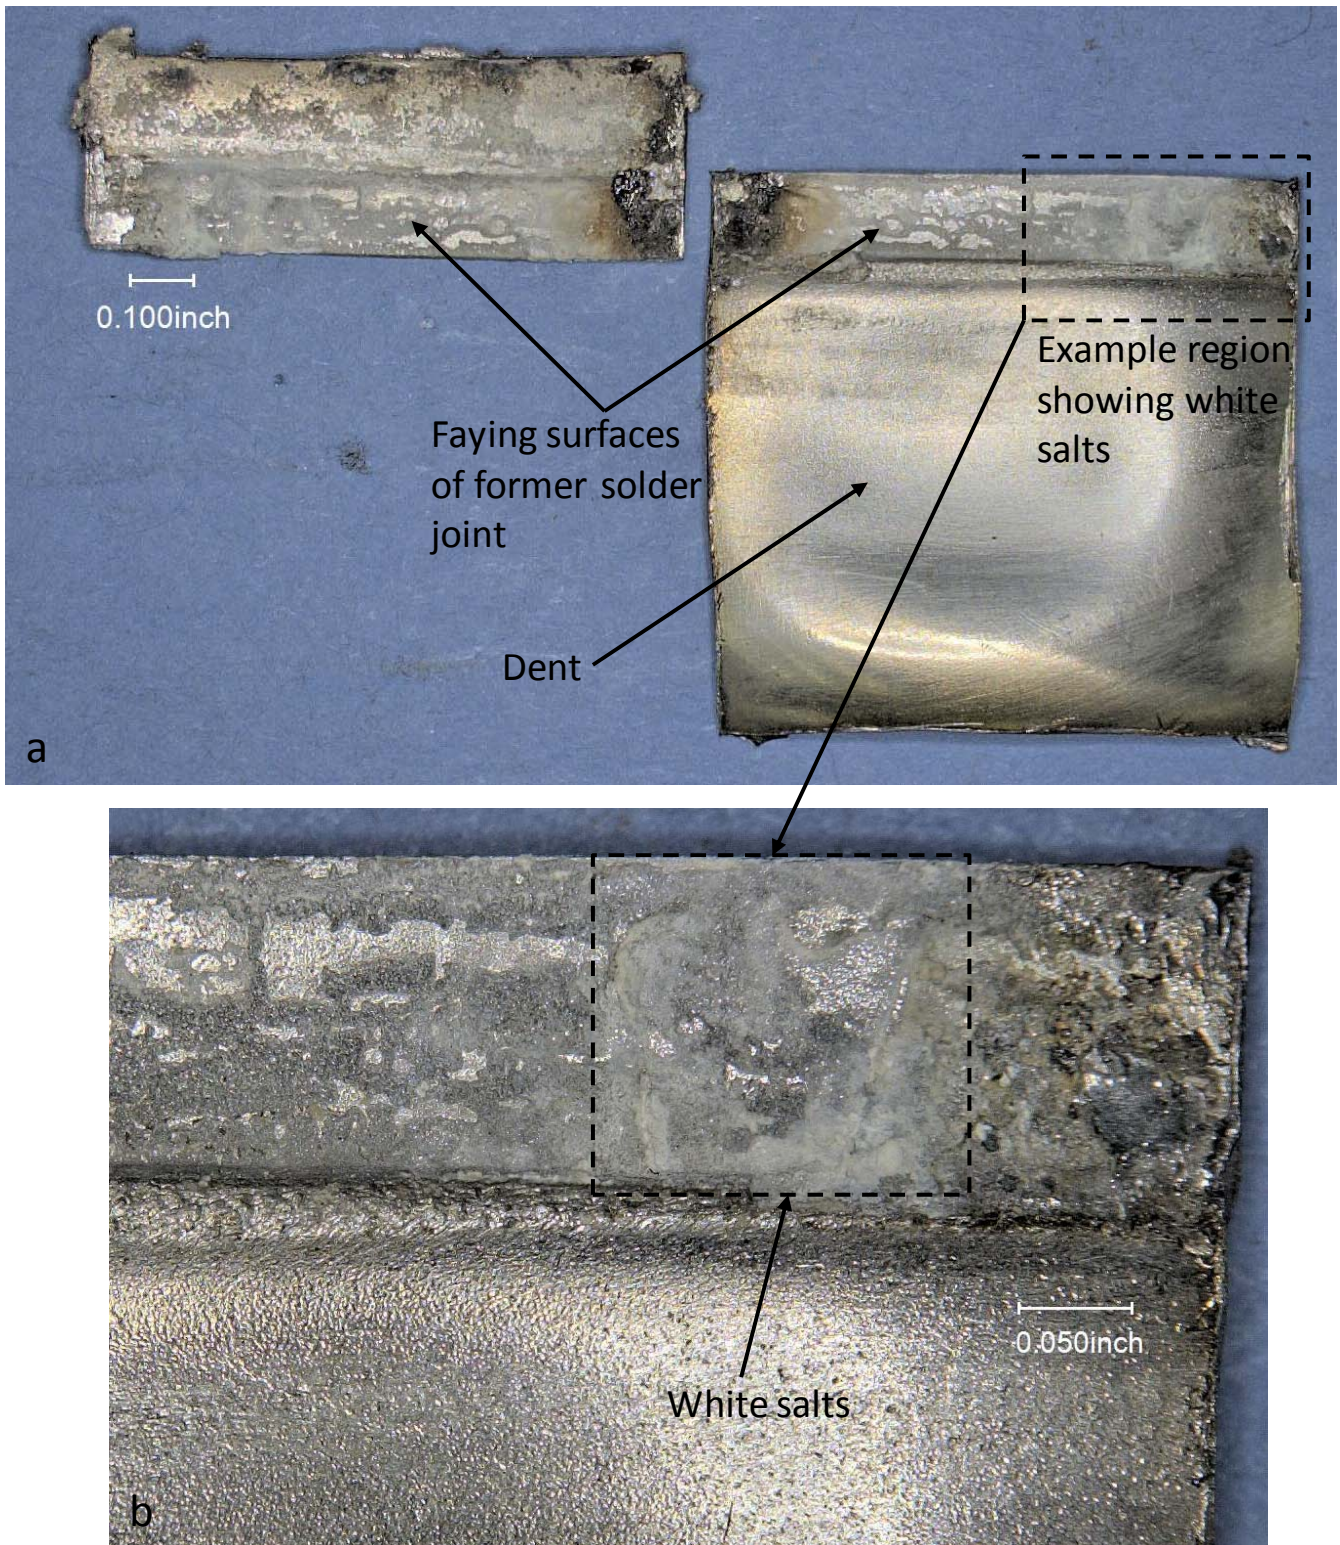
Examination of the fracture surface of the fractured solder joint sample using a 5X to 50X stereo zoom optical microscope revealed primarily areas of wetted solder interspersed with regions of dewetted voids and gas porosity. White salt corrosion product was present on the solder-wetted areas of the fracture surface on the fractured solder joint. The white salts on the fracture surface of the fractured solder joint were examined by semi-quantitative standardless energy dispersive x-ray spectroscopy (EDS) in accordance with ASTM E1508¹ (see Figure 8). Significant concentrations of carbon (C), oxygen (O), and lead (Pb) are present and minor concentrations of iron (Fe), sodium (Na), and potassium (K) are present as indicated in the typical spectrum in Figure 10. Similarly, corrosion product scraped from a soldered surface inside the float (see Figure 7b) contains significant concentrations of carbon, oxygen, and lead and minor concentrations of iron, sodium, and potassium as indicated in the typical EDS spectrum in Figure 11.

Figure 8 The fracture surfaces of the fractured solder joint after removal from the float is indicated in Figure 7.

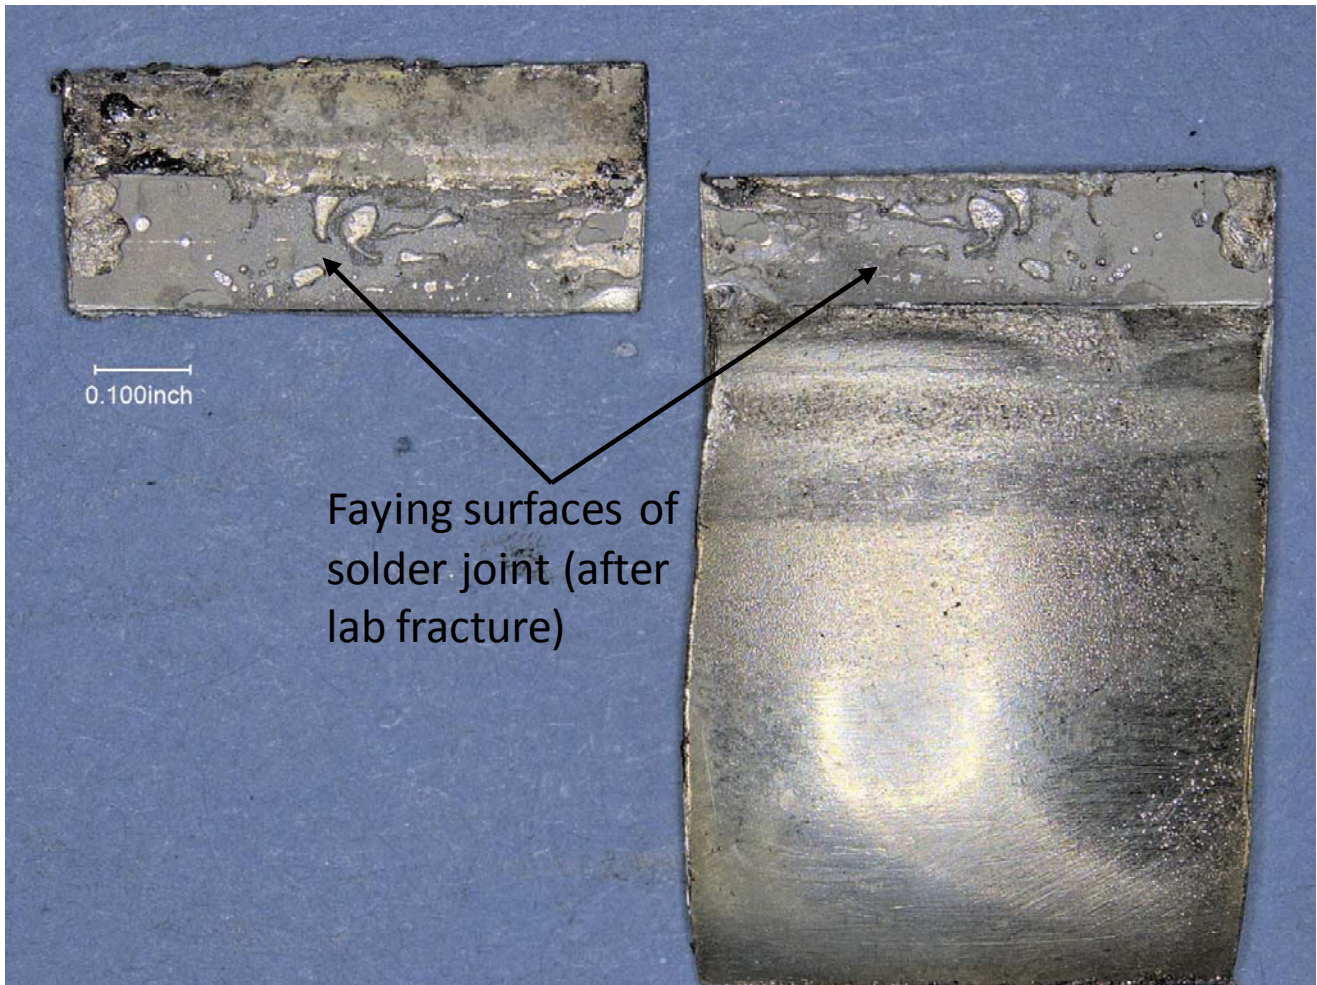
Examination of the fracture surface of the lab-fractured solder joint on the exemplar sample using a 5X to 50X stereo zoom optical microscope revealed primarily areas of wetted solder interspersed with regions of dewetted voids and gas porosity. EDS analysis of a faying surface of the example solder joint lab fracture (See Figure 9) revealed significant concentration of tin (Sn), copper (Cu), lead, and minor concentrations of oxygen, carbon, and iron as indicated in the typical spectra in Figure 12.

Figure 9 Sample removed adjacent to the area with the fracture solder joint (See Figure 7) showing fractured surfaces created by lab fracturing.

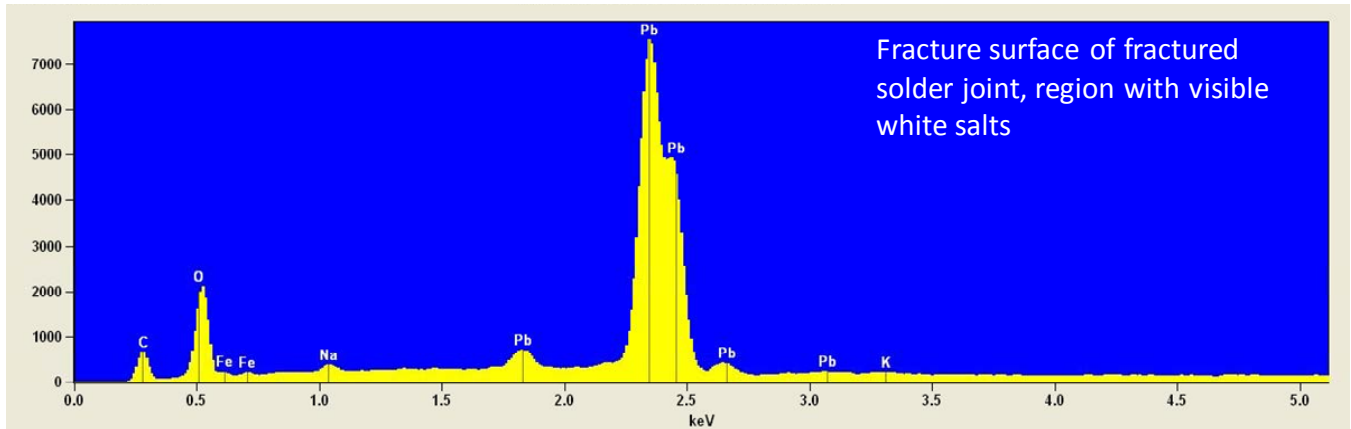
Figure 10 EDS spectra from an area on the fracture face of the fractured solder joint exhibiting significant white salts.

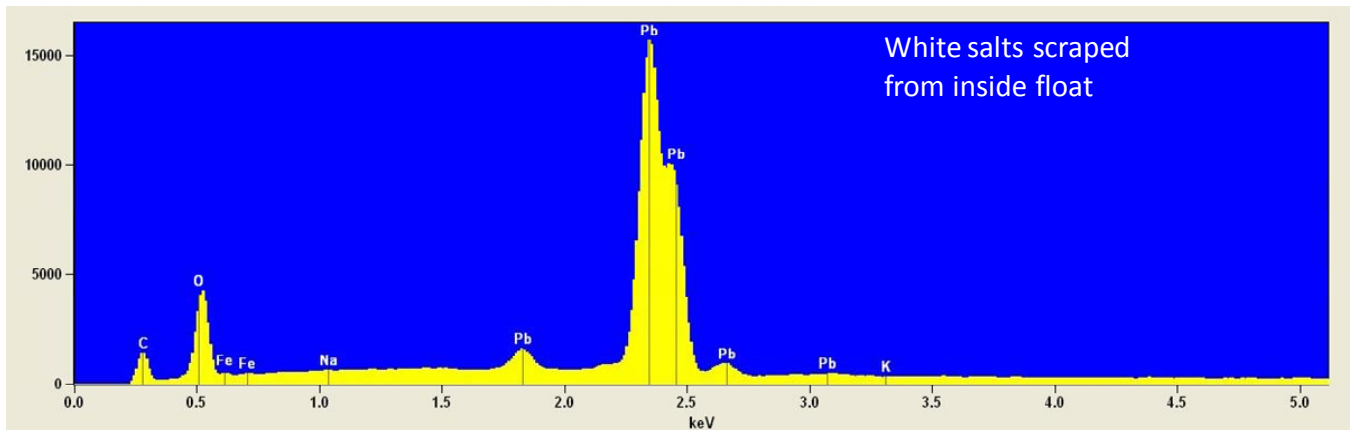
Figure 11 EDS spectra of white salts scraped from a soldered surface inside the cracked float.

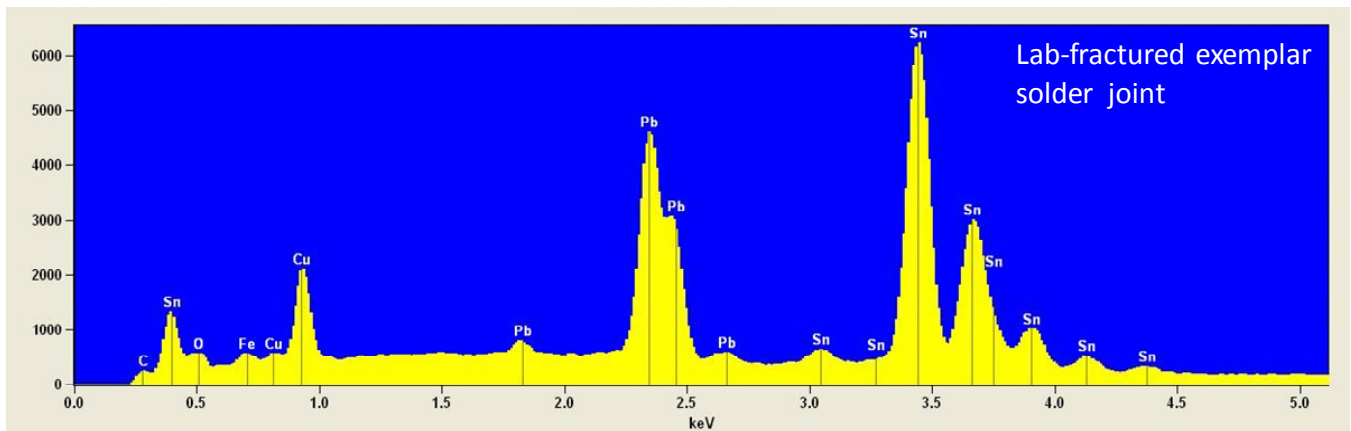
Figure 12 EDS spectra of the fracture surface of the example solder joint.
