NATIONAL TRANSPORTATION SAFETY BOARD

MATERIALS LABORATORY FACTUAL REPORT

Report No. 12-126

Place : Westminster, MD
Date : June 15, 2012
Vehicle : Remos GX
NTSB No. : ERA12FA395
Investigator : Luke Schiada, AS-ERA

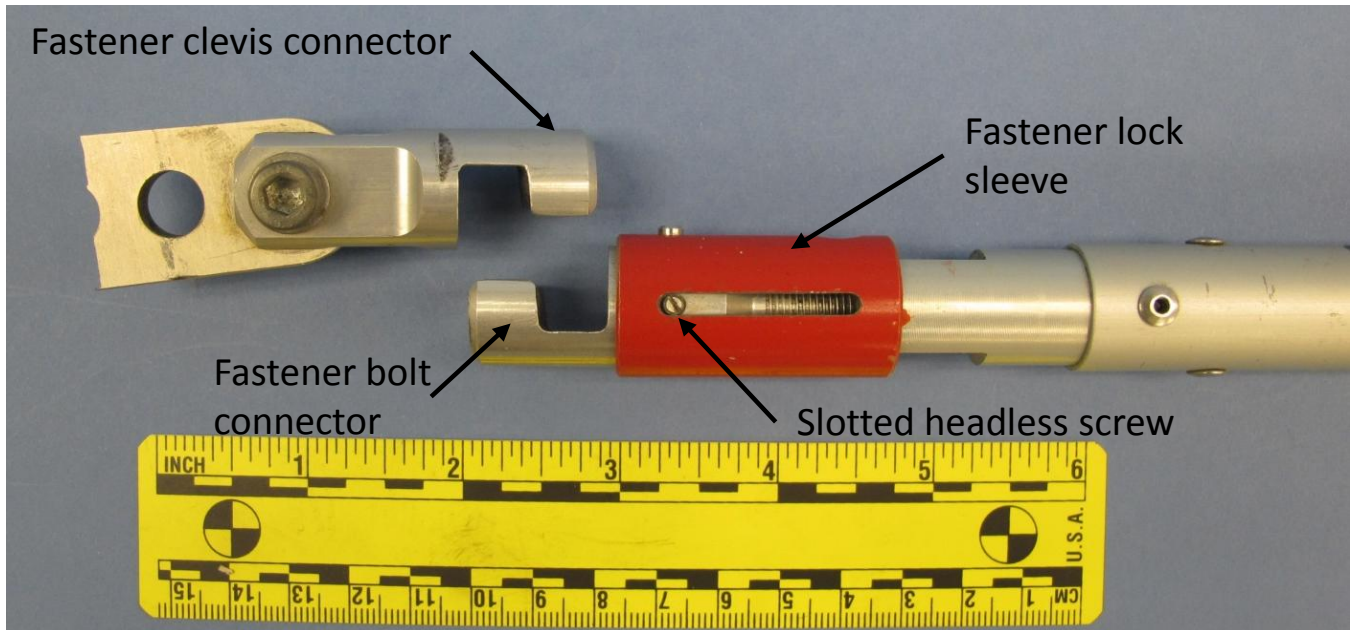
Figure 2 Closer view of pieces of the elevator control tube and quick fastener assembly. The key components of the quick fastener assembly are identified.

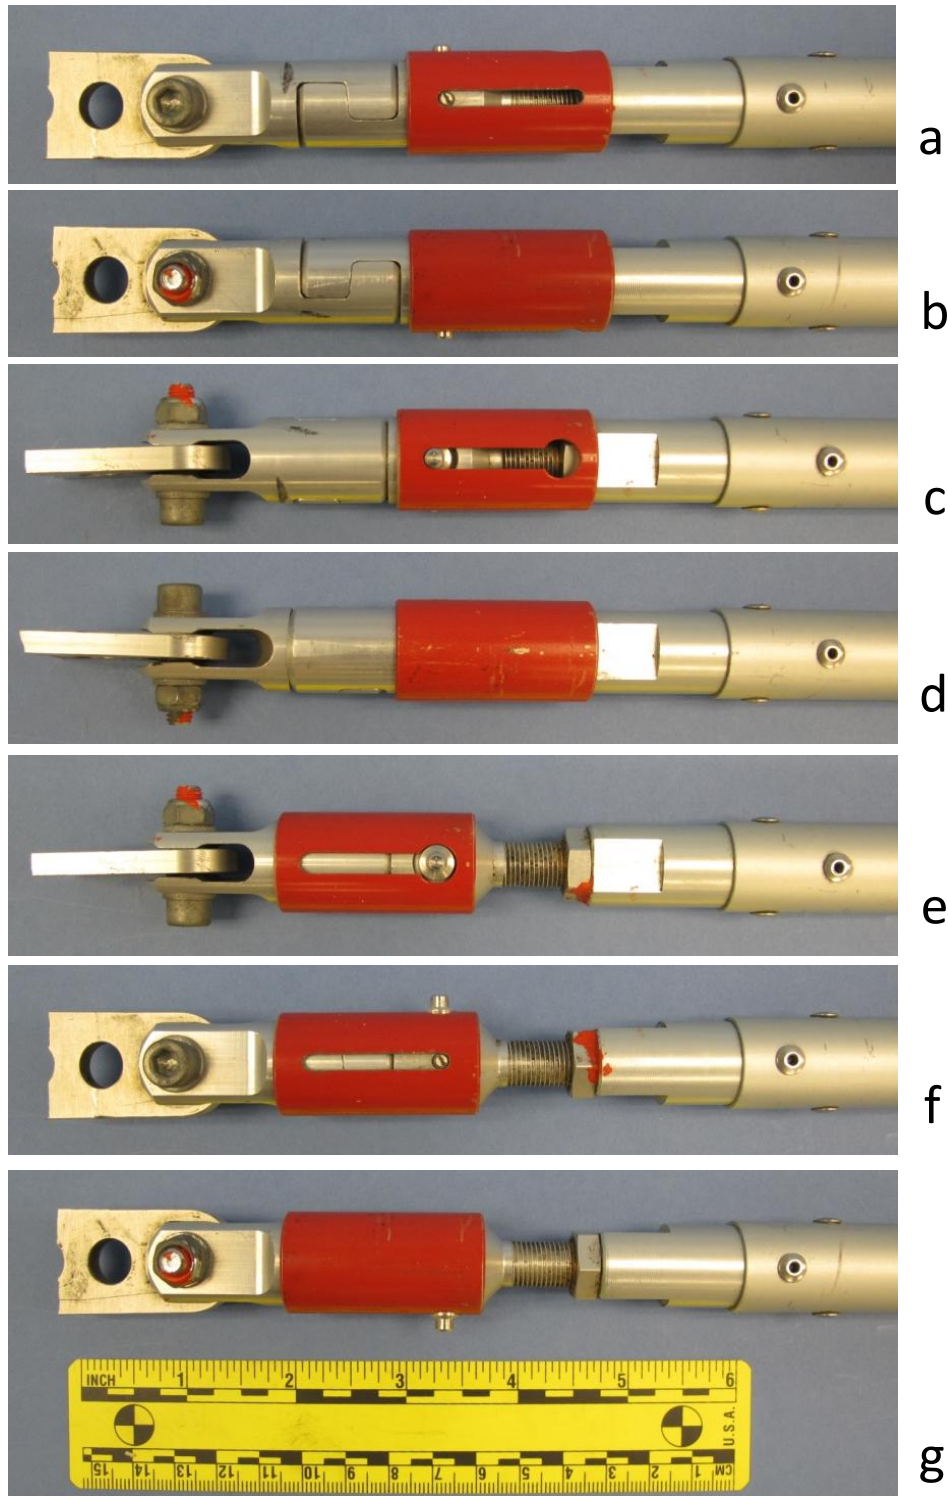
A closer side-view of the unassembled elevator quick-fastener assembly is shown in Figure 2 with key features identified. As indicated through the series of images in Figure 3, the assembly was functionally evaluated by assembling the connectors, actuating the lock button and sliding the lock sleeve into the closed position. All functions performed as-designed.

Figure 3 Multiple views of the elevator quick fastener assembly. Views (a-d) show images of the quick fastener assembly with the sleeve lock open. Views (e-g) show images of the quick fastener assembly with the sleeve lock fully closed and lock button extended.

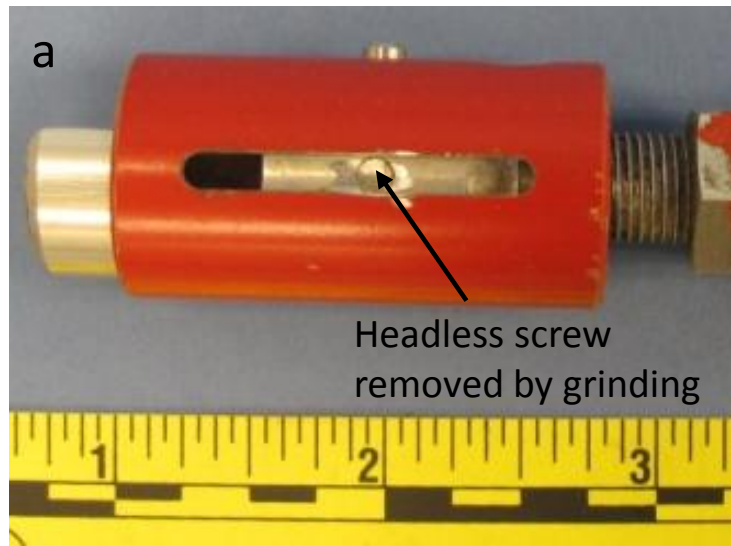
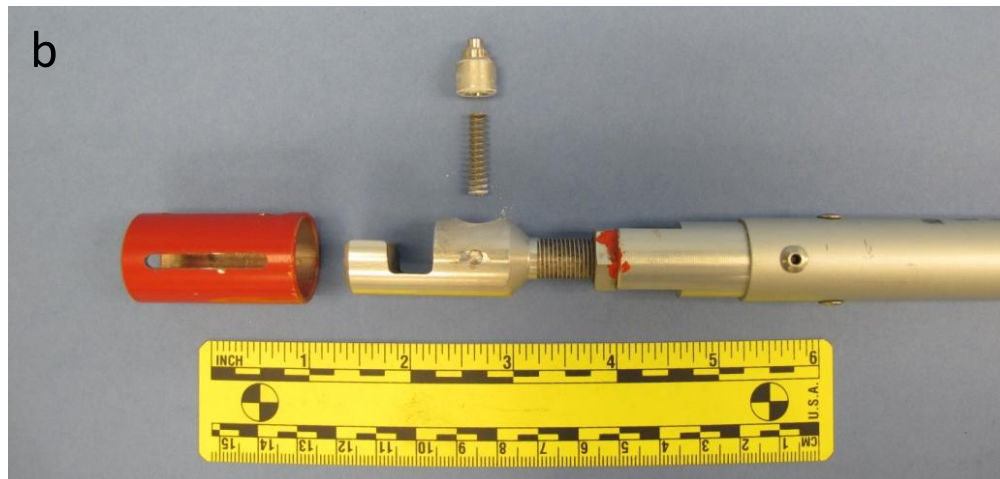
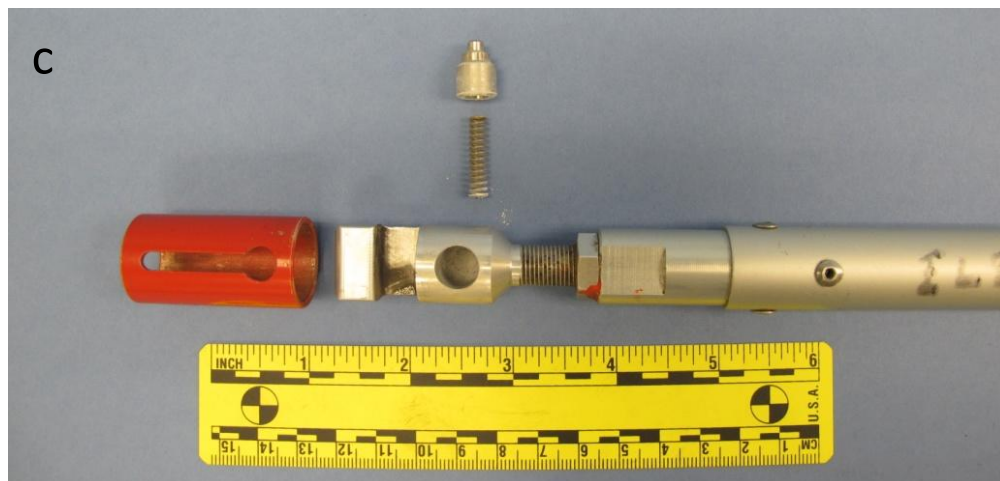
Through the sequence of images in Figure 4, the fastener bolt connector assembly (see Figure 2) was disassembled as indicated. The slotted headless screw was seized in place and was ground off to allow removal of the lock sleeve. Once the lock sleeve was removed, the lock button and spring were removed. White salts, consistent with aluminum corrosion product were observed in the cross-drilled hole that housed the spring and lock button (bolt connector is manufactured from type 6061 aluminum alloy). Closer views of the corrosion product with the cross-drilled hole and on the outside diameter of the lock button are shown in Figures 5 and 6. Dark deposits consistent with fretting wear scars and fretting corrosion are present on the flanks and root of the connector notch as indicated in Figure 5.

Figure 4 Images of the a portion of the elevator quick fastener assembly documenting removal of the headless screw (View a), and removal of the lock sleeve and lock button (Views b and c).

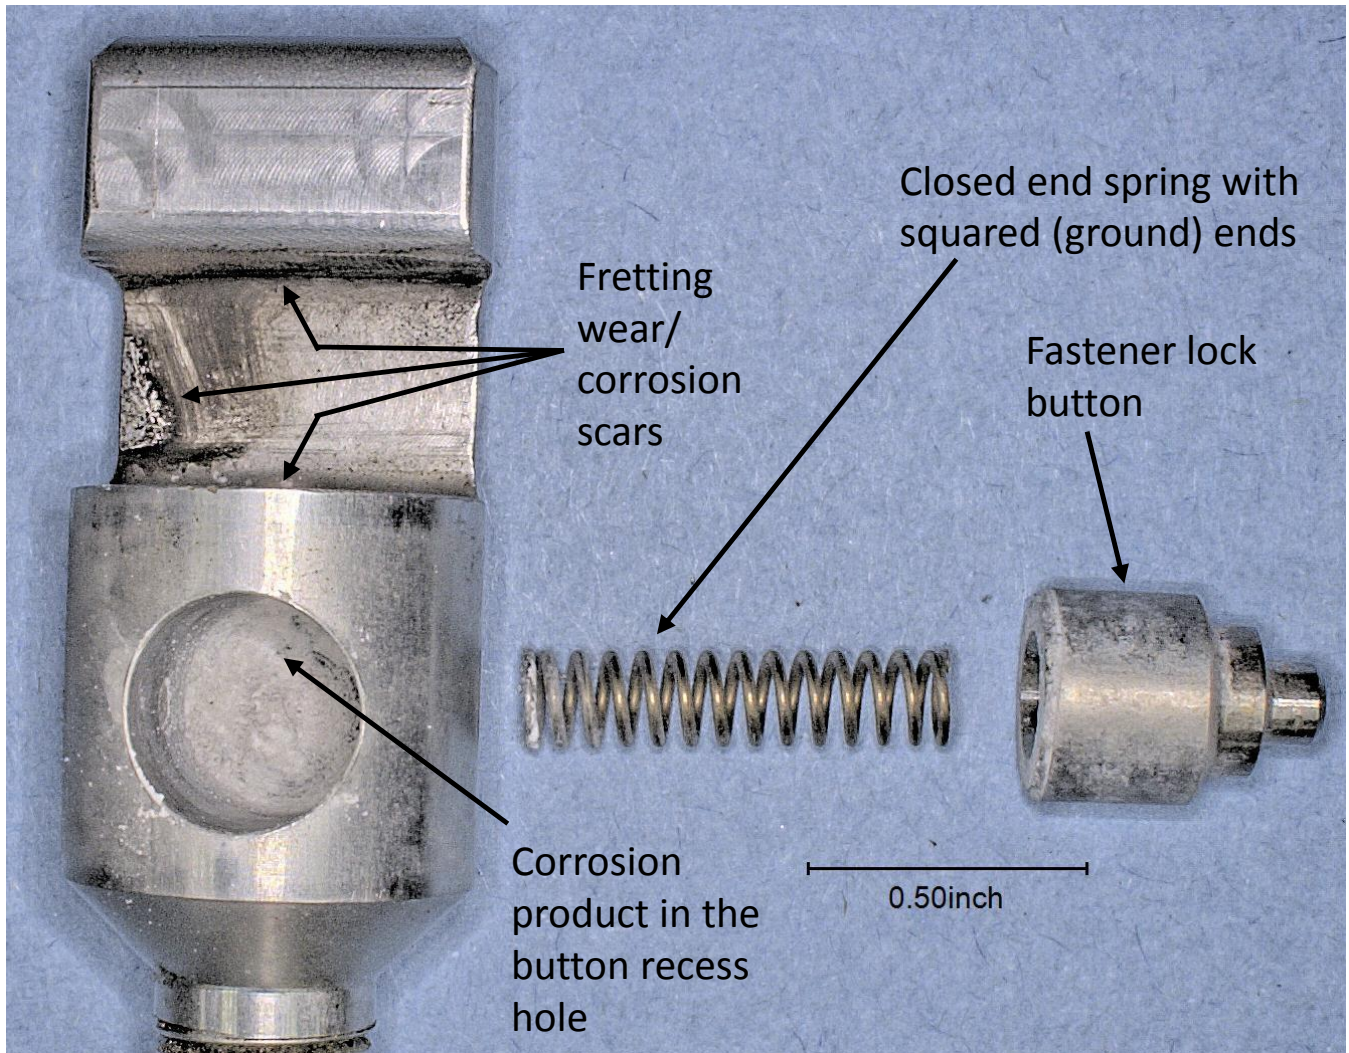
Figure 5 Closer image showing the fastener lock button, retraction spring, and bolt connector. Note the presence of white corrosion product in the button recess hole.

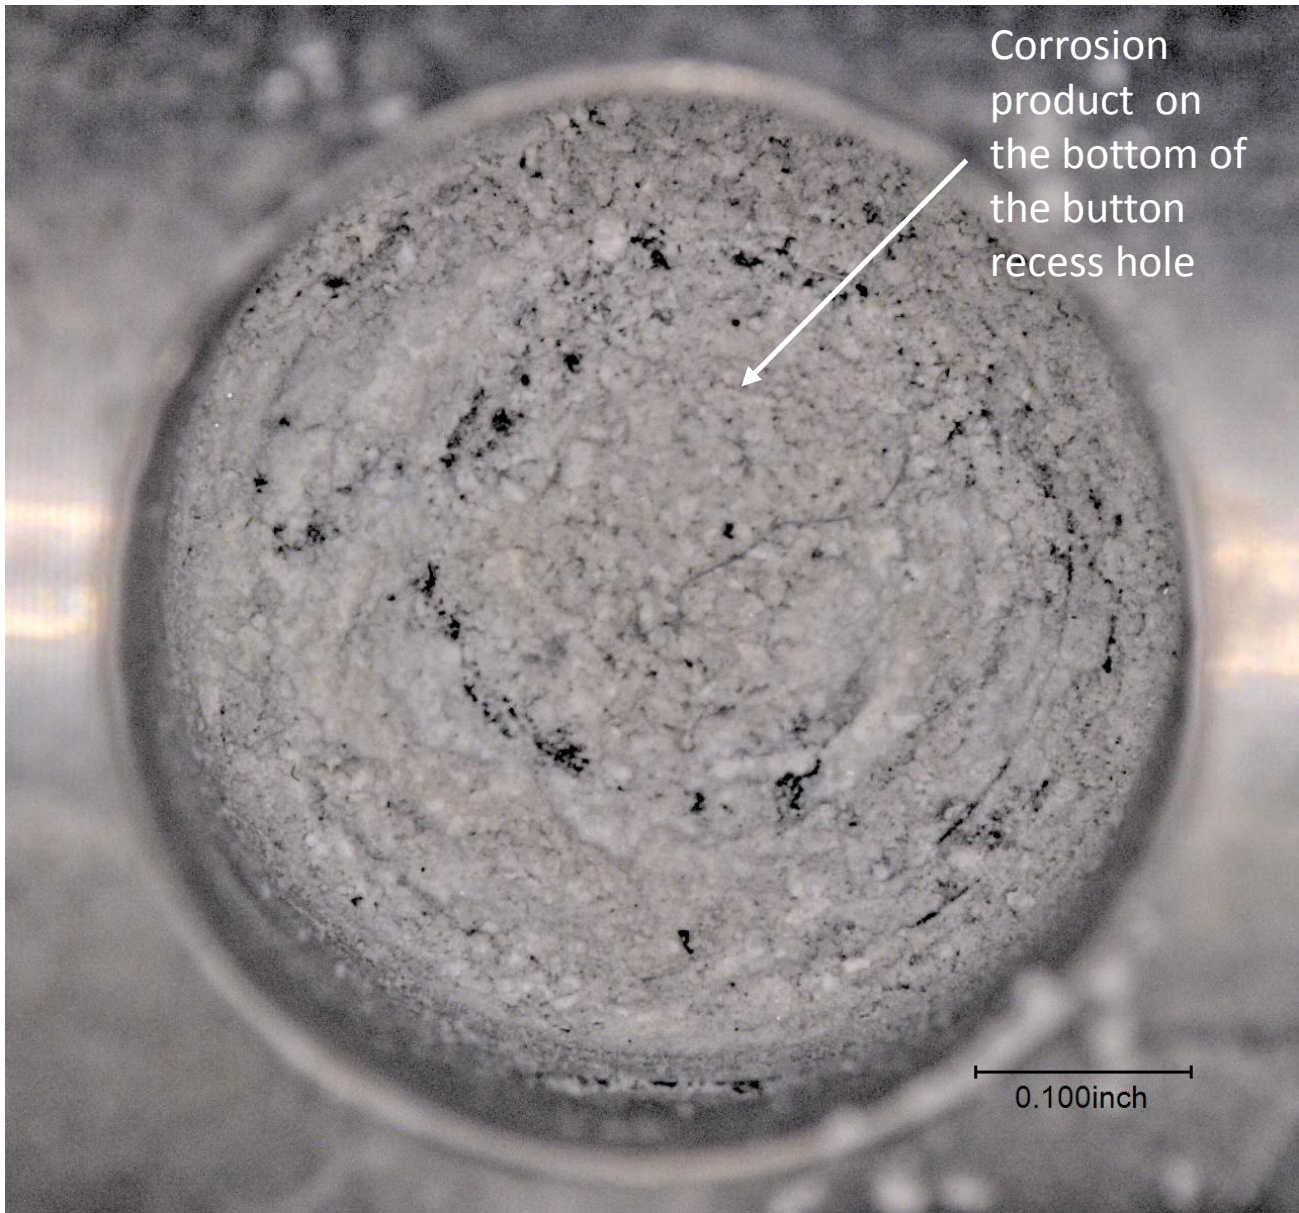
Figure 6 Higher magnification image of the button recess hole and the presence of corrosion product.

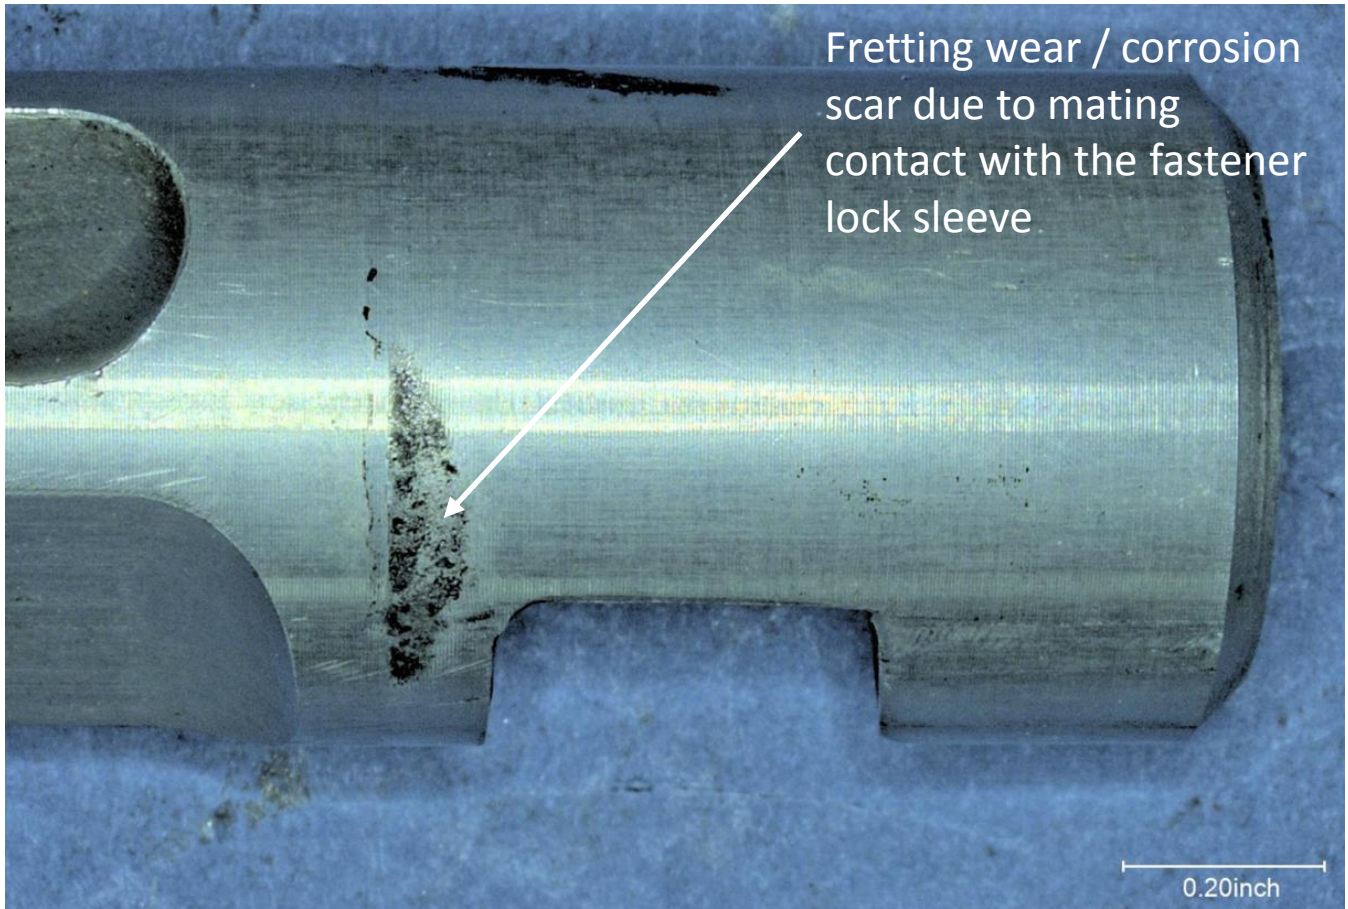
Figure 7 shows an image of the fastener clevis connector with an area exhibiting dark deposits consistent with fretting wear and fretting corrosion due to contact with the inside surface of the lock sleeve (when placed in the locked position.) A mating fretting wear scar was observed on the inside surface of the lock sleeve. The flanks and root of the clevis connector also exhibited mating fretting wear scars similar to those observed on the bolt connector.

Figure 7 Image of the fastener clevis connector showing areas with fretting wear and fretting corrosion.

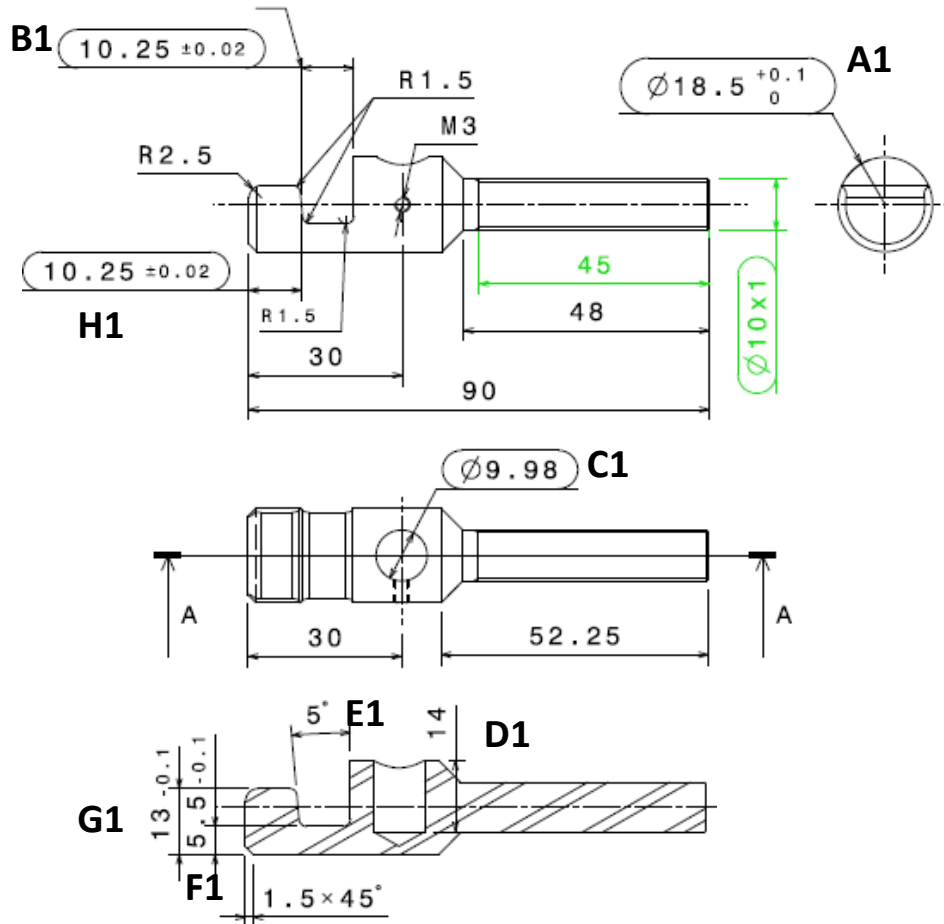
Figure 8 Summary of dimensional measurements for the locking features on the bolt connector.

Employing calipers, micrometers, and an optical comparator, the critical-to-locking dimensions on the bolt connector, clevis connector, lock sleeve, and lock button were measured. The dimensions are summarized in Figures 8-11 and are compared with the manufacturer's specified dimensions. A few dimensions were determined to be slightly outside specifications limits (Figure 8 B1, C1, E1 and Figure 11 B4, C4.)

Feature	Measured nominal dimension (mm)	Specified dimension (mm)
A1	18.6	18.5 to 18.6
B1	10.37	10.23 to 10.27
C1	10.02	9.98
D1	14	14
E1	5°2'	5°
F1	5.45	5.5 to 5.4
G1	12.84	12.90 to 13.00
H1	10.26	10.23 to 10.27

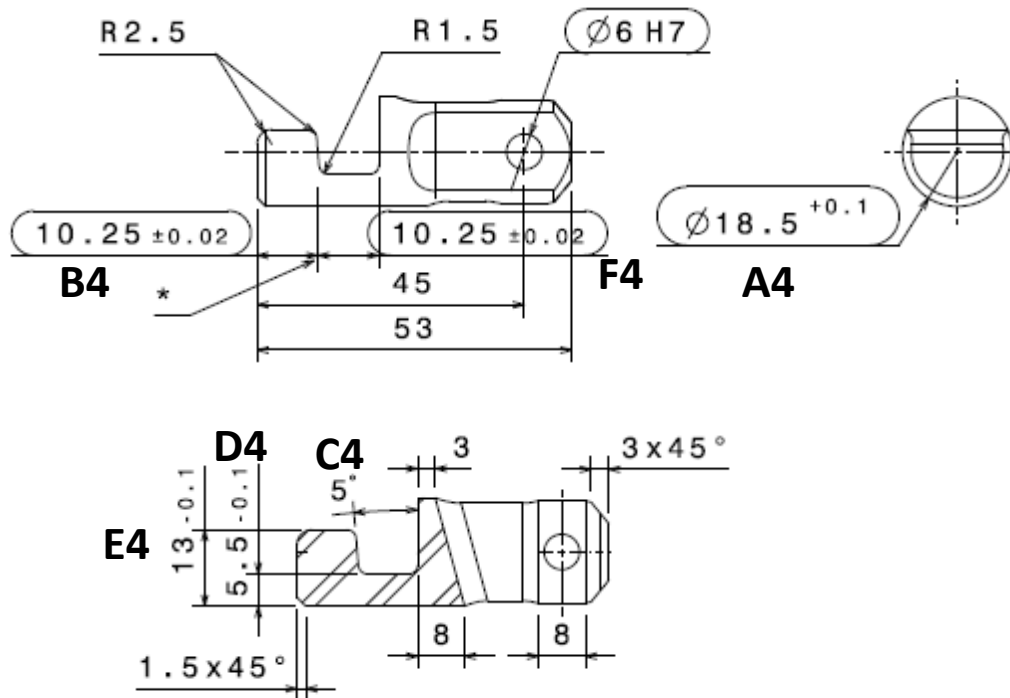
Figure 11 Summary of dimensional measurements for the locking features on the clevis connector.

Feature	Measured nominal dimension (mm)	Specified dimension (mm)
A4	18.56	18.5 to 18.6
B4	10.28	10.23 to 10.27
C4	5°7'	5°
D4	5.46	5.4 to 5.5
E4	12.96	12.90 to 13.00
F4	10.38	10.23 to 10.27
