**MATERIALS LABORATORY
FACTUAL REPORT 13-069**

**Bridge Collapse
Mount Vernon, WA; 05/23/2013**

HWY13MH012

MATERIALS LABORATORY FACTUAL REPORT

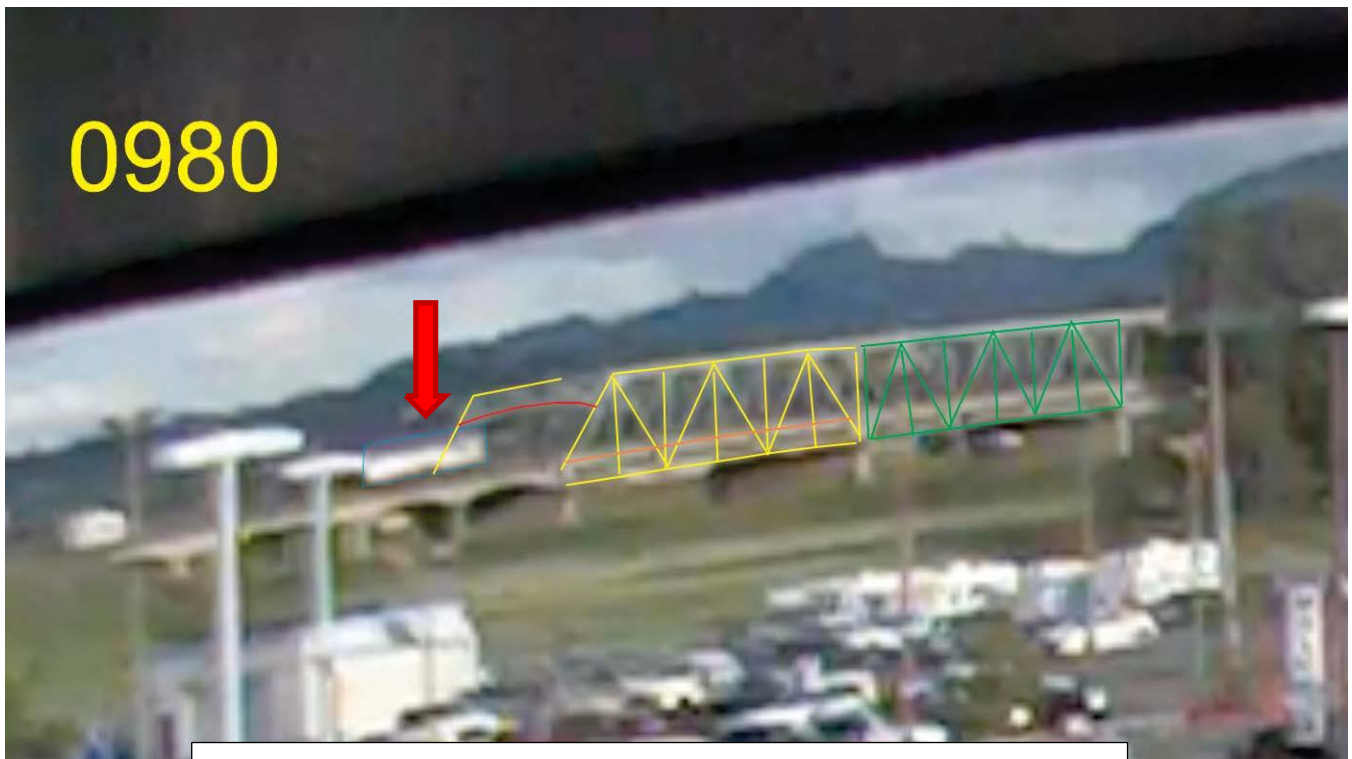
Figure 3. Frame 0980. Oversize load (arrow and blue box) and white trailer approach the north portal of the truss spans.

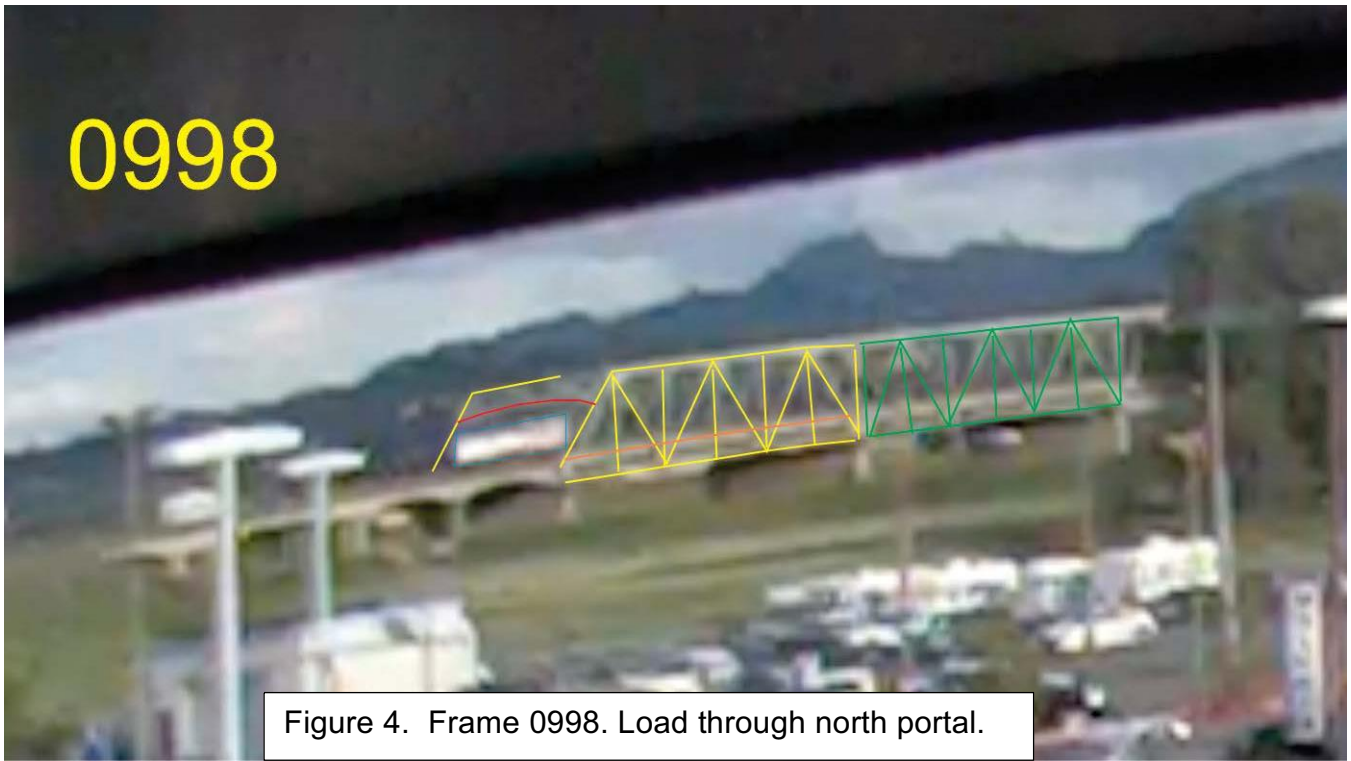
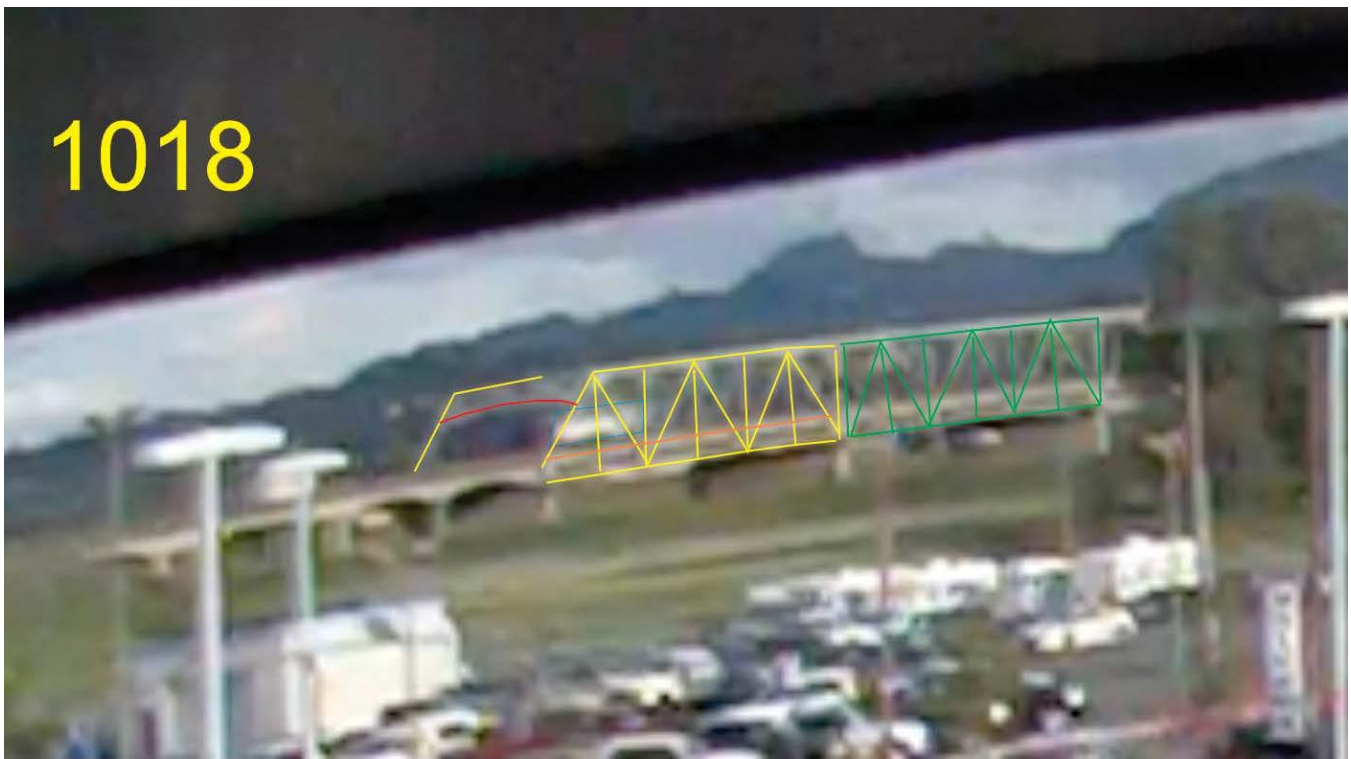
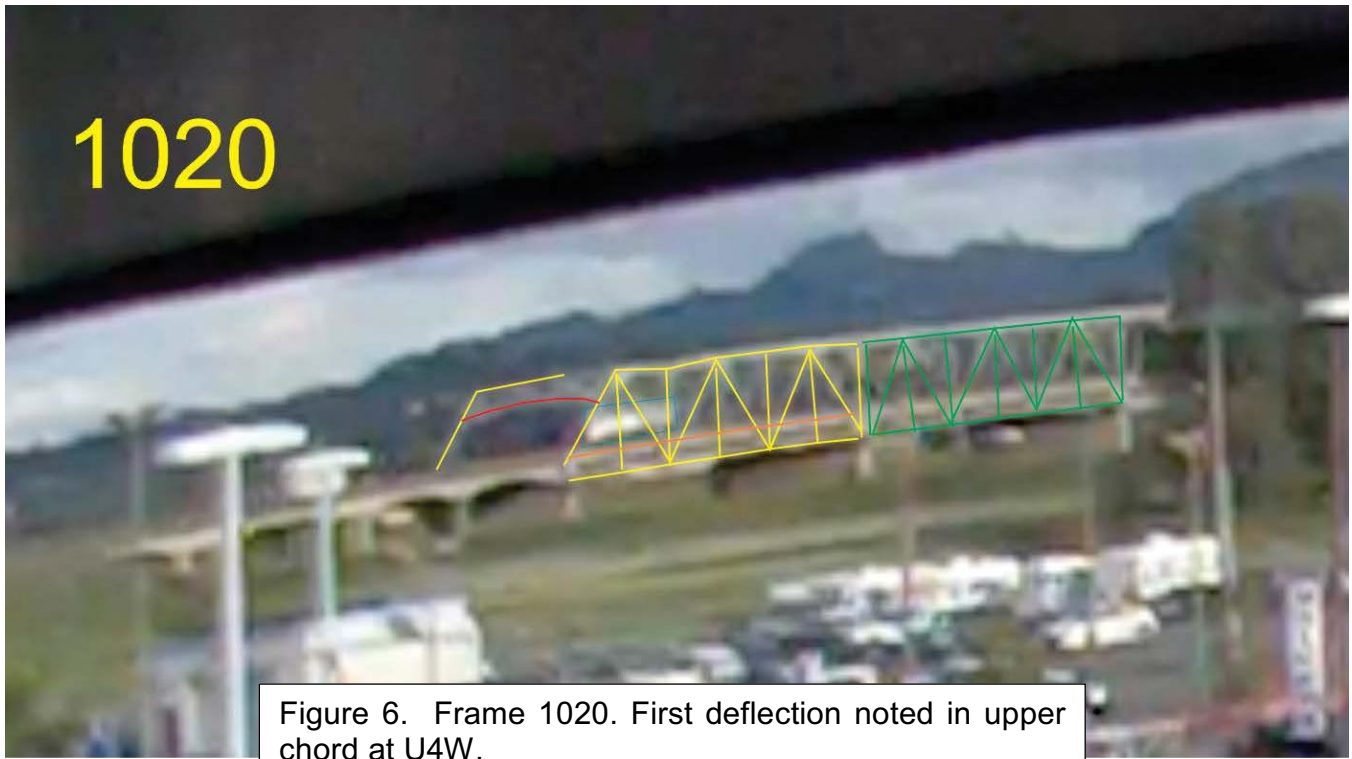
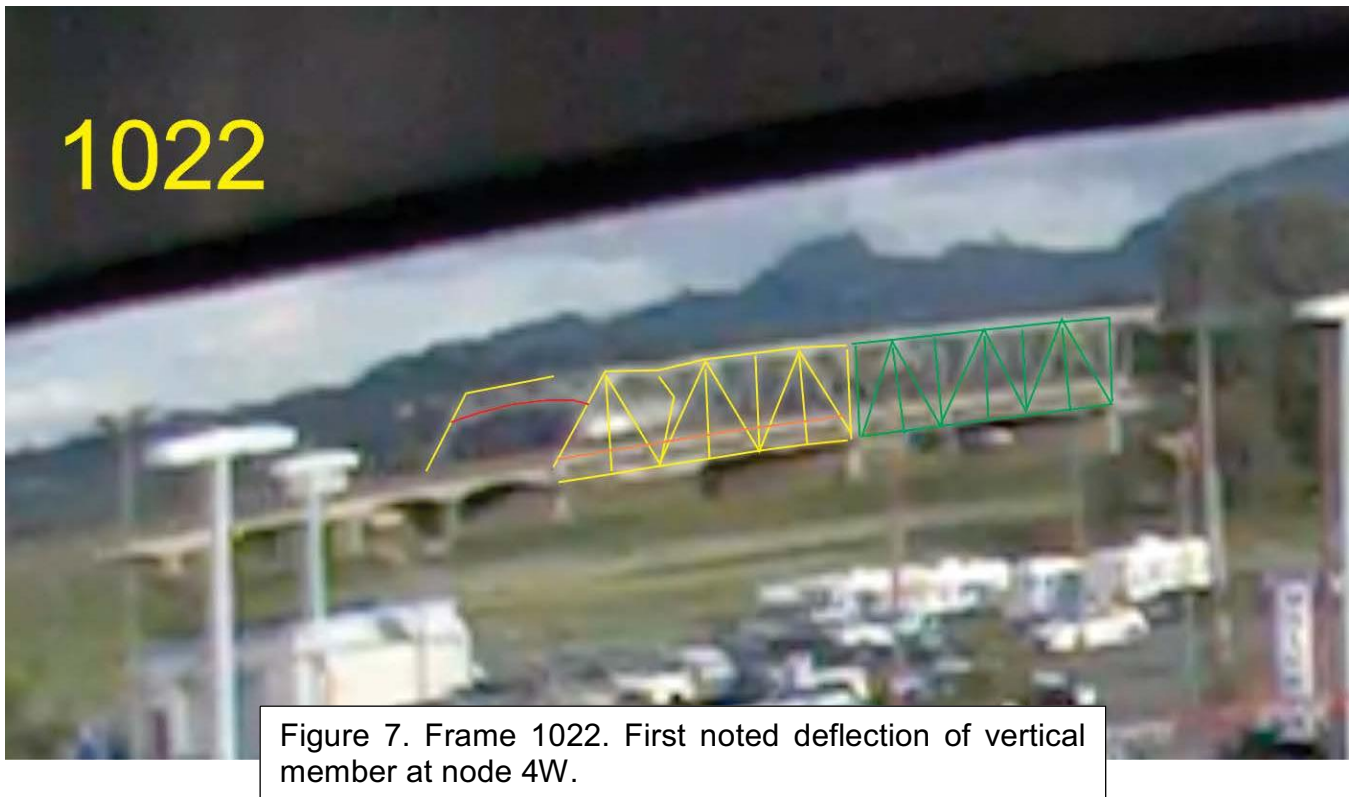
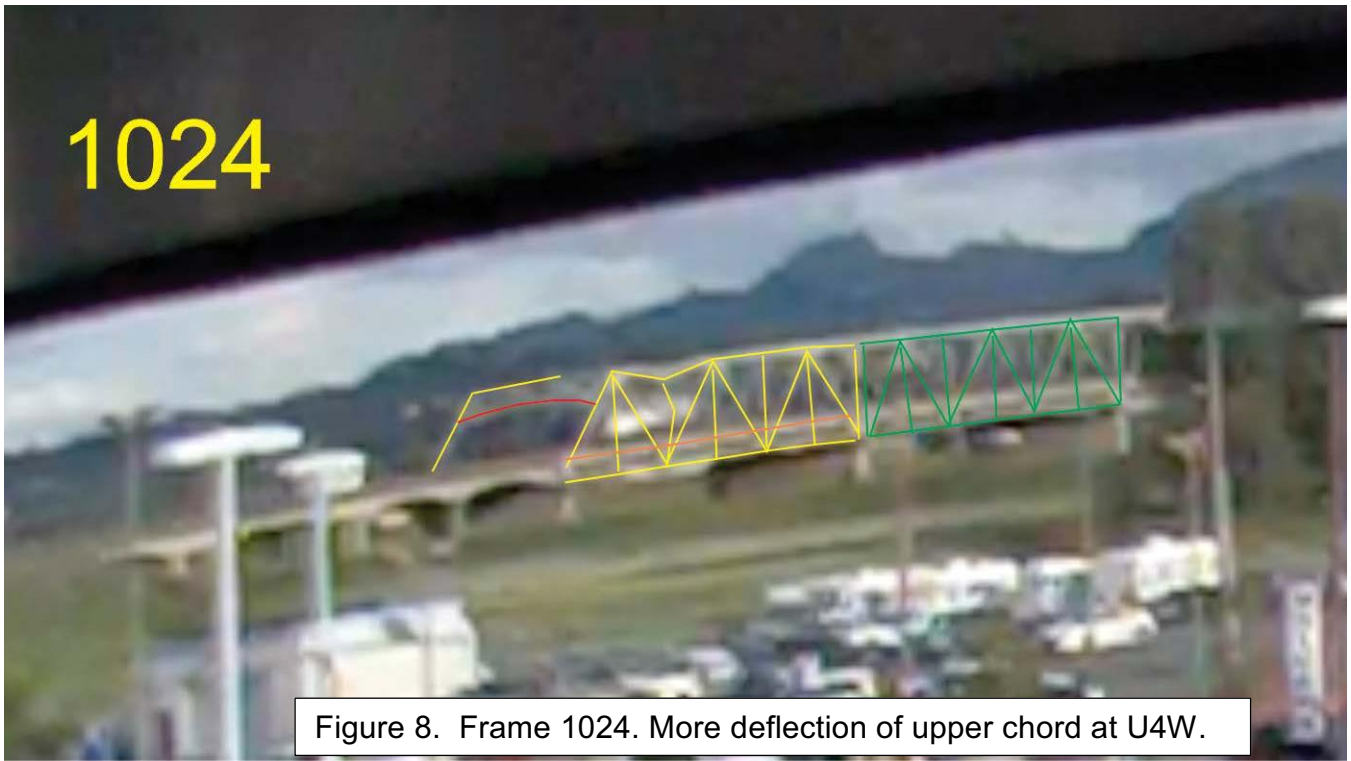
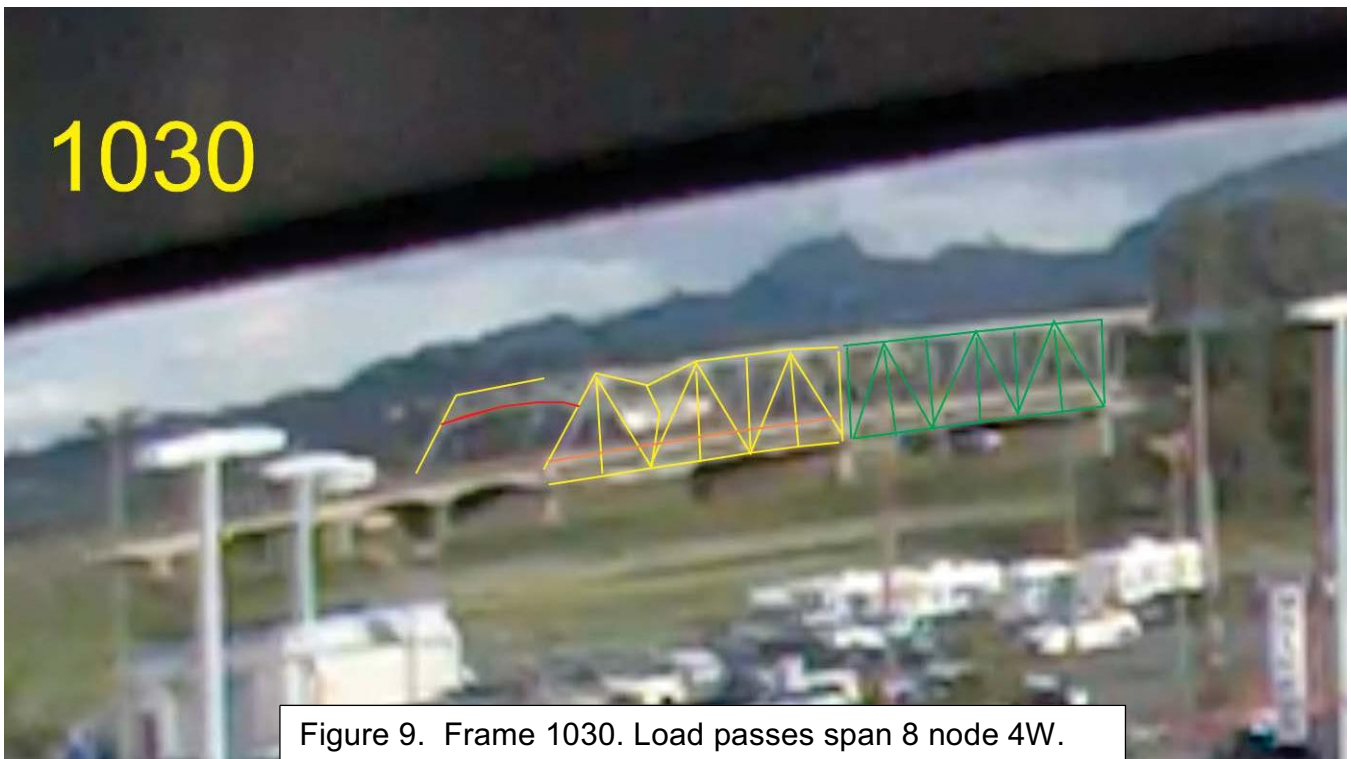
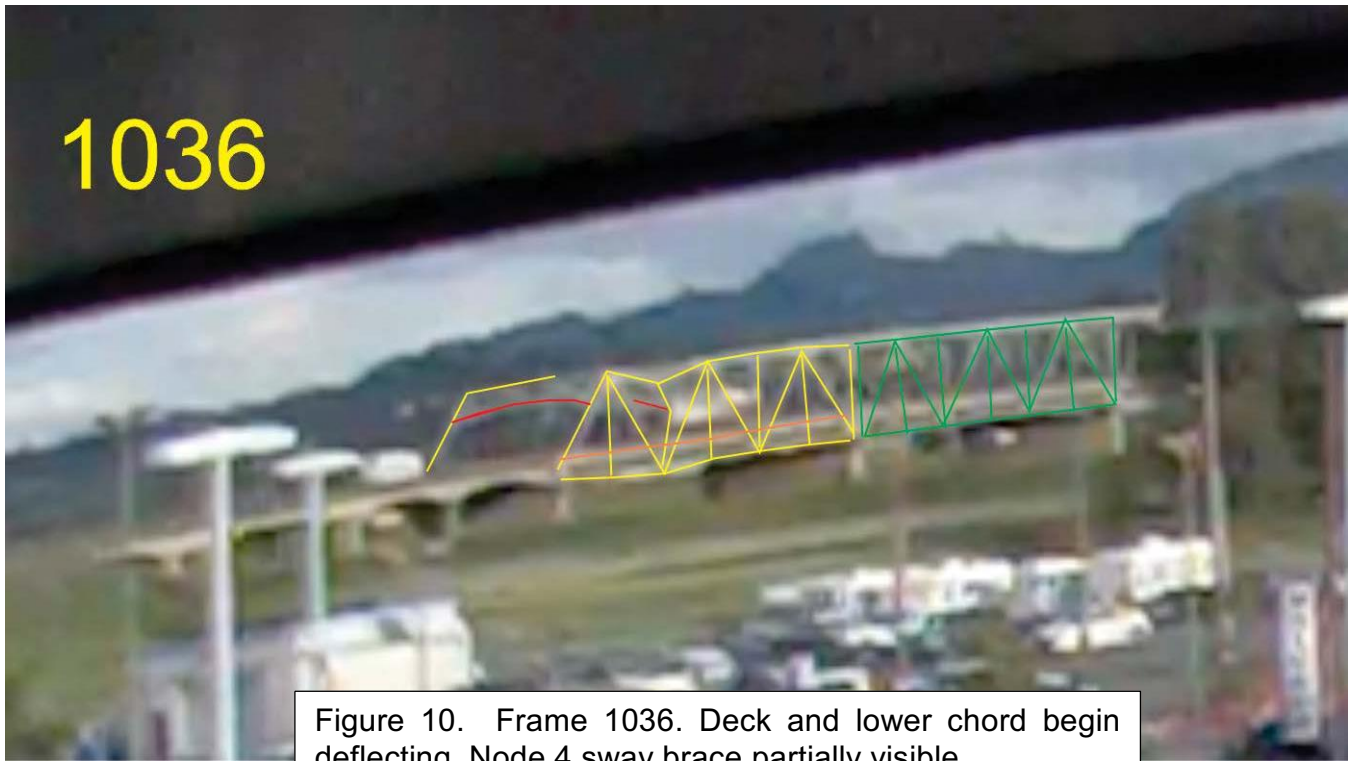
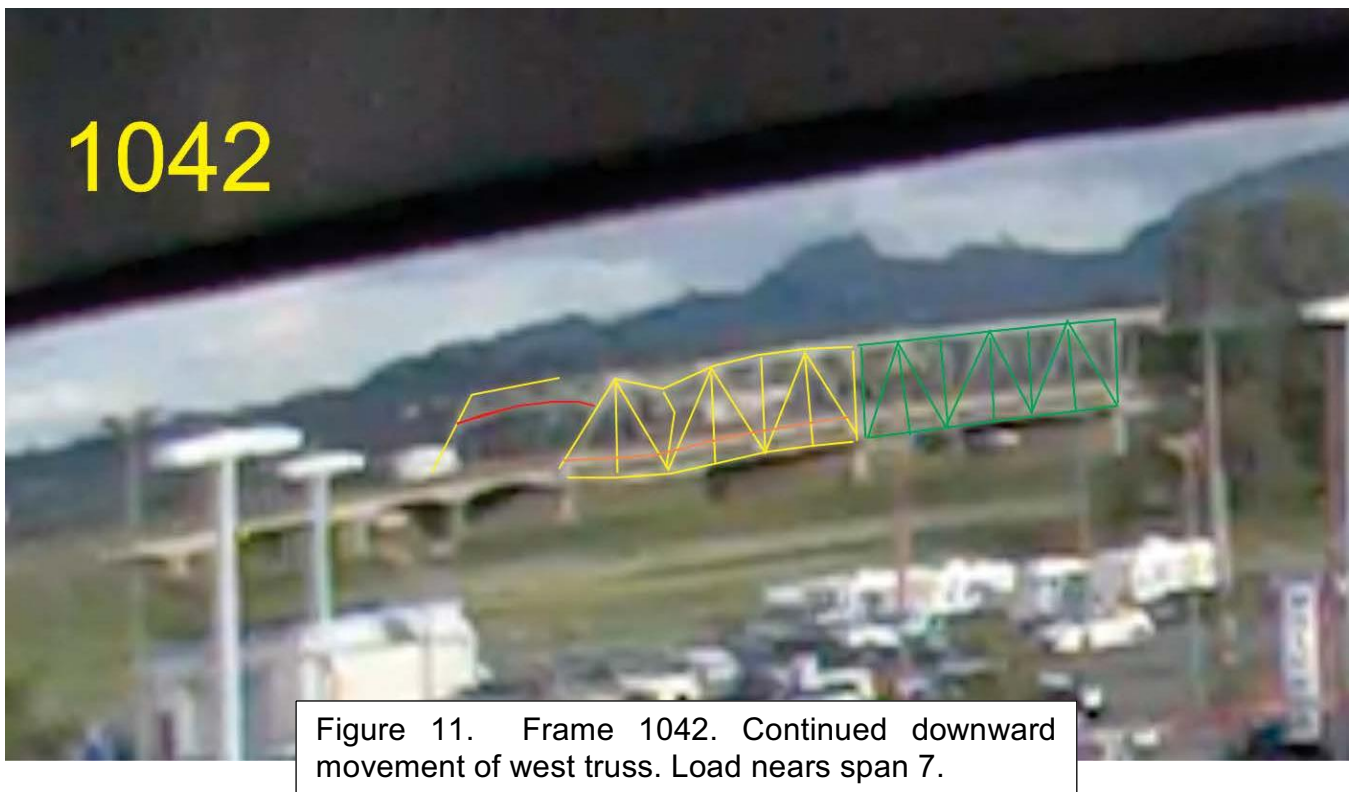
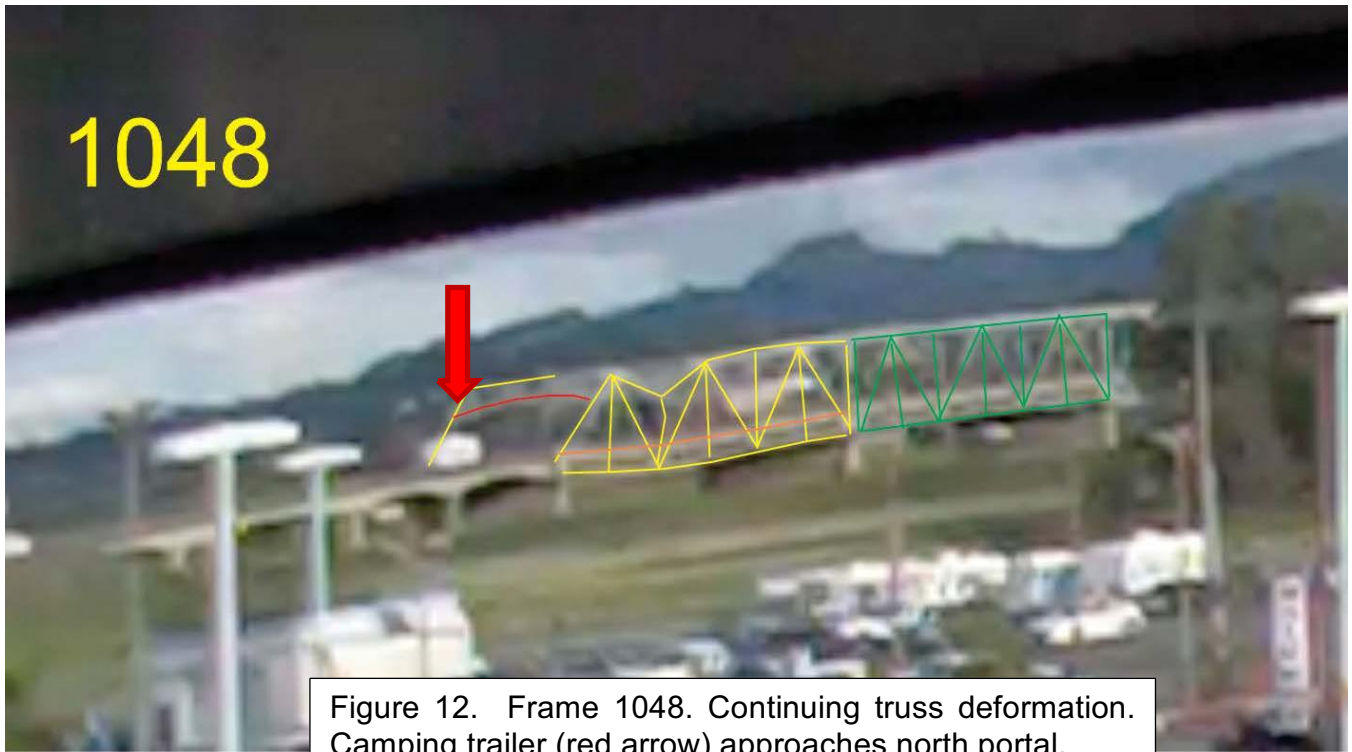
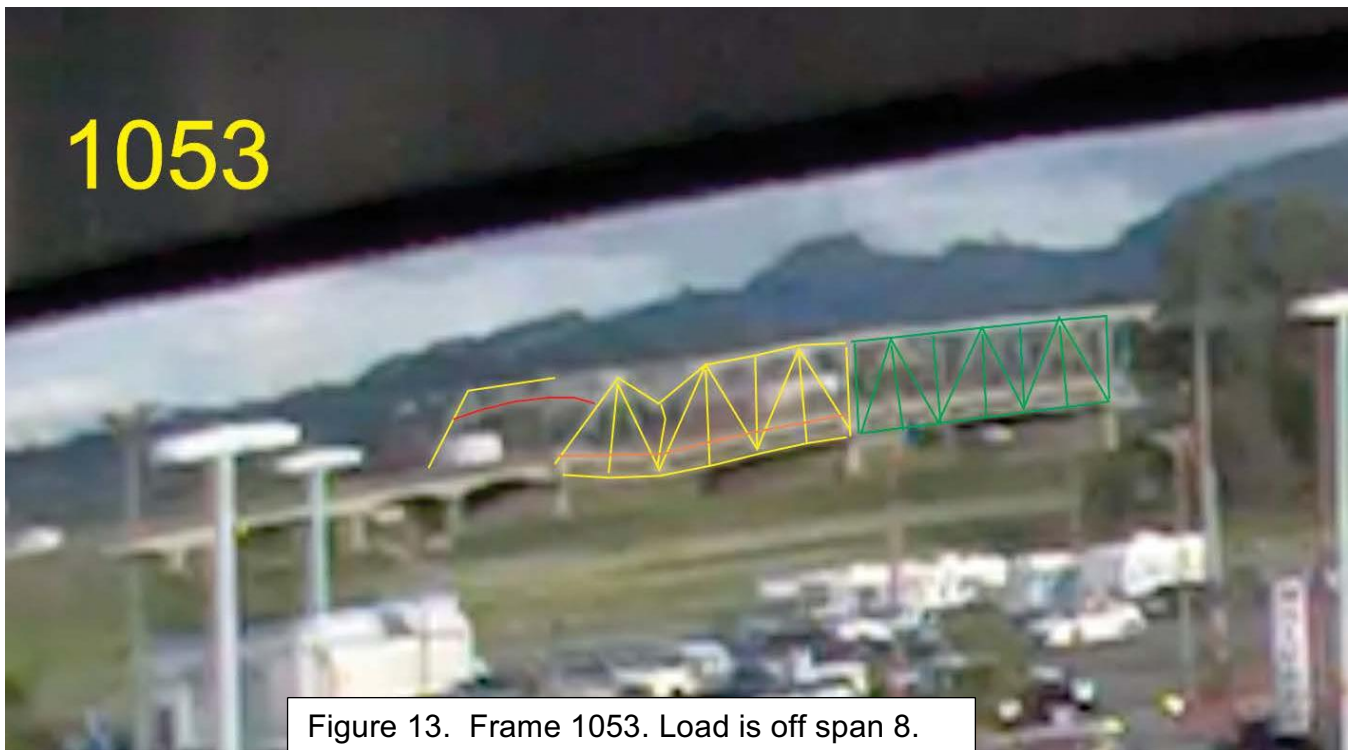
The selected frames are list below with the significant feature noted and shown as figures 3 through 14. Cumulative time is also listed in seconds with frame 0980 set to zero and assuming 25 frames per second.

Frame	Seconds	Feature
0980	0.00	Oversize load approaches the north portal of the truss spans.
0998	0.72	Load through the north portal.
1018	1.52	Front of load at Span 8 node 4 west.
1020	1.60	First deflection noted in upper chord at U4W.
1022	1.68	First noted deflection of vertical member at Node 4W.
1024	1.76	More deflection of upper chord at U4W.
1030	2.00	Load passes span 8 node 4W.
1036	2.24	Deck and lower chord begin deflecting. Node 4 sway brace visible.
1042	2.48	Continued downward movement of west truss. Tractor nears span 7.
1048	2.72	Continuing truss deformation. Camper trailer approaches north portal.
1053	2.92	Load is off of span 8.
1058	3.13	First movement of east side of portal. Load approaches Span 7 U4W. End of video.

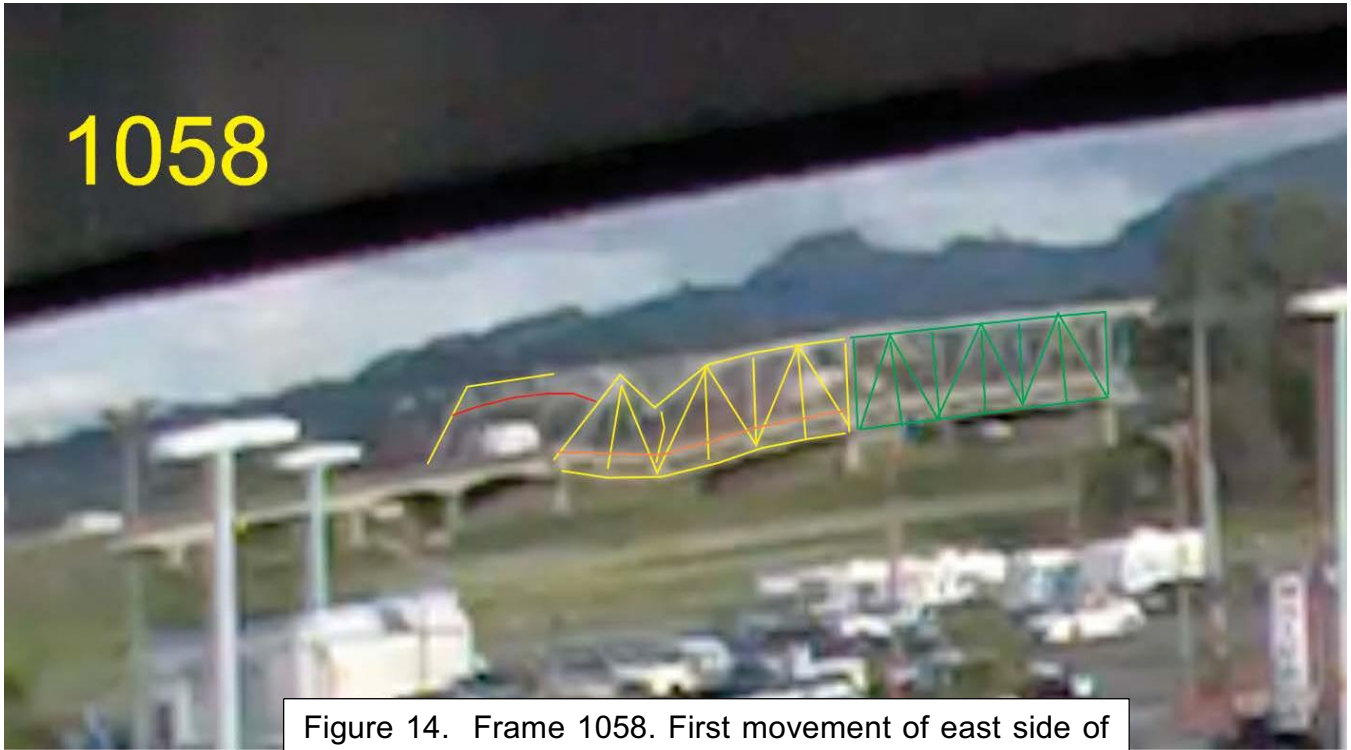
Figure 14. Frame 1058. First movement of east side of portal. Load approaches Span 7 U4W.
