**MATERIALS LABORATORY  
FACTUAL REPORT 13-070**

**Bridge Collapse  
Mount Vernon, WA; 05/23/2013**

**HWY13MH012**

MATERIALS LABORATORY FACTUAL REPORT

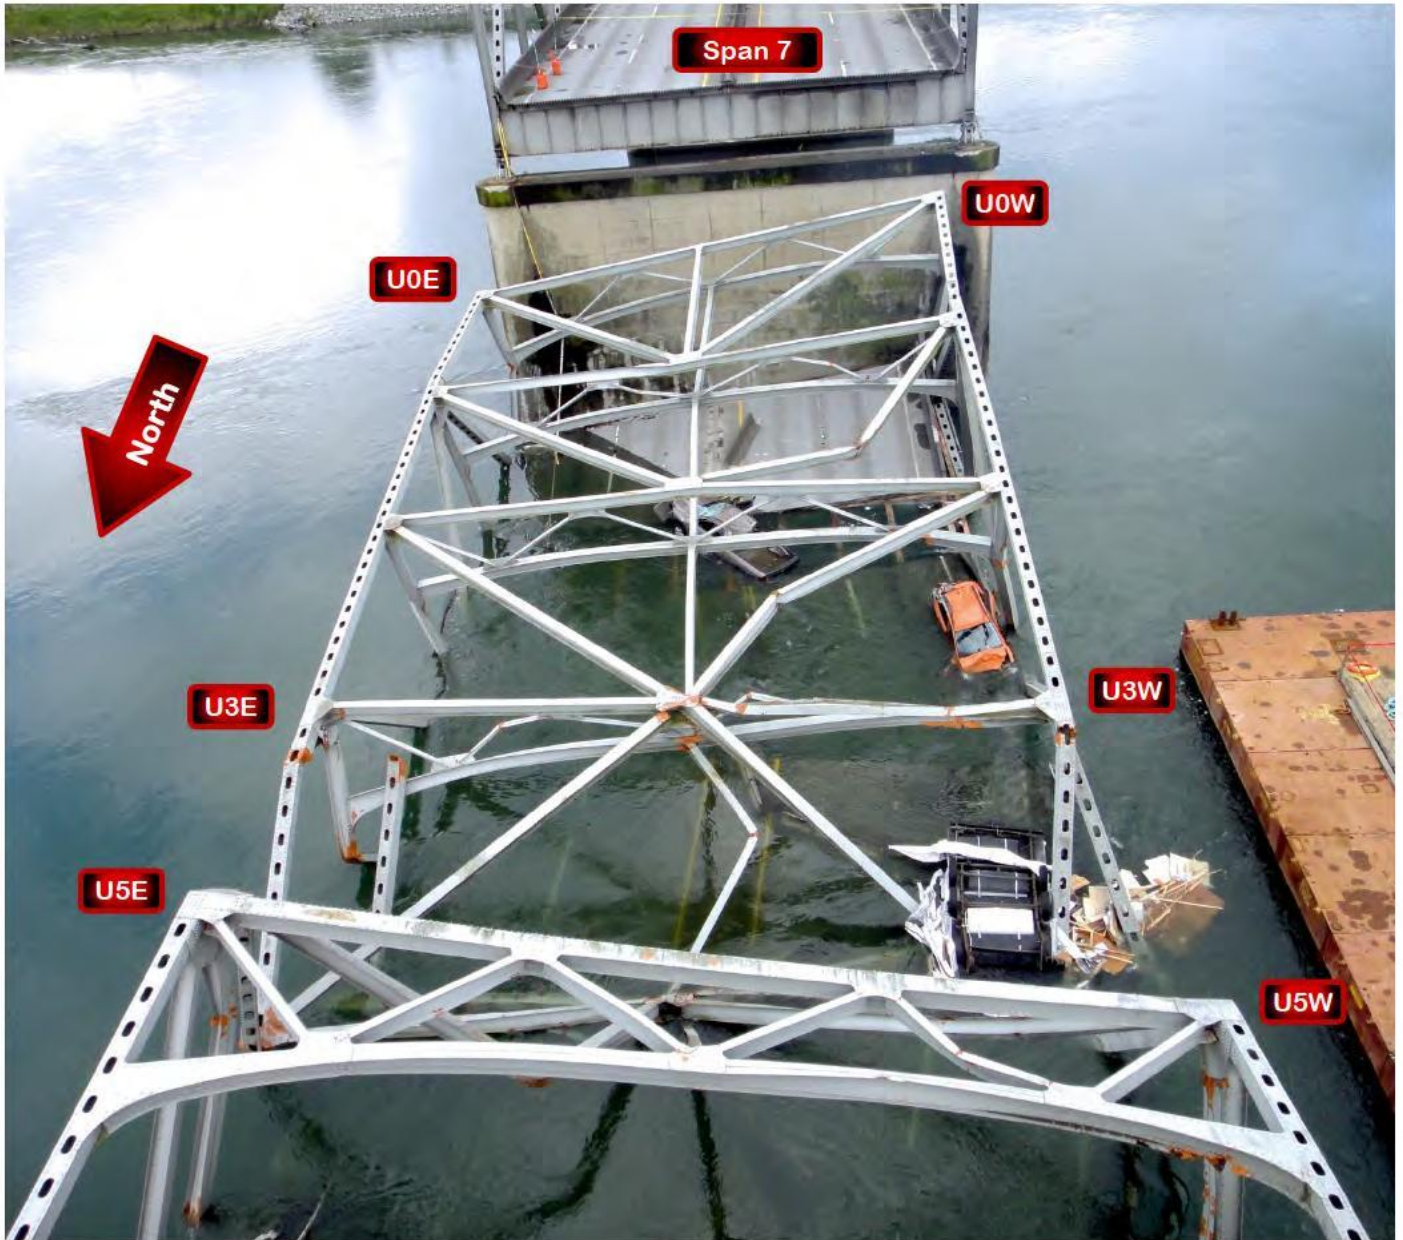
Initial inspections found that span 8 had completely collapsed into the Skagit River but was generally confined between its end piers. A prominent "V" shape was apparent across the collapsed span structure at U4E and U4W. South of the "V", the span structure was oriented nearly flat while the structure north of the "V" had rotated south end down such that the normally 45° north portal members were nearly horizontal. The upper chords of the east and west trusses were above the water and visually intact except around node U4W. At U4E and U4W both chords bent abruptly downward. The west upper chord entered the water and node U4W was not visible below the water line. The western upper chord became visible again about half way between node U4W and U5W on the rotated north side structure. The eastern upper chord bent downward at U3E then upward at U4E, but remained visible just above the water line, and then it bent again just south of U5E.

Three vehicles were present in the collapsed span. See Figure 4.

Figure 4. View looking down and south from the north pier at the collapsed span 8. “V” appearance of fallen structure between U3 and U5.

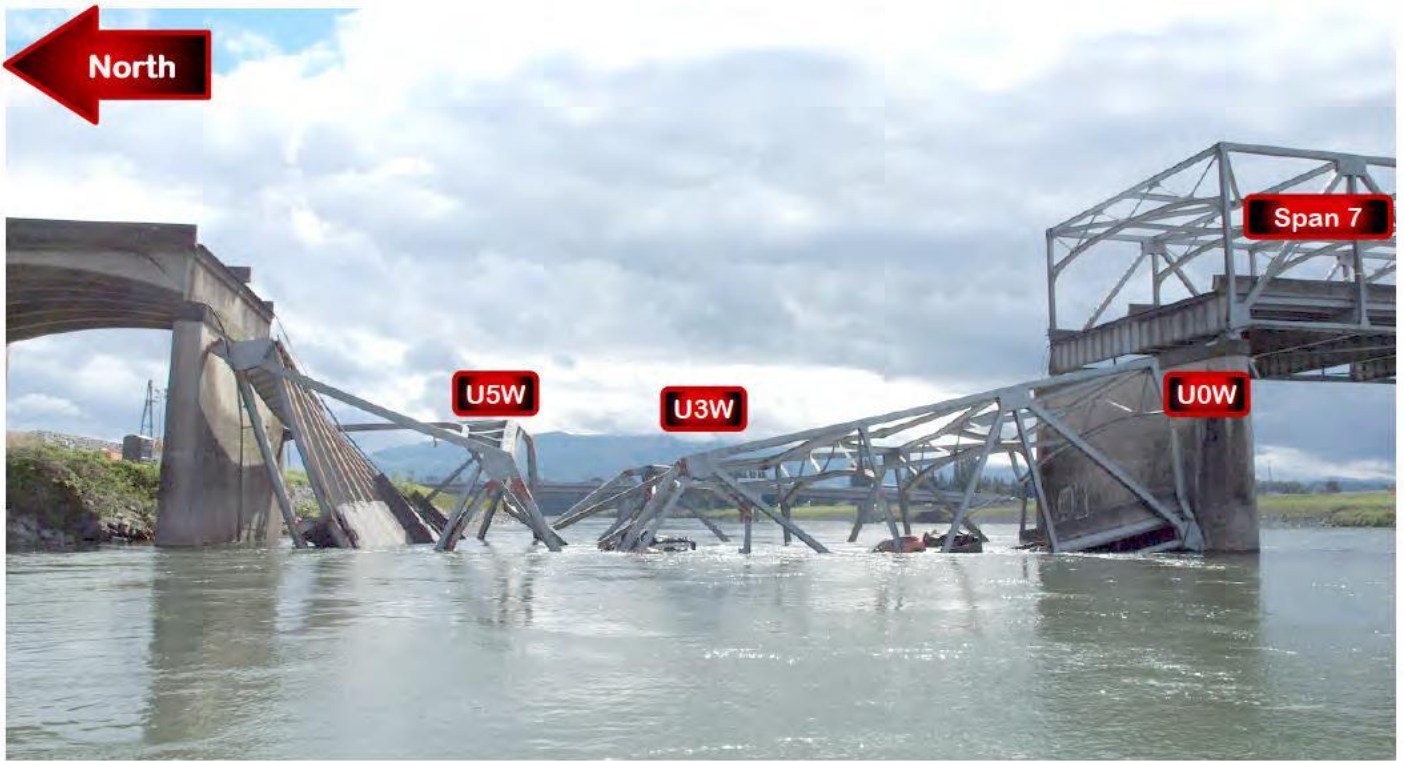
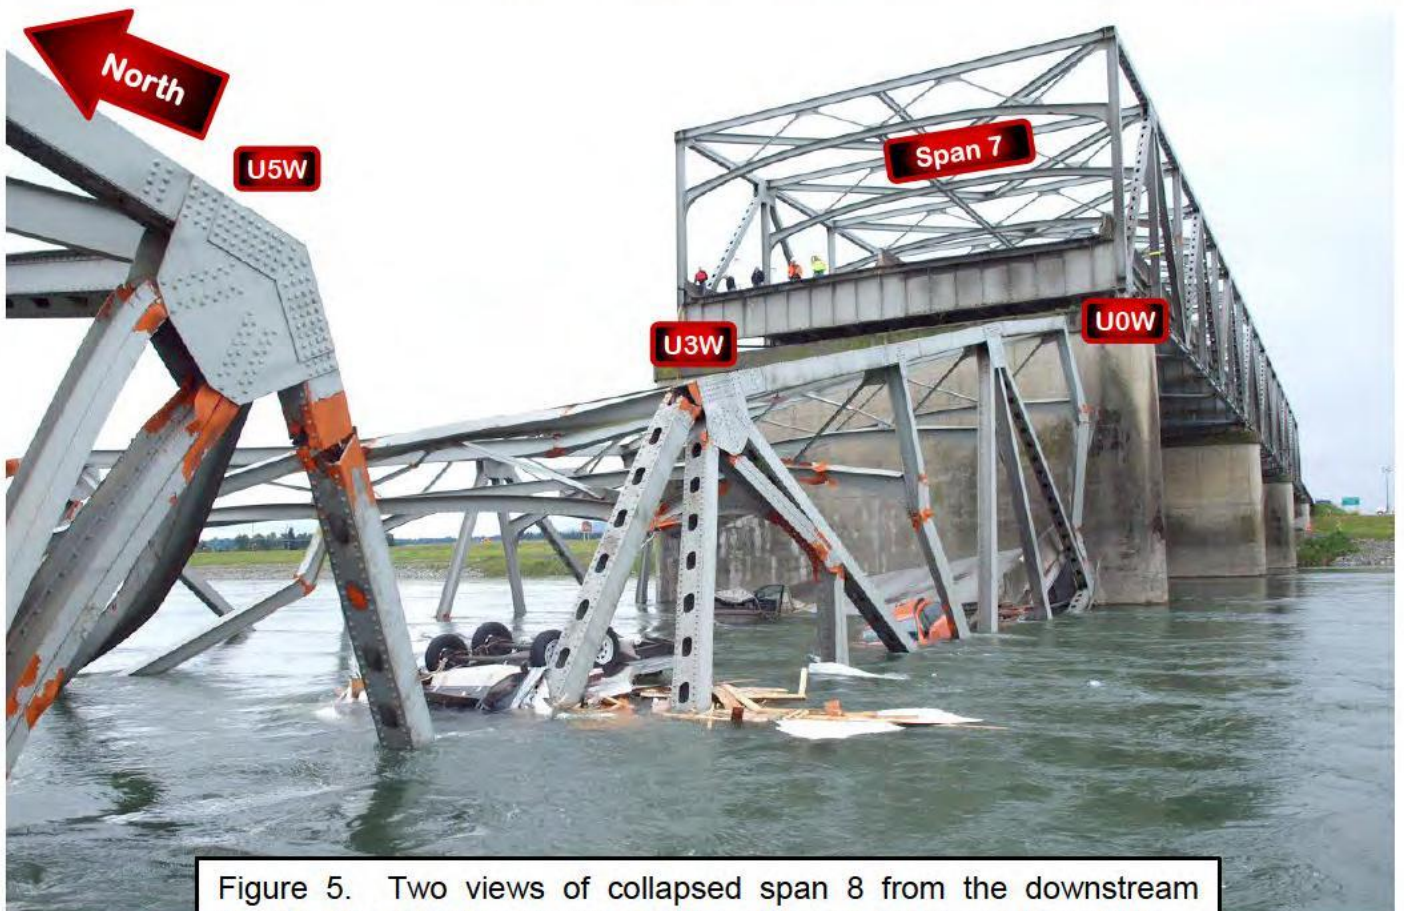
Figure 5. Two views of collapsed span 8 from the downstream (west) side. "V" appearance of fallen structure between U3 and U5.

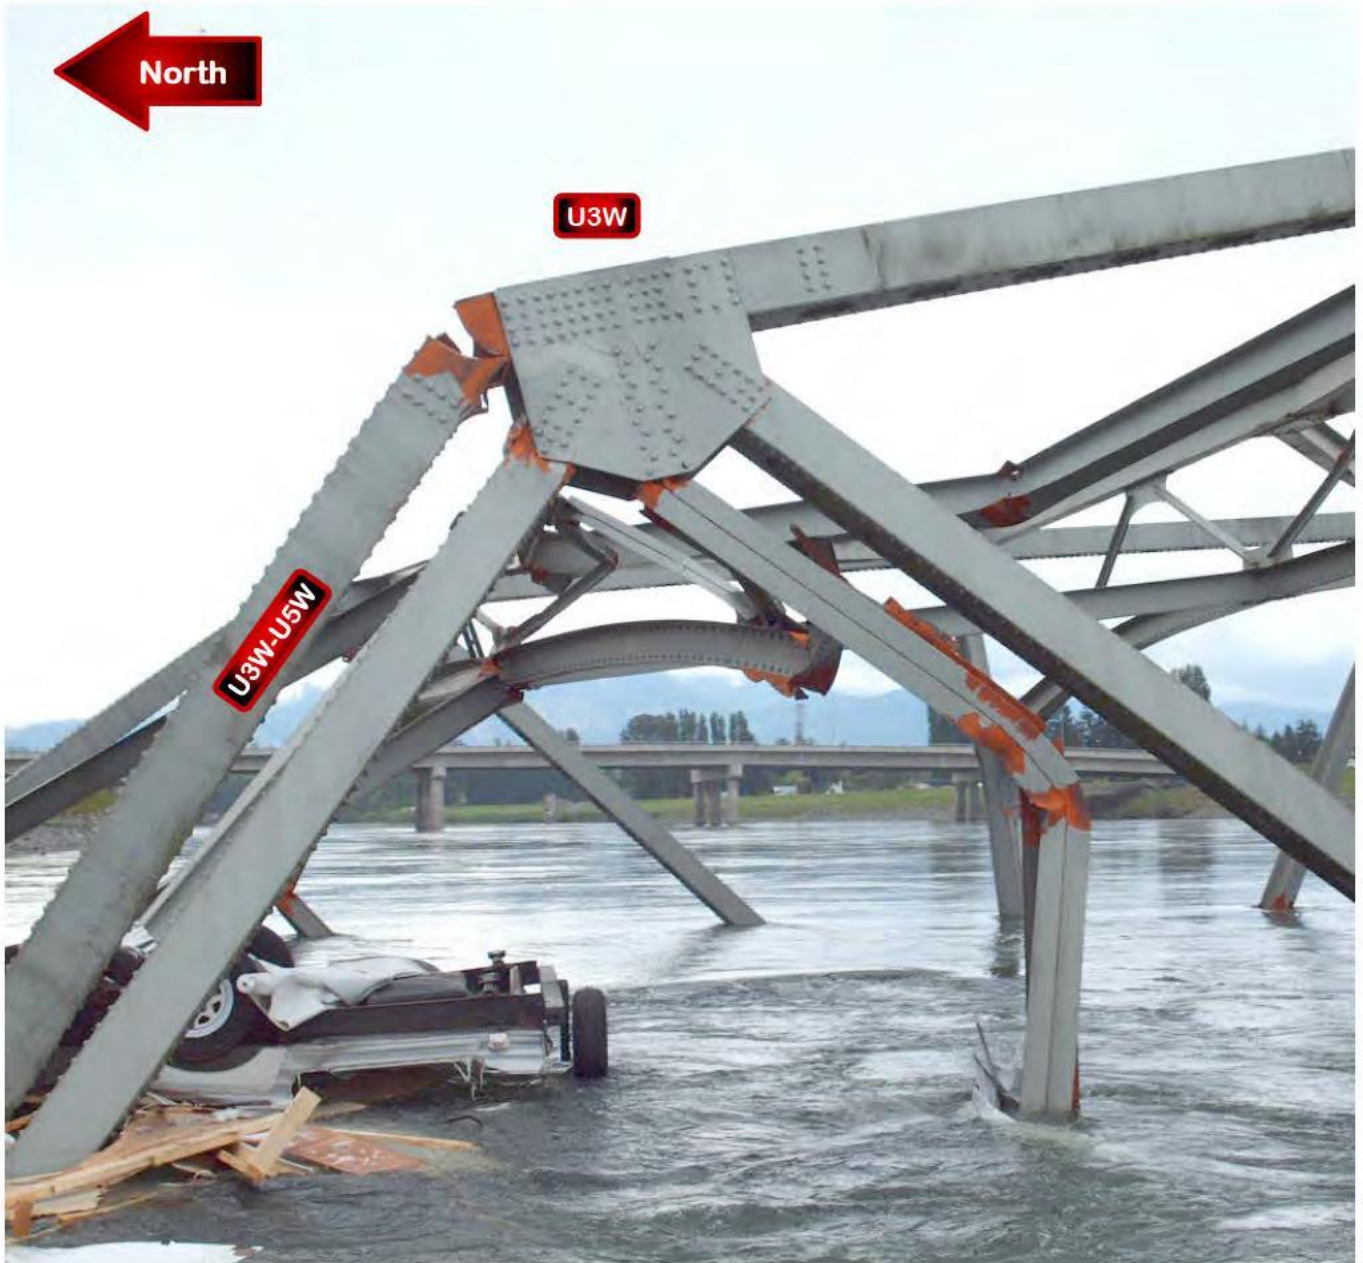
Adjacent to the north edge of the U3W node, the upper chord was bent, north end down, and the chord was partially fractured. The top cover plate and both "C" channels of the chord were overstress fractured and the lower cover plate was buckled. Only the lower cover plate held the chord together. Deformation accompanying the fractures was consistent with down bending of the upper chord north of node U3W. See Figure 6.

At the node vertical U3W-L3W was bent about 45° with the lower end southward. The vertical was partially fractured at the lower edges of the U3W gusset plates. The north flanges were tension fractured and the south flanges were buckled consistent with the lower end of the vertical member being displaced to the south. The vertical was bent again at about mid-height with the lower end to the north.

Figure 6. A view of node U3W and the surrounding damage.

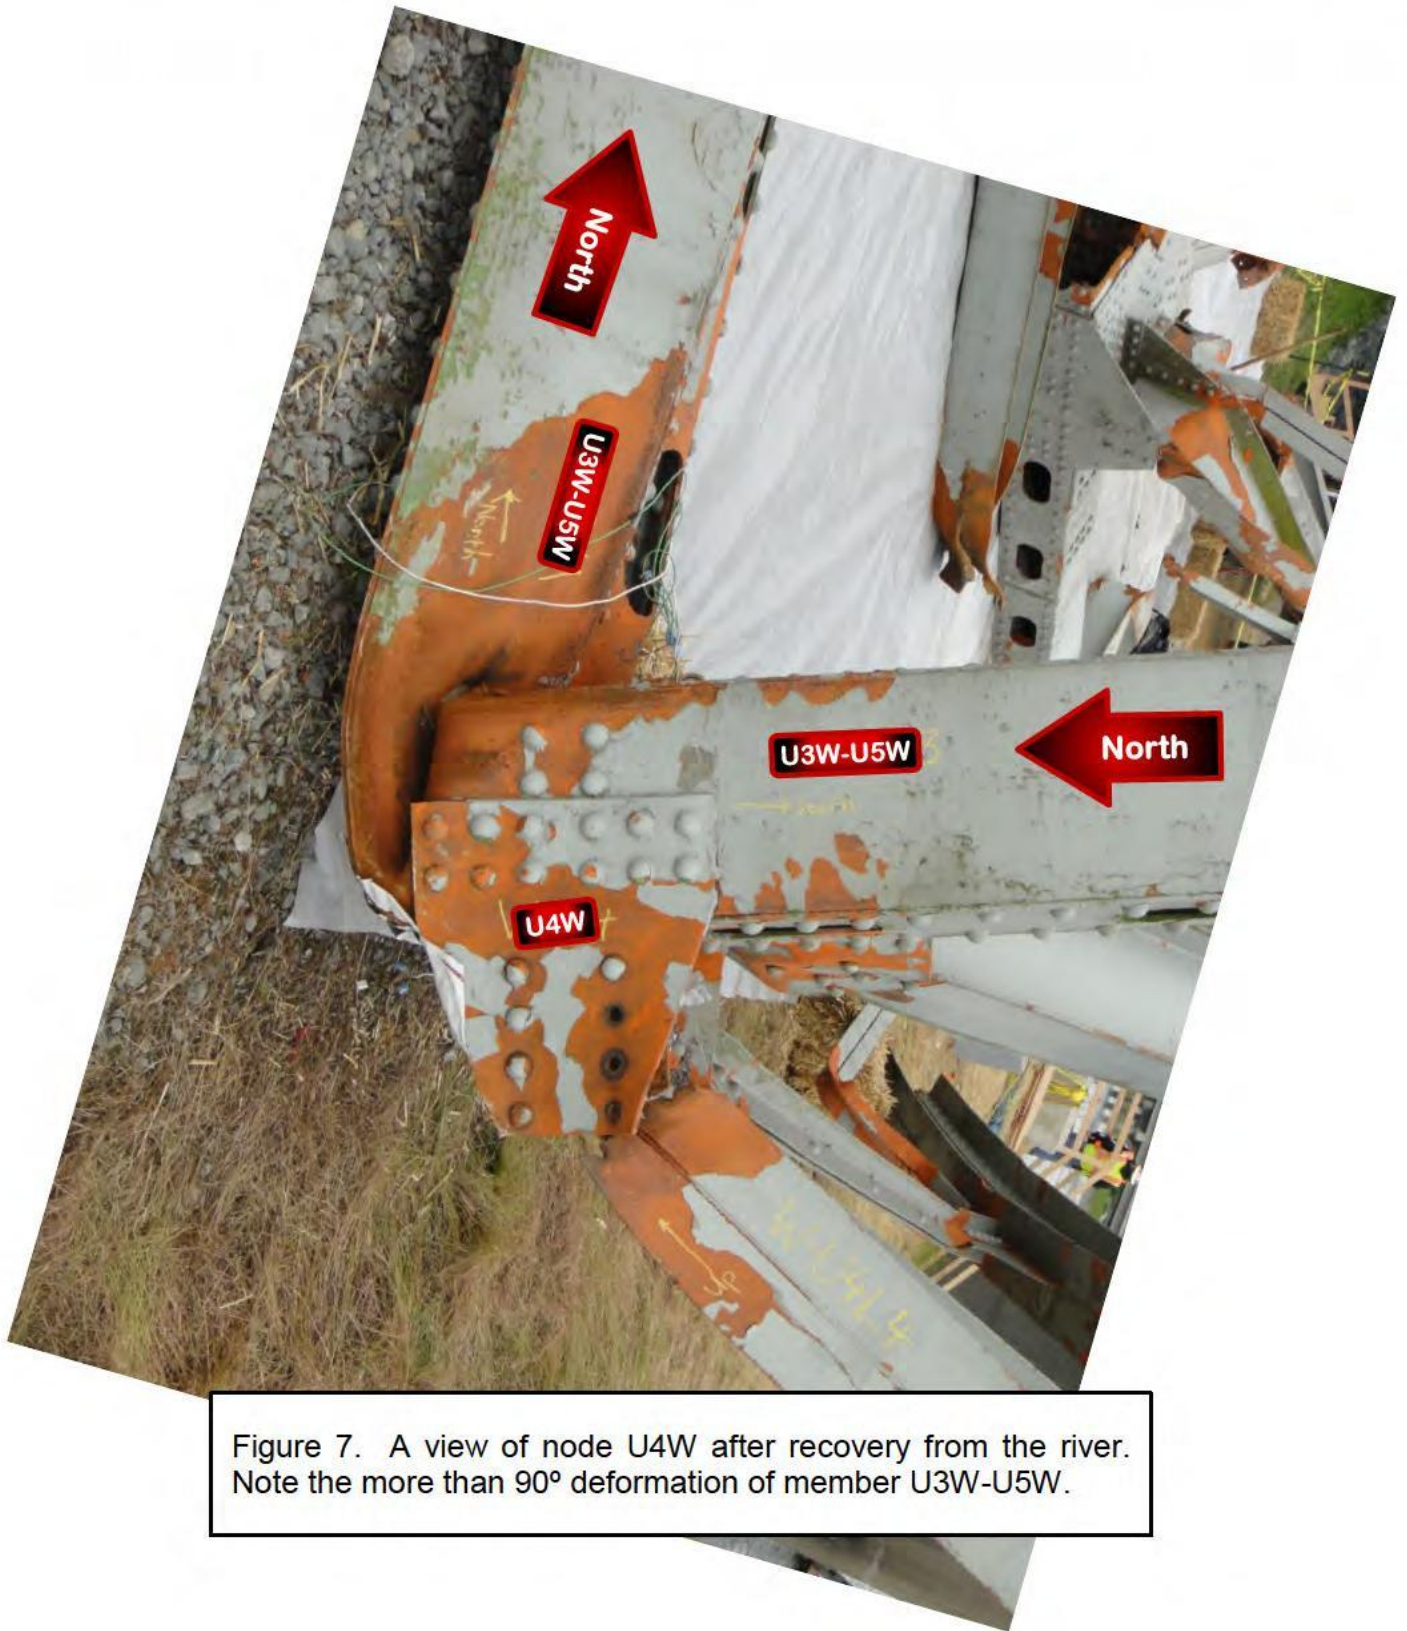
Member U3W-U4W was severely deformed adjacent to U4W into a "V" formation with the node down and the north and south portions of the chord up. The permanent deformation was greater than 90°. See Figure 7. The deformation was localized and centered at the north edge of the U4W gusset plates. The deformation severely folded and "S"-bent the "C" channels and top cover plate of the chord in a manner consistent with compression buckling of the chord followed by bending. See Figure 8 Upper. In one area, the box section of the chord collapsed bringing the top and bottom cover plates into near proximity. Small local fractures were present and several rivets were separated at some areas of severe deformation. As-recovered, pieces of aluminum, wood and low voltage wiring consistent with camping trailer materials were found embedded in the space formed by the deformed chord and adjacent gussets of the U4W node. See Figure 8 Lower

Figure 7. A view of node U4W after recovery from the river. Note the more than 90° deformation of member U3W-U5W.

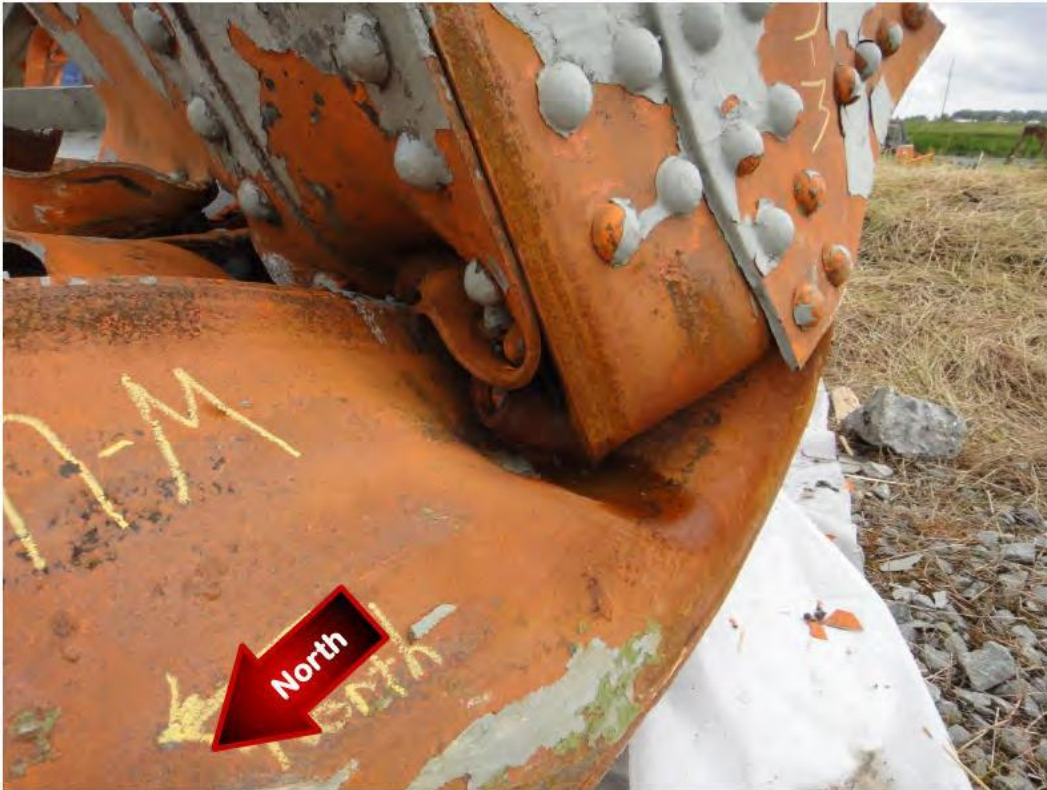
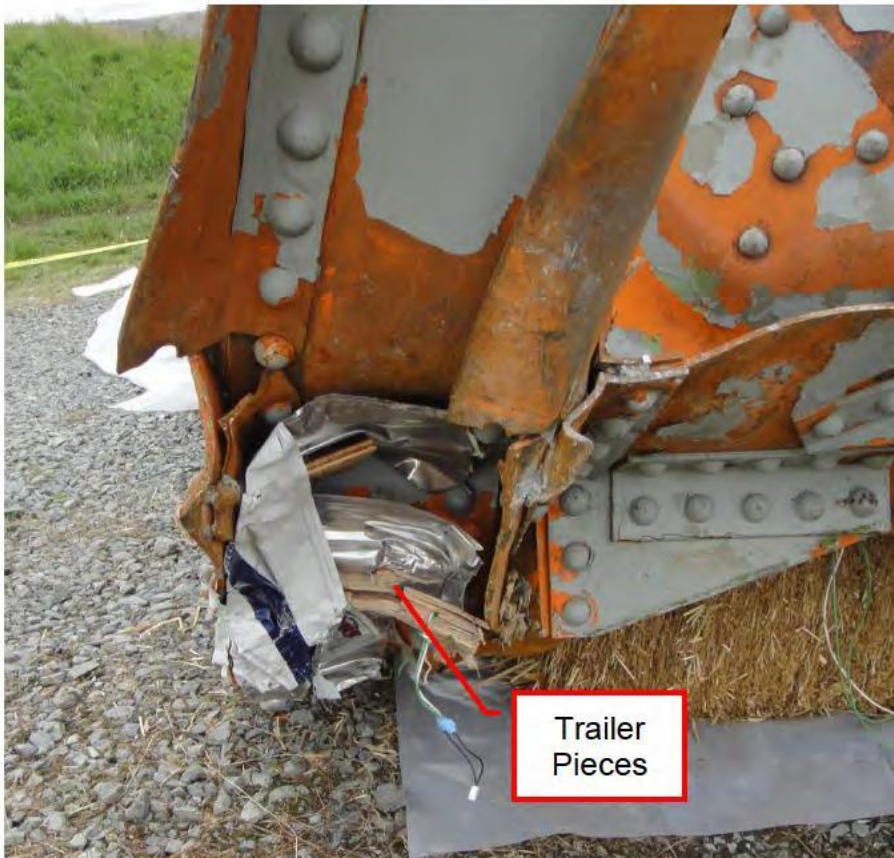
The U4W-L4W vertical was partially fractured and several rivets were missing at the U4W connection but it remained attached to the node. The north side flanges of the vertical were fractured and the south flanges were buckled consistent with the lower end of the member displacing to the south. As recovered, the vertical was bent lower end to the south to about 45° just below the node. The U4W-L4W vertical was also partially separated at the top edge of the sway brace attachment area. The east flanges and web were completely fractured and only the west side flanges connected the sway brace to the vertical. The vertical was completely fractured at the lower edge of the sway brace attachment area.

Figure 8. Two more views of the deformation at U4W. Lower view shows trapped pieces of the camper trailer.

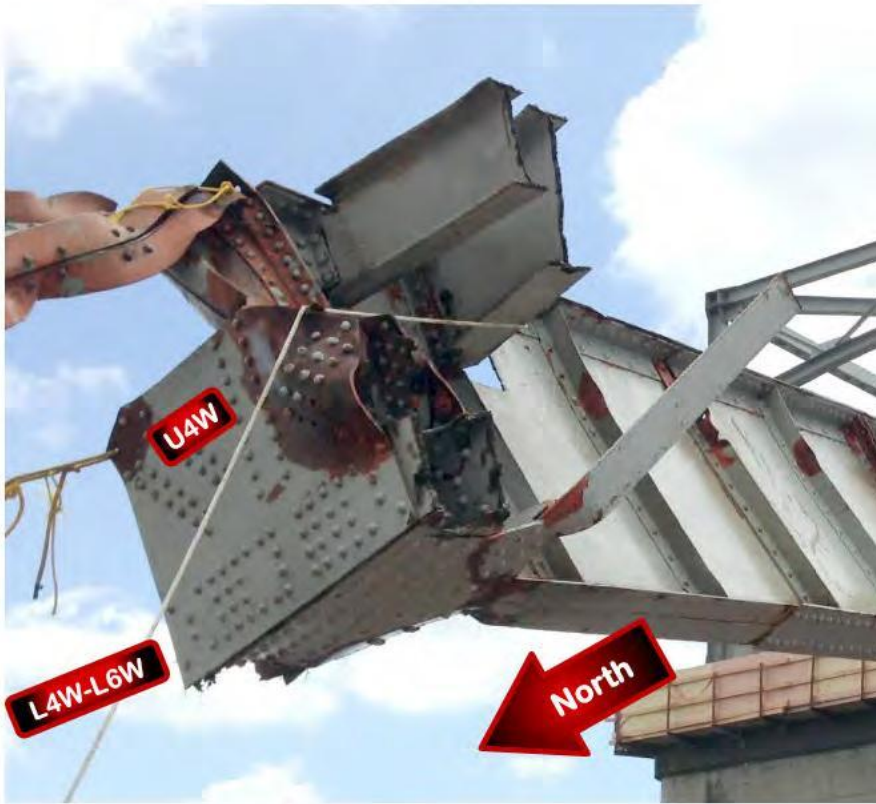
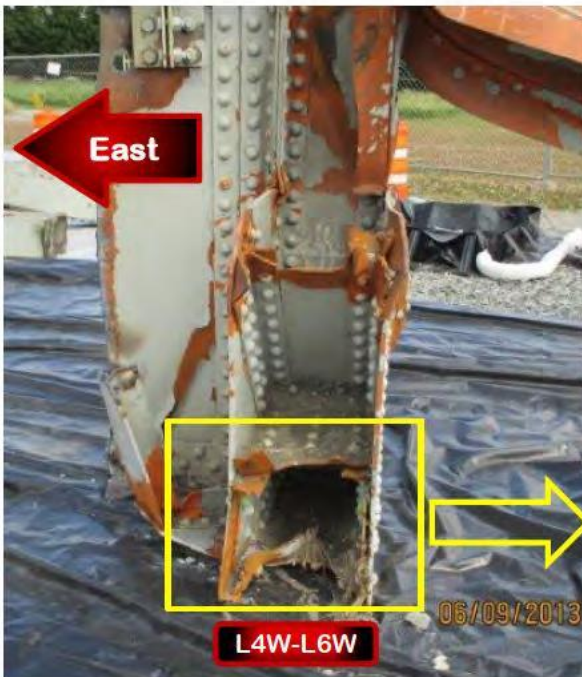
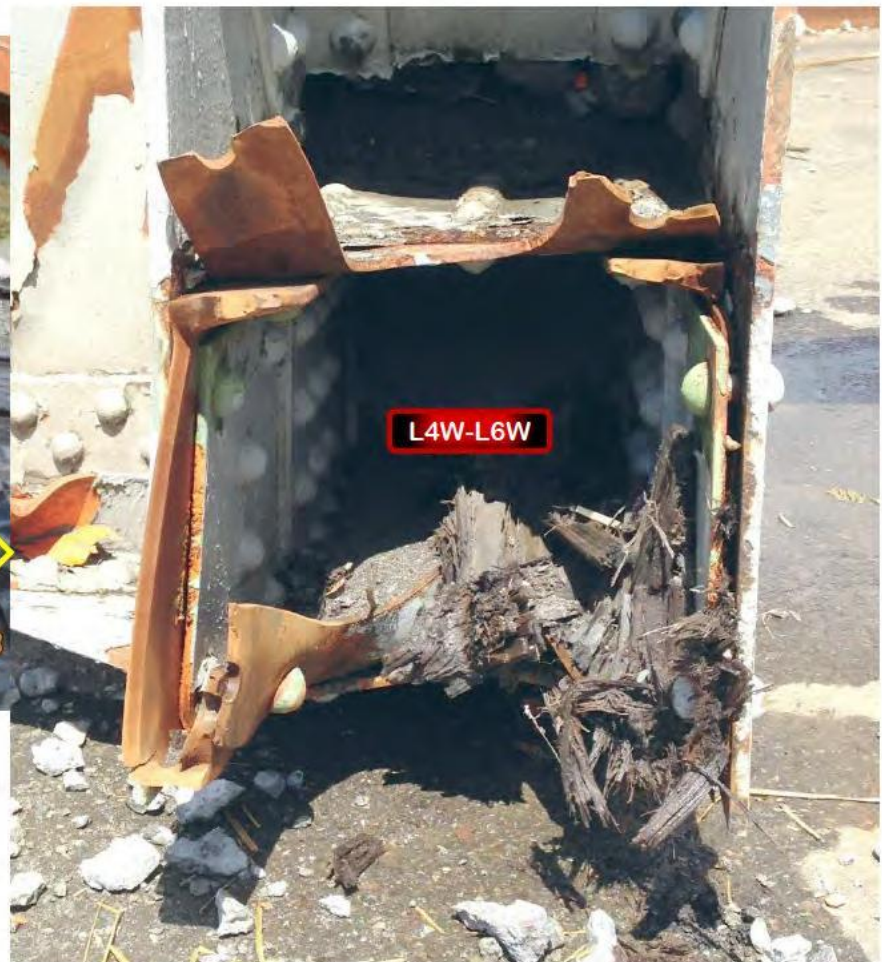
Member L4W-L6W was completely fractured immediately adjacent to the north edge of the gusset plates for node L4W. The fracture was overstress with no indications of preexisting cracking or corrosion. The deformation adjacent to the fractures and in the top cover plate was consistent with bending overstress load as if the node were displaced downward relative to the adjacent nodes. See figure 9.

Figure 9. At left, node L4W being recovered attached to floor beam 4. Below, two views of bending overstress fractured member L4W-L6W.

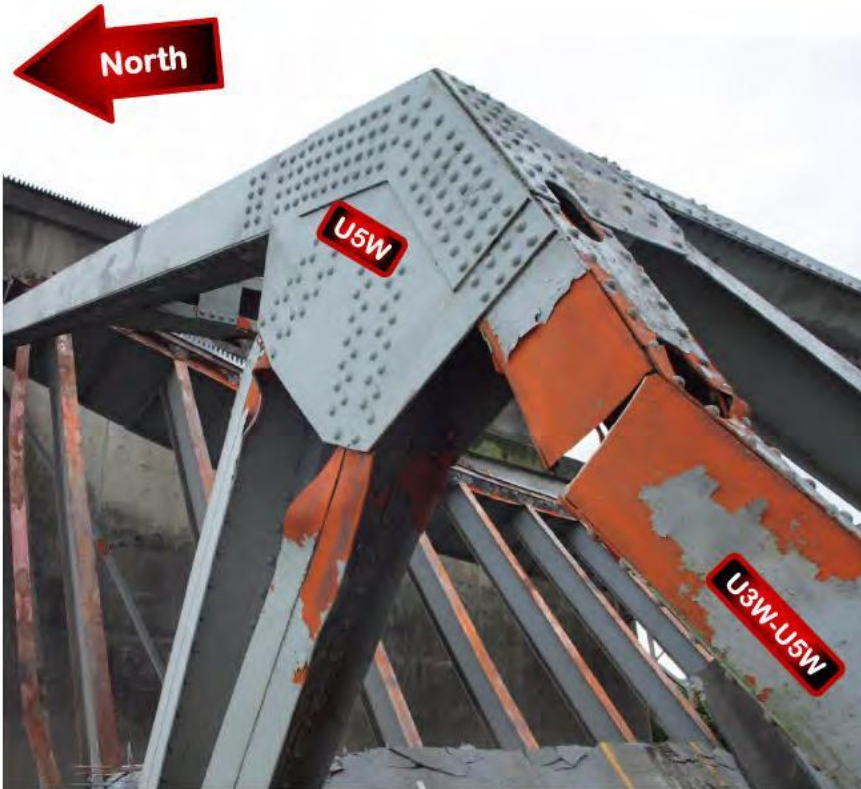
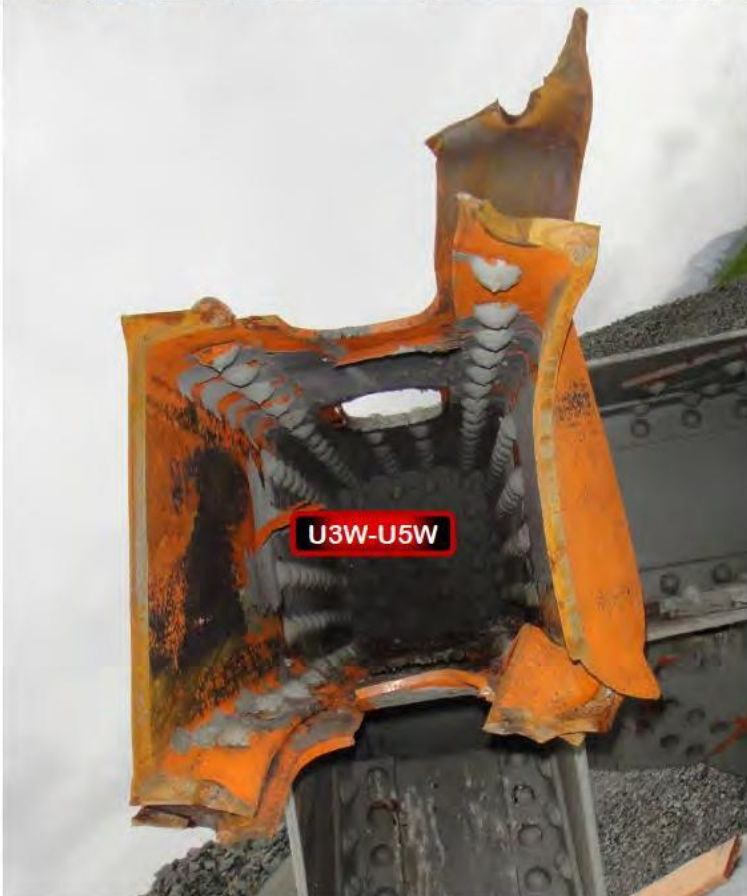
Member U3W-U5W was severely damaged and partially fractured about 2 feet south of the U5W node gusset plates. The lower cover plate and both "C" sides of the chord were completely fractured. The upper cover plate was fractured between the west edge and a hand hole and only the eastern ligament remained intact and holding the north and south side of the upper chord together. This ligament was later fractured during recovery. See Figure 10 Upper.

The "C" channel sides and lower cover plate of U3W-U5W were deformed adjacent to the fracture consistent with down and east movement of the U4W node. However, fracture features were more consistent with upward movement of the south end. The overall fracture and deformation pattern were consistent with an initial south end down motion deforming the chord followed by a south end upward motion fracturing the deformed structure. See Figure 10 Lower.

Figure 10. Top, an overall view of node U5W with a view of overstress fractured member U3W-U5W below.

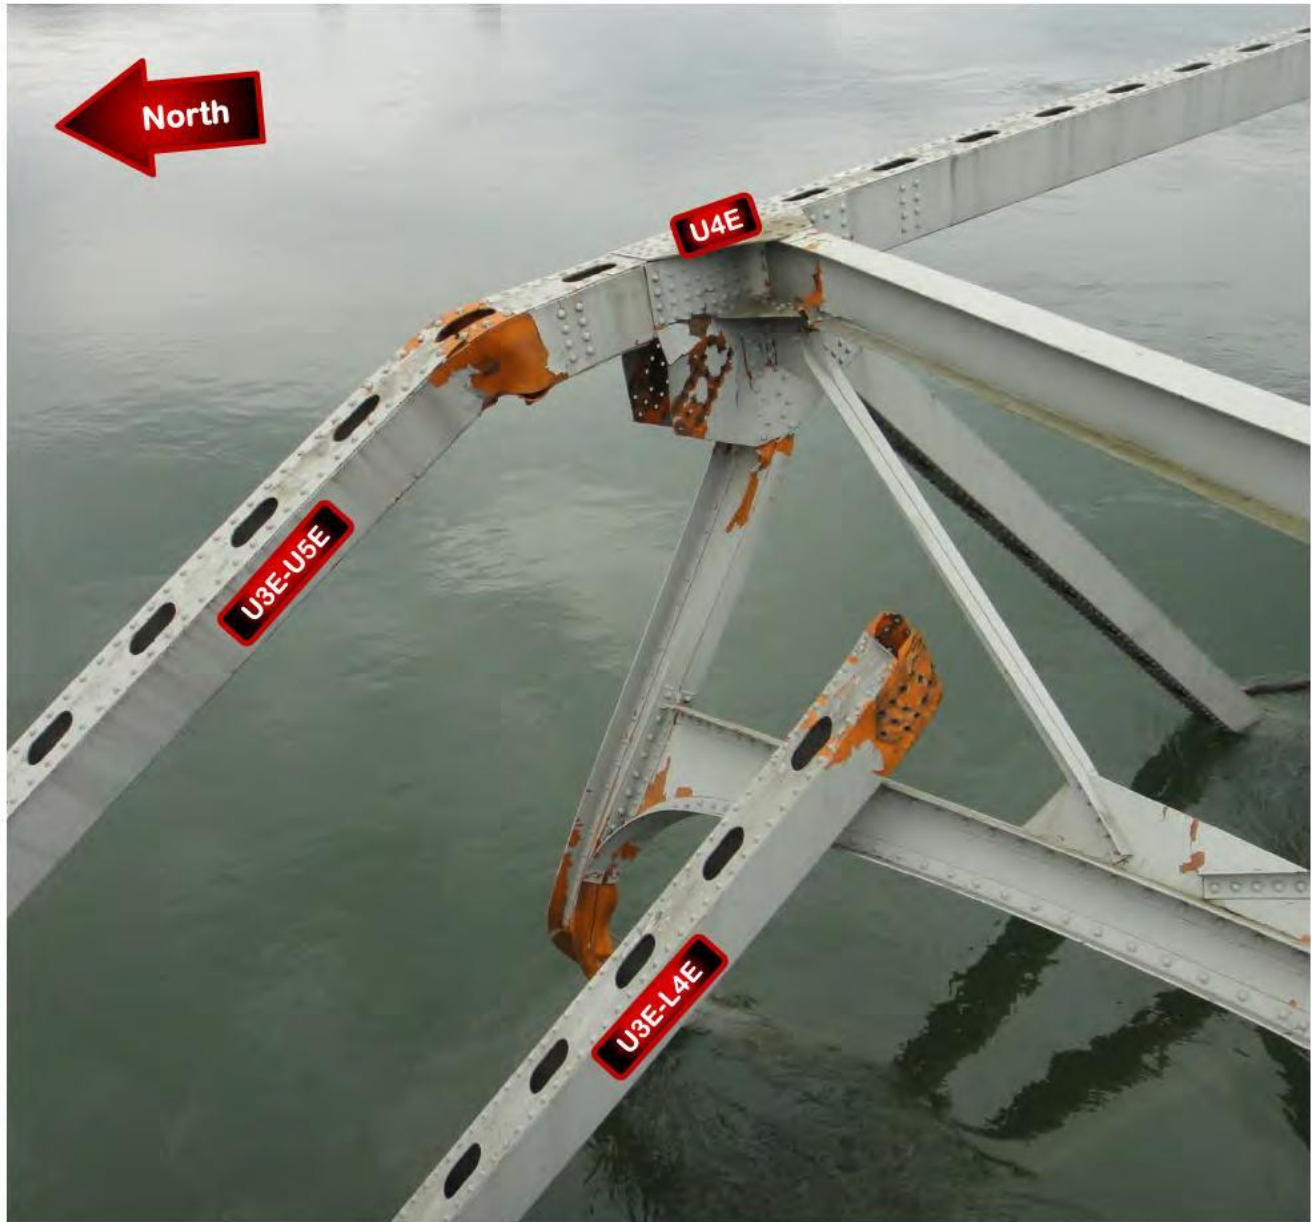
Member U3E-U5E was bent north end down about 4 feet from the north edge of the node with partial fracturing of the top and bottom chord cover plates. The lower plate showed buckling deformation and the top plate was tension-fractured. See Figure 11.

U3E-L4E was disconnected from the node and rested on other structure to the west of the node. All of the gusset plate rivets were fractured with only a few remaining in either the member or the gusset plates. The upper ends of the "C" channel side plates of the member were deformed and the area between the gusset plates was damaged consistent with the member being forced upward.

Figure 11. Node U4E with separated member U3E-L4E.

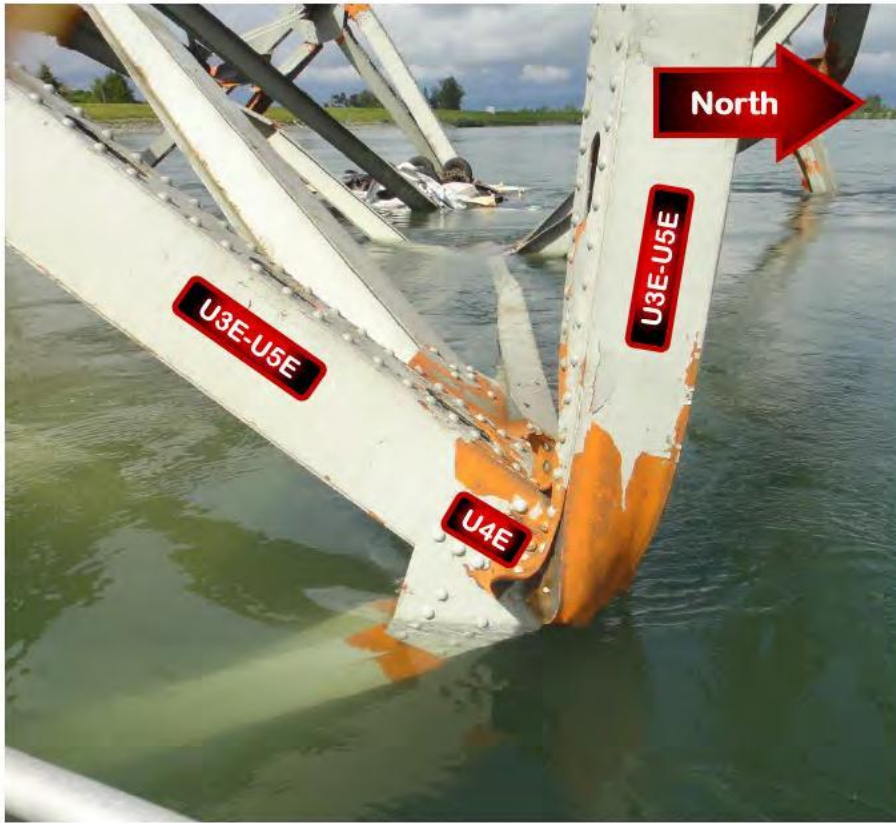
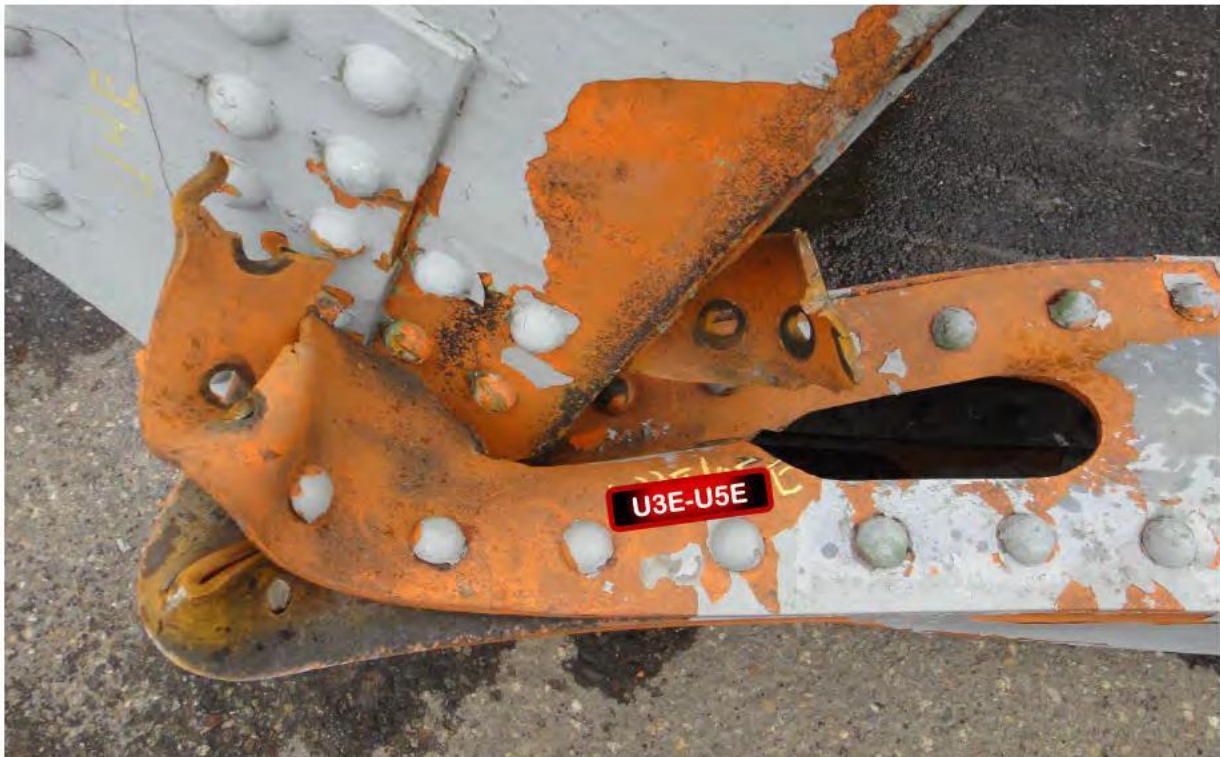
The U4E node was visible resting just above the water line. The upper chord, U3E-U5E, was bent more than 90° at node 4E with the majority of the deformation at the north edge of the node. The deformation was very similar to that seen at the U4W node and included severely folded and "S"-bent "C" channels and top cover plate consistent with compression buckling of the chord followed by bending. Small local fractures were present and several rivets were separated at some areas of severe deformation. See Figure 12.

Figure 12. Node U4E as-collapsed at left and after recovery below.

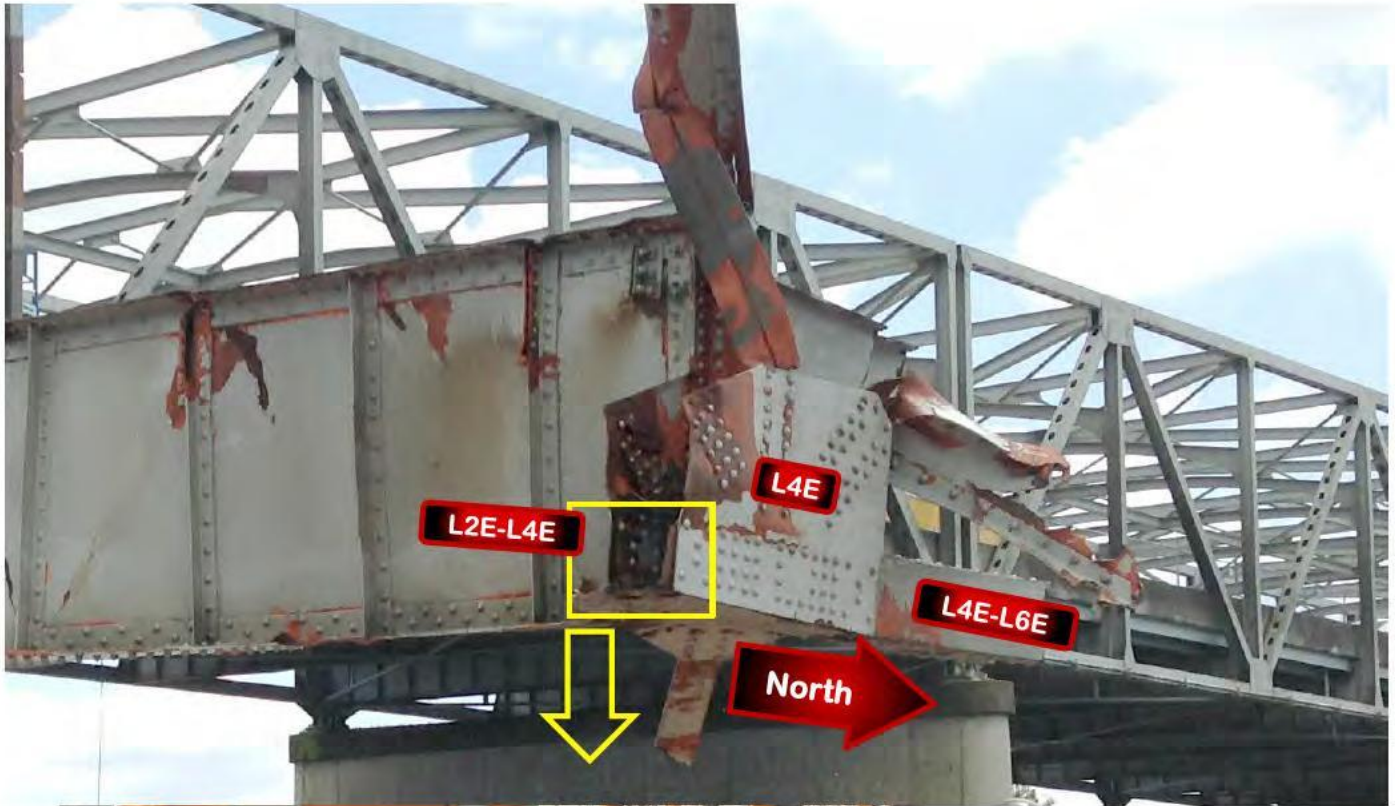
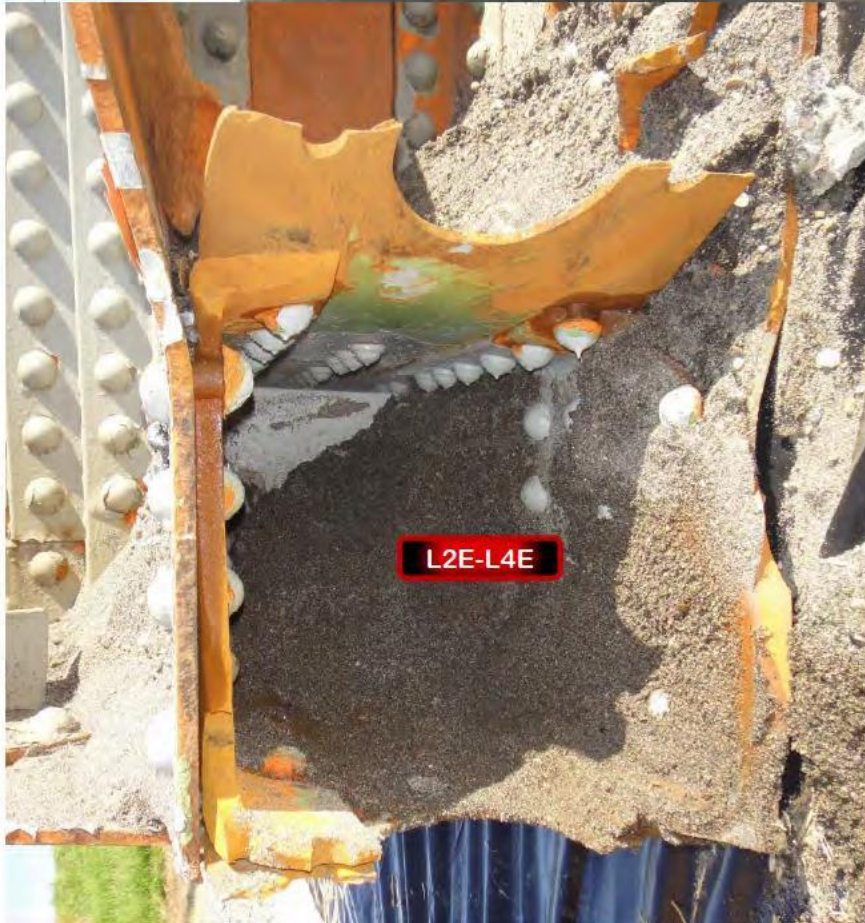
Member L2E-L4E was completely fractured immediately adjacent to the south edge of the gusset plates for node L4E. The fracture was overstress with no indications of preexisting cracking or corrosion. The deformation adjacent to the fractures and in the top cover plate was consistent with bending overstress load as if the node were displaced downward relative to the adjacent lower nodes. Member L4E-L6E also displayed an upward deflection of the north end consistent with downward deflection of the node relative to the adjacent nodes. See figure 13.

Figure 13. Node L4E attached to floor beam 4 above during recovery. The fracture face of member L2E-L4E at left.

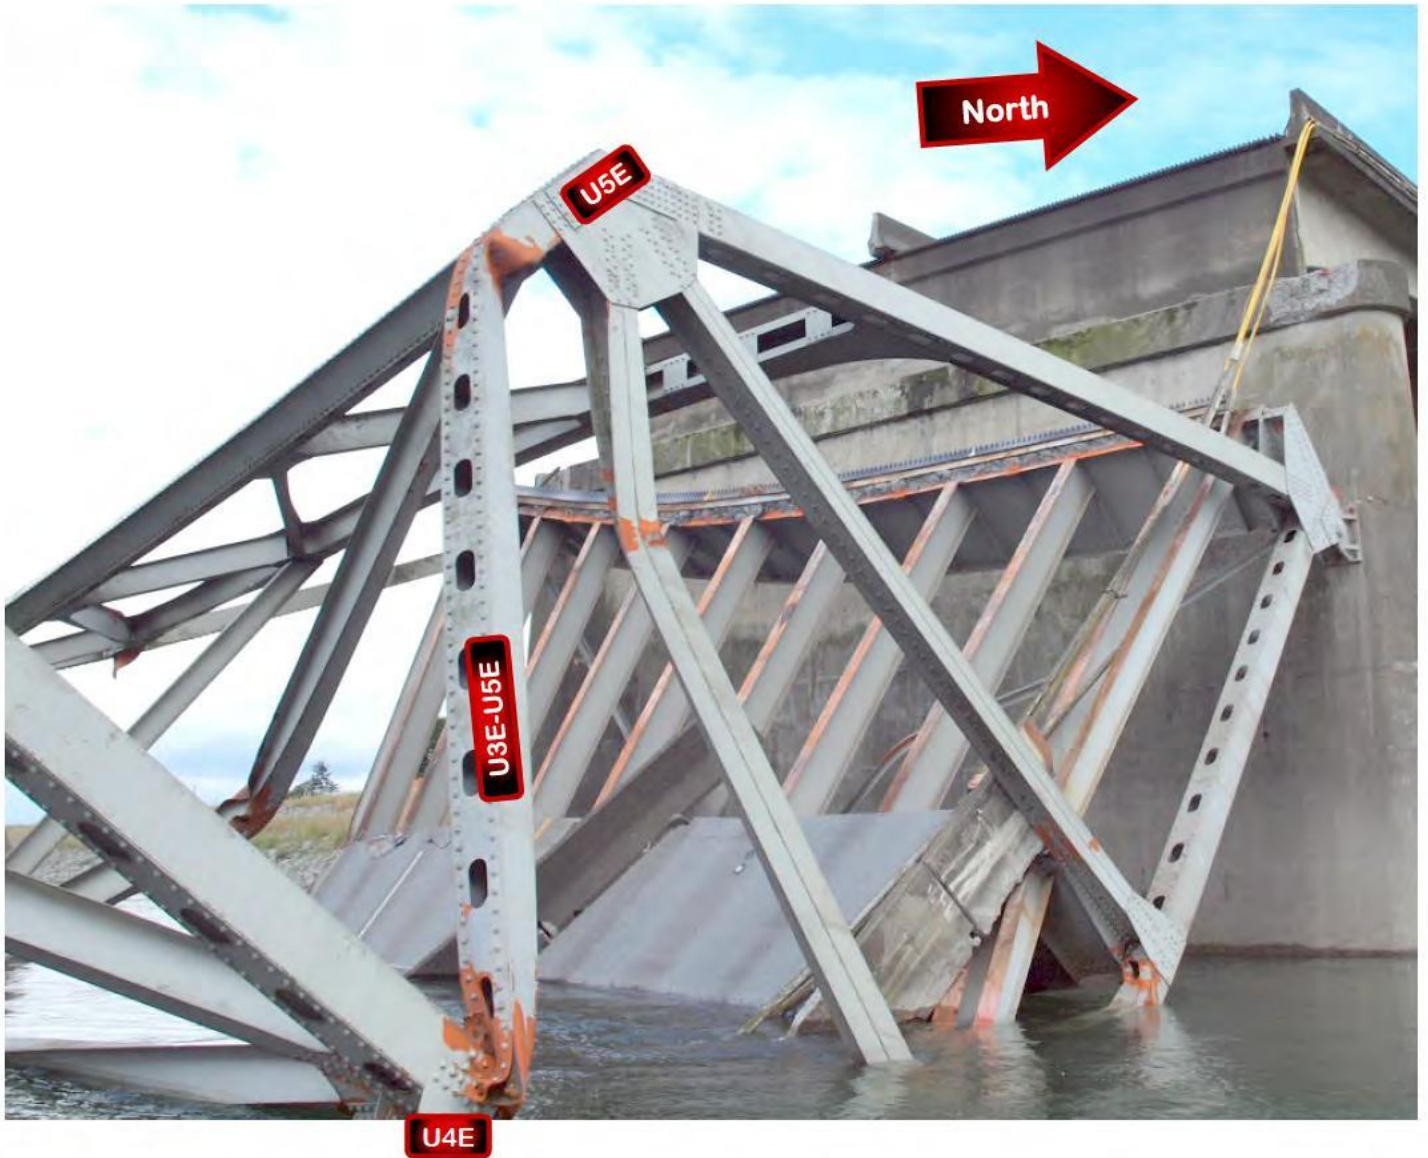
Node U5E was intact. However, upper chord member U3E-U5E was bent south end down about 2 feet south of the node U5E gusset plates. The bend was approximately 45 degrees with the lower cover plate and "C" channel side plates heavily deformed and somewhat twisted. The L4E-U5E diagonal member was bent lower end to the north about 8 feet from the node. See Figure 14.

Figure 14. Nodes U5E and U4E on the collapsed structure.
