**MATERIALS LABORATORY  
FACTUAL REPORT 13-070**

**Bridge Collapse  
Mount Vernon, WA; 05/23/2013**

**HWY13MH012**

MATERIALS LABORATORY FACTUAL REPORT

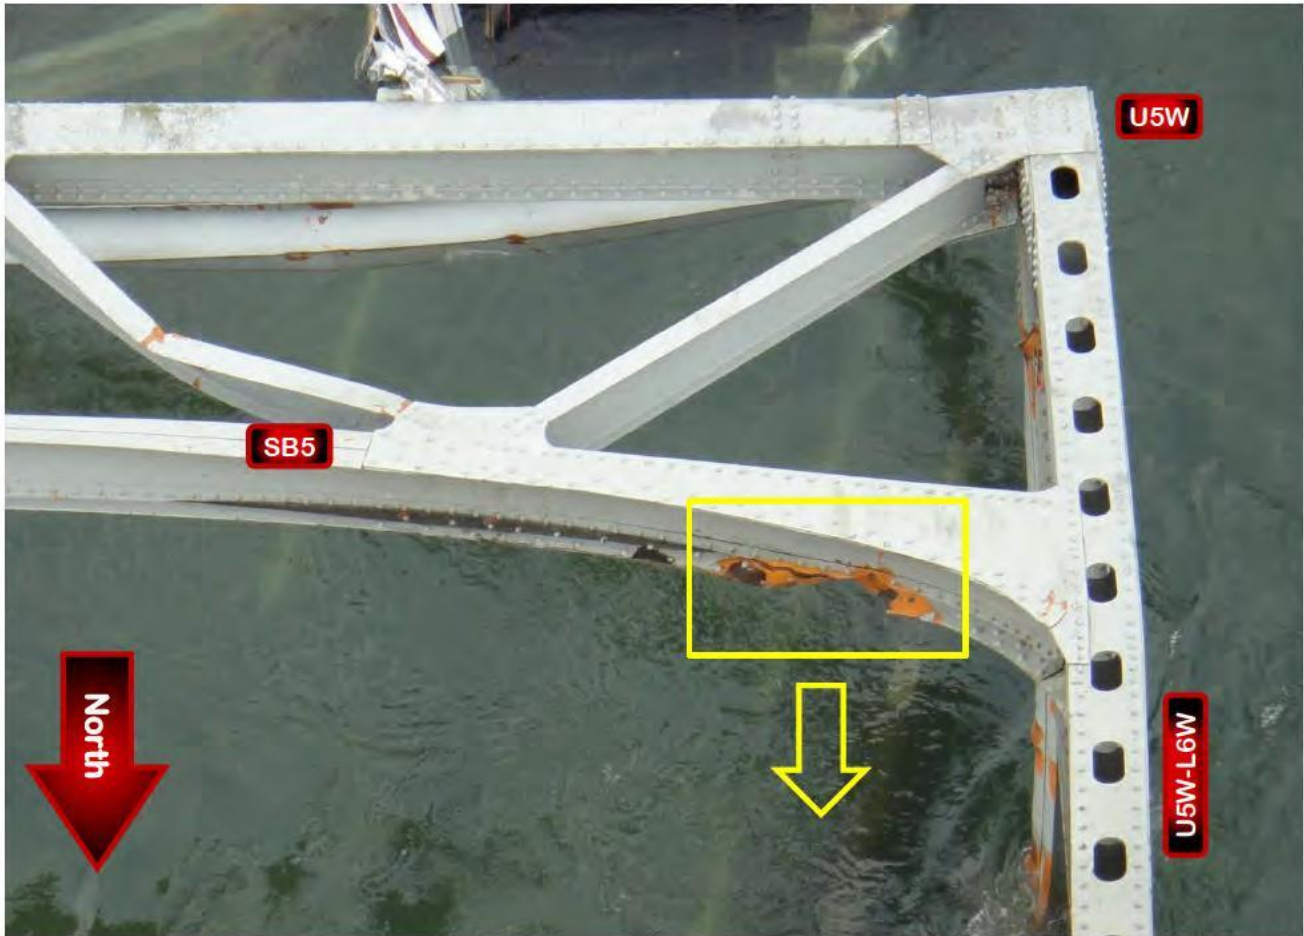
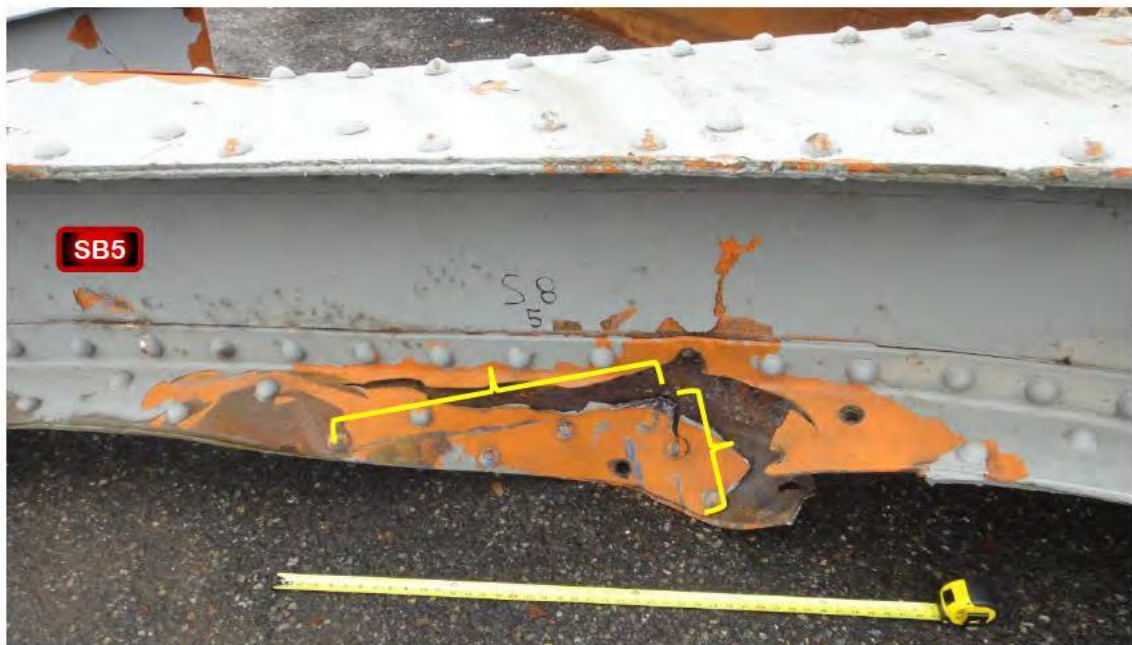
At the north portal, the south flange of the lower portal brace was partially torn and displaced to the south. Damage was apparent from about 33 inches to about 80 inches from the vertical. Blue paint transfer was visible on the upper surface of the south (lower) flange of the brace. The transferred paint outlined a square corner shape with a 23 inch long horizontal mark and an eight inch long vertical at the west edge of the horizontal. The vertical line and corner were approximately 42 inches from the vertical member. The south flange was torn for about 36 inches and the south face plate was torn along a weld at 33 inches from the vertical. The flange and face plate were bent more than 12 inches to the south. See Figure 15.

Figure 15. Impact damage to the north portal over the outside travel lane, yellow box in the upper view. A corner shape was evident in the damage as indicated by the yellow brackets in the lower view.

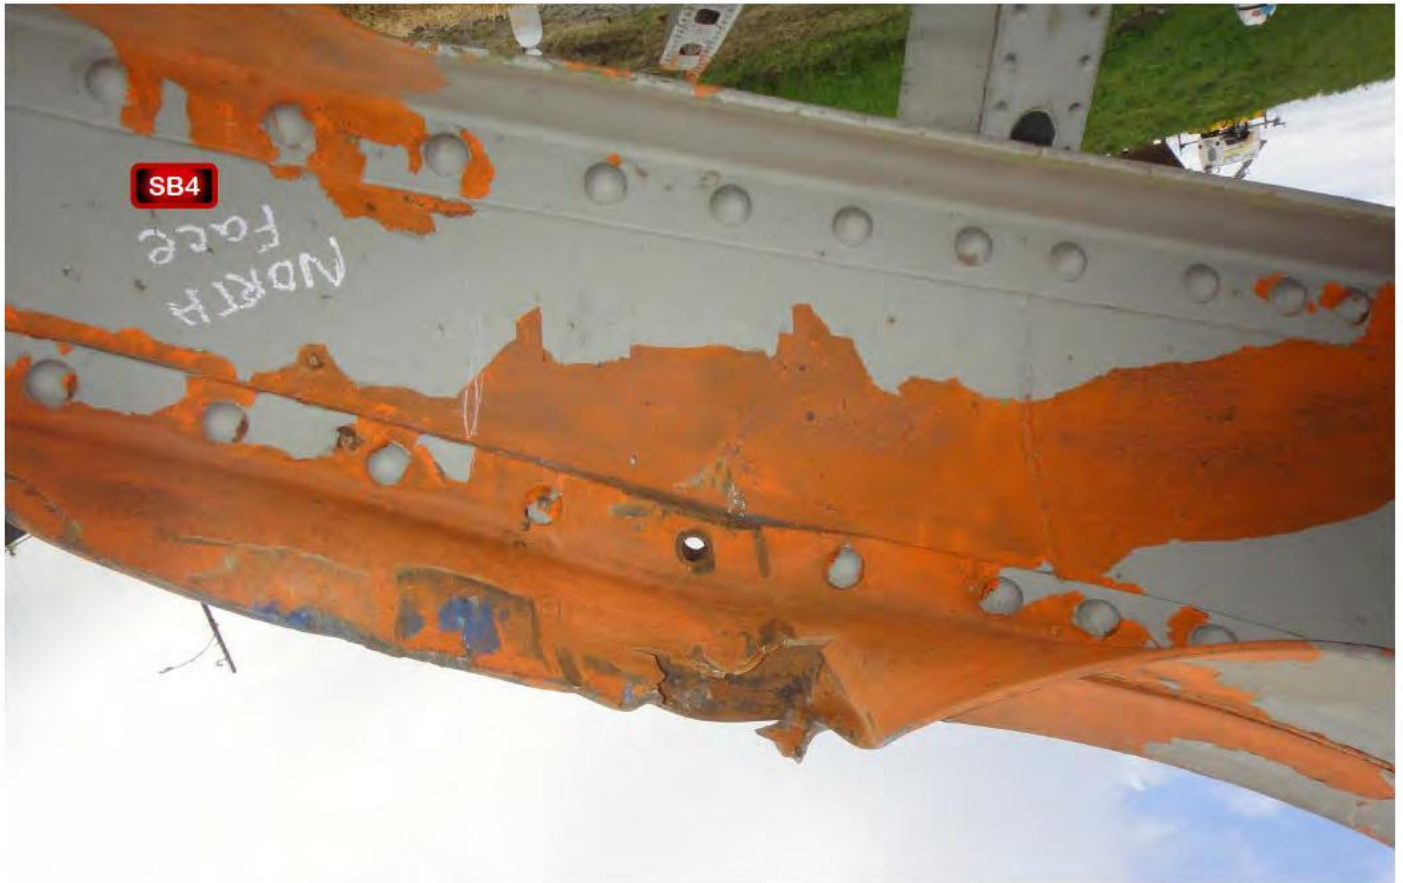
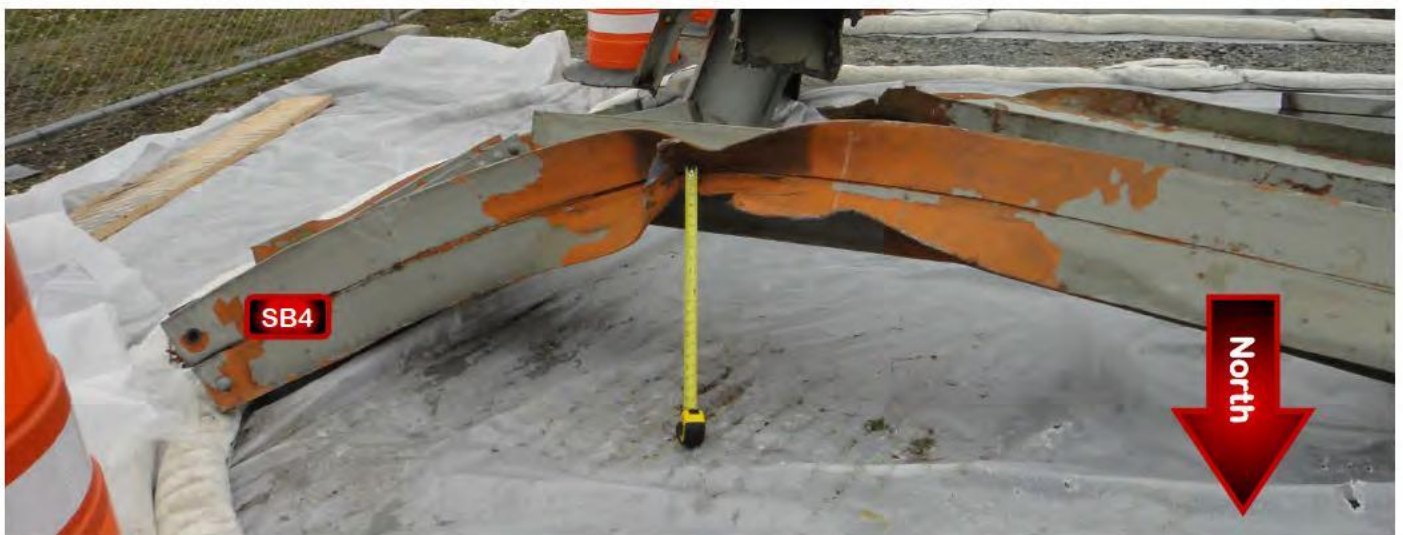
As collapsed, sway frame 4 was entirely underwater. When recovered, the sway brace showed significant deformation and contact damage over the right south bound traffic lane. The sway brace showed impact damage from about 33 inches to about 67 inches. The lower flange had a square tear between 34 inches and 41 inch (7 inches). Measurements from the east face of the vertical member. One flange rivet was missing above the tear. The north flange was bent downward starting just inboard of the tear and extending east to about 71 inches. See Figure 16 Upper.

Beginning at the tear and extending to the east there was heavy gouging and contact marks along the north edge of the north flange. Blue paint transfers were apparent on top of the flange starting at 32 inches continuing intermittently to 67 inches. The blue paint transfers were consistent with the exterior paint of the oversize load discussed in a following section.

The entire lower chord of the sway frame was deformed and bowed to the south centered at the tear across the width of the traffic lane. The permanent deflection from straight measured about 24 inches at the tear. The lower chord of the sway brace remained attached to the vertical. However, the vertical was fractured as noted in a previous section. See Figure 16 Lower.

Figure 16. Impact damage to sway brace 4 above with extent of bowing depicted below.

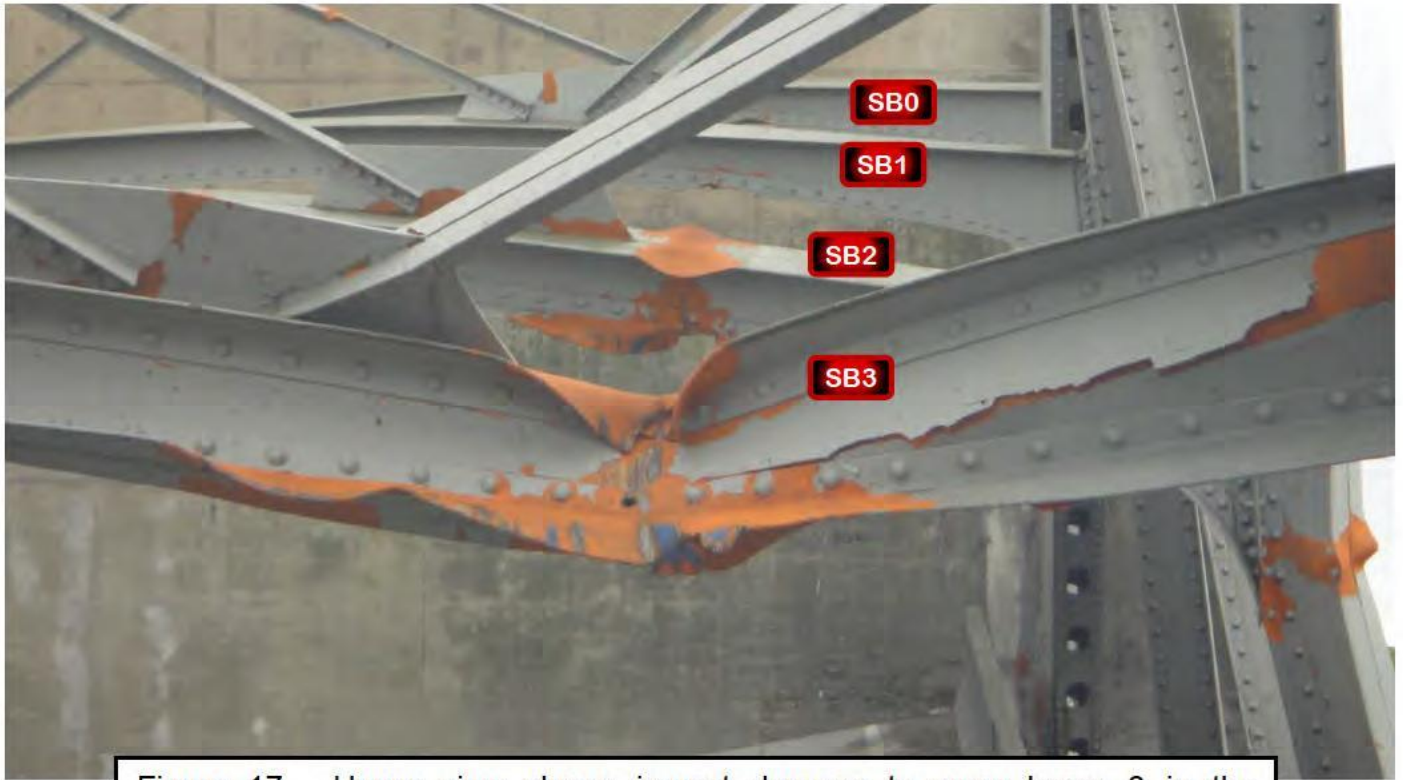
Damage to the sway brace started about 76 inches from the vertical and continued for 48 inch to about 124 inches. The heaviest damage occurred at about 82 inches where both the upper and lower north flanges of the brace were bent downward and the upper flange was torn. Blue paint transfers and vertical gouging was present at both flanges. See Figure 17 Upper.

The sway brace attachment to the vertical was mostly fractured through the flanges of the connecting angles. Only short sections of the angles remained connecting the sway brace to the vertical. See Figure 17 Lower

Figure 17. Upper view shows impact damage to sway brace 3 in the foreground along with impacts on SB2, 1 and 0 in the background. Separation of SB3 from vertical U3W-L3W is depicted below. Both views looking south.

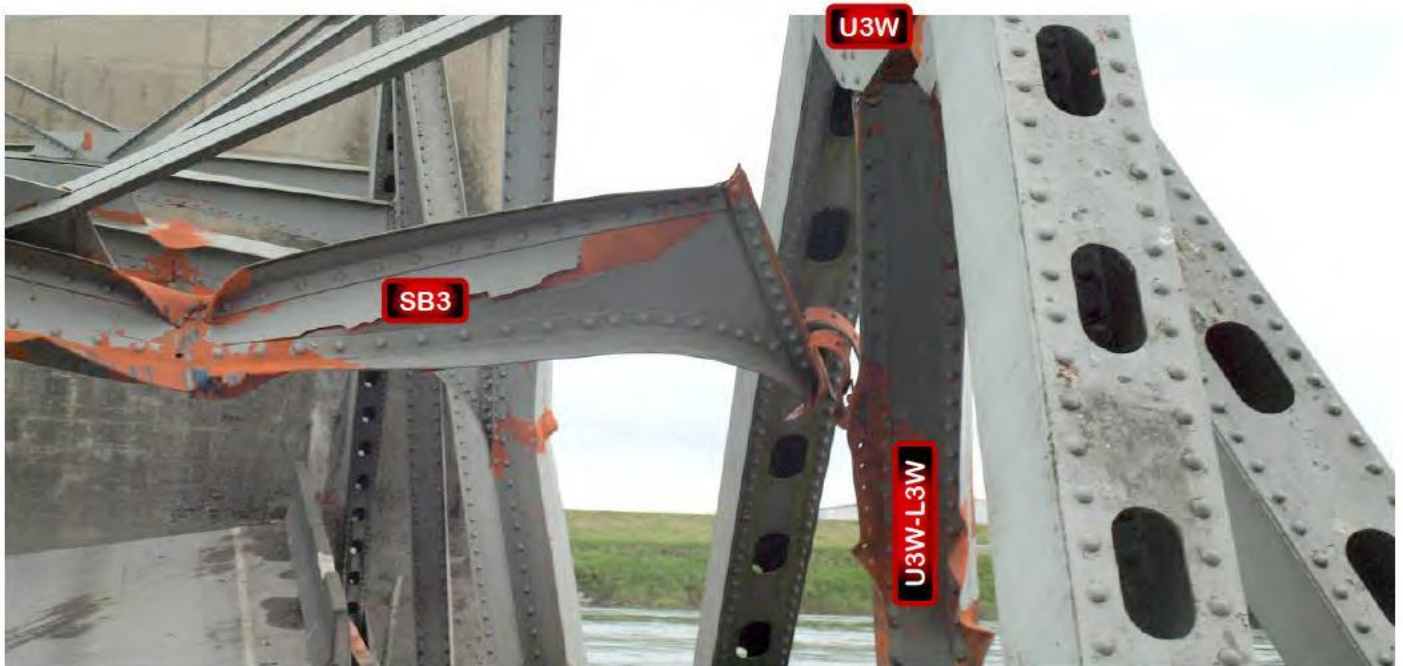
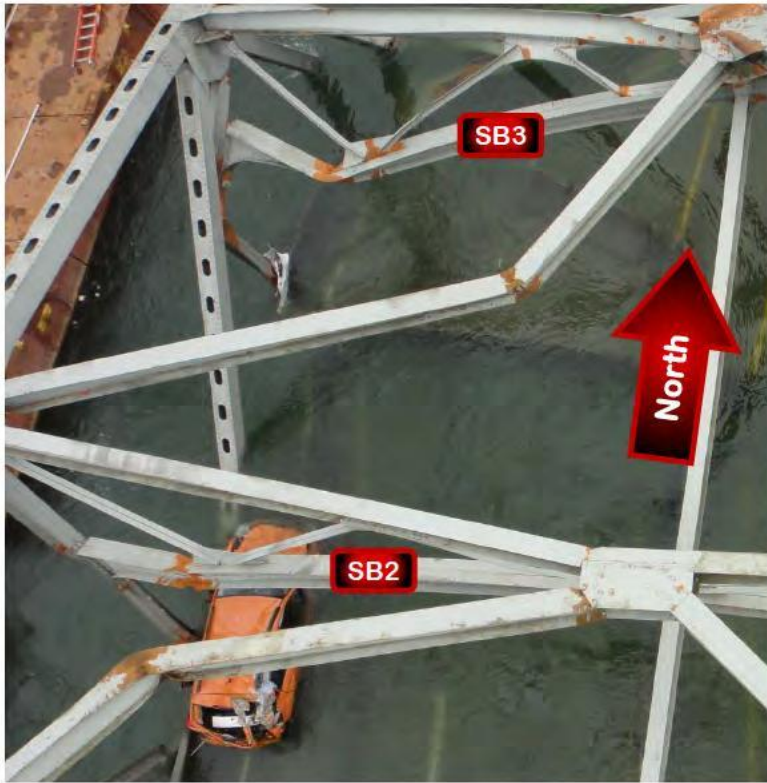
The lower chord of the sway frame was deformed (bowed) to the south an estimated 12 inches centered at the impact area from its original straight condition. See Figure 18 Upper.

Damage to the sway brace was centered at about 84 inches from the face of the vertical with the north flange turned downward and both upper flanges wrinkled in this area. The lower north flange was torn near the west side of the damage and the flange was turn to the south at both sides of the tear. See Figure 18 Lower.

The lower chord of the frame was permanently bowed to south centered at the damage area. See Figure 18 Upper.

Figure 18. Overhead view of damage and bowing on SB3 and SB2, at left. Lower view shows impact damage to SB2.

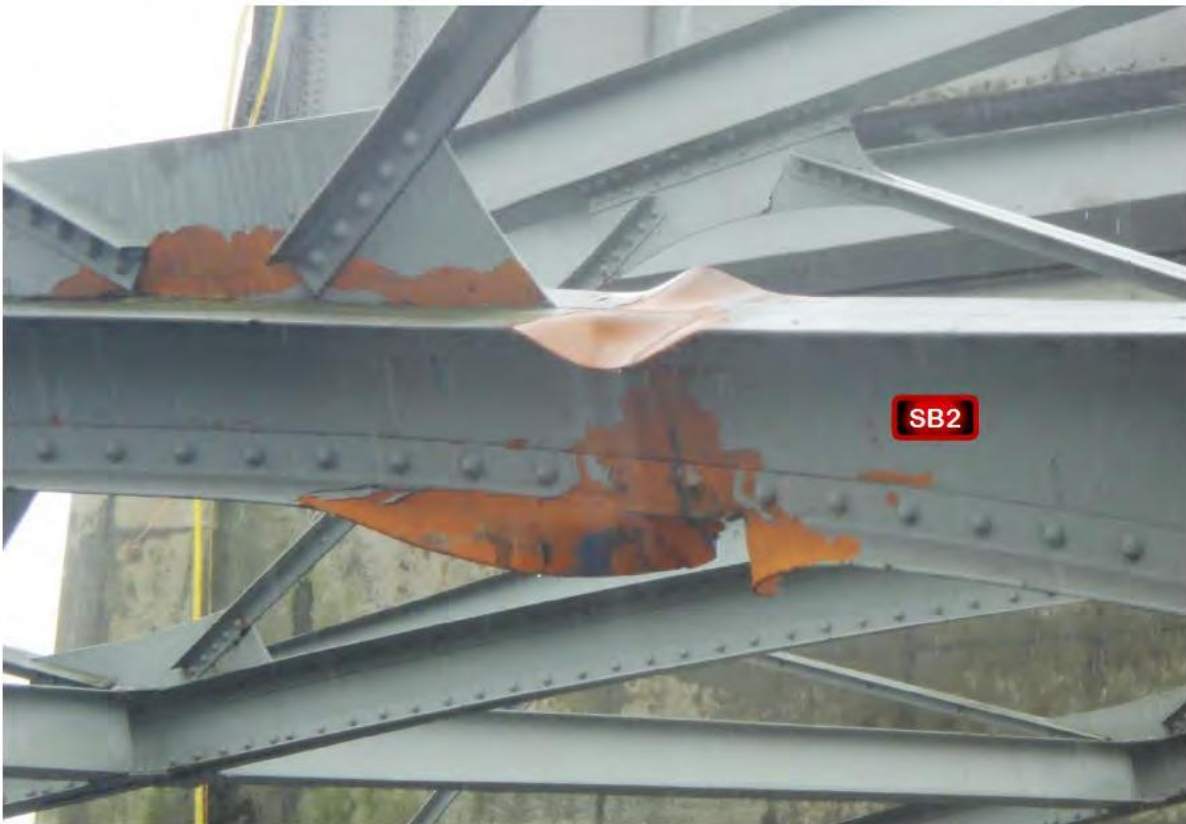
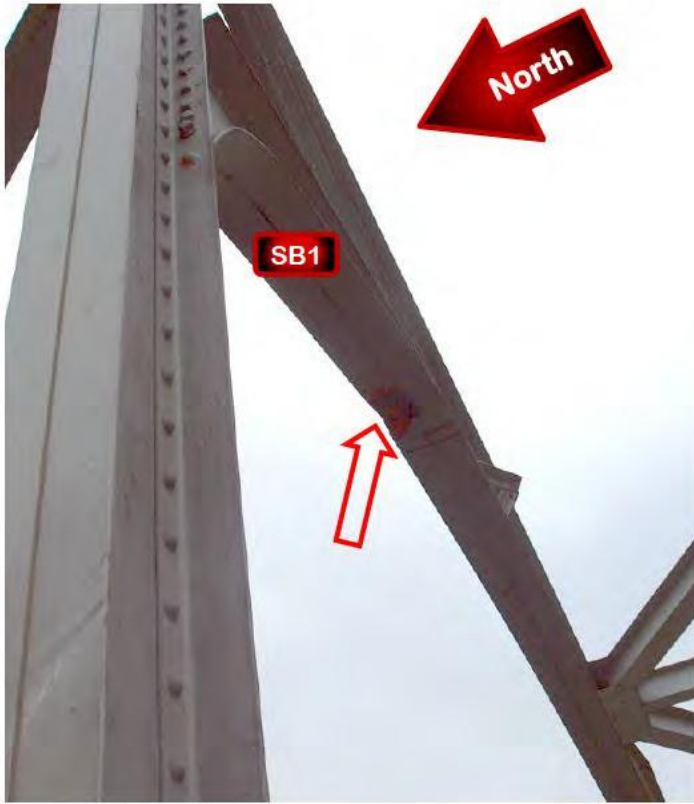
The lower north flange of the sway brace was damaged from about 80 inches to 90 inches from the vertical. The lower flange was bent upward but not torn. Deformation did not extend to the south flange. Blue paint transfers were apparent on the bottom side of the flange. See Figure 19.

Figure 19. View of damage (red arrows) to SB1.

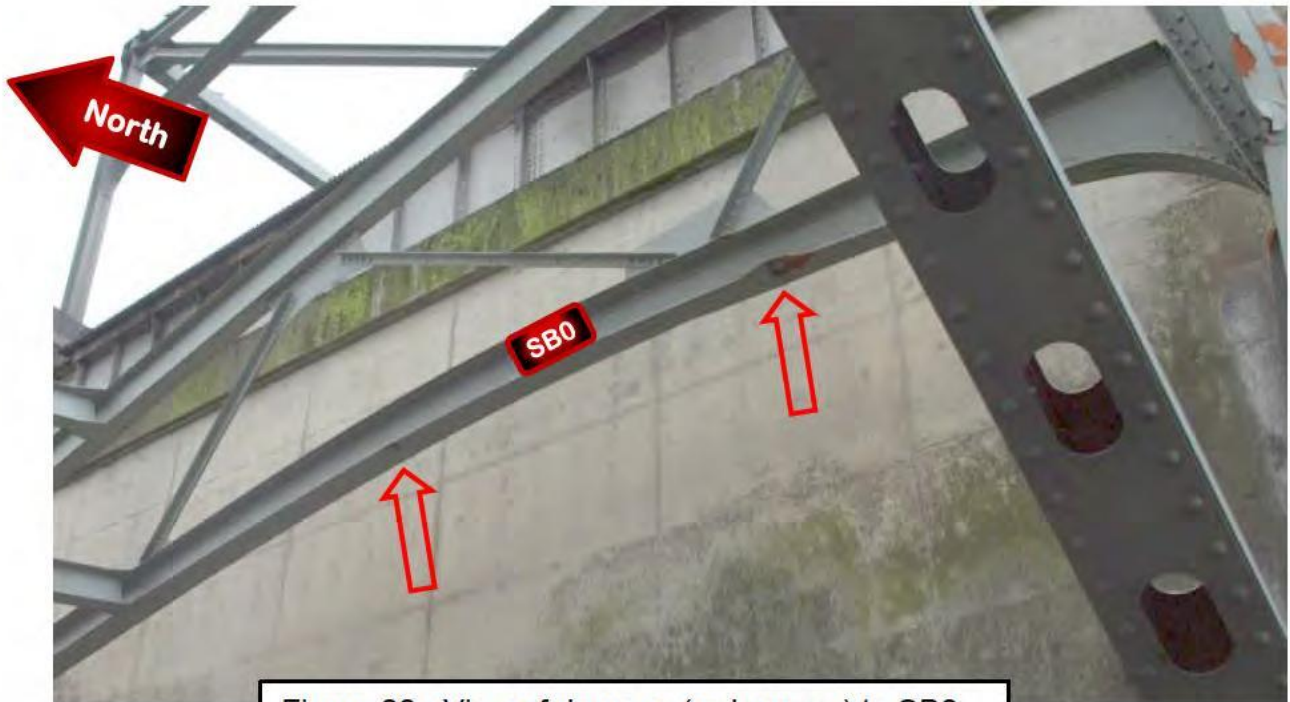
Figure 20. View of damage (red arrows) to SB0.

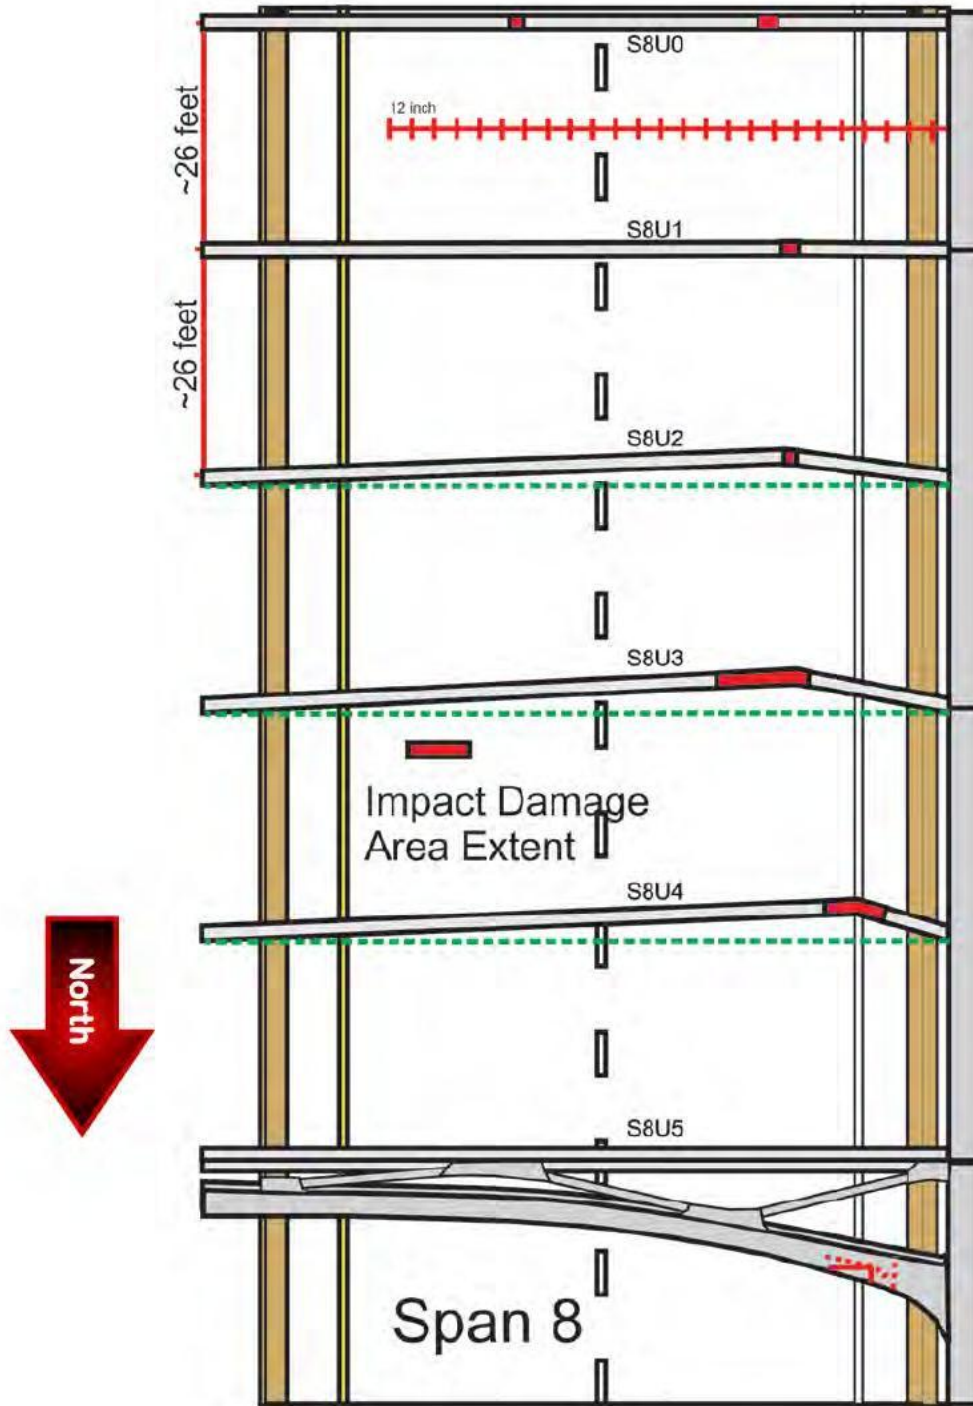
Figure 21. Top view illustration depicting damage to sway braces in span 8. Red areas denote approximate location and extent of damage. Bowing of sway braces also indicated. Measurement approximate.

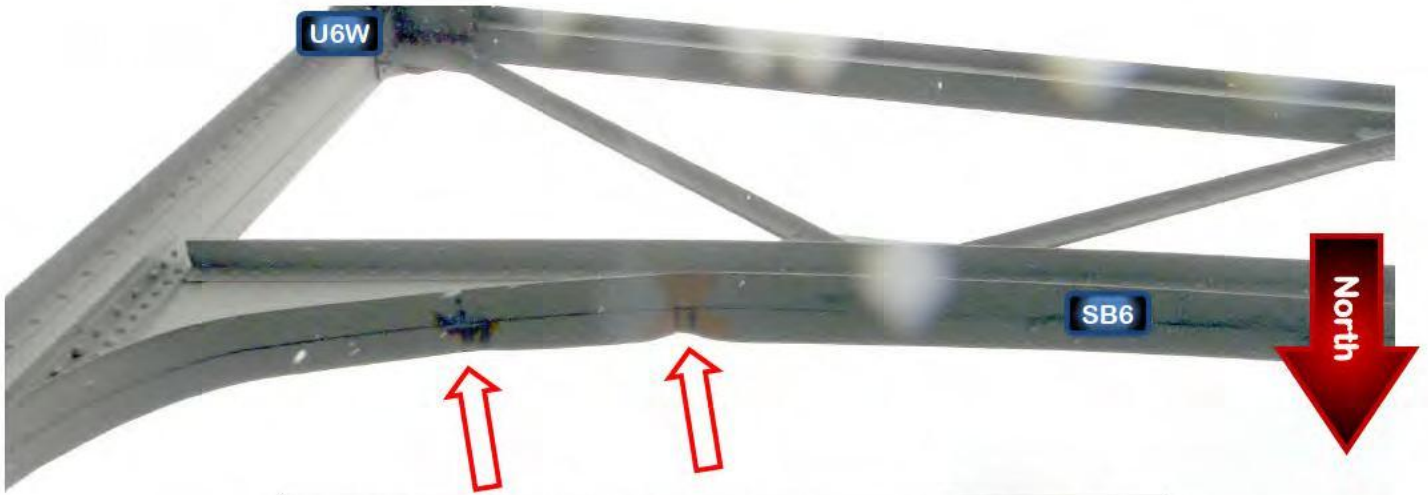
Due to the proximity of sway frame to the unprotected edge of the pier the damage was not closely examined and the locations of damage were estimated from a distance. The lower flange of the sway brace had damage at two locations. Markings were apparent on the lower north flange between 45 and 57 inches. No flange deformation was obvious and the damage appeared superficial. Both north and south flanges were damaged and distorted between an estimated 81 and 92 inches. Both flanges were bent upward and the north flange was creased. See Figure 22.

Figure 22. View of damage (red arrows) to SB6 on span 7.

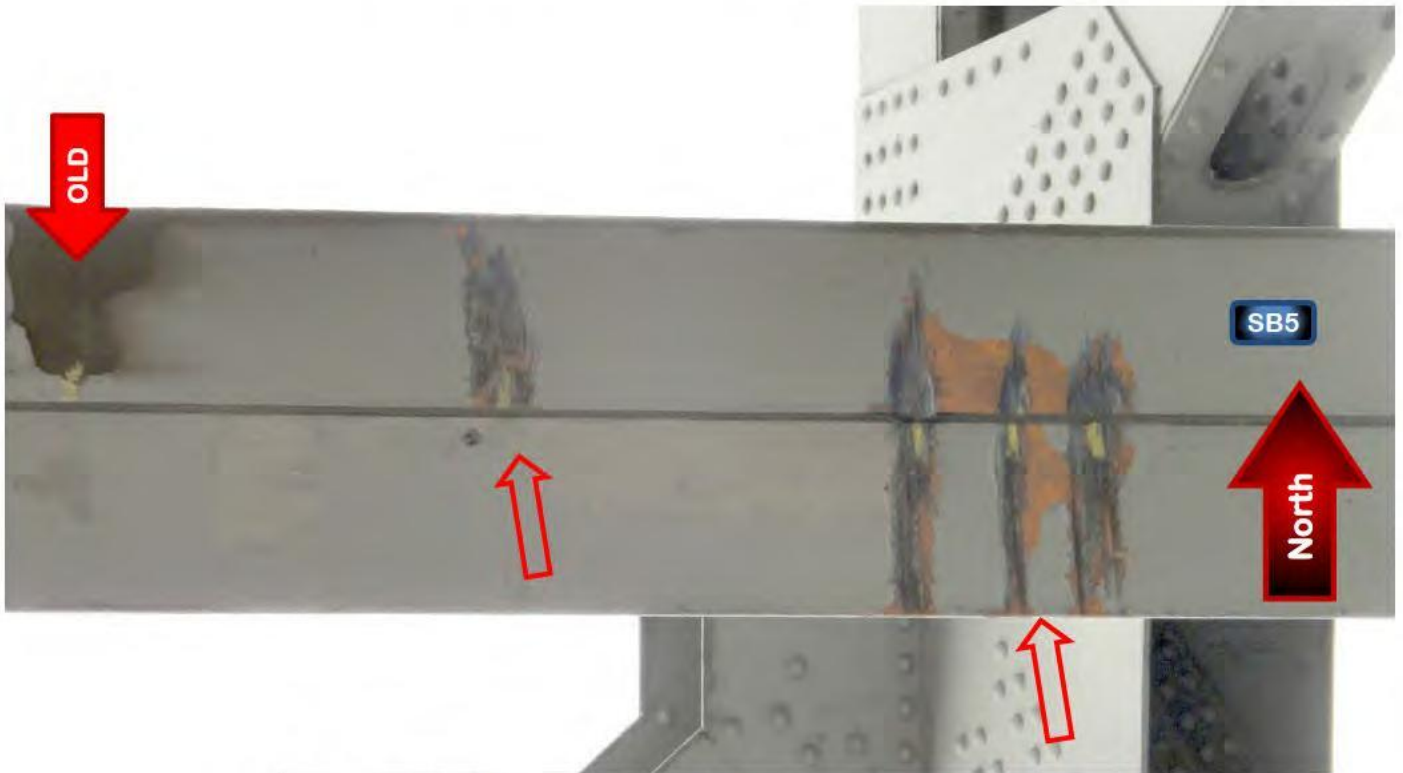
Figure 23. View of damage (red arrows) to SB5 on span 7.

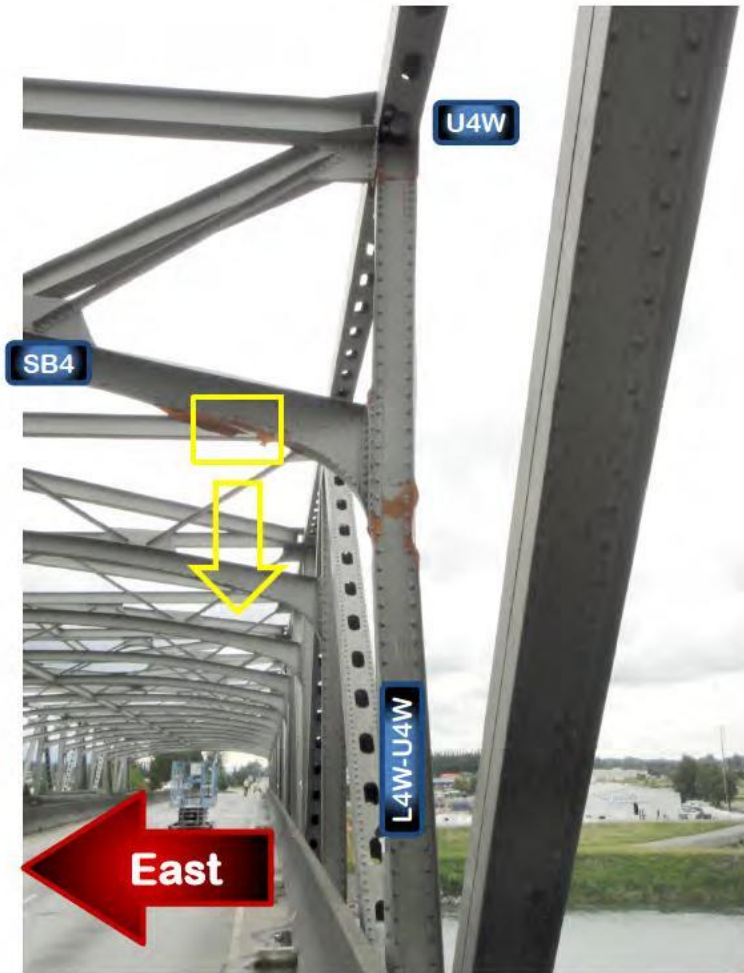
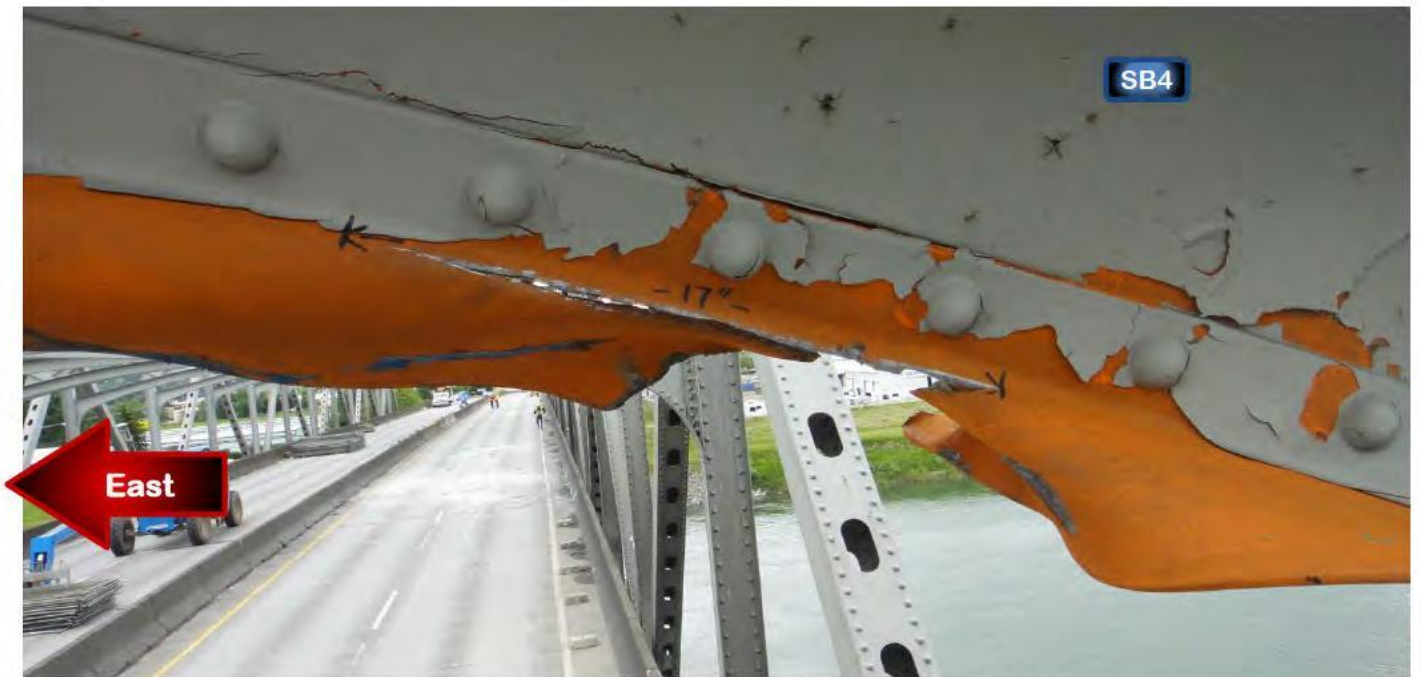
Sway frame 4 and the associated U4W-L4W vertical member were heavily damaged. The sway brace was impact damaged beginning at about 30 inches from the vertical and extending to at least 65 inches. In this area the lower north flange was rolled down and to the south with blue paint transfers noted on the north edge and top surface of the flange. The lower north flange was horizontally torn between 38 and 55 inches with a missing section centered at 45 inches. See Figure 24.

Figure 24. Damage to SB4 (yellow box left) and vertical U4W-L4W. Note eastward bow of the vertical at left. A closer view of the sway brace damage is shown below.

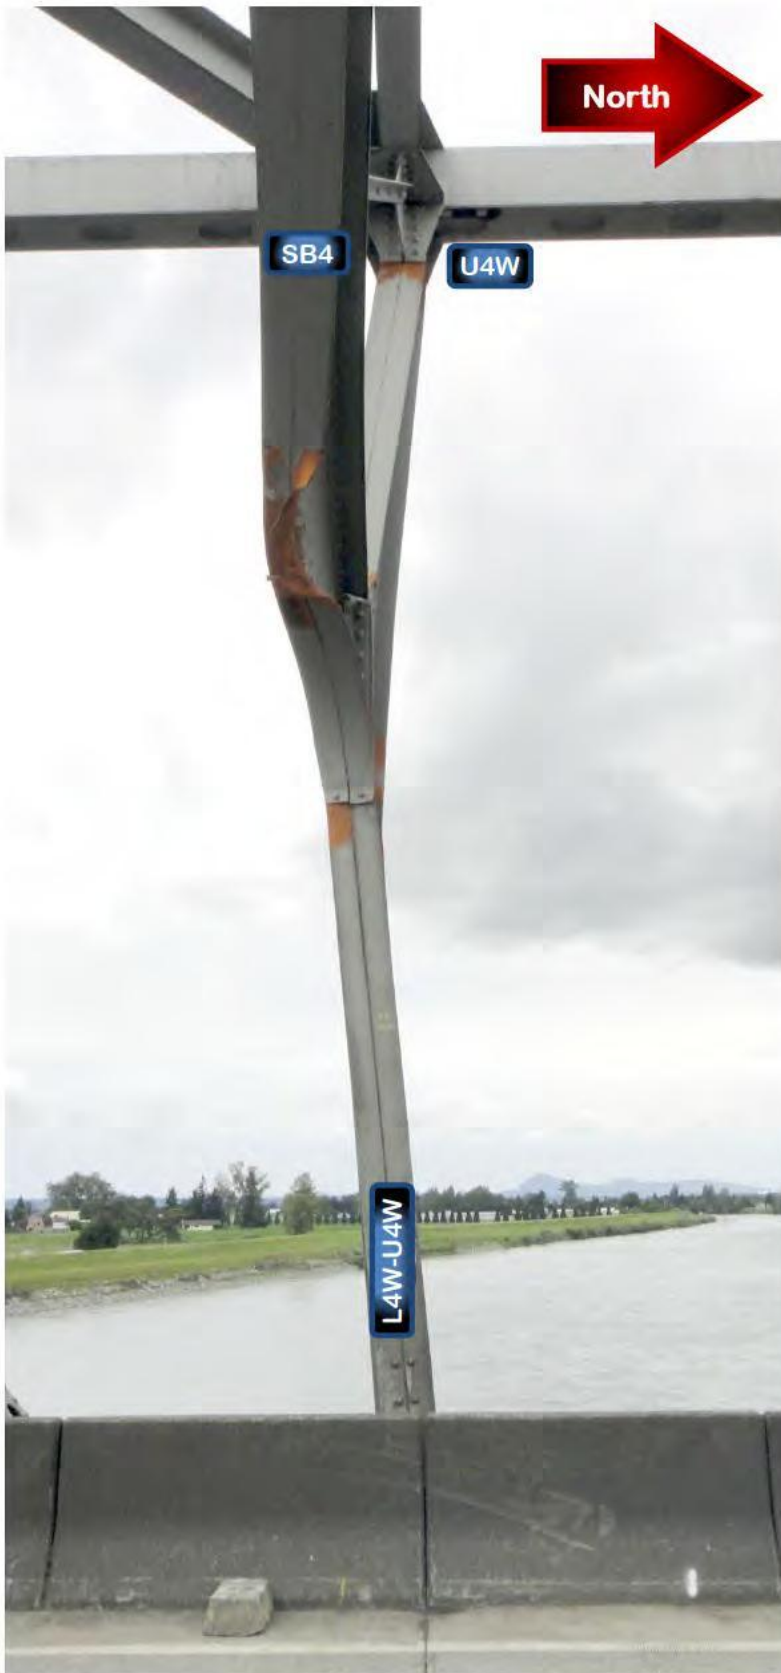
Figure 25. Looking west at damage to vertical L4W-U4W and SB4. Bowing of both members to the south.

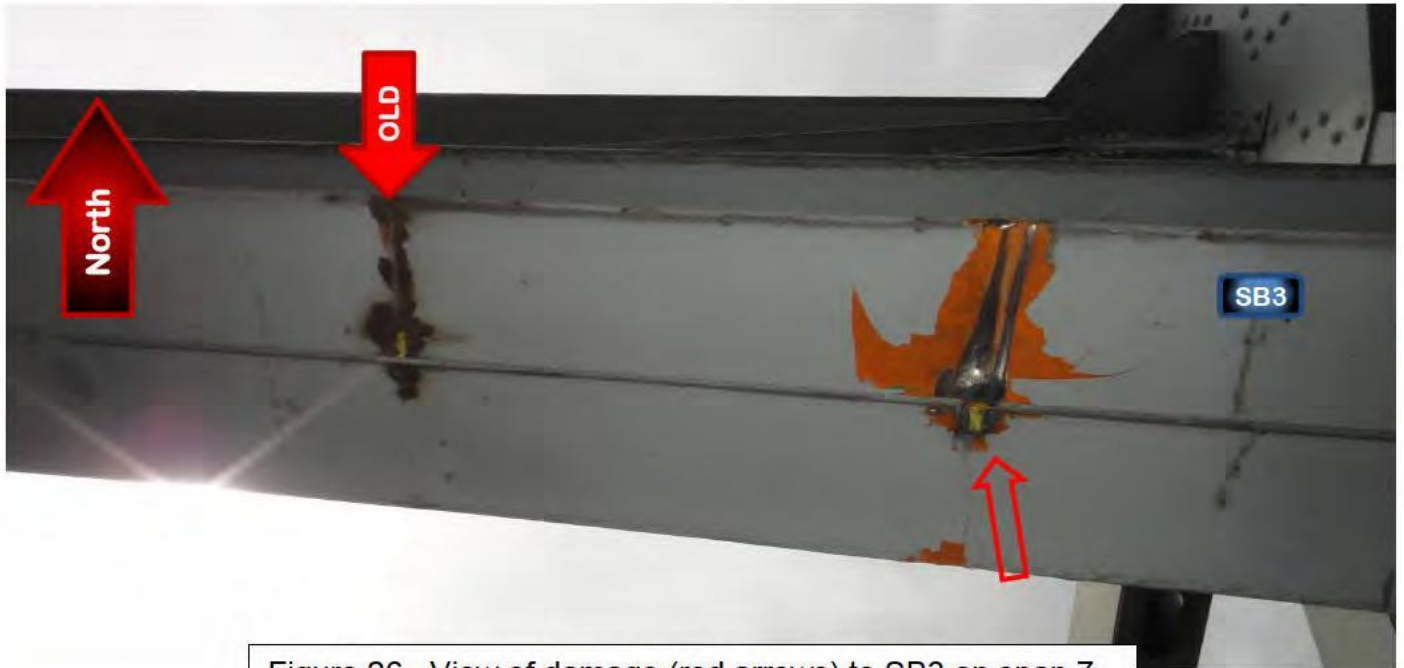
A corroded previous contact mark was noted on the lower flanges at about 80 inches from the brace. See Figure 26.

Figure 26. View of damage (red arrows) to SB3 on span 7.

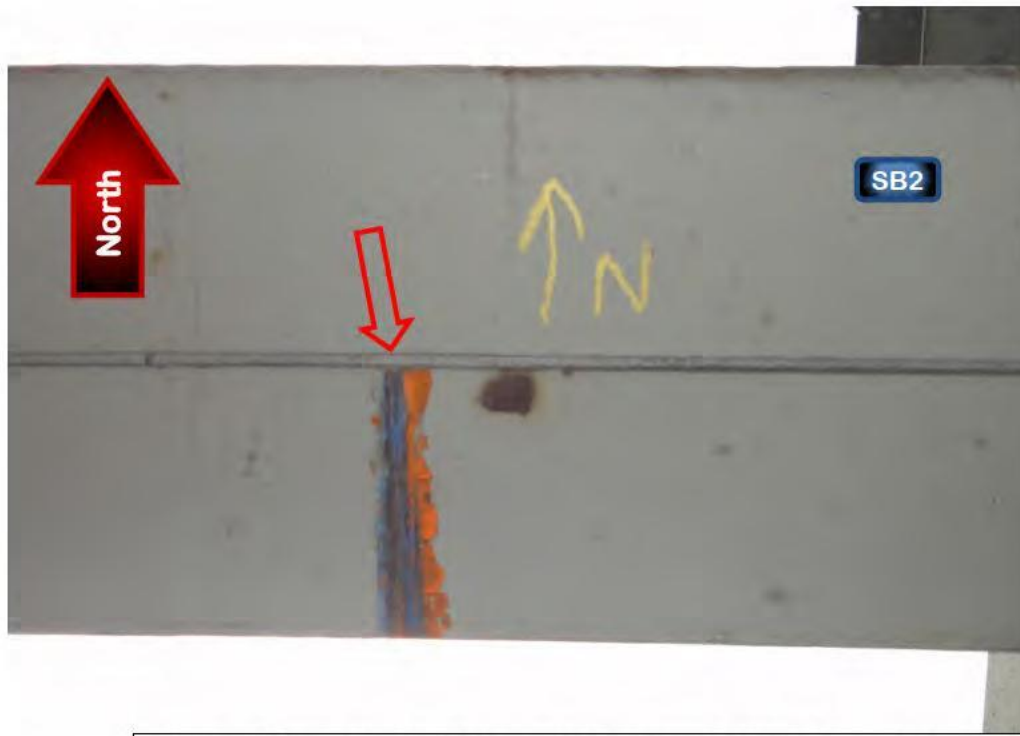
A north-south oriented scrape mark was noted on the underside of the south flange at 81 inches from the vertical. The scrape was about 6 inches long and 1 inch wide with blue paint transfers evident. See Figure 27.

Figure 27. View of damage (red arrows) to SB2 on span 7.

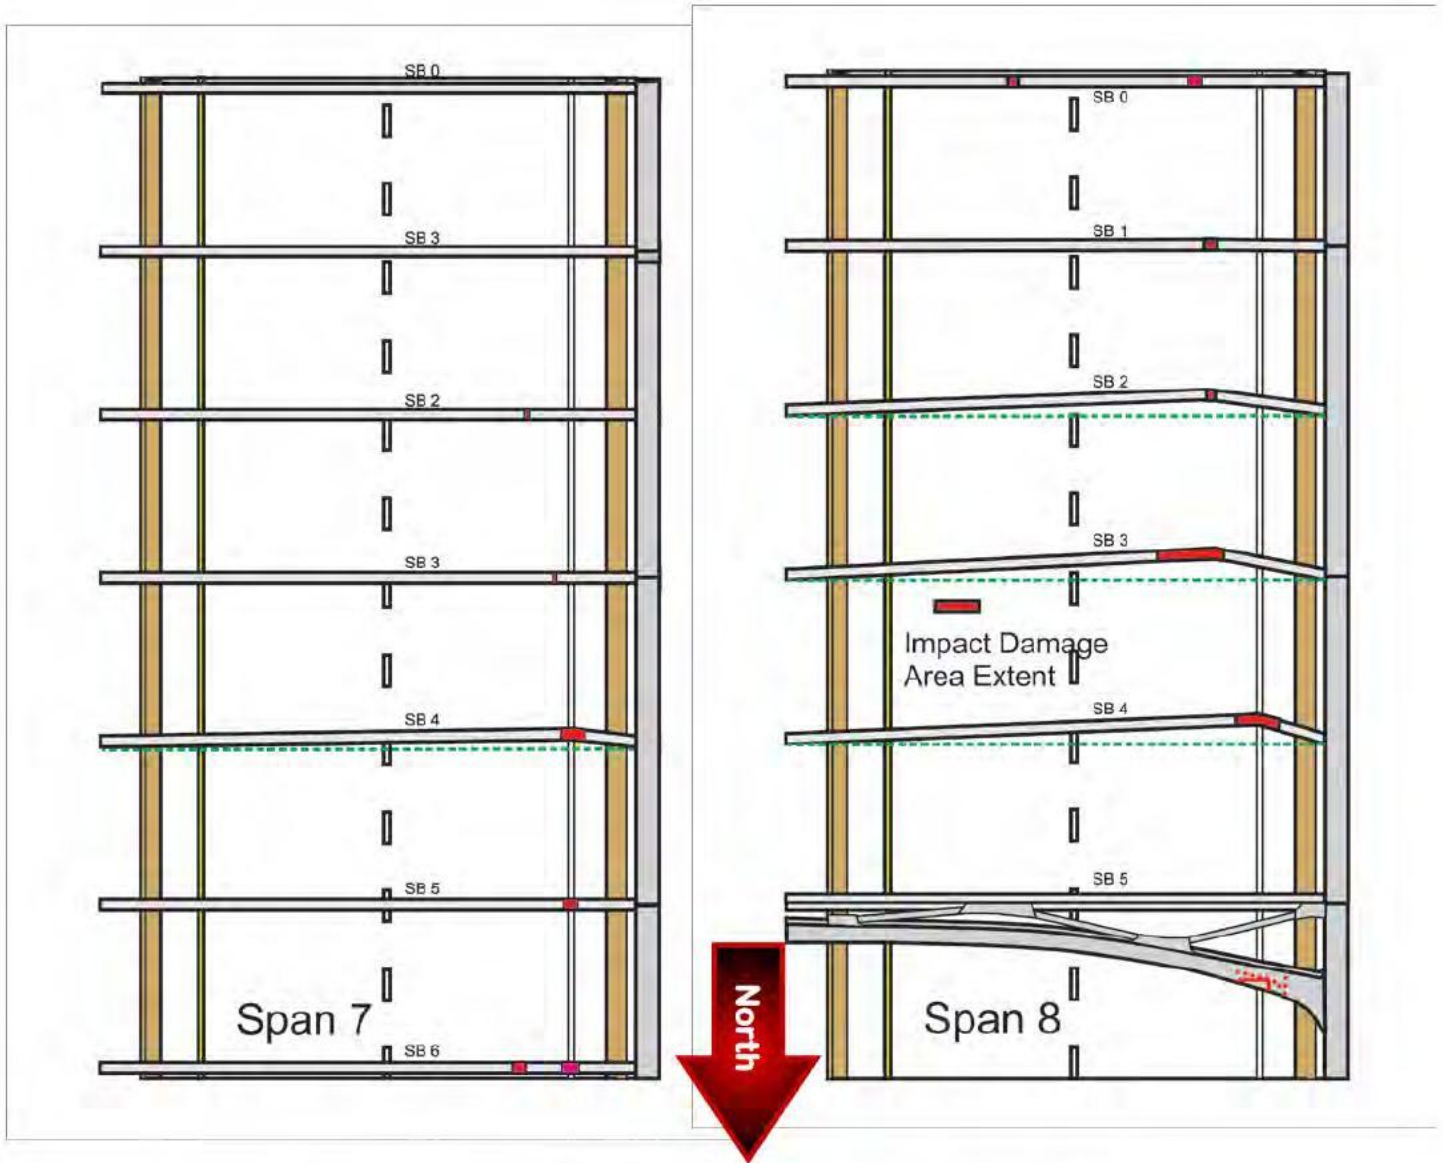
Figure 28. Top view summaries of damage to the span 7 sway braces at left with span 8 damage at right. Measurements are approximate.

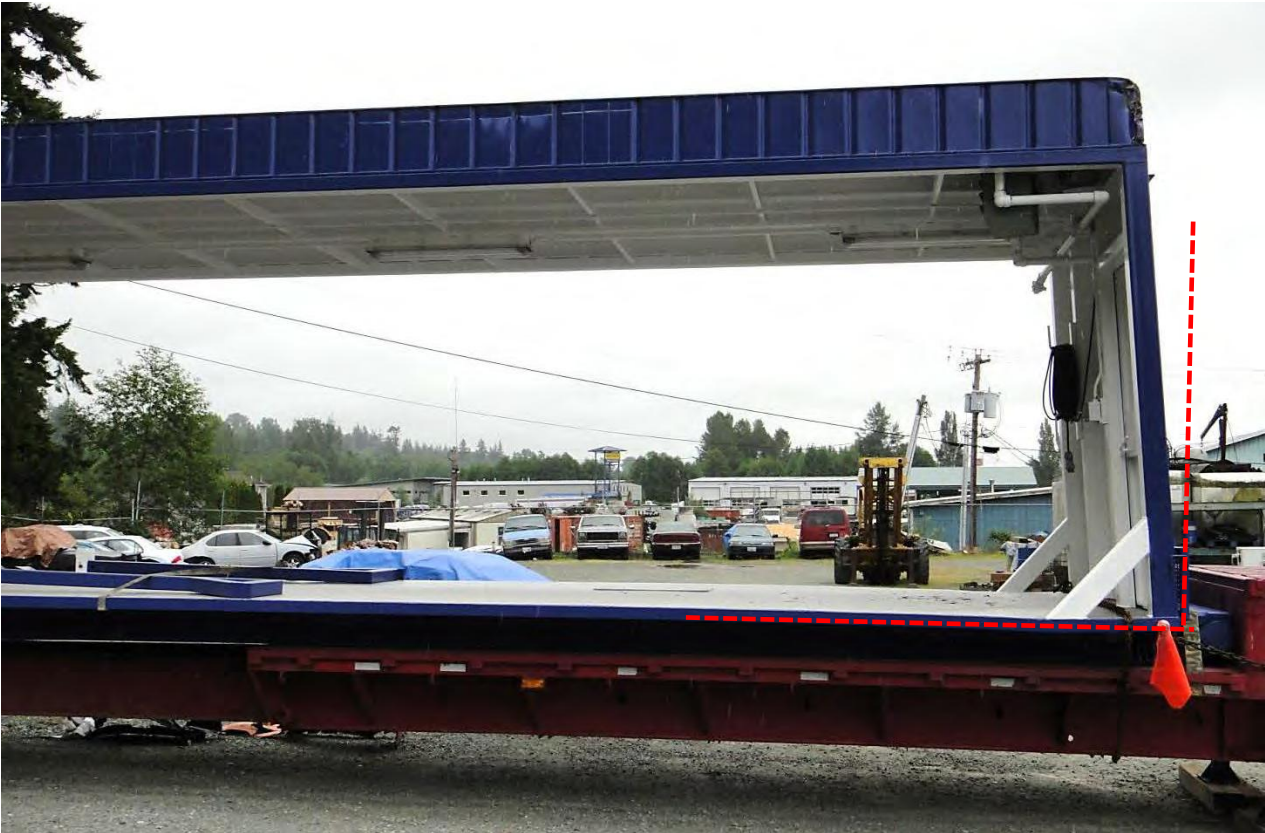
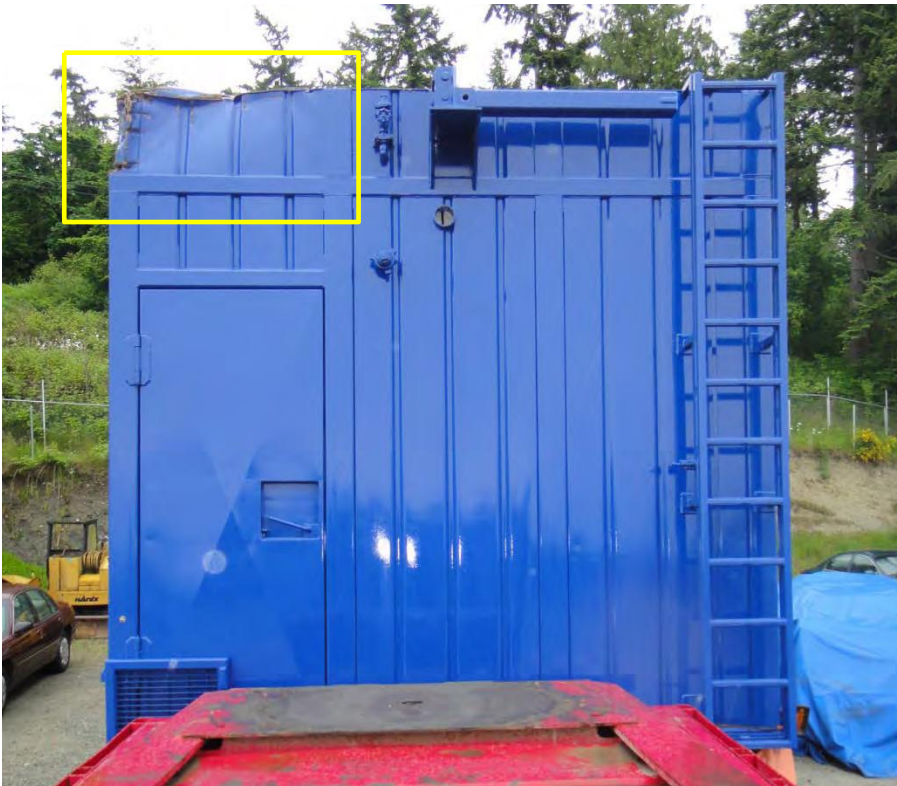
Inspection of the oversize load (casing shed) revealed impact damage to the upper right corner of the box structure. In addition, the normally rectangular casing shed was racked from front to back with the roof displaced rearward. See Figure 29. The exterior of the load was painted blue consistent with the blue paint transfers found on various components of span 7 and 8.

Figure 29. A side view of the casing shed at top showing the racking. Dotted red lines shown only as a visual reference. Left view is looking rearward at the front of the casing shed with the impact damage (yellow box) in the upper right corner of the shed. Boxed area shown in figure 30.
