**MATERIALS LABORATORY  
FACTUAL REPORT 13-070**

**Bridge Collapse  
Mount Vernon, WA; 05/23/2013**

**HWY13MH012**

MATERIALS LABORATORY FACTUAL REPORT

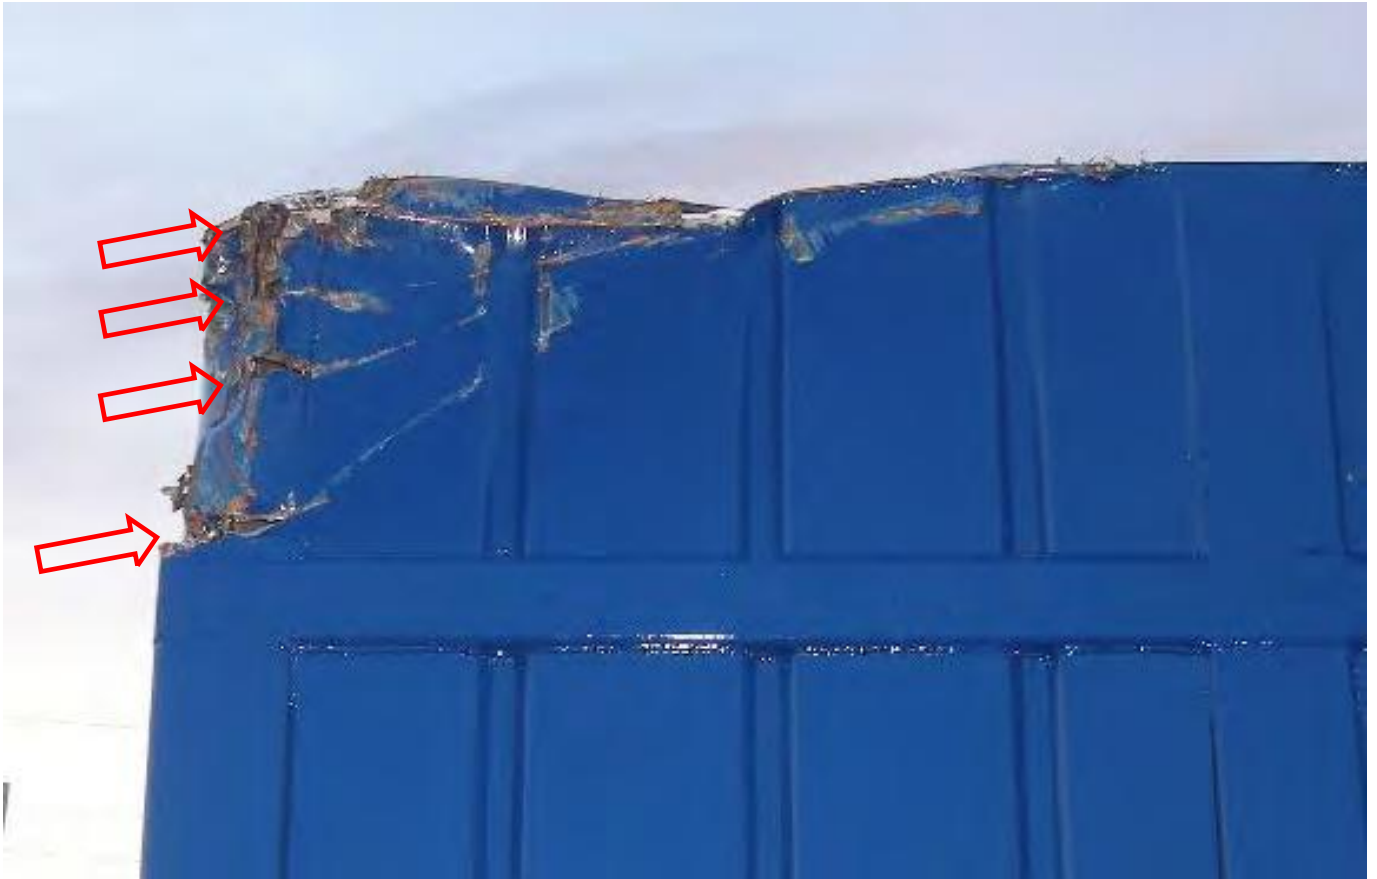
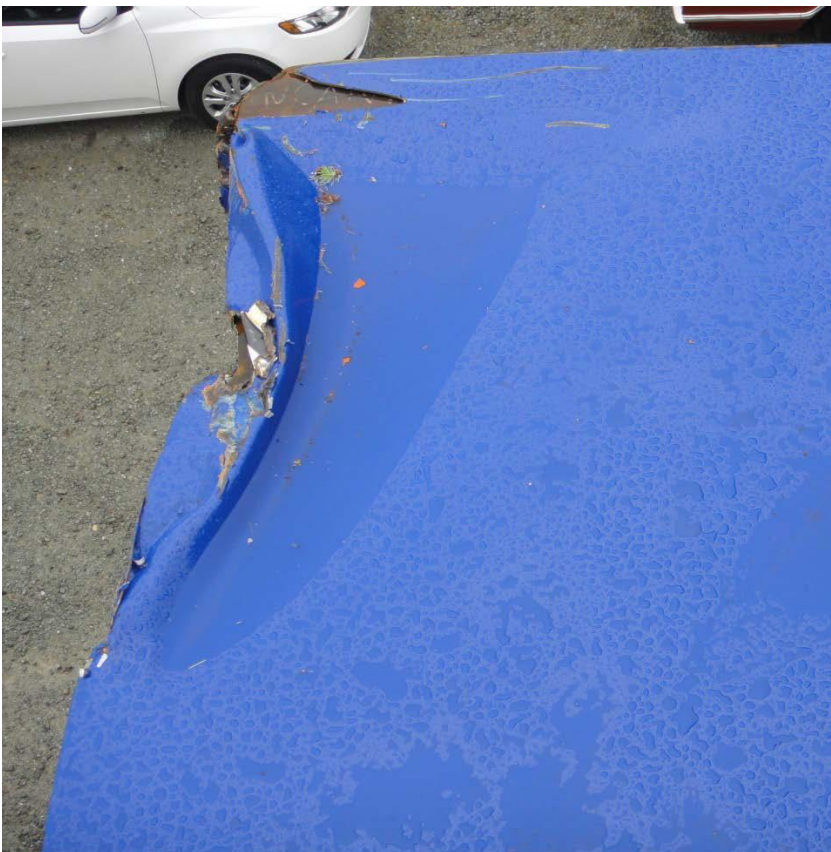
Four heavy impact marks were apparent on the front, upper right corner of the load in the roof area above the rim frame. The lowest mark displayed a curvature that closely approximated the curvature of the north portal and sway braces. See Figure 30. The heaviest damage was at the right side outboard roof runner where the sheet metal covering was cut completely through.

Figure 30. Closer view of the damaged area (boxed area from figure 29) from the front (top view) and top (left view).

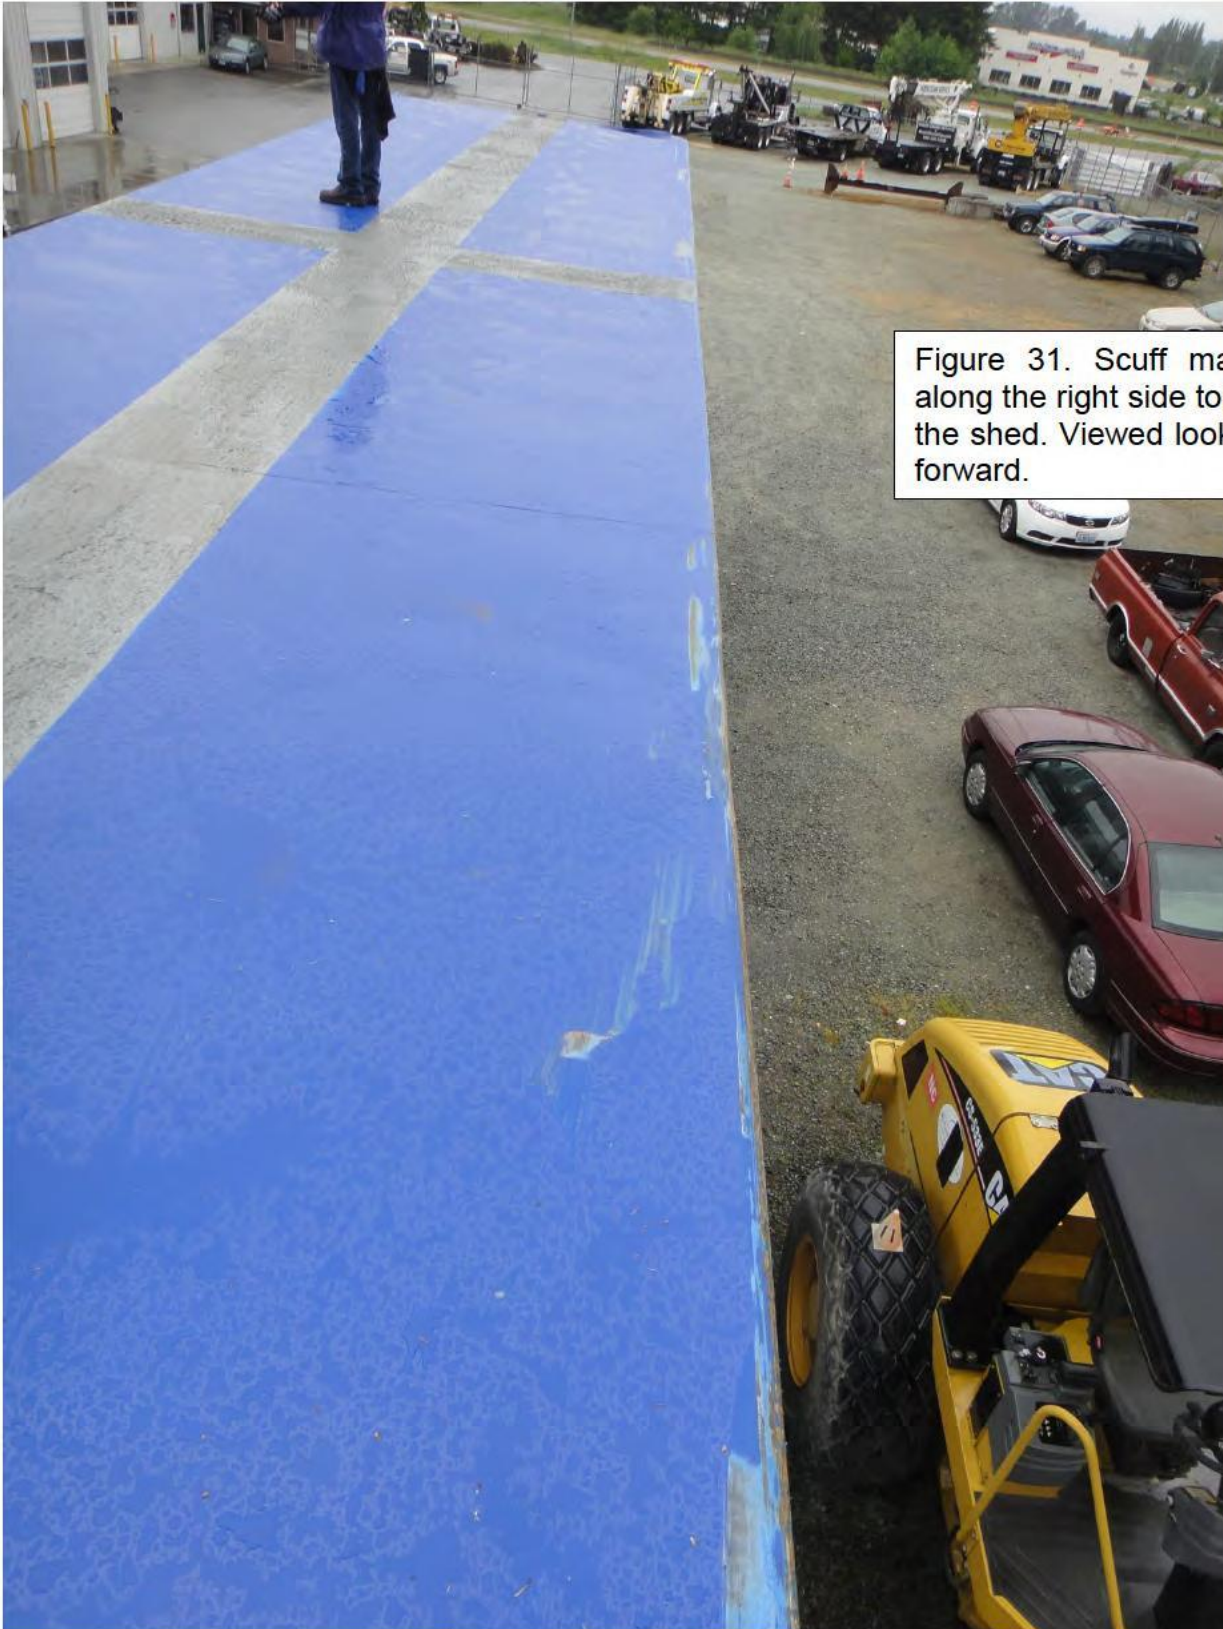
Figure 31. Scuff marks along the right side top of the shed. Viewed looking forward.
