NATIONAL TRANSPORTATION SAFETY BOARD

MATERIALS LABORATORY FACTUAL REPORT

Report No. 14-040

Place : New York, New York
Date : July 18, 2013
Vehicle : CSX freight train
NTSB No. : DCA13FR009
Investigator : Cy Gura, RPH-10

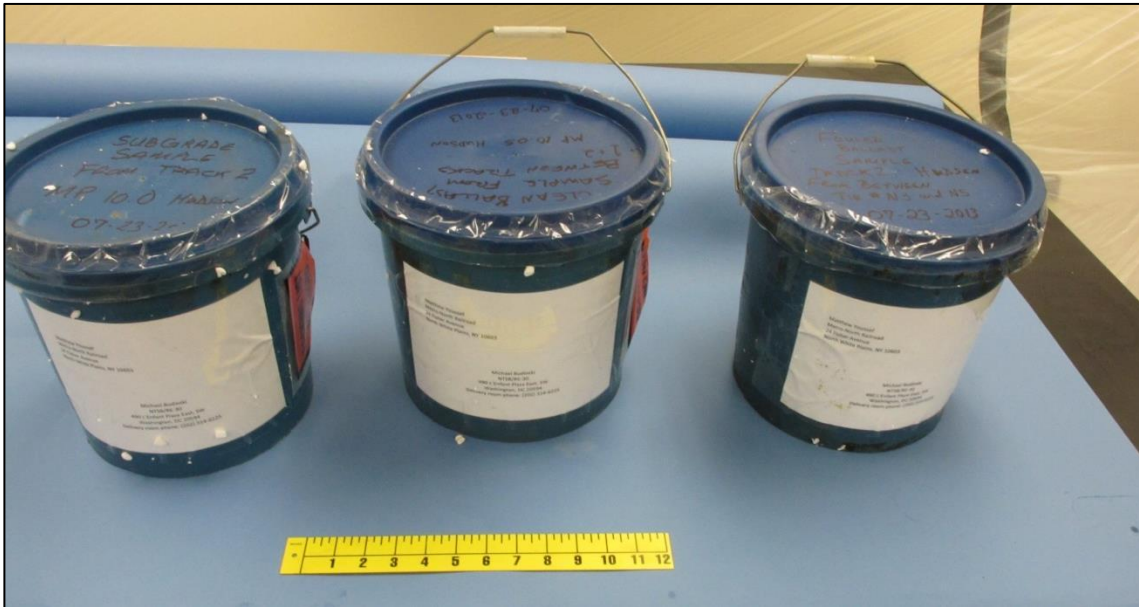
An overall view of the buckets containing ballast samples are shown in figure 1. The tops of the buckets were labeled "fouled ballast sample track 2 Hudson from between tie #N3 and N5 07-23-2013", "clean ballast sample from between tracks 1 and 2 MP 10.05 Hudson 07-23-2013", and "subgrade sample from track 2 MP 10.0 Hudson 07-23-2013", respectively. Overall views of the bucket contents are shown in figures 2 and 3. The contents of the buckets were moist and had a musty odor when opened on June 10, 2014.

Figure 1. Overall view of the buckets containing the ballast and subgrade samples as-received.

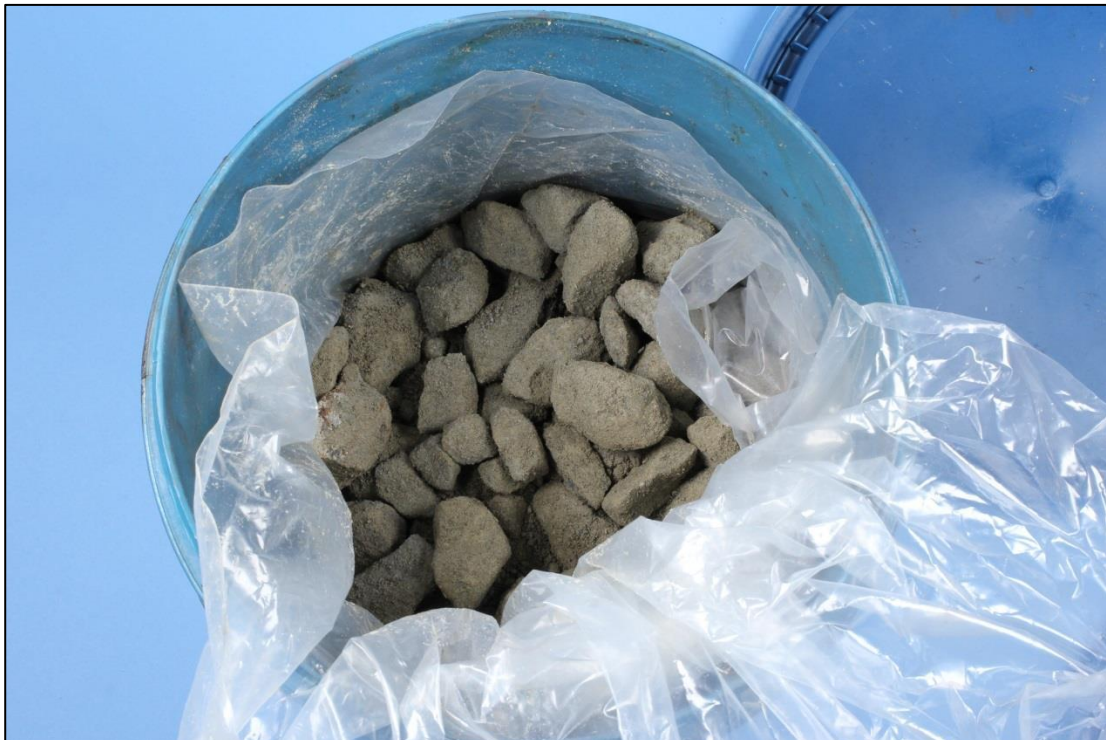
Figure 2. Overall view of the contents of the bucket labeled “fouled ballast sample”.

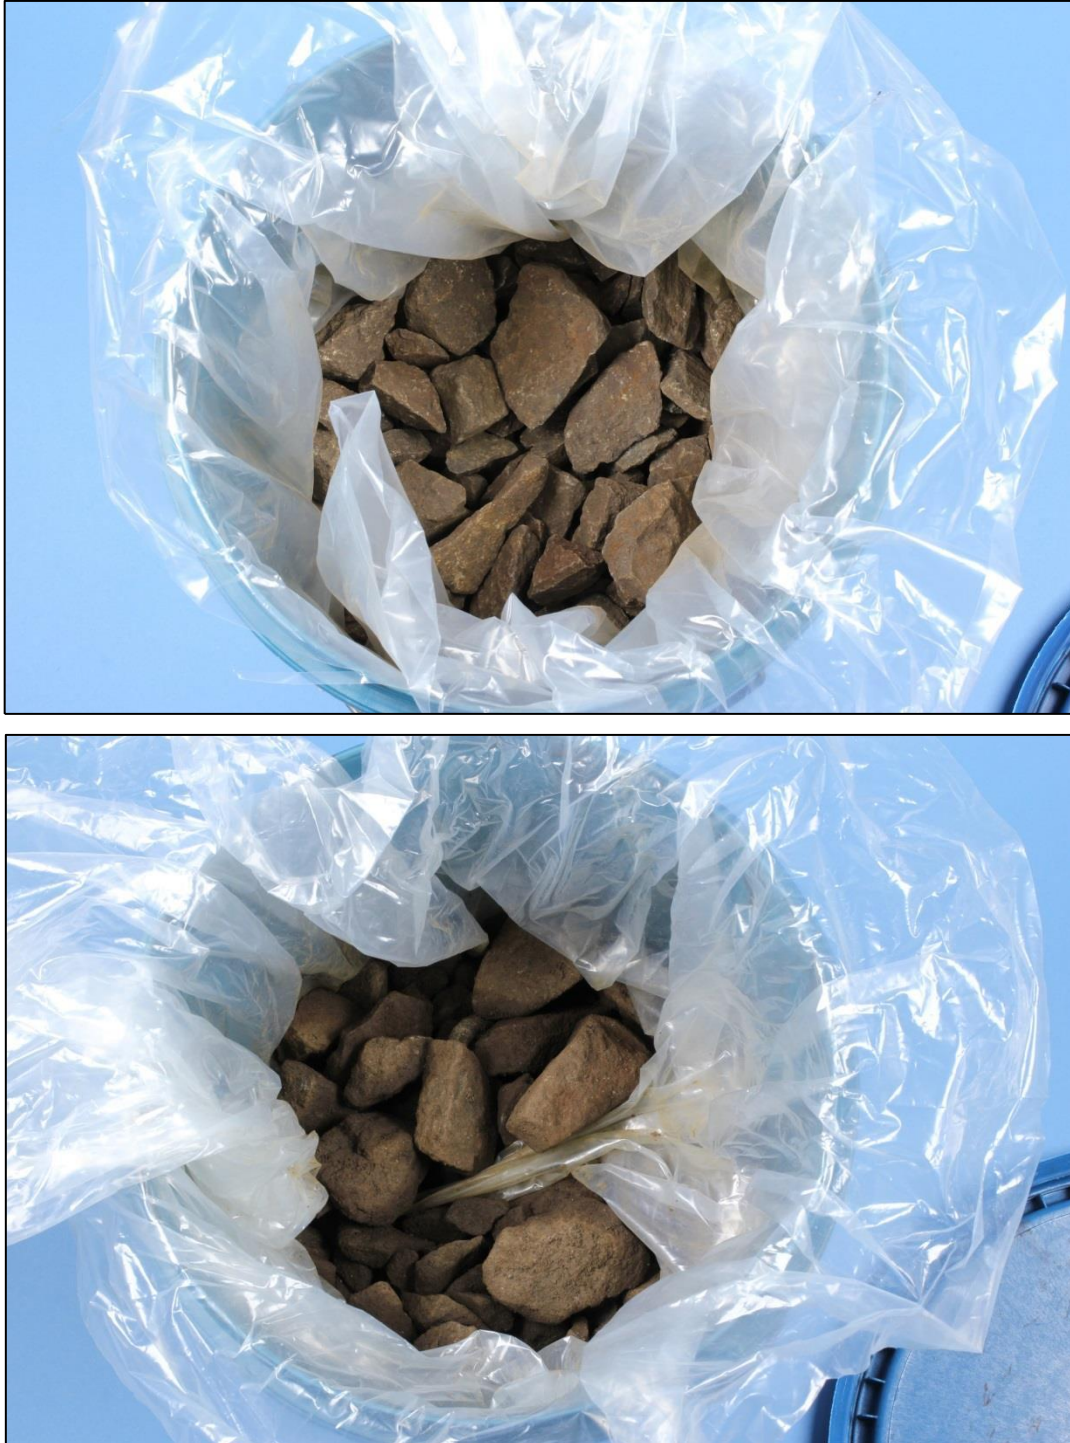
Figure 3. Overall views of the contents of the buckets labeled “clean ballast sample” (upper image) and “subgrade sample” (lower image).

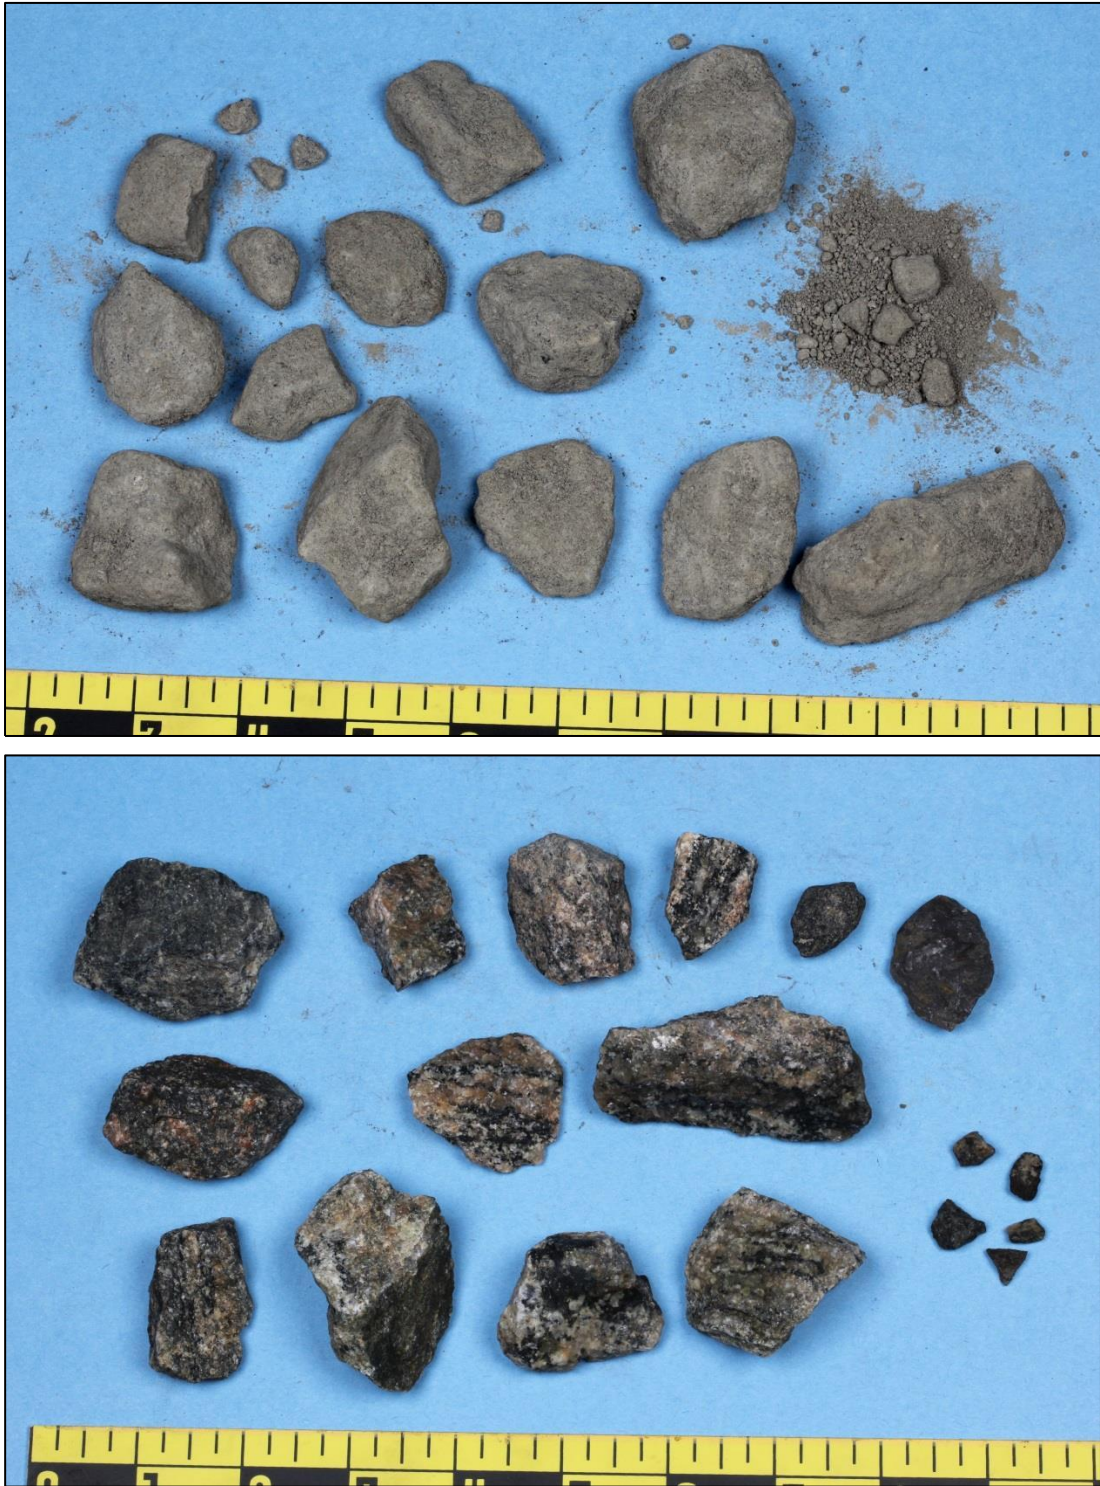
The rocks from the bucket labeled "fouled ballast sample" were medium gray in color when received. As they dried, the color turned to a light gray as shown in the upper image in figure 4. The exterior of the samples had a gritty powder substance covering the surface. The lower portion of the sample in the bucket also contained more of the powdery substance mixed with fine particulates, and a pile of the powder and particulate substance is shown in the upper image in figure 4. During cleaning, the gray powdery substance washed away from the surfaces, leaving the underlying rocks as shown in the lower image in figure 4.

Figure 4. View of rocks from the fouled ballast sample after being dried (upper image) and after cleaning and drying (lower image).

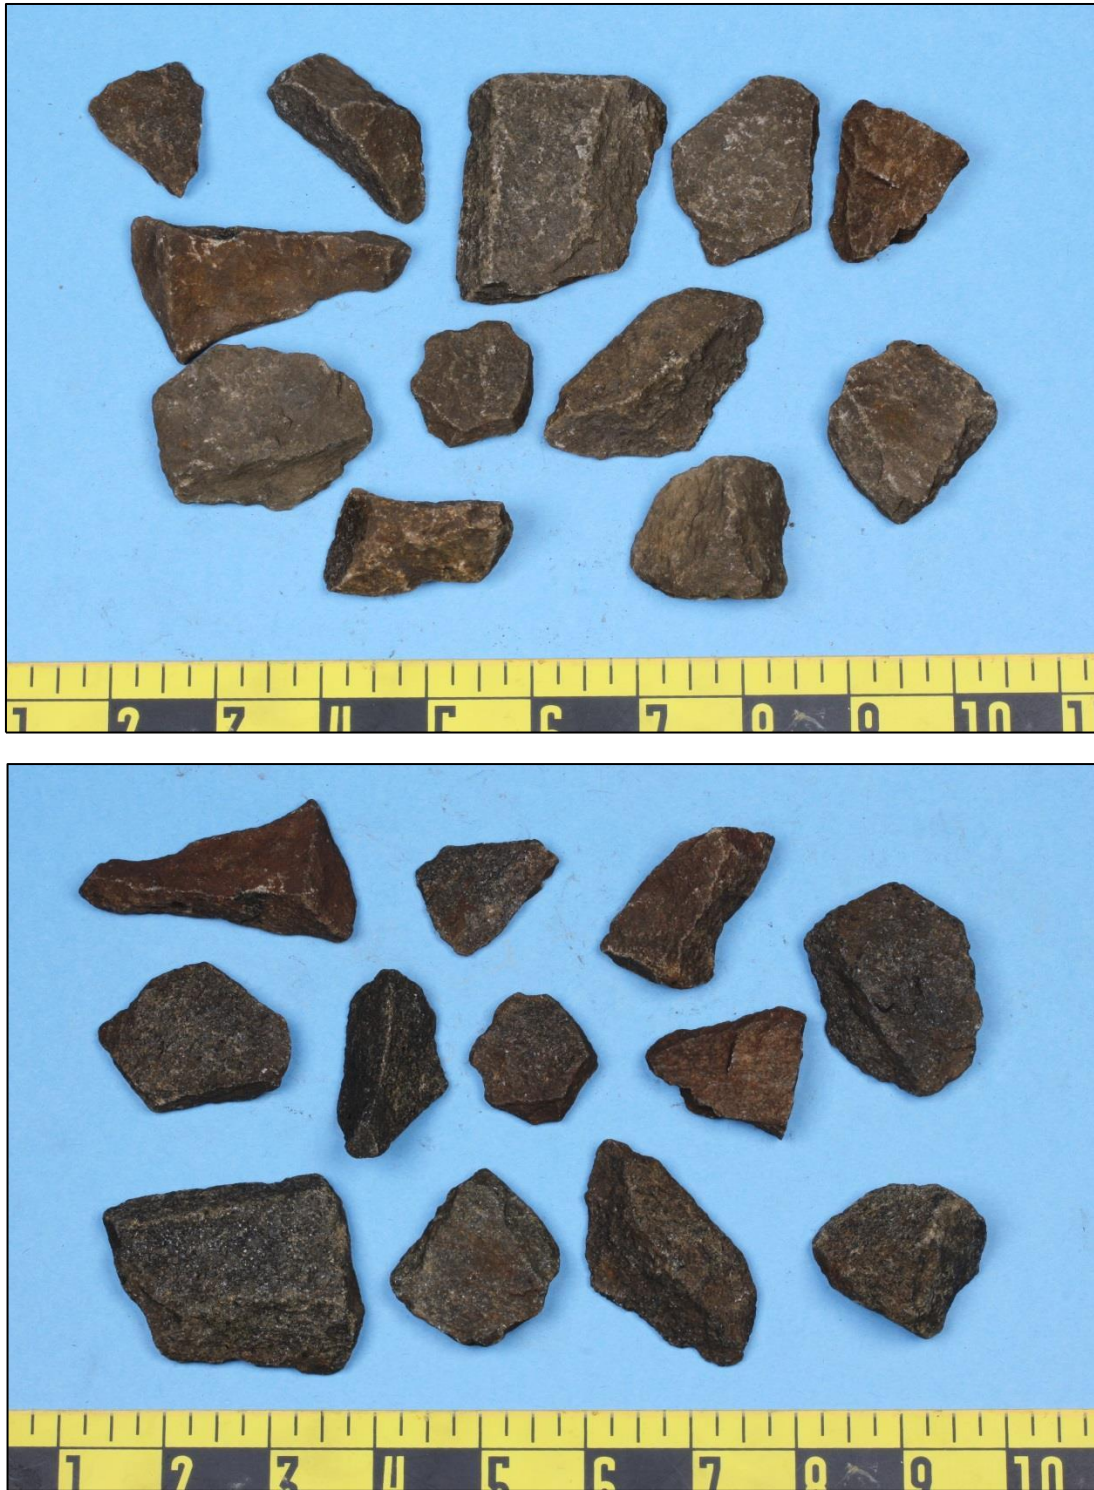
The rocks from the bucket labeled “clean ballast sample” were brown in color with gray-colored edges as shown in the upper image in figure 5. After cleaning, the rocks were mostly brown or dark green in color as shown in the lower image in figure 5.

Figure 5. View of rocks from the clean ballast sample after being dried (upper image) and after cleaning and drying (lower image).

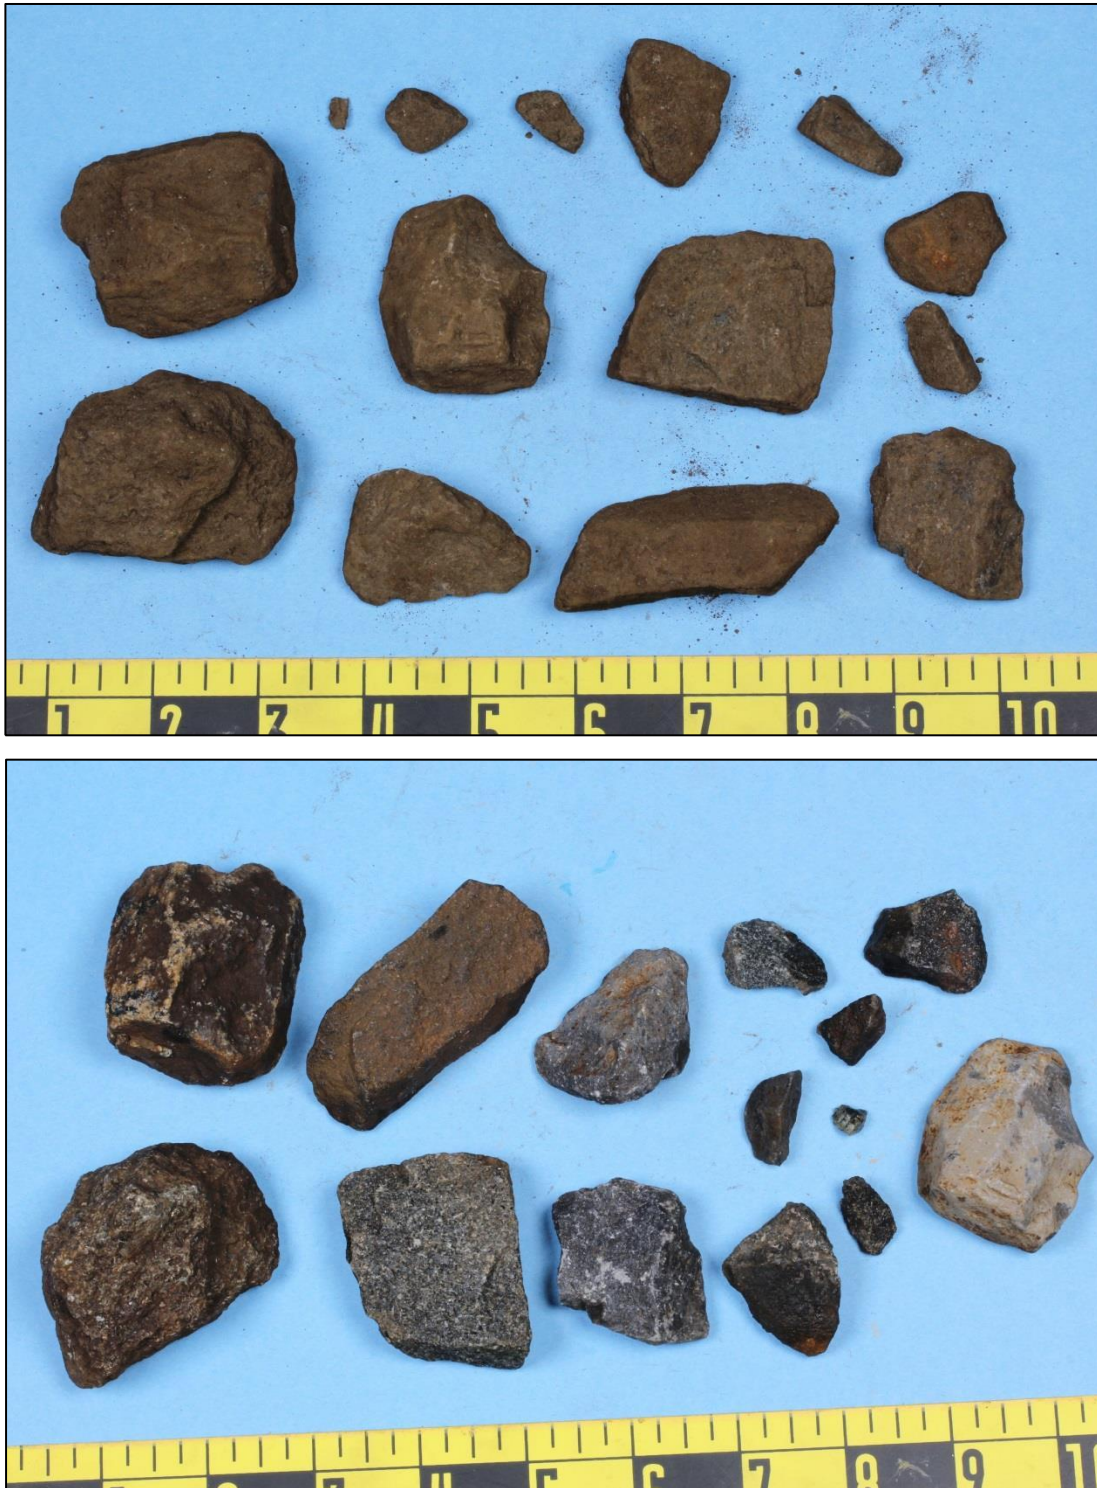
The rocks from the bucket labeled “subgrade sample” were also brown in color as shown in the upper image in figure 6. The surfaces were covered in fine brown particles that fell off during handling. The brown-colored surface deposits mostly washed off during cleaning, and the resulting cleaned rocks from the subgrade sample are shown in the lower image in figure 6.

Figure 6. View of rocks from the subgrade sample after being dried (upper image) and after cleaning and drying (lower image).
