NATIONAL TRANSPORTATION SAFETY BOARD

MATERIALS LABORATORY FACTUAL REPORT

Report No. 14-043

Place : Birmingham, Alabama
Date : December 17, 2013
Vehicle : Alabama Gas Corp (Alagasco) natural gas pipe
NTSB No. : DCA14MP001
Investigator : Ravi Chhatre (RPH-20)

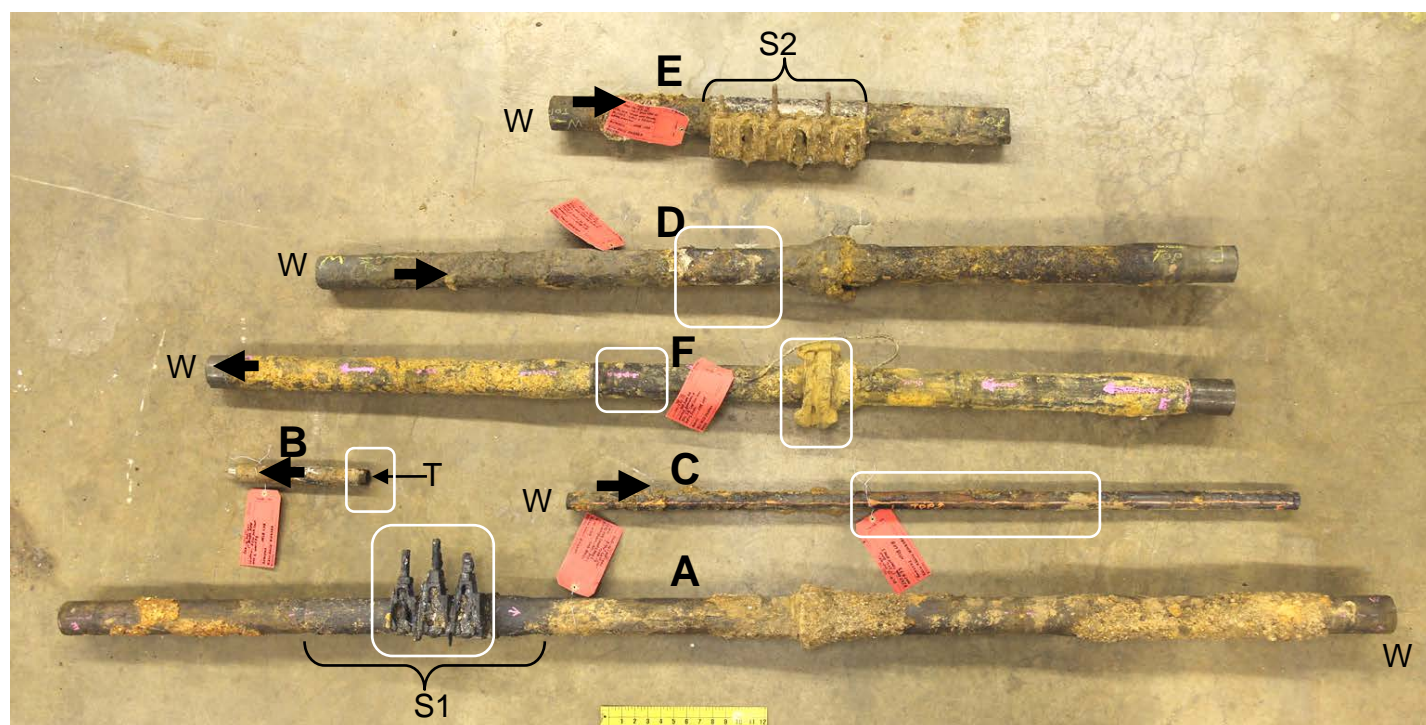
On-site testing by Alagasco disclosed that cast iron main pipe segment “A” in figure 1 contained a gas leak. The leak emanated from the bottom of the pipe. The outer surface around the pipe in the area of the gas leak was cleaned on-site, and a 7.5-inch long sleeve (clamp with three bolts and their attachment nuts) was installed over the leaking portion. The sleeve is indicated by bracket “S1” in figure 1. The sleeve with the pipe was shipped to the Safety Board Materials Laboratory.

Excavation work disclosed cast iron main pipe “E” in figure 1 was encased with a 12-inch long sleeve (clamp with six bolts and their attachment nuts) in the area indicated by bracket “S2” in figure 1. The threads and attachment nuts for the sleeve “S2” in figure 1 exhibited brown oxide scale oxidation consistent with a sleeve that had been buried in the ground. A representative from Alagasco confirmed that sleeve “S2” in figure 1 was on the pipe when it was uncovered (exposed) by excavation.

Figure 1. Photograph of the as-received pipe segments showing the top side. The pipe segments were arbitrarily labeled segments “A” through “F”.

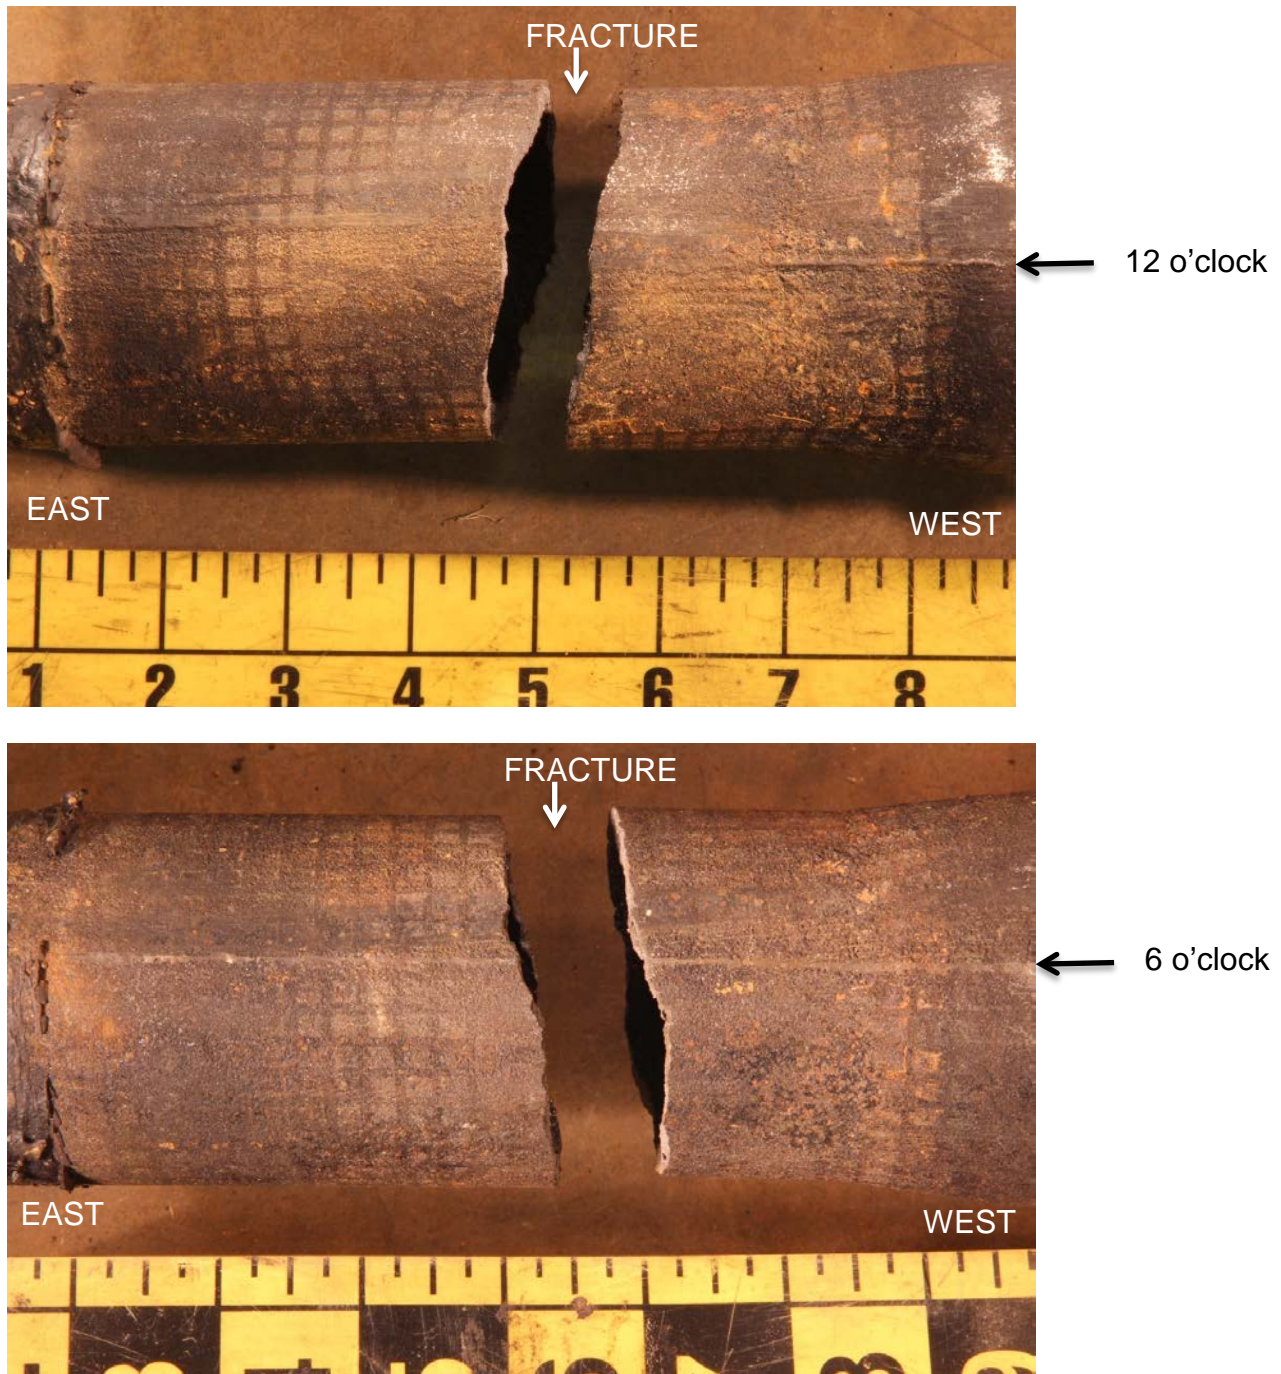
The sleeve on segment “A” was disassembled prior to May 27. Upon removal of the sleeve, the pipe segment in the area of the gas leak was found with a fracture that extended circumferentially all around the pipe (see figure 2). Figure 3 shows a photograph of the east face of the fracture. Bench binocular microscope examination of the east face

Figure 2. Photographs of pipe segment “A” showing the top and bottom sides of the pipe in the areas of the fracture (top and bottom of page, respectively). Casting mold parting lines that were oriented along the length of the pipe were located at the 12 and 6 o’ clock positions.

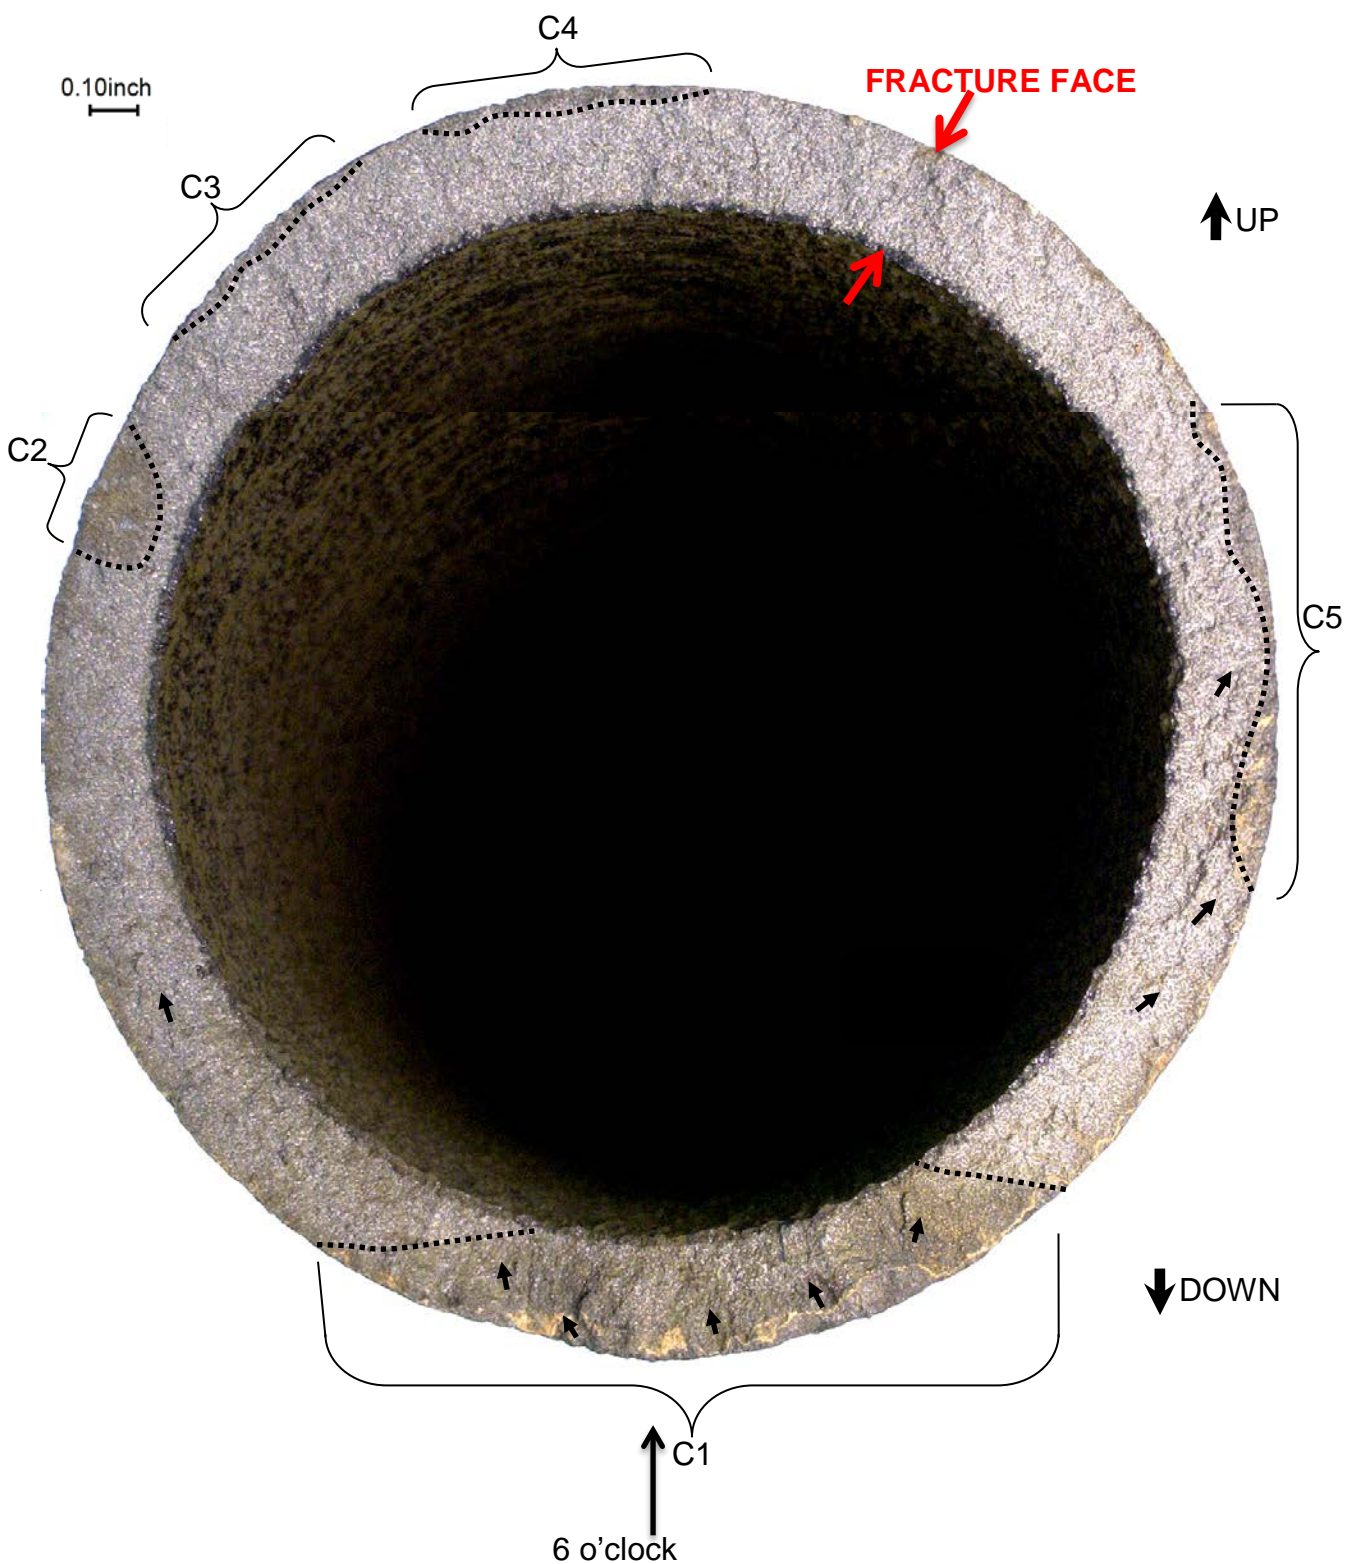
of the fracture surface revealed a radiating pattern that originated from the outer face at the bottom of the pipe. The fracture propagated up and radially outward. The fracture extended to each side of the fracture origin area and propagated circumferentially up toward the top side of the pipe, in the general direction indicated by unmarked arrows in figure 3. The fracture face exhibited five dark regions adjacent to the outside surface consistent with oxidized cast iron. The five oxidized regions are indicated by brackets "1" through "5" in figure 3. The largest oxidized region was located at the bottom of the pipe. The oxidized region at the bottom of the pipe extended through the thickness of the pipe, intersecting the outer and inner surfaces. On the outer surface, the circumferential length of the oxidized region measured approximately 1.6 inch. On the inner surface the circumferential length of the oxidized region measured approximately 0.7 inch.

Figure 3. Composite photograph of the east face portion of the fracture from cast iron main pipe segment "A" in the as-received condition (prior to cleaning) showing five areas that contained dark regions. General direction of fracture propagation is indicated by unmarked arrows.

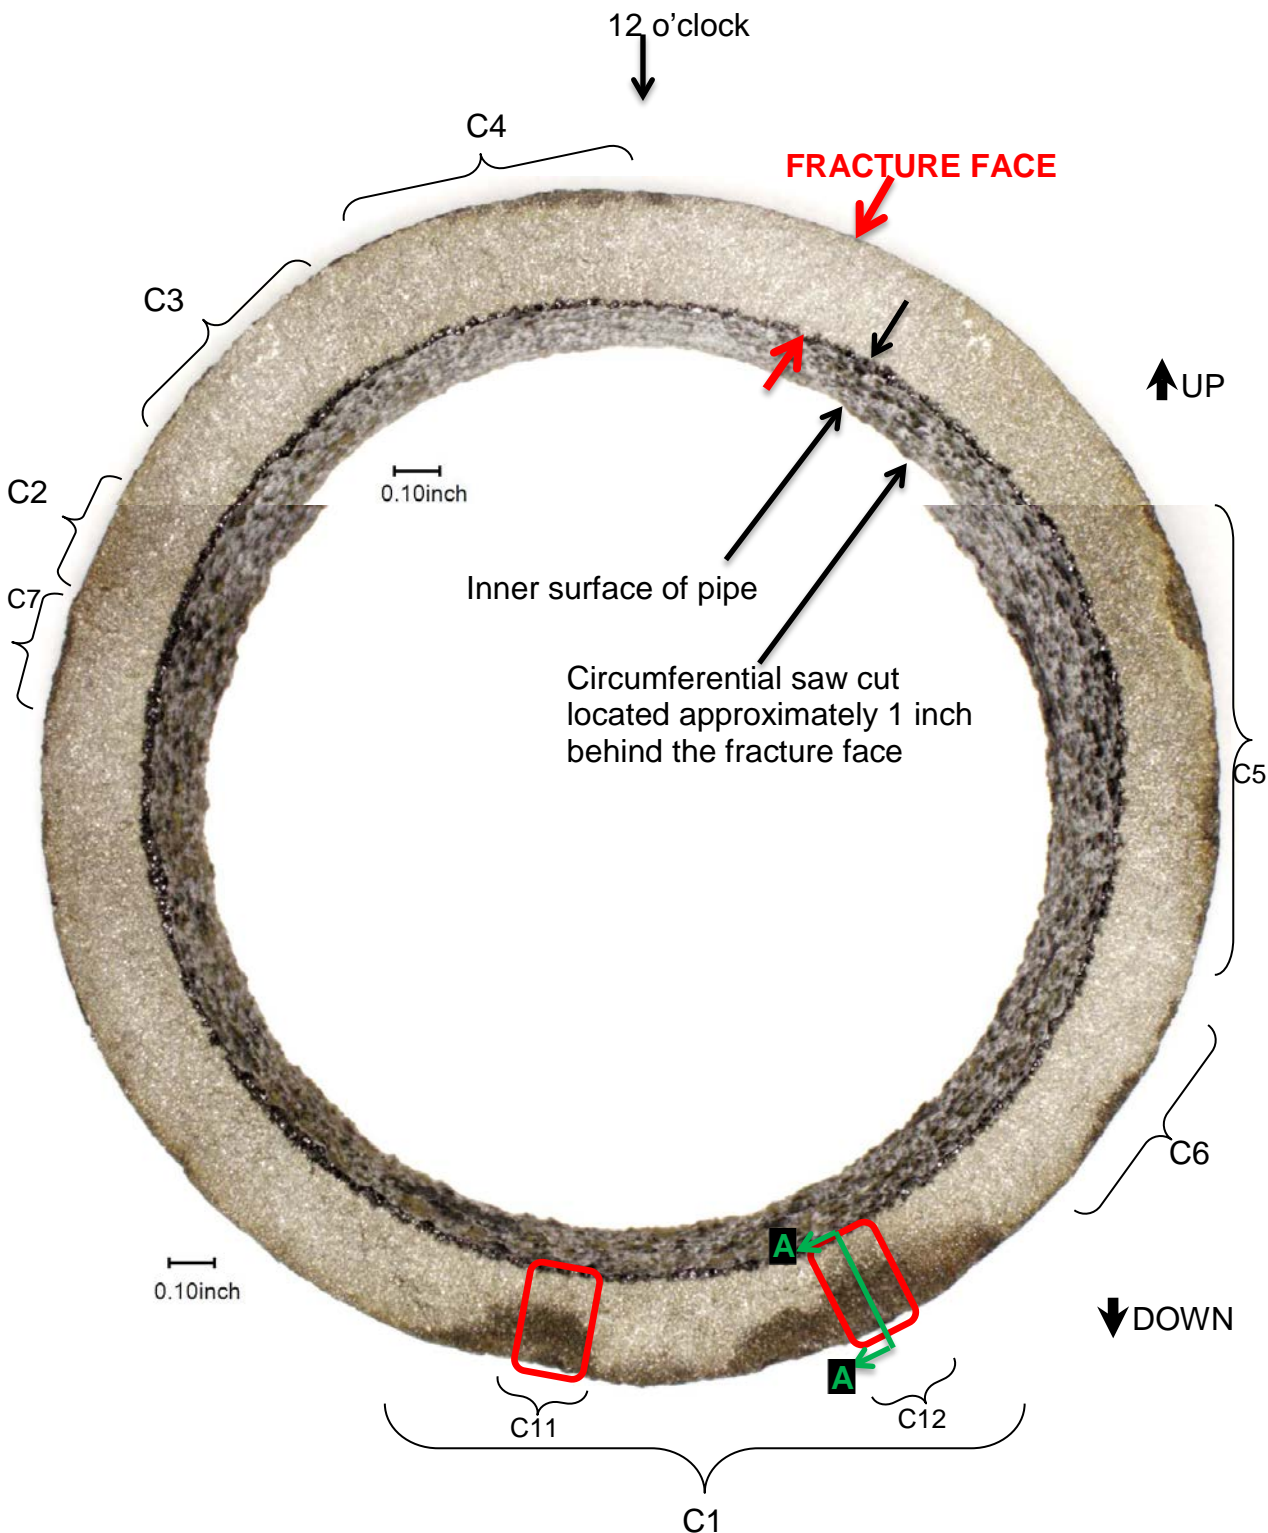
A circumferential-radial saw cut was made through pipe segment "A" in the area located approximately 1 inch away from the east face of the fracture. The approximately 1-inch wide ring that contained the east face of the fracture was removed and ultrasonic cleaned with Alconox, a commercial soap solution. The cleaning process removed the oxidized regions and exposed black regions that were located within the oxidized regions. Figure 4 shows a composite photograph of the black regions on the clean fracture face. The black regions are located adjacent to the outer surface and were smaller than the oxidized regions in figure 3. The black regions adjacent to the outer surface in figure 4 are consistent with graphitic corrosion in gray cast iron. Graphitic corrosion is defined as deterioration of gray cast iron in which the metallic constituents are selectively leached or converted to corrosion products leaving the graphite phase intact.² The ultrasonic cleaning process exposed two additional graphitic corrosion areas indicated by brackets "C6" and "C7" in figure 4. The oxidized region indicated by bracket "C2" in figure 4 is barely visible after cleaning compared to the same respective area before cleaning (figure 3).

Figure 4. Composite photograph of the east face portion of the fracture from cast iron main pipe segment "A" looking down the length of the pipe segment after ultrasonic cleaning. Black areas on the fracture face and adjacent to the outer surface, in areas indicated by brackets "C1" through "C7", are consistent with graphitic corrosion in gray cast iron.

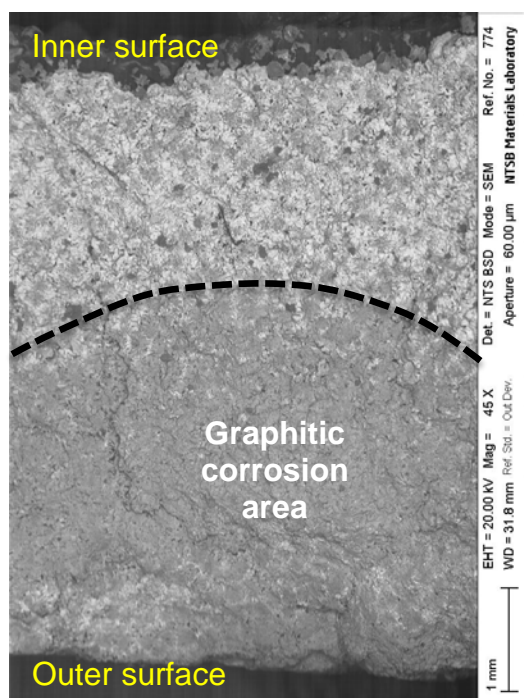
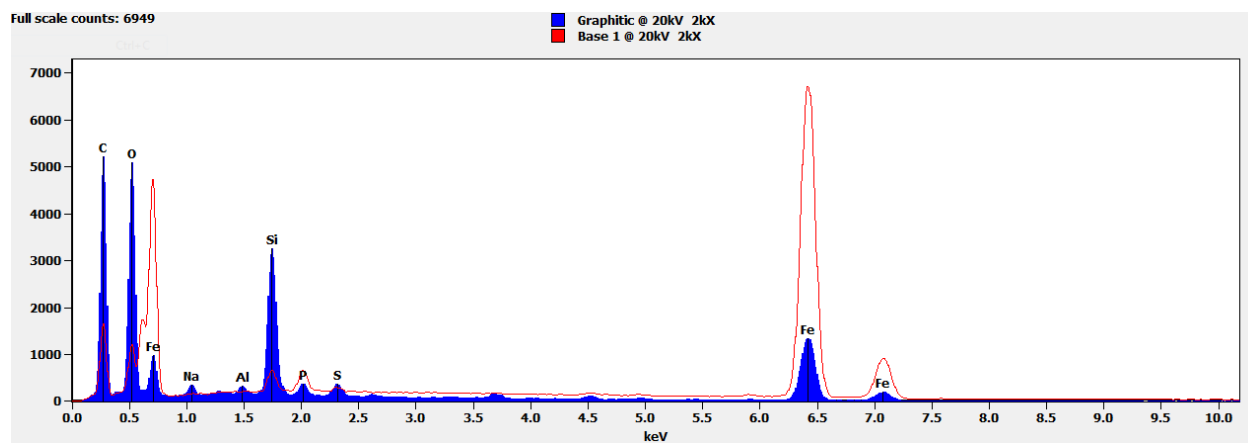
Scanning electron microscope (SEM) examination of the east face of the fracture using an electron backscatter detector³ after ultrasonic cleaning revealed the graphitic corrosion region at the bottom of the pipe in the area indicated by bracket "C11" in figure 4 extended as deep as 60% of the wall thickness. X-ray energy dispersive spectroscopy (EDS) analysis of the pipe fracture face in the area located outside of the graphitic corrosion region showed elemental peaks of iron, phosphorus, oxygen and carbon (see

figure 5). EDS spectrum of the graphitic corrosion regions showed iron peaks that were smaller and carbon, silicon, and oxygen peaks that were greater than the same respective elements in the areas located outside of the graphitic corrosion regions. The graphitic corrosion region at the bottom of the pipe in the area indicated by bracket "C12" in figure 4 extended as deep as 50% of the wall thickness. Figures 5 and 6 show SEM electron backscatter images of the extent of graphitic corrosion regions in areas "C11" and "C12", respectively. The graphitic corrosion areas in electron backscatter images appear as gray areas in figures 5 and 6, whereas, fracture areas located outside of the graphitic corrosion region appear as light luster. The size of the graphitic corrosion regions observed on the electron backscatter images are consistent the size of those observed on the optical microscope and visual examination (figure 4), with the exception of the graphitic corrosion in the area indicated by bracket "C2" in figure 4. When viewing the fracture face with an SEM in electron backscatter mode, the graphitic corrosion area indicated by bracket "C2" in figure 4 did not exhibit a clear border. The graphitic corrosion area indicated by bracket "C2" in figure 4 was less severe compared to the graphitic corrosion areas "C11" and "C12" in figures 5 and 6, respectively.

In this SEM electron backscatter image the graphitic corrosion area appears as dull gray.

Figure 5. Scanning electron microscope (SEM) photograph in electron backscatter mode of a portion of the east face of the fracture from pipe segment “A” in the area located within box labeled “C11” in figure 4 showing graphitic corrosion that extended through approximately 60% of the wall (see top image). The dashed line indicates the border of the graphitic corrosion region. The bottom side of the page shows energy dispersive spectroscopy spectra of an area located outside of the graphitic corrosion region (red line) compared to an area located within the graphitic corrosion region (solid blue peaks).

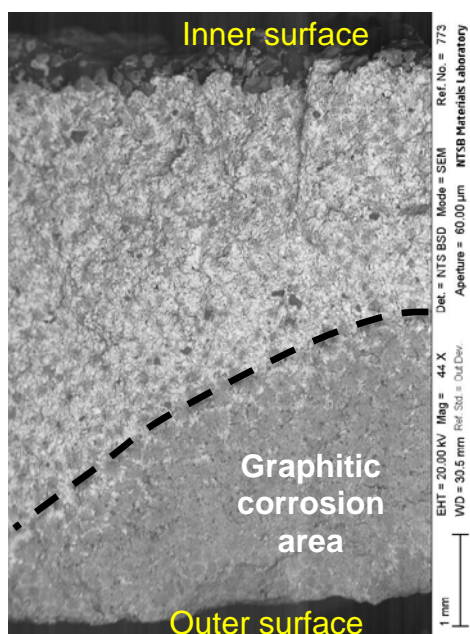
Figure 6. SEM electron backscatter image of a portion of the east face of the fracture of pipe segment “A” located within the box labeled “C12” in figure 4 showing graphitic corrosion that extended through approximately 50% of the wall.

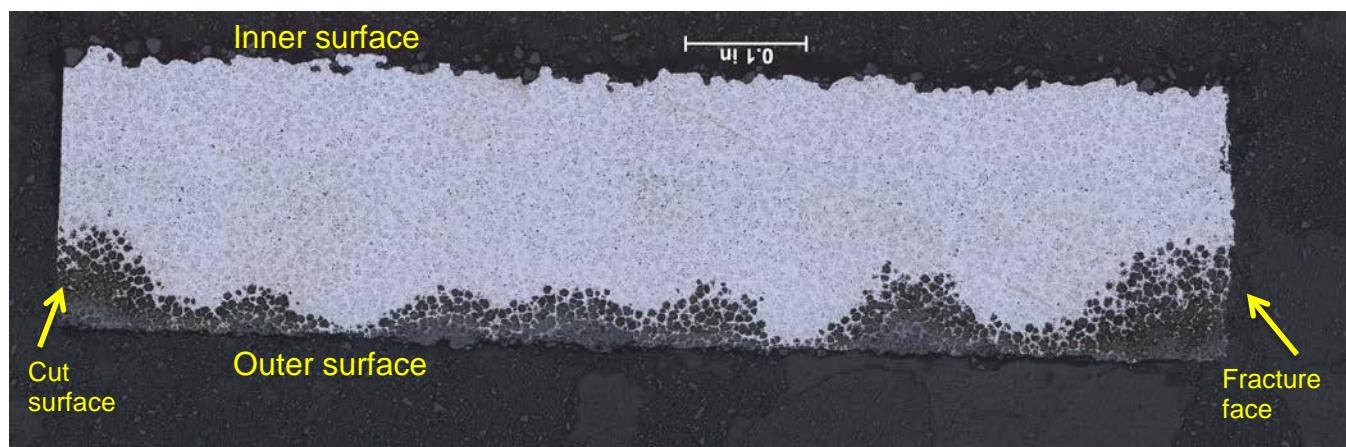
A radial-longitudinal metallurgical section was made through a graphitic corrosion area at the bottom of the pipe, in the area indicated by section line "A-A" in figure 4. The section was encased in a metallurgical mount and polished. Figure 7 shows a photograph of polished section "A-A". Examination of the polished section revealed the outer surface of the pipe and fracture face contained black areas consistent with graphitic corrosion in gray cast iron. Examination of the polished section revealed graphite flakes in a matrix of pearlite consistent with gray cast iron. The graphite flakes at the core of the pipe were consistent with graphite flake type B (rosette groupings, random orientation); graphite form VII; and graphite size 5 when compared with template standards in ASTM A247, titled "Evaluating the Microstructure of Graphite in Iron Castings". Section "A-A" was etched with 2% Nital reagent. The etched section showed a microstructure of graphite flakes in a matrix of pearlite.

Figure 7. Longitudinal-radial metallurgical section that was through the fracture face of pipe segment “A” in the orientation indicated by section “A-A” in figure 4 showing graphitic corrosion (black areas) on the outer face of the pipe. Polished section.

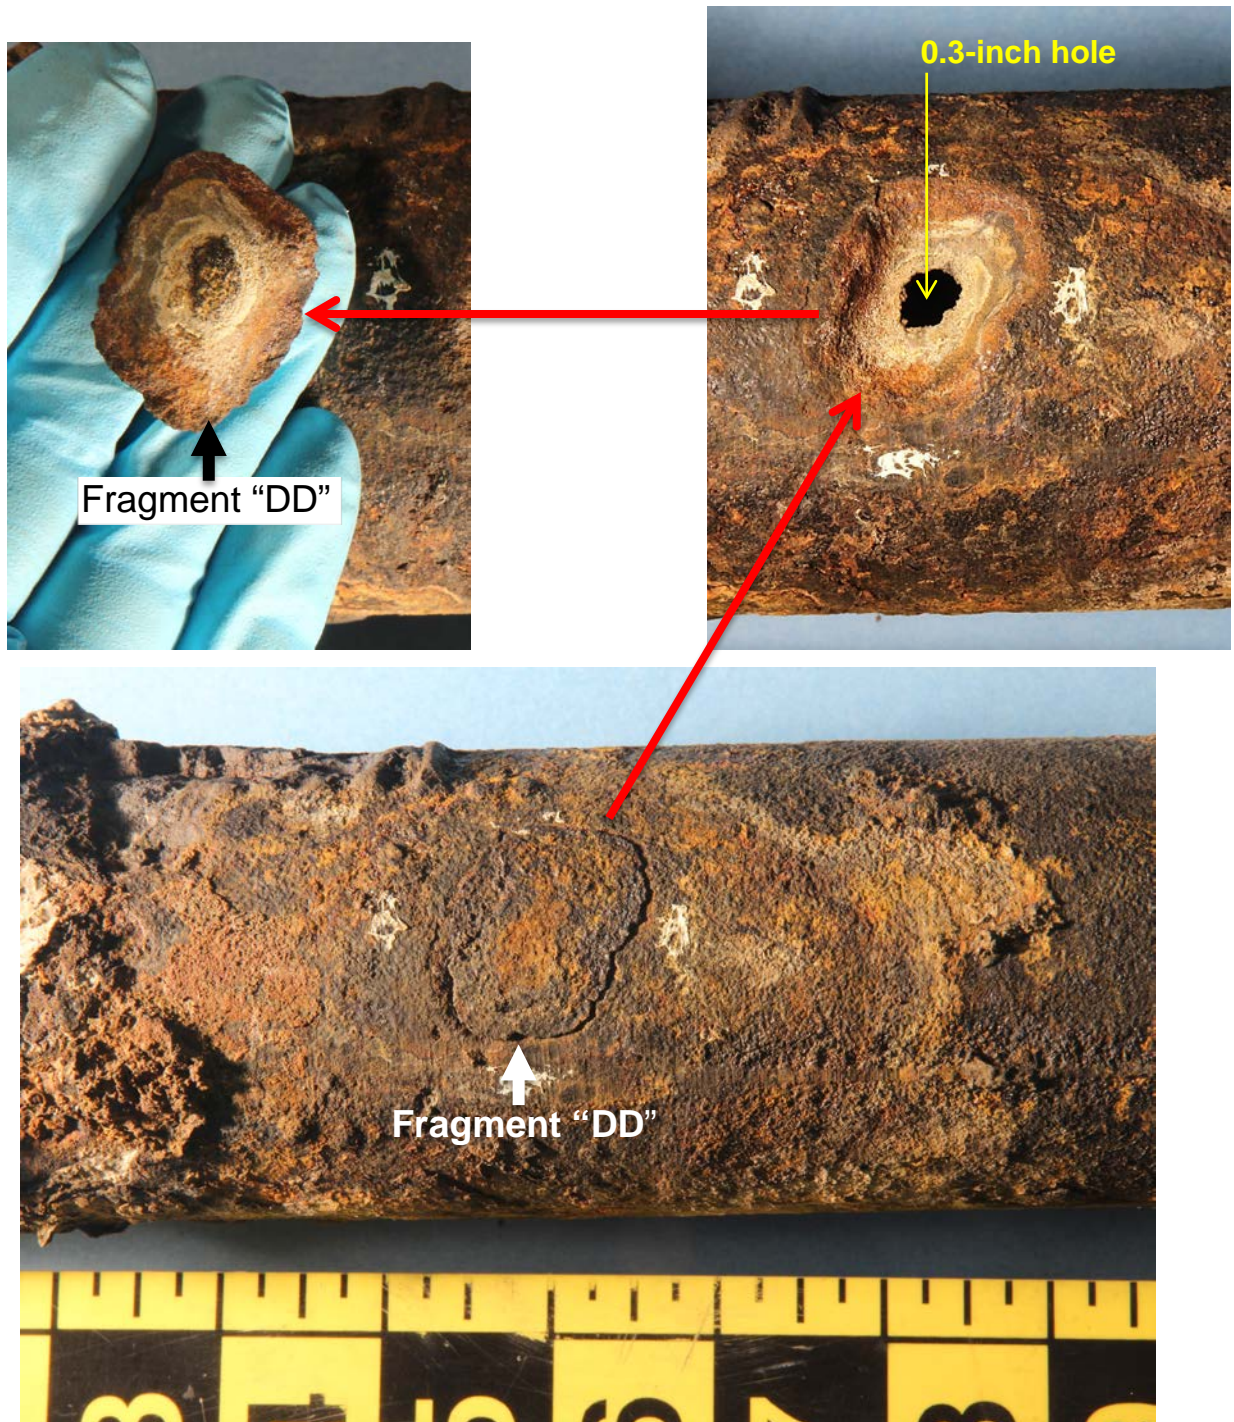
Segment “D” is a 2-1/4 inch nominal diameter cast iron pipe. During pressure run-up in preparation for the gas flow test described in section 5.3, a conical-shaped fragment referred as fragment “DD” in figure 8 fractured from the wall, leaving behind an irregular hole in the wall of the pipe. This segment had remained intact during the “Pressure Decay Test” that was conducted in section 5.2 of this report. The largest dimensions of the fragment measured approximately 1 inch by 1.5 inch. The diameter of the hole in the wall of the pipe measured approximately 0.3 inch. Visual and binocular microscope examination of the particle revealed the fracture surface contained multiple irregular bands that extended around the fracture face (see figure 8). The color of the bands on the fracture face varied between brown, black, gray, and tan-like (in no specific order). The fracture surface showed evidence of corrosion deterioration. The outer and inner surface of the fragment showed evidence of multiple cracks that in many areas intersected each other.

Figure 8. Lower image shows a portion of pipe segment "D" prior to pressure testing with wall fragment indicated by arrow "DD" intact and attached to the pipe. Top left image shows fragment "DD" that fractured from the pipe during pressure testing at the NTSB Materials Laboratory (inner surface of the fragment is shown). Top right image shows an approximately 0.3-inch diameter hole in the wall after fragment "DD" fractured from the pipe.

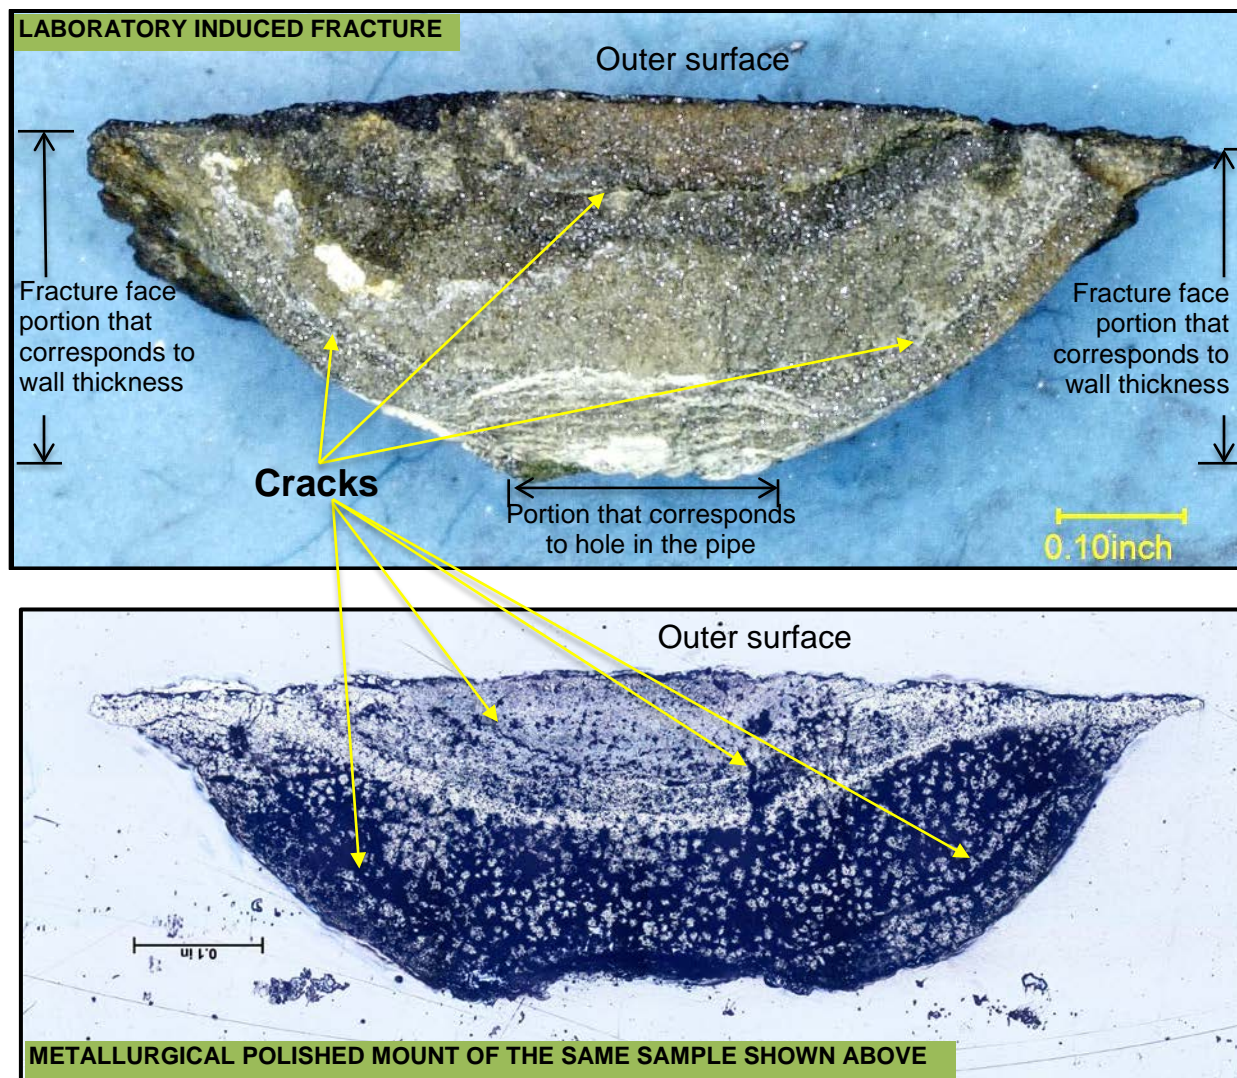
At the Safety Board Materials Laboratory, fragment “DD” was intentionally broken in half to expose internal fracture features. Figure 9 (top of page) shows the laboratory induced fracture that was in the longitudinal-radial orientation and shows internal cracks and discolored fracture regions. Figure 9 (bottom image) shows image of the same fracture face after it was ground down with grit paper, encased in metallurgical mount, and polished to further reveal the internal structure. The polished metallurgical mount in figure 9 (bottom of page below) shows evidence of internal cracks and graphitic corrosion. The metallurgical mount shows porosity and graphitic corrosion in all areas of the fragment.

Figure 9. The Safety Board Materials Laboratory intentionally broke fragment “DD” shown in figure 8 in half to expose internal features. The upper photograph shows the laboratory induced fracture face (that was in the longitudinal-radial orientation) that contained internal cracks and discolored regions. The lower photograph shows the same sample after the fracture face was ground down with grit paper, encased in metallurgical mount, and polished to further reveal the internal structure of the fragment. The polished metallurgical mount (bottom of page) exhibits severe porosity and graphitic corrosion in all areas of the fragment.

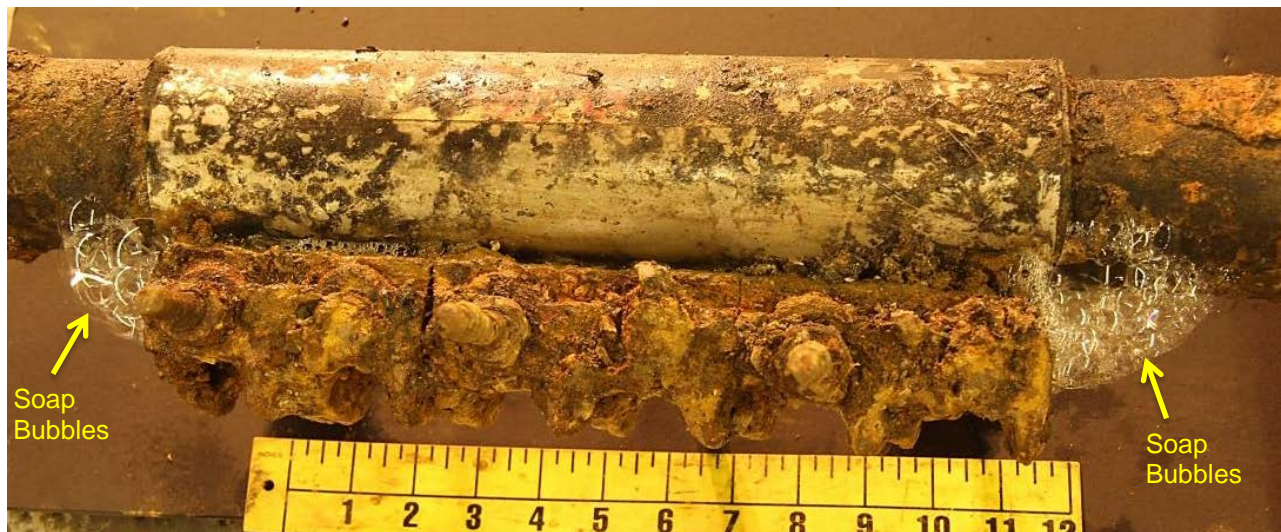
Leak testing of segment “E”, a 2-1/4 inch nominal diameter cast iron pipe, revealed evidence of a leak at the ends of the sleeve “S2” in figure 10 that was not detected by Alagasco (during the on-scene evaluation of the pipe after the accident).

Figure 10. Photograph showing pipe segment "E" in area of the sleeve "S2" during pressure testing showing soap bubbles emitting from the ends of the sleeve. The soap bubbles show evidence of a leak.

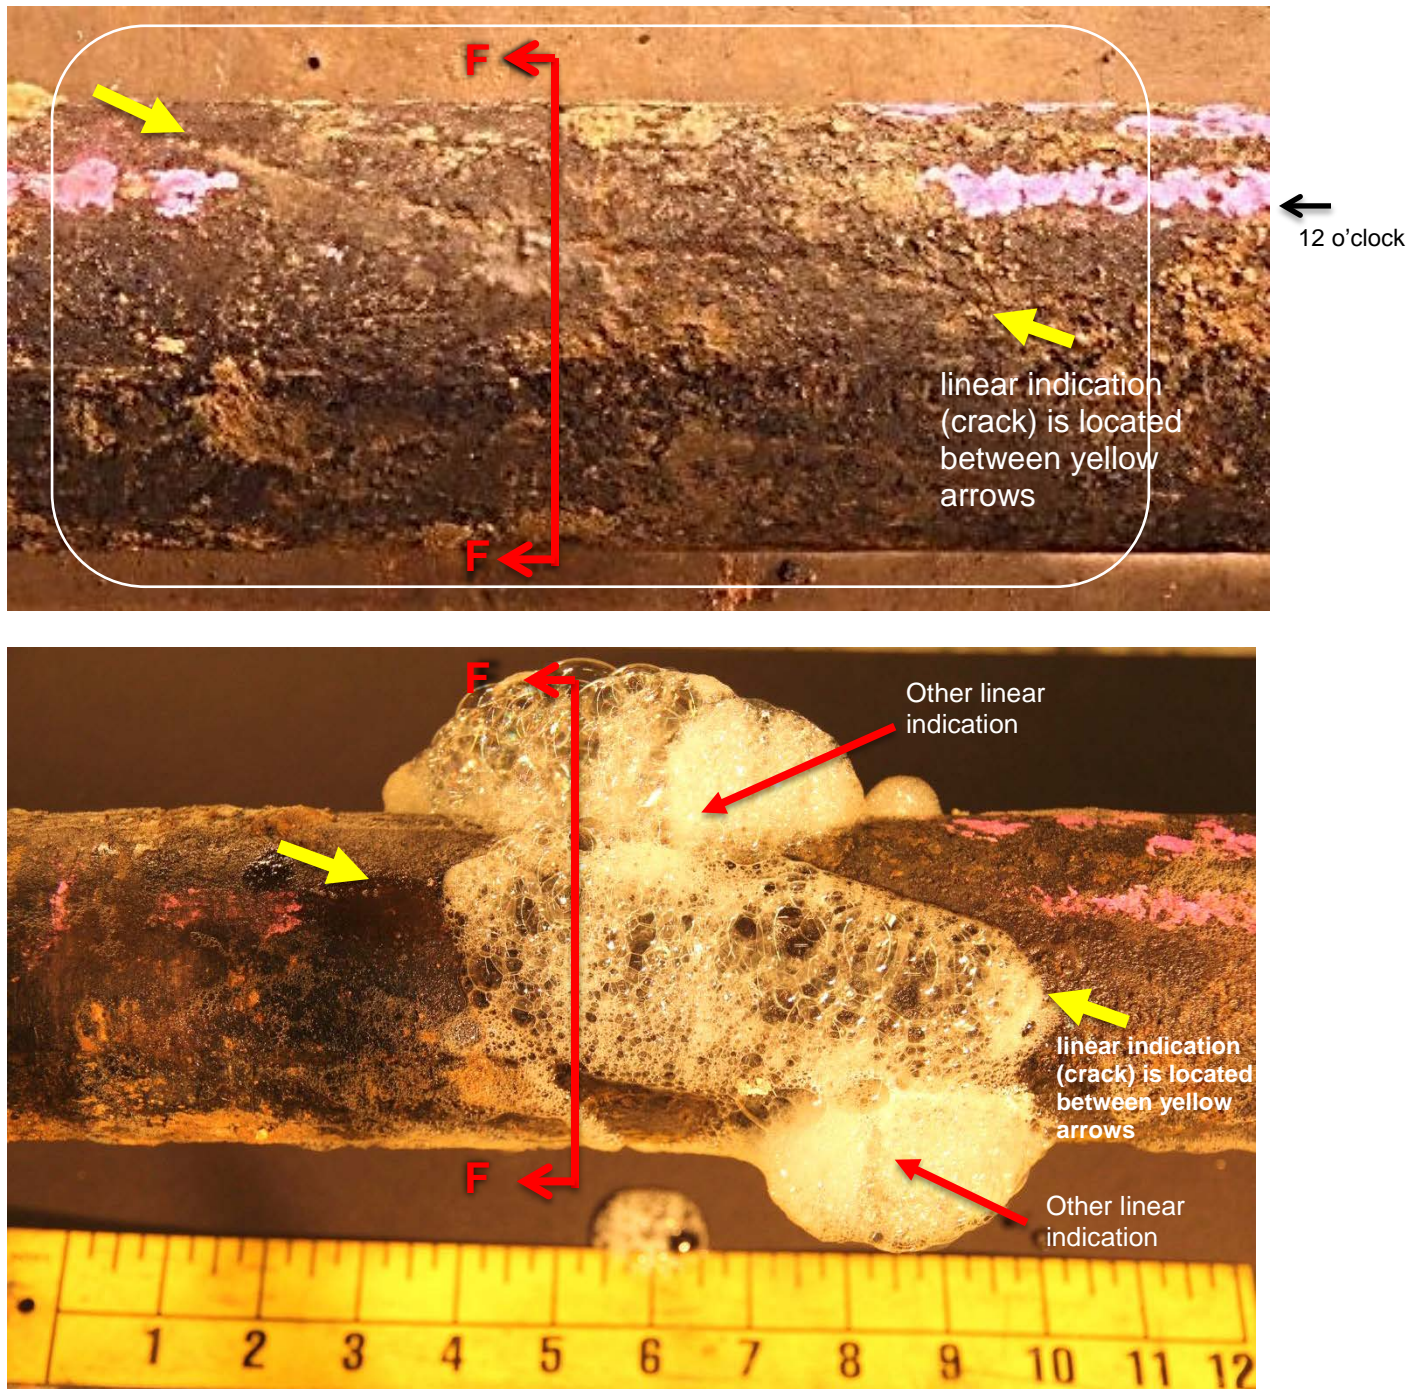
Visual examination of segment “F”, a 2-1/4 inch nominal diameter cast iron pipe, revealed a linear indication at the 12 o'clock position. The length of this linear indication measured approximately 4 inches. Leak testing of segment “F” showed soap bubbling that emanated from this linear indication (12 o'clock) and two additional linear indications (10 o'clock and 1 o'clock positions) as summarized in table 5. The length of the 10 o'clock and 1 o'clock crack measured approximately 3.6 inches and 2 inches, respectively. Based on the soap bubbling pattern observed during pressure testing, the cracks were oriented longitudinal relative to the length of the pipe, with the ends oriented slightly diagonal relative to the length of the pipe. A metallurgical section was made through the pipe that included the three linear indications, in the orientation indicated by section line “F-F” in

Figure 11. The upper photograph shows the top surface of a portion of pipe segment “F” in the area enclosed by the left white box in figure 1 before pressure testing and evidence of a linear indication (crack). The lower photograph shows the same area during pressure leak testing with soap bubbles emanating from the linear indication (crack) and another two linear indications.

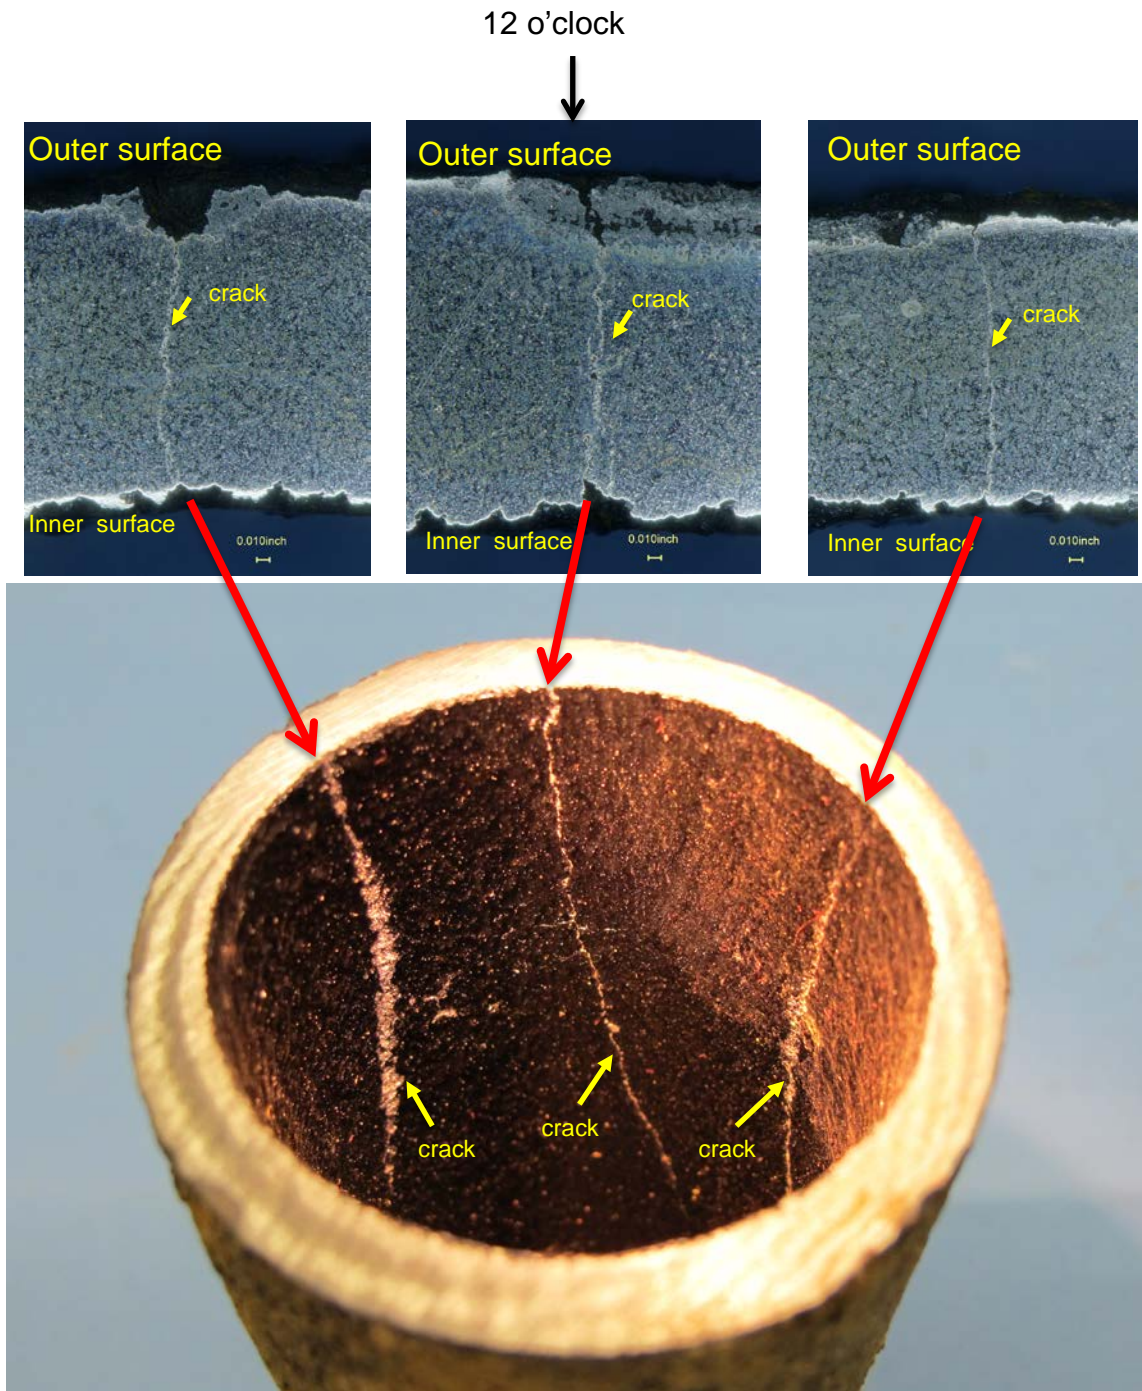
figure 11. The section was made approximately 10 inches west of the bell and spigot assembly. Examination of section "F-F" revealed the three linear indications were cracks that penetrated the wall of the pipe (see figure 12). The three cracks showed evidence of graphitic corrosion at the outer surface that did not exceed 20% of the wall thickness. The portion of the three cracks that extended below outer surface graphitic corrosion regions showed no evidence of graphitic corrosion.

Figure 12. The lower photograph of section “F-F” that was made through pipe segment “F”, looking west, showing three cracks on the inner surface of the pipe. The cut surface is shown prior to polishing the wall. The upper photographs on the top side of the page show the individual cracks after the saw cut surface was polished to expose cracks that penetrated the wall.

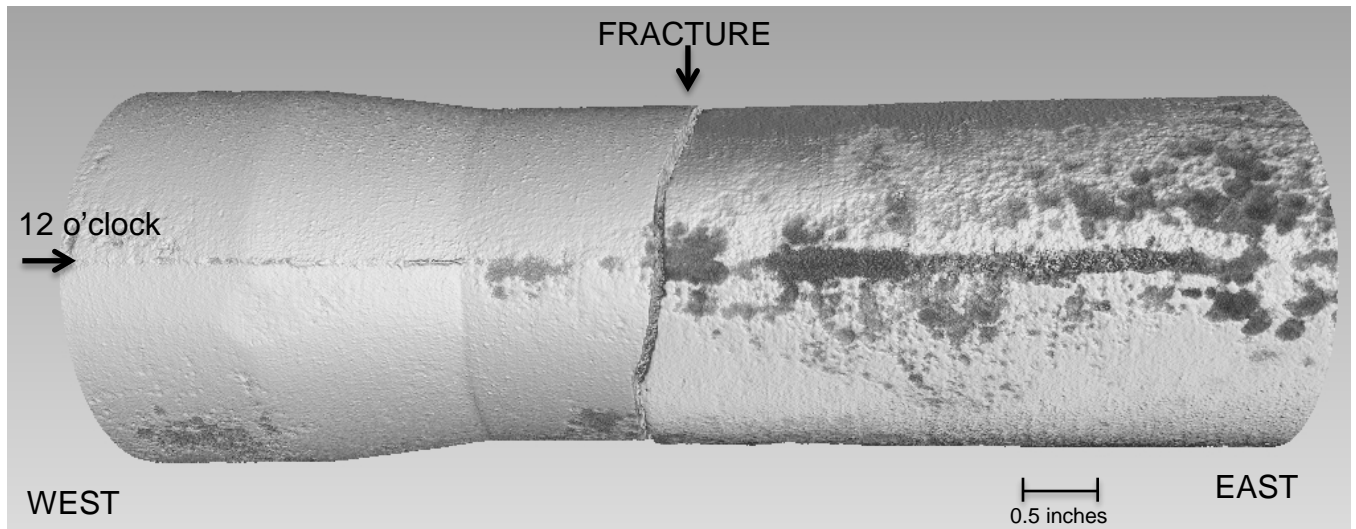
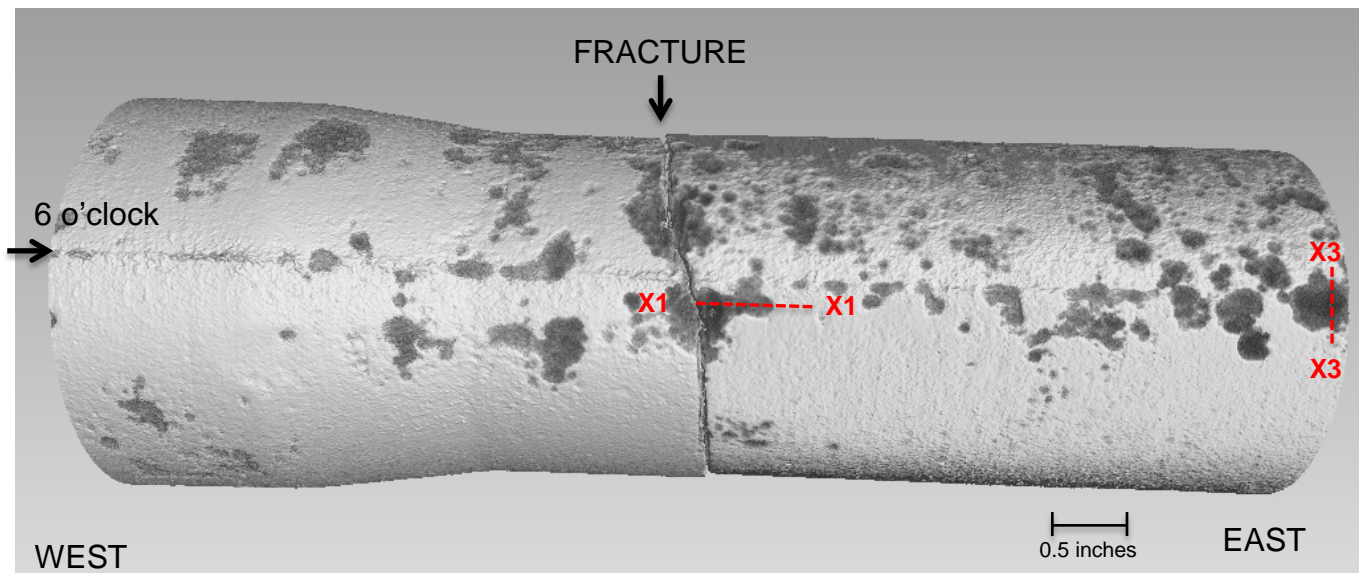
Examination of the X-ray CT images revealed the outer surface of all pipe segments contained isolated areas of low density material (radio-opacity) compared to the core and inner surface of the pipe consistent with graphitic corrosion. Appendix "A" show typical X-ray CT images of pipe segment "A" (graphitic corrosion indicated by black-gray areas). On the fracture faces, the size and distribution of graphitic corrosion areas were consistent with those visually observed on the east face of the fracture. The X-ray CT images showed evidence of graphitic corrosion at five isolated areas of pipe segment "A" and at various clock positions. The graphitic corrosion areas extended as deep as between 50% and 60% of the wall (areas indicated between arrows "G" in Appendices "A3" through "A8").

APPENDIX A1: X-ray CT reconstructed images of pipe segment “A” in the area of fracture showing the top side (upper image) and bottom side (lower image). Dark isolated areas are graphitic corrosion areas. These images were reconstructed so that the mating fracture faces are facing each other.
