NATIONAL TRANSPORTATION SAFETY BOARD

MATERIALS LABORATORY FACTUAL REPORT

Report No. 14-043

Place : Birmingham, Alabama
Date : December 17, 2013
Vehicle : Alabama Gas Corp (Alagasco) natural gas pipe
NTSB No. : DCA14MP001
Investigator : Ravi Chhatre (RPH-20)

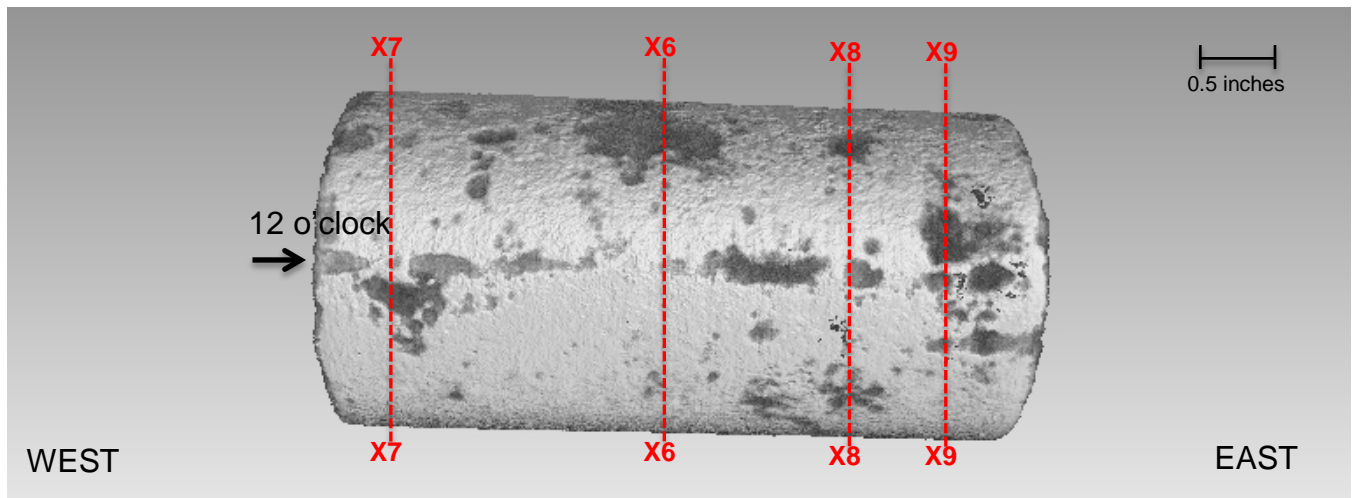
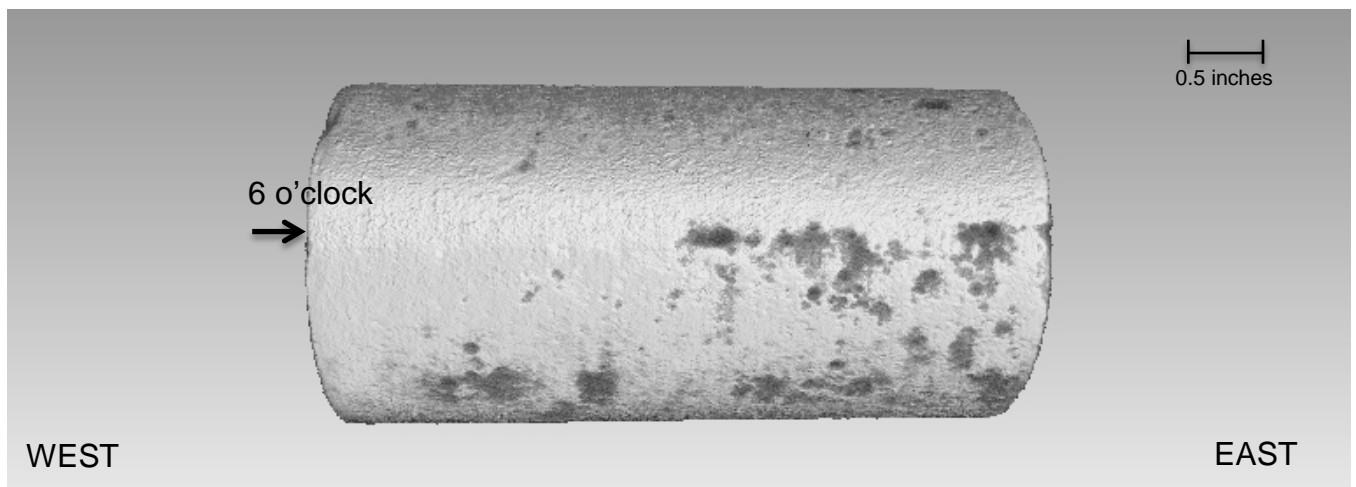
APPENDIX A2. X-ray CT images from pipe segment “A” in the area located between 1 foot and 1.5 feet west of the fracture showing the top side (upper image) and bottom side (lower image).

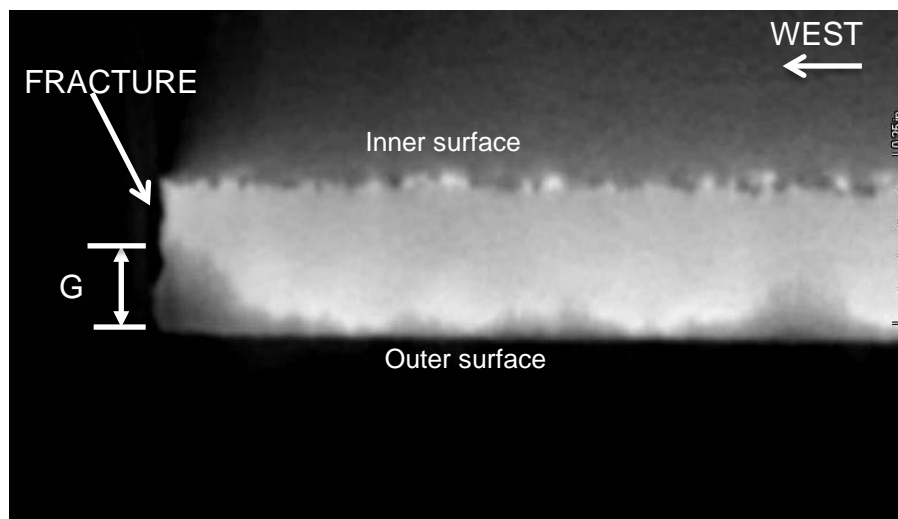
Appendix A3. X-ray CT scan of the bottom wall portion of pipe segment A showing a longitudinal-radial cross section in the area indicated by dashed line "X1-X1" in Appendix A1. Dark areas on the outer surface are graphitic corrosion. "G" indicates deepest extent of graphitic corrosion on the fracture face.

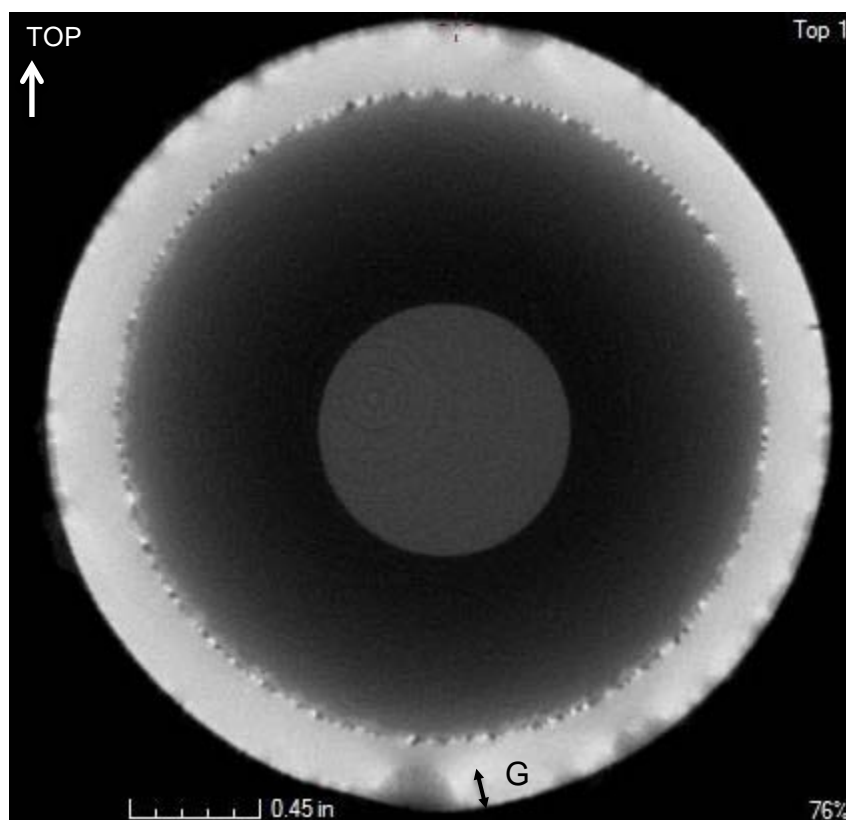
Appendix A4. X-ray CT scan of pipe segment A showing circumferential-radial cross section in the area indicated by dashed line "X3-X3" in Appendix A1, looking east. "G" indicates deepest extent of graphitic corrosion.

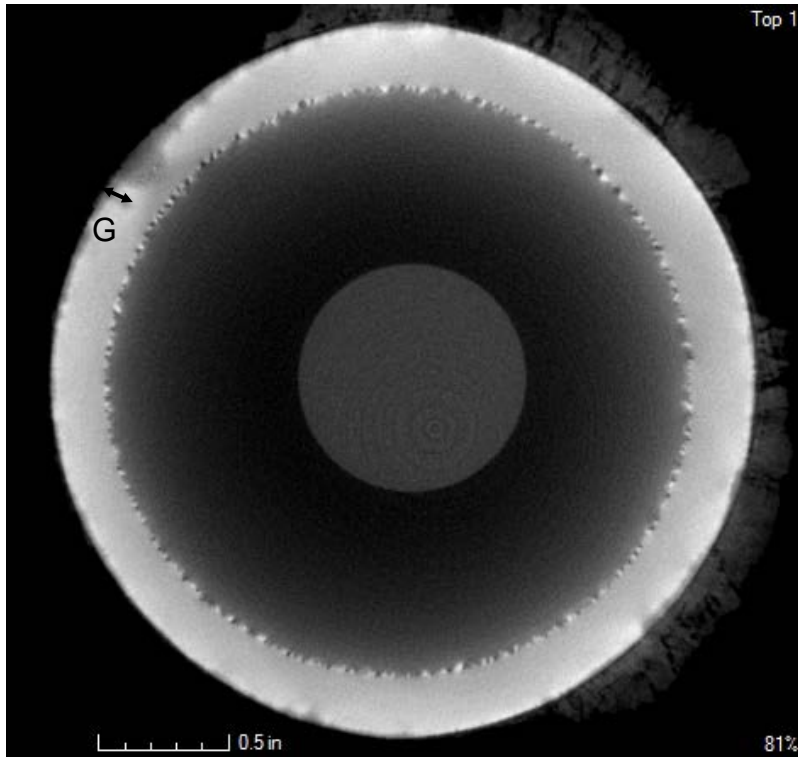
Appendix A5. X-ray CT scan of pipe segment A showing a circumferential-radial cross section in the area indicated by dashed line "X6-X6" in Appendix A2, looking east. "G" indicates deepest extent of graphitic corrosion.

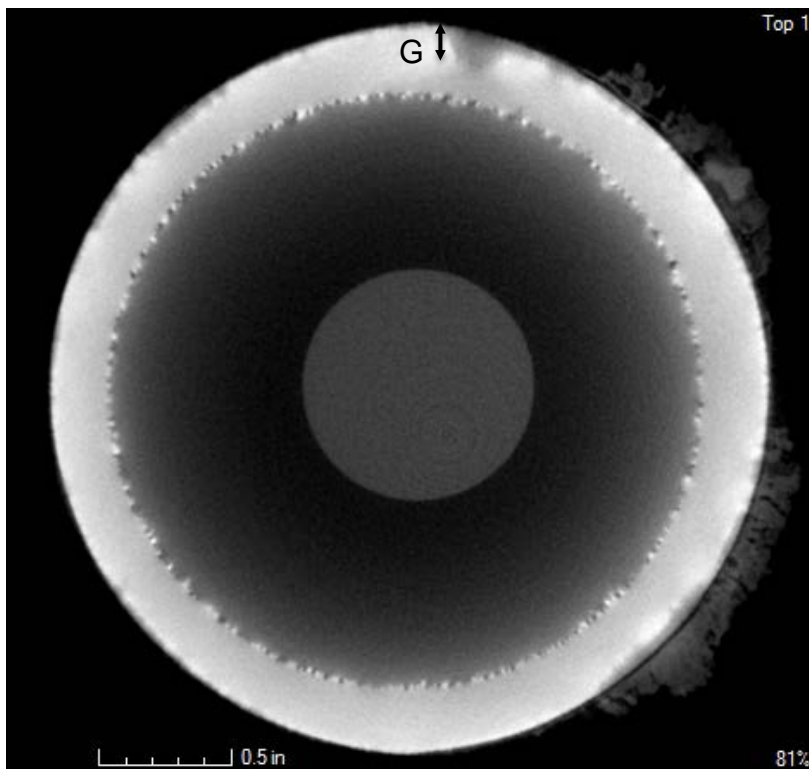
Appendix A6. X-ray CT scan of pipe segment A showing a circumferential-radial cross section in the area indicated by dashed line "X7-X7" in Appendix A2, looking east. "G" indicates deepest extent of graphitic corrosion.

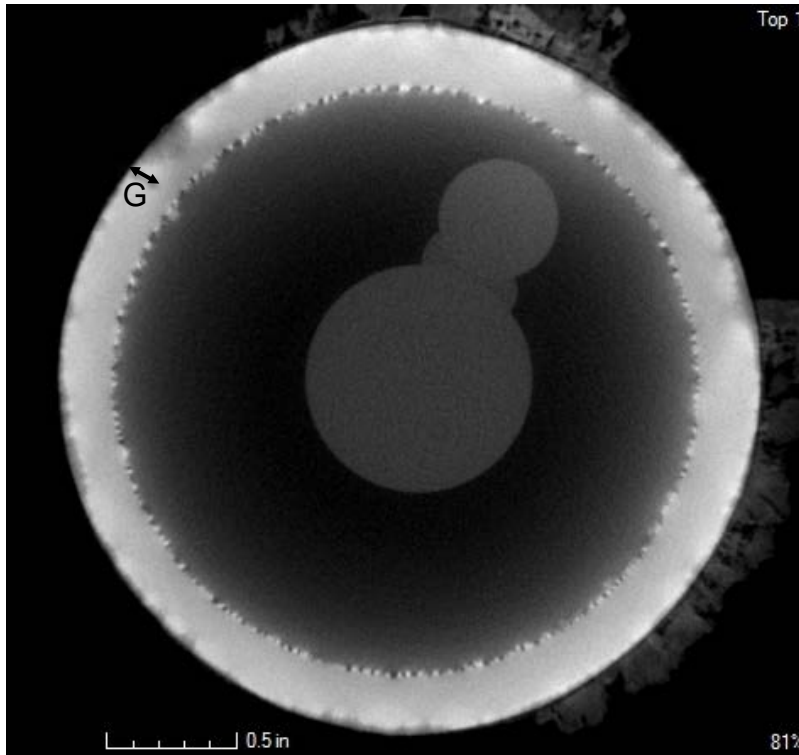
Appendix A7. X-ray CT scan of pipe segment A showing a circumferential-radial cross section in the area indicated by dashed line "X8-X8" in Appendix A2, looking east. "G" indicates deepest extent of graphitic corrosion.

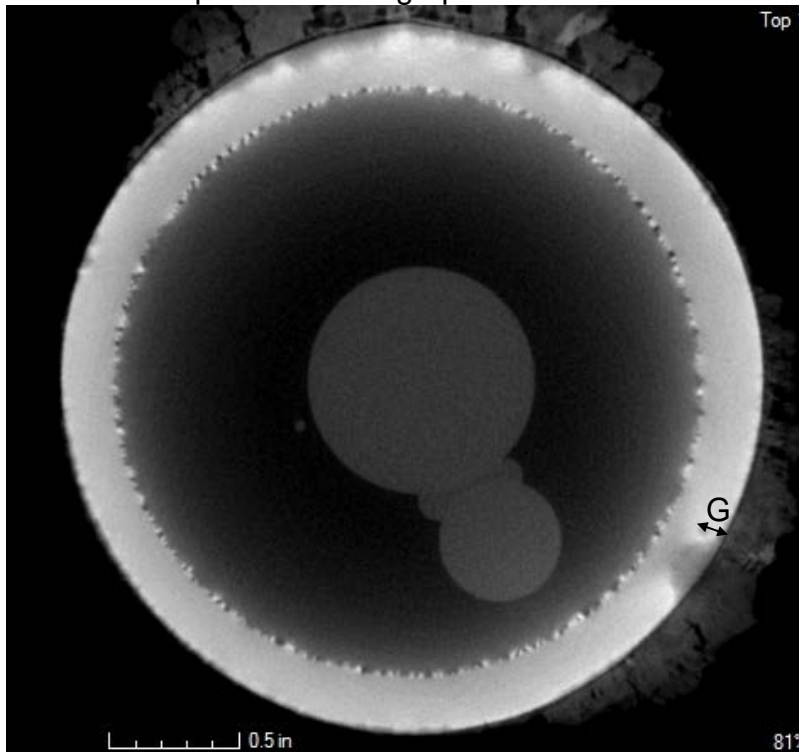
Appendix A8. X-ray CT scan of pipe segment A showing a circumferential-radial cross section in the area indicated by dashed line "X9-X9" in Appendix A2, looking east. "G" indicates deepest extent of graphitic corrosion.
