NATIONAL TRANSPORTATION SAFETY BOARD

MATERIALS LABORATORY FACTUAL REPORT

Report No. 14-053

Place : Duluth, Minnesota
Date : June 7, 2014
Vehicle : Lancair IV, N86NW
NTSB No. : CEN14FA278
Investigator : Jim Silliman, ASI-CEN

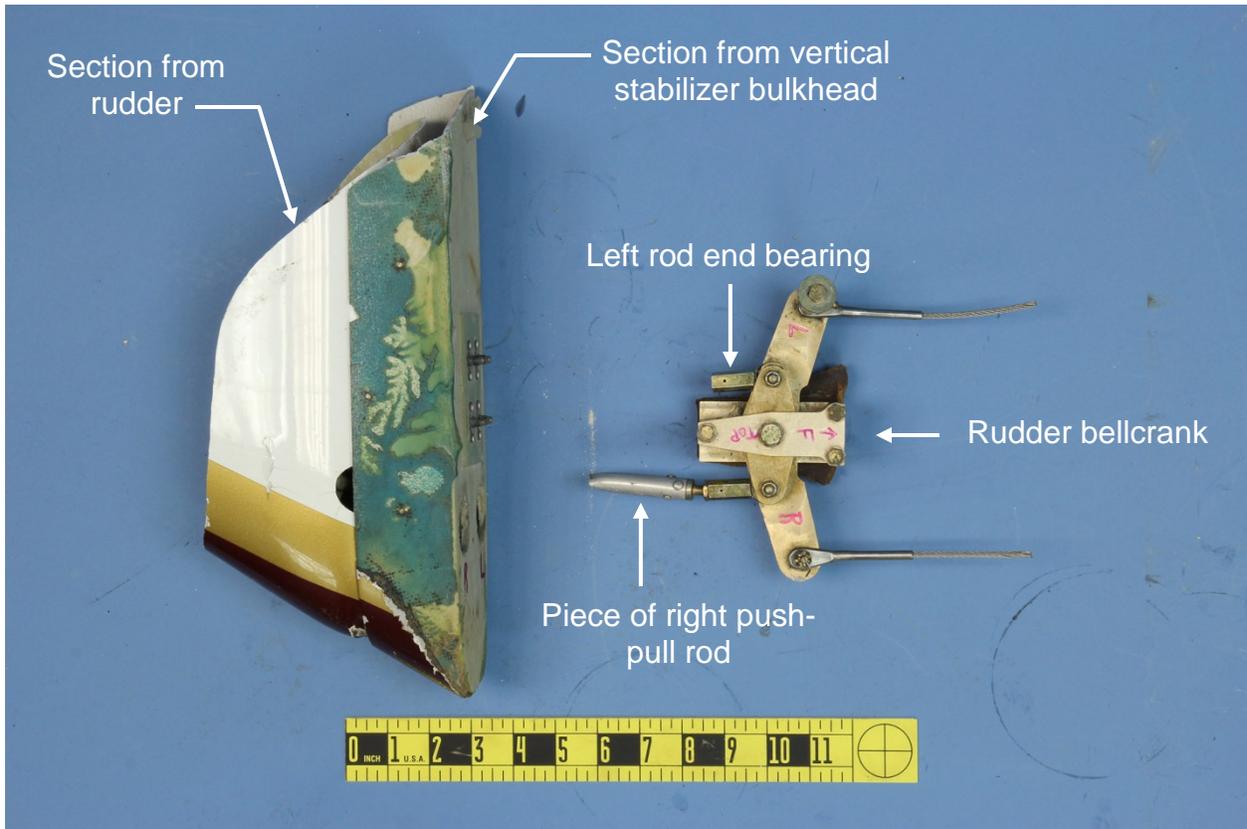
The rudder bellcrank and rudder/stabilizer bulkhead assemblies were received by the Lab as shown in figure 1. The rudder bellcrank was comprised of a left arm and a right arm. On each arm, there were attachment points for a control cable input and a push-pull rod output. There were two holes in the vertical stabilizer bulkhead, as shown in figures 2 and 3a, that allowed the push-pull rods (hereafter referred to as rods) to connect to the forward rudder spar via an attachment fitting (see figure 3b). The right and left rods were fractured. Pieces of the right and left rods were attached to the rudder and a piece of the right rod was attached to the bellcrank. By contrast, there was no corresponding piece of the left rod attached to the bellcrank. A closer examination of the right rod fracture surfaces revealed that they did not match, indicating that the right rod had fractured in two or more locations and an intermediate section had been separated and was not recovered. An examination of the bellcrank revealed a deformation mark on the forward portion of the right arm in the vicinity of the bellcrank stop as indicated in figure 4.

Figure 1: The rudder bellcrank with attached piece of right push-pull rod and section of vertical stabilizer bulkhead/rudder, as-received.

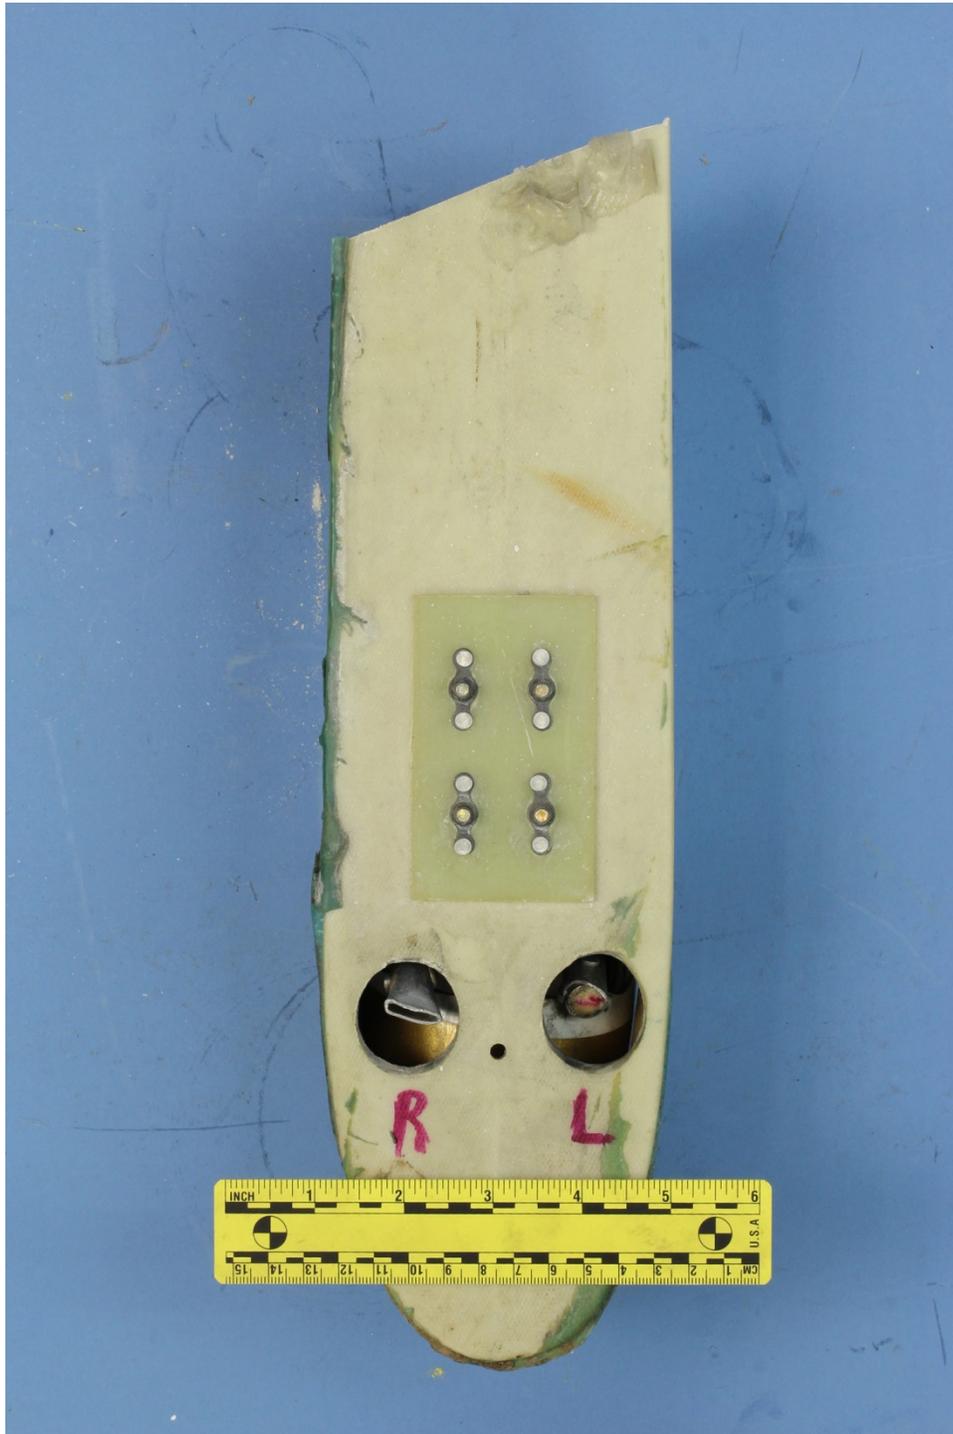
Figure 2: View of the vertical stabilizer bulkhead section and push-pull rods viewed looking in the aft direction.

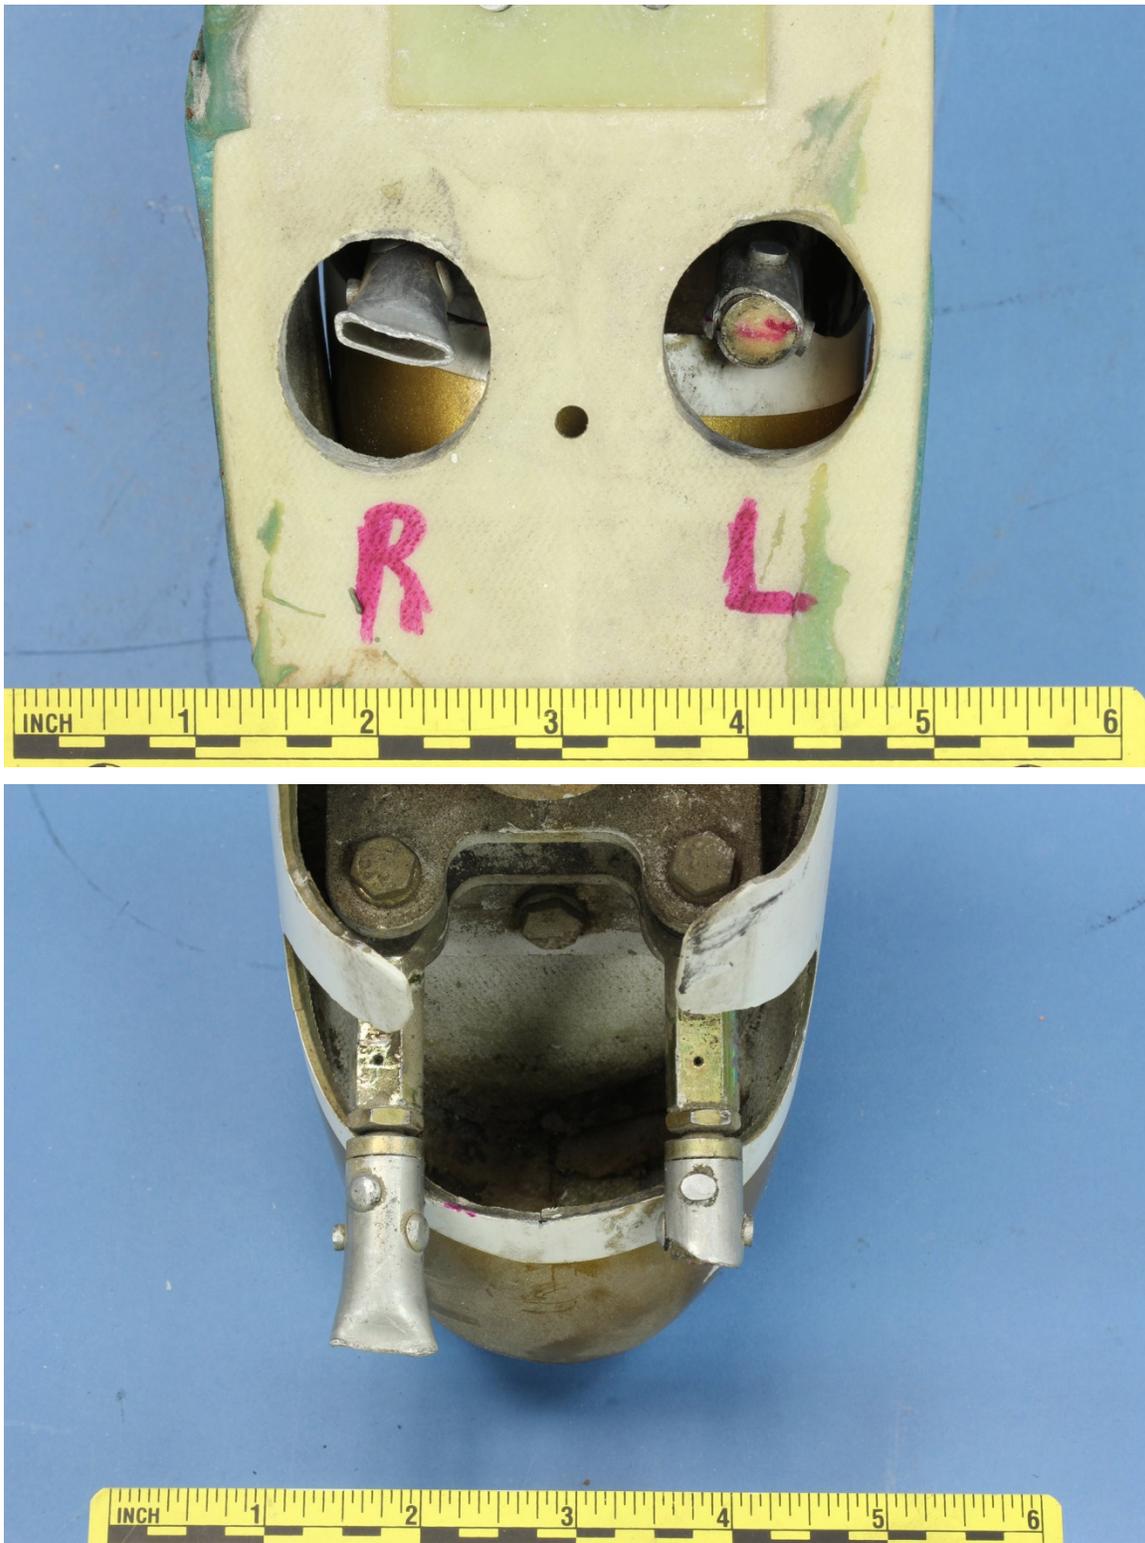
The left and right rod fracture surfaces were visually examined using a stereomicroscope. The fracture surface on the left rod piece attached to the rudder consisted of inclined slant fractures, and no apparent out-of-plane deformation, consistent with a tensile overstress fracture. The right rod had collapsed near each fracture. The initially circular tube cross sections had deformed by elongating in one direction and collapsing in the other direction. The rod end at the forward end of the right rod (attached to the bellcrank via a rod end bearing) was bent. The features were consistent with overload by compressive buckling.

The vertical stabilizer and rudder sections were separated by disassembling the spherical bearing connection and the rod ends were examined. As shown in figure 3b, the jamb nuts were seated against the female-threaded rod end bearings and the rod ends were fully inserted into the jamb nuts. An attempt was made to back the rod ends out of their respective end connections by hand, but neither rod end could be backed out. By comparison, the rod end at the forward end of the right rod (attached to the bellcrank) could be backed out by hand.

Figure 3: Closer views of the pieces of the fractured left and right push-pull rods that were attached to the rudder; a) end-on view showing the rod fracture surfaces and b) after removal of the vertical stabilizer bulkhead showing how the rod ends were fully inserted into the female-threaded rod end bearings.

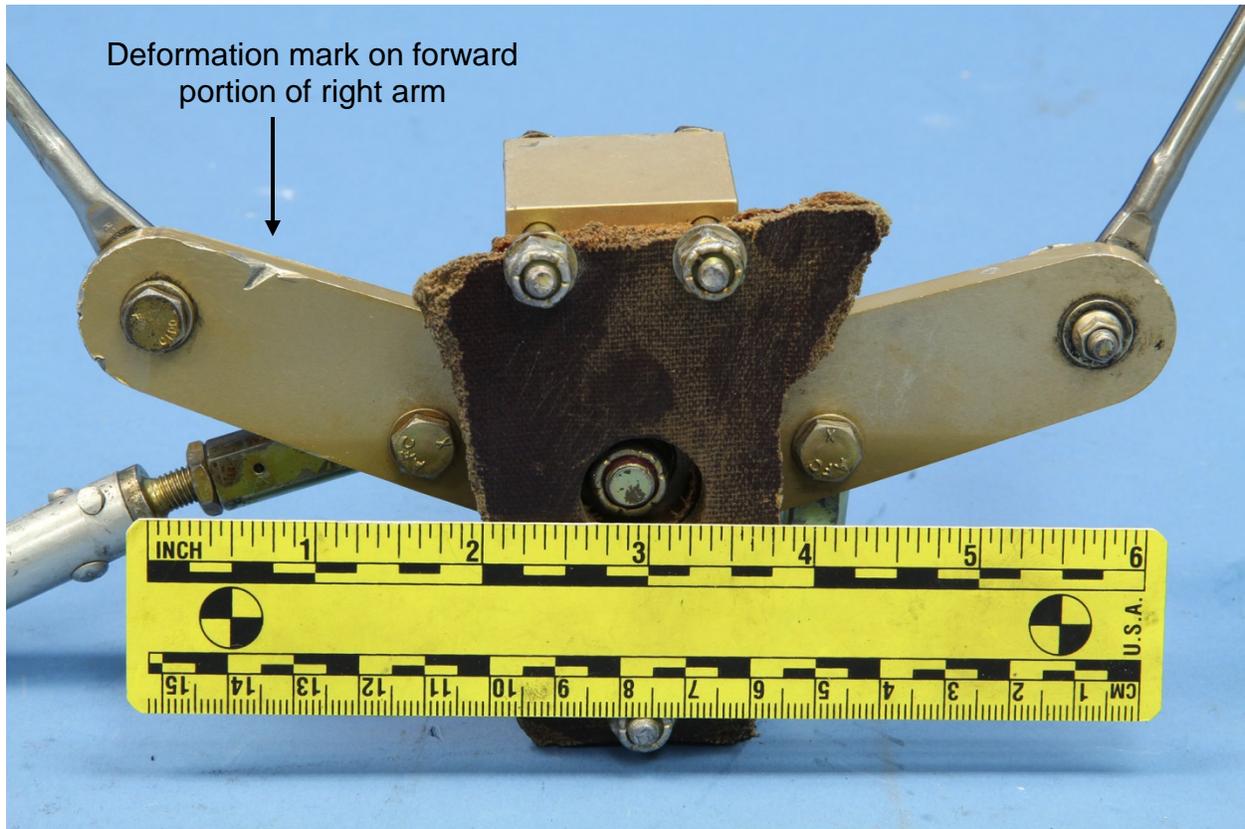
Figure 4: Image of the underside of the rudder bellcrank where a deformation mark on the forward portion of the right arm in the vicinity of the bellcrank stop was observed.

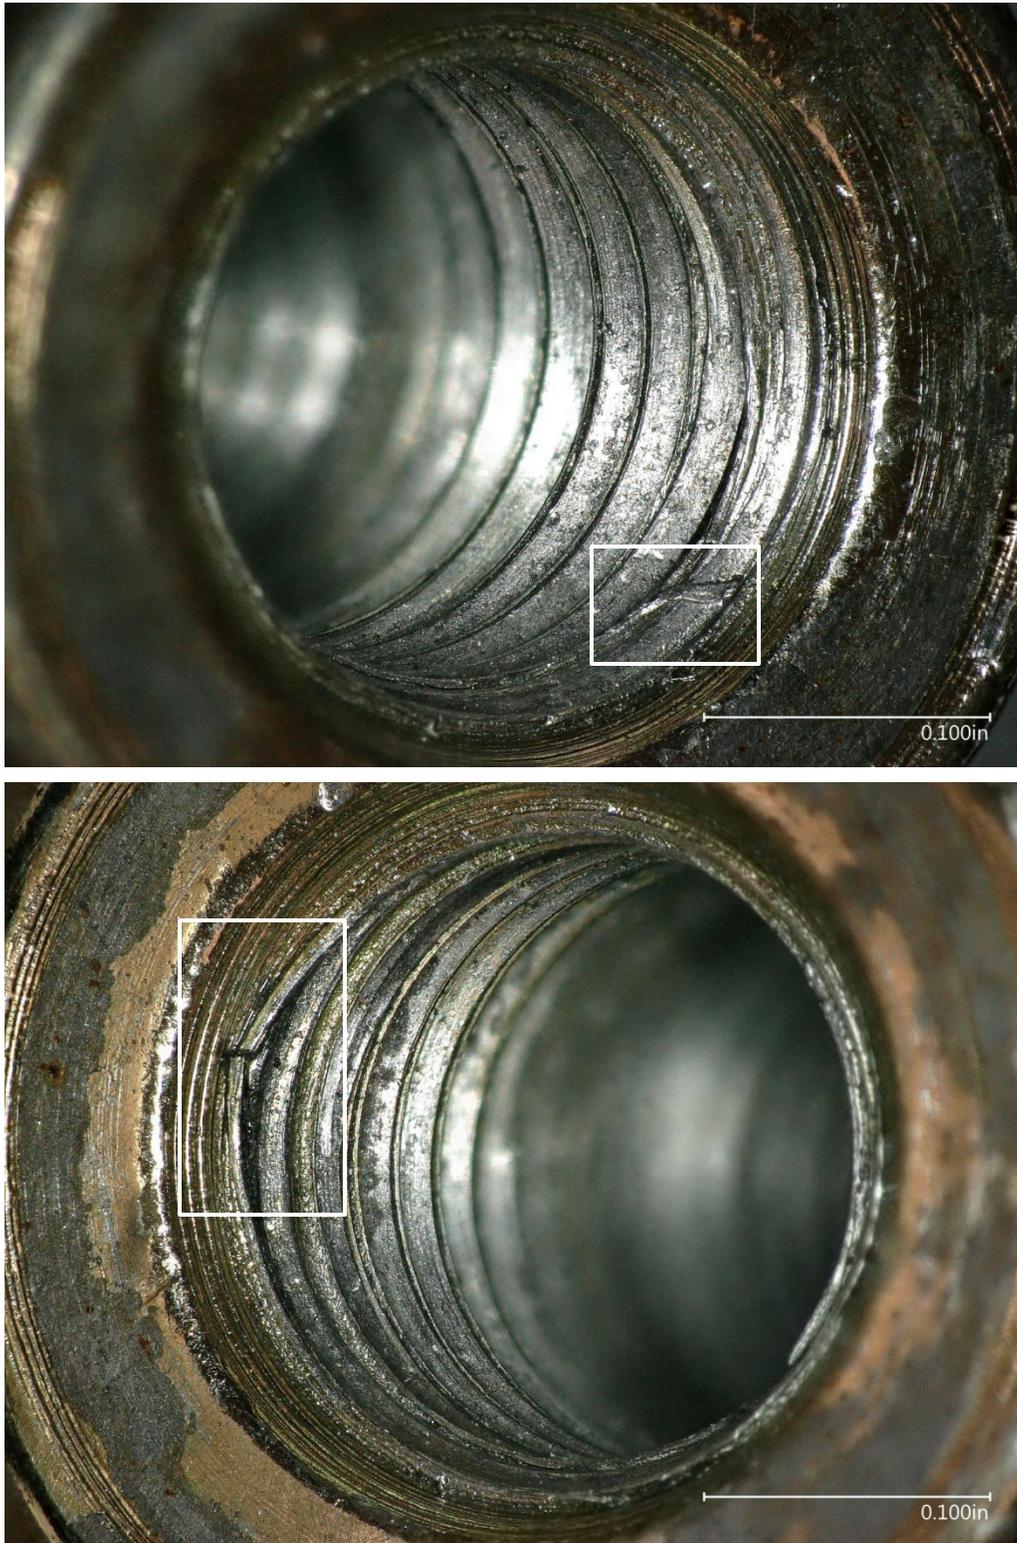
The female threads in the rod end bearings attached to the bellcrank were examined with a stereomicroscope. For the left rod end bearing, there were two isolated spots along the outermost thread where the thread was deformed, as indicated by the boxes in figure 5. Similarly for the right rod end bearing, there were two isolated spots along the outermost thread where the thread was deformed, as indicated by the boxes in figure 6.

Figure 5: Digital microscope images of the left bellcrank rod end bearing female threads. White rectangles indicate two isolated spots where deformation was observed along the outermost thread.

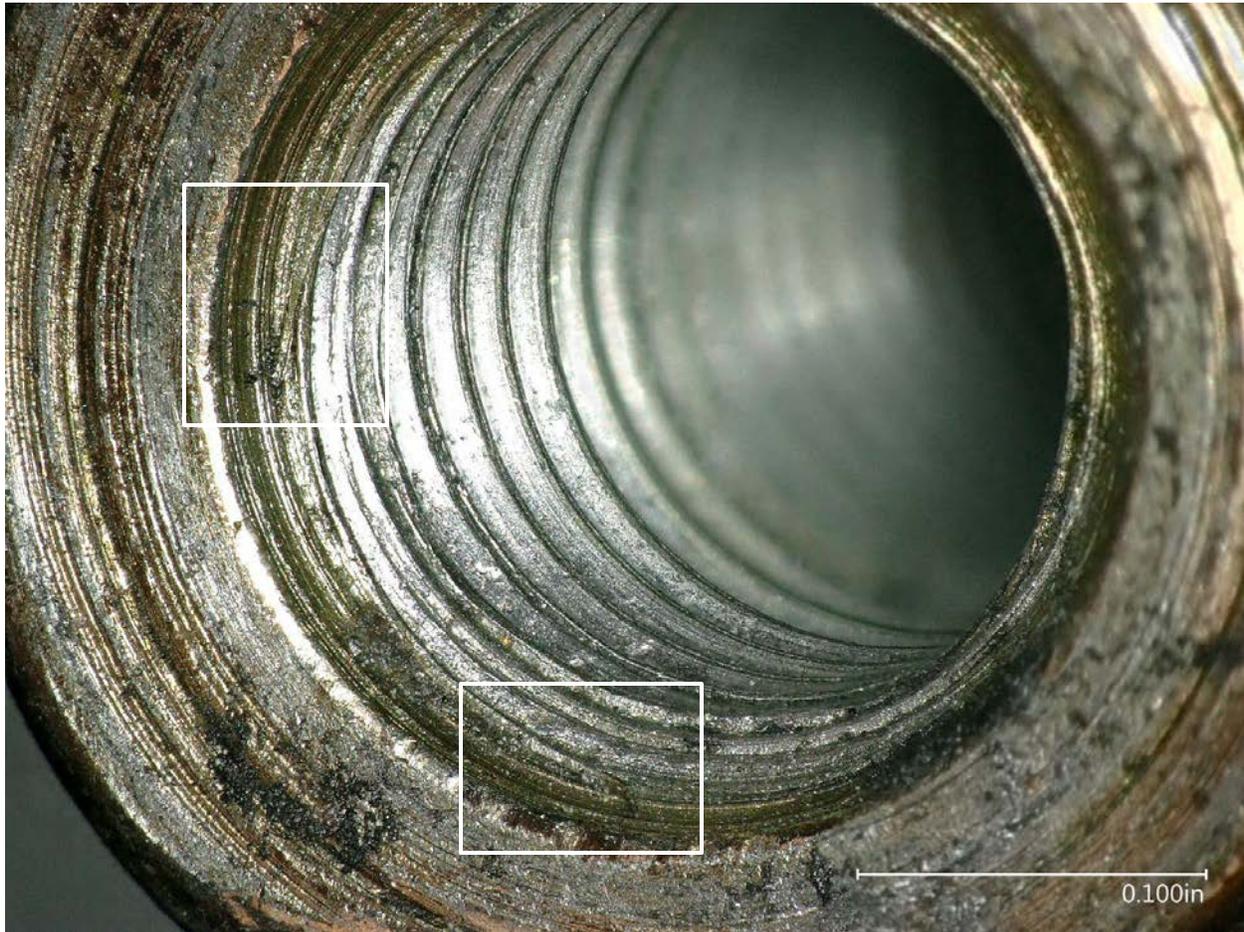
Figure 6: Digital microscope image of the right bellcrank rod end bearing female threads. White rectangles indicate two isolated spots where deformation was observed along the outermost thread.
