NATIONAL TRANSPORTATION SAFETY BOARD

MATERIALS LABORATORY FACTUAL REPORT

Report No. 14-083

Place : Dunnellon, Florida
Date : April 5, 2014
Vehicle : Fortuna Sonex, N229P
NTSB No. : ERA14FA464
Investigator : Tim Monville, ERA-ASI

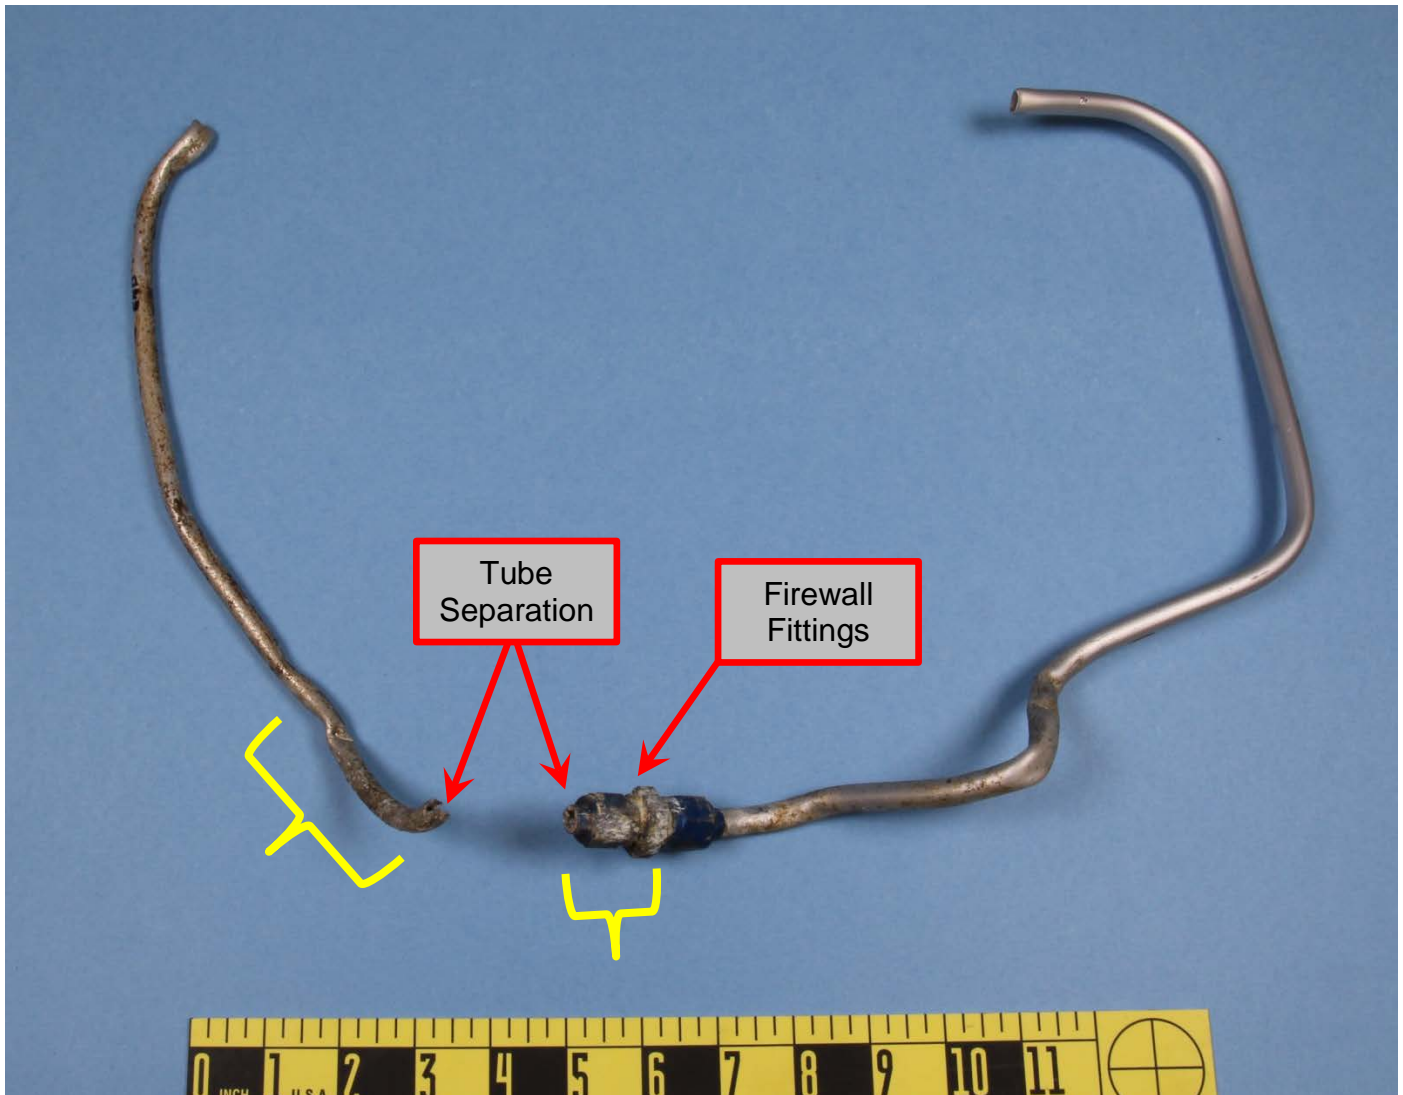
The as-received fuel line is displayed in figure 1. The line was composed of two aluminum tube sections joined by fittings at the engine firewall. In figure 1, the tube on the left and part of the fitting were reported to be from inside the cockpit and connected to the fuel shut off valve.

As-received the cockpit side tube was separated at the firewall fitting, as shown in figure 1. Magnified optical examinations found severe pitting corrosion of both the tube and cockpit side fittings in the area of separation, indicated by the yellow brackets in figure 1. The corrosion had removed significant material from the surfaces of the fittings and from both the exterior and interior surfaces of the tube. No fracture features were present on the tube separation. A hole and cracks were also apparent adjacent to the separation, see figure 2. The hole and cracks were consistent with corrosion penetration.

The remaining length of the cockpit side tube showed lesser amounts of corrosion. The engine side fuel tube showed little or no corrosion.

Figure 1. Overall view of the received fuel line. The cockpit side fuel tube was separated adjacent to the firewall fittings as indicated. Areas denoted by yellow bracket were severely corroded.

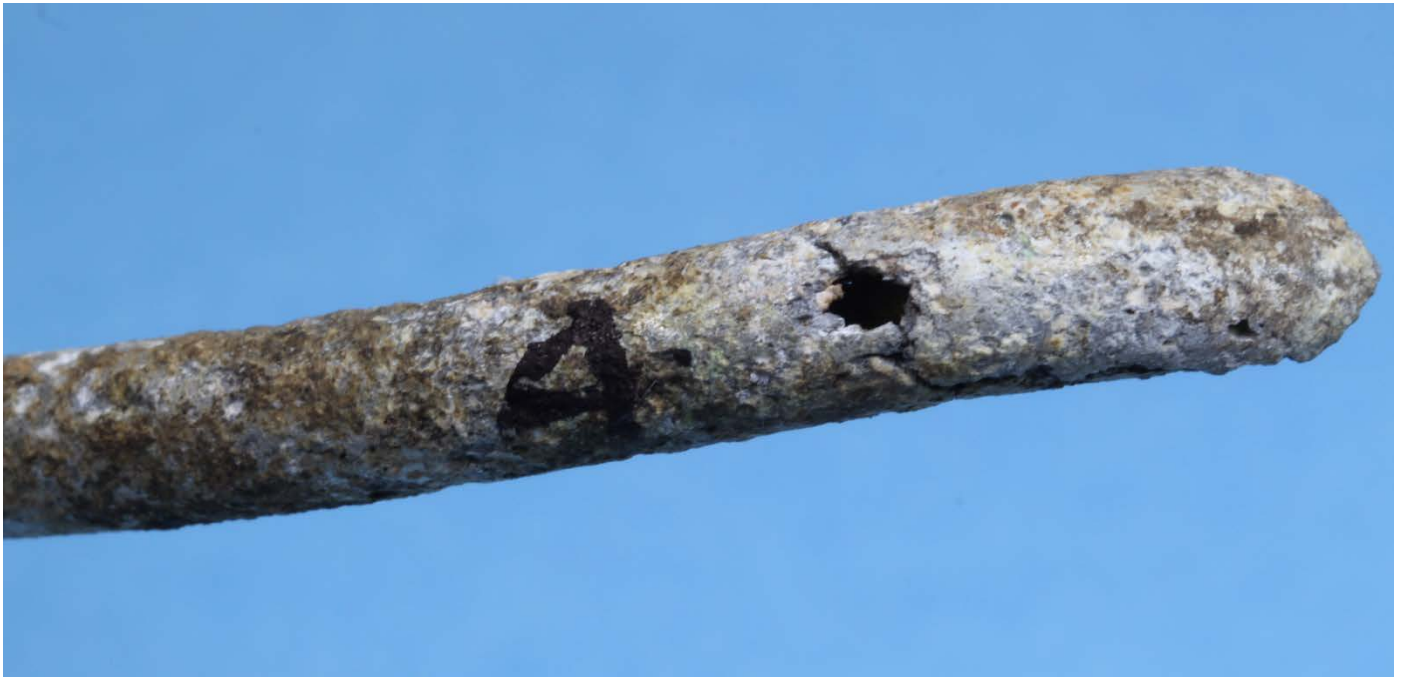
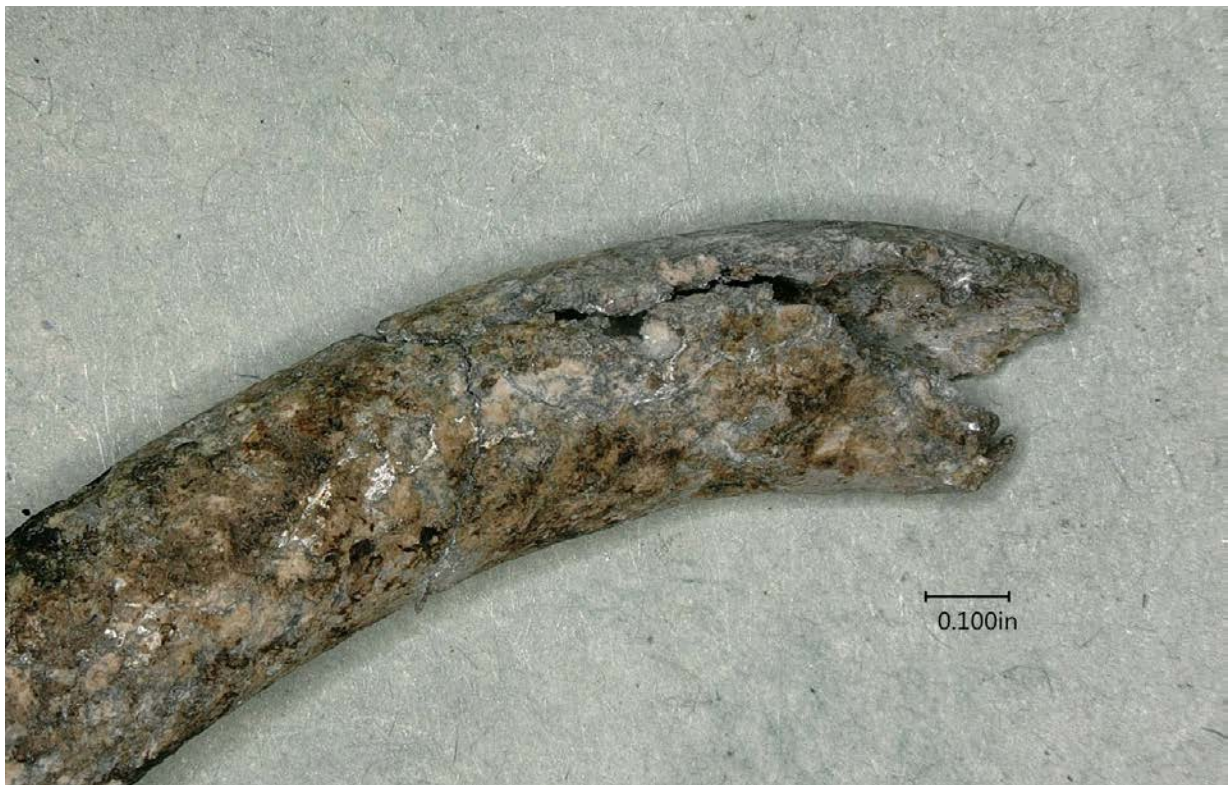
Figure 2. Two different views of the severely corroded and separated end of the cockpit side fuel tube.
