NATIONAL TRANSPORTATION SAFETY BOARD

MATERIALS LABORATORY FACTUAL REPORT

Report No. 15-007

Place : Lynchburg, Virginia
Date : April 30, 2014
Vehicle : CSX train KO8227
NTSB No. : DCA14FR008
Investigator : Richard Hipkind, RPH-10

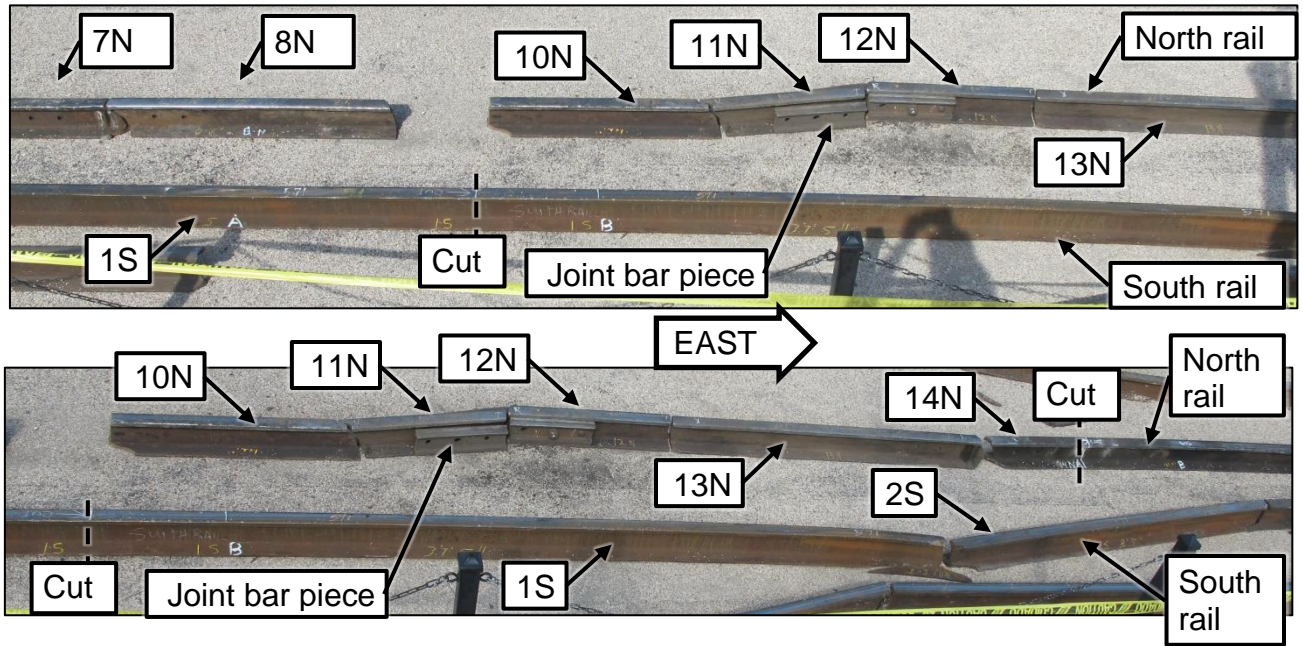
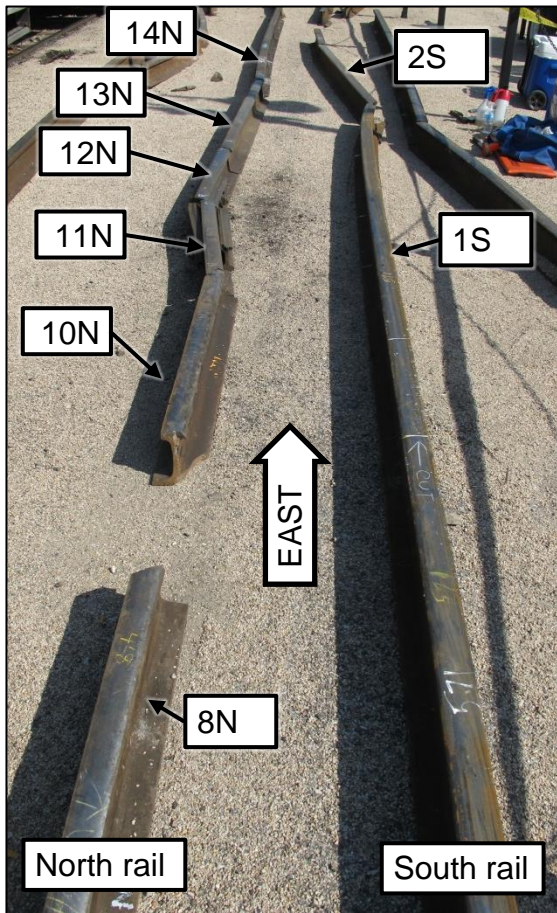
Pieces were examined from the north rail (high rail, or outside of the curve) and the south rail (low rail, or inside of the curve). Mating fractures were identified on the recovered rail and joint bar pieces, and the broken rail was reconstructed on-scene as shown in figures 1 and 2 by placing mating fractures in close proximity to each other. The reconstructed pieces from the north and south rail were independently numbered from west to east, and a suffix N or S was added to the number to indicate the north or south rail, respectively.

After work on scene was completed, pieces 14N and 1S were cut at the locations shown in figure 1. Then pieces 10N, 11N, 12N, 13N, the segment of 14N west of the cut (labeled 14N-A), the segment of 1S east of the cut (piece labeled 1S-B), and the joint bar piece that mated to the piece attached to 12N were shipped to the NTSB Materials Laboratory for further examination.

Figure 1. Overall views of the rail reconstruction at the point of derailment.

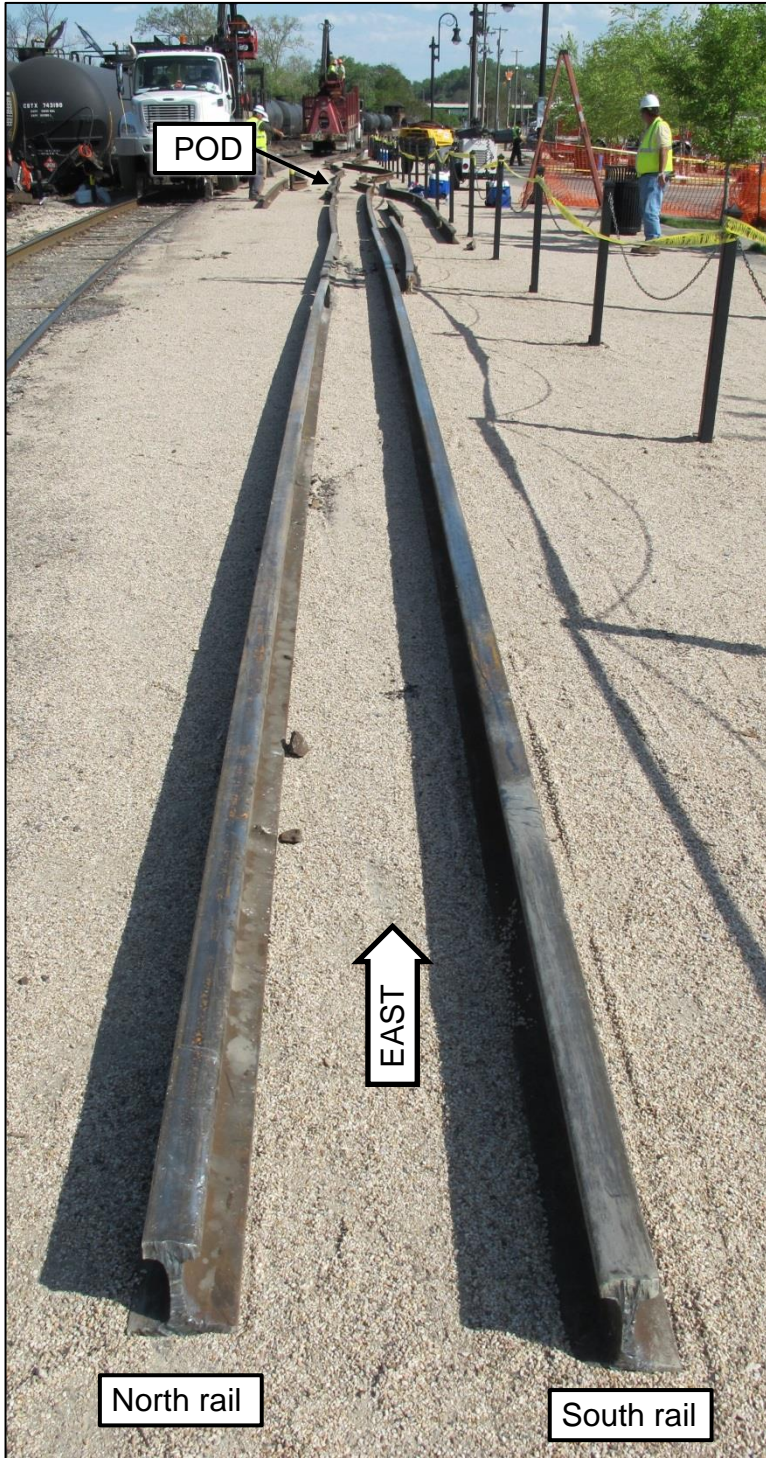
Figure 2. Another view of the rail reconstruction as viewed from torch-cut ends at the west end where the rails were cut from intact track.

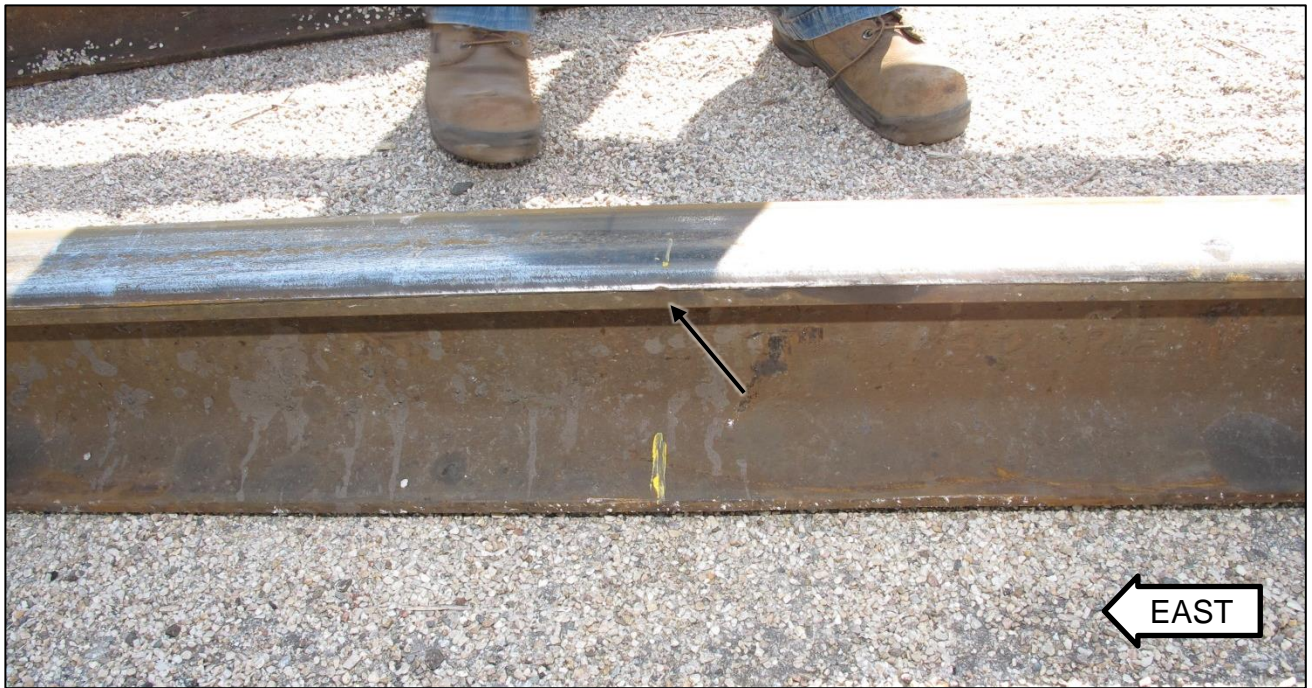
During the on-scene work and first group examination, wheel contact marks were identified on the low rail in the vicinity of the POD as shown in figures 3 and 4. At a location 101.5 inches west of the fracture in piece 1S-B, the flow lip at the gage corner was deformed (see arrow in figure 3). Further east on piece 1S-B, wheel marks were observed angled across the running surface to the gage corner (see arrows in figure 4). The wheel marks intersected the gage corner in piece 1S-B approximately 63 inches and 75 inches west of the fracture, respectively. Another angled wheel mark was observed intersecting the gage corner at a location 37 inches west of the fracture. Center spalling was observed on the running surface on piece 1S-B and appeared most prominent in the vicinity of the deformed flow lip.

Figure 3. Gage side of the low rail showing a disturbance of the flow lip at the gage corner of the head as indicated with an arrow.

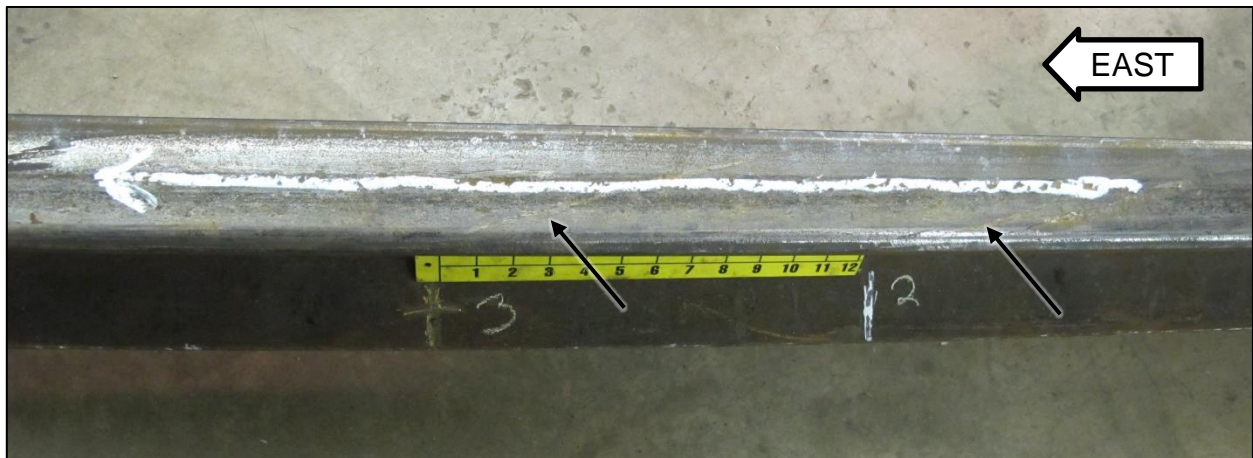
Figure 4. View of the head of the low rail showing wheel marks going across the head to the gage corner (indicated with arrows).

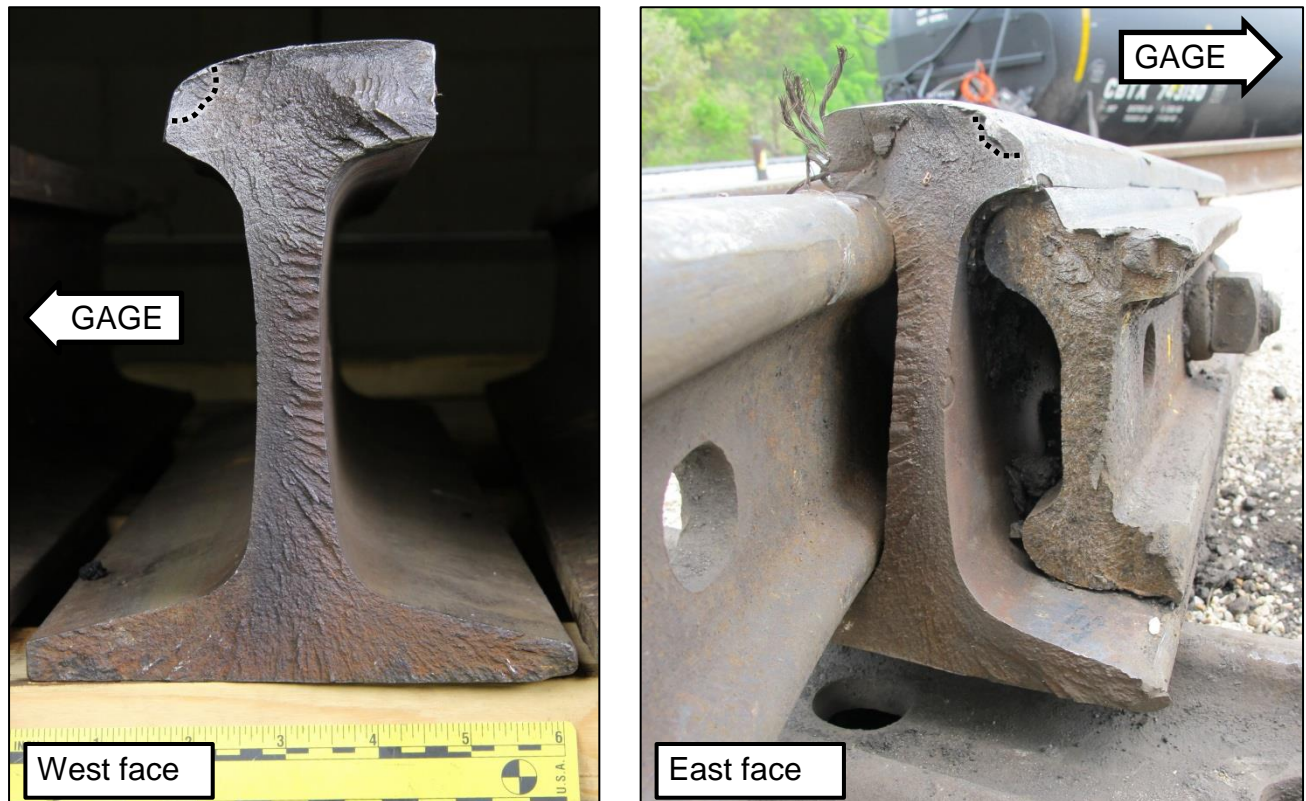
Views of the east and west faces of the fracture between pieces 11N and 12N (barred service failure) are shown in figure 5. A dashed line in figure 5 indicates the boundary of a detail fracture observed on the fracture surface. The detail fracture extended across approximately 5 percent of the remaining head area. Slight flow of the running surface over the fracture face was observed on the west face of the fracture. The area of the detail fracture on the east face (on piece 12N) was partially obliterated by receiving batter.

Figure 5. Overall views of the barred service failure. The south joint bar (on the gage side of the rail) was fractured, and bolts attaching the joint bars to piece 11N were missing. Dashed lines indicate the boundary of a detail fracture on the fracture surface.

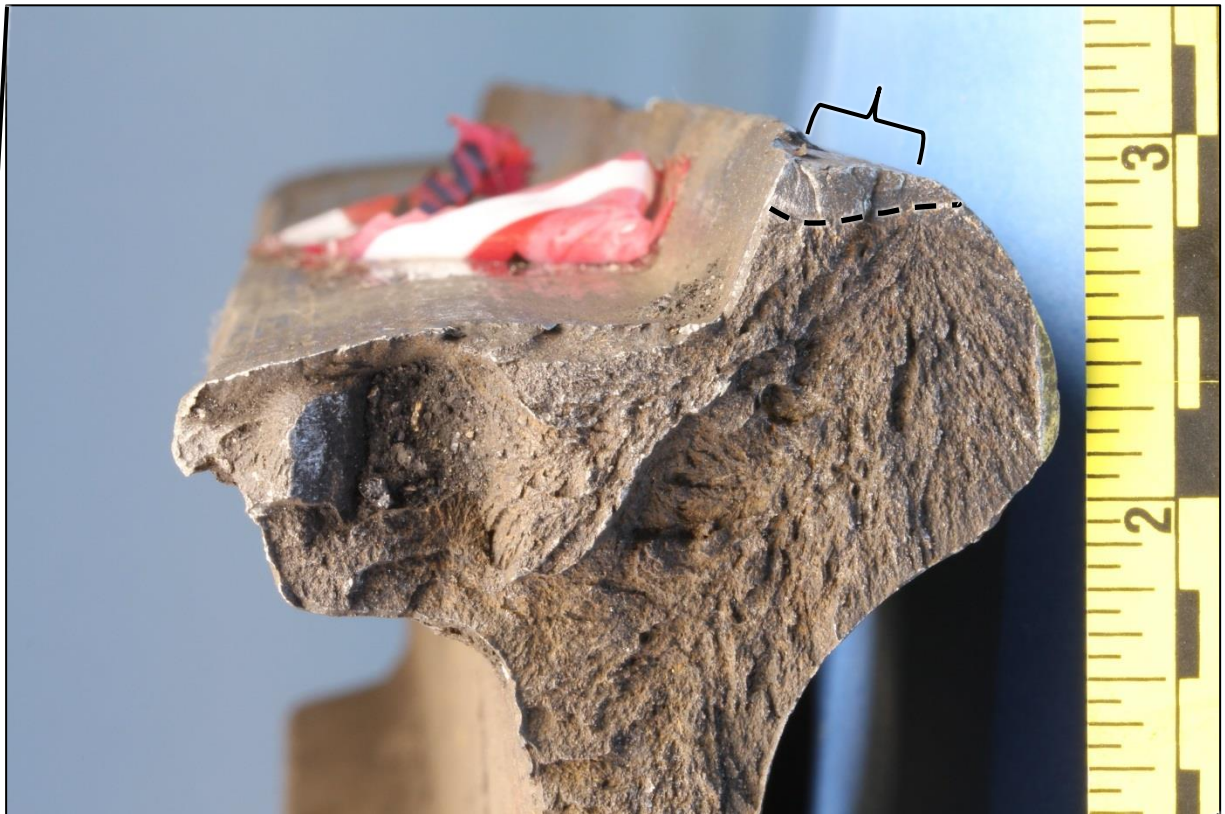
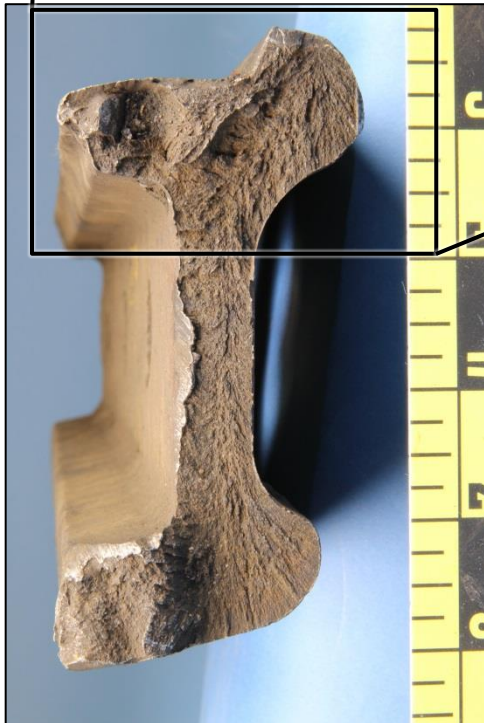
centerline of the rail. The joint bar on the gage side of piece 12N was fractured near the middle the span. The west face of the joint bar fracture (mating side of the fracture face shown in figure 5) is shown in figure 6. Smooth fracture features with a dark oxide and a curving boundary were observed consistent with fatigue cracking. The fatigue features emanated from an origin at the upper side of the joint bar (see the bracket in figure 6) where it contacted the underside of the rail head. A dashed line in figure 6 indicates the extent of fatigue crack propagation to a depth of approximately 0.16 inch from the upper surface of the joint bar.

Figure 6. Views of the fracture surface on the south joint bar showing the west side of the fracture. A bracket in the upper image indicates the fatigue origin area, and a dashed line indicates the fatigue boundary.

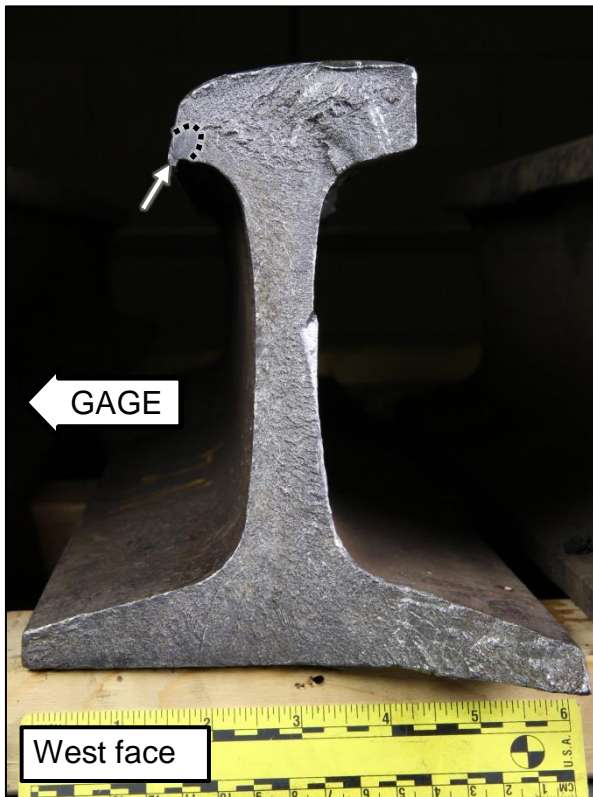
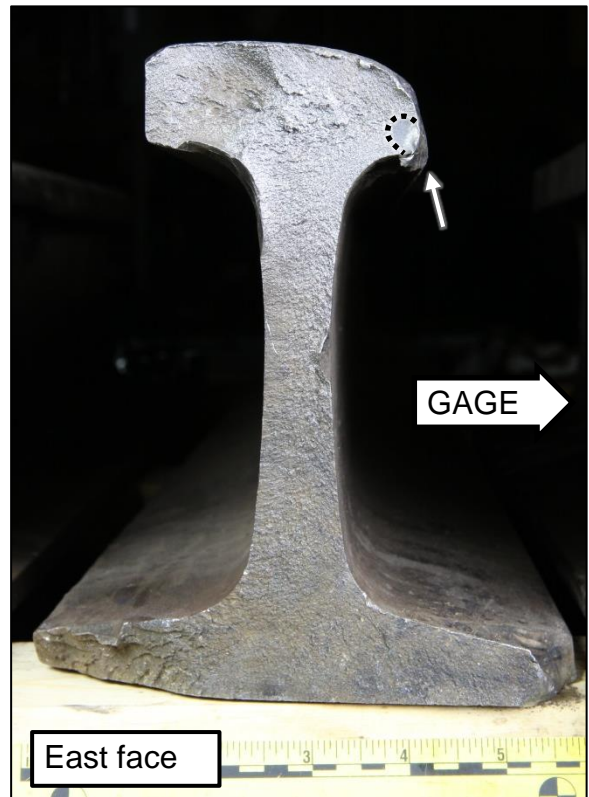
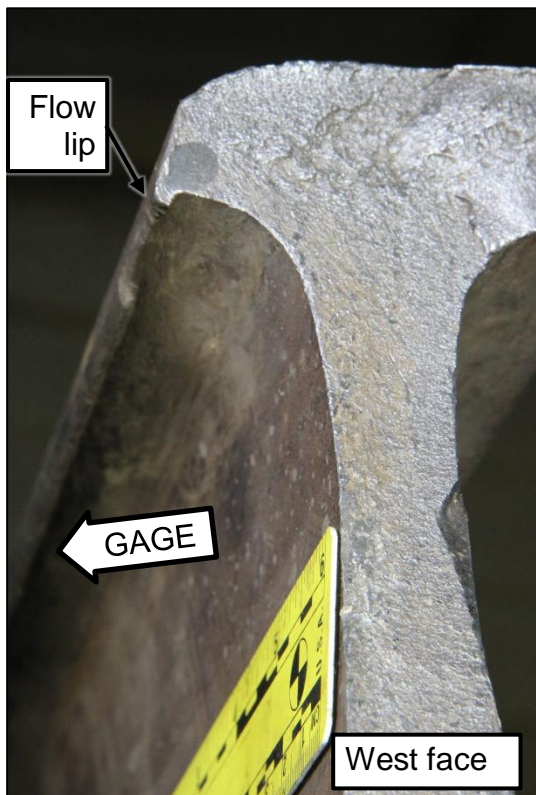
Views of the fracture between pieces 12N and 13N are shown in figure 7. A reverse detail fracture was observed at the lower corner on the gage side of the head. Dashed lines in figure 7 indicate the extent of propagation of the reverse detail fracture, and arrows indicate the origin located at a flow lip at the lower corner of the head. An oblique view of the fracture showing the underside of the head and the flow lip is shown in the lower left image in figure 7. The reverse detail fracture extended across approximately 3 percent of the remaining head area. On the west side of the fracture, flow was observed at the running surface consistent with leaving batter. On the east side of the fracture, the lower corner on the gage side showed post fracture damage, and material at the running surface was deformed over the fracture surface. Sliding contact marks were observed on the running surface at the west end of piece 13N consistent with contact with sliding equipment.

Figure 7. Views of the fracture between pieces 12N and 13N showing the east and west mating surfaces and an oblique view of the west surface. In the upper images, arrows point to the origin of the reverse detail defect, and dashed lines indicated the boundary.

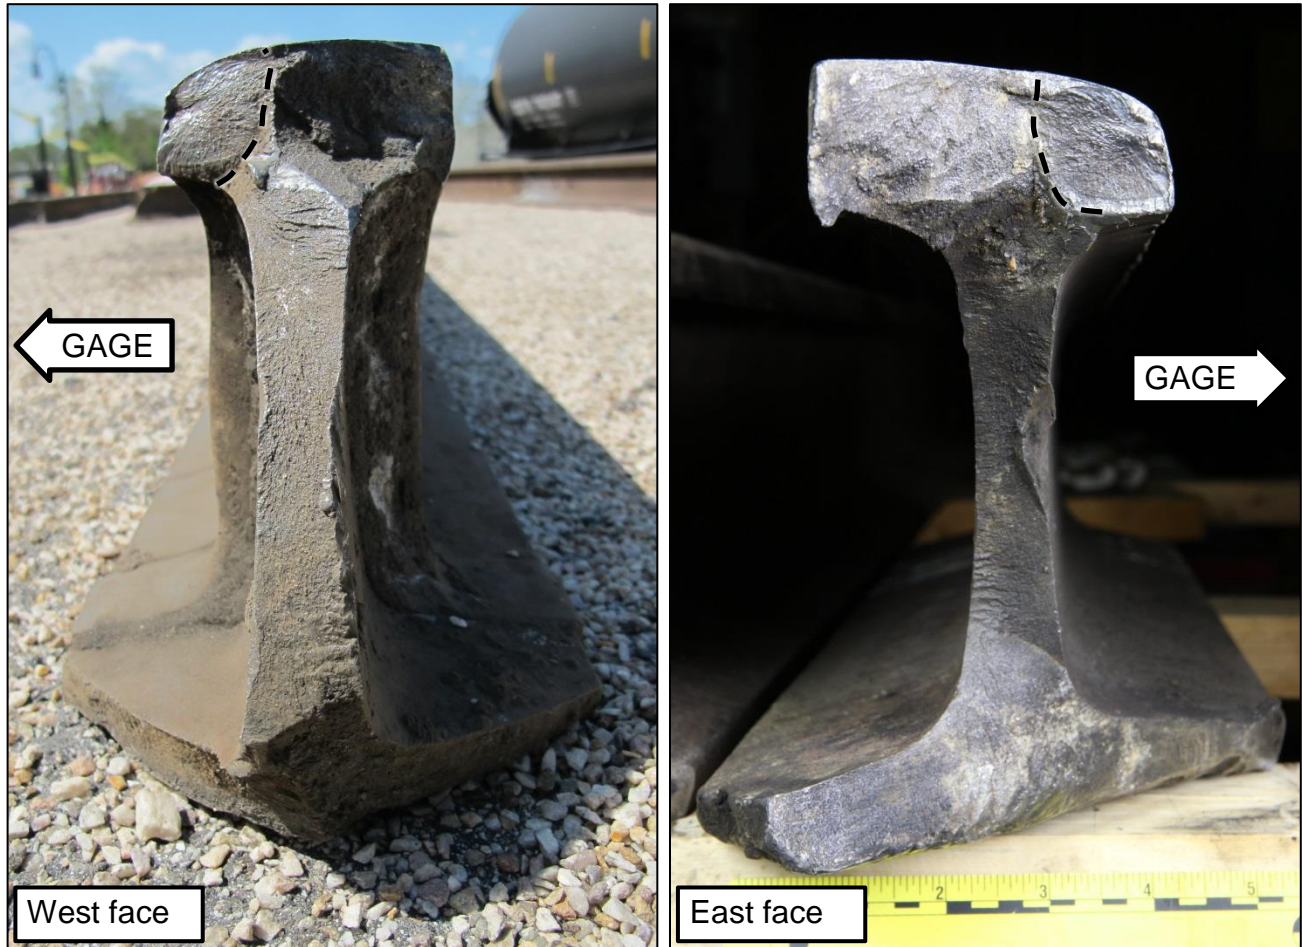
Views of the fracture between pieces 13N and 14N are shown in figure 8. The fracture occurred adjacent to the field weld east of the weld. A detail fracture was observed covering approximately 26 percent of the remaining head area. Dashed lines in figure 8 indicate the extent of propagation of the detail fracture. No rail end batter was observed on either of the fracture faces.

Figure 8. Views of the east and west faces of the fracture between pieces 13N and 14N. A dashed line indicates the boundary of the detail fracture.

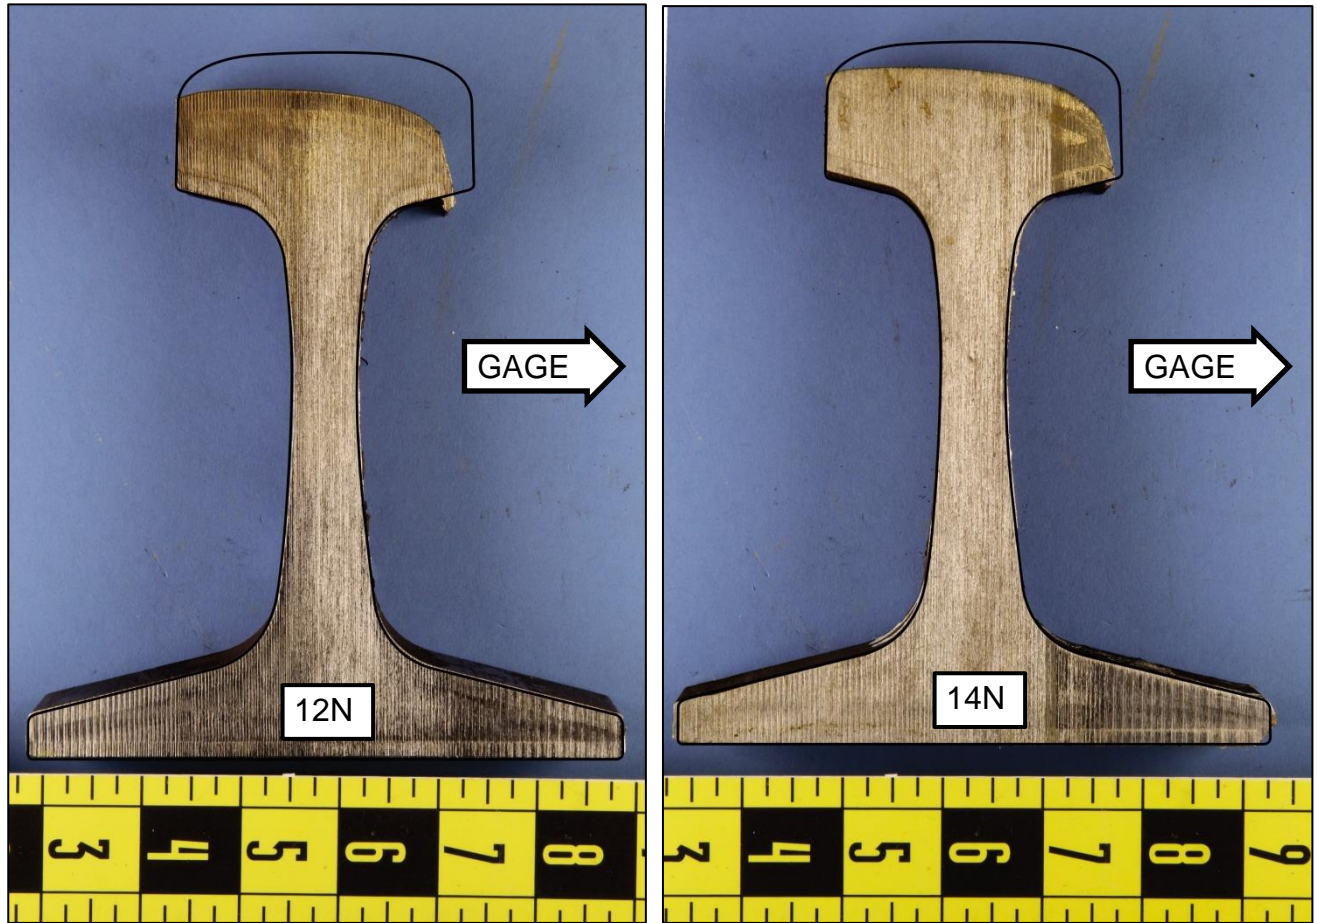
Transverse cuts were made through rail the rail near the west end of 12N and the east end of 14N to reveal the existing cross-section of the rail. Views of the cross-sections at the cut locations are shown in figure 9. Black lines in figure 9 show the outline of a new 132-pound rail cross-section for comparison. The percent remaining head area was calculated by measuring the area of the remaining head relative to the head area of the new rail profile in the images shown in figure 9. The remaining head area for both the 12N and 14N samples was 78 percent of the new head area.

The rail height and head width was measured on the two cross-sections shown in figure 9. The pieces were placed on a granite table, and the rail heights were measured with a vernier caliper at the rail centerline. The rail heights were 6.681 inches and 6.710 inches for the pieces from 12N and 14N, respectively. The head width on each piece was measured with a vernier caliper at a location approximately 5/8 inch below the running surface. The head widths were 2.680 inches and 2.770 inches for pieces from 12N and 14N, respectively.

0.44 inch and 0.42 inch for the pieces from 12N and 14N, respectively. The side wear was 0.32 inch and 0.23 inch for the pieces from 12N and 14N, respectively. According to the track owner's maintenance of way instructions for main line track, 132-pound RE rail is to be scheduled for replacement when the vertical wear reaches 0.438 inch (7/16 inch) or when the side wear reaches 0.625 inch (5/8 inch).

Figure 9. Cross-sections through pieces 12N and 14N. A black outline in each image shows the profile of a new 132-pound rail for reference.

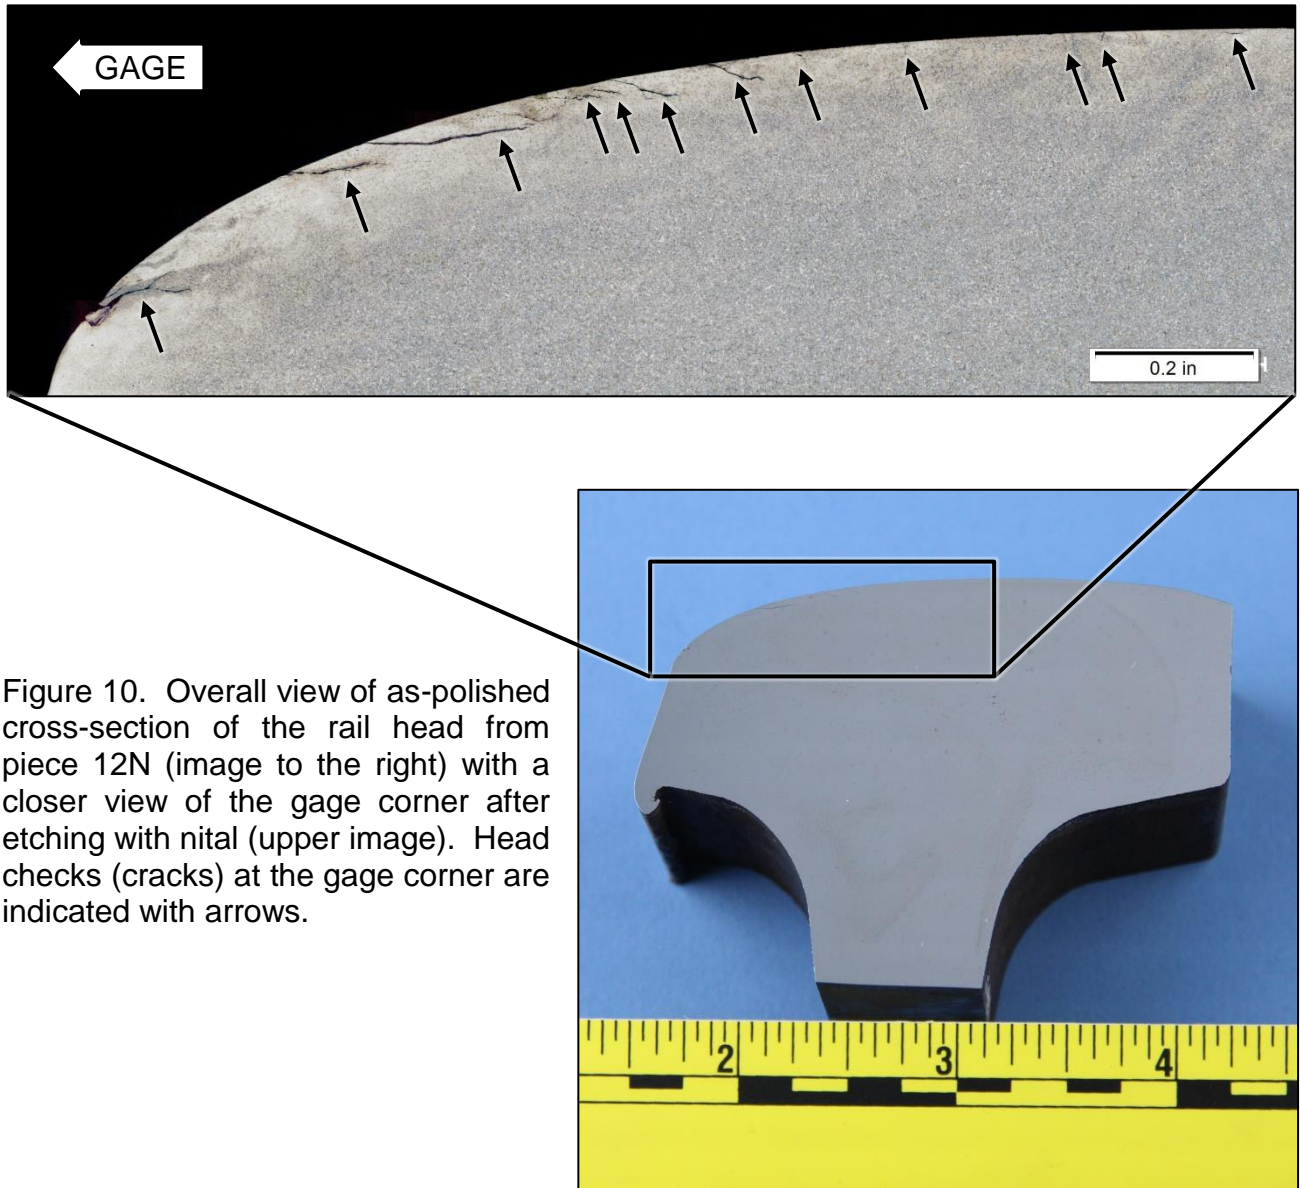
Cross-sections of the rail head from pieces 12N and 14N were polished and then etched using 2 percent nital.¹ Overall views of the as-polished cross-sections are shown in the lower images in figures 10 and 11, and closer views of the gage corner after etching are shown in the upper images. As indicated with arrows in figures 10 and 11, cracks consistent with head checking, a form of rolling contact fatigue damage, were observed in the gage corner of each of the cross-sections.

Figure 10. Overall view of as-polished cross-section of the rail head from piece 12N (image to the right) with a closer view of the gage corner after etching with nital (upper image). Head checks (cracks) at the gage corner are indicated with arrows.

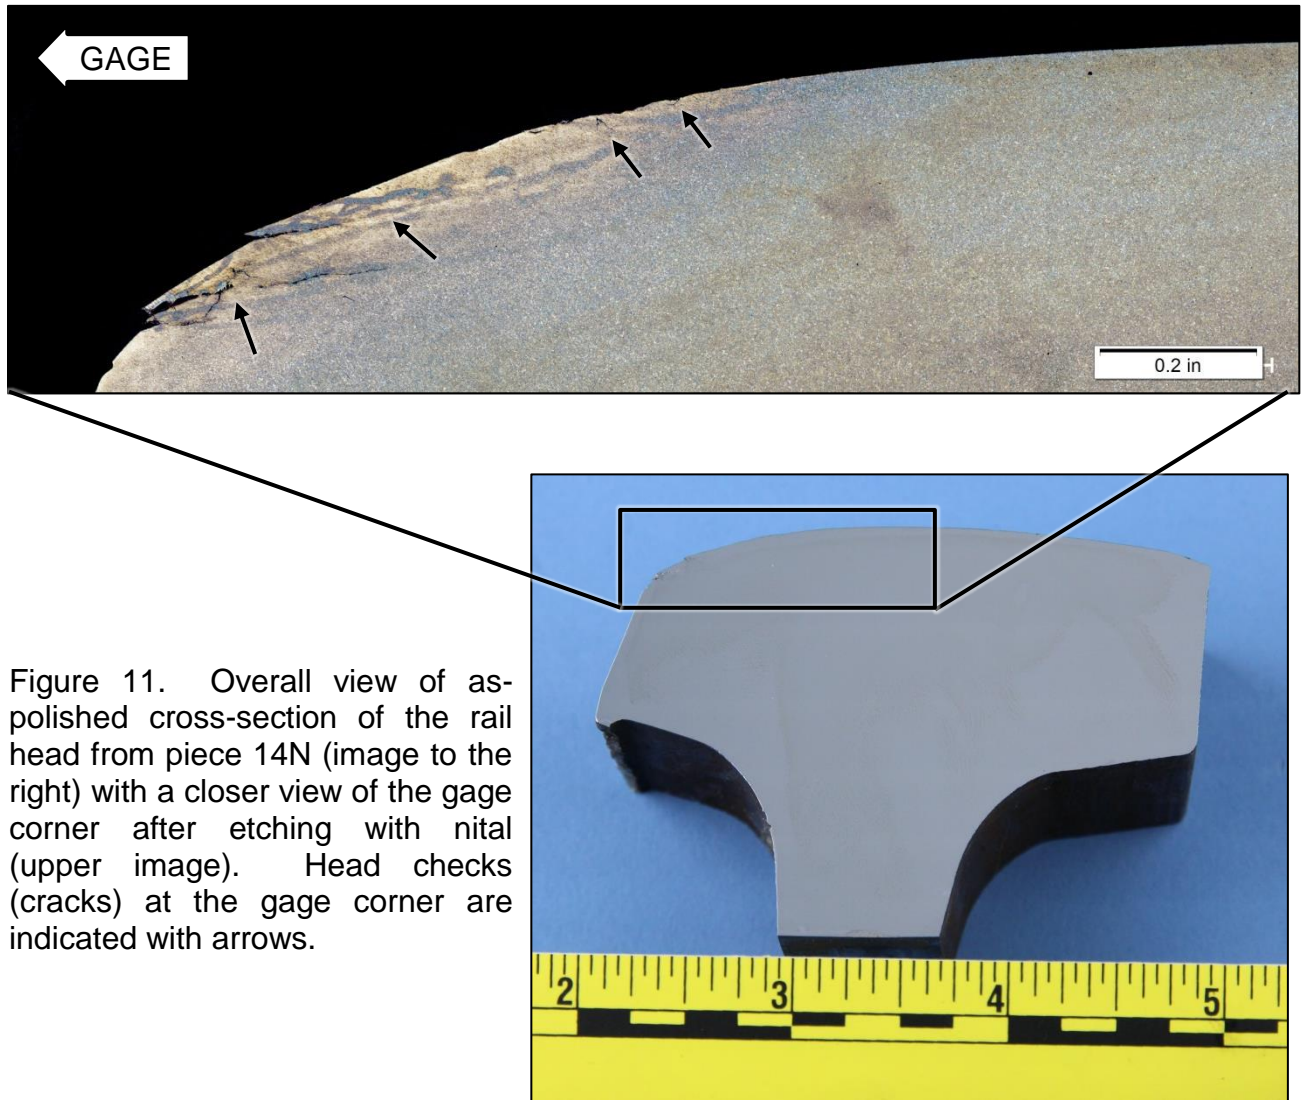
Figure 11. Overall view of as-polished cross-section of the rail head from piece 14N (image to the right) with a closer view of the gage corner after etching with nital (upper image). Head checks (cracks) at the gage corner are indicated with arrows.

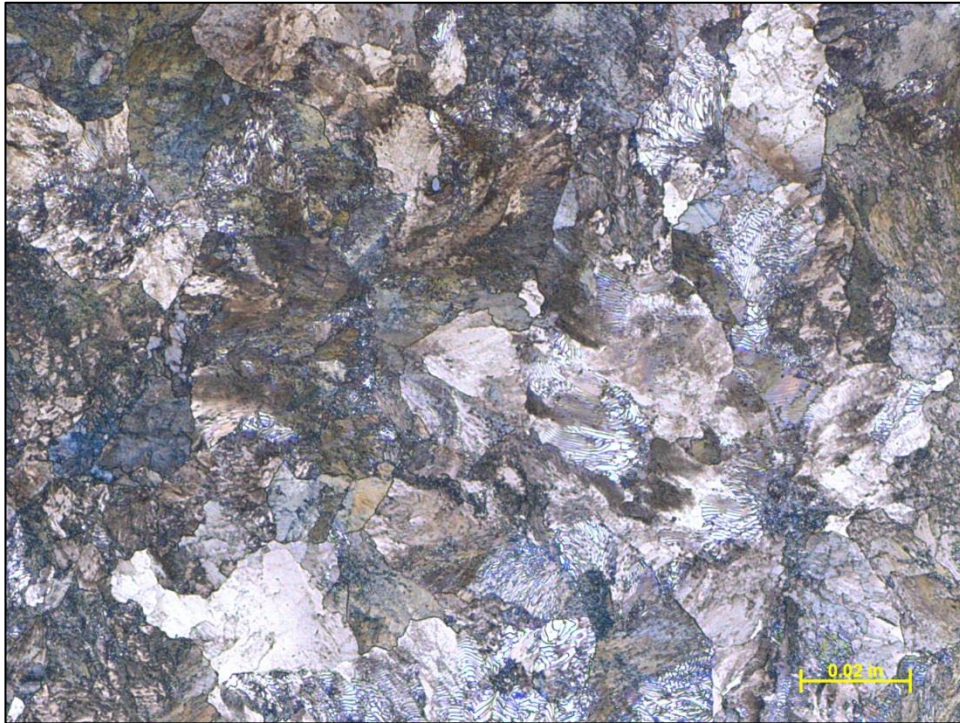
The rail heads from pieces 12N and 14N showed fully pearlitic microstructures in both polished and etched cross-sections. A micrograph from head piece 12N showing features typical of the two etched cross-sections is shown in figure 12.

Figure 12. Micrograph from the polished and etched cross-section through the head of piece 12N showing a pearlite microstructure (nital etchant).
