NATIONAL TRANSPORTATION SAFETY BOARD

MATERIALS LABORATORY FACTUAL REPORT

Report No. 15-010

Place : Bellevue, TN
Date : February 3, 2014
Vehicle : Gulfstream 690C, N840V
NTSB No. : ERA14FA112
Investigator : Luke Schiada, AS-ERA

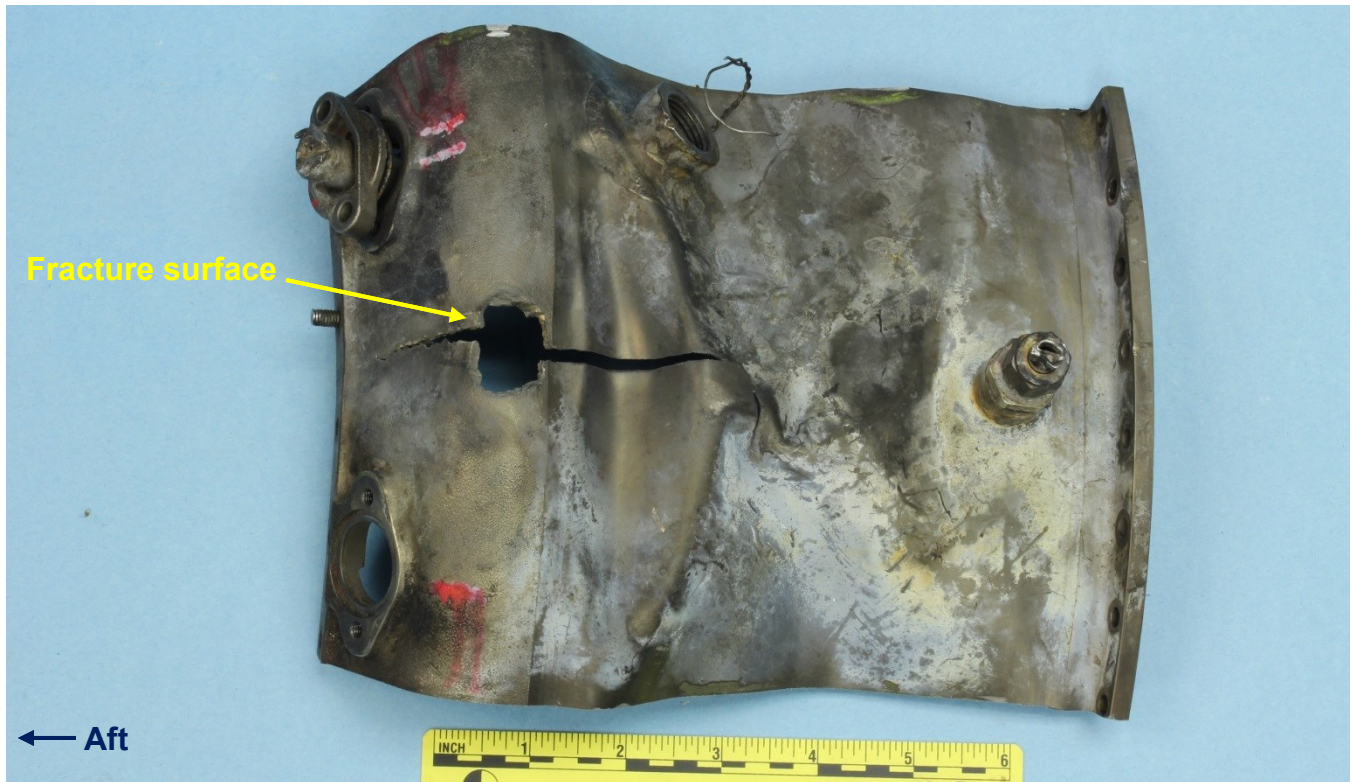
Figure 1 and Figure 2 show the combustor chamber case section, as received. The case section had been removed from the rest of the case before shipment to the NTSB Materials Laboratory. The case section exhibited indications of buckling parallel to the

circumferential direction of the case. The outboard face of the case section exhibited white residue consistent with exposure to the post-crash fire.

Figure 1 – The combustor case section viewed from the outboard side, as received.

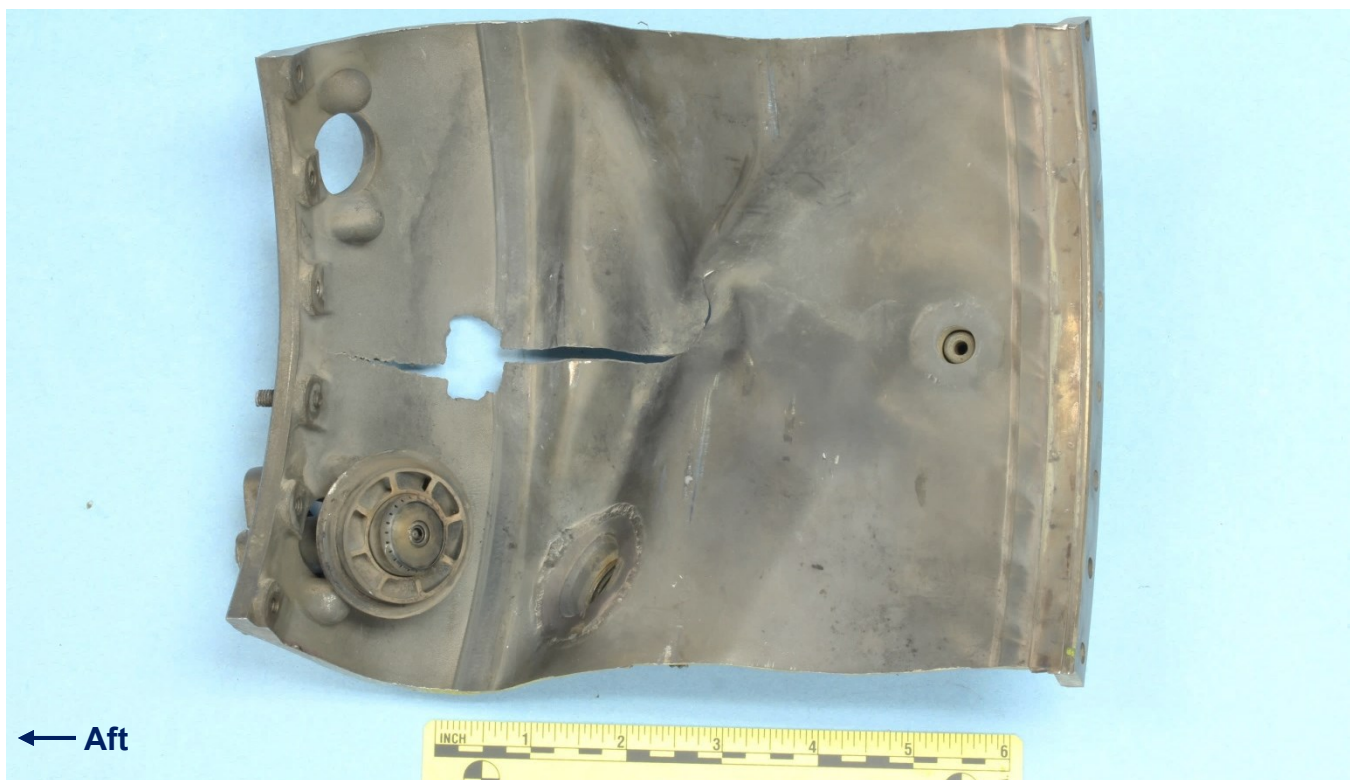
Figure 2 – The combustor case section viewed from the inboard side, as received.

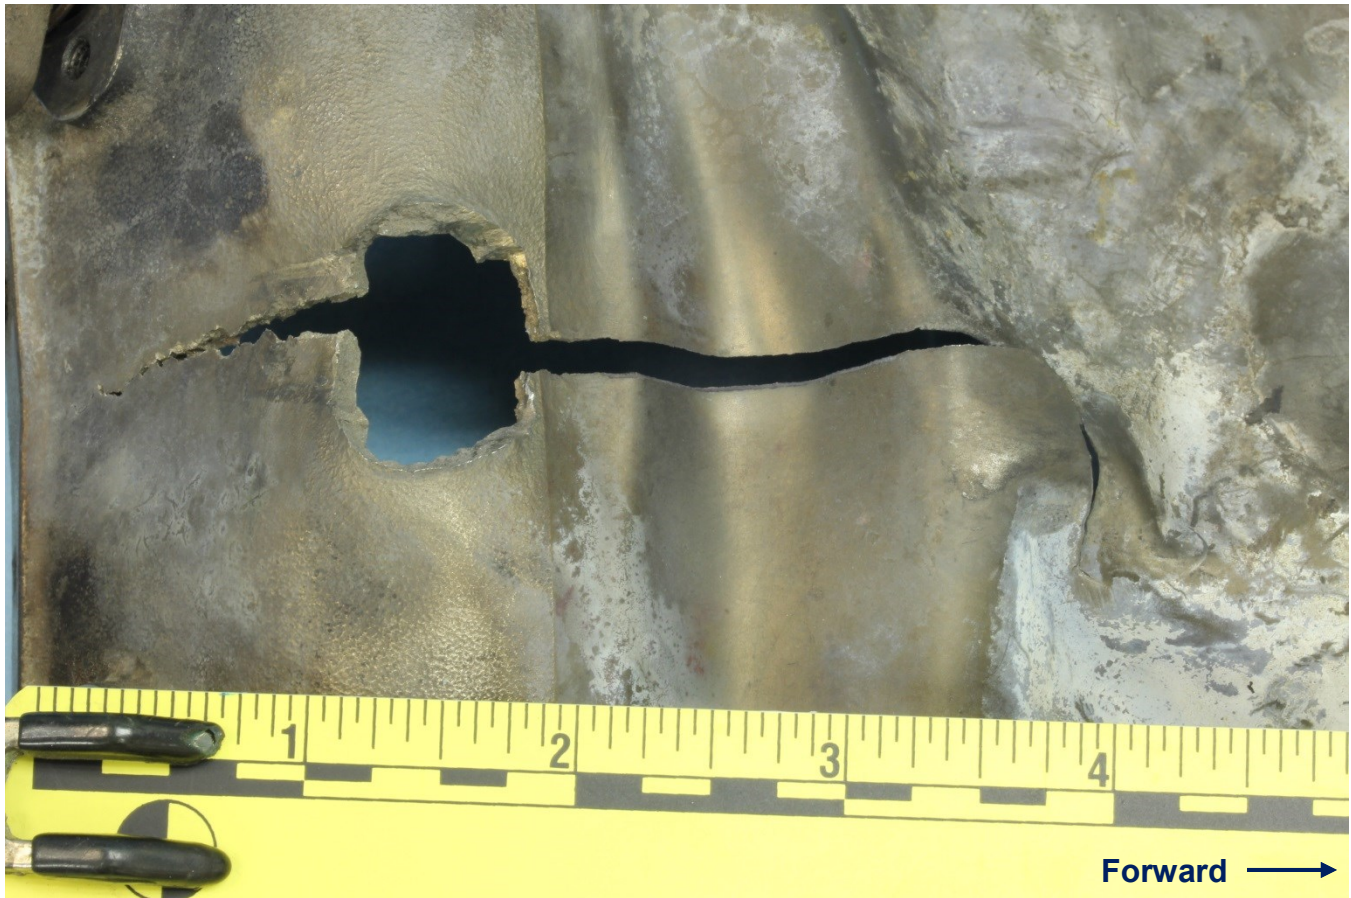
The case contained a longitudinal crack parallel to the engine axial direction (see Figure 3). This crack was approximately 3.75 inches in length and included a “hole-shaped” portion that was generally shinier and smoother than the adjacent fracture surface. The fracture was intentionally backcut and overstressed to separate the fracture halves. Figure 4 shows a closer view of the “hole-shaped” portion of the fracture. This region of the fracture surface exhibited radial marks directed outboard consistent with smearing damage. The case section was bowed outboard in the region. As shown in Figure 5, the case had buckled about the “hole-shaped” portion of the fracture. Discussions with the IIC and a Honeywell representative revealed that this “hole-shaped” region of the fracture corresponded with the position of a missing drain boss. This boss was welded onto the combustion chamber case.

Figure 3 – The combustor case fracture, as viewed from inside looking out.

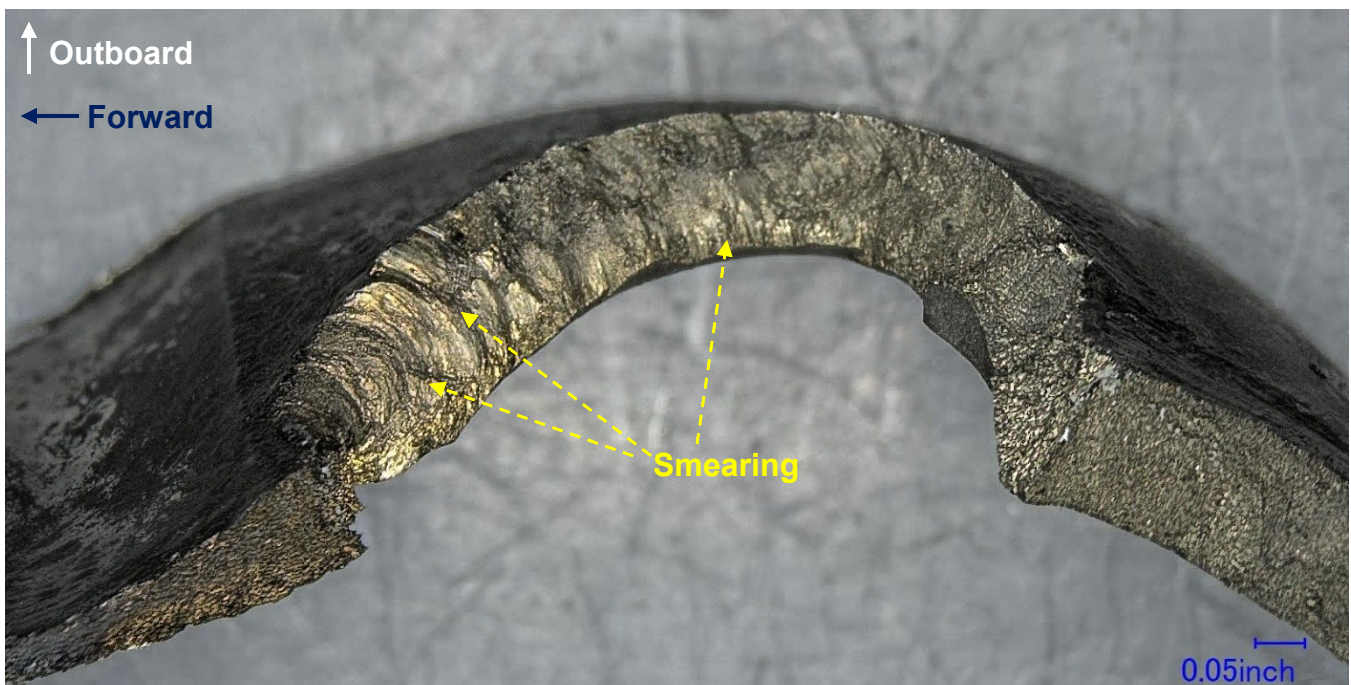
Figure 4 – The hole-shaped portion of the fracture, after backcutting and opening. The hole-shaped portion exhibited shiny, smear marks.

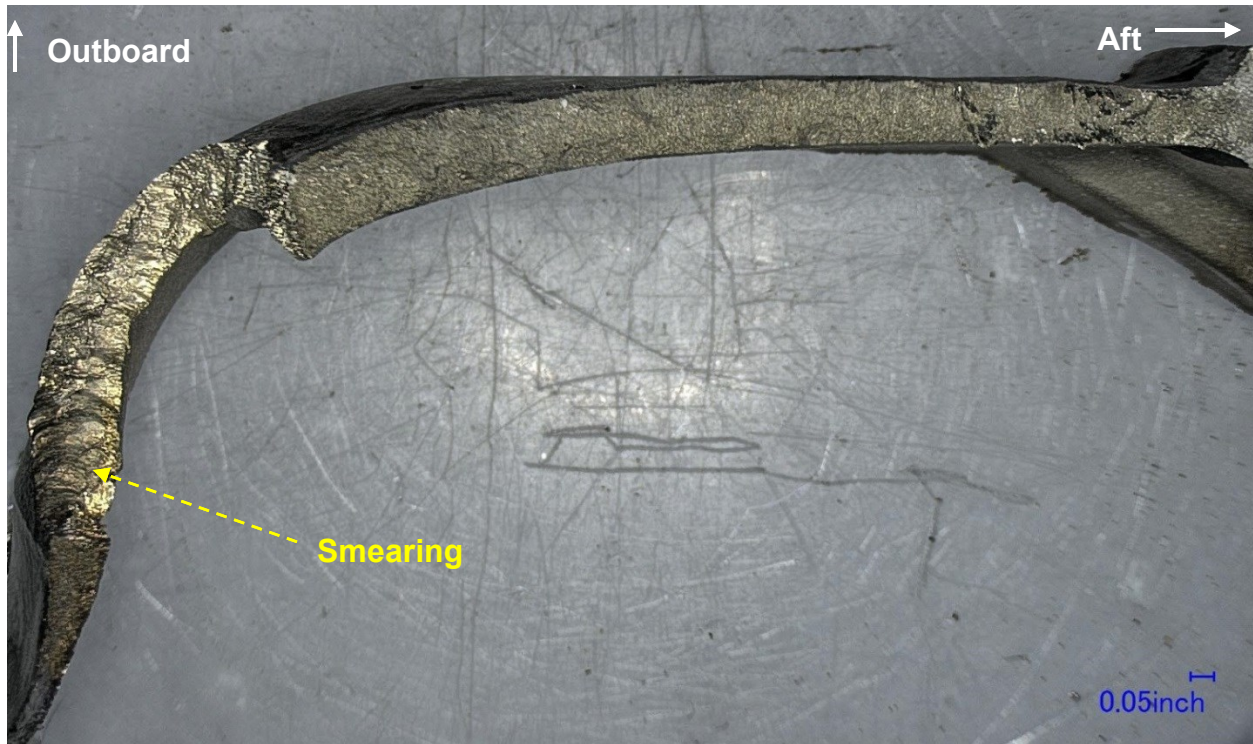
The portions of the fracture surface outside of the “hole-shaped” region exhibited a dull luster and generally rougher surface morphology (Figure 5). One half of the fracture surface was examined using a scanning electron microscope (SEM). Figure 6 illustrates the fracture surface aft of the “hole-shaped” region. The fracture surface exhibited a cross-pattern morphology, consistent with the dendritic microstructure common to superalloy castings. Closer examination of the fracture surface revealed dimple rupture, consistent with tensile overstress failure (see Figure 7).

Figure 5 – The fracture surface of the cast portion of the case, after opening. The hole-shaped portion is on the left, which is shinier than the rest of the fracture.

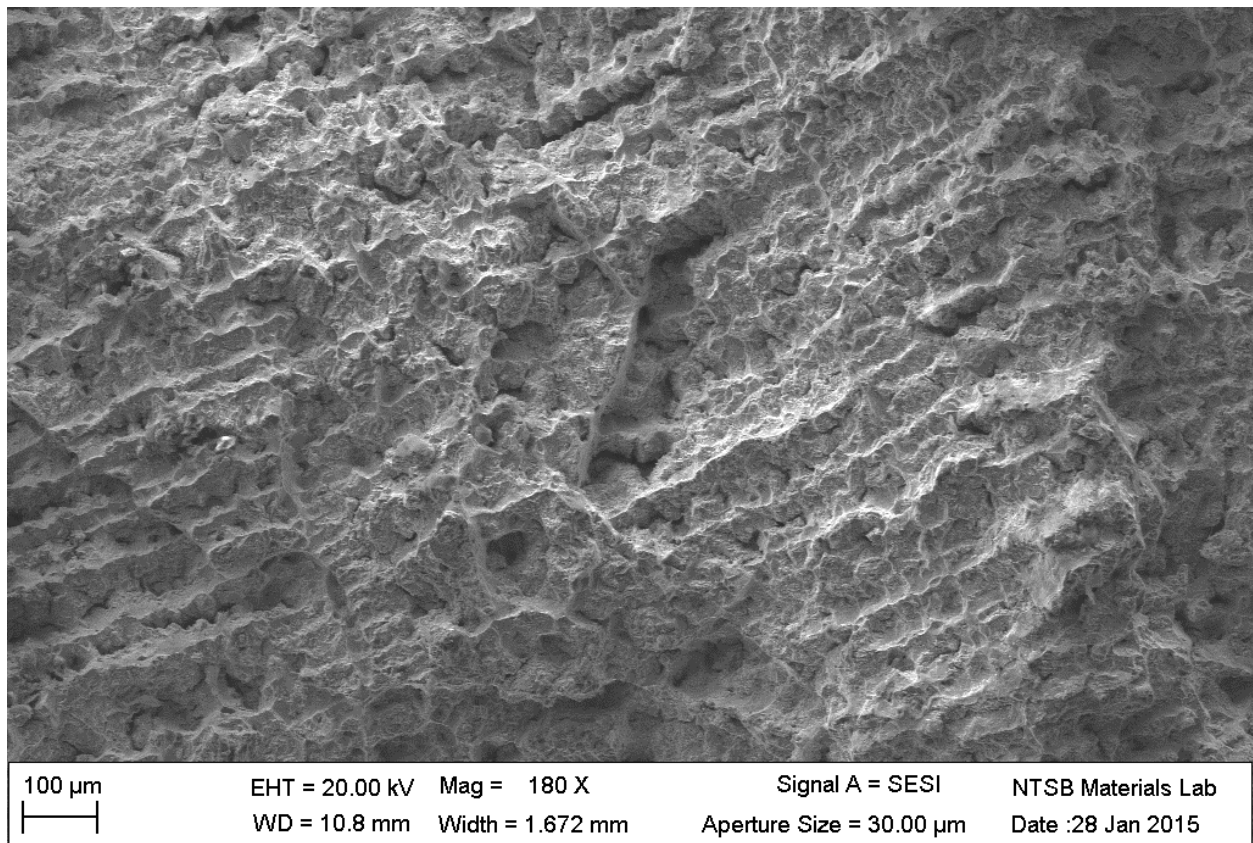
Figure 6 – Secondary electron (SE) micrograph of the fracture surface of the cast portion of the case.

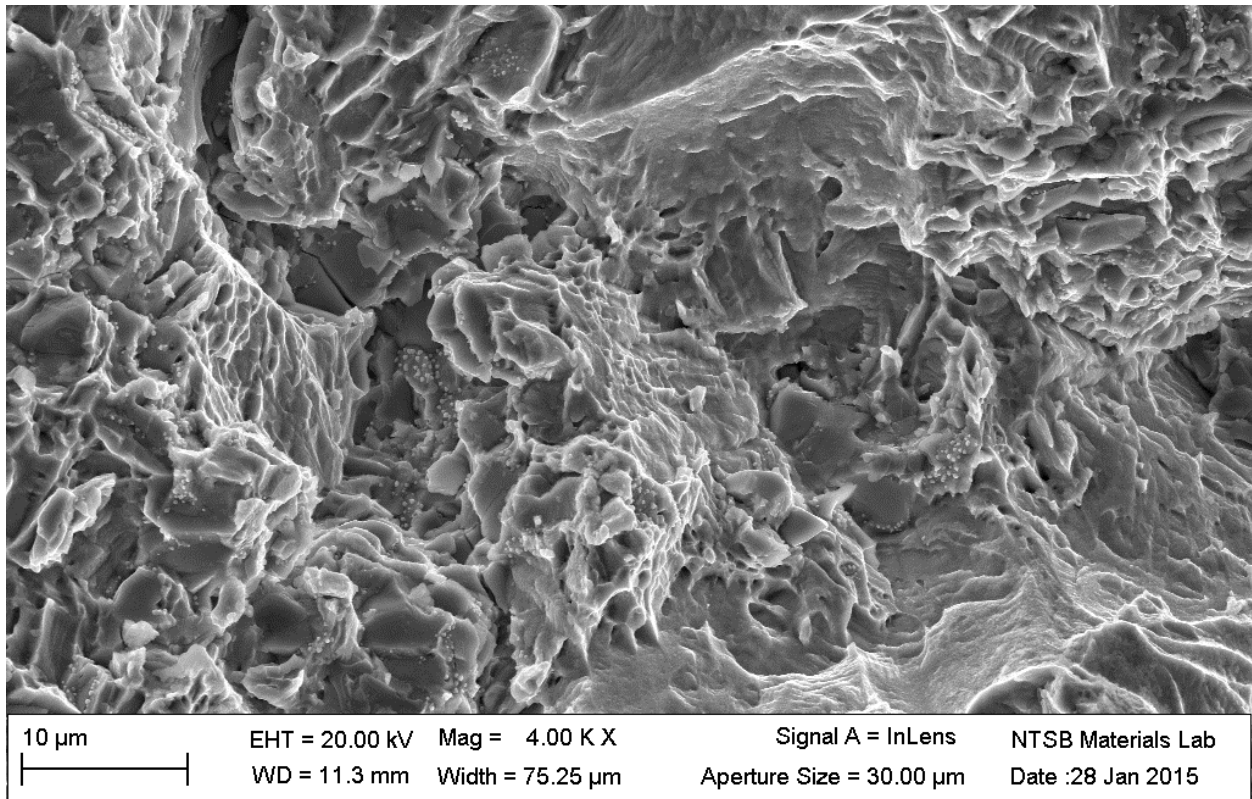
Figure 7 – SE micrograph showing the cast portion of the case fracture surface, exhibiting dimple rupture.

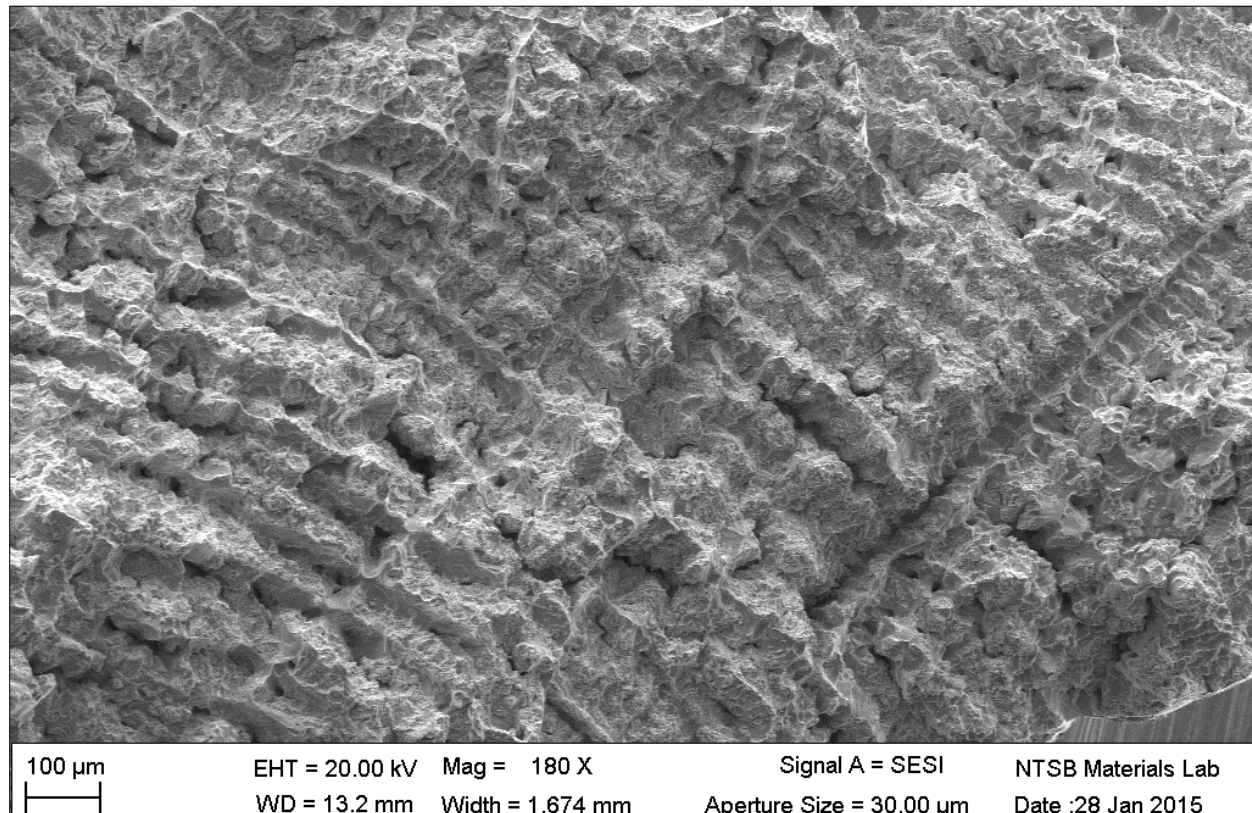
The area aft of the as-received fracture that was fractured in the laboratory was examined and is shown in Figure 8. Like the fracture surface in the cast portion of the case section, the laboratory fracture exhibited a dendritic morphology with dimple rupture features (see Figure 8 and Figure 9). These laboratory-produced overstress features were comparable to that of the as-received fracture surface.

Figure 8 – SE micrograph of the intentionally overstressed region of the cast section of the case, revealing morphology consistent with the fracture surface shown in Figure 6.

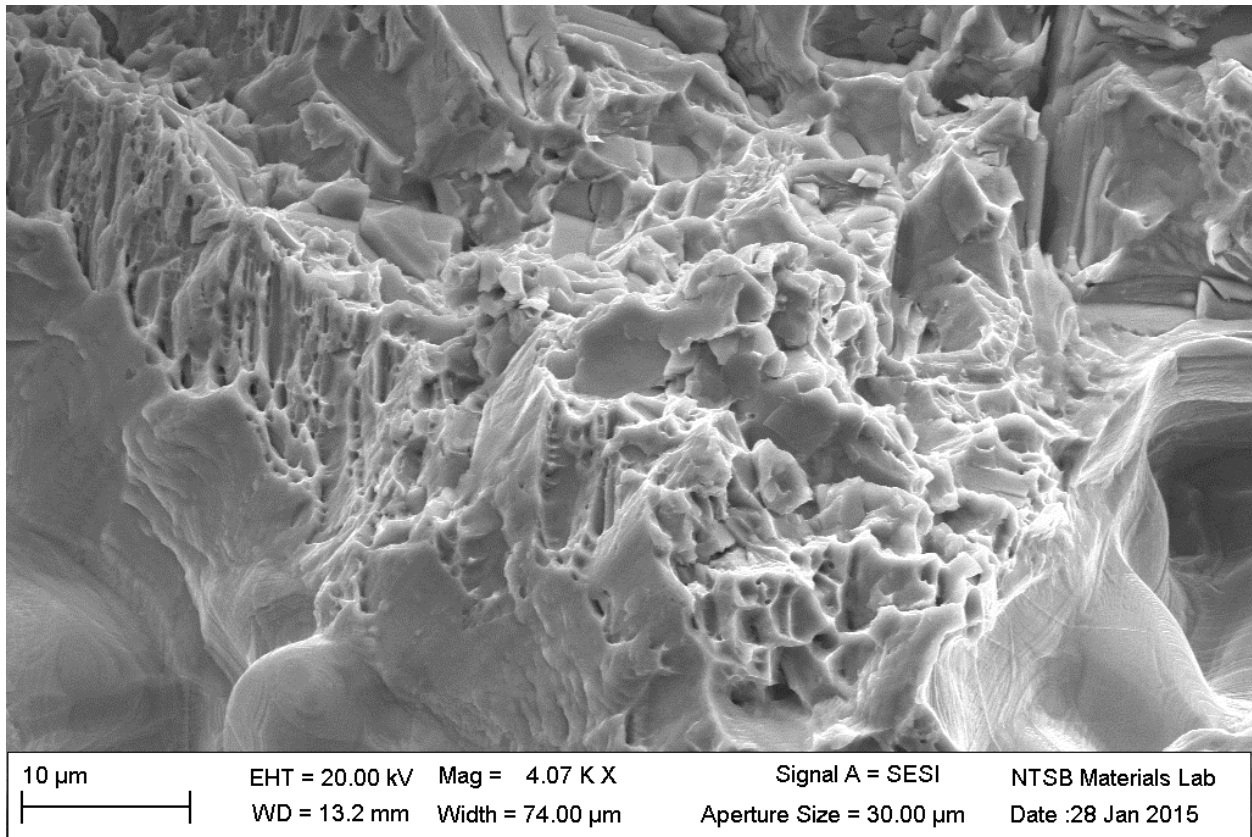
Figure 9 – SE micrograph of dimple rupture in the intentionally overstressed cast fracture surface.

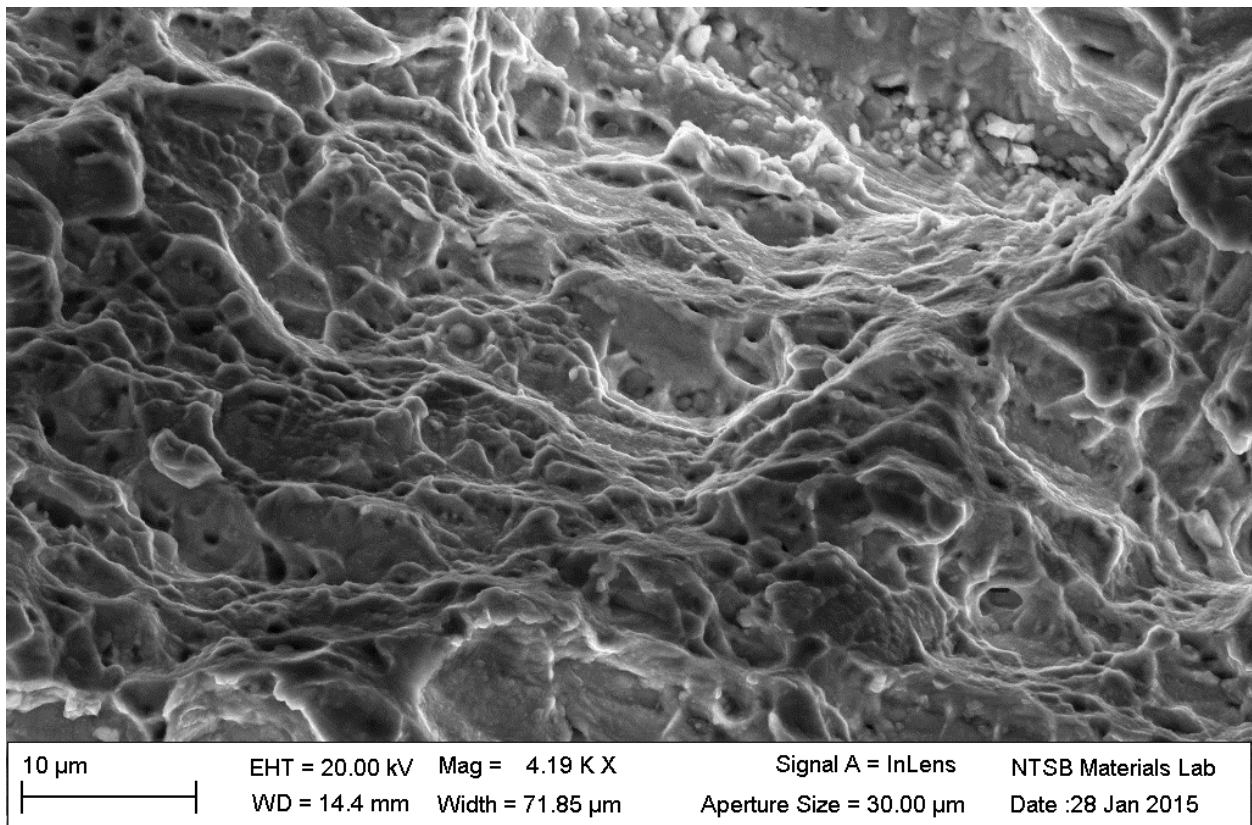
The fracture surface forward of the “hole-shaped” region exhibited different macroscopic features than the aft cast portion. The fracture surface exhibited an approximately 45° slant and showed a smoother texture than the aft region. When examined in a SEM, the forward portions of the fracture surface revealed dimple rupture (see Figure 10). These fracture features were consistent with tensile overstress in a wrought superalloy material.

Figure 10 – SE micrograph of dimple rupture in the wrought portion of the case fracture surface.

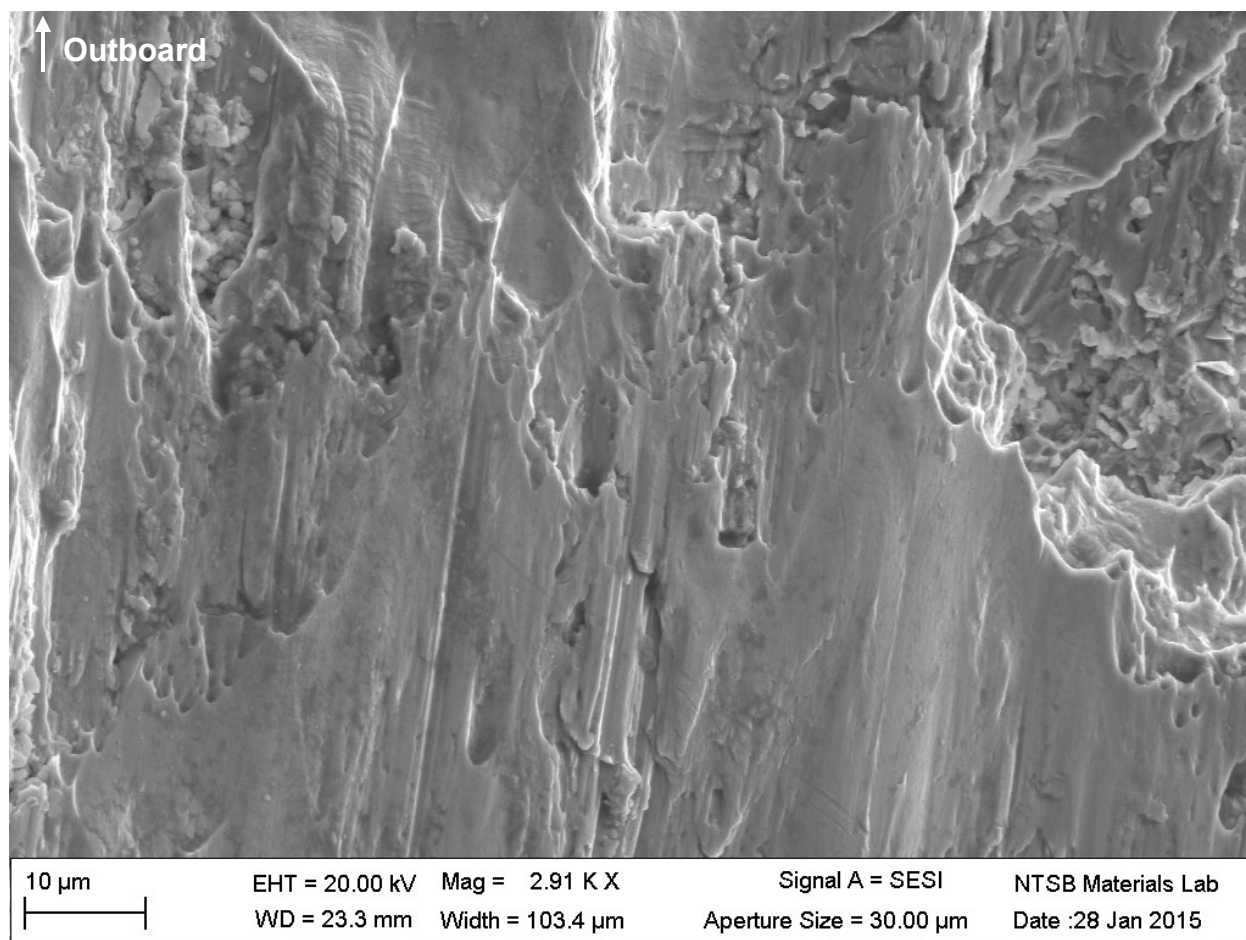
The fracture surface of the “hole-shaped” region was also examined in the SEM. Most of the fracture features had been obliterated by smearing. However, as illustrated in Figure 11, some features of the fracture surface were present that were consistent with elongated dimple rupture. The shape of the dimples and direction of the smearing was consistent with overstress towards the outward direction. No indications of other failure modes were observed on the fracture surface.

Figure 11 – SE micrograph of the hole-shaped region of the case fracture, showing smearing and elongated dimple rupture.
