NATIONAL TRANSPORTATION SAFETY BOARD

MATERIALS LABORATORY FACTUAL REPORT

Report No. 15-018

Place : Lynchburg, Virginia
Date : April 30, 2014
Vehicle : CSX train KO8227
NTSB No. : DCA14FR008
Investigator : Paul Stancil, RPH-20

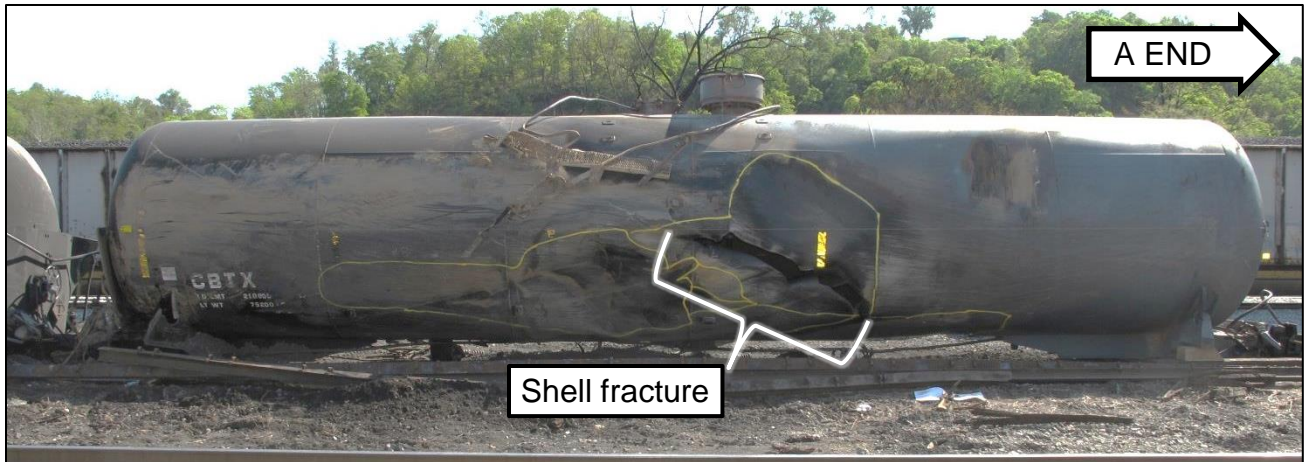
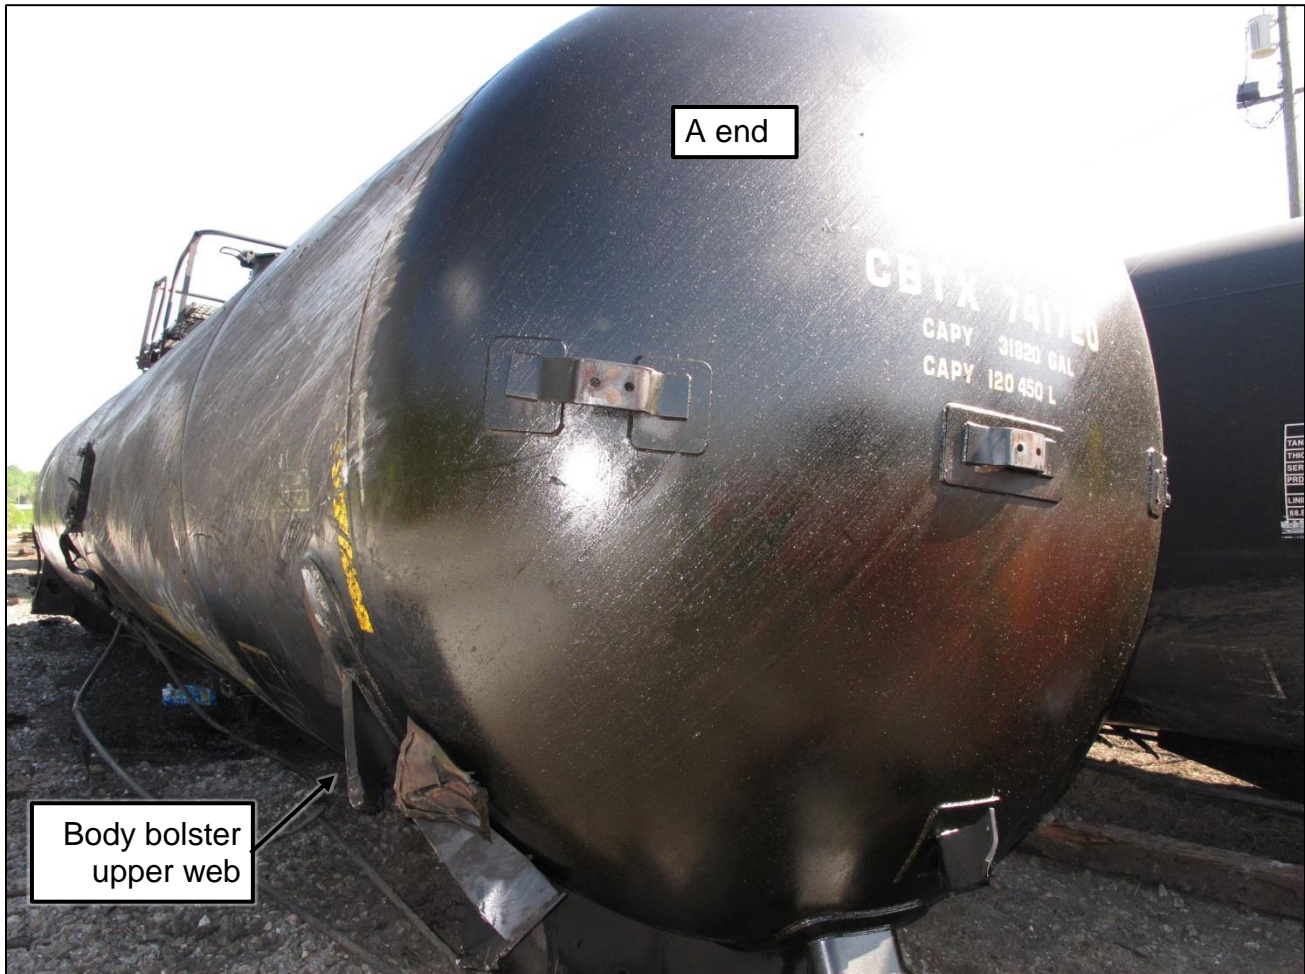
Tank cars CBTX 741712 and CBTX 741720 were initially examined on scene, and overall views of the tank cars are shown in figure 1. For reference, the ends of the tank cars are shown labeled A and B, where the B end was the end with the brake wheel. Right and left sides of the car are as viewed looking away from the B end toward the A end. The shell of tank car CBTX 741712 was fractured on the right side starting at the middle (lengthwise) of the tank and propagating toward the A end of the tank. The fracture extended approximately 8 feet along the middle and lower portion of the right side of the tank as indicated with a bracket in figure 1. On the right side of tank car CBTX 741720, the lower portion of the body bolster at the A end of the tank car was fractured from the upper portion of the body bolster web, and the body bolster was bent with the outboard end deflected toward the A end of the tank car.

Figure 1. Overall views of the right side of tank car CBTX 741712 (upper image), and the A end and right side of tank car CBTX 741720 (lower image) as examined on scene.

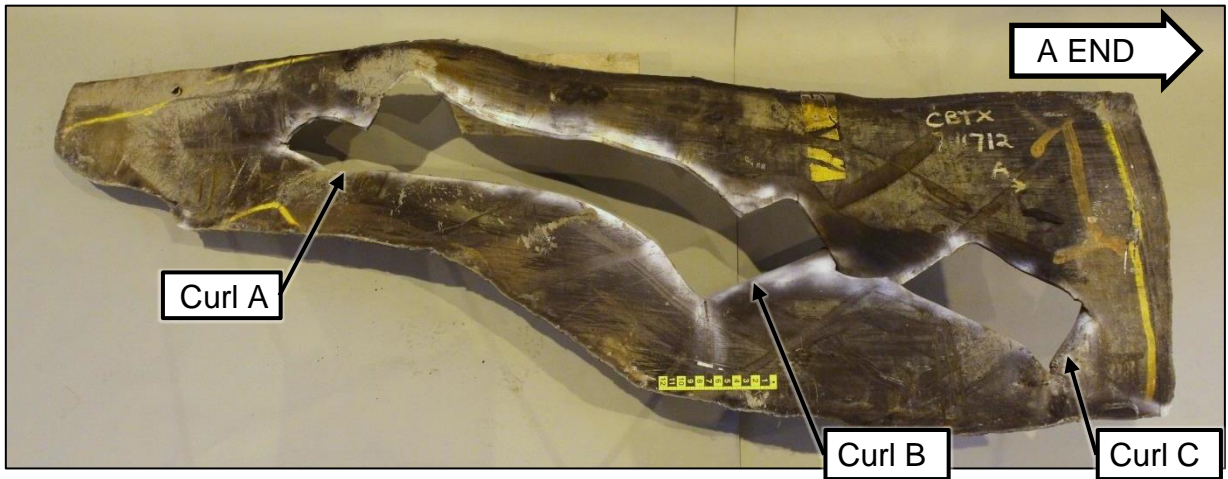
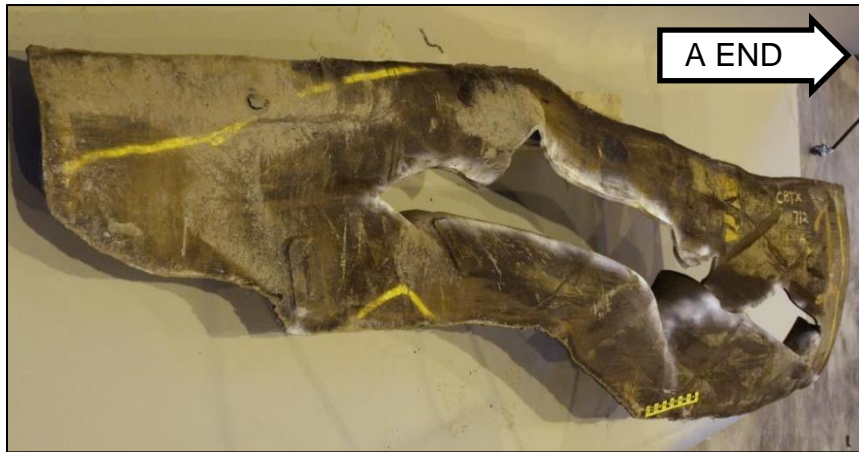
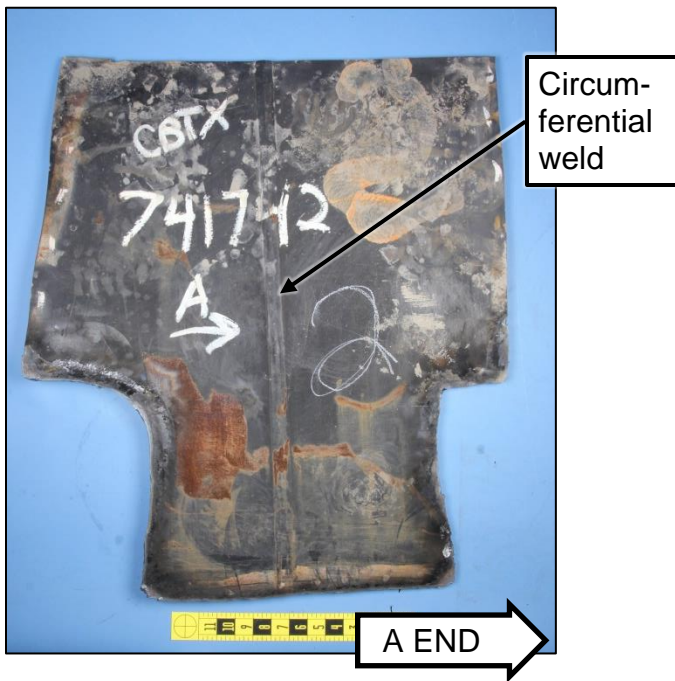
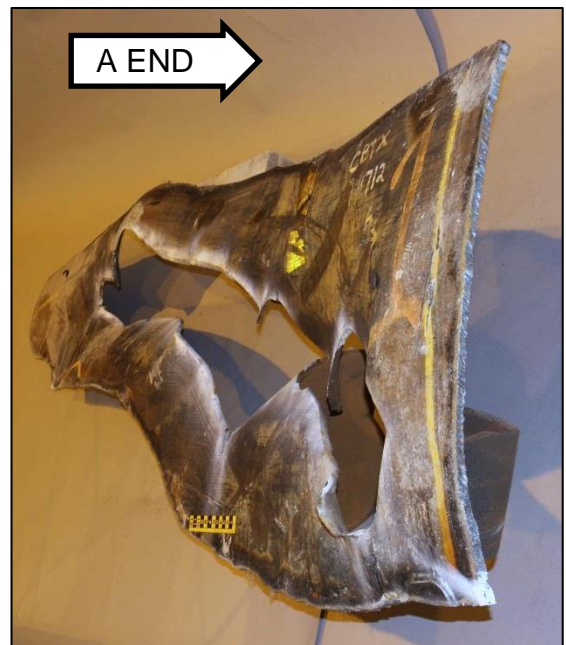
Pieces were cut from each of the tank cars and shipped to the NTSB Materials Laboratory in Washington, DC, and to the NTSB Training Academy in Ashburn, Virginia for further examination and testing. Overall views of pieces cut from tank car CBTX 741712 are shown in figures 2 and 3. The larger piece shown in figures 2 and 3 contained the shell fracture, and the smaller piece (lower left image in figure 2) was cut

Images of the shell fracture from various angles showing the external and internal faces of the shell piece are shown in figures 2 and 3. All fracture faces showed matte features on slant angles along with adjacent deformation and contact marks, features consistent with ductile overstress fracture from contact with another object. During the course of the fracture, pieces of the tank shell were deformed inward into a curled shape, leaving curled material attached to the tank wall at three locations labeled A through C as shown in figures 2 through 4.

Figure 2. Overall views of the pieces cut from tank car CBTX 741712 including pieces containing the shell fracture (top, middle, and lower right images) and the piece cut for mechanical and chemical testing (lower left image).

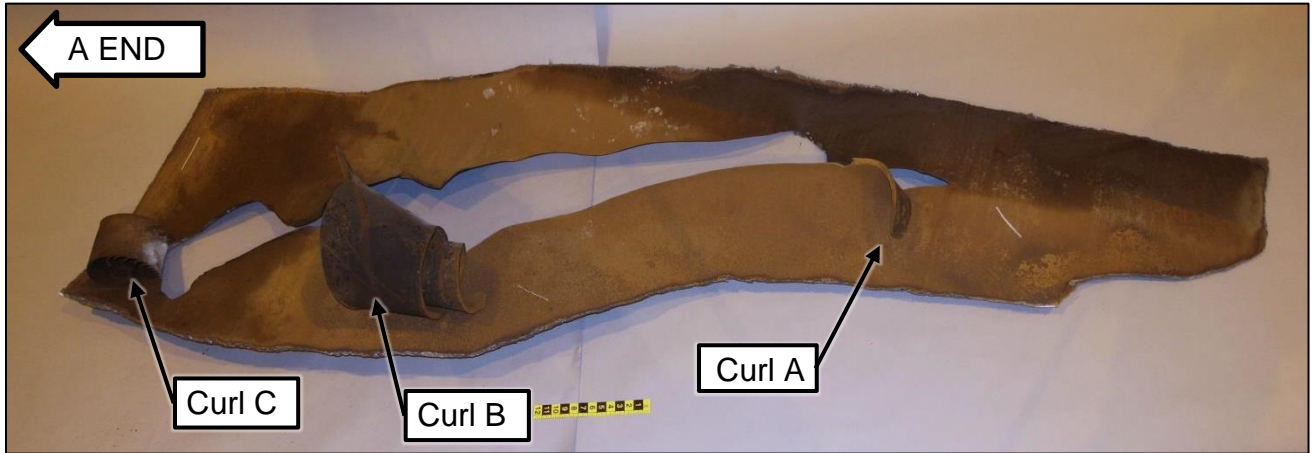
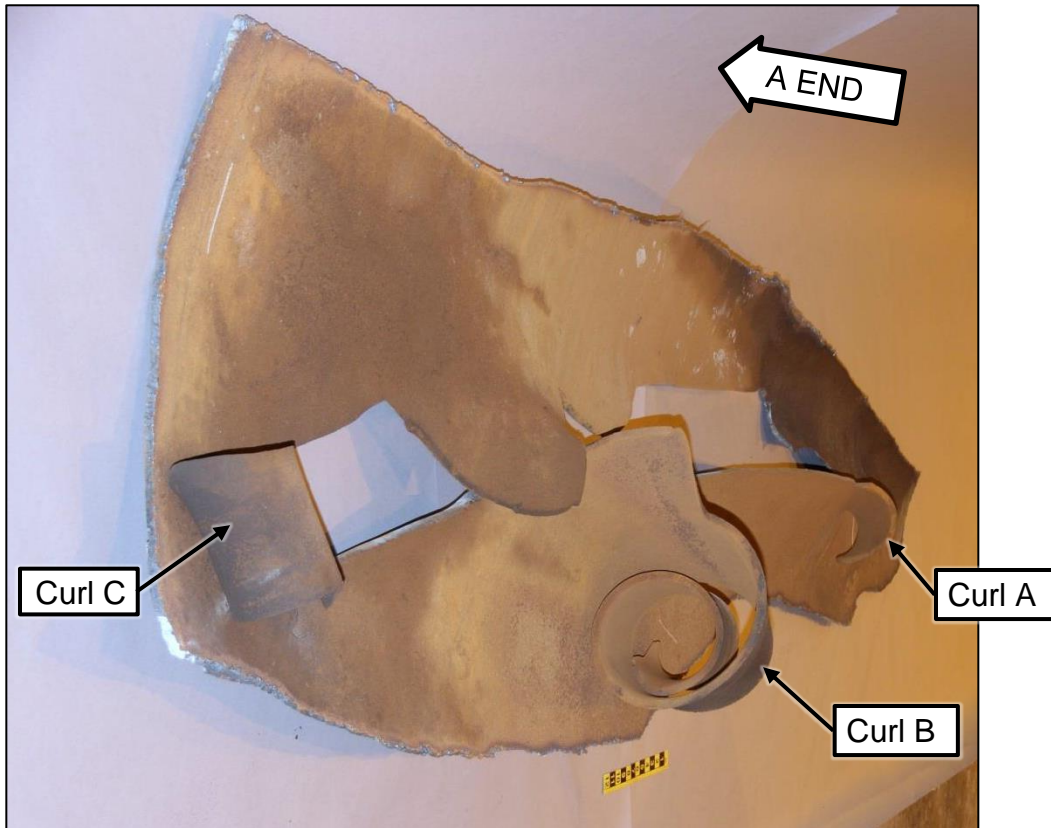
Within 6 inches past curl A, the fracture opened to a width of approximately 13 inches. Material from the opening in the portion of the fracture between curl A and curl B was deformed inward and curled to form curl B. The deformed material in curl B wrapped around itself approximately 3 times (see figure 3, lower image). A view of curl B as viewed looking upward from the interior side of the shell is shown in figure 6. A sliding contact mark was observed approximately midway between the fractures aligned approximately parallel to the fracture faces. Additional sliding contact marks were observed at an angle to the mark indicated in figure 6. The marks at an angle corresponded to angled marks observed on the shell exterior above and below the fracture, indicating that the angled marks were present prior to fracture.

Figure 3. Views of the shell fracture showing the interior face of the shell piece.

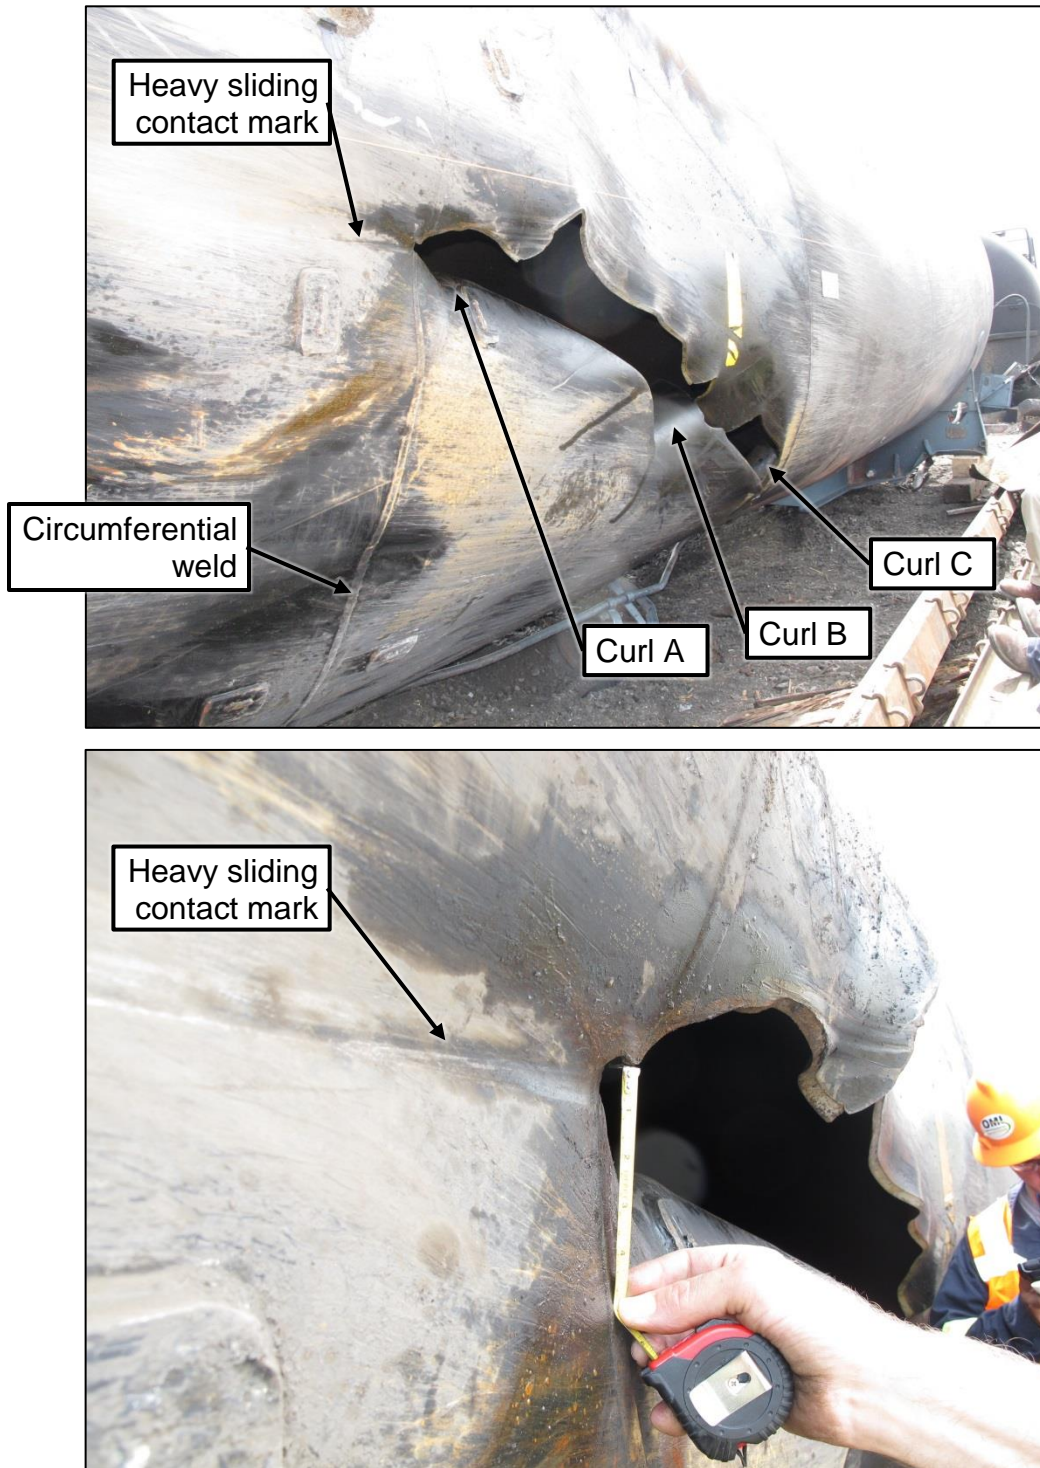
Views of the fracture origin are shown in figure 4. The fracture initiated at a location just below the tank longitudinal centerline where a longitudinally-oriented sliding contact mark intersected the B side of the circumferential weld between shell segments 2 and 3. (The tank shell consisted of 6 cylindrical segments numbered starting at the B end of the shell.) The tank shell was creased inward at the location of the sliding contact mark, consistent with relatively heavy contact compared to other longitudinal sliding contact marks in the vicinity. The smeared surface features associated with the heavy sliding contact mark was approximately 2 inches wide at the location where the mark intersected the fracture.

Figure 4. Views of the B end of the shell fracture (as viewed on scene) showing a longitudinally-oriented sliding contact mark and inward deformation at the fracture initiation.

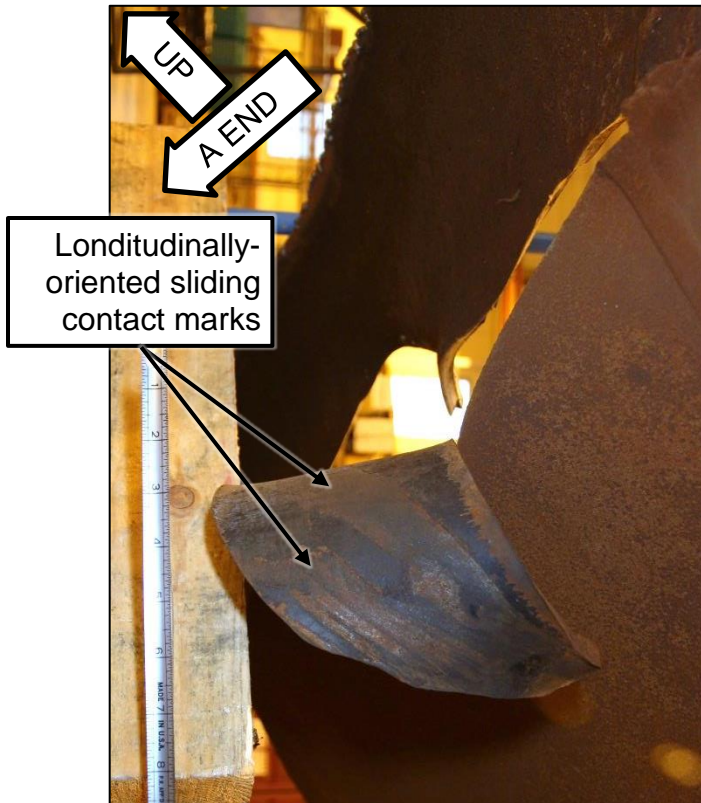
Within a foot of the fracture origin, the fracture opened to a 6.75-inch-wide opening. The shell material from the opening curled inward to form curl A attached to the shell at the lower side of the fracture opening. A view of curl A viewed from the interior surface of the shell is shown in figure 5. Longitudinally-oriented sliding contact marks including one that emanated from the end of the curl with the fracture origin were observed on the exterior surface of the curl.

Figure 5. Interior face of the fractured shell piece at curl A showing longitudinally-oriented sliding contact marks on the exterior face of the curl.

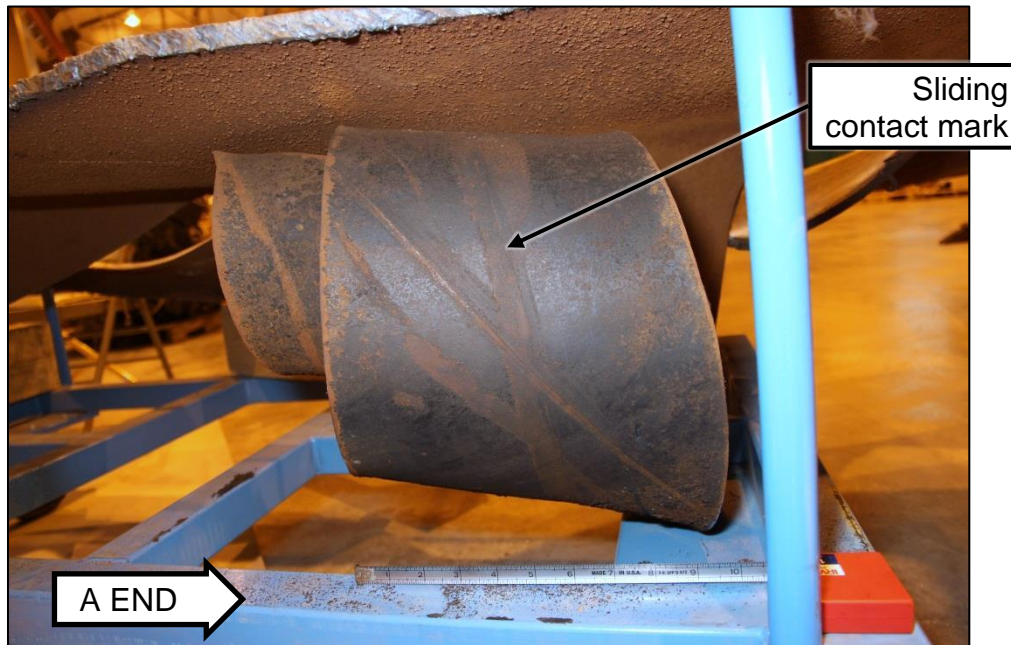
Figure 6. Interior face of the fractured shell piece looking upward showing a sliding contact mark on the exterior face of curl B approximately parallel to the fractures on either side of the curl.

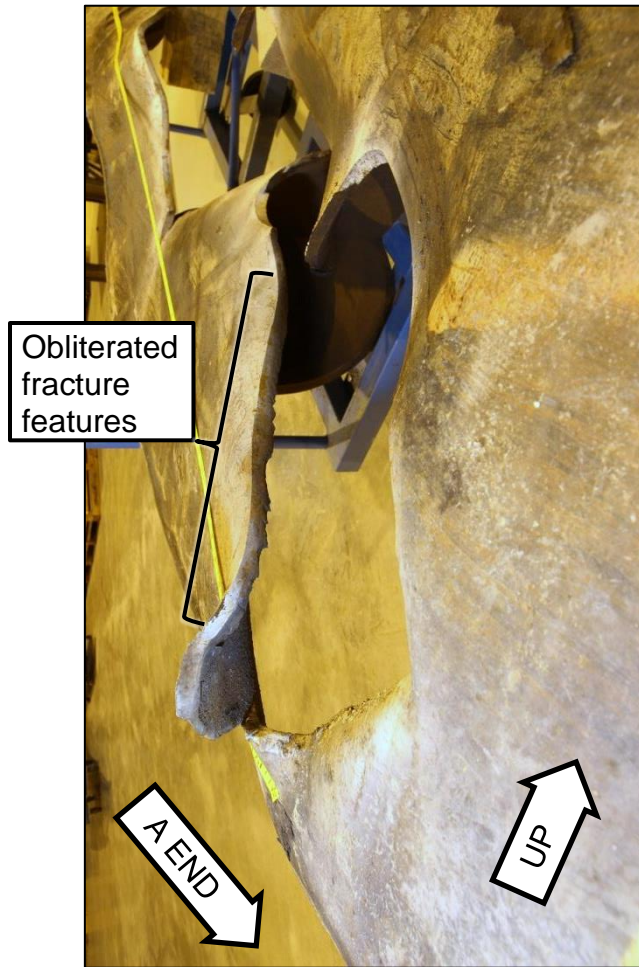
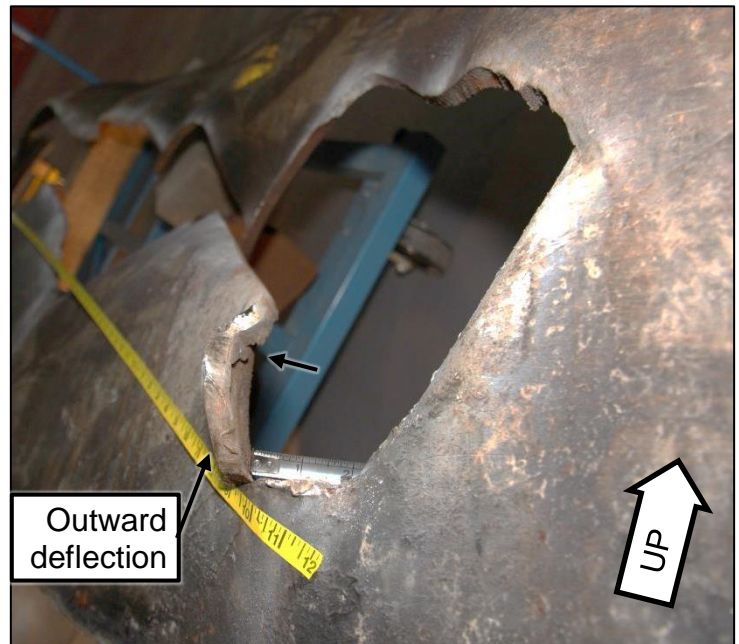
Past the overlapping fracture, the crack opened to a 7-inch-wide opening, and the material from the opening was deformed into curl C. The fracture on the lower side of the opening within this segment of the fracture was obliterated by post-fracture contact as indicated in figure 7. The fracture face was flattened consistent with heavy contact. A lip of deformed material was readily visible extending approximately 0.13 inches into the interior, and a small lip of deformed material was also visible upon close inspection at the exterior edge of the flattened fracture face.

At the B end of the fracture, the tank wall at the lower side of the fracture was bent outward as indicated in figure 7. The outward bend was associated with a fracture along 2 inches of the tank wall at the lower edge of the outward-bent material. A sharp change in the extent of deflection was observed near the upper edge of the outward-bent portion along with a change in the deformation lip at the edge of the fracture face, features consistent with contact with an edge or corner on the contacting object. An unlabeled arrow in the lower image in figure 7 points to this feature in the deformation of the shell wall, which was particularly evident when viewed looking inward toward the B end as in the lower image in figure 7.

Figure 7. Views of the B end of the shell fracture showing the obliterated fracture features on the lower fracture face (left image) and outward deflection of the shell at the end of the fracture. An unlabeled arrow in the lower image indicates a sharp change in the deformation consistent with contact with an edge or corner on the contacting object.

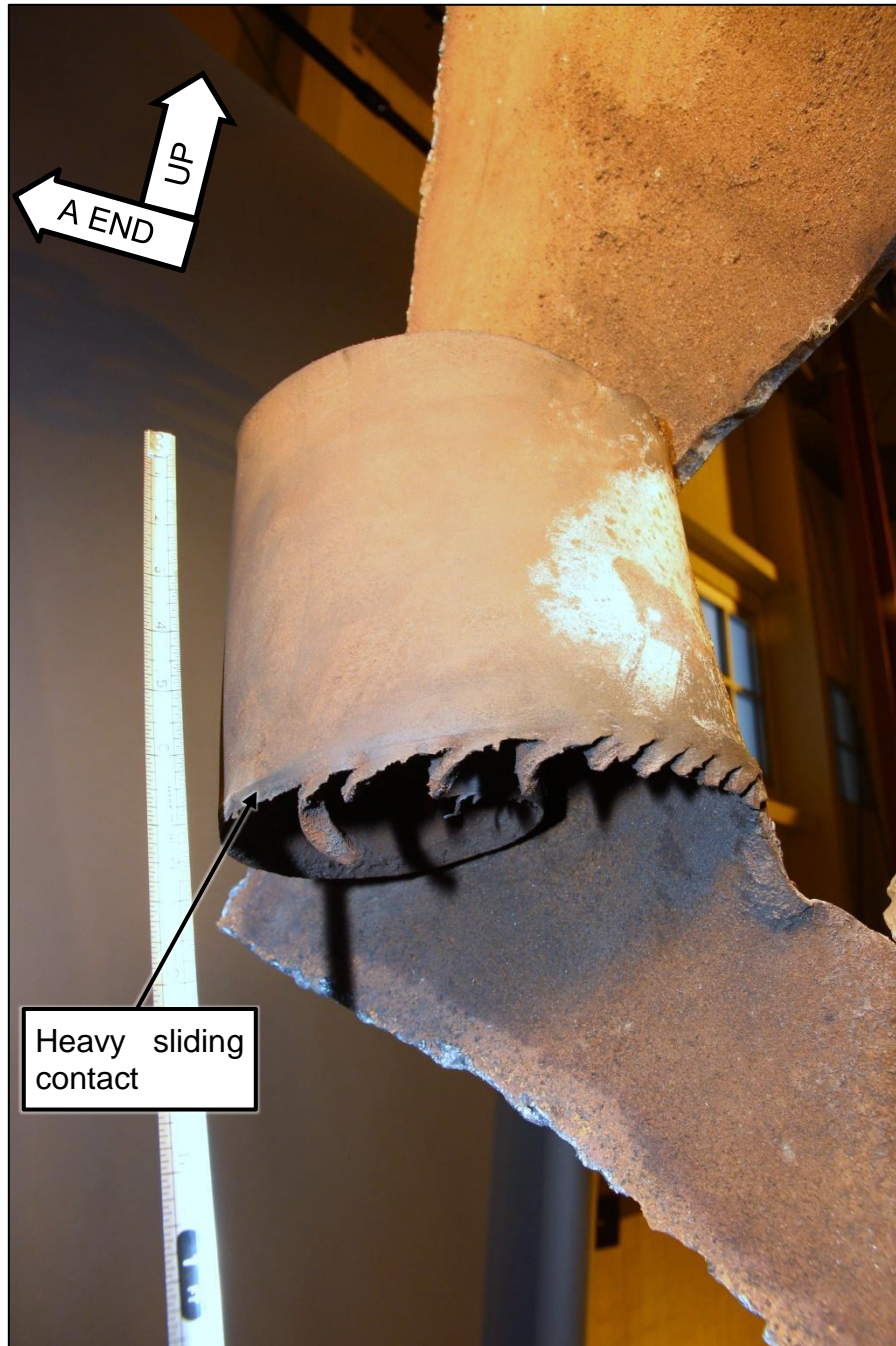
A view of curl C as viewed from the interior side of the fractured shell piece is shown in figure 8. Heavy sliding contact marks were observed on the lower edge of the curl as indicated in figure 8. Secondary fractures were also present at the lower edge of curl C, and pieces of the lower edge were curled inward in the same direction as the main curl.

Figure 8. Interior of the fractured shell piece showing curl C at the A end of the fracture. Heavy sliding contact was observed at the lower edge of the curl as indicated.

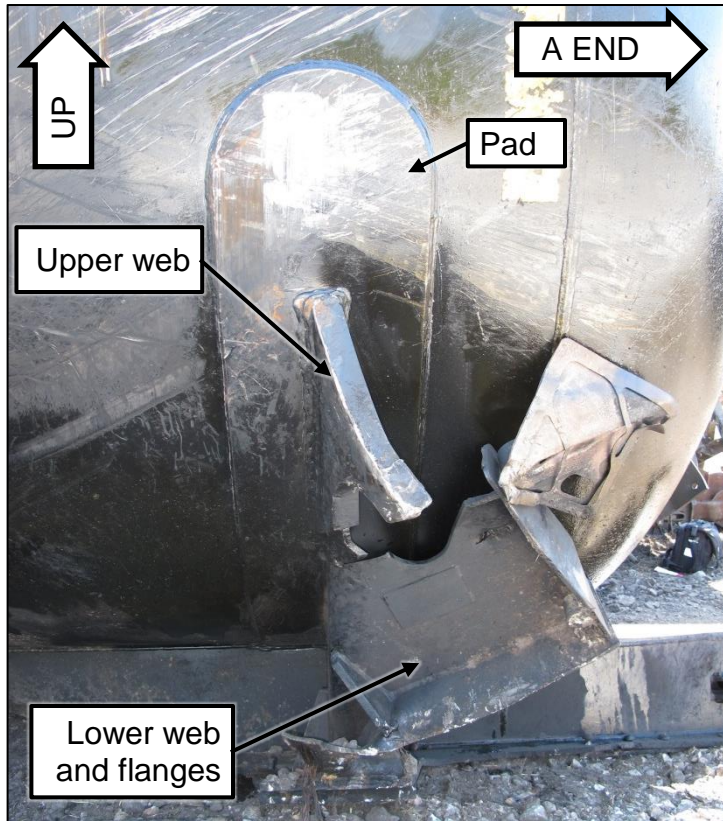
Views of the body bolster at the right side, A end of tank car CBTX 741720 as it was examined on-scene are shown in figures 9 and 10. The body bolster at the right side, B end of the tank car was intact and showed slight bending deformation with the outboard end deflecting toward the A end of the tank car. Oil was present on the exterior of the tank shell and head at the A end of the tank car.

The body bolster included an upper web section that was 2 inches thick. Thinner web and flange sections comprising the lower portion of the body bolster were welded to the lower side of the upper web piece. The lower web and flanges were fractured from the upper web piece and the web was bent such that the outboard end deflected toward the A end of the tank car. The upper web was also bent such that the outboard end was deflected toward the A end of the tank car.

Figure 9. Overall view of the damage to the A-end body bolster on the right side of tank car CBTX 741720.

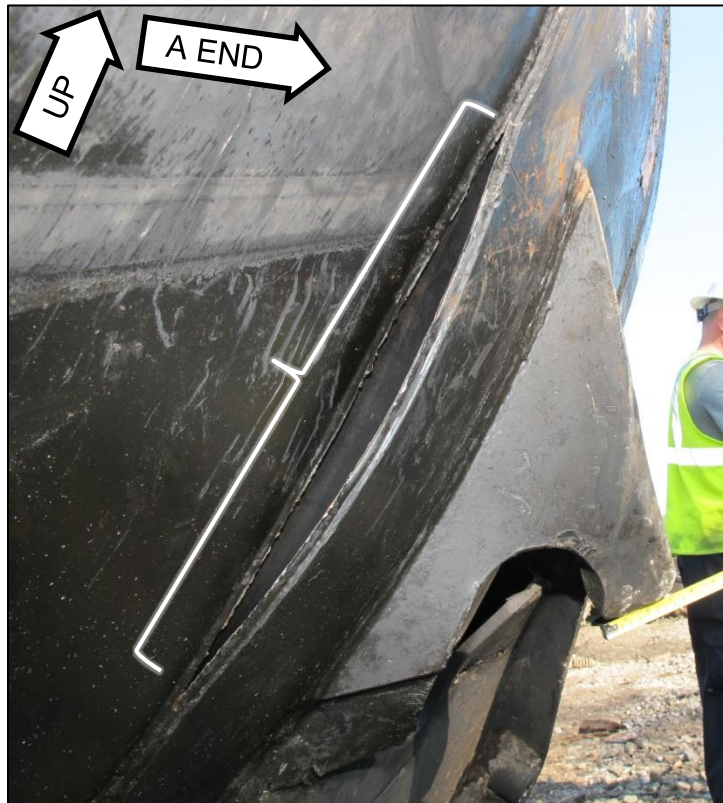
The pad was fractured from the shell through a portion of the body bolster pad weld at the B side of the pad as shown in figure 10. The tank shell was intact, but was deformed slightly inward adjacent to the pad edge weld fracture. The pad was also

deformed slightly outward between the ends of the edge weld fracture. An angled sliding contact mark was observed in the area of the tank shell deformation.

Figure 10. The weld at the B side of the body bolster pad was fractured in the area indicated with an unlabeled bracket.

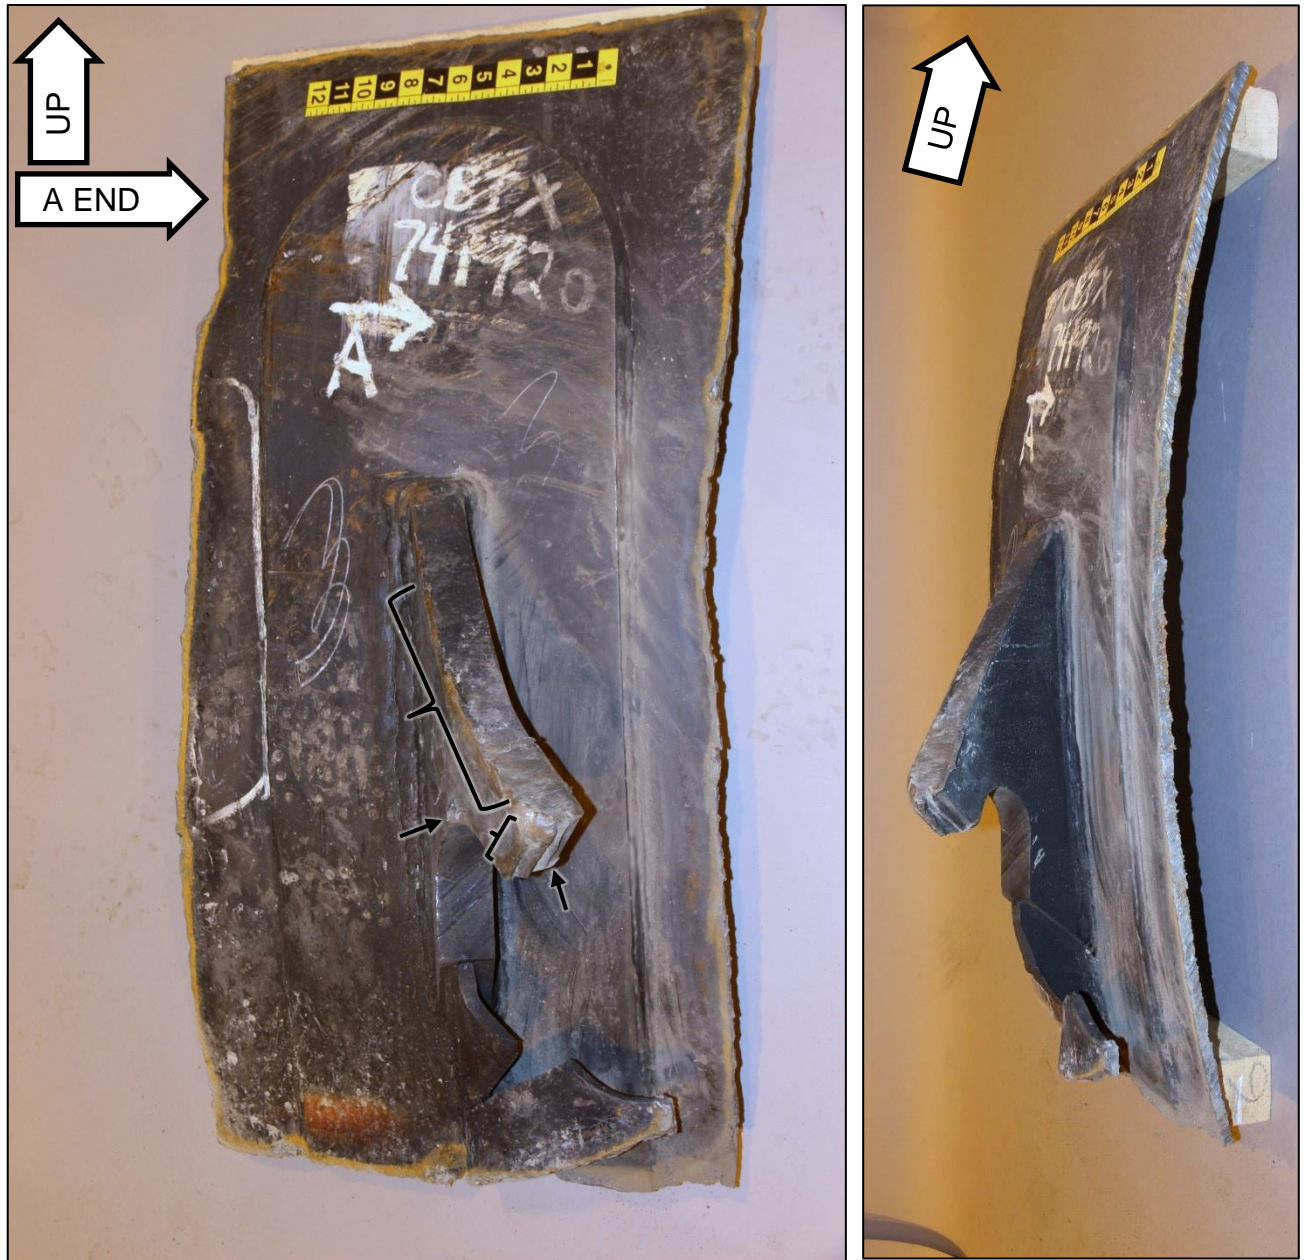
The upper web portion of the body bolster with attached pieces of the body bolster pad and tank shell was cut from tank car CBTX 741720. Views of the cut body bolster piece as-received at the NTSB Training Center are shown in figure 11. Relatively heavy sliding contact marks associated with deformed edges of the web were observed in multiple locations of the upper web piece as indicated with unlabeled brackets and arrows in figure 11. Sliding contact marks with deformed edges were observed at the edge formed by the intersection of the upper face and the B face (larger unlabeled bracket in figure 11) with contact marks continuing onto the B face. The outermost corner of the upper web on the B side (corner between the two brackets in figure 11) showed the greatest deformation and sliding contact damage. The edge between the lower face and the B face of the upper web (smaller unlabeled bracket in figure 11) was also deformed from sliding contact with another object. The inboard corner at the lower end of the web on the A side of the web was deformed (right unlabeled arrow in figure 11), and contact marks with deposited metal shavings were present on the B side near the upper end of the hoist hole (left unlabeled arrow in figure 11).

Figure 11. Views of the piece cut from tank car CBTX 741720. Unlabeled arrows and brackets indicate locations of sliding contact marks with edge deformation.

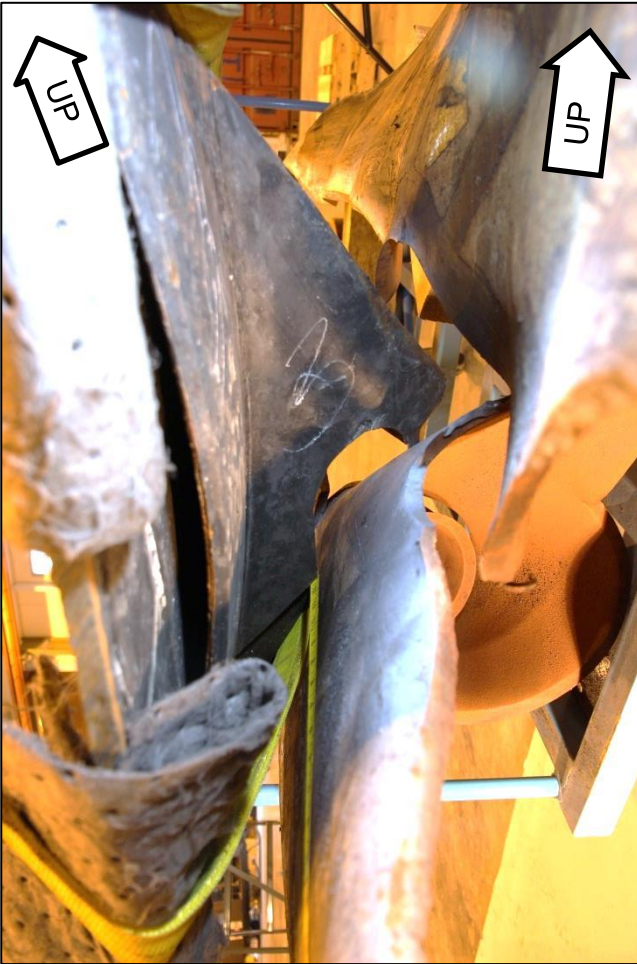
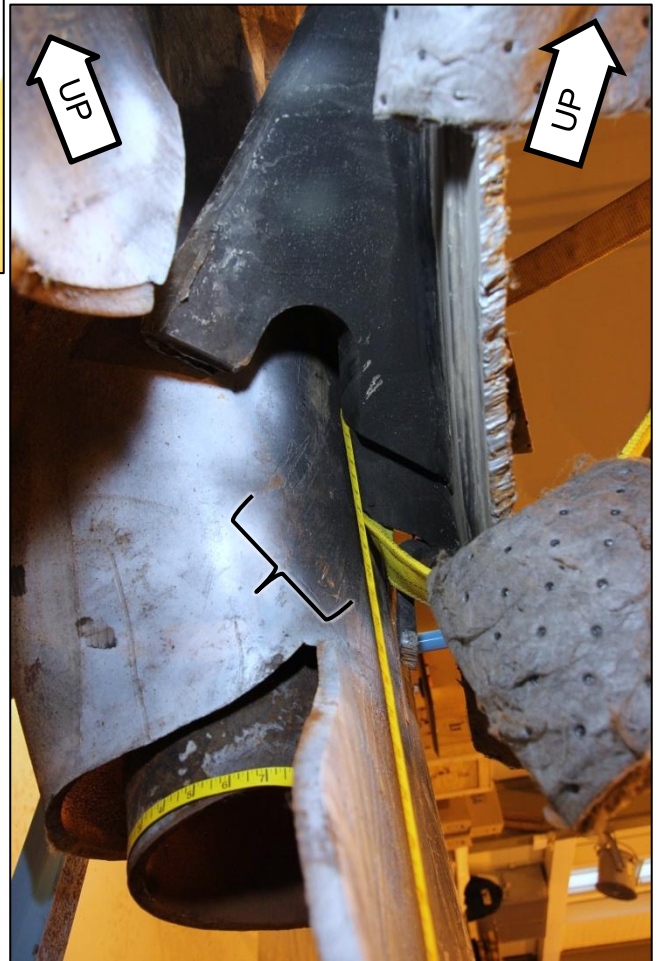
Figure 12 shows two views with the bolster upper web from the bolster piece placed in close proximity to curl B on the fractured shell piece. An unlabeled bracket indicates a series of sliding contact marks that appeared to initiate near the base of curl B near the lower side. The sliding marks were aligned with the general direction of the shell fracture toward the A end and downward.

Figure 12. Views showing the bolster piece in close proximity to curl B in the shell fracture looking toward the B end of the fractured shell piece (upper image) and in the opposite direction looking downward and toward the A end of the fractured shell piece (image at the right). A bracket indicates sliding contact marks that appeared to initiate near the base of curl B.

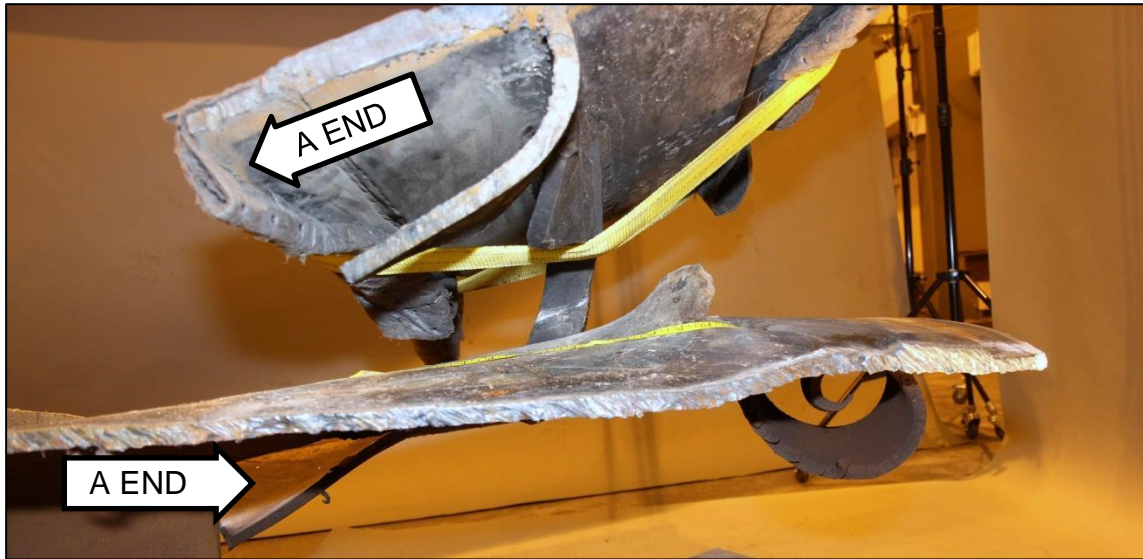
Figures 13 through 15 show the bolster piece in close proximity to the shell fracture in the area of the fracture between curl B and curl C. In figures 13 and 14, the A side inboard corner of the bolster upper web (right unlabeled arrow in figure 11) is

shown contacting the obliterated fracture surface on the lower side of the shell fracture (bracketed are in figure 7). In figure 15, the bolster piece is shown closer to the fractured shell piece, where the area of the bolster web with deposited metal shavings on the B side near the upper end of the hoist hole (left unlabeled arrow in figure 11) is shown in close proximity to the obliterated fracture surface on the lower side of the shell fracture.

Figure 13. Tank car pieces shown in close proximity near the A end of the shell fracture.

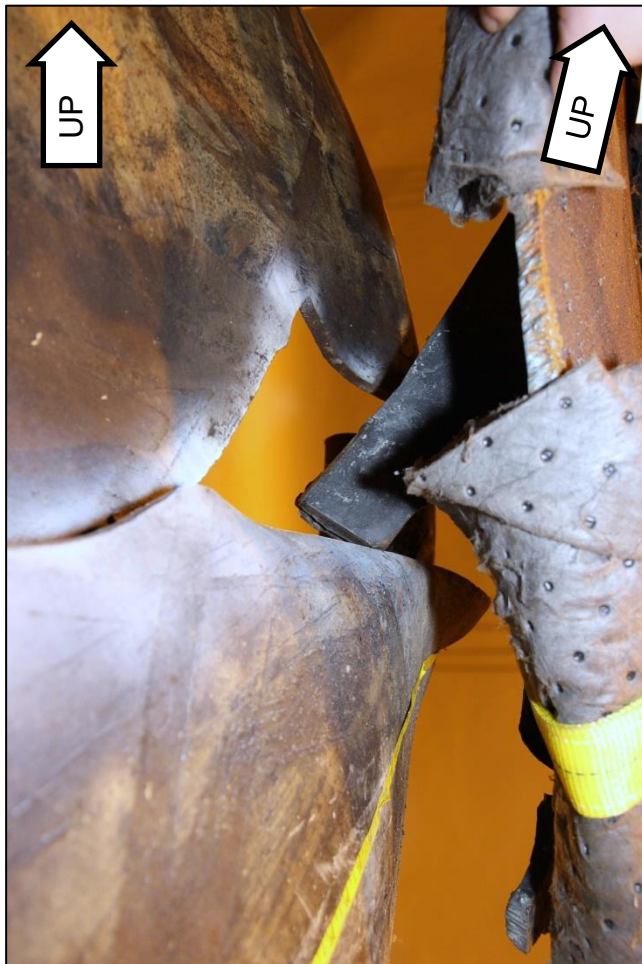
Figure 14. View looking toward the A end of the fractured shell piece and the B end of the bolster piece with the pieces shown in close proximity in the position shown in the previous figure.

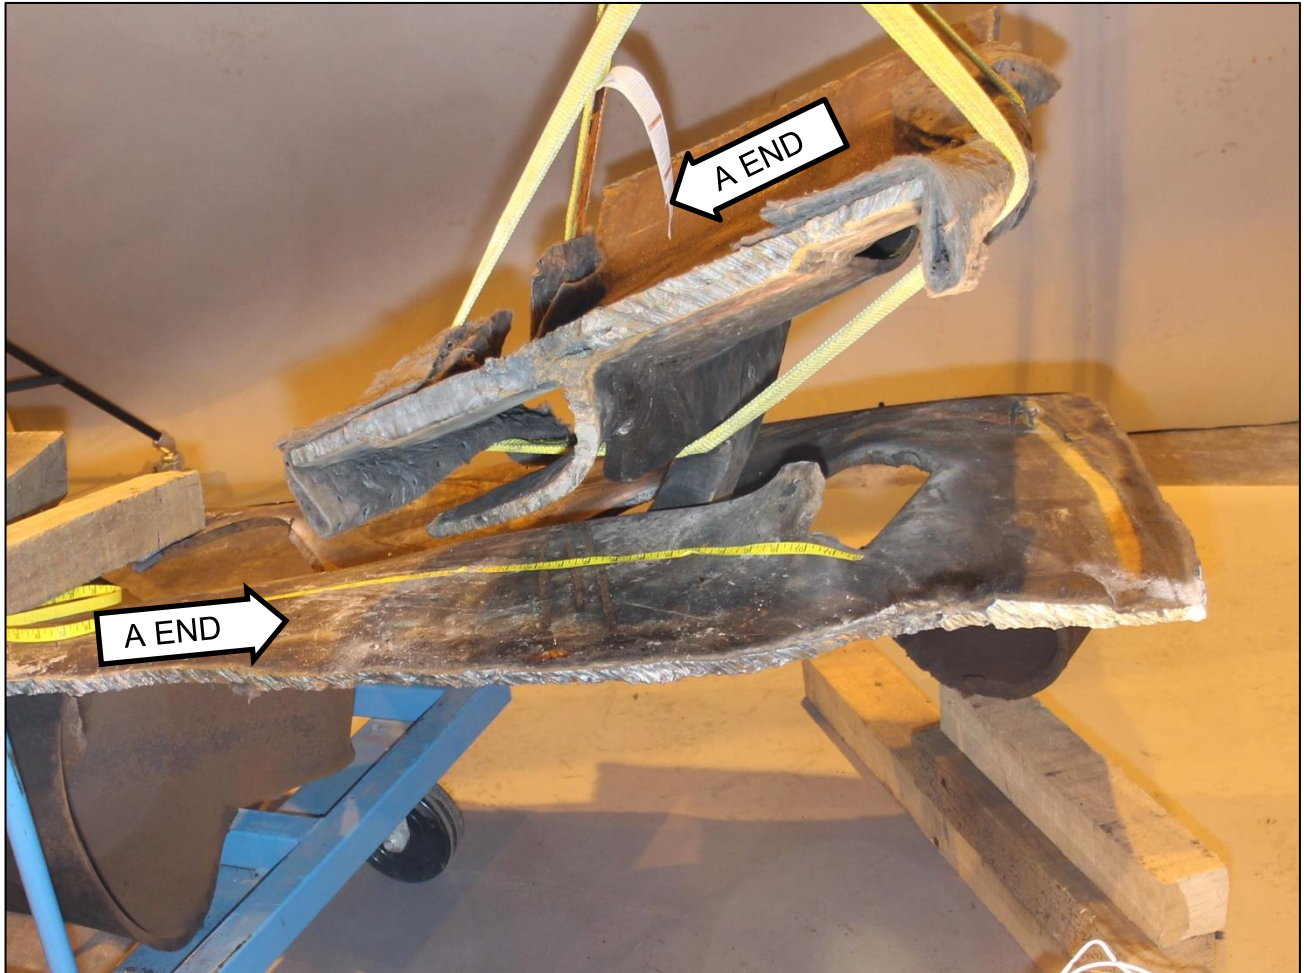
Figure 15. Another view looking upward showing the pieces in close proximity near the A end of the shell fracture with the bolster web piece positioned closer to the fractured shell piece.

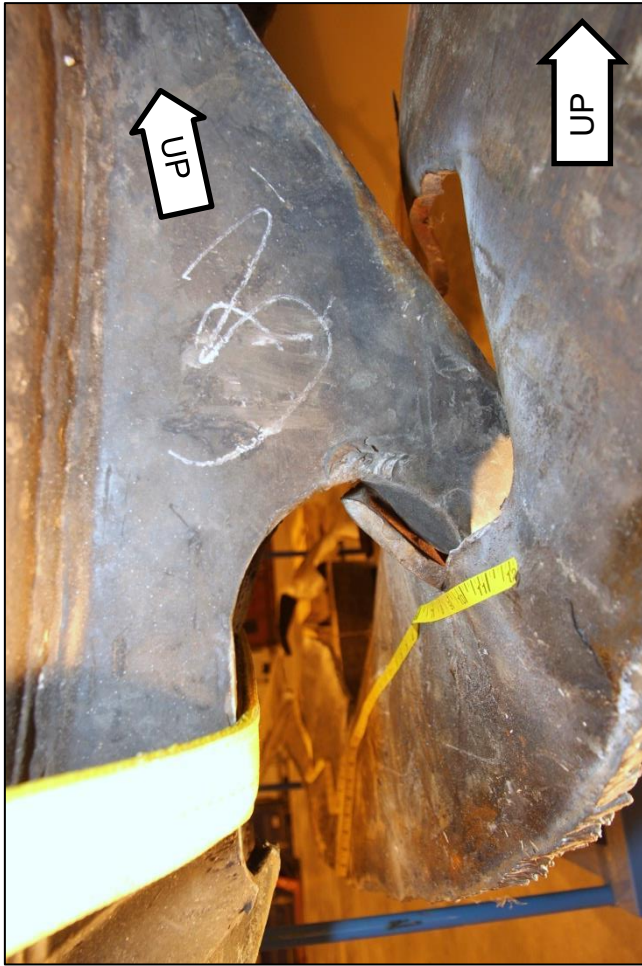
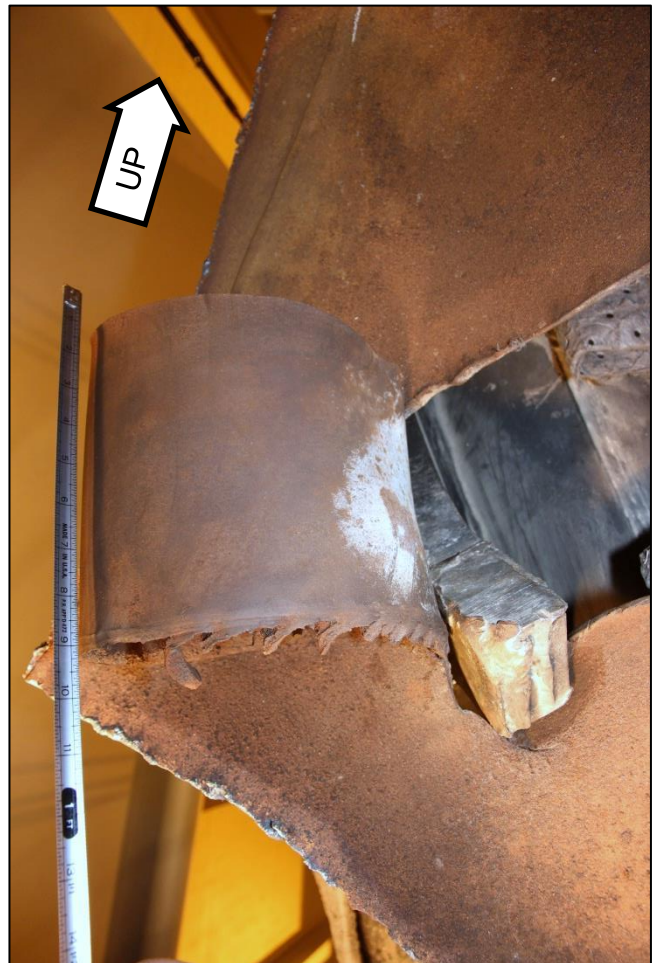
Figures 16 through 18 show images with the body bolster upper web placed in close proximity to curl C on the fractured shell piece. In figures 16 and 17, the bolster piece is shown closer to the fractured shell piece, where the area of the bolster web with deposited metal shavings is shown in close proximity to the obliterated fracture surface on the lower side of the shell fracture. In figures 18 and 19, the bolster piece is shown positioned slightly further from the fractured shell piece with the lower outboard end of the bolster upper web positioned within the area where the shell was deformed outward on the fractured shell piece.

Figure 16. Views of the fractured shell piece and the bolster piece in close proximity at the A end of the fracture as viewed from the exterior looking toward the B end of the fractured shell piece (image above) and from the interior looking toward the A end of the fractured shell piece (image to the right).

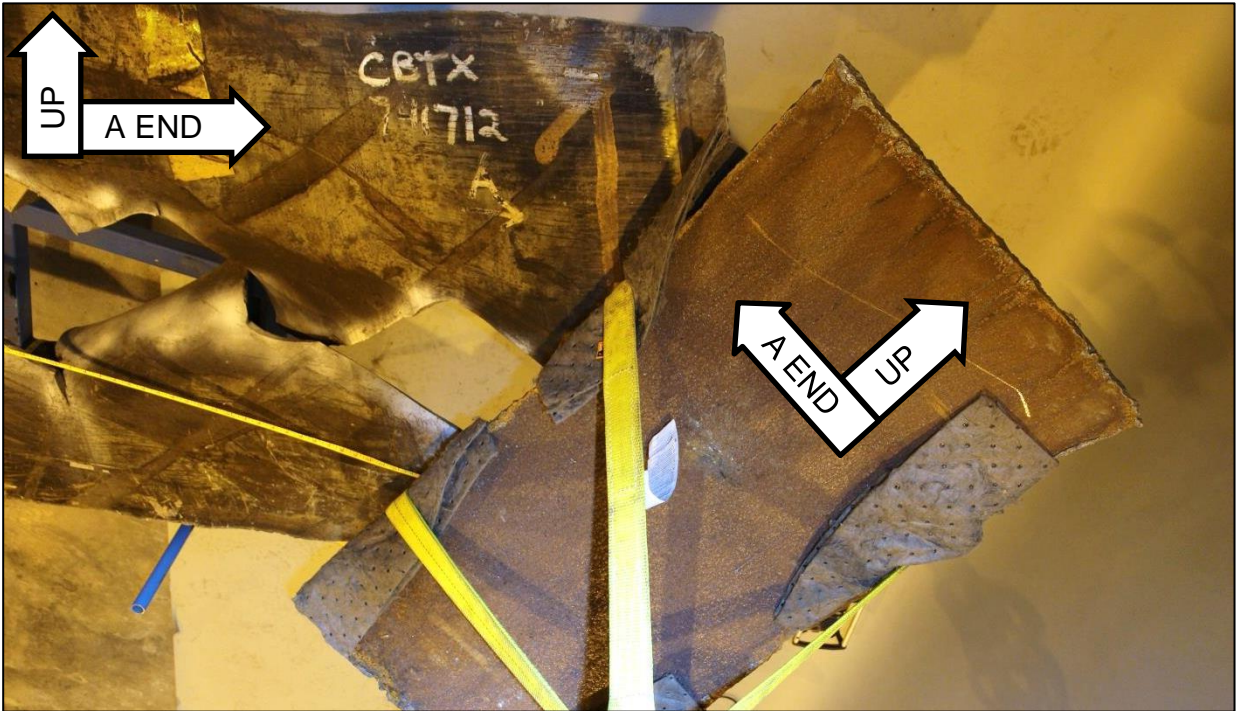
Figure 17. Overall view of the pieces in the positions shown in the previous figure showing the relative shell orientations.
