NATIONAL TRANSPORTATION SAFETY BOARD

MATERIALS LABORATORY FACTUAL REPORT

Report No. 15-018

Place : Lynchburg, Virginia
Date : April 30, 2014
Vehicle : CSX train KO8227
NTSB No. : DCA14FR008
Investigator : Paul Stancil, RPH-20

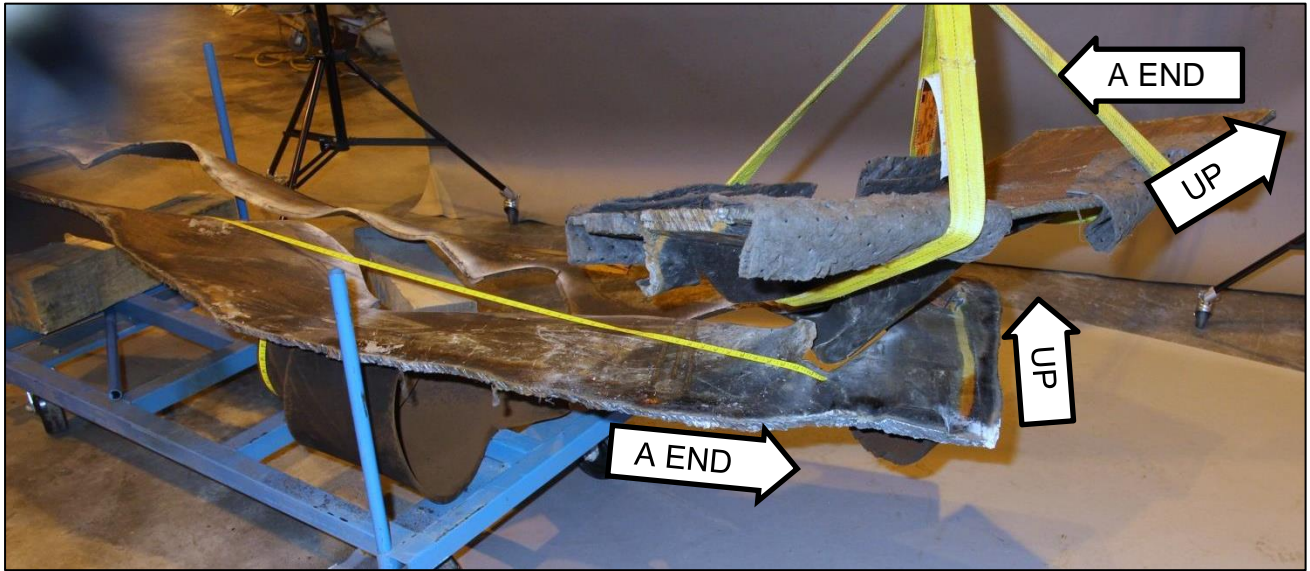
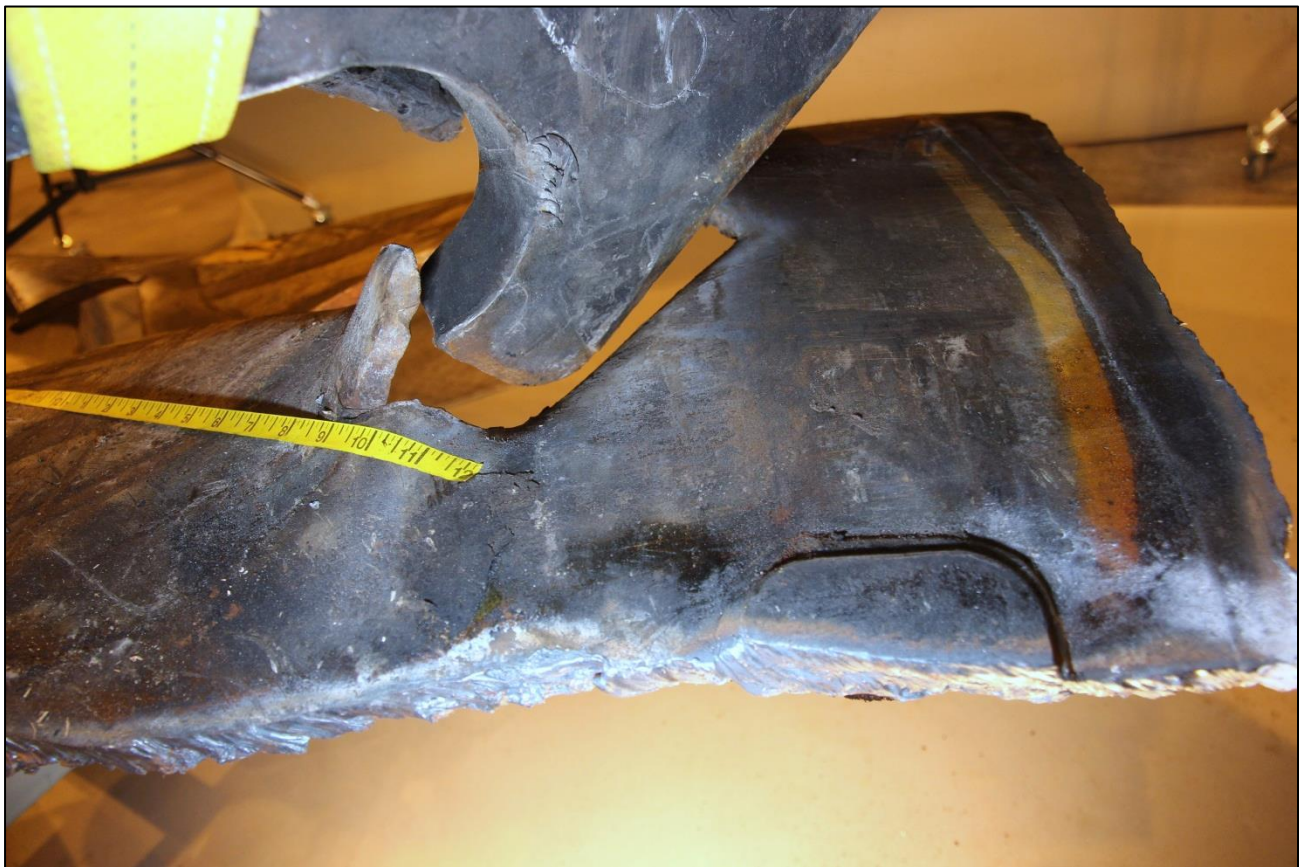
Figures 16 through 18 show images with the body bolster upper web placed in close proximity to curl C on the fractured shell piece. In figures 16 and 17, the bolster piece is shown closer to the fractured shell piece, where the area of the bolster web with deposited metal shavings is shown in close proximity to the obliterated fracture surface on the lower side of the shell fracture. In figures 18 and 19, the bolster piece is shown positioned slightly further from the fractured shell piece with the lower outboard end of the bolster upper web positioned within the area where the shell was deformed outward on the fractured shell piece.

Figure 18. Views of the fractured shell piece and the bolster piece shown in close proximity with the bolster piece positioned near the A end of the shell fracture as viewed looking upward relative to the fractured shell piece.
