NATIONAL TRANSPORTATION SAFETY BOARD

MATERIALS LABORATORY FACTUAL REPORT

Report No. 15-020

Place : Penwell, Texas
Date : January 14, 2015
Vehicle : TX Dept. of Criminal Justice Inmate Transport Bus
NTSB No. : HWY15MH004
Investigator : Peter Kotowski, HS-20

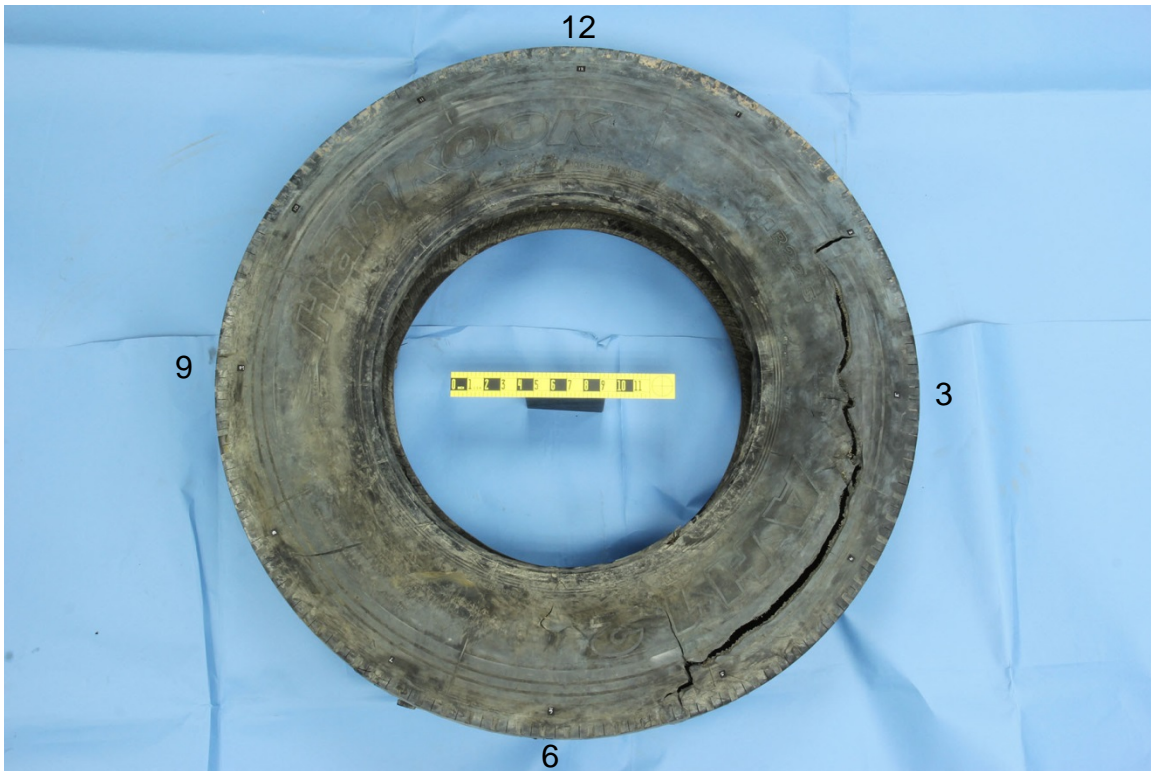
The tire was received by the NTSB Materials Laboratory as shown in figure 1. The tire was manufactured by Hankook and was an AH12 model tire. The tire identification number (TIN) was displayed on the outboard sidewall of the tire and was DOT BB3T PKH 4813, which indicated that the tire was manufactured in 48th week of 2013. Other notable markings on the tire were as follows:

The “O” in “DOT” on the full TIN-side of the tire (outboard-facing side) was used for establishing reference clock positions on the tire, as indicated in figure 1, with 12:00 starting at the “O” and proceeding clockwise. Photographs of the outboard sidewall, tread, and inboard sidewall were taken at each clock position and are included in Appendices A – C. Visual examination indicated that there was a circumferential tear in the outboard sidewall of the tire from approximately the 2:00 position to the 5:00 position, as shown in figure 1. Closer examination revealed two additional features between 3:00 and 4:00 (centered approximately at 3:15), as shown in figures 2a and 2b. The first feature was a circular hole that measured 5/8 inch in diameter. The second feature was a triangular gouge approximately 1 inch across located approximately 3 inch clockwise from the hole.

Figure 1: The outboard sidewall of the left front tire. The indicated clock positions are referenced off of the "O" in "DOT", part of the tire identification number.

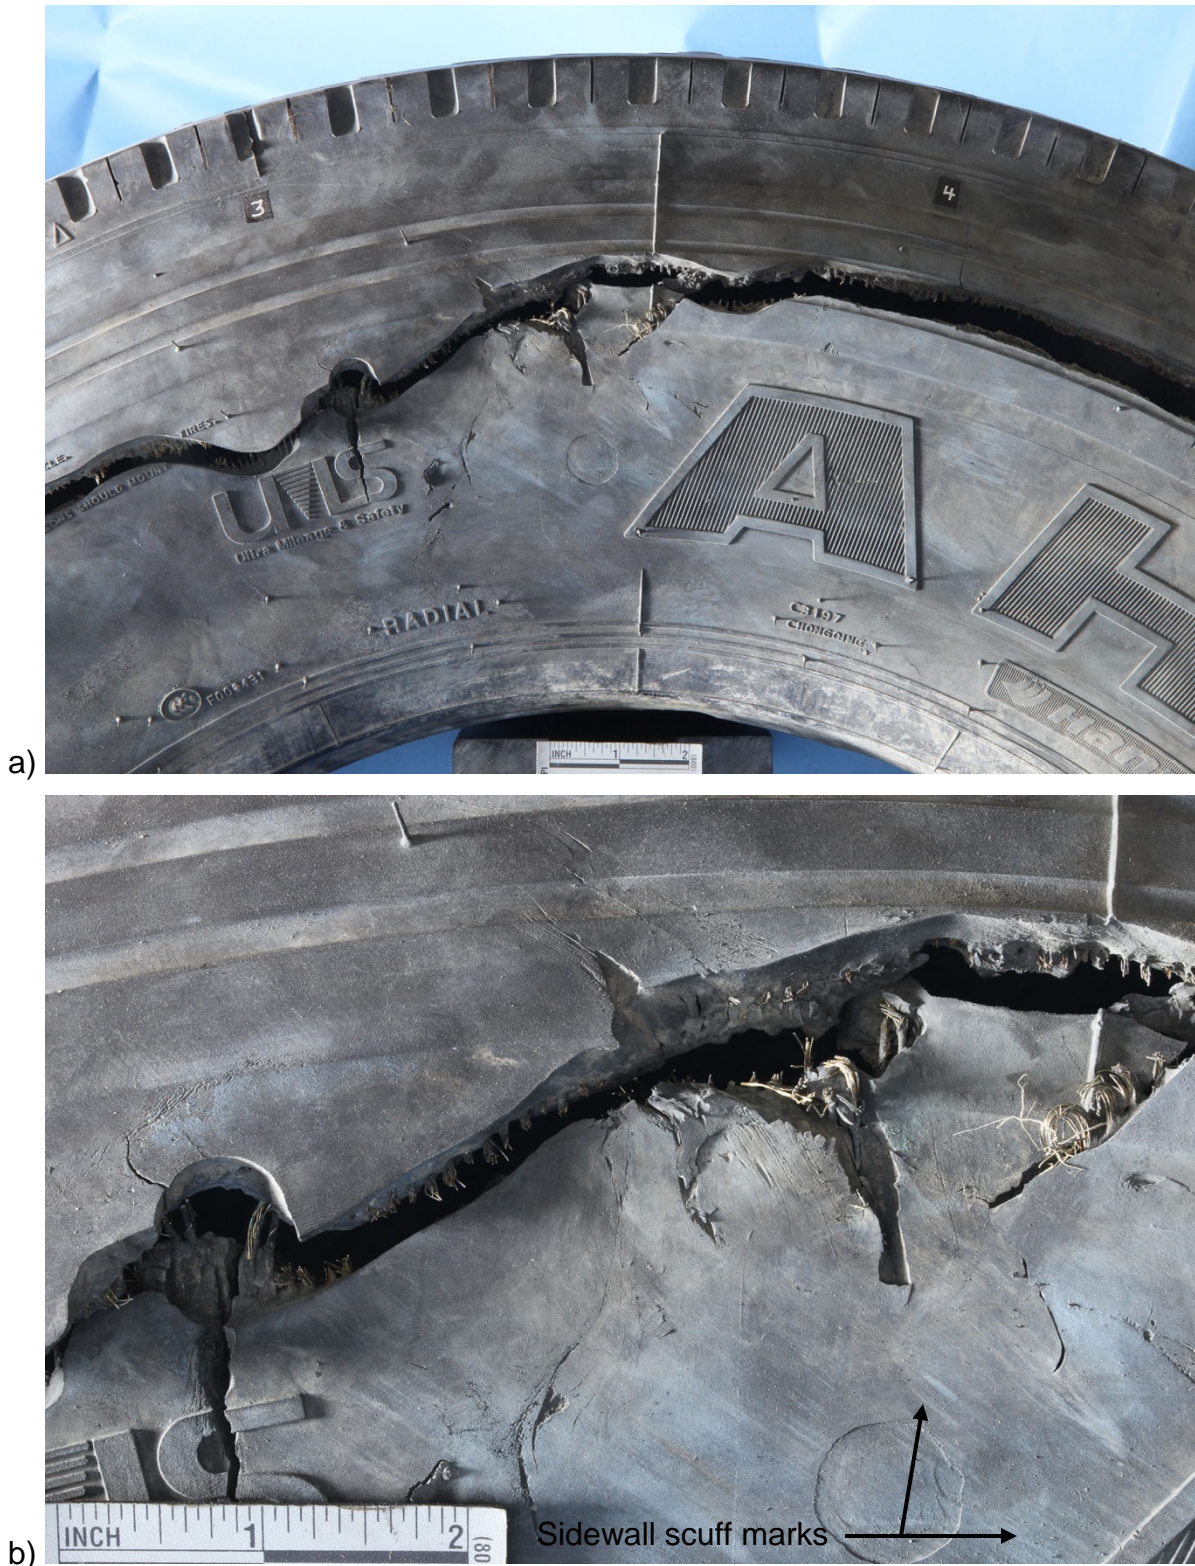
Light-colored scuff marks were observed on the sidewall of the tire radially inward and clockwise of the hole and triangular gouge, several of which are indicated in figure 2b. The composition of the light-colored material was determined by pressing a piece of carbon tape into the marks and pulling the tape off, which lifted a sample of the material off of the tire. The sample was examined using a scanning electron microscope equipped with energy dispersive spectroscopy (EDS). The resulting spectrum is shown in figure 3. The elements that were detected included titanium (Ti), iron (Fe), oxygen (O), aluminum (Al), silicon (Si), and Calcium (Ca).

Figure 2: a) The outboard sidewall of the left front tire between 3:00 and 4:00 and b) higher magnification image of two notable features at approximately the 3:15 position: a round hole, approximately 5/8 inch in diameter and a triangular gouge, approximately 1 inch across.

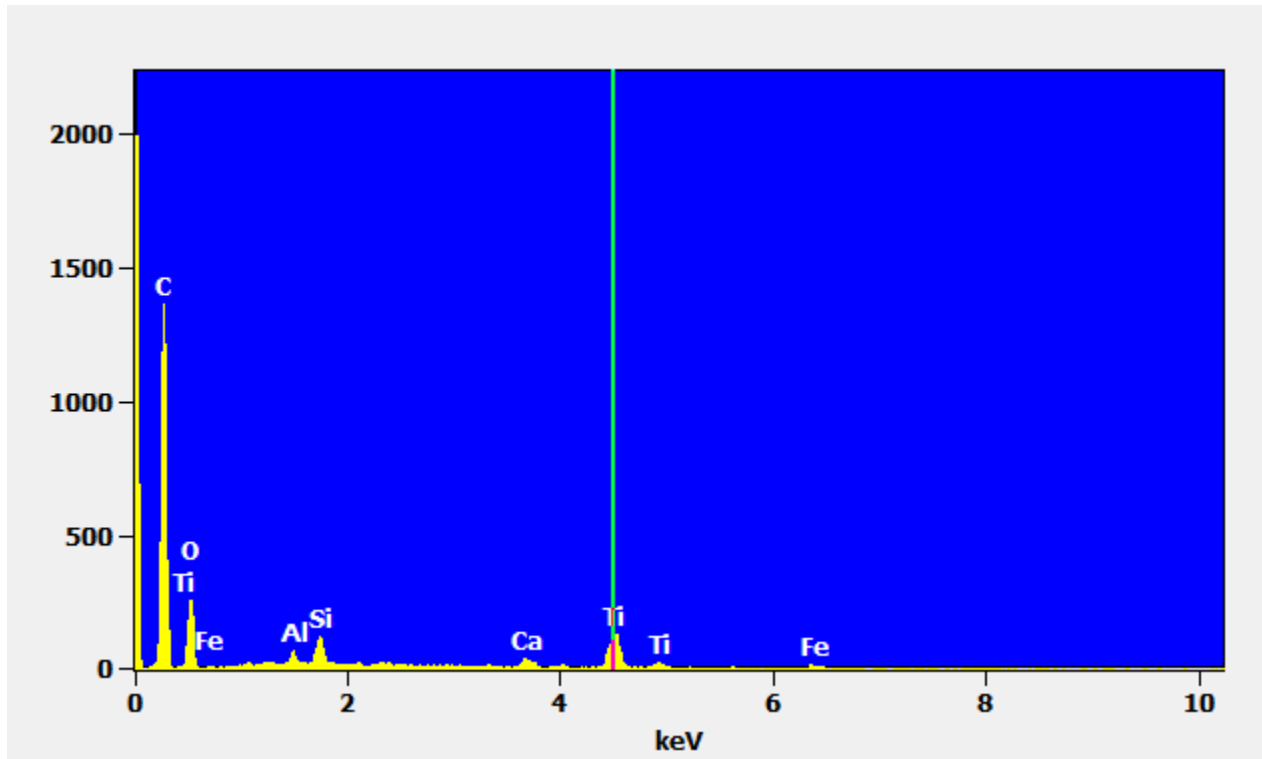
Figure 3: Energy dispersive spectroscopy spectrum from material lifted off of scuff marks on the sidewall of the tire.

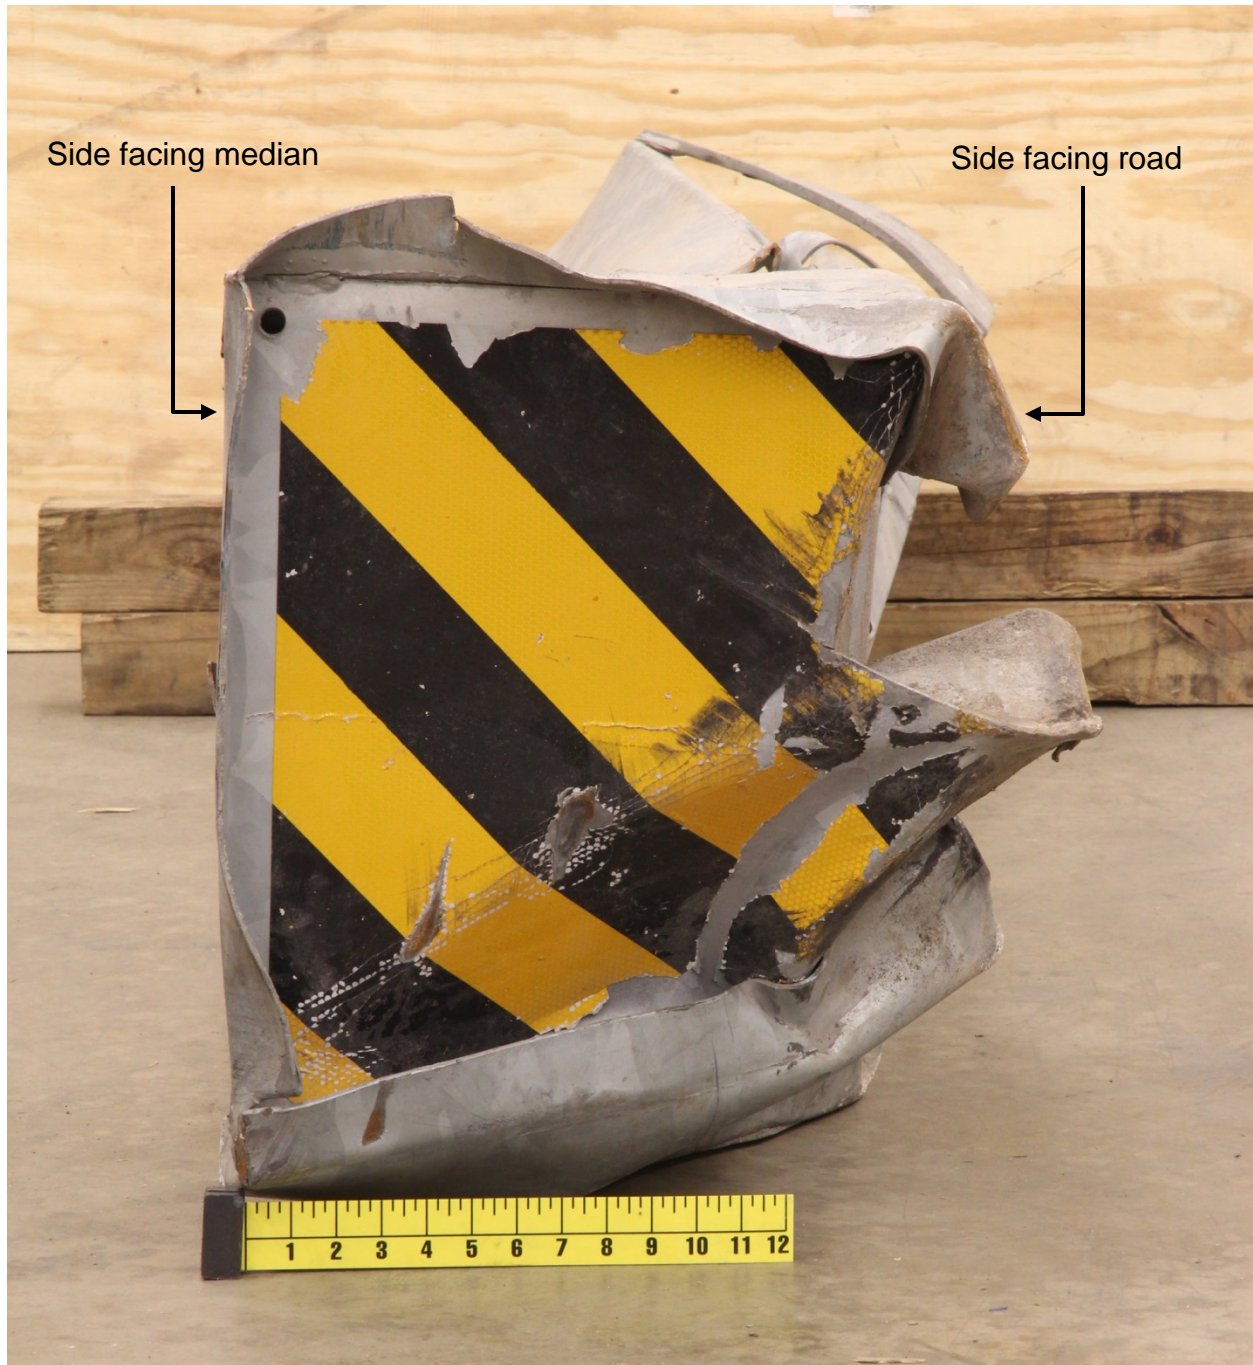
The guardrail end treatment was received by the laboratory as shown in figures 4 and 5. The end treatment was struck and damaged by a motor vehicle the day prior to the accident and was set in the median adjacent to the shoulder as shown in figure 6a. The guardrail was positioned and photographed in the lab at an angle similar to the photograph taken in the field as shown in figure 6b.

Figure 4: End view of the guardrail end treatment.

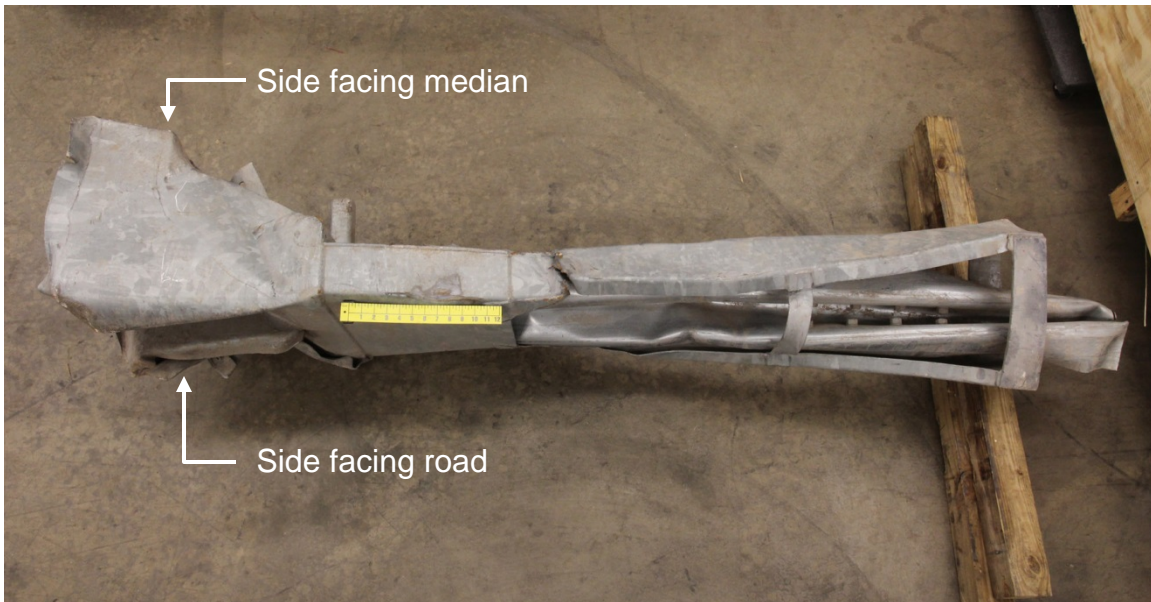
Figure 5: Top down view of the guardrail end treatment.

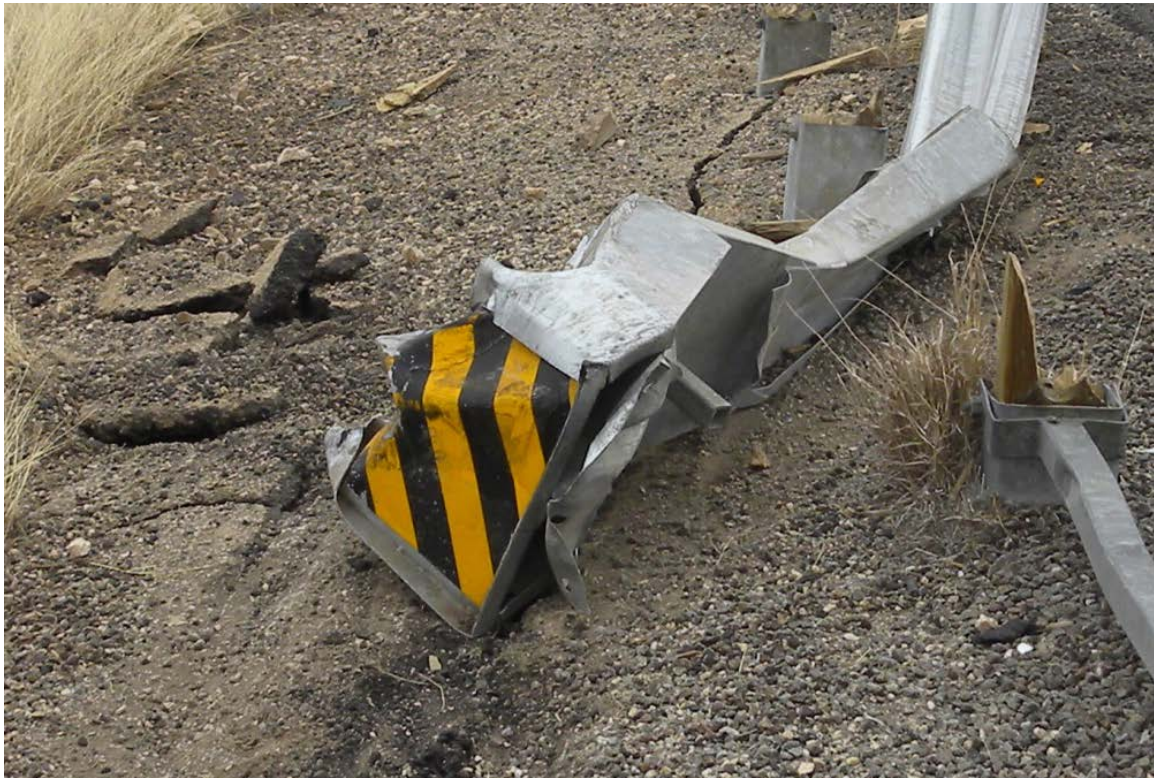
Figure 6: a) Image of the guardrail end treatment taken the day before the accident after it was struck by a motor vehicle and moved off of the shoulder of the road and b) image of the end treatment in the lab oriented and photographed at a similar angle as the image in part a).

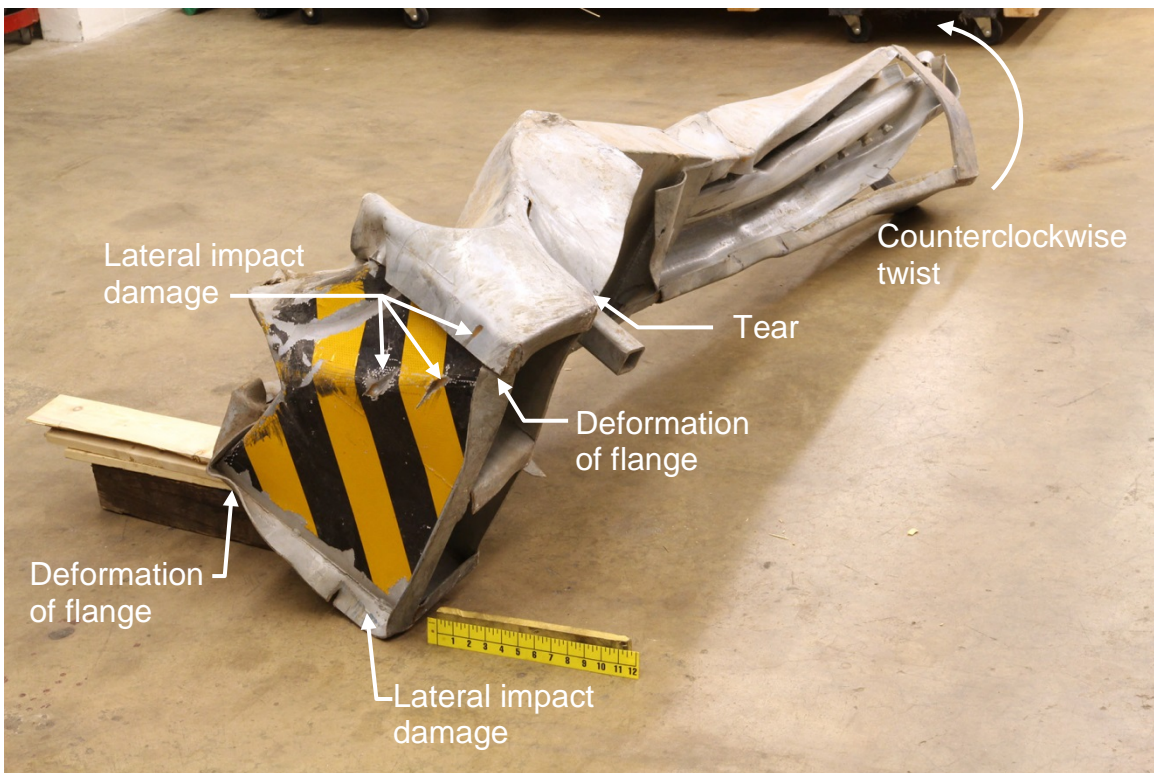
b)

Additional deformation and damage to the end treatment, as indicated in figure 6b, was observed by comparing the two photographs. There were multiple lateral impact damage marks on the face of the end treatment and deformations to the flange around the perimeter of the face, as indicated in figure 6b. There was also a counterclockwise twist to the end treatment, consistent with torsional deformation, and a tear in the sheet metal behind the head of the end treatment.

The end treatment was examined for features with a similar size and spacing as the features that were observed on the sidewall of the tire (described previously) but none were found.
