# NATIONAL TRANSPORTATION SAFETY BOARD

MATERIALS LABORATORY FACTUAL REPORT

Report No. 15-059

Place : Bellevue, Tennessee  
Date : February 3, 2014  
Vehicle : Gulfstream Commander 690C, N840V  
NTSB No. : ERA14FA112  
Investigator : Luke Schiada, AS-ERA

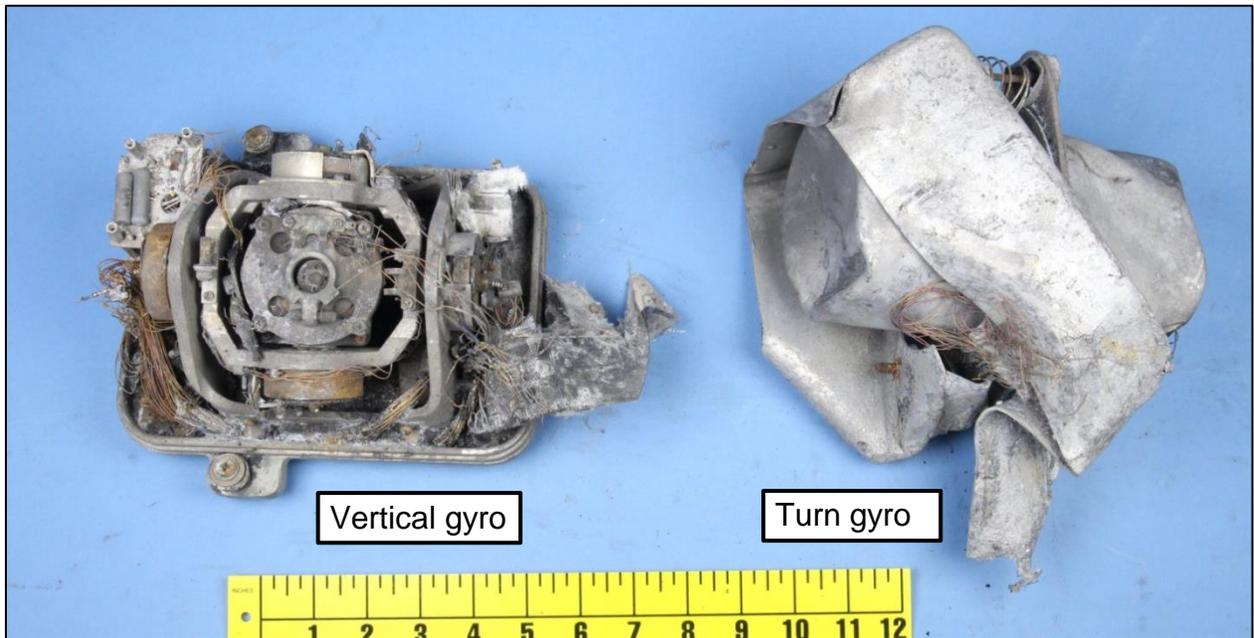
An overall view of the submitted gyros as received is shown in figure 1. Both components showed damage consistent with impact and exposure to fire. The cover from the vertical gyro was missing. A data plate was located on the base of the vertical gyro that indicated it was a Collins Avionics Divisions/Rockwell International Type 332D-11T vertical reference unit, Collins part number 622-4565-002, serial number 4661. No data plate was located on the turn gyro. According to installation drawings for the accident airplane, the airplane was to be equipped with one Collins 332D-11T gyro and two Sperry C-14 directional gyros.

Figure 1. Overall view of the submitted gyros as received.

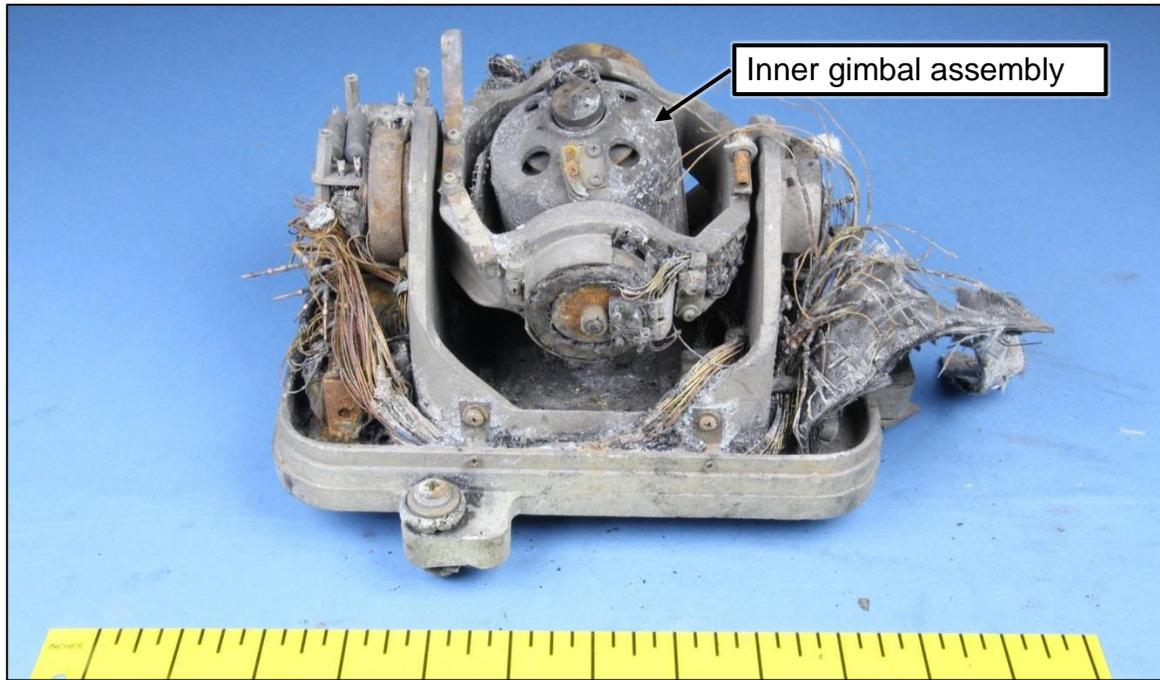
Views of the vertical gyro with the inner gimbal assembly rotated in different positions are shown in figures 1 and 3. The stator shaft was displaced toward the left end of the inner gimbal assembly such that the right end plug was disengaged from the threads of the housing cover toward the interior of the inner gimbal assembly, and the

Figure 4. View of the vertical gyro with the inner gimbal assembly rotated approximately 180 degrees from the position shown in figure 1.

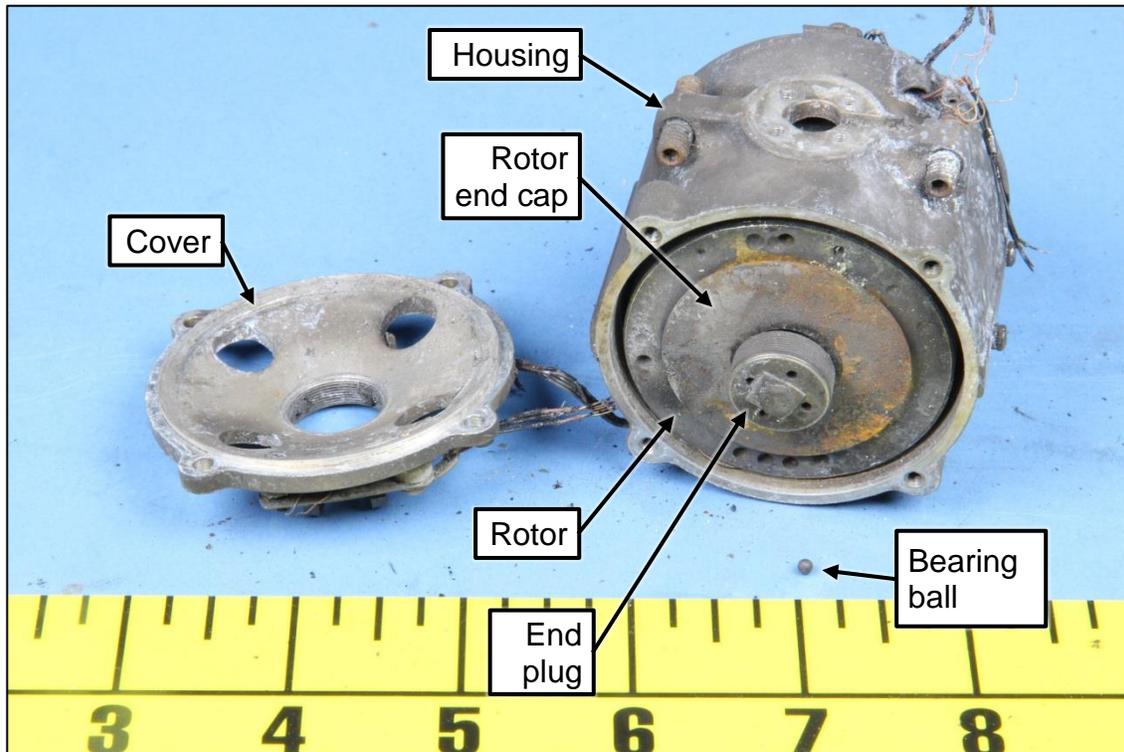
The inner gimbal assembly was removed from the rest of the unit, and then the housing cap was unscrewed from the housing. Figure 4 shows the inner gimbal assembly after it was disassembled from the rest of the unit and after the housing cover was removed to show the rotor assembly. As indicated in figure 4, a bearing ball fell out of the inner gimbal assembly as it was disassembled.

Figure 3. Inner gimbal assembly of the vertical gyro after removing the inner gimbal housing cover. A bearing ball that fell out when the cover was removed is also shown in the upper image.

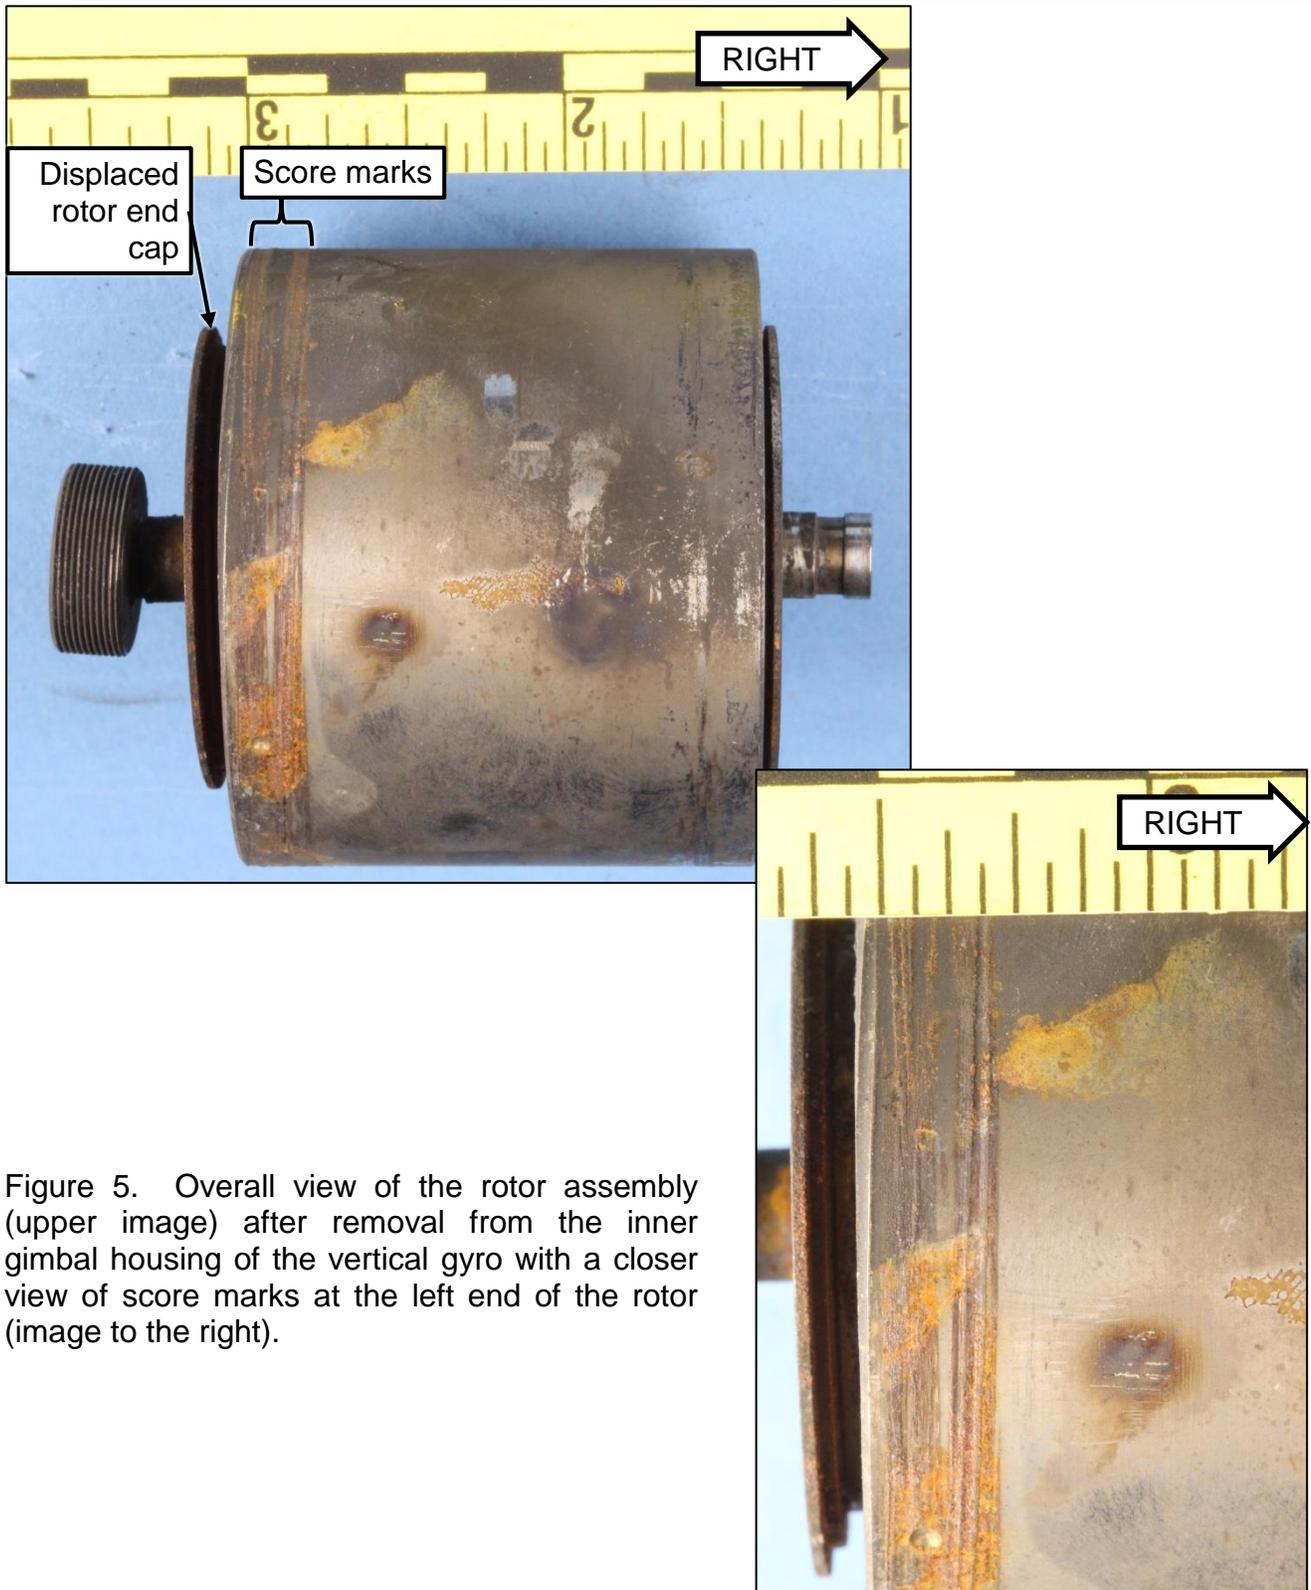
Figure 5 shows the rotor assembly after it was removed from the gimbal housing. The rotor end cap at the left end of the assembly was displaced from the rotor end surface. The axial distance of the displacement was between 0.047 inch and 0.068 inch. The rotor end cap at the opposite end of the rotor was not displaced, positioned tight against the rotor. Circumferential scoring was observed on the outer diameter of the rotor near the left end of the rotor as indicated with a bracket in figure 5.

Figure 5. Overall view of the rotor assembly (upper image) after removal from the inner gimbal housing of the vertical gyro with a closer view of score marks at the left end of the rotor (image to the right).

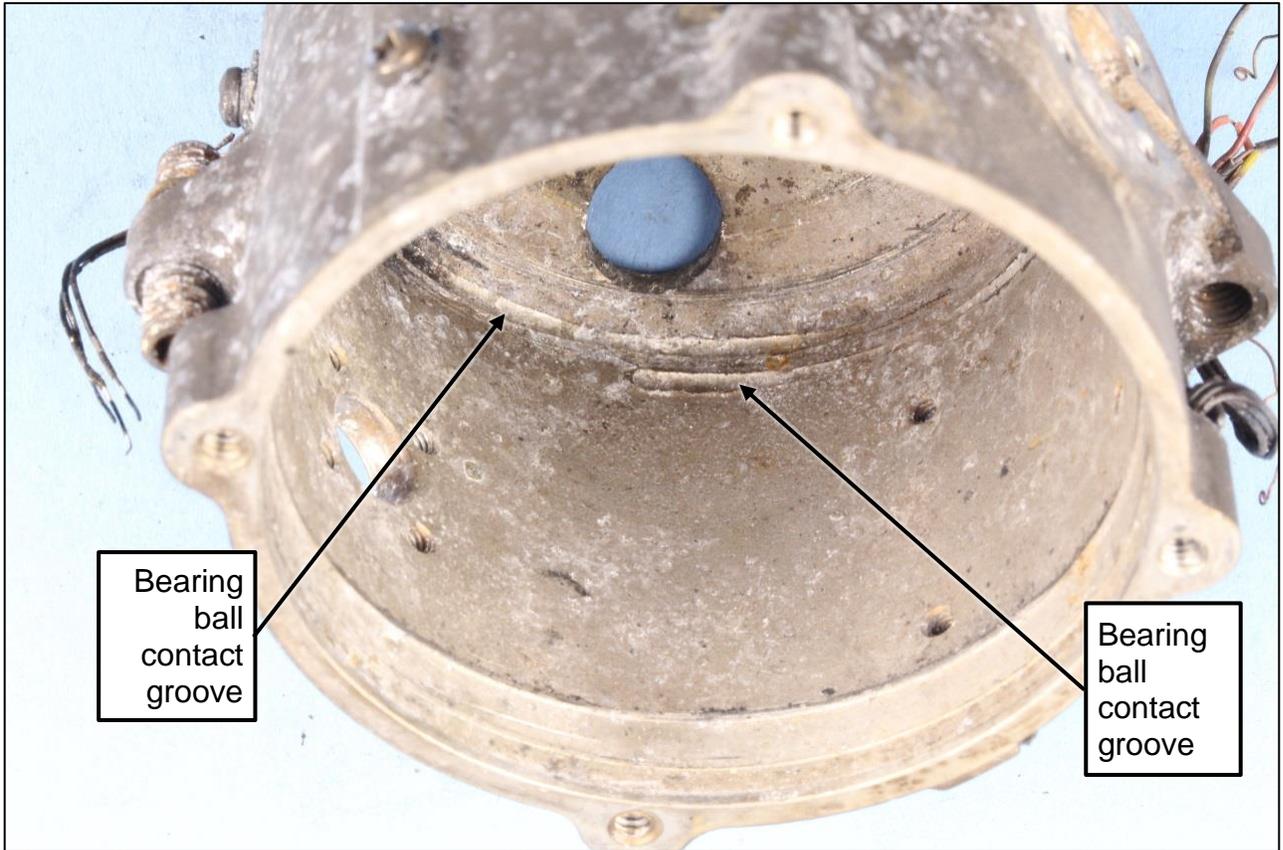
Grooves were observed around the outer diameter of the inner gimbal housing interior surface at the left end of the housing as indicated in figure 6. The rounded shape of the groove was consistent with contact with a sliding or rolling bearing ball under load, and the bearing balls recovered during disassembly of the inner gimbal assembly fit into the observed grooves. The location of these grooves corresponded to the location of the circumferential scoring marks on the rotor. Grooves consistent with rolling or sliding bearing ball contact under load were also observed around the outer edge of the interior face of the inner gimbal housing cover as indicated in figure 7.

Figure 6. Interior surface of the inner gimbal housing showing bearing ball contact grooves near the left end of the housing.

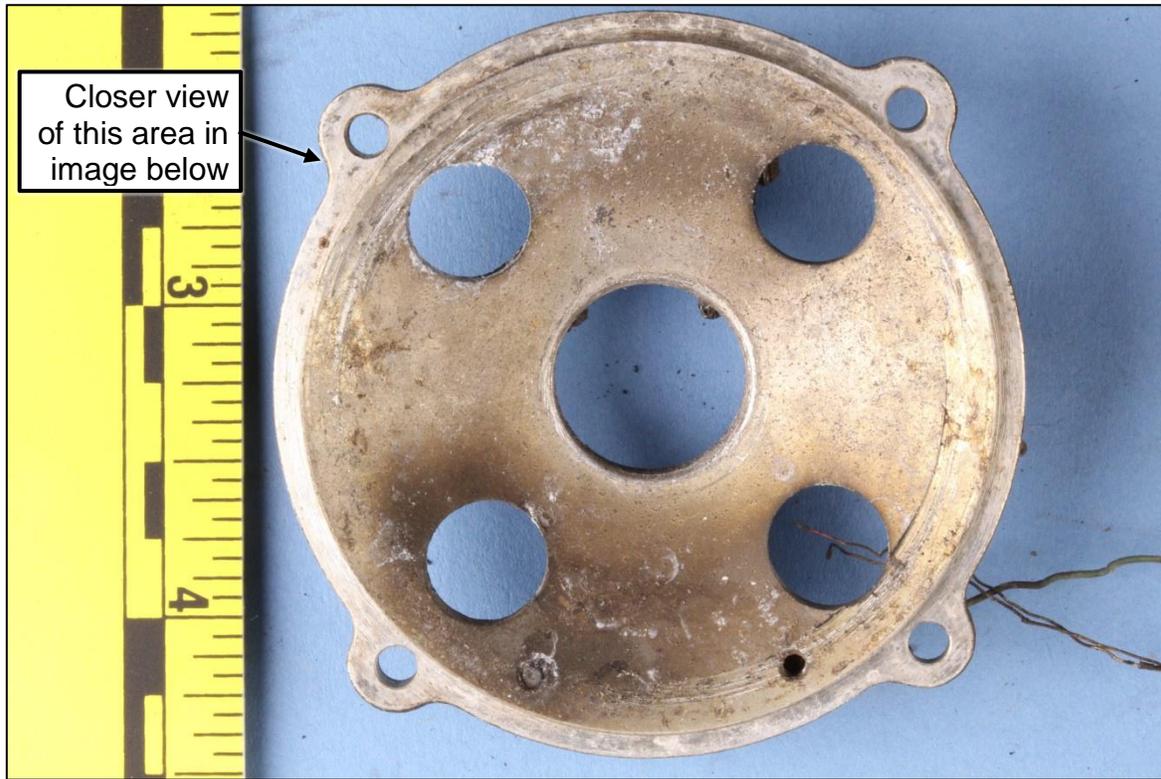
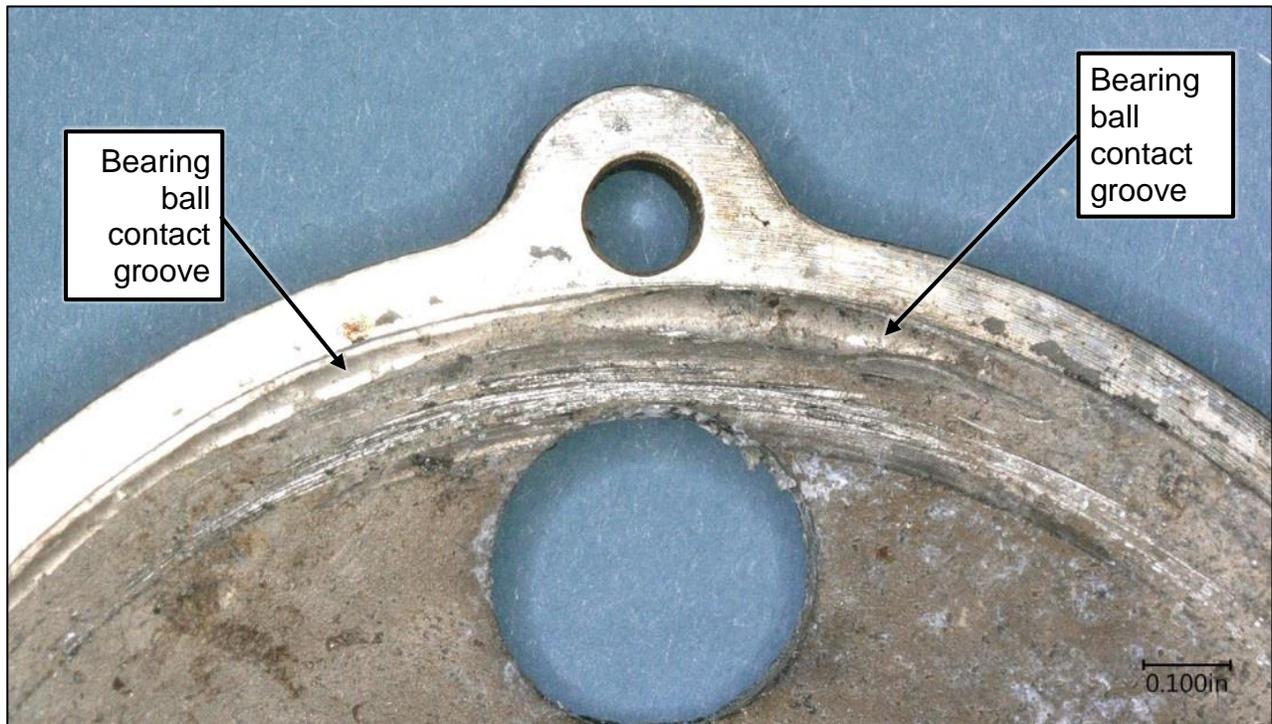
Figure 7. Views of the interior face of the inner gimbal housing cover showing grooves around the edges of the cover consistent with bearing ball contact.

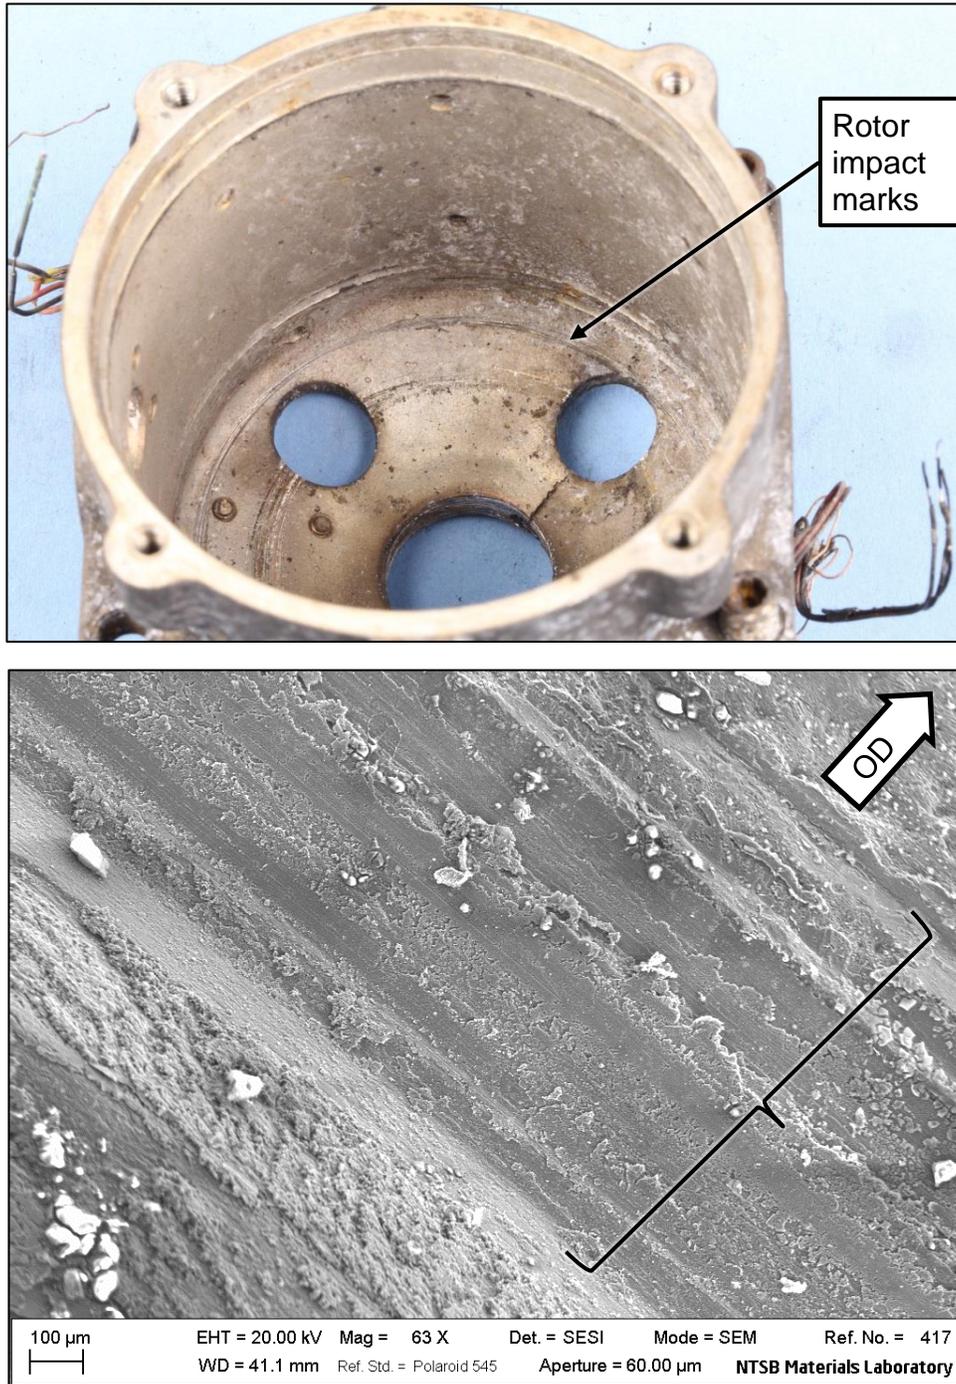
Impact marks corresponding to the outer circumference of the rotor were observed on the left face of the interior of the inner gimbal housing (see figure 8). Additional circumferential marks were observed on the end faces of the housing and cover. However other marks had less depth and appeared to have disturbed the oxides on the surfaces as compared to the impact marks noted in figure 8.

The inner gimbal housing was sectioned longitudinally to facilitate an examination of the rotor impact marks shown in figure 8 using a scanning electron microscope (SEM). A view of typical features observed within the area of impact is shown in figure 8. Multiple contact marks corresponding to the edge of the rotor were observed within the region indicated with a bracket in the lower image in figure 8. Most of the deformation associated with the impact marks was radially inward and outward, but marks within the impact areas were oriented circumferentially. The surface appeared oxidized, but some of the fine features had deformation patterns consistent with contact with an object rotating clockwise relative to the surface, which is the direction of rotation of the rotor under normal operation.

Figure 8. Impact marks on the inner gimbal housing corresponding to contact with the outer diameter edge of the rotor. Bracket in the SEM image (lower image) indicates area of multiple contacts.

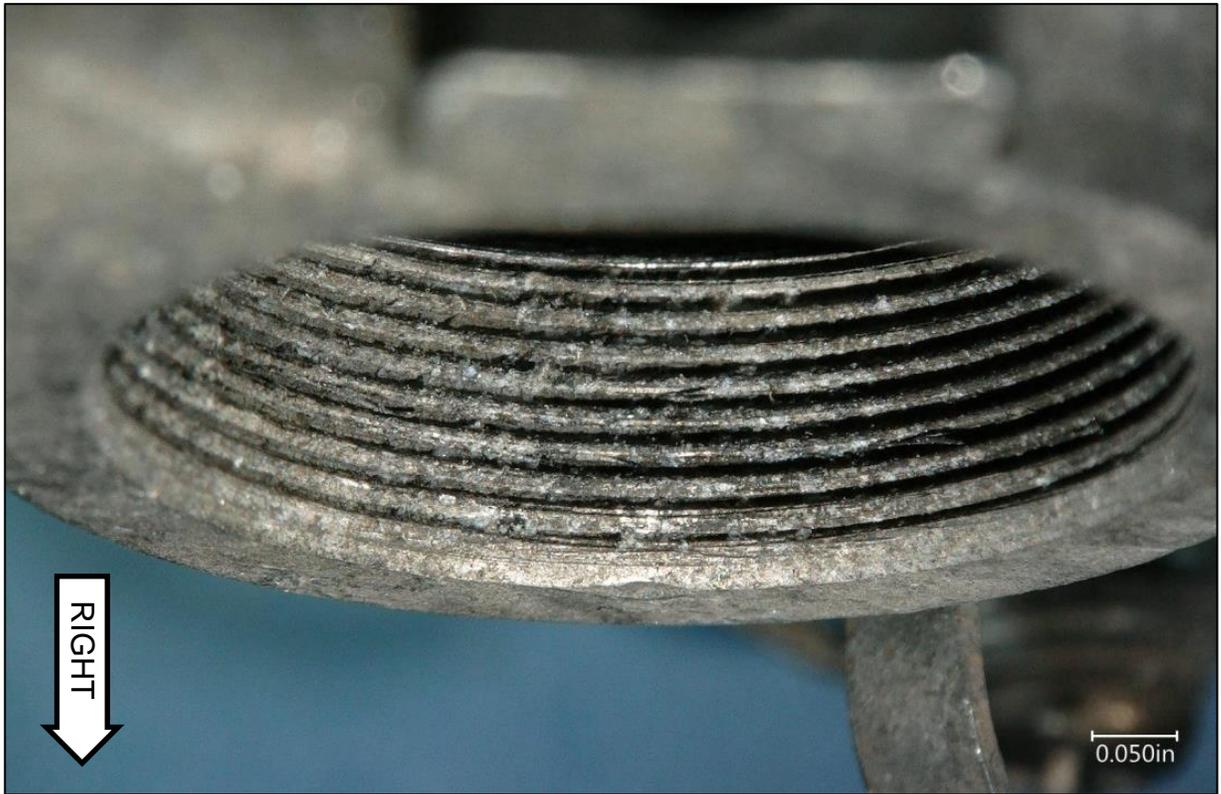
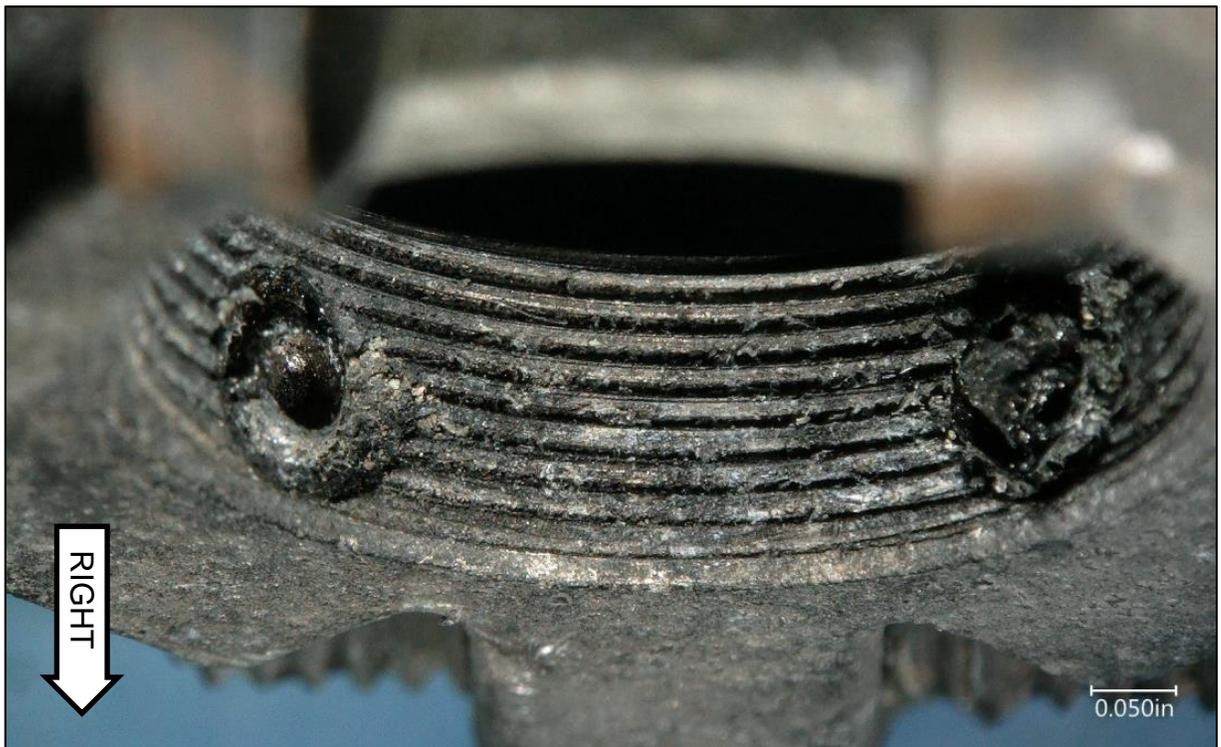
Views of threads in the inner gimbal housing cover are shown in figure 9. The end plug attachment threads within the cover were intact. In contrast, the threads at the left end of the inner gimbal housing were sheared as shown in figure 10.

Figure 9. View of intact rotor plug attachment threads on the inner gimbal housing cover.

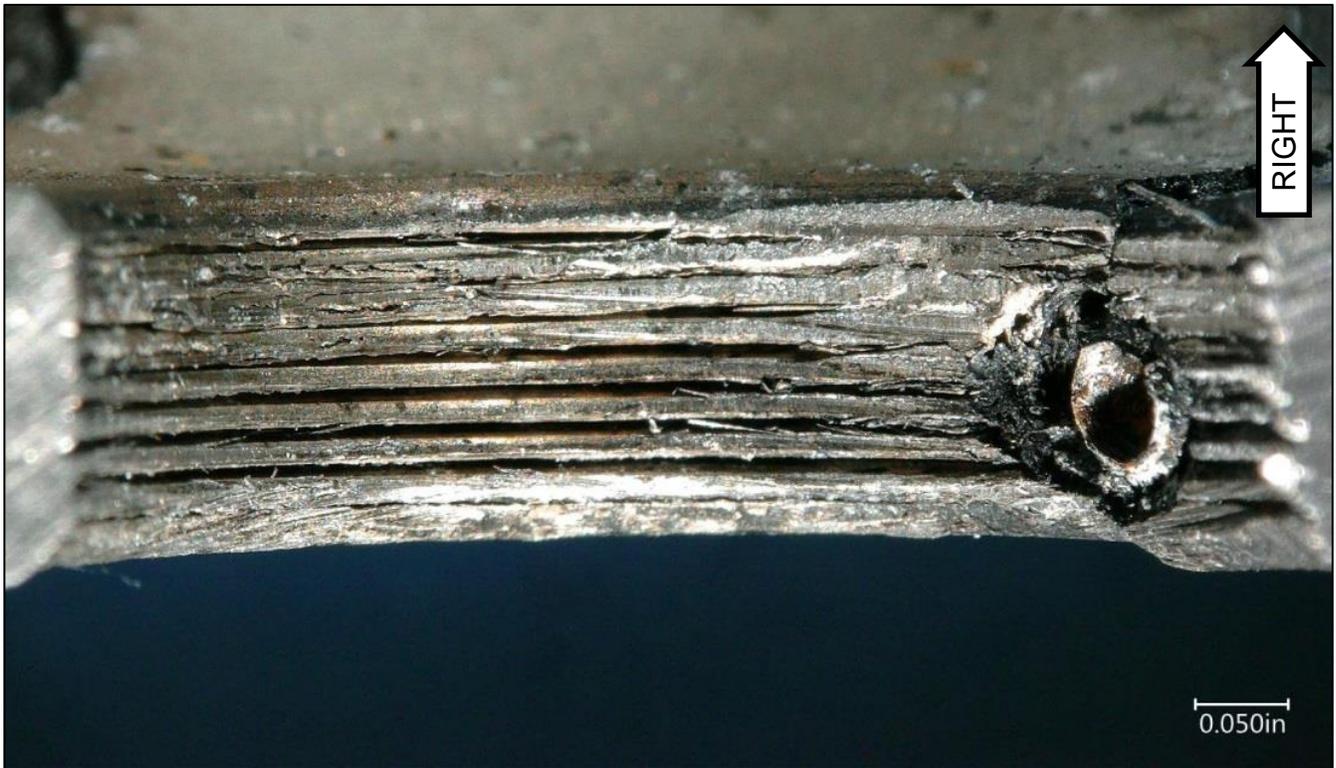
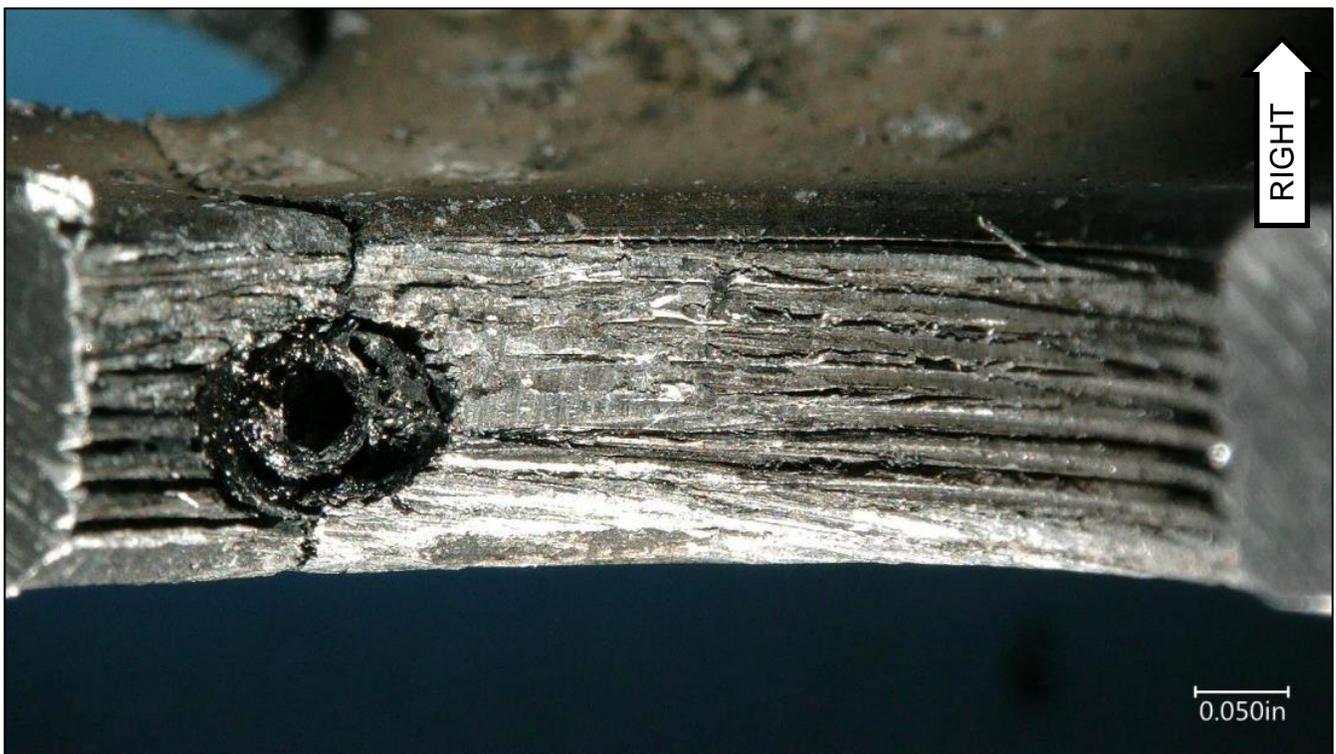
Figure 10. Thread damage on the rotor plug attachment threads of the inner gimbal housing.

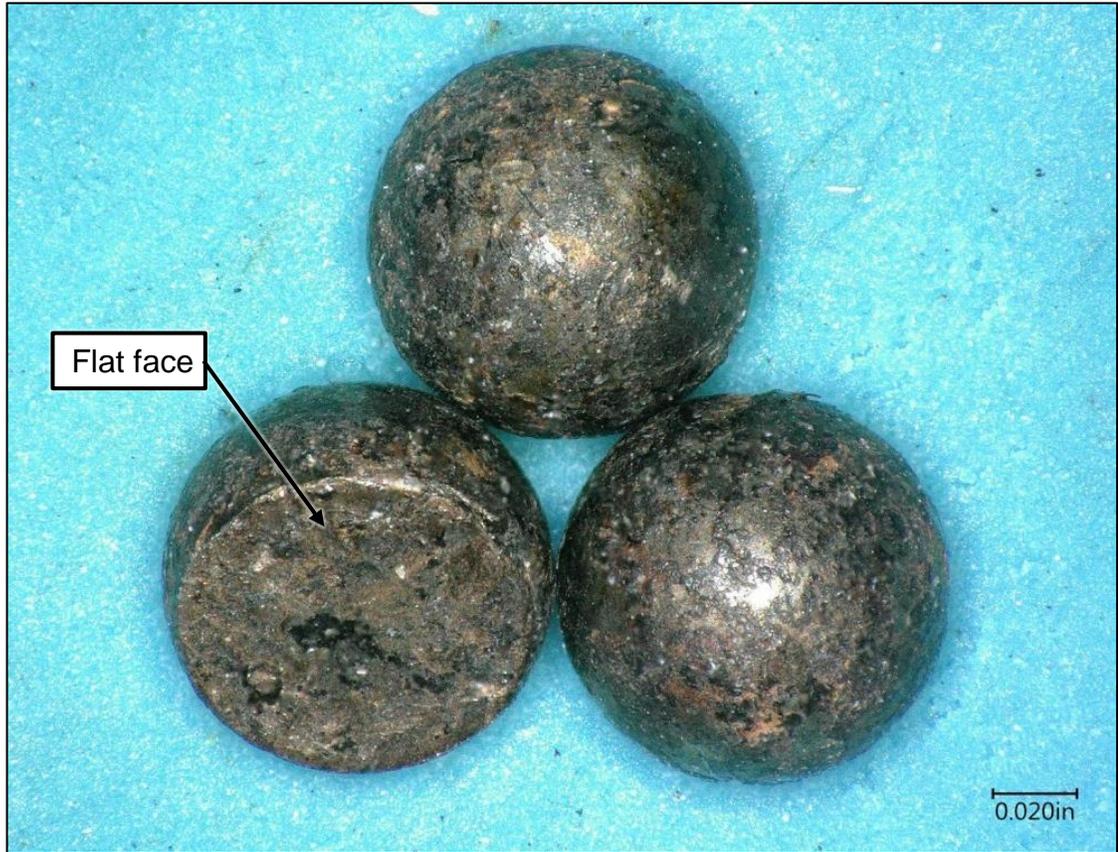
Figure 11. Close view of bearing balls that fell out when disassembling the inner gimbal cover and the rotor assembly from the inner gimbal housing.

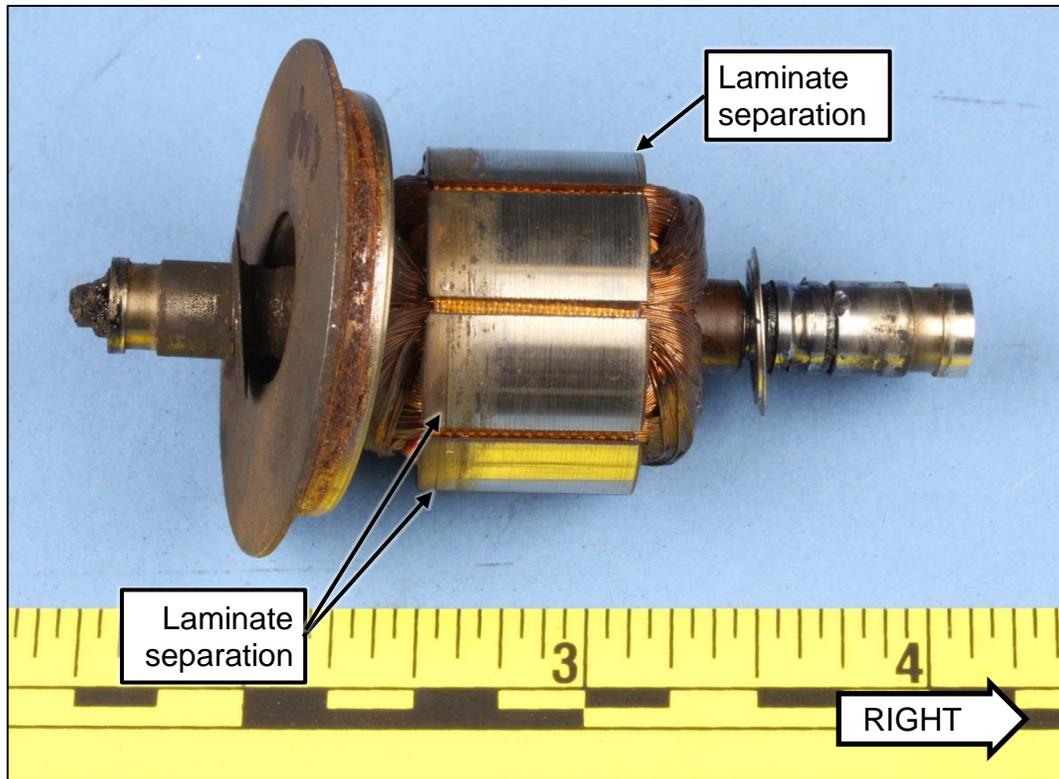
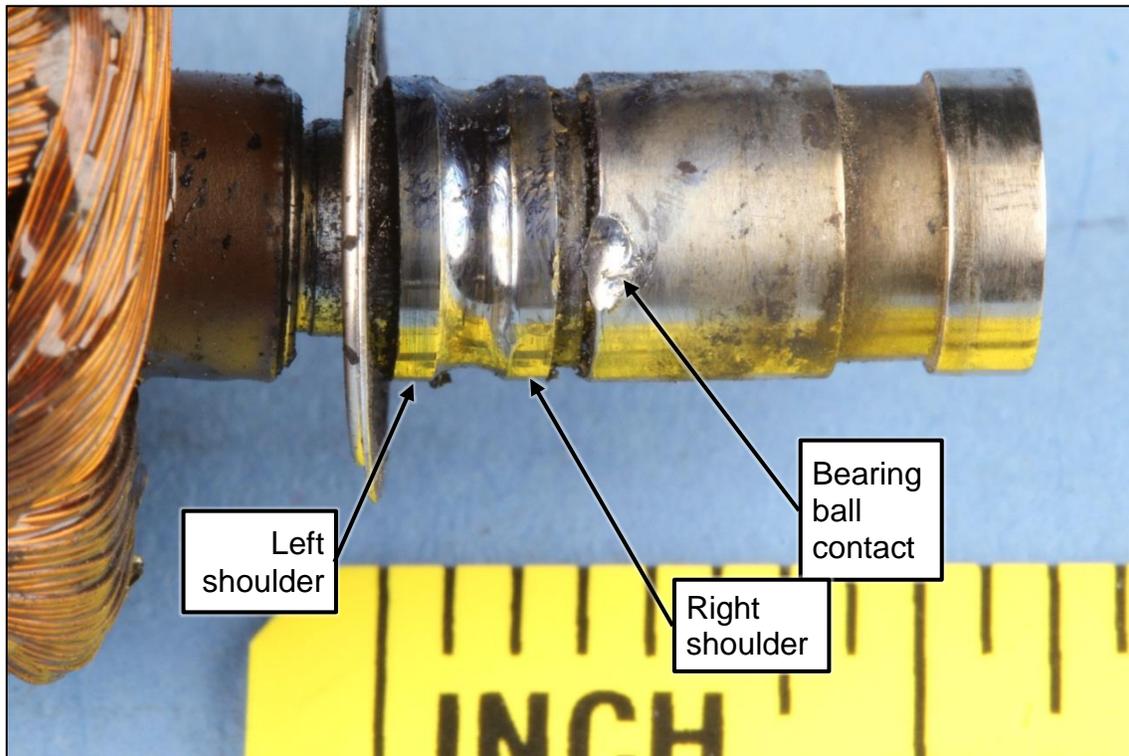
A view of the stator assembly with the rotor removed is shown in figure 12. Separation was observed between laminates of the core across 2 core segments at the left end of the core and similarly at 2 different segments at the right end of the core as indicated in figure 12. The stator shaft was bent in the area between the winding and the right bearing inner race, and the area of laminate separation at the left end of the core was located in the outside of the bend. Blue colored grease was present at the

Grease was cleaned from the surfaces of the right bearing inner race. The bearing inner race did not show evidence of heat distress as shown in the close view of the bearing inner race in figure 12. The ball wear pattern was located closer to the right shoulder than the left shoulder, consistent with a preloaded bearing. The right shoulder of the inner race had an impression on the shoulder edge that spiraled onto the shoulder and around to the right face of the bearing race. In addition, the right shoulder had ball impressions at 5 locations around 1/3 of the circumference. A bearing ball imprint was observed on the corner of the preload sleeve as shown in figure 12.

Figure 12. Overall view of the stator assembly (upper image) after removal from the rotor with a closer view of the bearing inner race and preload sleeve at the right end of the stator shaft (lower image).

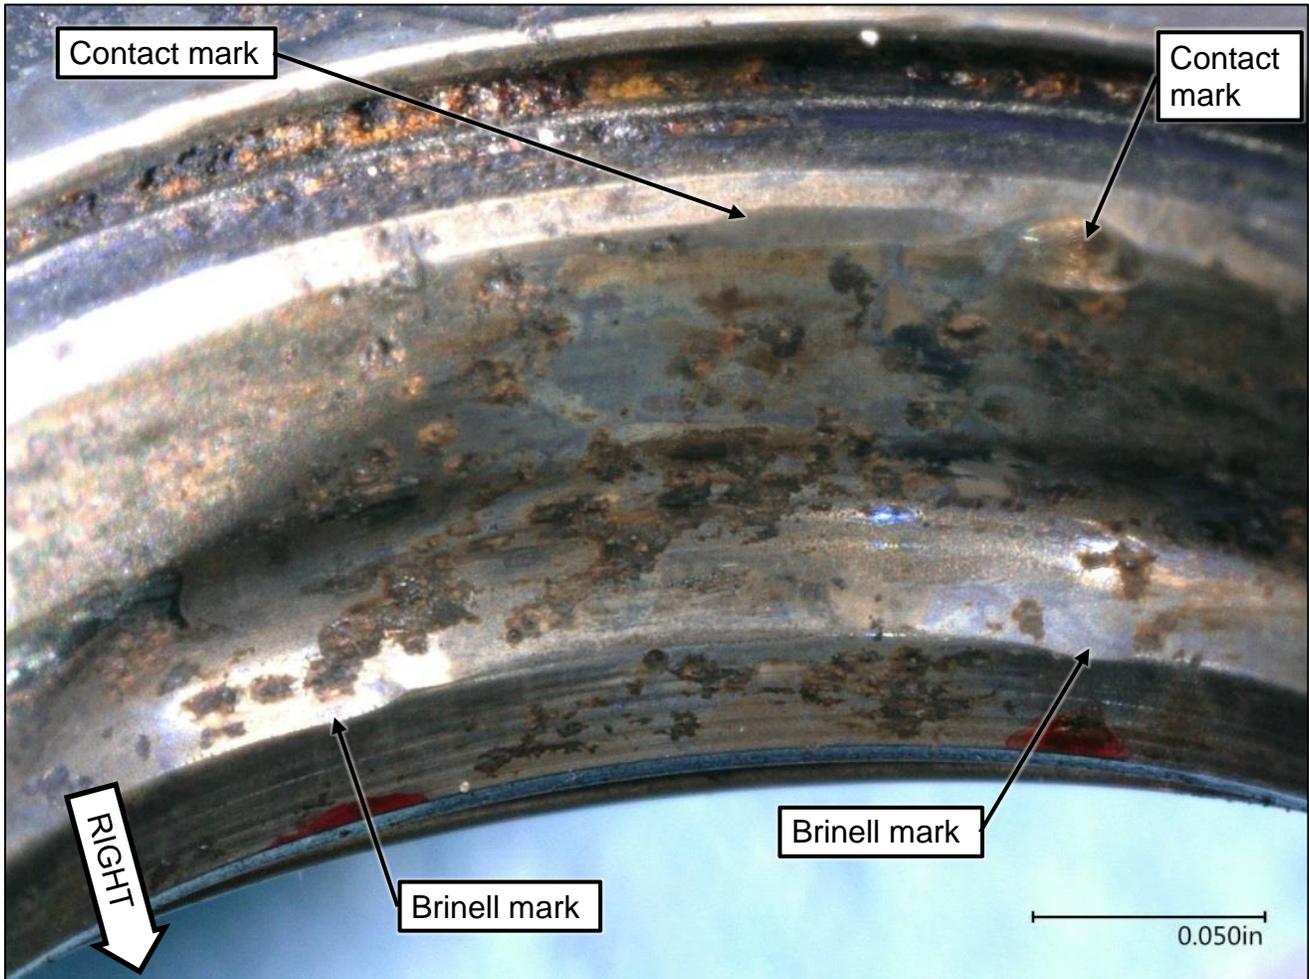
The left bearing outer race had 8 equally-spaced brinell marks around the circumference on the right shoulder. Two of the marks are shown in the close view of the outer race in figure 13. Ball contact marks were also observed on the left shoulder at the location shown in figure 13.

Figure 13. Close view of the left bearing outer race. Two of the eight equally-spaced brinell marks observed on the outer race are indicated.

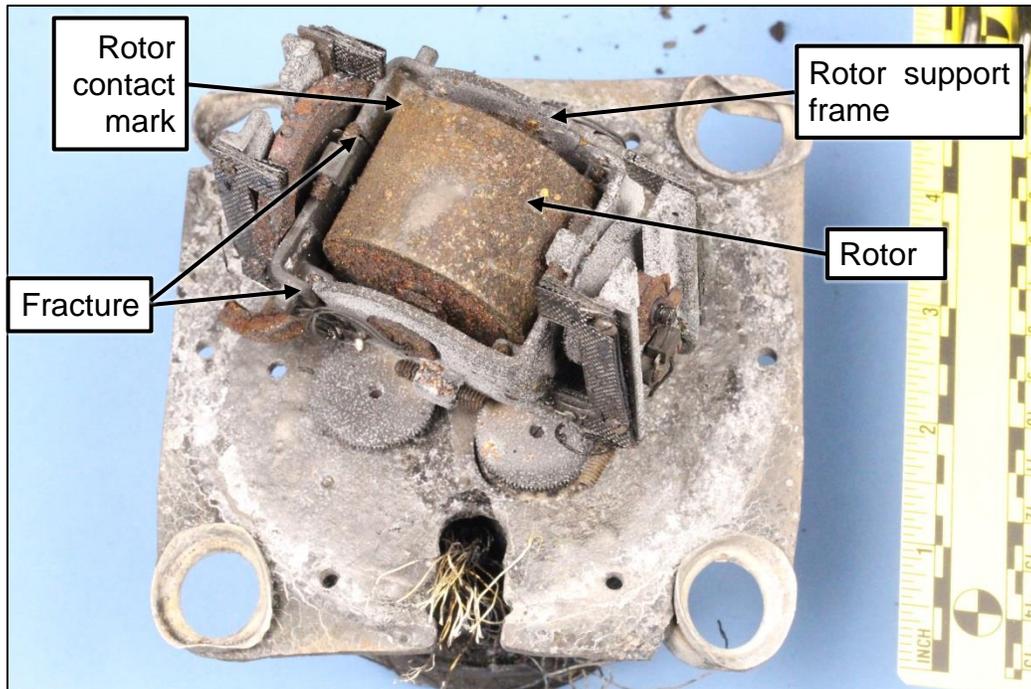
The turn gyro was disassembled by removing the gyro assembly from the base and then removing the cover from the gyro gimbal assembly. An overall view of the gyro assembly with the cover removed is shown in figure 14. The frame supporting the rotor was fractured in two locations as indicated in figure 14.

Figure 14. Overall view of the turn gyro after the gyro assembly was separated from the base and after the cover was removed.

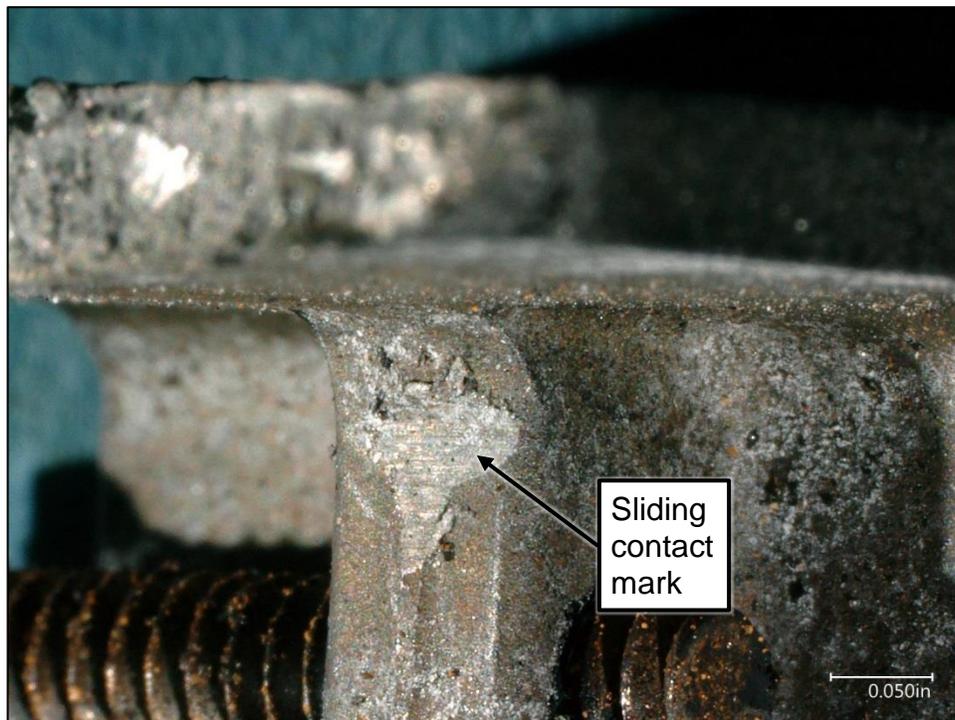
contact marks. A sliding contact mark was observed at one corner of the frame at the location indicated in figure 14 corresponding to contact with the edge of the rotor. A closer view of the sliding contact mark is shown in figure 15.

Figure 15. Sliding contact mark on the rotor support frame corresponding to contact with the edge of the rotor at the location indicated in the previous figure.
