# NATIONAL TRANSPORTATION SAFETY BOARD

MATERIALS LABORATORY FACTUAL REPORT

Report No. 15-061

Place : Philadelphia, Pennsylvania  
Date : May 12, 2015  
Vehicle : Train 188, Passenger Coach 81528  
Operator : Amtrak  
NTSB No. : DCA15MR010  
Investigator : Dana Sanzo, RPH-40

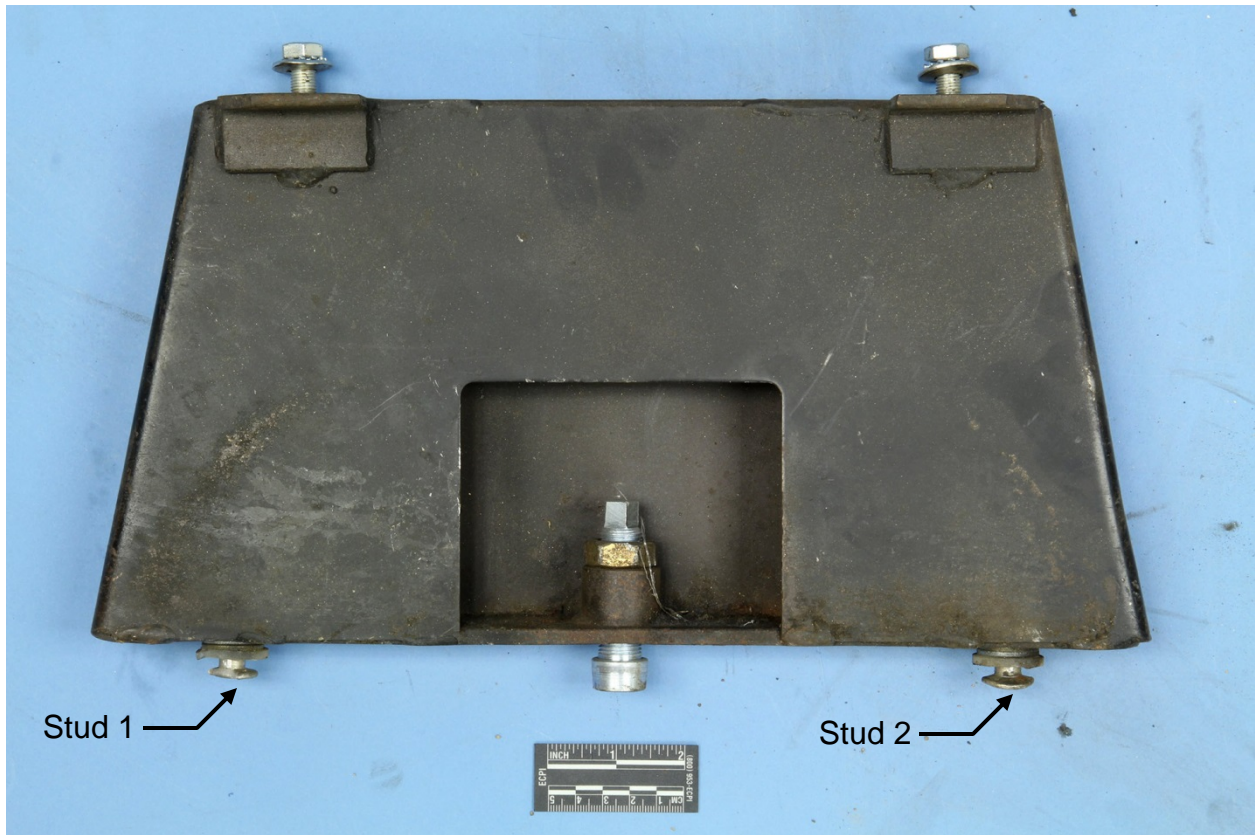
A seat pedestal was submitted to the NTSB Materials Laboratory for examination. The pedestal, as it was received, is shown in figure 1. The pedestal had two studs along its bottom face with the purpose of anchoring the seat to the floor of the rail car. For convenience, the two studs were labelled as "Stud 1" and "Stud 2", as indicated in figure 1. Both studs were fractured. Longitudinal and side view images of Stud 1 are shown in figures 2a and 2b, respectively. Similarly, longitudinal and side view images of Stud 2 are shown in figures 3a and 3b, respectively.

**Figure 1:** Image of the seat pedestal with fractured studs at the bottom of the image. For convenience, the studs were labelled “Stud 1” and “Stud 2”.

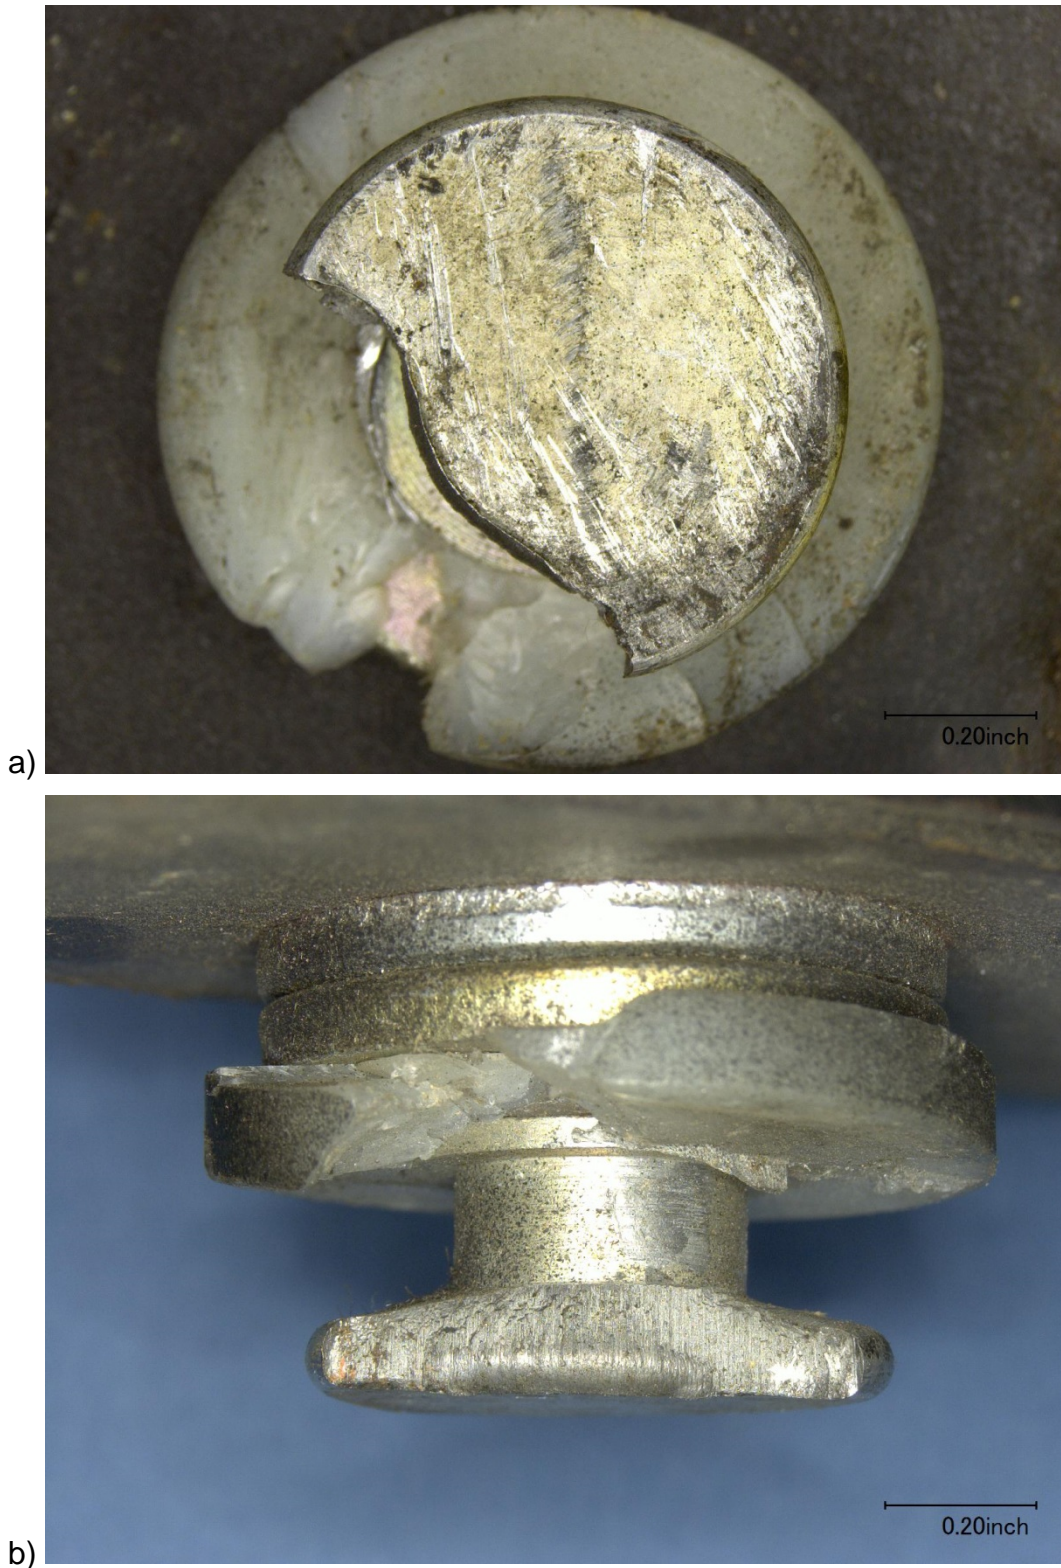
Each stud's flange was fractured on one side adjacent to the shank of the stud. There was an additional crack in the flange of Stud 2 approximately 180° from the fracture, also adjacent to the shank. The fracture surfaces were examined and each fracture surface exhibited parallel smear lines consistent with a shear overstress fracture of each flange.

**Figure 2:** Images of Stud 1: a) Longitudinal view of the stud and b) side view showing the fracture surface.

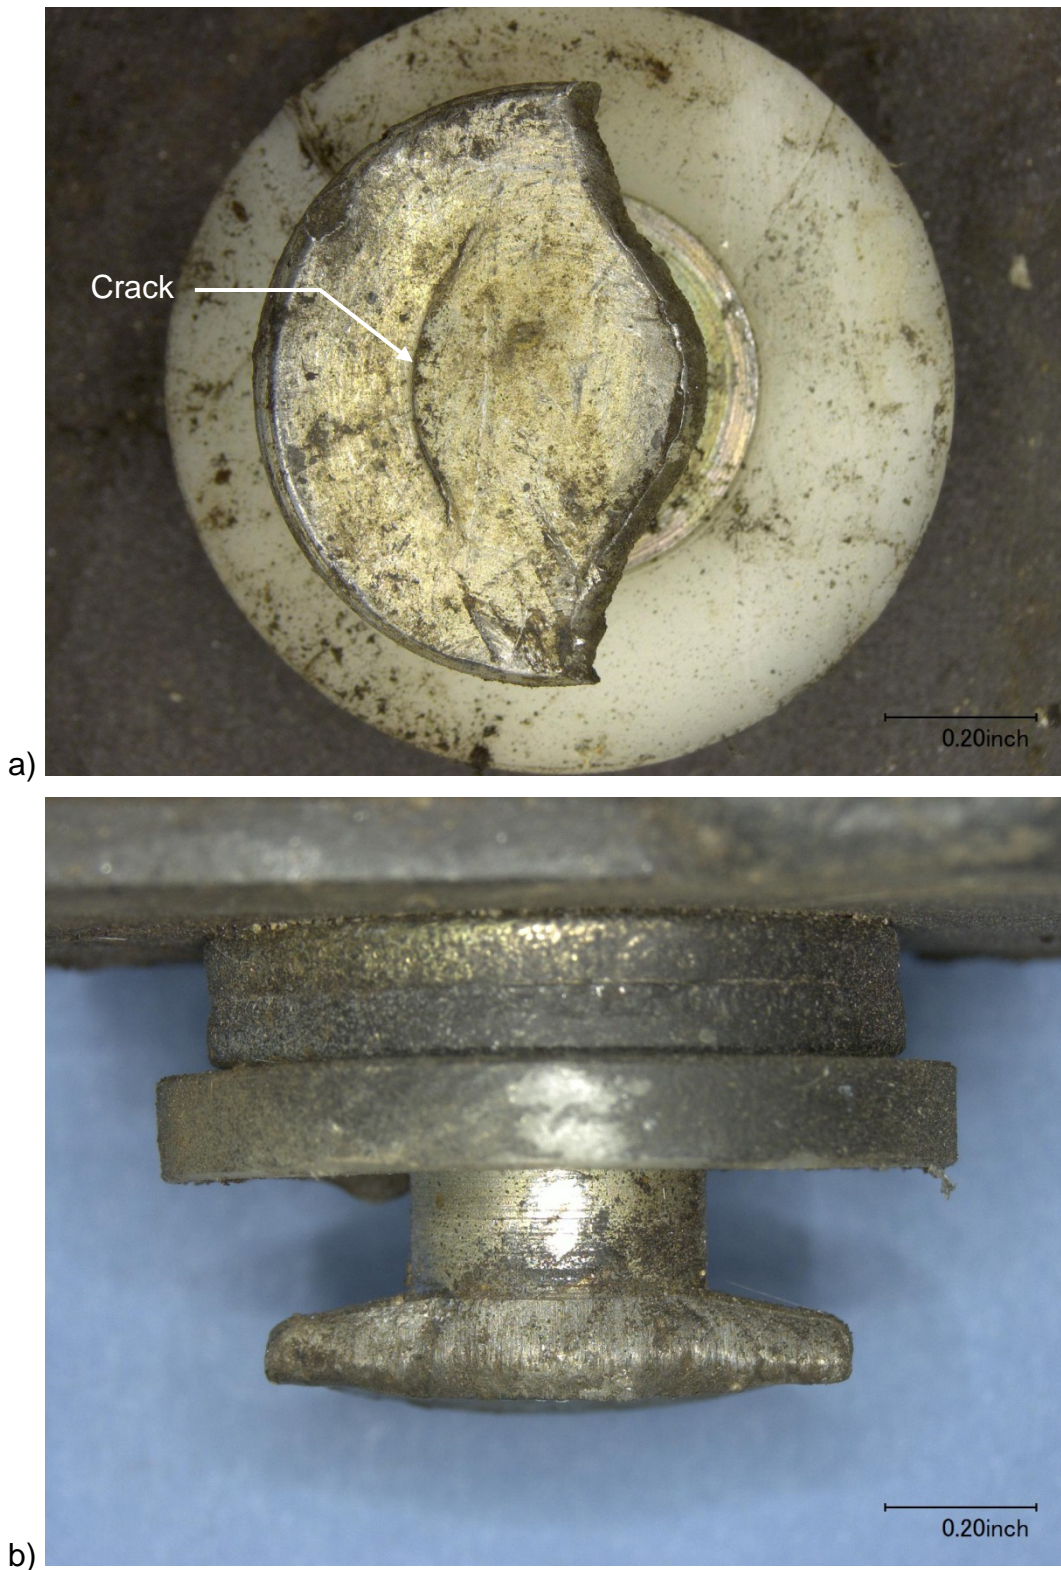
**Figure 3:** Images of Stud 2: a) Longitudinal view of the stud head and b) side view showing the fracture surface.
