NATIONAL TRANSPORTATION SAFETY BOARD

MATERIALS LABORATORY FACTUAL REPORT

Report No. 15-071

Place : Littleton, North Carolina
Date : June 27, 2014
Vehicle : Cessna 182Q
NTSB No. : ERA14FA313
Investigator : Eric Alleyne, AS-ERA

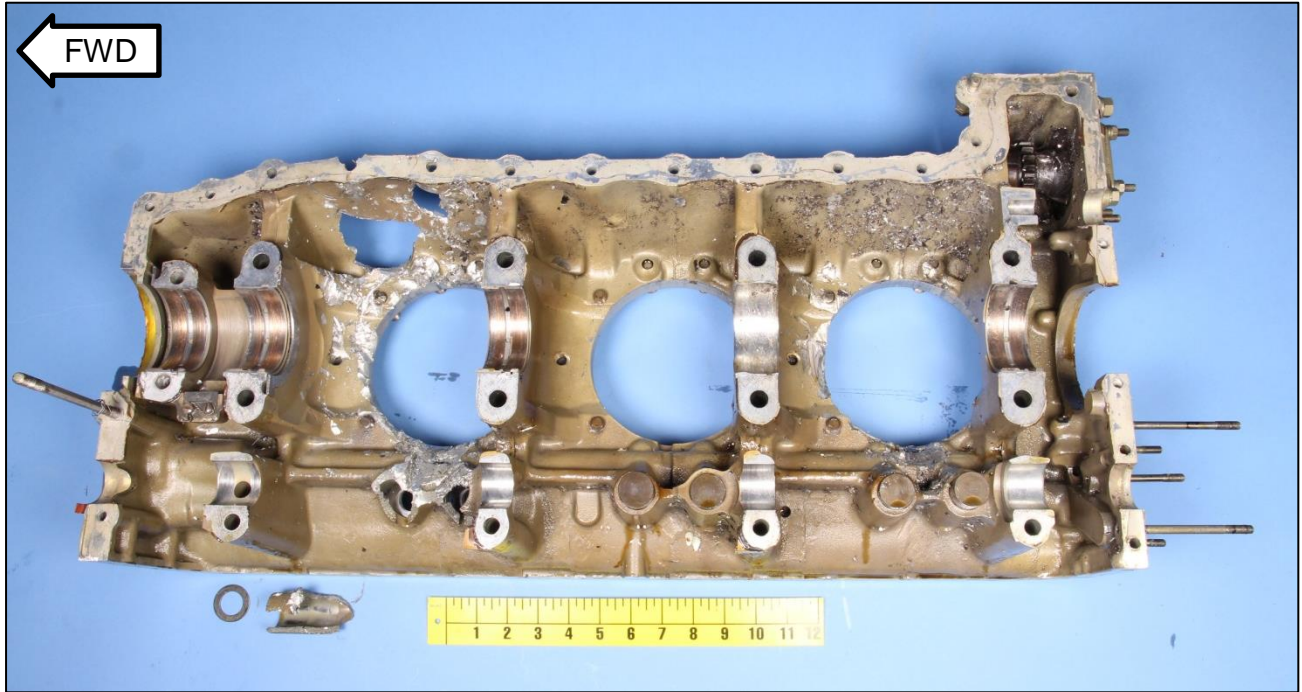
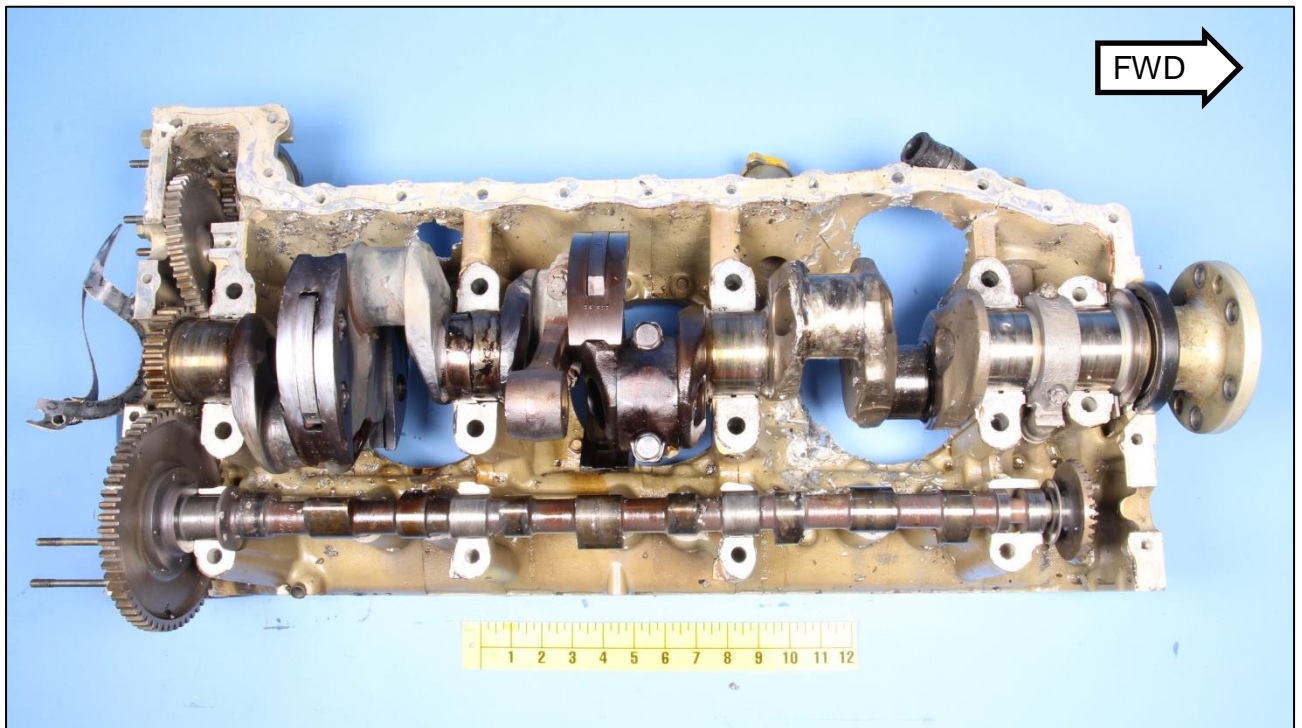
Overall views of the interior surfaces of the engine case halves are shown in figure 1. The data plate on the exterior of the right engine half indicated the engine was a P. Ponk O-470-50 engine modified from a Continental O-470 series engine in accordance with Supplemental Type Certificate SE 4985 NM. The engine was reportedly overhauled, modified, and reassembled in 2010, and had about 300 hours time in service since overhaul. In this report, cylinder positions and crankshaft journals are numbered from back to front in accordance with the Continental Engines numbering convention.

The engine case halves showed impact damage in the vicinity of the numbers 1, 2, 5, and 6 cylinder locations, including holes in the crankcase above the numbers 2, 5, and 6 cylinder bores. Metallic debris was scattered throughout the interior surfaces. Gray-colored sealant with silk thread was observed around the perimeter of the mating crank case halves. A bead of sealant was observed at the edges of the mating surfaces both on the interior and exterior edges of the mating faces.

Figure 1. Overall views of the right crankcase half (upper image) and the left crankcase half (lower image) as-received including the crankshaft and camshaft in the left crankcase half.

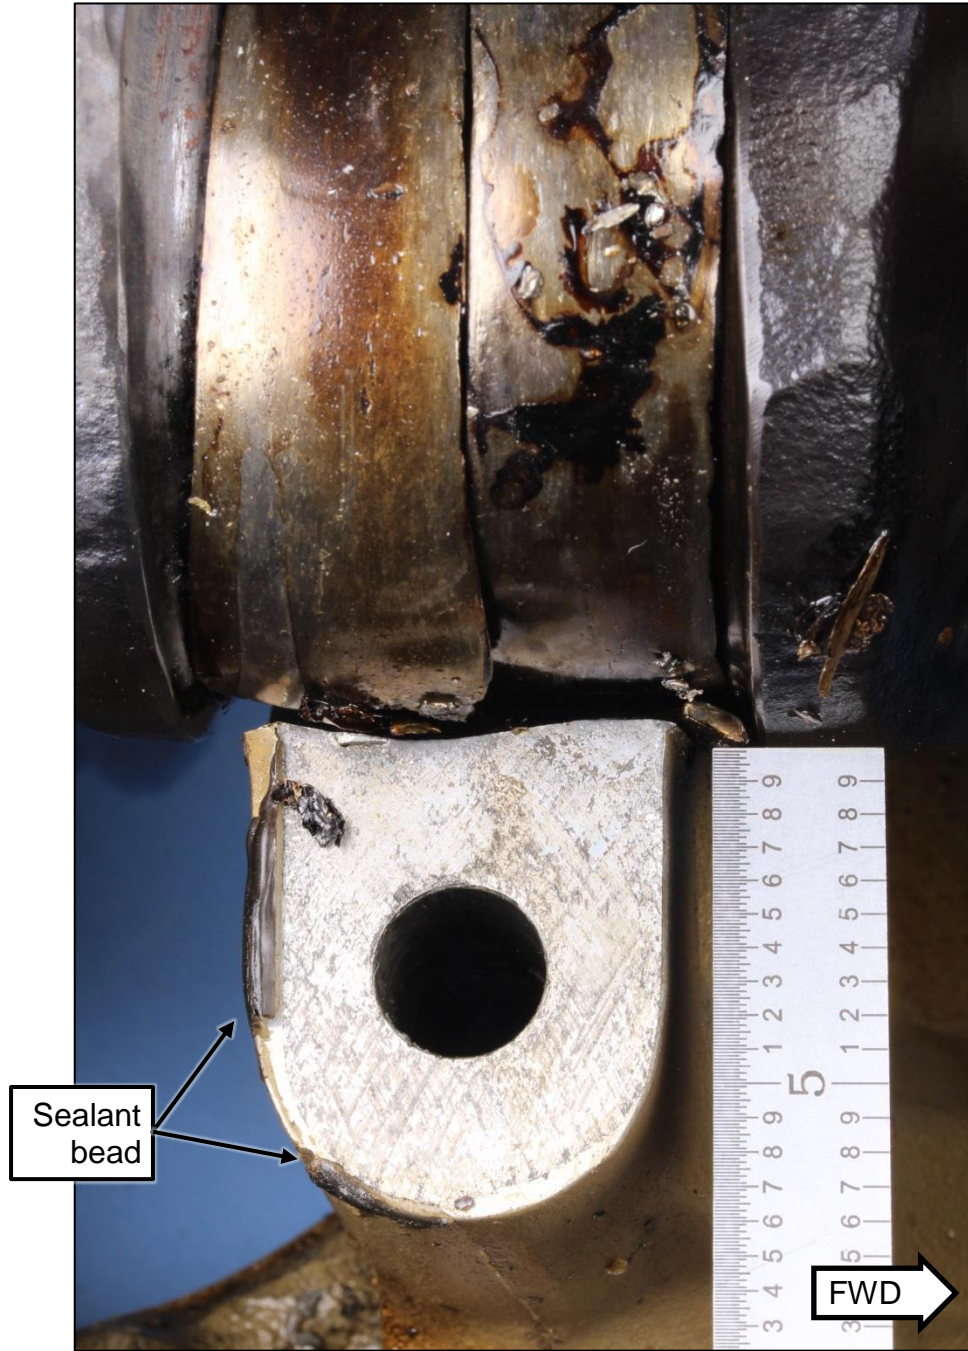
A close view of the number 2 main bearing lower saddle boss on the left crankcase is shown in figure 2. Pieces of the number 3 main bearing on the crankshaft are also visible at the top half of figure 2. A dark gray cross-hatch pattern was observed on the saddle boss surface corresponding to fine machining marks on the surface of the saddle boss. A bead of gray sealant was observed at the edge of the saddle boss, and the surface of the bead was stained dark brown or black. The dark gray material on the

surface of the saddle boss was easily scraped from the surface by rubbing with a gloved finger or finger nail.

Each of the saddle bosses for the crankshaft had features similar to that shown in figure 2 with a gray cross-hatch pattern with a bead of sealant at the edges of the boss mating surfaces (see figures 3 and 4). No evidence of fretting damage was observed on the main saddle bosses. Some segments of the sealant beads remained attached to the left crankcase half, while other segments remained attached to the right crankcase half. No attempt was made to determine if and segments of the bead were either discontinuous or fractured from both sides.

Figure 2. Close view of the number 2 main bearing lower saddle boss, crankshaft, and bearing pieces.

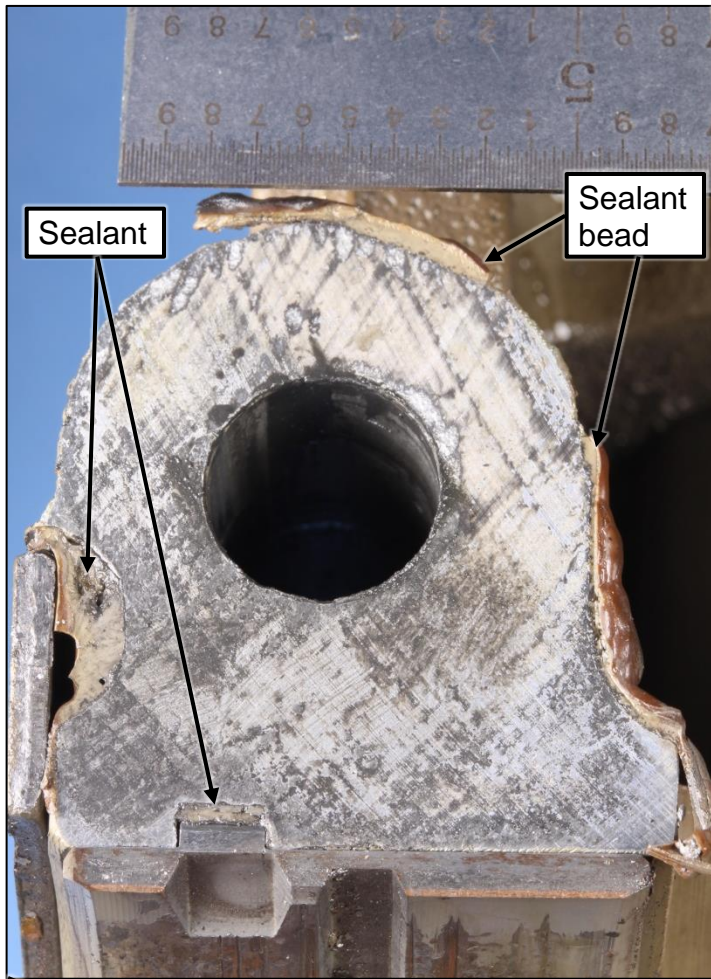
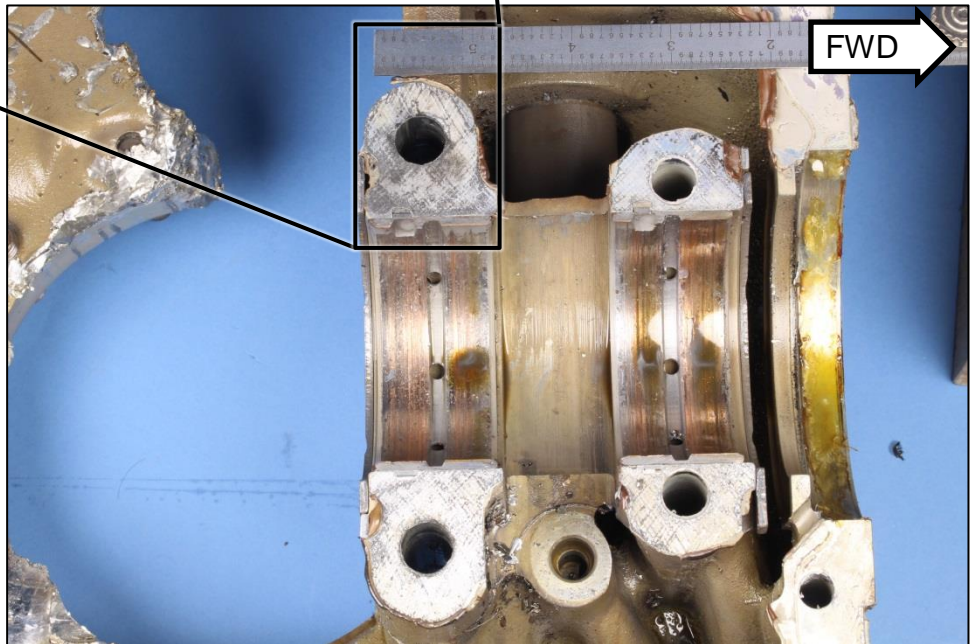
A view of the number 4 and 5 main journal bearings on the left crankcase half after removal of the crankshaft is shown in figure 3. As with the other saddle bosses, the dark gray cross-hatch pattern was observed, and sealant was observed around the edges of the mating saddle boss contact surface. The closer view of the number 4 main bearing upper saddle boss shows a bead of sealant that was observed around the edge of the saddle boss. Additional sealant was observed in the gap between the saddle boss and the thrust washer and in the gap between the bearing and the saddle within the bearing tab slot.

Figure 3. Numbers 4 and 5 journal saddles after removal of the crankshaft on the left crankcase half (lower image) with a closer view of the upper number 4 main bearing saddle boss (left image).

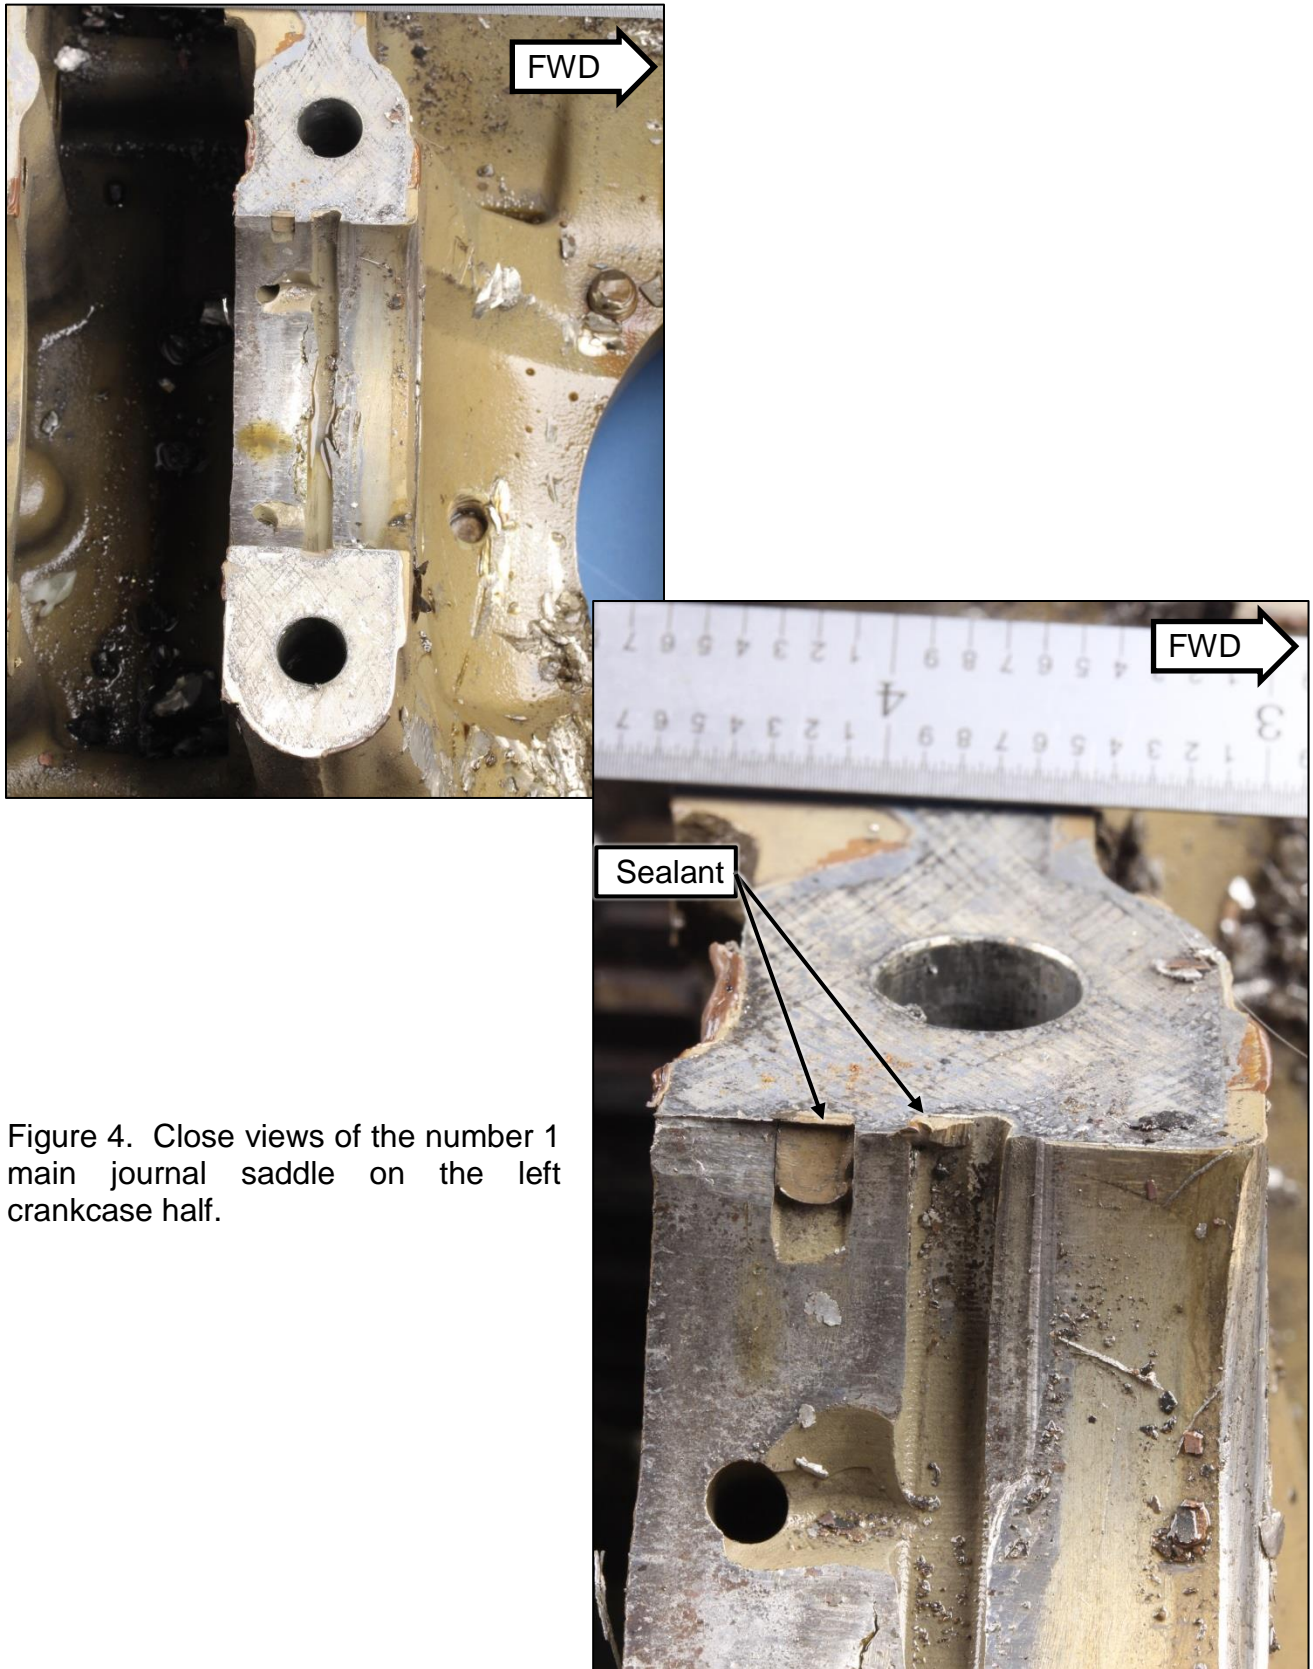
Views of the number 1 main bearing saddle on the left crankcase half after removal of the main bearing are shown in figure 4. As with the other saddle bosses, the dark gray cross-hatch pattern was observed, and sealant was observed around the edges of the mating saddle boss contact surface. The close view of the upper saddle area (image at the right in figure 4) shows the presence of sealant within the bearing tab slot and within the oil slot.

Figure 4. Close views of the number 1 main journal saddle on the left crankcase half.

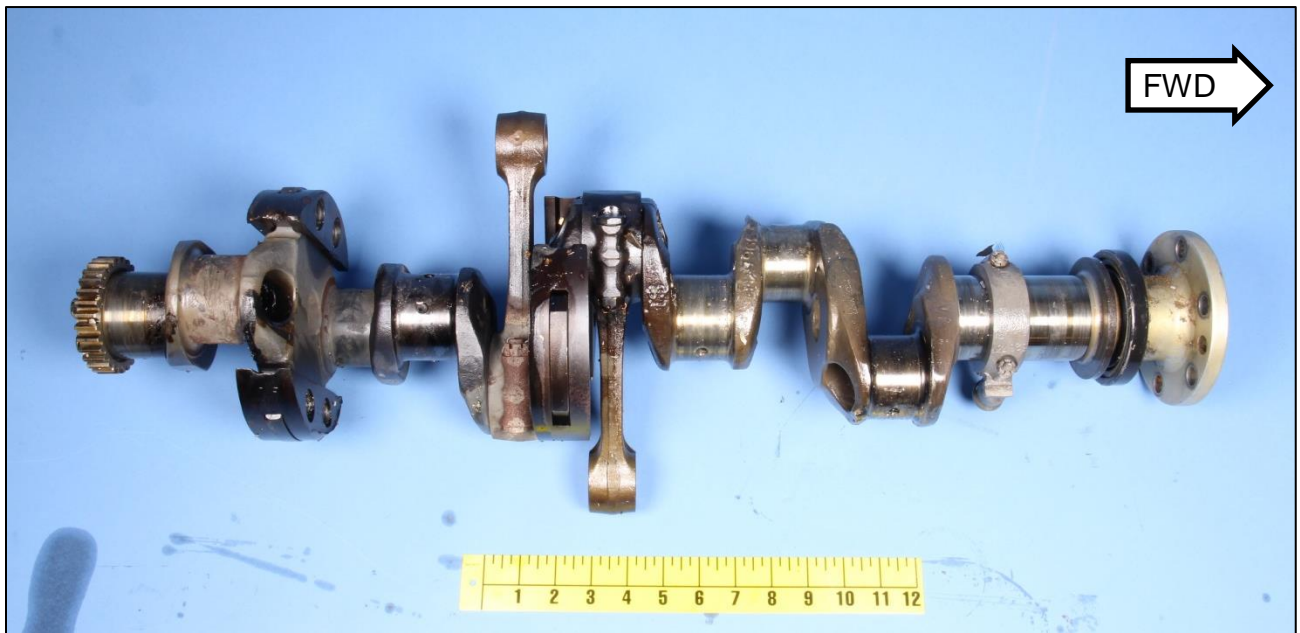
An overall view of the crankshaft is shown in figure 5. Markings on the side of the propeller flange included "R45707-1" "M010MP" "RN R93/U". The crankshaft was intact, and the number 3 and 4 connecting rod assemblies remained attached to their respective journals. The sides of the connecting rods were identified with "646126F A16". Oil tubes in the cheeks between the main journals and the adjacent connecting rod journals were visually examined and appeared to be intact.

The main journals showed varying levels of circumferential scoring and heat damage. The number 2 main journal was tinted black and showed relatively heavy scoring with coked oil and debris on the surface. Relatively shallow circumferential scoring damage was observed on the numbers 1, 3, 4, and 5 main journals. The numbers 1 and 3 main journals had areas tinted blue and gold, and the numbers 4 and 5 main journals had some areas with gold tint.

Figure 5. Crankshaft after removal from the crankcase.

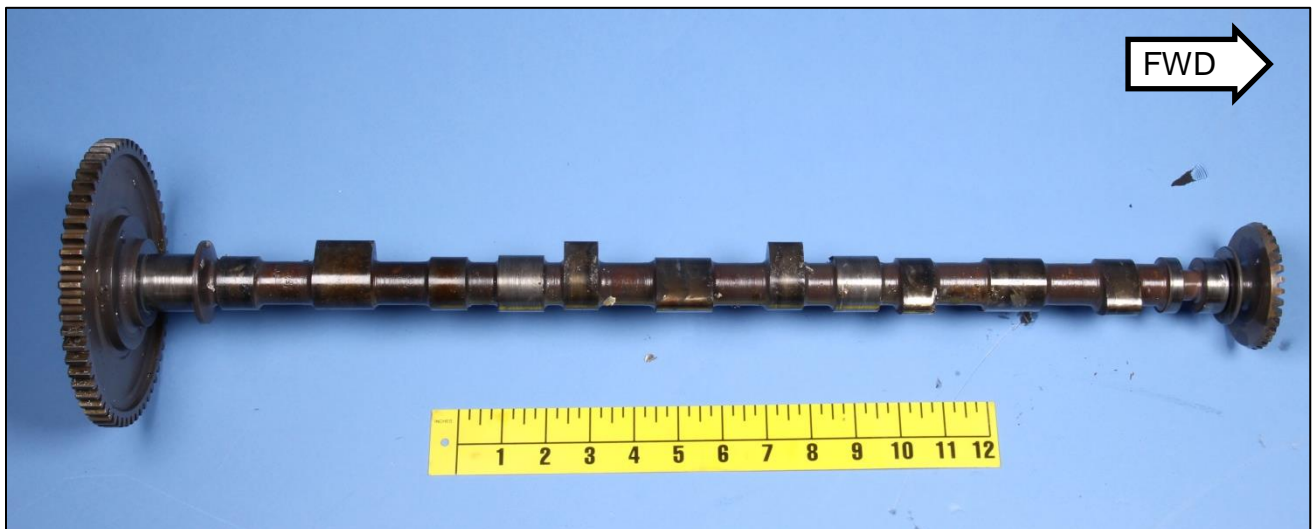
An overall view of the camshaft is shown in figure 6. Lobe damage was observed on some of the cams consistent with foreign object damage in areas where the crankcase was also damaged. Each of the camshaft journals showed circumferential scoring damage.

Figure 6. Camshaft after removal from the crankcase.

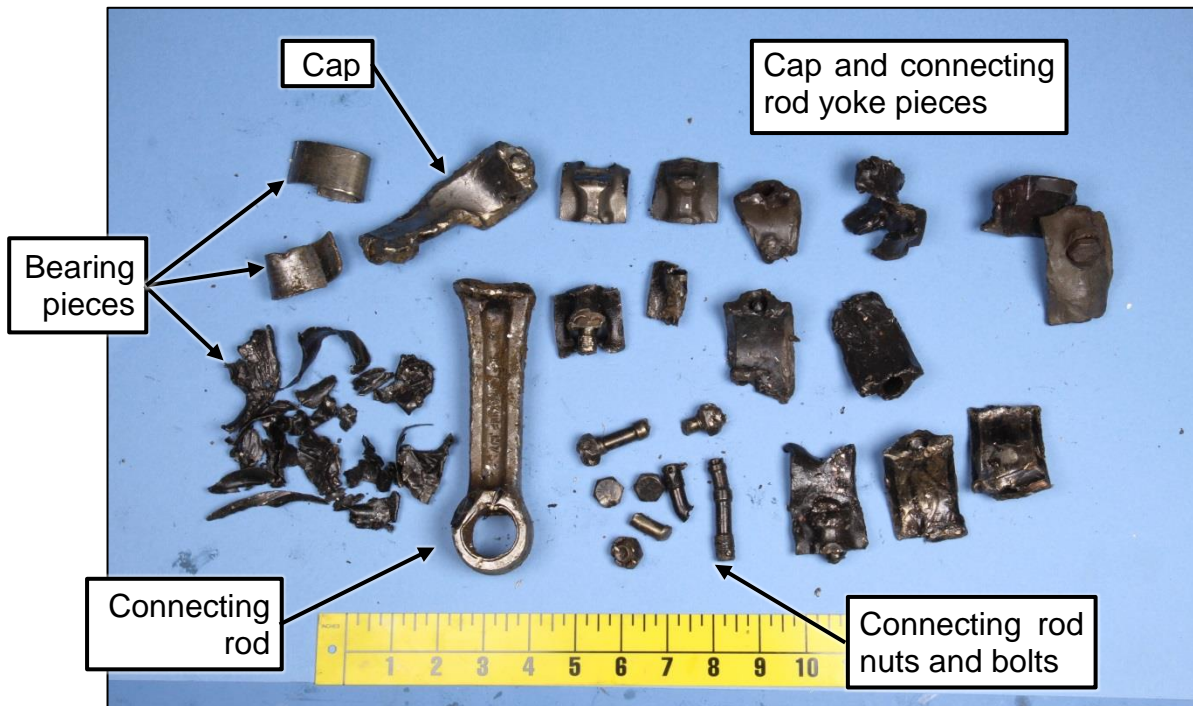
The contents of the bag containing pieces from connecting rod assemblies, a piston assembly, tappets, and crankcase were examined visually. An overall view of connecting rod pieces sorted from the bag is shown in figure 7. The piston end and middle portion of one connecting rod was included in the bag as shown in figure 7 (piece labeled connecting rod). The connecting rod was fractured through the yoke at the crankshaft end and was tinted black in the area adjacent to the fracture. The bag also included cap and yoke pieces from 4 connecting rods shown in figure 7. One cap was intact and showed no substantial heat tinting, although it did have impact damage. Two of the yoke pieces also showed little evidence of heat tint. The remaining cap and yoke pieces showed varying levels of elevated heat exposure with dark brown and black tints. Connecting rod nuts and bolts also showed heat tints consistent with exposure to elevated temperature. All fractures of the connecting rod nuts, bolts, cap, and yoke pieces were consistent with overstress fracture.

Connecting rod bearing pieces from the bag are also shown in figure 7. Two of the bearing pieces were intact with Babbitt material on the surface. The back of the intact bearing pieces were marked "11-09" "SA630826M10" "FAA-PMA" "GVBS VP3N". The remaining bearing pieces consisted of fractured, bent, and thinned steel backing material with a black tint.

Figure 7. Connecting rod assembly pieces from within the bag containing pieces of connecting rod assemblies, piston assemblies, and crankcase.

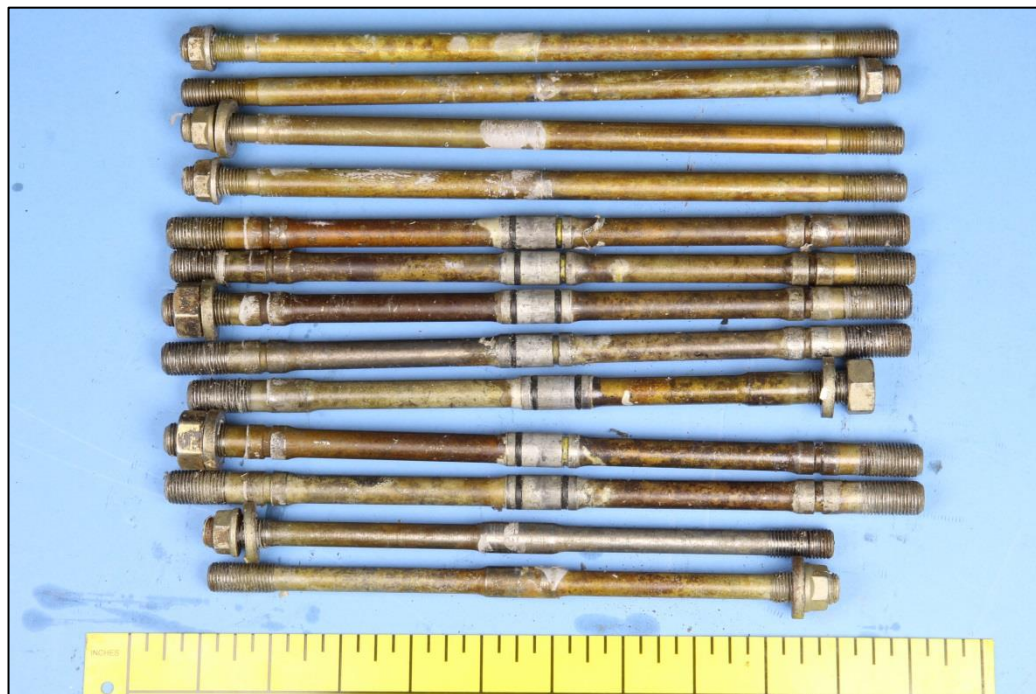
An overall view of the crankcase through-bolts is shown in figure 8. Gray sealant material was observed on the shanks of most of the through-bolts.

Figure 8. Engine crankcase through-bolts.

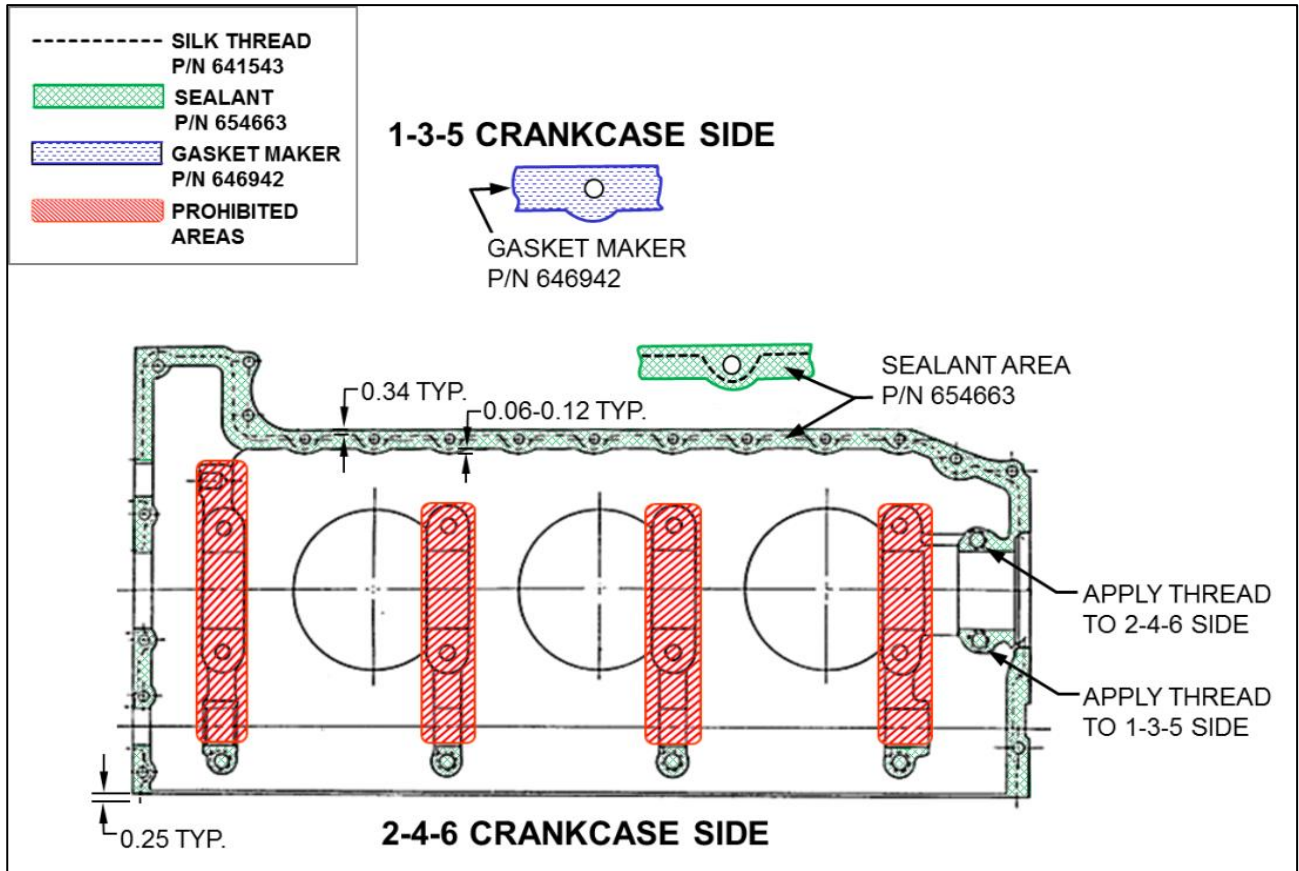
Figure 9. Sealant application diagram for the Continental O-470 engine as illustrated in Continental SIL99-2C.

According to P. Ponk Aviation Service Information Letter 001, dated September 24, 2002,¹ the P. Ponk O-470-50 engine should be maintained, repaired, or overhauled in accordance with current Continental O-470 and TSIO-520-C Service Manuals and Service Bulletins. Continental Service Information Letter SIL99-2C, issued March 29, 1999, and revised September 16, 2014,² includes information for properly applying sealant to the crankcases of O-470 and TSIO-520 series engines. The diagram for sealant application and silk threading on the Continental O-470 engine is shown in figure 9 as shown in Continental SIL99-2C. As indicated in figure 9, no sealant should be applied on the main journal bearing saddle bosses. Additionally, Continental SIL99-2C further describes in areas where the silk threading is applied, the gasket sealant should be applied in a thin even coat that is allowed to air dry to a tacky condition before applying the silk thread.
