# NATIONAL TRANSPORTATION SAFETY BOARD

MATERIALS LABORATORY FACTUAL REPORT

Report No. 15-131

Place : Las Vegas, Nevada  
Date : September 8, 2015  
Vehicle : Boeing 777-200, G-VIIO  
NTSB No. : DCA15FA185  
Investigator : Lorenda Ward, AS-10

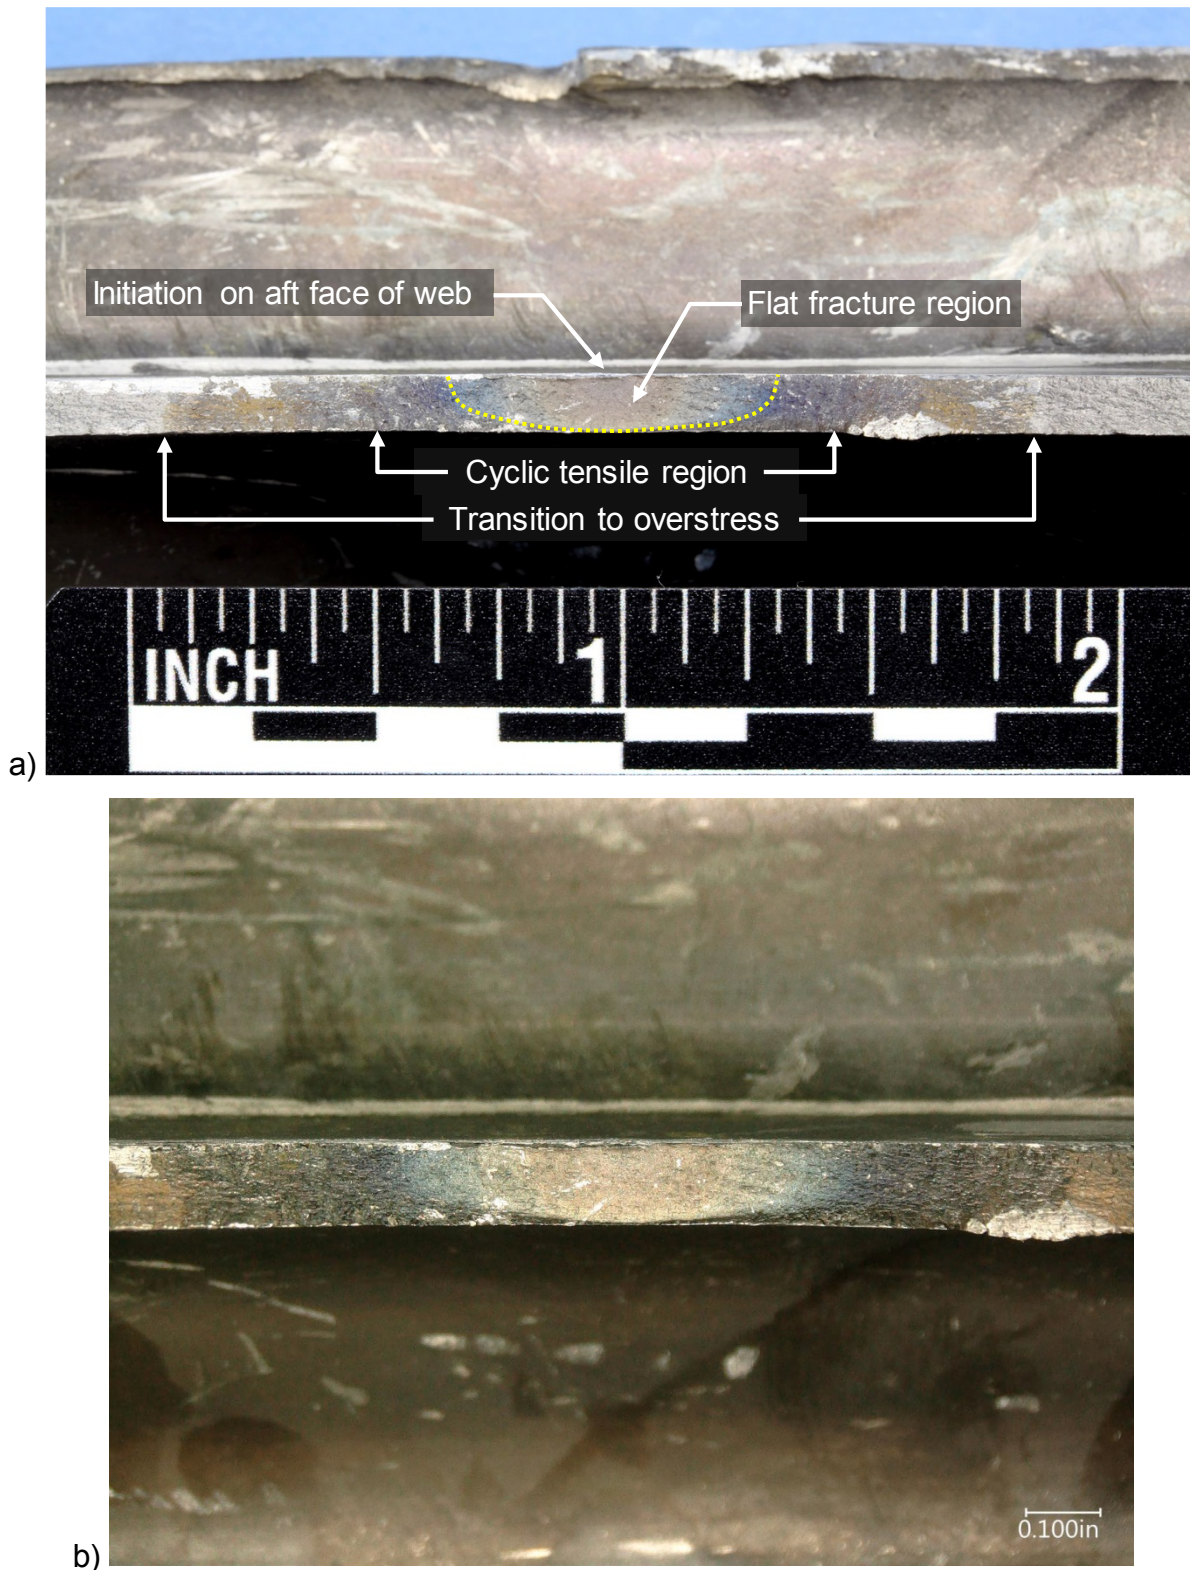
**Figure 4:** a) and b) Higher magnification images of the underside of the HPC stage 8 disk rim piece at the location indicated in figure 3b. Metallurgical examination indicated that a crack initiated at the aft face of the web at this location and progressed in the longitudinal direction and the circumferential direction.

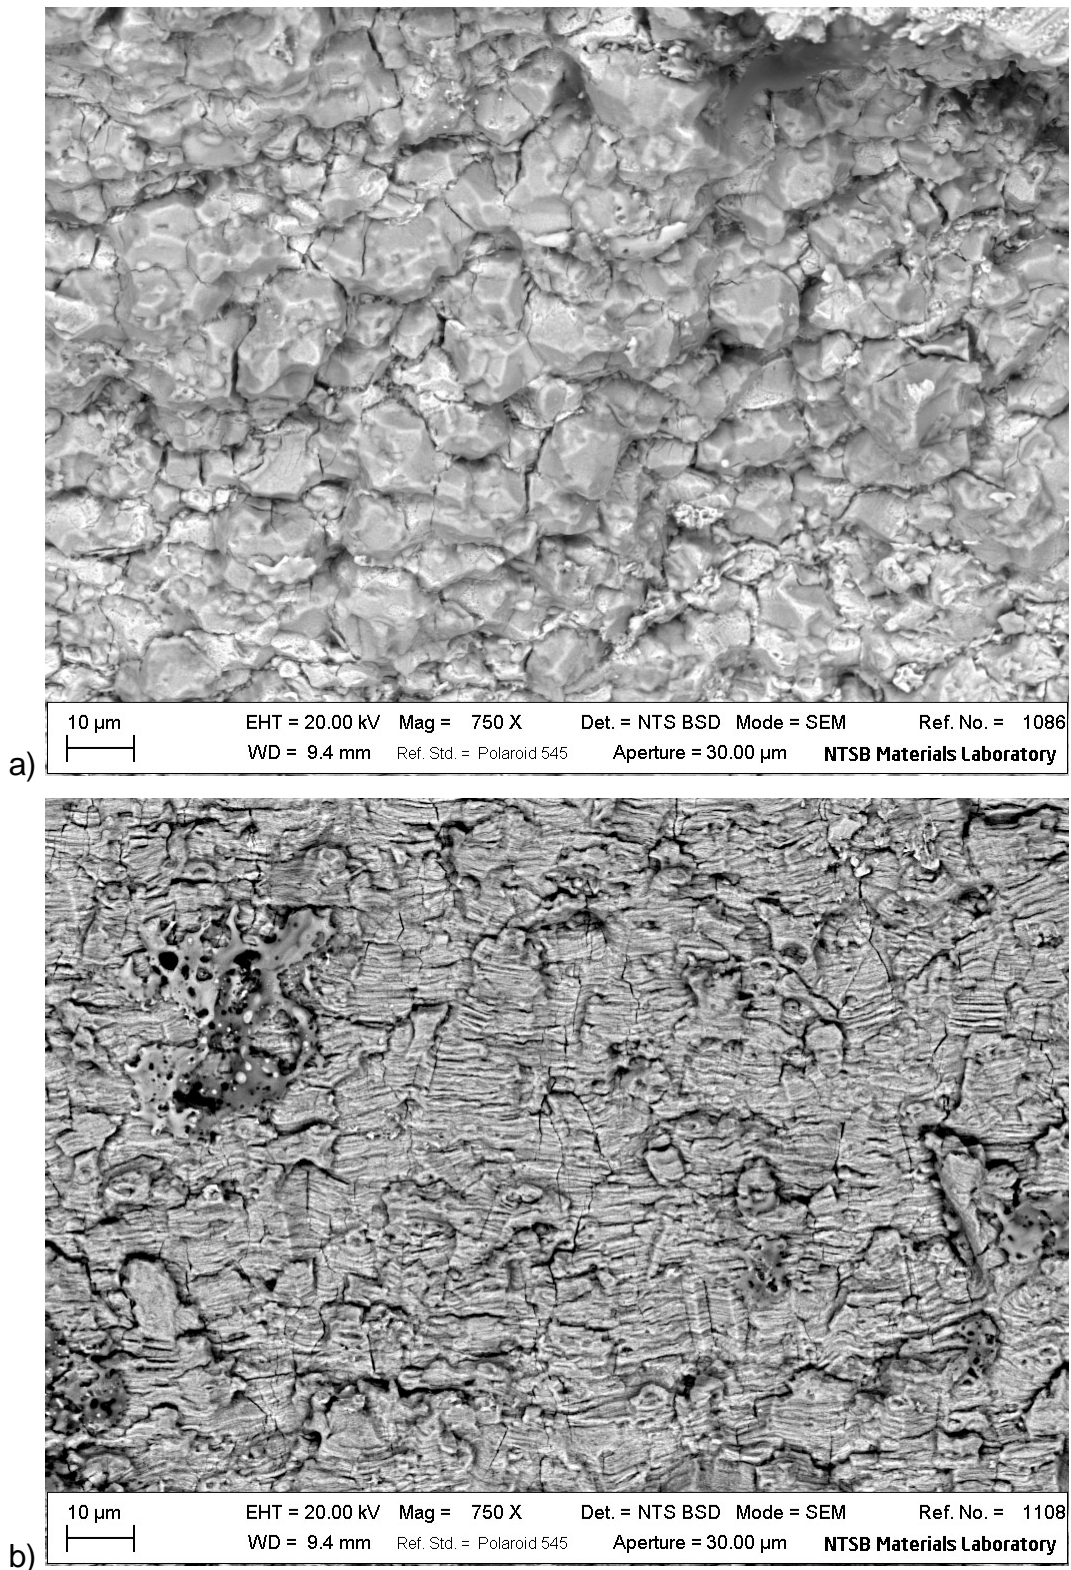
figure 5.<sup>1</sup> Representative higher magnification views of the intergranular and transgranular regions are shown in figures 6a and 6b, respectively. At this magnification the transgranular regions exhibited fatigue striations consistent with high alternating stress low-cycle fatigue crack growth. Detailed characterization and determination of crack propagation mode of the intergranular region was carried out at a later date.<sup>2</sup>

**Figure 6:** Higher magnification SEM images showing the fracture morphology in the a) intergranular region and b) transgranular region.

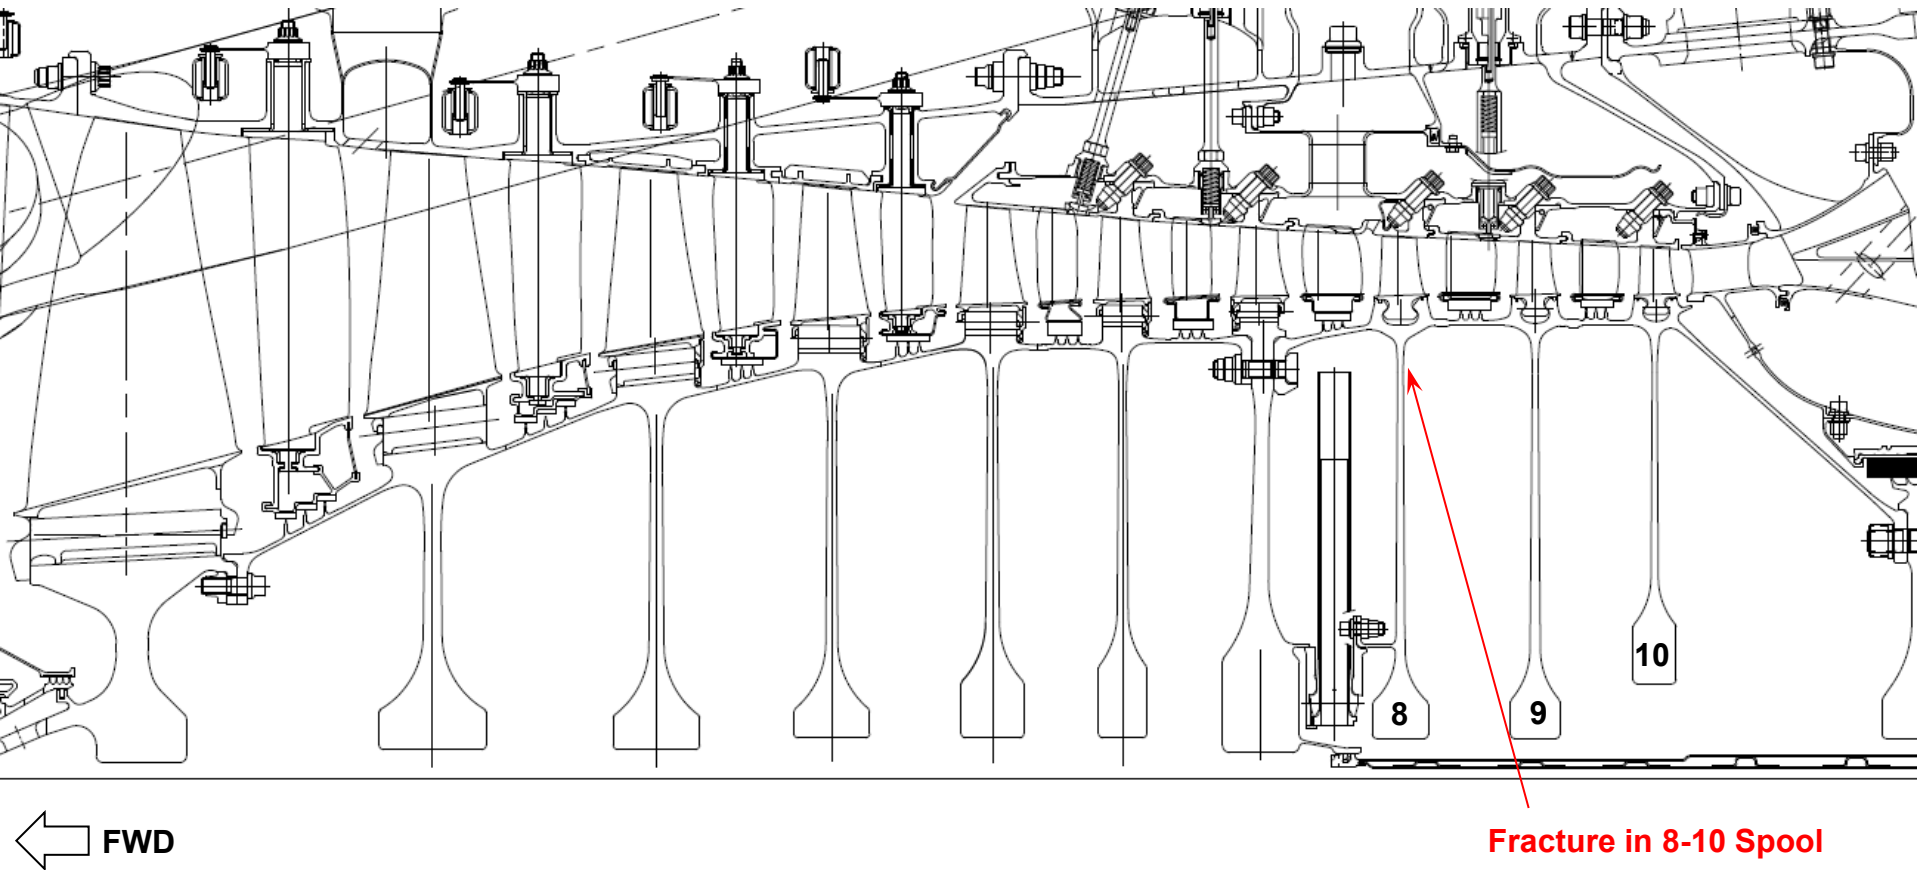
**Figure 2:** Schematic of the GE90 HPC cross-section showing the geometry of the 8-10 spool and the location where the primary fatigue crack was found in the stage 8 disk web near the rim.

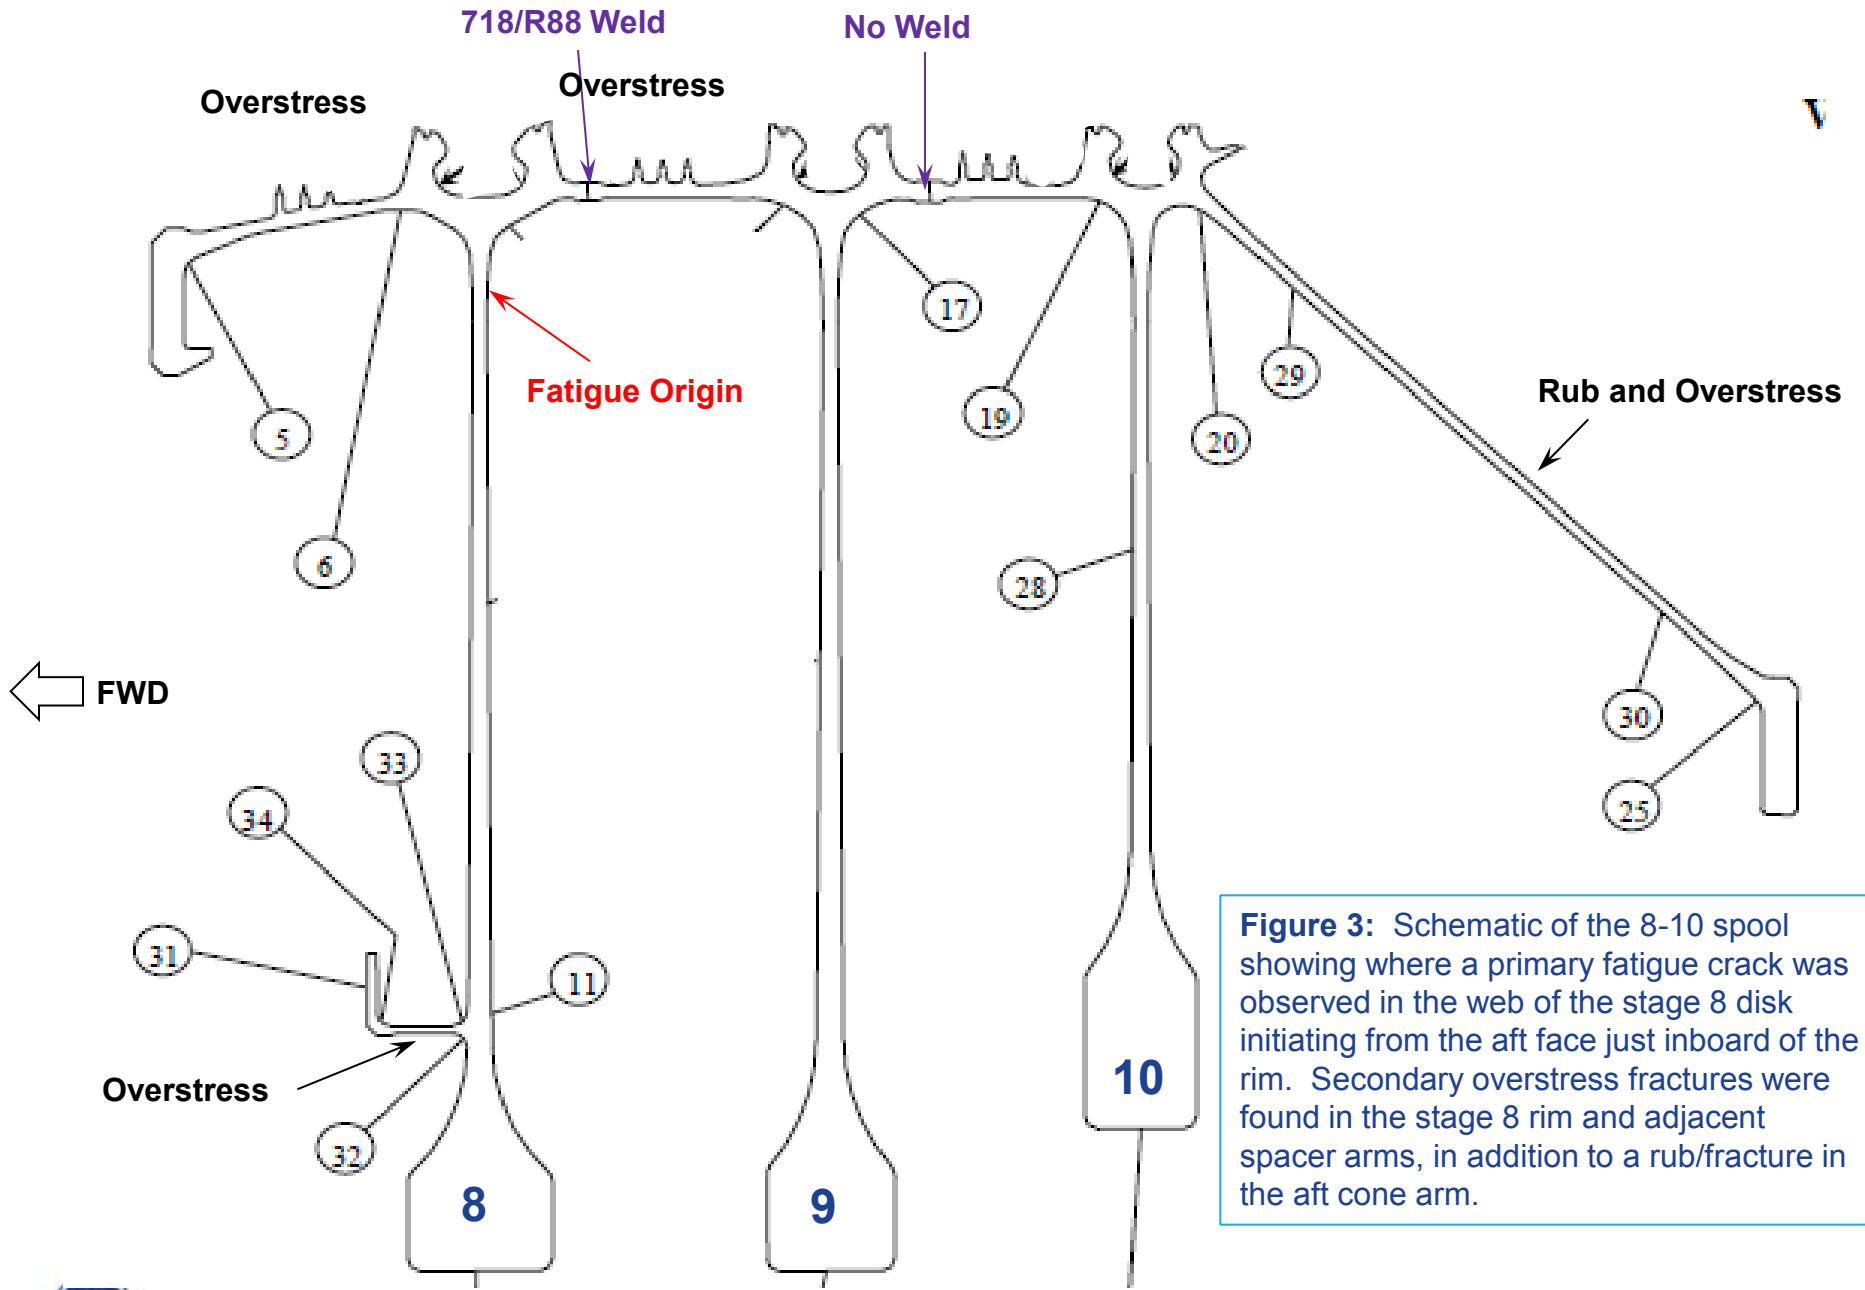
**Figure 3:** Schematic of the 8-10 spool showing where a primary fatigue crack was observed in the web of the stage 8 disk initiating from the aft face just inboard of the rim. Secondary overstress fractures were found in the stage 8 rim and adjacent spacer arms, in addition to a rub/fracture in the aft cone arm.

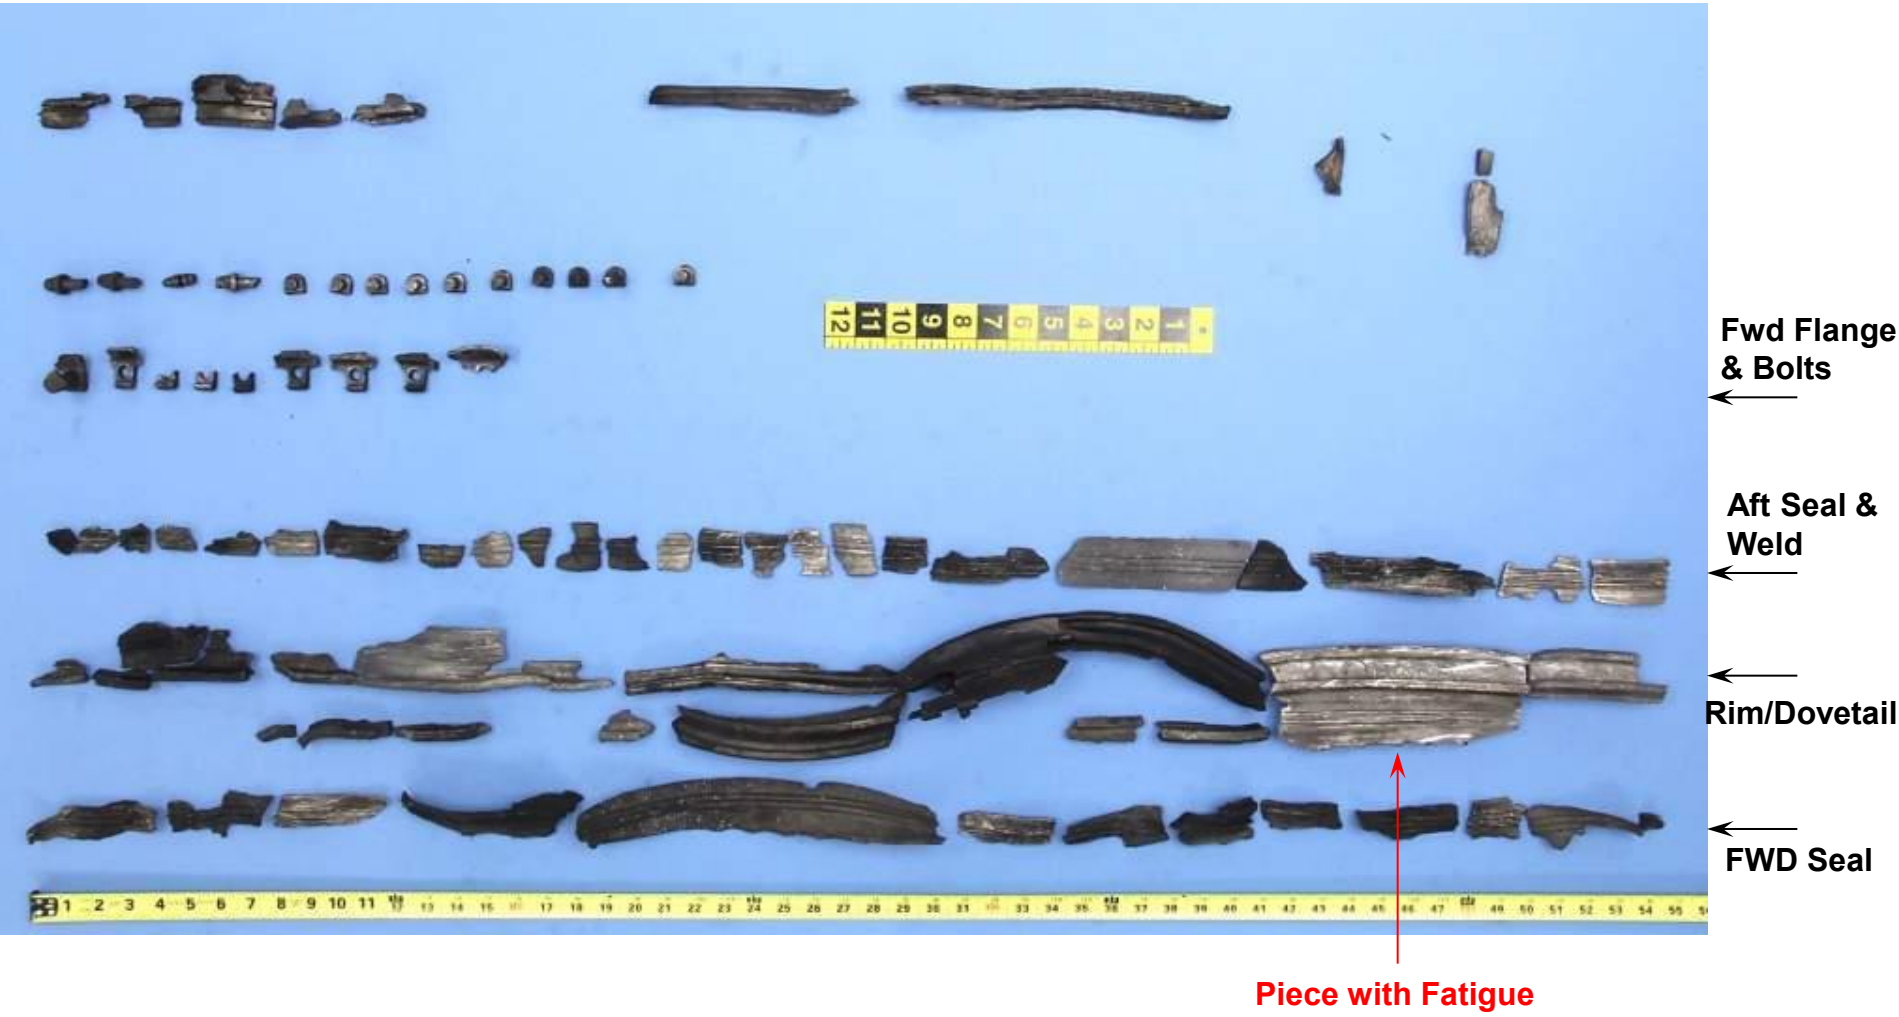
**Figure 4:** Overall optical view of the liberated fragments of the stage 8 disk rim that were recovered on-site and were returned to the NTSB laboratory for examination. Approximately 4 of 7 feet of the rim were recovered (remaining rim was still on disk). A circumferential fatigue crack was found in the web near the rim and all other fractures were consistent with overstress.

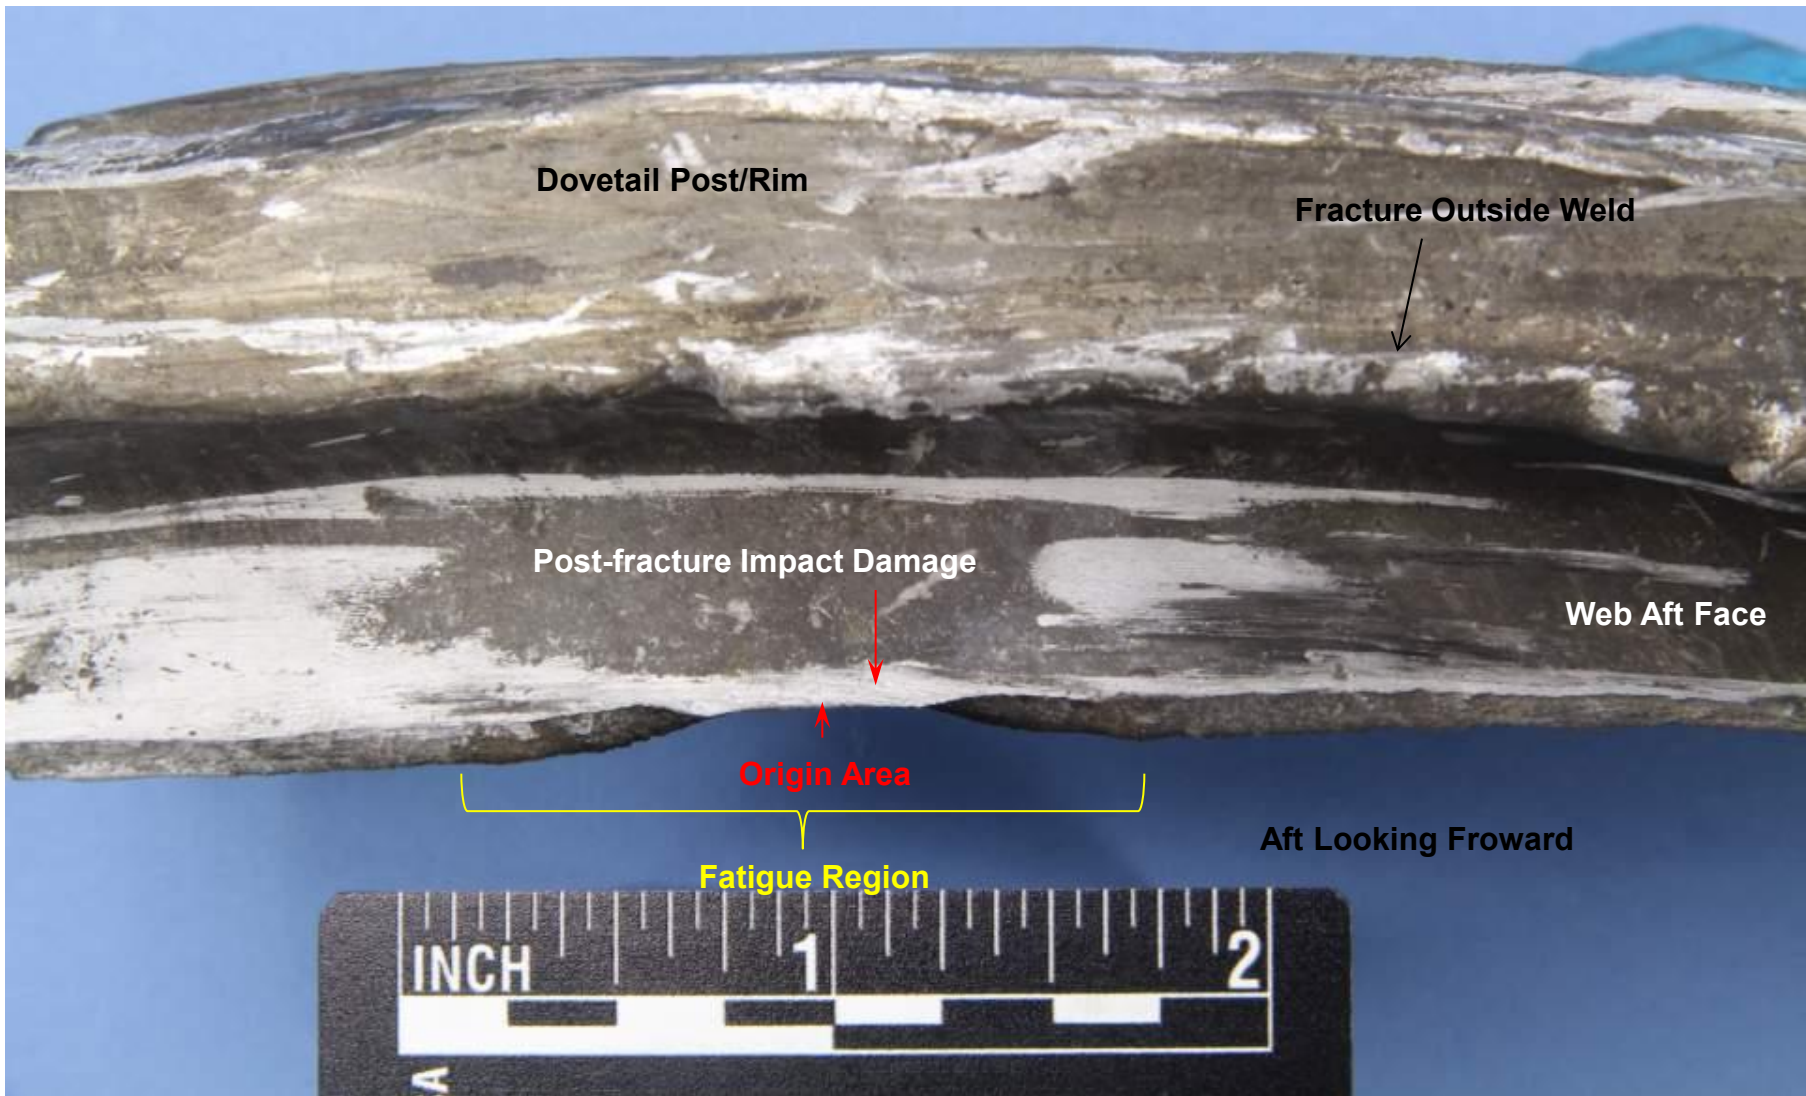
**Figure 7:** View of the aft side of the web showing the region of fatigue that was initially planar and then grew at a slant angle. The aft face near the origin was damaged by post-fracture impact damage (white debris).

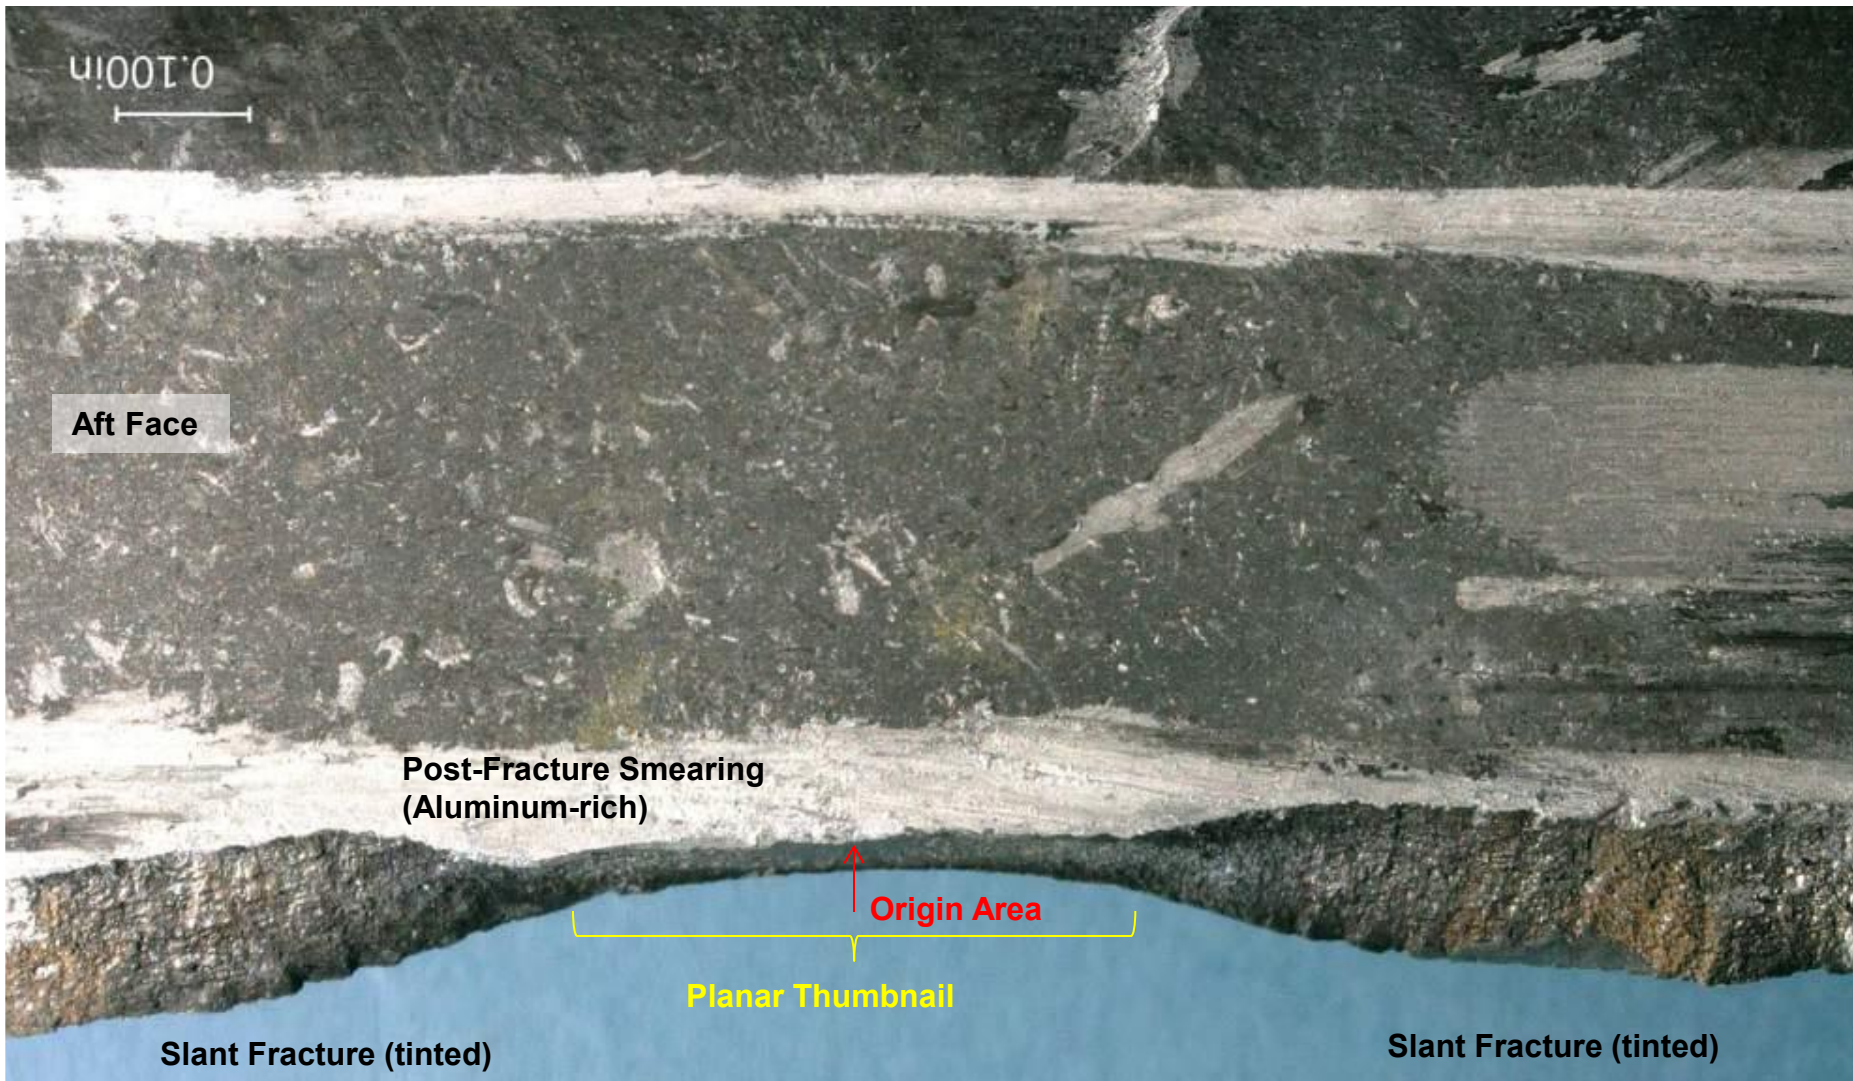
- The fatigue region extended in a circumferential/axial plane and was initially planar for approximately **0.62 inch** long then extended at a slant angle for a total combined length of approximately **1.72 inches**, prior to transitioning to overstress fracture (Figures 6-8, 10-11).

**Figure 8:** Higher magnification view of the fatigue fracture showing the initial planar region (approximately 0.62 inch long circumferentially) and the adjacent slant fracture region consistent with cyclic tensile that reached a total length of approximately 1.72 inch, prior to transitioning the overstress.

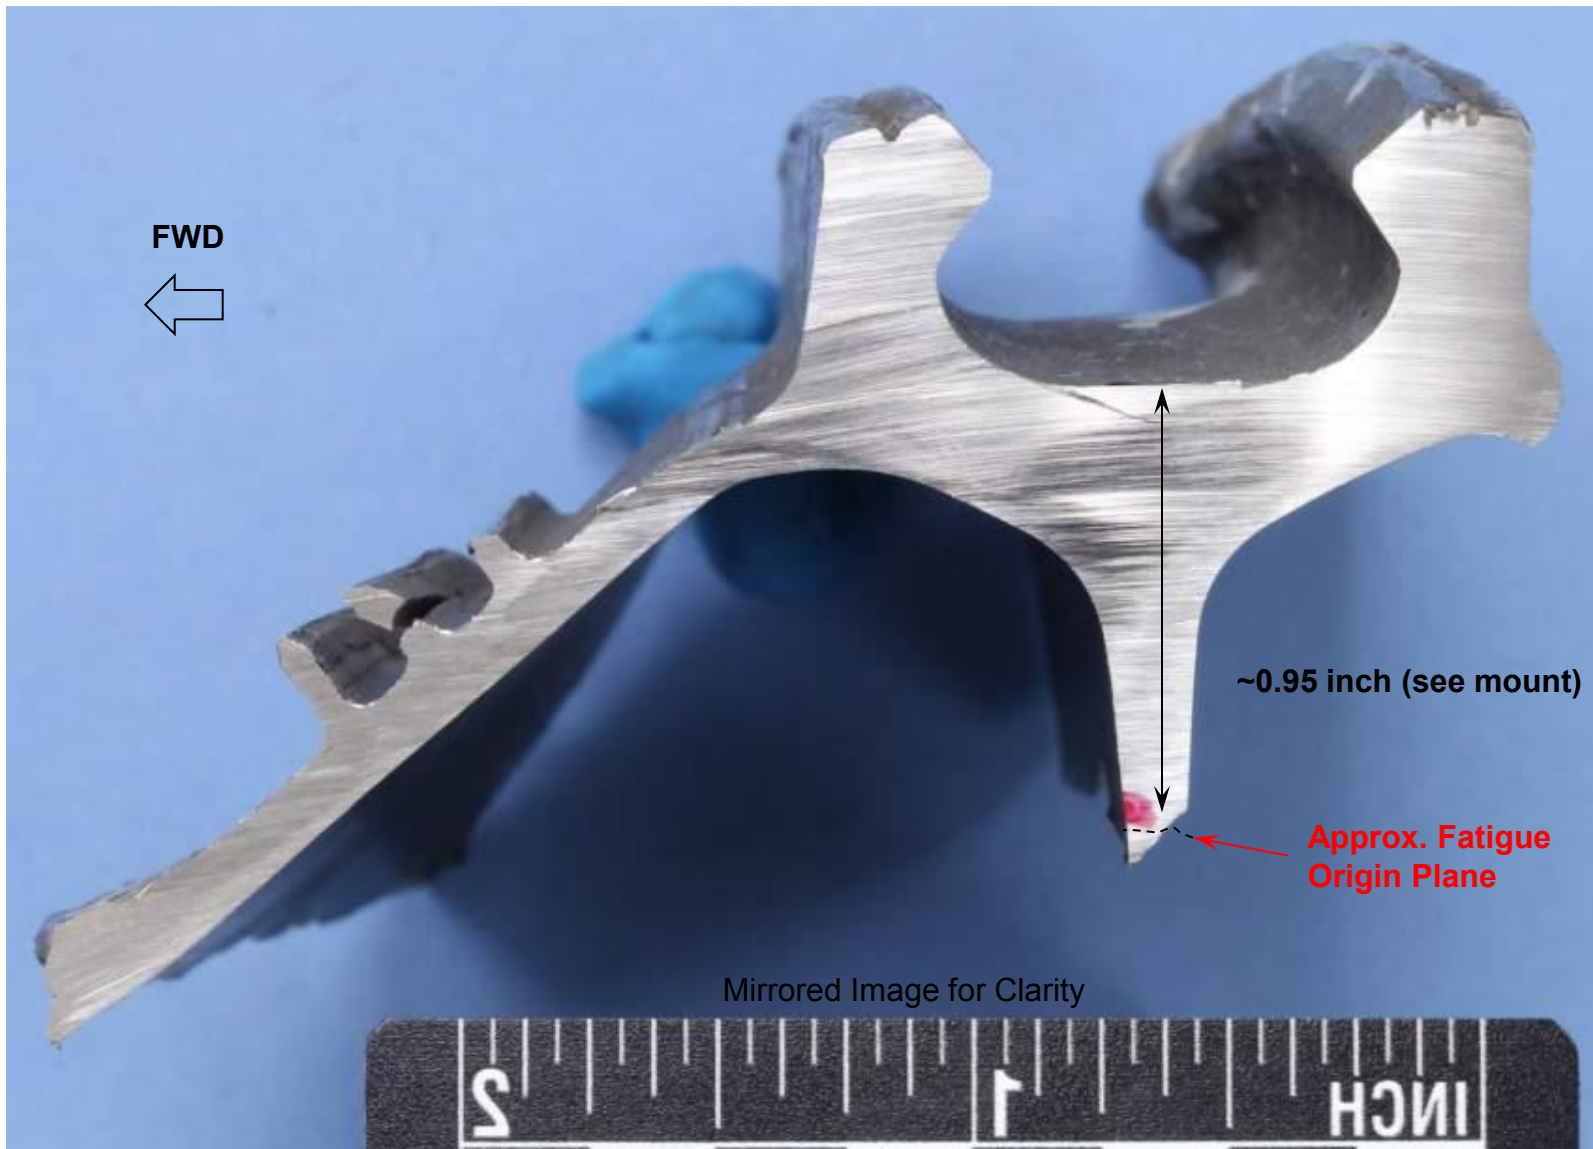
**Figure 9:** Optical view of a lab-cut section of the outboard liberated piece showing that the fatigue fracture was located approximately 0.95 inch inboard of the slot bottom in the thinnest portion of the web near the rim (better view shown in metallographic mount).

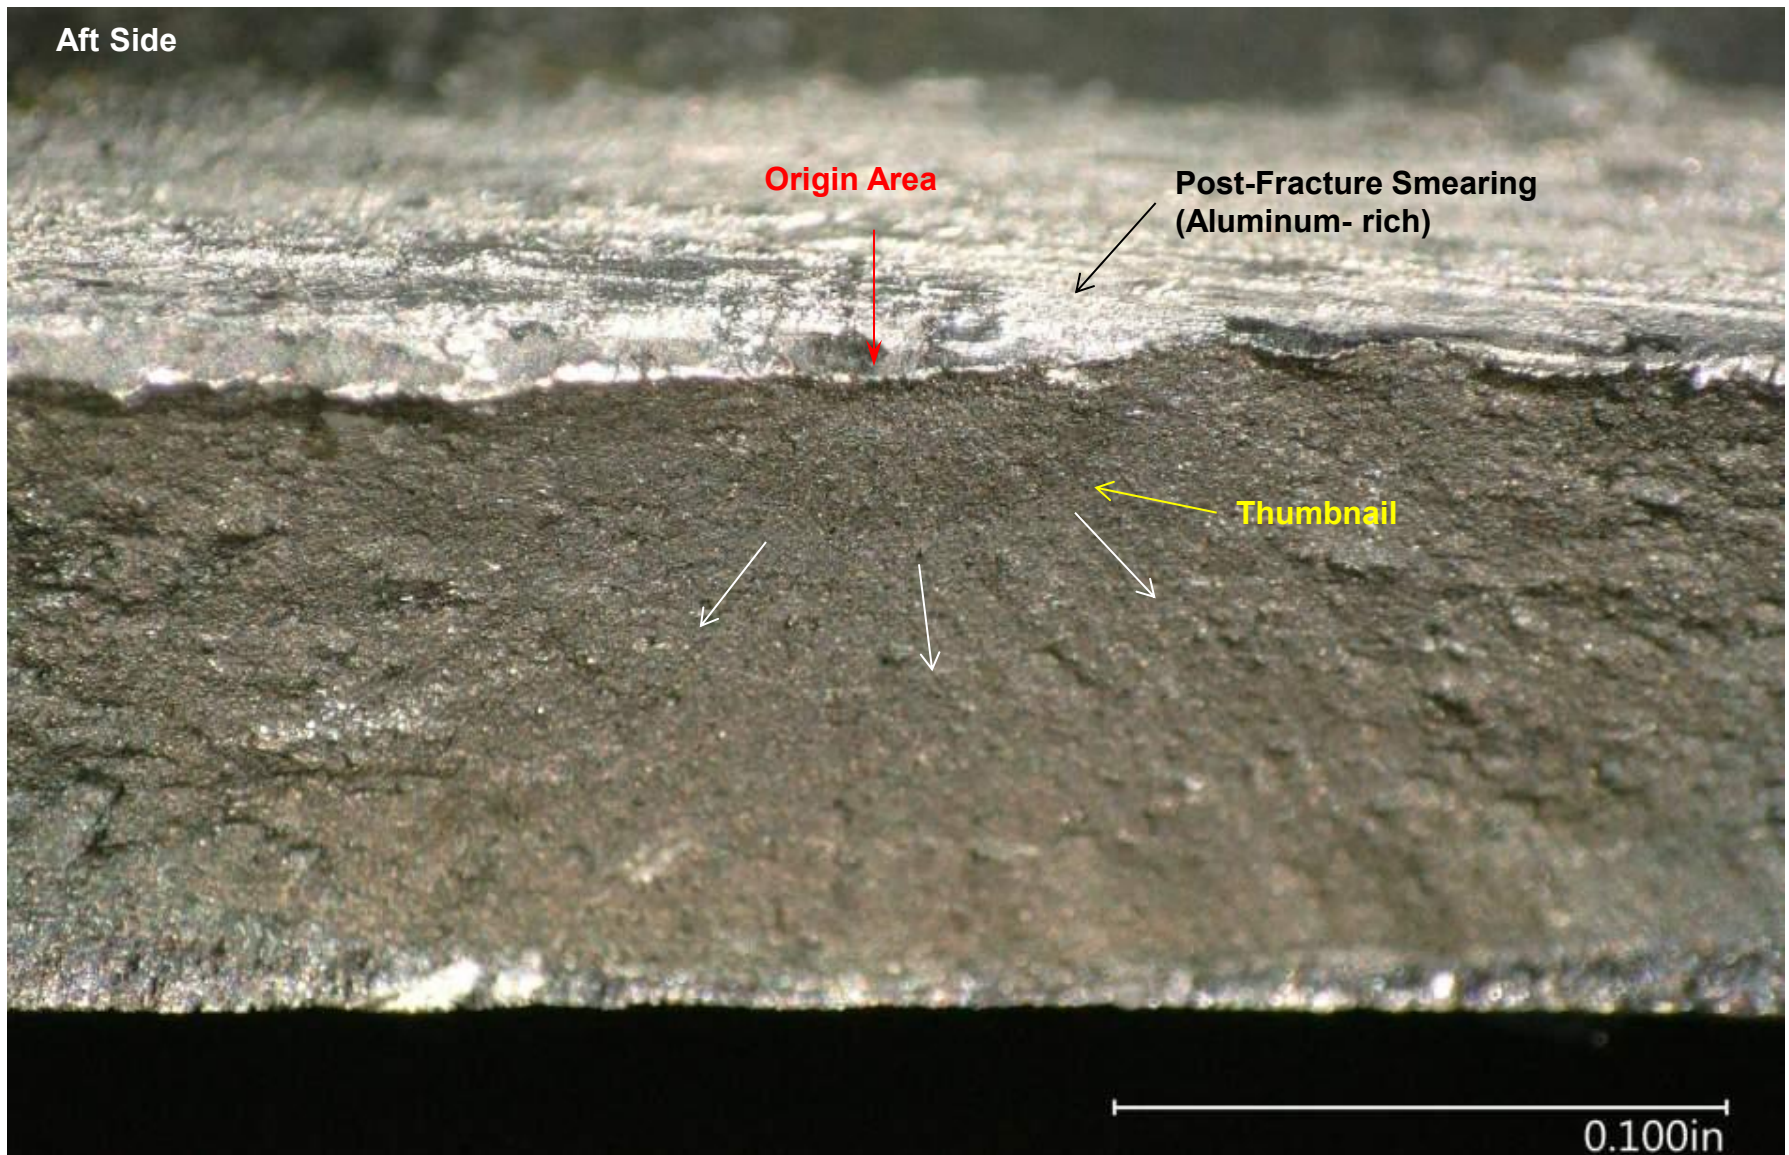
**Figure 12:** Higher magnification angled view of the planar fatigue region showing a small thumb-nail beach-mark in the early portions of the propagation (showing the crack shape in the early stages of growth). The fracture at the aft face/origin was deformed upward by post-fracture impact damage.

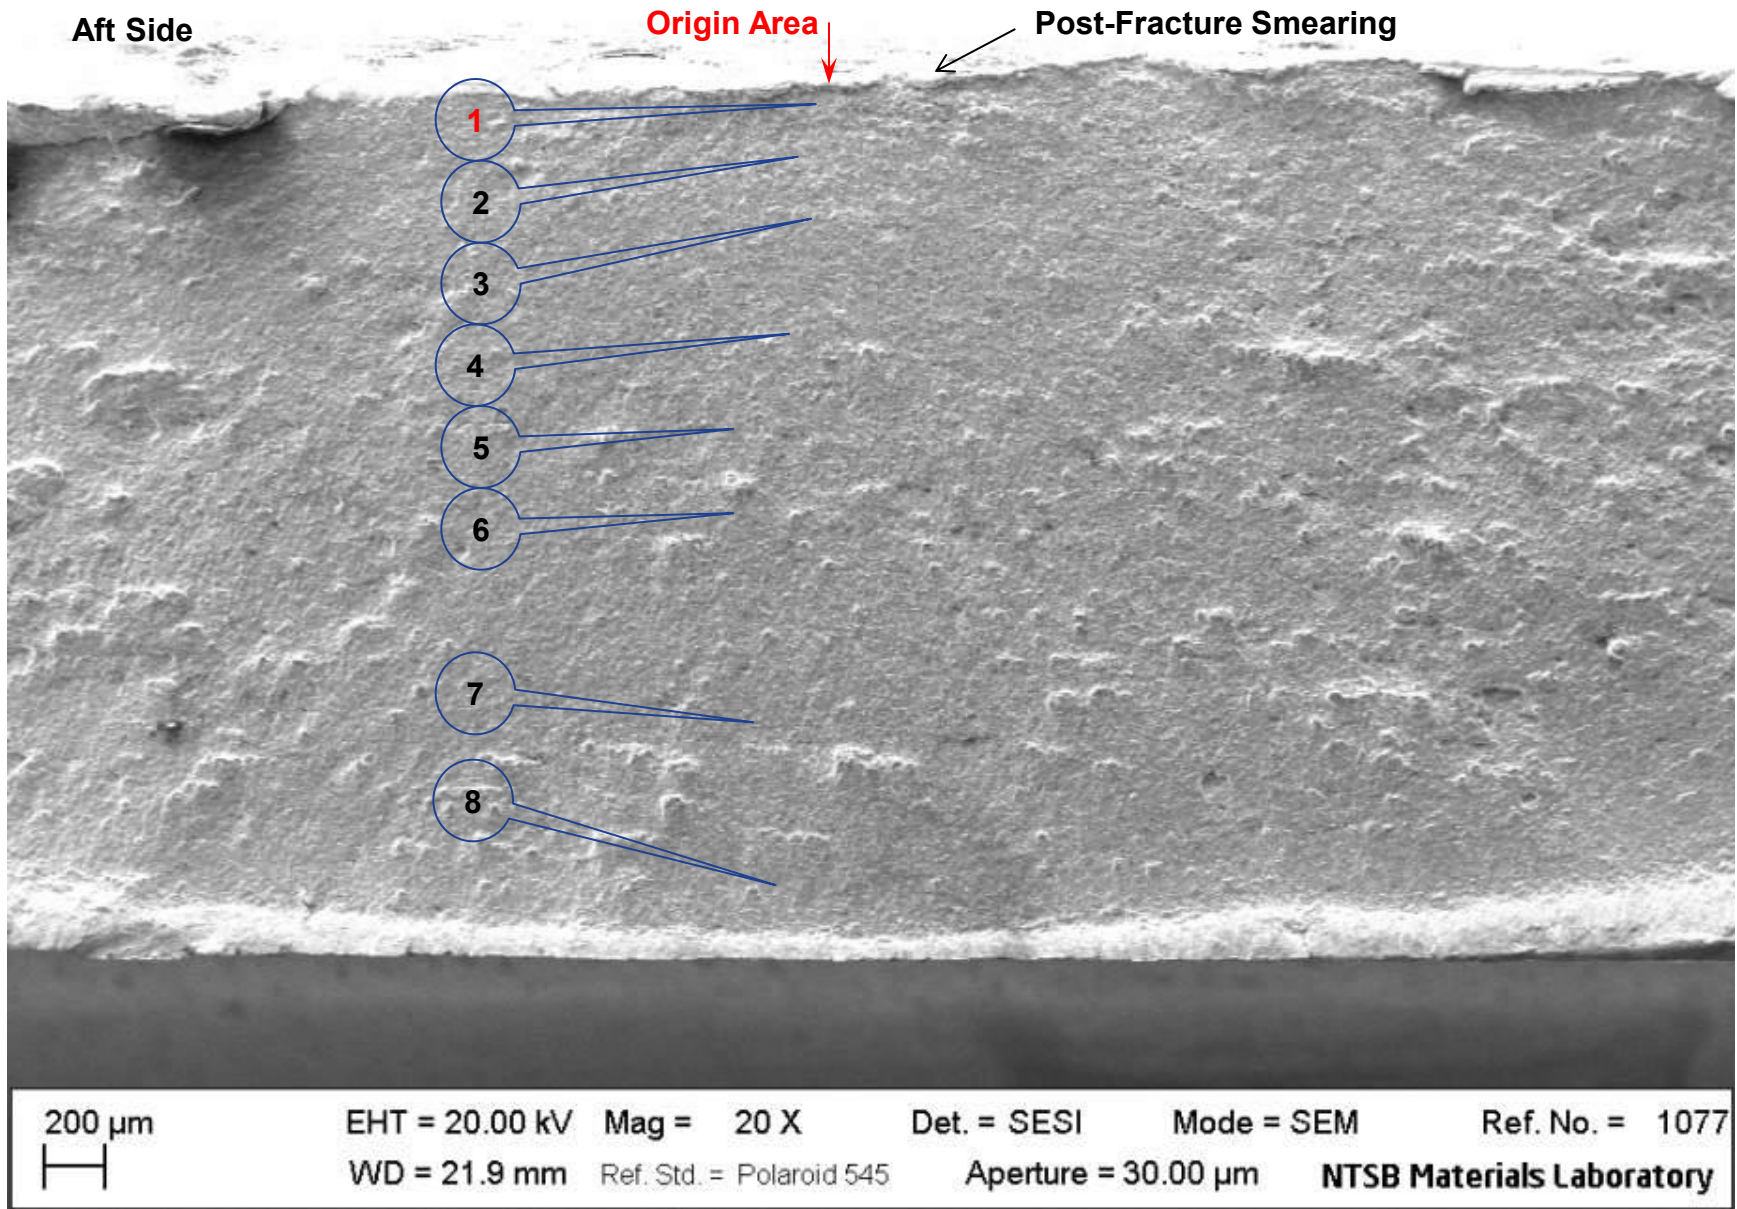
**Figure 13:** Low magnification SEM map of the outboard fracture areas examined further: in area 1 the fracture was intergranular and in areas 2-8 the features were transgranular with striations that decreased in density.

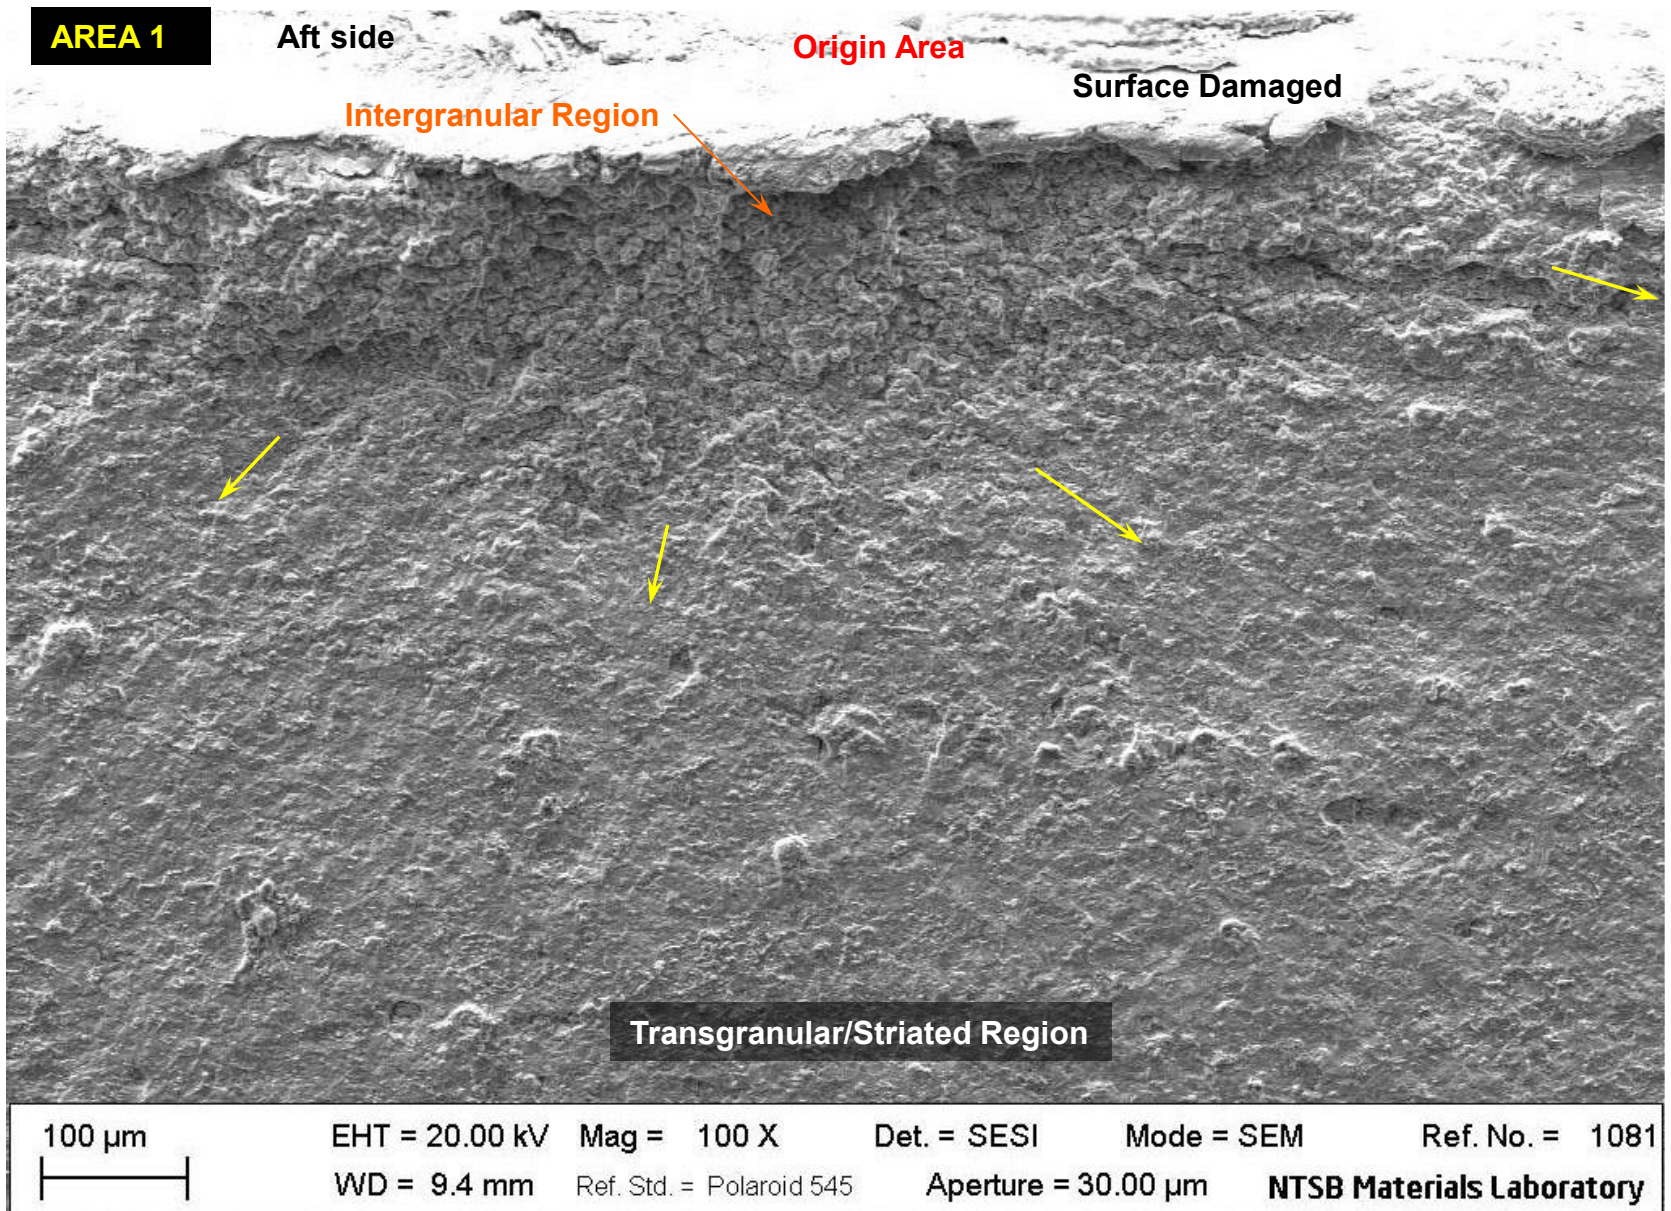
**Figure 15:** Intermediate magnification SEM view of the origin area showing that there was an initial region of intergranular growth prior to transitioning to transgranular/striated features.
