# NATIONAL TRANSPORTATION SAFETY BOARD

MATERIALS LABORATORY FACTUAL REPORT

Report No. 15-131

Place : Las Vegas, Nevada  
Date : September 8, 2015  
Vehicle : Boeing 777-200, G-VIIO  
NTSB No. : DCA15FA185  
Investigator : Lorenda Ward, AS-10

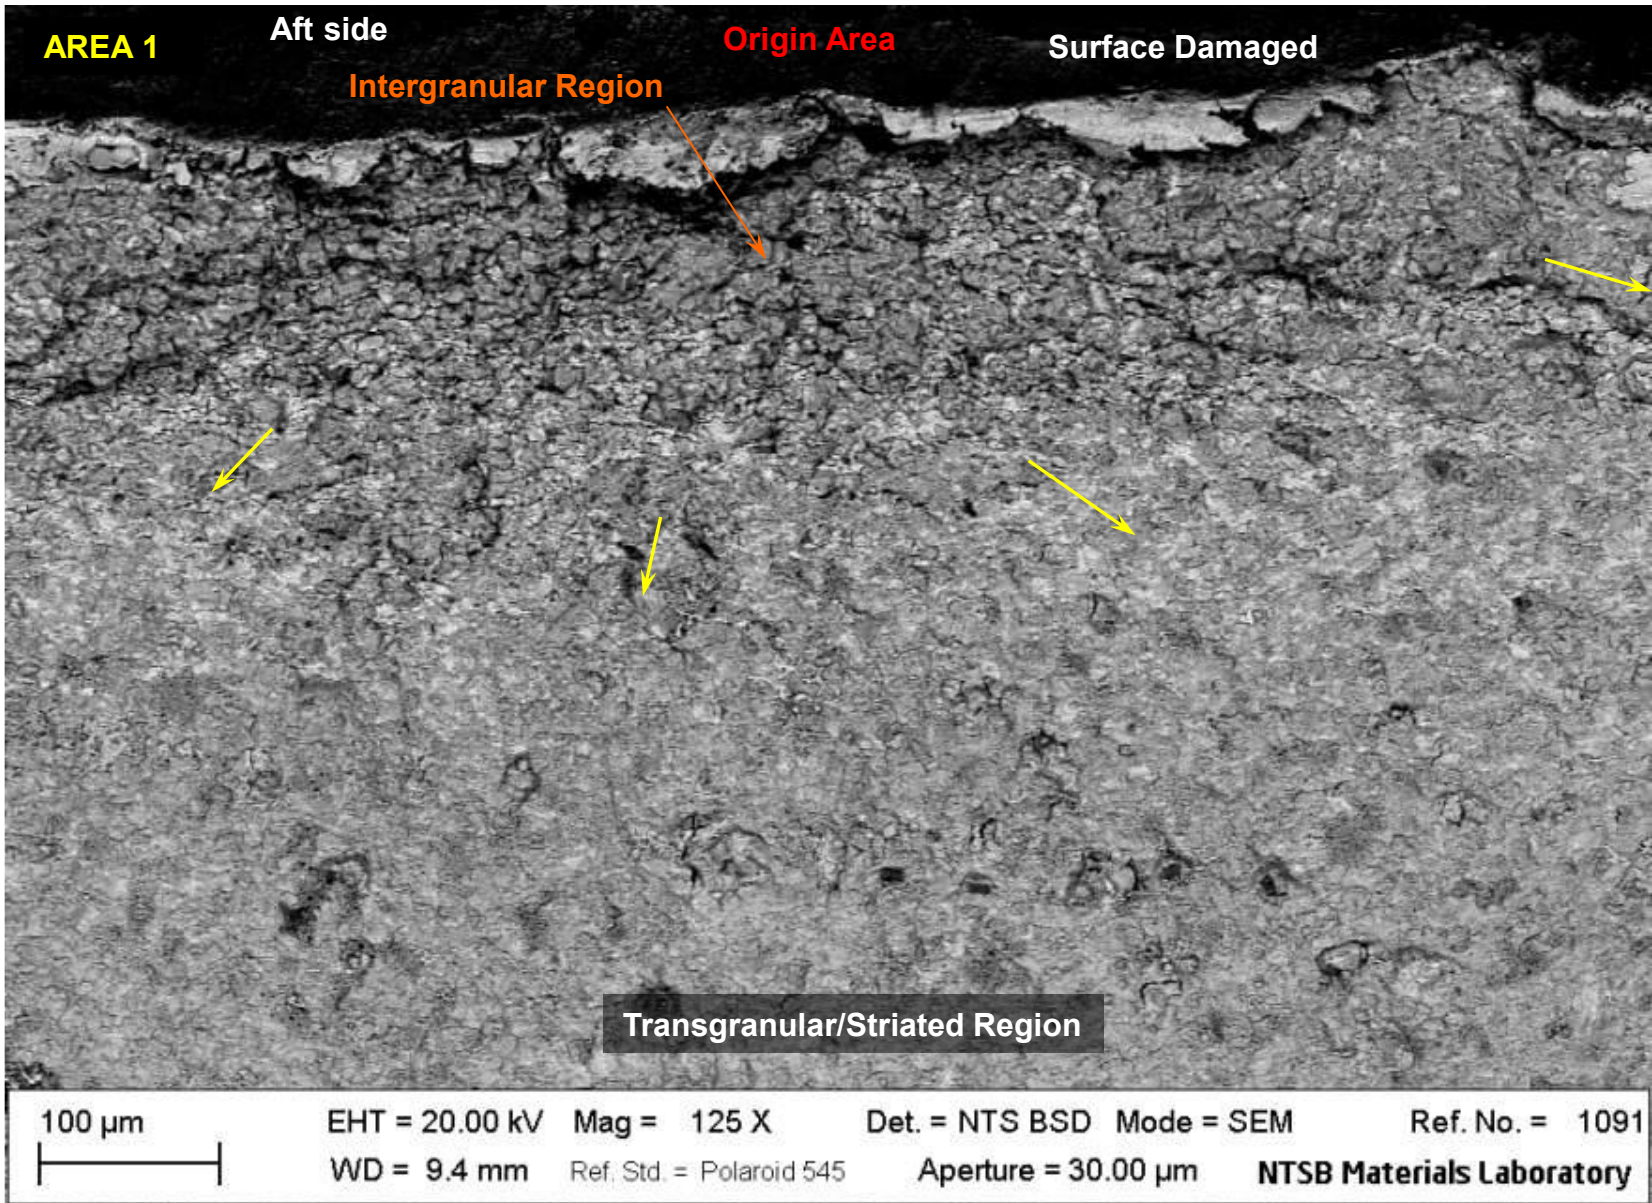
**Figure 16:** Similar view of the fracture in backscatter imaging mode showing the changes in morphology from intergranular to transgranular with no material anomalies observed. The post-fracture smearing is also visible at the aft surface.

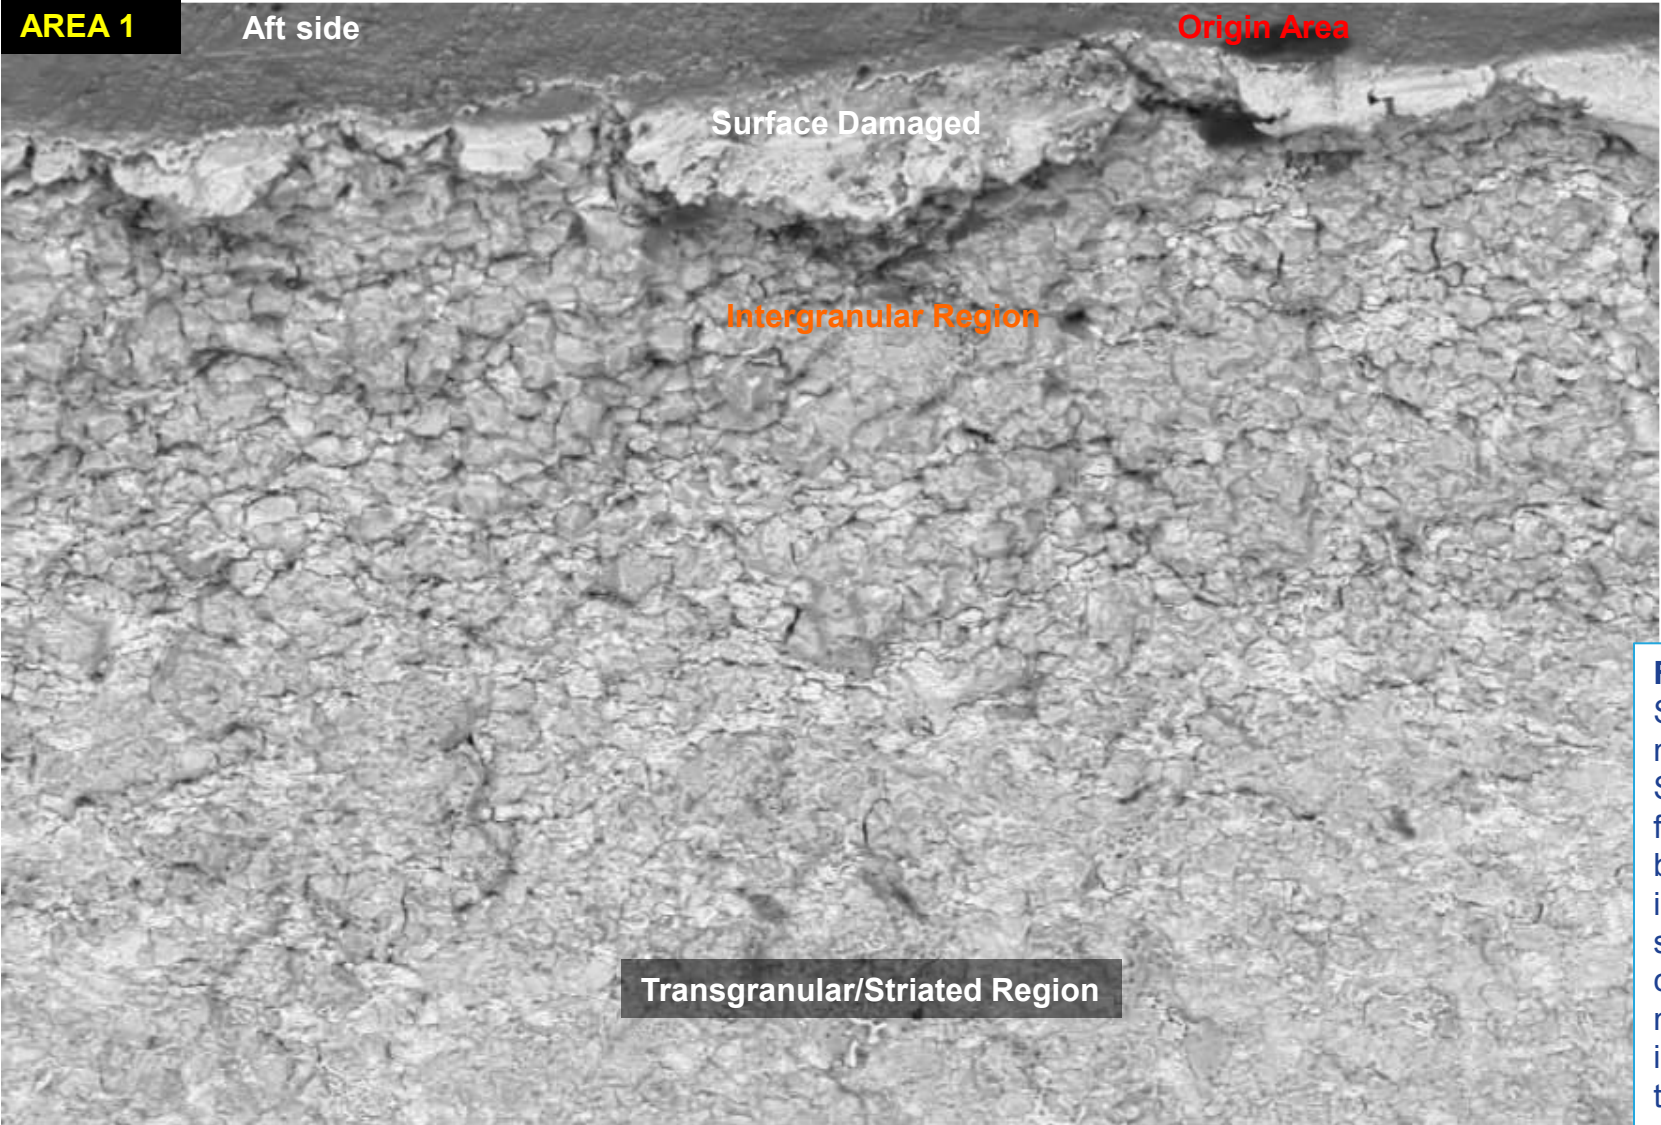
**Figure 17:** Slightly higher magnification SEM view of the fracture in backscatter imaging mode showing the changes in morphology from intergranular to transgranular with no material anomalies observed.

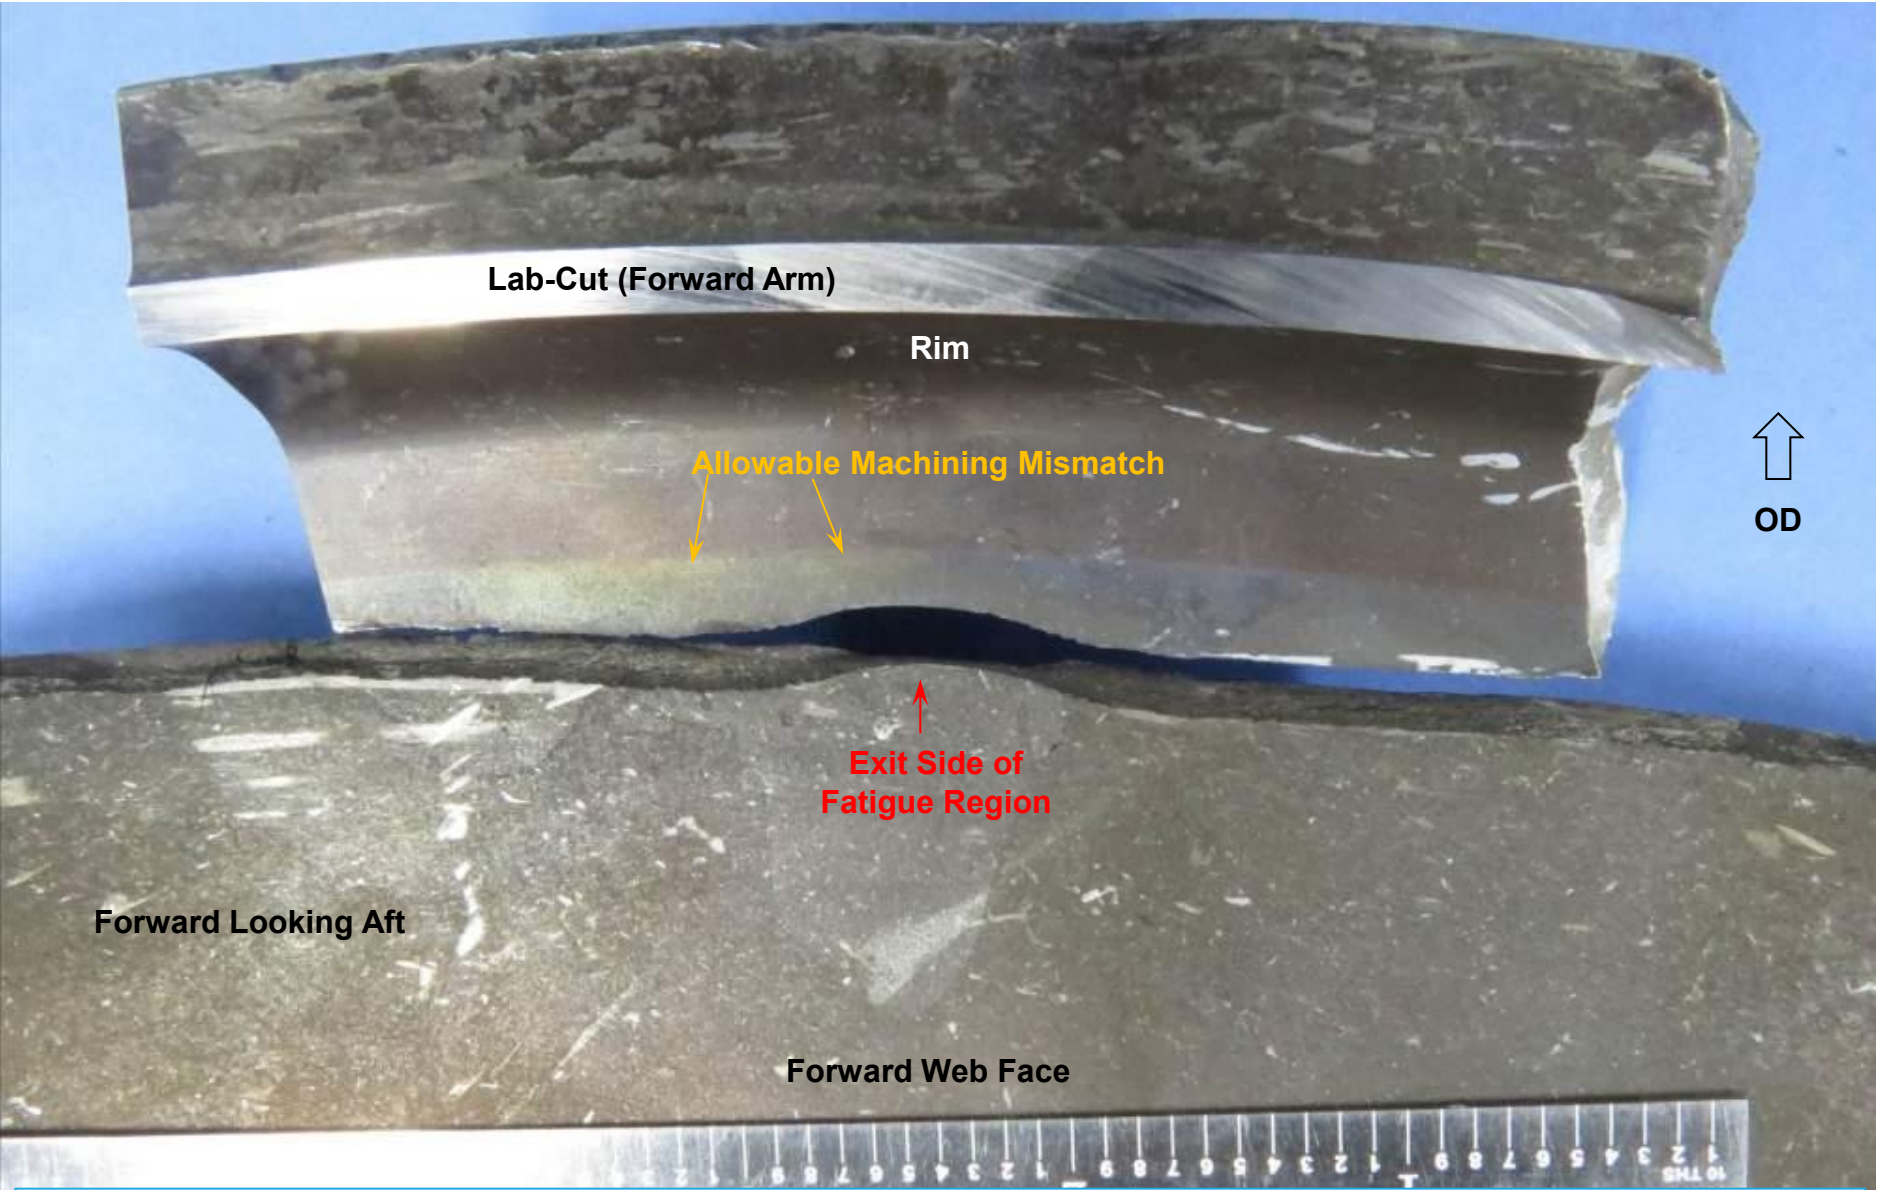
**Figure 26:** Optical view of the forward side of the web mating fracture halves showing that the fracture extended in the rim to web transition region, approximately 0.15 inch inboard of the machining mismatch.

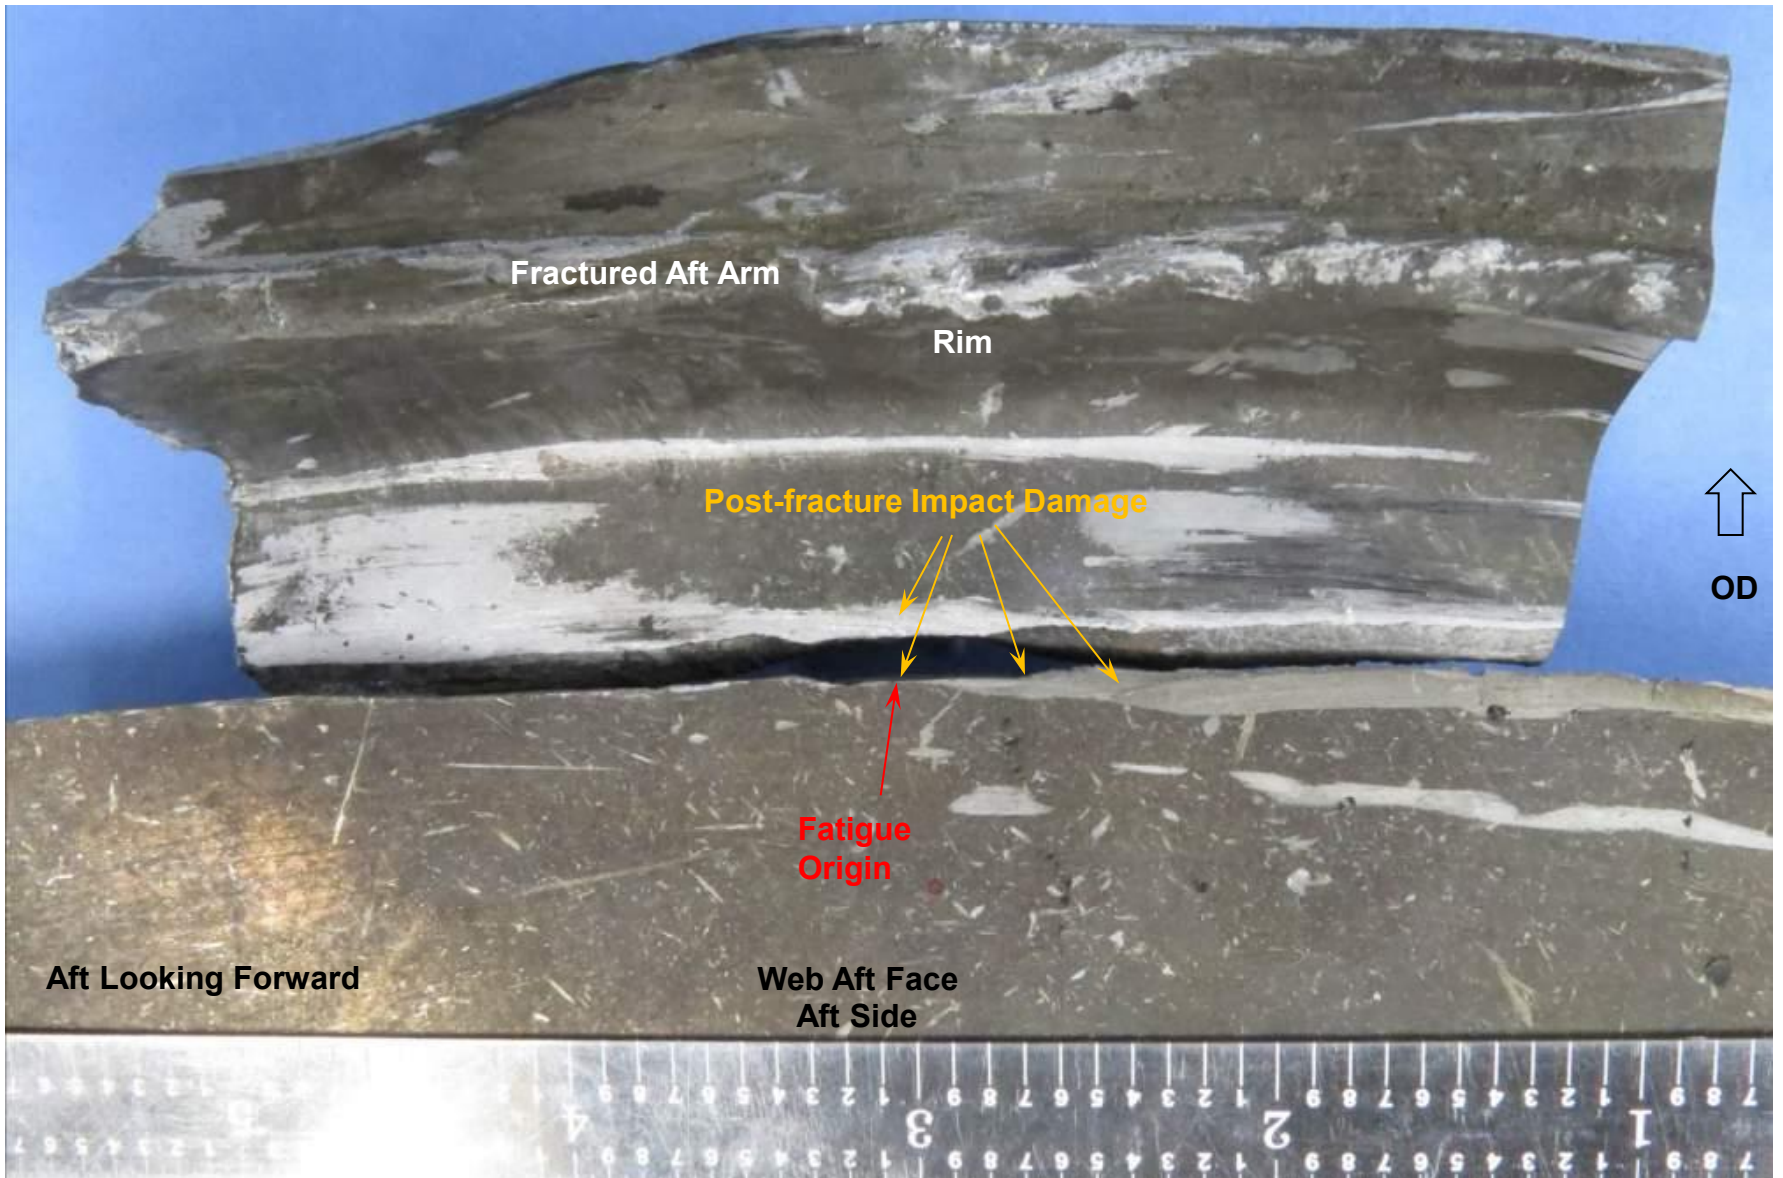
**Figure 27:** Optical view of the aft side of the web mating fracture halves showing that the fracture extended in the rim to web transition area. Both aft faces of the web at the origin area were damaged by post-fracture impact smearing damage.

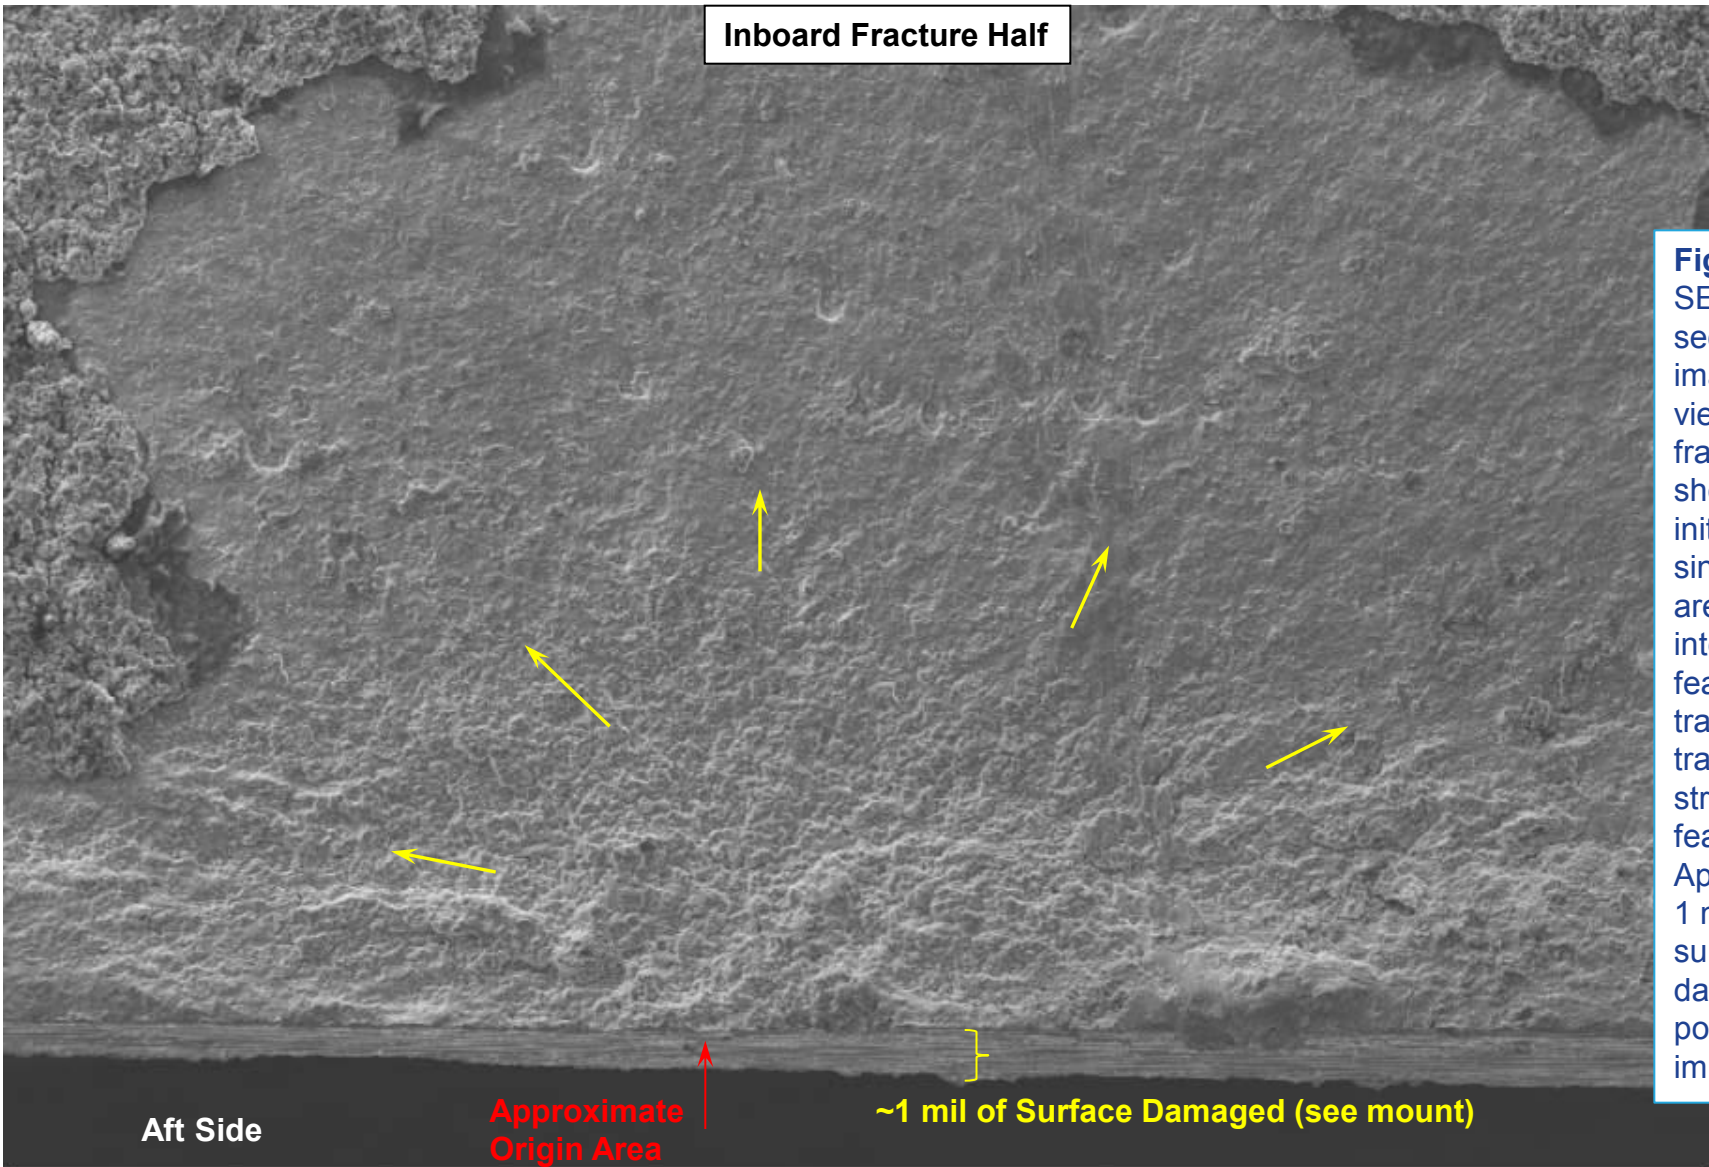
**Figure 30:**  
SEM secondary imaging mode view of the fracture showing initiation from a single origin area that had intergranular features, that transitioned to transgranular/striated features. Approximately 1 mil of the surface was damaged by post-fracture impact.

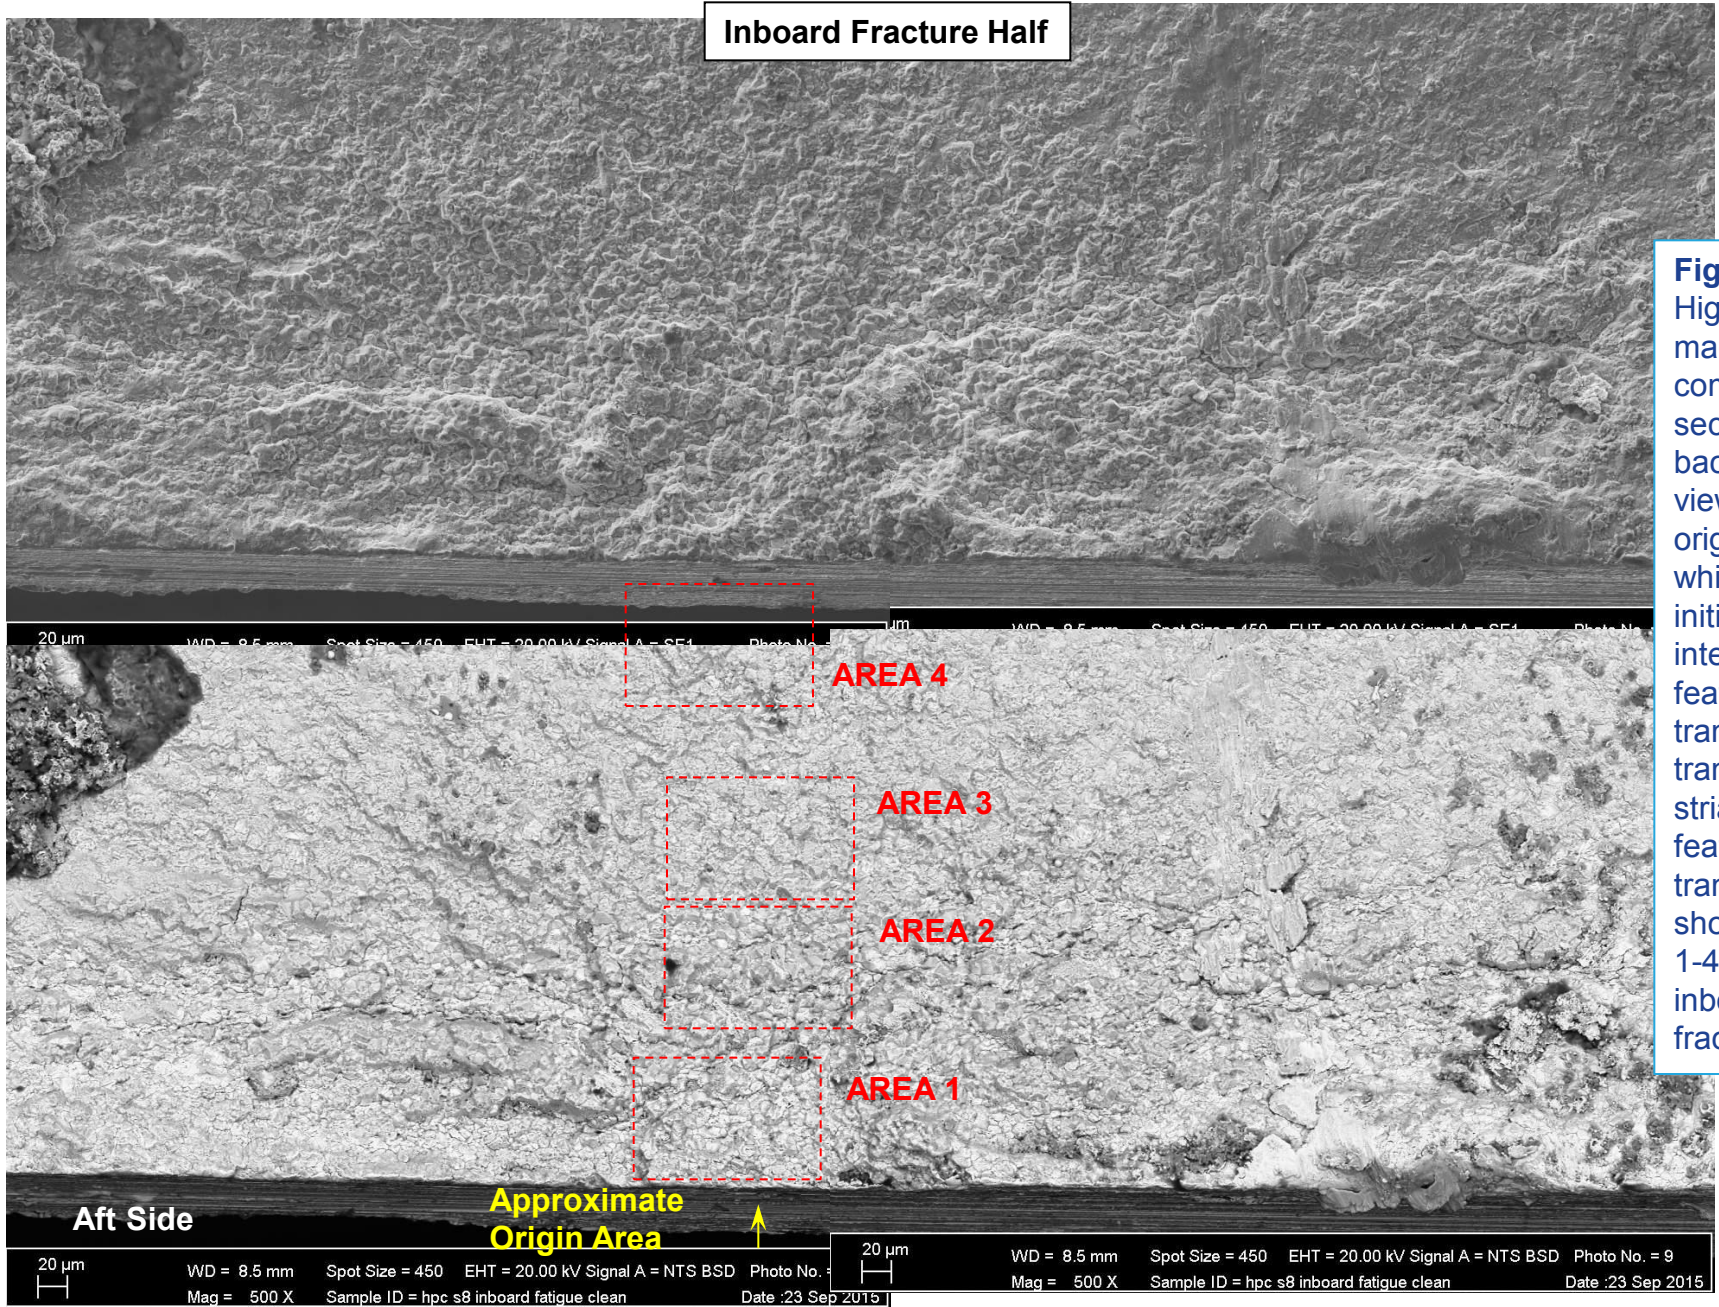
**Figure 32:** Higher magnification secondary and backscatter views of the origin area which showed initially intergranular features that transitioned to transgranular/striated features (the transition is shown in areas 1-4; also see inboard fracture).

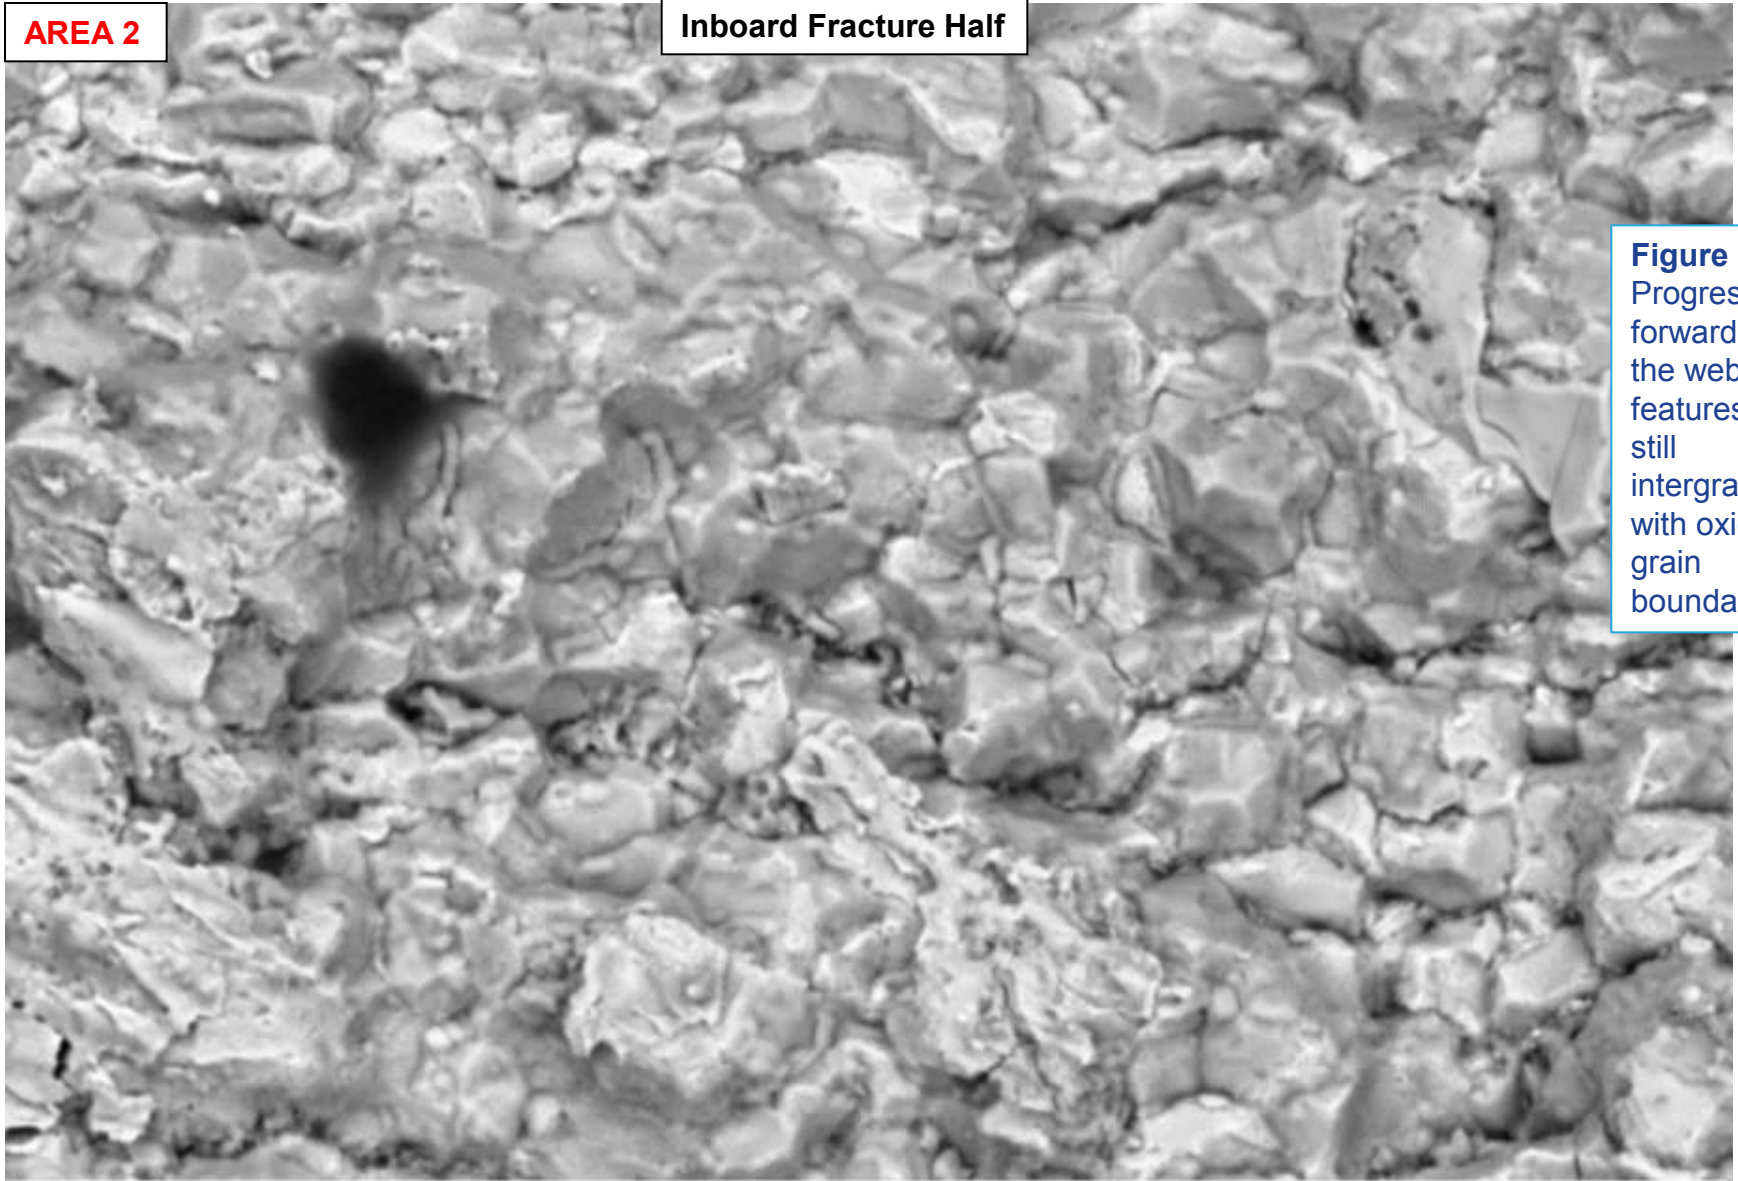
**Figure 34:** Progressing forward across the web the features were still intergranular with oxidized grain boundaries.

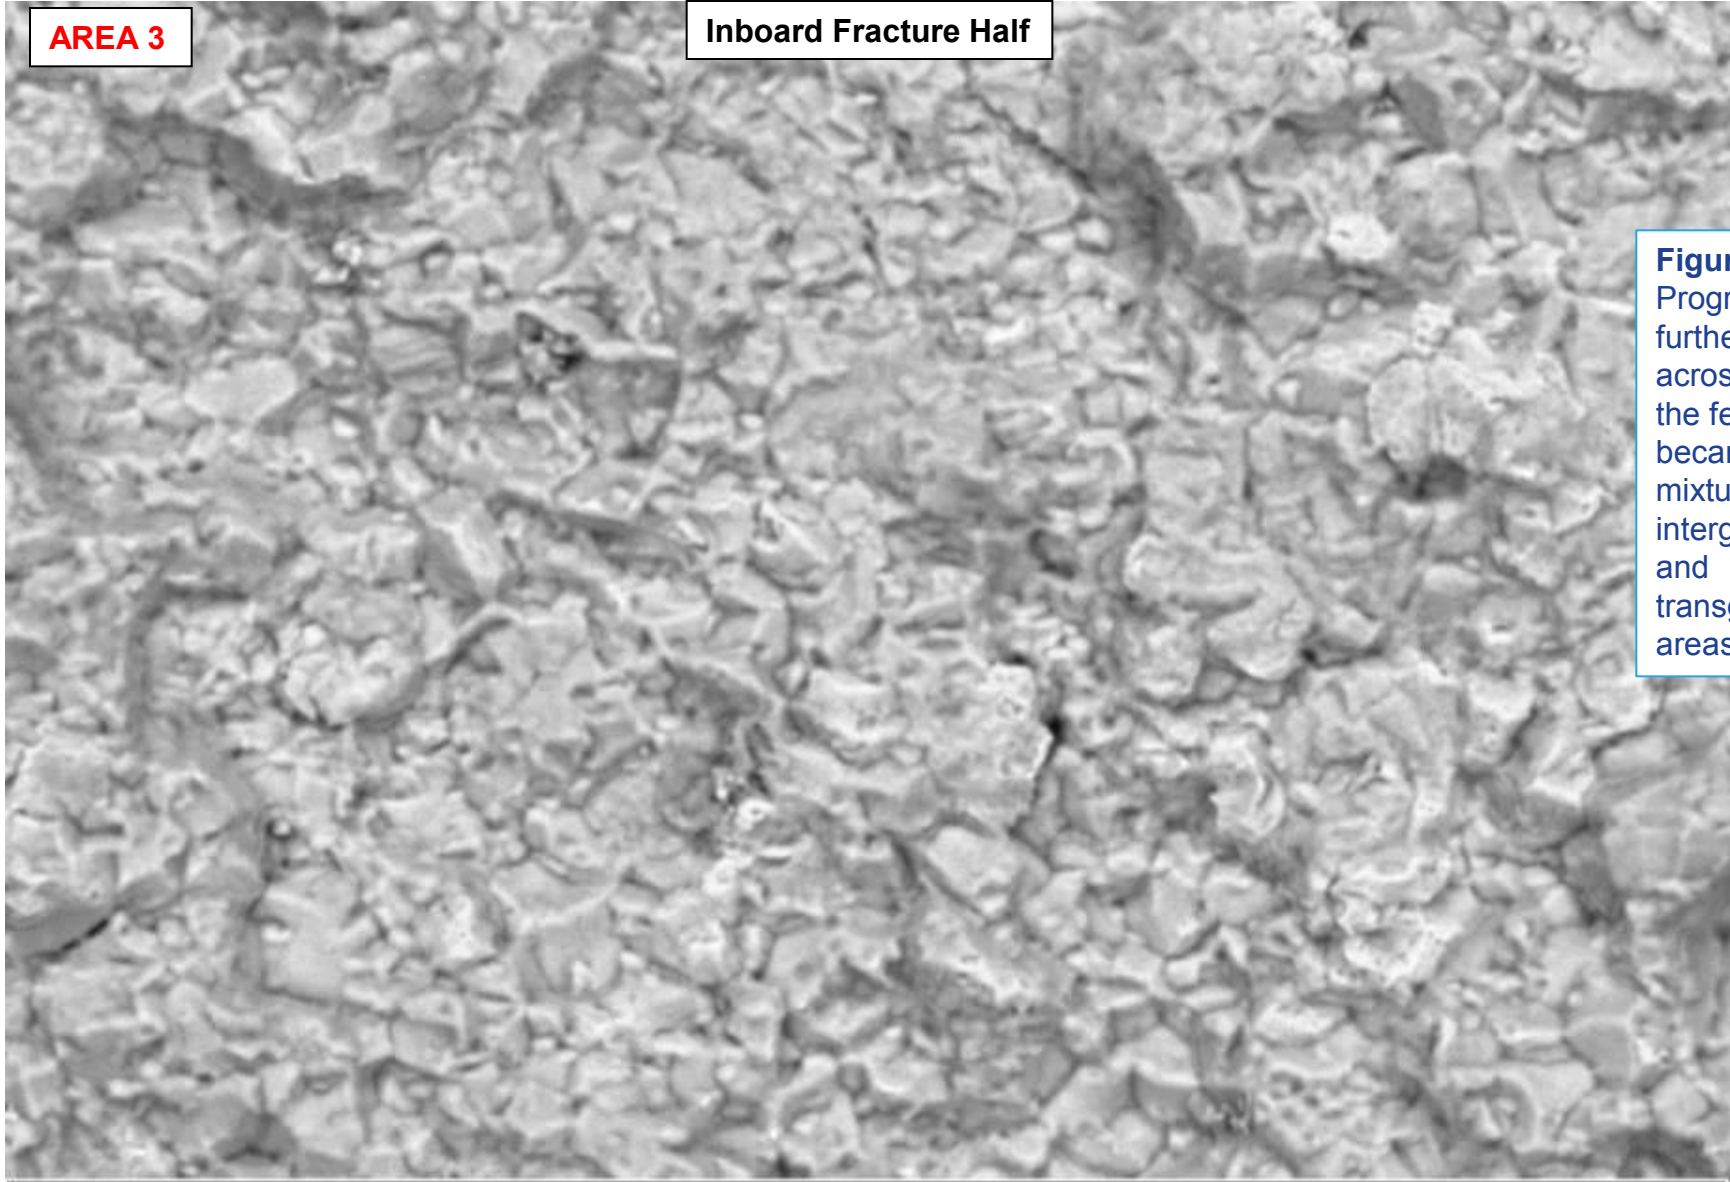
**Figure 35:** Progressing further forward across the web the features became a mixture of intergranular and transgranular areas.

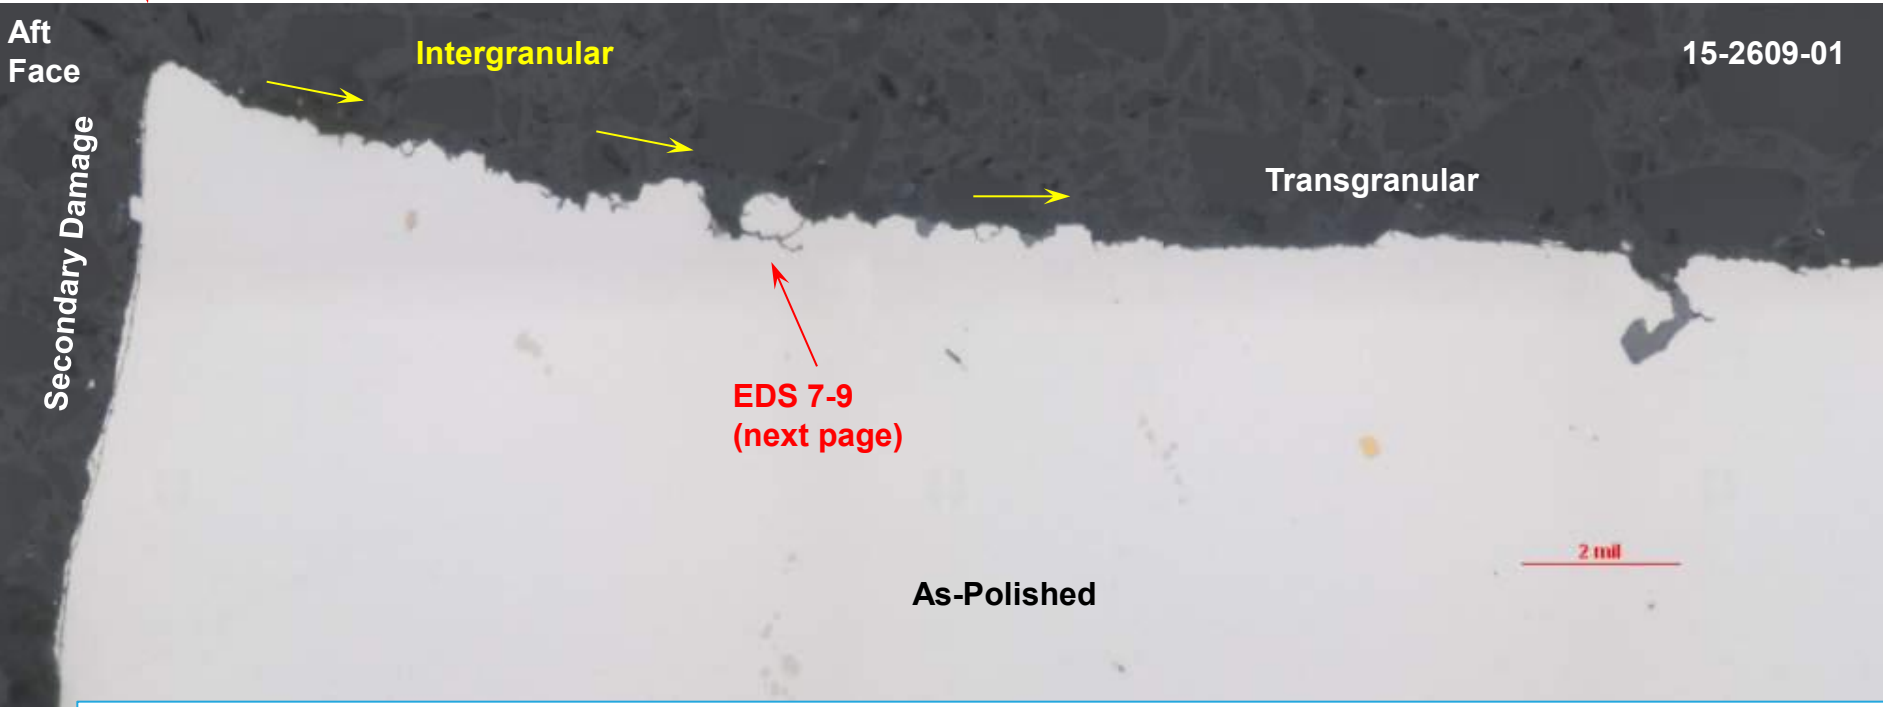
Figure 38: As-polished 1<sup>st</sup> step view of the inboard fracture showing initial intergranular growth that transitioned to transgranular growth with no material anomalies noted. The first 1 mil of the aft face was damaged by post-fracture smearing.

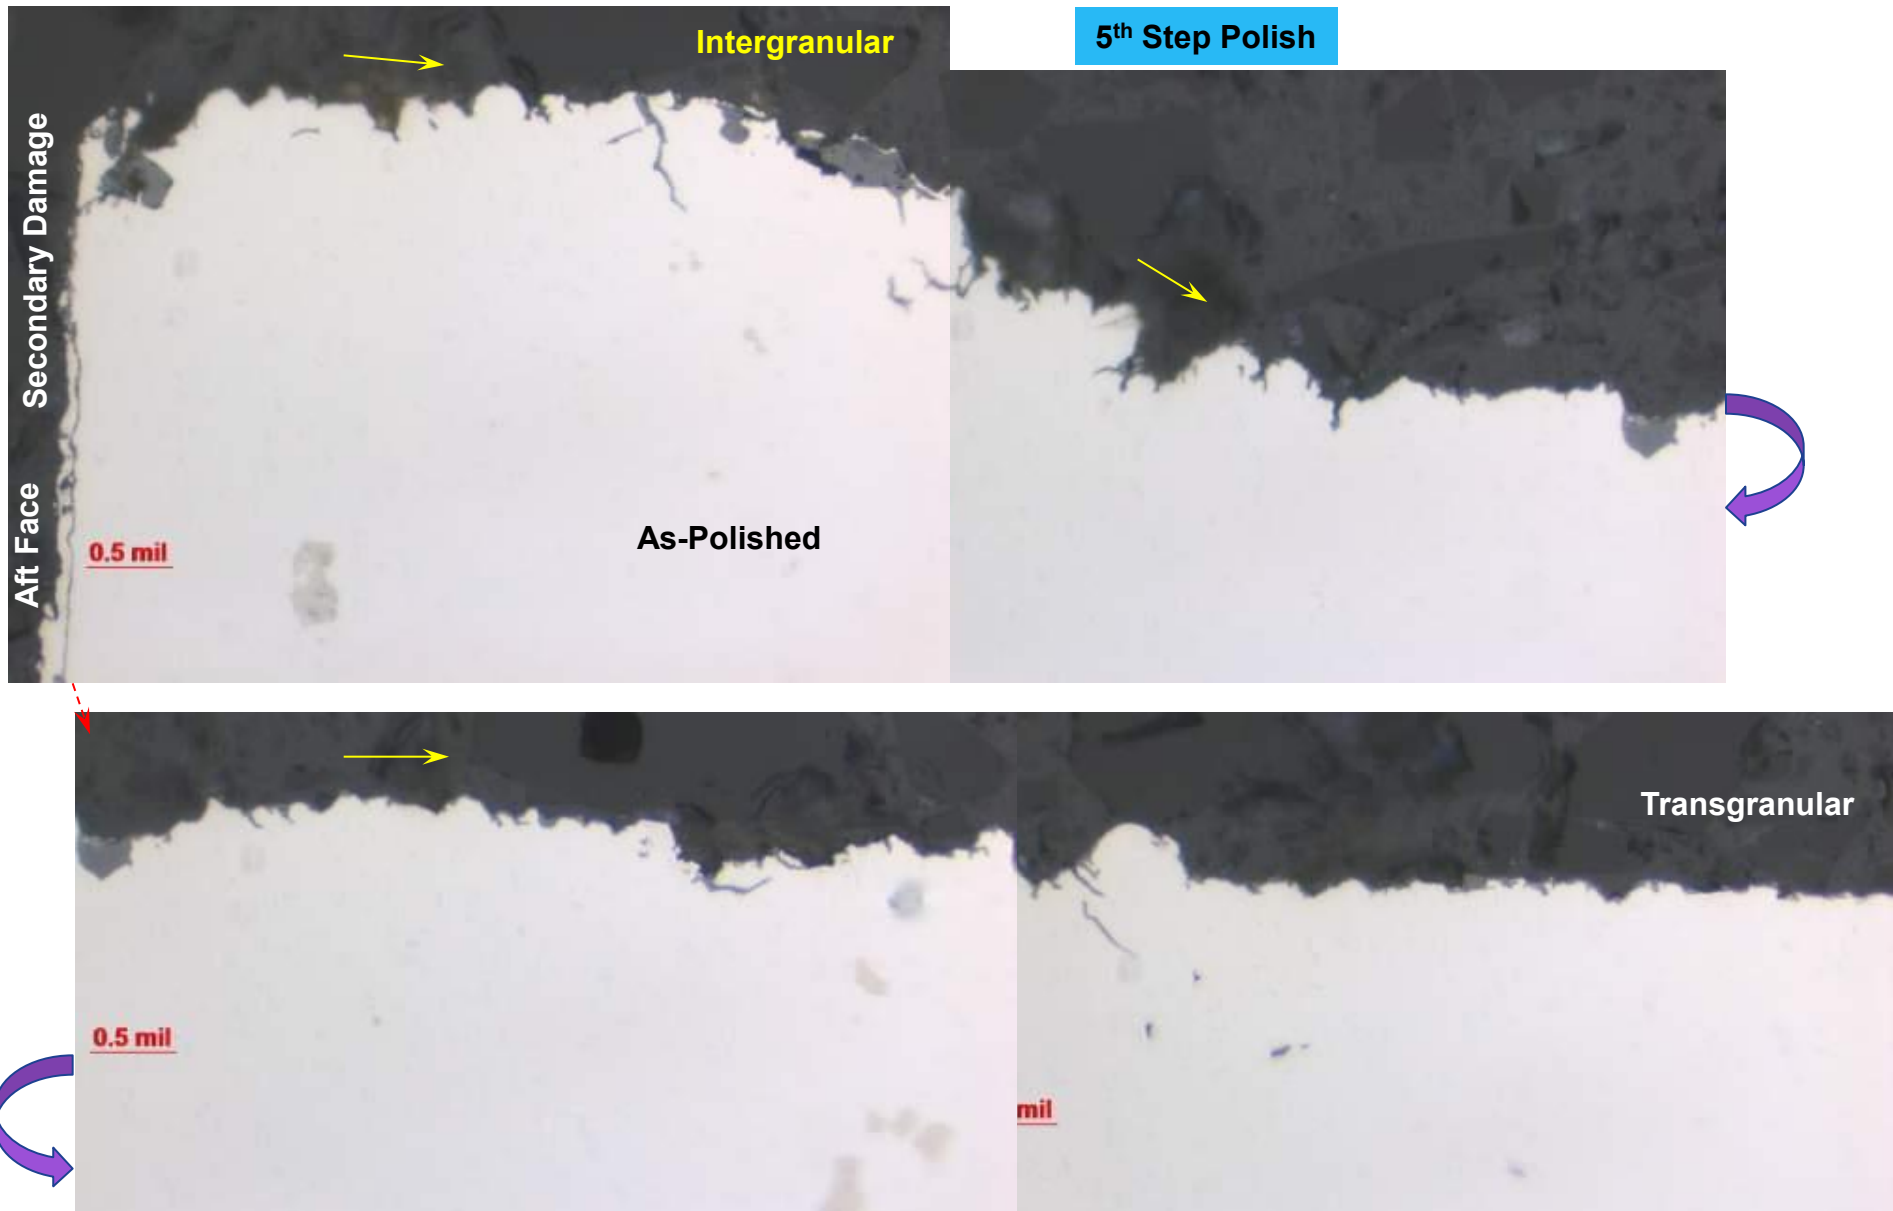
**Figure 45:** Higher magnification view of the origin area showing initial intergranular features that transitioned to transgranular features with no anomalies noted.

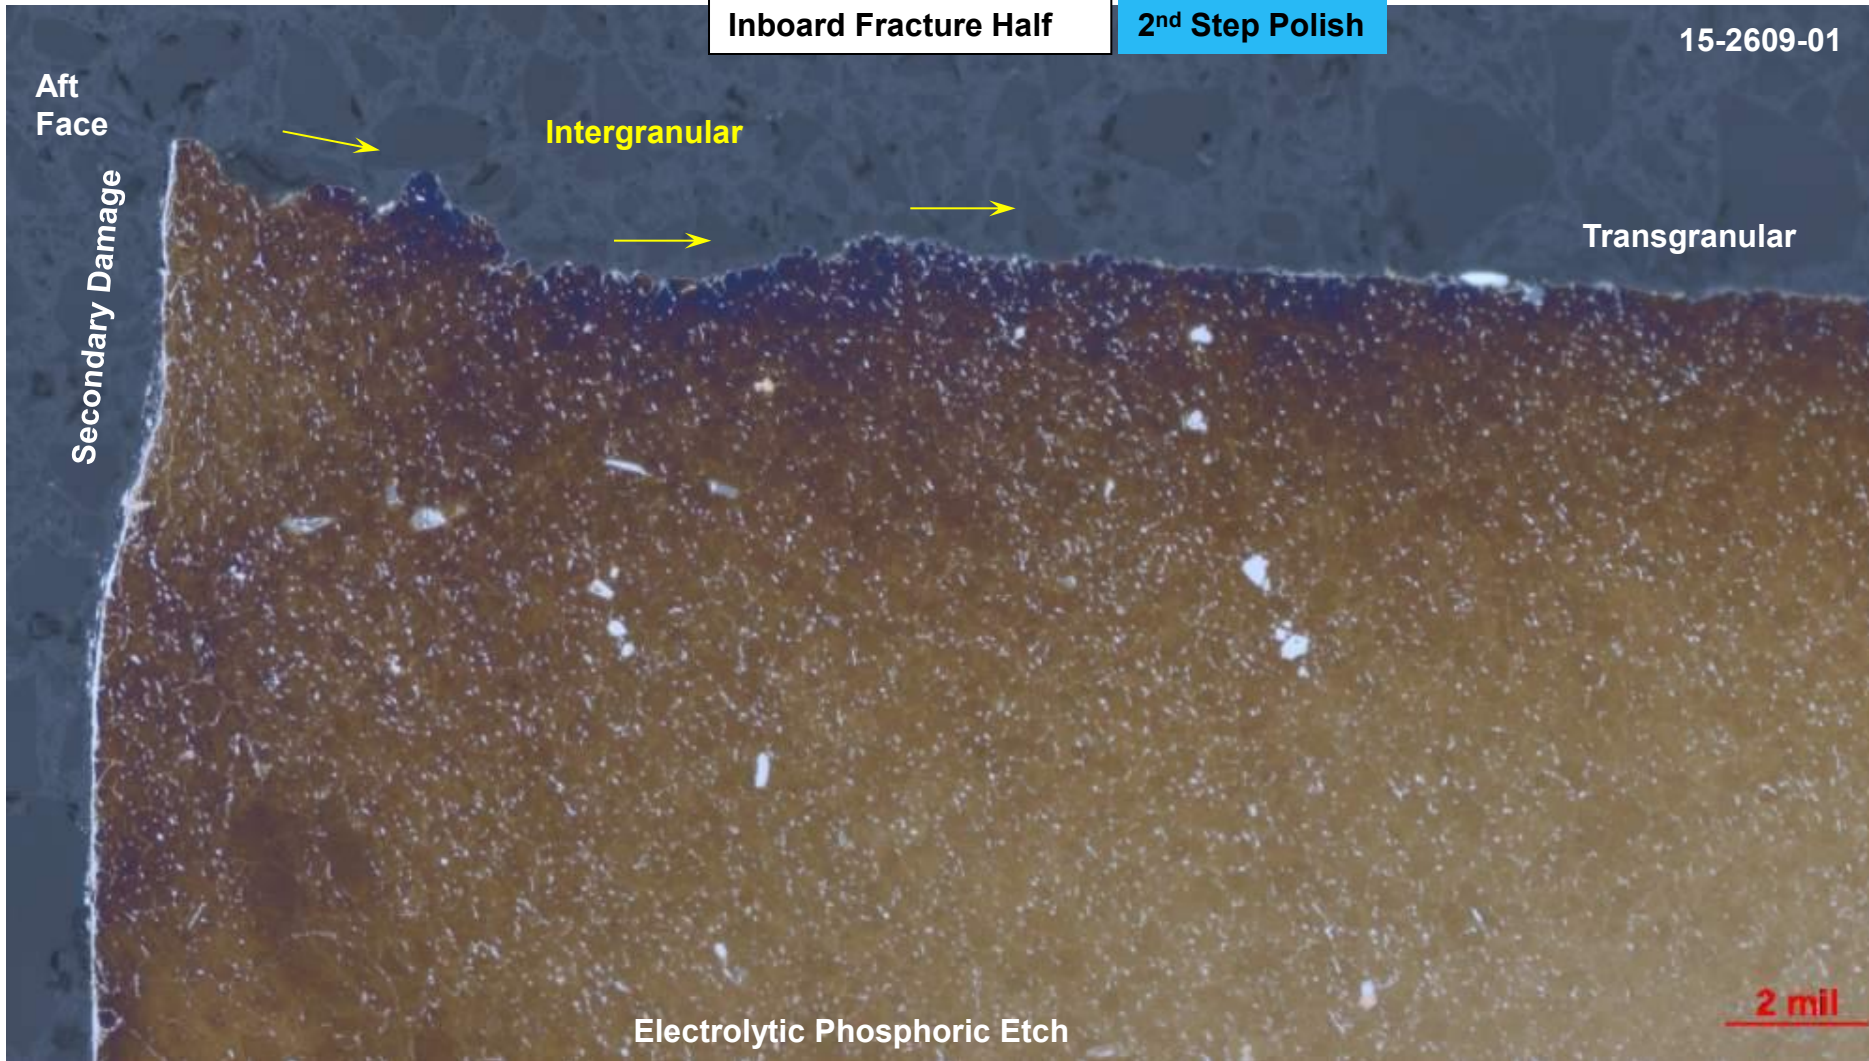
**Figure 47:** View of the 2<sup>nd</sup> step polish into the inboard side of the fracture after etching with electrolytic phosphoric showing a microstructure consistent with properly processed material with no anomalies noted. The corner in the impacted areas was slightly worked, consistent with secondary damage (also see Kalling's etch).
