# NATIONAL TRANSPORTATION SAFETY BOARD

MATERIALS LABORATORY FACTUAL REPORT

Report No. 15-131

Place : Las Vegas, Nevada  
Date : September 8, 2015  
Vehicle : Boeing 777-200, G-VIIO  
NTSB No. : DCA15FA185  
Investigator : Lorenda Ward, AS-10

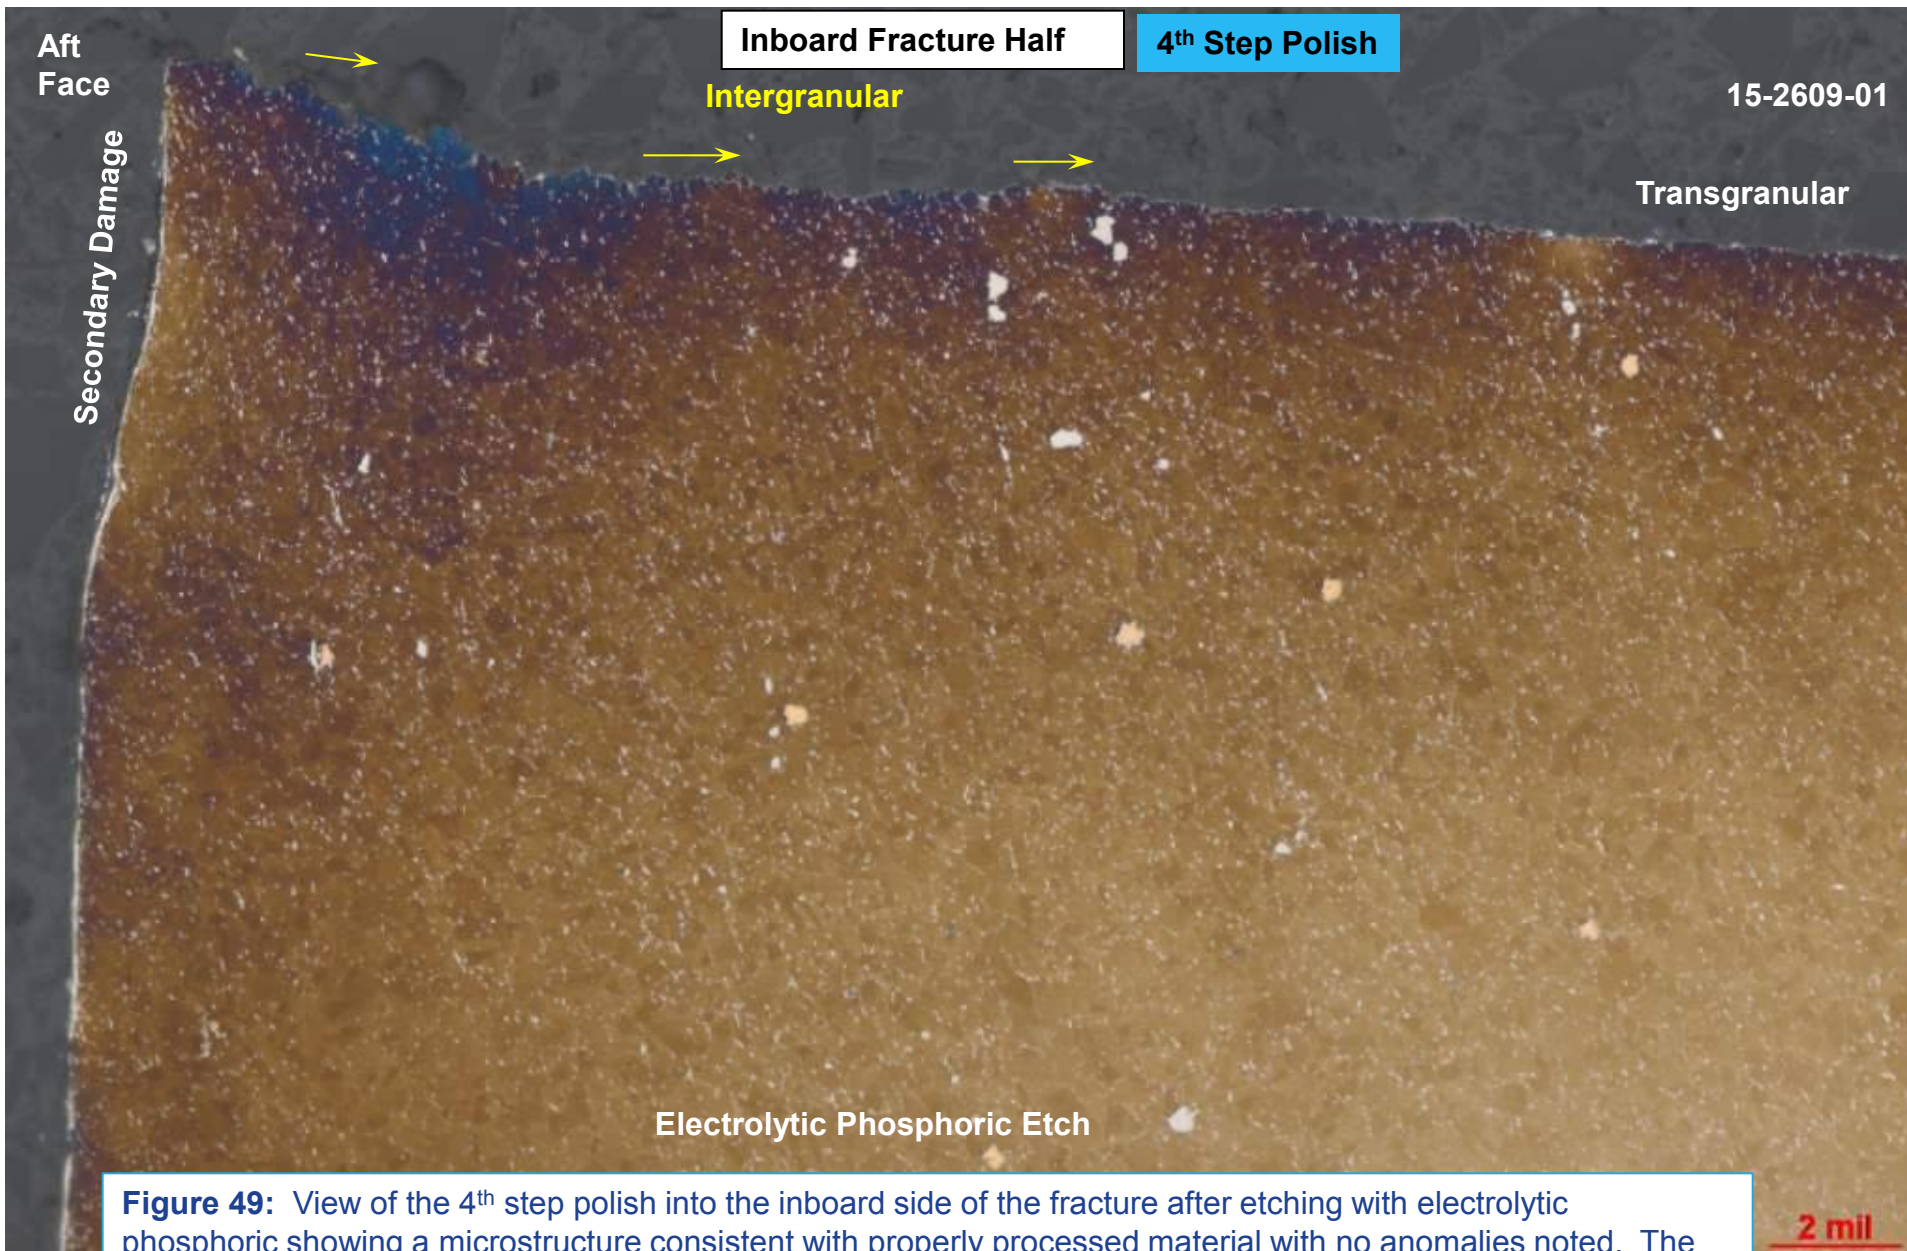
**Figure 49:** View of the 4<sup>th</sup> step polish into the inboard side of the fracture after etching with electrolytic phosphoric showing a microstructure consistent with properly processed material with no anomalies noted. The corner in the impacted areas was slightly worked, consistent with secondary damage (also see Kalling's etch).

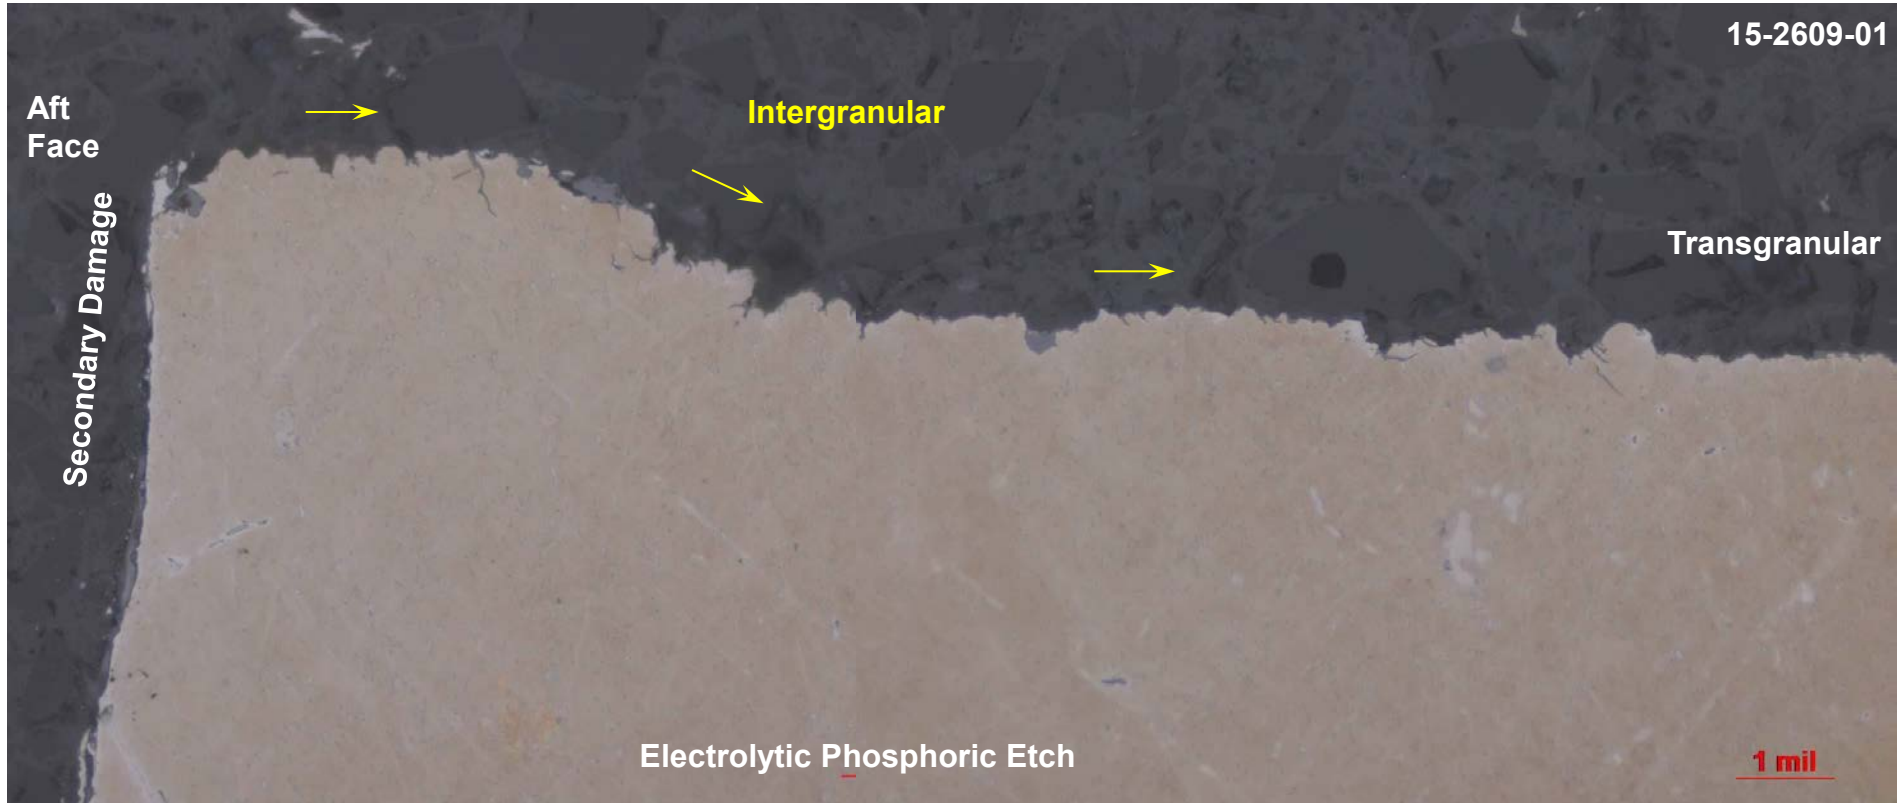
**Figure 50:** View of the 5<sup>th</sup> step polish into the inboard side of the fracture after etching with electrolytic phosphoric showing a microstructure consistent with properly processed material with no anomalies noted. The corner in the impacted areas was slightly worked, consistent with secondary damage (also see Kalling’s etch in next few pages).

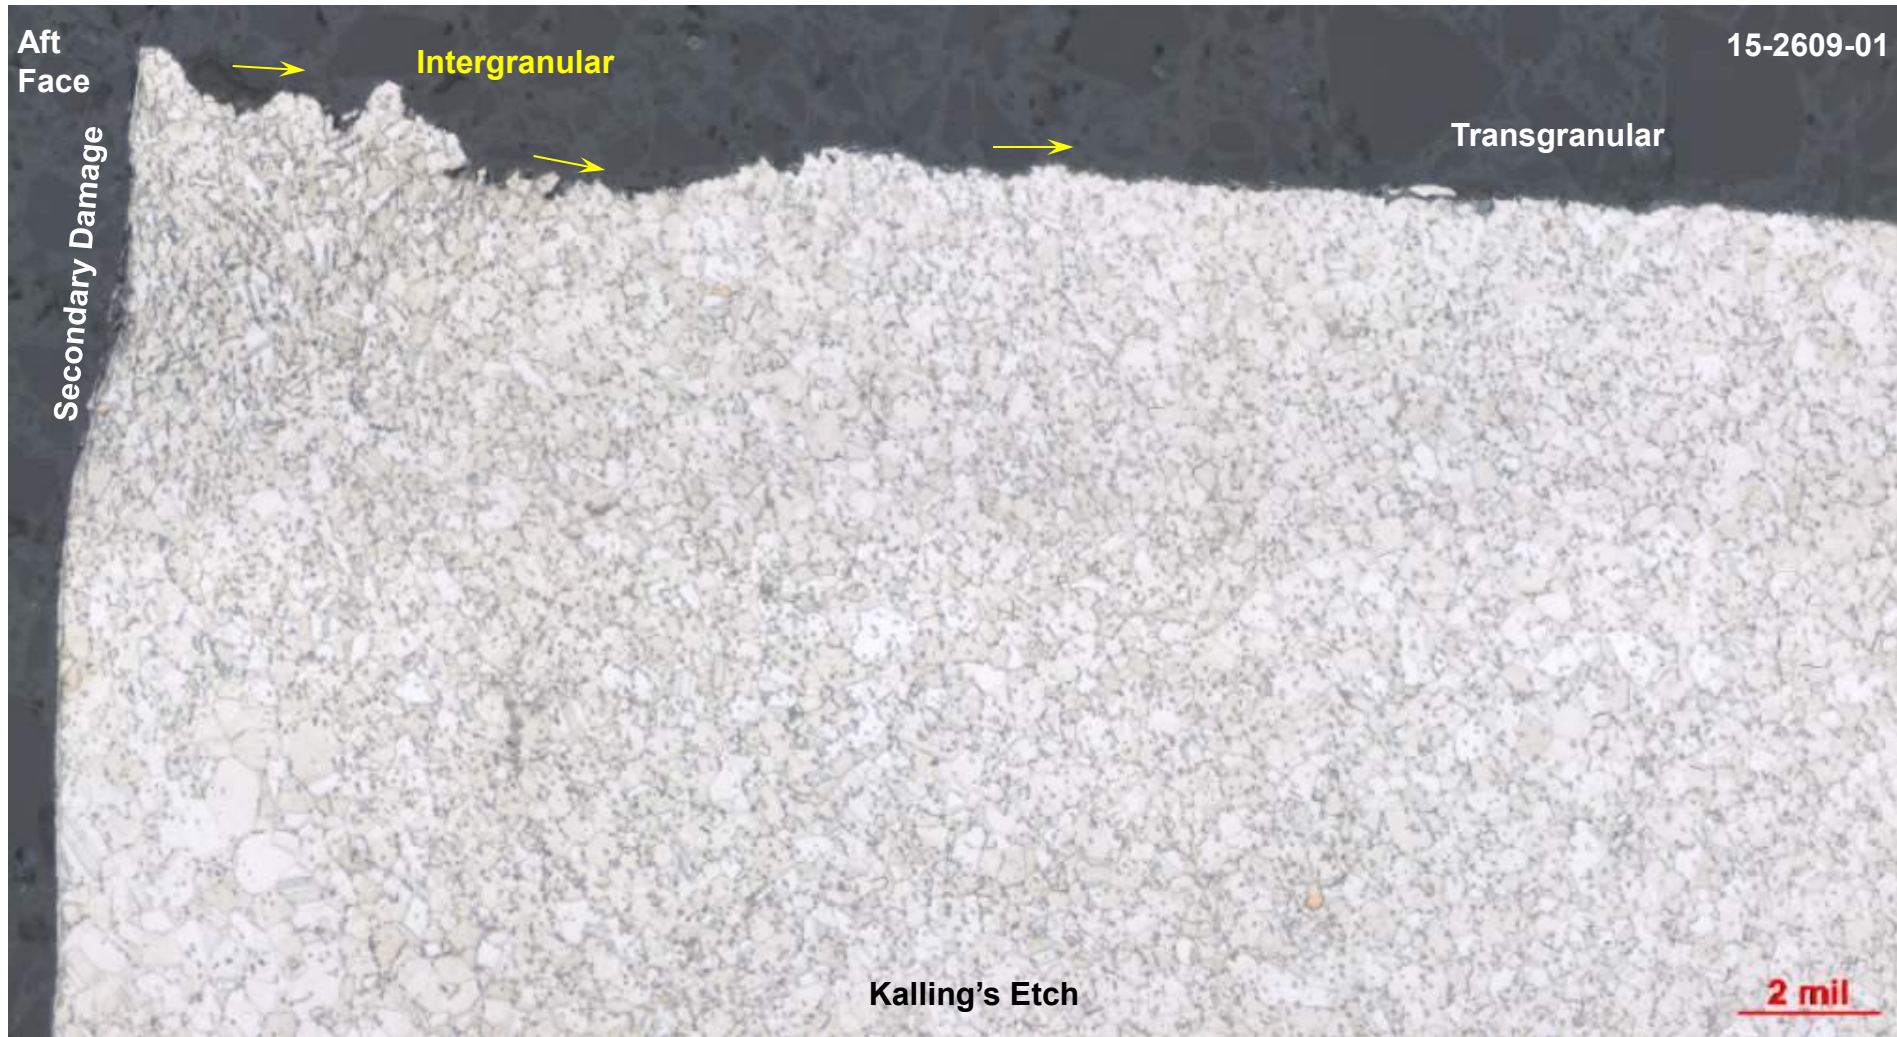
**Figure 52:** View of the 2<sup>nd</sup> step polish into the inboard side of the fracture after etching with Kalling's etch showing a microstructure consistent with properly processed material with no anomalies noted. The corner in the impacted areas was slightly worked, consistent with secondary damage.

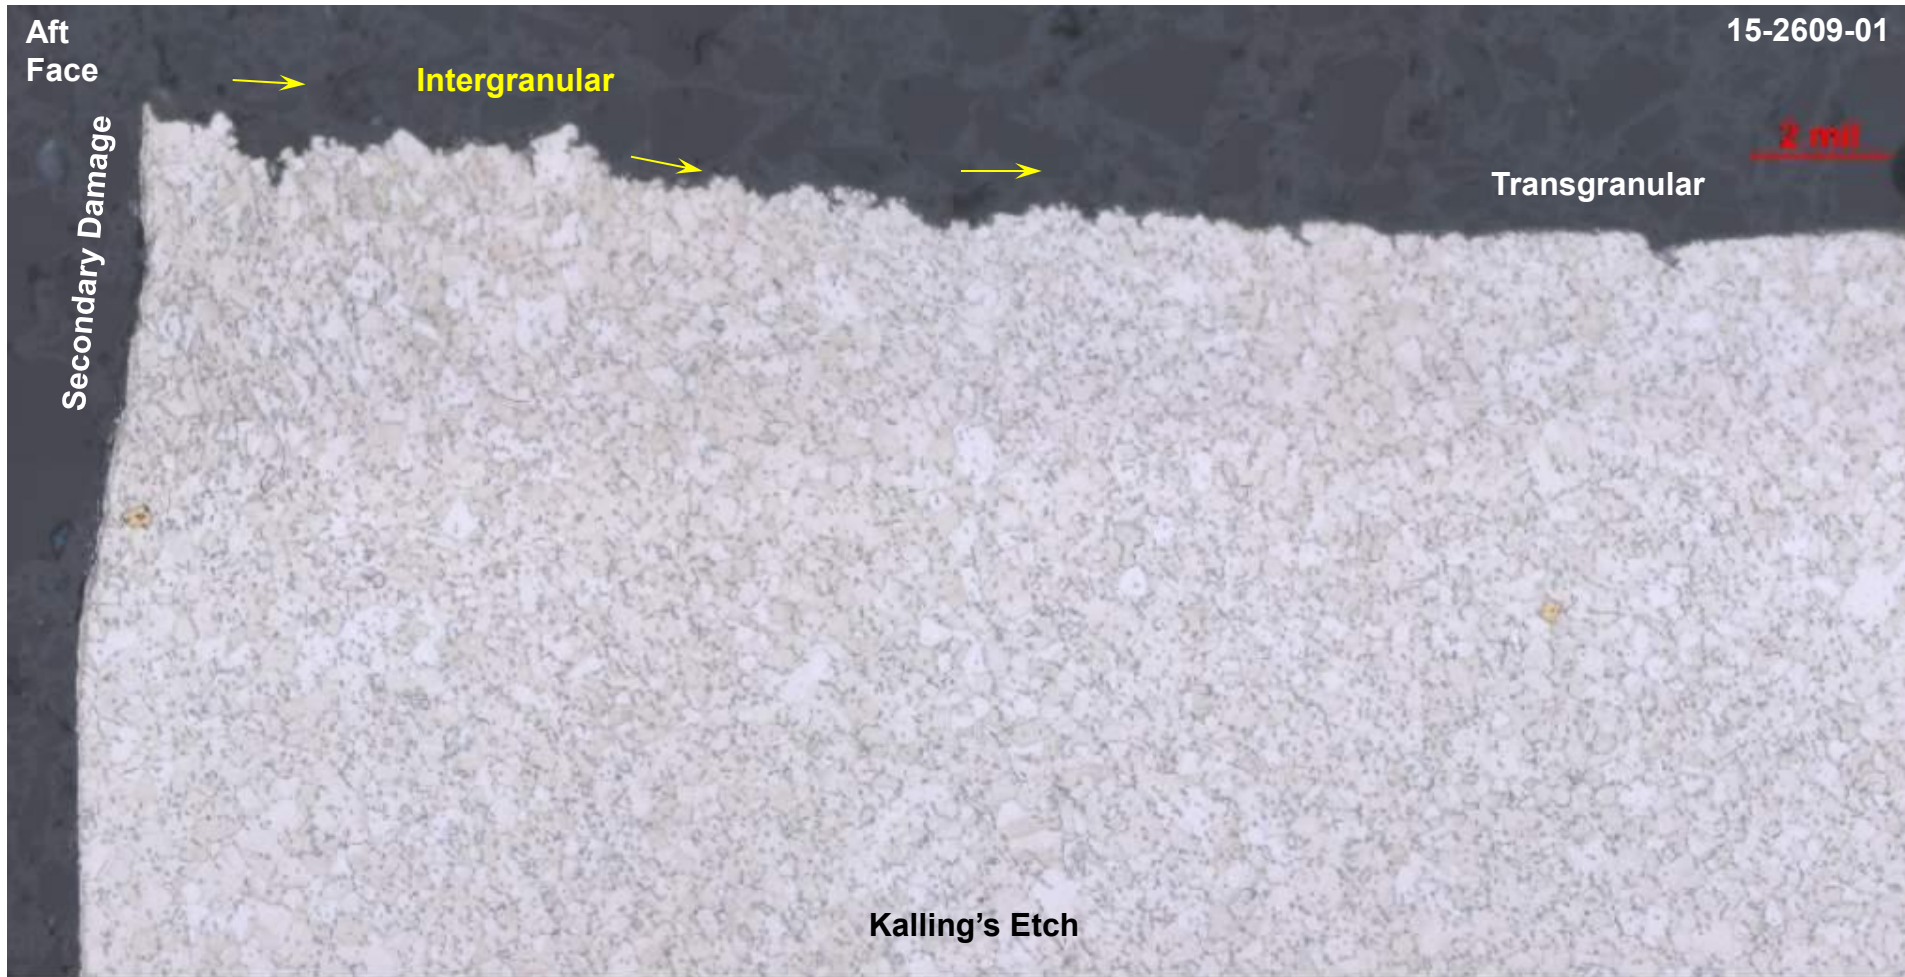
**Figure 53:** View of the 3<sup>rd</sup> step polish into the inboard side of the fracture after etching with Kalling's etch showing a microstructure consistent with properly processed material with no anomalies noted. The corner in the impacted areas was slightly worked, consistent with secondary damage.

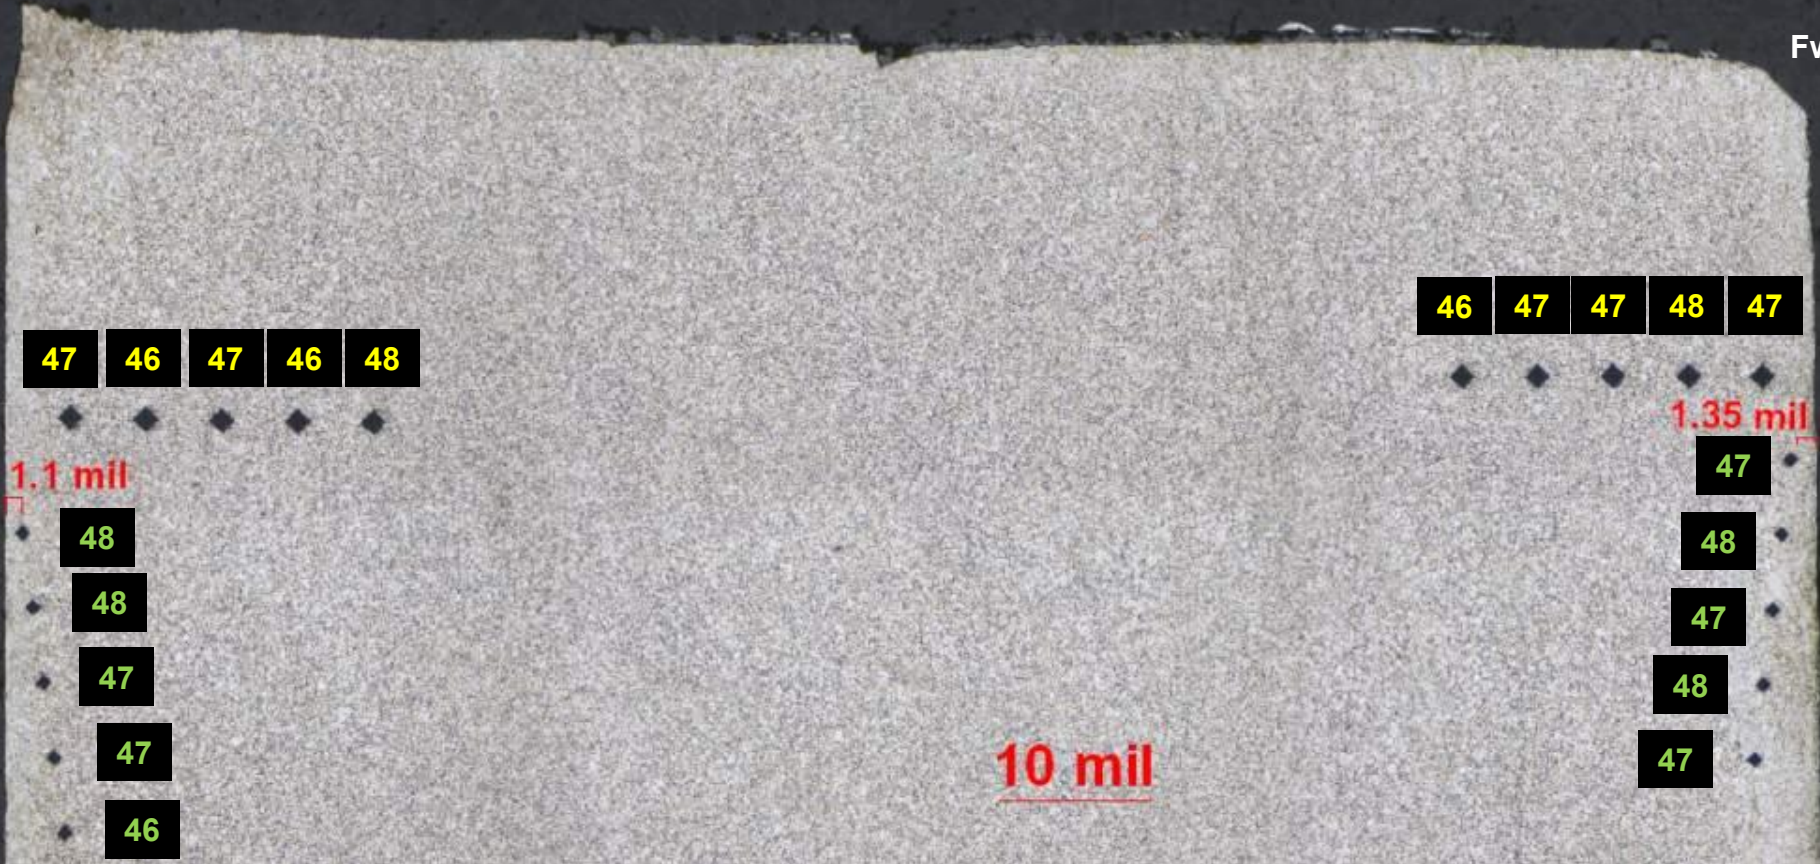
**Figure 55:** Micro-hardness measurements taken near the forward and aft faces ranged between HRC 46-48 and conformed to the requirement of C50TF81.

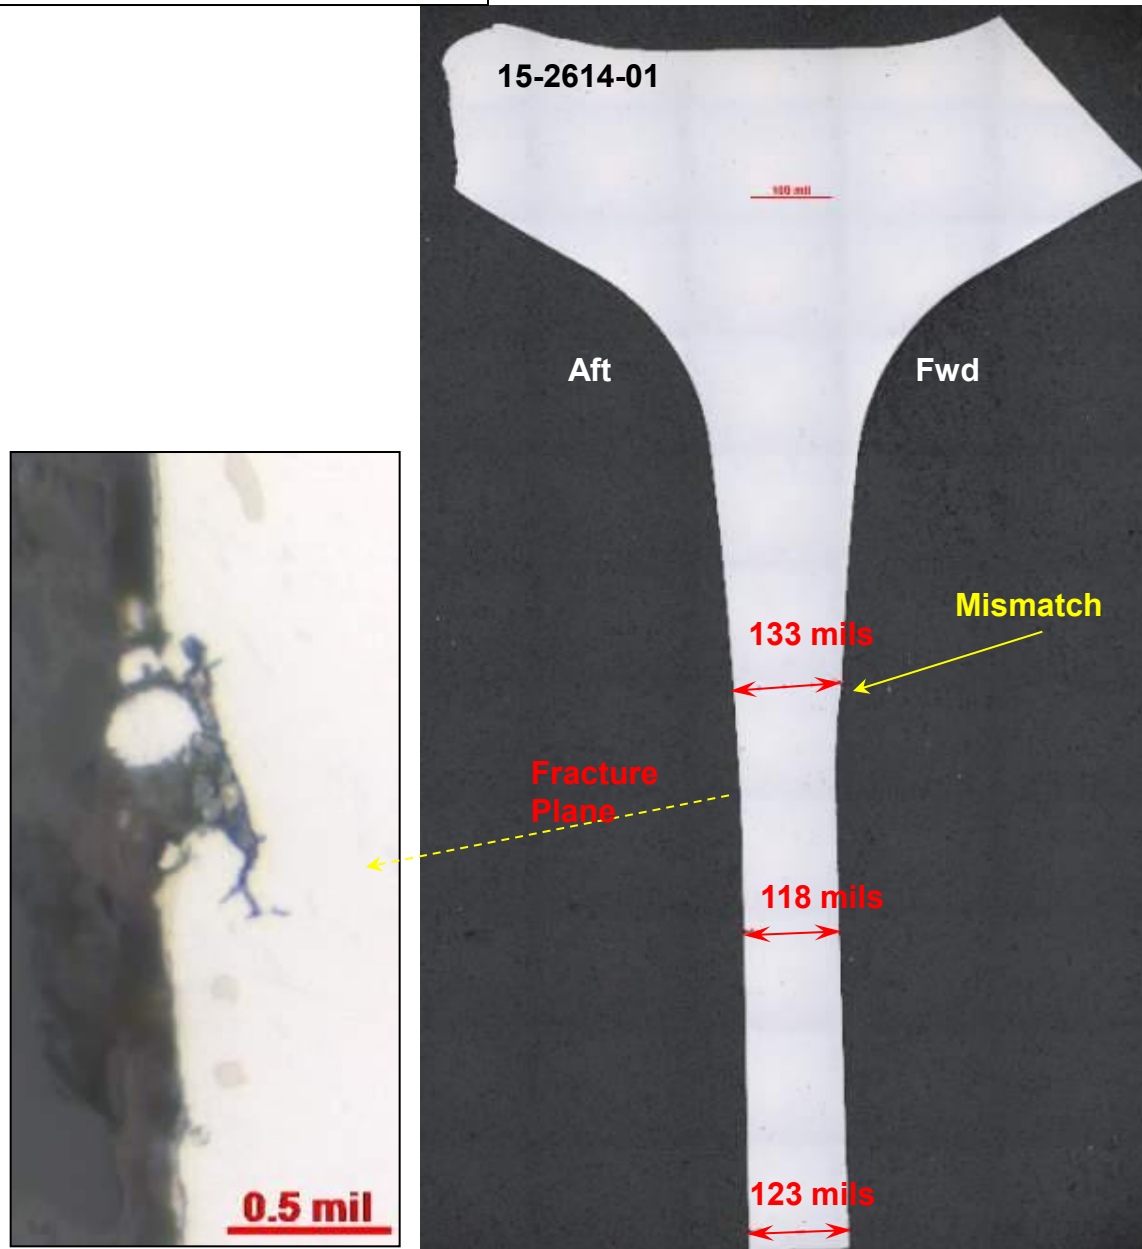
**Figure 63:** A mount made on the diametrically opposed side of the disk showed that the fracture was at the web to rim transition area where the wall thickness was approximately 0.118 inch (thinnest region of web). On the forward side an allowable mismatch was observed further outboard.

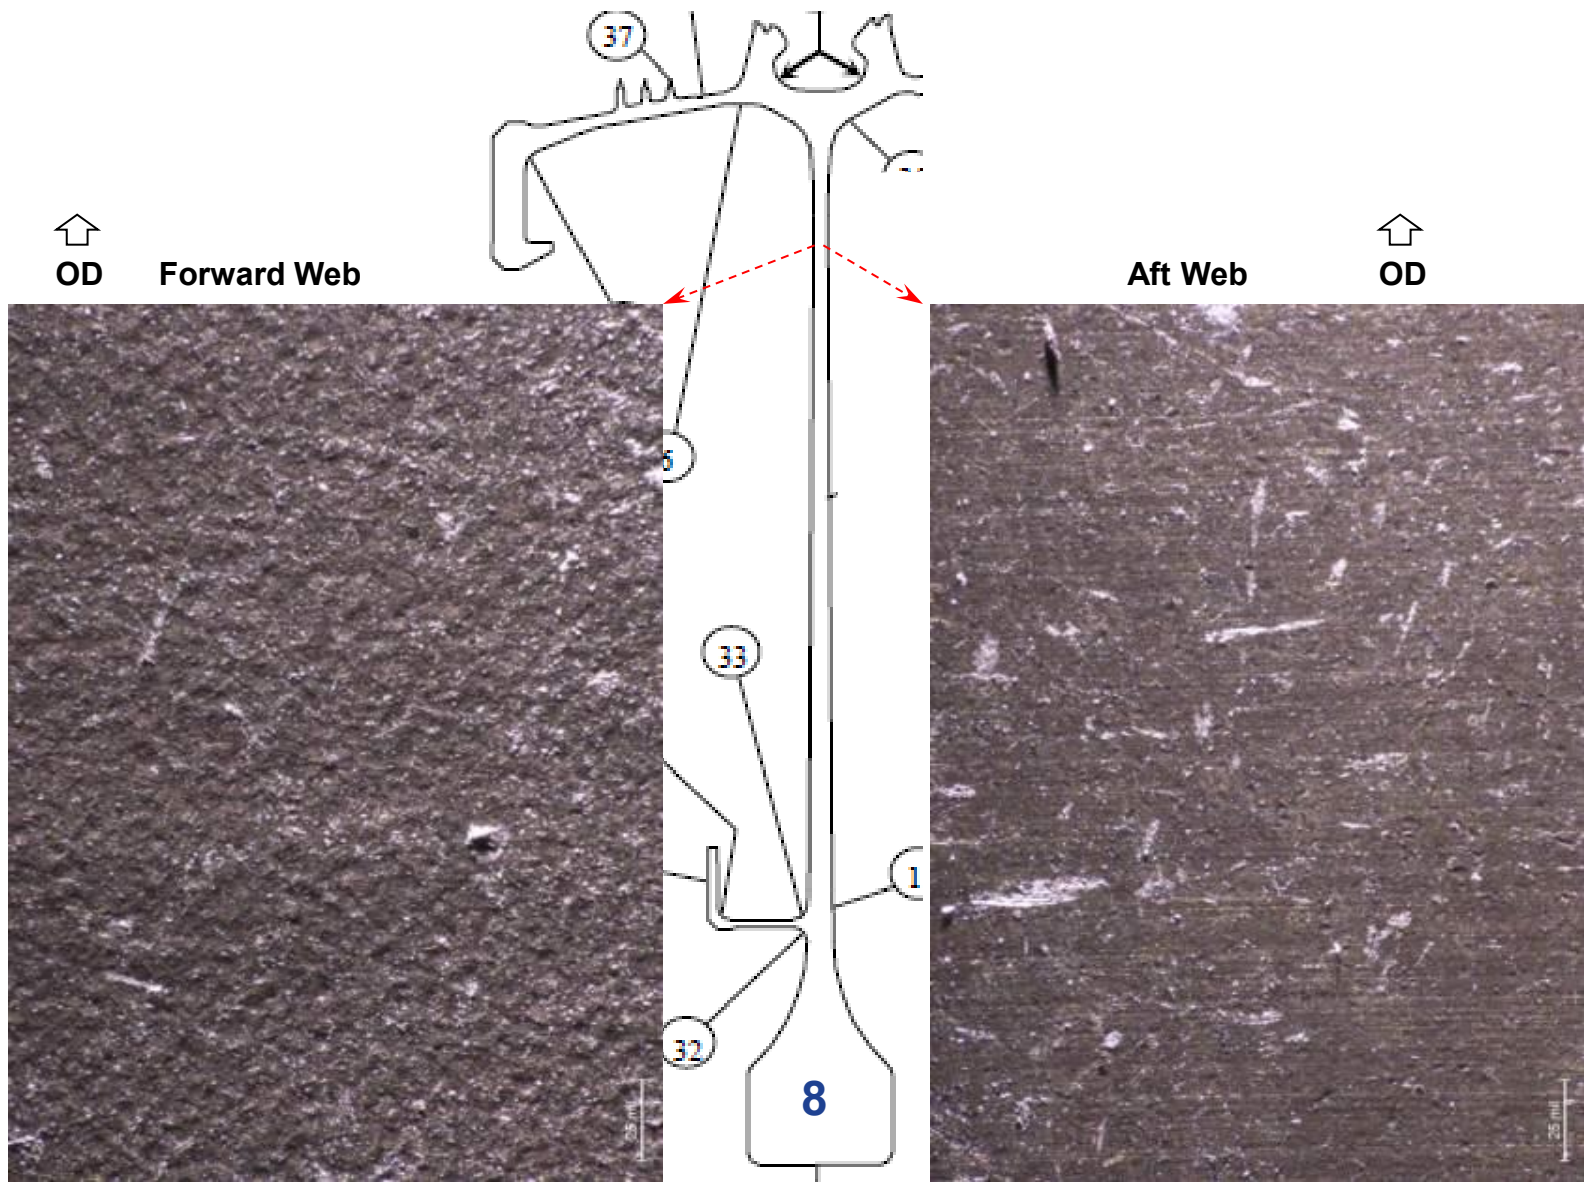
**Figure 64:** Optical views at similar magnifications of the forward and aft web surfaces in a similar radial plane as the fracture. The images showed that the peening on the forward side was more pronounced than the aft side.

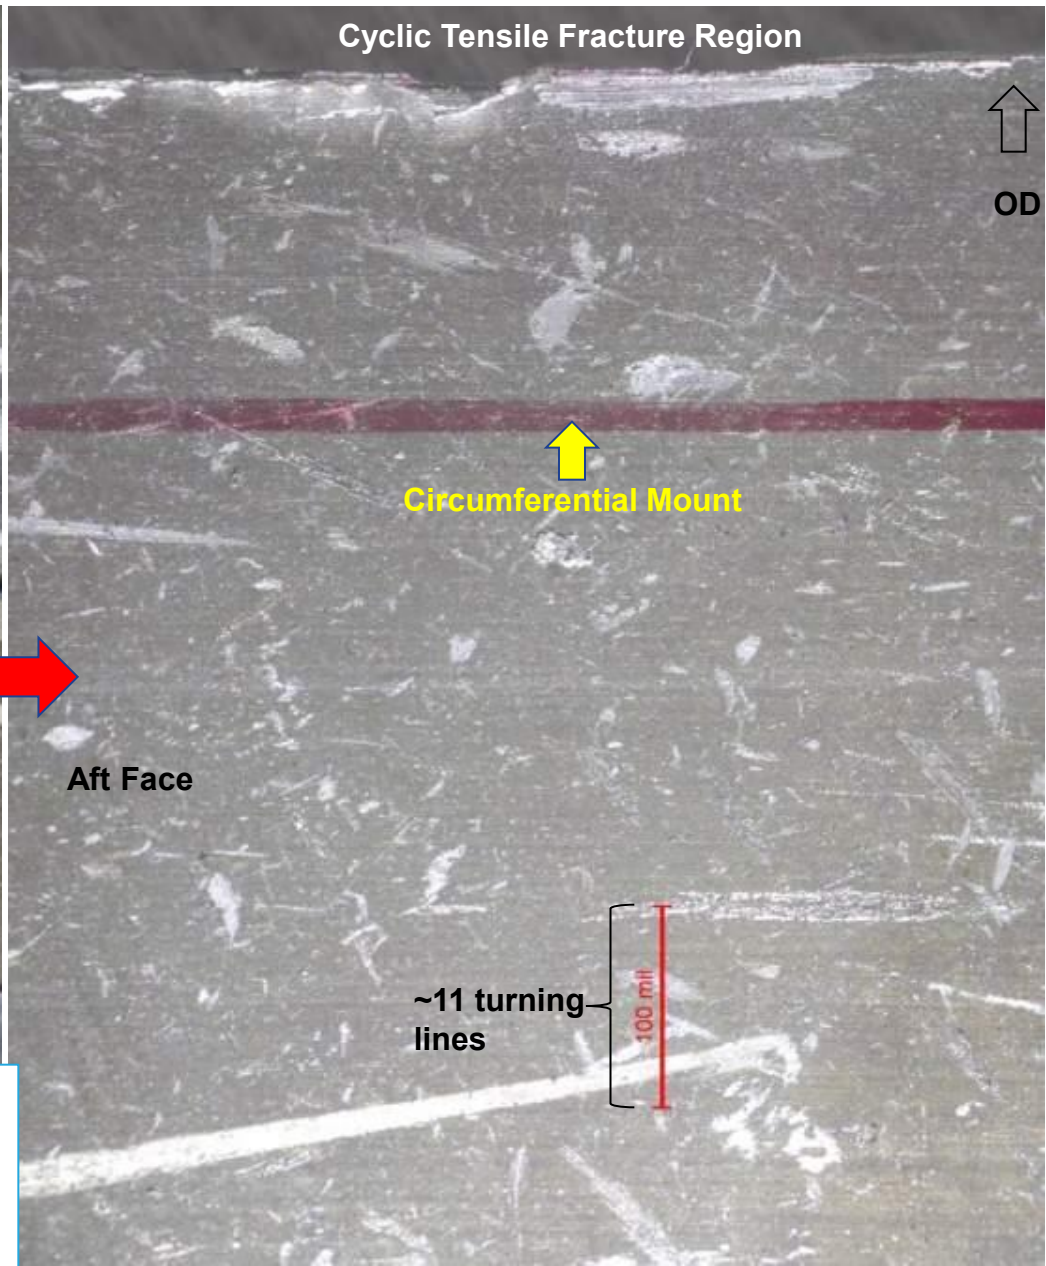
**Figure 65:** Optical views of the aft face of the web showing where a circumferential mount was made to assess the machined surfaces. The right image shows that approximately 11 turning lines were observed within 0.1 inch.

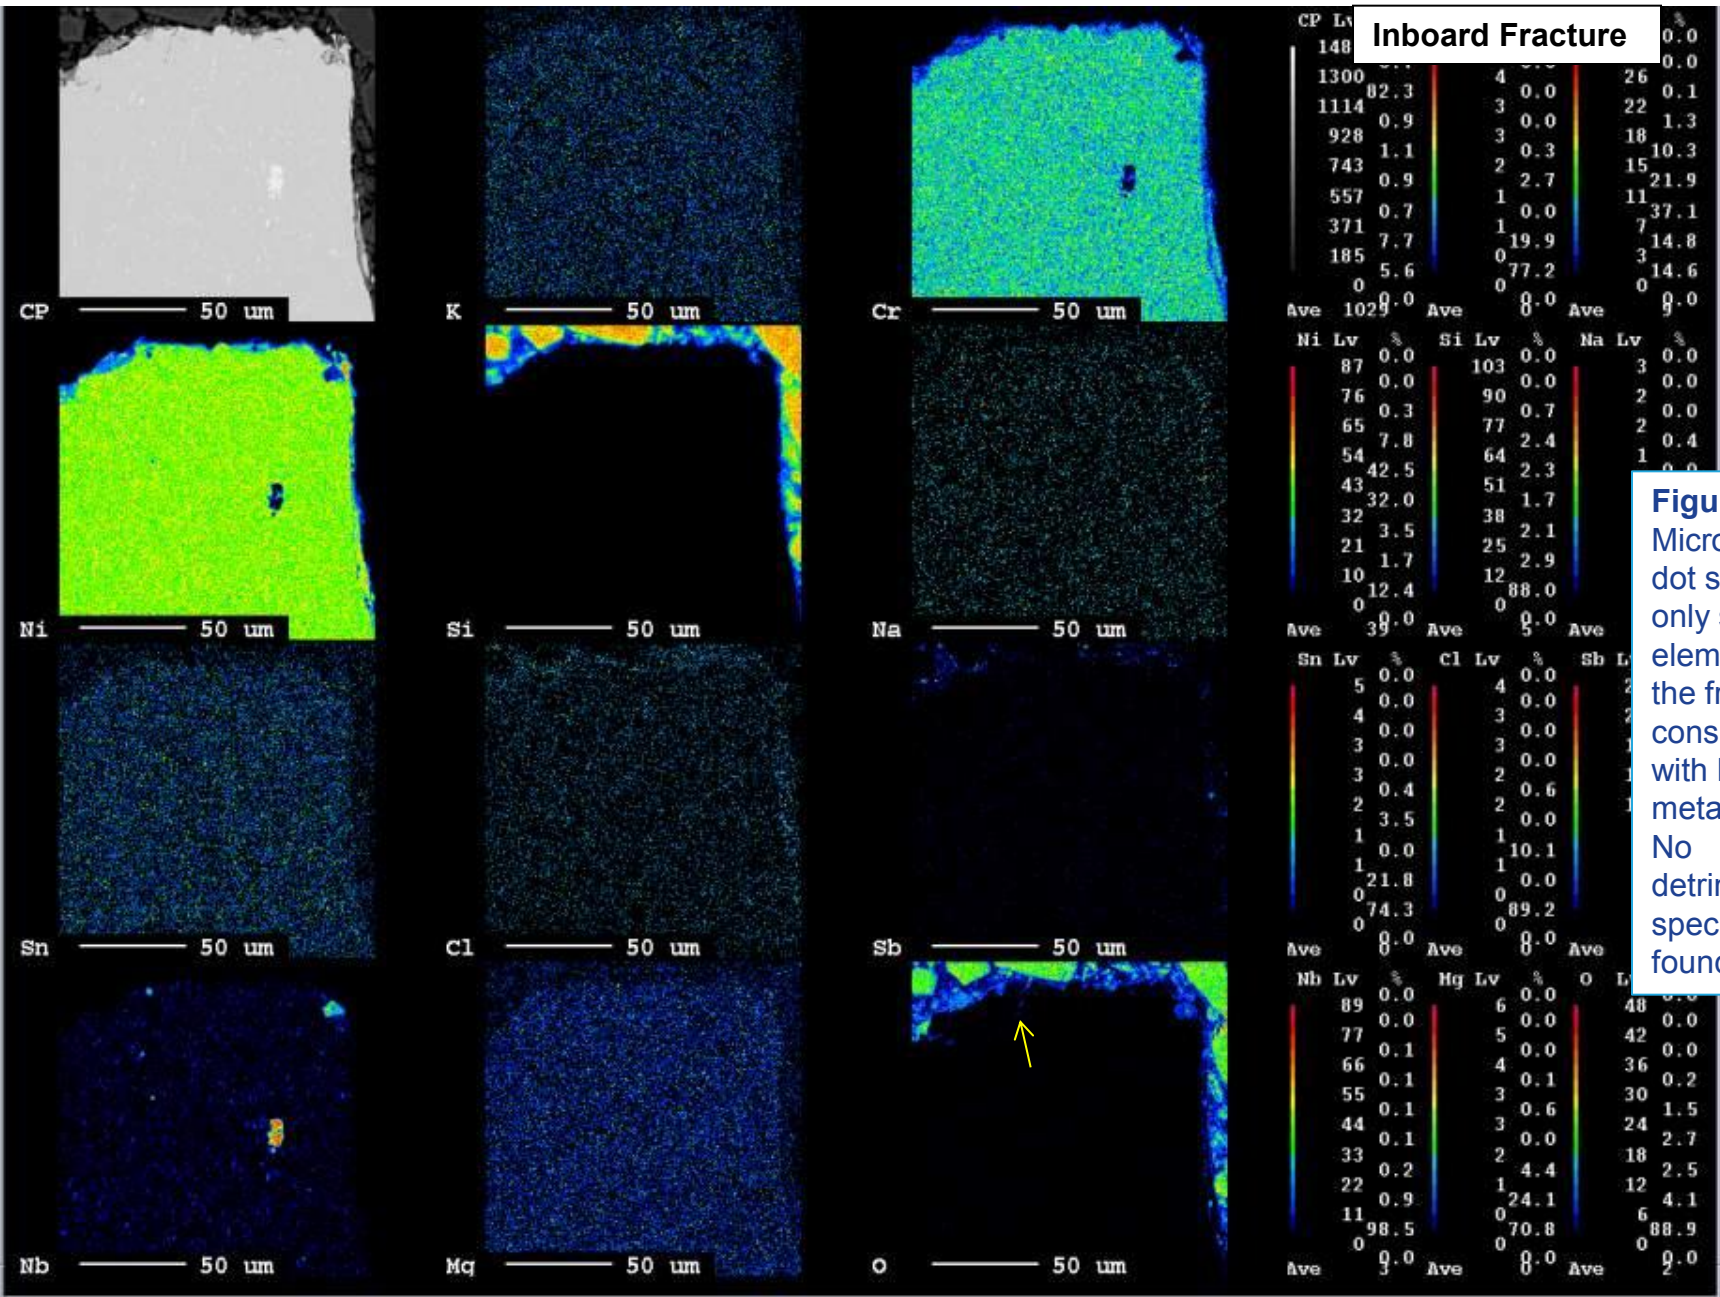
**Figure 68:** Microprobe dot scans only showed elements on the fracture consistent with base metal oxides. No detrimental species were found.

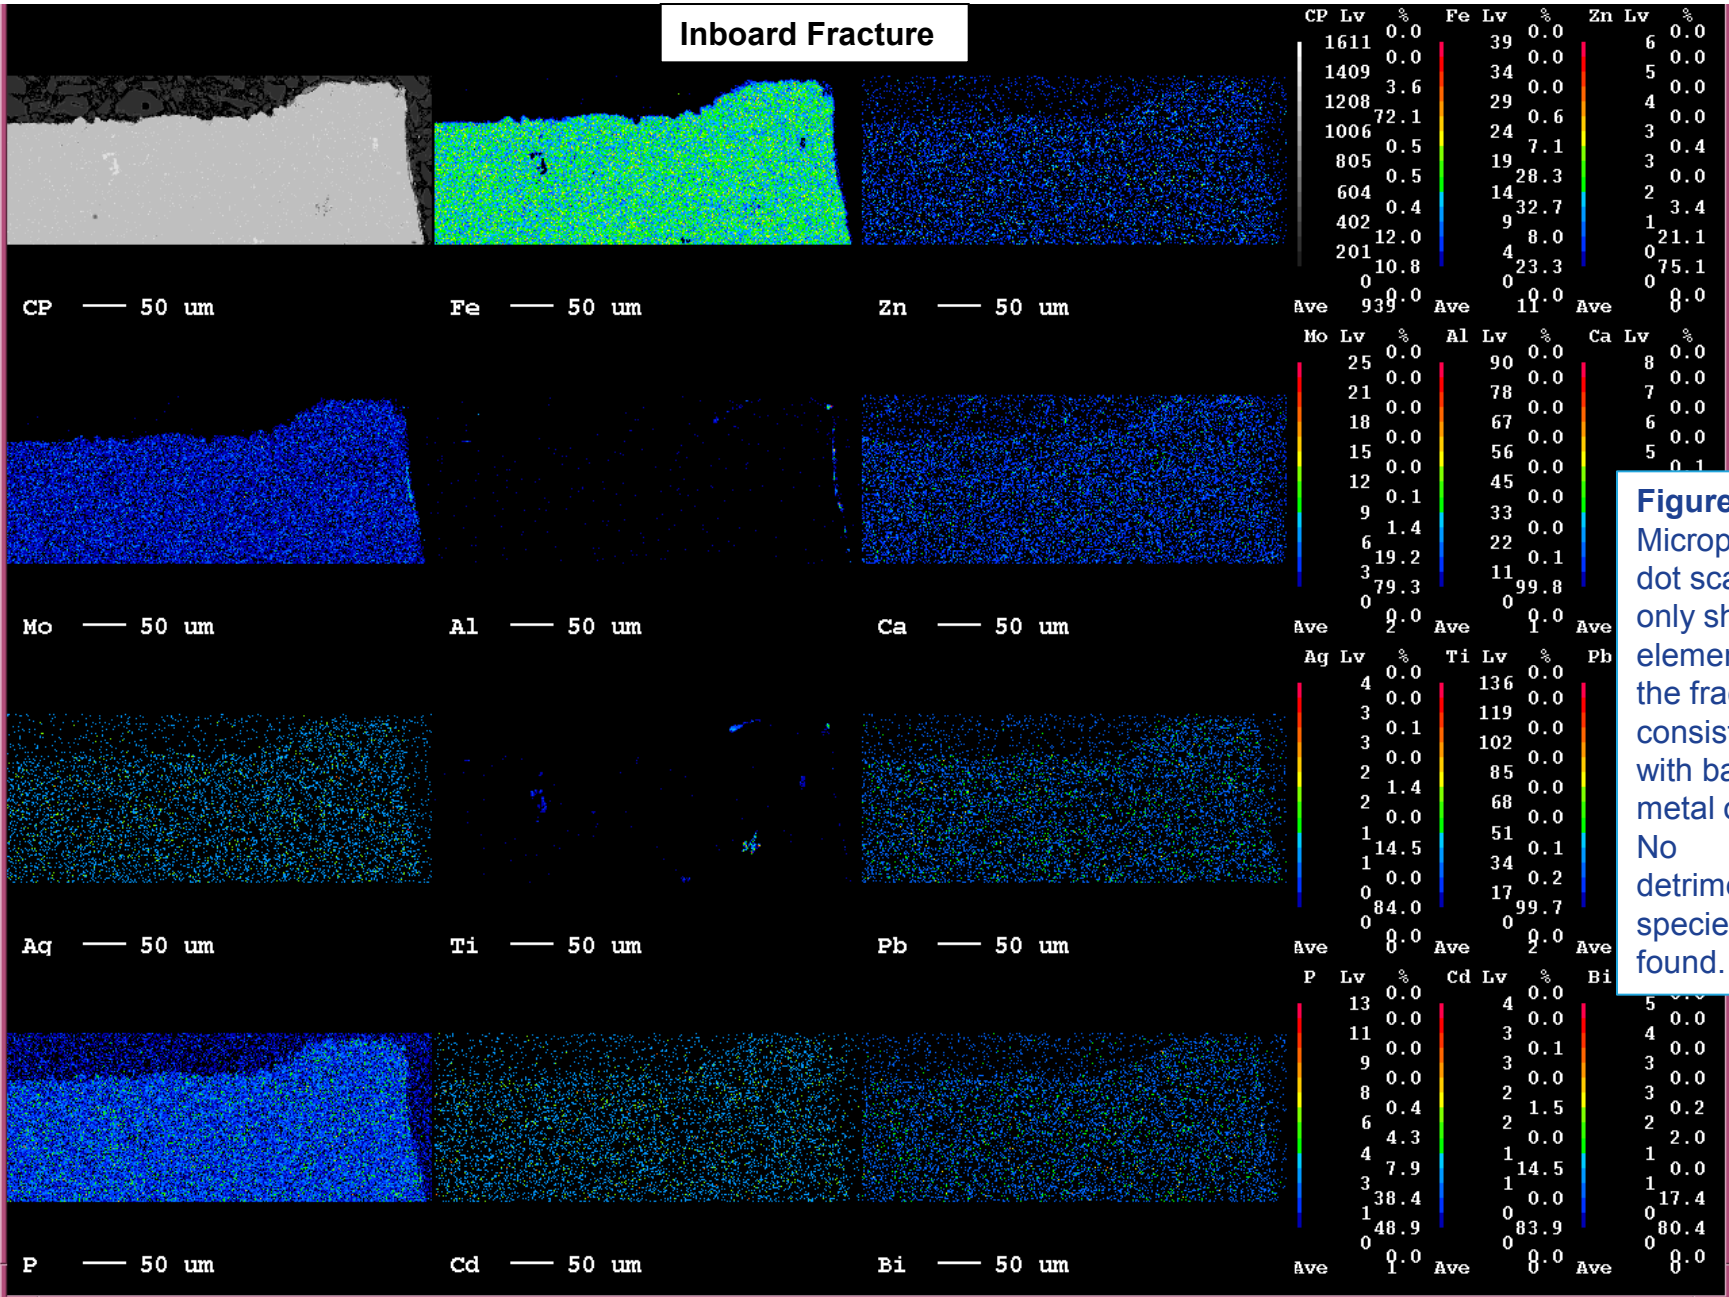
**Figure 71:** Microprobe dot scans only showed elements on the fracture consistent with base metal oxides. No detrimental species were found.

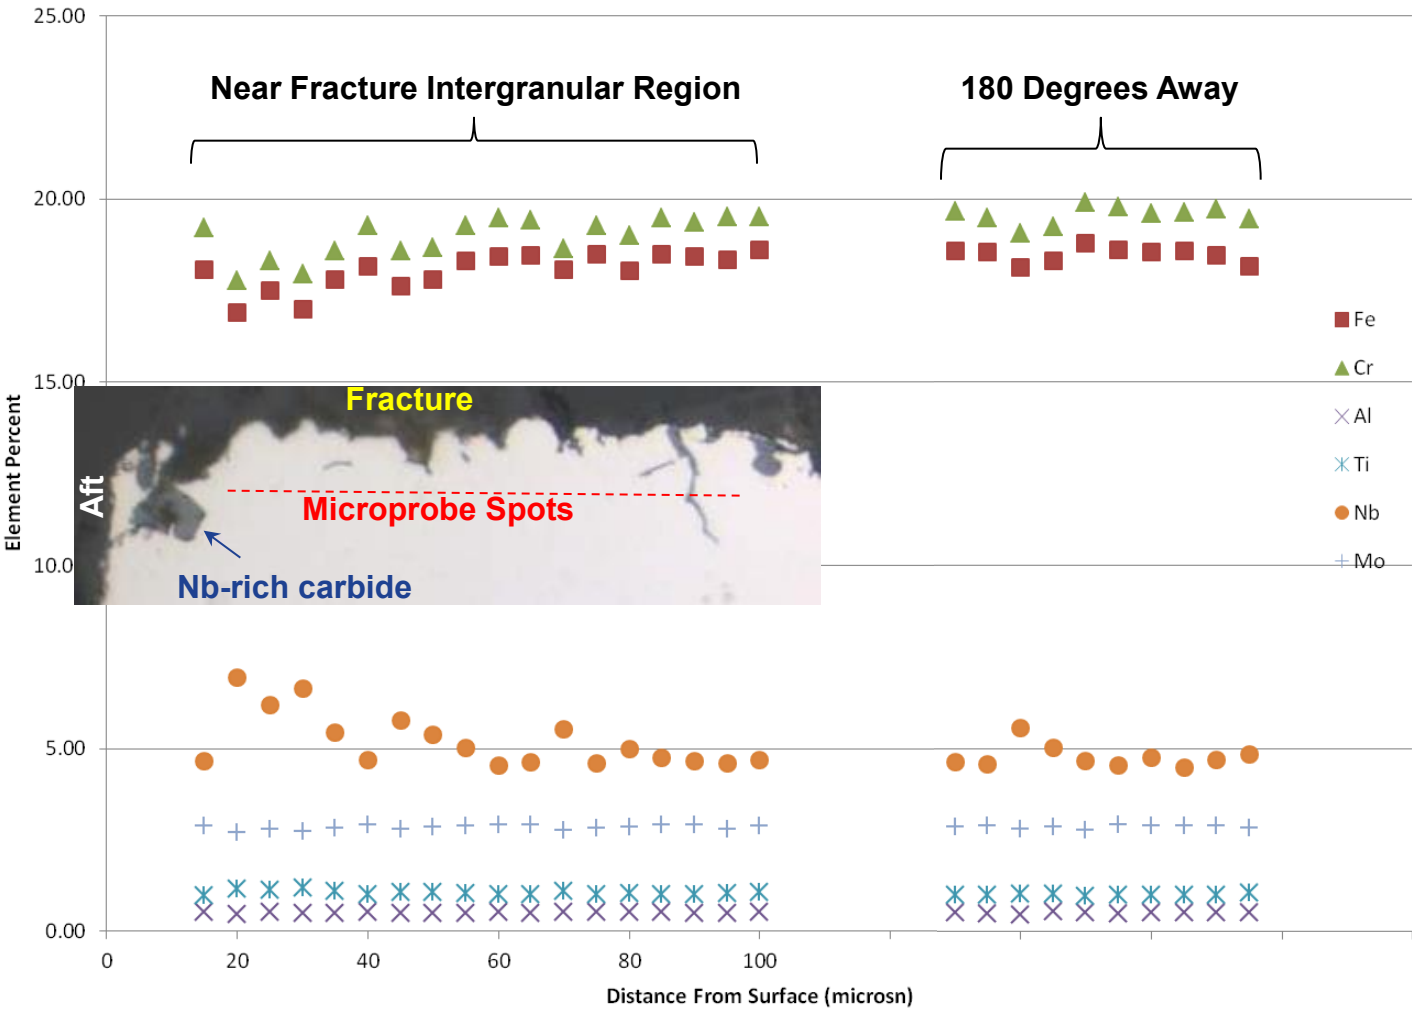
- Microprobe analysis of the base metal adjacent to the intergranular fracture (and in the mount on the opposite side of the disk) revealed a composition consistent with the requirement of alloy 718, though it was slightly enriched in Nb near the surface carbide (Figure 73).

**Figure 73:** Microprobe compositional readings were taken across the base material near the fracture showed slightly elevated Nb (near a carbide) compared to the baseline deeper into the part and on the opposite side of the disk. No Nb-lean areas were found and the readings were within the expected range for the alloy.

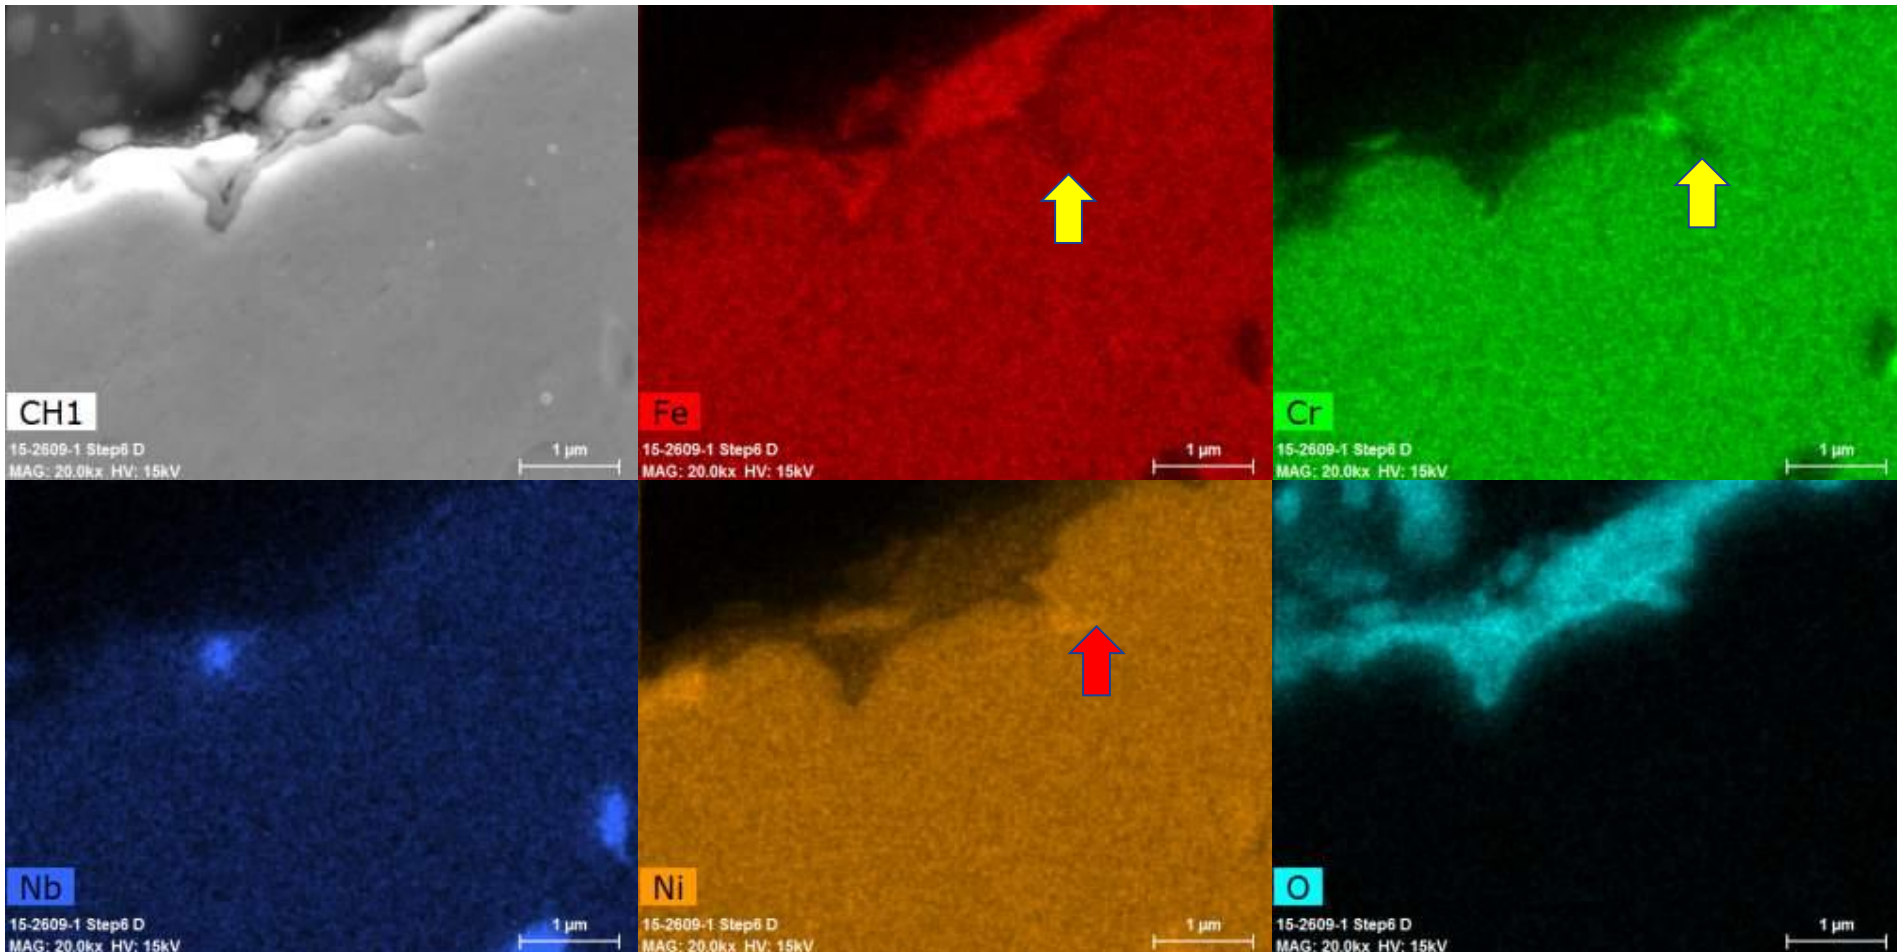
**Figure 79:** The compositional dot-maps showed that at the fracture branched crack approximately 1 mil from the aft surface was depleted in Fe and Cr ahead of the crack front (yellow arrows) and therefore, richer in Ni (red arrow). The crack itself only contained base metal oxides and no detrimental species were found.
