# NATIONAL TRANSPORTATION SAFETY BOARD

MATERIALS LABORATORY FACTUAL REPORT

Report No. 15-131

Place : Las Vegas, Nevada  
Date : September 8, 2015  
Vehicle : Boeing 777-200, G-VIIO  
NTSB No. : DCA15FA185  
Investigator : Lorenda Ward, AS-10

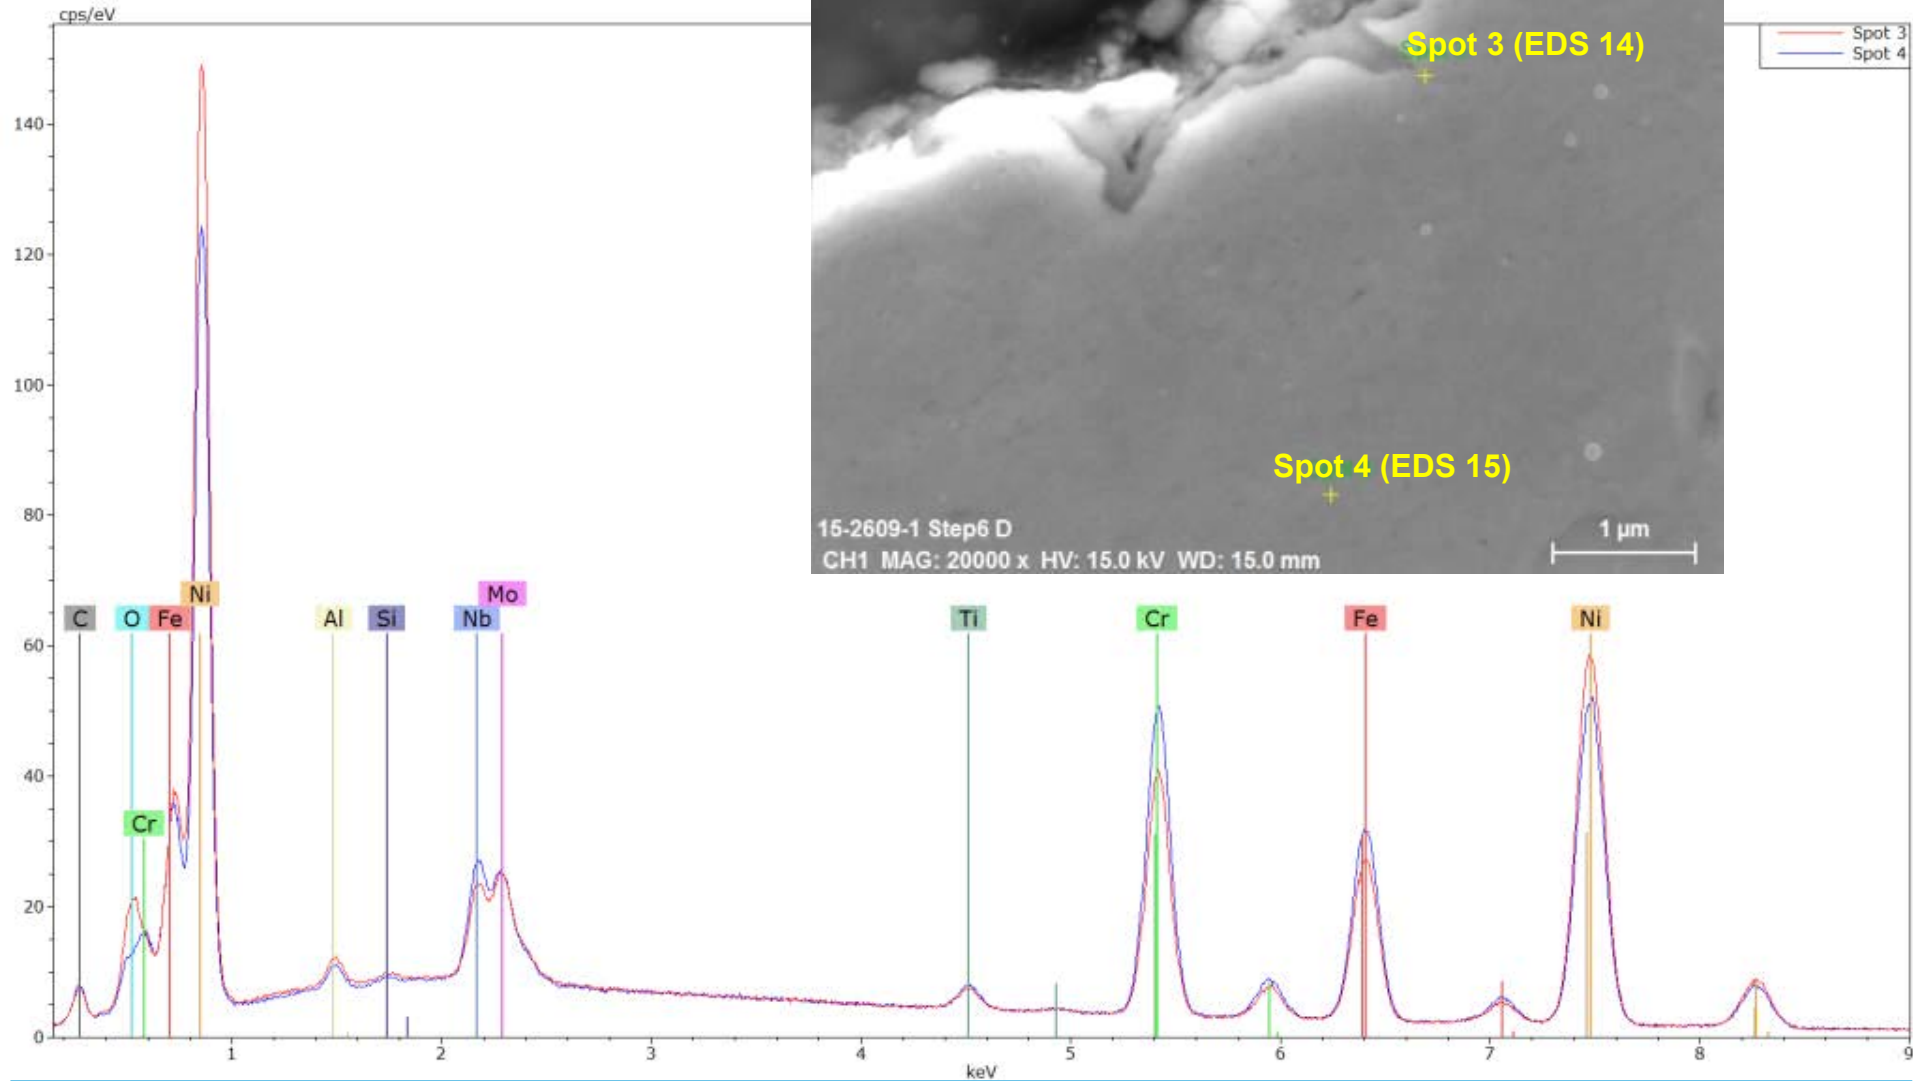
**Figure 80:** Superimposed EDS spectra of the baseline (spot 4- EDS 15) and region ahead of the crack-tip (spot 3- EDS 14), showed that the latter was depleted in Fe and Cr, and richer in Ni.

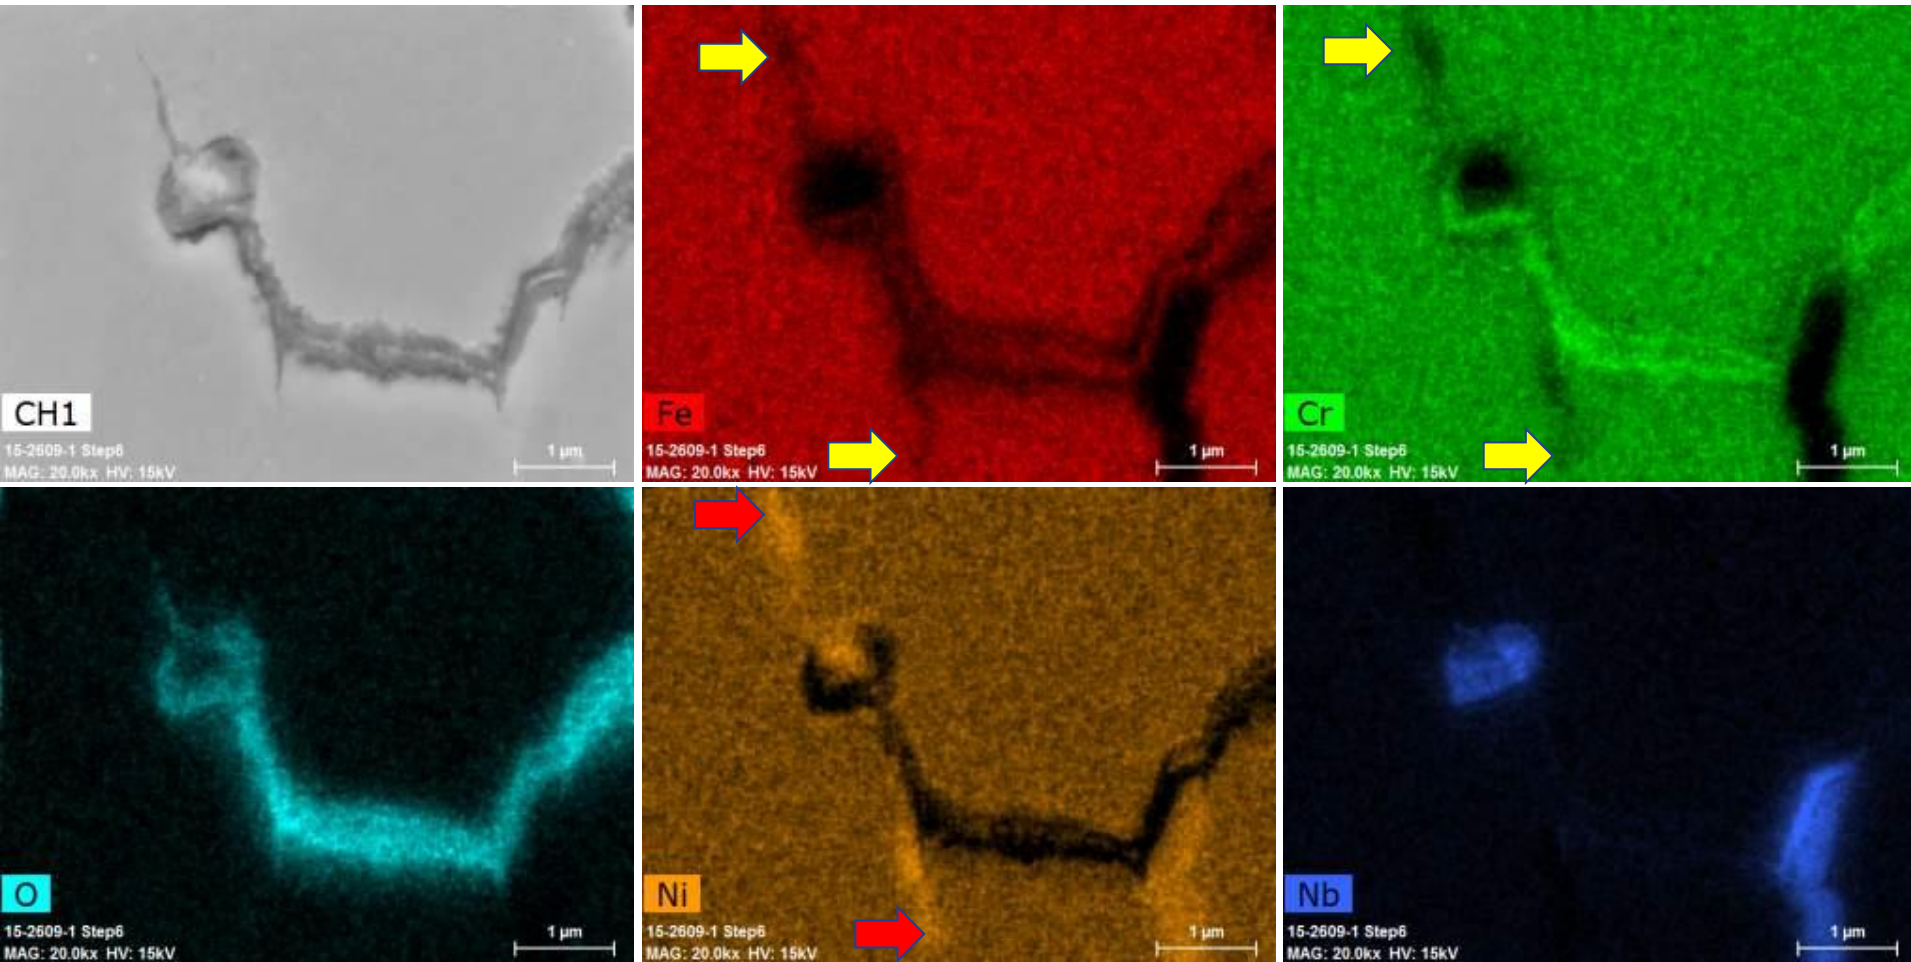
**Figure 82:** The compositional dot-maps showed that at the fracture branched crack approximately 4 mils from the aft surface was depleted in Fe and Cr ahead of the crack front (yellow arrows) and therefore, richer in Ni (red arrow). The crack itself only contained base metal oxides and no detrimental species were found.

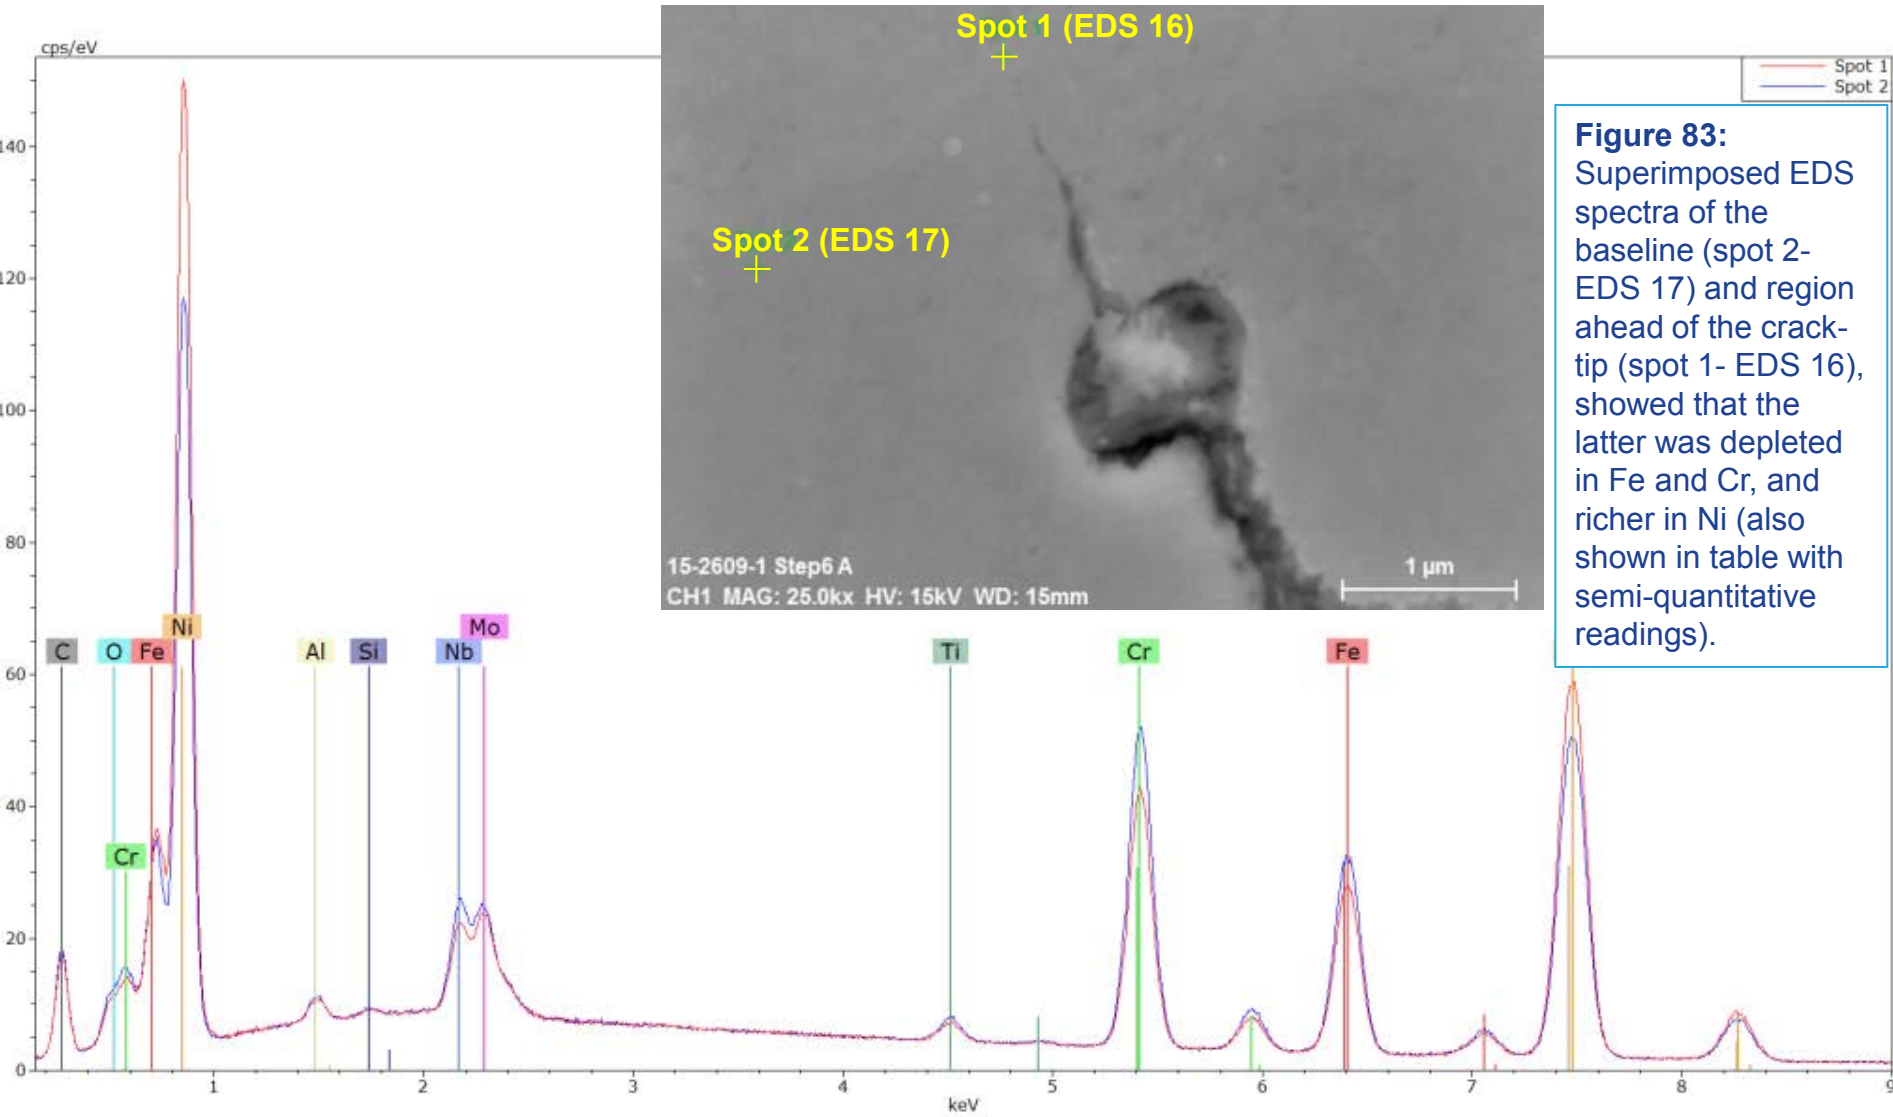
**Figure 83:** Superimposed EDS spectra of the baseline (spot 2- EDS 17) and region ahead of the crack-tip (spot 1- EDS 16), showed that the latter was depleted in Fe and Cr, and richer in Ni (also shown in table with semi-quantitative readings).

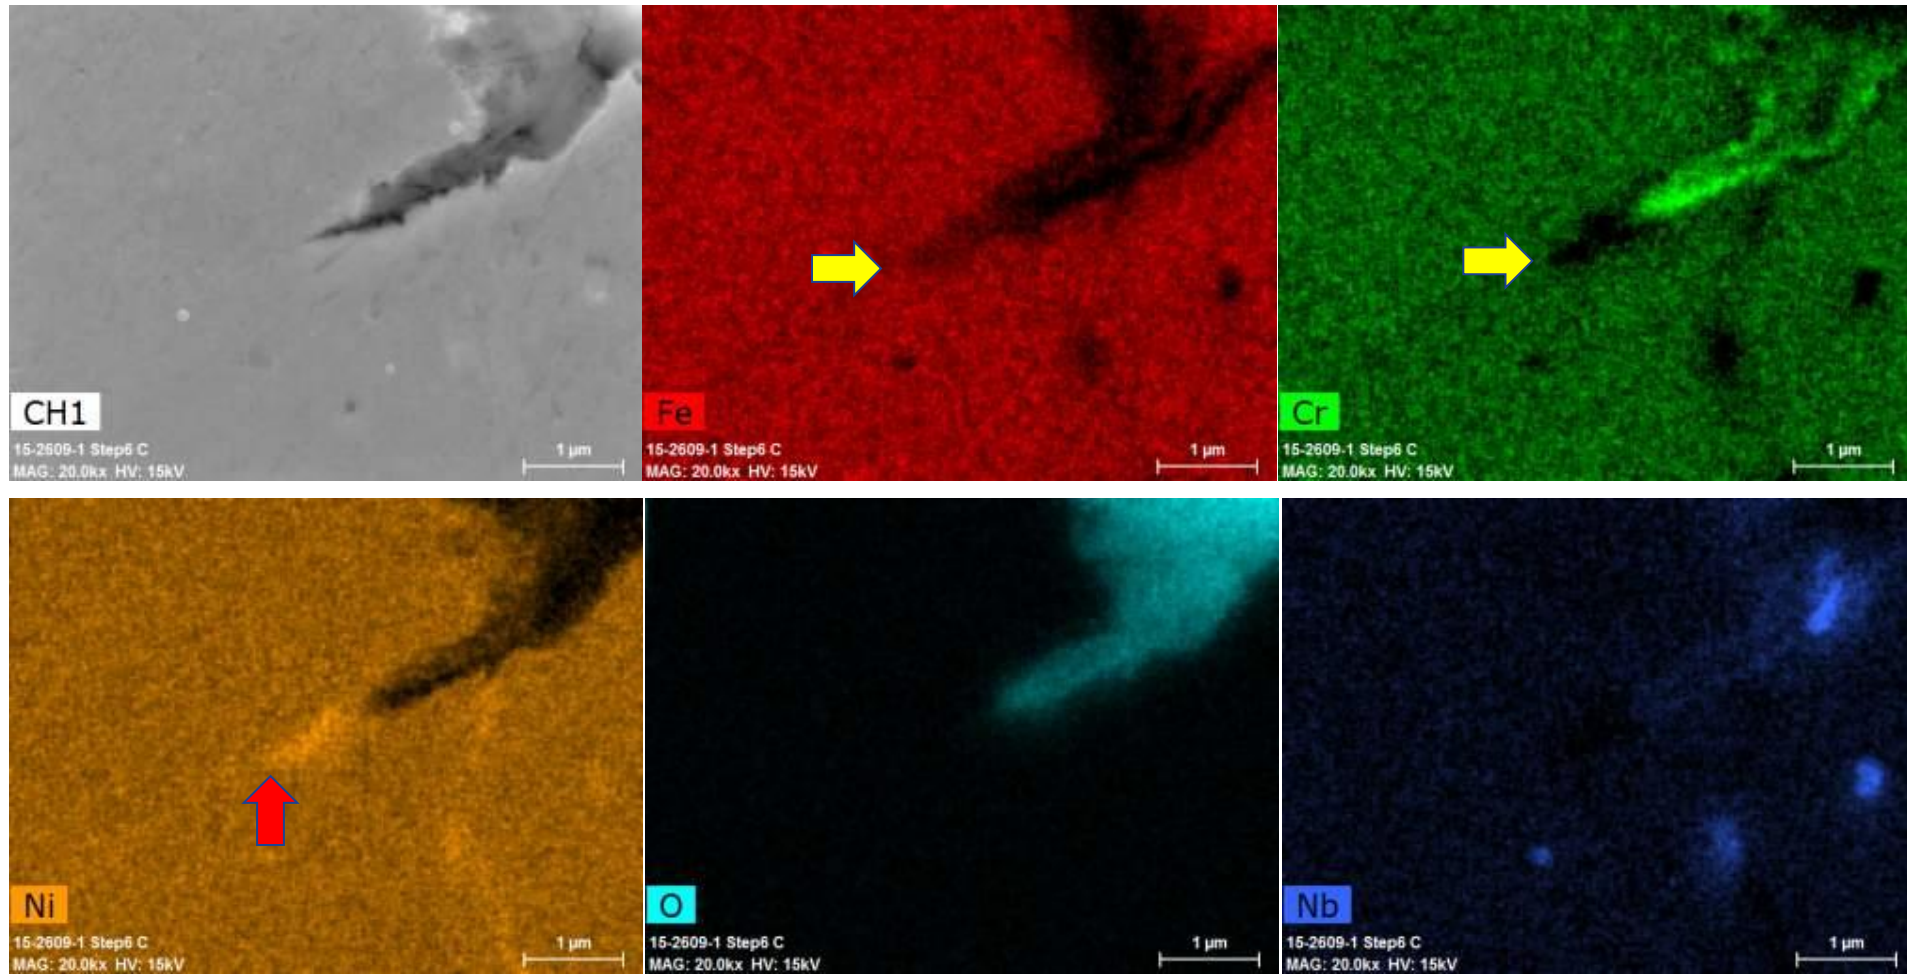
**Figure 85:** The compositional dot-maps showed that at the fracture branched crack approximately 4 mils from the aft surface was depleted in Fe and Cr ahead of the crack front (yellow arrows) and therefore, richer in Ni (red arrow). The crack itself only contained base metal oxides and no detrimental species were found.

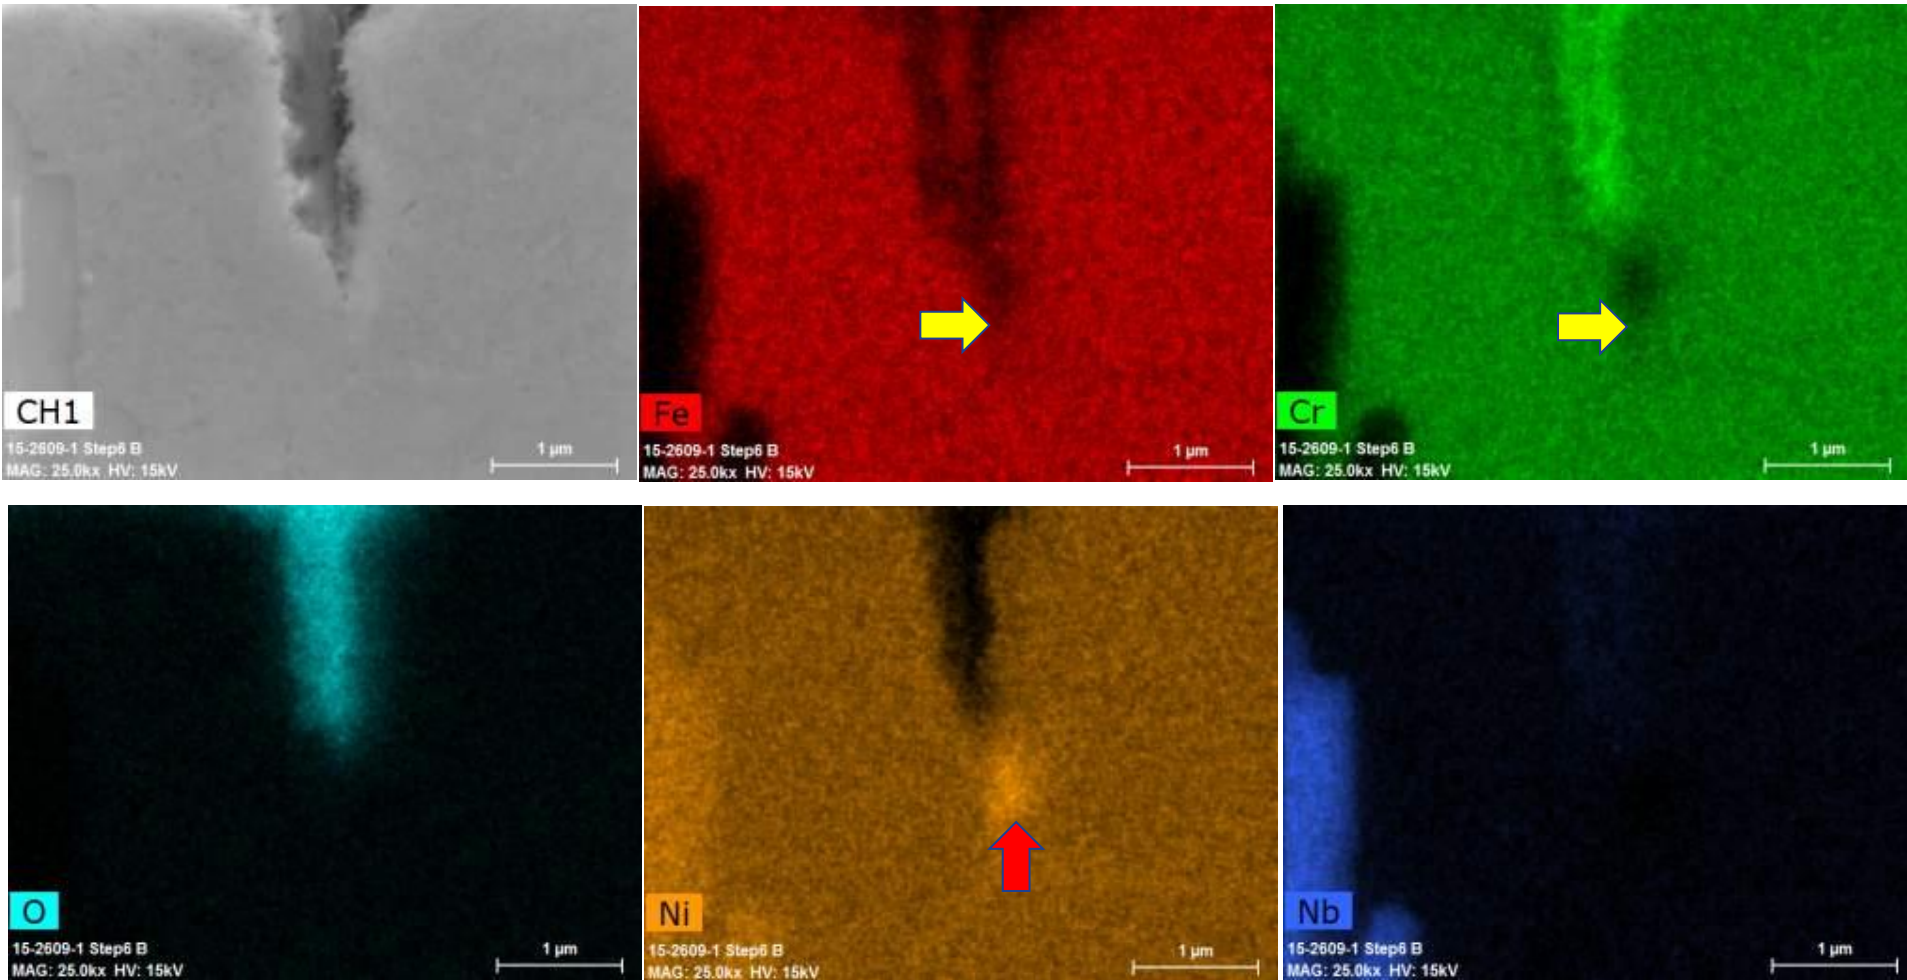
**Figure 87:** The compositional dot-maps showed that at the fracture branched crack approximately 4 mils from the aft surface was depleted in Fe and Cr ahead of the crack front (yellow arrows) and therefore, richer in Ni (red arrow). The crack itself only contained base metal oxides and no detrimental species were found.

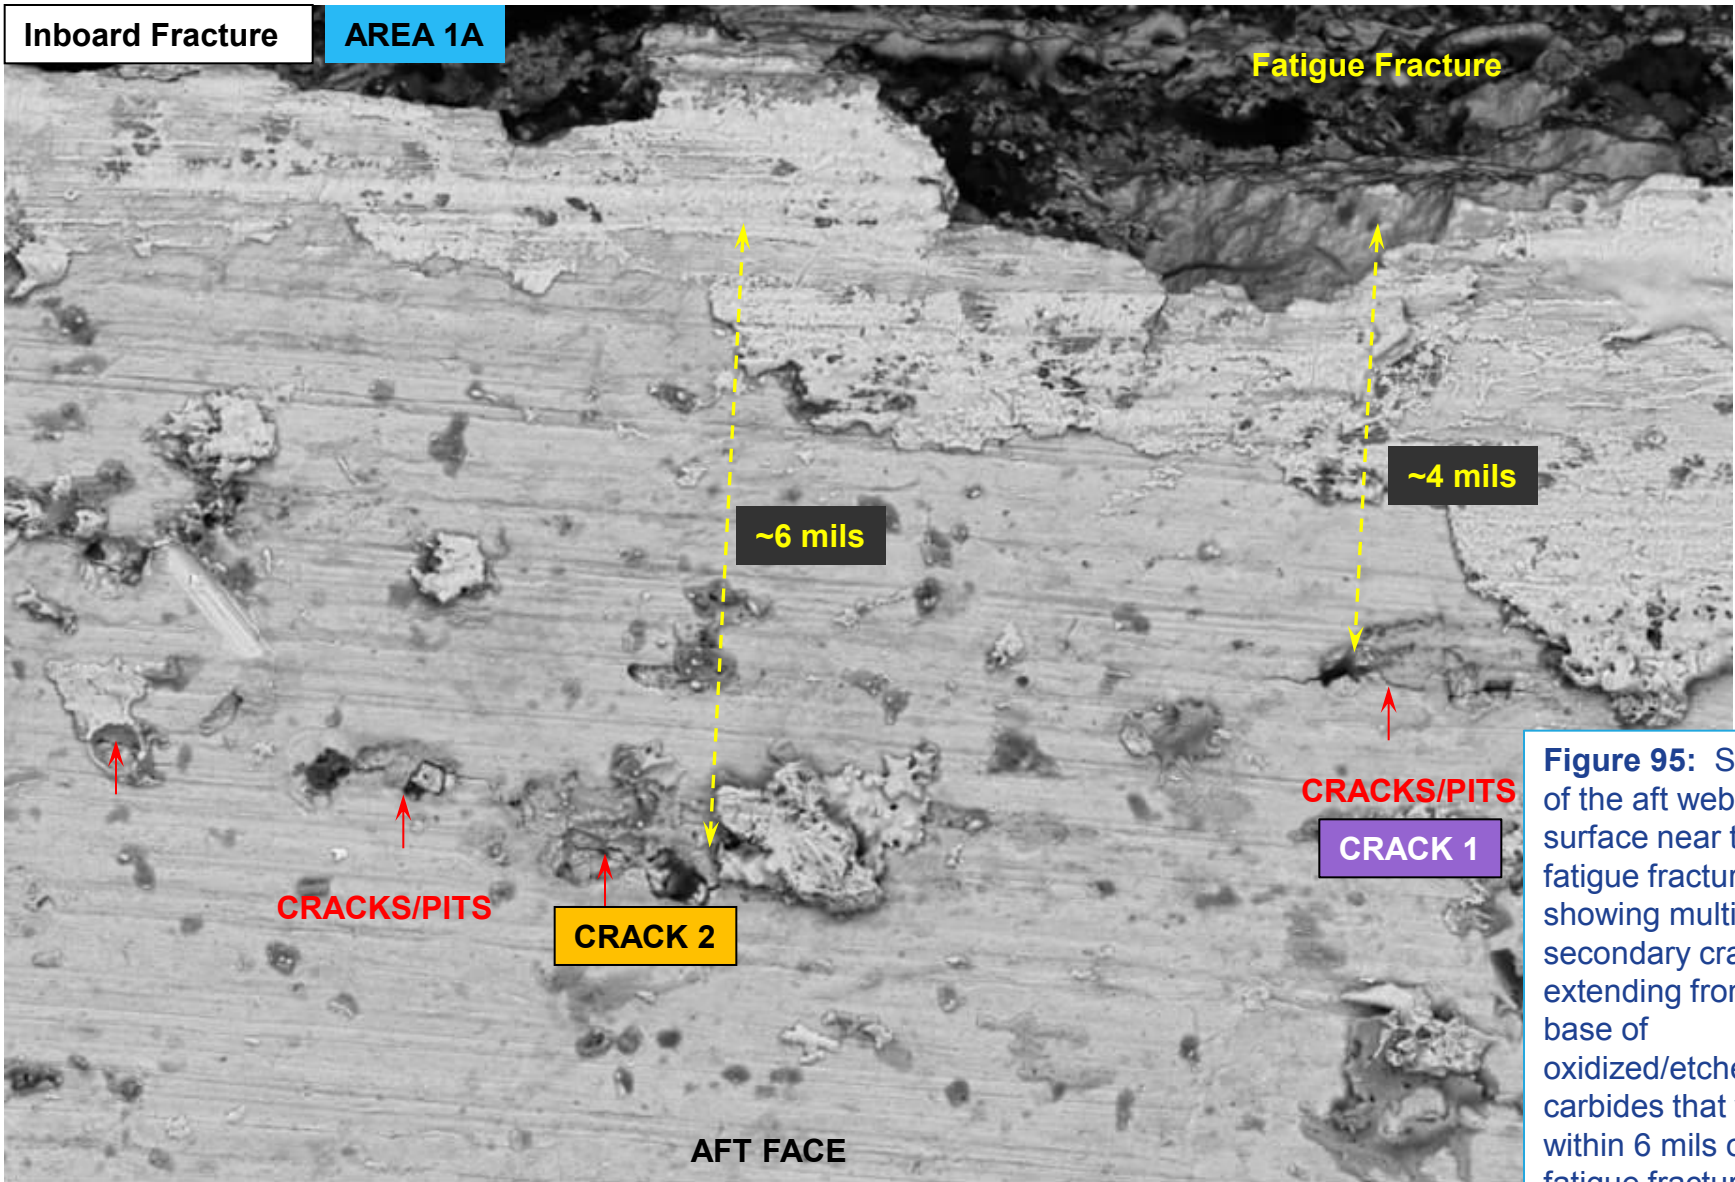
**Figure 95:** SEM view of the aft web face surface near the fatigue fracture showing multiple secondary cracks extending from the base of oxidized/etched carbides that were within 6 mils of the fatigue fracture locally. Cracks 1 and 2 were evaluated further.

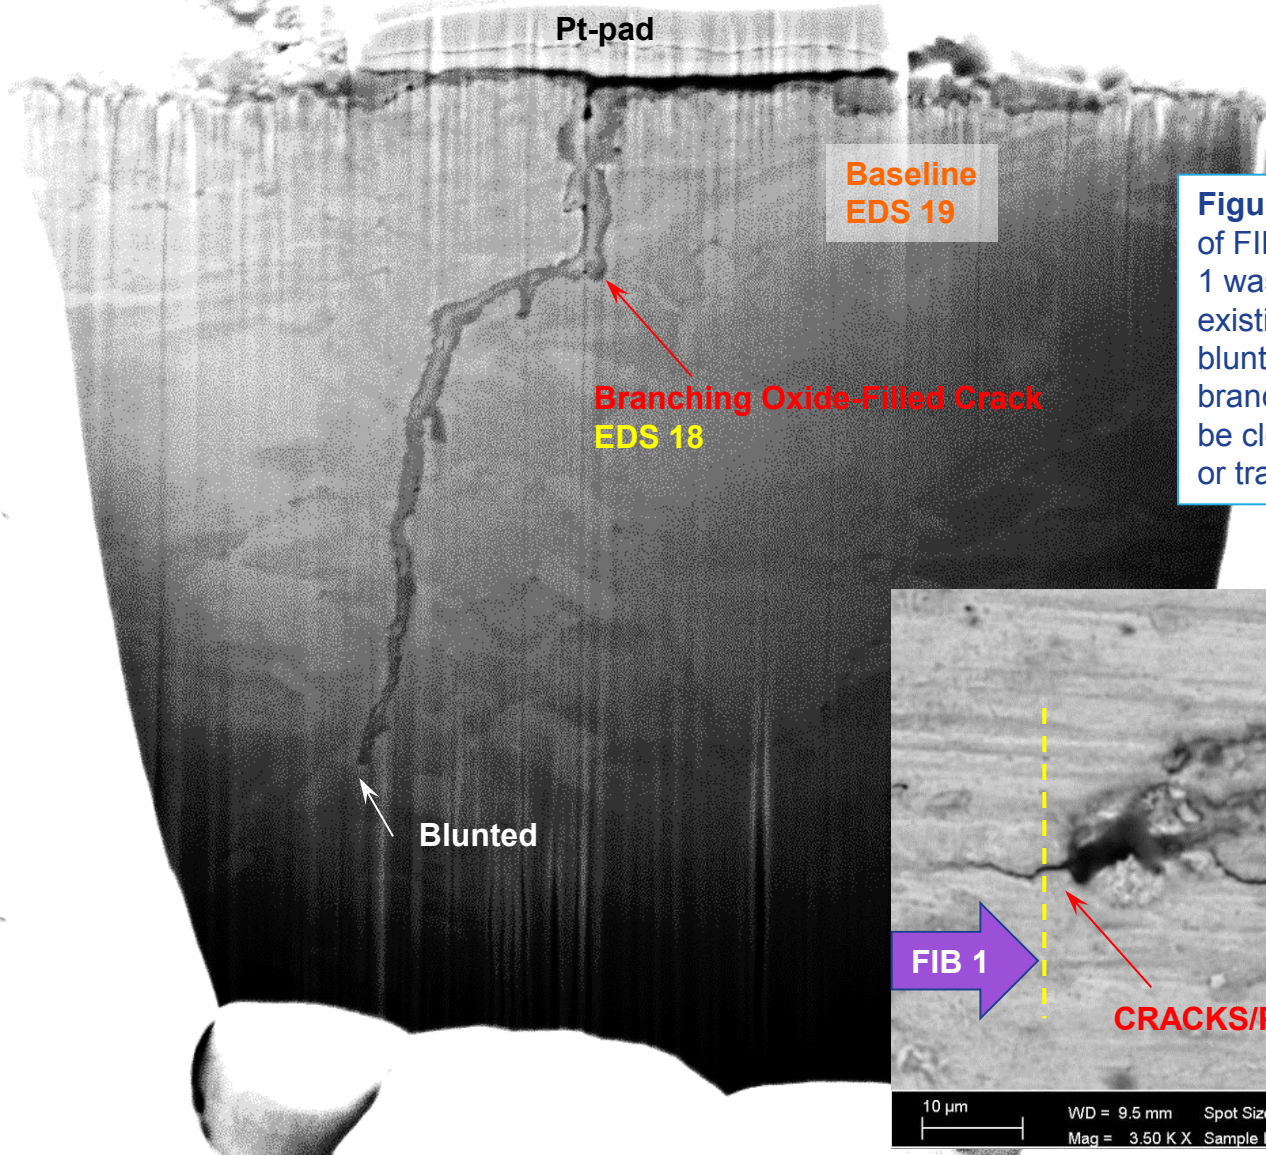
**Figure 106:** SEM backscatter image of FIB1A section showing that Crack 1 was oxidized, consistent with a pre-existing crack and the crack tip was blunted. The crack branched/meandered, but could not be clearly interpreted as intergranular or transgranular.

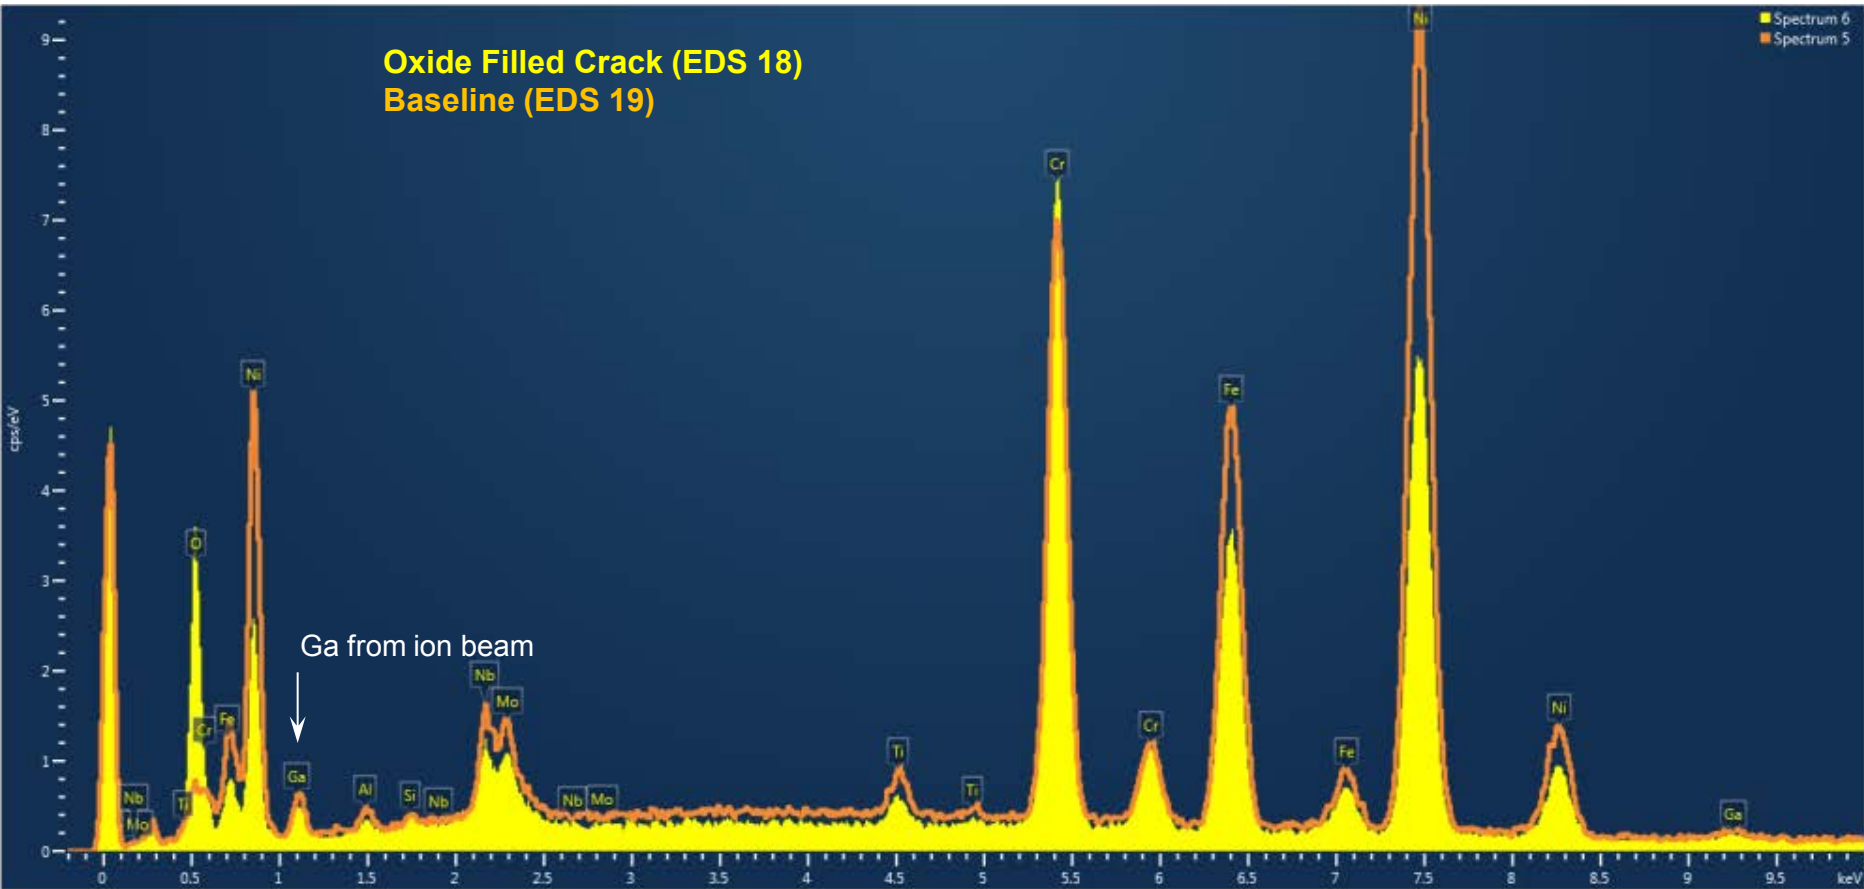
**Figure 107:** Superimposed EDS spectra showed that the crack only had elements consistent with oxidized base material (EDS 18), with the baseline shown in EDS 19. No detrimental species were found in the oxides.

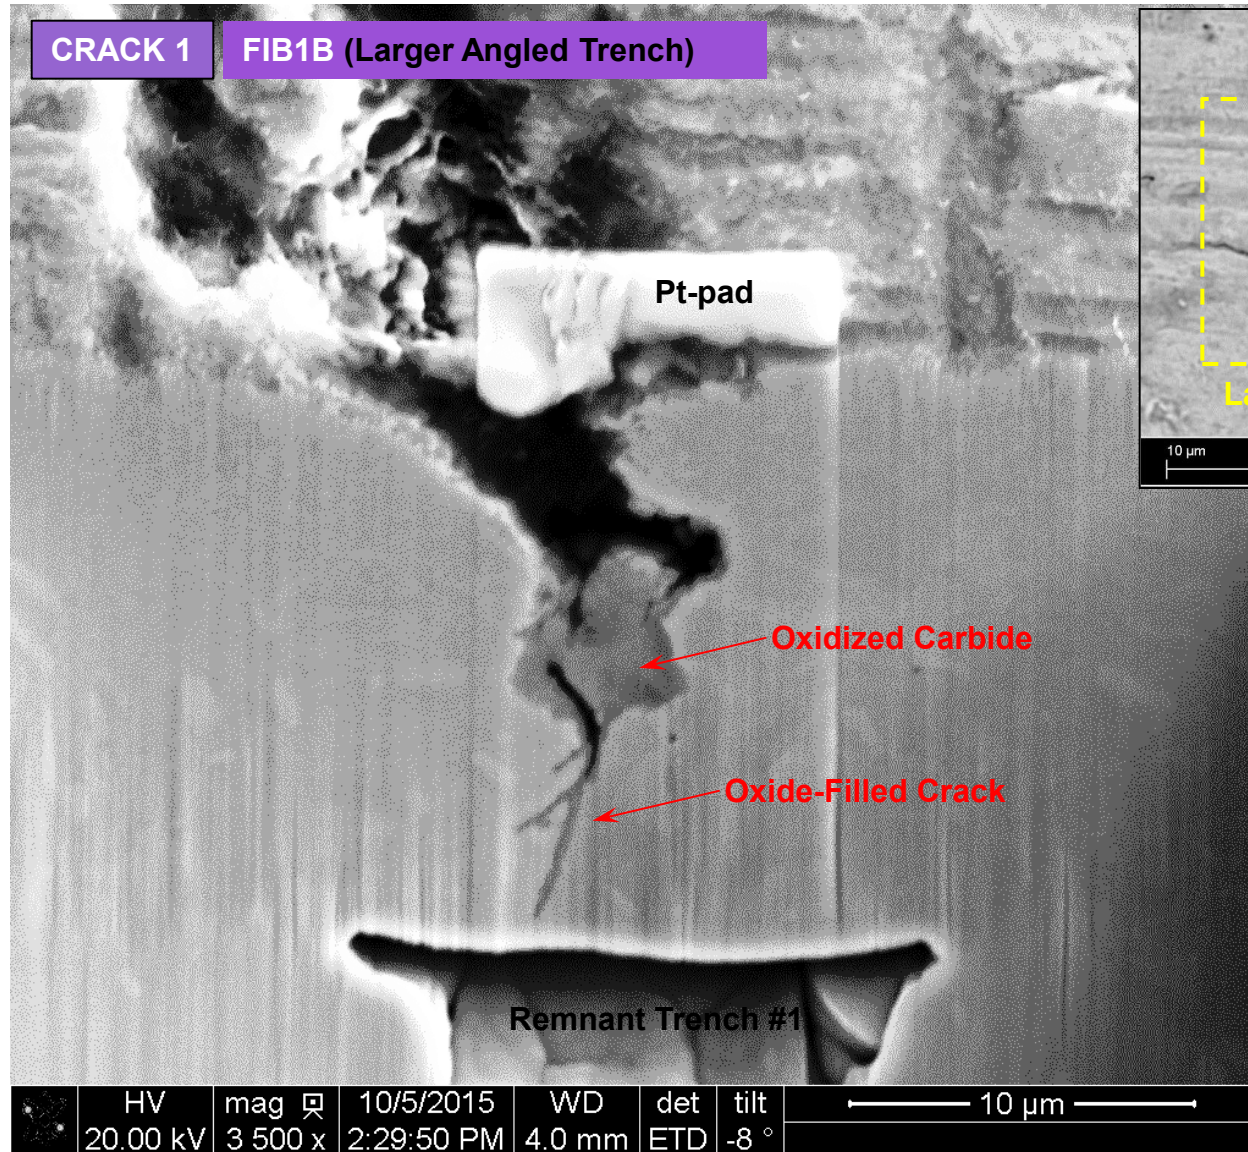
**Figure 108:** A second trench was generated into secondary Crack 1 that showed cracking below the surface carbide with branched features.

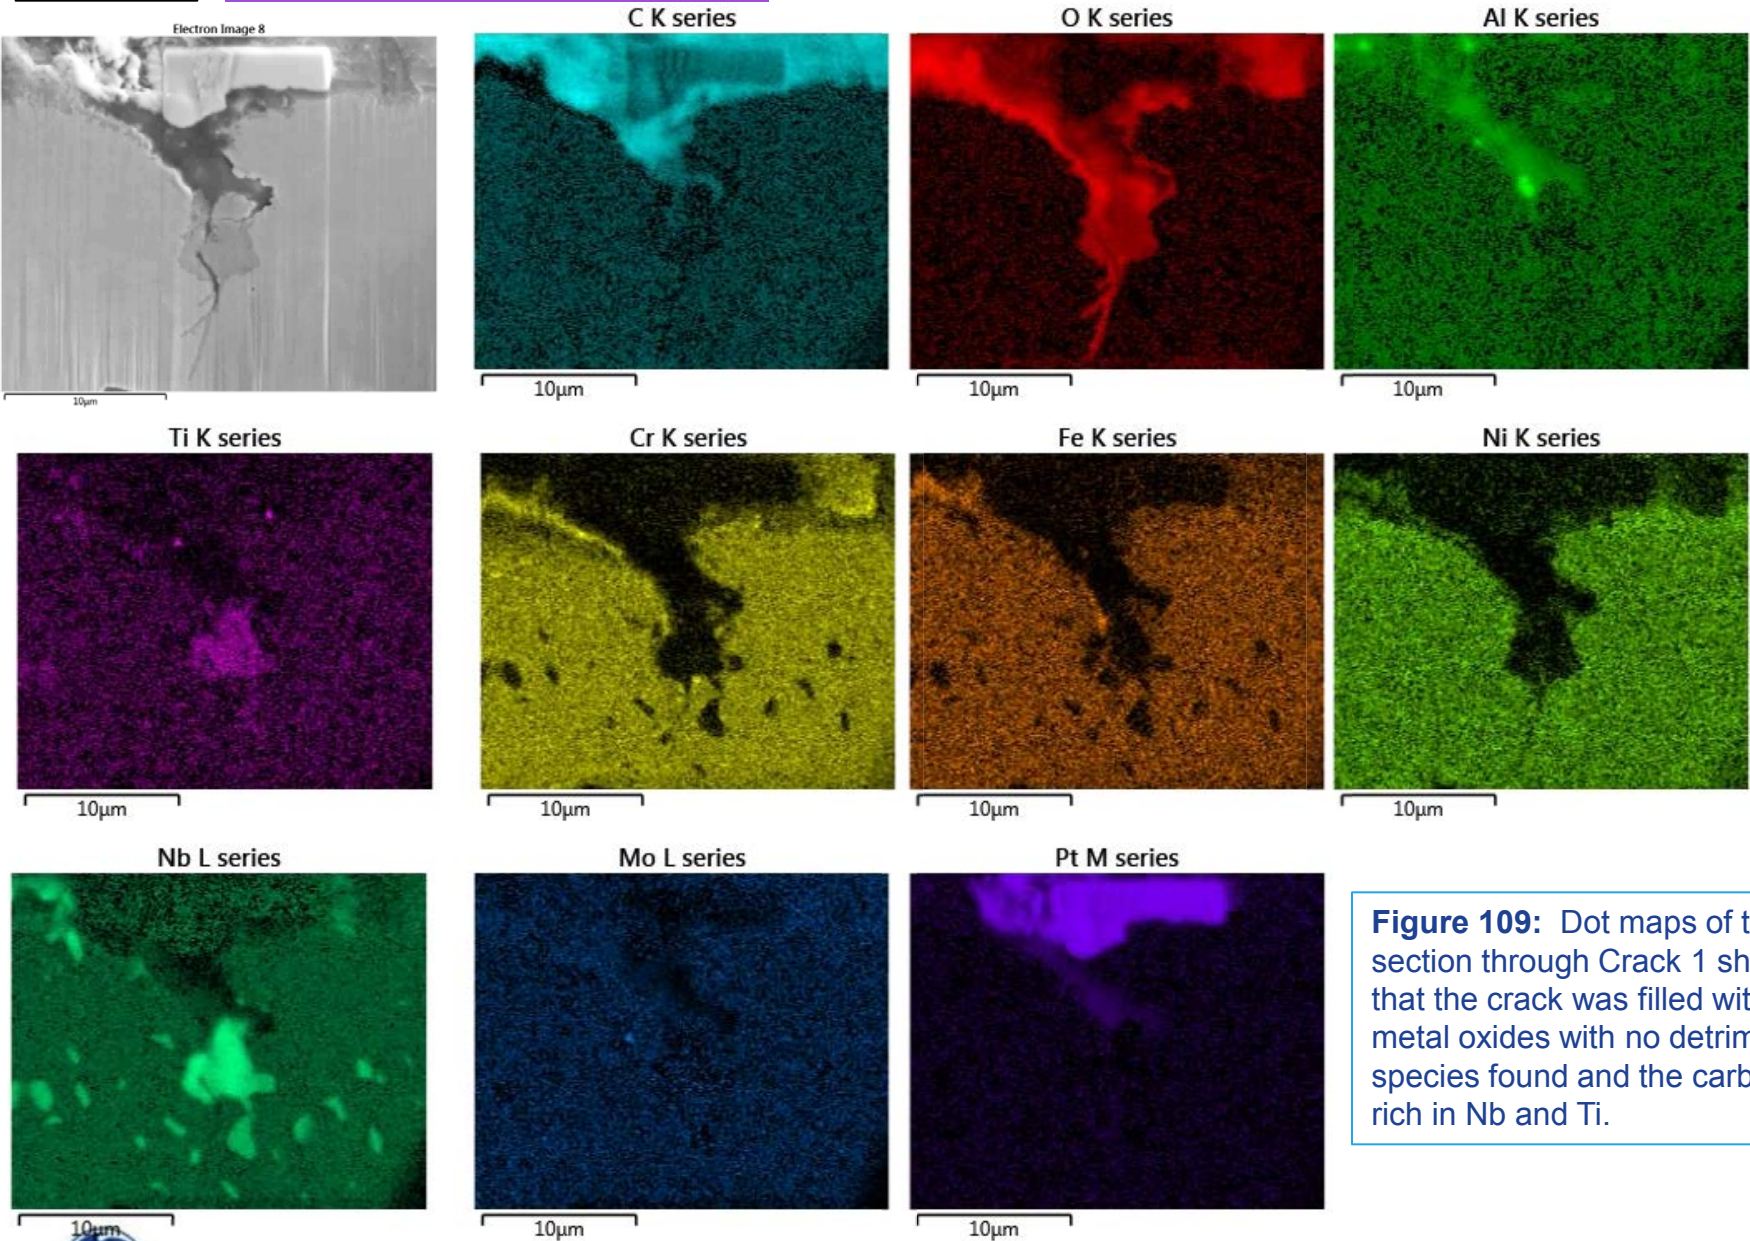
**Figure 109:** Dot maps of the FIB section through Crack 1 showed that the crack was filled with base metal oxides with no detrimental species found and the carbide was rich in Nb and Ti.

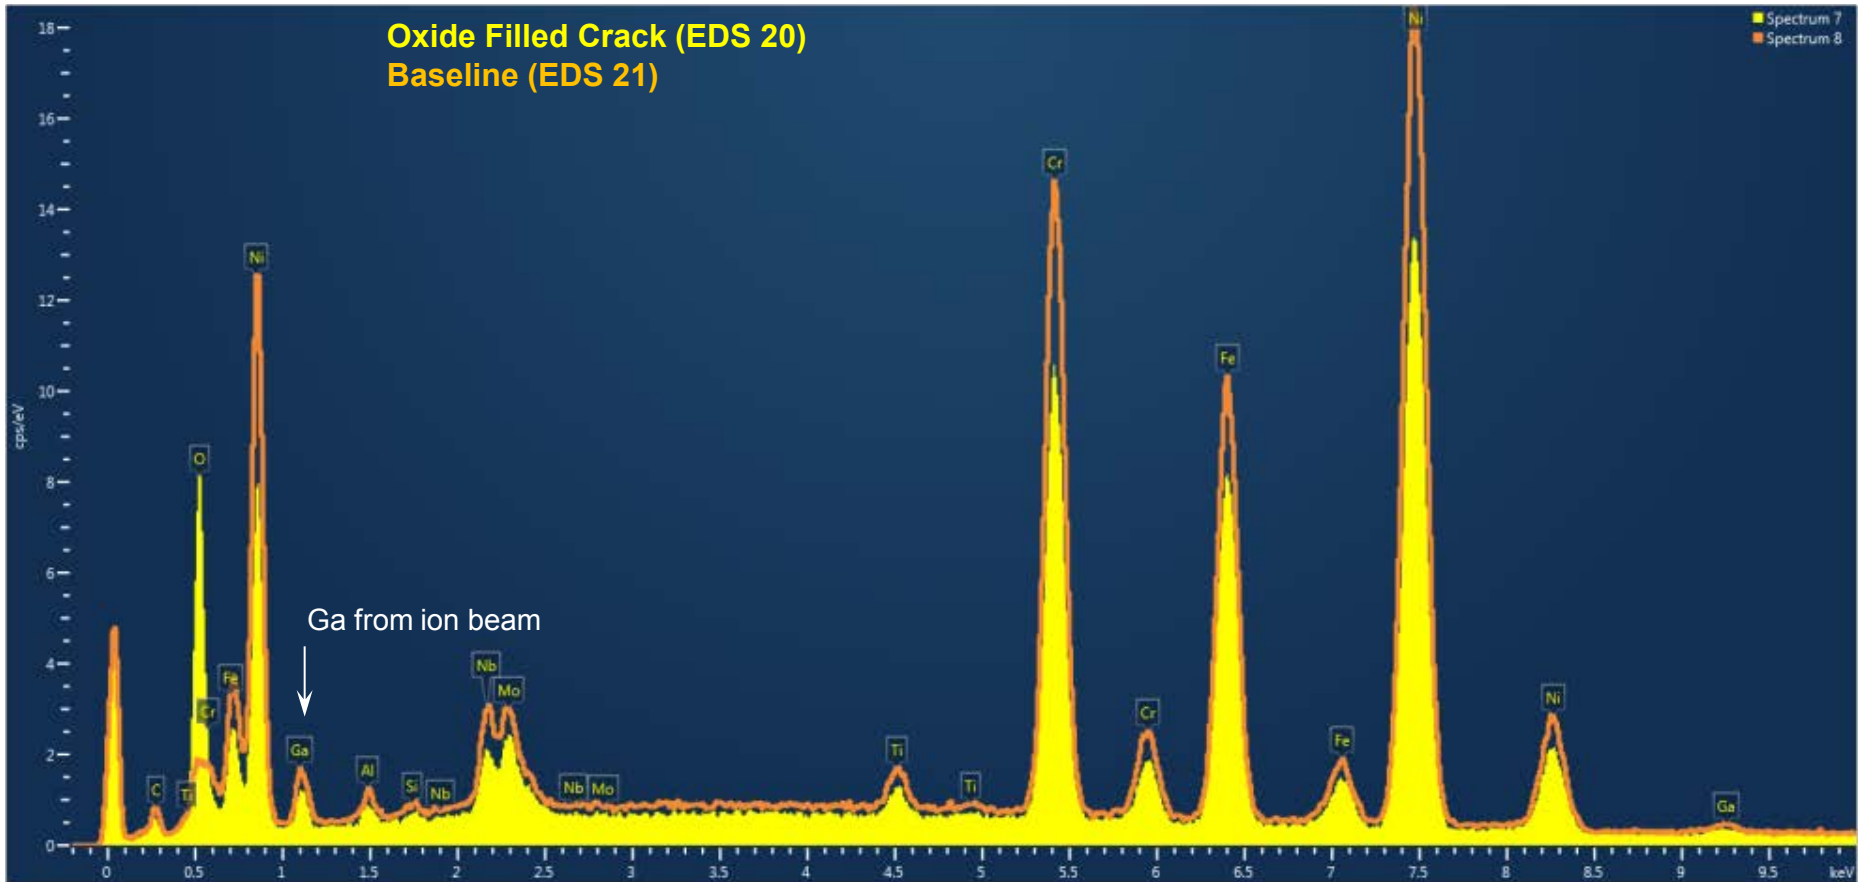
**Figure 115:** Superimposed EDS spectra showed that the crack only had elements consistent with oxidized base material (EDS 20), with the baseline shown in EDS 21. No detrimental species were found in the oxides.
