NATIONAL TRANSPORTATION SAFETY BOARD

MATERIALS LABORATORY FACTUAL REPORT

Report No. 15-133

Place : Bloomington, Illinois
Date : April 7, 2015
Vehicle : Cessna 414A, N789UP
NTSB No. : CEN15FA190
Investigator : Andrew Todd Fox, AS-CEN

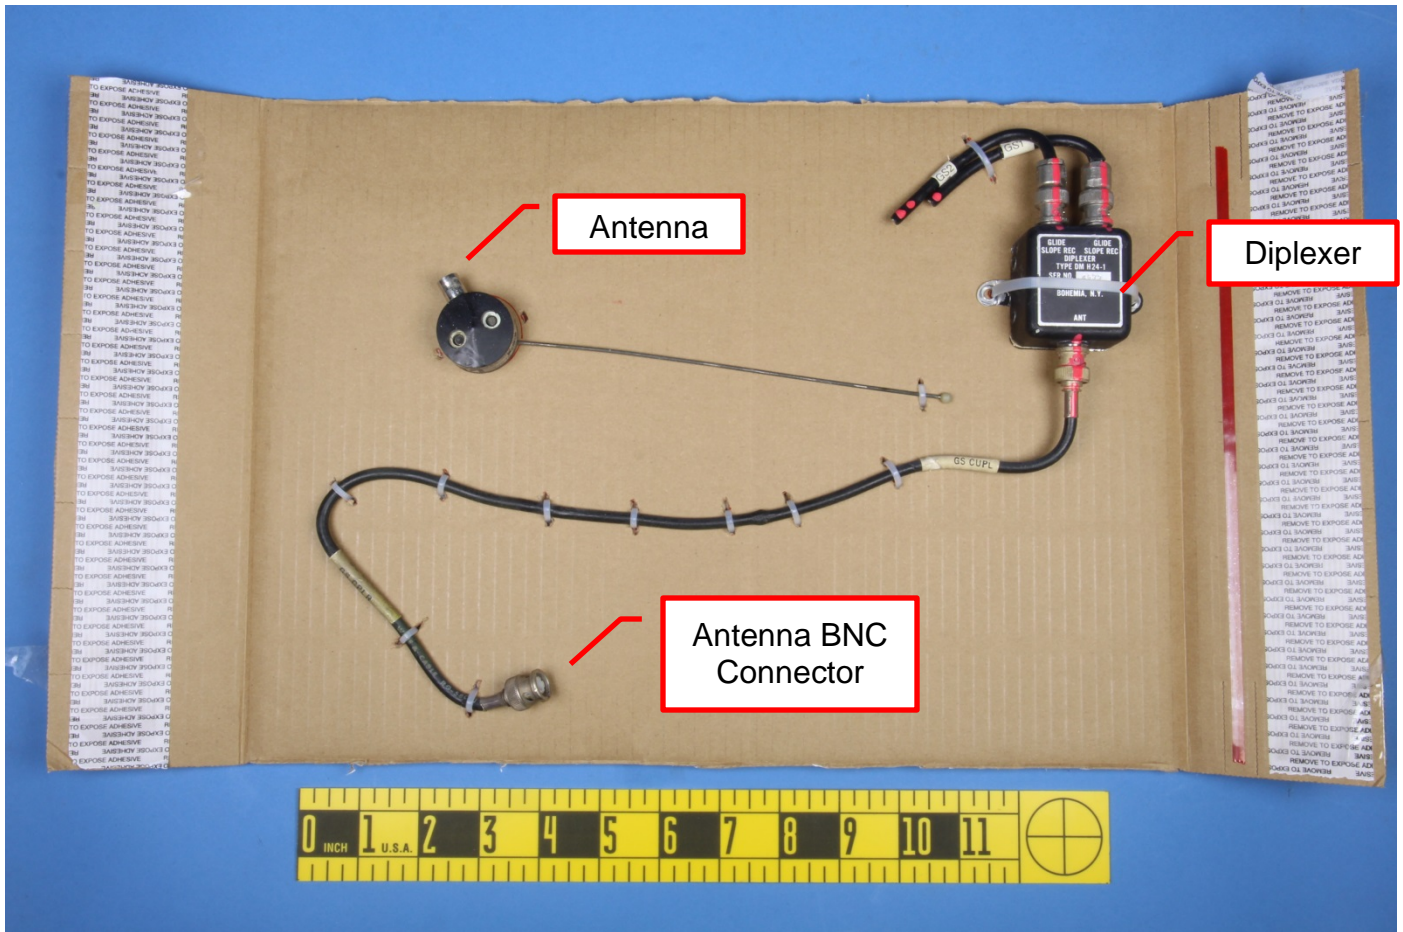
The as-received components are labeled and displayed in figure 1. The cable connecting the diplexer and the antenna was disconnected at the antenna. The cable connector was a quarter turn twist lock BNC¹ with the male side on the coaxial cable.

Figure 1. Overall view of the as-received glideslope diplexer, antenna and cable.

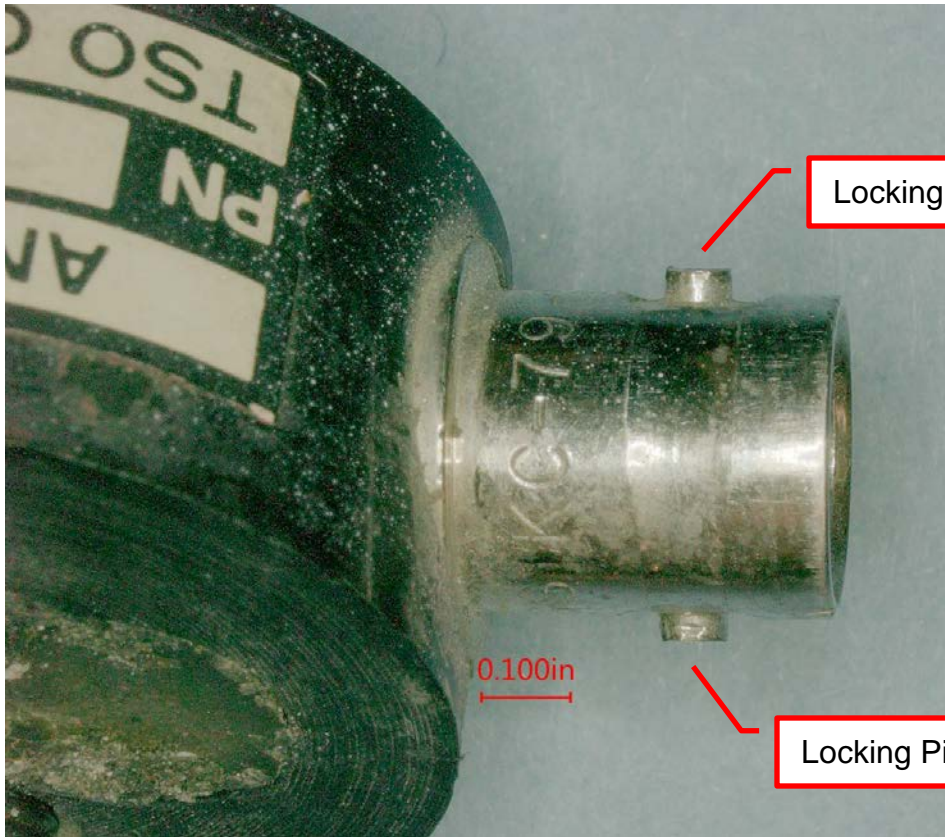
Examinations of the female BNC cable connector on the antenna found it intact with some minor deformation (arrow) and light debris on the interior and exterior surfaces, see figure 2. The locking pins were intact and no corrosion was apparent. The antenna rod was straight when received but accidentally bent during examination.

Figure 2. Closer views of the female BNC cable connector on the antenna with intact pins and slight deformation at arrow.

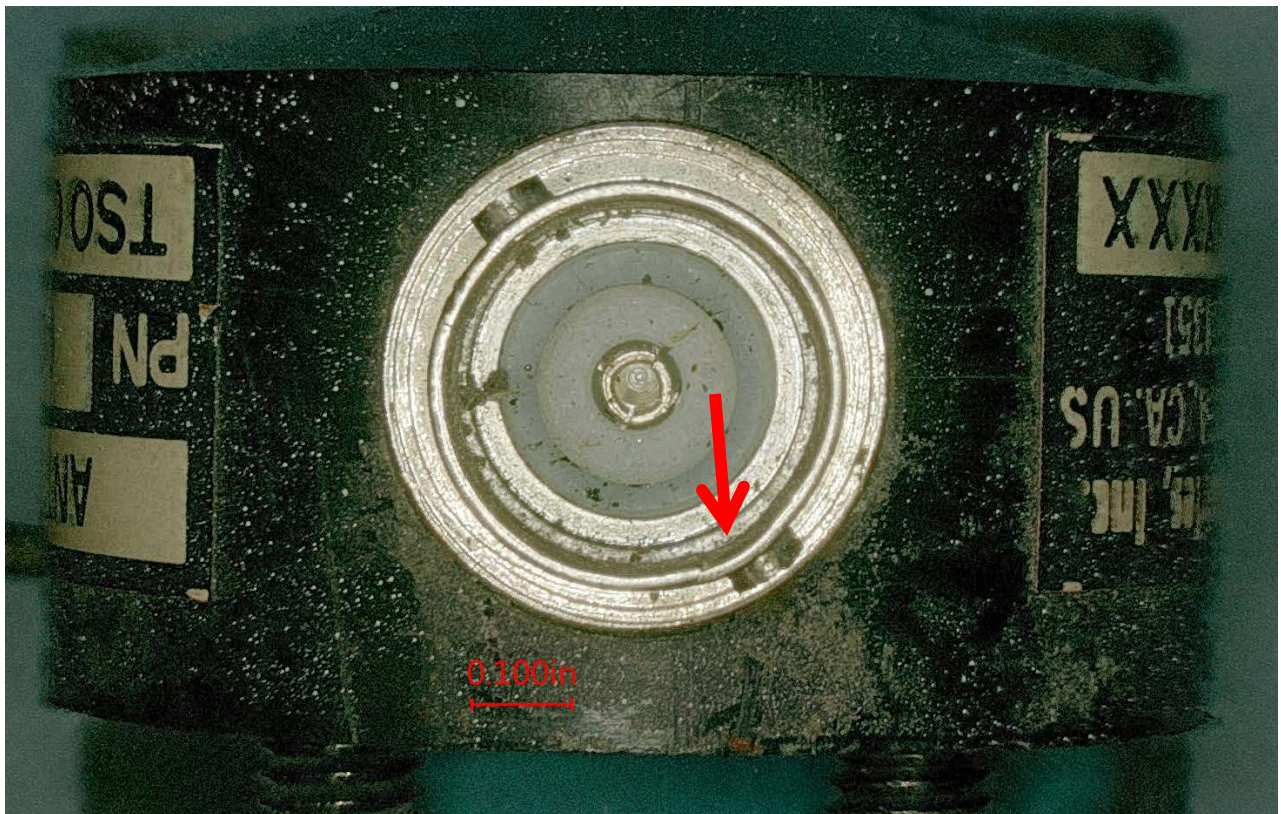
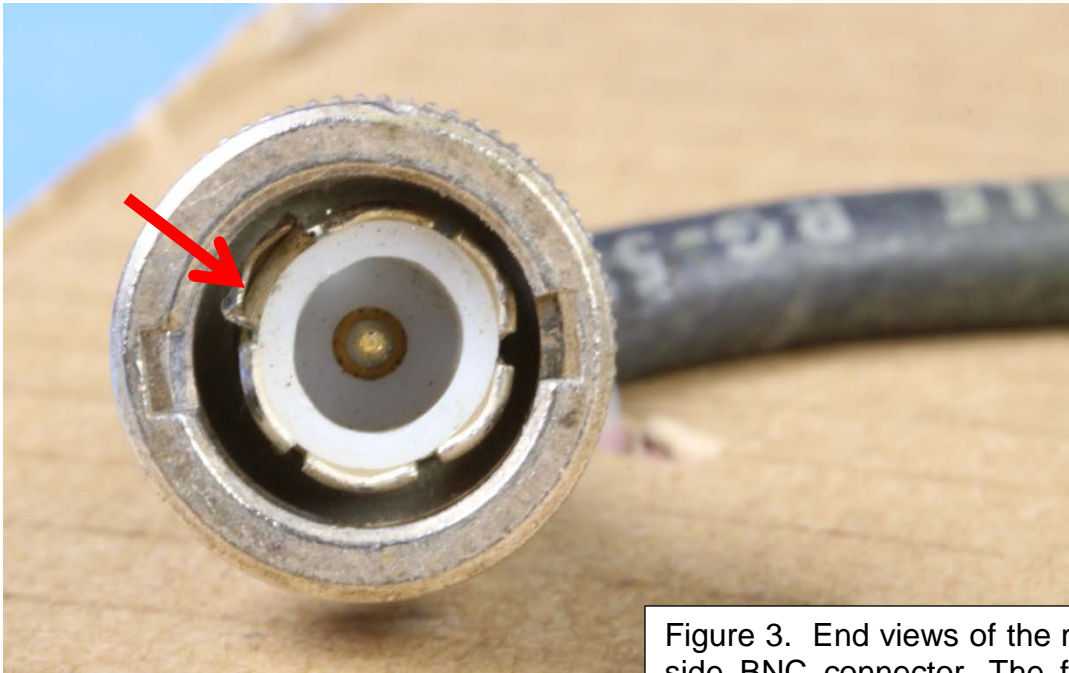
The mating male BNC connector is shown in figure 3. Overall the connector was intact and undamaged except for one of six shielding / ground fingers, see arrow. The damaged finger was folded and "S" bent back into the connector. The central conductor pin was undamaged and no corrosion was apparent.

Figure 3. End views of the male cable side BNC connector. The folded and "S" bent shield finger is denoted by the red arrows in both views.

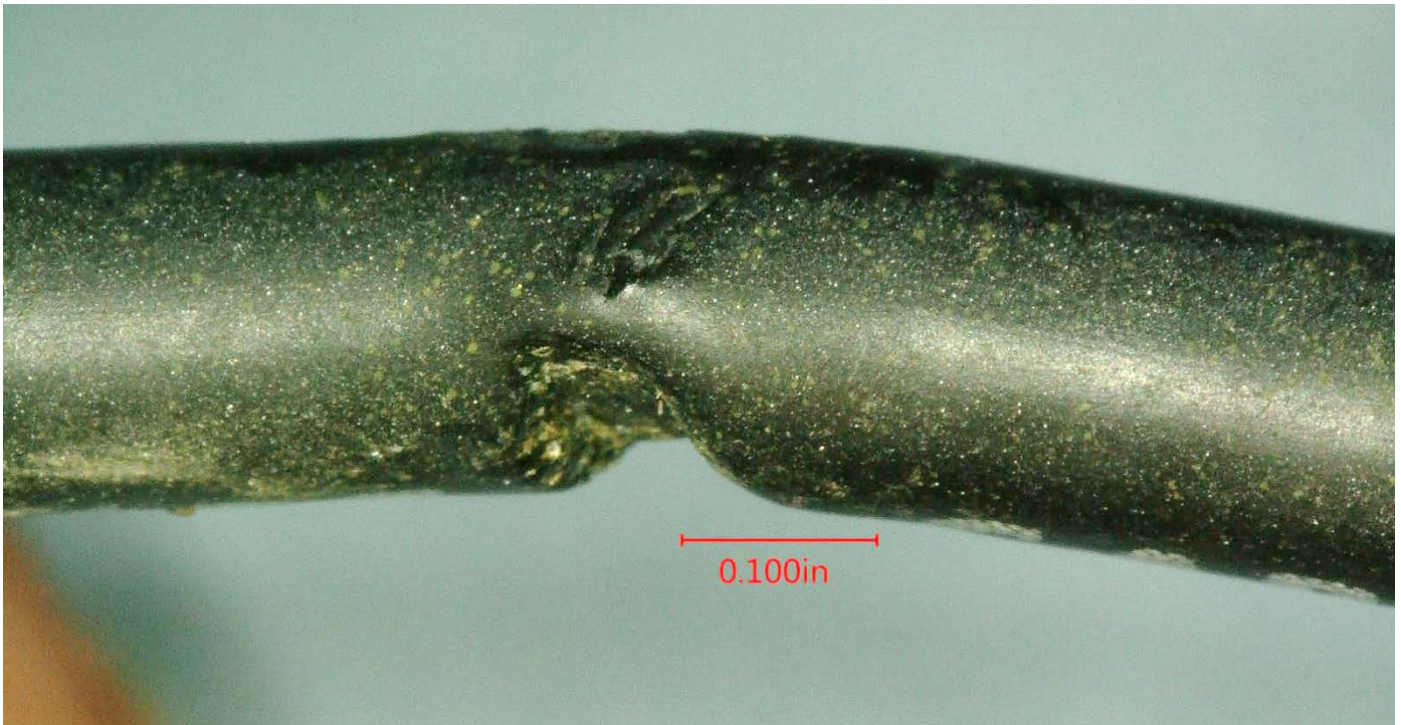
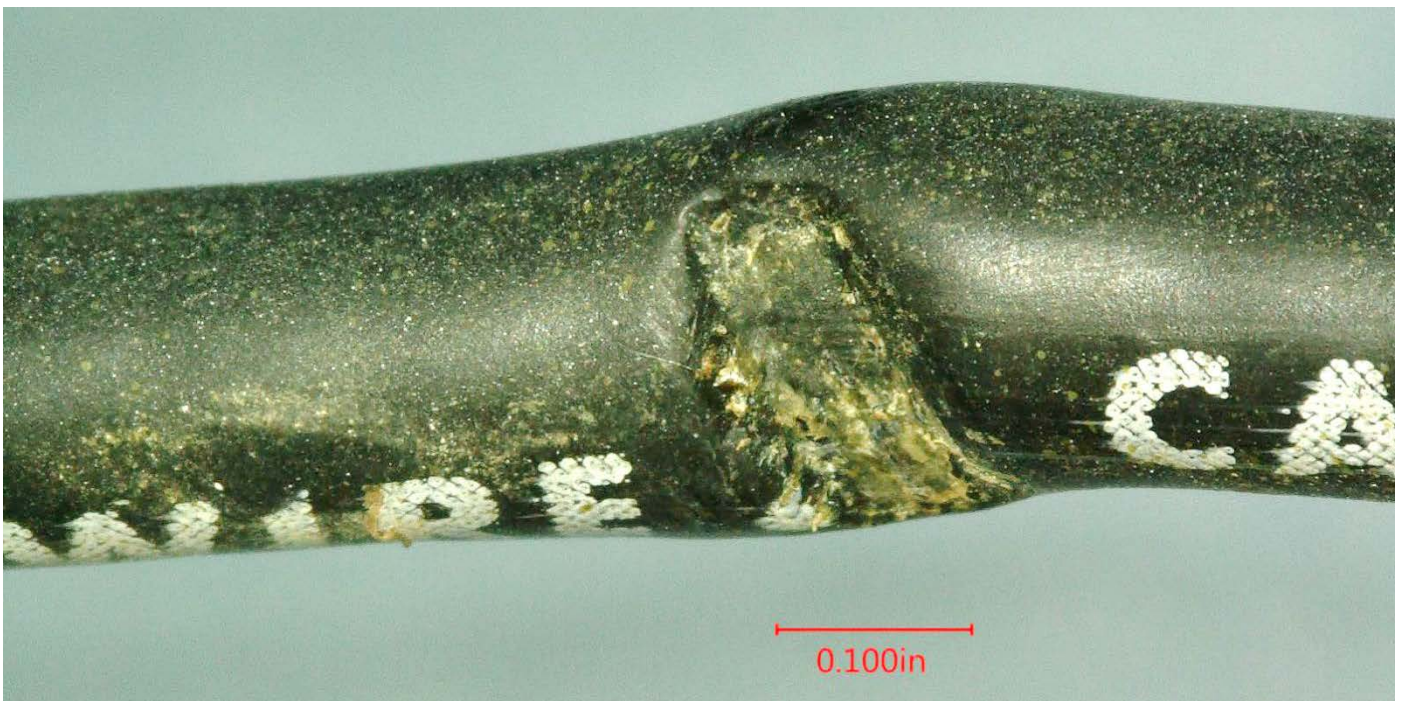
A significant crimp was noted at about the midpoint of the cable as shown in figure 4. The electrical properties of the cable and connection were not tested.

Figure 4. Two views of the crimping damage to the coaxial antenna cable.
