# NATIONAL TRANSPORTATION SAFETY BOARD

MATERIALS LABORATORY FACTUAL REPORT

Report No. 16-002

Place : Orlando, Florida  
Date : March 22, 2015  
Vehicle : Robinson R44 II, N30242  
NTSB No. : ERA15FA164  
Investigator : Eric Alleyne, ASI-ERA

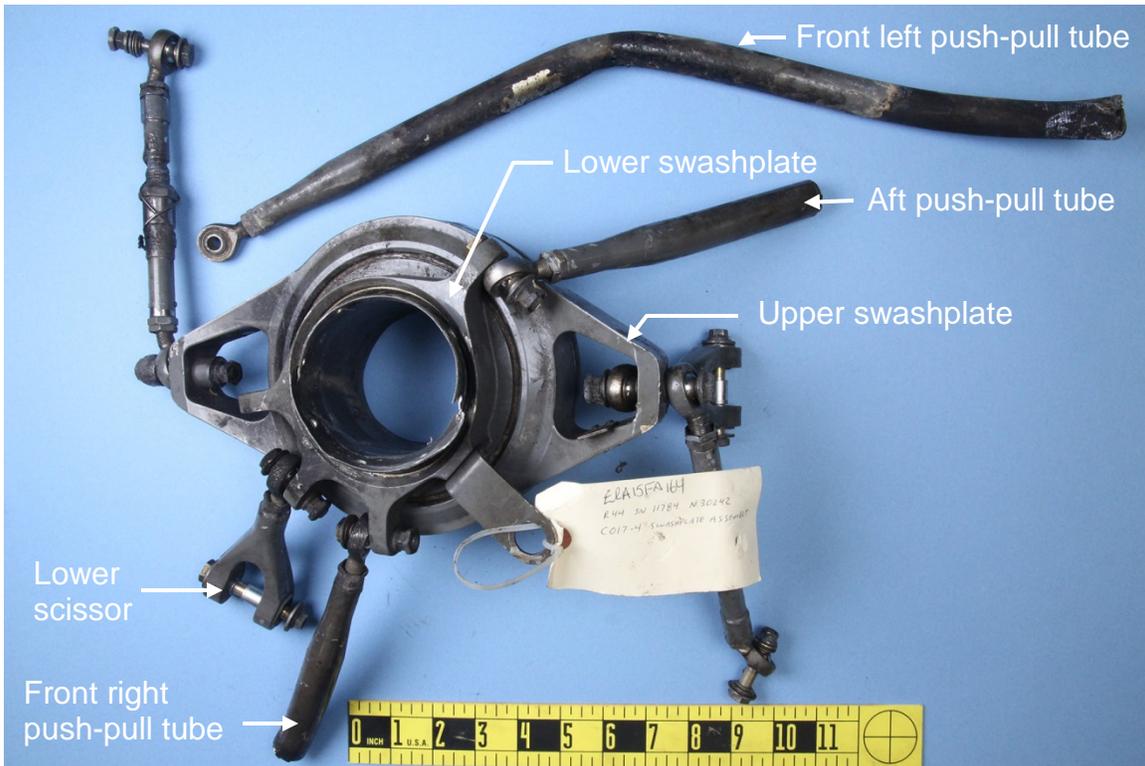
A swashplate assembly and a portion of a push-pull tube were sent to the NTSB Materials Laboratory for examination. As indicated in figure 1, the swashplate assembly consisted of an upper swashplate and a lower swashplate. The lower swashplate had four push-pull tube attachment lugs: aft, front left, front right, and front scissor (middle). Push-pull tubes were connected to the aft attachment lug, front right attachment lug, and front scissor attachment lug. The front left push-pull tube was not attached to its corresponding lug, as shown in figures 2 and 3a, and the associated attachment bolt assembly was missing.

**Figure 1:** Image of the swashplate assembly and connecting rods as received. In the image, the assembly is oriented such that the lower swashplate is on top of the upper swashplate.

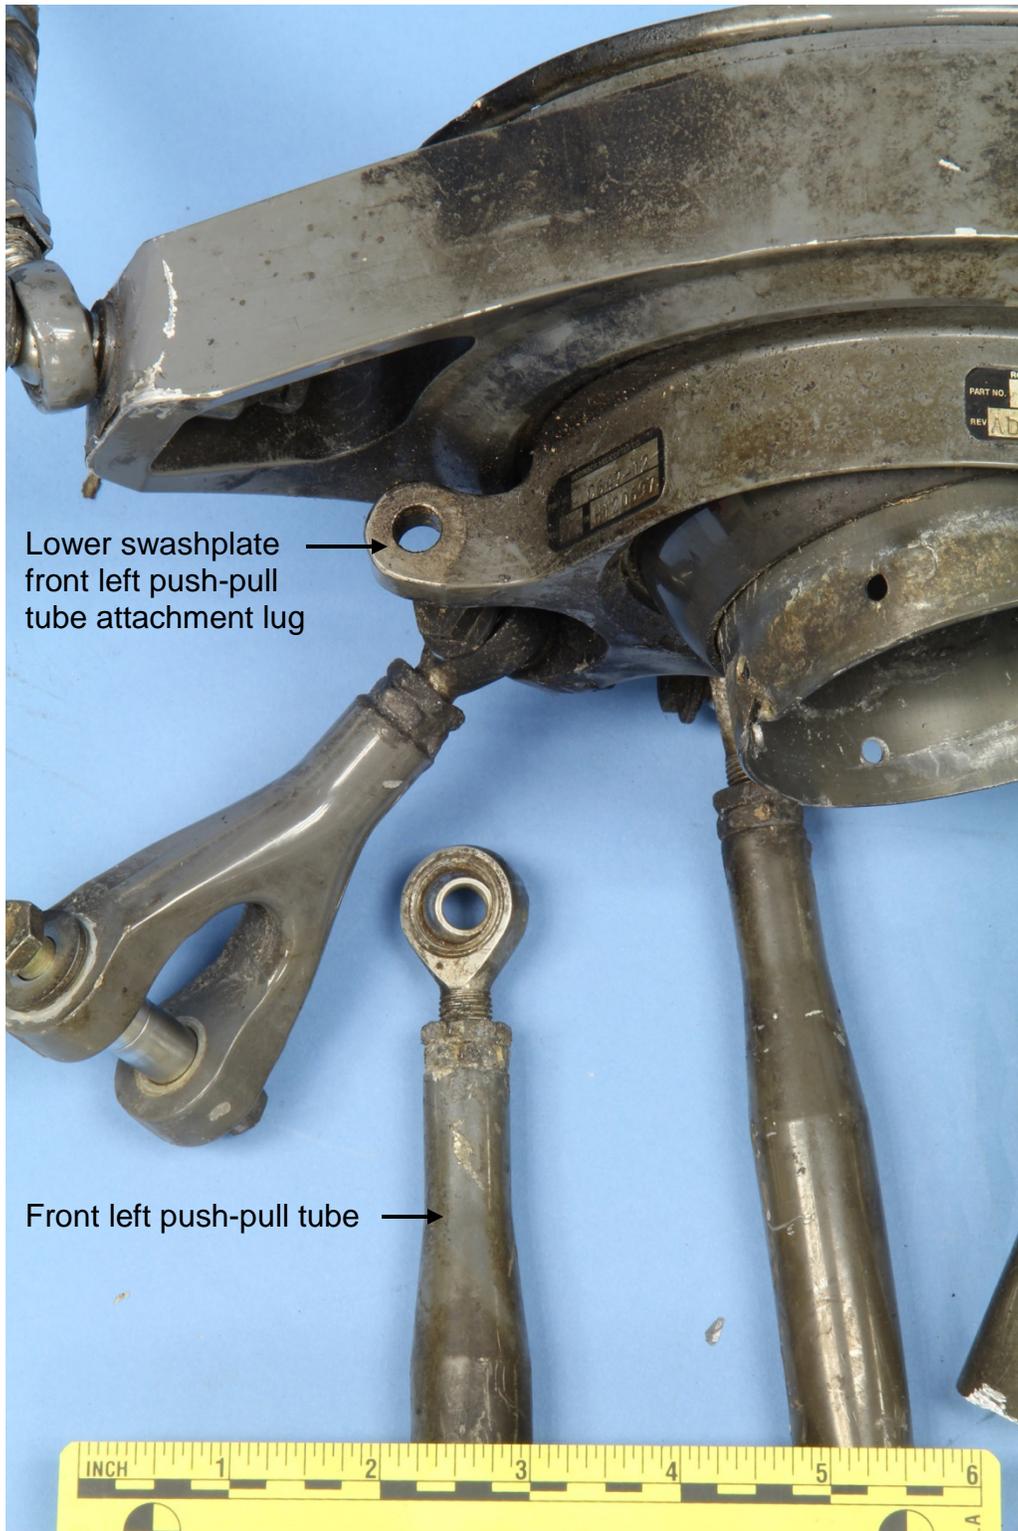
**Figure 2:** Side view of lower swashplate and front left push-pull tube, with missing front left push-pull tube rod end to attachment lug bolt assembly.

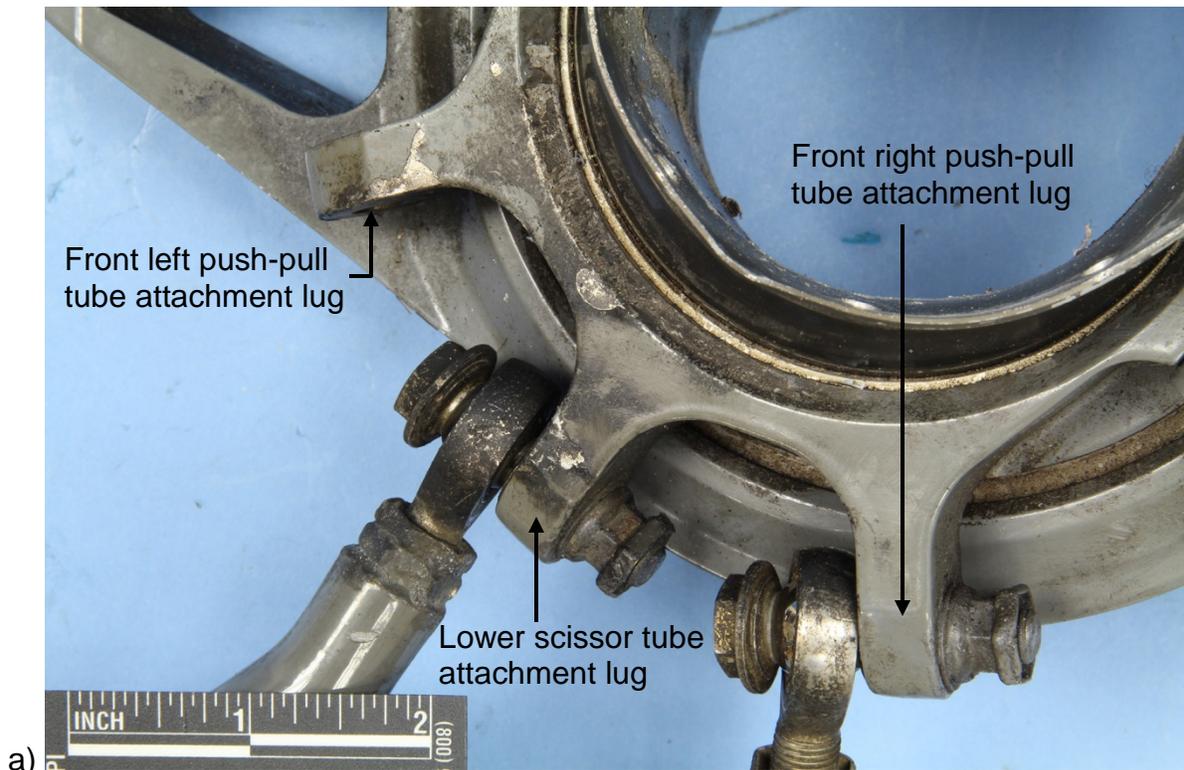
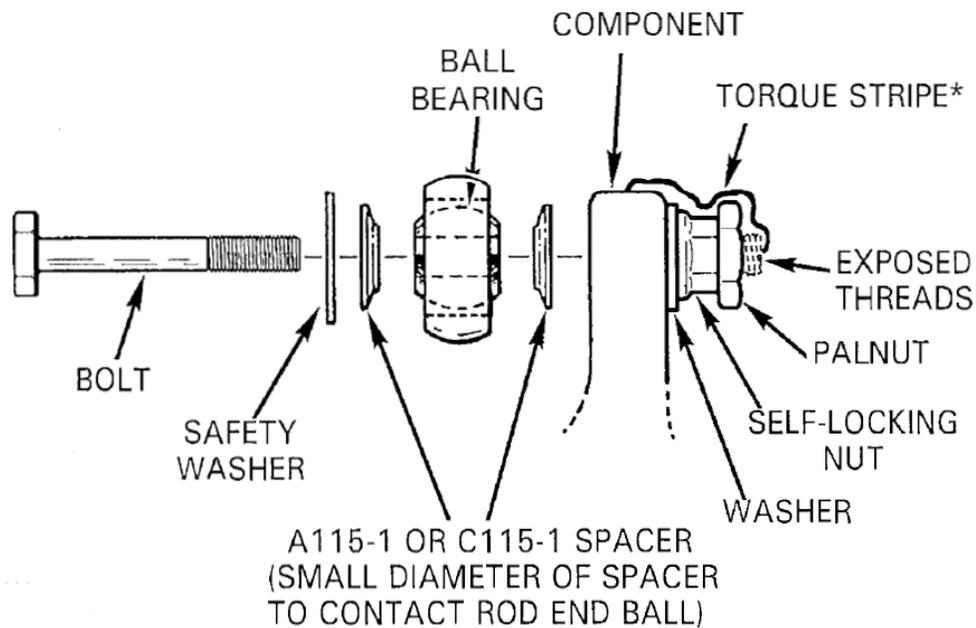
Push-pull tube rod ends are connected to the swashplate attachment lugs by a bolt assembly as illustrated in figure 3b. According to the R44 maintenance manual, the assembly consists of a bolt, safety washer, two spacers on either side of the rod end

ball bearing, washer, self-locking nut, palnut, and a torque stripe.<sup>1</sup> Remnants of torque striping were observed on the aft attachment lug bolt assembly but not on the forward right or front scissor lug bolt assemblies. The forward left attachment lug was examined for any remnant of a torque stripe but none was found.

**Figure 3:** a) Image of the forward portion of the lower swashplate with missing front left push-pull tube rod end to attachment lug bolt assembly and b) schematic illustrating the rod end to attachment lug bolt assembly.

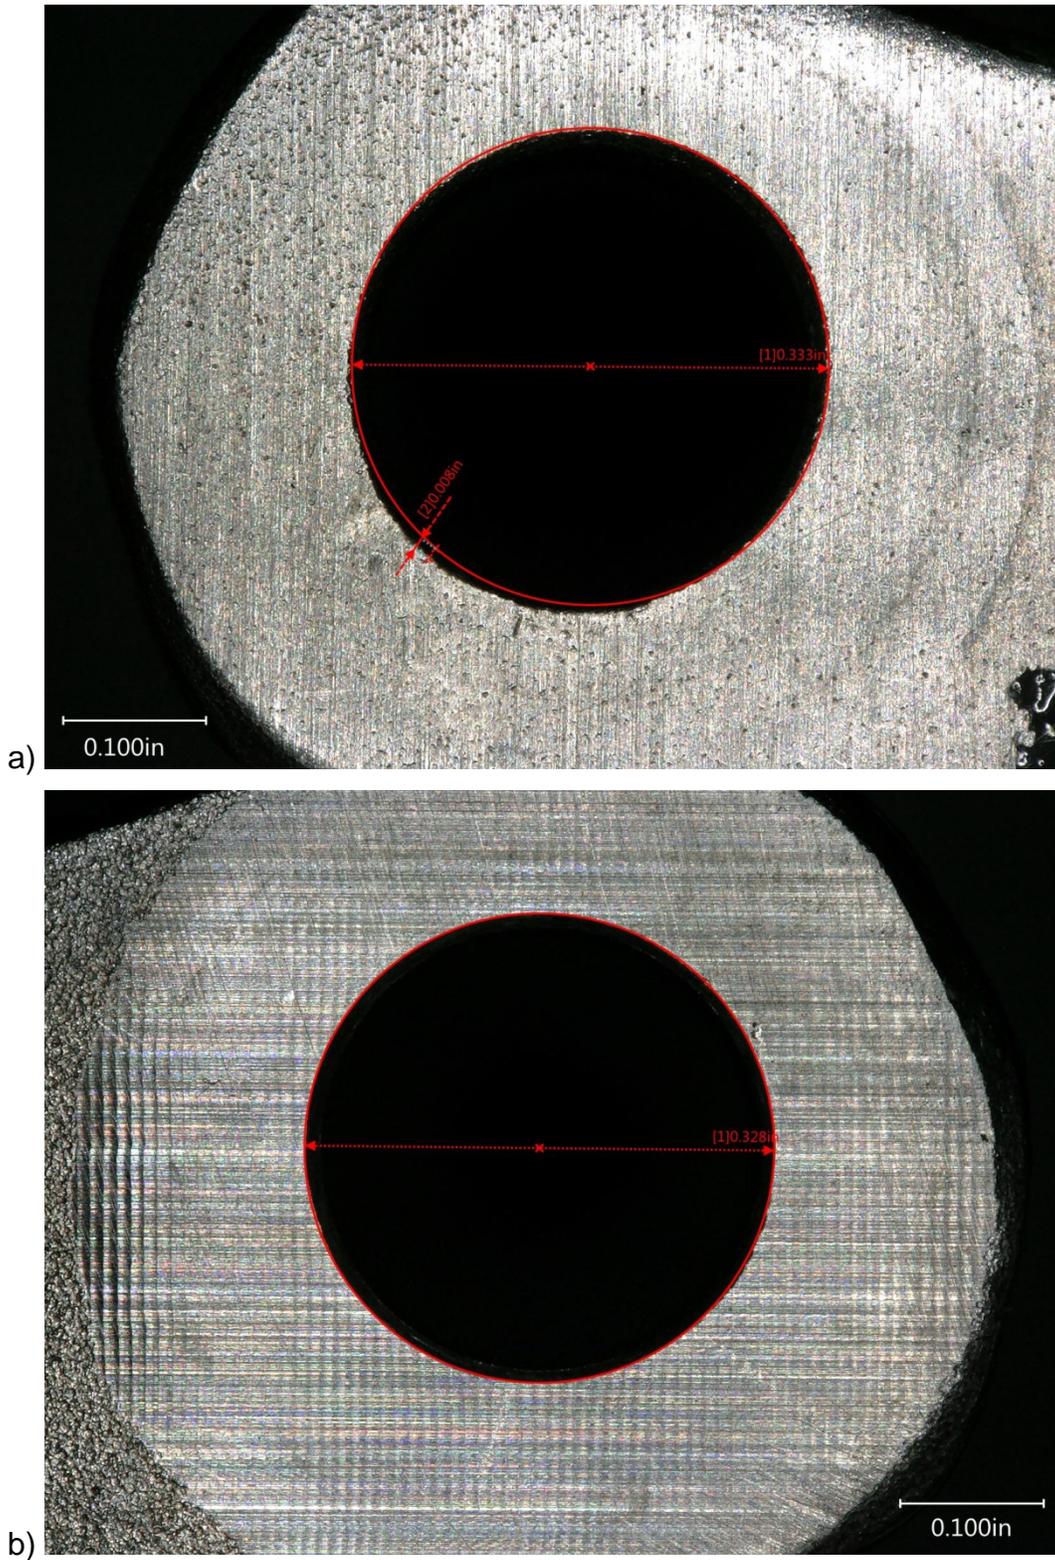
The lower swashplate attachment lug bolt holes were examined for indications of damage or deformation. For convenience, the side of the lug that butted up against the rod end was referred to as the "rod end-side" of the lug and the other side was referred to as the "opposite side." As shown in figure 5a, the rod end-side of the front left push-pull tube attachment lug exhibited approximately 0.008 inch of outward deformation along the outer lower portion of the bolt hole. There were no other notable features on the front left lug nor were there any signs of deformation on any of the other lugs (see figures 5b through 8).

**Figure 4:** Lower swashplate front left push-pull tube attachment lug; a) rod end-side of lug; b) opposite side of lug.

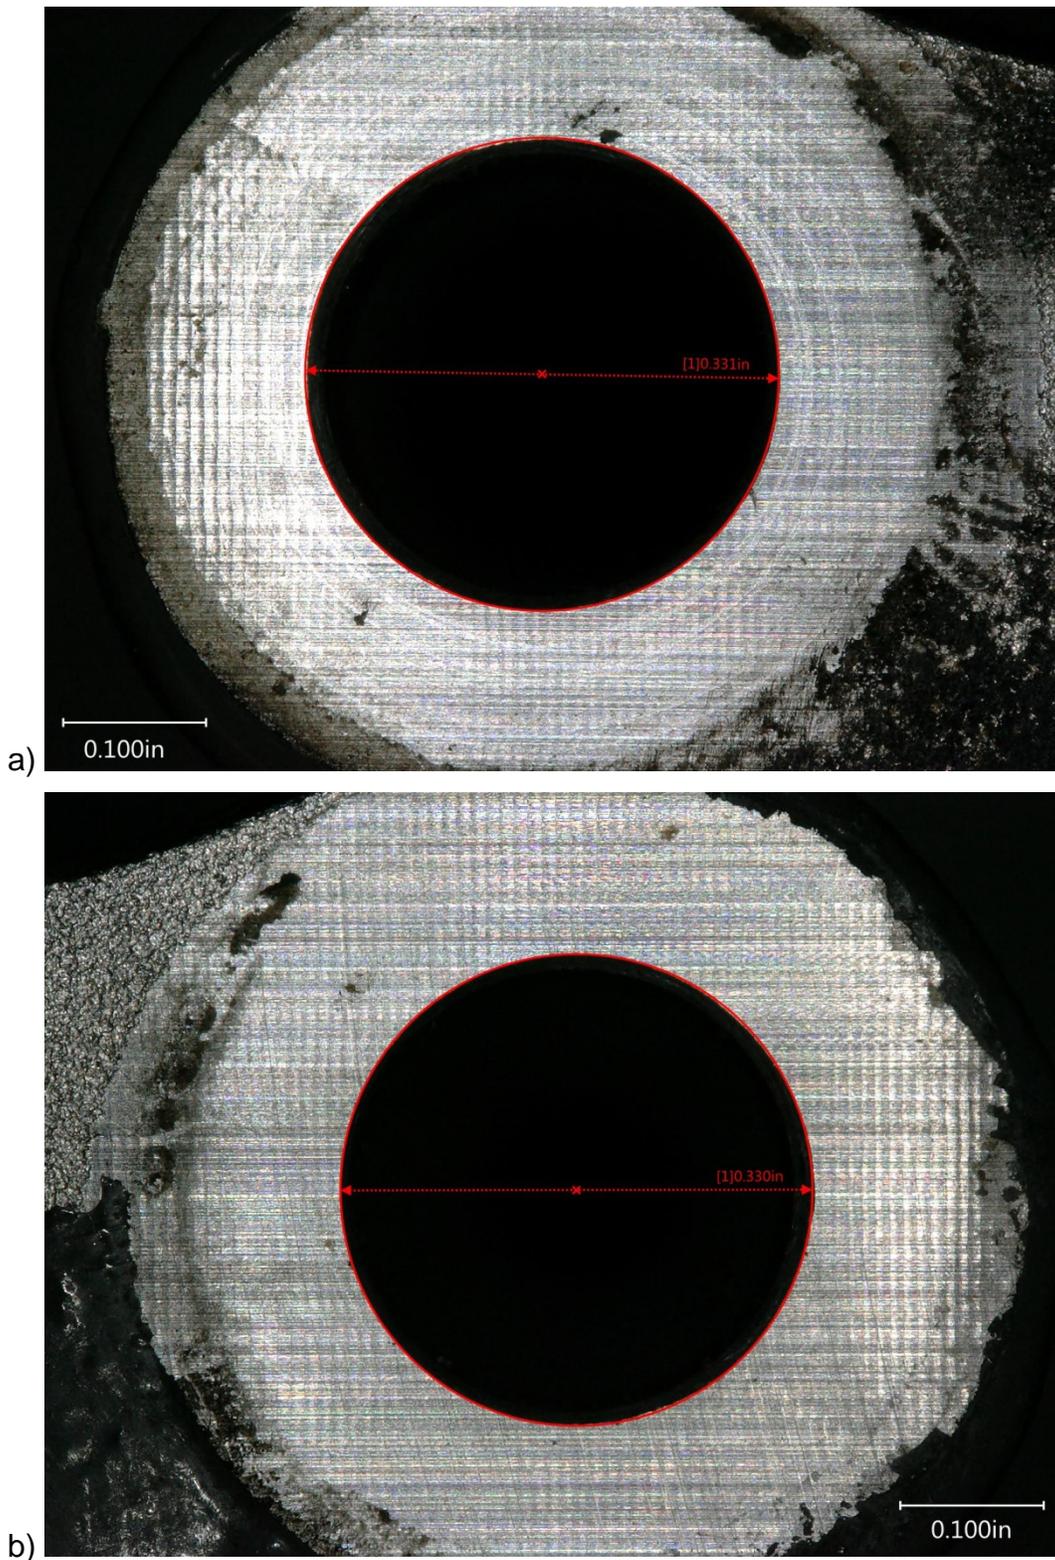
**Figure 5:** Lower washplate scissor attachment lug, front-middle; a) rod end-side of lug; b) opposite side of lug.

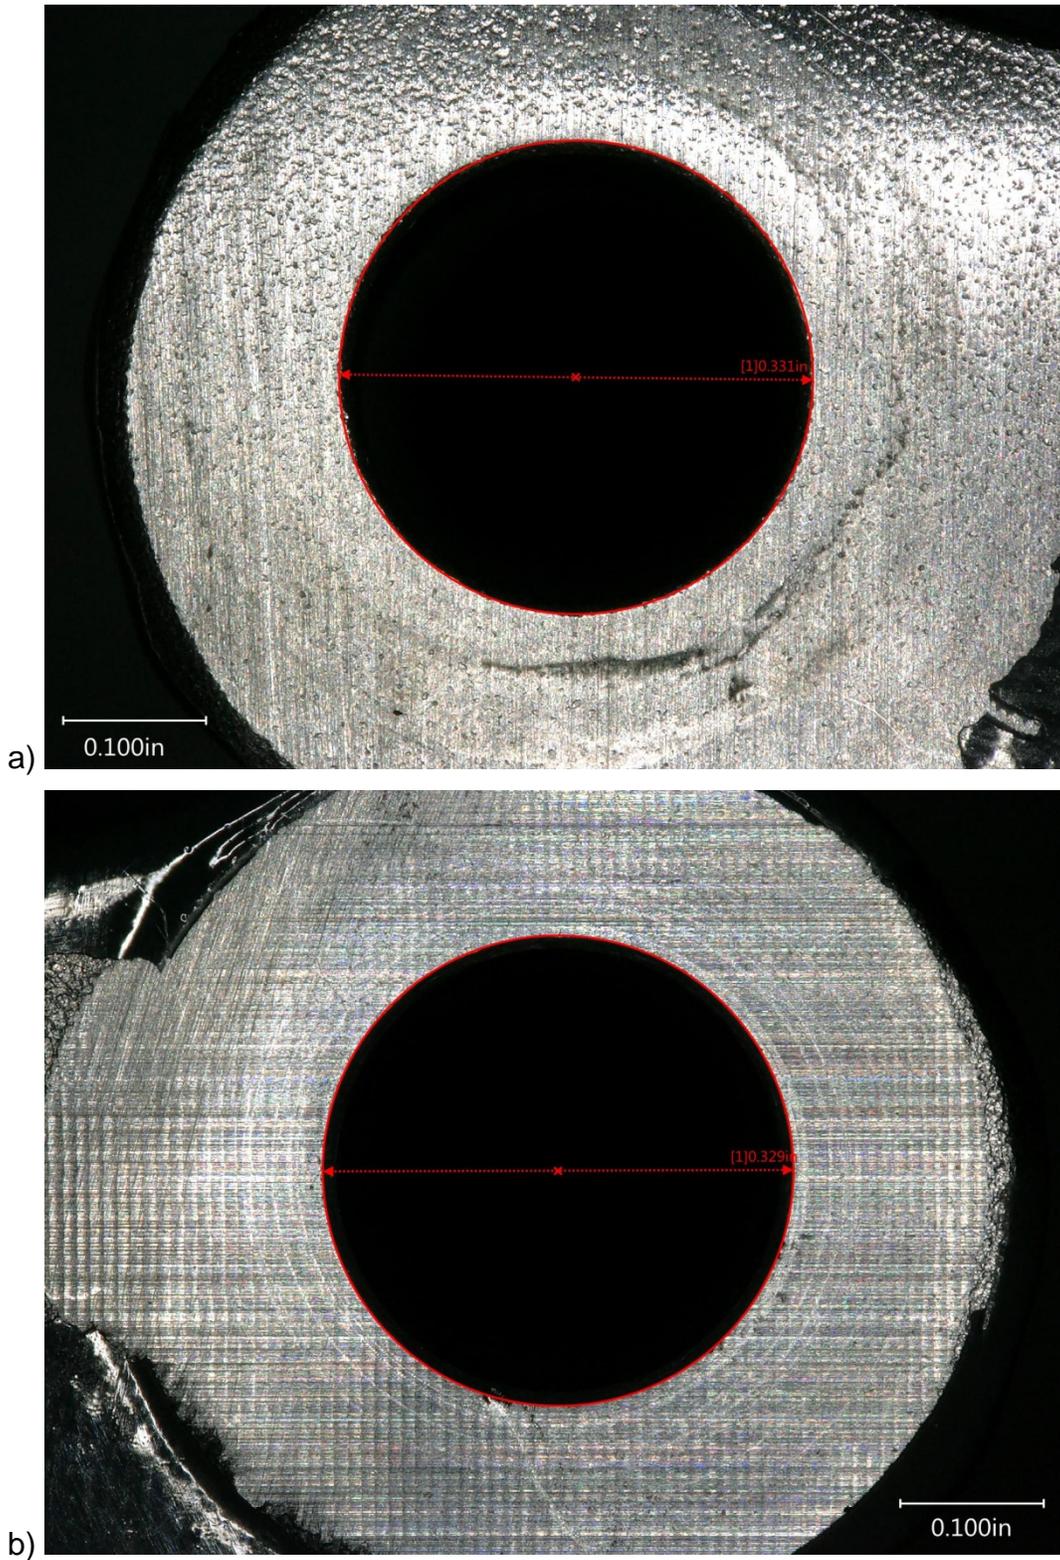
**Figure 6:** Lower swashplate front right push-pull tube attachment lug; a) rod end-side of lug; b) opposite side of lug.

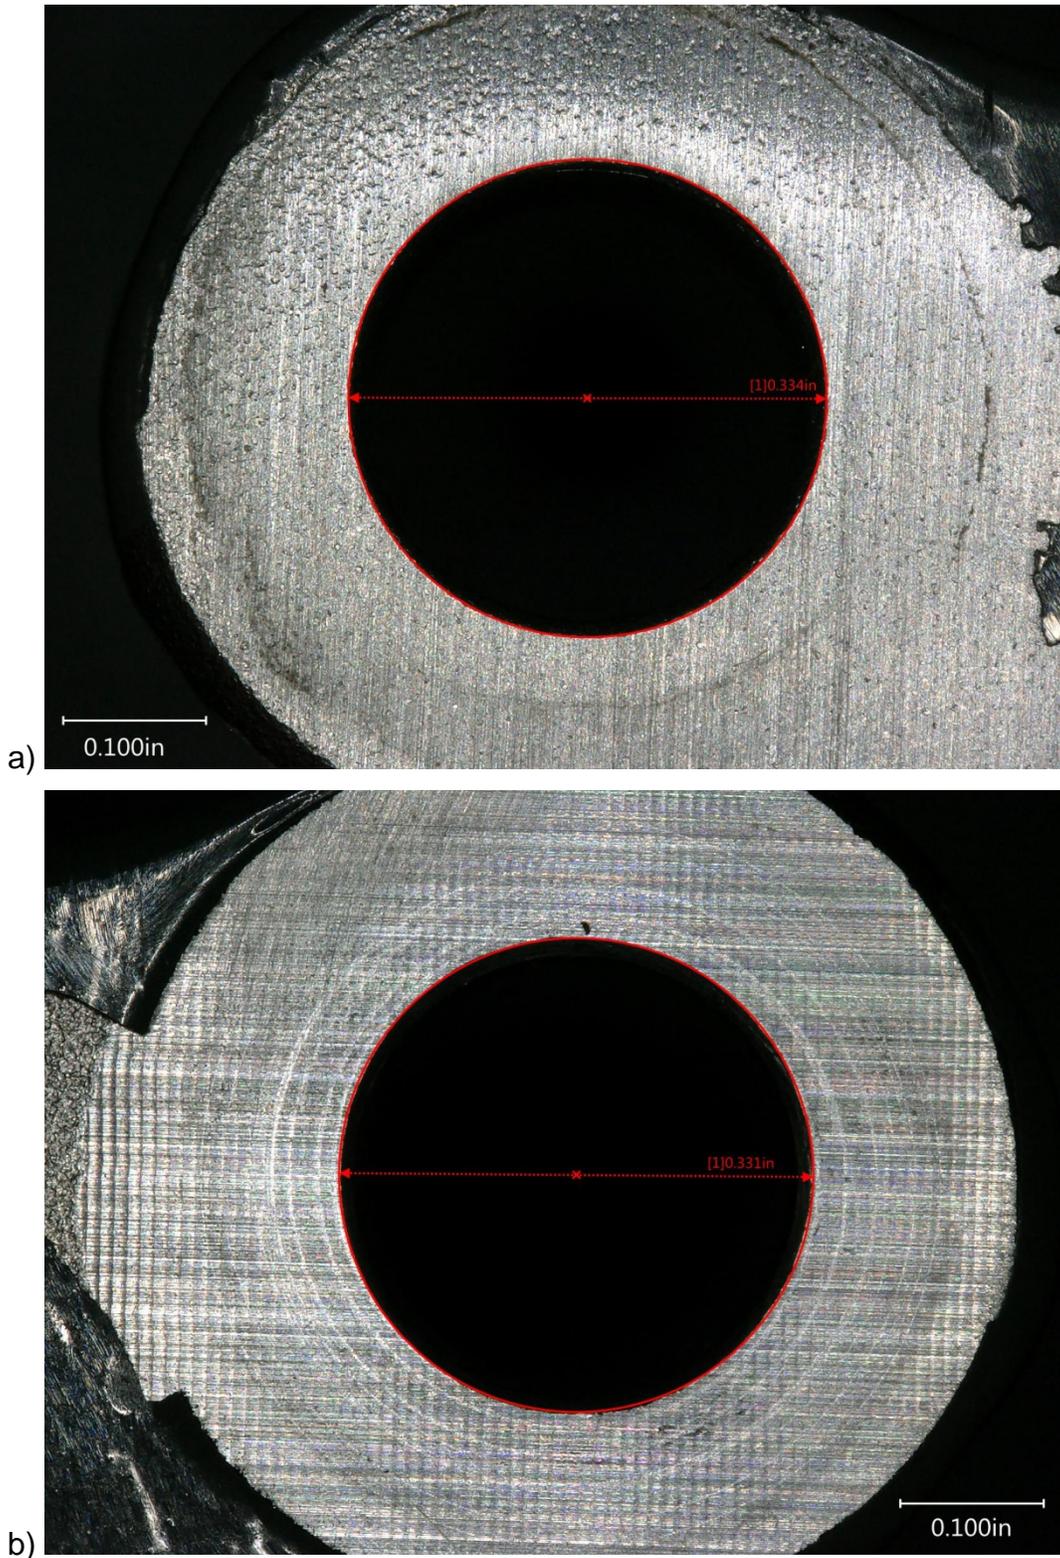
**Figure 7:** Lower swashplate aft push-pull tube attachment lug; a) rod end-side of lug; b) opposite side of lug.

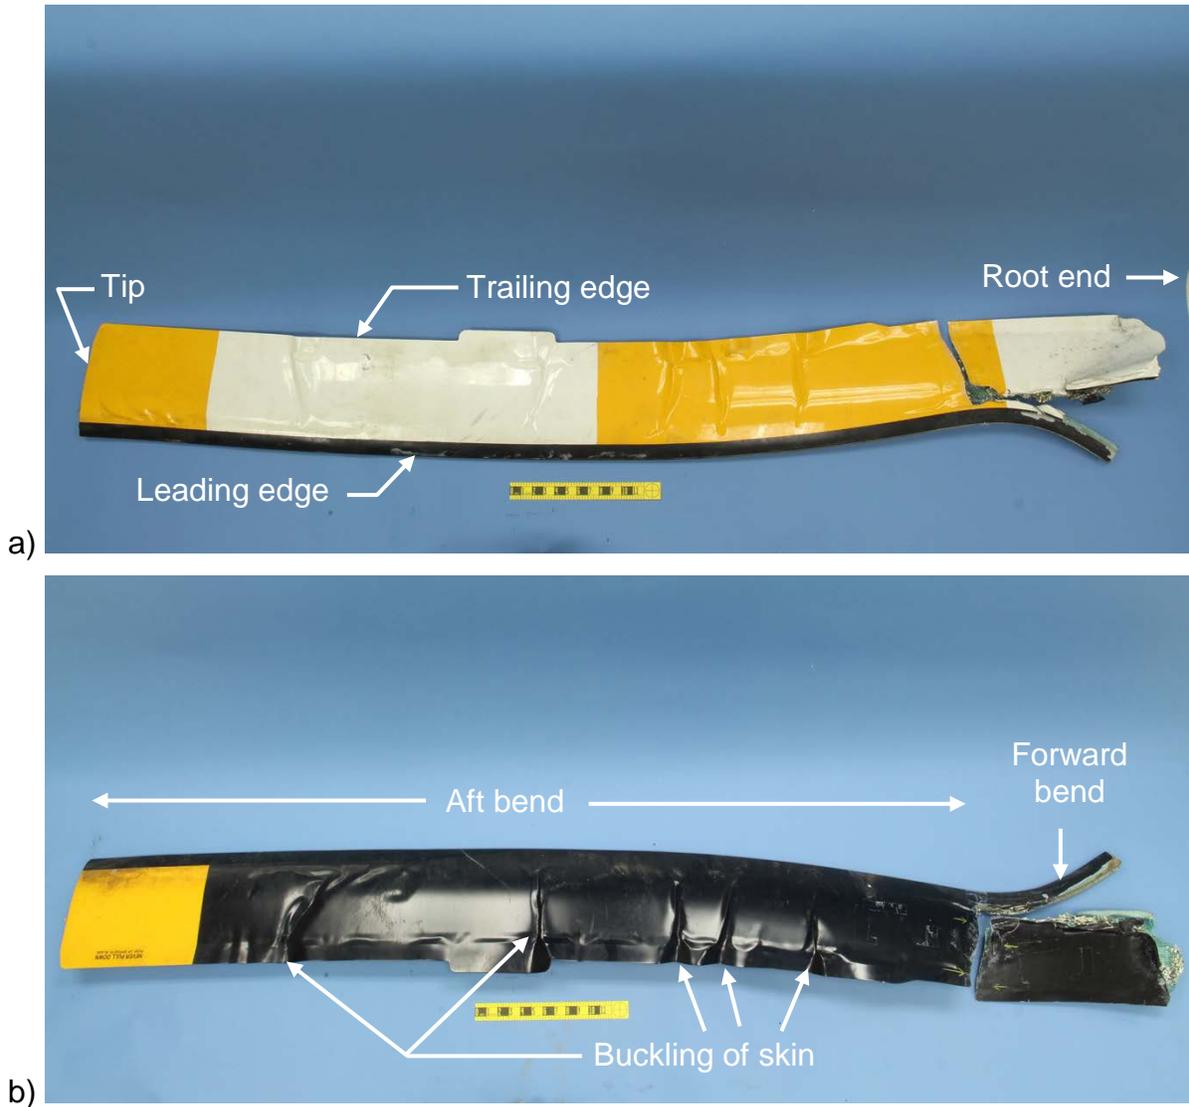
Two pieces of a main rotor blade were also sent to the NTSB Materials Laboratory for examination as shown in figures 8a and 8b. The pieces consisted of an approximately 95-inch long section of blade from the outboard tip to a fracture through the spar at the inboard end and a smaller piece of the blade consisting of the trailing edge, upper and lower skins, and honeycomb core. The small piece was separated from the rest of the blade by a chordwise fracture approximately 80 inch from the blade tip and a longitudinal fracture that proceeded inboard just aft of the spar.

The deformation and fracture features on the blade were visually examined. The blade exhibited an aft bend that extended from the blade tip to the approximate position of the chordwise fracture, buckling of the upper and lower skins, and a comparatively severe forward bend at the inboard end, as indicated in figure 8b. The fracture at the inboard end of the spar (not shown) was located at a circular hole in the spar and exhibited 45° inclined fracture surfaces, consistent with an overstress fracture. The features were consistent with compressive buckling of the rotor blade.

**Figure 8:** Images of the main rotor blade pieces: a) top side and b) bottom side.

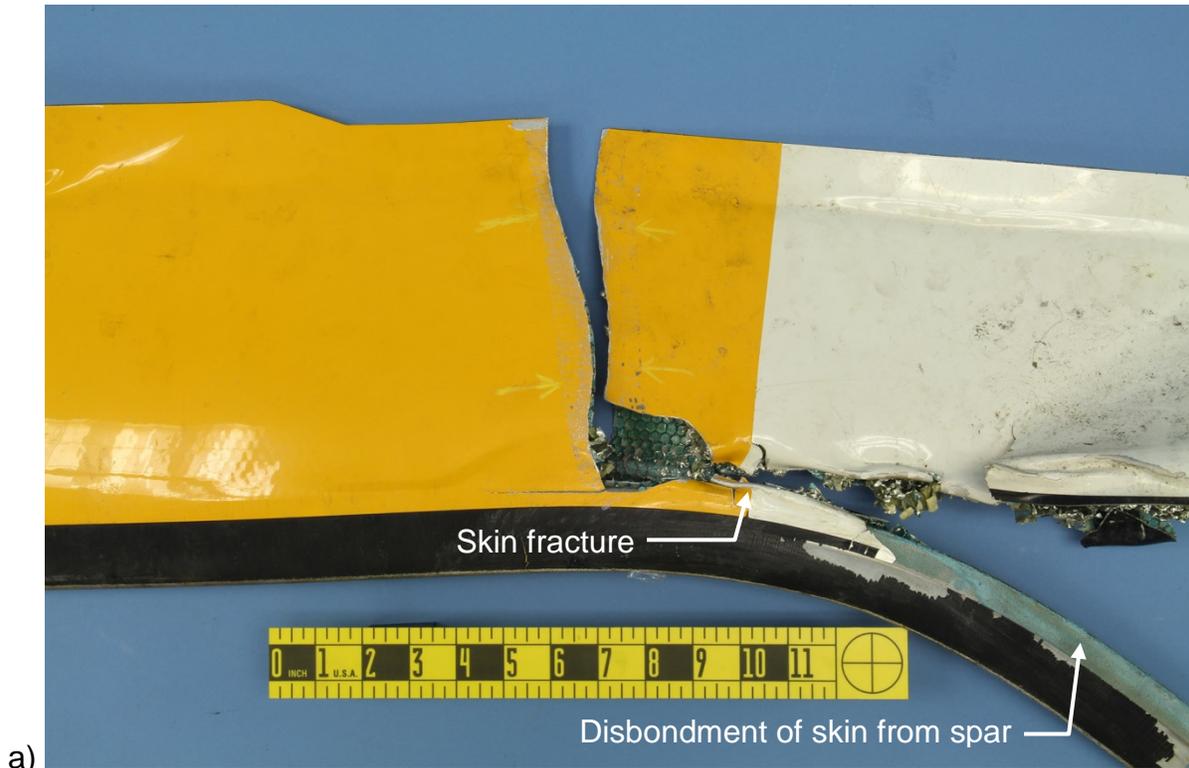
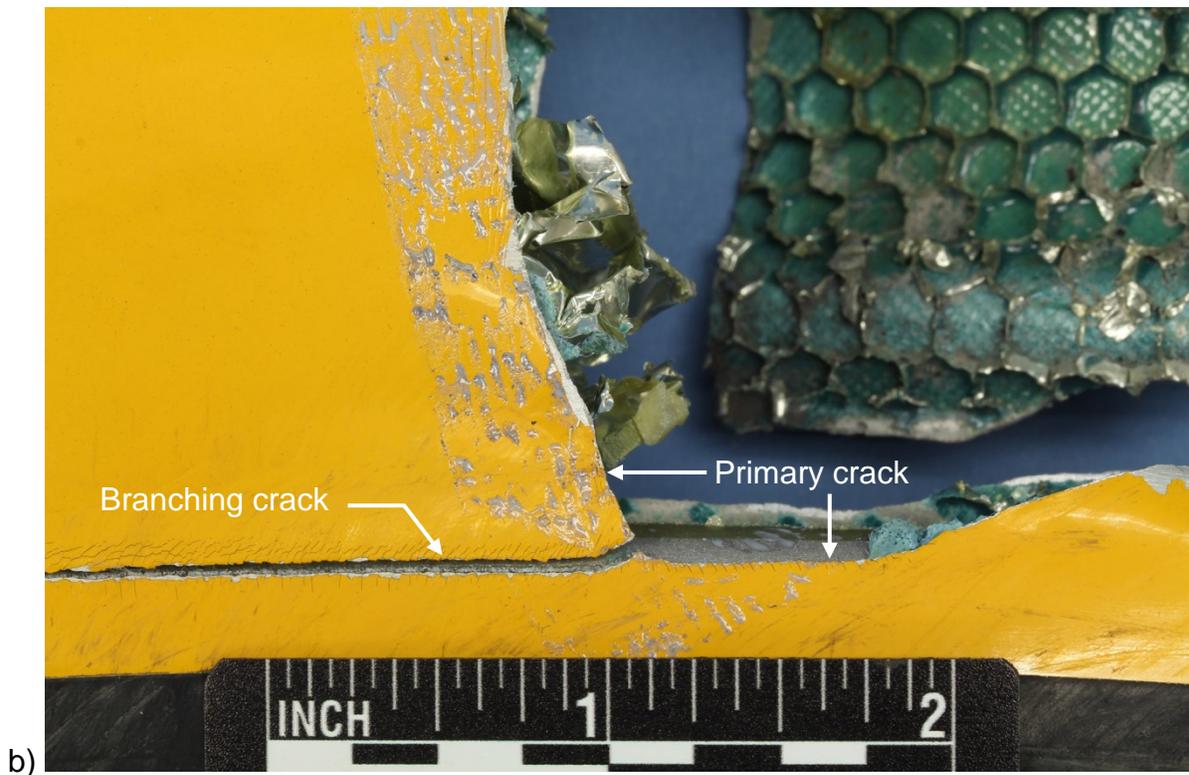
The fracture features on the smaller piece of the blade are shown in greater detail in figures 9a and 9b. Along the outboard portion of the longitudinal fracture, the

upper and lower blade skins were fractured aft of the spar. As the fracture progressed inboard, the path of separation transitioned to a disbondment between the skin and the spar, as indicated in figure 9a, consistent with a transition to a tearing mode. The transition from the chordwise fracture to the longitudinal fracture is shown in greater detail in figure 9b. The chordwise and longitudinal fractures formed a continuous curve, consistent with the primary fracture path. A branching crack, indicated in figure 9b, started at a 90° angle to the primary path and progressed outboard along the trailing edge of the spar approximately 2.5 inch. The observed features were consistent with the skin separation initiating at the trailing edge of the blade.

**Figure 9:** a) Image of the main rotor blade top side at the chordwise fracture through the trailing edge, skin, and core; b) higher magnification image near the leading edge adjacent to the spar.

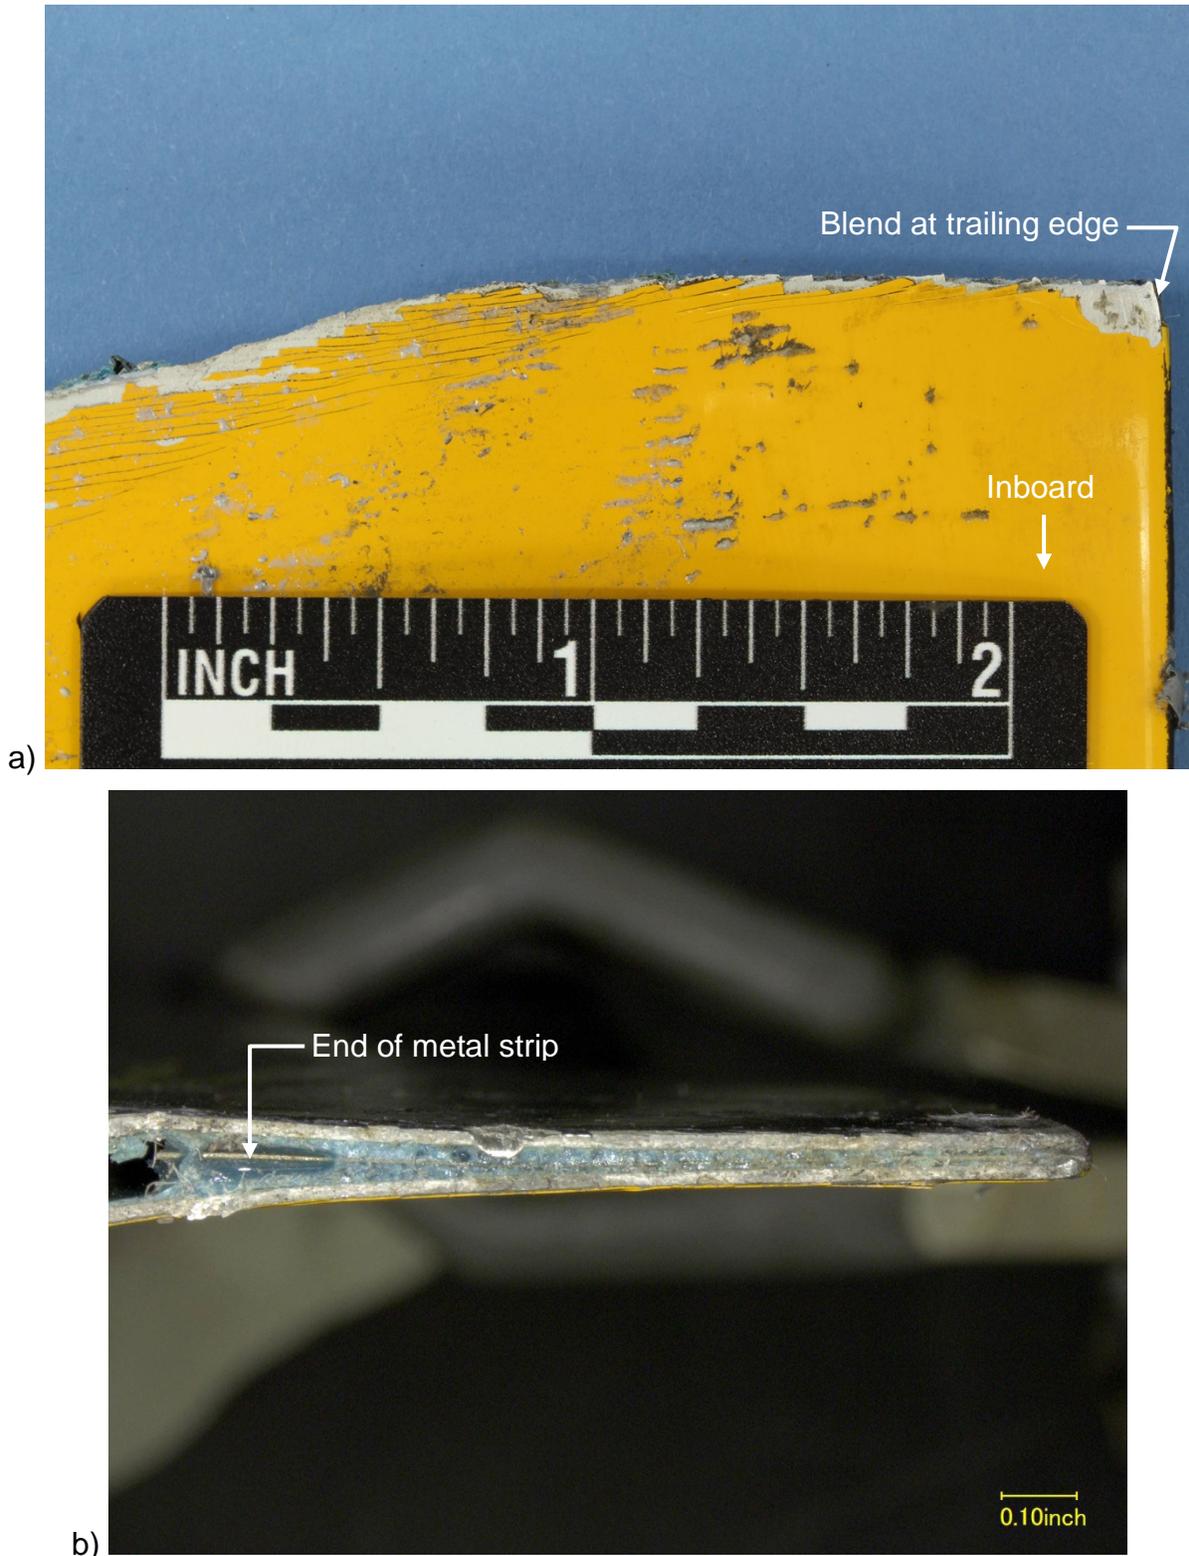
The fracture at the trailing edge was examined in greater detail as shown in figures 10a and 10b. The fracture at the trailing edge was comparatively straight and the paint was cracked adjacent to the fracture, as shown in figure 10a. The fracture surfaces, the inboard half being shown in figure 10b, were inclined at 45° to the skin and were consistent with an overstress fracture. Notable features at the fracture included a blend along the trailing edge, as indicated in figure 10a, and the end of a metal strip in the inboard portion of the trailing edge, as indicated in figure 10b. The plane of the fracture coincided with the end of the strip, as the metal strip was not observed on the outboard half of the fracture.

**Figure 10:** Images of the inboard half of the fracture at the trailing edge: a) image of the upper skin exhibiting cracks in the paint; b) image of the inboard half of the fracture.
