# NATIONAL TRANSPORTATION SAFETY BOARD

MATERIALS LABORATORY FACTUAL REPORT

Report No. 16-005

Place : Houston, Texas  
Date : September 15, 2015  
Vehicle : School bus  
NTSB No. : HWY15FH010  
Investigator : Daniel Walsh, OHS

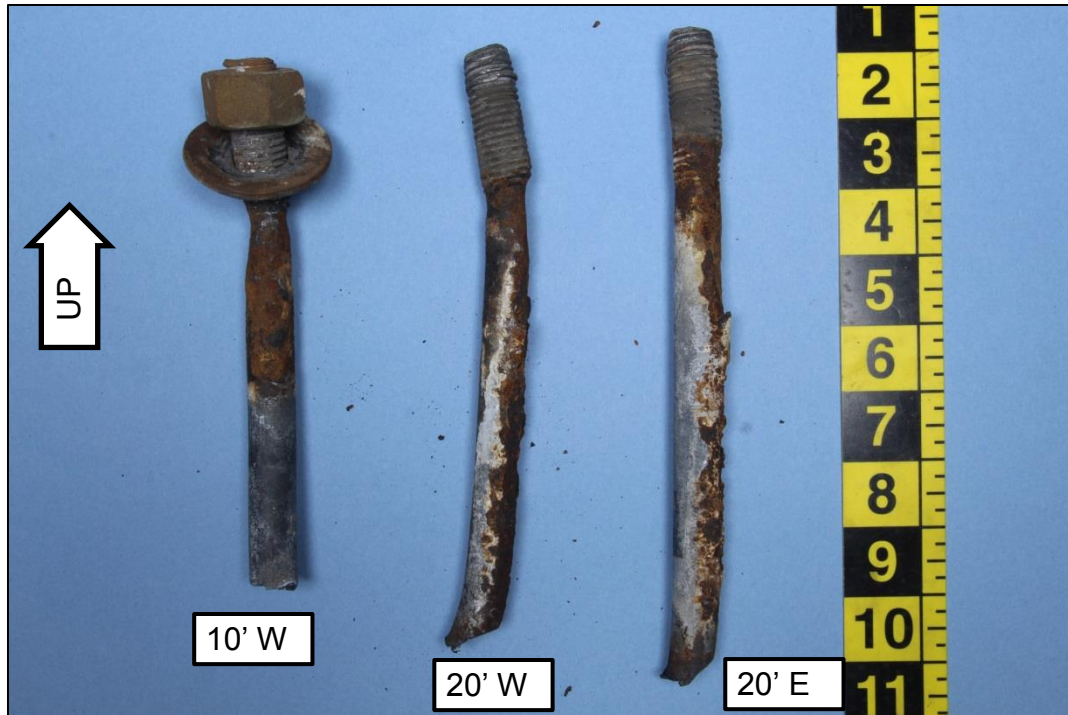
The pieces shown in figure 1 were the south legs (legs of the "U" further from traffic) from 3 of the u-bolt anchors embedded in the concrete parapet. The pieces were received labeled 10' W, 20' W, and 20' E as shown in figure 1. The piece labeled 10' W was from the west u-bolt on the first post east of the expansion joint between bridge spans 1 and 2. The pieces labeled 20' W and 20' E were from the west and east u-bolts, respectively, anchoring the second rail post east of the same expansion joint.

The nut remained attached to piece 10' W as shown in figure 1. One washer was also received with piece 10' W. The upper side of the washer had an impression pattern consistent with contact with the edges of the nut, and the lower side of the washer had an impression pattern consistent with contact with the slotted attachment hole at the base of the rail post. Thread remnants were trapped within the threads at the upper ends of pieces 20' W and 20' E consistent with sheared threads from the attachment nuts on those u-bolts segments.

The pieces showed substantial corrosion including reduced diameter, particularly in the area near the lower end of the threads. Corrosion on the surface of piece 10' W was observed around the circumference up to 4.51 inches from the upper end of the piece. On pieces 20' W and 20' E, corrosion was observed along the entire length of the pieces on the side of the piece on the outside of the bend; up to 8.30 inches from the upper end of piece 20' W and 9.04 inches from the upper end of piece 20' E. At the inside of the bend, corrosion was present up to 4.35 inches from the upper end of piece 20' W and up to 2.79 inches from the upper end of piece 20' E.

Figure 1. Overall view of the submitted u-bolt pieces.

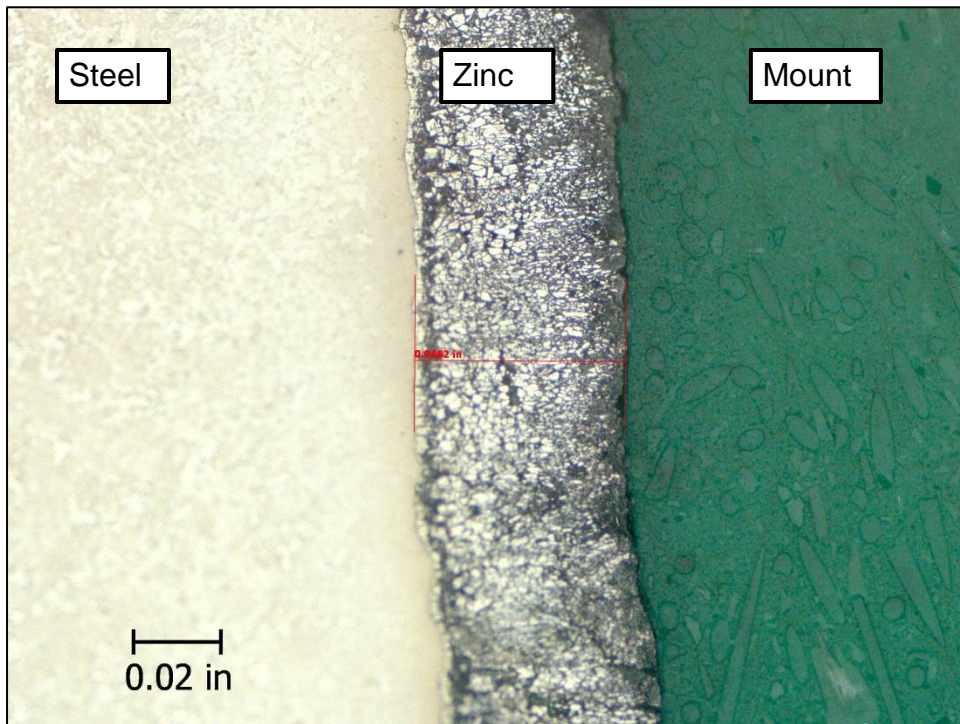
A transverse cross-section of each of the u-bolt pieces was prepared for metallographic examination near the lower end of each piece. The cross-sections were mounted in an edge-retaining compound, polished, and then lightly etched with a 2% Nital etchant. Results showing representative images of the zinc coating on each piece are shown in figures 2 through 4. The zinc coating was fairly uniform around most of the diameter on piece 10' W appearing similar to that shown in figure 2. The coating on pieces 20' W and 20' E was generally thinner and showed more variability in the thickness around the circumference and was missing from a quarter to a third of the circumference.

Figure 2. Metallograph showing the zinc coating on piece 10' W.

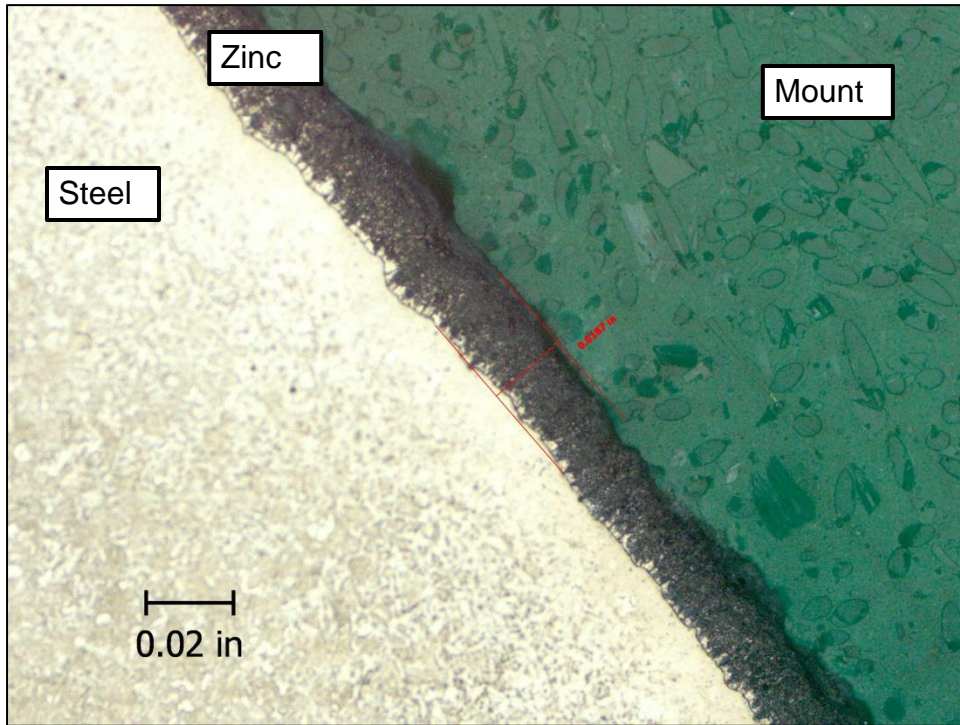
Figure 3. Metallograph showing the zinc coating on piece 20' W.

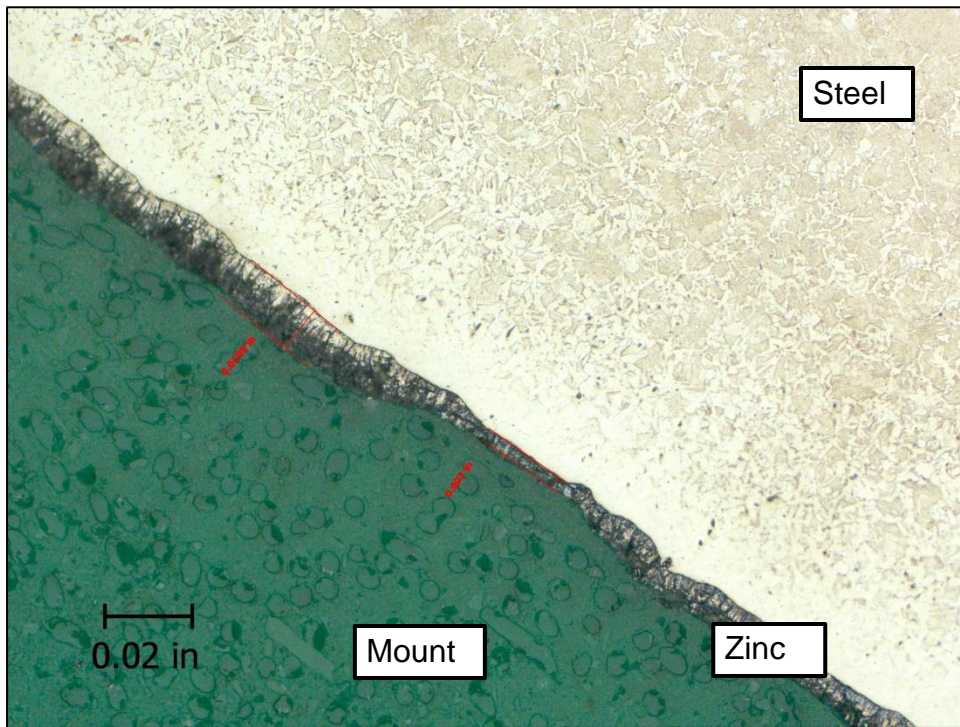
The zinc coating thickness was measured on each piece at 8 positions around the circumference. Results of the coating thickness measurements are listed in table 2. In cases such as that shown in figure 4 where variability was observed within the image, the thinnest area within the view at the magnification shown in images 2 through 4 was measured and listed in table 2.

Figure 4. Metallograph showing the zinc coating on piece 20' E.
